**BACKGROUND ON
FAILURE OF TETON DAM
Near Rexburg, Idaho
June 5, 1976**

J. David Rogers, Ph.D., P.E., R.G.

Part 1

EVOLUTION OF THOUGHT ON HYDRAULIC PIPING POSING A THREAT TO DAM STABILITY 1922-65

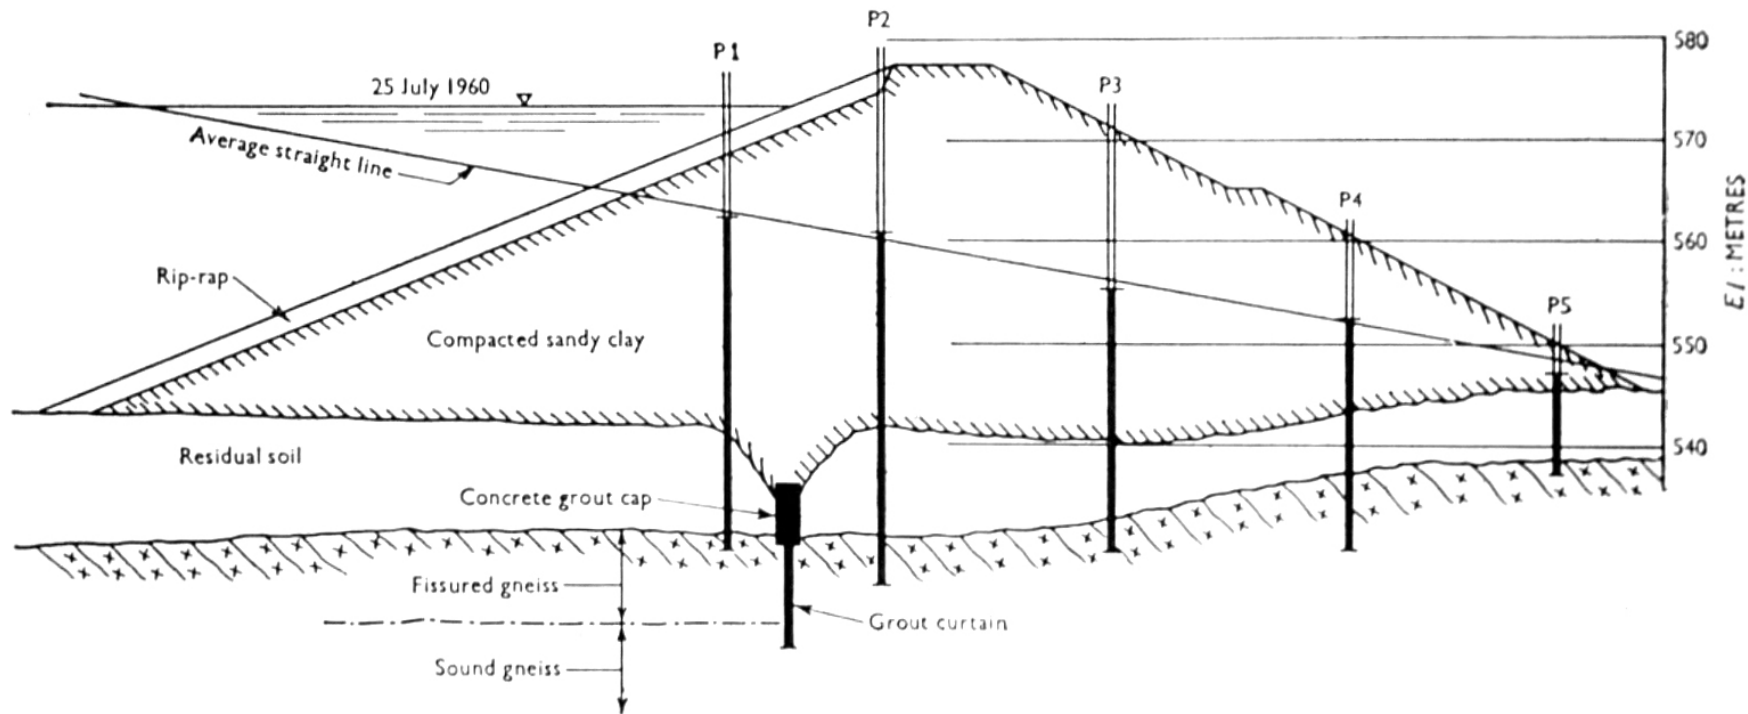
- Casagrande then asserted that the most damaging seepage pressures tend to develop within the foundation rock, the character and fracturing intensity of which is highly variable. This example from his Rankine Lecture shows that seepage through fissured gneiss was able to “bypass” the grout curtain placed beneath the dam’s core and seepage cutoff keyway.**

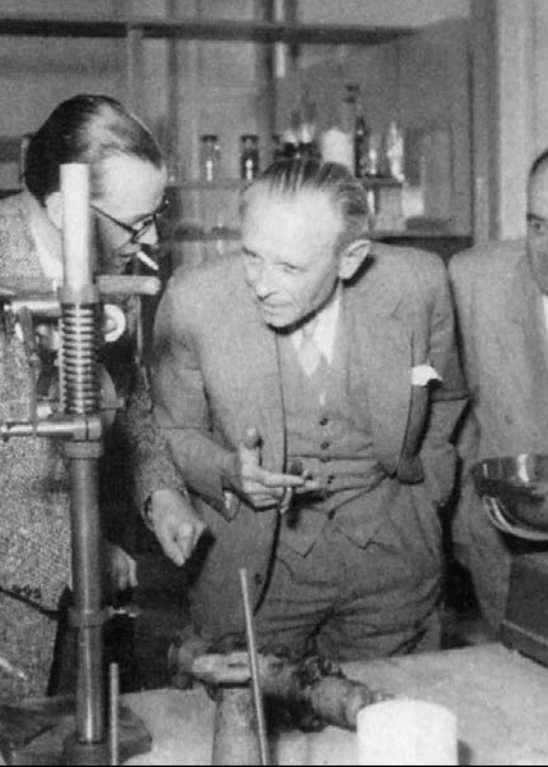
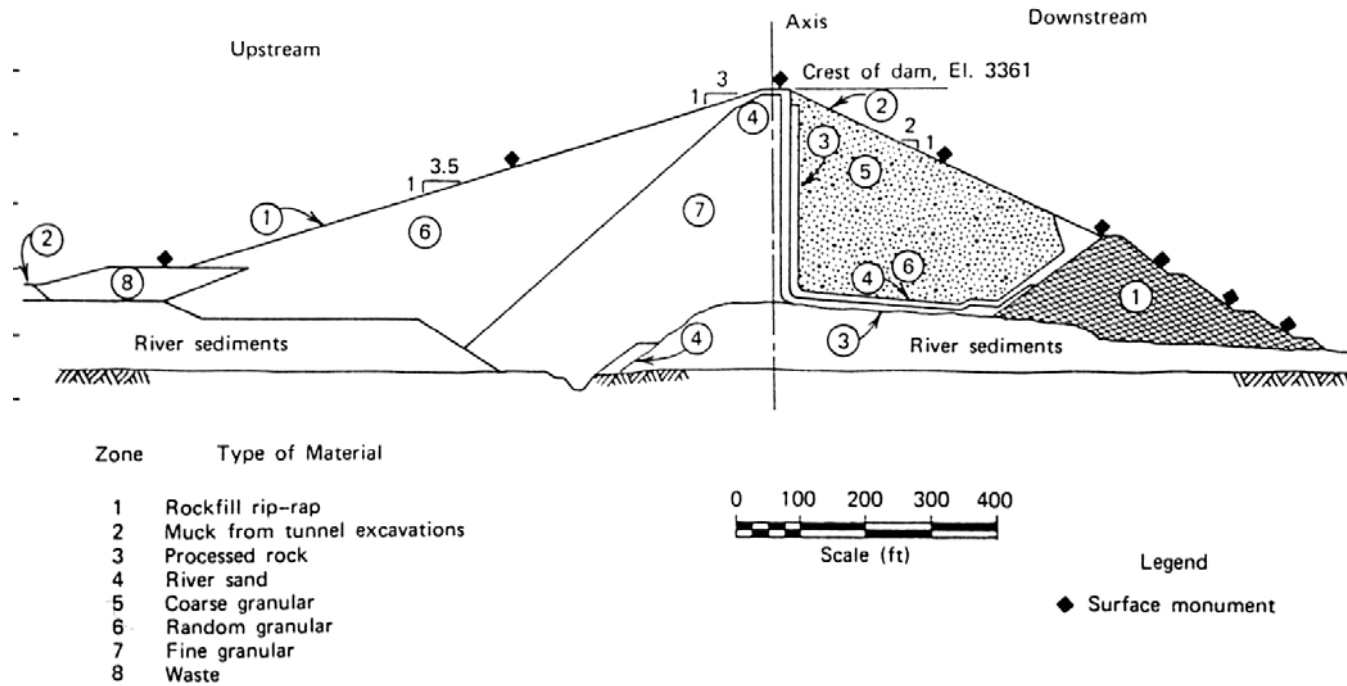
MAMMOTH POOL DAM

- When **Mammoth Pool Dam** was being constructed in the late 1950s along the San Joaquin River in California's Sierra Nevada Mountains, the builders encountered valley-side sheet joints which kept opening up as the abutments were excavated, through-going creating voids in the abutments.
- As these blocks were excavated, new sheet joints formed beneath the abutments. Reservoir seepage could pass through these open joints without significant head loss.

- Terzaghi was brought in as a consultant on Mammoth Pool Dam. He recommended grouting the open sheet joints in the abutments **after** the dam was complete and added a massive rockfill rip rap toe to the embankment, as well as zoned chimney and blanket drains downstream of the core. These were intended to decant any excess seepage through the abutments.

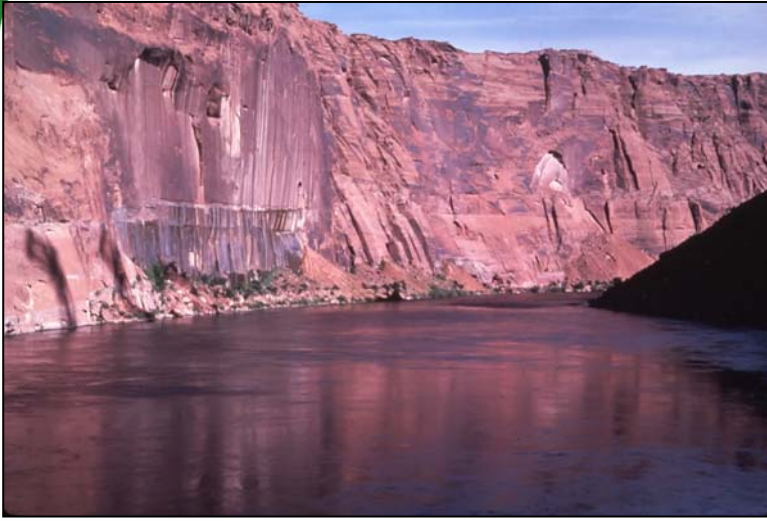
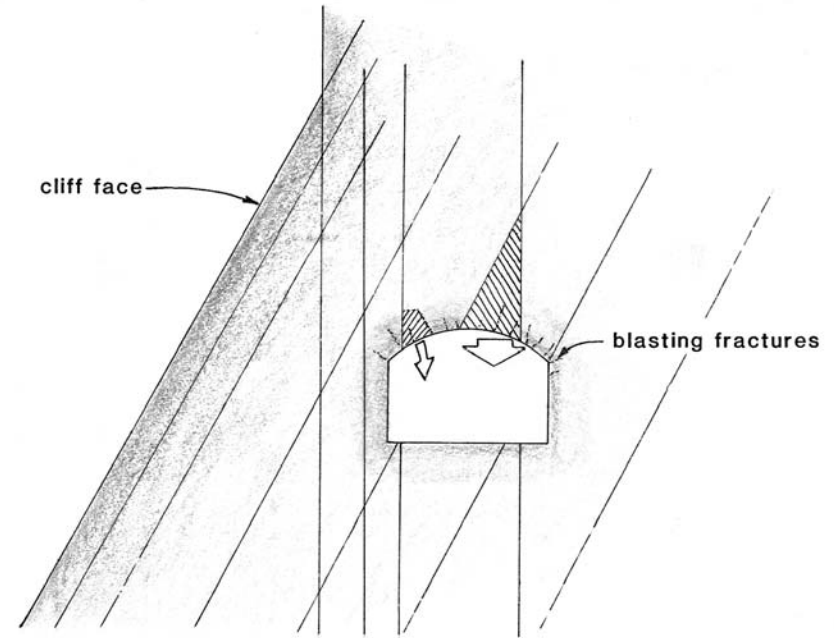
GLEN CANYON TUNNEL FAILURE

Roof cave-ins in the Glen Canyon Powerplant Service Tunnel during construction in 1958.

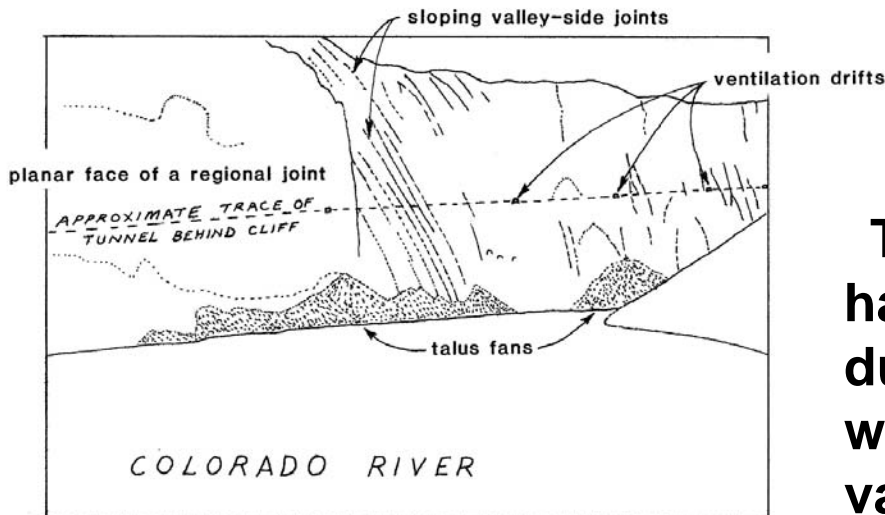
The Glen Canyon Powerplant Tunnel had a series of deadly block failures during excavation in 1958 because of wedges formed between inclined valley side and systematic joints, as sketched above.

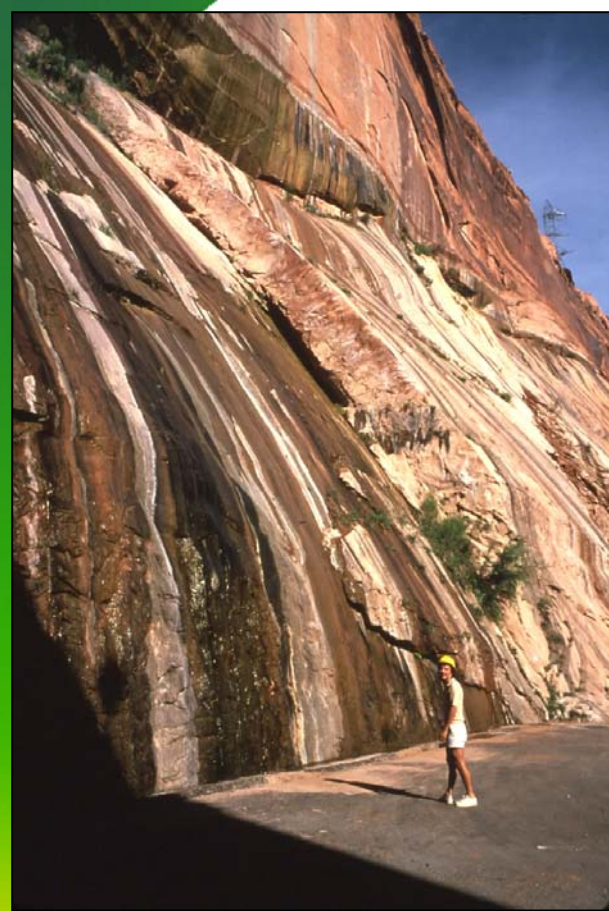
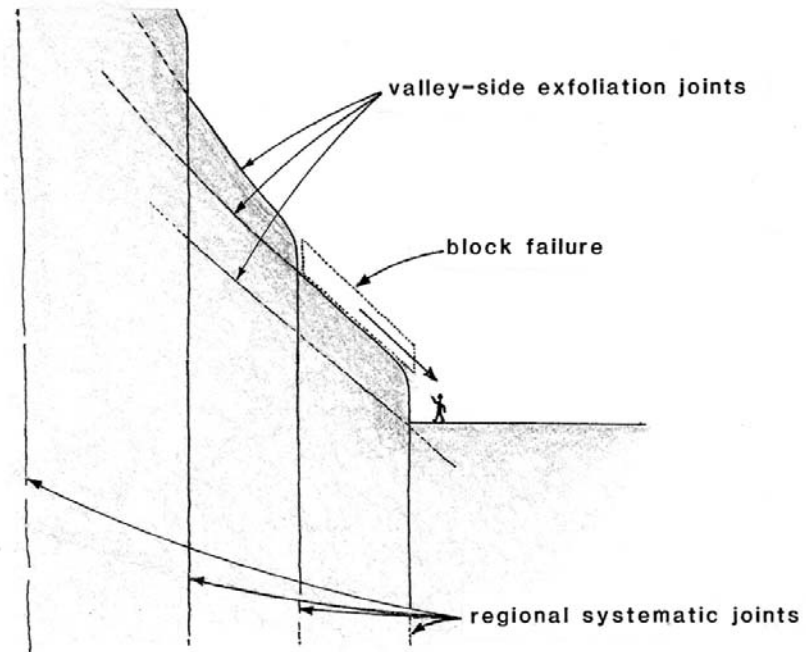
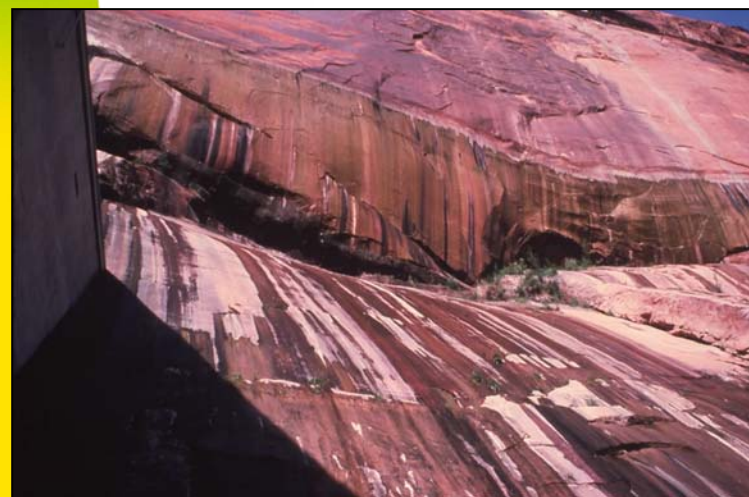
BLOCK FAILURES at GLEN CANYON DAM

Valley side joints are usually inclined. Where these intercept near vertical systematic joints, massive blocks are formed on steep inclines. When these are undercut the blocks slide off. A little bit of water hastens the process by decreasing the friction markedly.

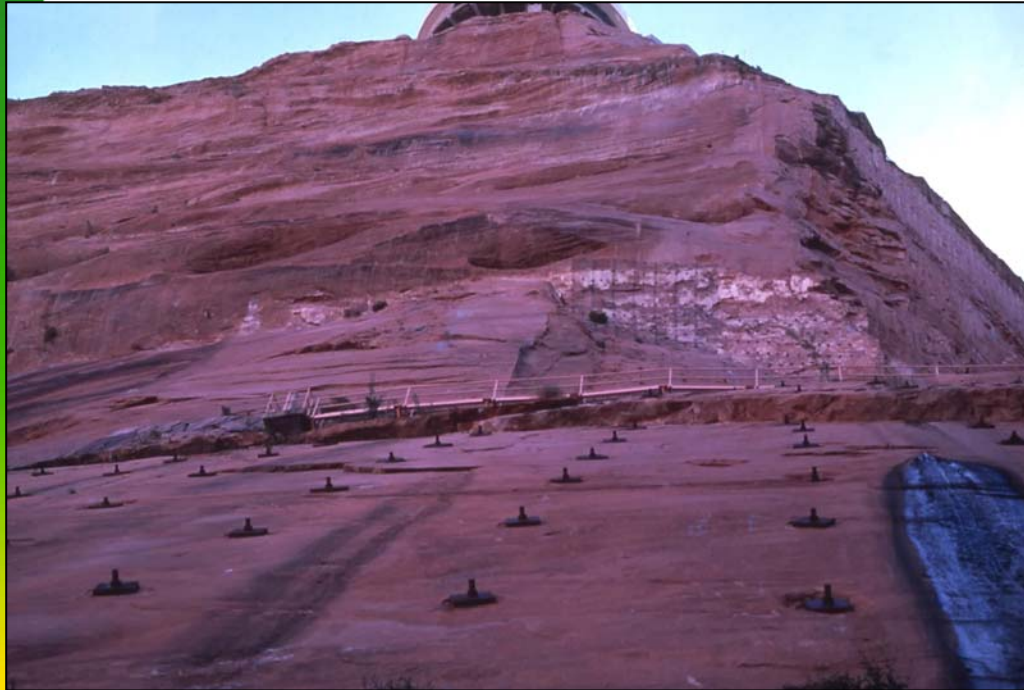
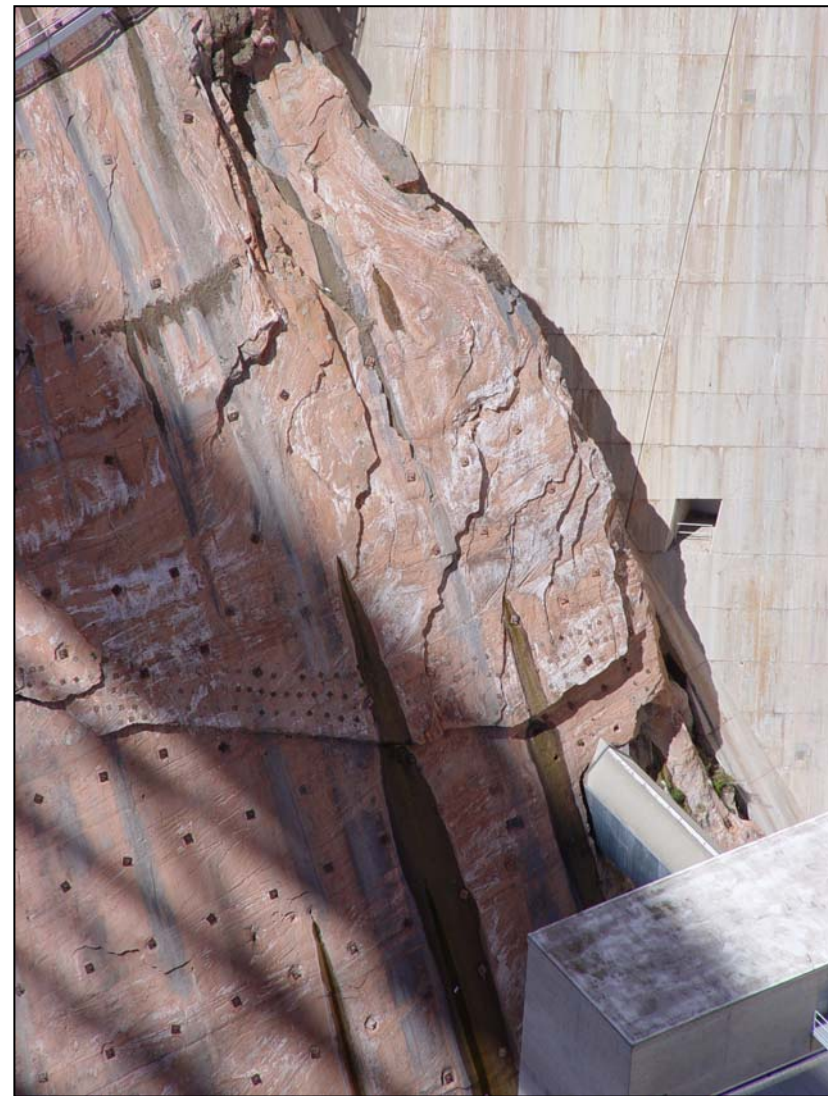
Rockbolts Used at Glen Canyon Dam

- 1500 post-tensioned rockbolts were employed at Glen Canyon Dam in 1960-61 to secure valley-side sheet joints. Seepage averaged over 5500 gpm on each abutment.

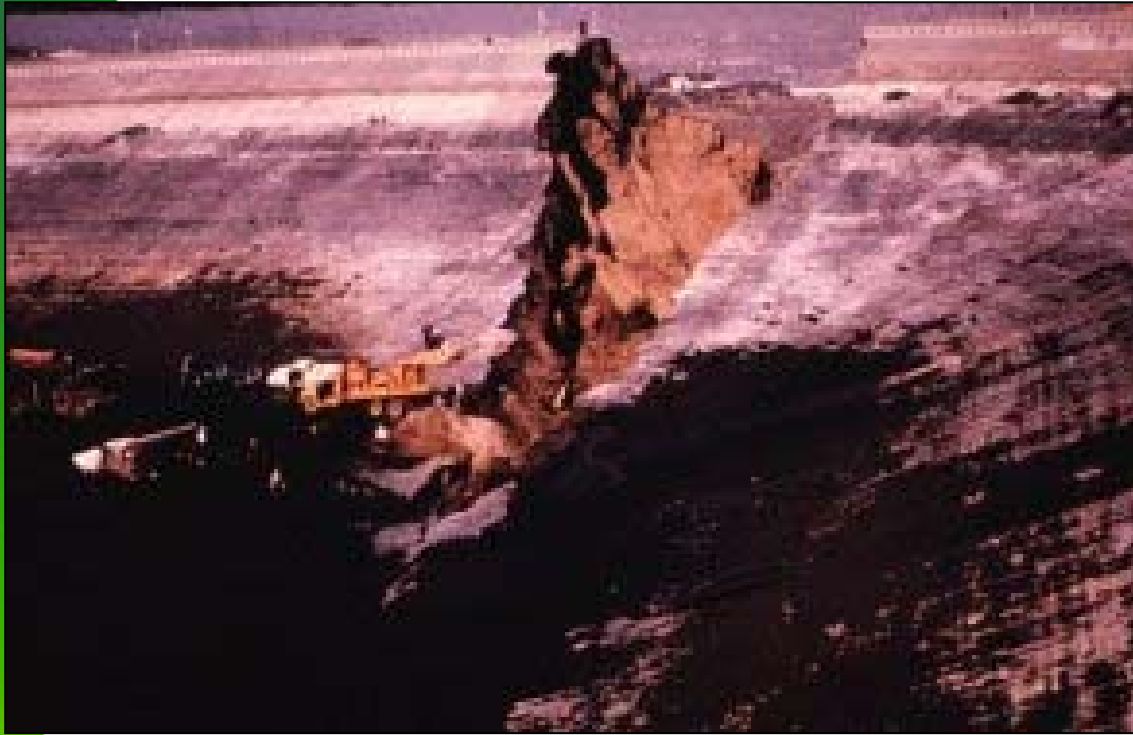
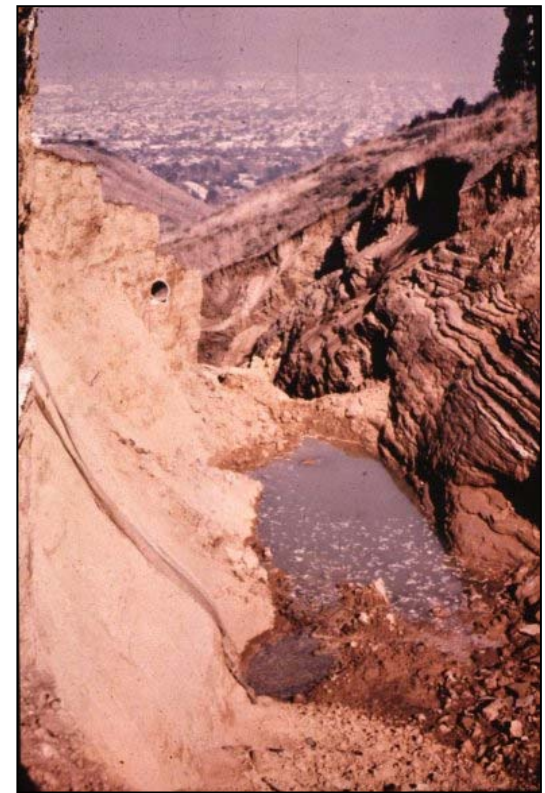
- The outflow lasted 77 minutes, till 4:55 PM
- Afterwards, the eroded chasm was 90 feet deep and 70 feet wide, curiously dry in appearance afterwards (right)
- **The water had leaked through joints in the abutment rock of the underlying Pico Formation** (shown at right), first noted at the downstream face/abutment contact, 82 feet below crest.

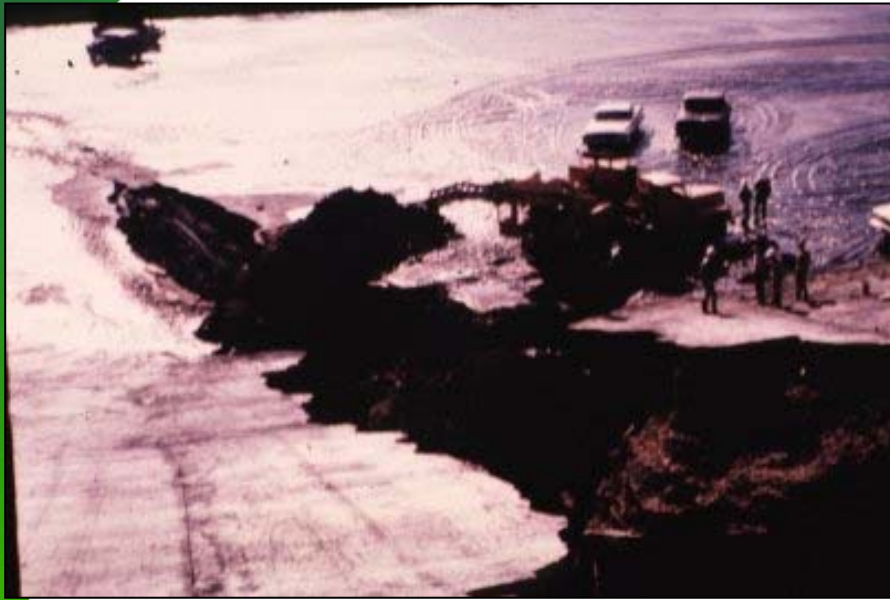
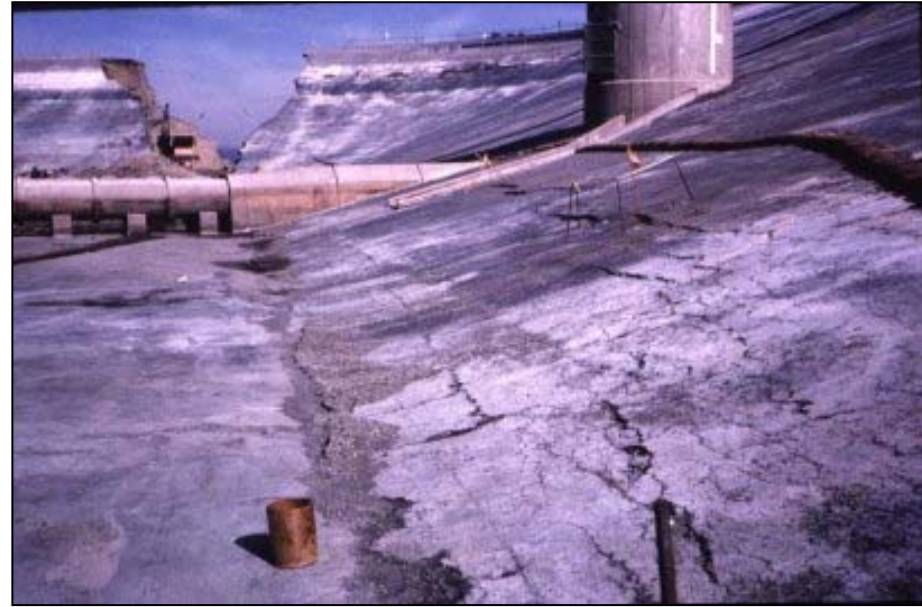
- The eroded chasm extended into the reservoir floor along a linear north-south trend (left)
- Subsequent examination revealed an active fault scarp extending through the reservoir floor, shown in right view
- **Up to 12 inches of vertical offset** was noted along four strands of this fault exposed in the reservoir floor, diminishing towards the southerly side of the reservoir. The fault dipped 70 degrees west

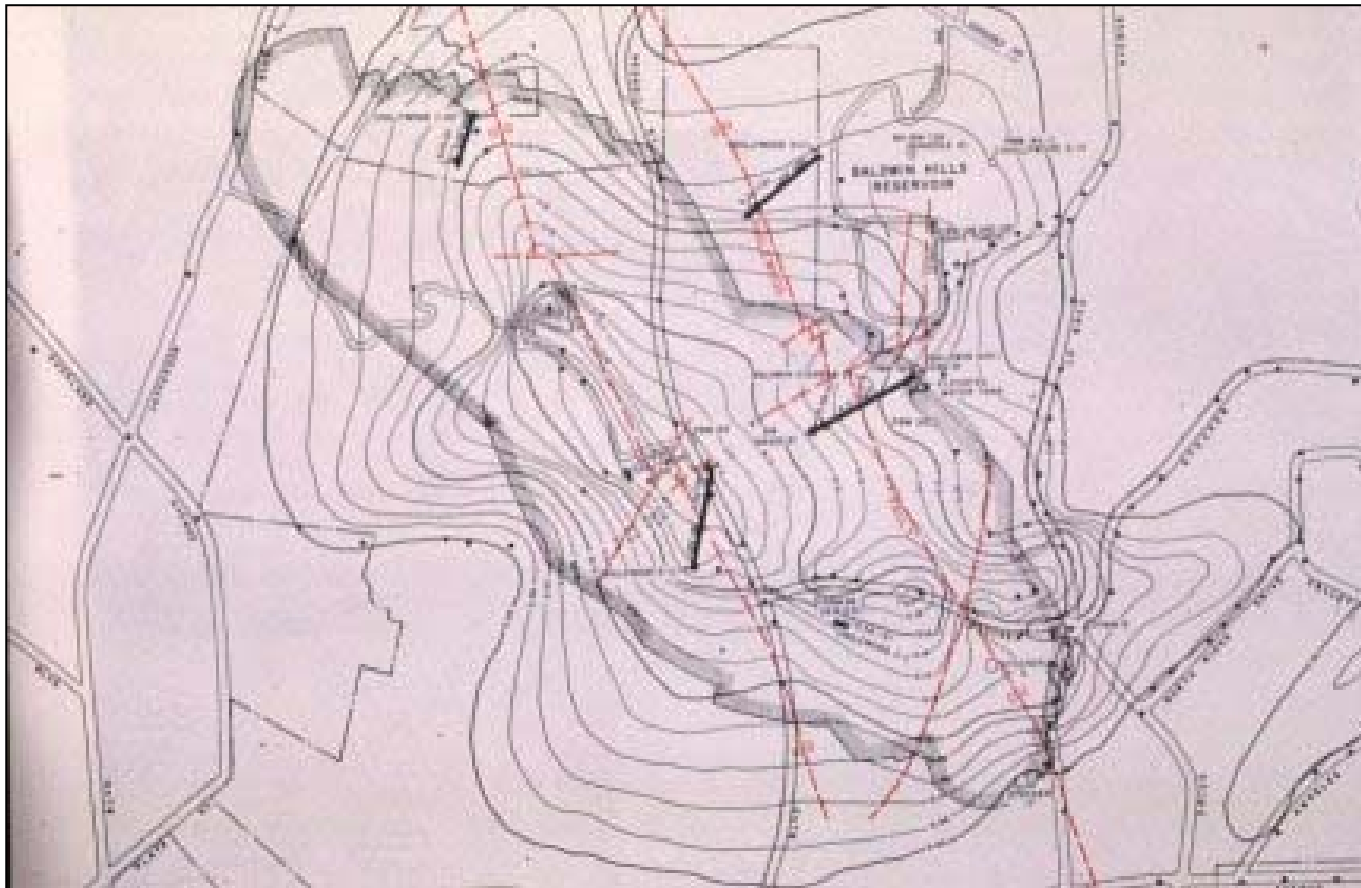
- A map showing faults and measured ground subsidence in the Inglewood Oil Field suggests that petroleum withdrawal over the previous 20+ years likely triggered movement along the **short fault strand** that extended through the reservoir area, precisely where the seepage occurred. **A little over 1.5 feet of subsidence** was measured during the brief 9-year life of the reservoir!

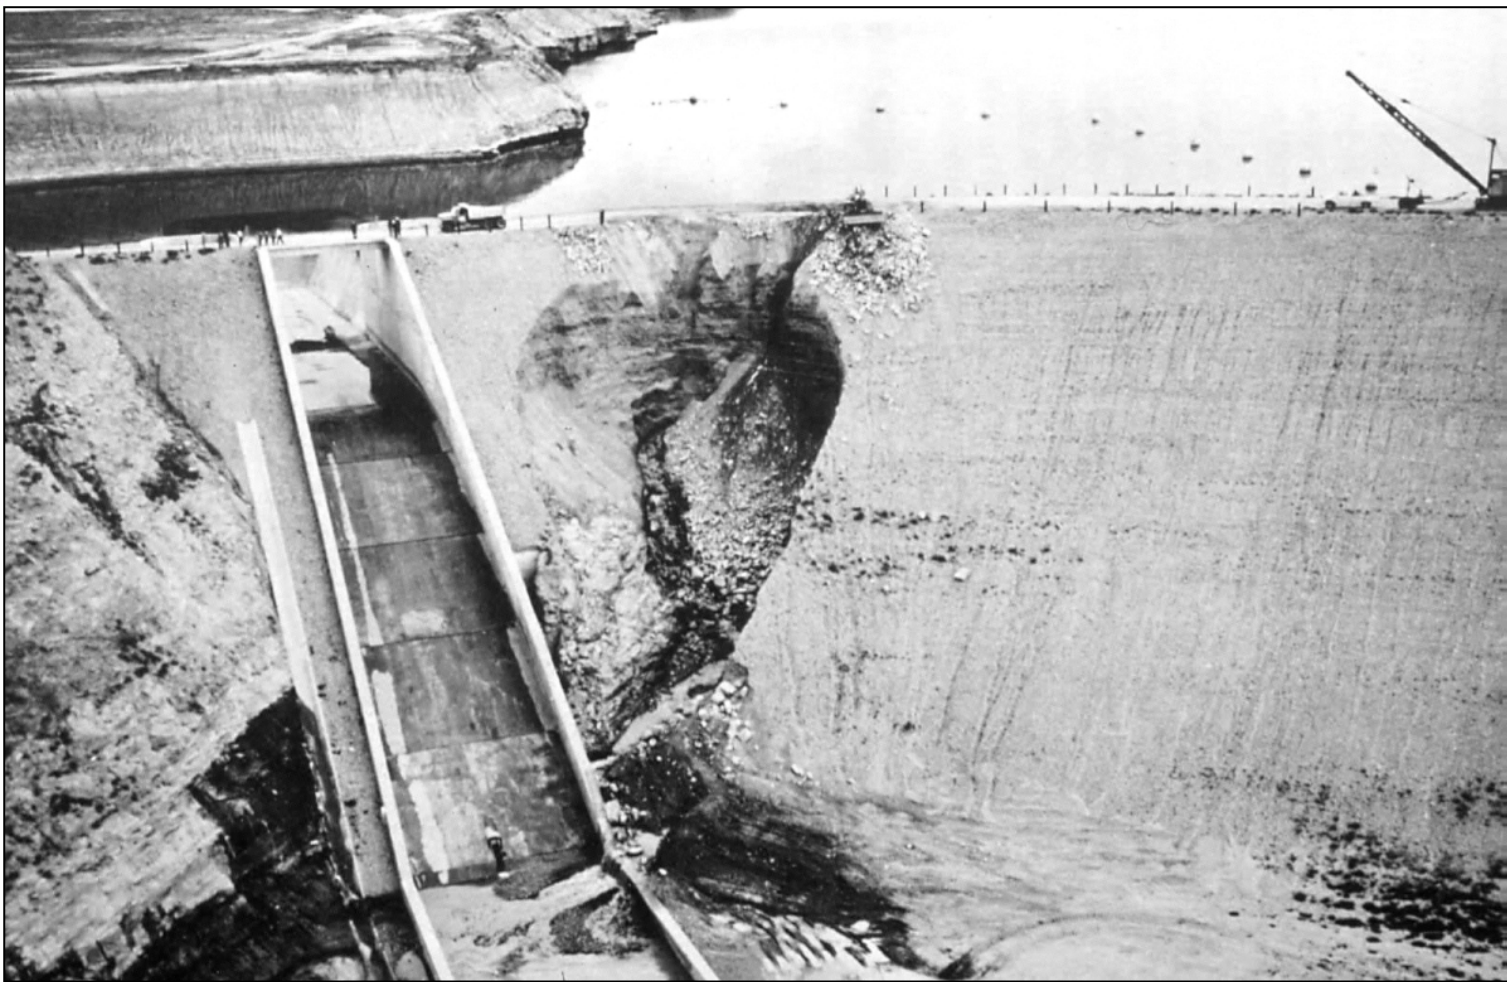
- **Fontenelle Dam** was constructed by the US Bureau of Reclamation on the Green River in Wyoming in 1960-63, with a single line grout curtain. In September 1965 a serious piping failure occurred on the right abutment, with reservoir water percolating along valley-side sheet joints in the sandstone (with only 46 feet of head). **The dam came dangerously close to failing.**

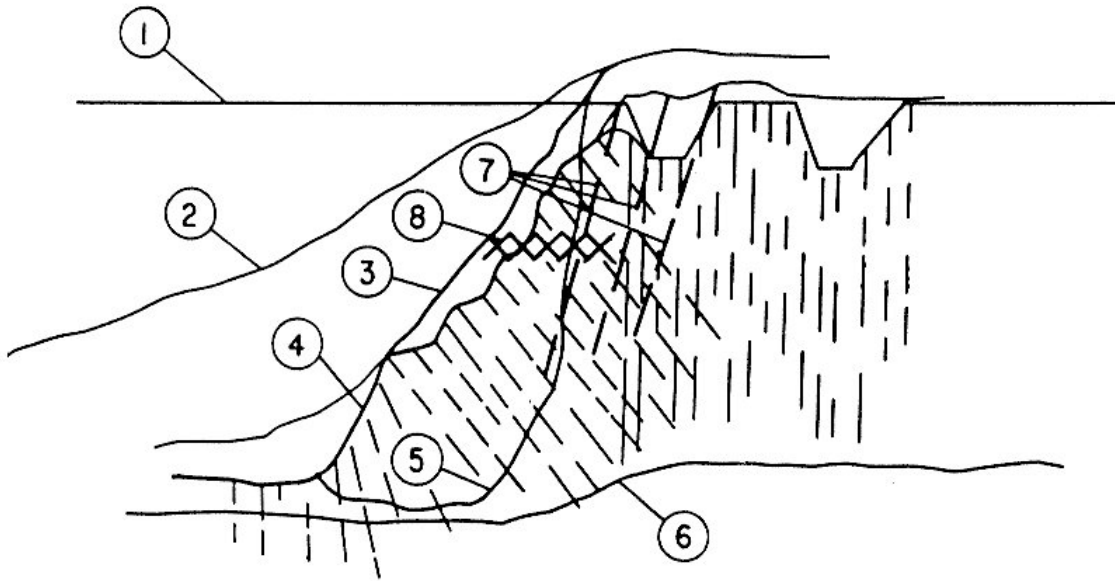
Right Abutment of Fontinelle Dam

- (A) Embankment.
- (B) Spillway.
- (C) Canal outlet.
- (D) Road.
- (E) September 3, 1965, leakage and slough.
- (F) Open cracks.

- (2) Downstream abutment slope.
- (3) Abutment slope at dam centerline.
- (4) Bedrock surface at dam centerline.
- (5) Upstream abutment slope.
- (6) Lower limit of grout acceptance.
- (7) Open cracks.
- (8) Approximate location of leak.

- After the piping failure the right abutment area was excavated, revealing a series of inclined valley-side joints

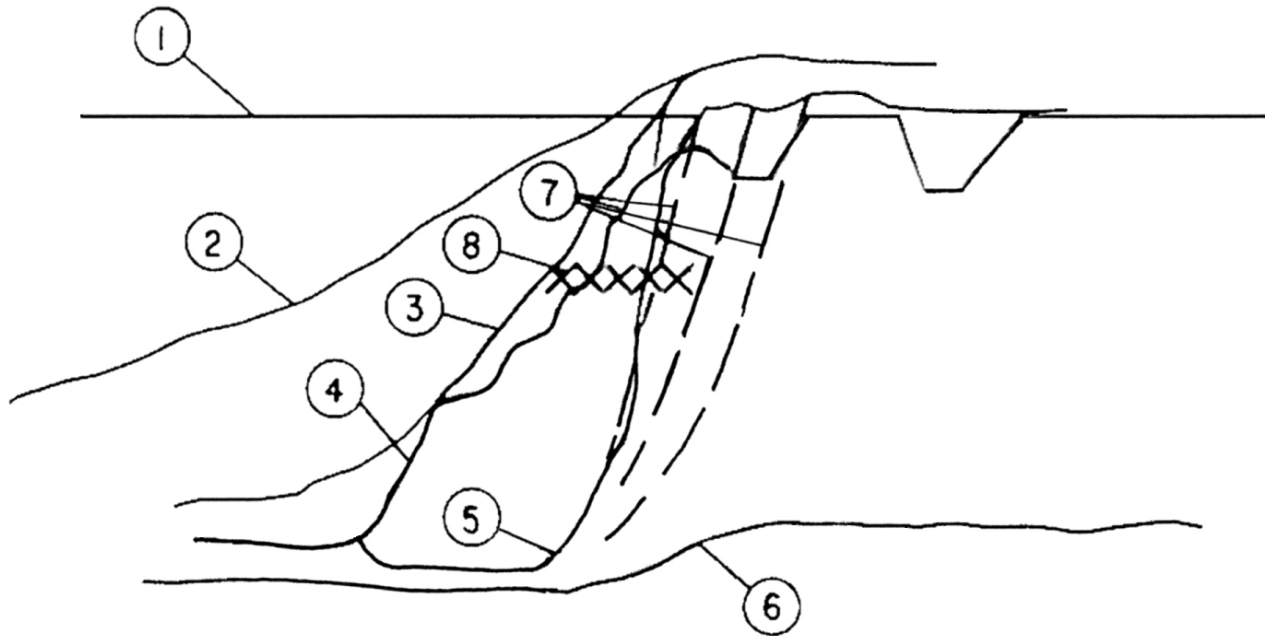
FONTENELLE DAM REPAIRS

- The seepage that almost caused the dam's failure percolated along undiscovered valley-side joints (#7) in bedded sedimentary rocks at position #8
- **8 lines of grout holes** were then drilled and filled with **203,500 sacks of cement**
