Retrospective on
THE FAILURE OF
TETON DAM

Near Rexburg, Idaho
June 5, 1976

J. David Rogers, Ph.D., P.E., R.G.

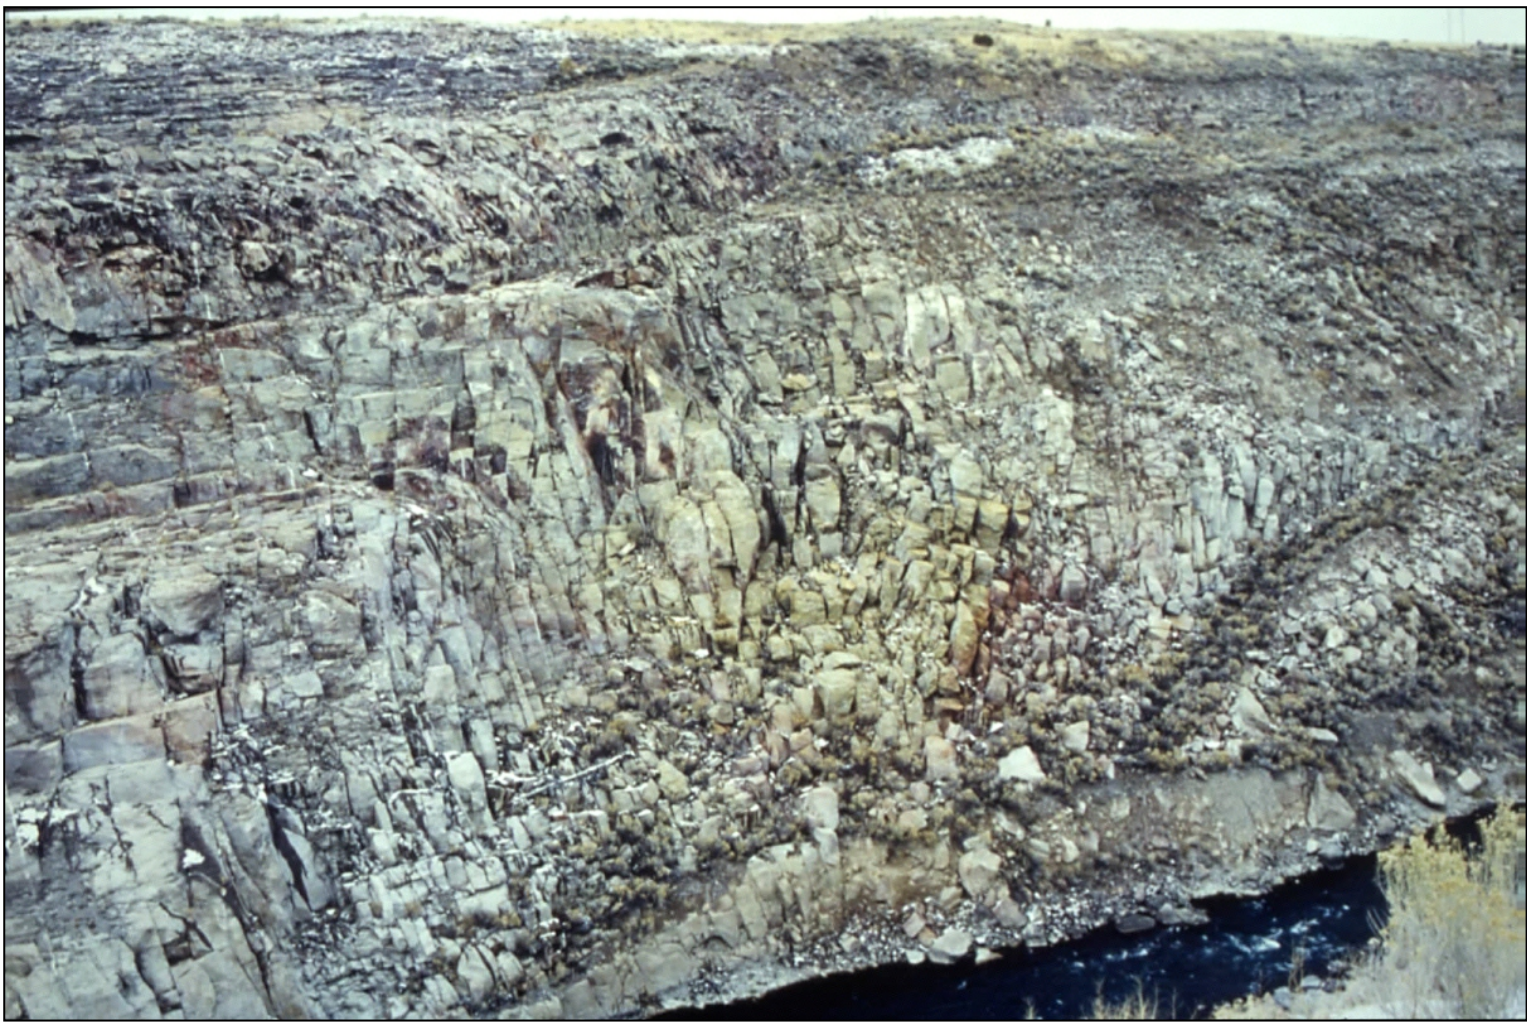
- **The dam's abutments were comprised of a perversely fractured welded ash-flow tuff (rhyolite), with beds of lapilli tuff and basalt. Large voids associated with volcanic fumaroles were detected during construction.**

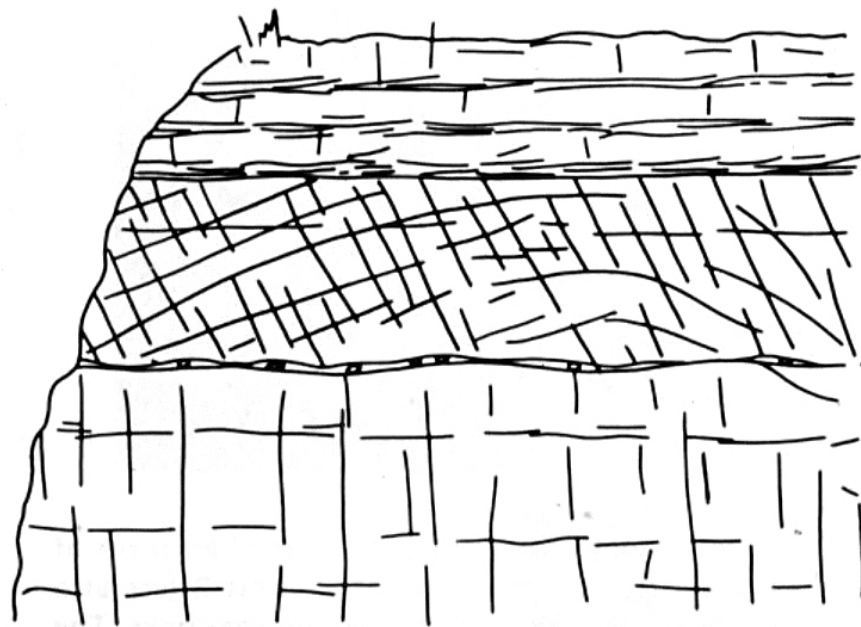
UNIT 1	Prominent and very abundant zones of low-angle platy joints
UNIT 2	Blocky, with closely to widely spaced moderately to steeply dipping (30° to 60°) joints dominant, some low-angle joints in upper part
UNIT 3	Blocky, massive, with moderately abundant near-vertical and low-angle joints

- The three principal flow units identified in the dam abutments are shown here. Unit 2 was observed to be intensely jointed, with joint apertures of as much as 6 inches. Although many of the largest joints were filled with concrete slurry, **no filter was placed between some of the open joints and the silty loess fill in the abutment keyways**

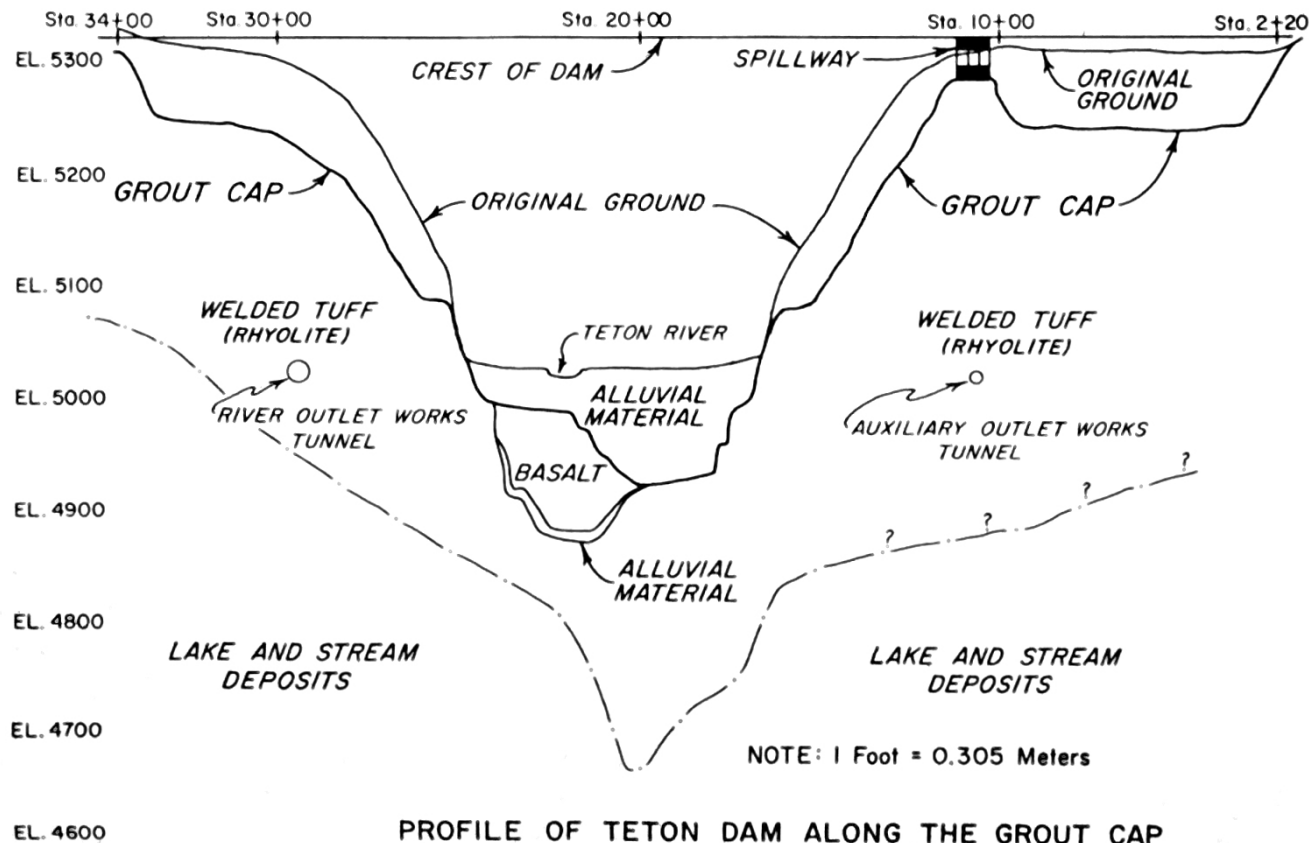
- The exposure of so much jointed and blocky rock led to a **major design change**, calling for the excavation of deep seepage cutoff trenches, or keyways, in each abutment. The grout curtain was extended to the depth indicated on this vertically exaggerated elevation view.

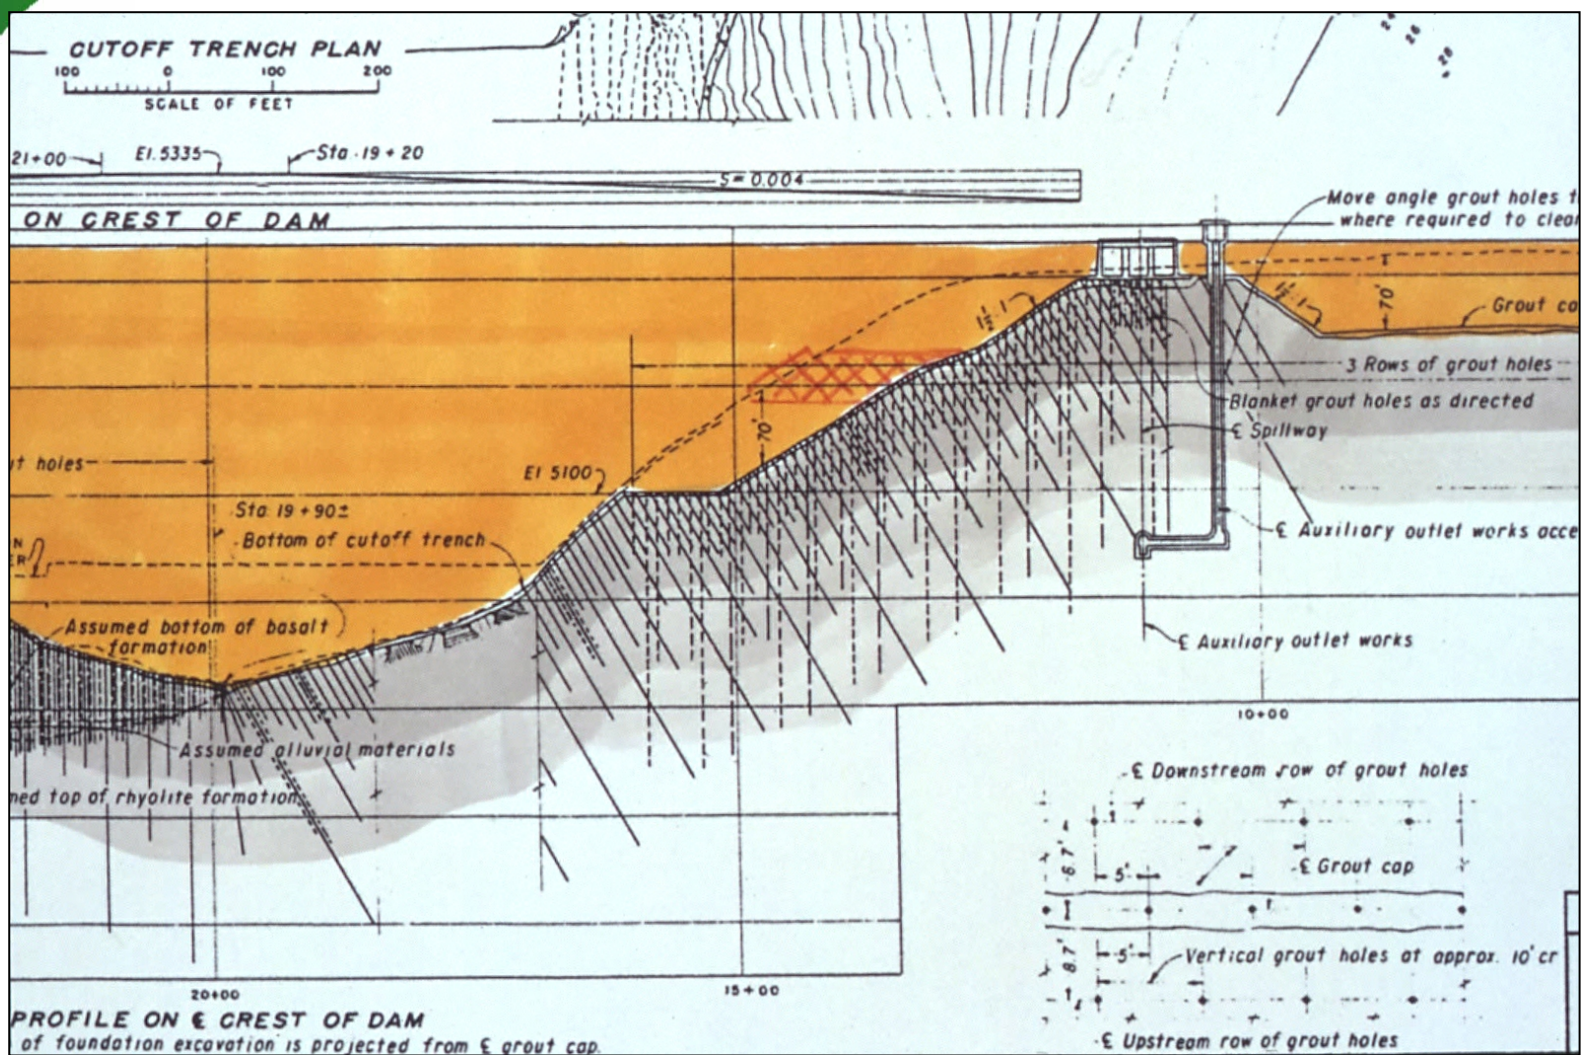
- A single line of grout holes was utilized beneath the embankment because the grout takes were more than double what had been allotted for the project. The portion of the right keyway trench that failed is shown in red cross hatching.

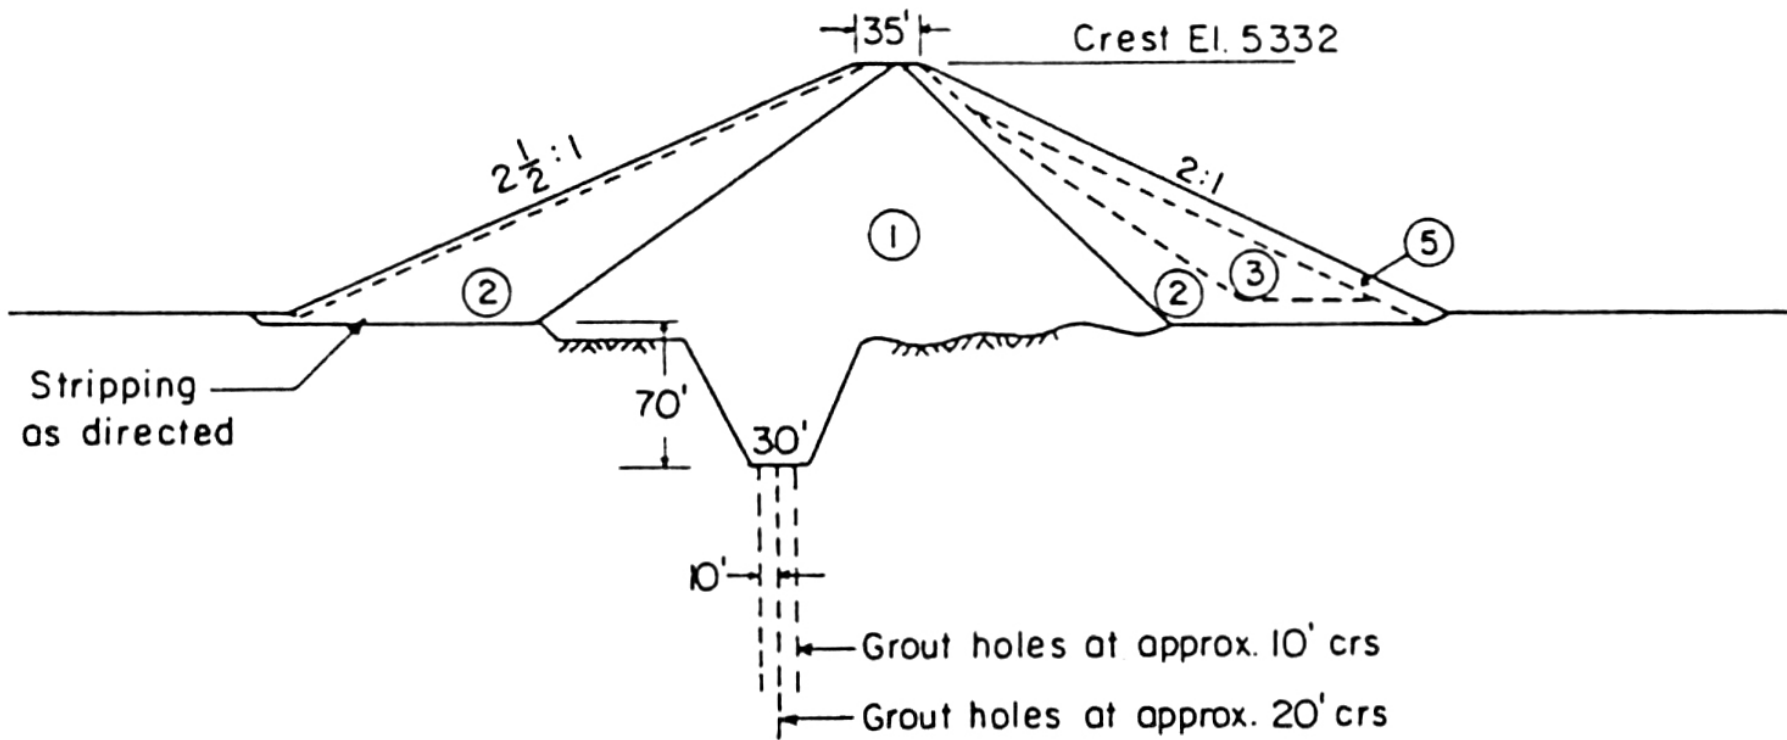
- **The abutment keyway trenches were about 60 feet deep, excavated on 60 degree side slopes and 30 feet wide at their base. Although three lines of grout holes were shown in the amended design (seen here), these were not grouted sufficiently to create an effective seepage curtain.**

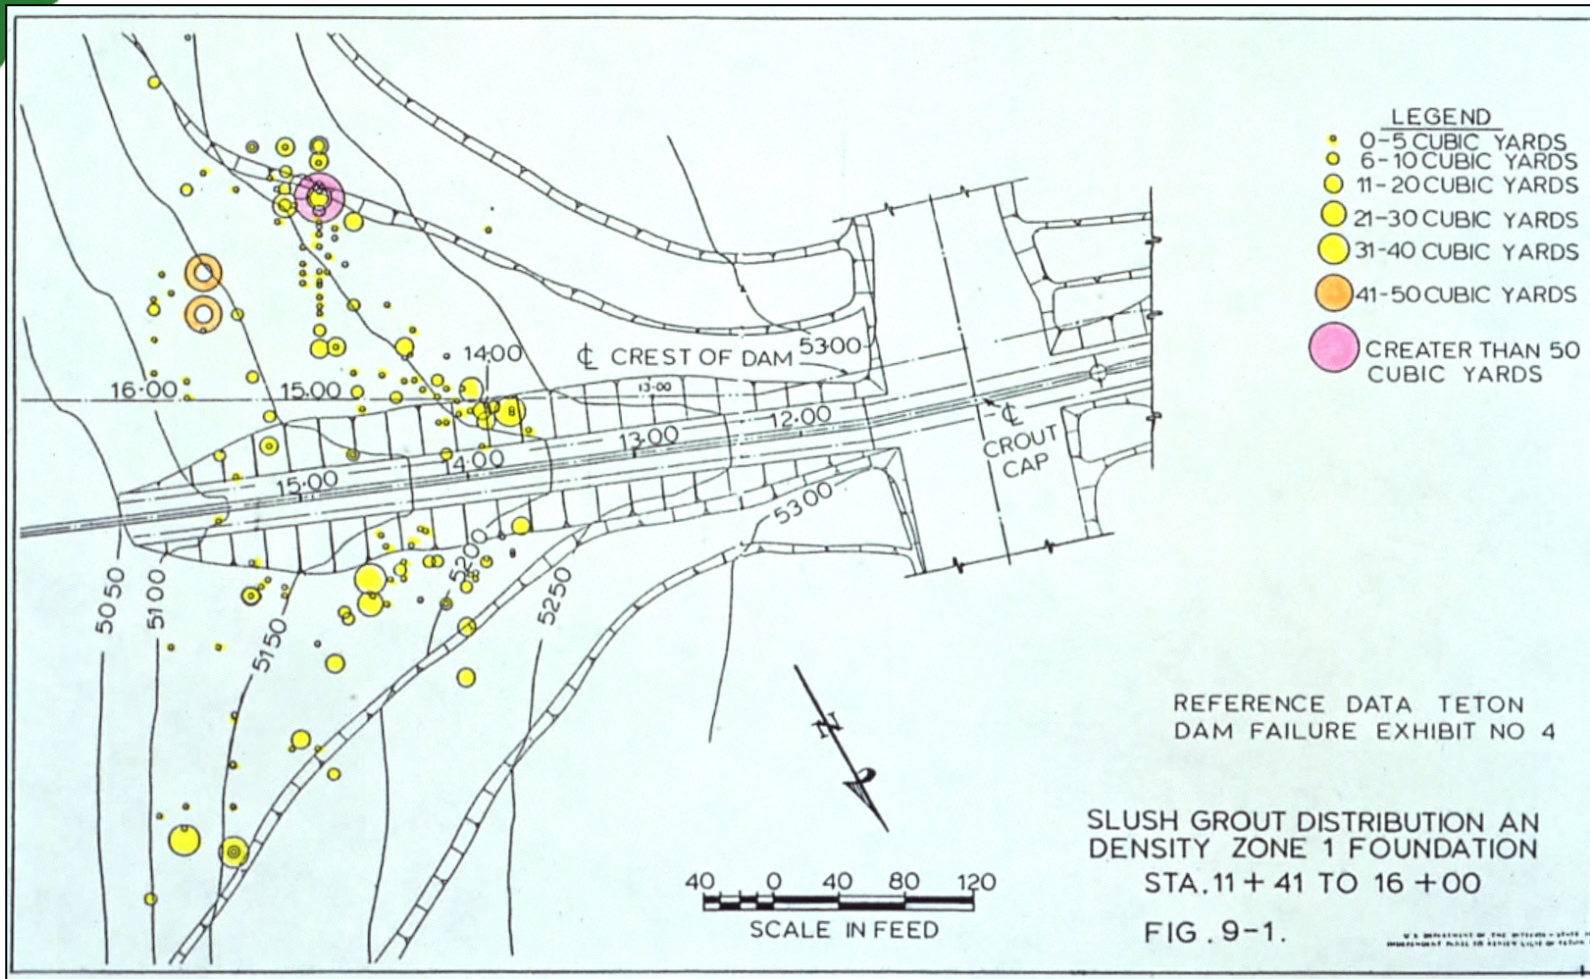
- **A grout test program** was implemented which drilled 118,000 lineal feet of grout holes and injected 600,000 ft³ of grout! This shows the volumes of slurry concrete applied to open fissures in the right abutment keyway area. **Note the significantly high intake between Stations 14 and 15, where the seepage failure subsequently occurred.**

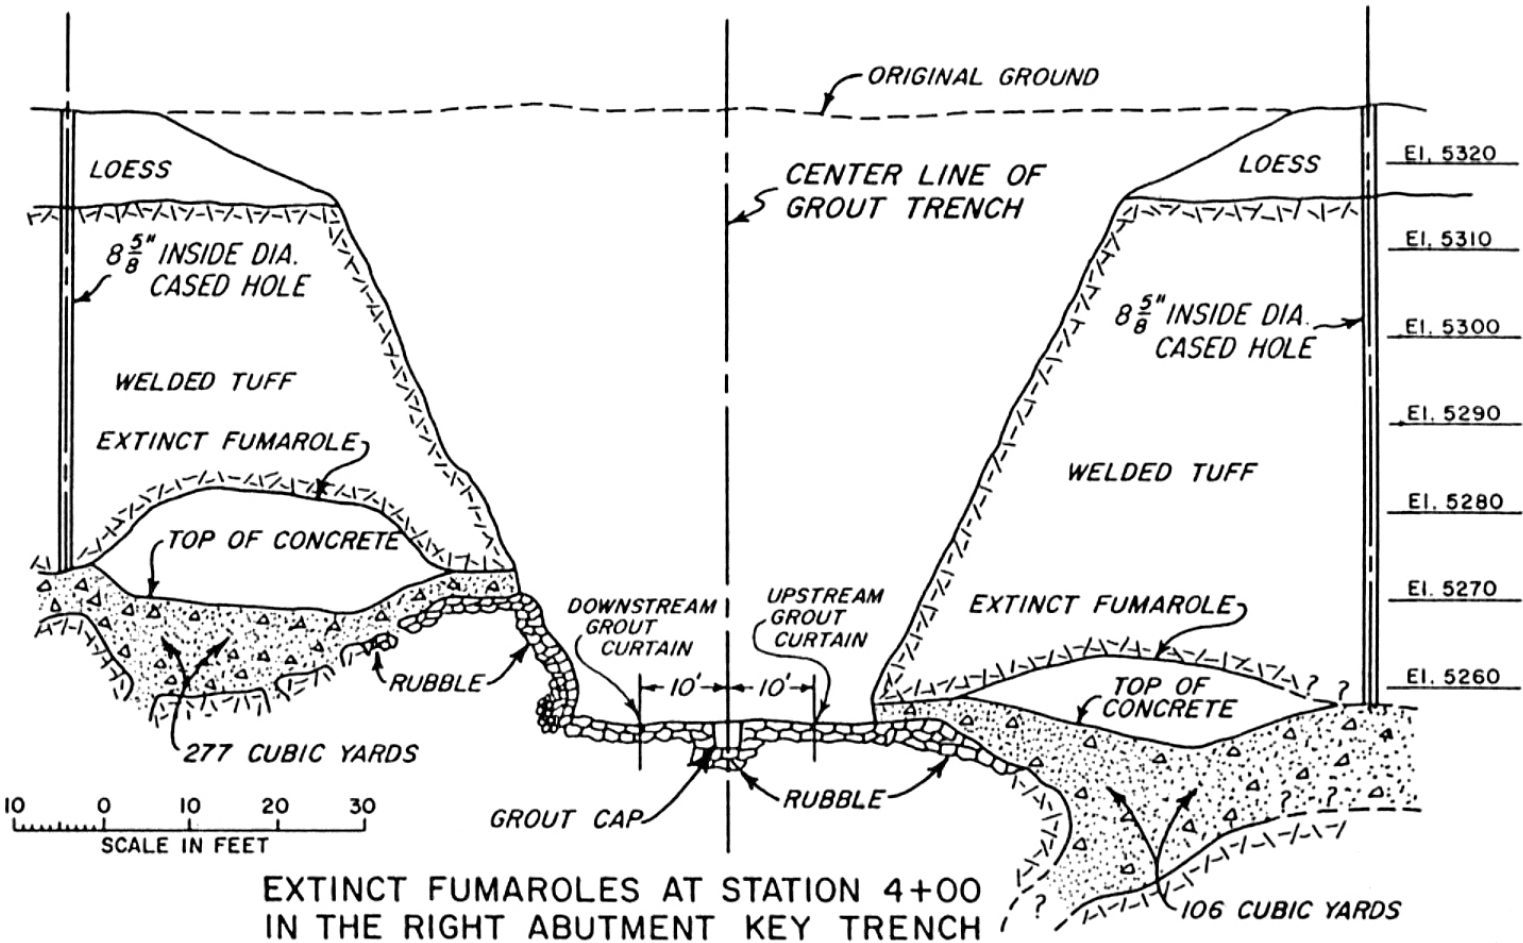
- Section thru the Right Abutment keyway showing the enormity of the slurry concreting. One fissure was 6 feet wide! Most of the larger voids were thought to be “extinct volcanic fumaroles”

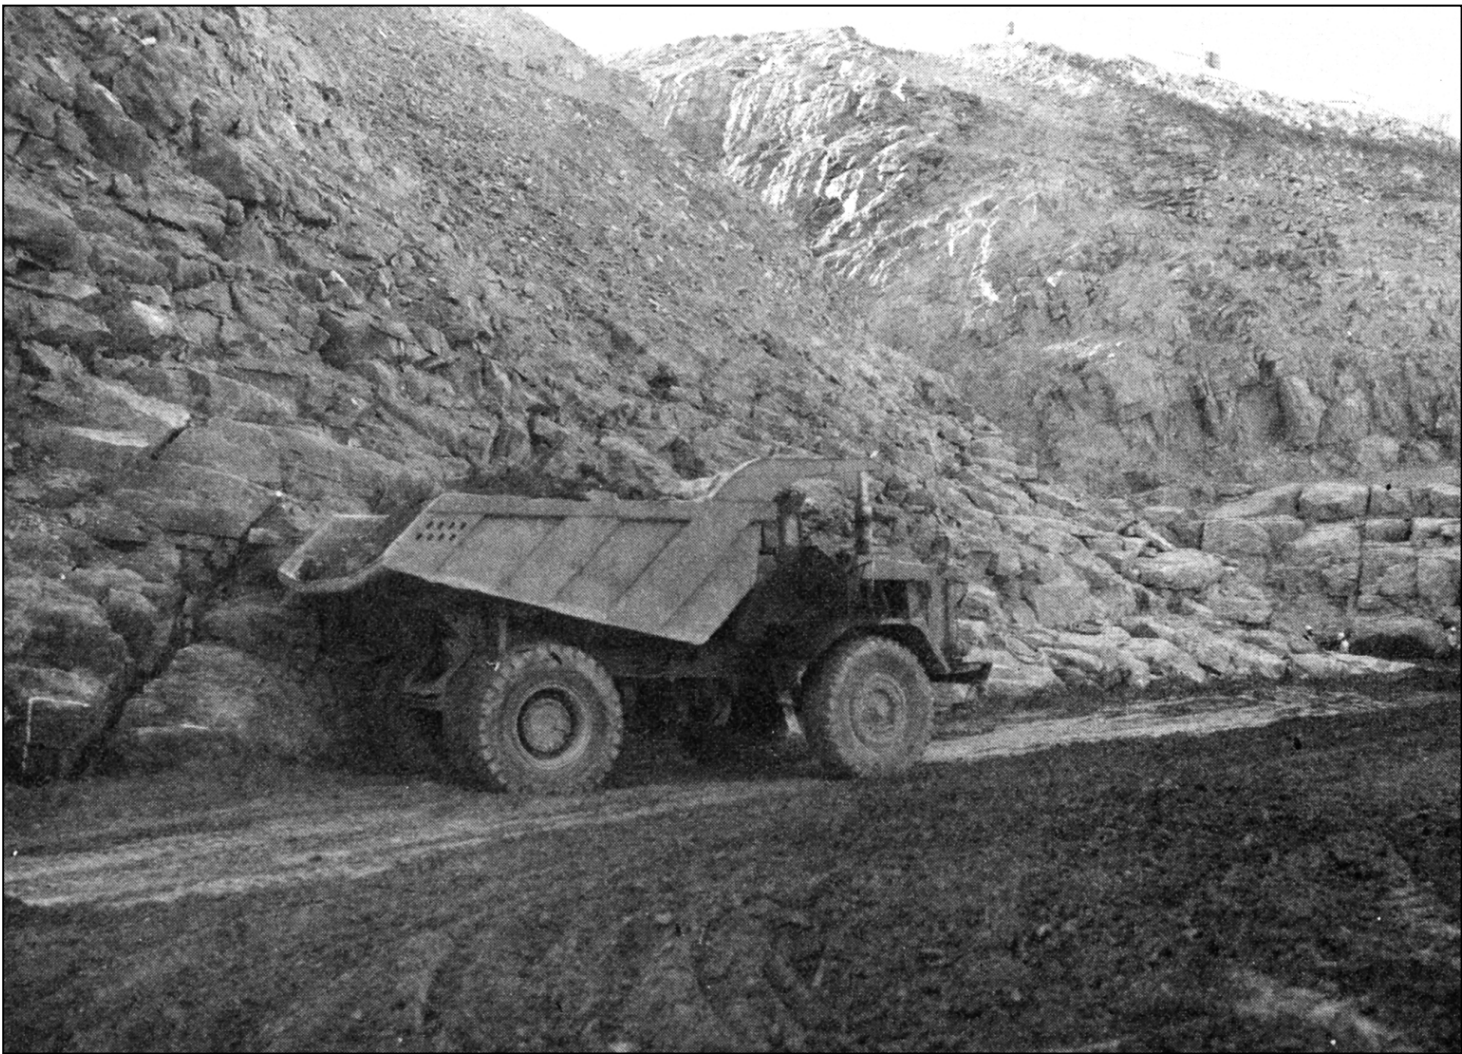
- **Euclid TD-74 dump trucks filled with Zone 5 rockfill were used to compact Zone 1 material (loess) up next to the abutments, as shown here. Right abutment keyway trench can be seen in background.**

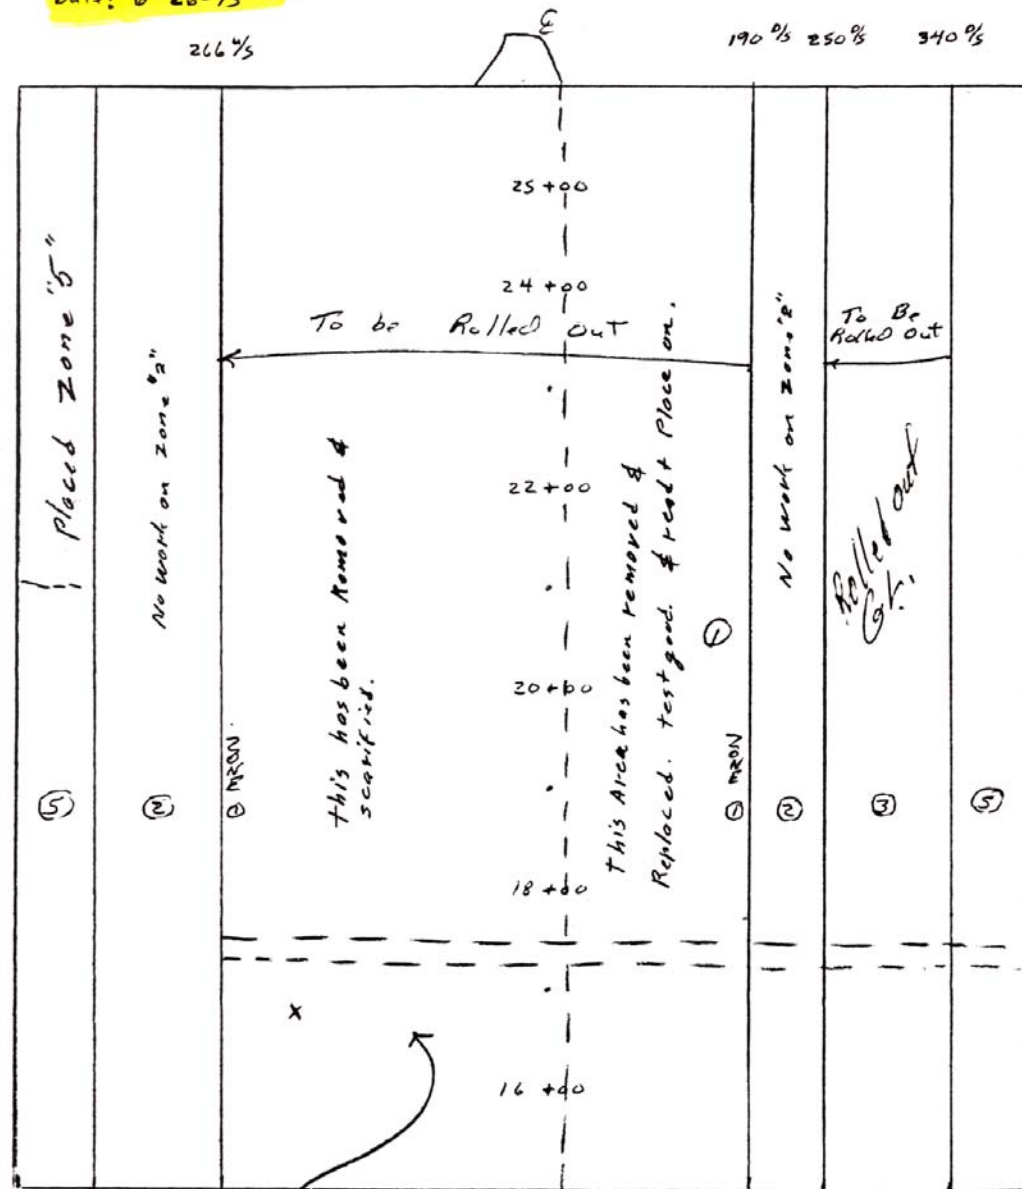
Area from road to Rt. Abutment has been plowed with dozer blade, disked, rolled & bladed. Still very wet in places

- Embankment plan from pass-on book during swing shift on June 26, 1975
- It indicates that material between Station 17+50 and the right abutment keyway had to be plowed with a dozer blade, and striped, disked, rolled and bladed because it was "very wet in places" from June 1975 rains.

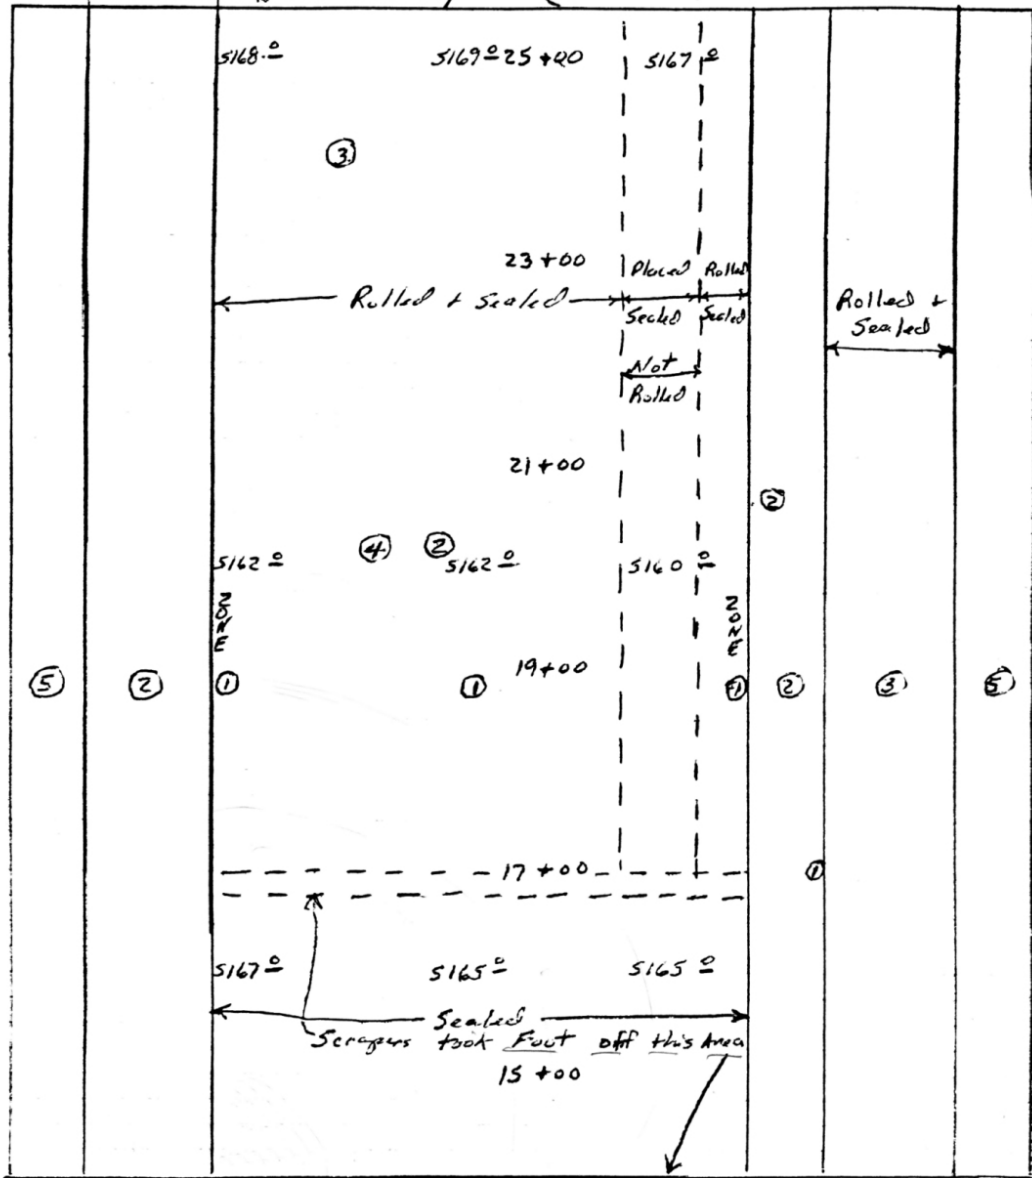
- Embankment plan in pass-on book for swing shift on June 27, 1975 showing right abutment area near elevation 5165 feet
- Scrapers were ordered to remove a foot of wet material from this area

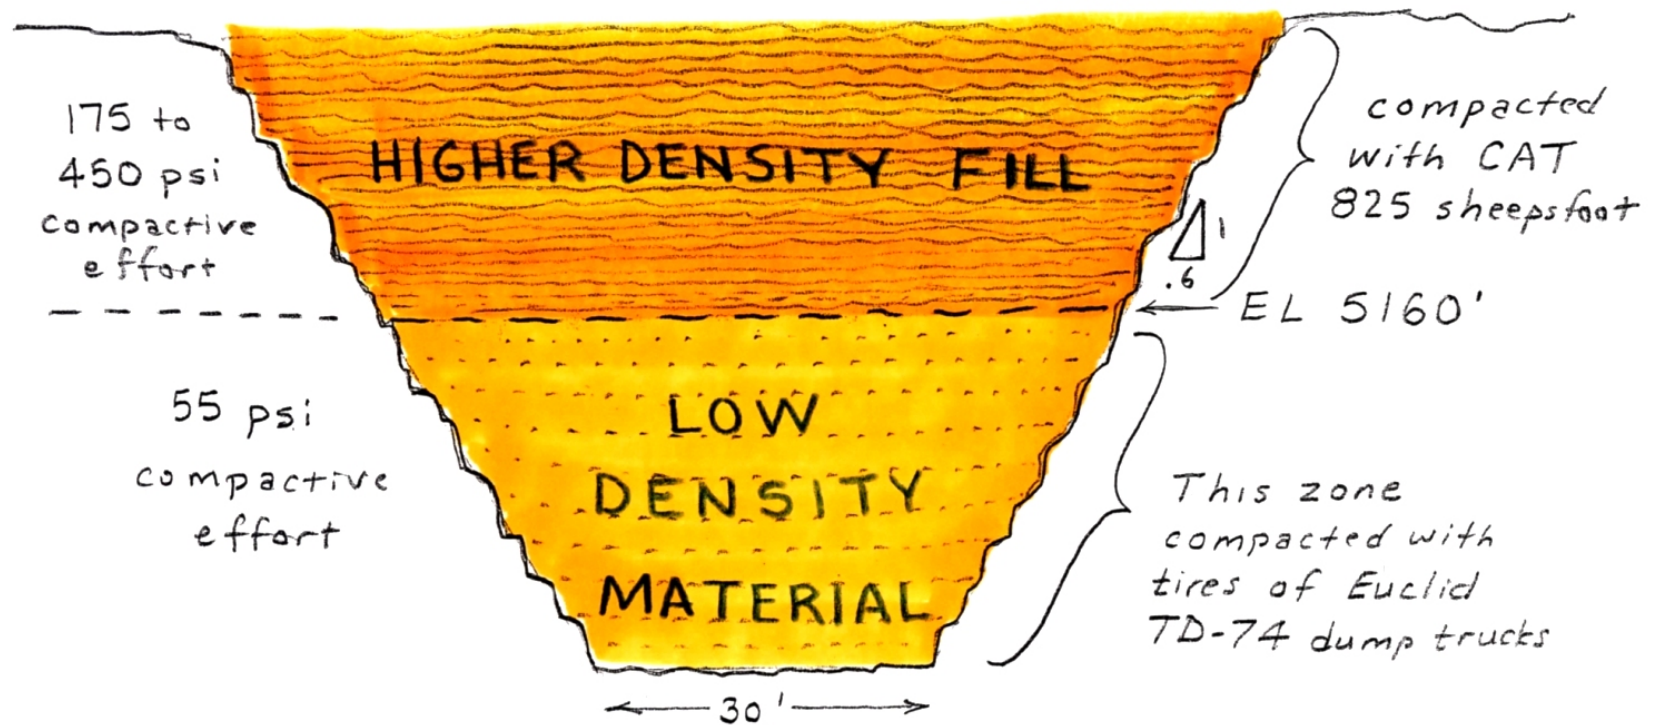
SECTION THRU ABUTMENT KEYWAY
 FILLED WITH COMPACTED ZONE 1 FILL

- By changing from the TD-74 dump trucks to the CAT 826, the compactive effort was increased more than five-fold.
- A much stiffer wedge of fill was thereby created above lower density fill in the base of the keyway trench

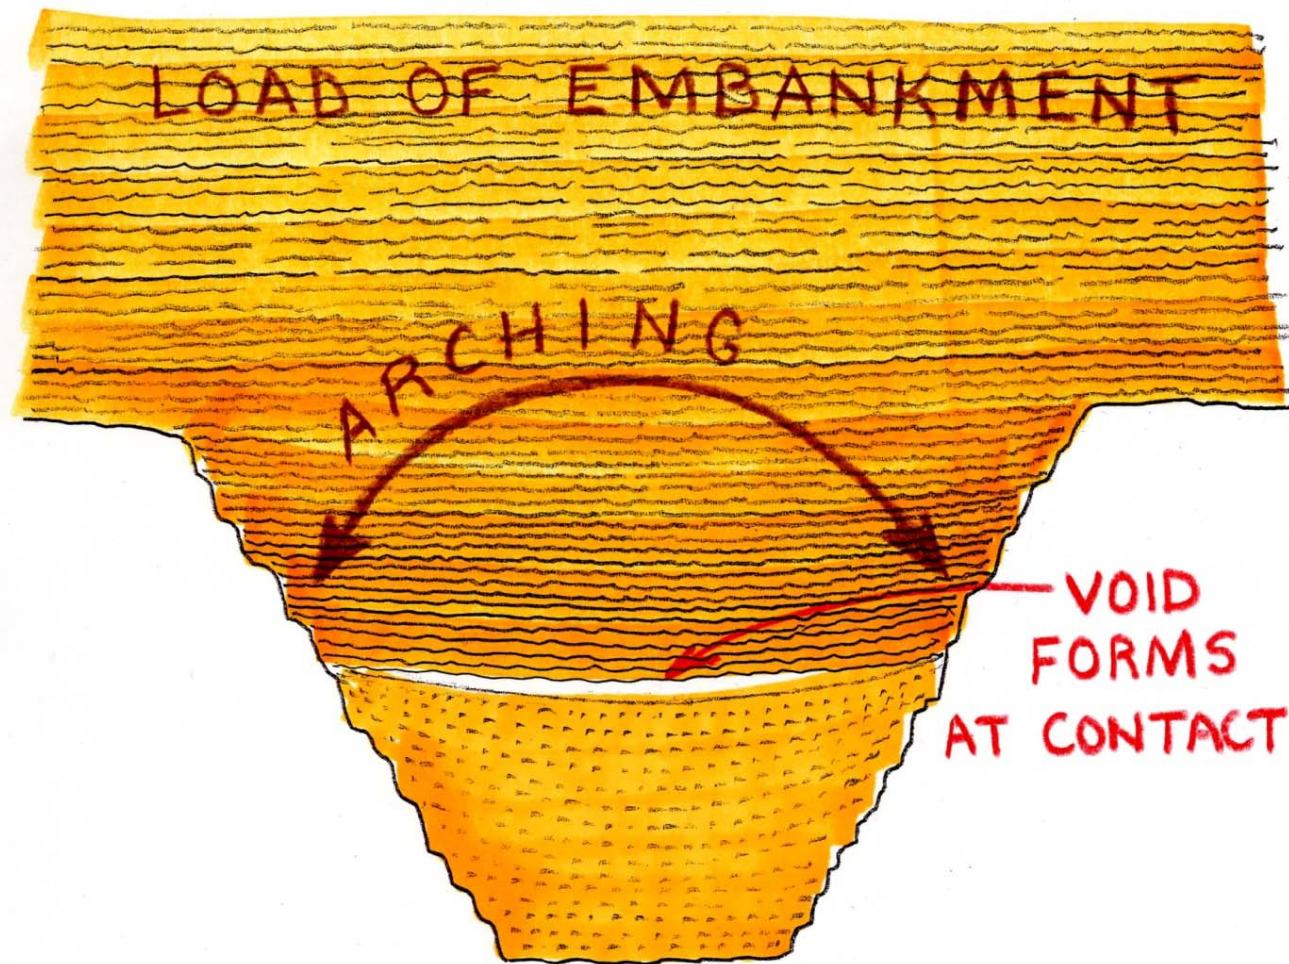
- When the **reservoir filled**, the compacted loess would have been **wetted**. Low density loess compacted dry-of-optimum moisture content would be **more susceptible** to **hydrocompaction**.
- Hydrocompaction-induced settlement may have contributed to the formation of voids and subsequent hydraulic fracturing between fill of contrasting density, as sketched here.

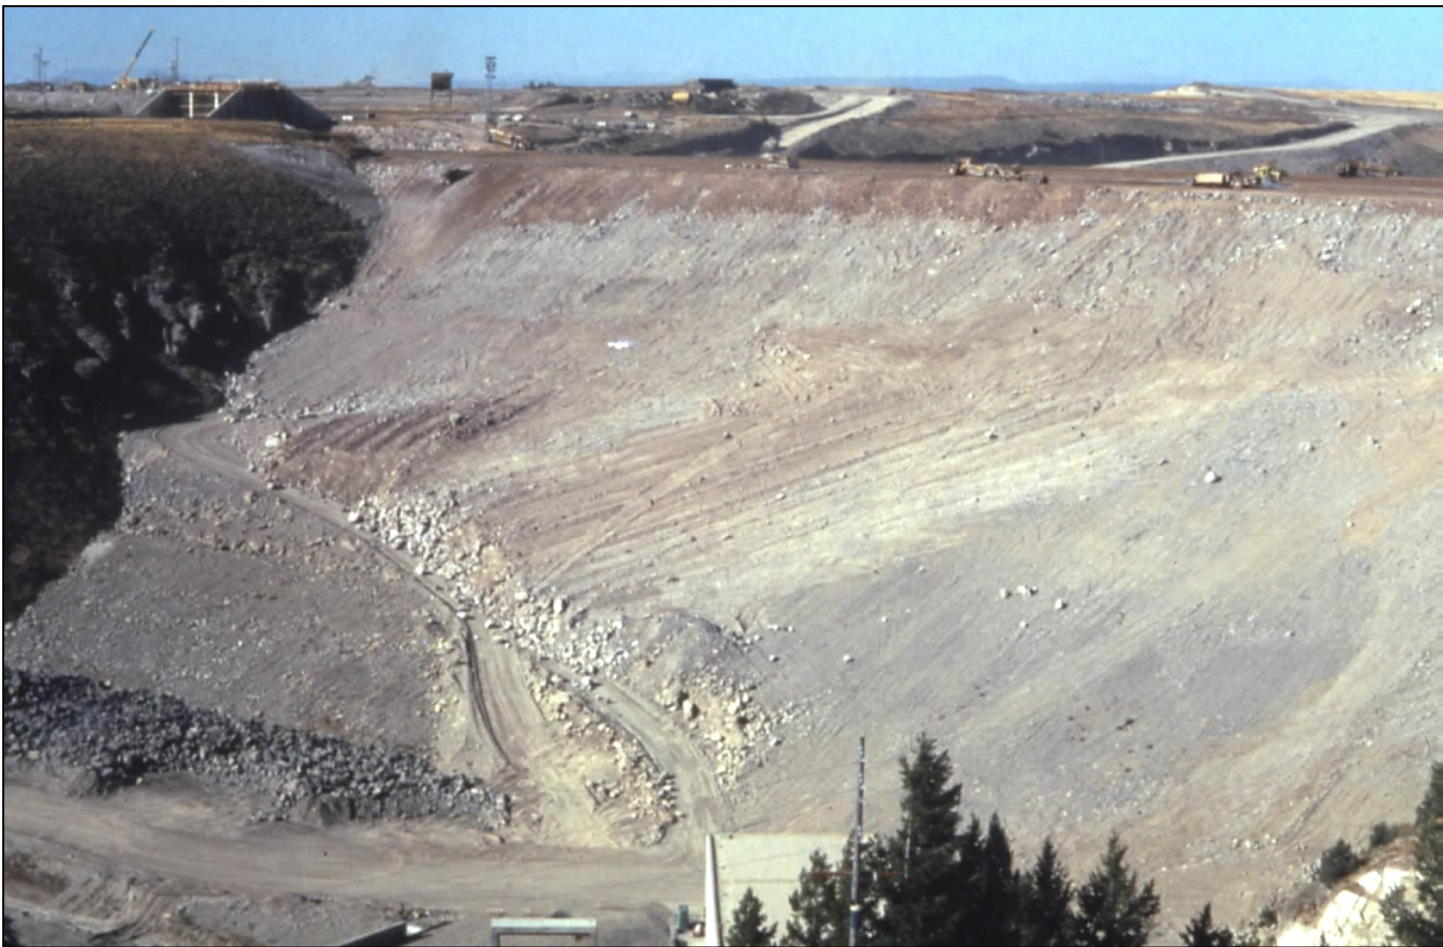
- **Newly-completed Teton Dam as it appeared in mid-May 1976, as the reservoir was filling at the rate of 3 feet per day. The rate of filling is usually limited to no more than 1 foot per day. This view is looking towards right abutment**

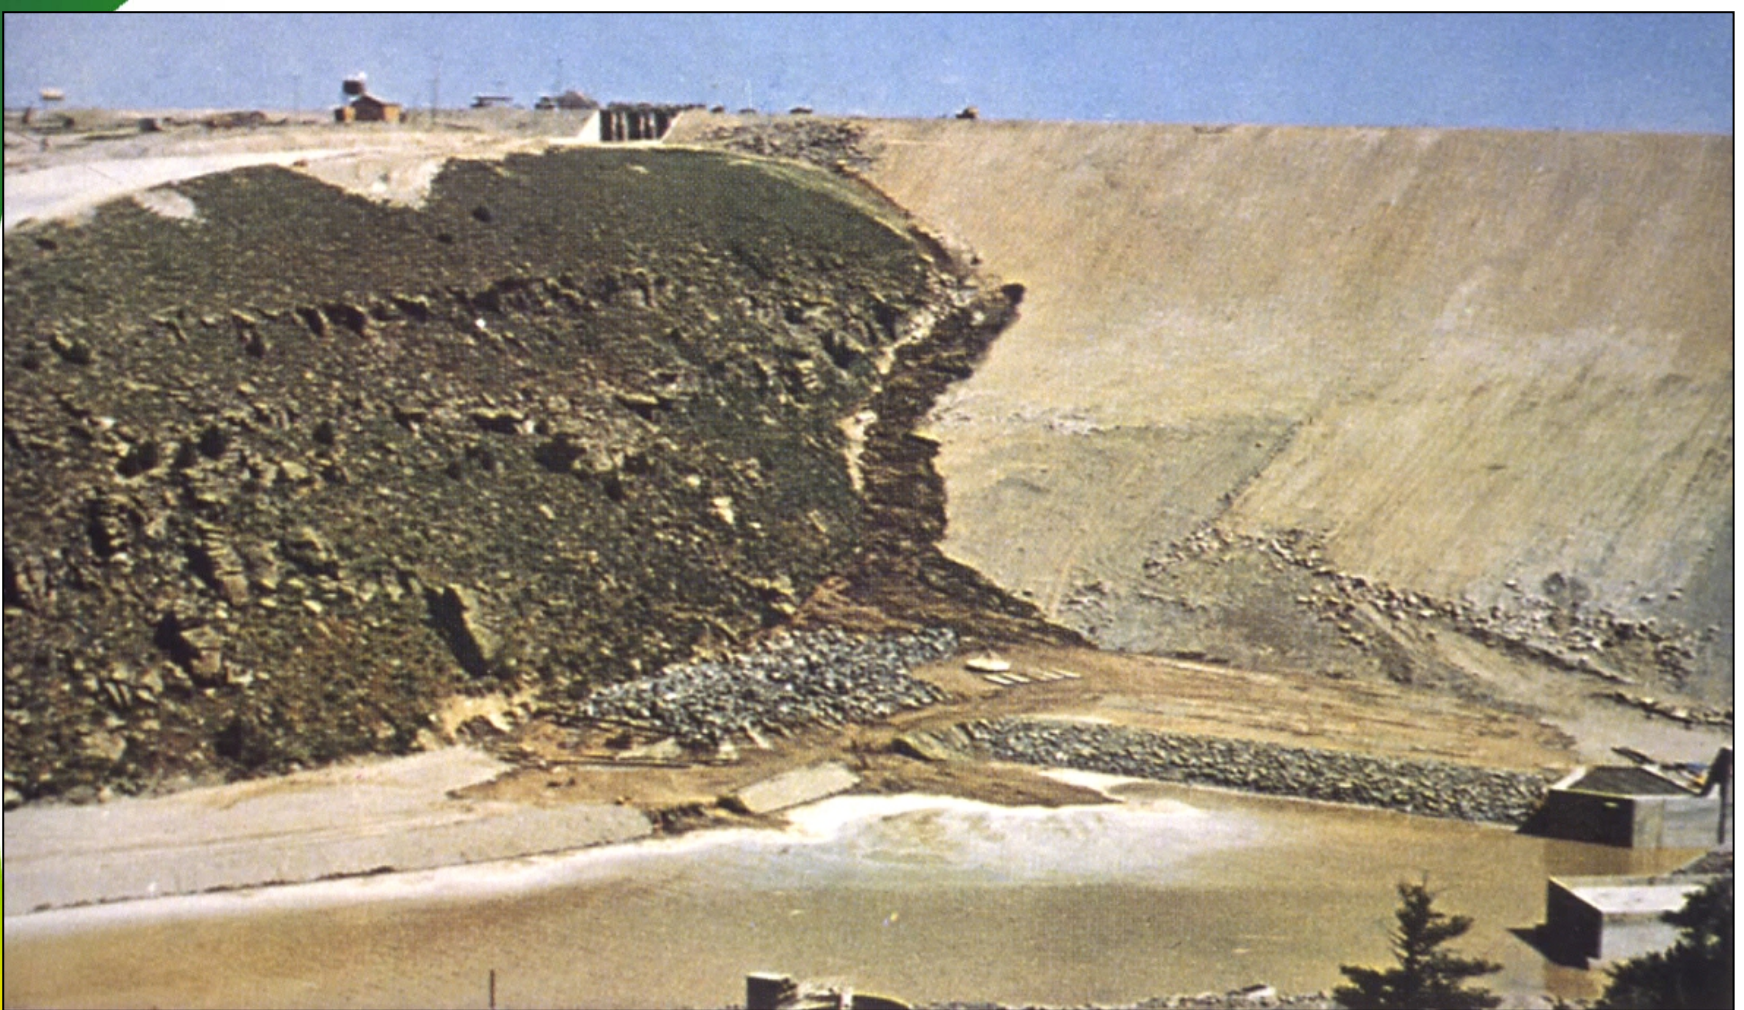
- **Leakage was initially noted around 7 AM on Saturday June 5, 1976. This view shows a dozer being sent down to fill in the hole at elevation 5200 around 10:45 AM**

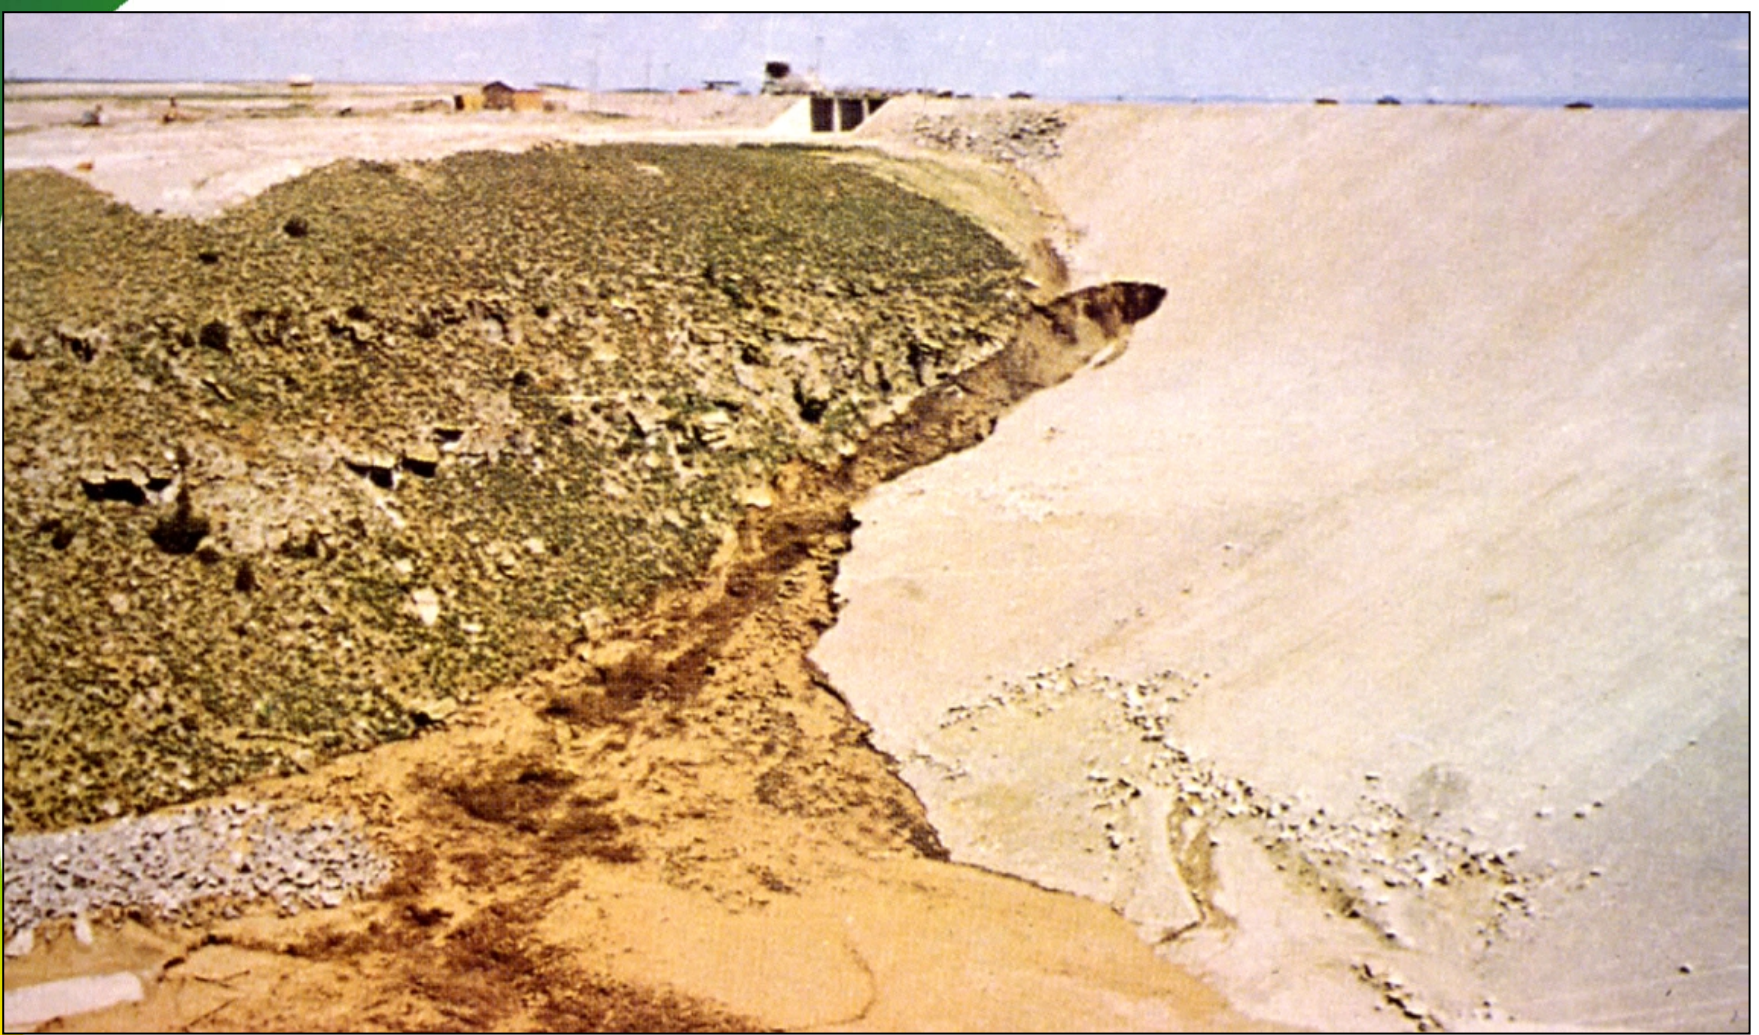
- **The dozer is lost in the expanding hole, around 11:20 AM on June 5th. Note turbid nature of outflow along the abutment**
