Retrospective on
THE FAILURE OF
TETON DAM

Near Rexburg, Idaho
June 5, 1976

J. David Rogers, Ph.D., P.E., R.G.

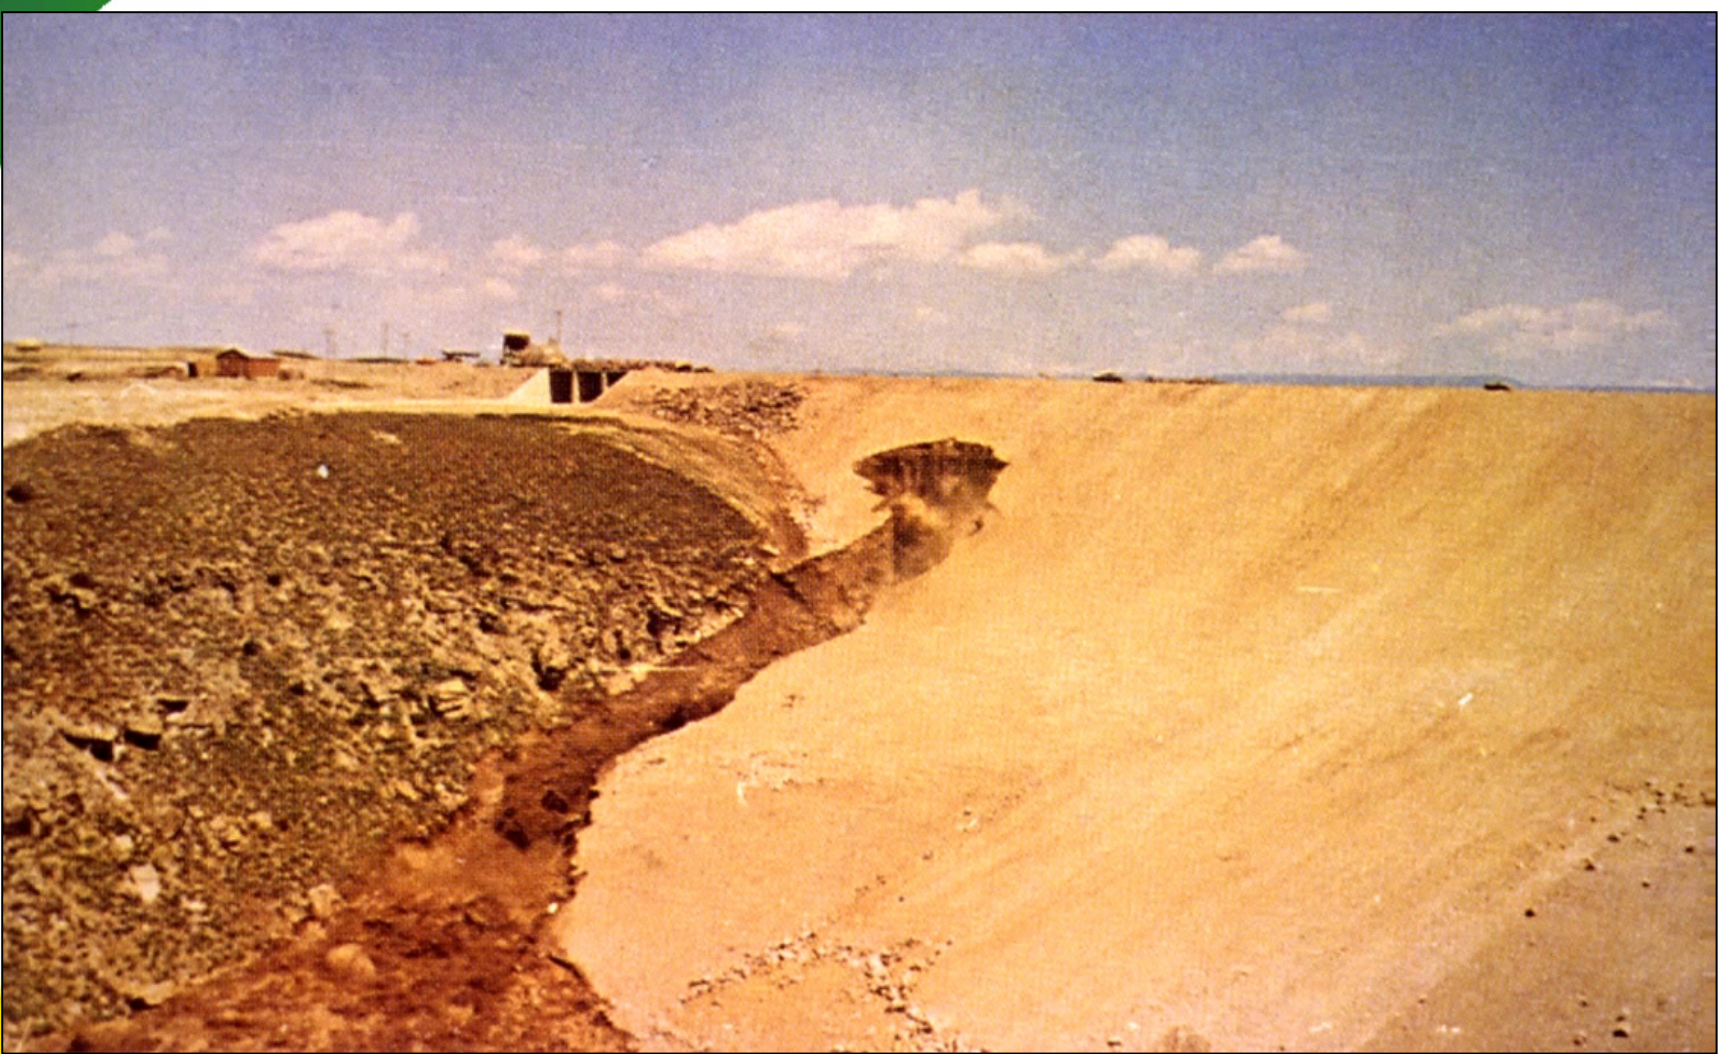
- **Rapidly deteriorating situation as it appeared around 11:30 AM. A massive hole has developed in the downstream face of the embankment and is migrating upward**

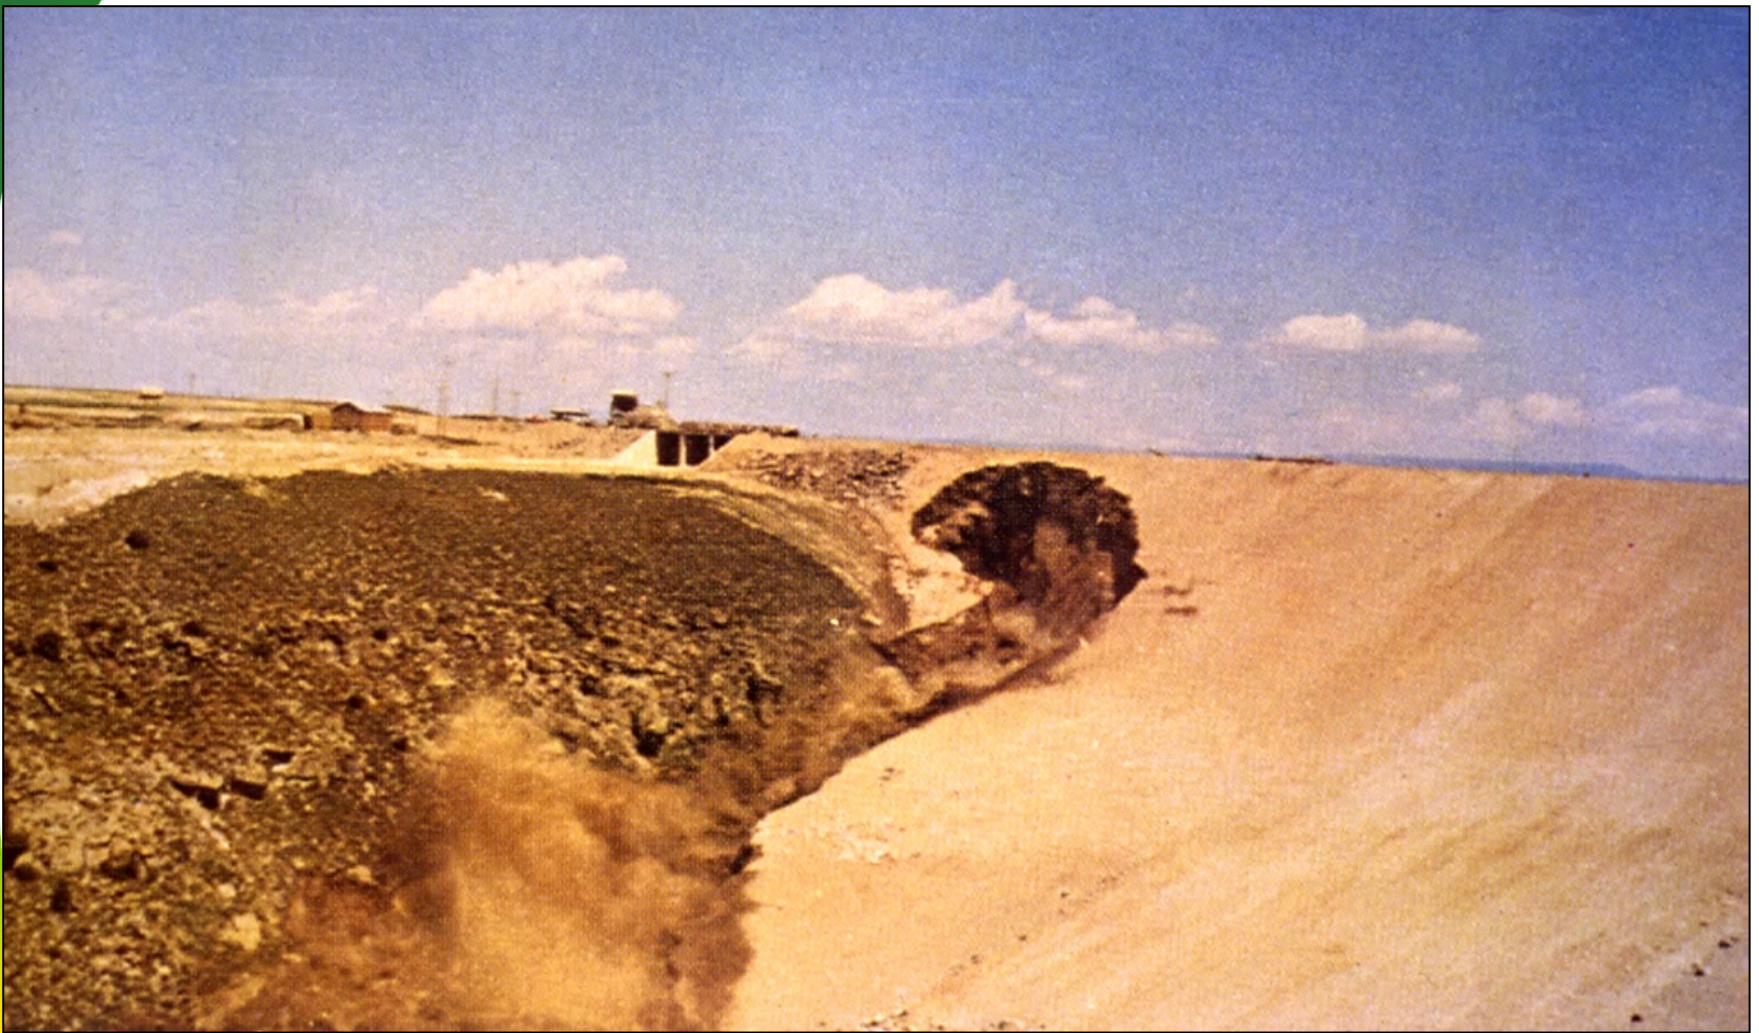
- **The hole continues to enlarge and rise toward the crest of the right abutment. This is about 11:50 AM**

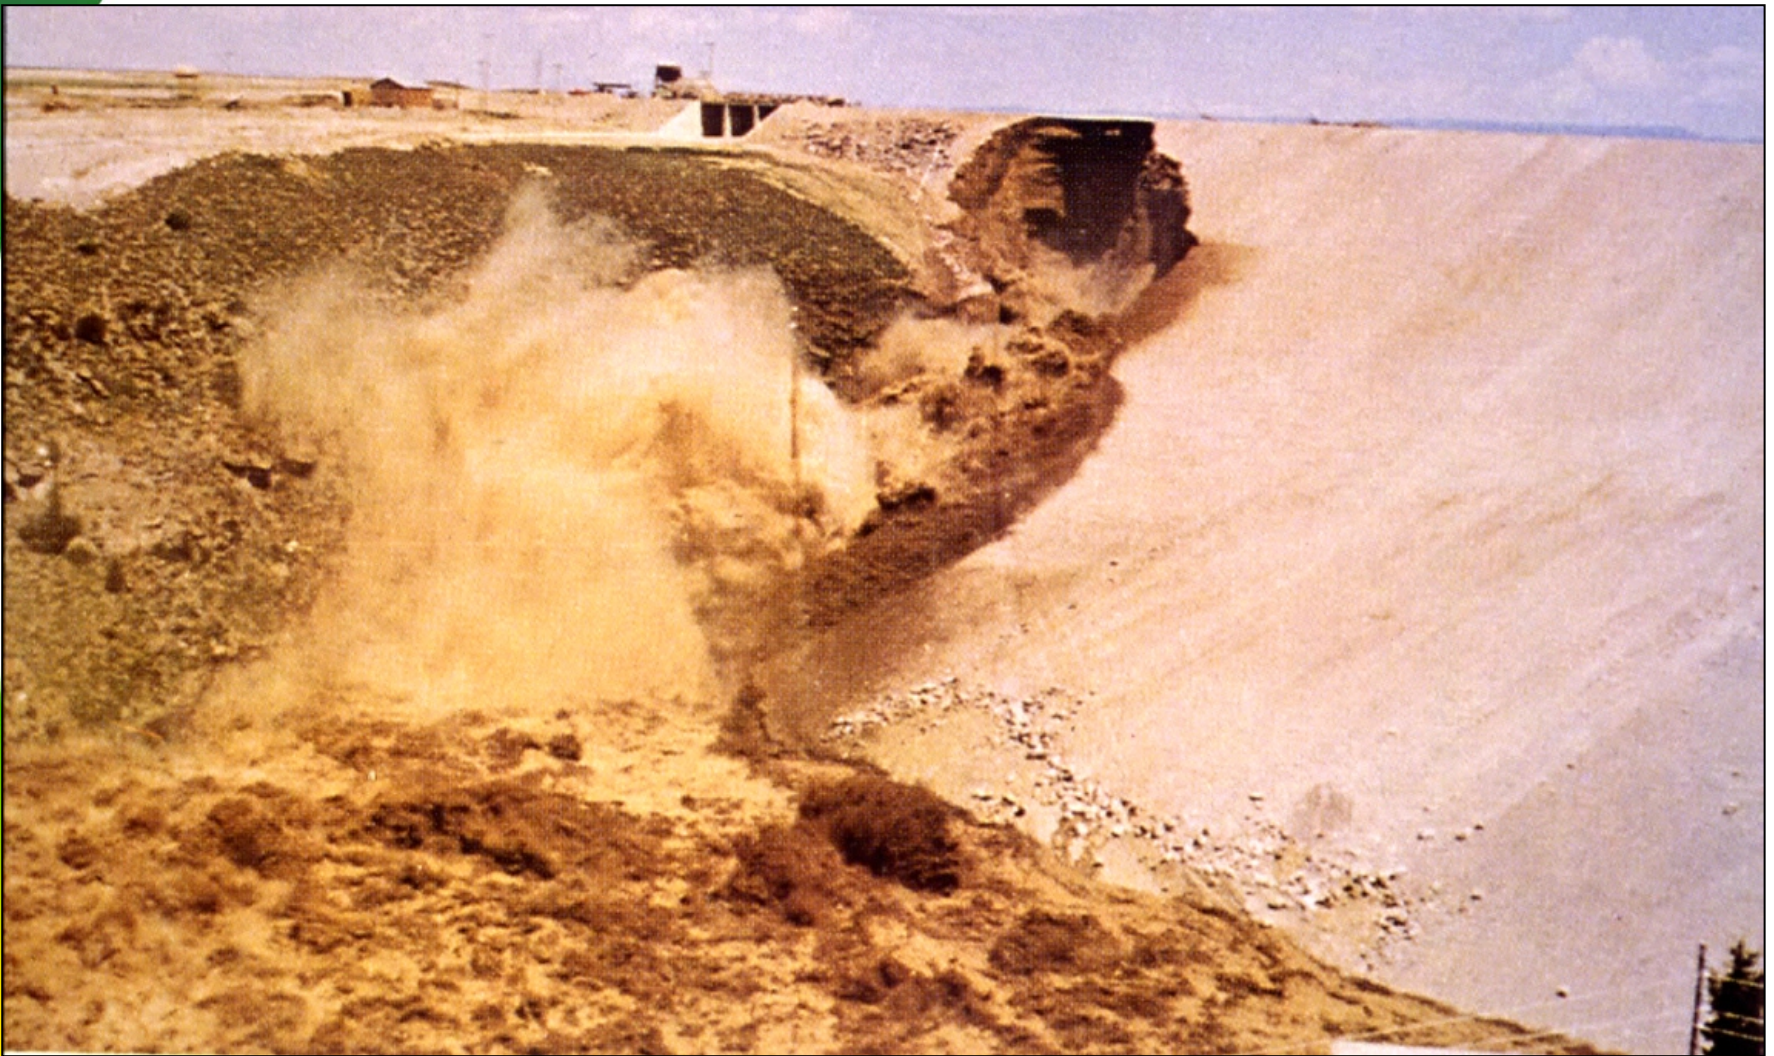
- **Dam crest beginning to breach at 11:55 AM on Saturday June 5, 1976. Note increasing discharge.**

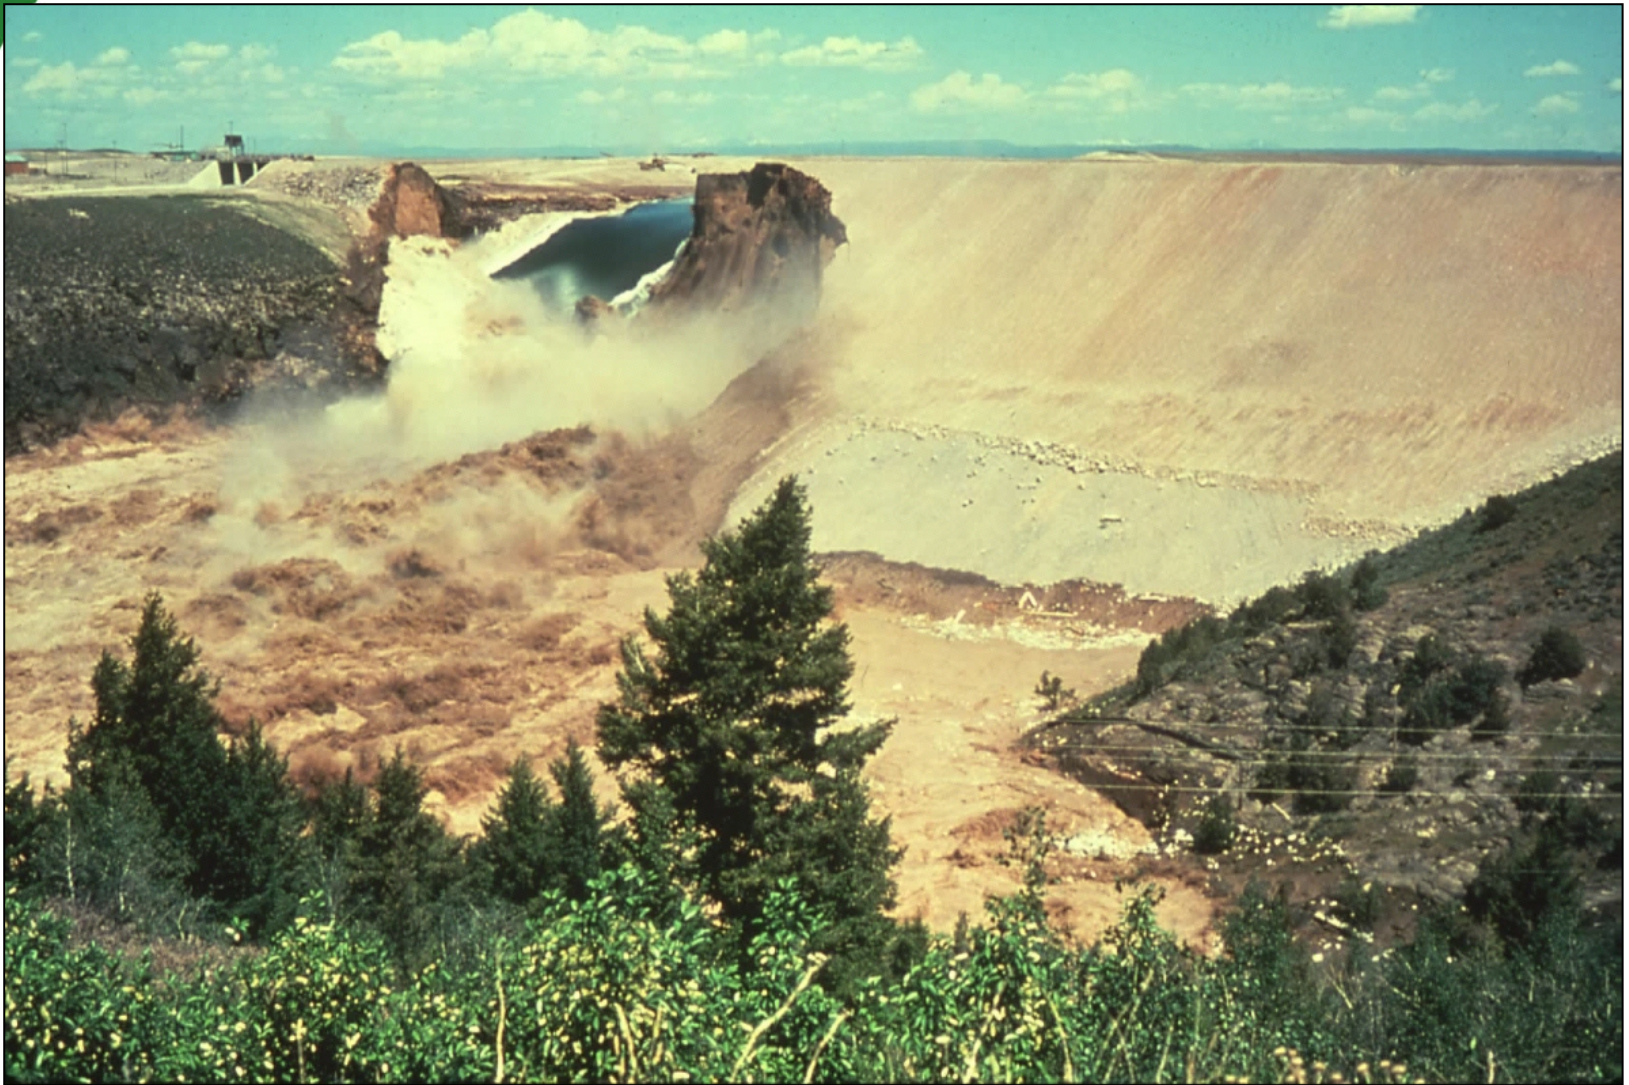
- **Maximum flood discharge emanating from gap in dam's right abutment, just after noon on June 5th, 1976**

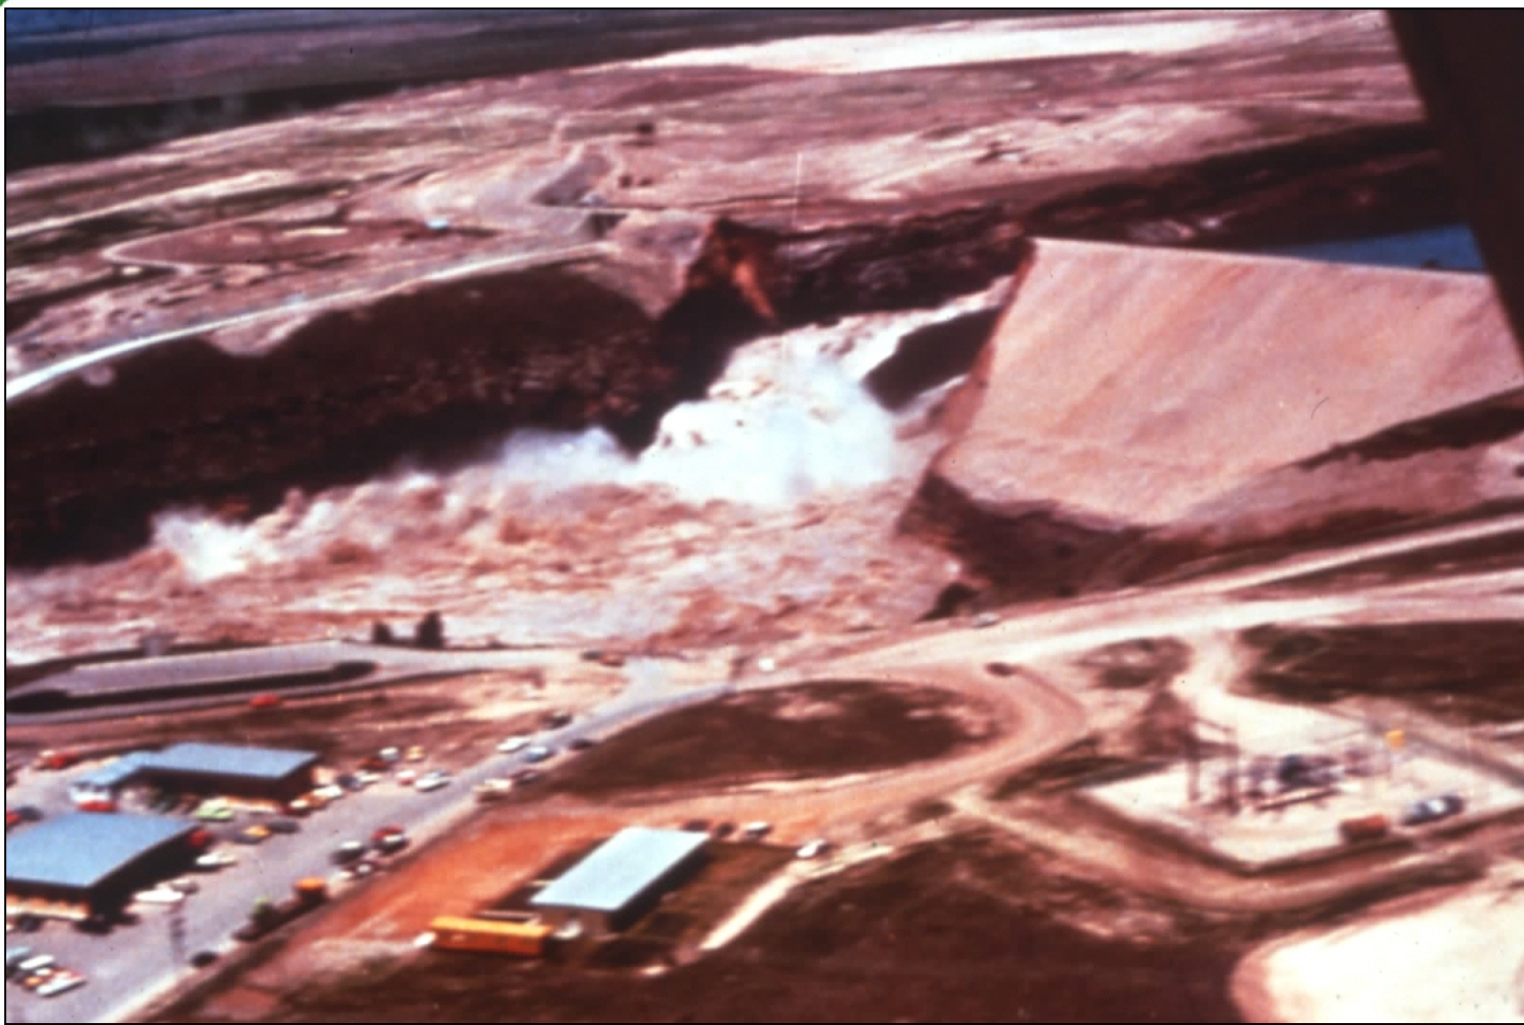
- **The final breaching is filmed from a helicopter that was sent out to warn people downstream of the imminent failure. Amazingly, one of two men fishing a half mile downstream survived!**

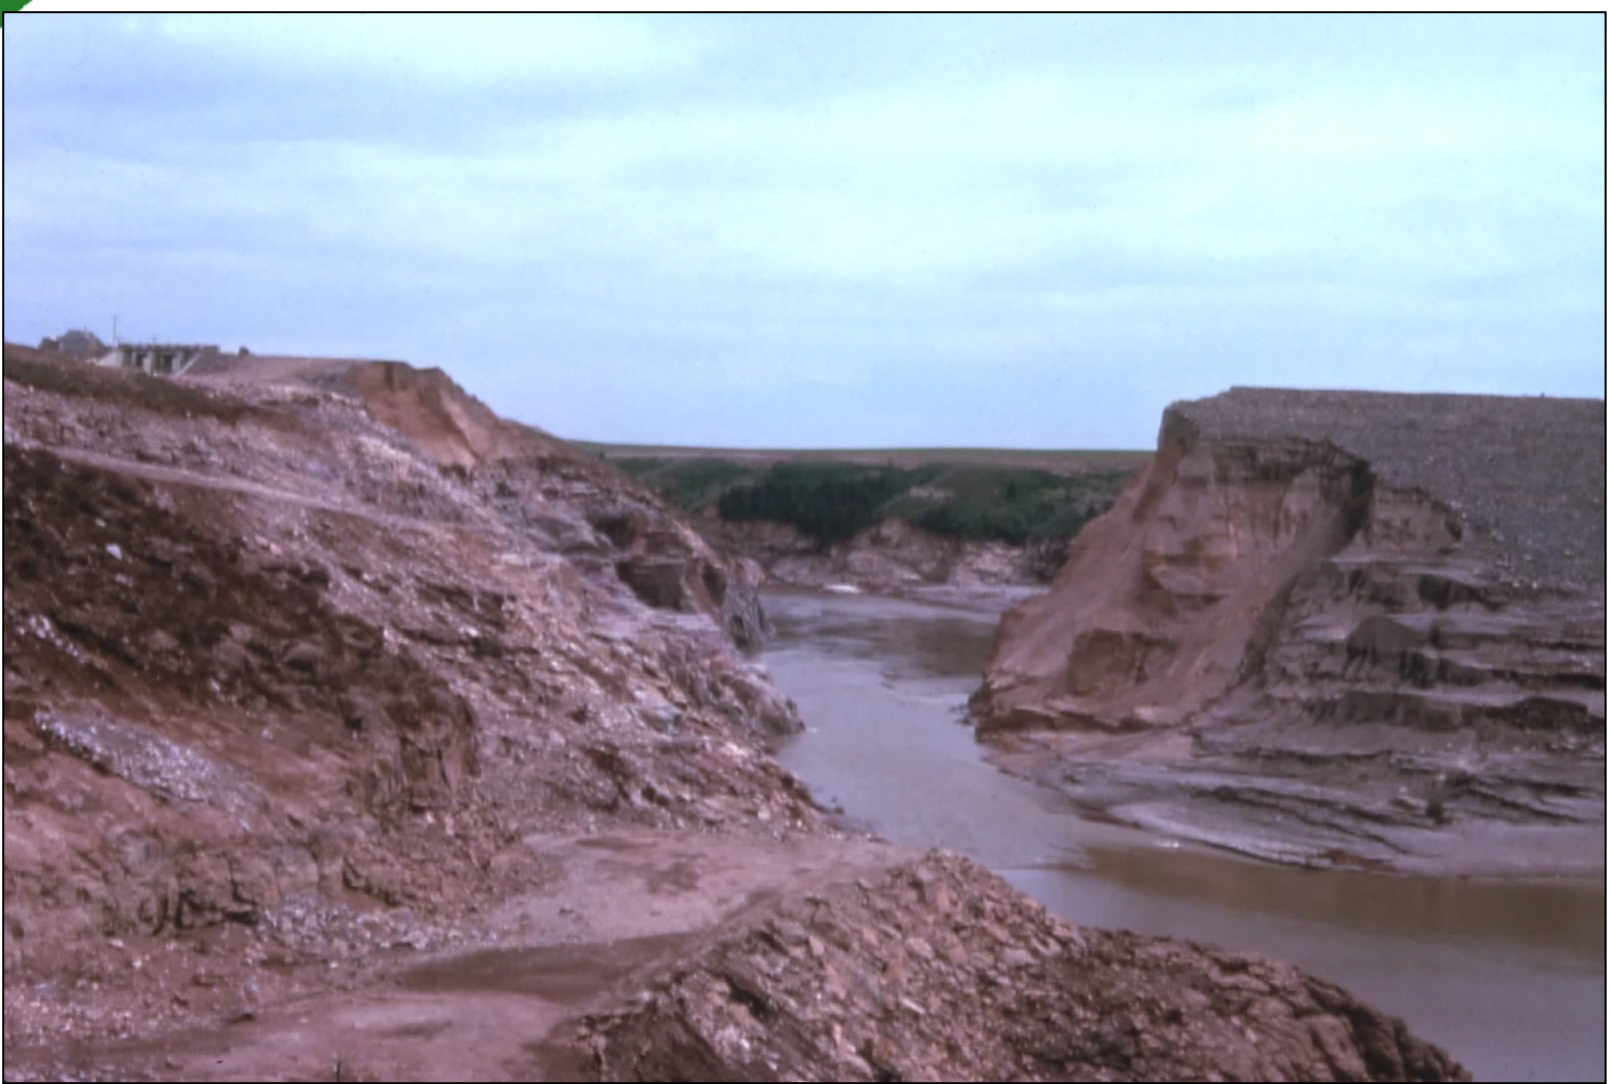
- **View looking upstream the day after the failure. The piping failure initiated on the right abutment, between elevations 5190 and 5230.**

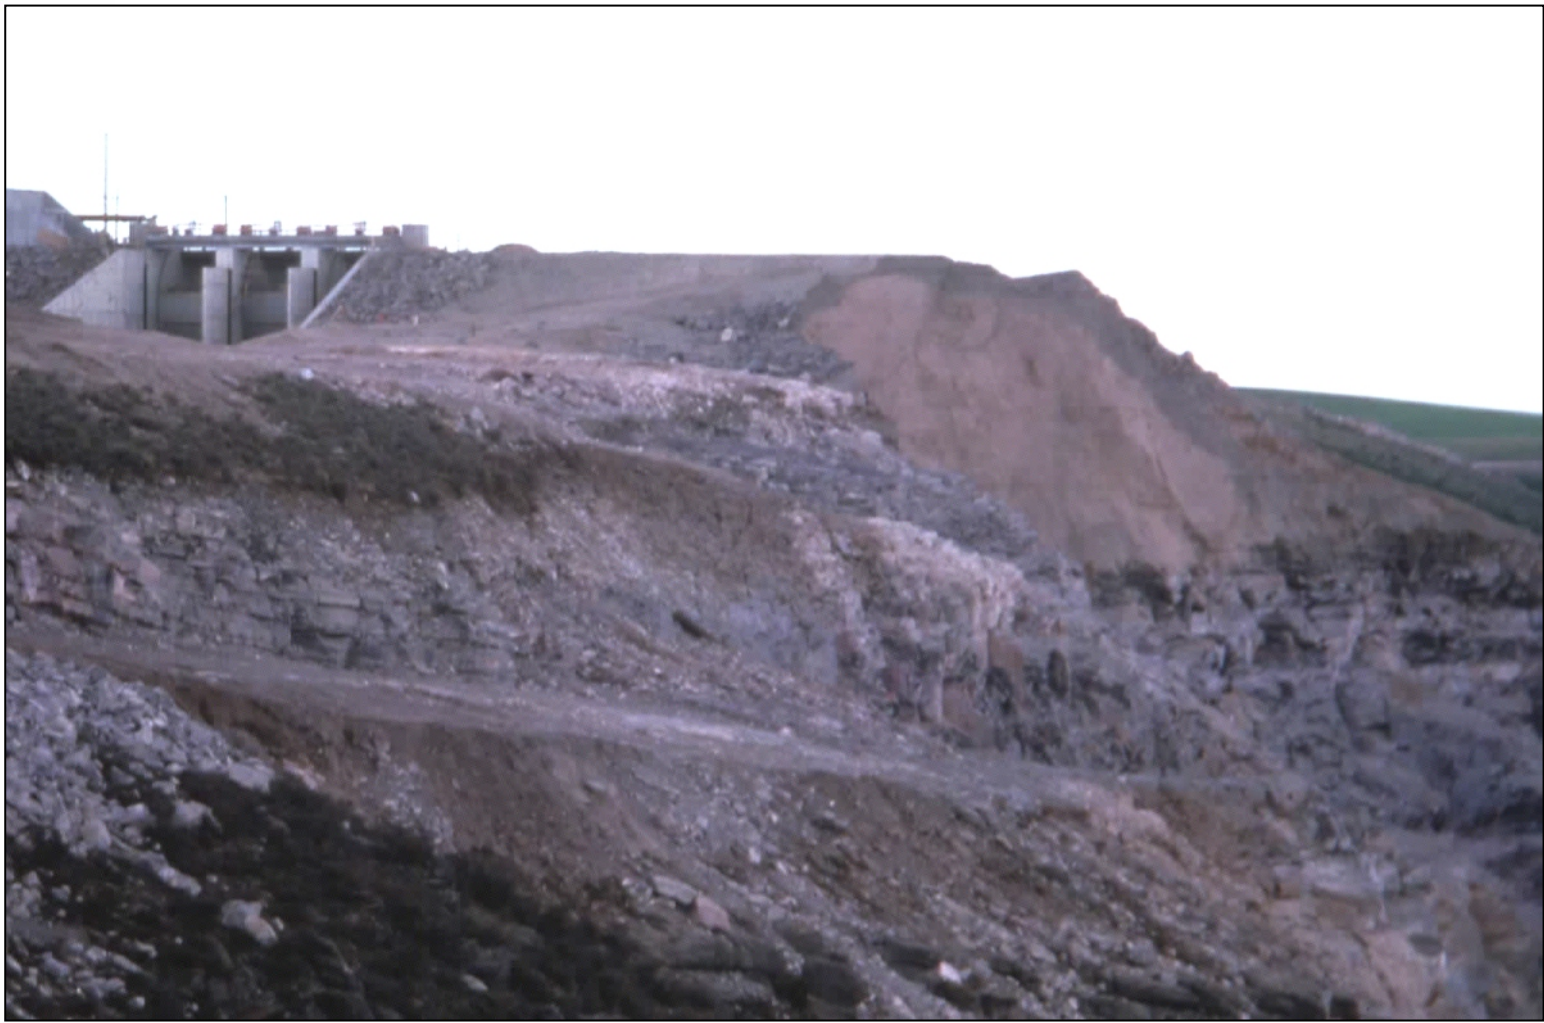
- **Telephoto view of crest of right abutment, showing remains of the right abutment keyway, crest embankment and spillway gates.**

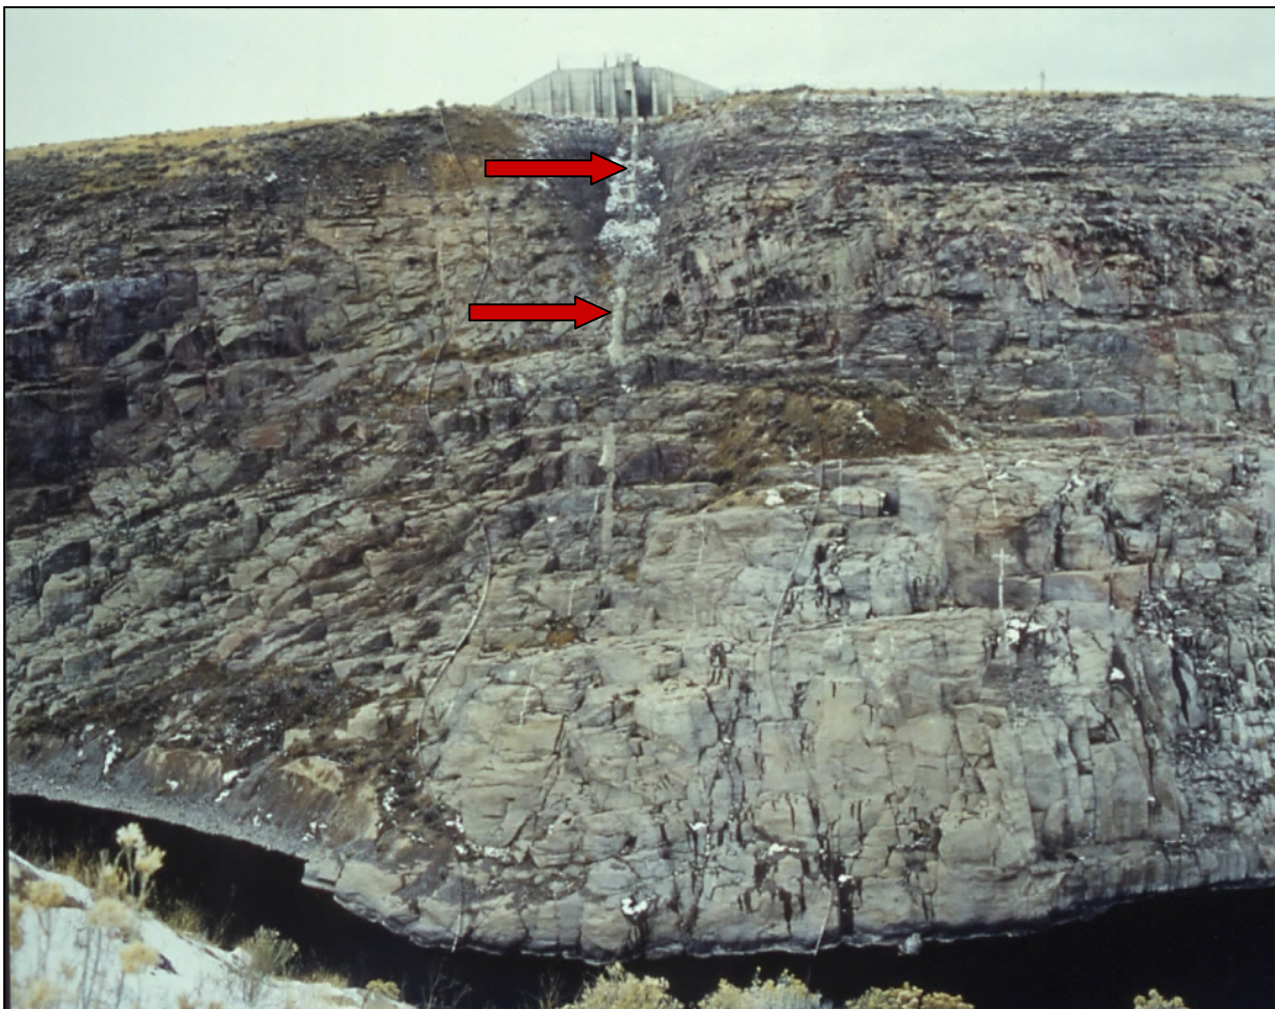
- **Looking at the right abutment and the remains of the grout cap (arrows). The 60 foot deep V-notched keyway was swept away during the flood**

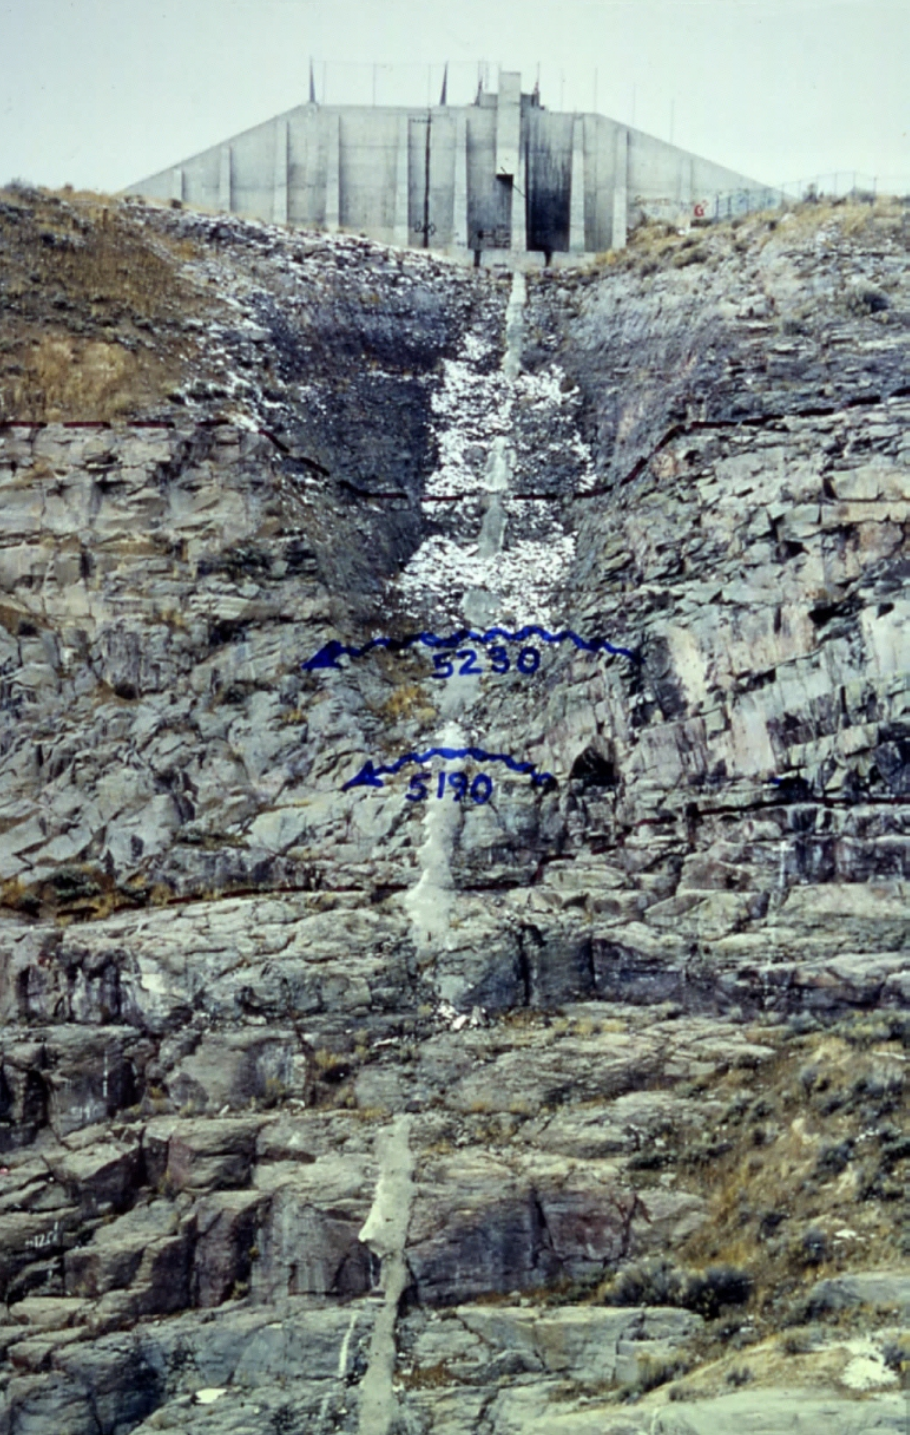
- **Detail of right abutment keyway area, showing zone between elevations 5190 and 5230 underlain by blocky Unit 2 rhyolite**
- **This is the fatal seepage zone, where water appears to have jumped across the keyway, initiating hydraulic piping of the Zone 1 loess fill**

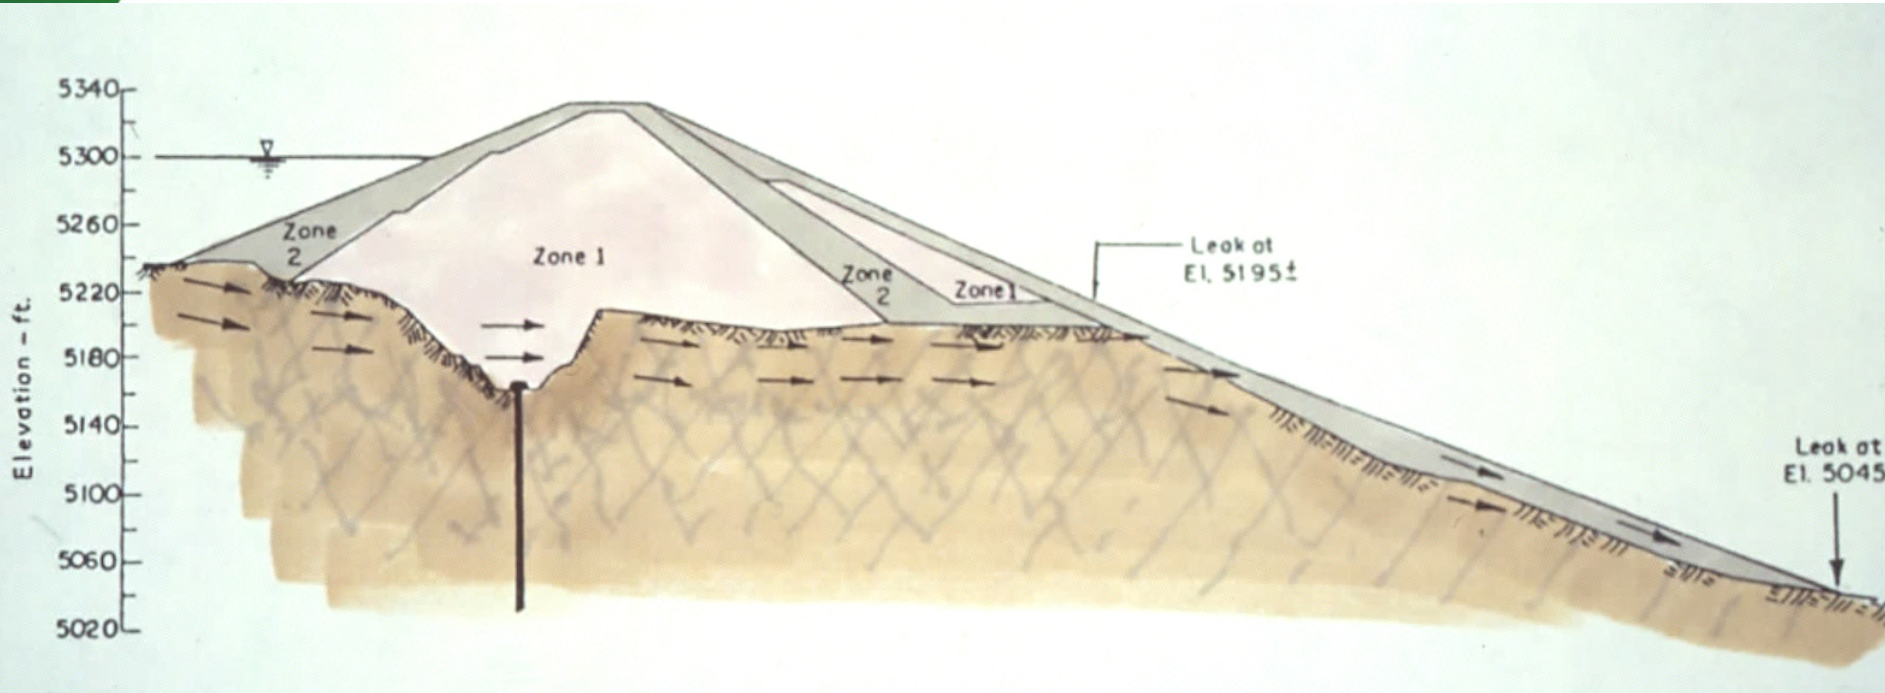
- **Cross section of right abutment keyway and crest embankment where the keyway trench was between elevations 5165 and 5220. The hydraulic piping appears to have initiated at this elevation in the keyway, based on observations the morning of the failure.**

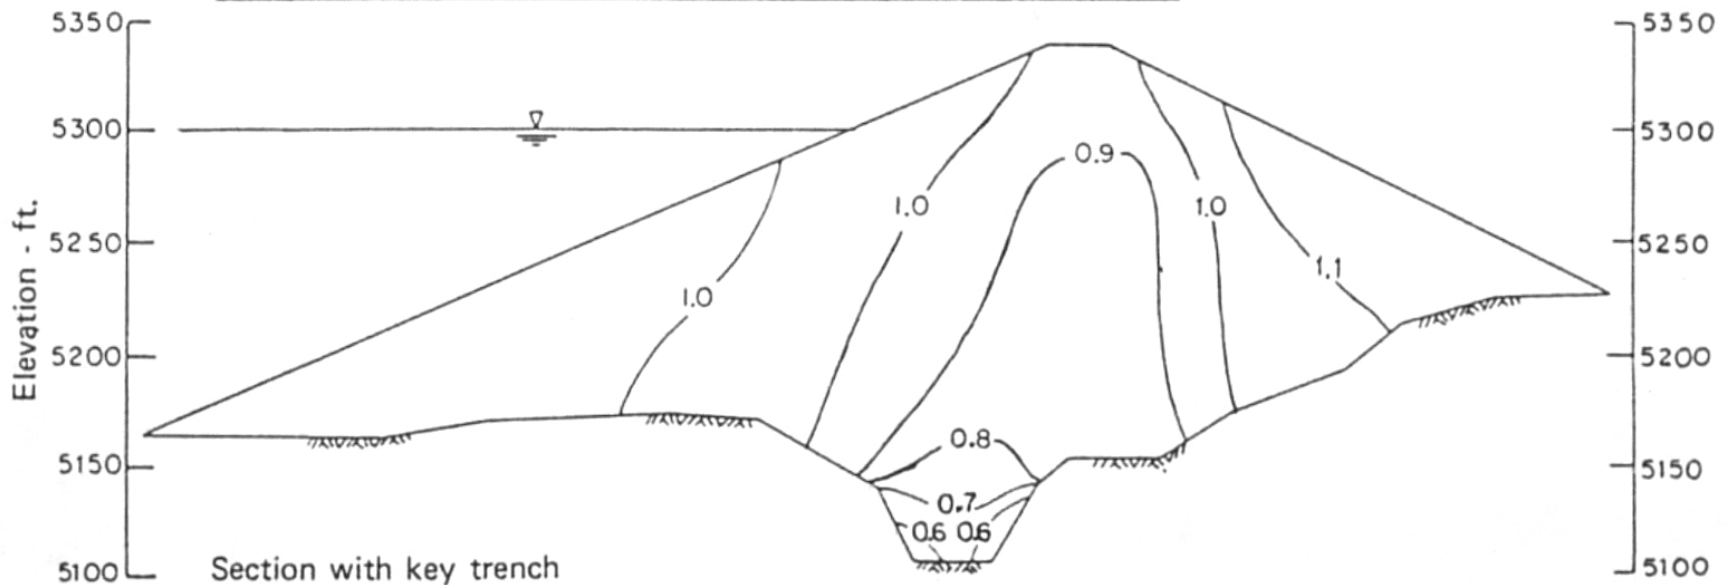
- Results from finite element analyses at U.C. Berkeley showing contours of ratio between vertical stress in embankment to overburden pressure in the keyway trench at Sta. 15+00, before wetting of the loess fill. The analysis suggests the load of the embankment was being arched across the steeply-inclined keyway trench.**

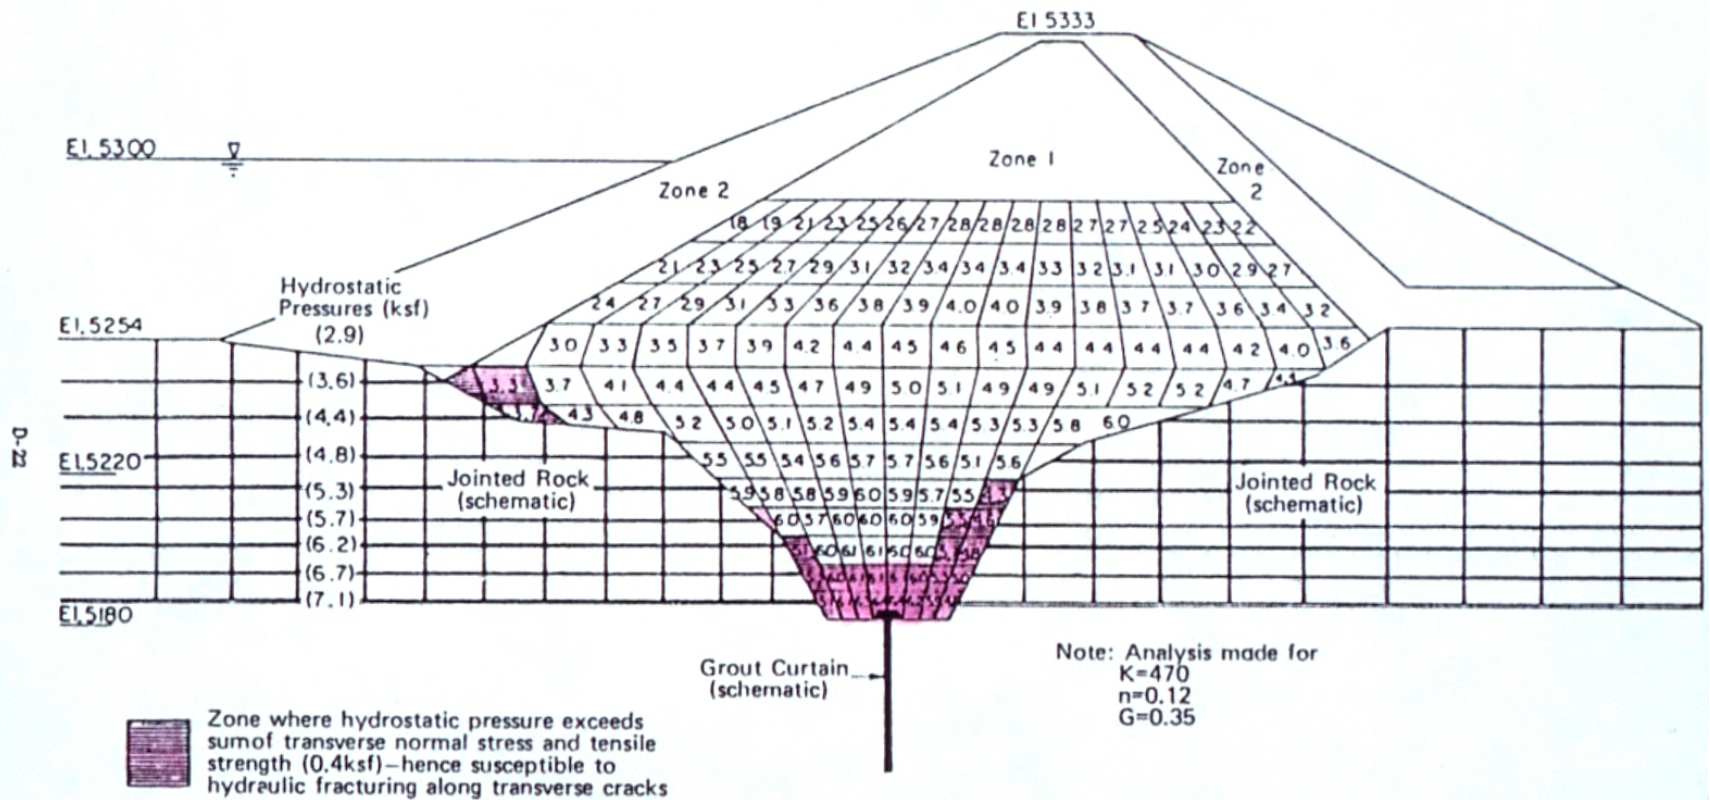
- Computed values of normal stress on cross section of right abutment at Sta. 13+70. The highlighted areas are where the predicted hydrostatic pressure **exceeds** the sum of the transverse normal stress and tensile strength of the Zone 1 fill. **These zones would have been susceptible to hydraulic fracturing.****

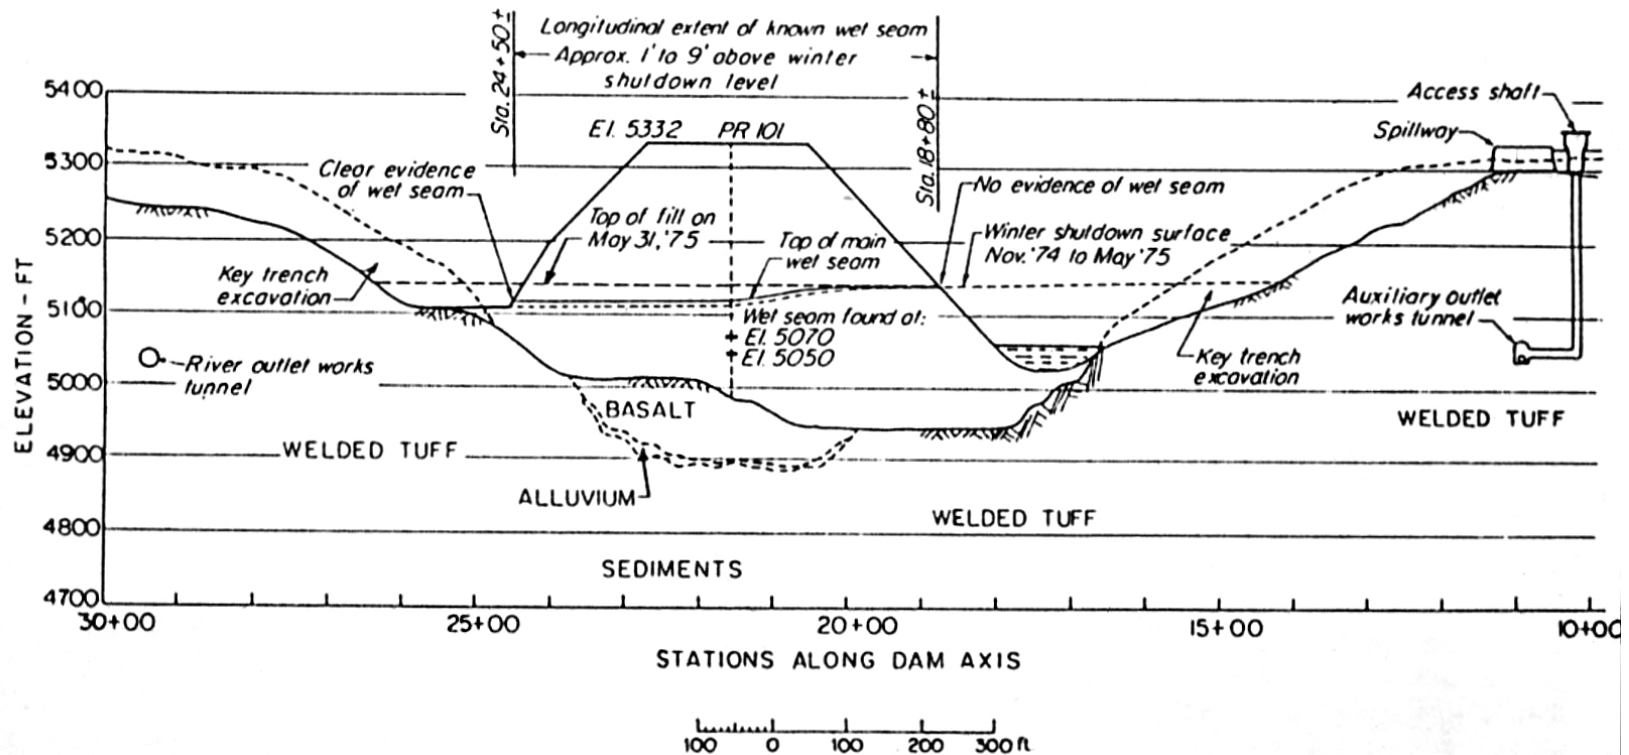
- In 1977 the Bureau of Reclamation dissected the remaining embankment and unearthed the **left abutment keyway** to examine the embankment fill and abutment contacts

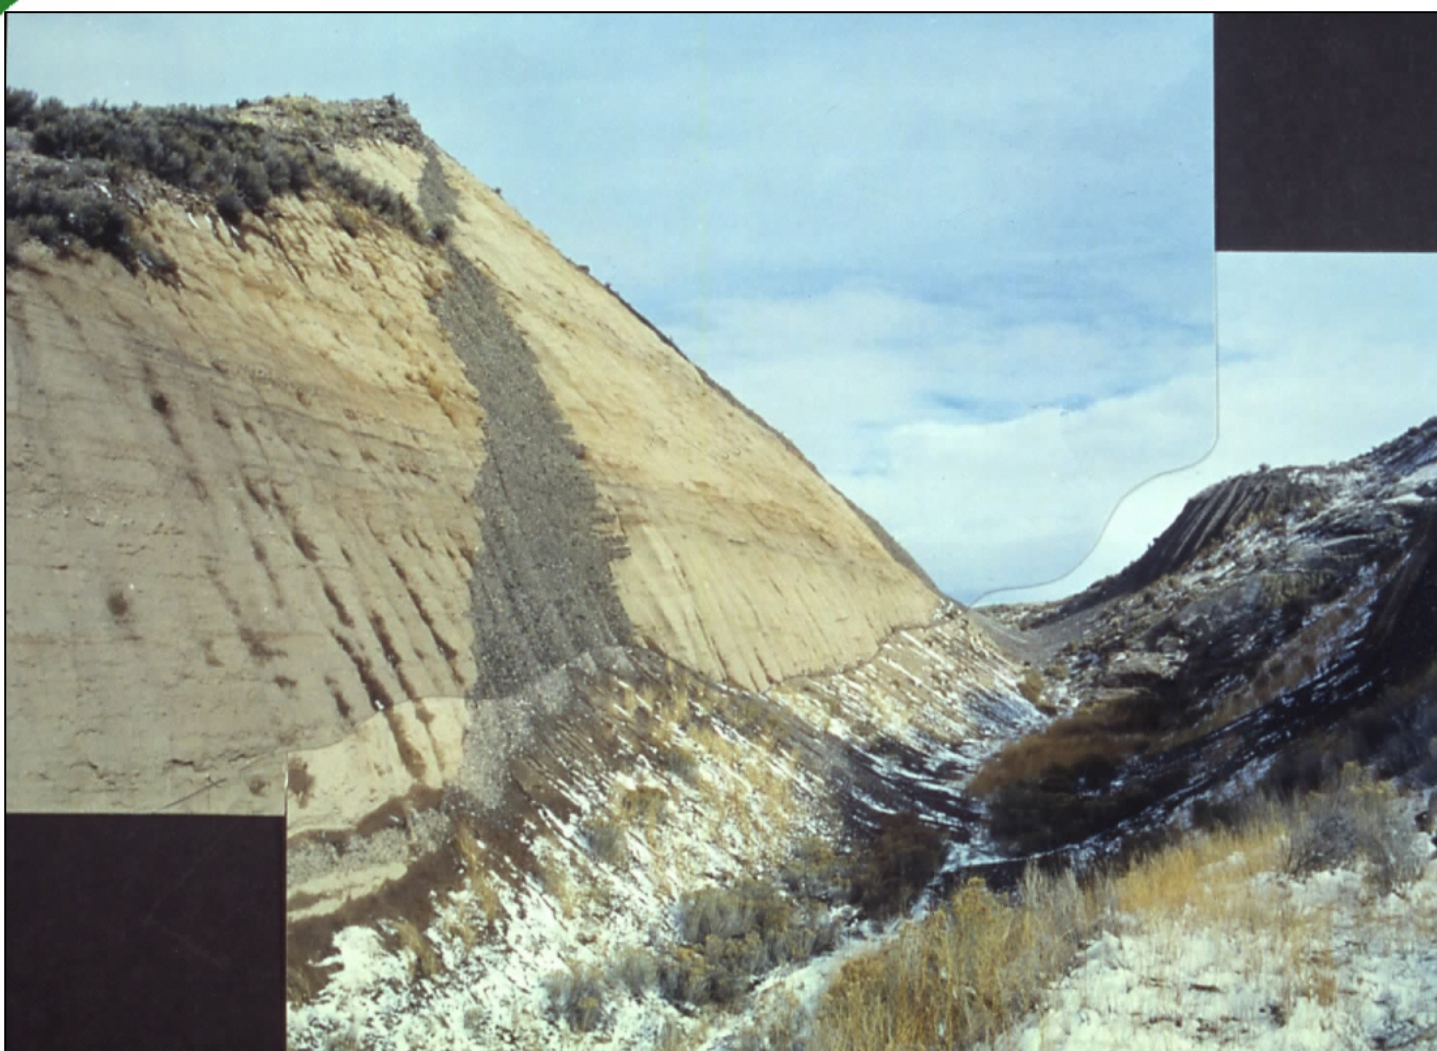
- **This shows the enormous cut severing the left side of the main embankment fill, exposing the inclined Zone 2 gravel drain. This is how the dam appears today.**
