Geologic Conditions Underlying the 2005 17th Street Canal Levee Failure in New Orleans

J. David Rogers, Ph.D., P.E., P.G.
Missouri University of Science & Technology

for Technical Session #15 on
New Orleans Levees and Hurricane Katrina

17TH Street Drainage Canal Failure:

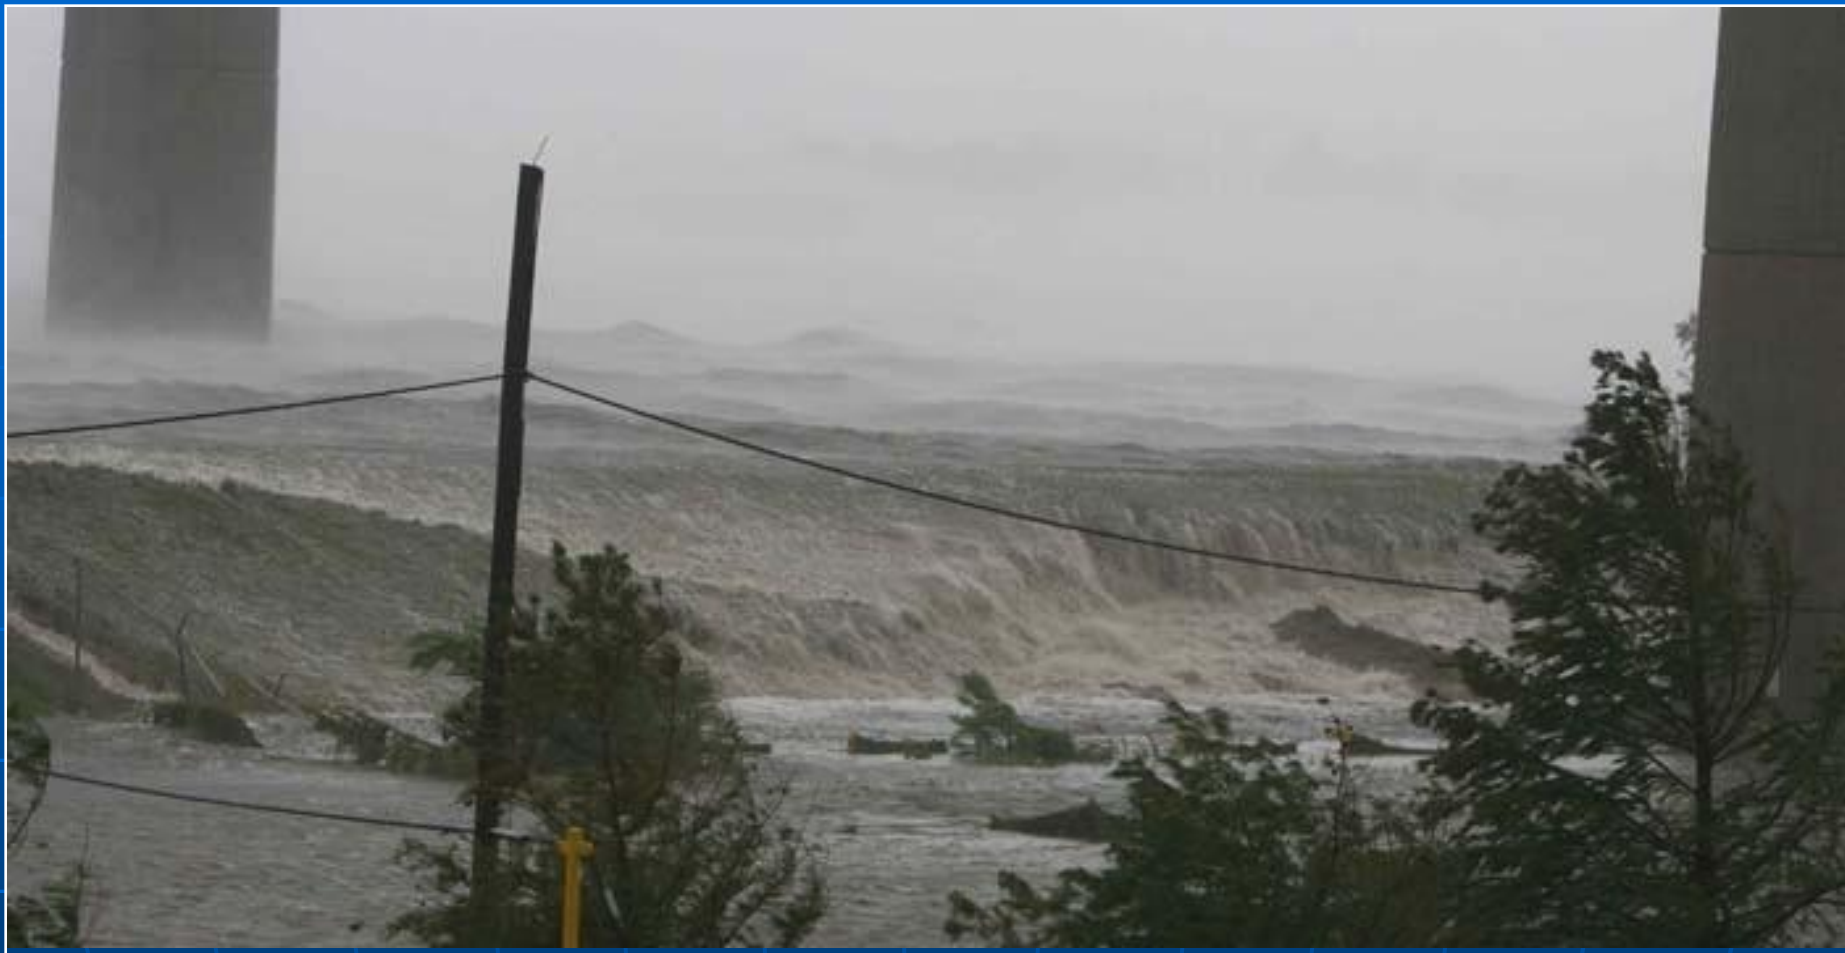
- **Around 6 AM on August 29th the 9 ft storm surge swept into the Inner Harbor Navigation Canal area, engulfing the Entergy Power Plant area with waves up to 17 ft high.**

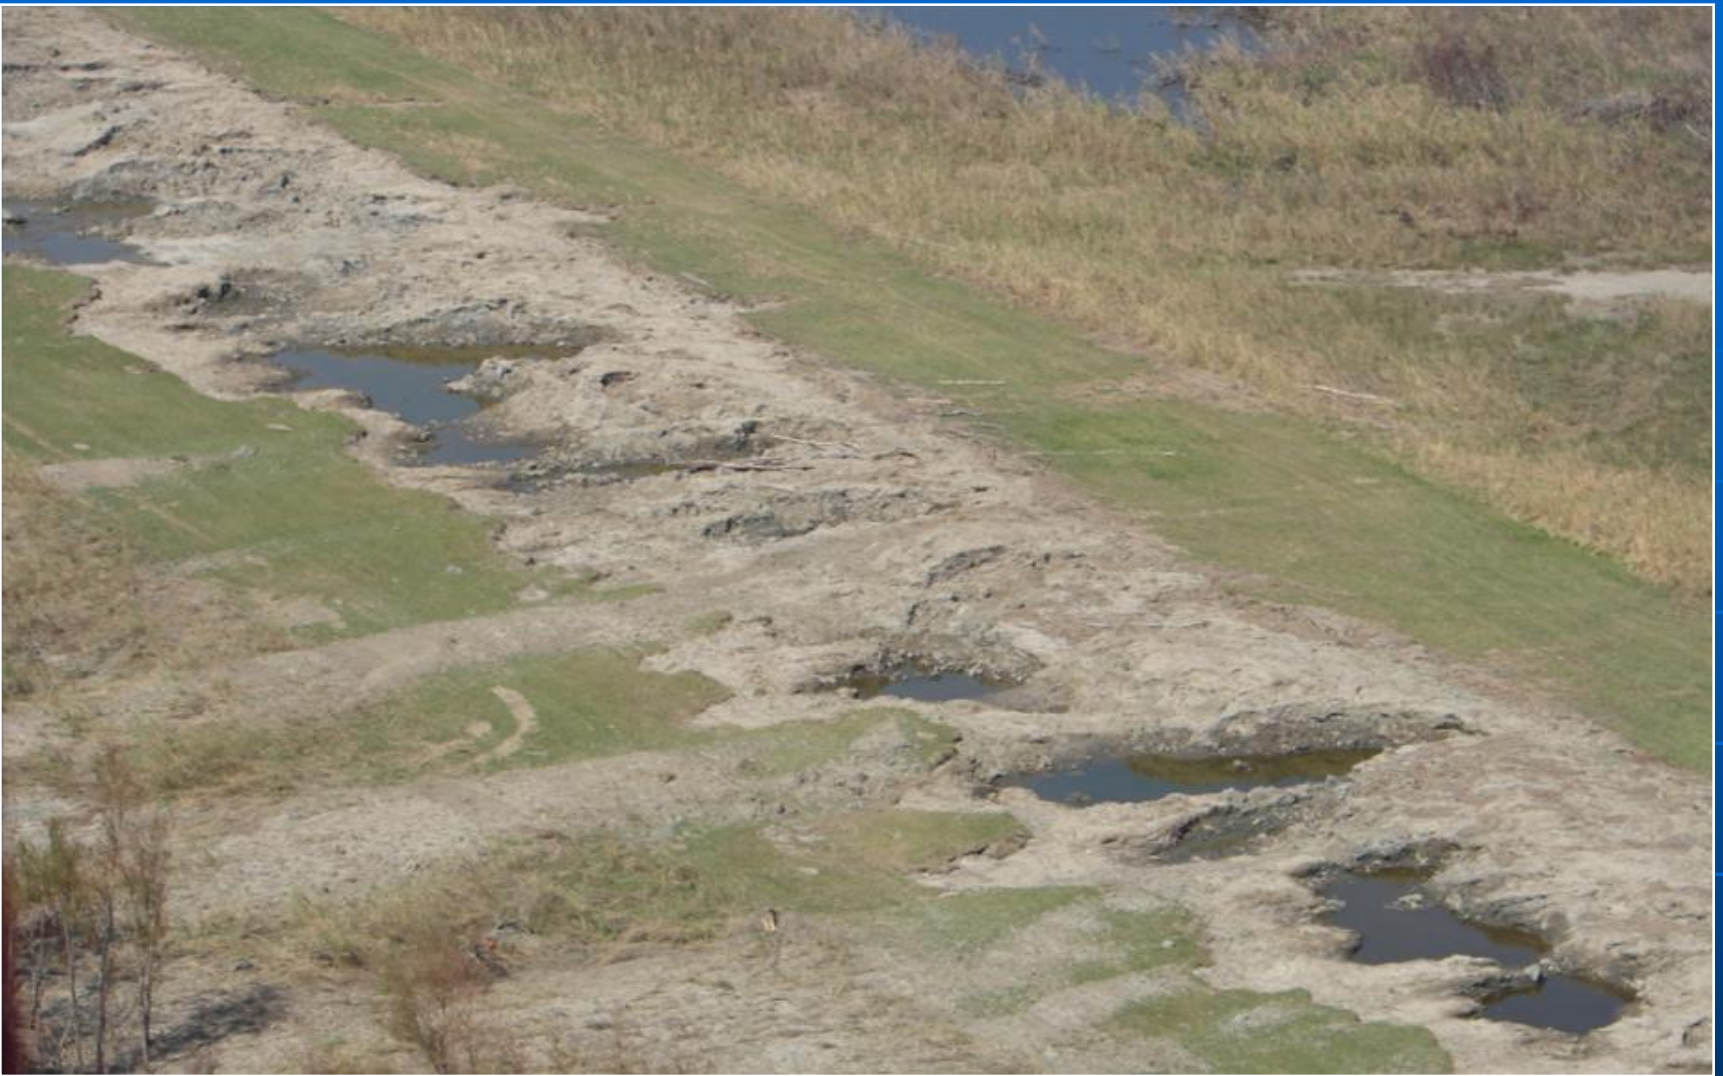
- **Miles of levees just disappeared: MRGO levee completely washed away about two miles southeast of Bayou Dupree.**

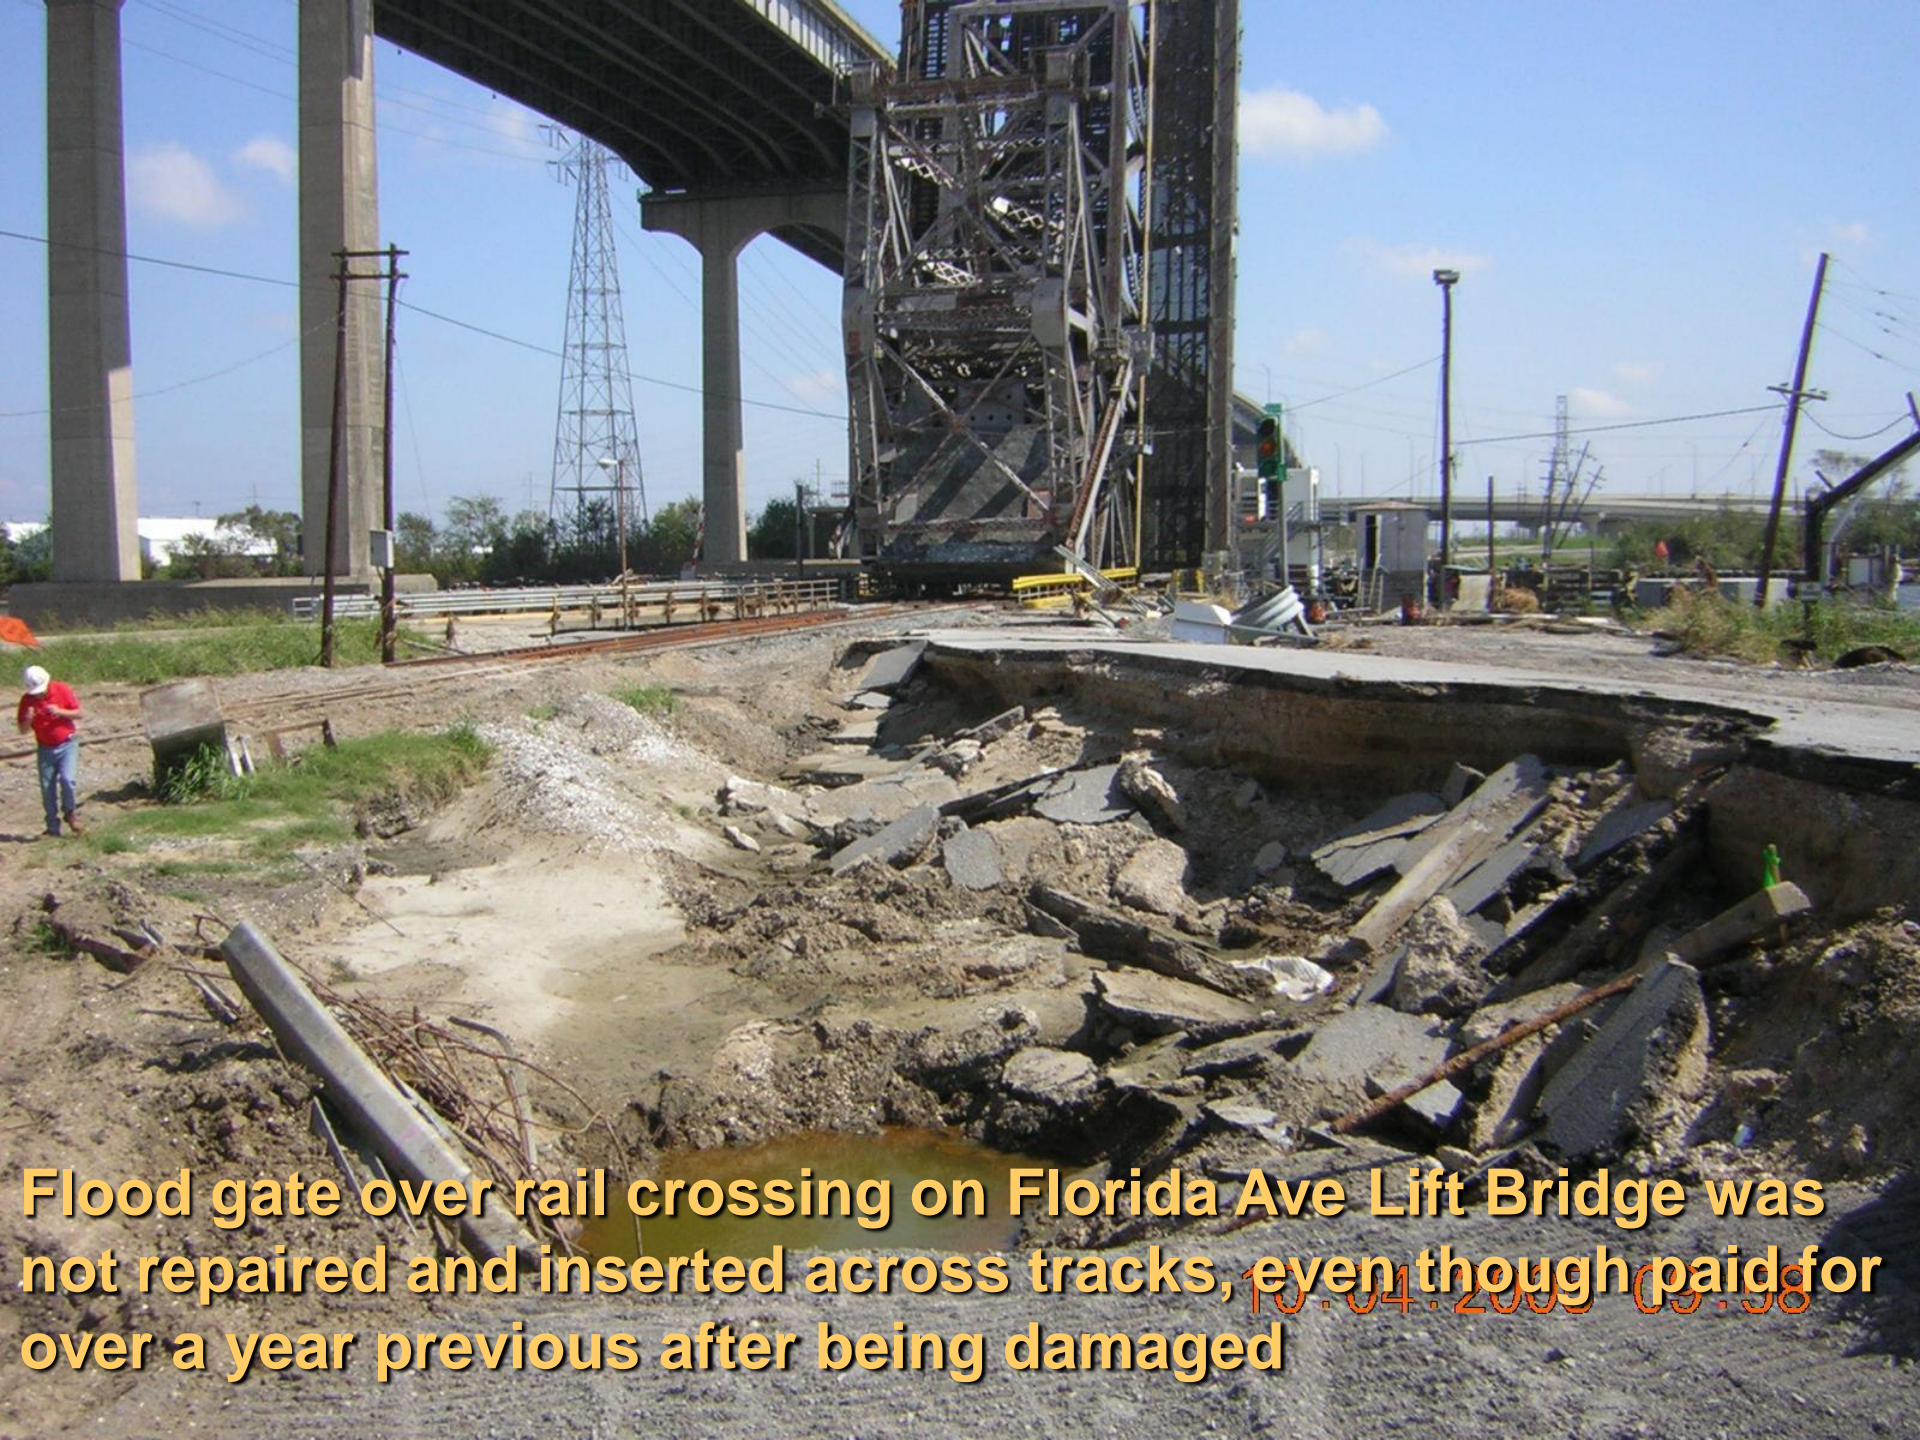
Flood gate over rail crossing on Florida Ave Lift Bridge was not repaired and inserted across tracks, even though paid for over a year previous after being damaged

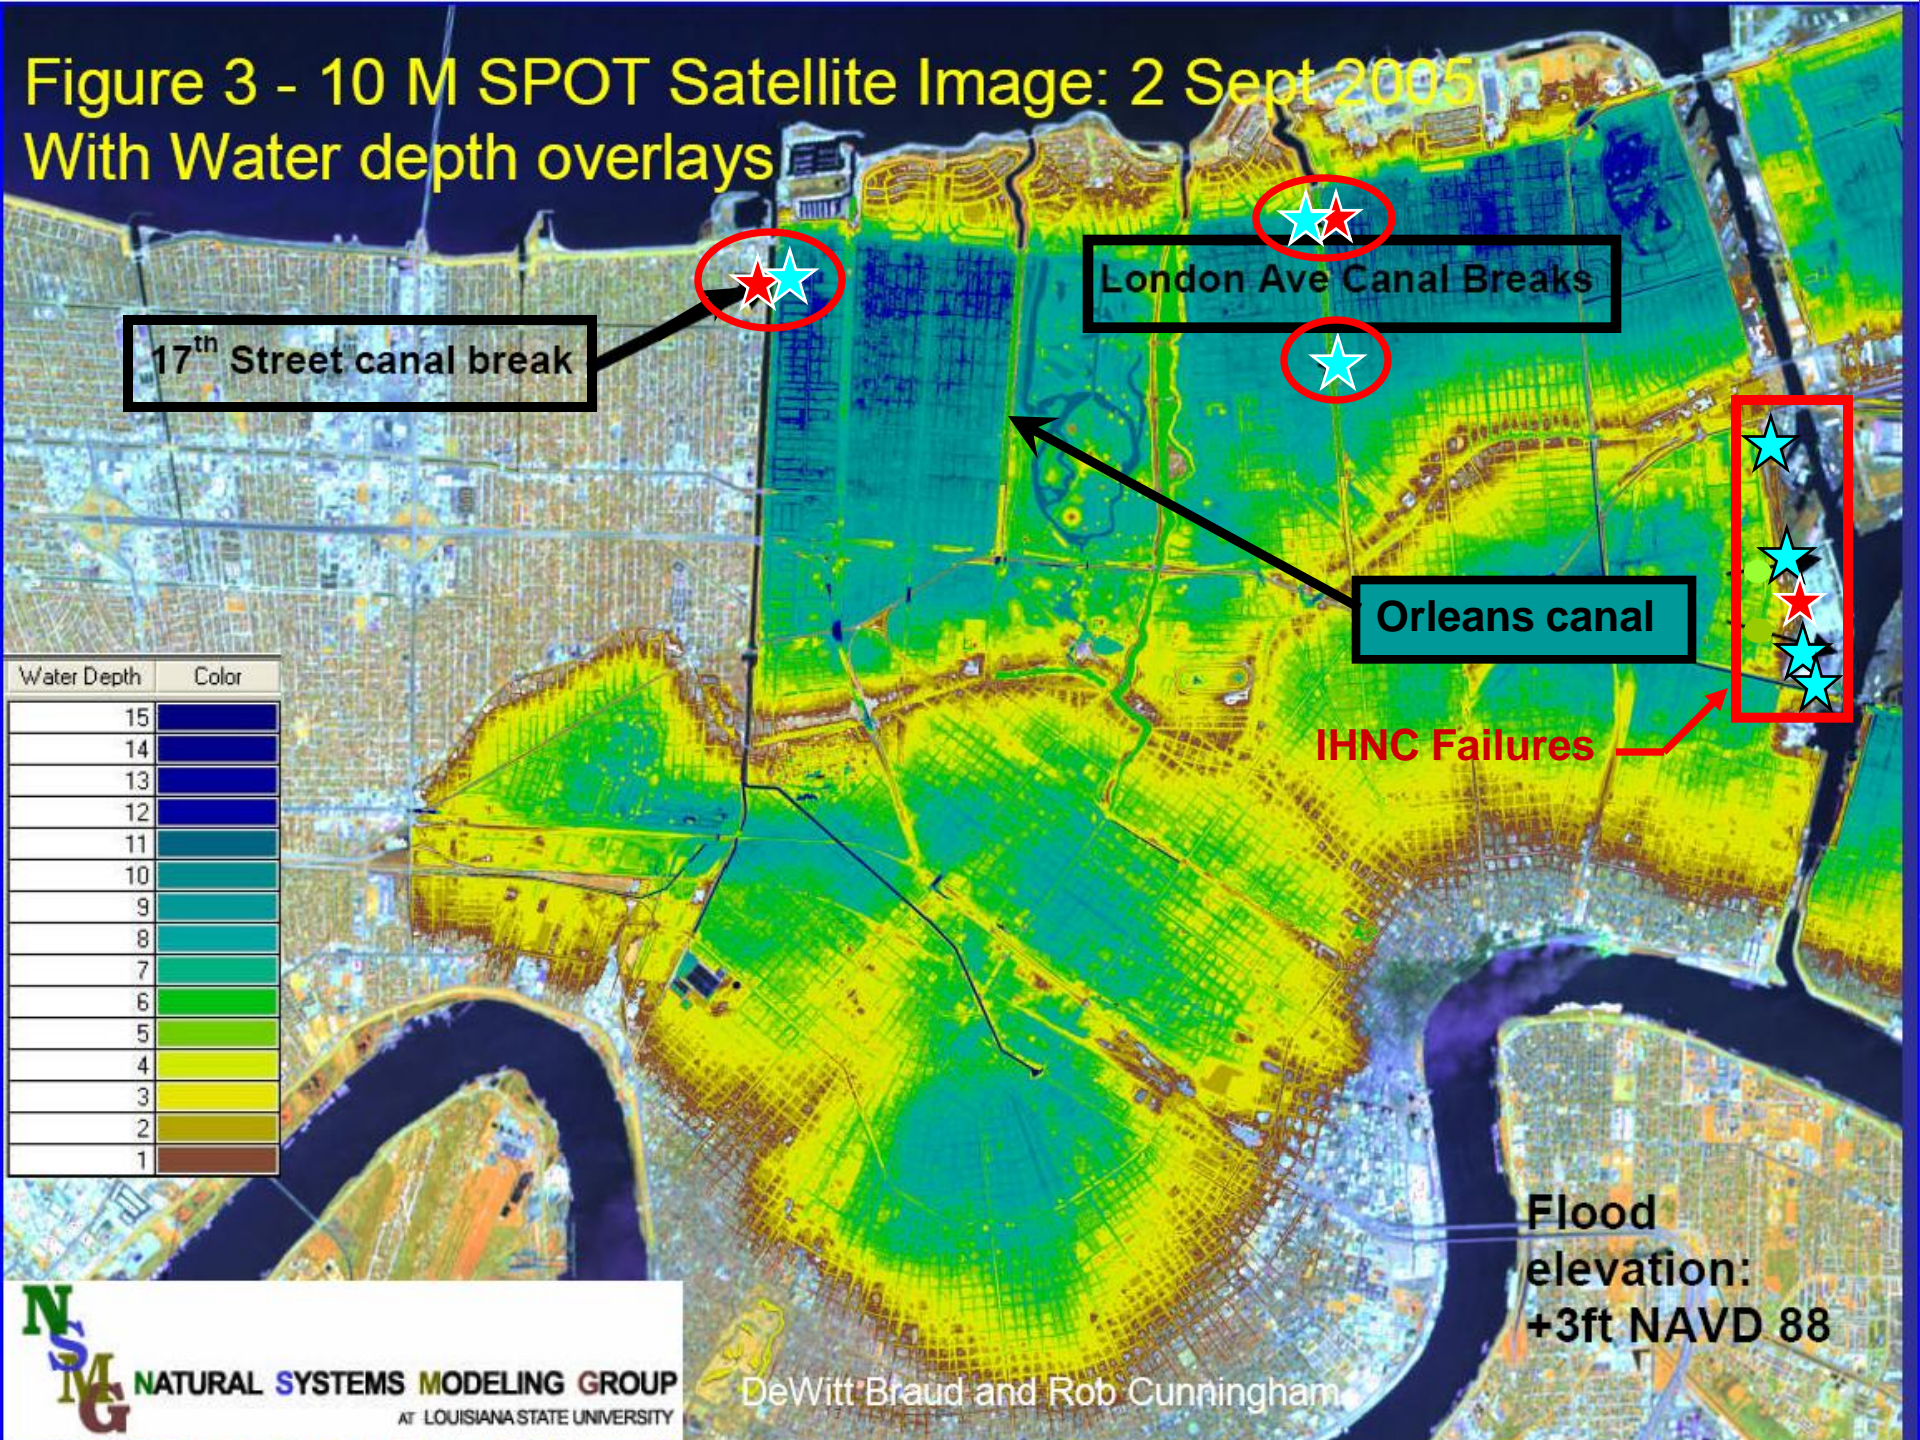
Figure 3 - 10 M SPOT Satellite Image: 2 Sept 2005
 With Water depth overlays

17th Street canal break

London Ave Canal Breaks

IHNC Failures

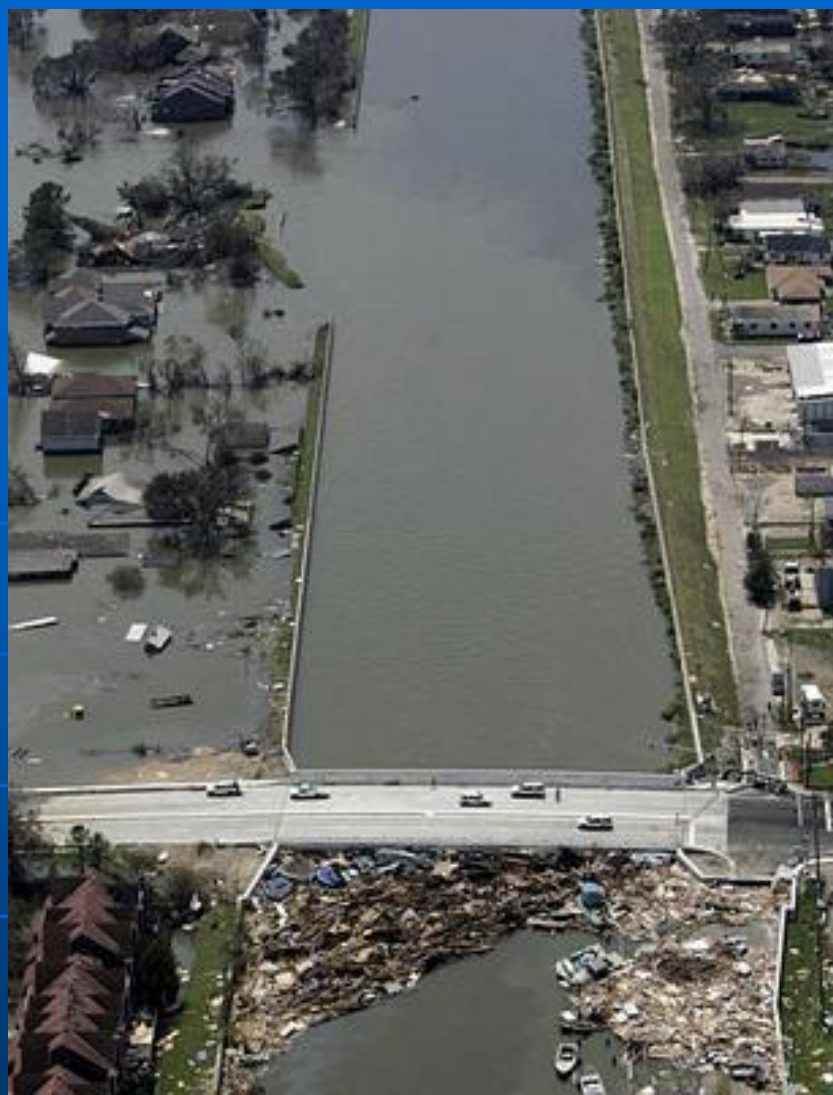
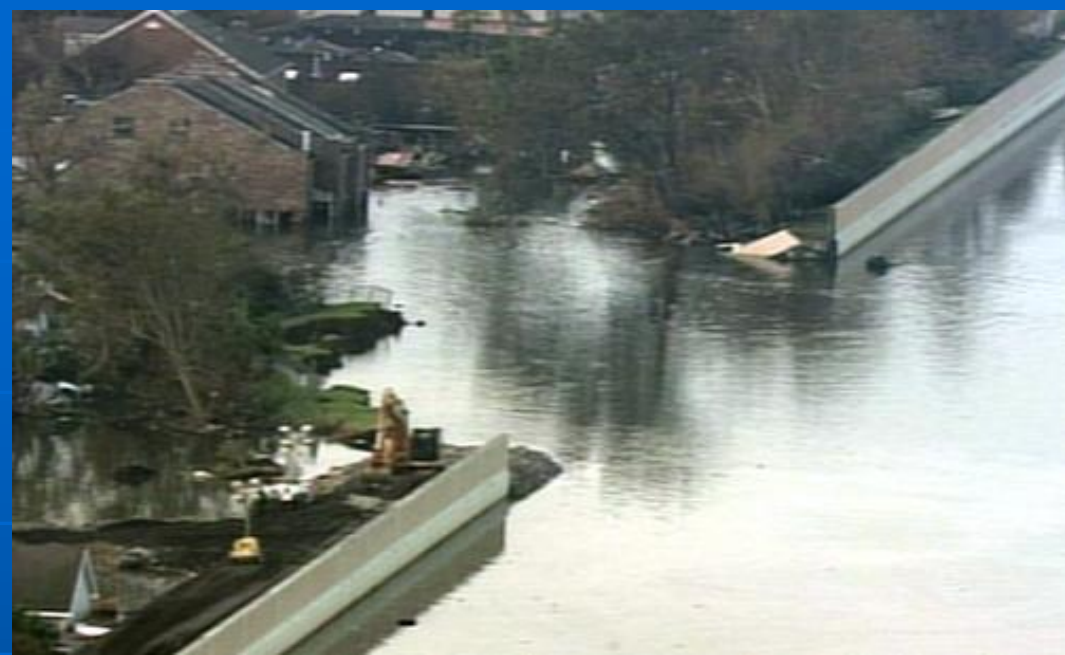
- **Breach began with noticeable leakage around 6 AM when the storm surge level reached +6 ft**

Eyewitness accounts suggest that the entire breach took about 4 hours to develop, commencing just before 6 AM and enlarging itself until about 10 AM

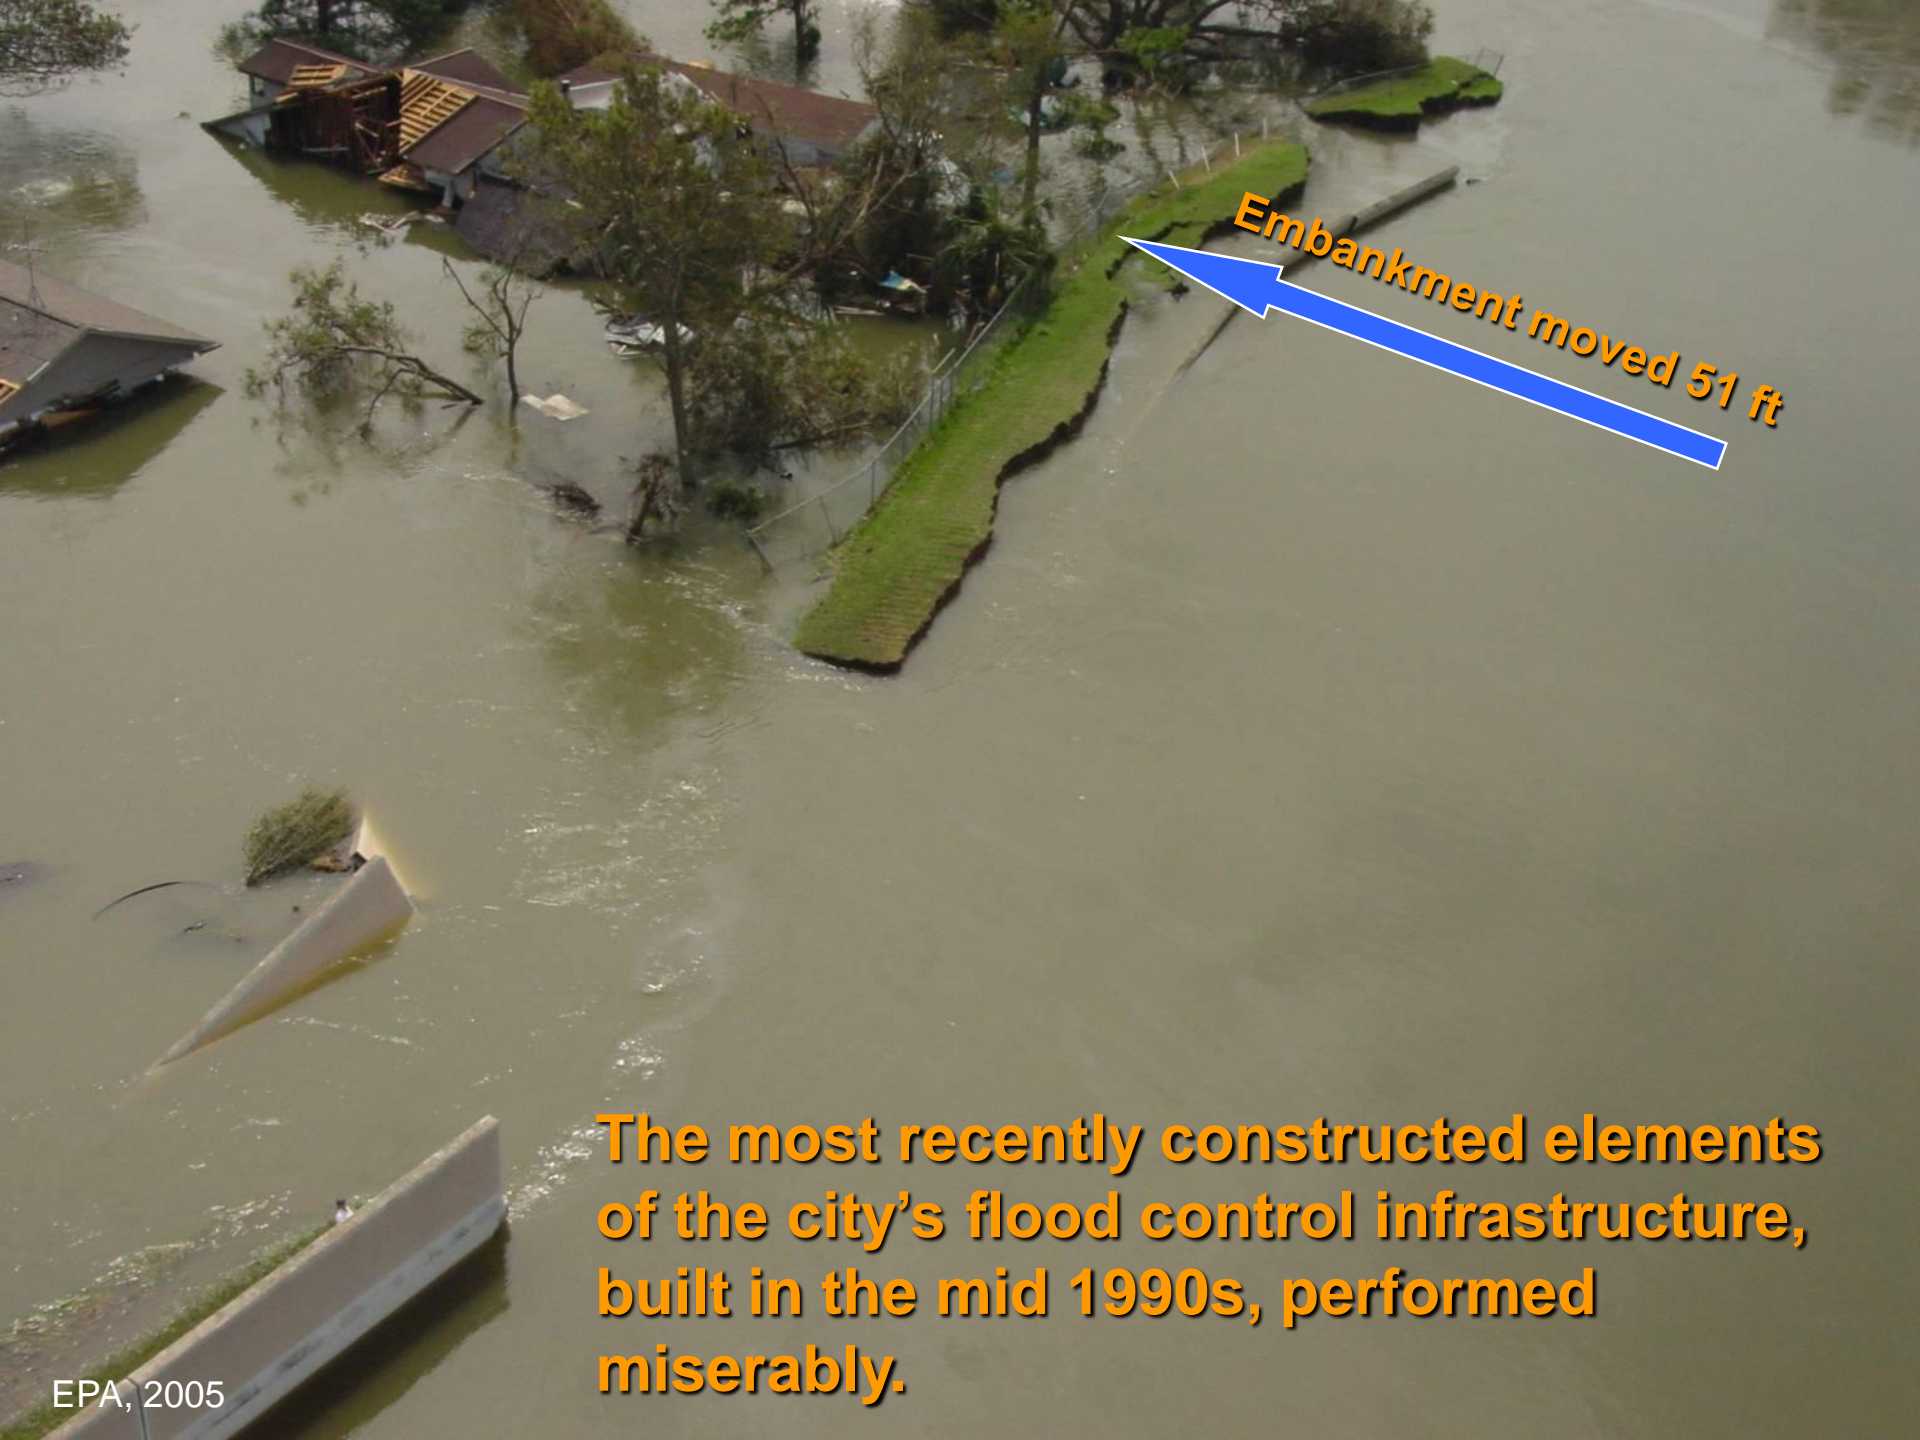
Embankment moved 51 ft

The most recently constructed elements of the city's flood control infrastructure, built in the mid 1990s, performed miserably.

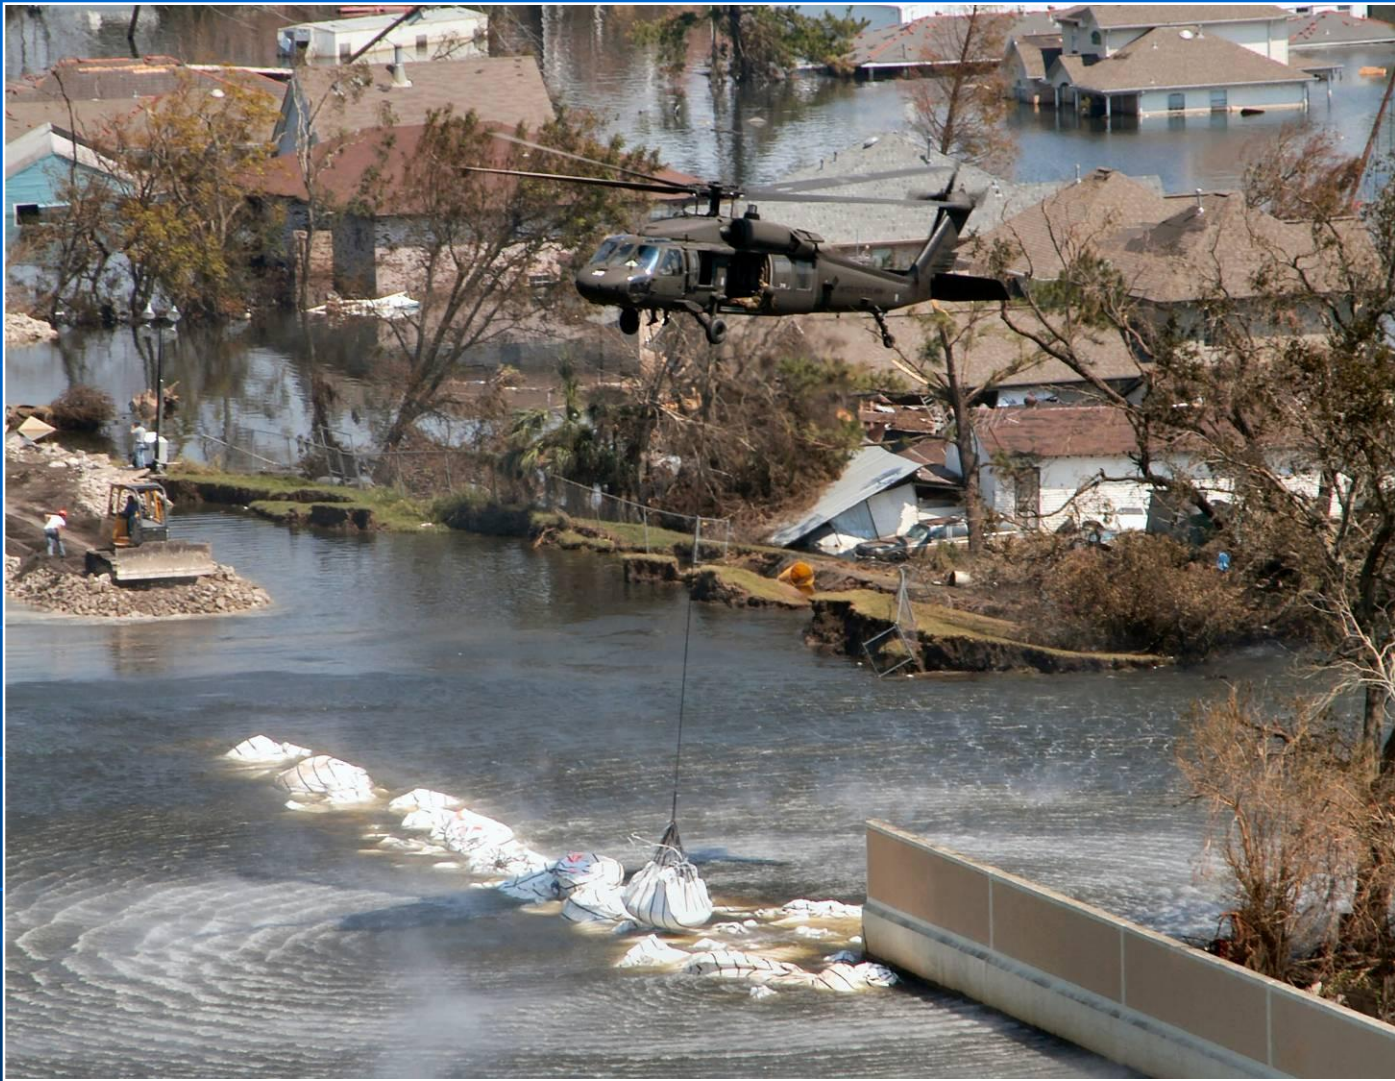
- **Army helicopters and contractors worked for weeks to fill the enormous gaps in the levee system, BEFORE pumping could begin.**

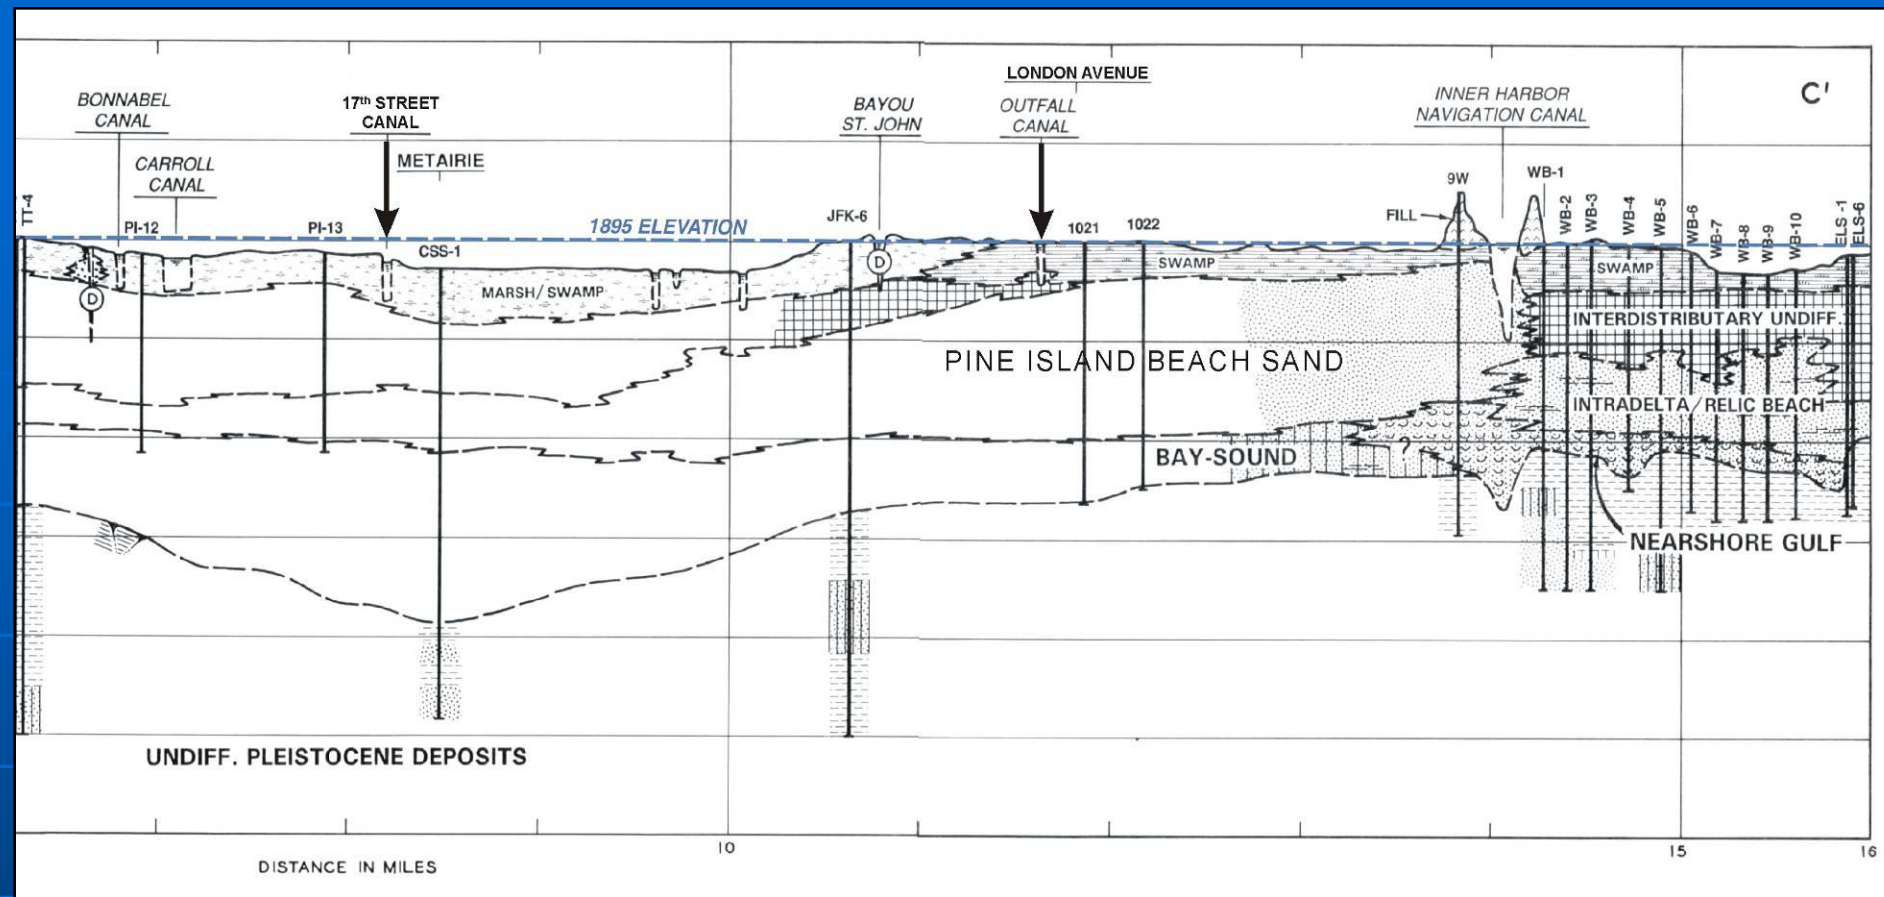
- **Geologic cross section along south shore of Lake Pontchartrain in the Lakeside, Gentilly, and Ninth Ward neighborhoods, where the 17th Street, London Avenue, and IHNC levees failed during Hurricane Katrina on Aug 29, 2005.**
- **Note the apparent settlement that has occurred since the city survey of 1895 (blue line), and the correlation with the marsh-swamp deposits.**

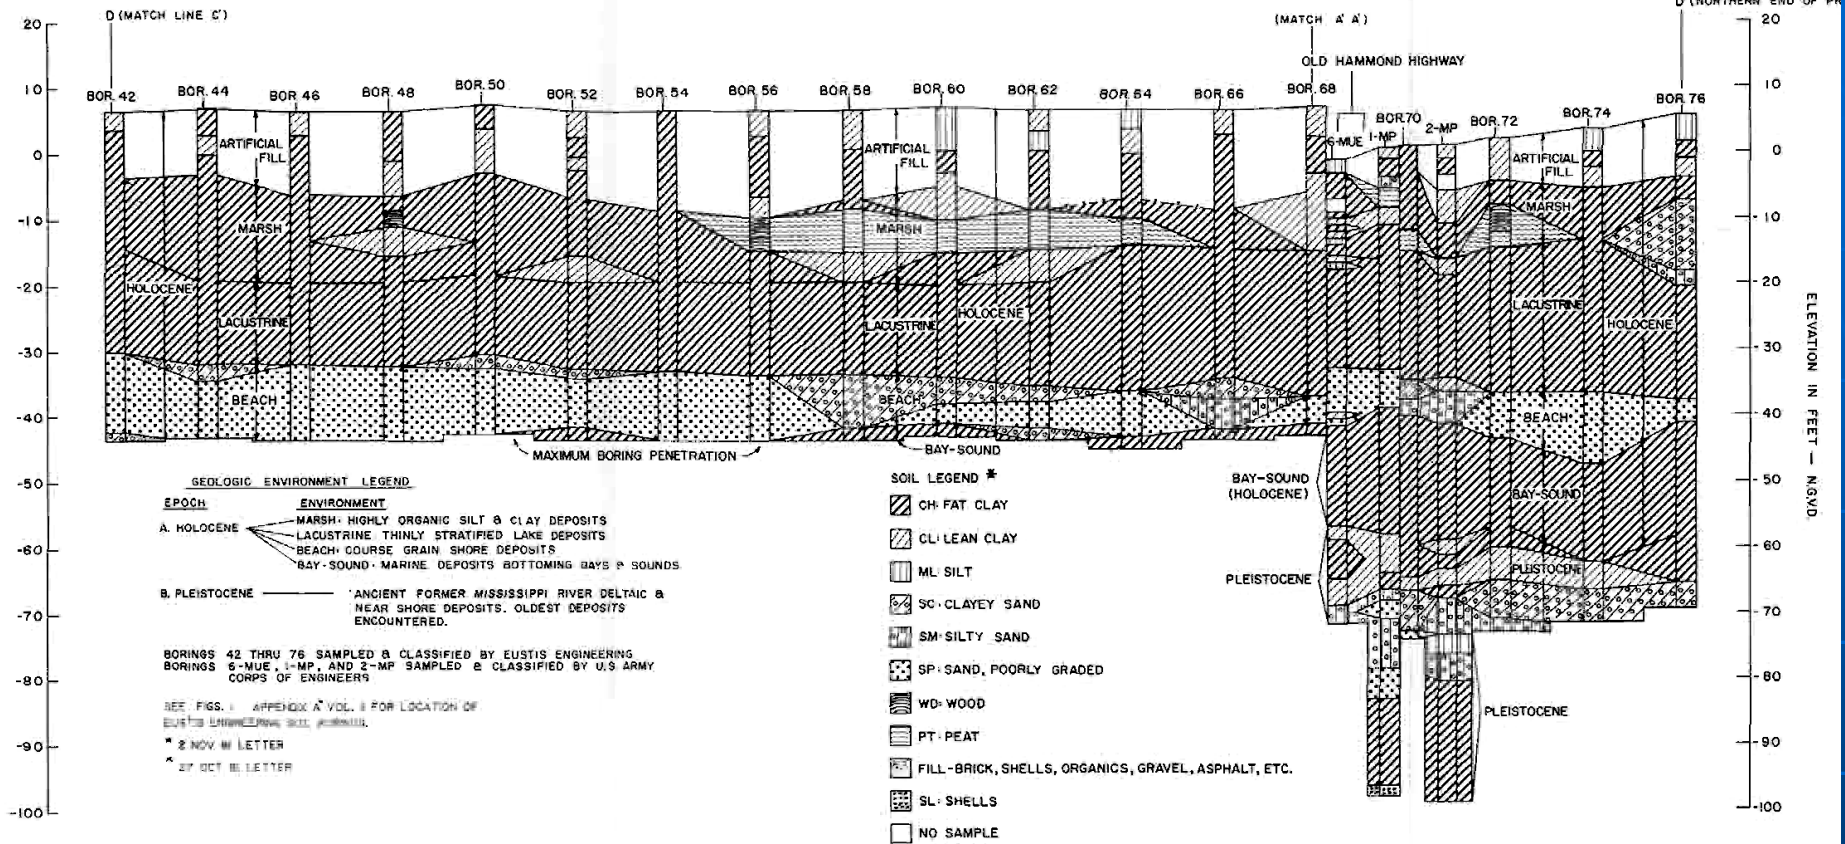
Geologic profile for the 17th St Canal flood wall prepared by Corps' New Orleans District office in 1990. Three of four holes in vicinity of the 2005 failure (spaced 500 ft apart) had zero sample recovery. These contacts were projected and the sheet pile tips designed, accordingly.

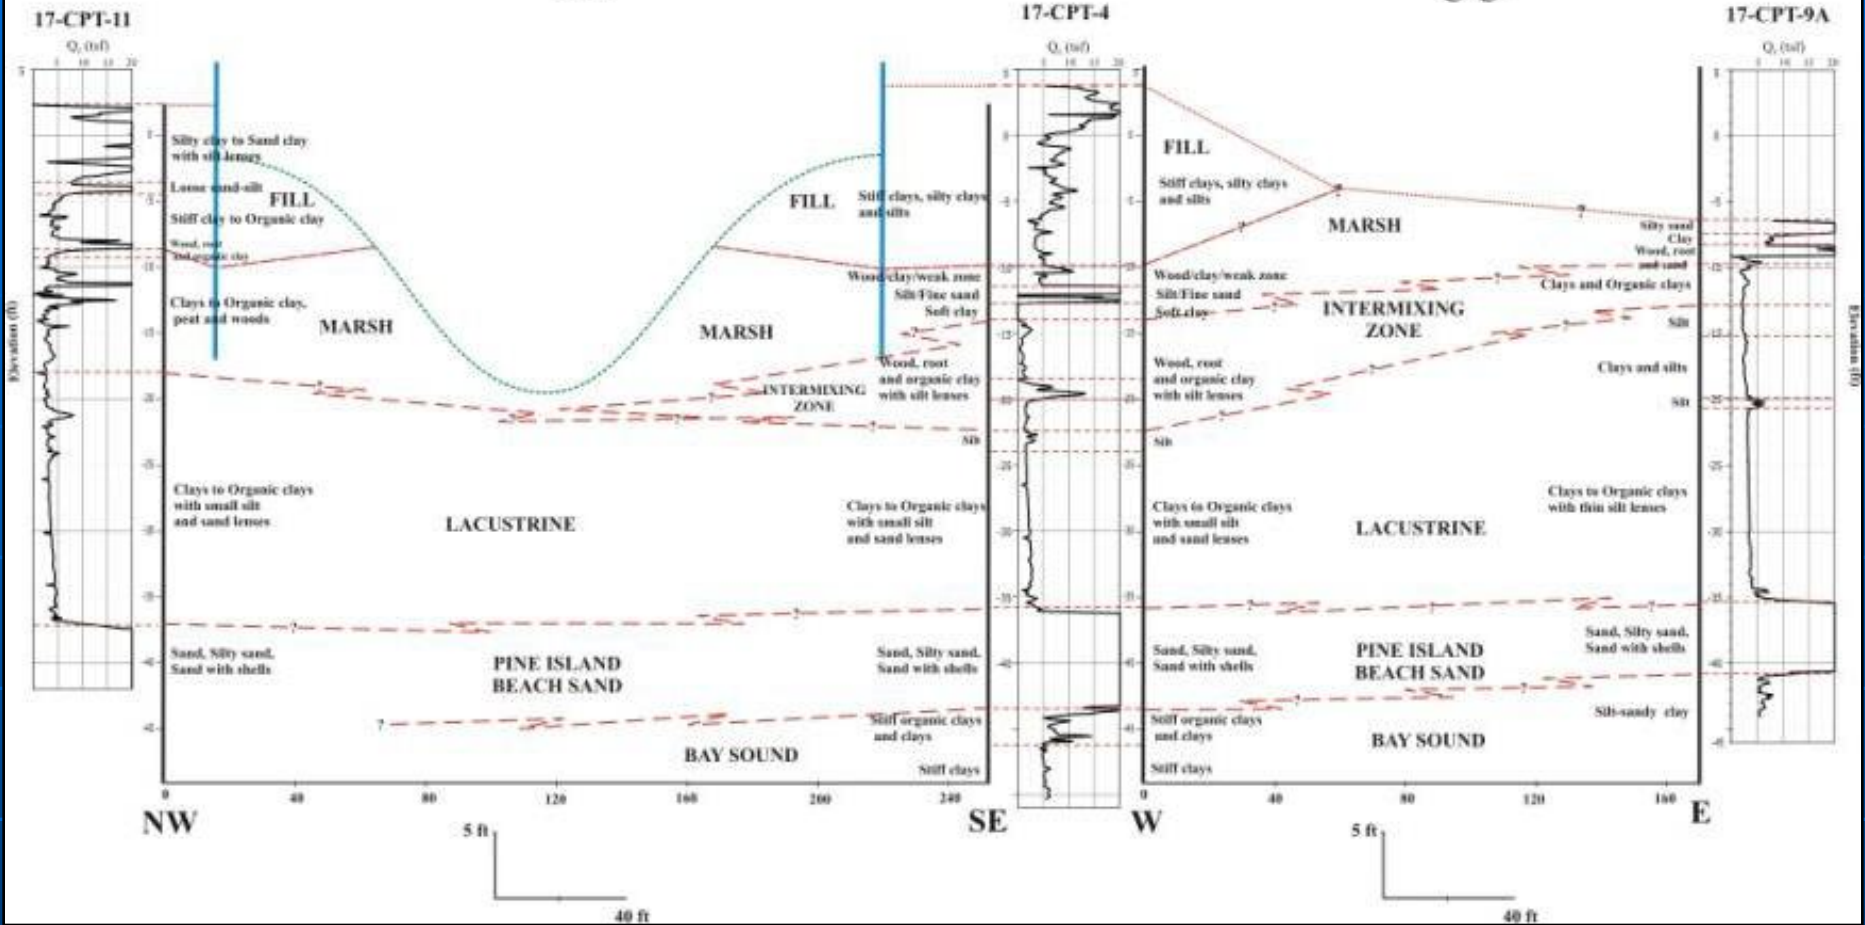
- Stratigraphic interpretations across the 17th Street Canal breach. The swamp much appeared to be thinning northerly, as does the underlying Pine Island Beach Trend. The lacustrine clays appear to thicken southward, as shown.

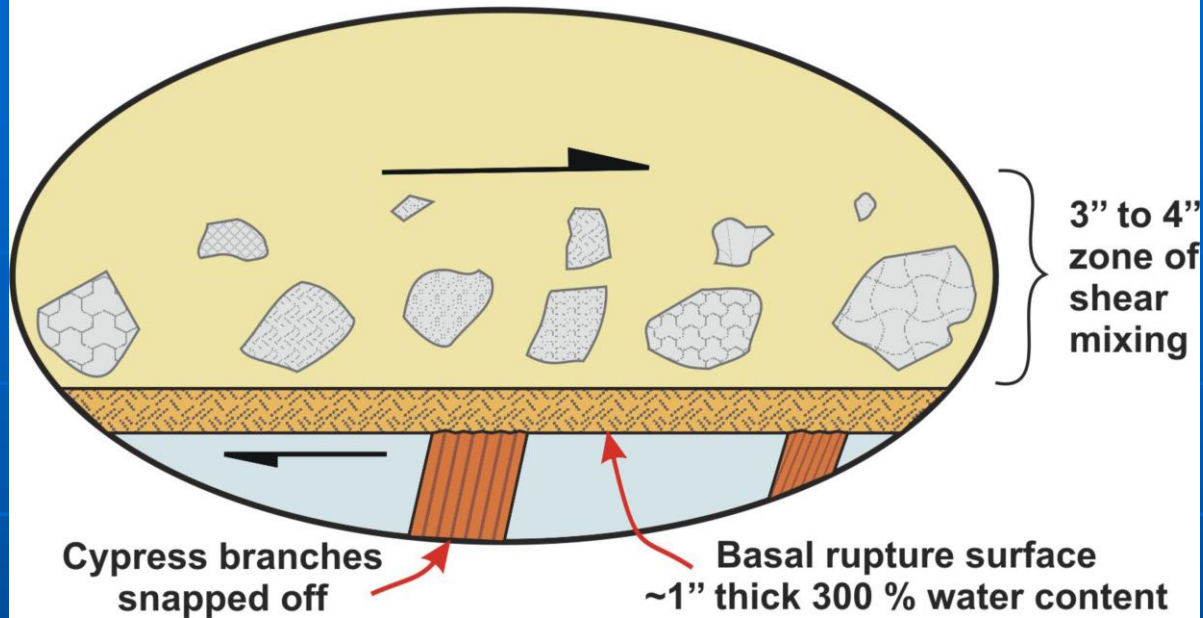
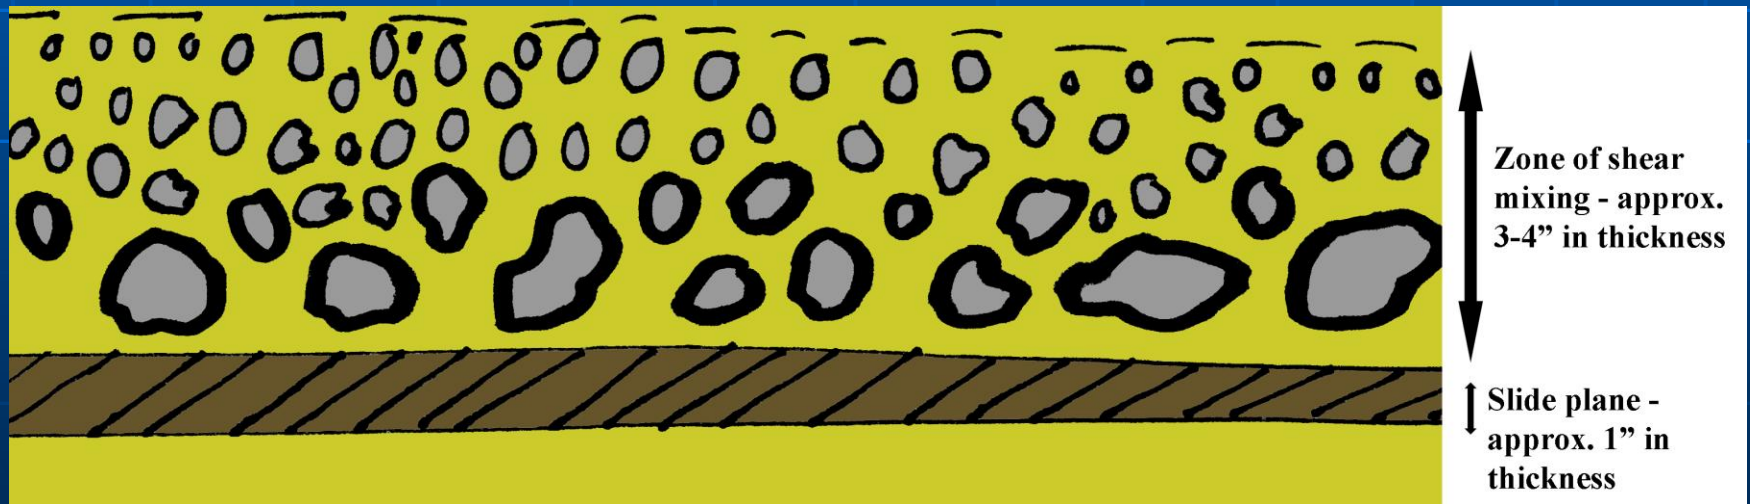
DETAIL OF SLIDE PLANE

- Sampling the slip surface was only the first hurdle
- Shear testing of this toothpaste consistency paludal clay proved far more difficult
- The results eventually showed a peak shear strength of 50 psf, degrading to zero after a half inch of rotation

- **Details of the buried slip surface**

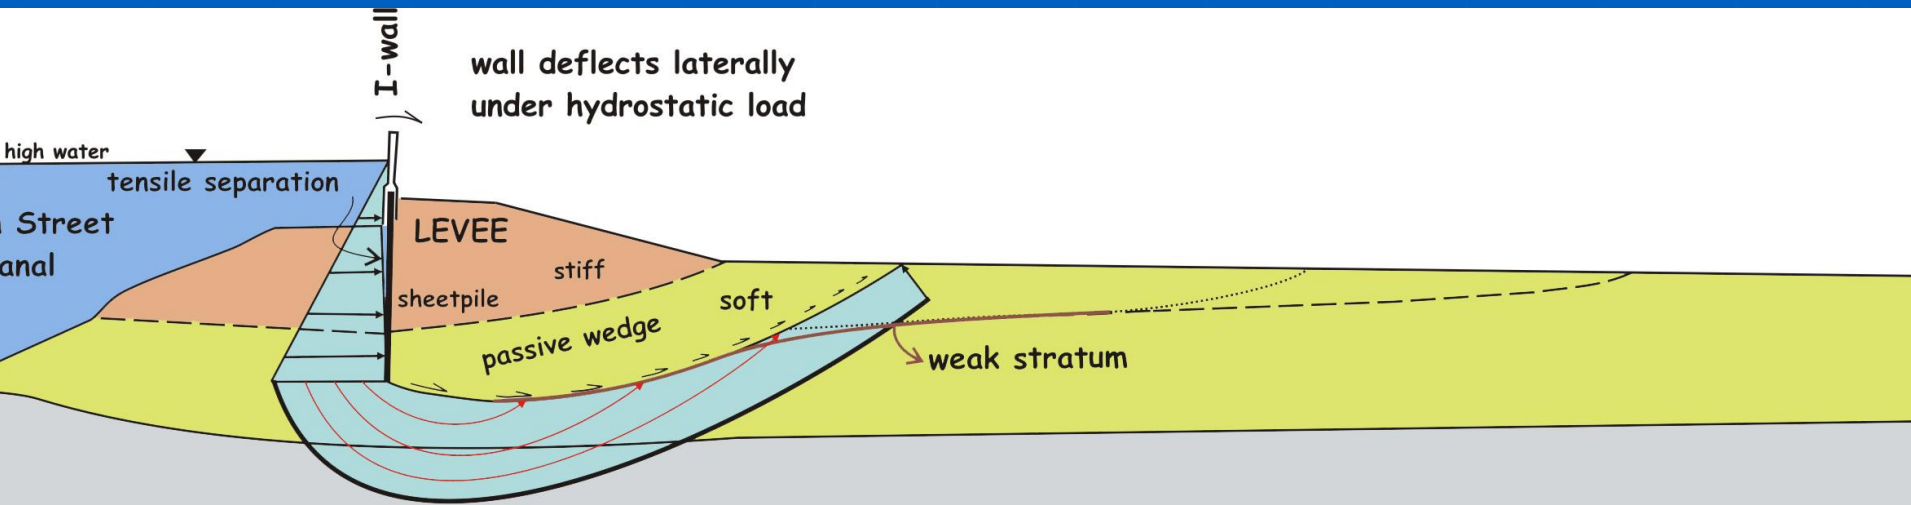
As the I-wall tilted, a tension crack, or gap, formed which allowed pore water pressures to be transferred to the passive reaction wedge
