Geologic Conditions Underlying the 2005 17th Street Canal Levee Failure in New Orleans

J. David Rogers, Ph.D., P.E., P.G.
Missouri University of Science & Technology

for Technical Session #15 on
New Orleans Levees and Hurricane Katrina

17TH Street Drainage Canal Failure:

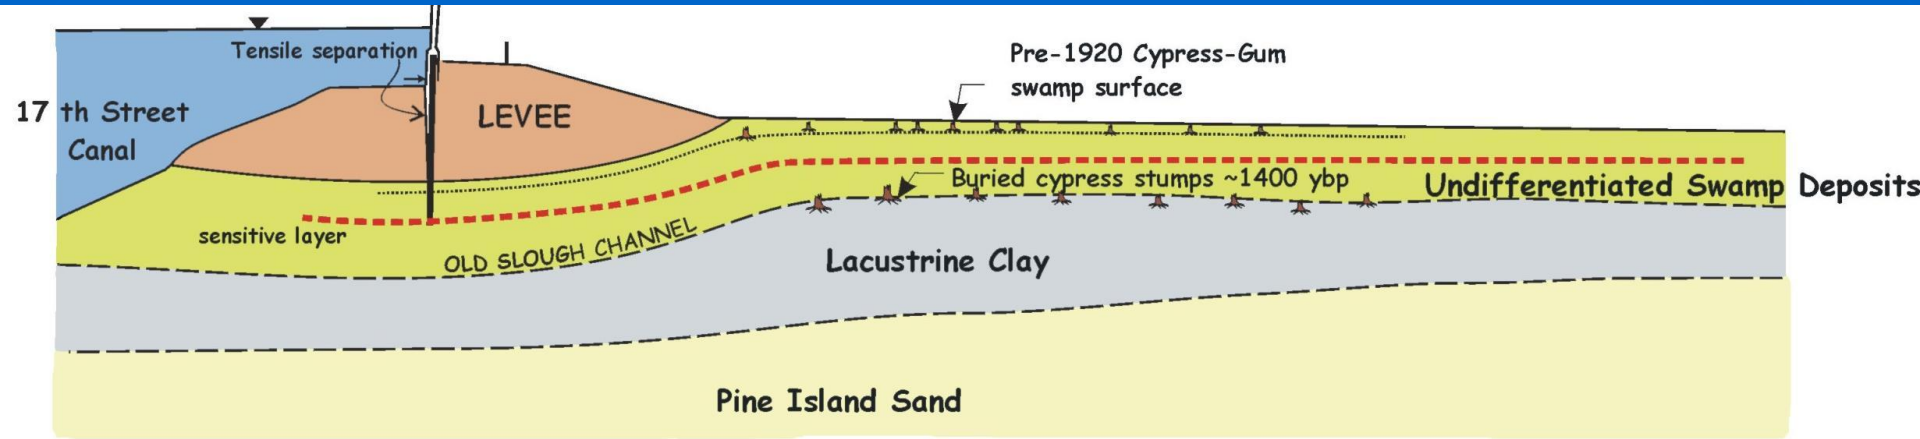
The passive reaction wedge coincided with stratigraphic horizon, which was depressed by the weight of the levee embankment on the compressible cypress marsh deposits

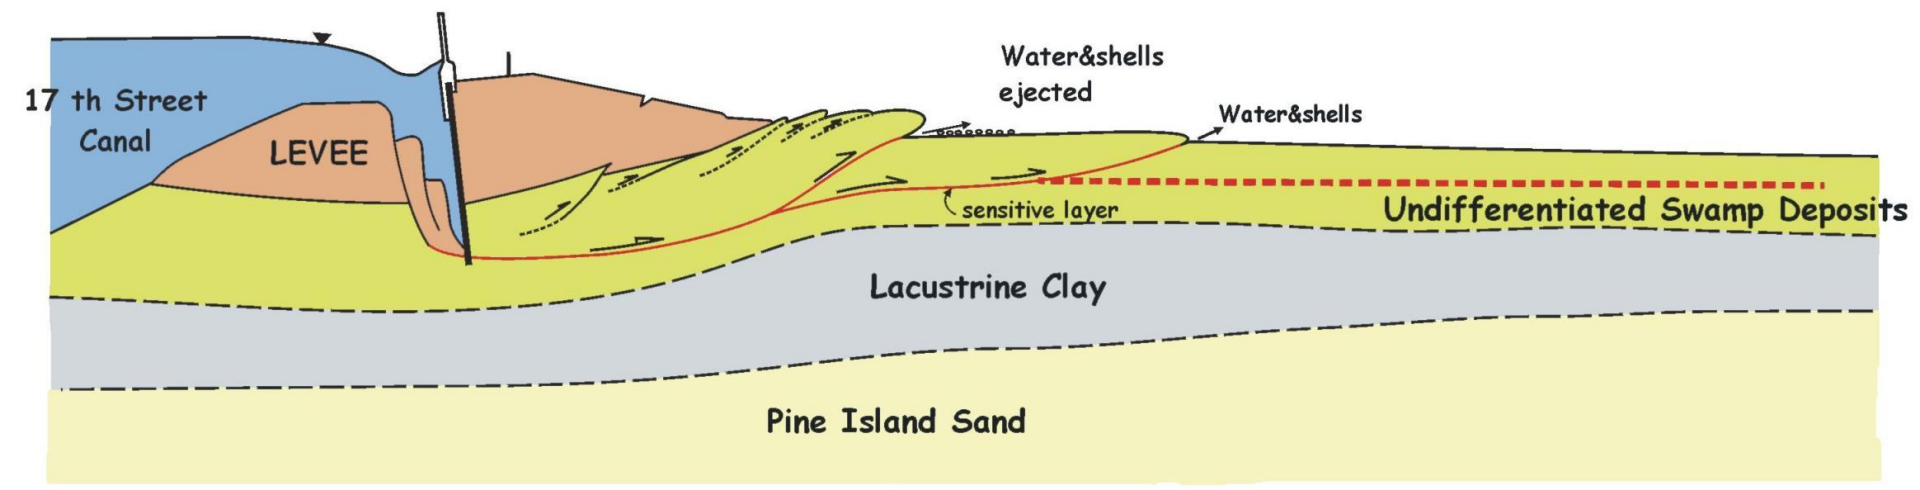
En-echelon traction shears noted along base of original embankment. Note initial back rotation component of motion and development of planar thrusting

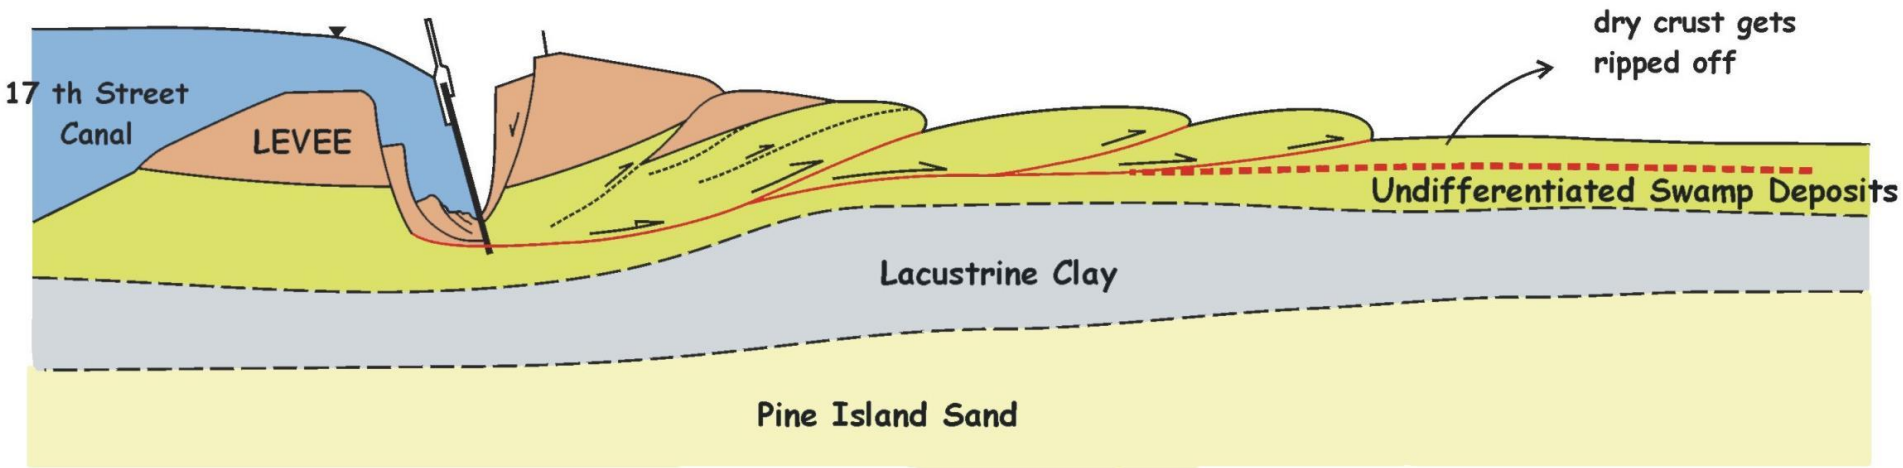
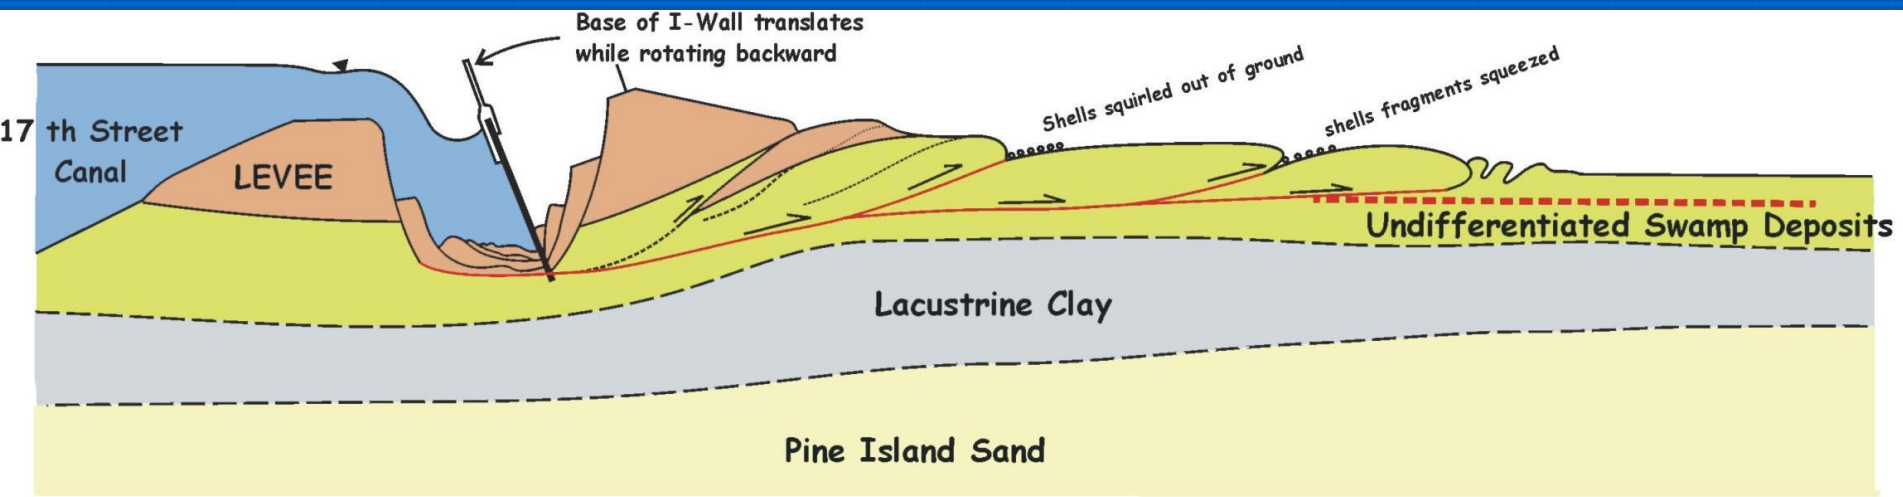
Initial loading conditions. Storm surge rises to within 4 feet of flood wall crest. Hydrostatic pressures on sheetpile supported I-wall highlighted in blue. Translational failure begins.

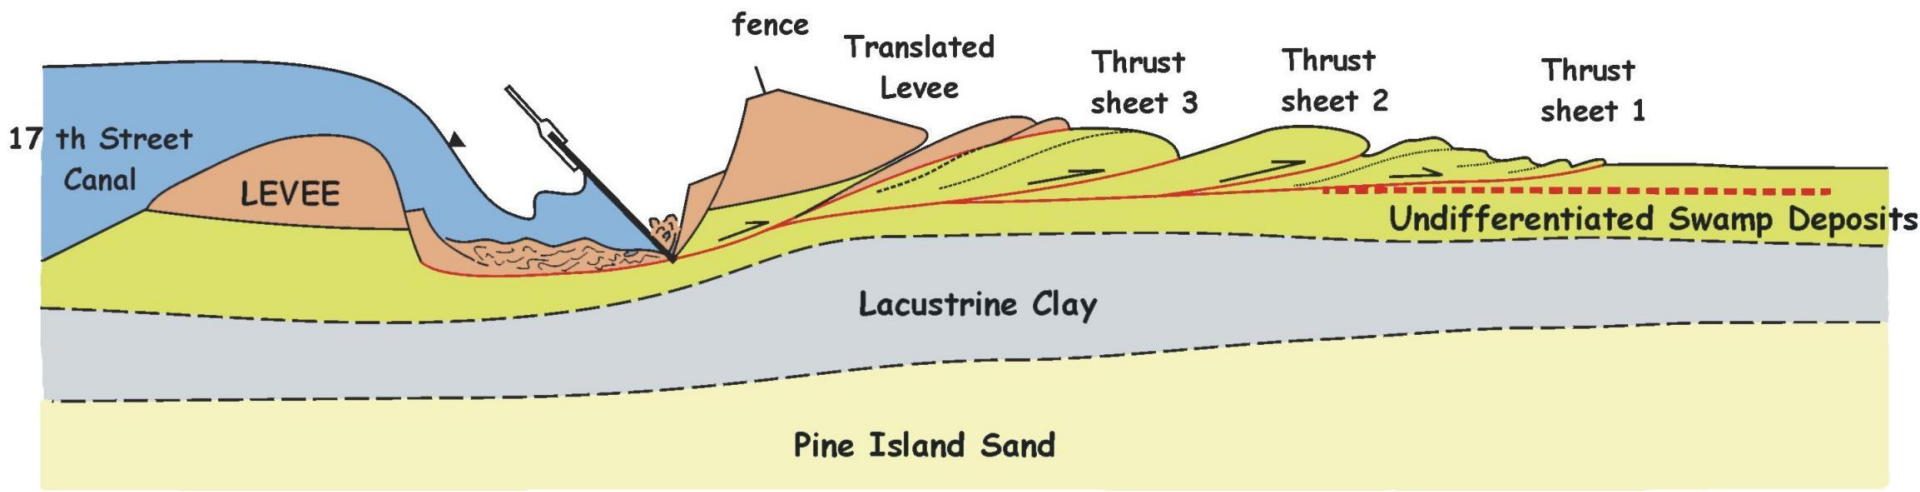
Progression of translational failure sequence. Multiple thrust sheets develop in partially saturated crust, comprised of sandy fill on top of organic cypress swamp deposits. The upper crust buckles like a rug being rolled up.

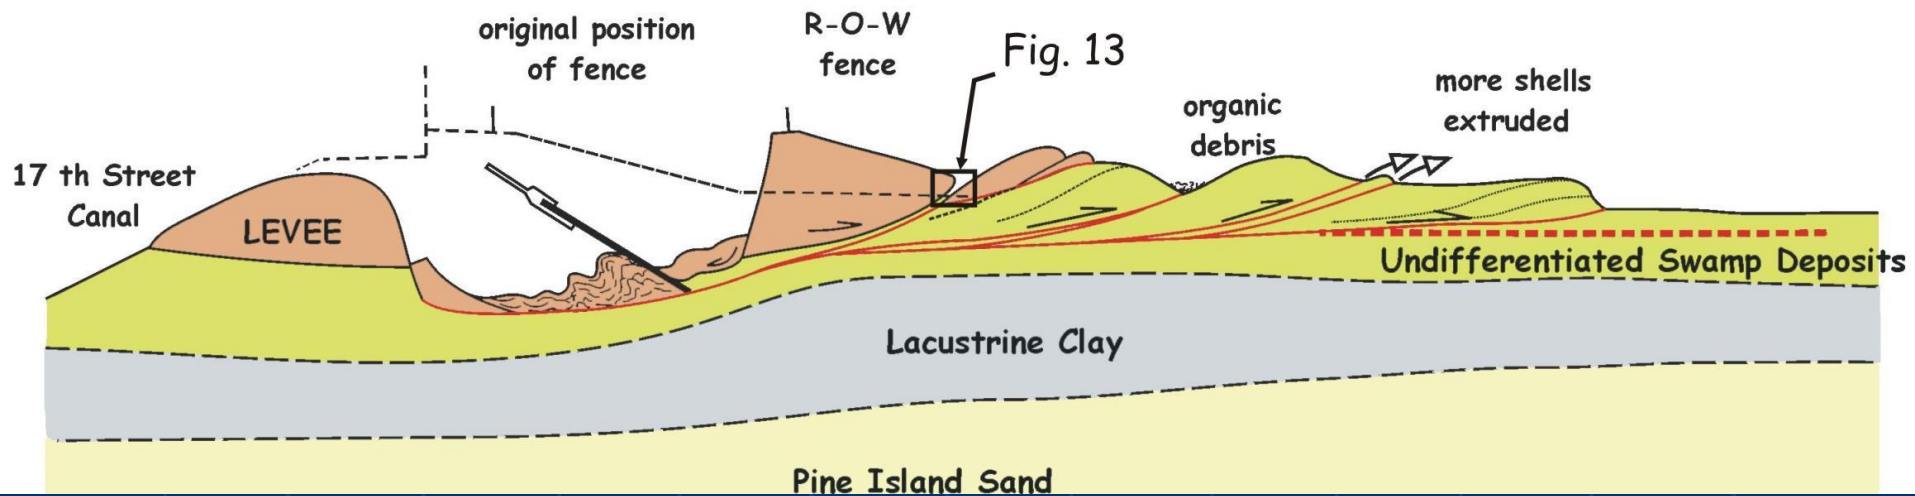
Final stages of translational failure sequence. Lower section shows failed levee after 51 feet of displacement. The void was quickly backfilled with gravel as part of sealing the breach.

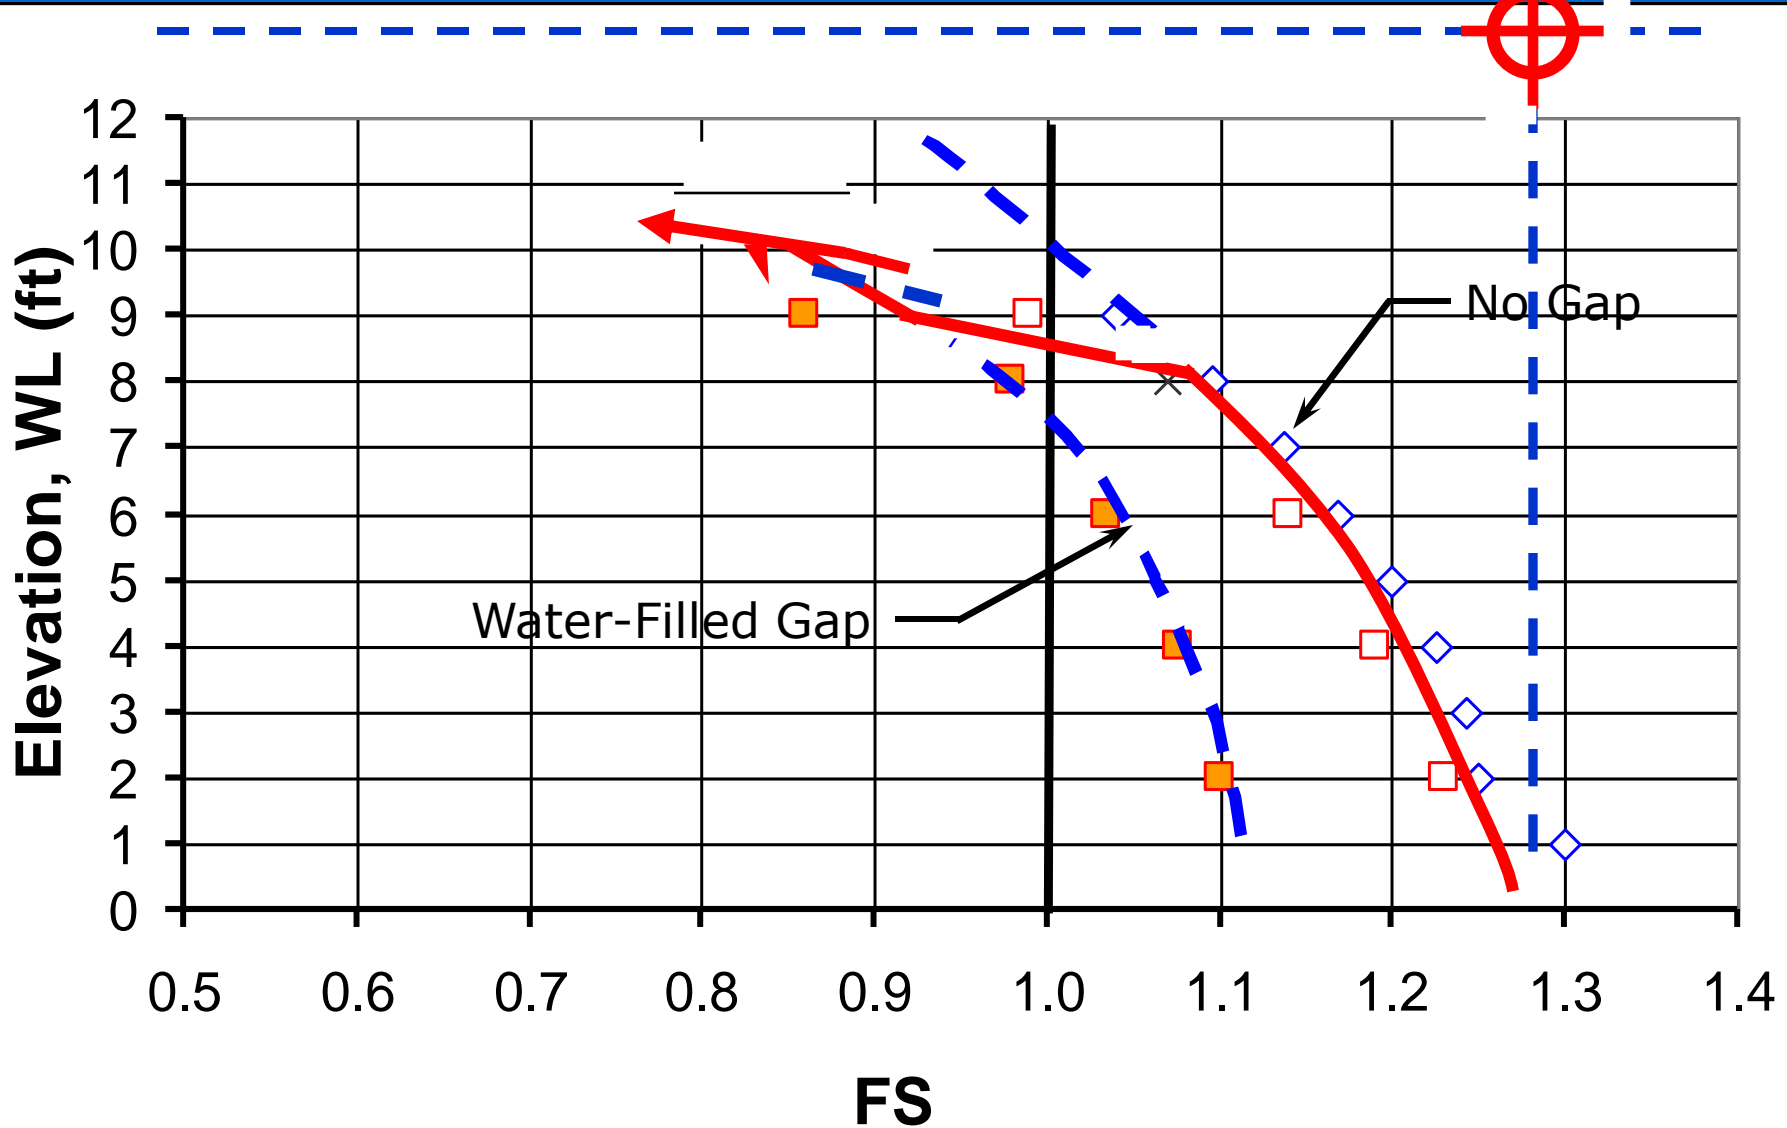
17th Street Canal East Side Analysis

(Water Elev. +12.5 feet)

(FS = 1.3)

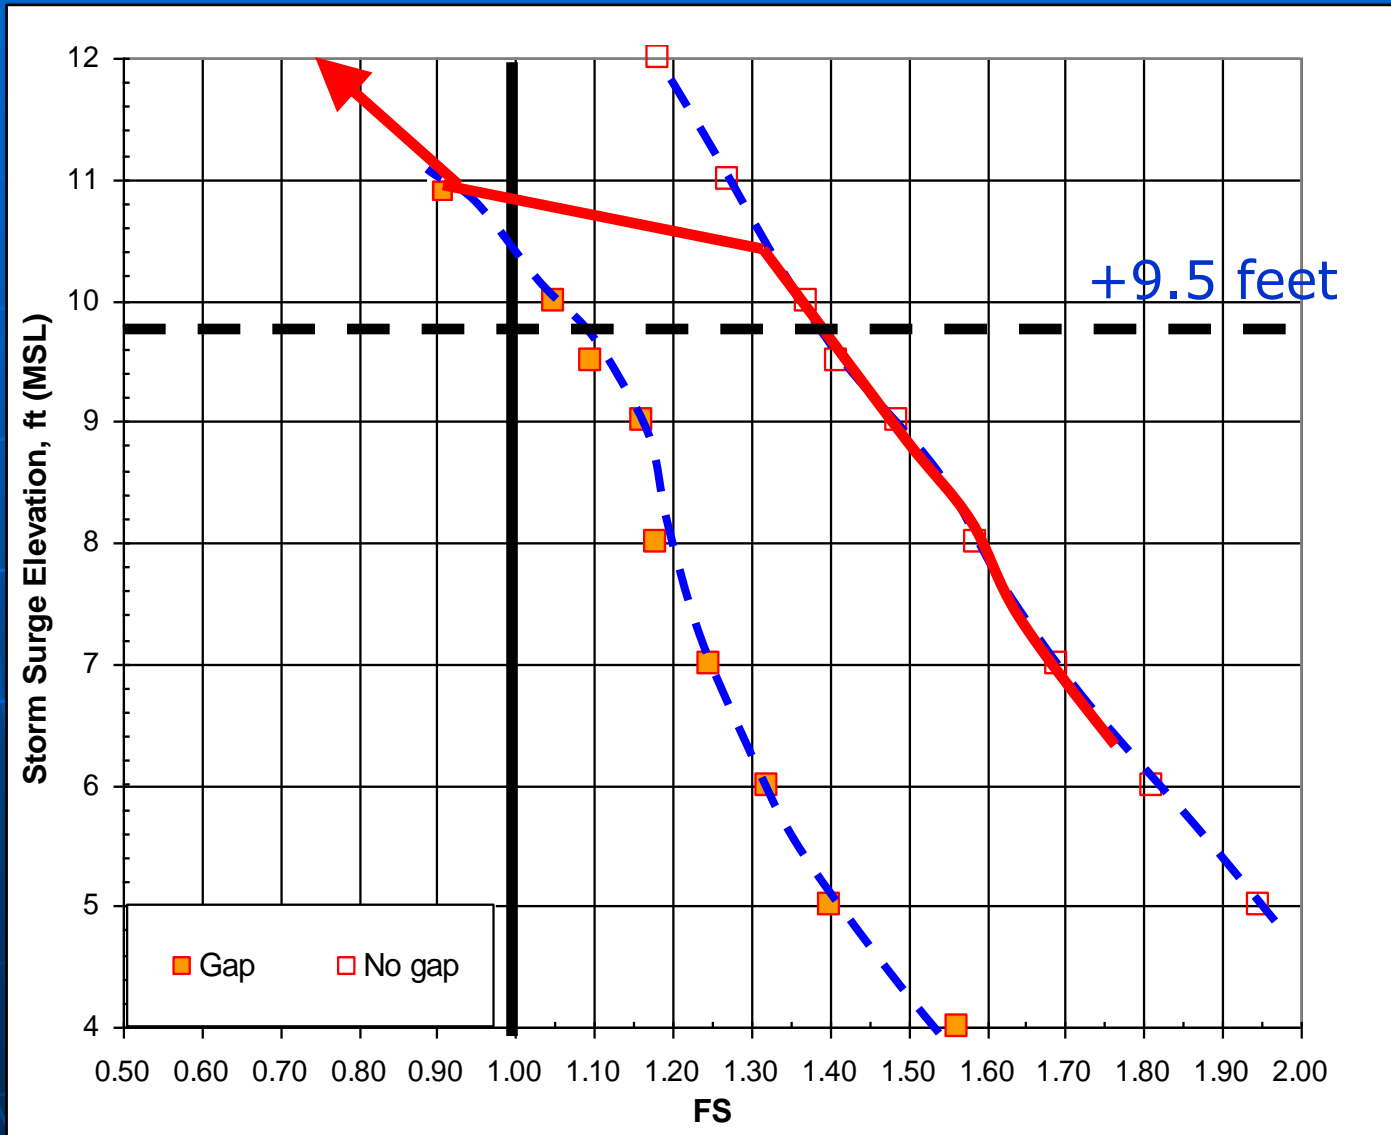
17th Street Canal, West Bank Analysis

- The NSF team assuaged that the bend in the flood wall on the west (unfailed) side of the 17th St Canal was evidence of an incipient failure
- This section of the underlying levee failed in 1947, before the flood wall was built
