GEOLOGIC INFLUENCE ON FLOOD CONTROL INFRASTRUCTURE DURING HURRICANE KATRINA

J. David Rogers, Ph.D., P.E., P.G.

Missouri University of Science & Technology

October 6, 2011

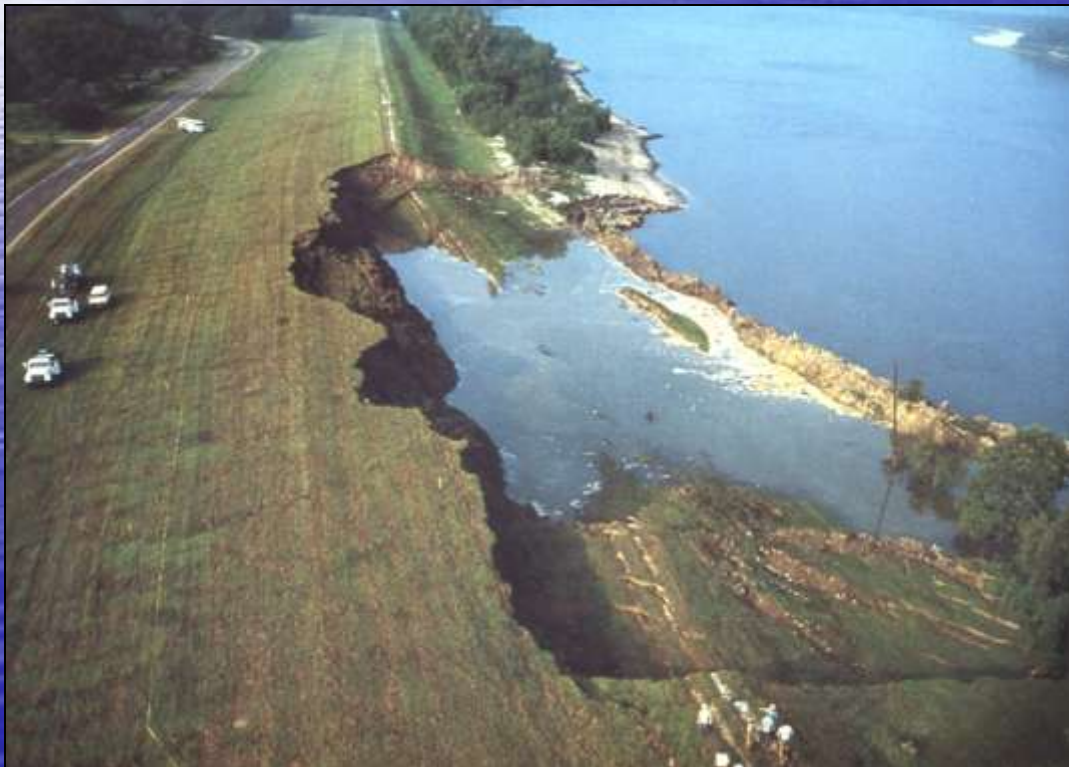
- 700 ft section of levee that slid into the Mississippi River on August 23, 1983 at Darrow, in Ascension Parrish, LA. The slide occurred shortly after a high water stage had receded, suggesting that toe undercutting & rapid drawdown likely contributed to the failure.
- After the MR&T Project was quasi completed in 1960, occasional levee failures have occurred because of **underseepage problems, toe scour, and overtopping**

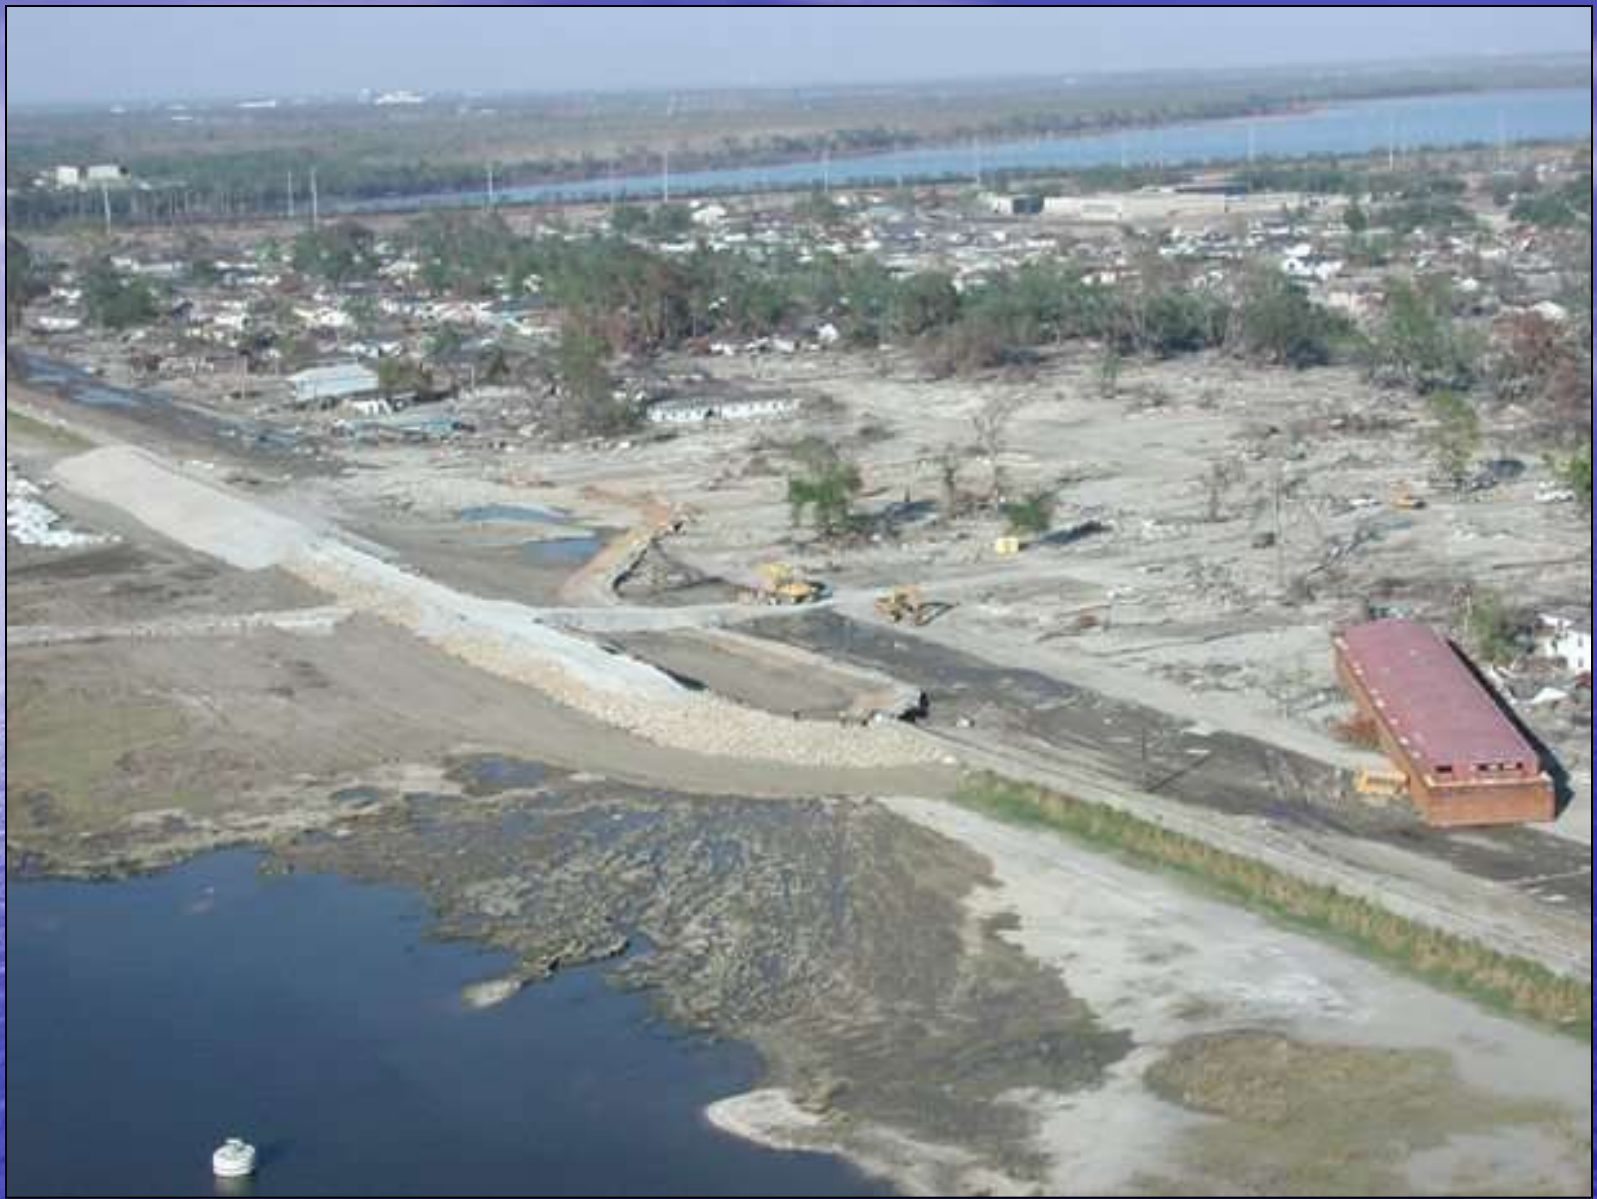
Seepage crevasse exposed at the east levee of the IHNC breach after Hurricanes Katrina and Rita

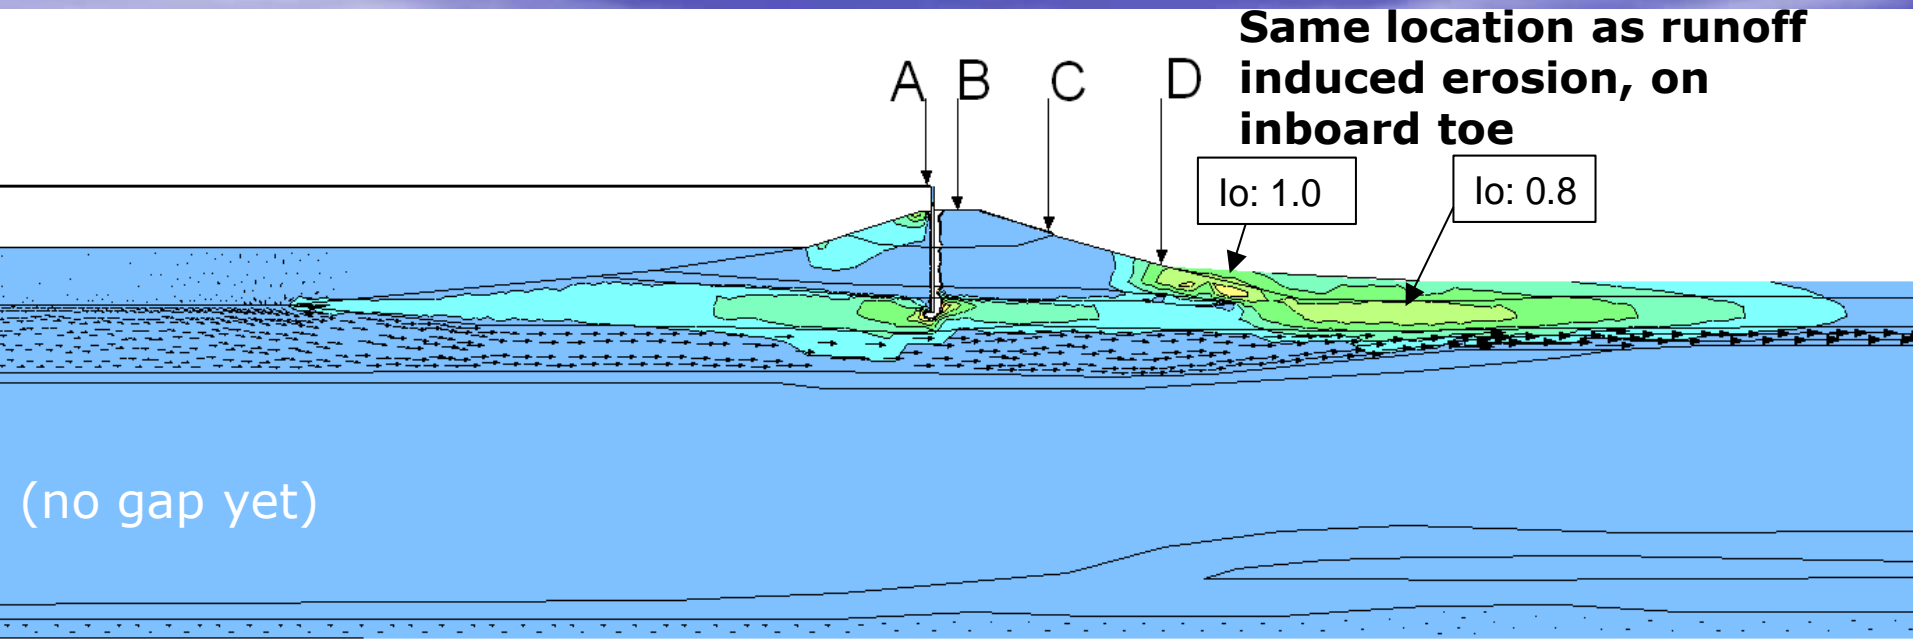
- Hydraulic gradients for the south breach on IHNC east bank; storm surge at 14.4ft (MSL). Maximum exit gradient at the levee toe is $i_o \approx 0.8$ to 1.0, at threshold for hydraulic piping.
- This may help to explain the persistent wet spot noted on the backfill of the Jourdan Avenue conduit backfill for weeks afterward.

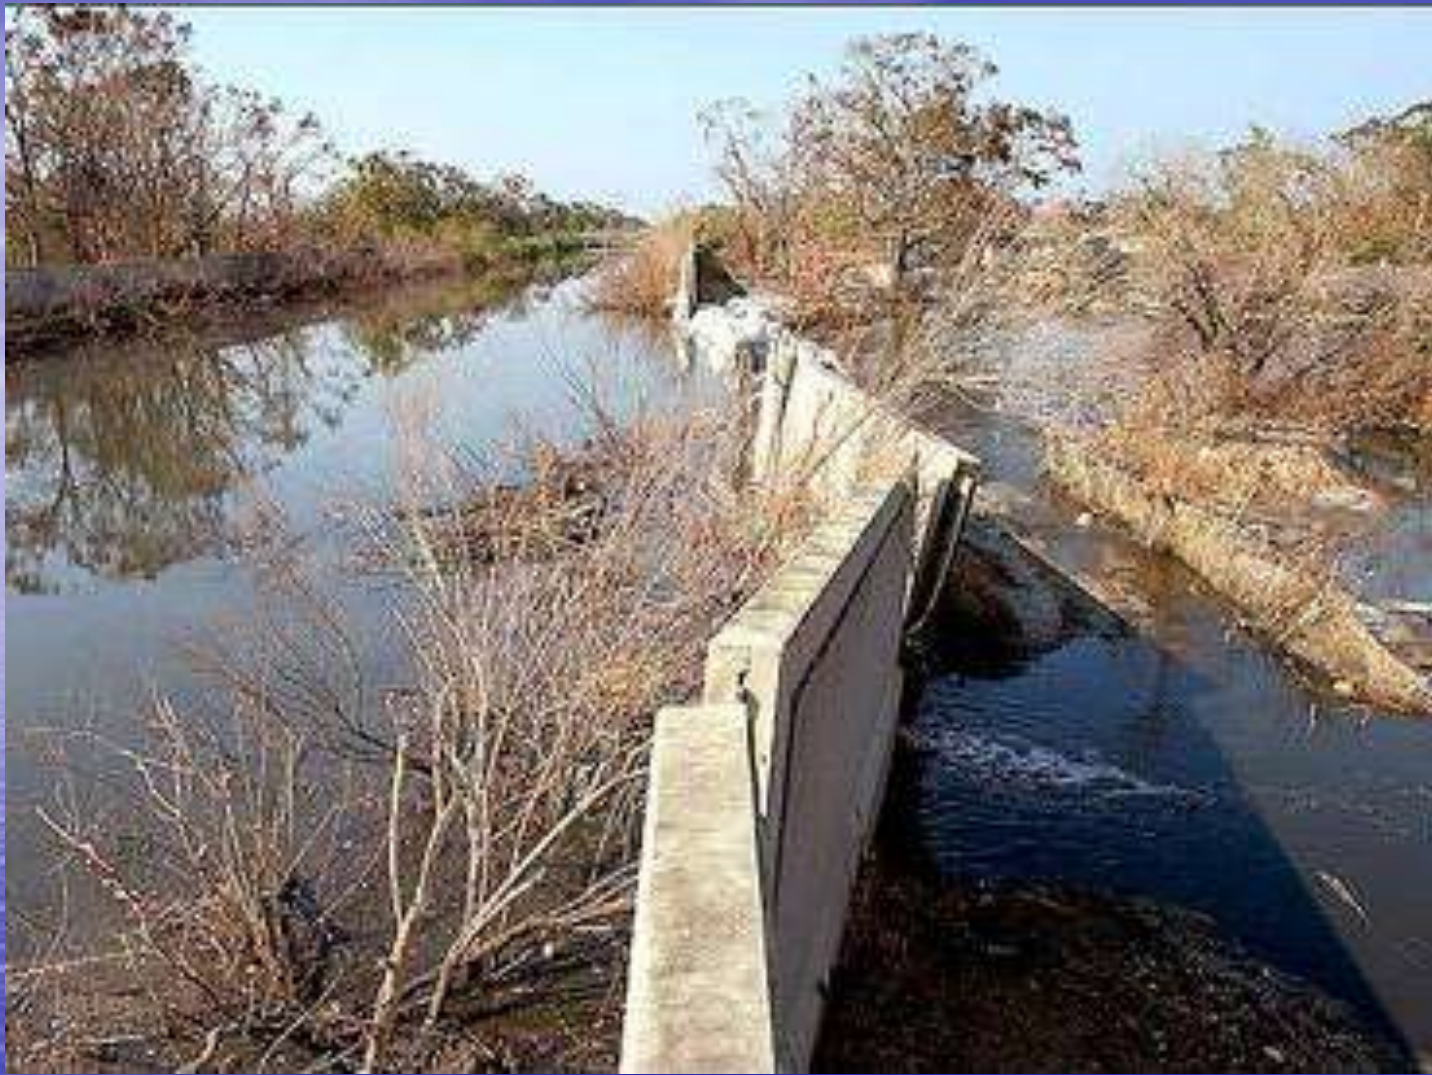
London Ave Canal – Filmore Breach

Deflected flood wall along the London Avenue Drainage Canal in New Orleans. This failure was driven by excessive transient pore pressures developed in the underlying Pine Island Sands.

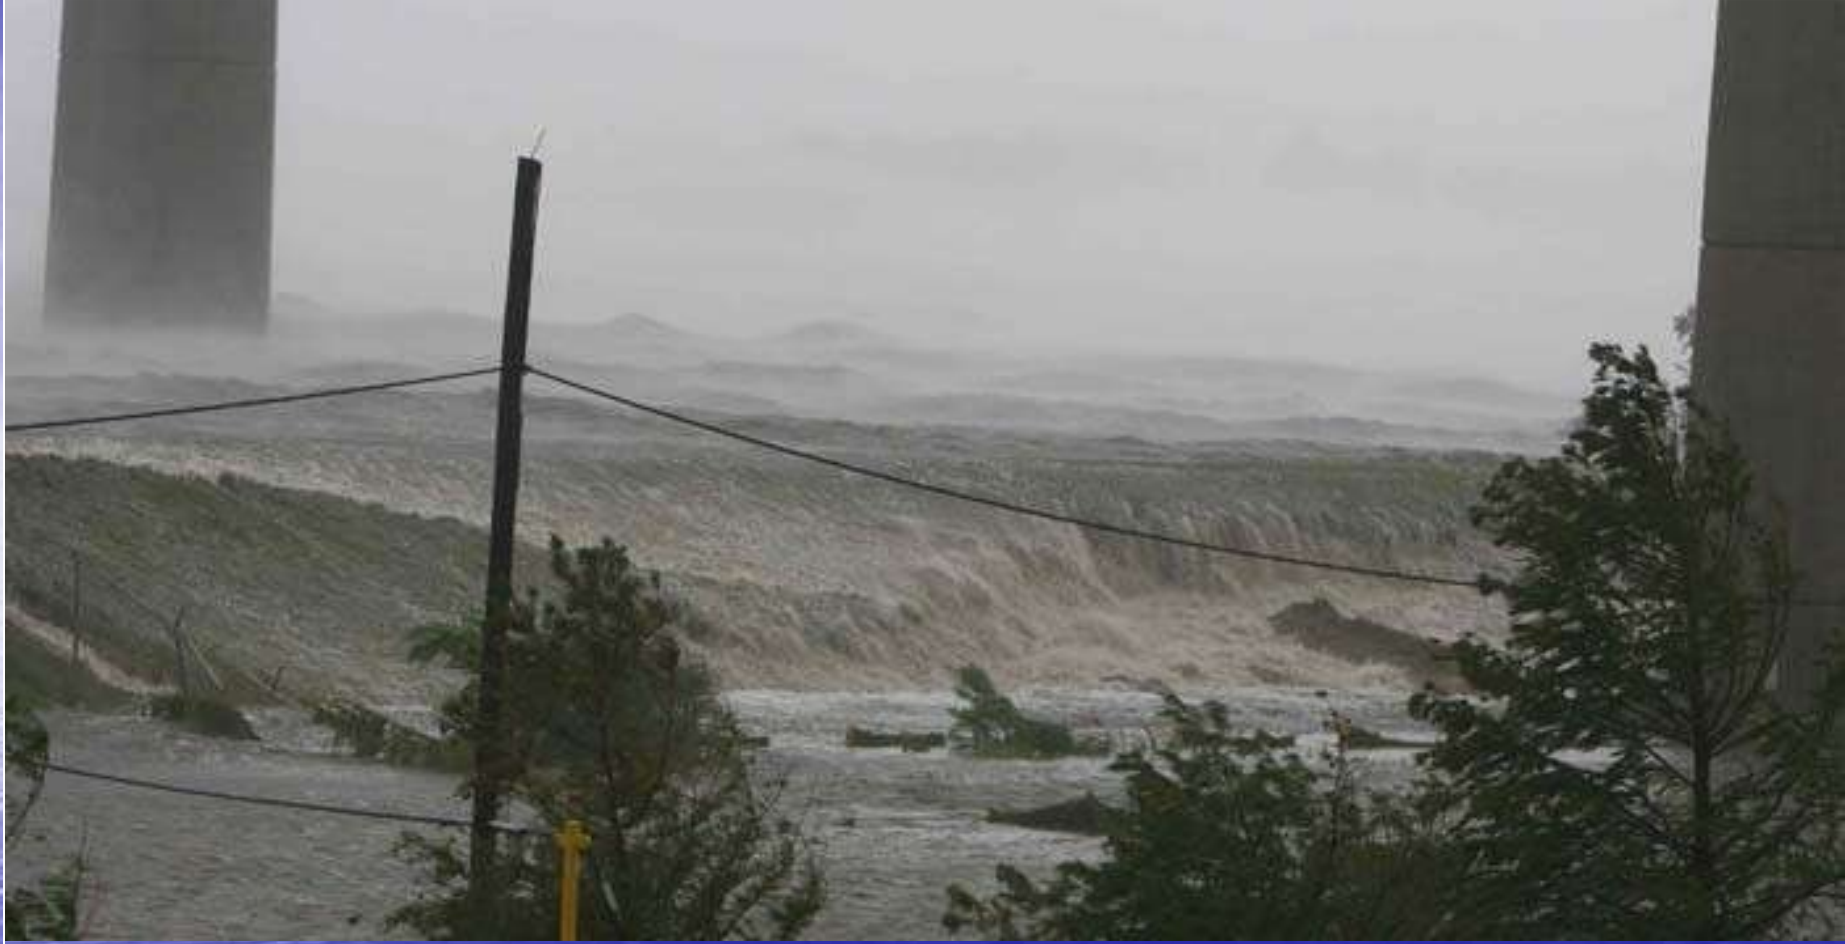
- **Overtopping:** Earthen levee being overtopped at the Entergy Power Plant along the MRGO/ICWW channel. This began around 6 AM on August 29th, 2005. 9 ft storm surge with crest heights up to 17 ft.

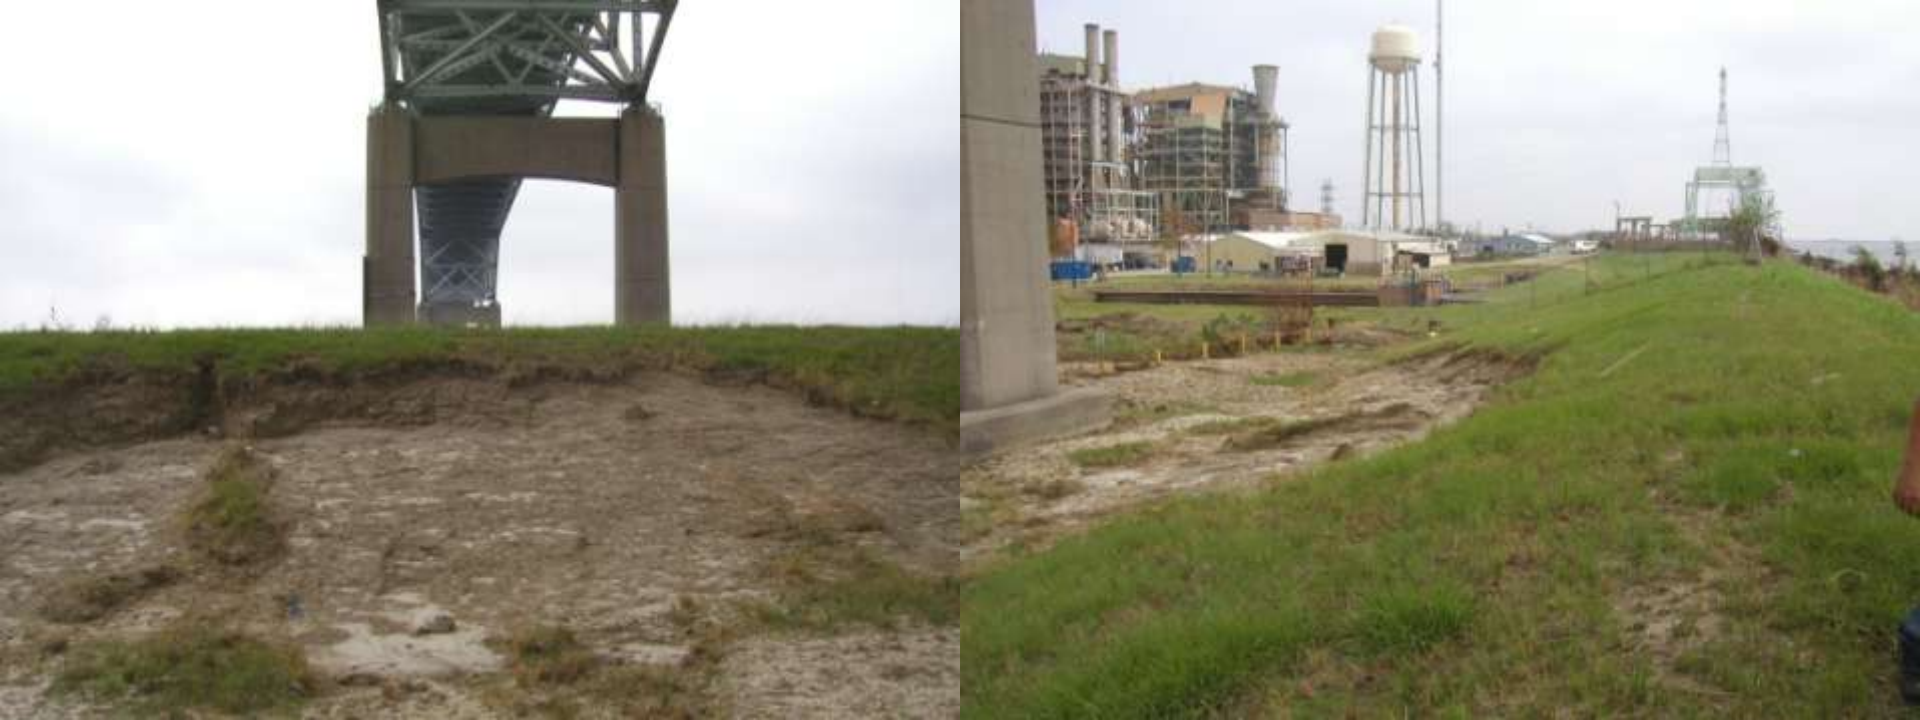
- **Resilient structures:** The levee protecting the Entergy Power Plant beneath the Route 47/Interstate 310 viaduct over the MRGO/ICWW channel at Michoud survived 8+ hours of overtopping with only moderate erosion.

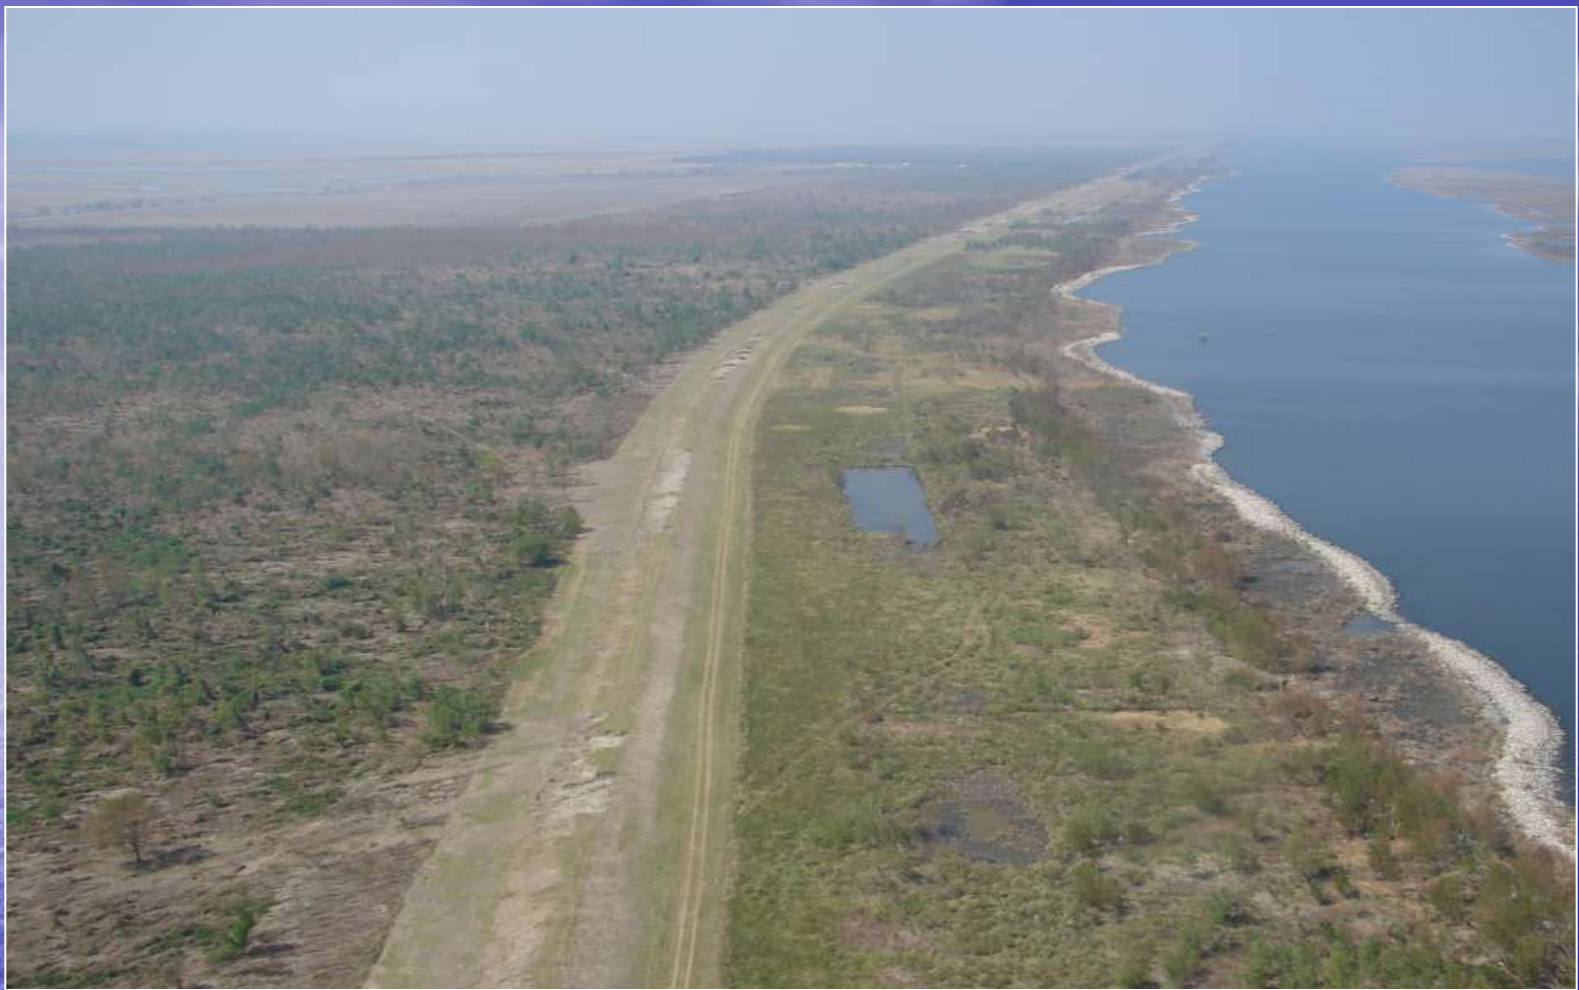
- **Good performance:** some portions of the **Mississippi River Gulf Outlet (MRGO) Channel** survived waves as high as 17 feet, triggered by a 9+ foot storm surge off Lake Borgne (to the right)

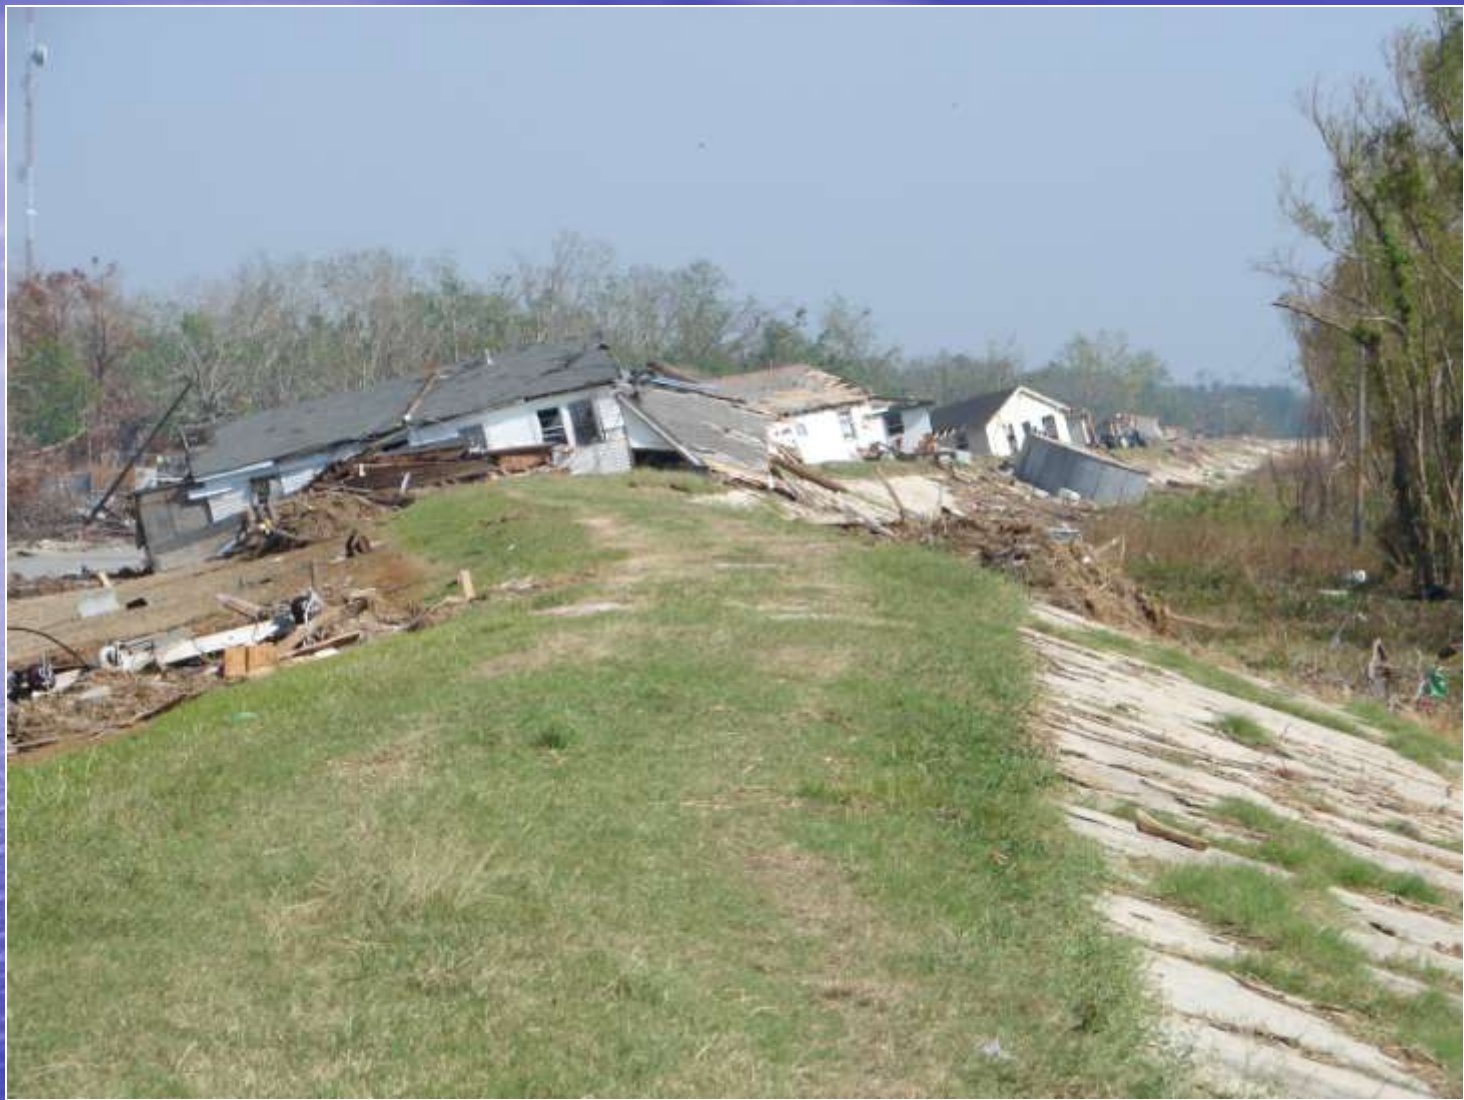
- **Survivable levees:** The storm surge pushed houses up on top of some levees, leaving them scattered about ...

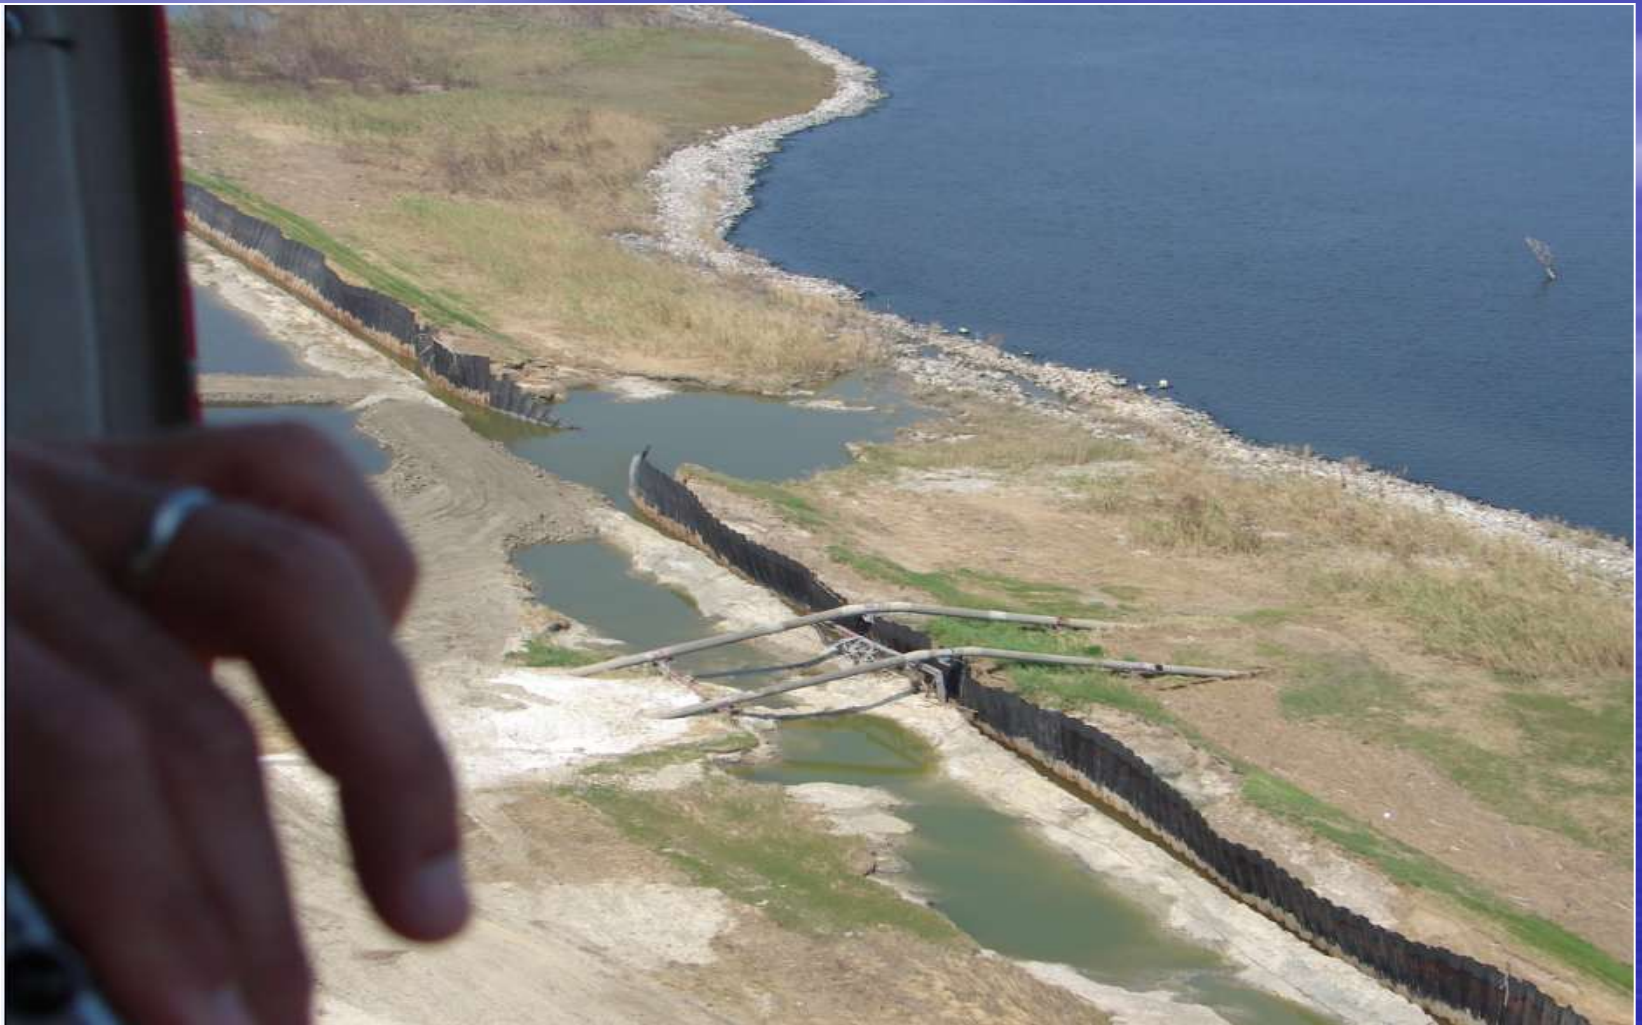
- **Poor performance:** Skeleton of **steel sheetpile cutoff walls** is all that remains of the **MRGO levee** between Bayou Bienvenue and Bayou Dupree

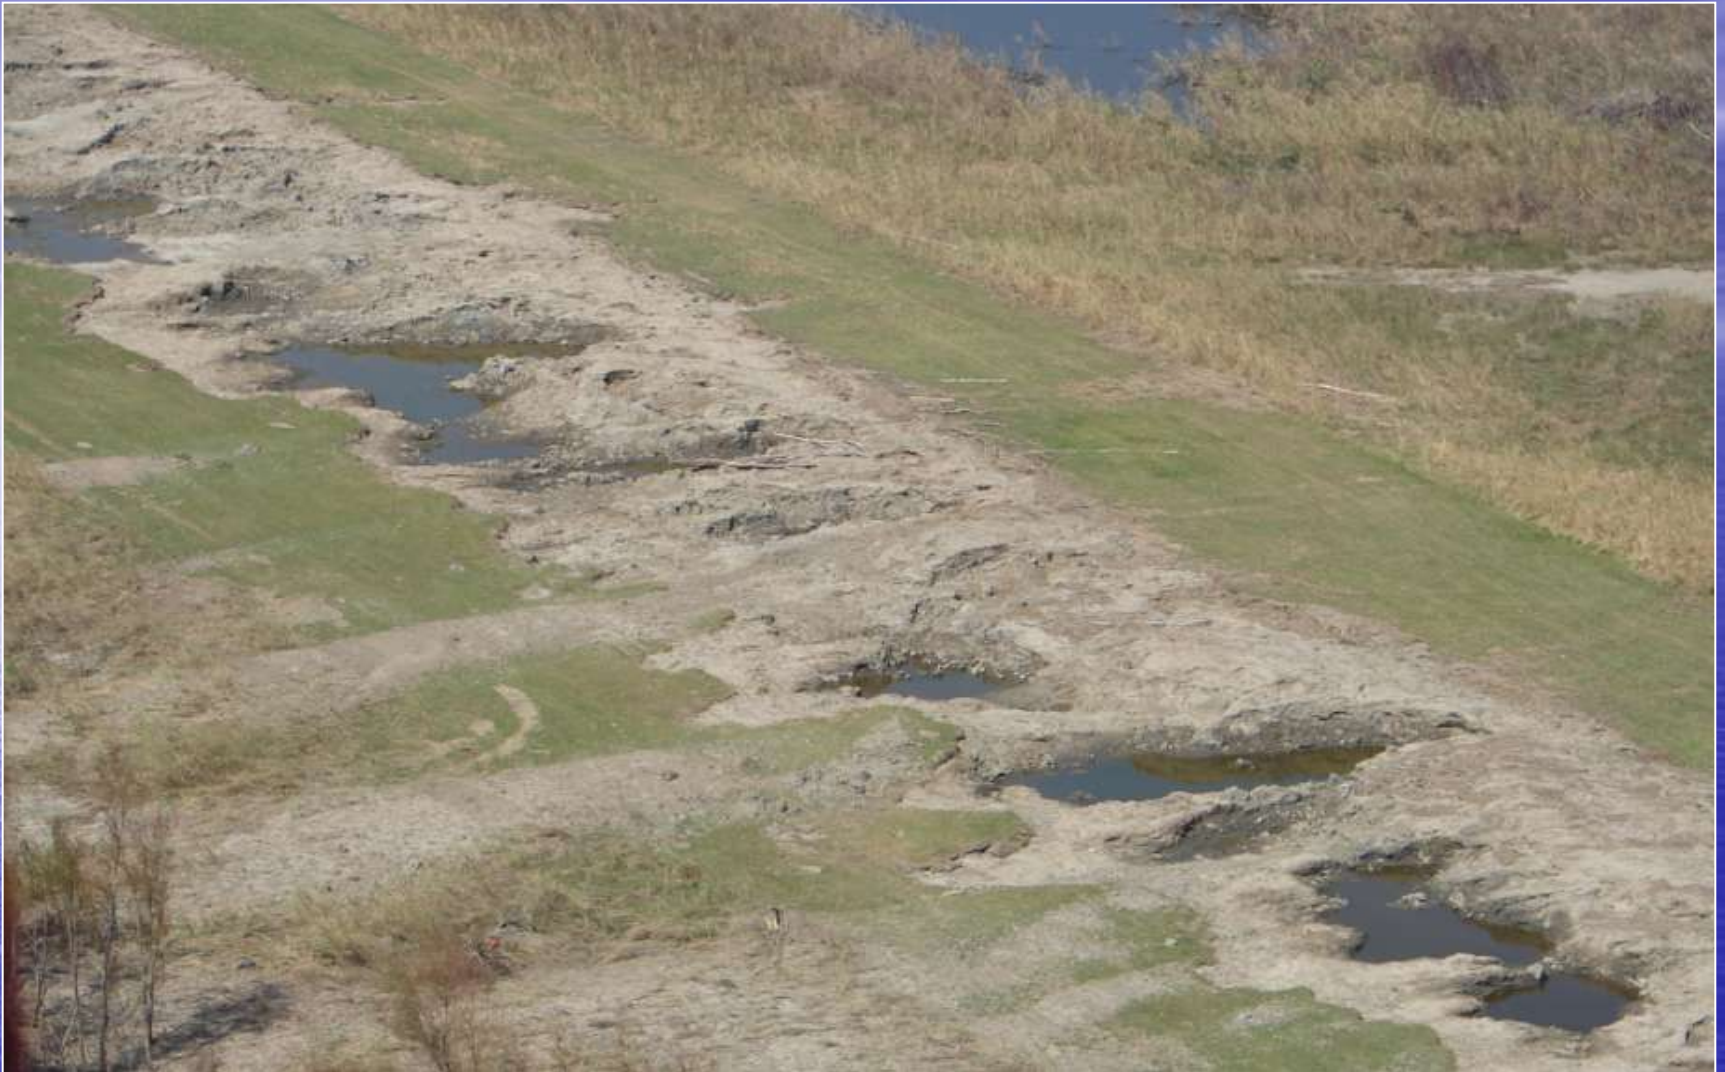
- **Poor performance:** MRGO levee completely washed away, about two miles southeast of Bayou Dupree.

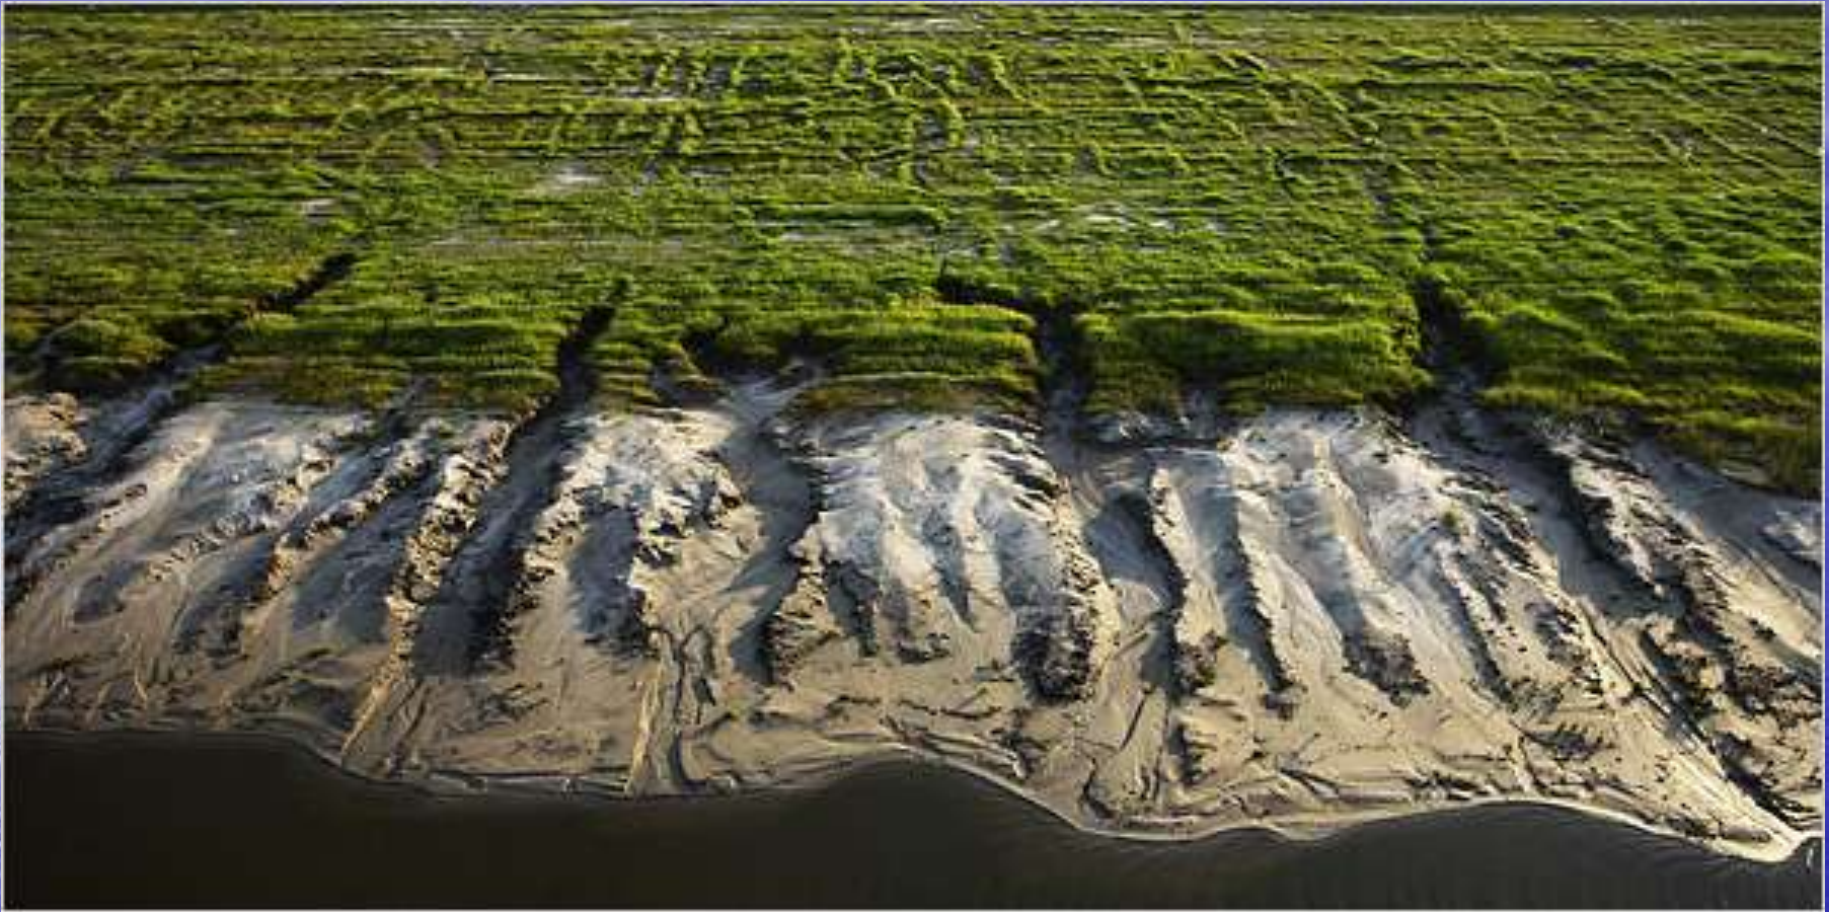
- **Surficial erosion of the outboard toe of embankment bordering a borrow area along the western side of the reconstructed MRGO channel; as seen in 2007. This is suggestive of low cohesion fill.**

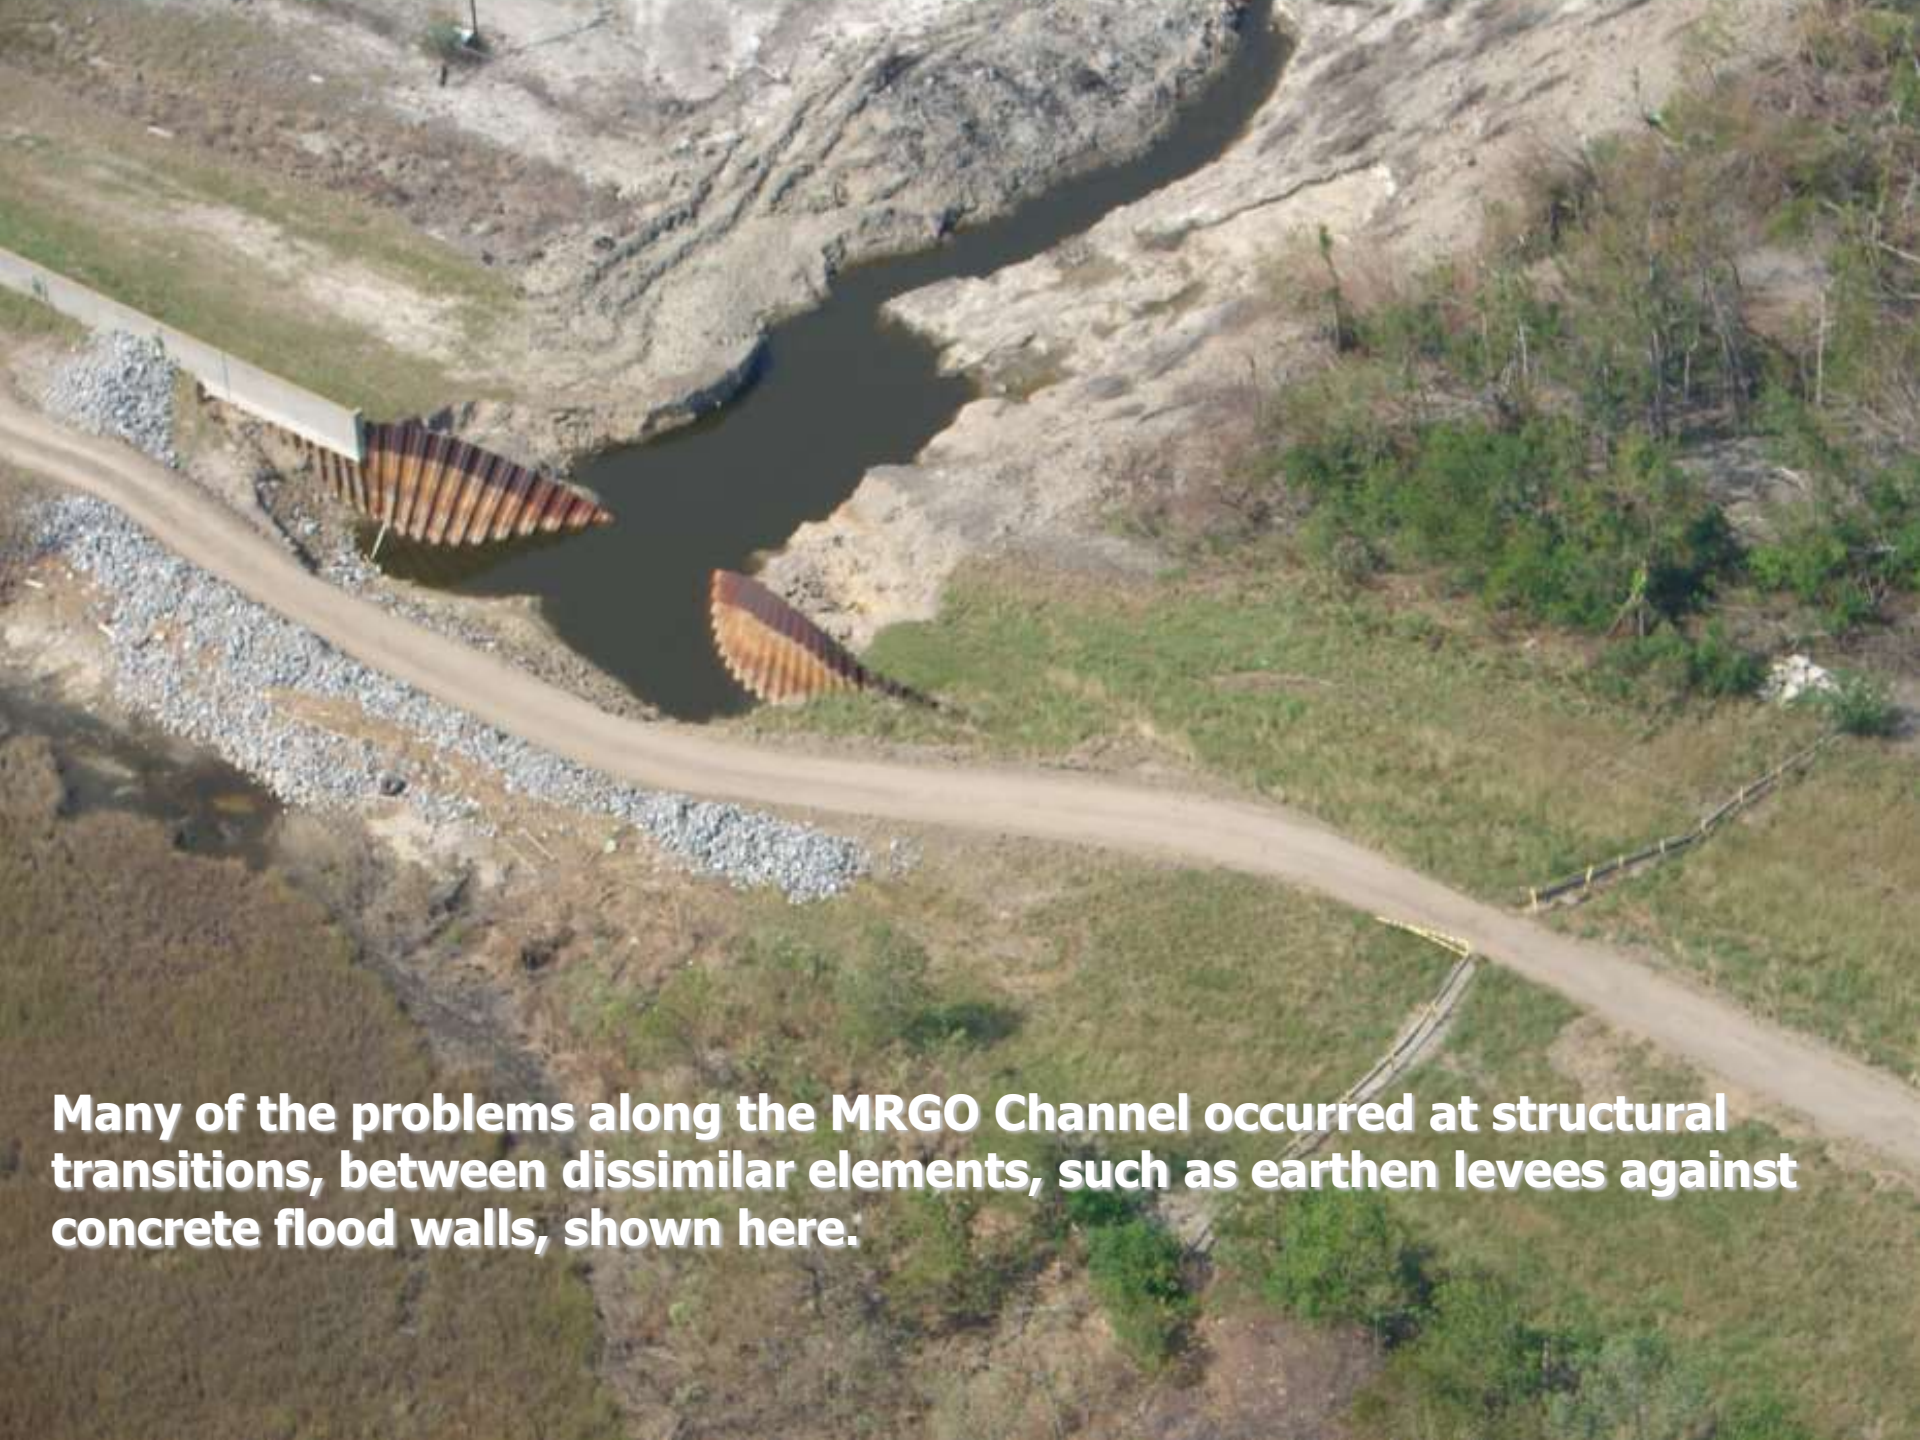
Many of the problems along the MRGO Channel occurred at structural transitions, between dissimilar elements, such as earthen levees against concrete flood walls, shown here.

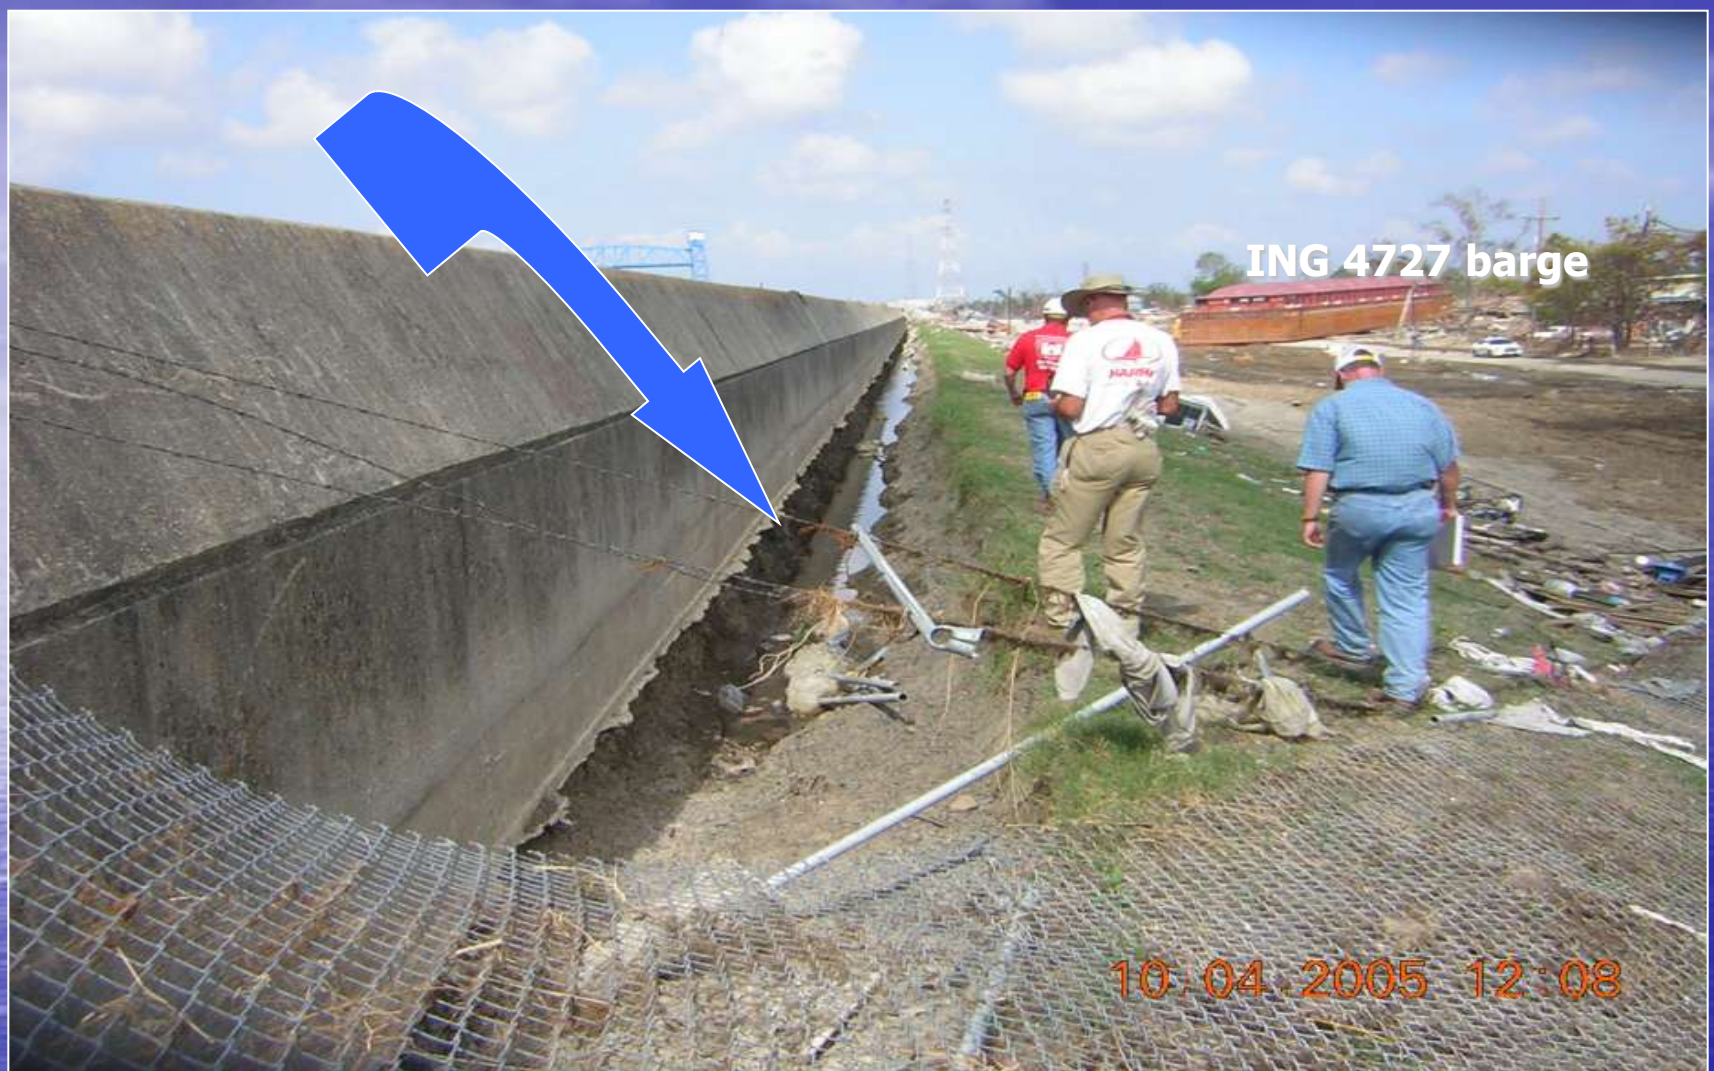
- **Some sections survived:** Evidence of sustained overtopping of concrete flood wall along the IHNC in the Lower Ninth Ward.
