GEOLOGIC INFLUENCE ON FLOOD CONTROL INFRASTRUCTURE DURING HURRICANE KATRINA

J. David Rogers, Ph.D., P.E., P.G.

Missouri University of Science & Technology

October 6, 2011

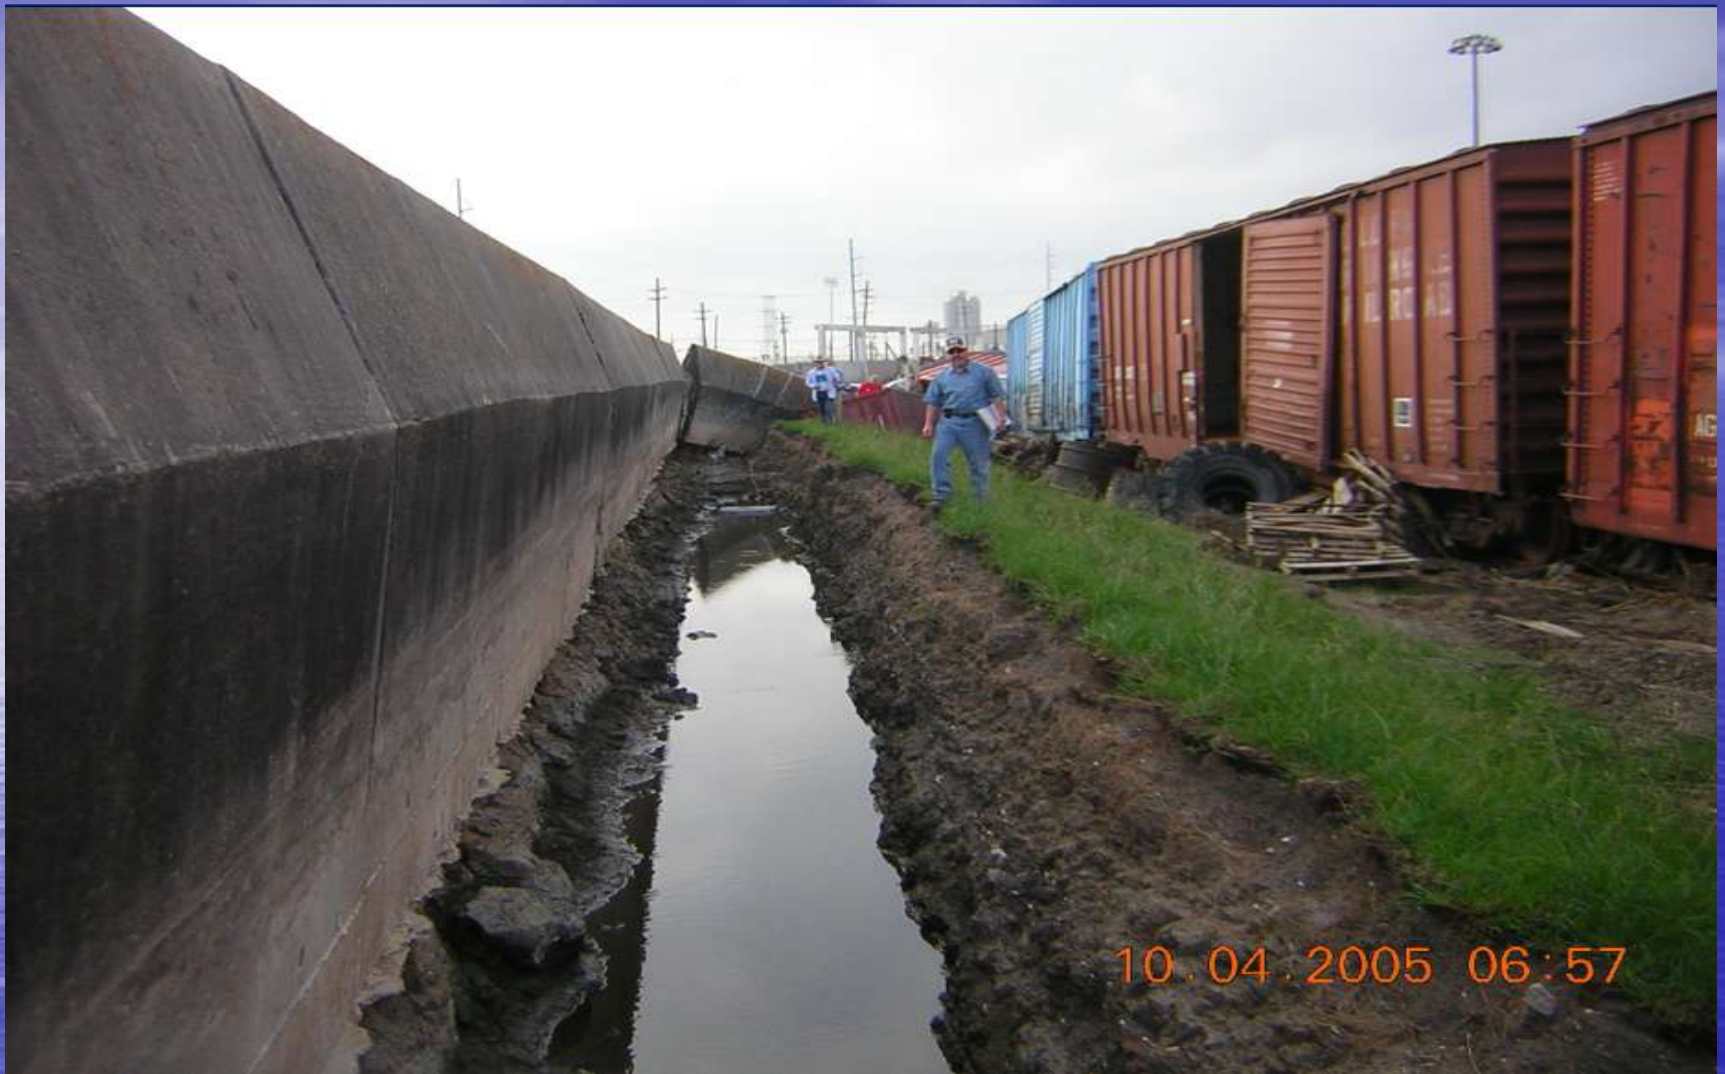
- Overtopping scour holes along landside of flood wall on west side of the IHNC. Note broken wall in background. A splash pad on inboard side could have prevented this undercutting for less than 0.5% of the flood wall cost, making the structure **“Class 3 survivable.”**

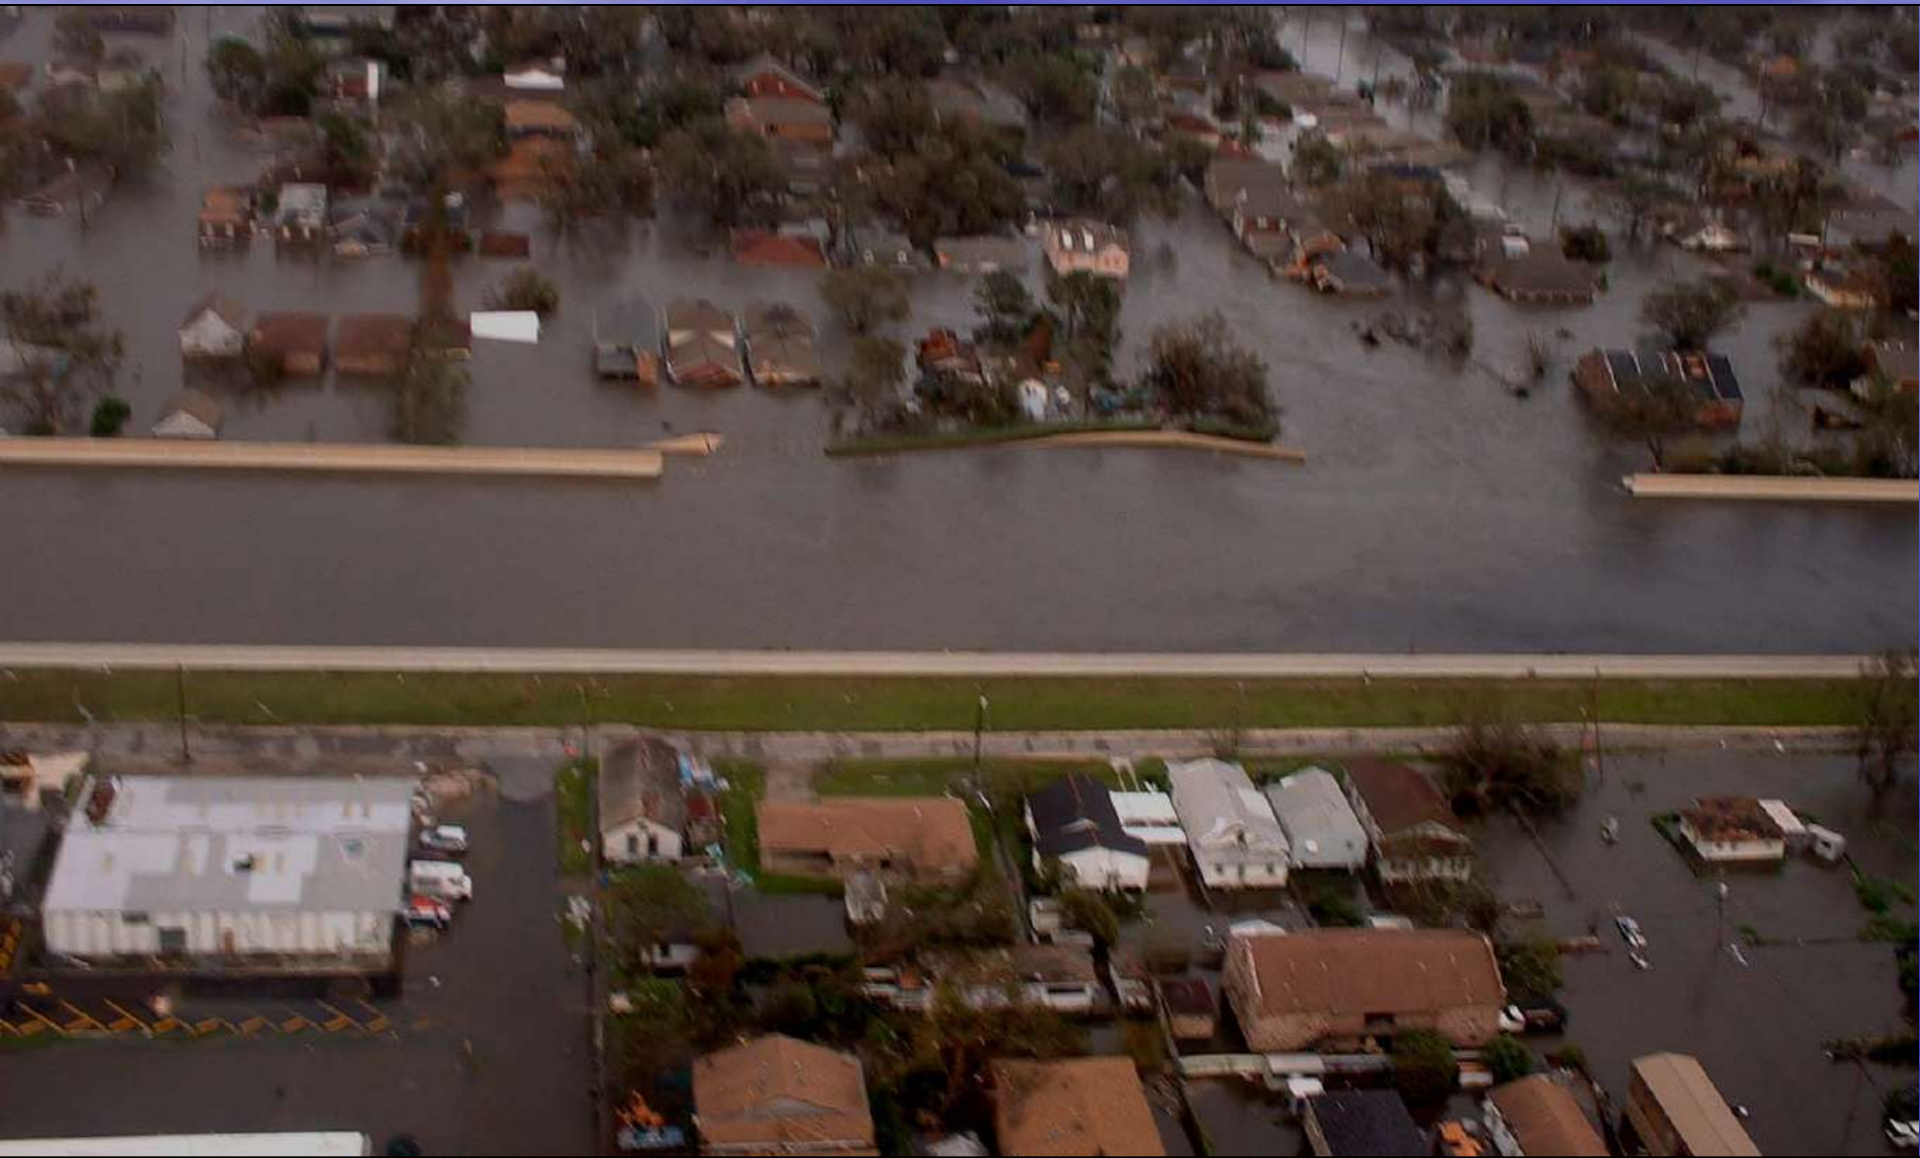
- **Aerial oblique view of the 17th Street Canal break, looking east. Note lateral translation of concrete flood wall, between 35 and 50 ft. Photo by Ivor van Heerden.**

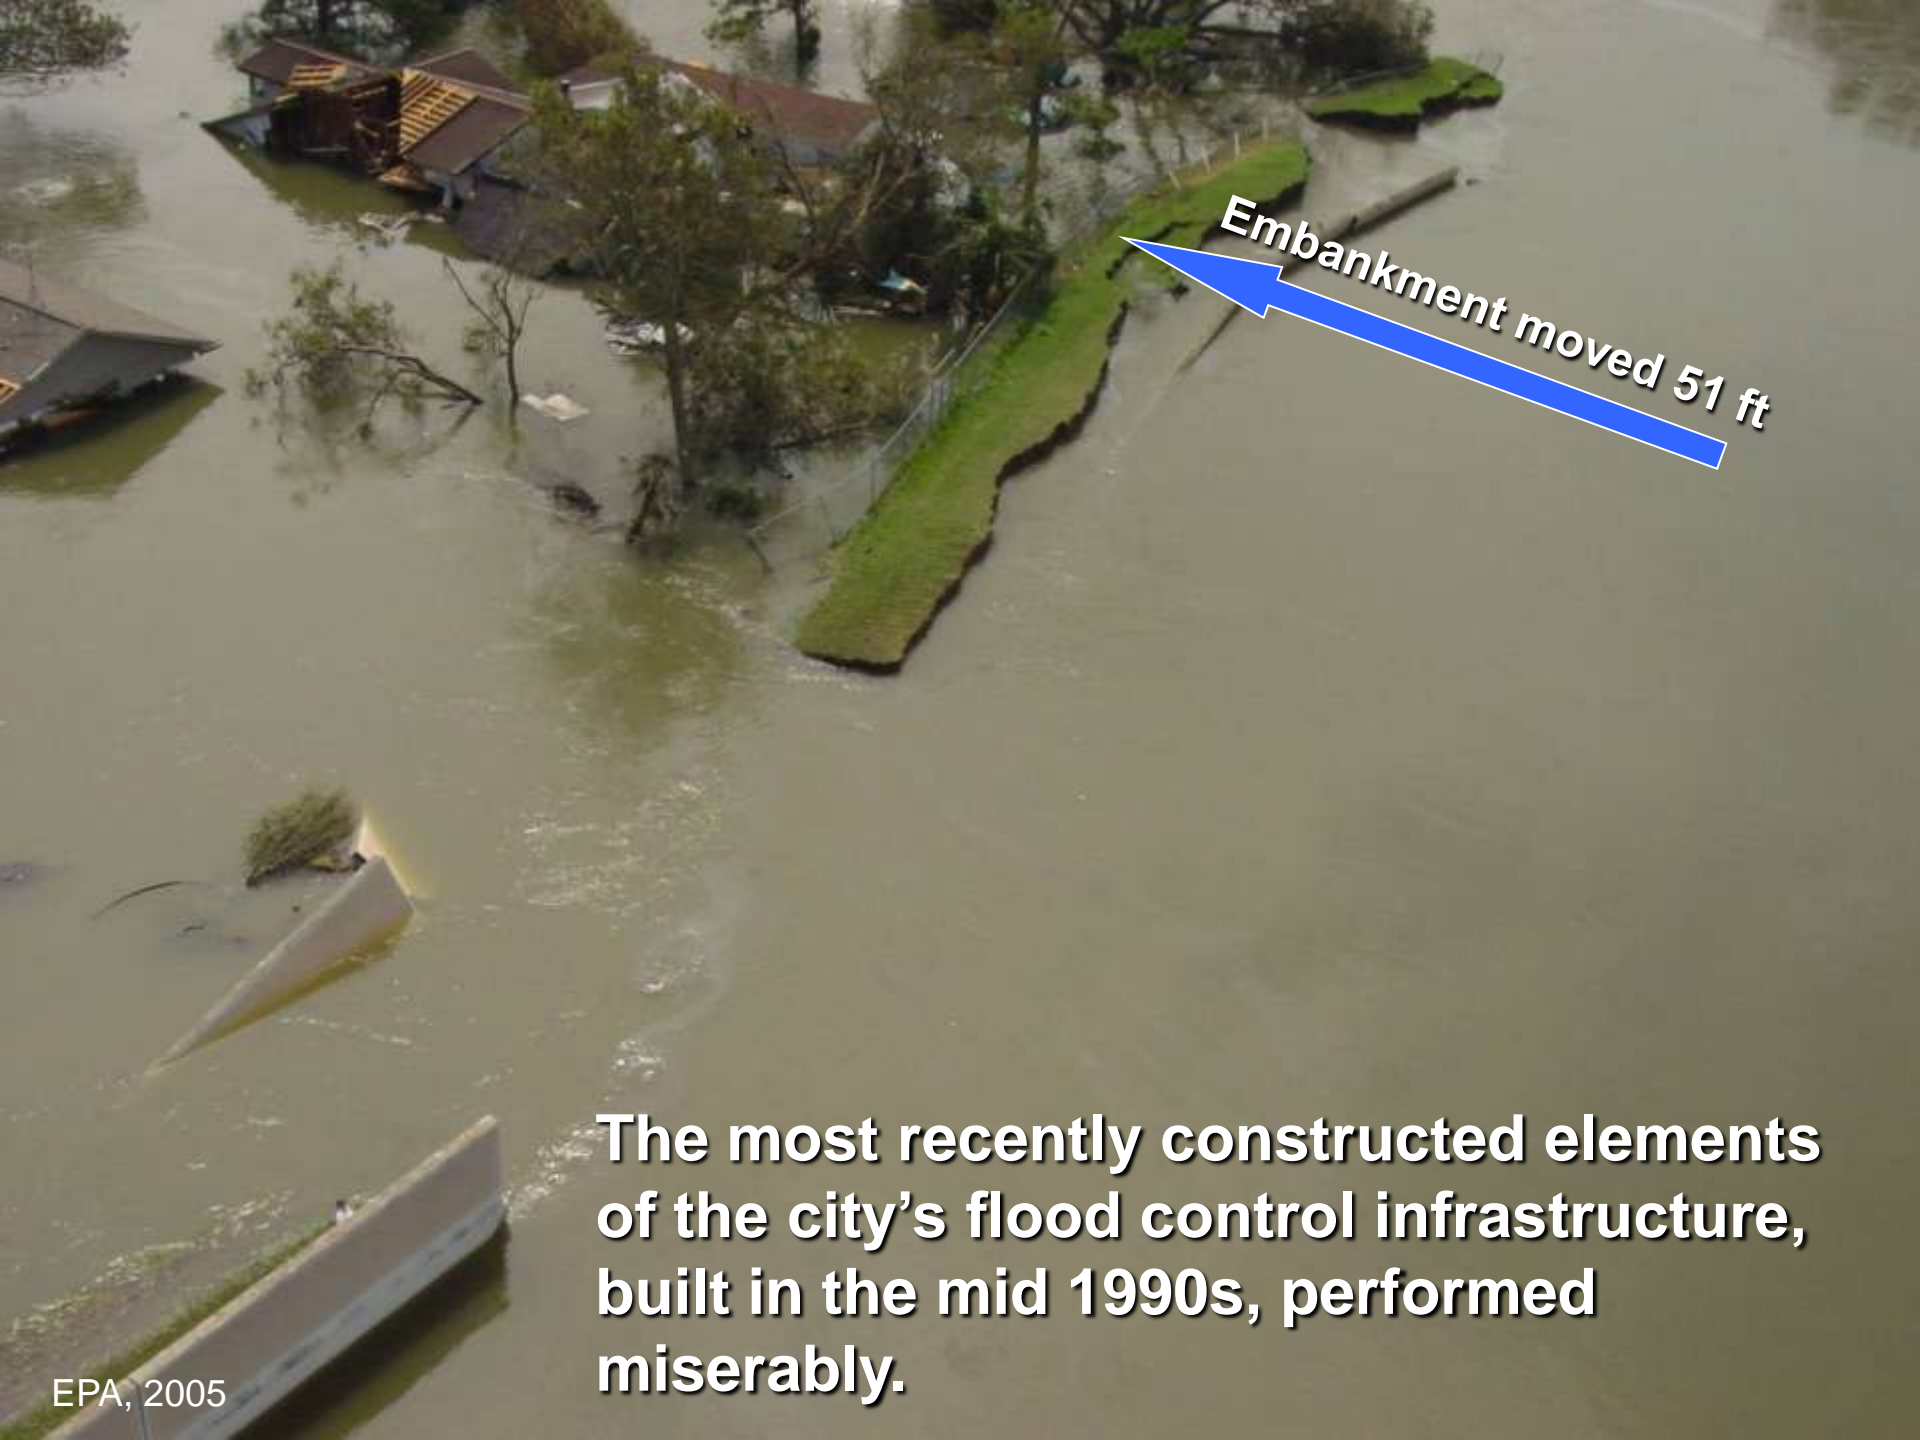
Embankment moved 51 ft

The most recently constructed elements of the city's flood control infrastructure, built in the mid 1990s, performed miserably.

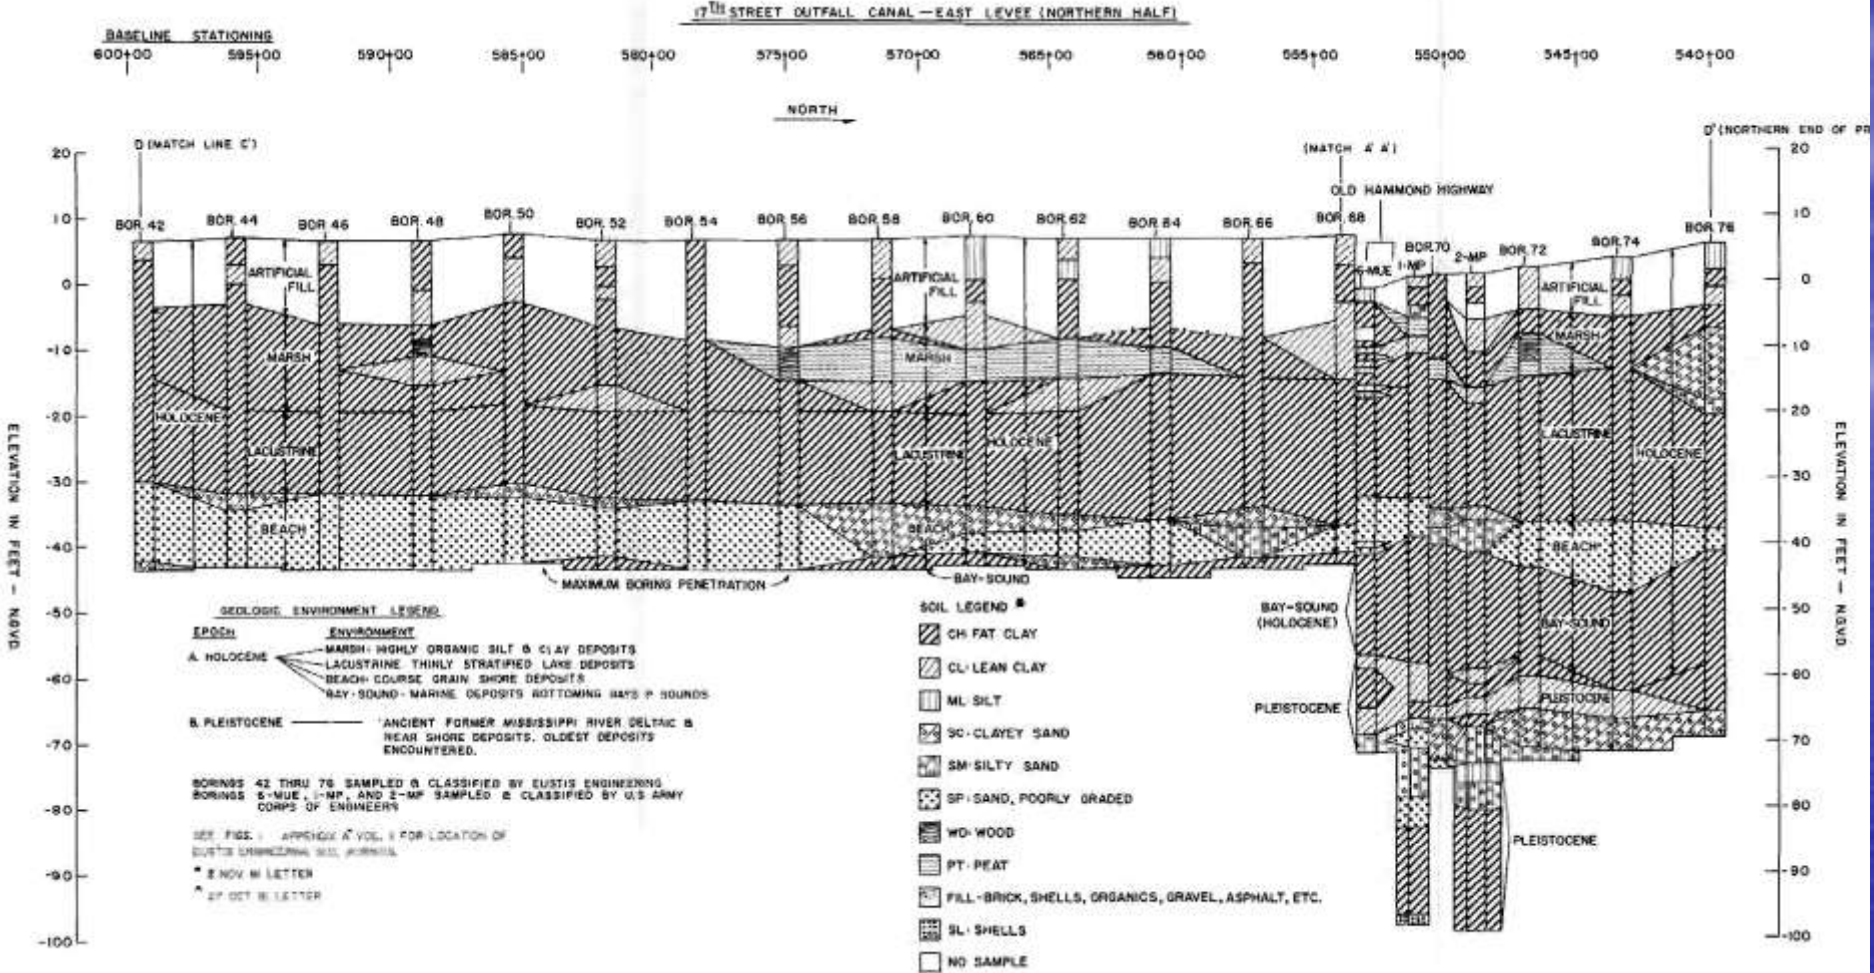
Geologic profile for the 17th St Canal flood wall prepared by Corps' New Orleans District office in 1990. Three of four holes in vicinity of the 2005 failure (spaced 500 ft apart) had zero sample recovery. These contacts were projected and the sheet pile tips designed, accordingly.

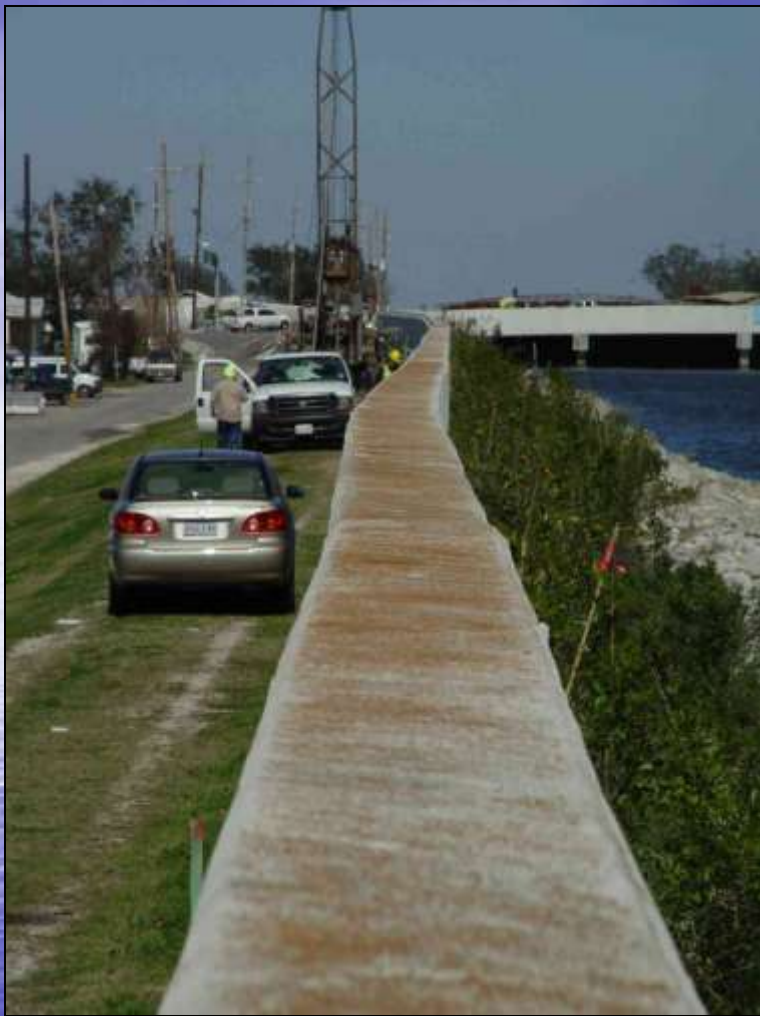
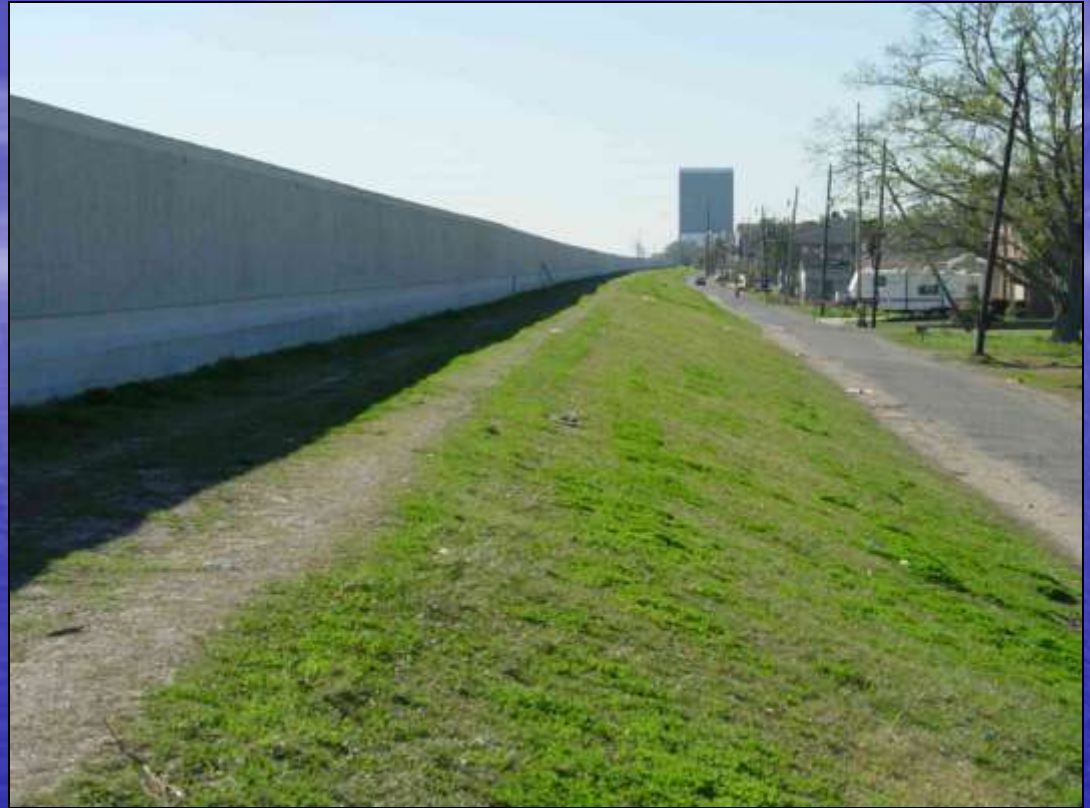
- **Apparent displacement of the 17th Street Canal flood wall on the west (Jefferson Parish) side, opposite the 17th Street failure.**

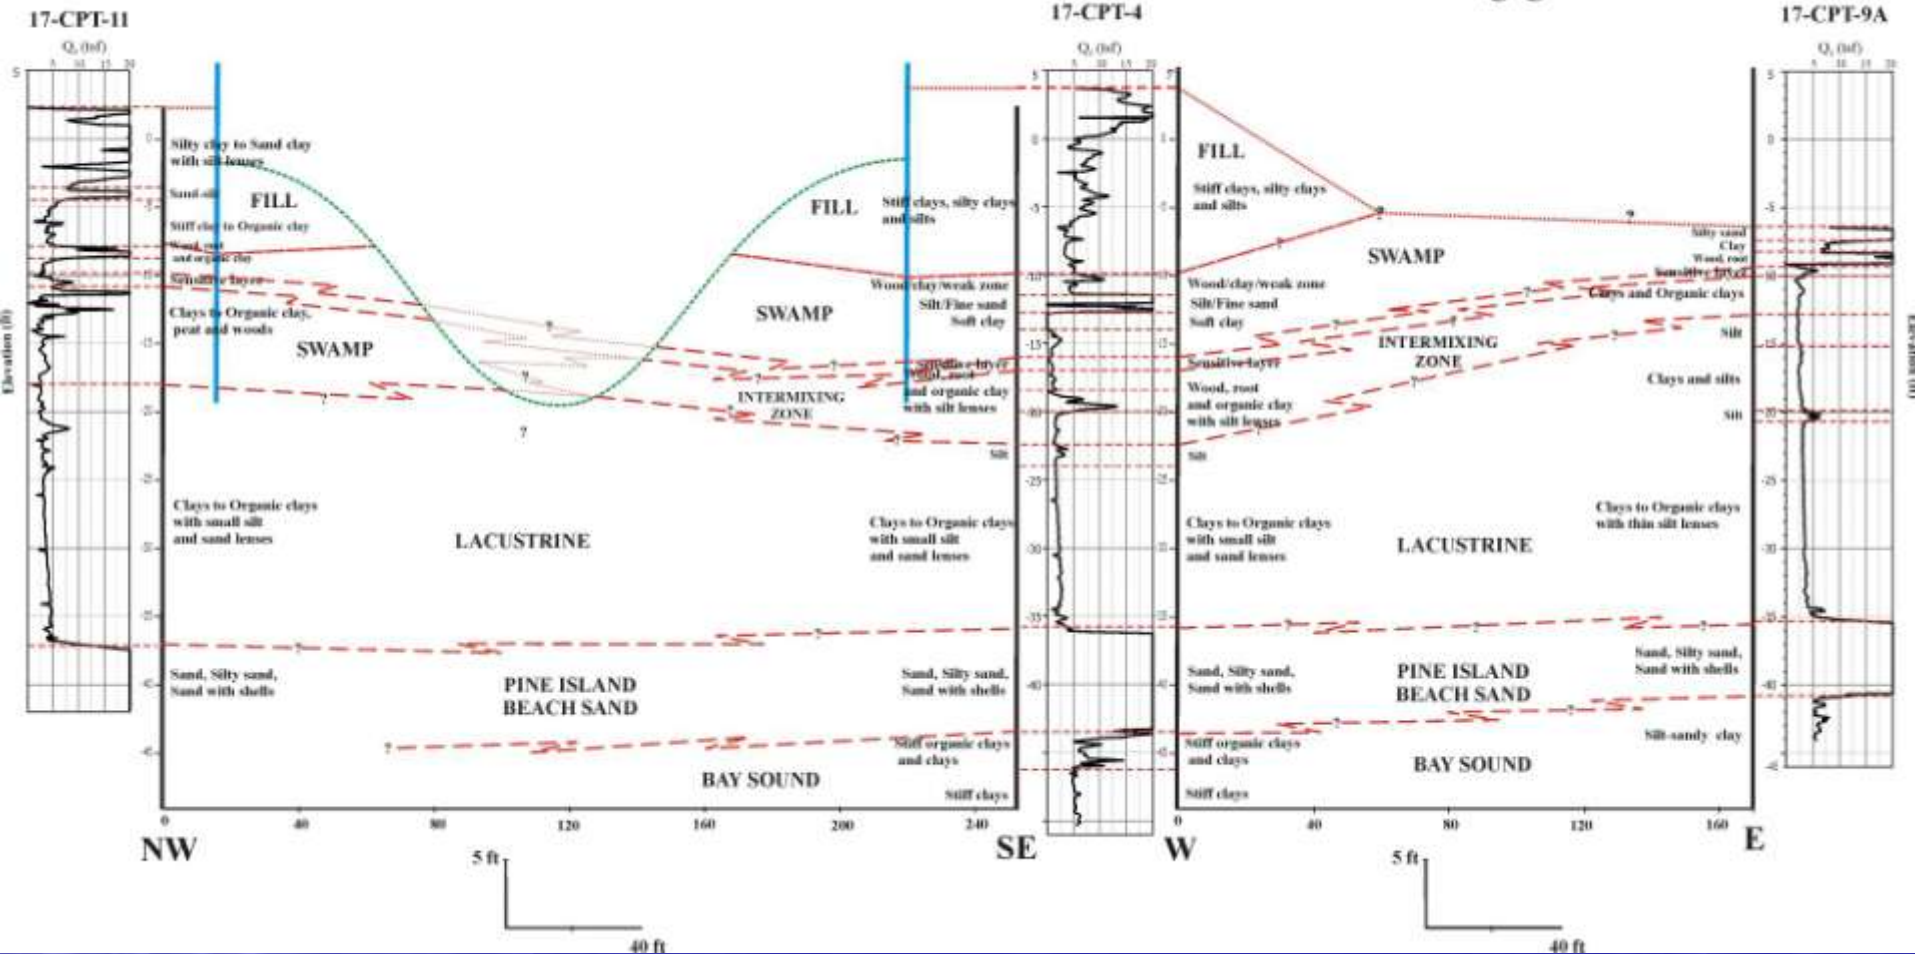
- Stratigraphic interpretations across the 17th Street Canal breach. The swamp much appeared to be thinning northerly, as does the underlying **Pine Island Beach Trend**. The lacustrine clays appear to thicken southward, as shown.
- The approximate positions of the flood walls (light blue) and canal bottom (dashed green) are based on information provided by the Corps of Engineers.

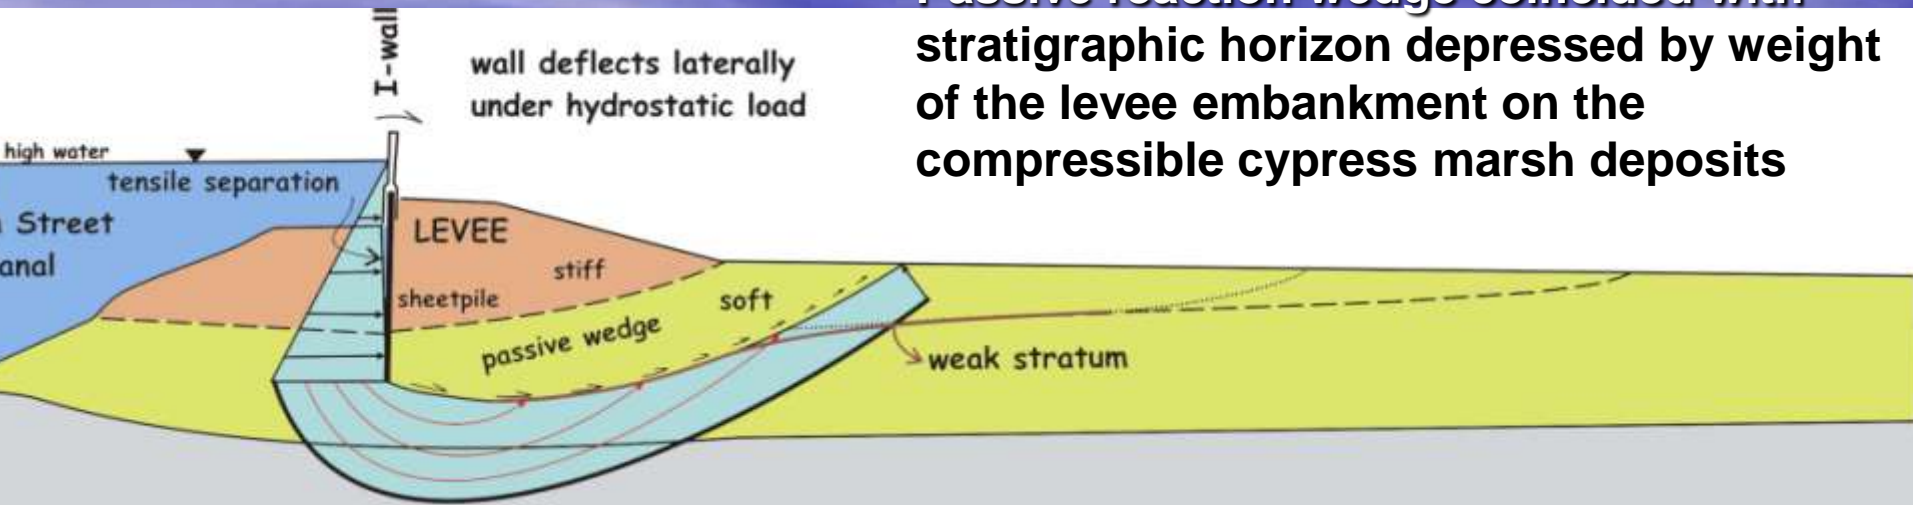
Traction shears noted along base of embankment. Note initial back rotation component of motion and development of planar thrusting

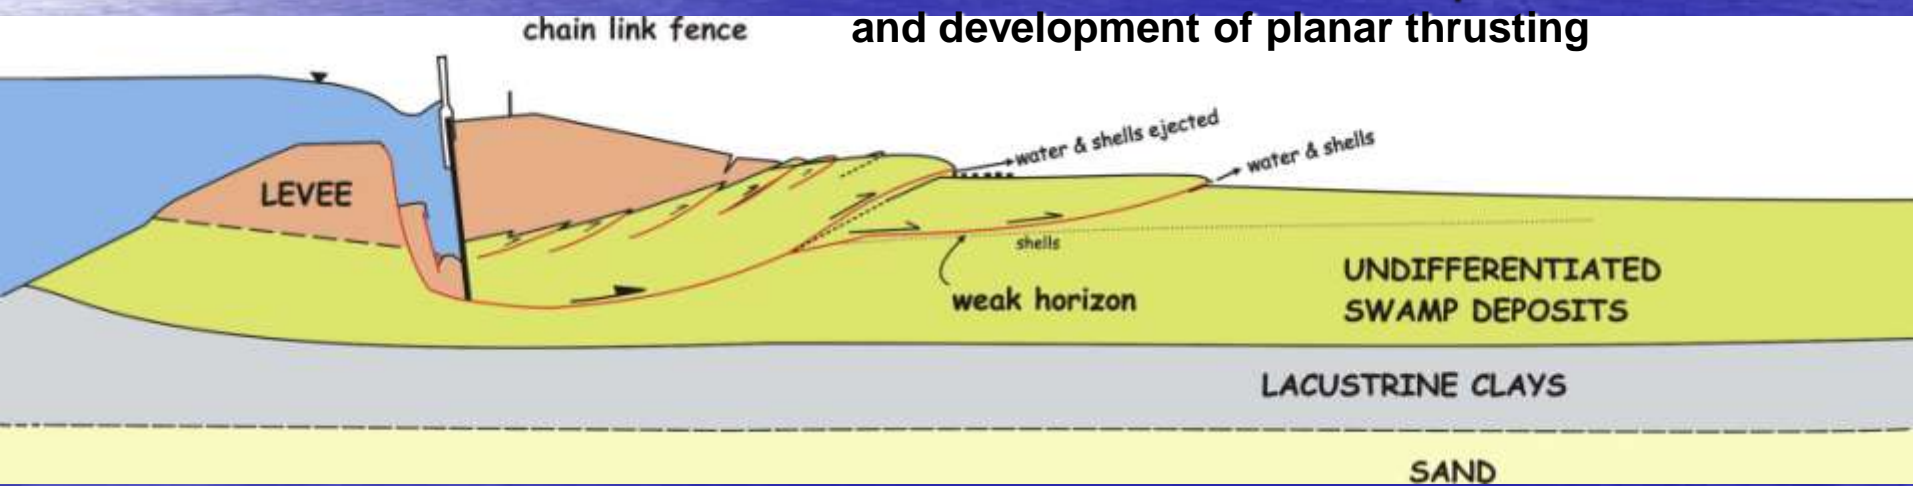
Initial loading conditions. Storm surge rises to within 4 feet of flood wall crest. Hydrostatic pressures on sheetpile supported I-wall highlighted in blue. Translational failure begins.

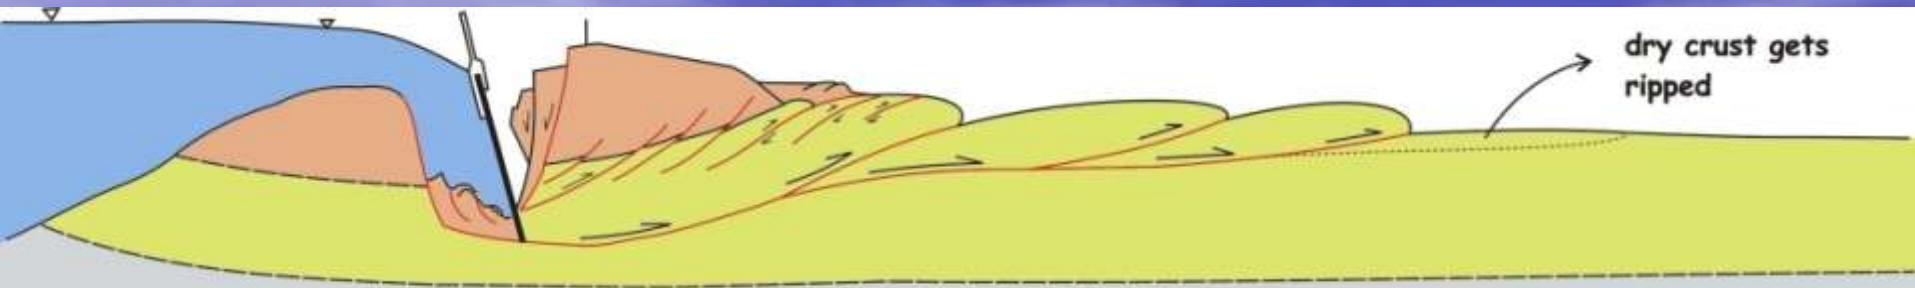
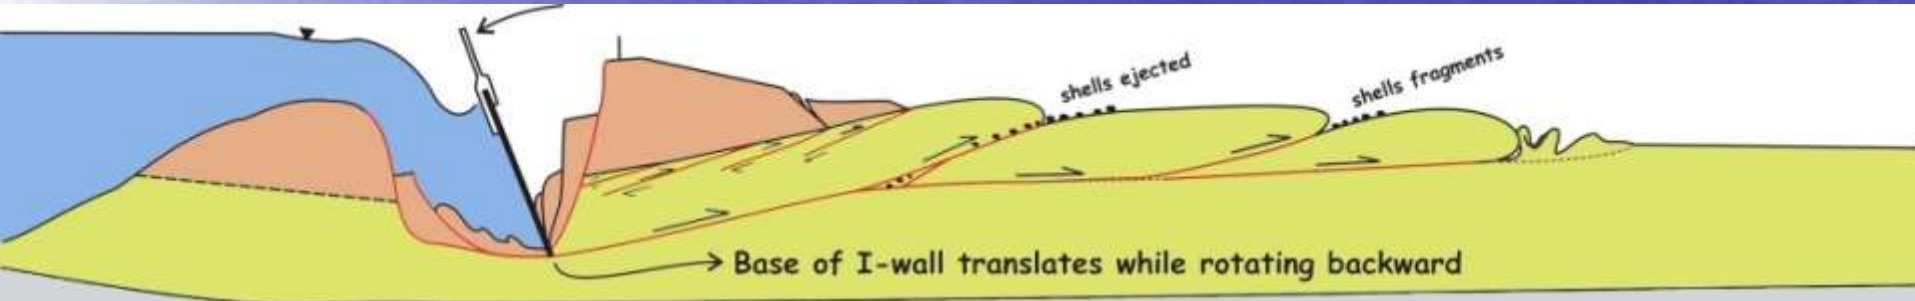
Progression of translational failure sequence. Multiple thrust sheets develop in partially saturated crust, comprised of sandy fill over organic cypress swamp deposits. The upper crust buckles like a rug being rolled up.

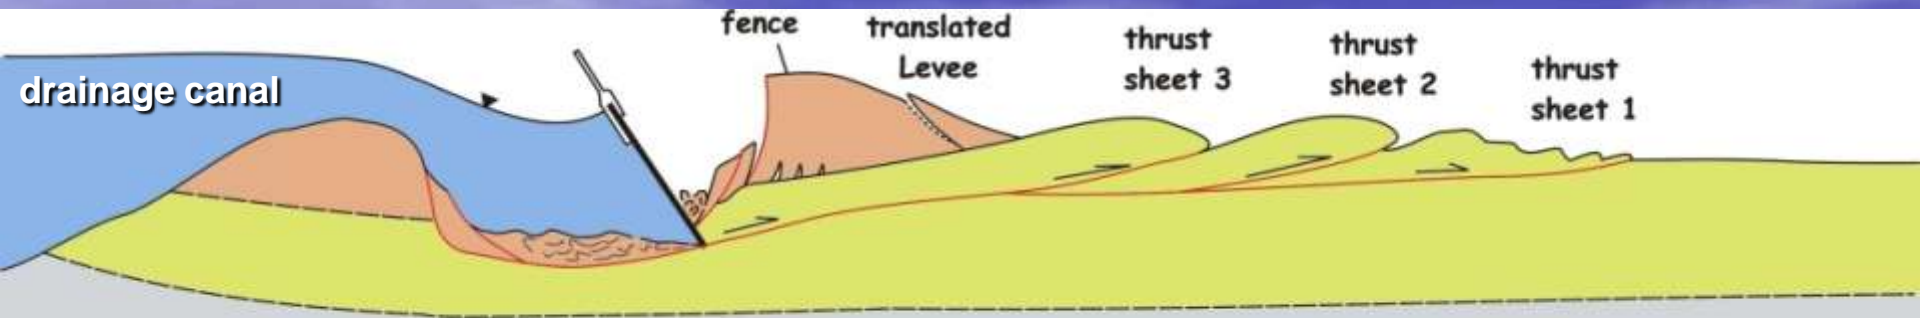
Some sheetpile supported I-walls fell backward; others fell forward

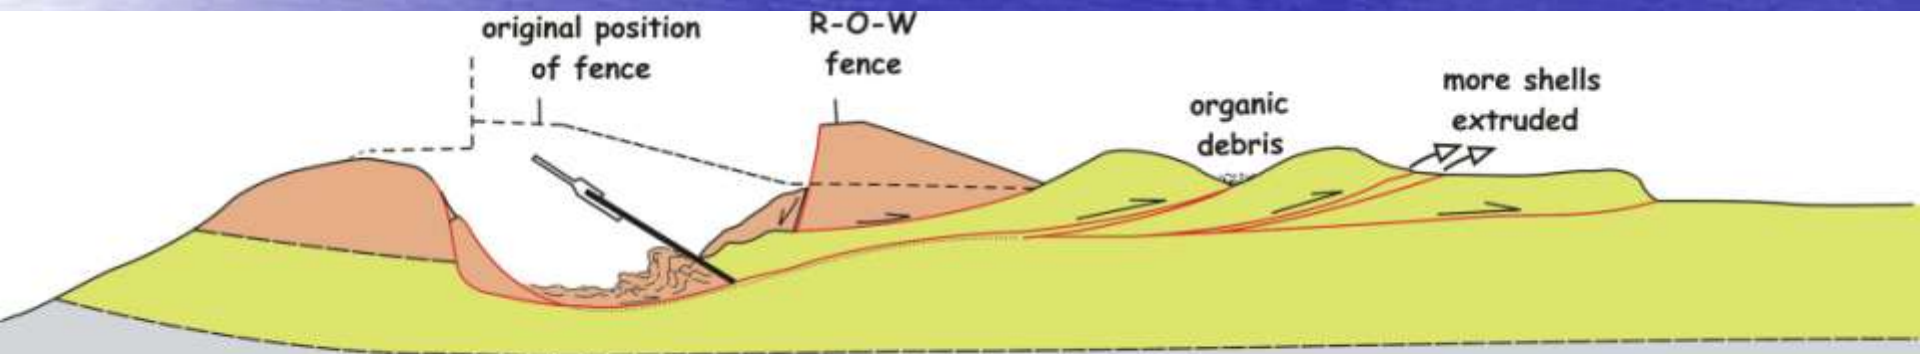
Final stages of translational failure sequence. Lower section shows failed levee after 51 feet of displacement. The void was quickly backfilled with gravel as part of sealing the breach.
