FACTORS CONTRIBUTING TO THE 2005 TAUM SAUK UPPER RESERVOIR FAILURE

December 14, 2005

Reynolds County, Missouri

RECONSTRUCTED FAILURE SEQUENCE

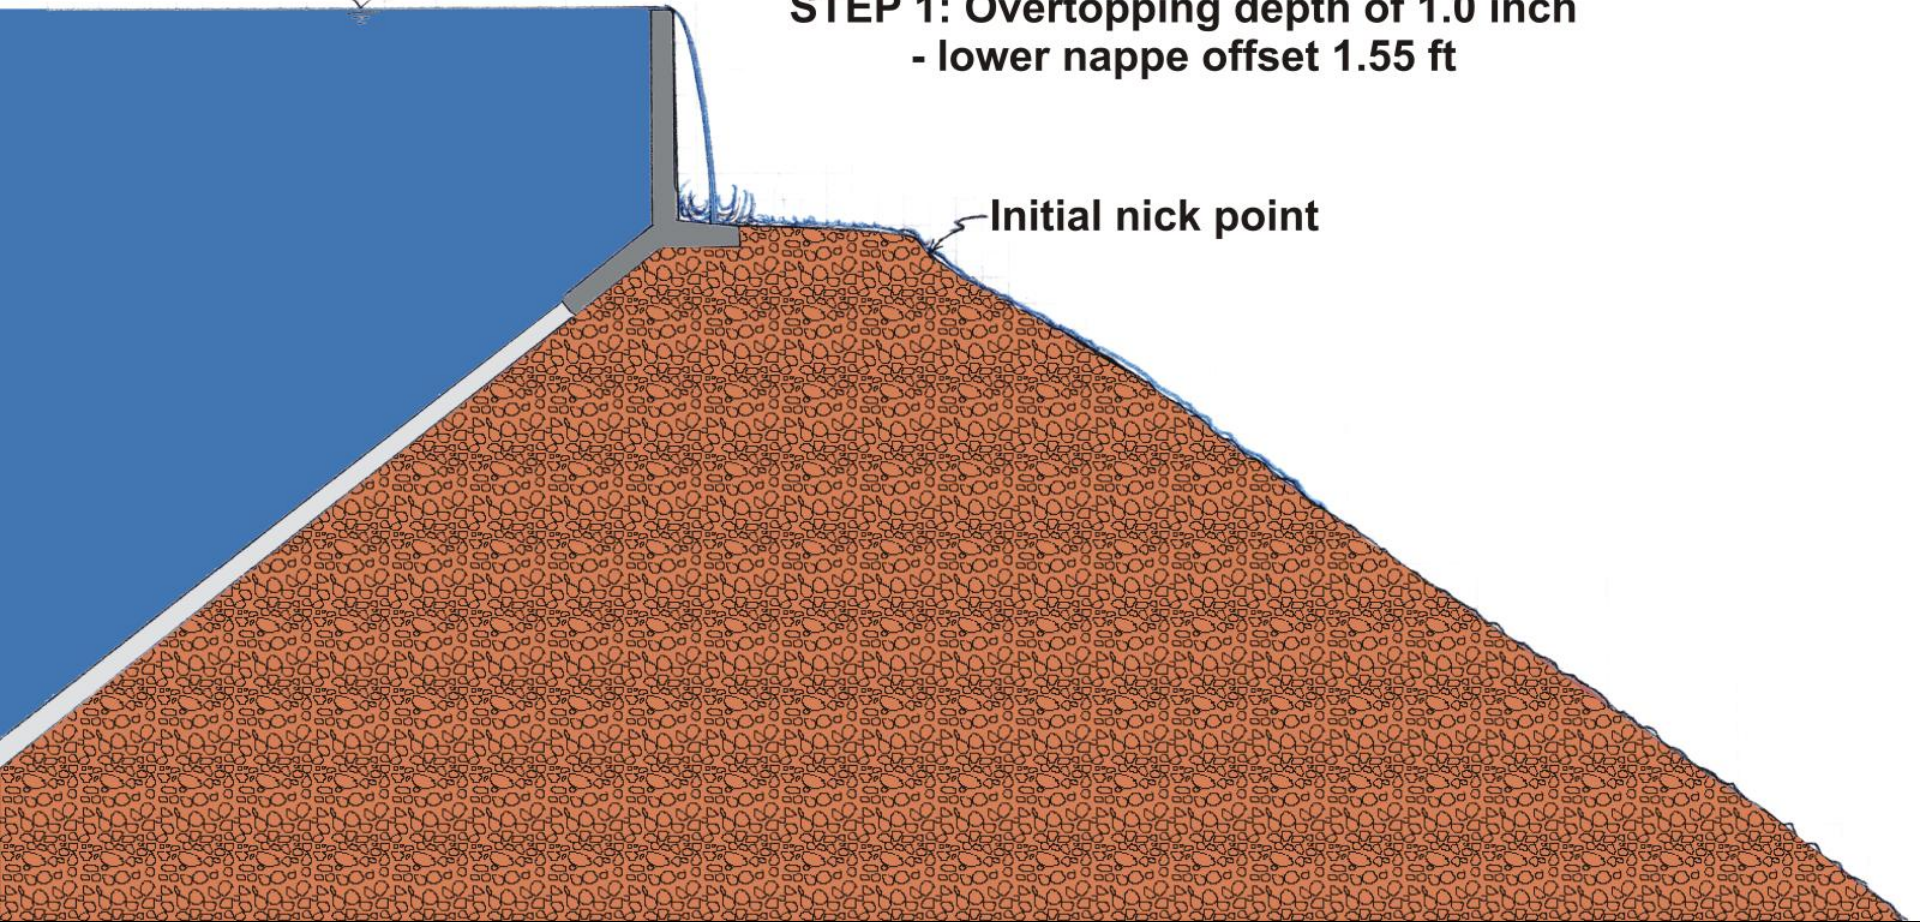
Time: ~5:09:00 AM

STEP 1: Overtopping depth of 1.0 inch
- lower nappe offset 1.55 ft

Initial nick point

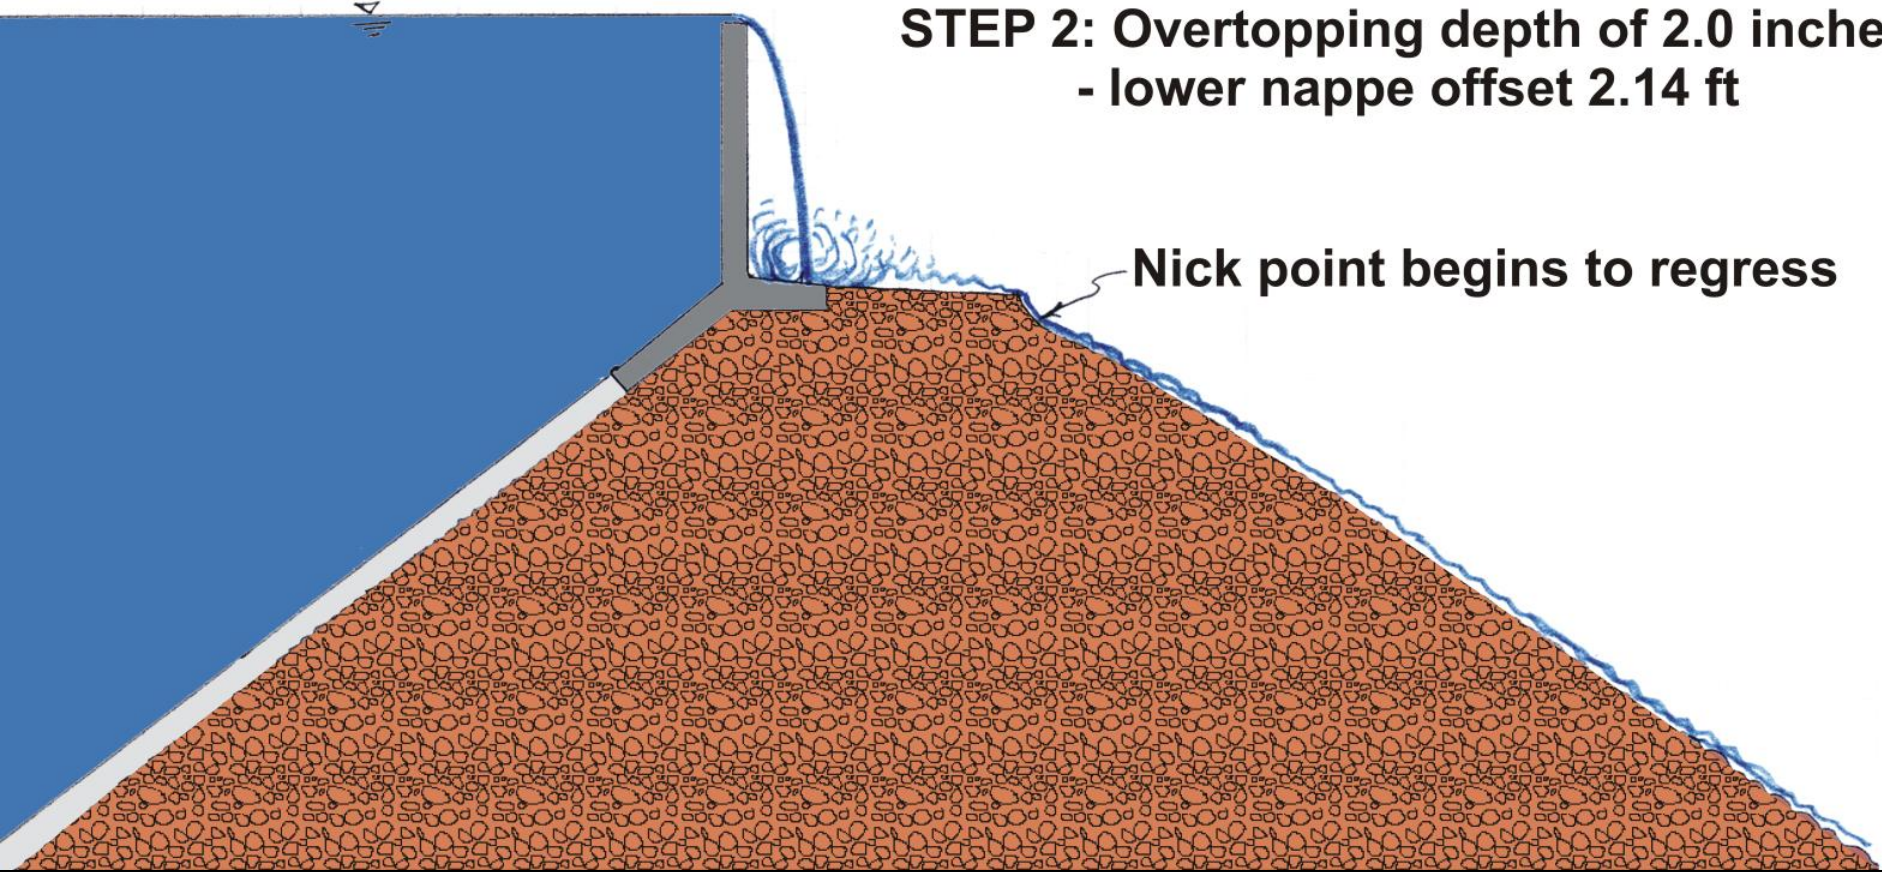
Time: ~5:10:30 AM

**STEP 2: Overtopping depth of 2.0 inches
- lower nappe offset 2.14 ft**

Nick point begins to regress

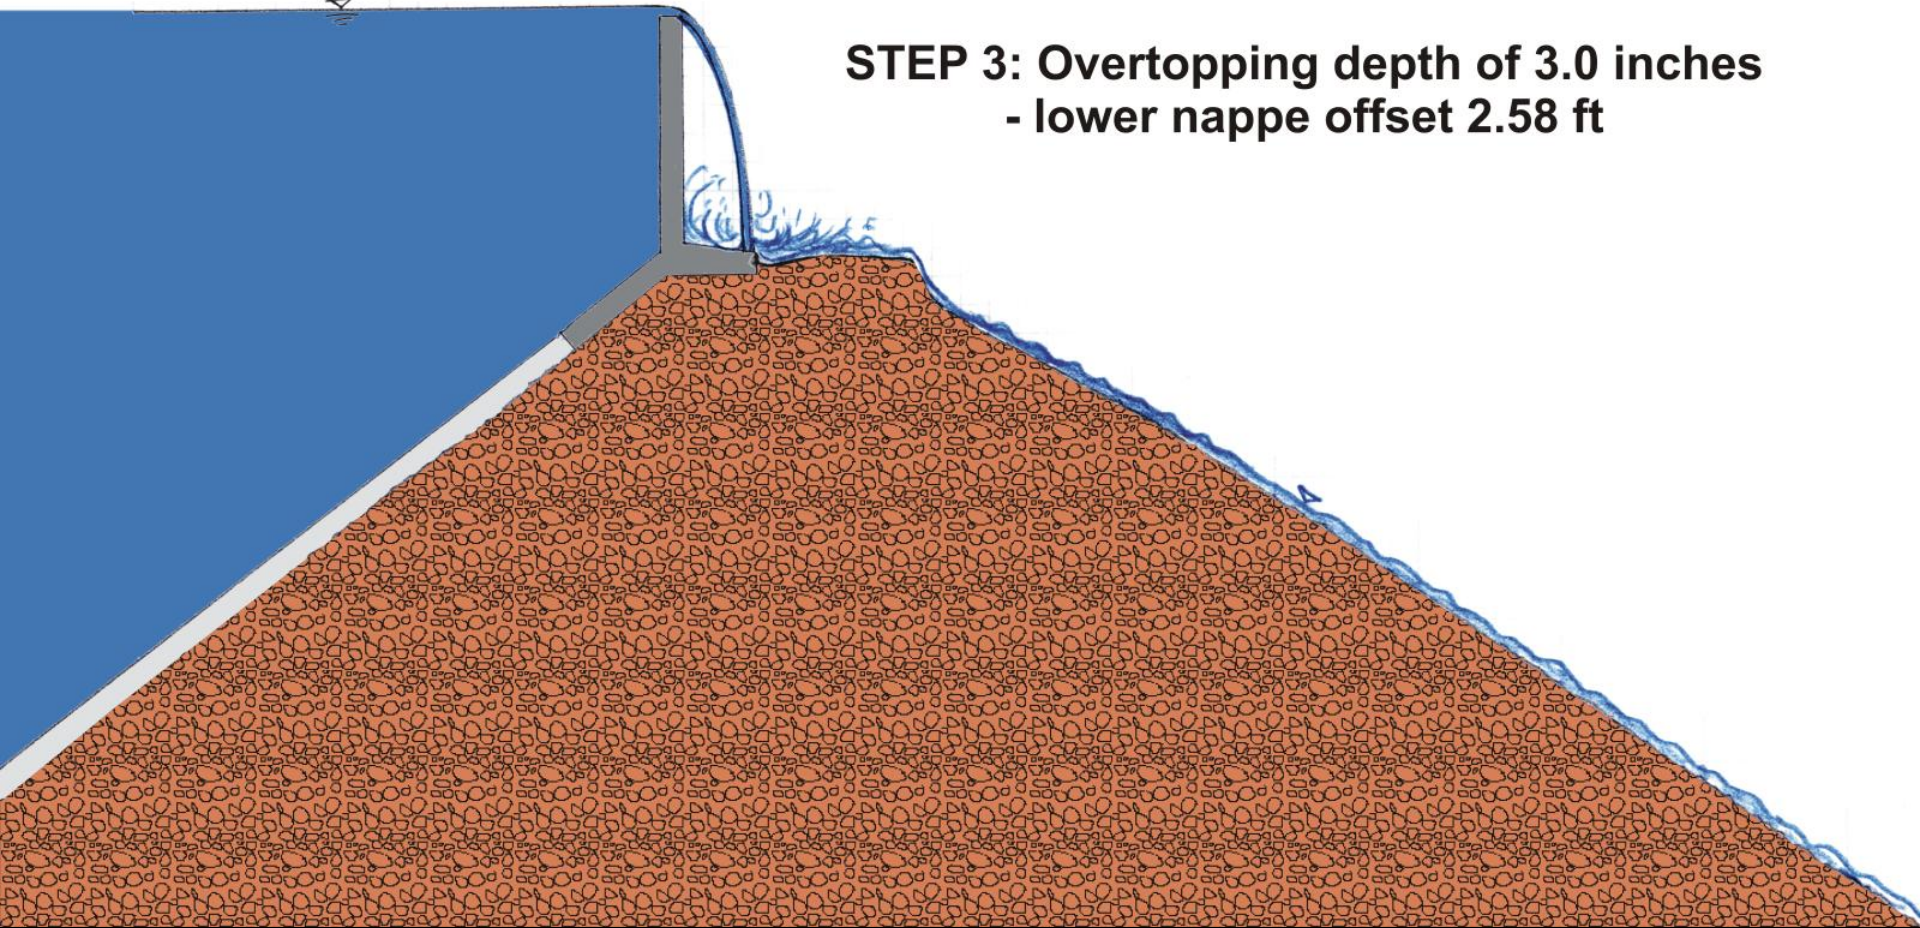
Time: ~5:11:55 AM

**STEP 3: Overtopping depth of 3.0 inches
- lower nappe offset 2.58 ft**

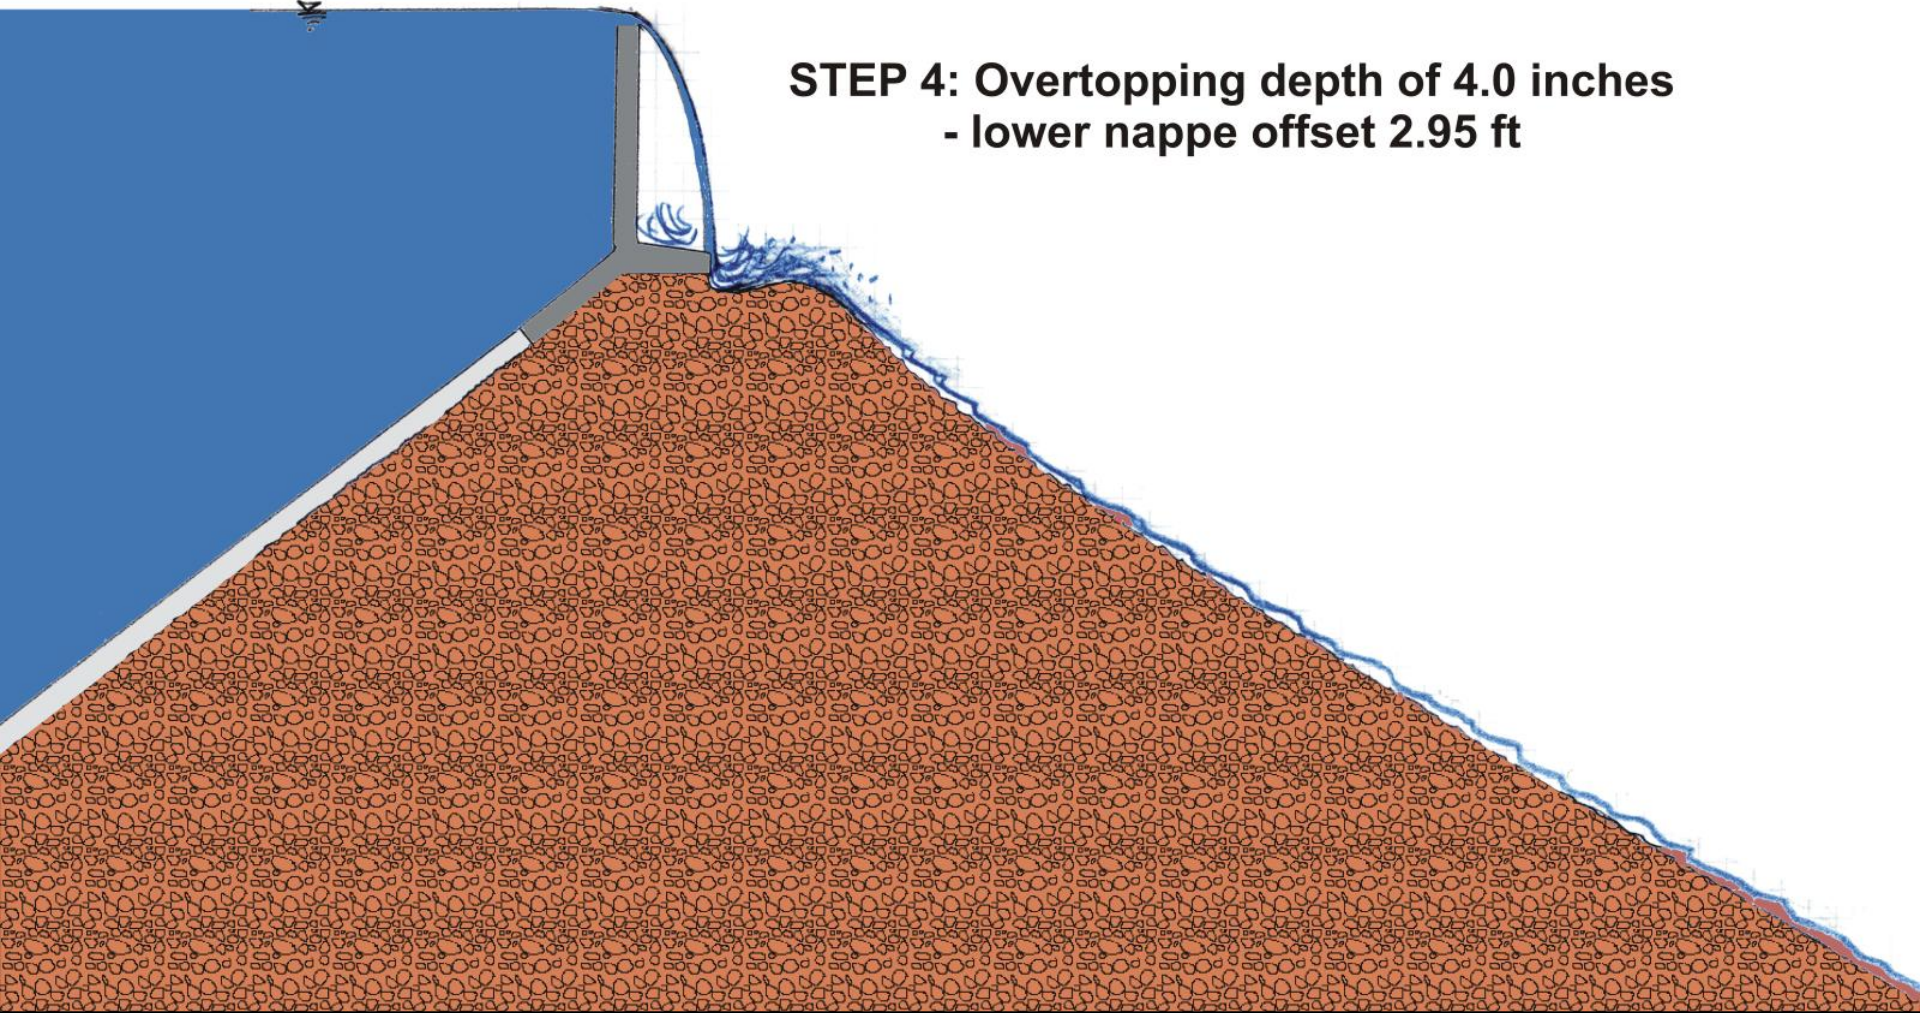
Time: ~5:12:55 AM

**STEP 4: Overtopping depth of 4.0 inches
- lower nappe offset 2.95 ft**

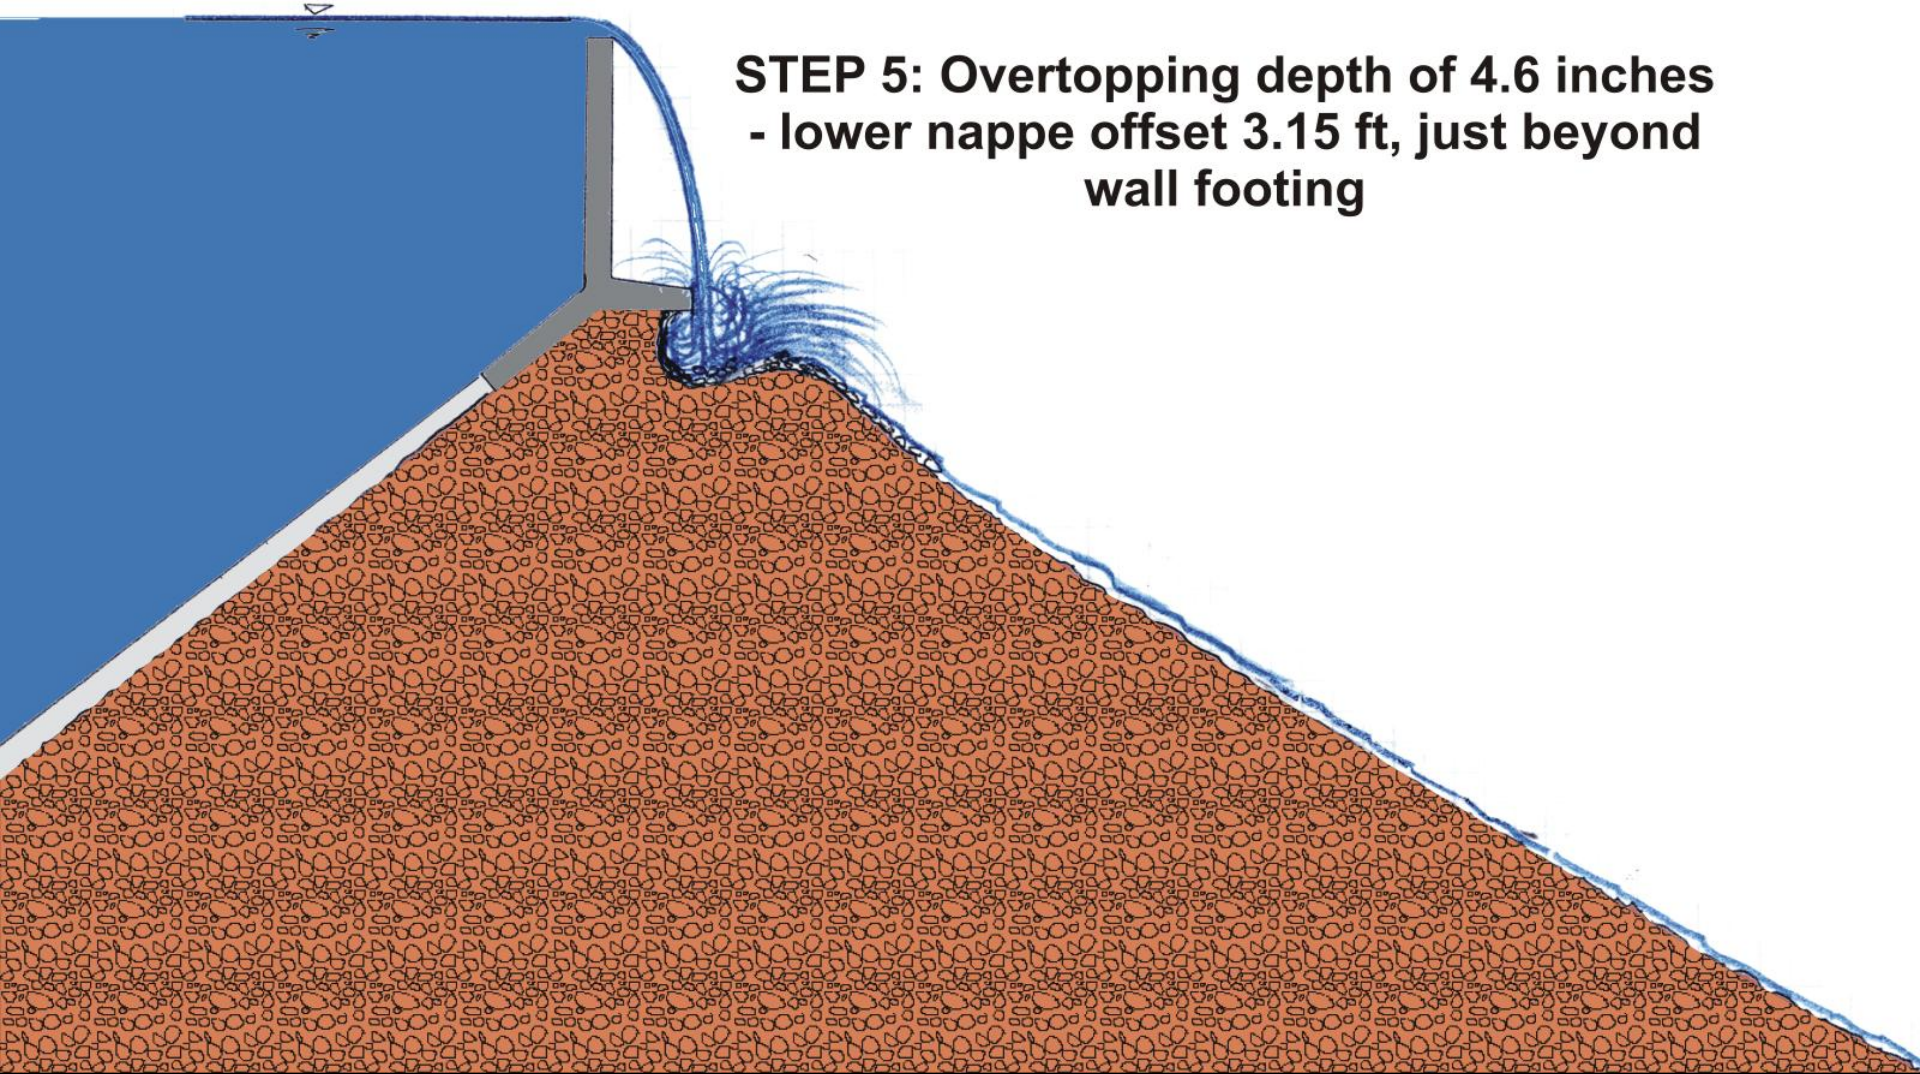
Time: ~5:13:35 AM

**STEP 5: Overtopping depth of 4.6 inches
- lower nappe offset 3.15 ft, just beyond
wall footing**

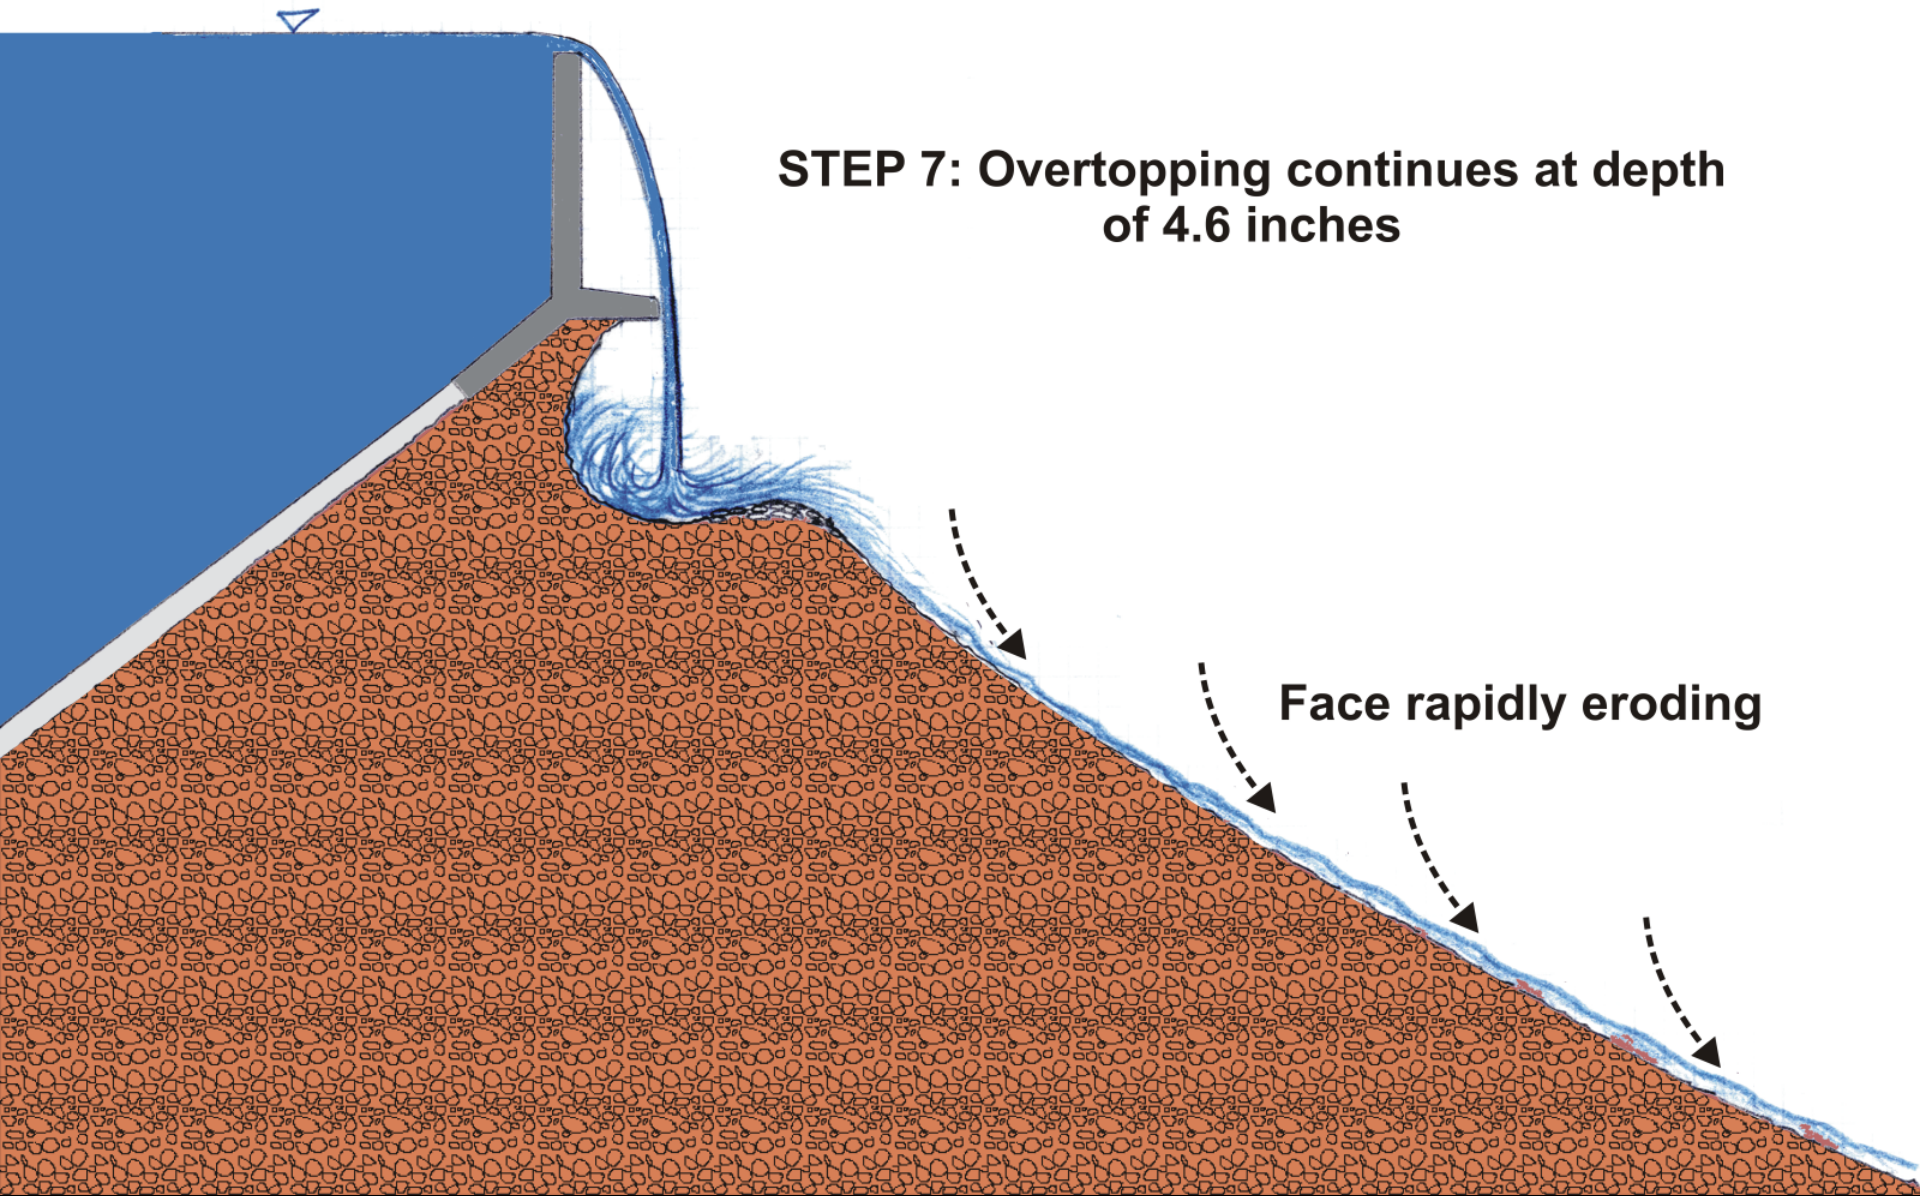
Time: ~5:14:00 AM

STEP 7: Overtopping continues at depth of 4.6 inches

Face rapidly eroding

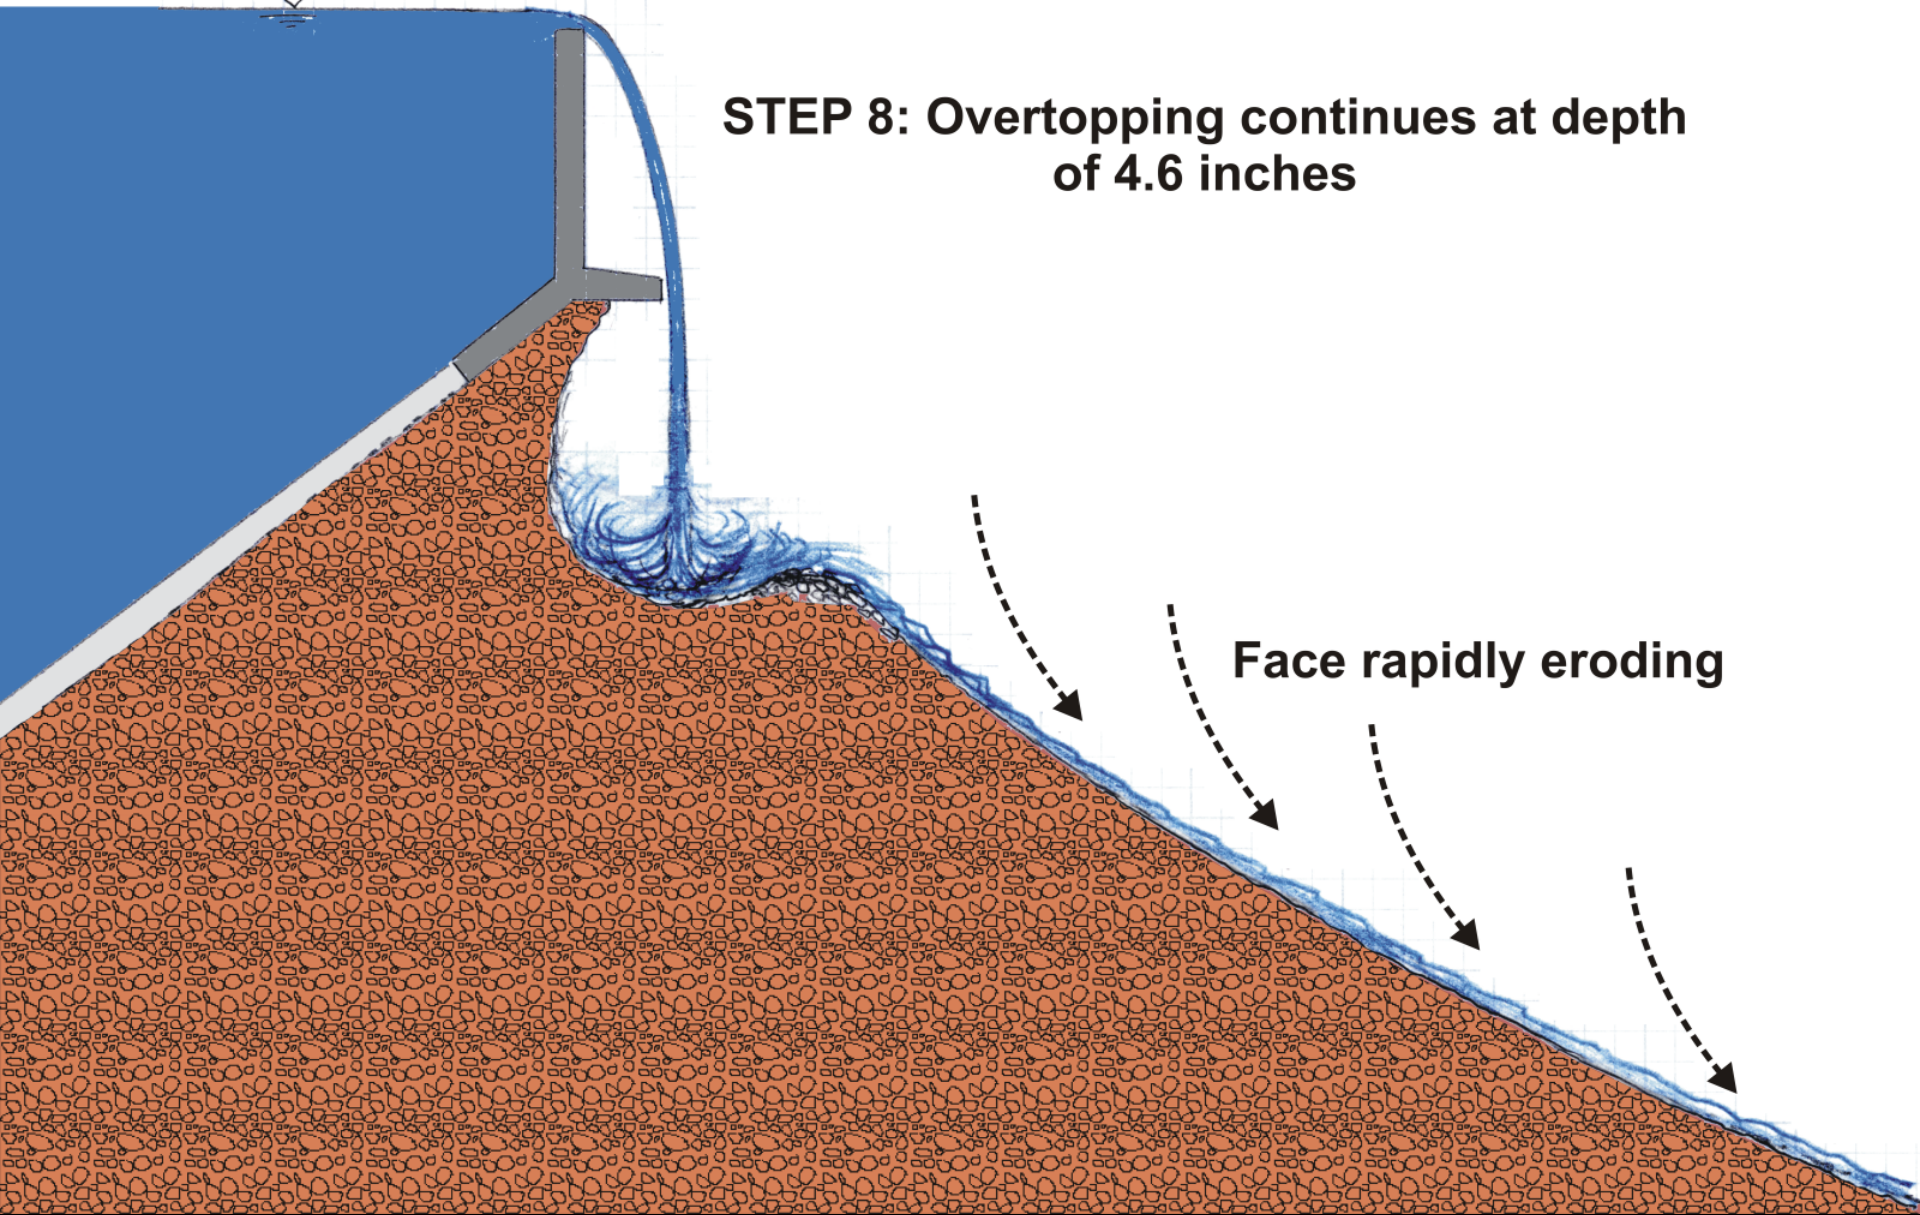
Time: ~5:14:15 AM

STEP 8: Overtopping continues at depth of 4.6 inches

Face rapidly eroding

3 Dimensional effects allowed wall to stand with extensive undermining

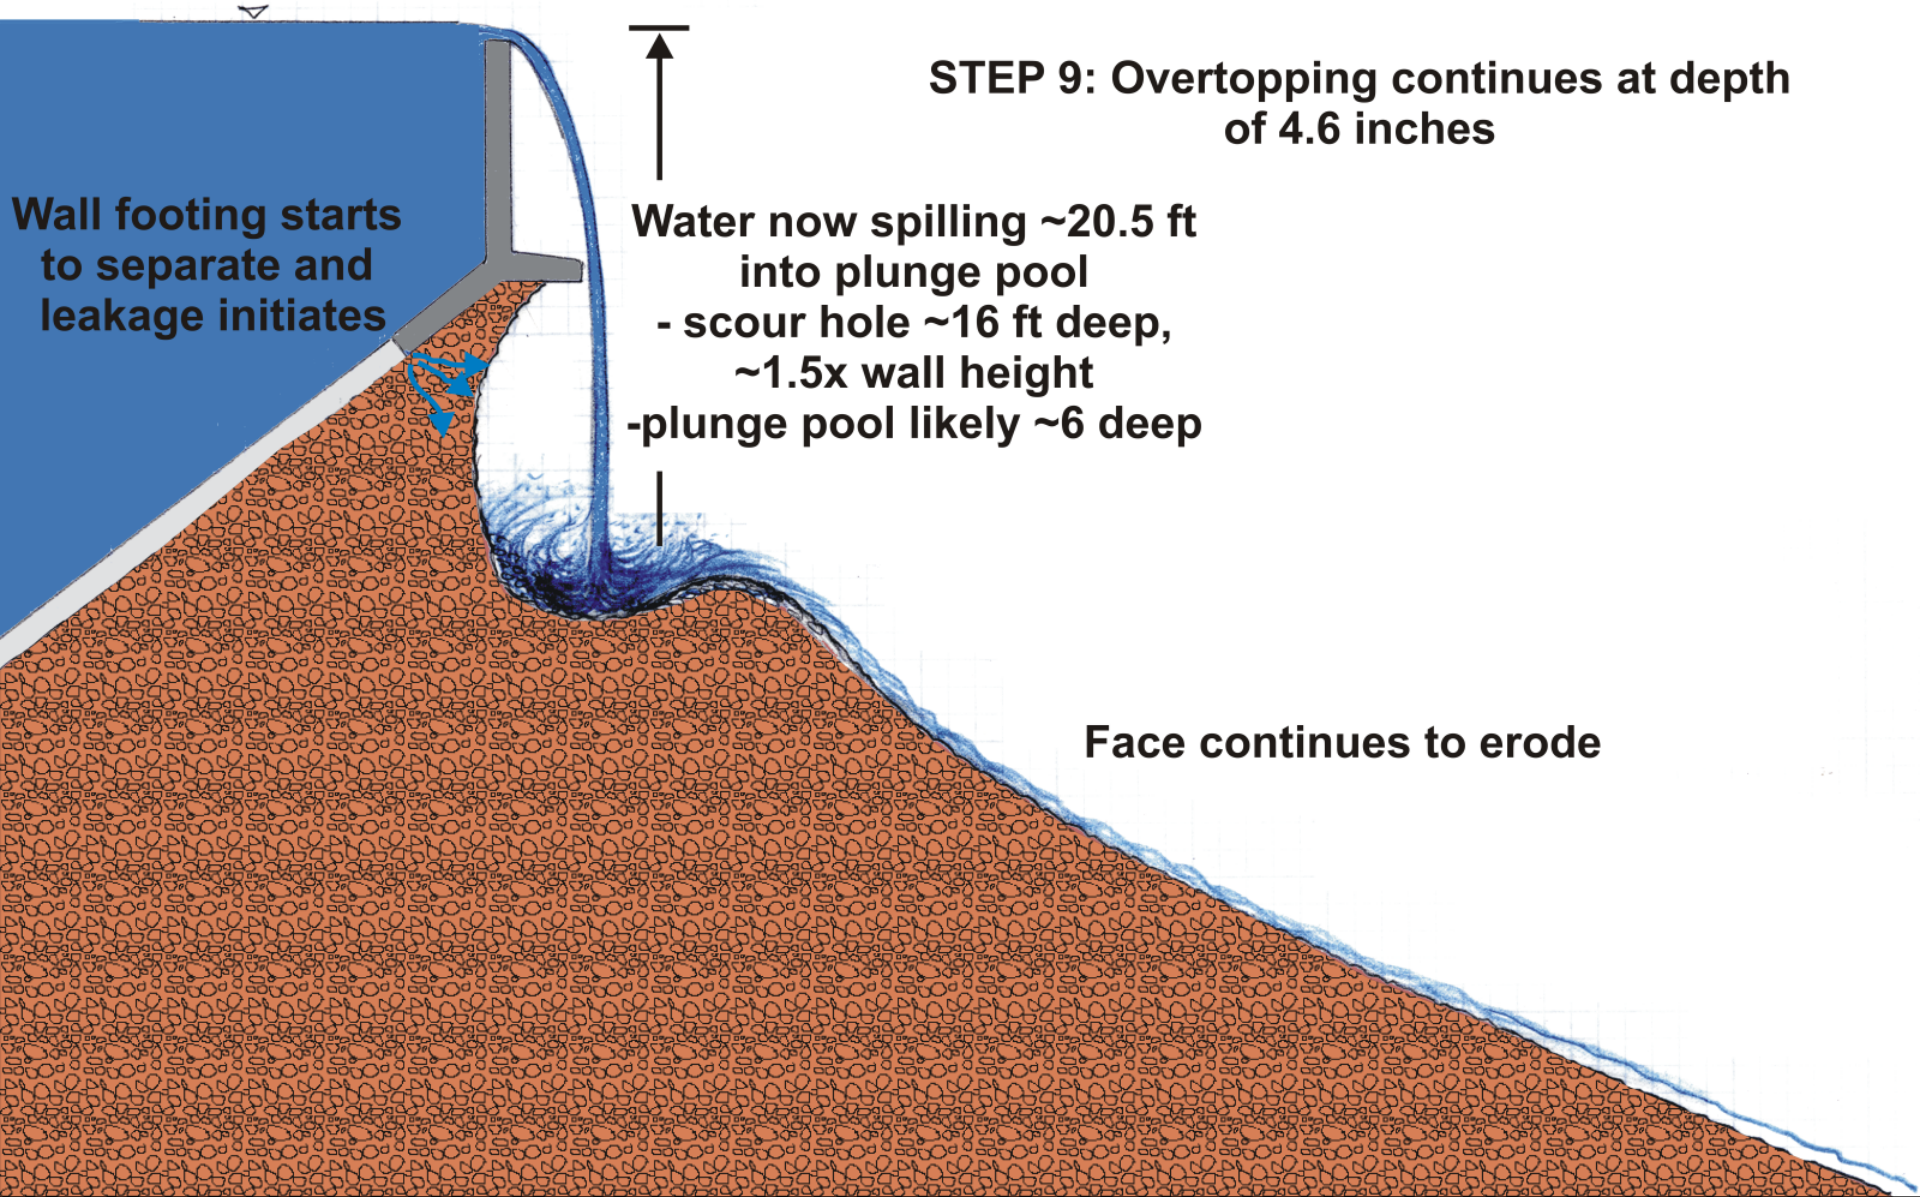
Time: ~5:14:35 AM

Wall footing starts to separate and leakage initiates

STEP 9: Overtopping continues at depth of 4.6 inches

Water now spilling ~20.5 ft into plunge pool
- scour hole ~16 ft deep, ~1.5x wall height
- plunge pool likely ~6 deep

Face continues to erode

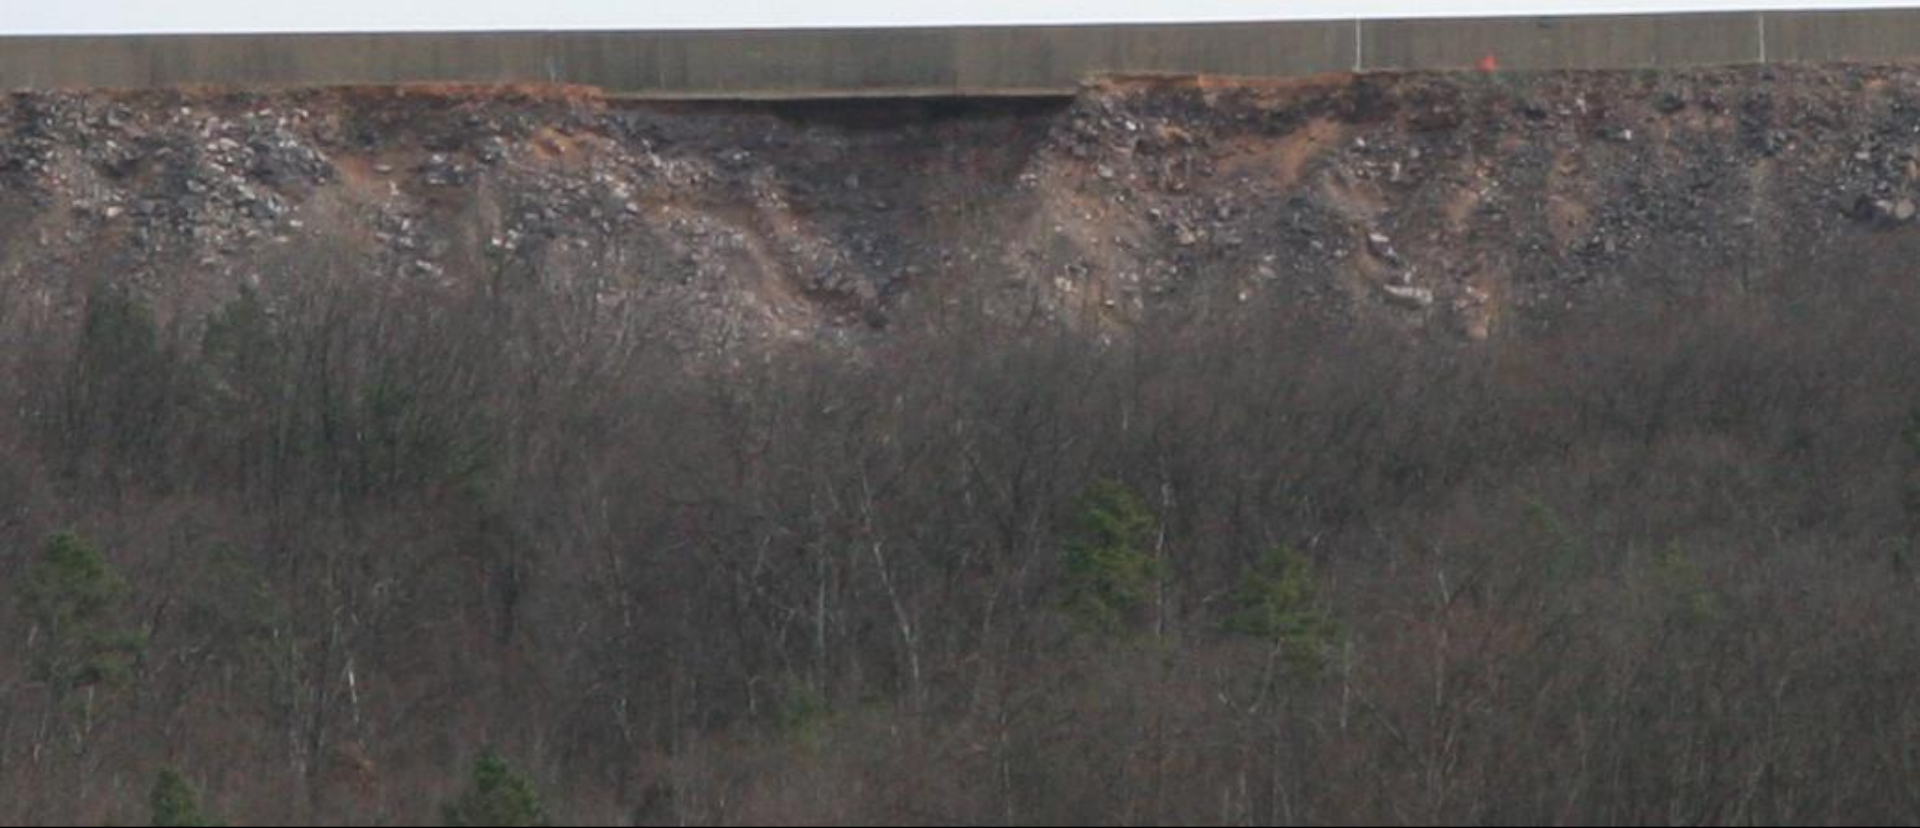
Water pouring over the parapet wall scoured away the fill supporting the wall's foundation. A portion of the wall appears to have toppled, unleashing a flow of water that catastrophically eroded a 680 foot wide section of the embankment, emptying the reservoir in ~12 minutes. This view shows the joint between wall Panels 72/73.

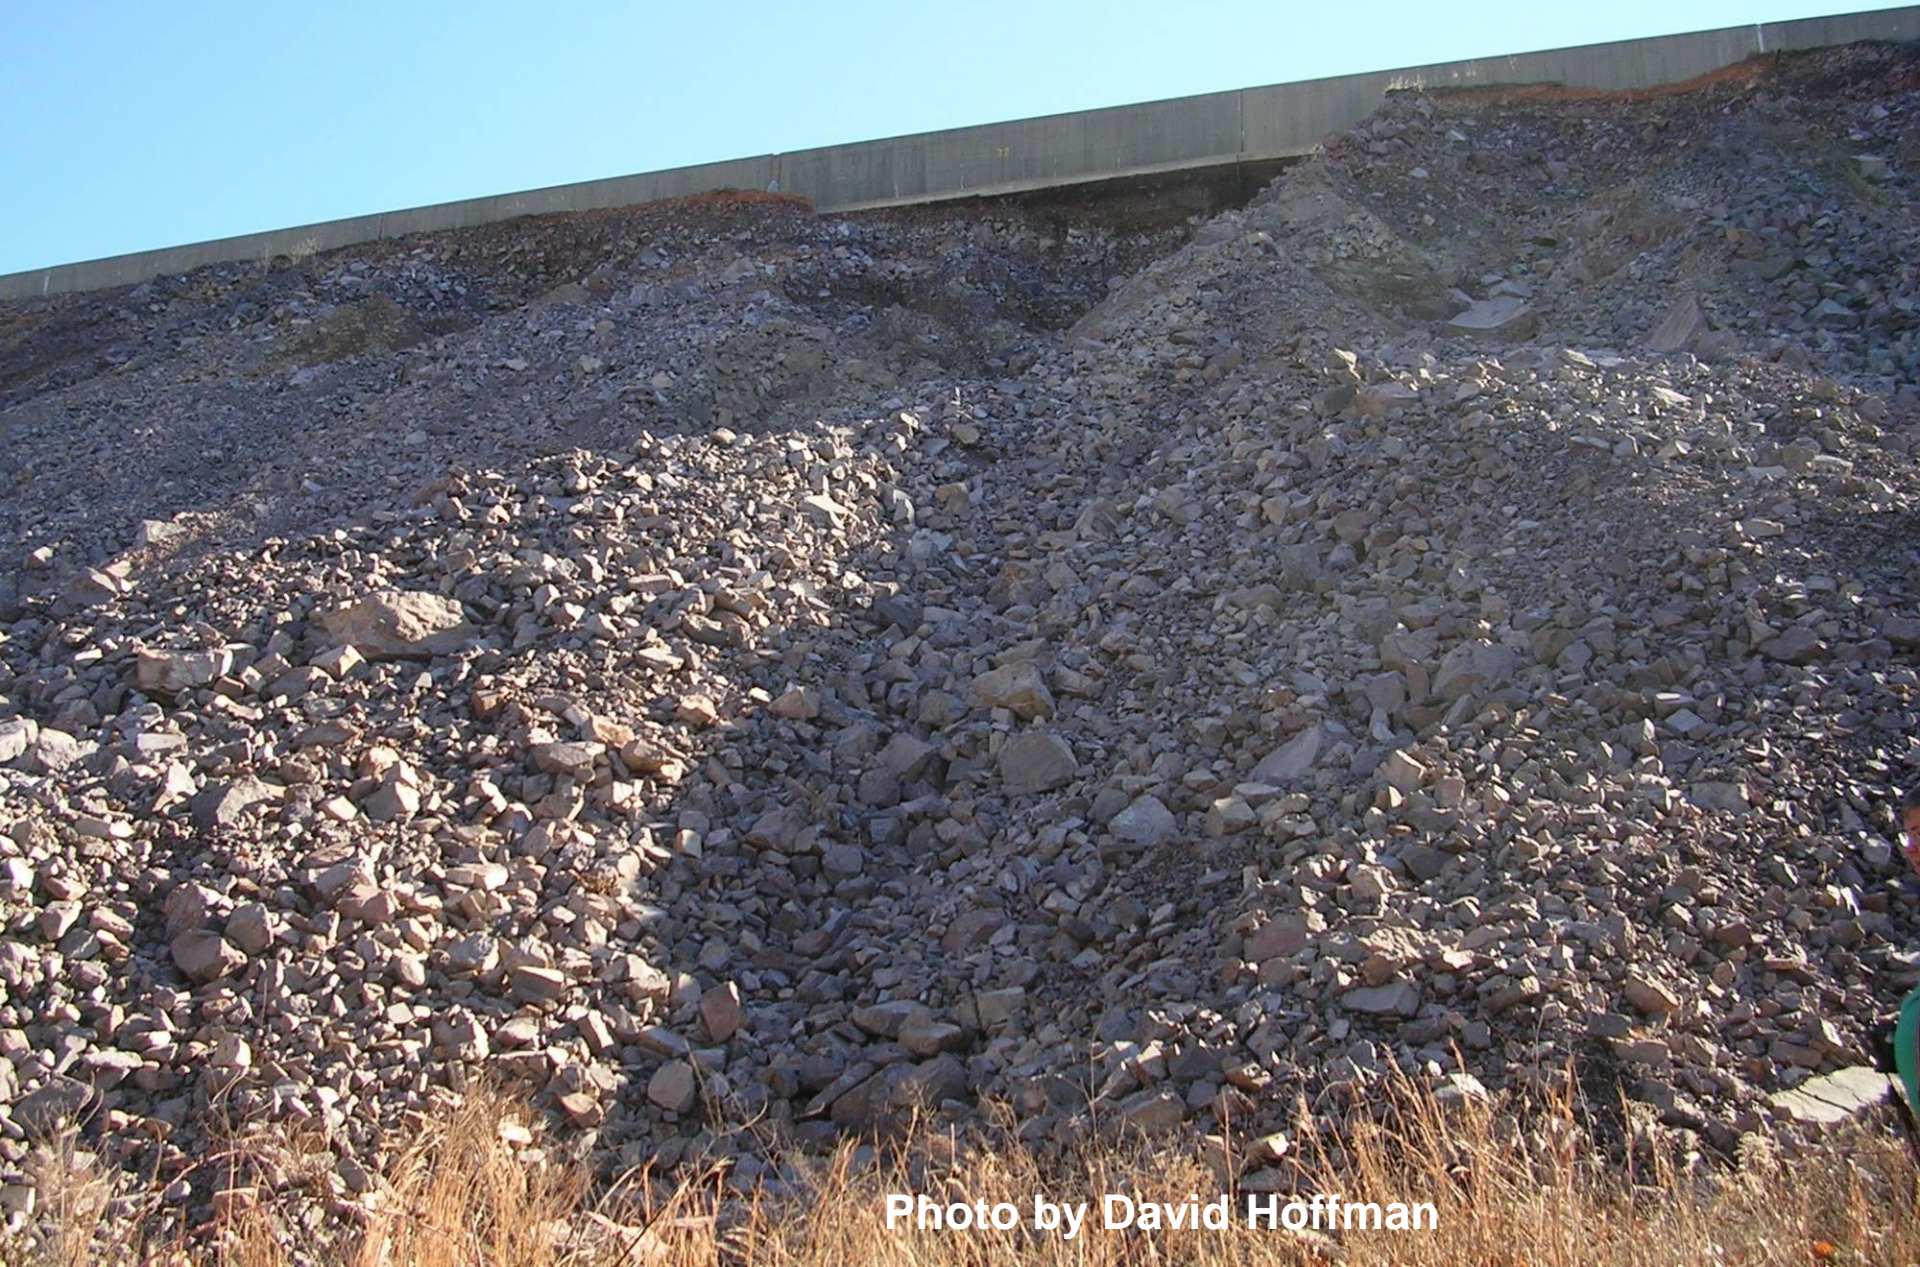
The parapet wall was completely undermined near the joint between wall panels 72/73. Note the clean character of the rockfill at this location.

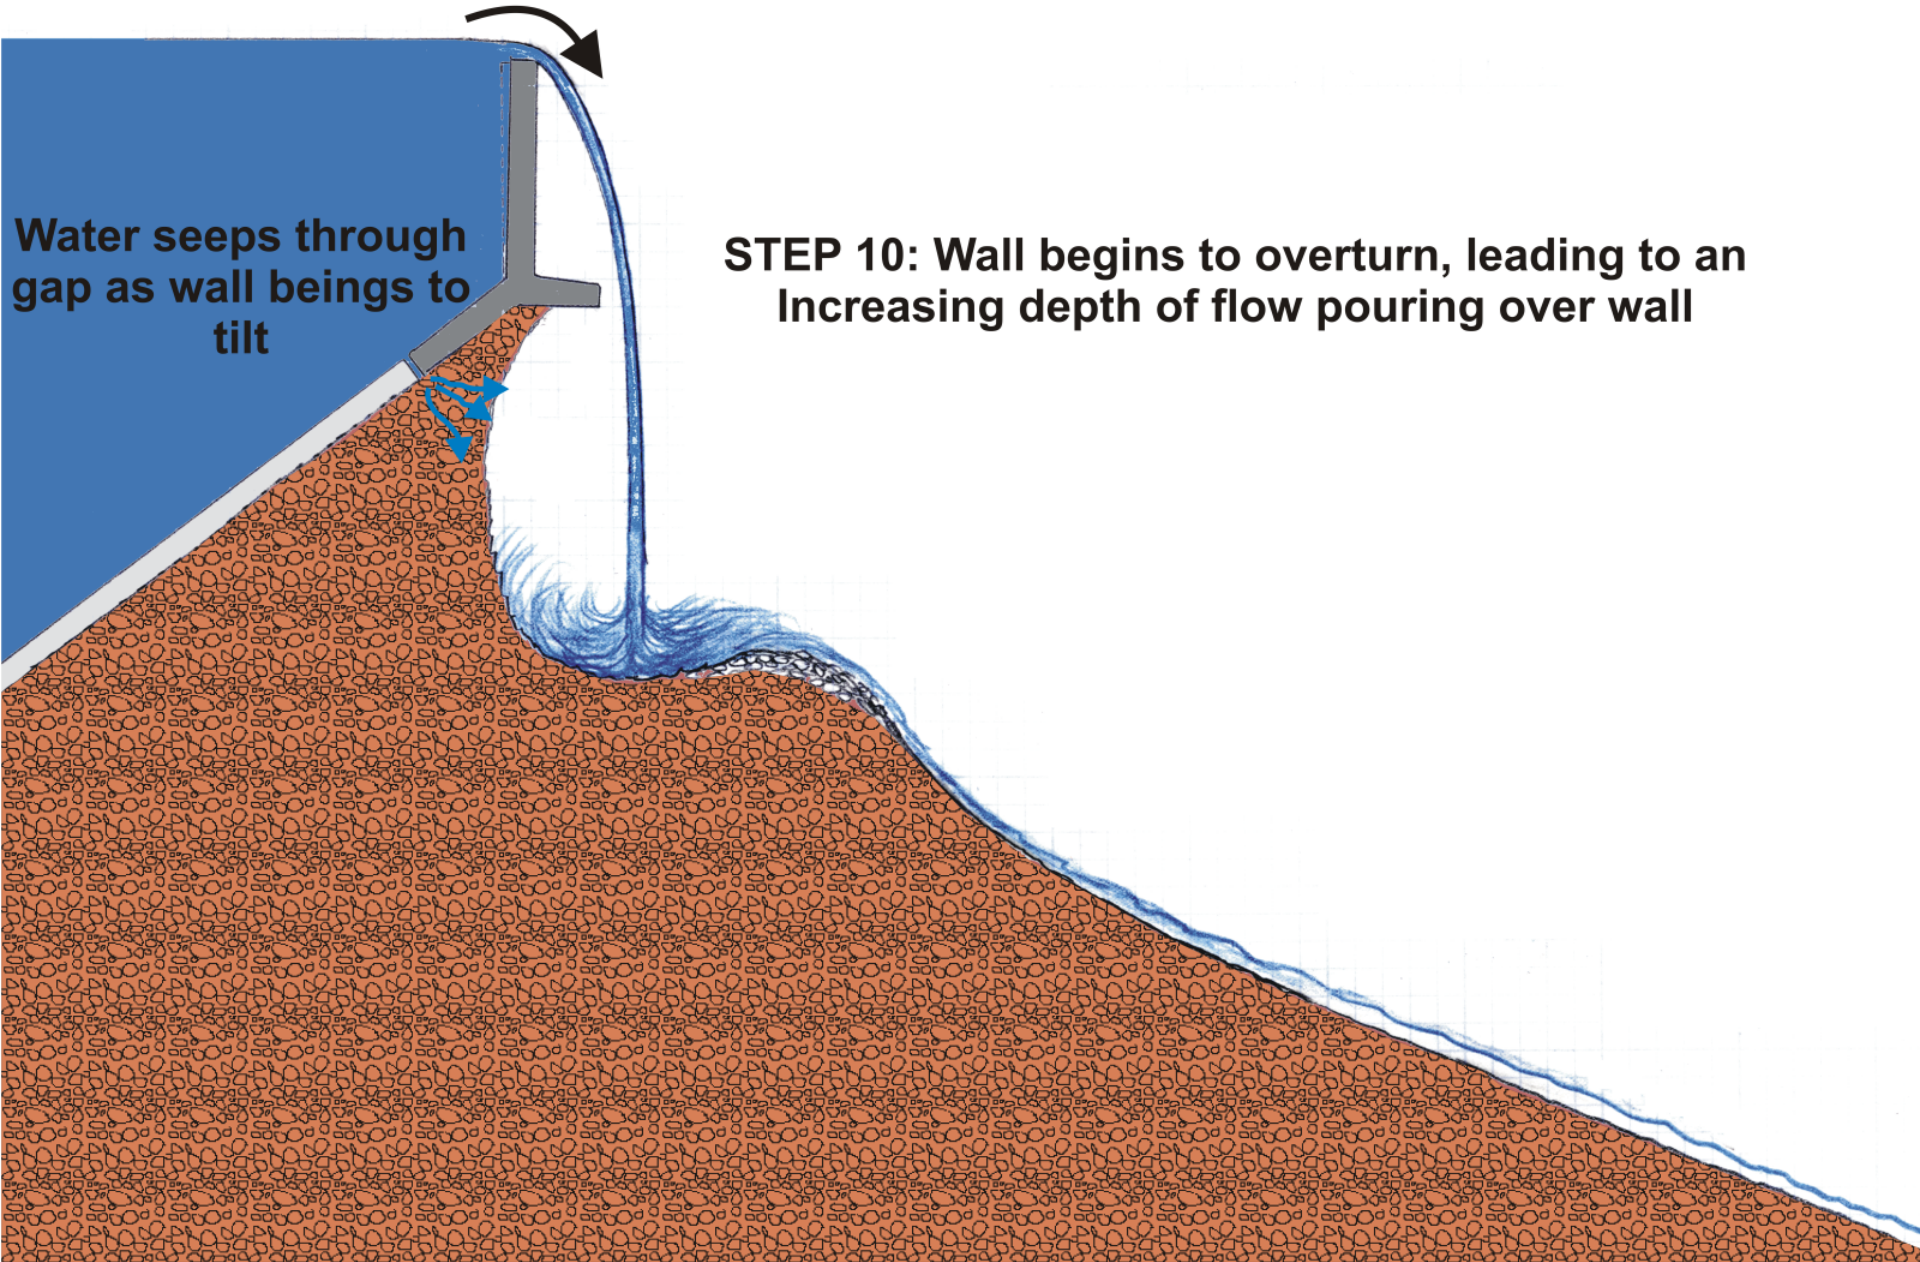
Time: ~5:14:45 AM

Wall starts to tilt

Water seeps through gap as wall begins to tilt

STEP 10: Wall begins to overturn, leading to an increasing depth of flow pouring over wall
