FACTORS CONTRIBUTING TO THE 2005 TAUM SAUK UPPER RESERVOIR FAILURE

December 14, 2005

Reynolds County, Missouri

RECONSTRUCTED FAILURE SEQUENCE

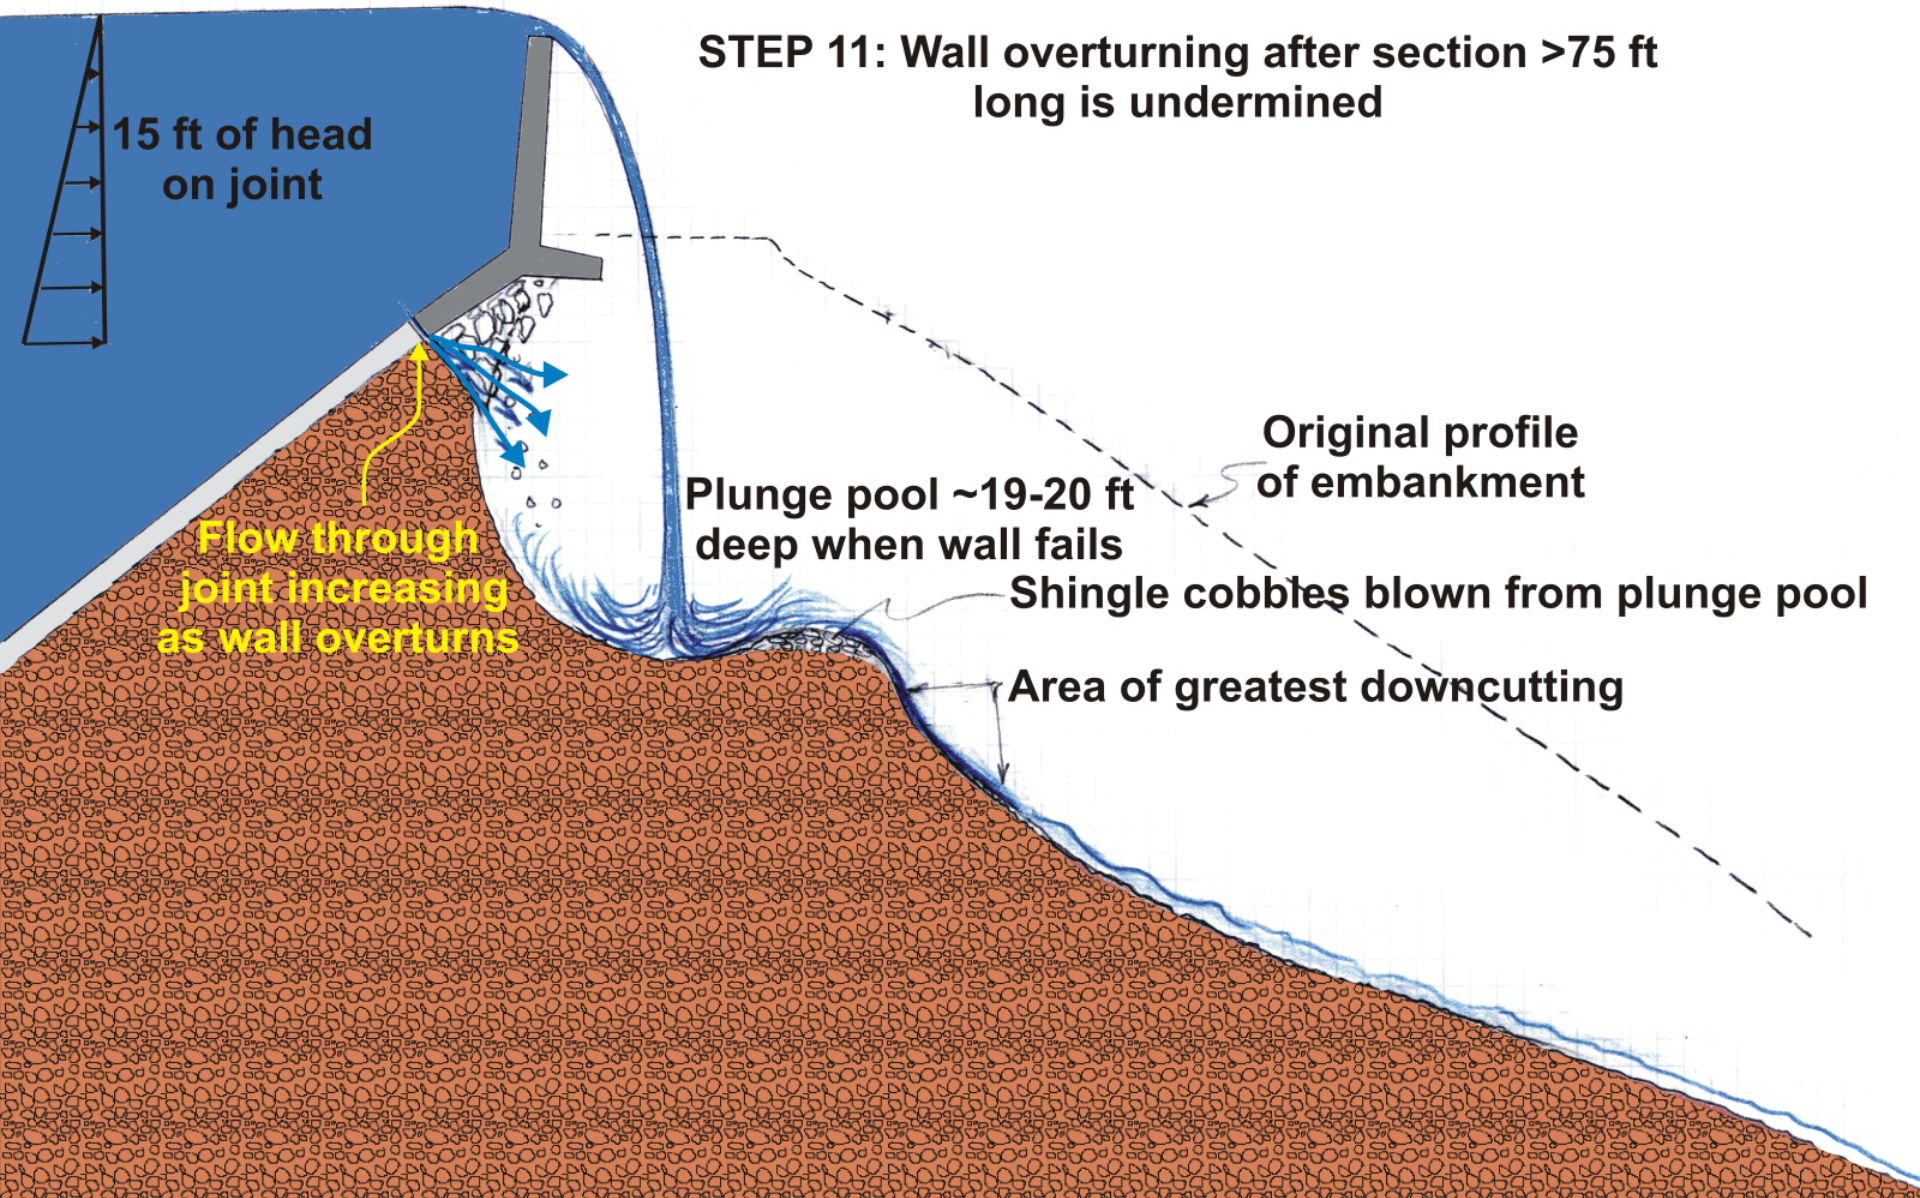
Time: ~5:15:00 AM

STEP 11: Wall overturning after section >75 ft long is undermined

15 ft of head on joint

Flow through joint increasing as wall overturns

Plunge pool ~19-20 ft deep when wall fails

Original profile of embankment

Shingle cobbles blown from plunge pool

Area of greatest downcutting

**Exposed foundation
of parapet wall**

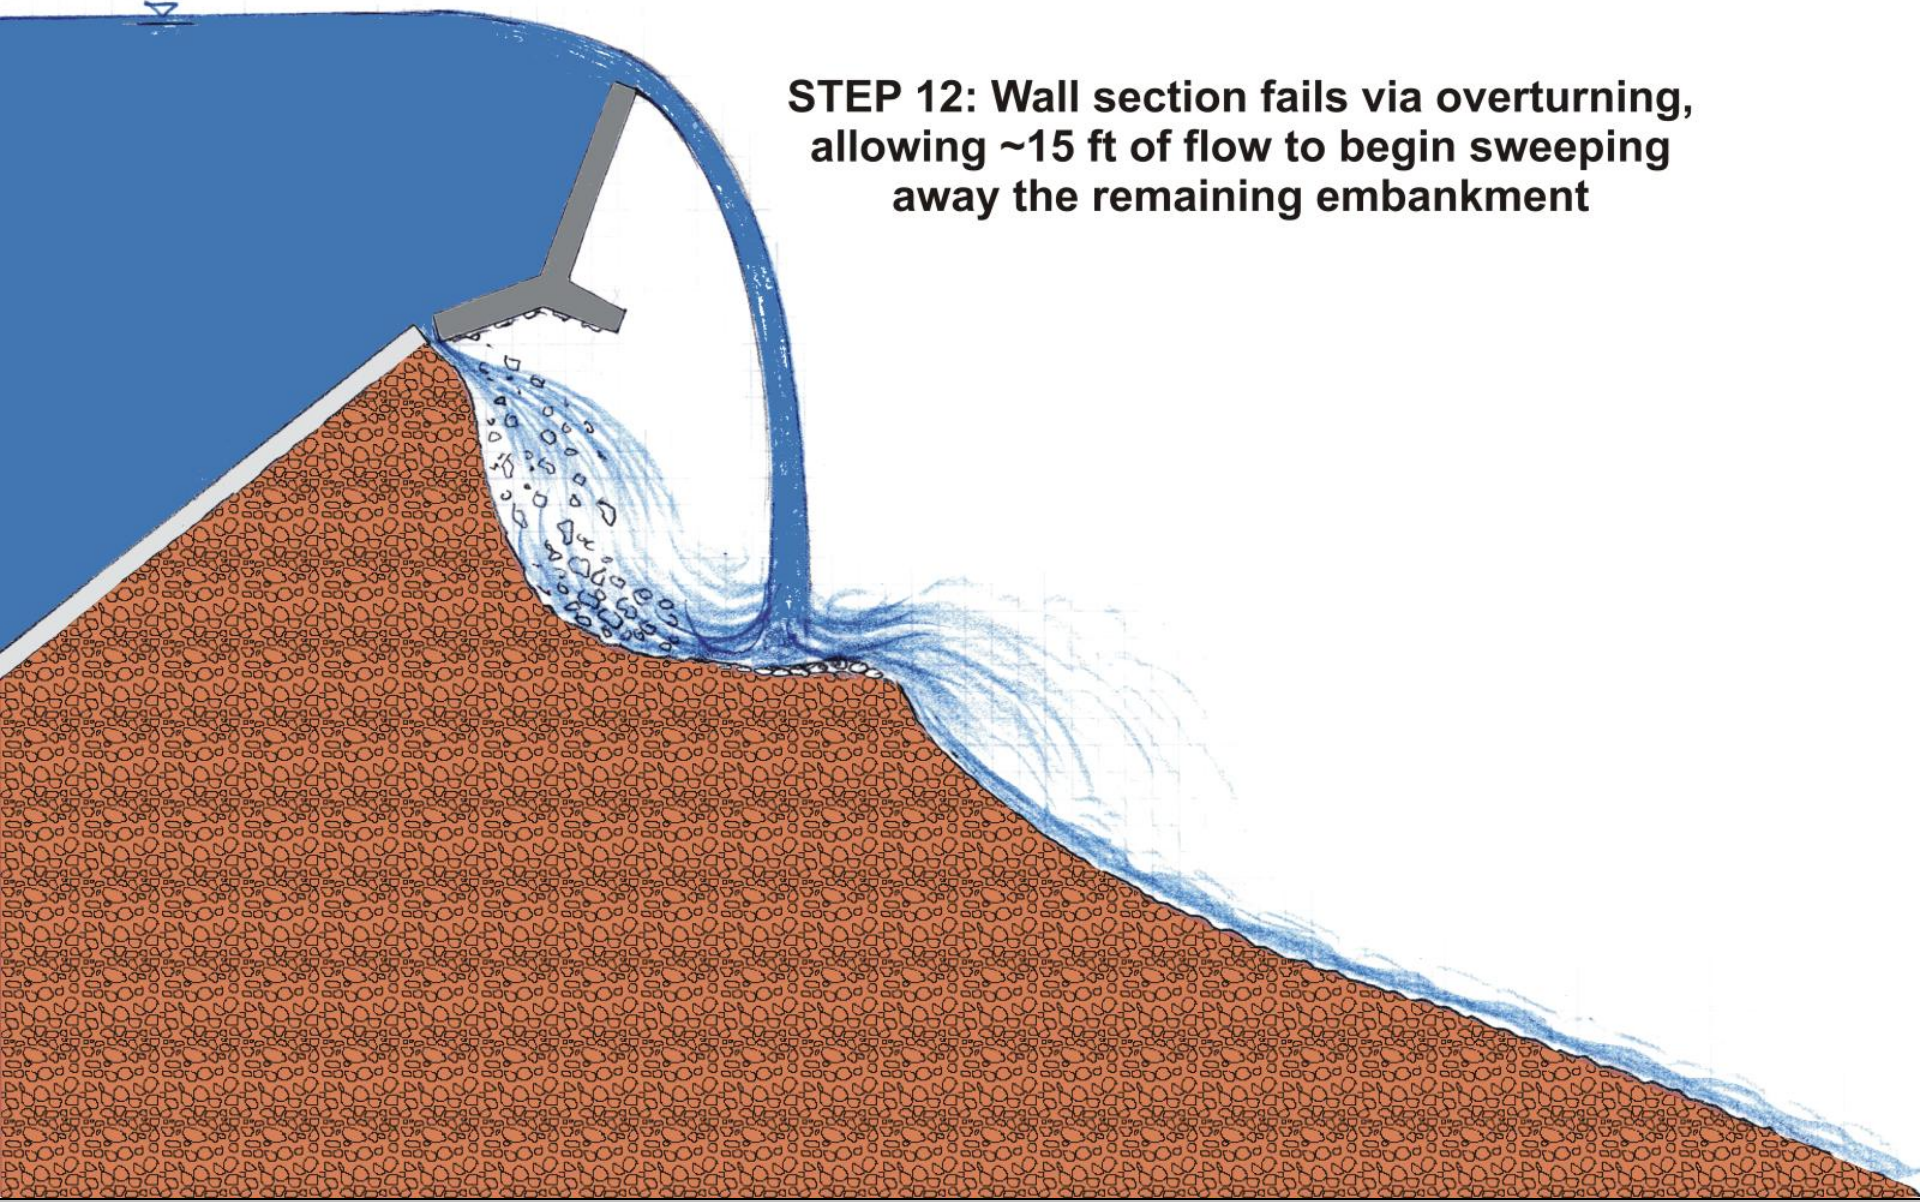
Time: ~5:15:00 AM

STEP 12: Wall section fails via overturning, allowing ~15 ft of flow to begin sweeping away the remaining embankment

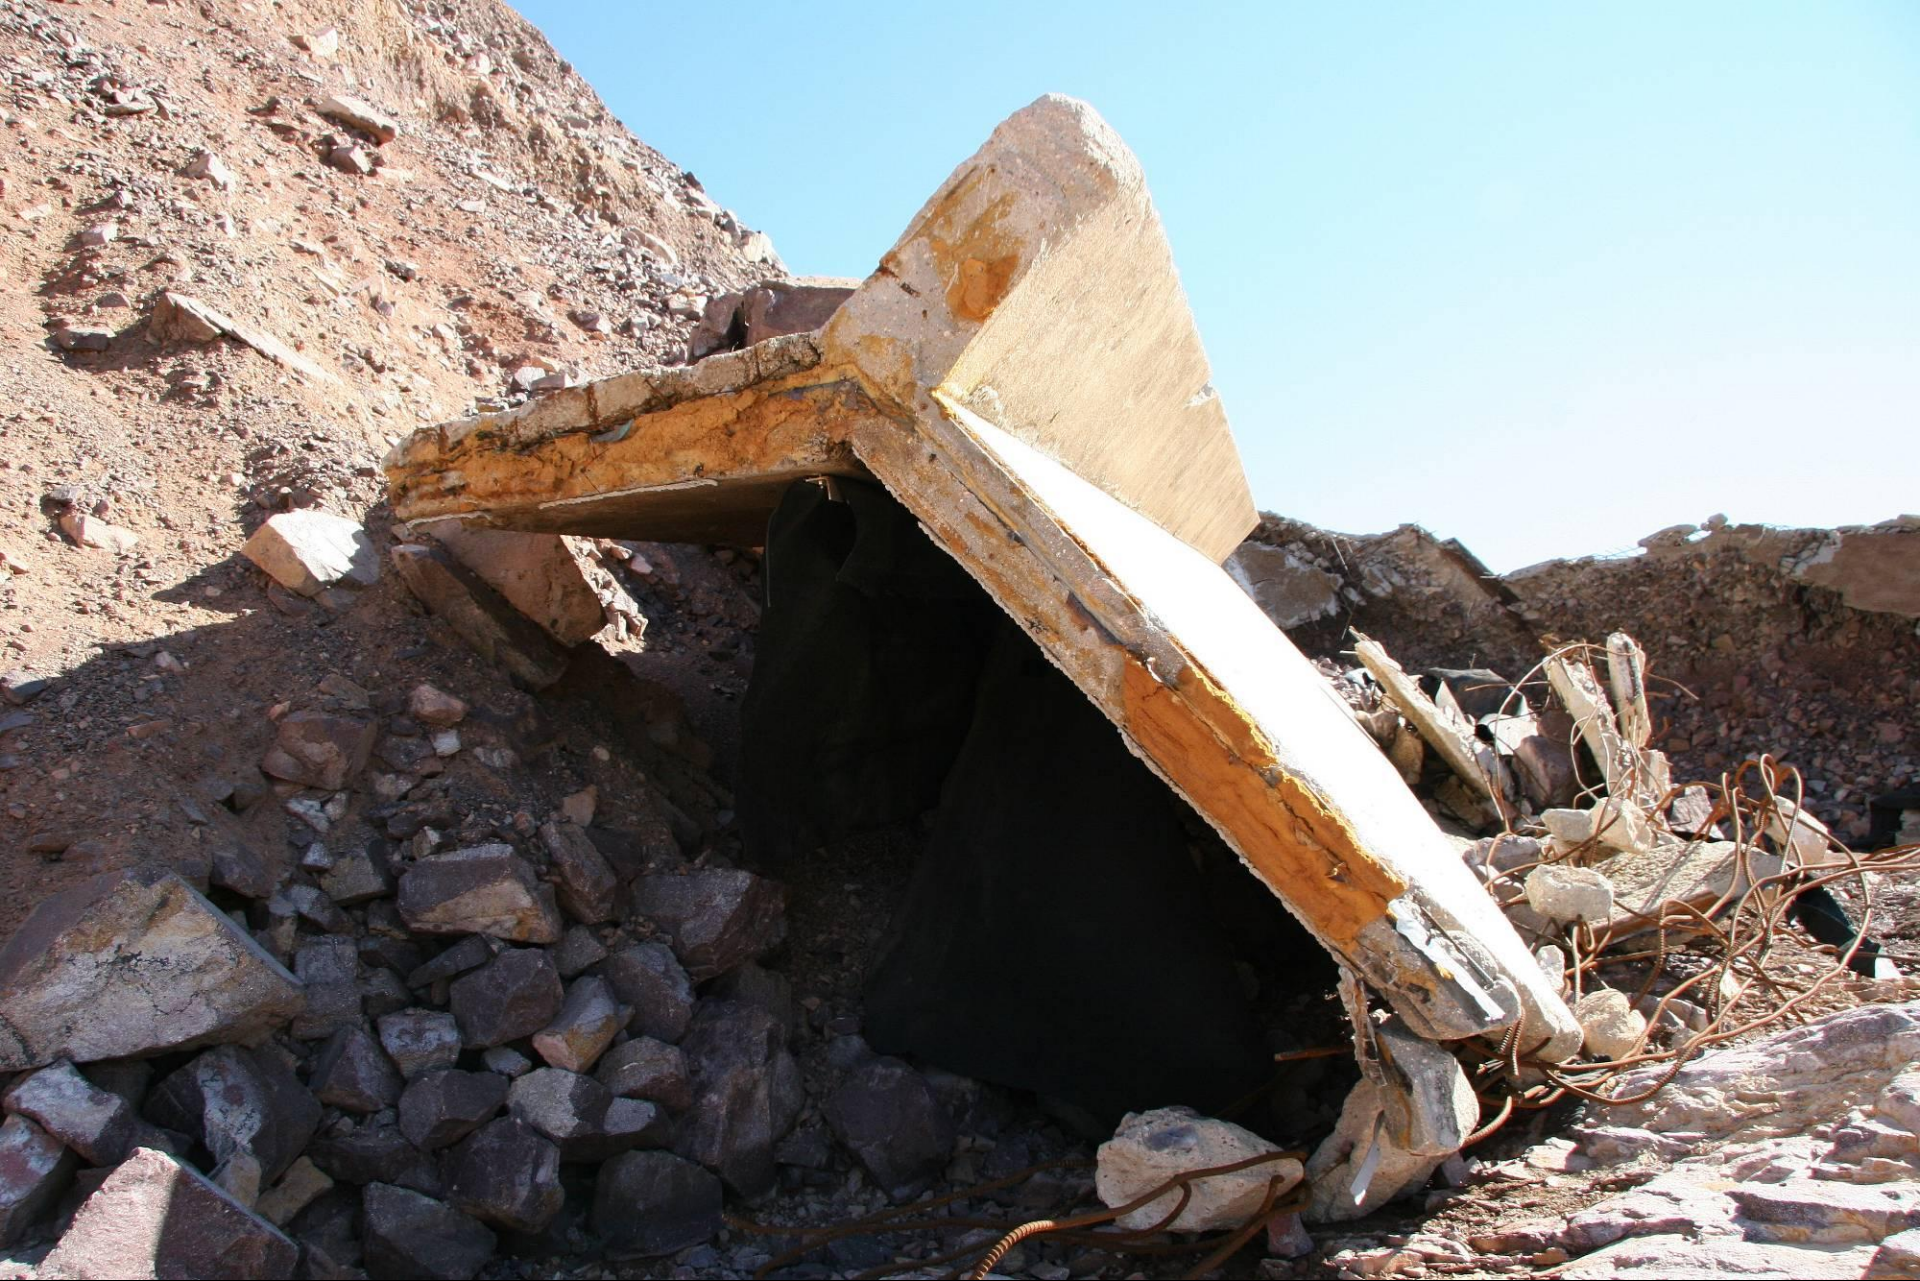
Wall panels toppled over after extensive undercutting, initiating the catastrophic failure sequence.

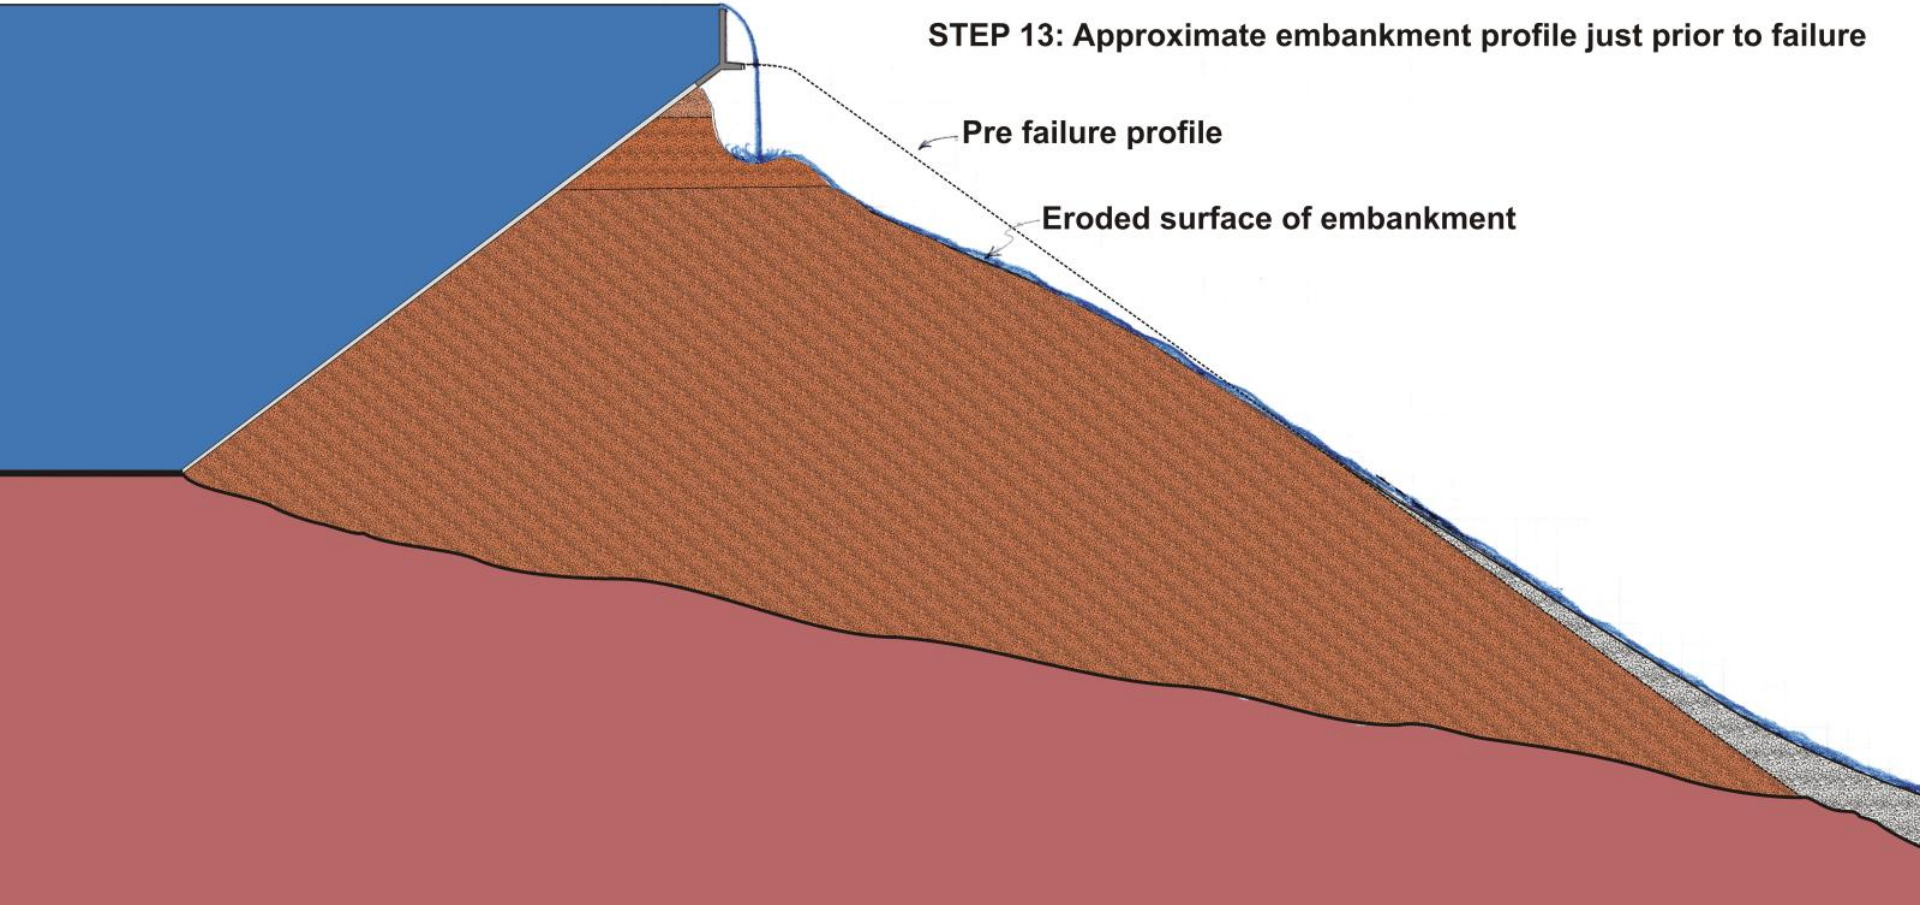
Time: 5:14:50 AM

STEP 13: Approximate embankment profile just prior to failure

Pre failure profile

Eroded surface of embankment

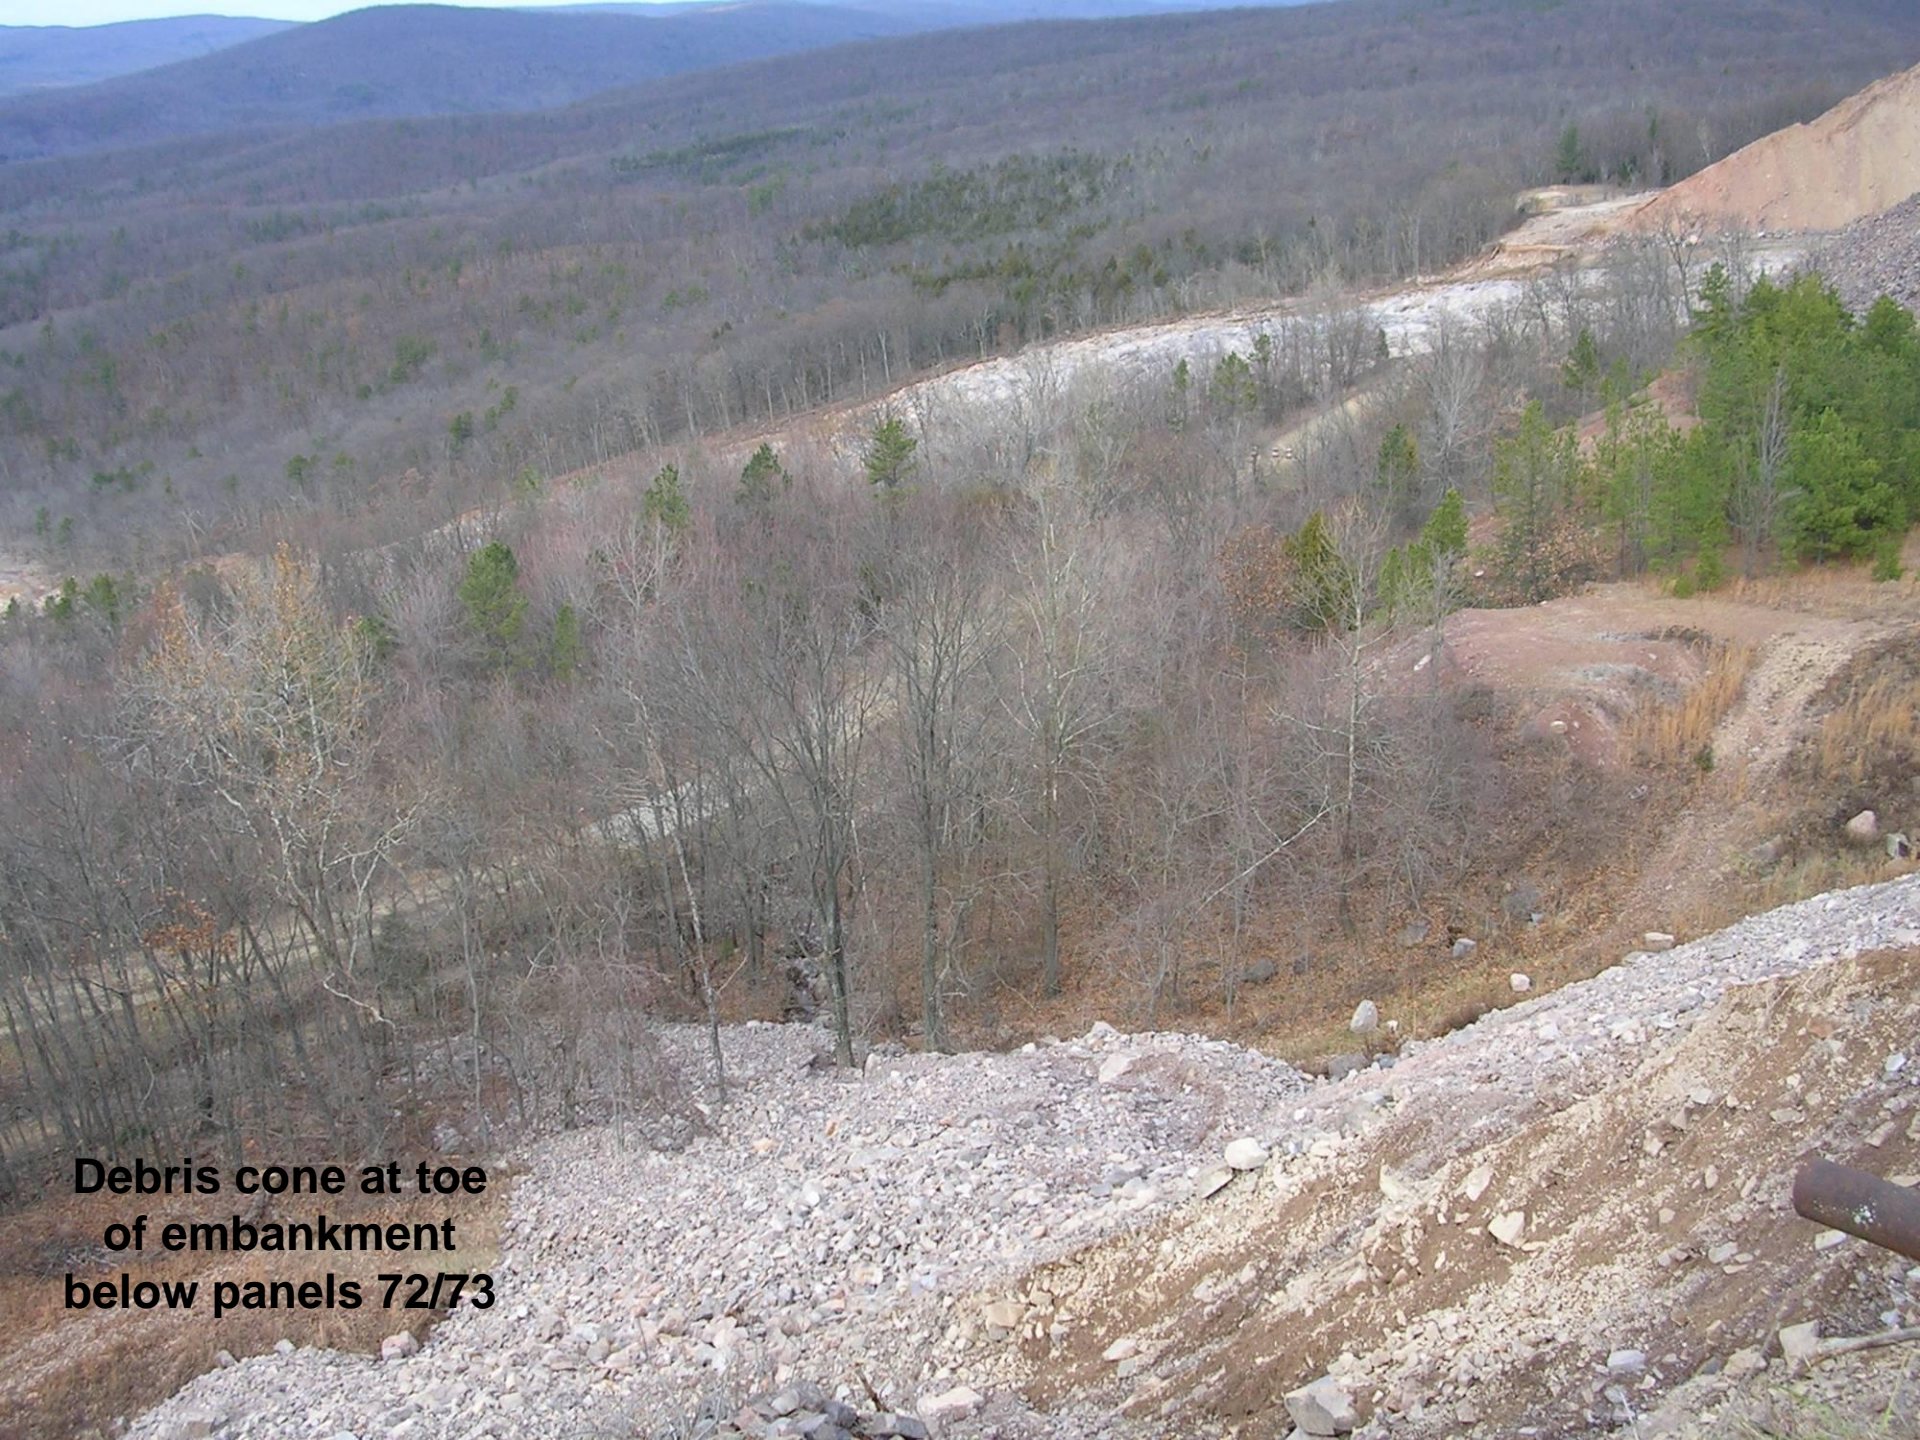
**Debris cone at toe
of embankment
below panels 72/73**

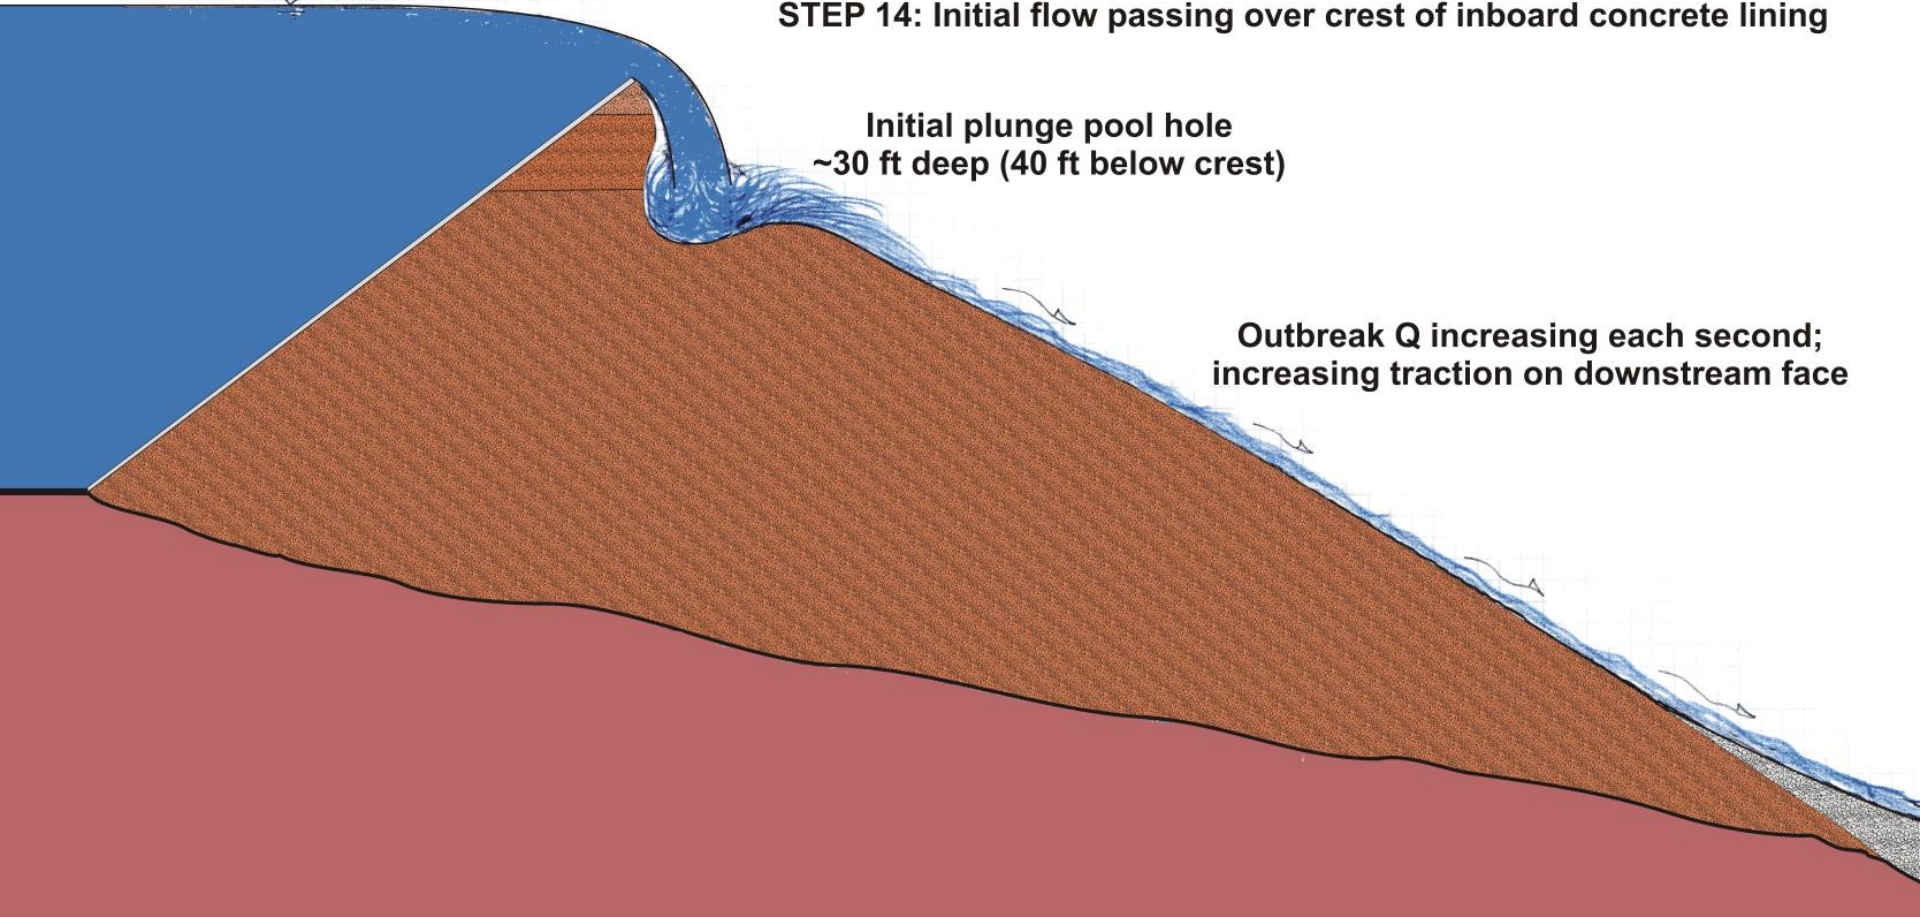
Time: 5:15 a.m.

STEP 14: Initial flow passing over crest of inboard concrete lining

**Initial plunge pool hole
~30 ft deep (40 ft below crest)**

**Outbreak Q increasing each second;
increasing traction on downstream face**

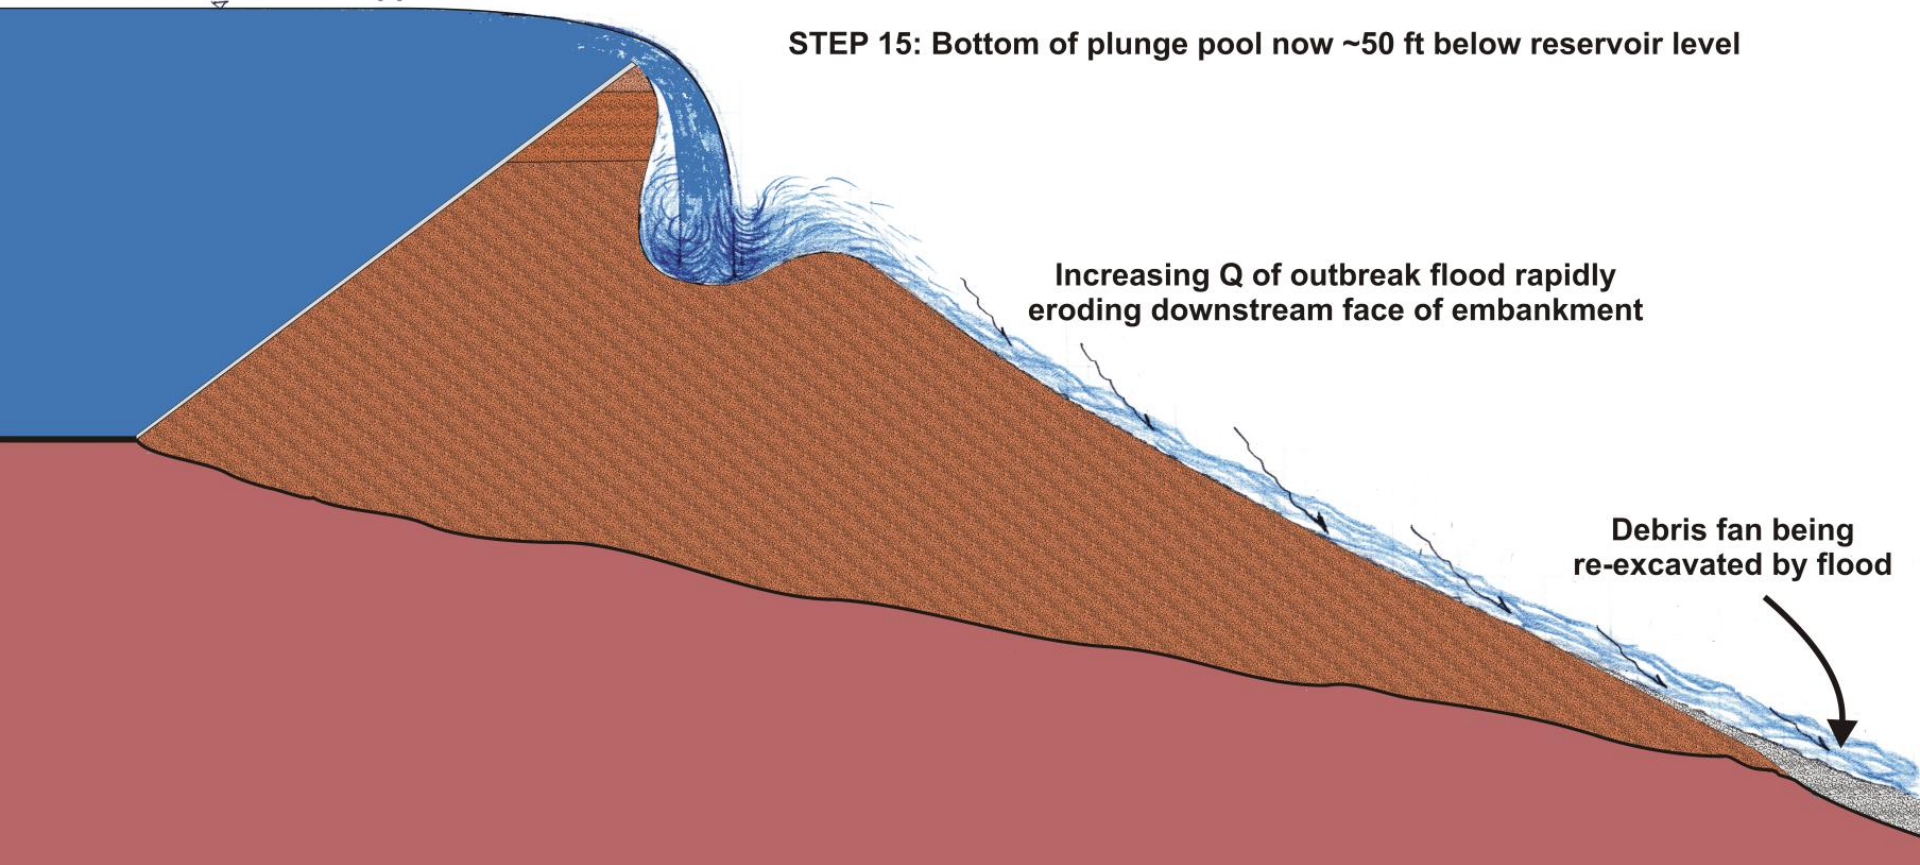
Time: 5:16:30 AM

STEP 15: Bottom of plunge pool now ~50 ft below reservoir level

Increasing Q of outbreak flood rapidly eroding downstream face of embankment

Debris fan being re-excavated by flood

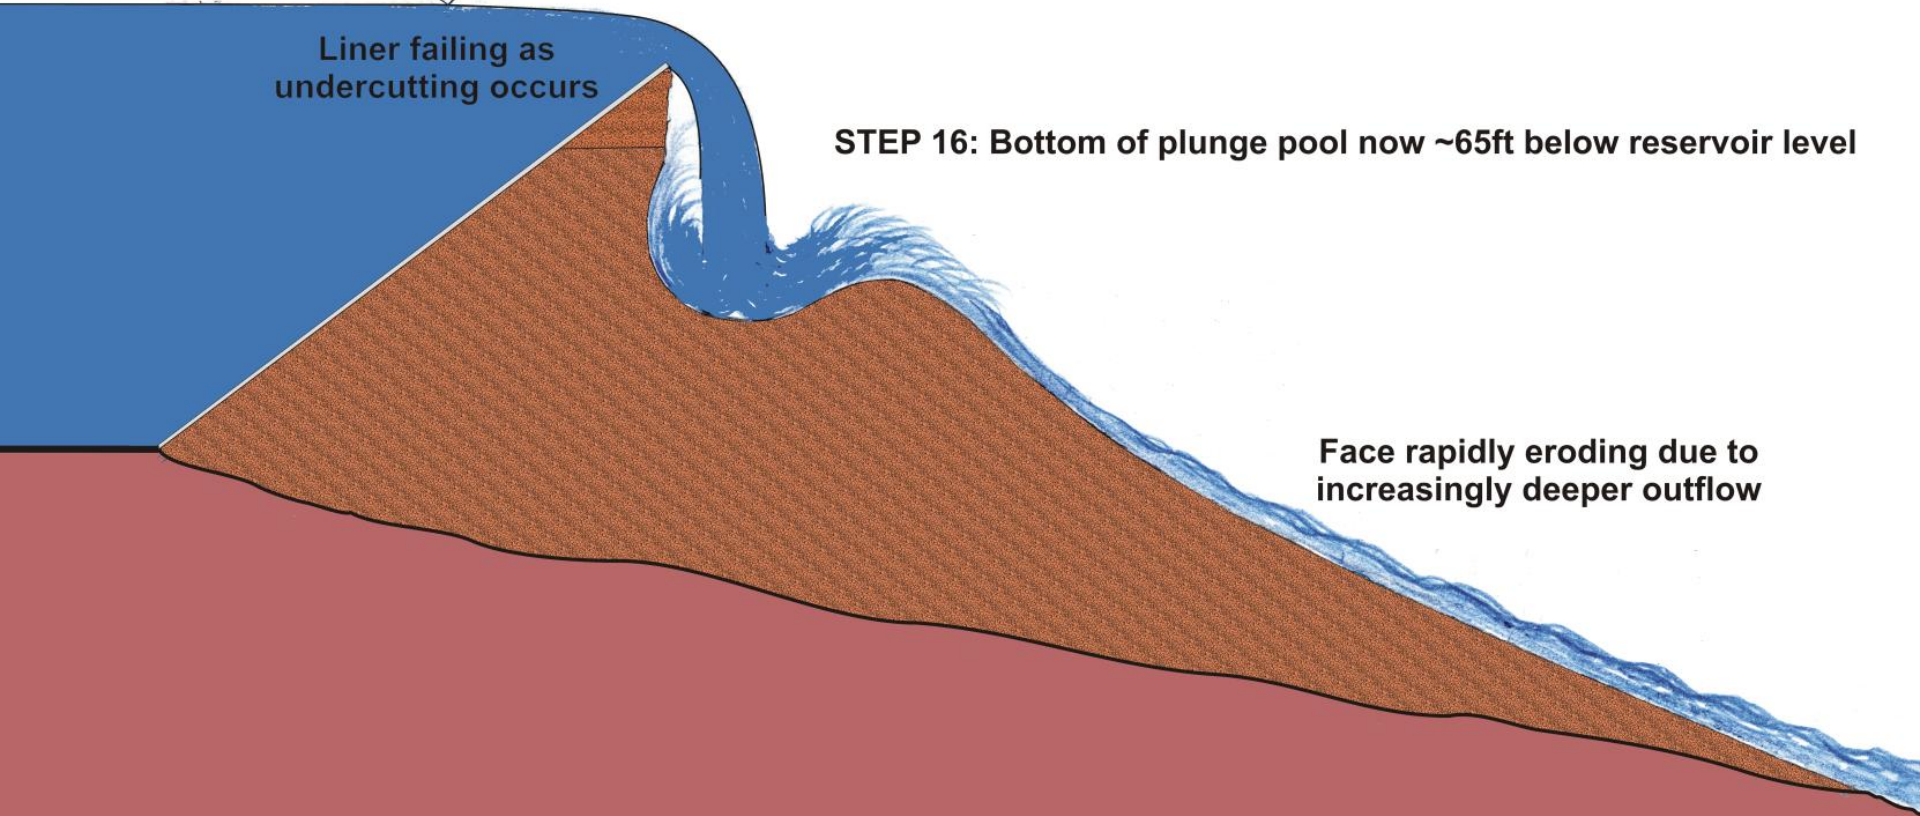
Time: 5:17:15 AM

Liner failing as undercutting occurs

STEP 16: Bottom of plunge pool now ~65ft below reservoir level

Face rapidly eroding due to increasingly deeper outflow

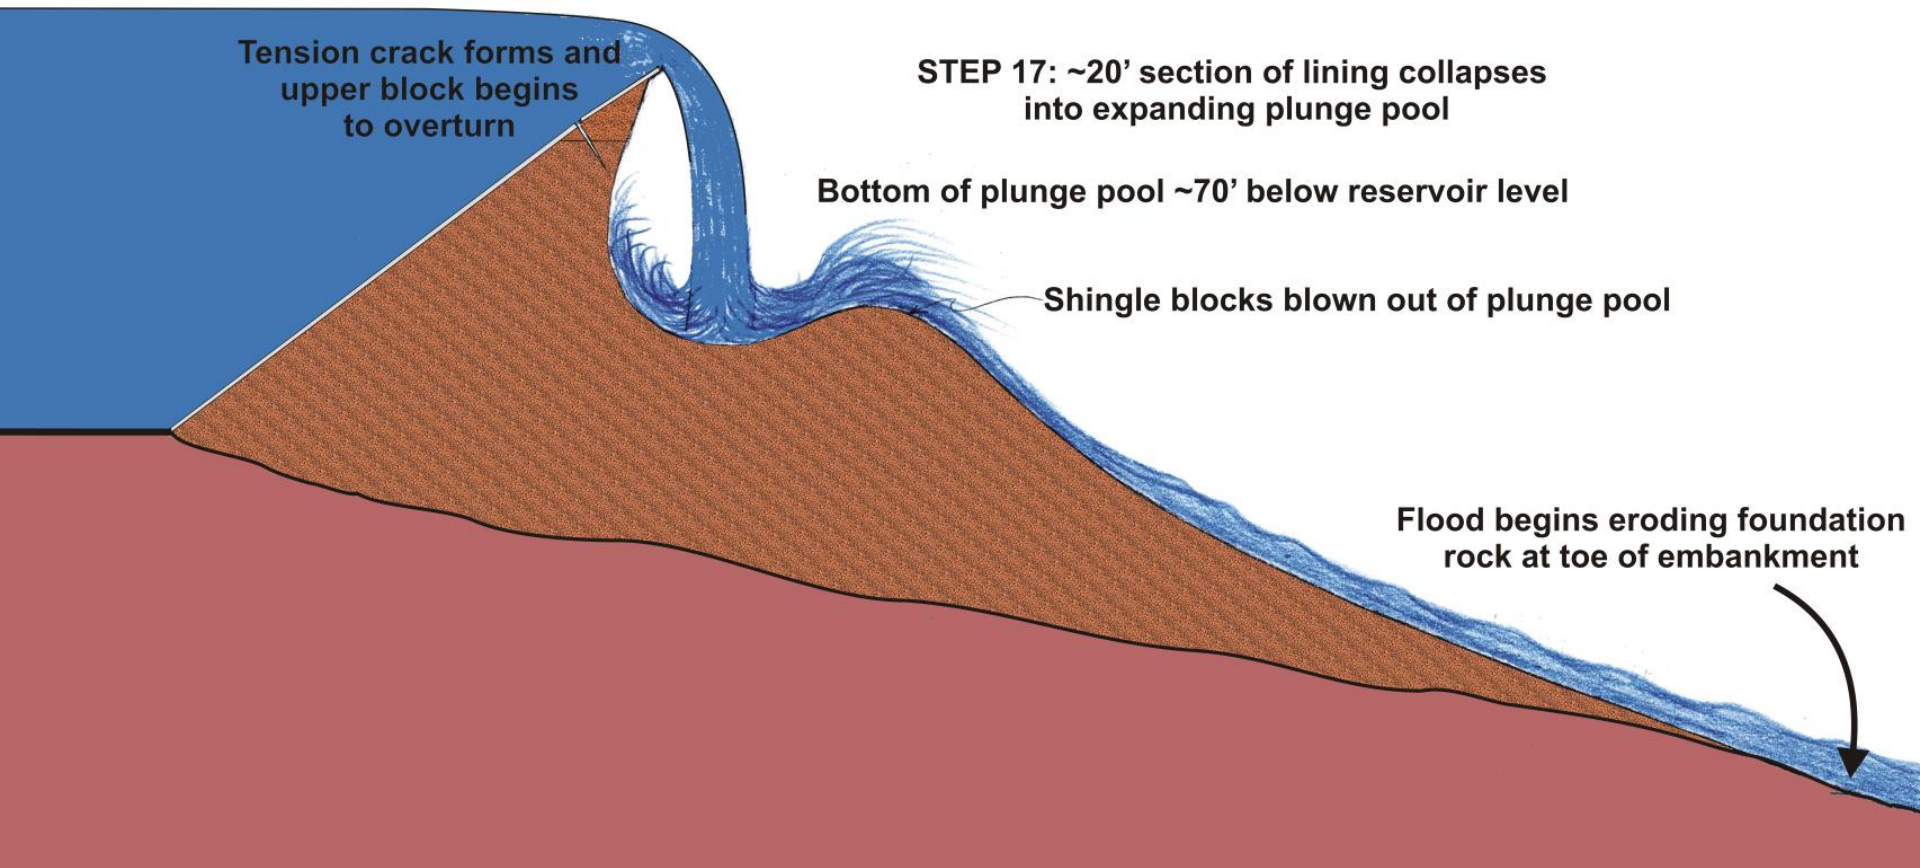
Time: 5:17:30 AM

Tension crack forms and upper block begins to overturn

STEP 17: ~20' section of lining collapses into expanding plunge pool

Bottom of plunge pool ~70' below reservoir level

Shingle blocks blown out of plunge pool

Flood begins eroding foundation rock at toe of embankment

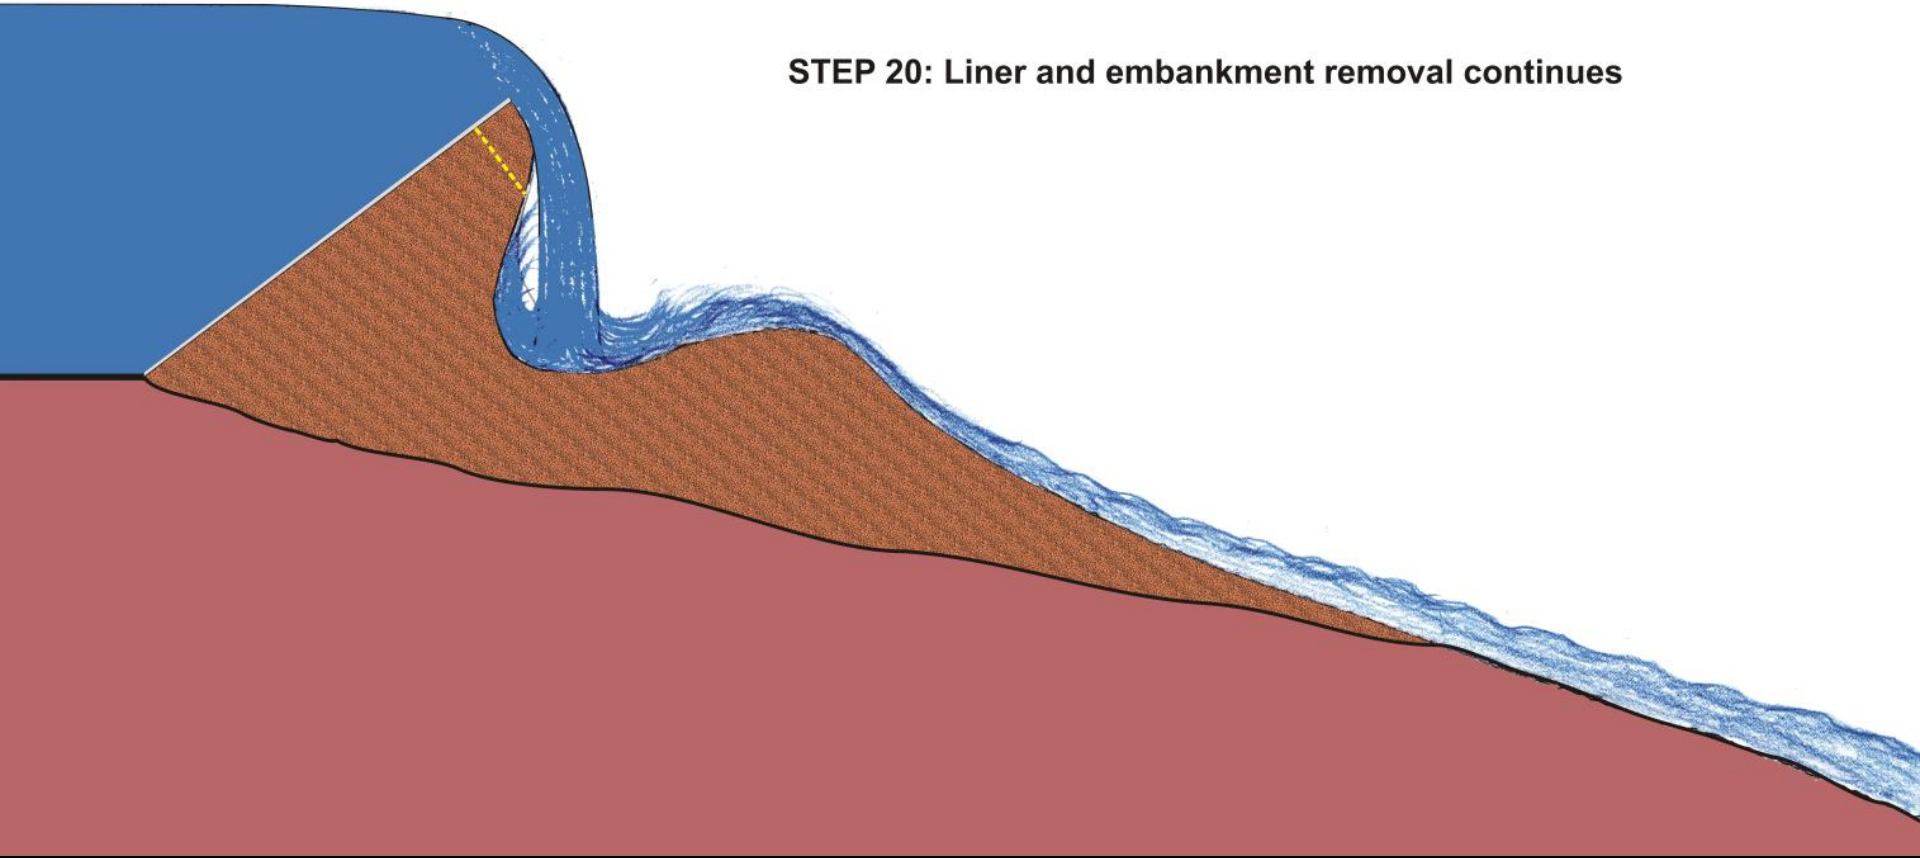
Time: 5:20:25 AM

STEP 20: Liner and embankment removal continues

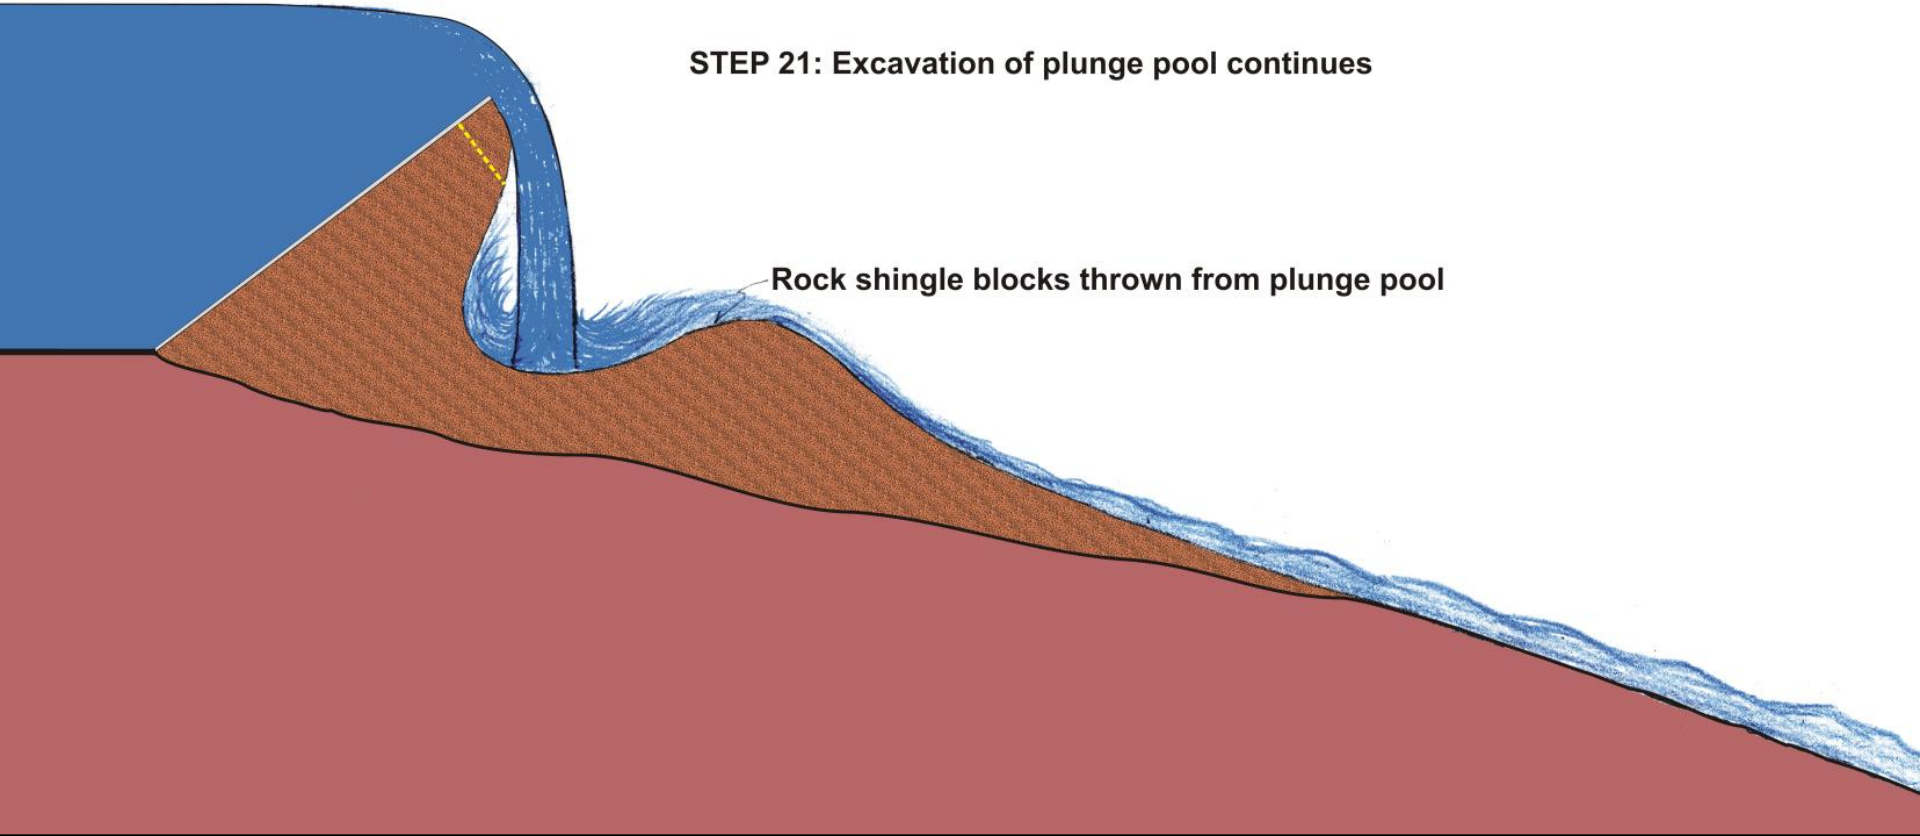
Time: 5:21:05 AM

STEP 21: Excavation of plunge pool continues

Rock shingle blocks thrown from plunge pool
