FACTORS CONTRIBUTING TO THE 2005 TAUM SAUK UPPER RESERVOIR FAILURE

December 14, 2005

Reynolds County, Missouri

RECONSTRUCTED FAILURE SEQUENCE

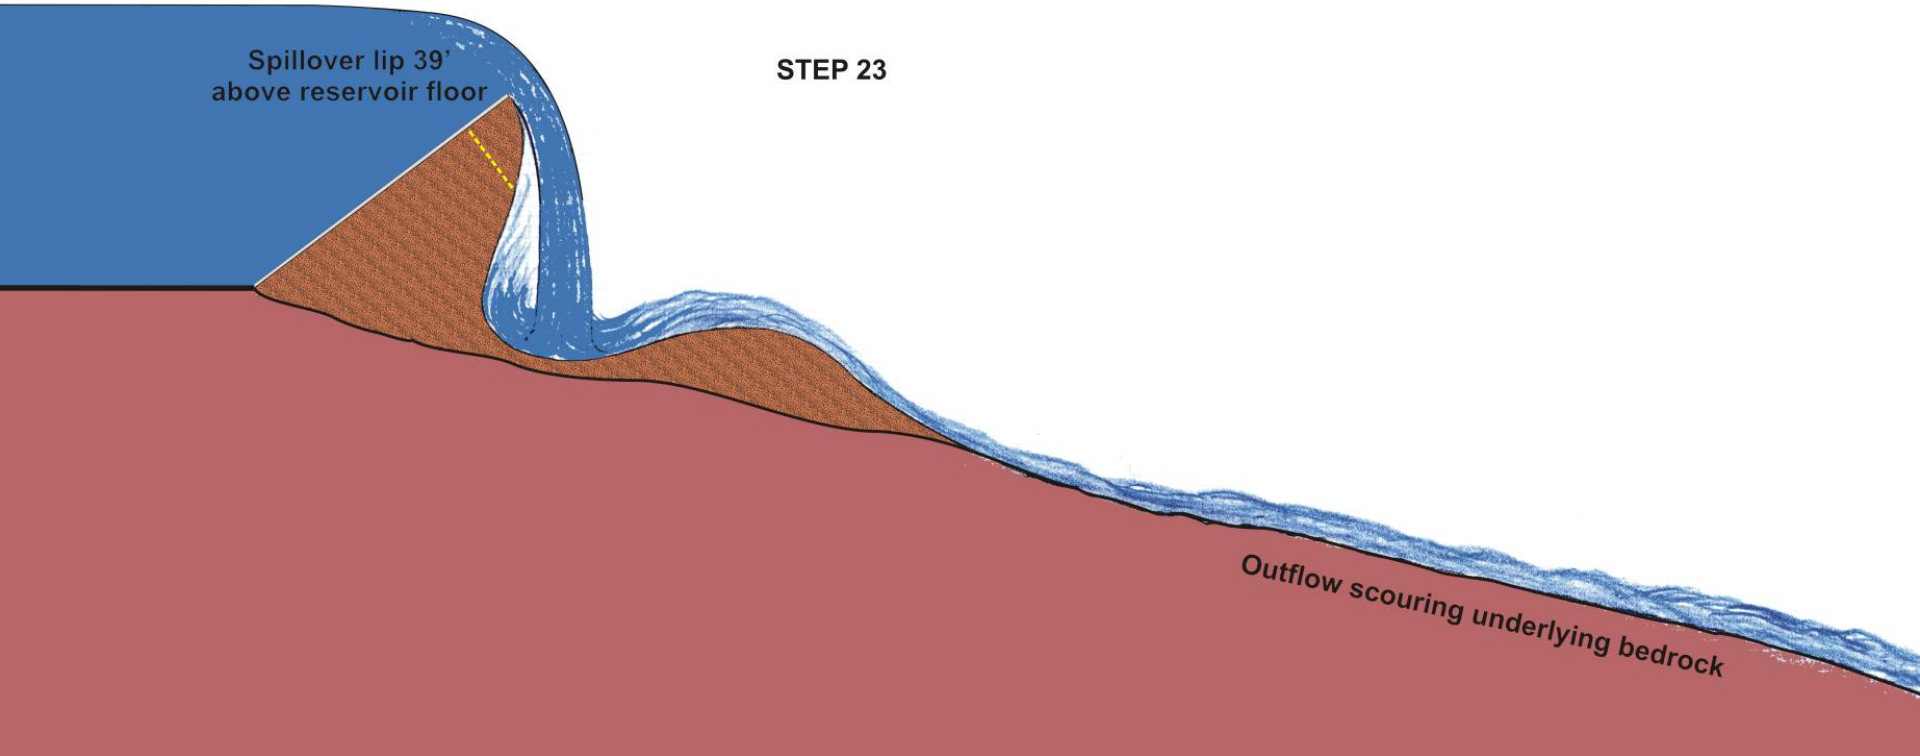
Time: 5:22:50 AM

Spillover lip 39'
above reservoir floor

Outflow scouring underlying bedrock

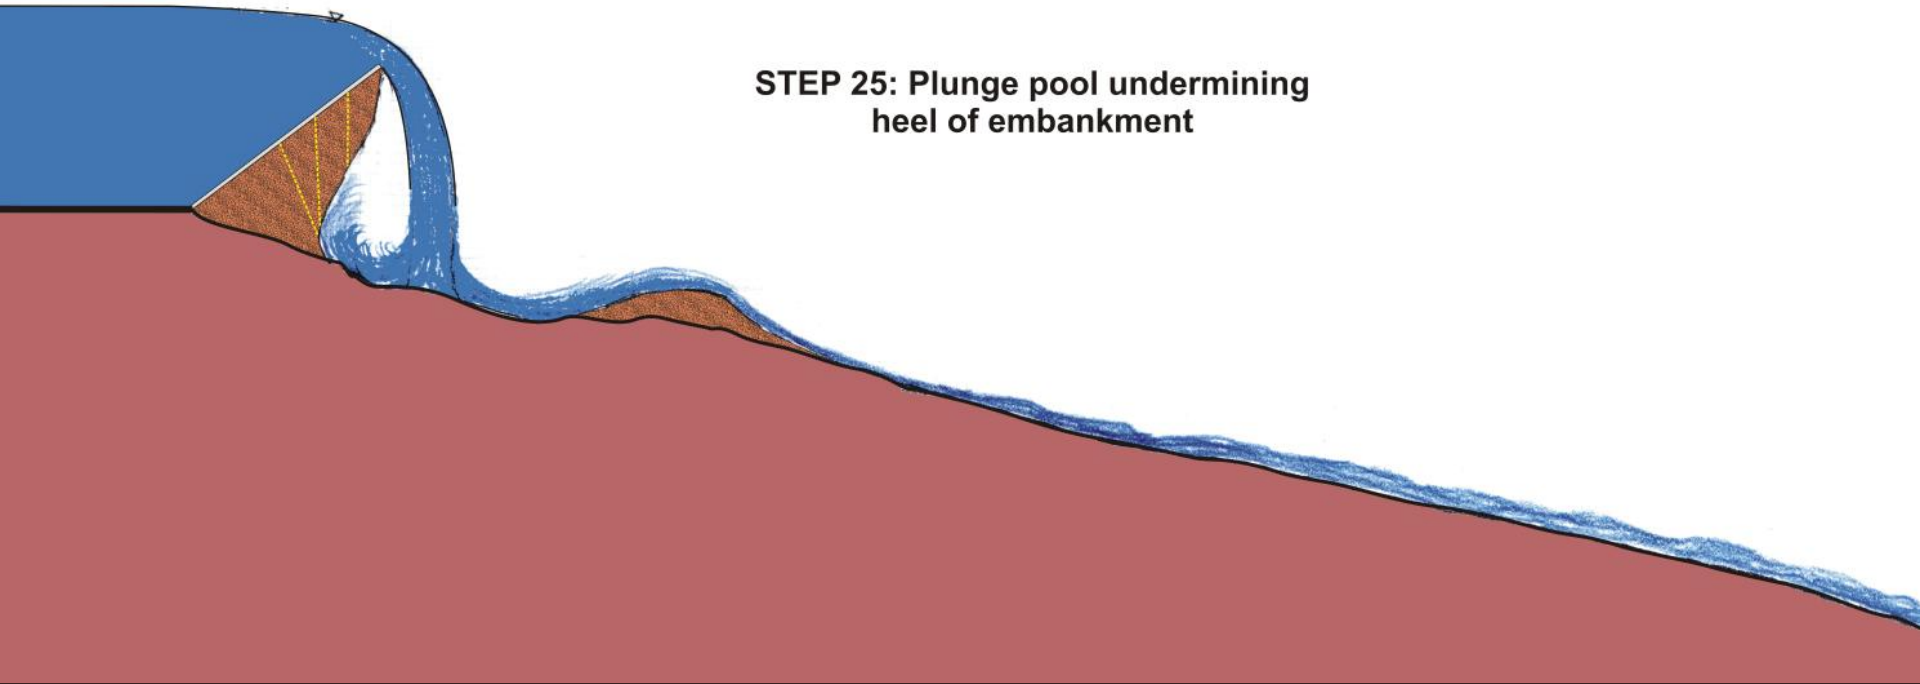
Time: 5:25:05 AM

STEP 25: Plunge pool undermining
heel of embankment

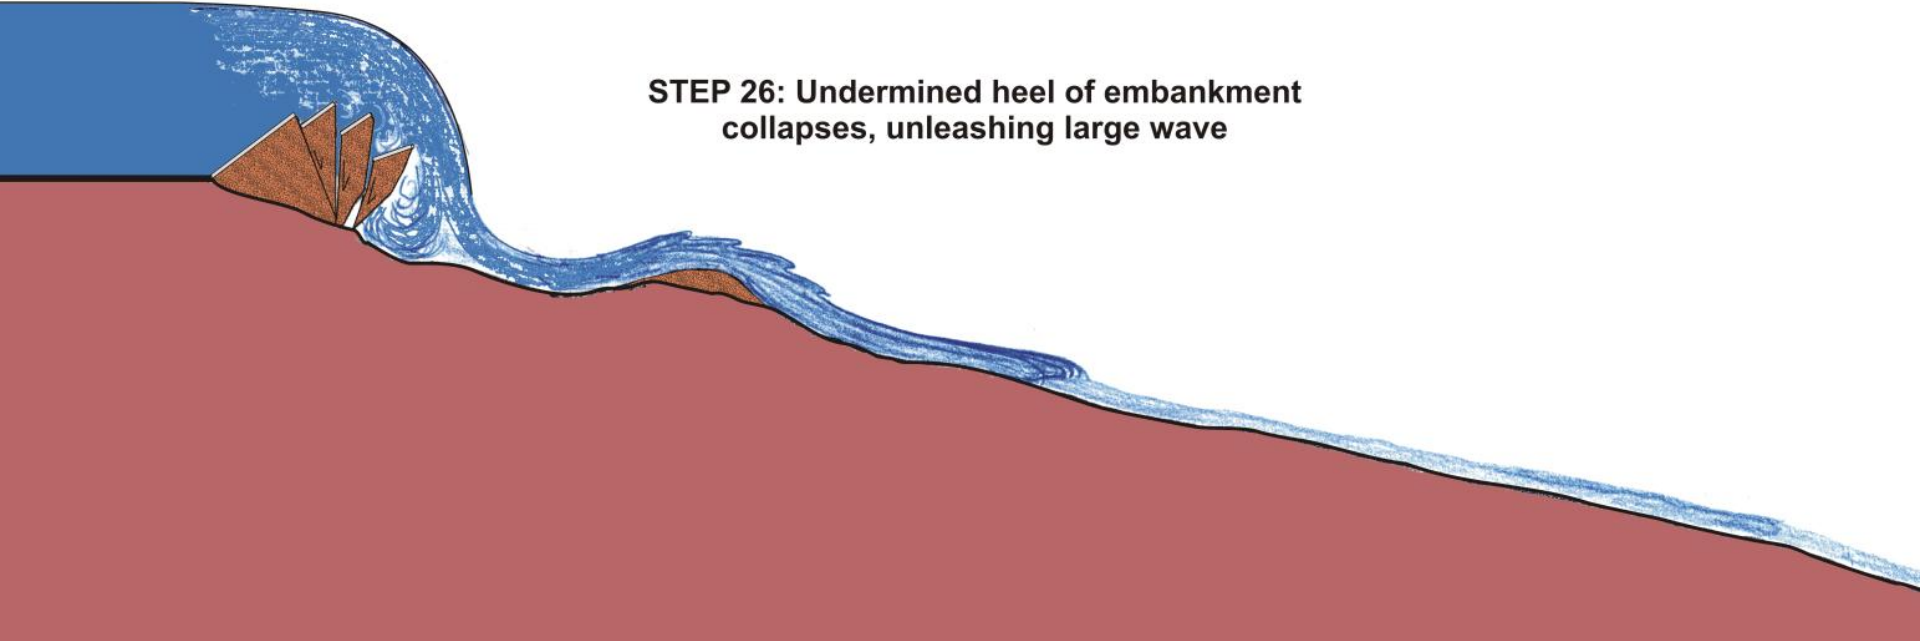
Time: 5:25:50 AM

**STEP 26: Undermined heel of embankment
collapses, unleashing large wave**

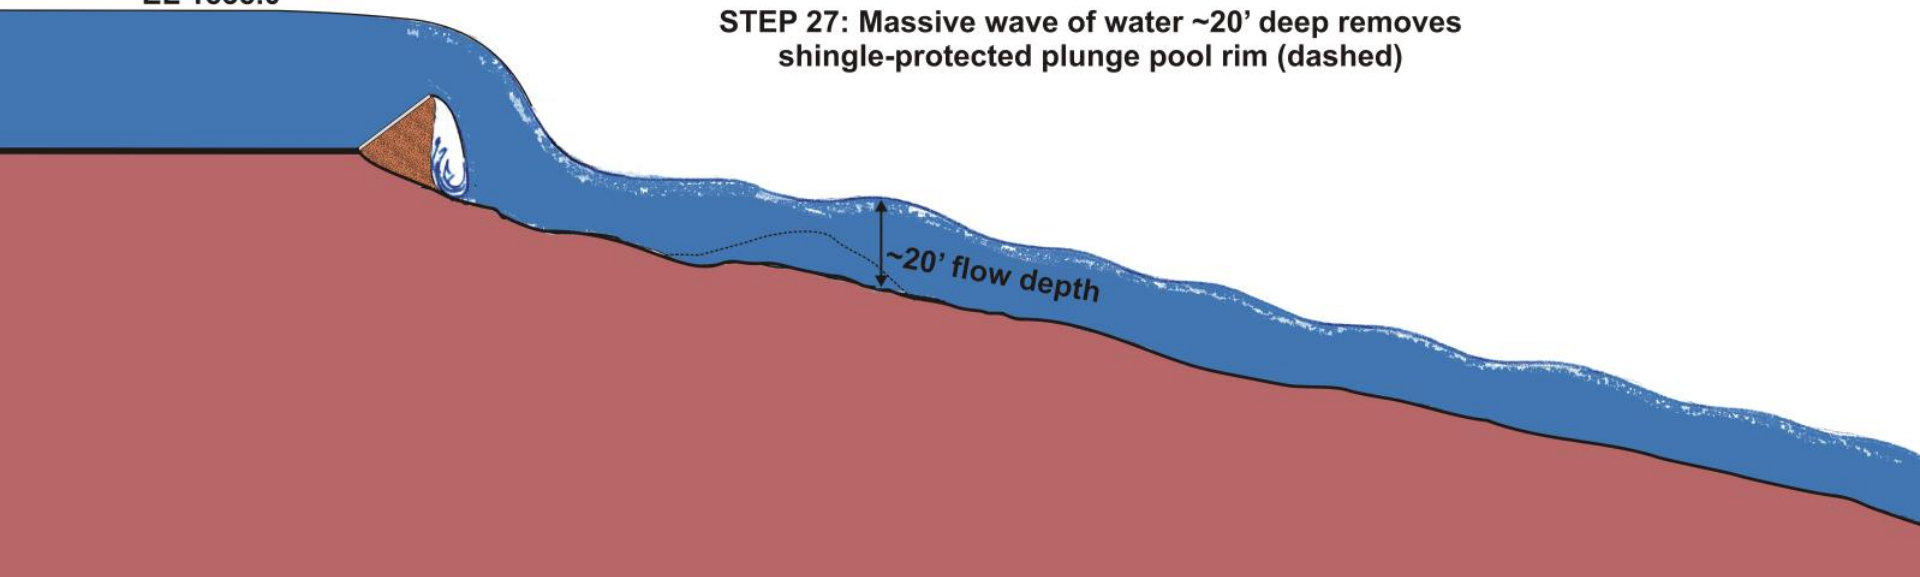
Time: 5:22:15 AM

STEP 27: Massive wave of water ~20' deep removes
shingle-protected plunge pool rim (dashed)

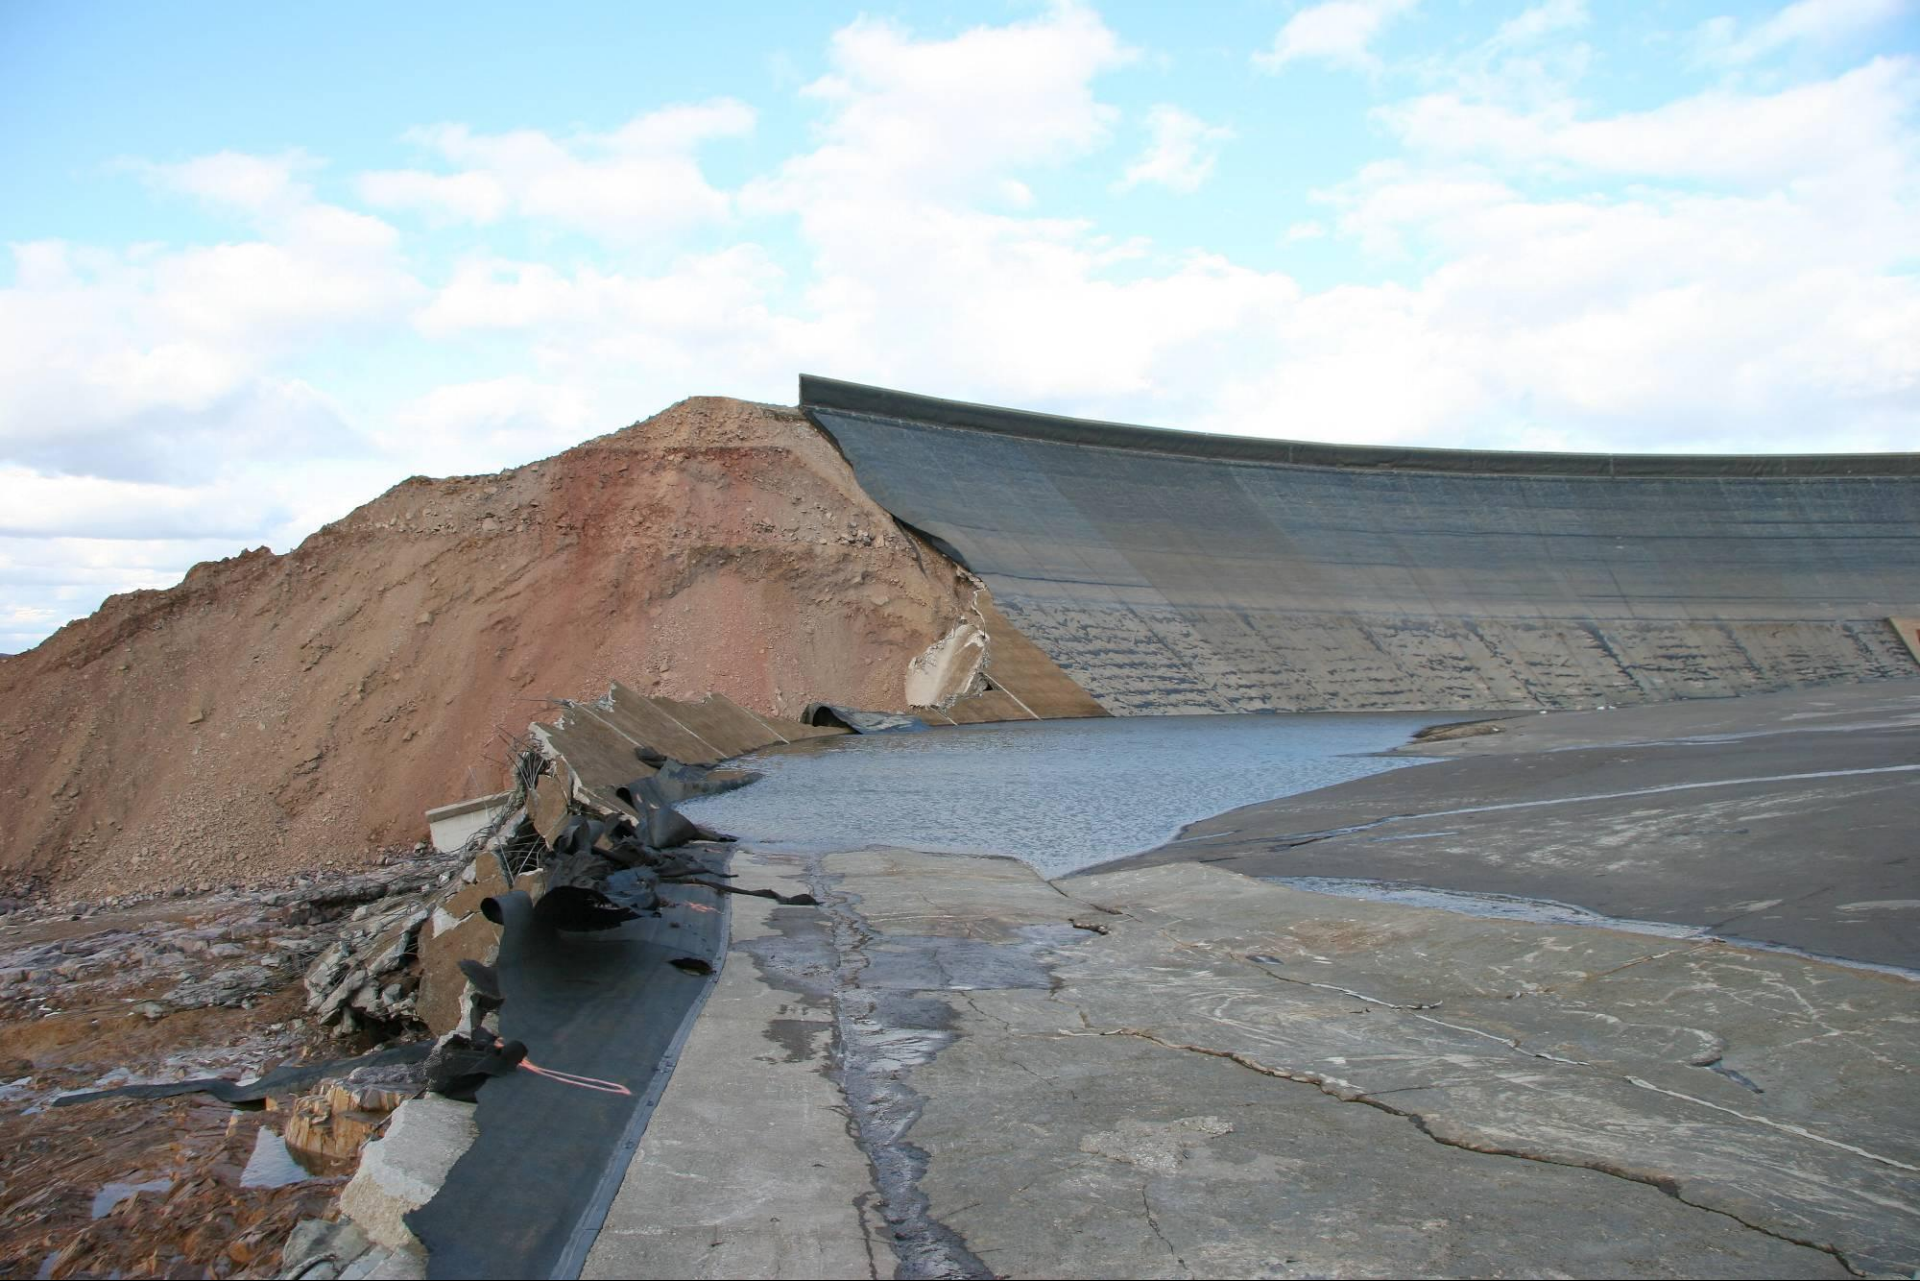
A small lip of material armored by portions of the concrete liner remained in a few locations at the breach site.

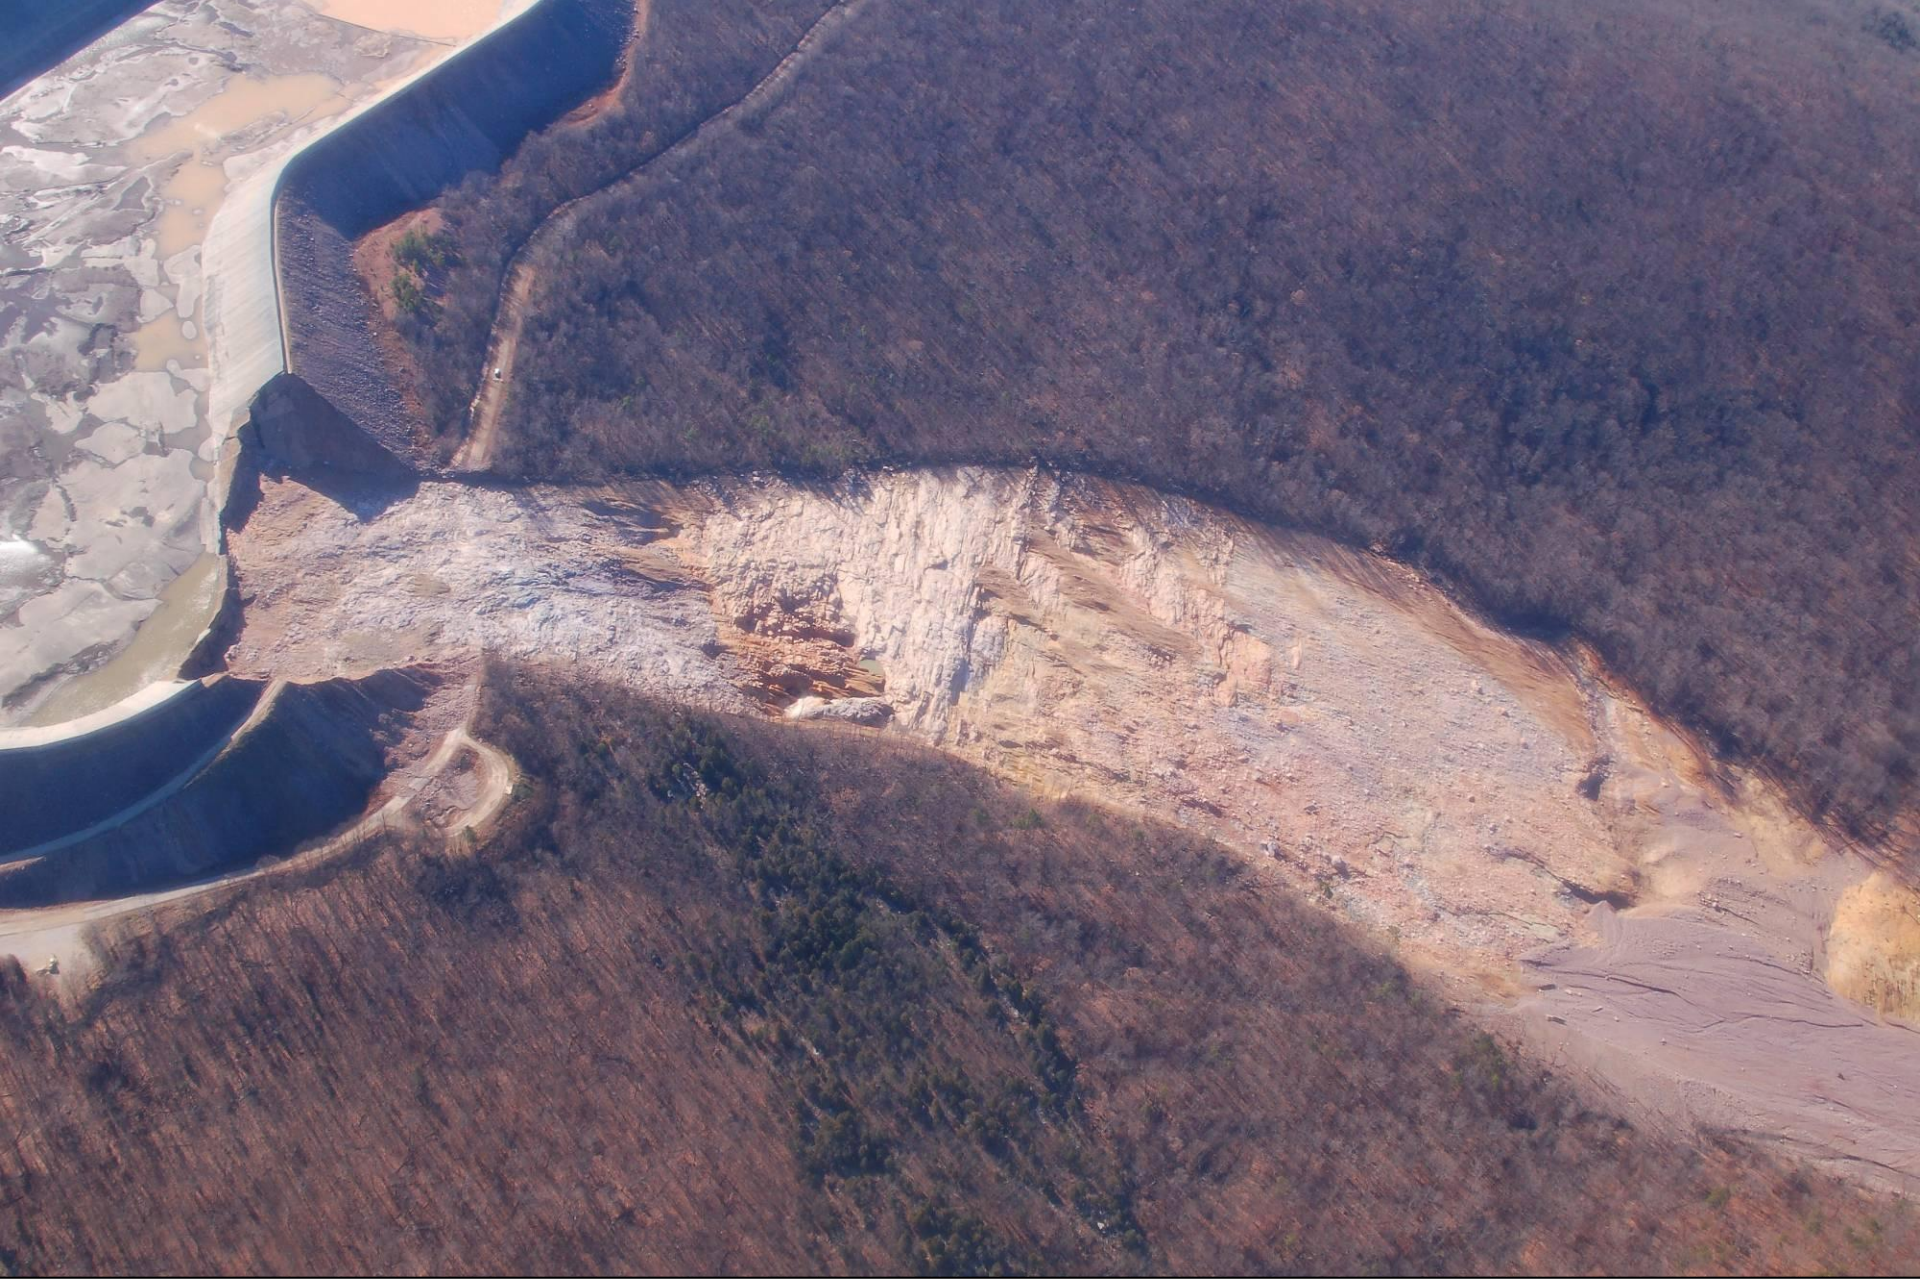
The flow path down the slope of Proffit Mountain was stripped down to the underlying bedrock (photo by Jeff Spooner (USGS)).

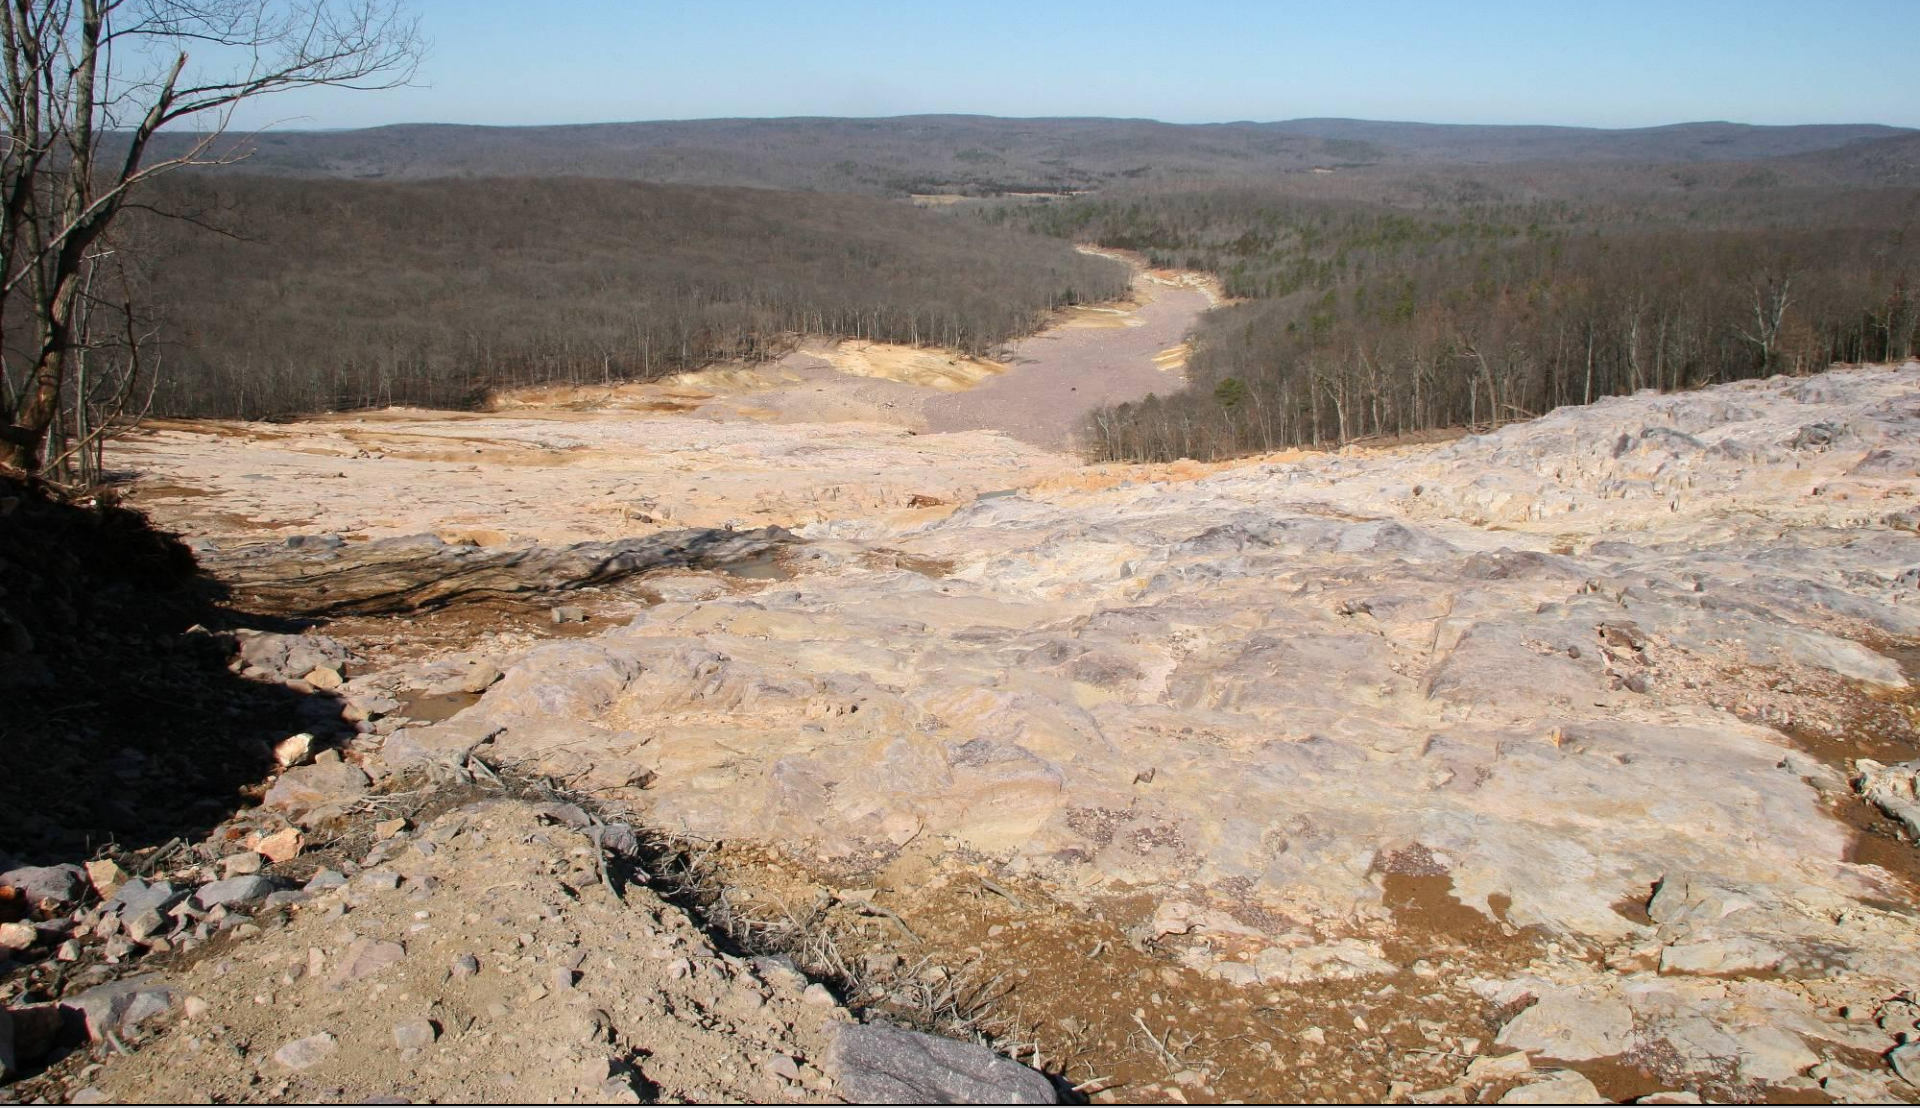
The raging flood incorporated soil, rock, concrete, rebar, and HDPE liner, forming a very turbid flow. This flood accumulated soil, rock, and thousands of trees. The momentum of the water allowed it to ramp up the side slopes around the bends.

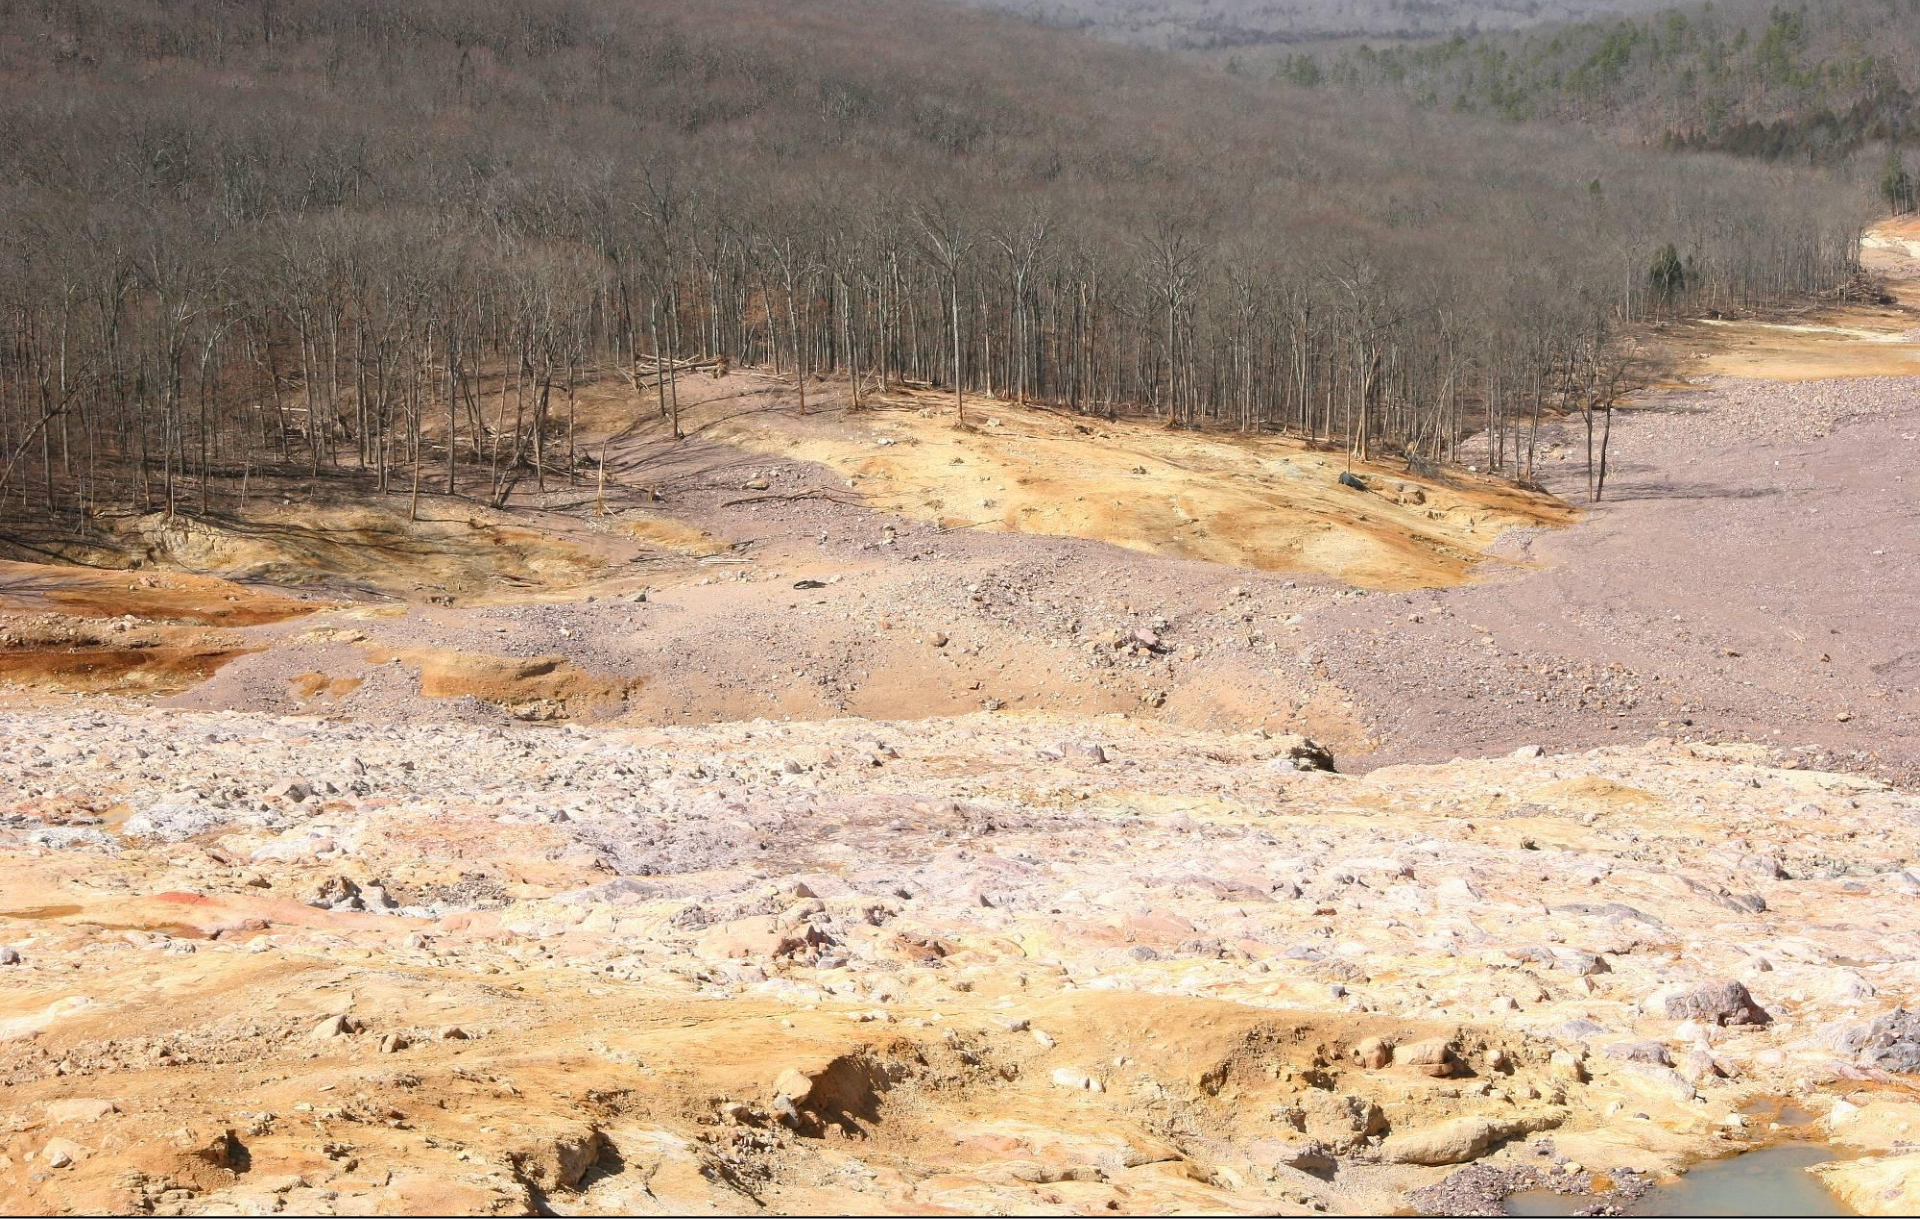
The momentum of the surging waters allowed them to flow up and over this hill (an old landslide), which formed a flow constriction ~100' above the valley floor. Note hydraulic jump and deposition of coarse detritus.

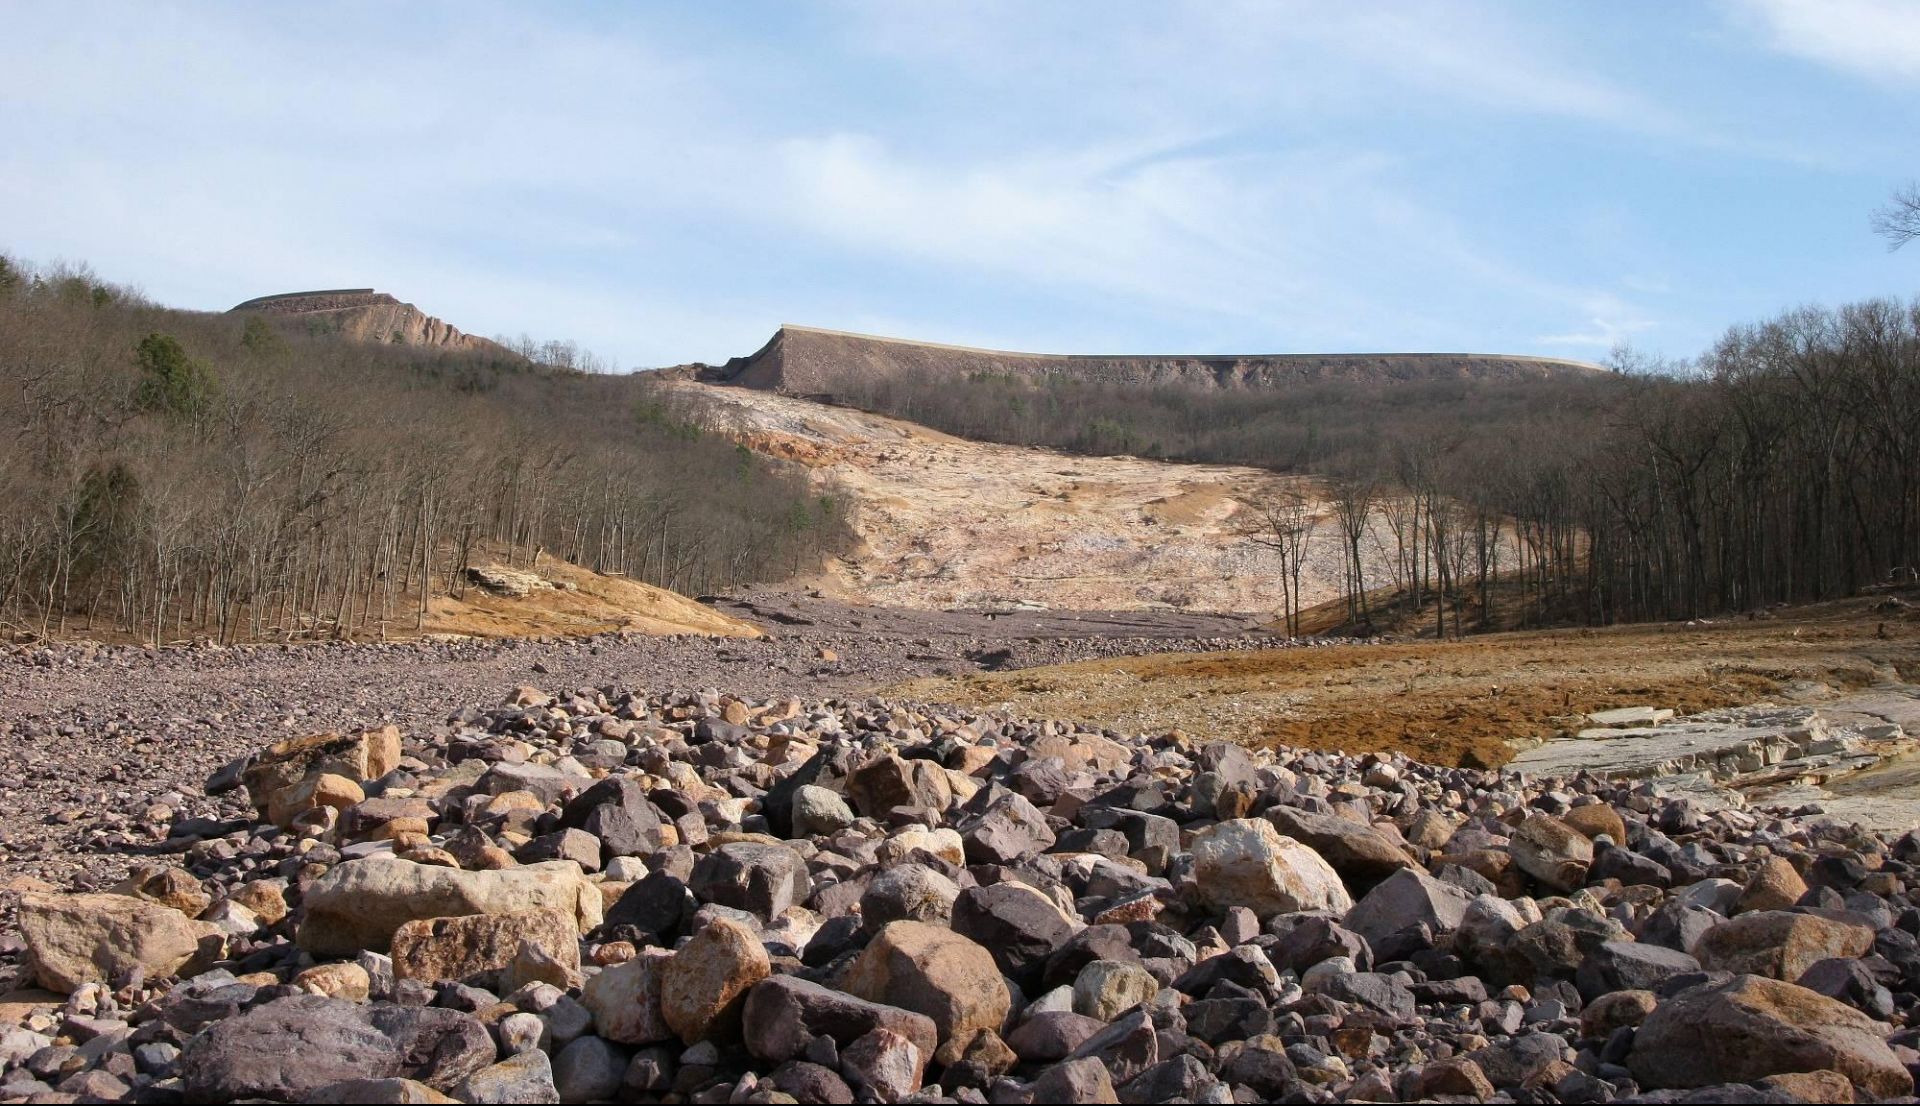
A massive hydraulic jump (near center) developed as the gradient of the slope decreased where Ordovician carbonates onlap onto Precambrian igneous formations underlying Proffit Mountain. The water dropped over 400 feet down this now barren slope of Proffit Mountain.

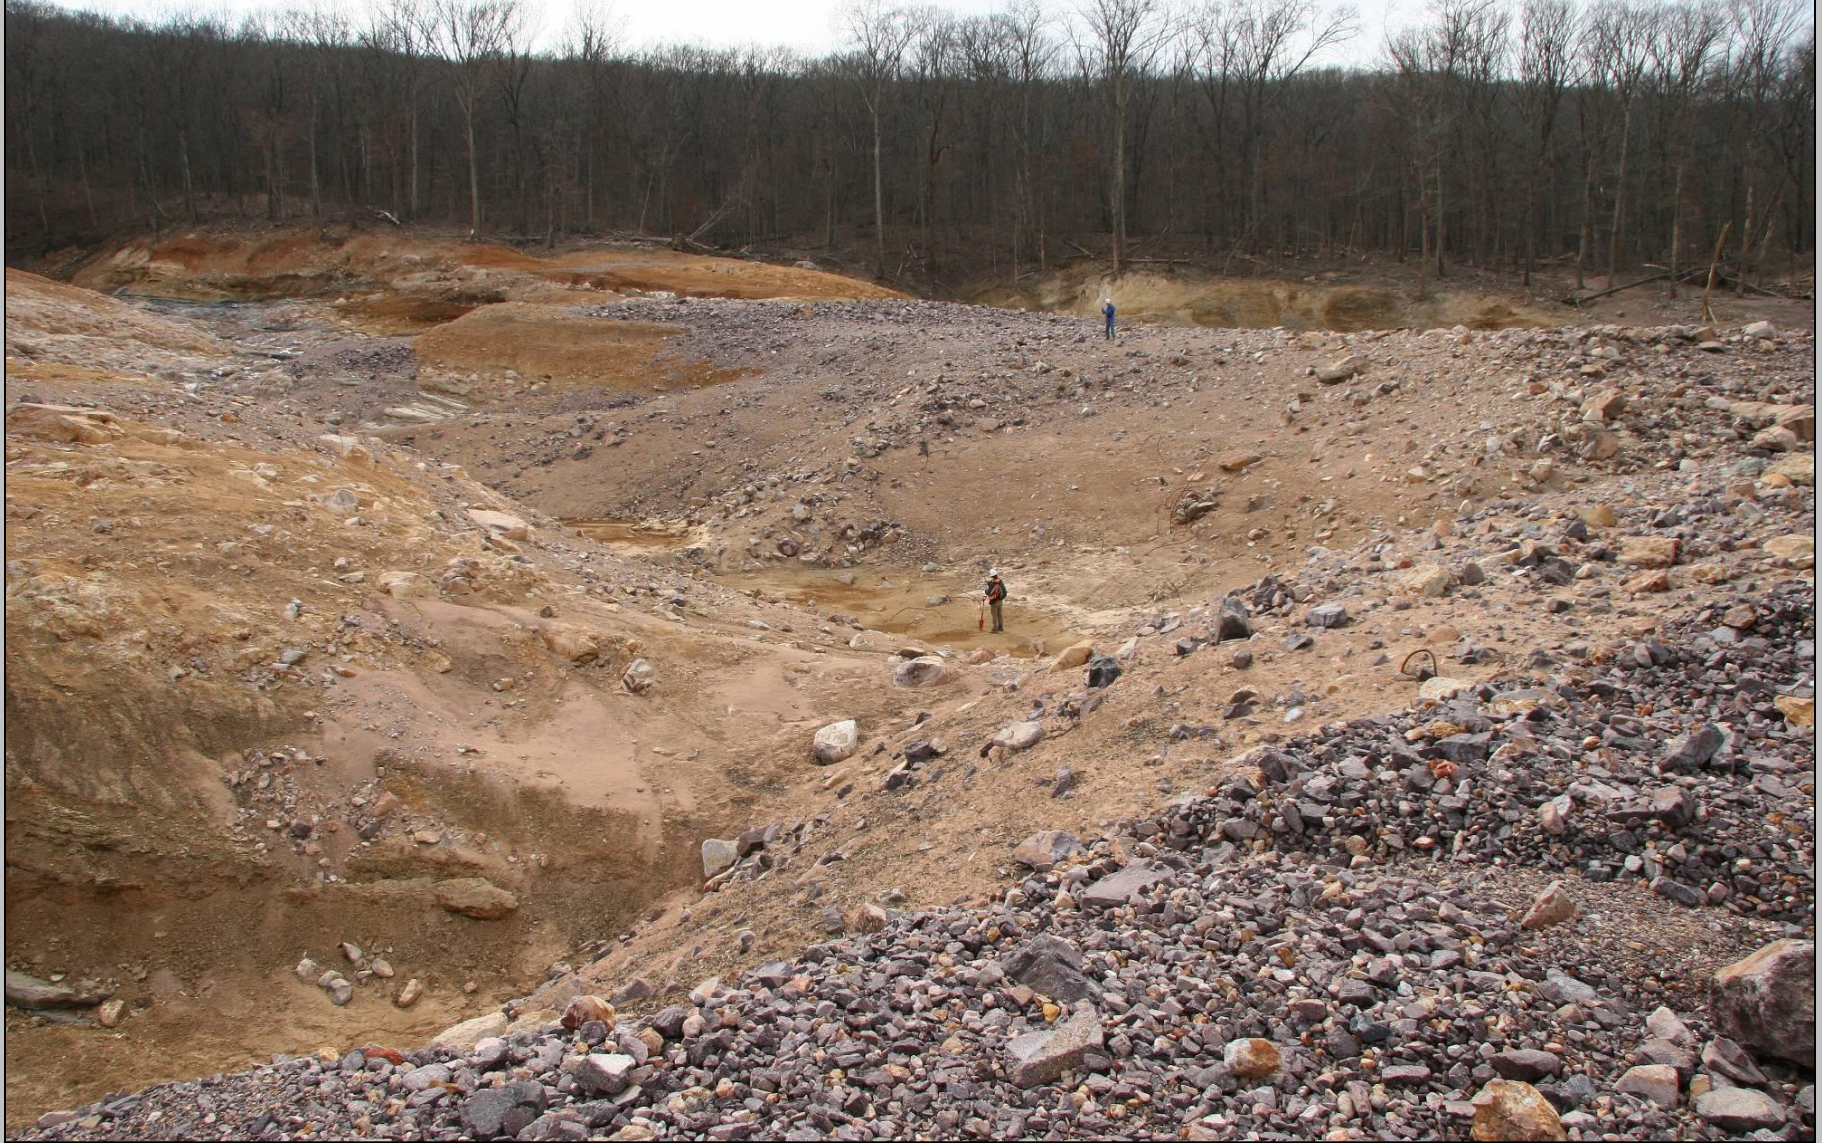
A massive scour hole >20 feet deep formed at the hydraulic jump where the channel gradient suddenly decreased. The coarse bedload fraction began to drop out of the flow, although the bed of the channel remained active. This transition appears to have been “rinsed” by one final wave of water, towards the end of the flood sequence.

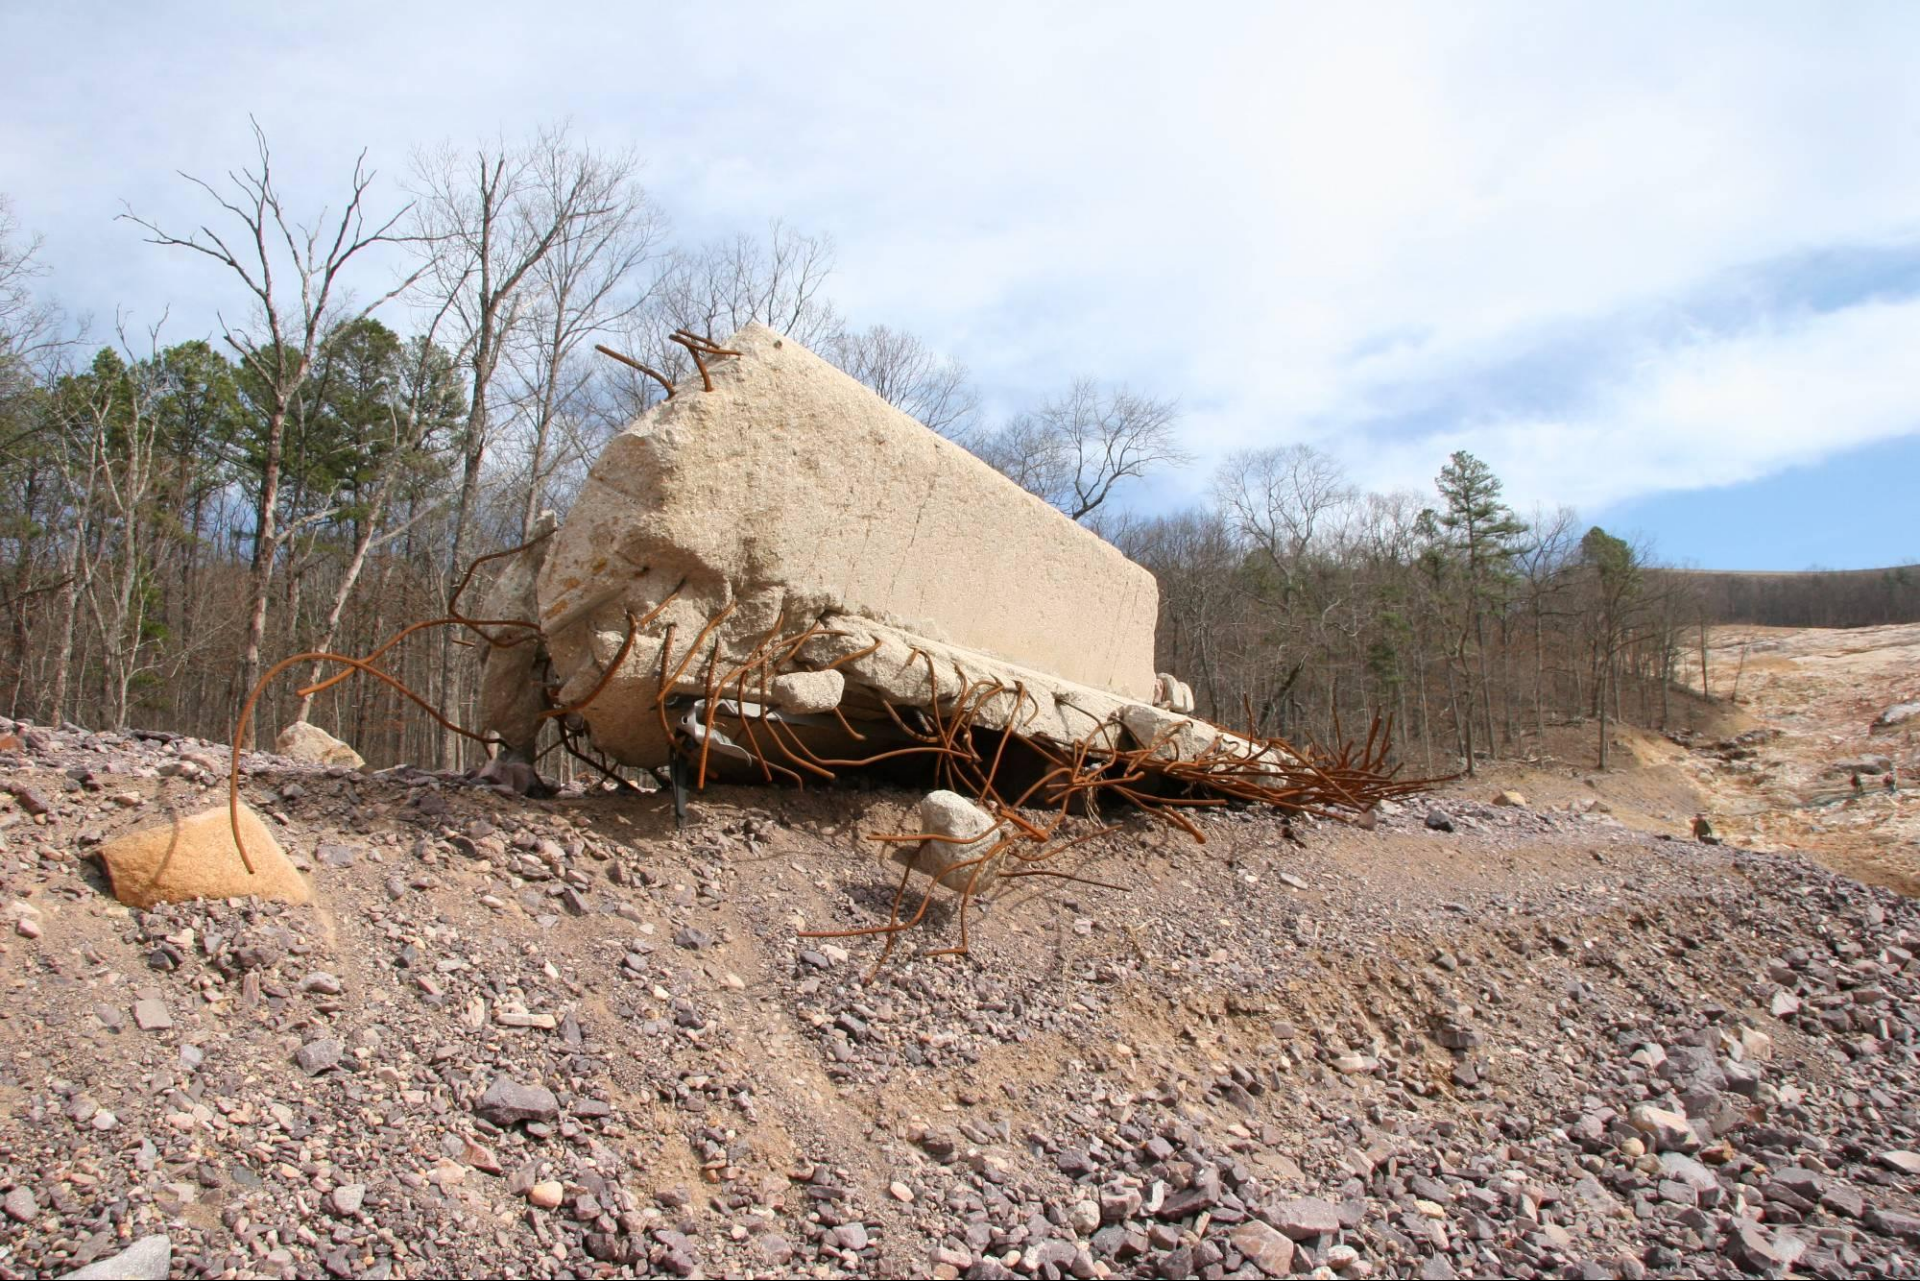
Huge pieces of rock and concrete were carried downslope by the turbid flow. A large section of a concrete wall panel is shown here.
