FACTORS CONTRIBUTING TO THE 2005 TAUM SAUK UPPER RESERVOIR FAILURE

December 14, 2005

Reynolds County, Missouri

RECONSTRUCTED FAILURE SEQUENCE

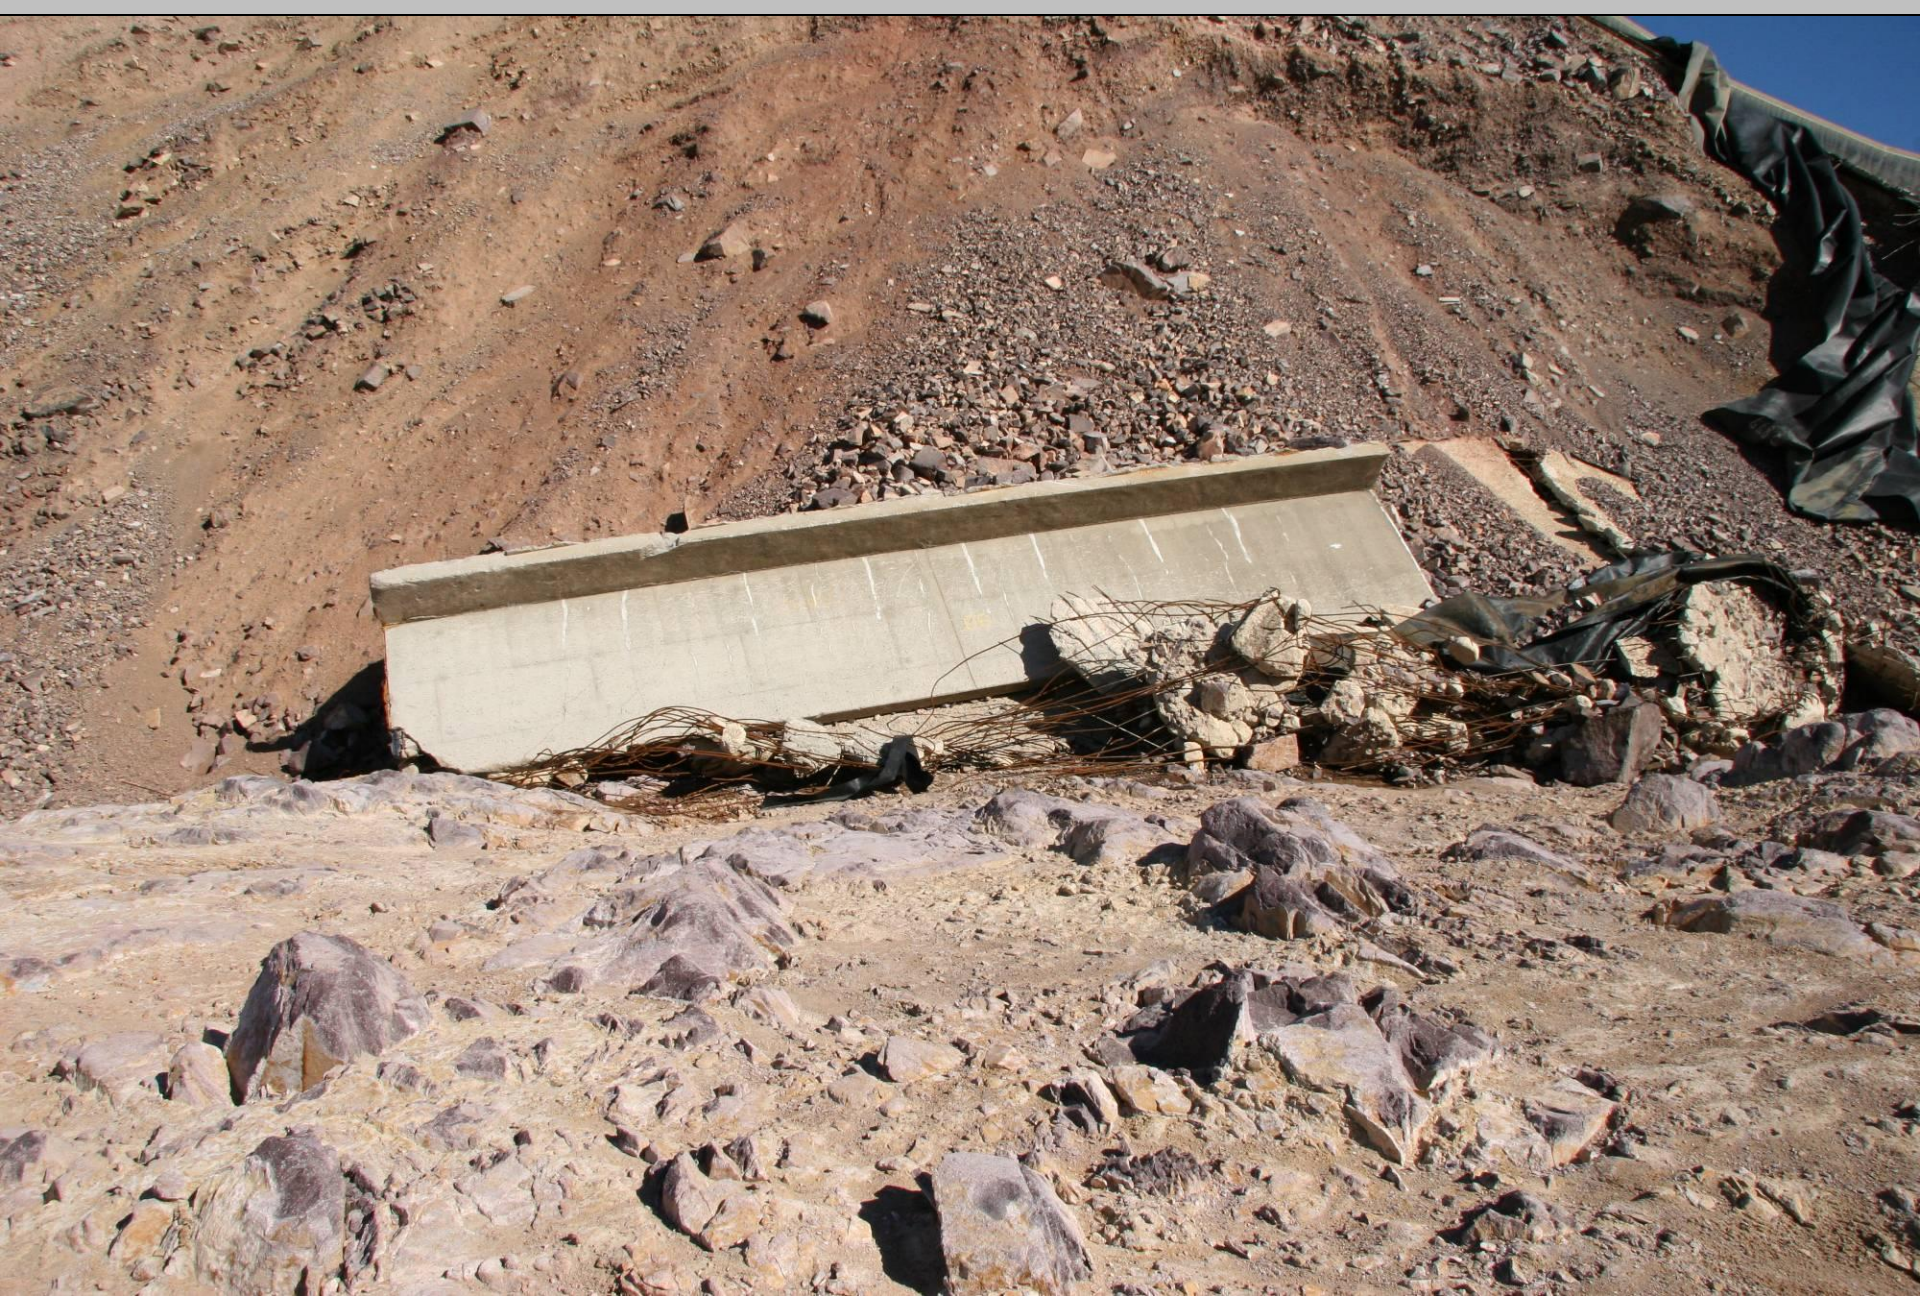
Toppled wall panel at north end of breach. The stem was 10 feet high.

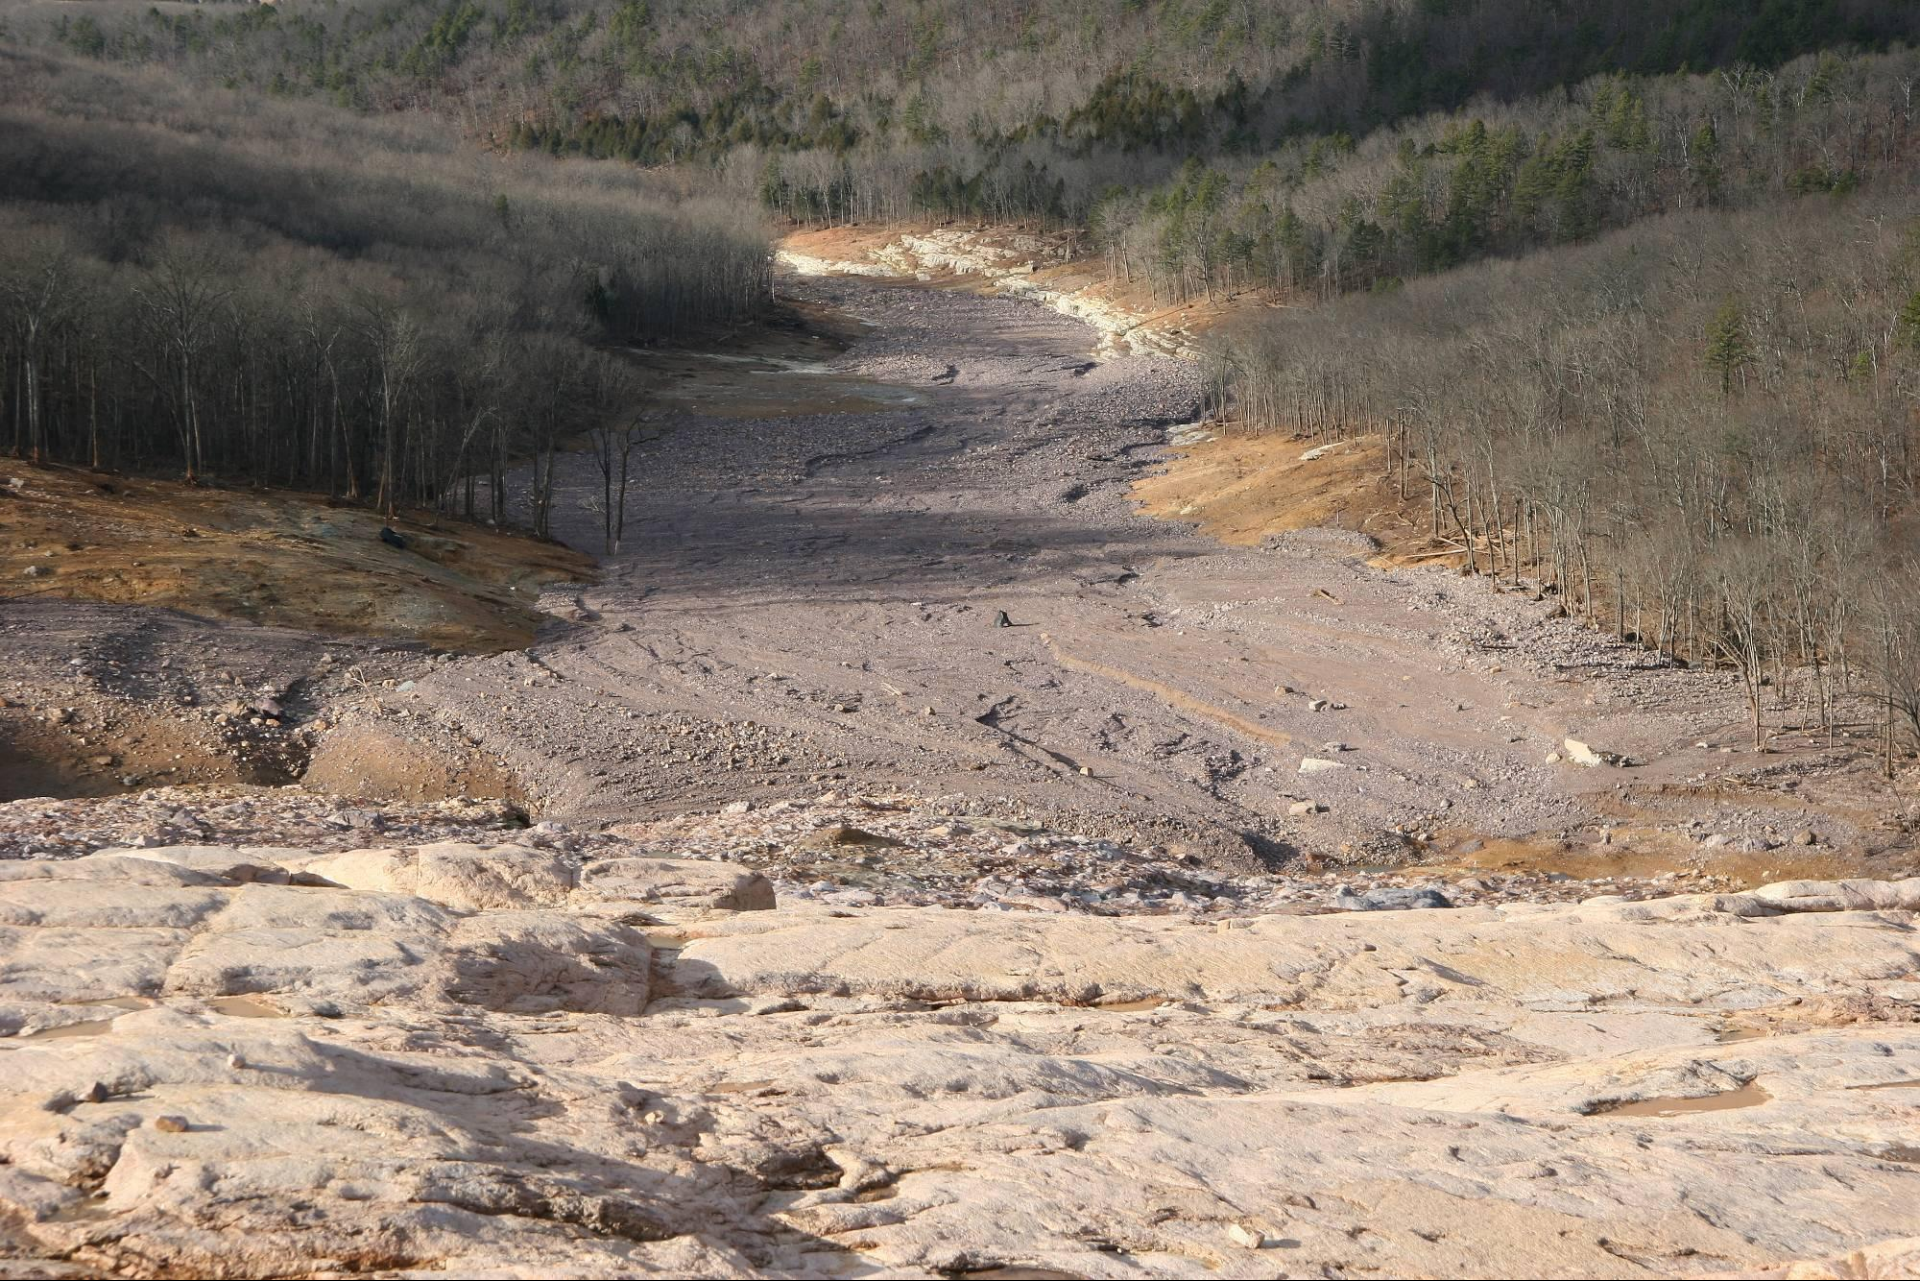
Lower portion of the scour channel and precipitous drop, immediately below the reservoir. Note demarcation between bedrock and gravels.

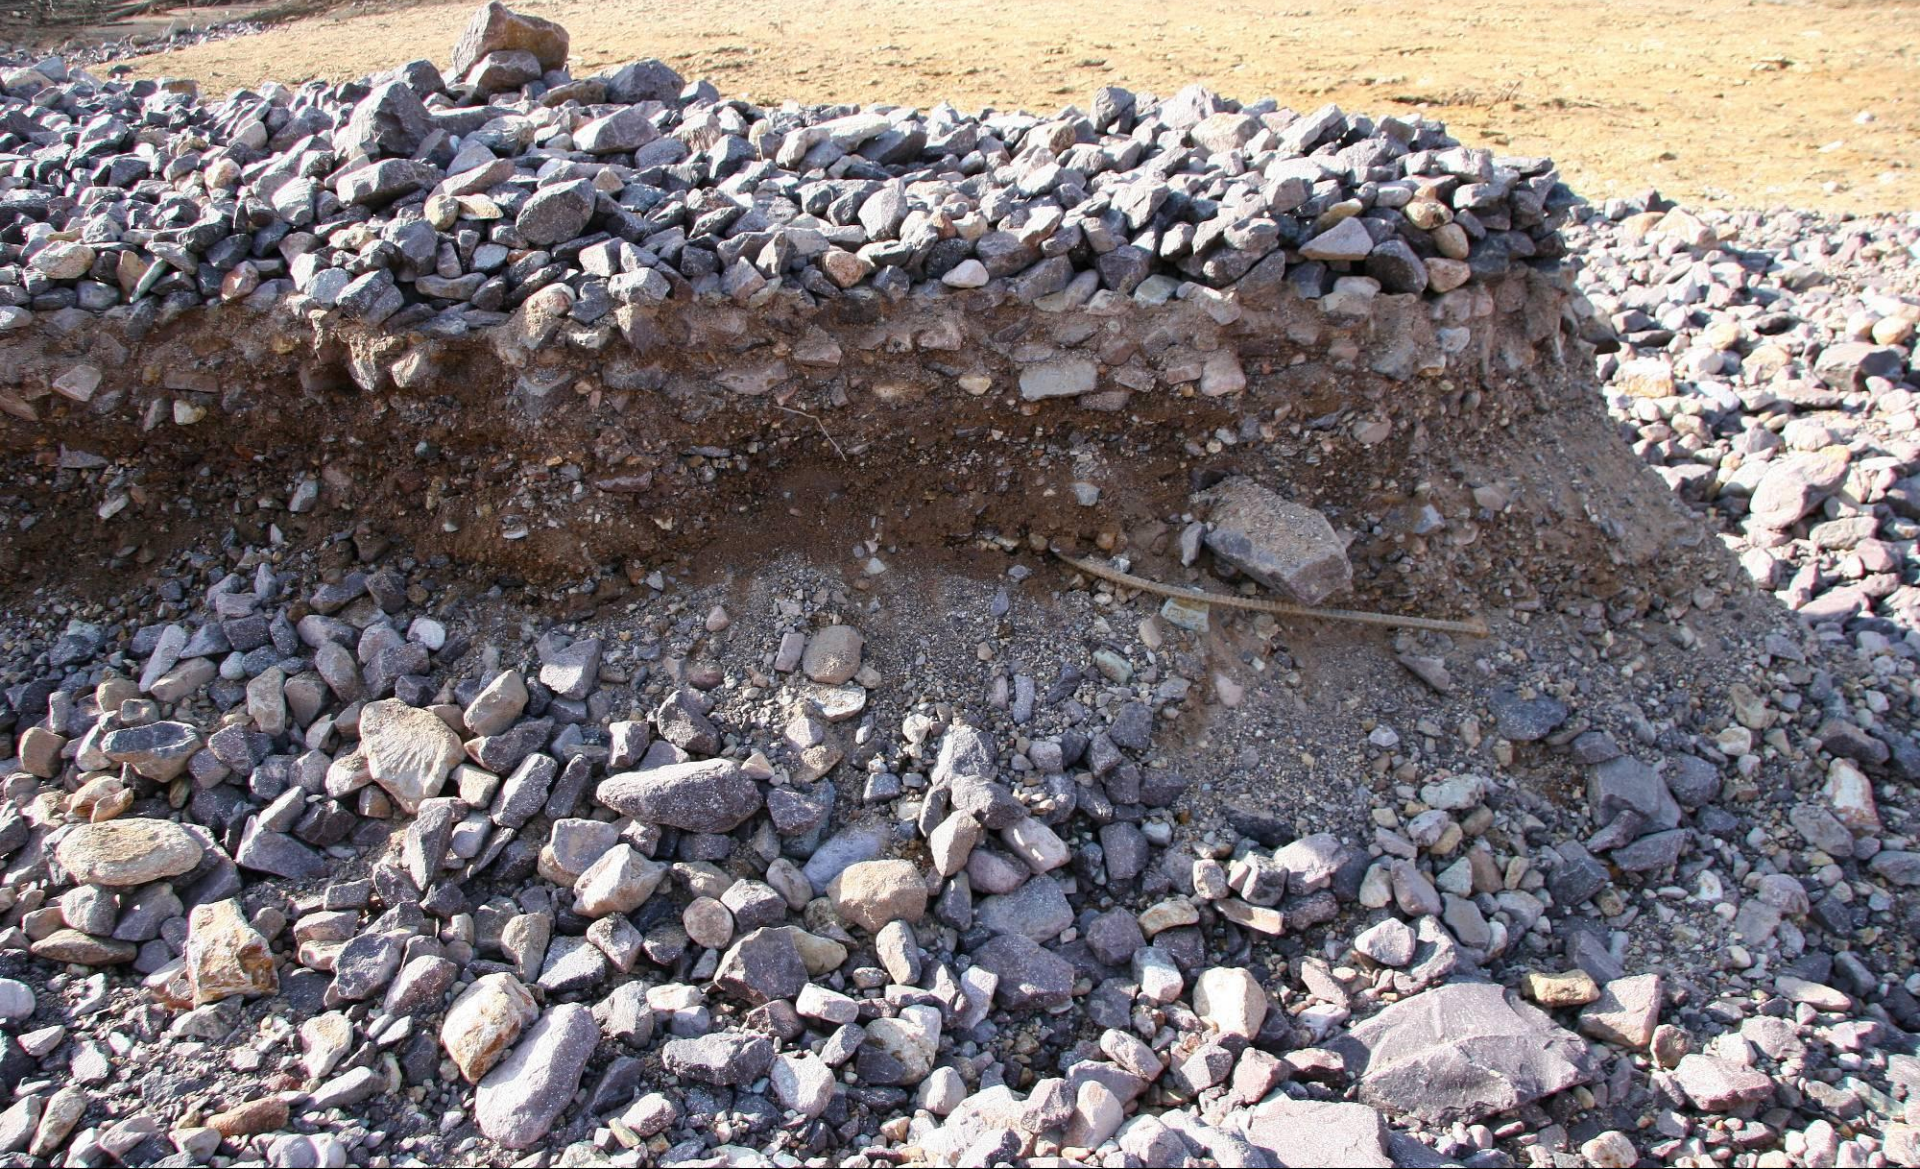
Much of the coarse debris fraction appears to have been reworked and sluiced of fines by tail flows, as the flood waters subsided. Note the coarsening upward nature of this deposit and the inclusion of steel rebar, from the shotcrete liner.

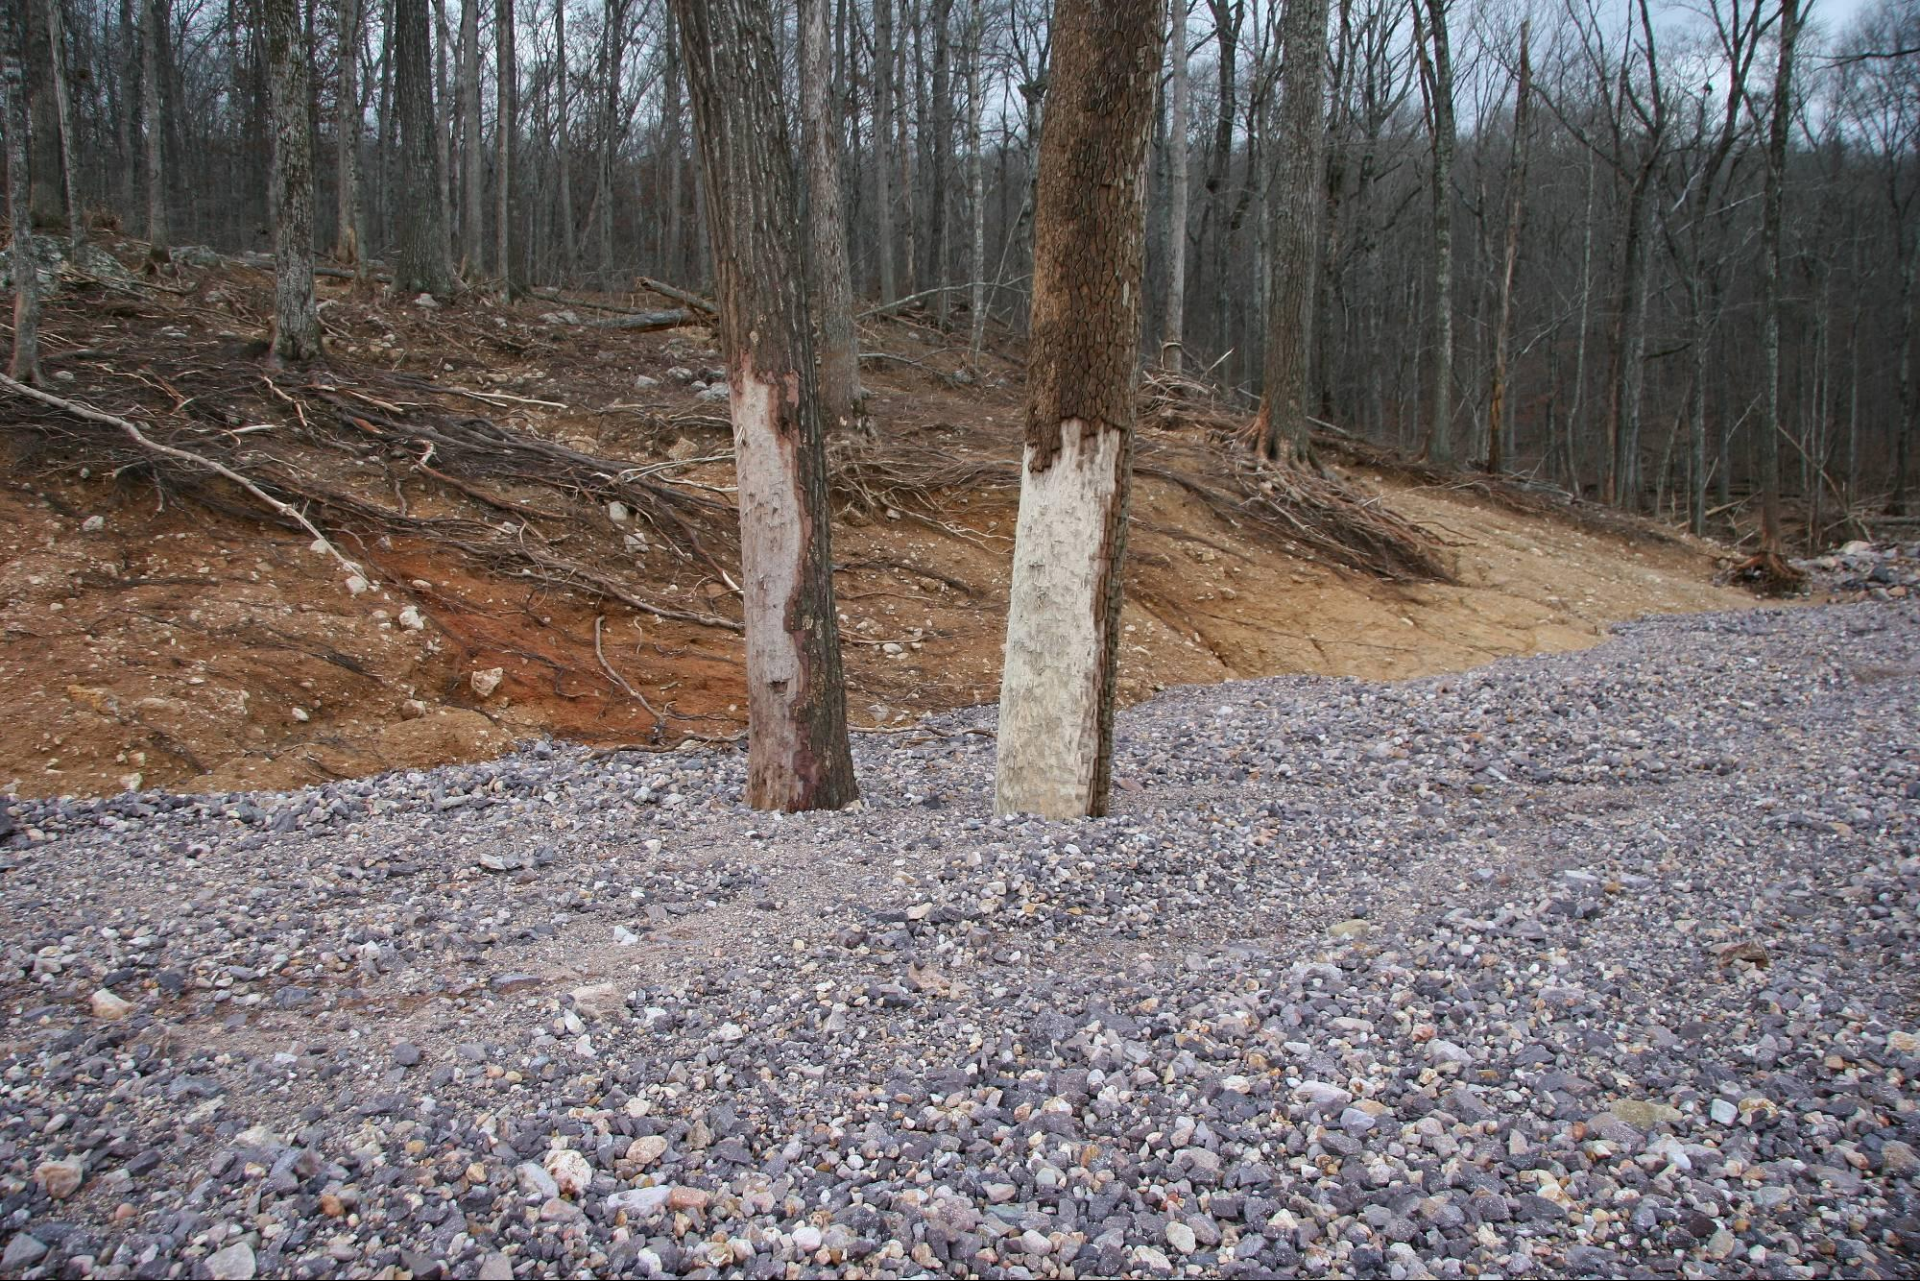
The upstream side of two trees had all of their bark abraded by the turbid outflow.

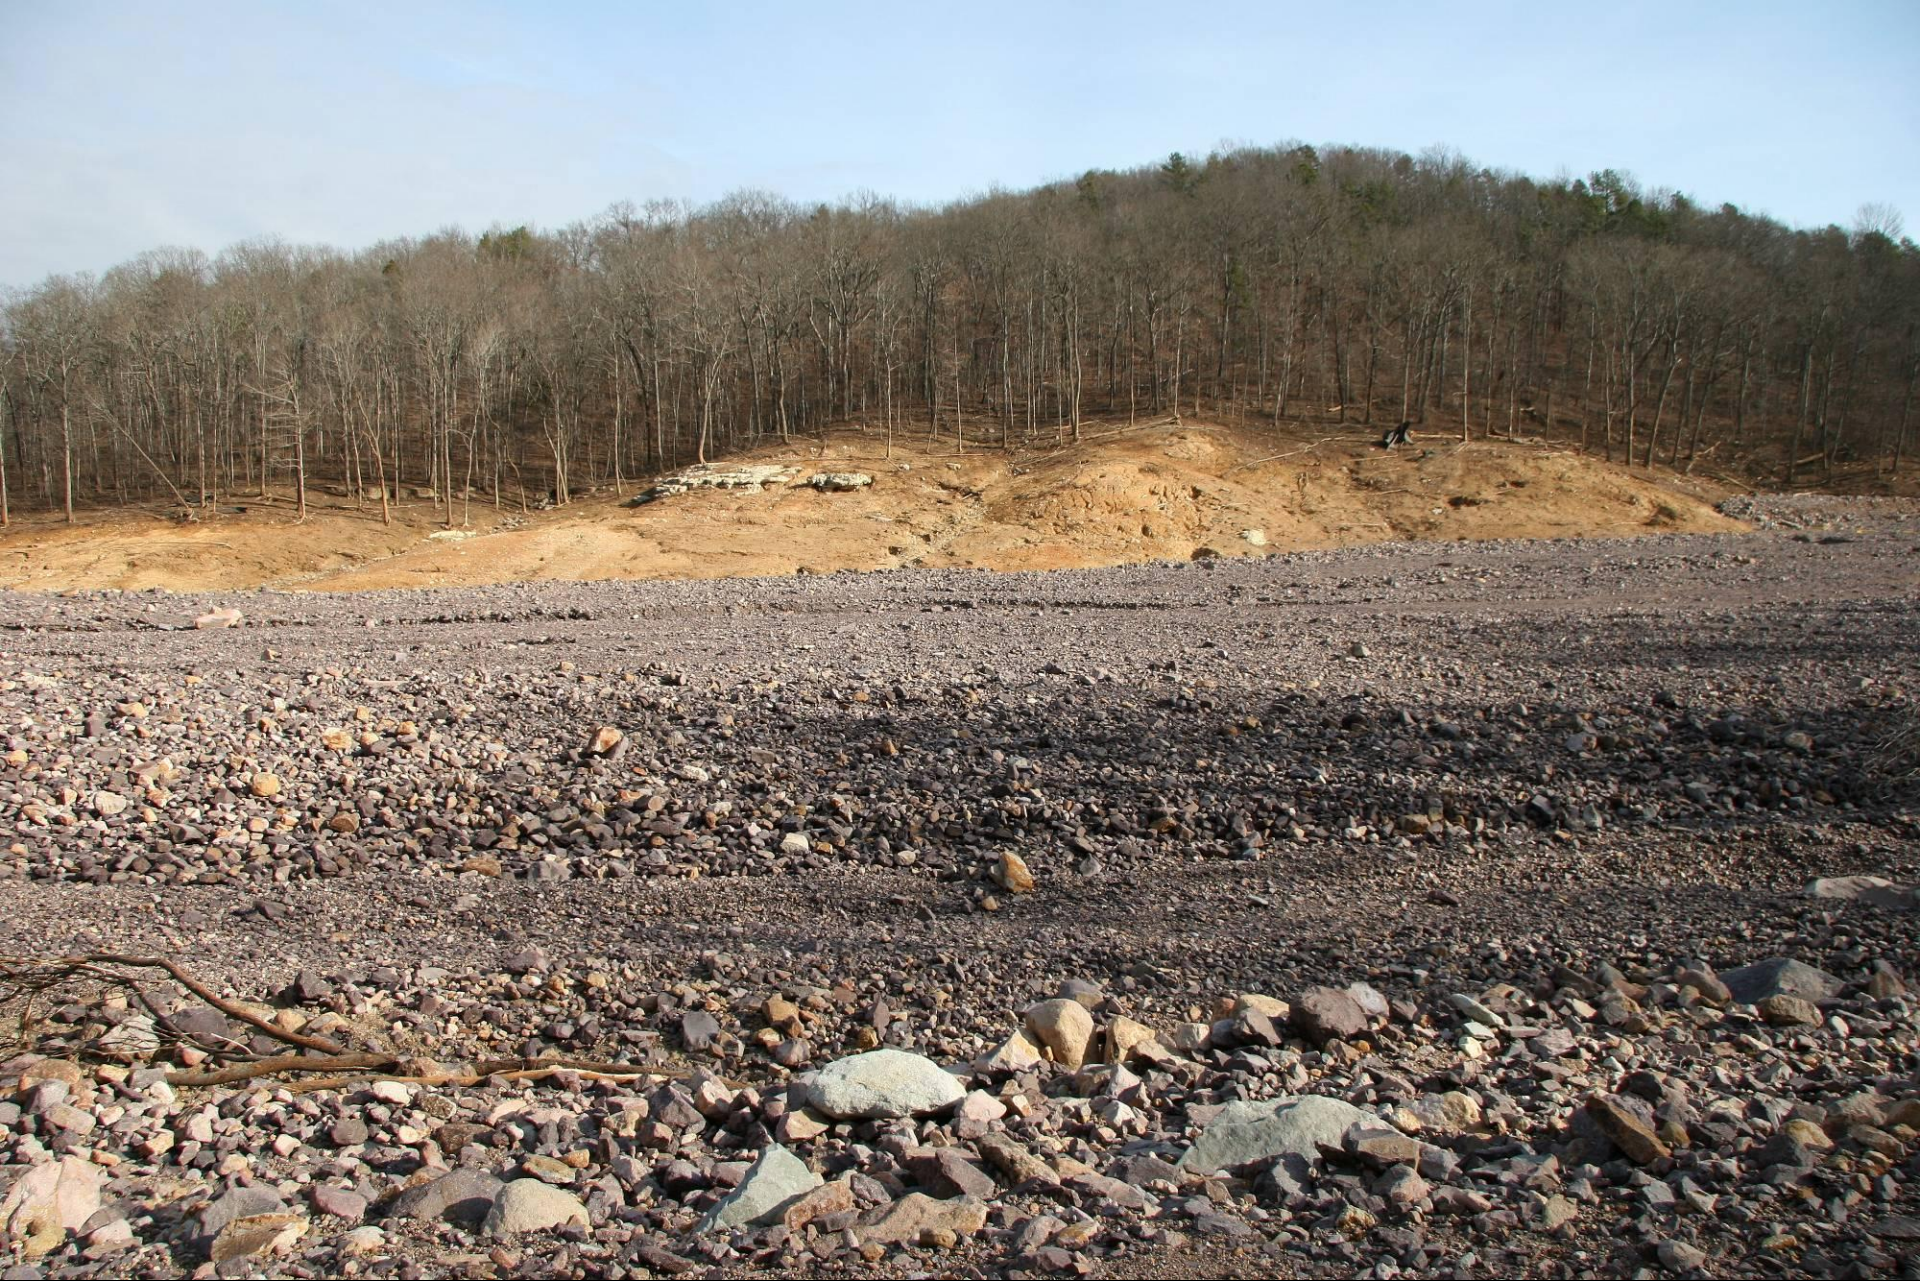
Reworked boulders, cobbles, and gravels fill the lower portion of the scour channel, along with twisted remnants of concrete and rebar.

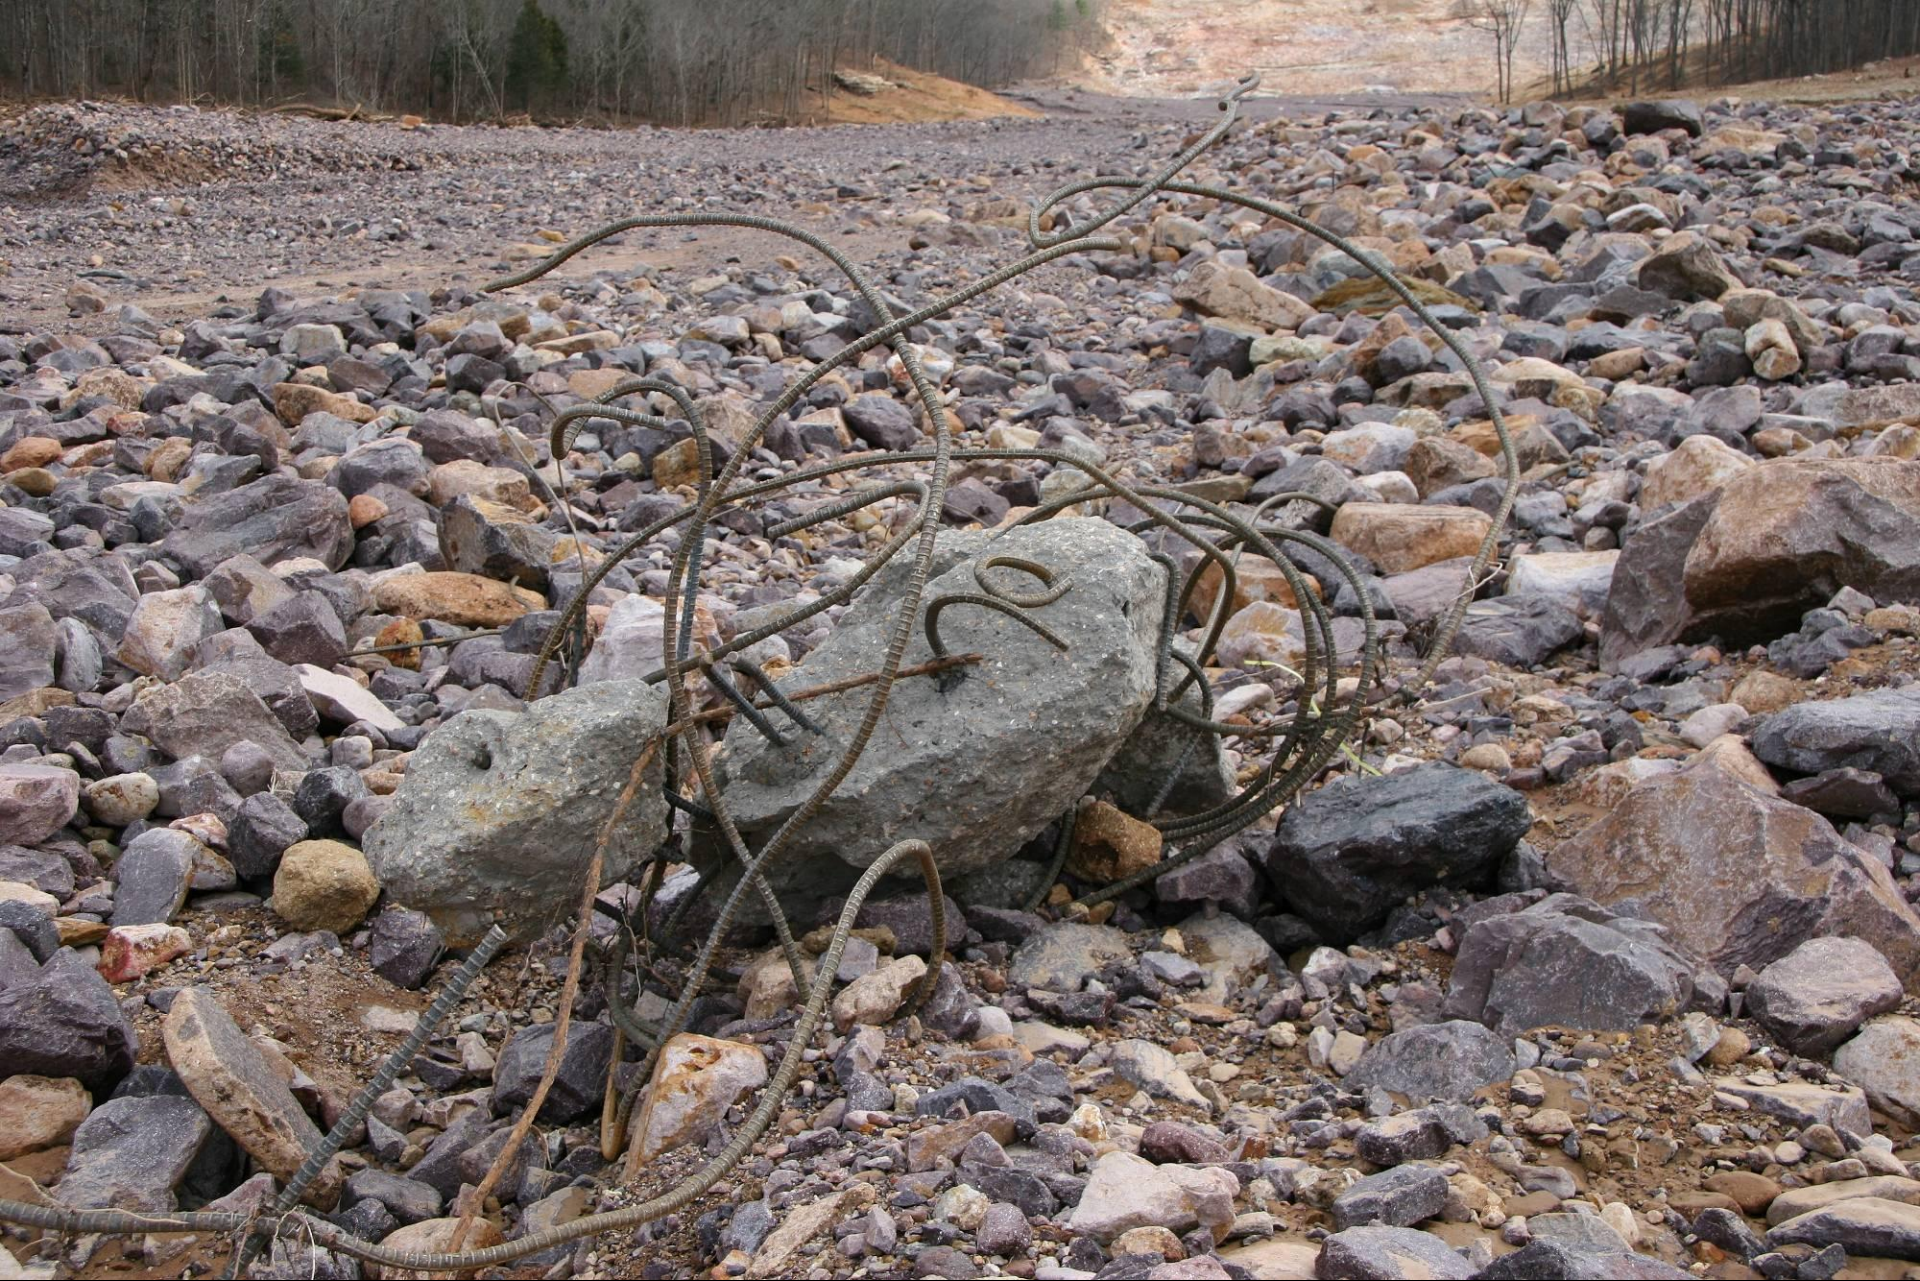
Concrete and rebar from the dike littered the scour channel.

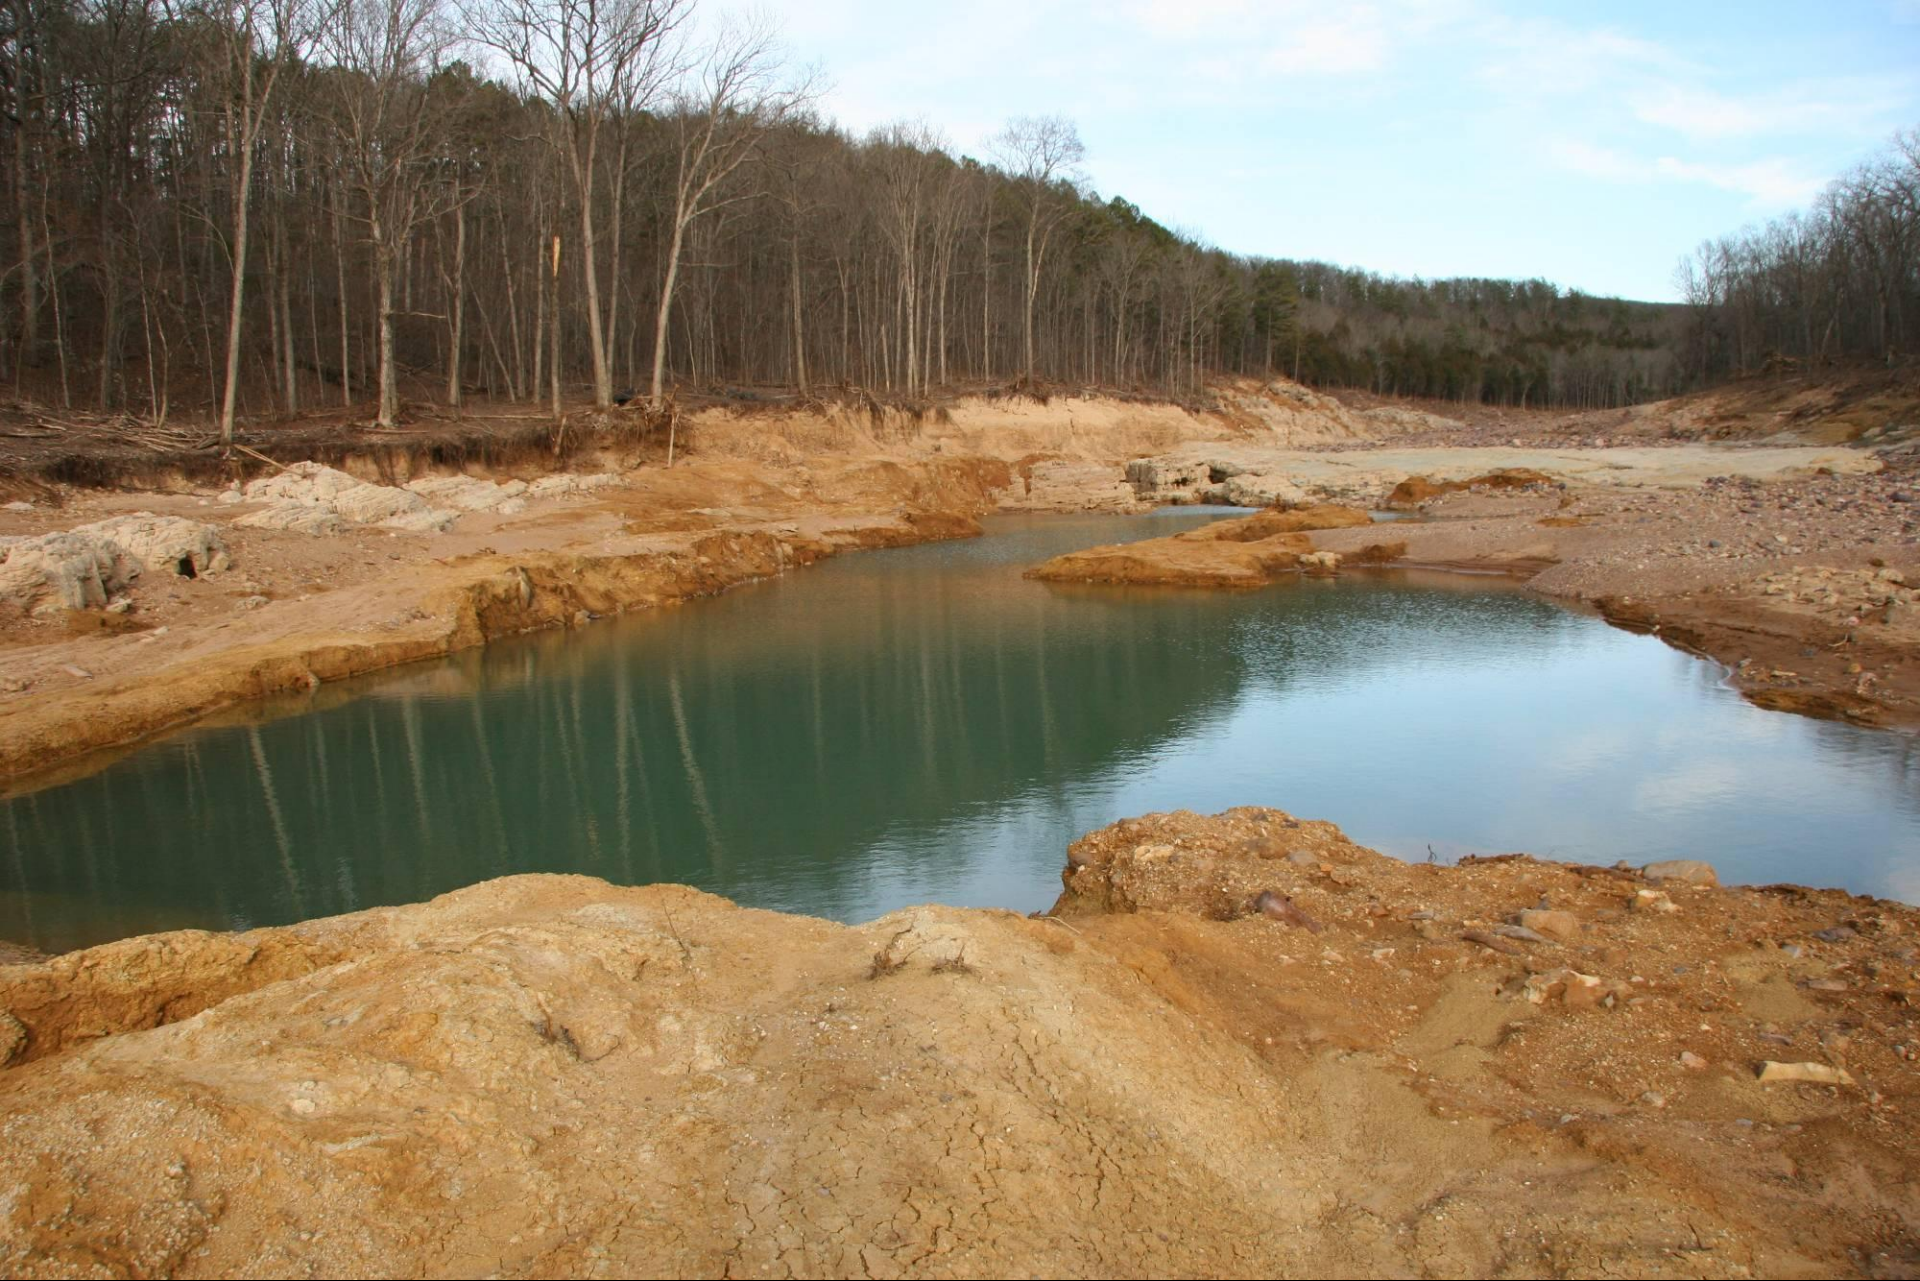
Scour holes were excavated into the residuum and weathered carbonate rock near the junction with the flood plain of the Black River.

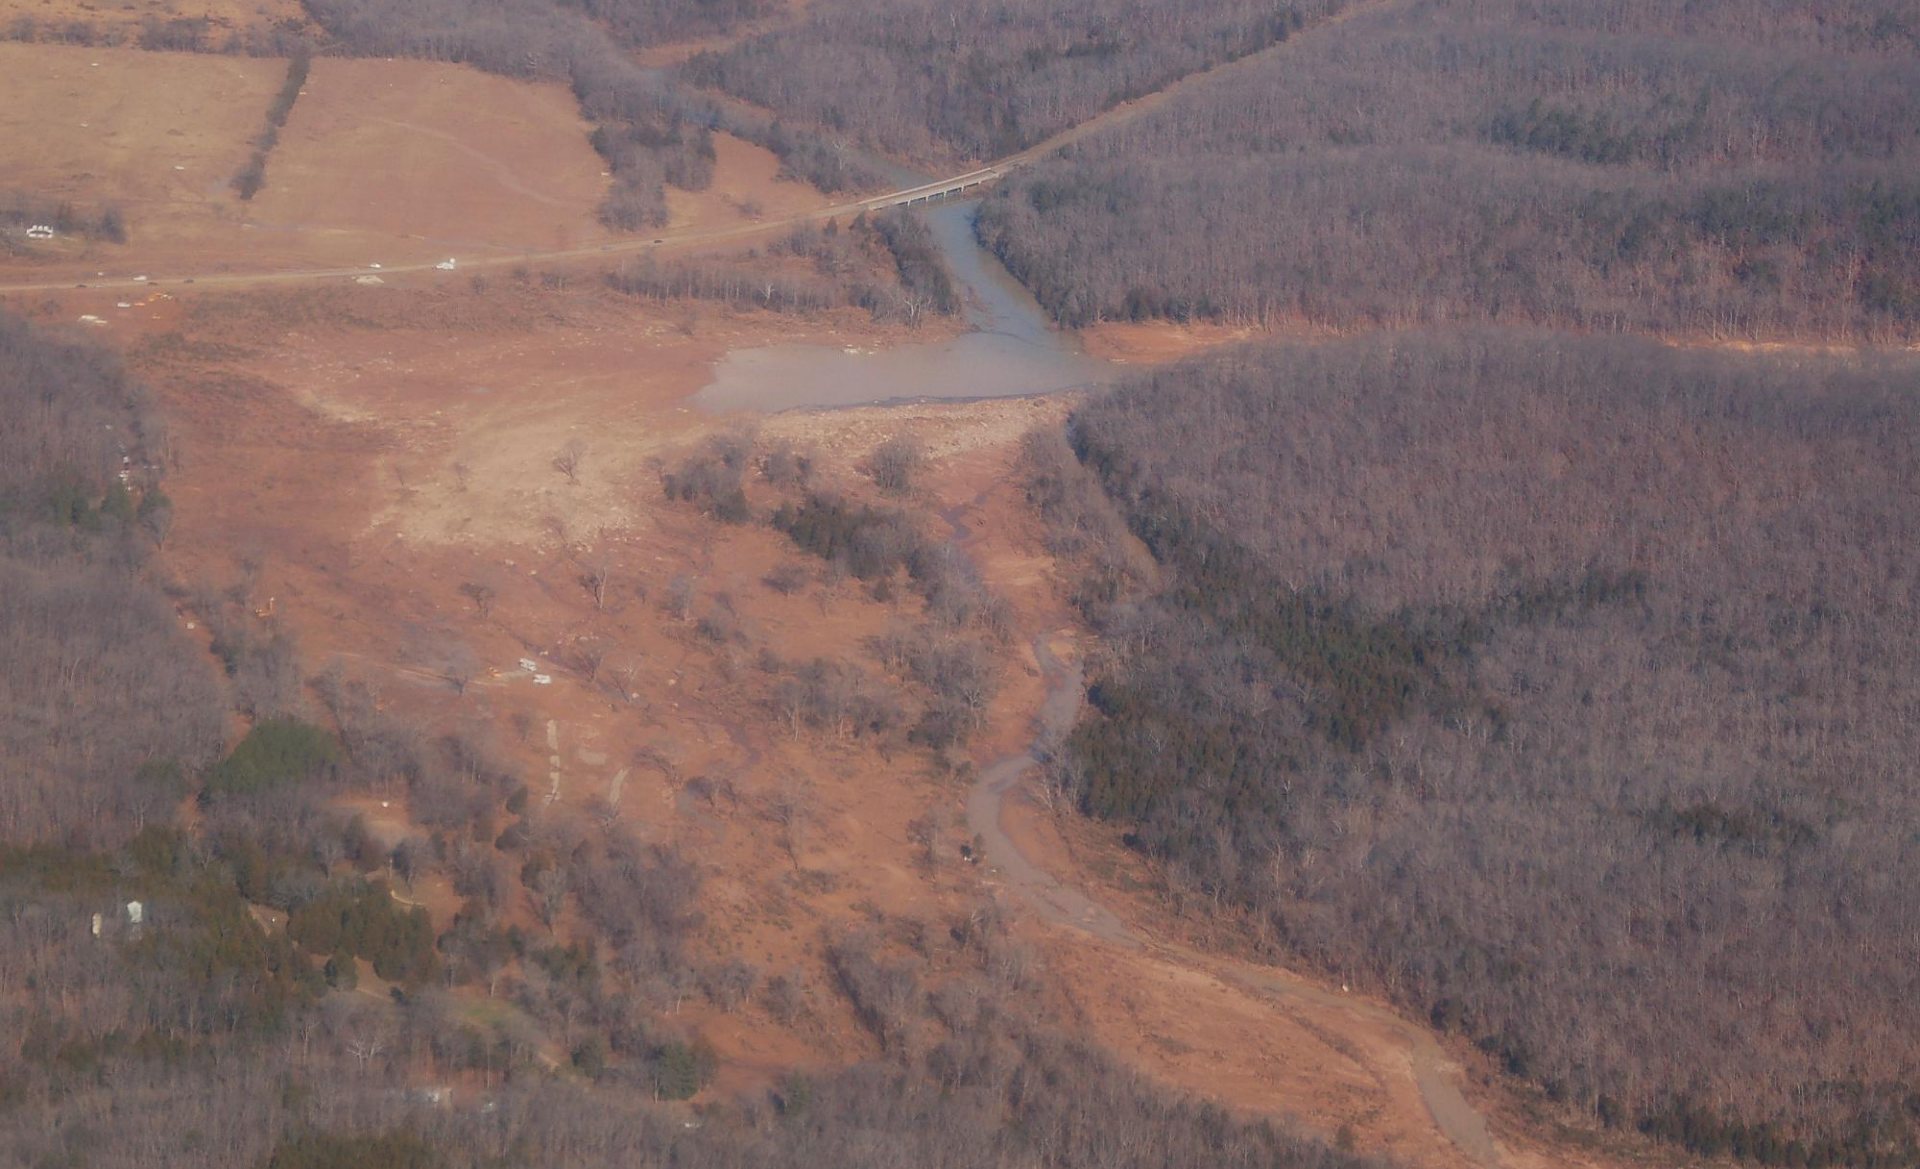
As the flood roared into the Black River flood plain, it scoured a deep hole, seen here. The sudden drop in gradient caused the flood waters to drop its sediment, forming a debris dam that backed up this six acre lake (photo by Jeff Spooner USGS-MCGSC).

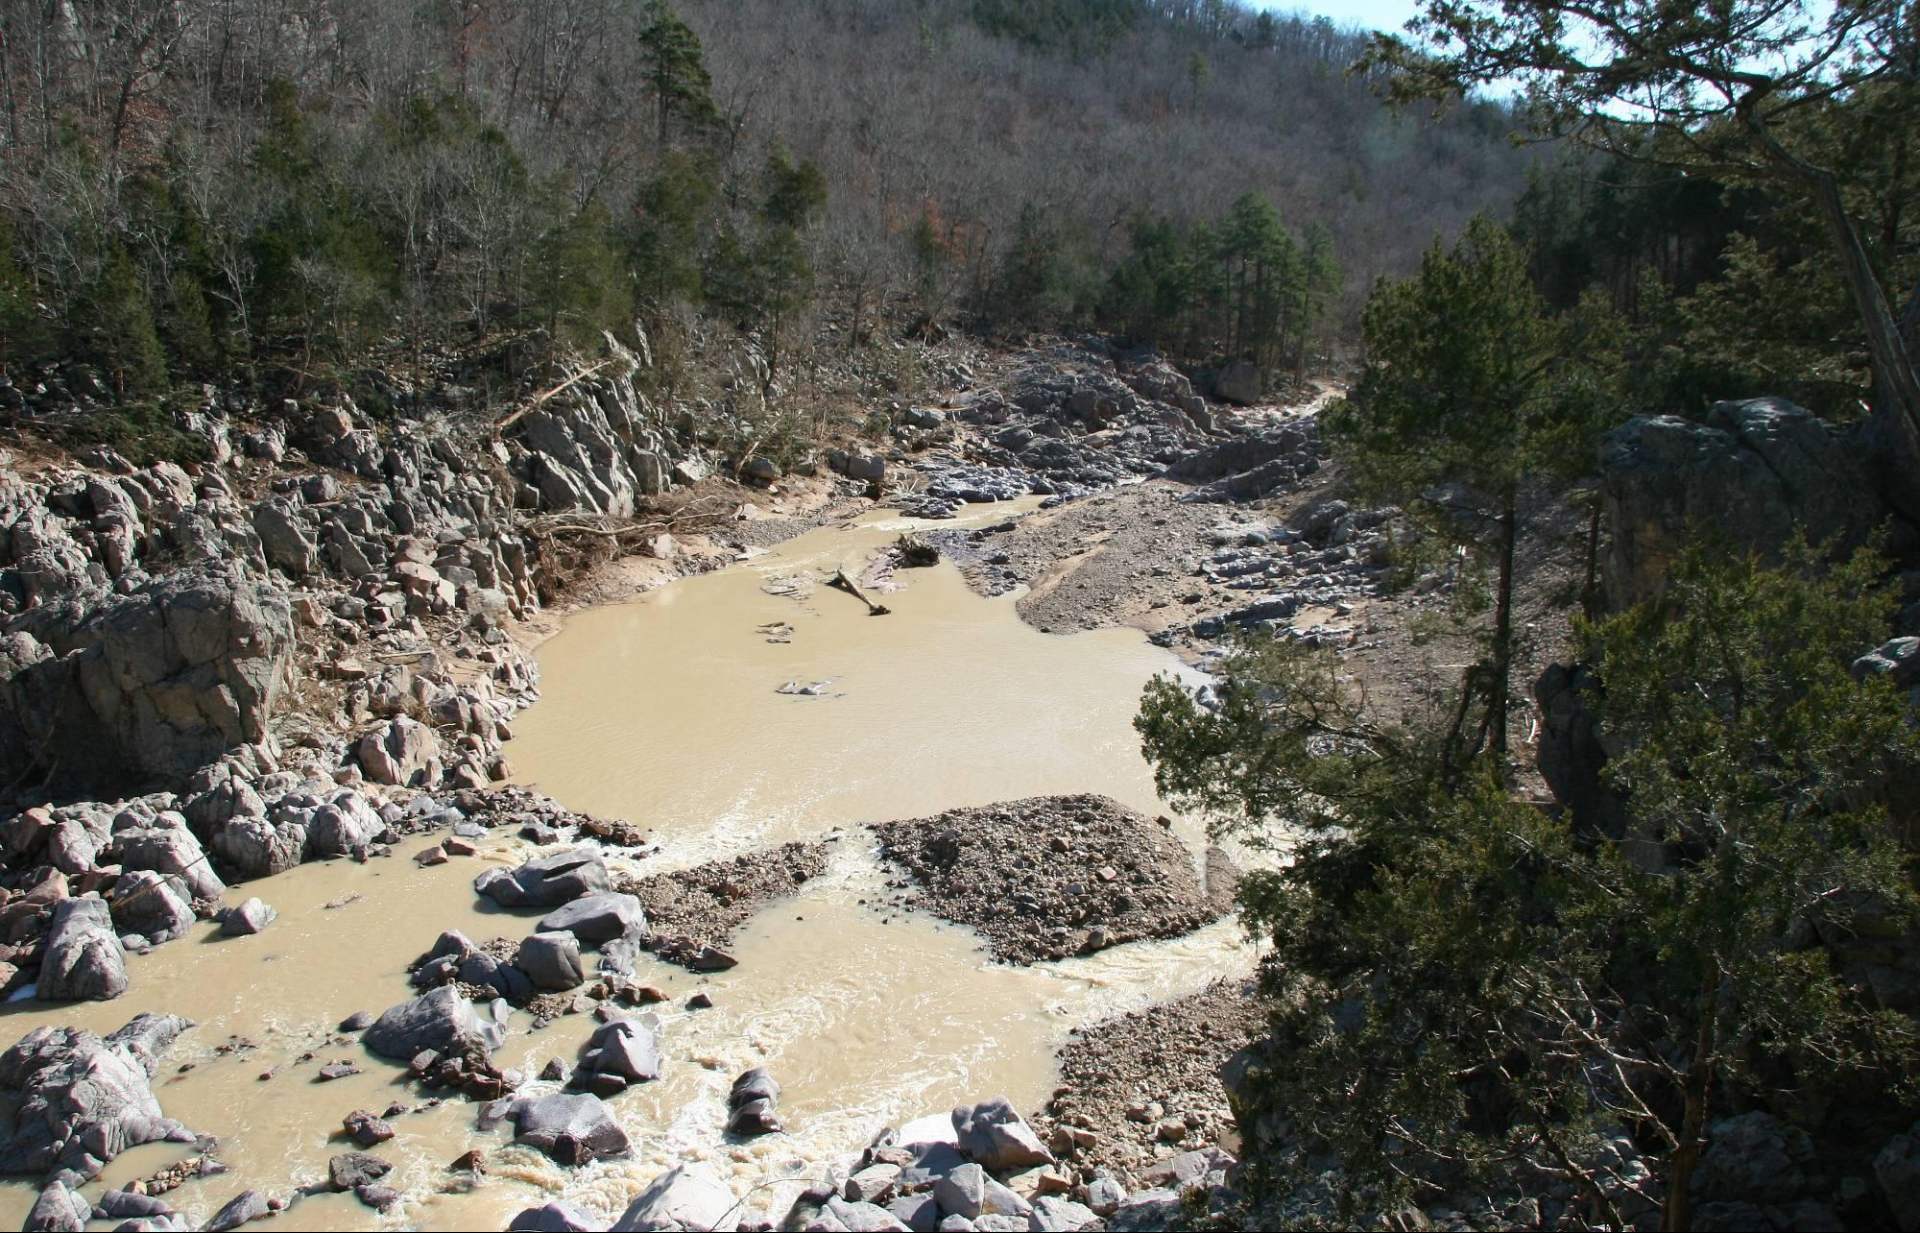
A hydraulic jump formed as the flow changed from an upper to lower flow regime, between the upper and lower shut-ins. Gravel was deposited in this once open hole after the transition to a low flow regime.
