FACTORS CONTRIBUTING TO THE 2005 TAUM SAUK UPPER RESERVOIR FAILURE

December 14, 2005

Reynolds County, Missouri

RECONSTRUCTED FAILURE SEQUENCE

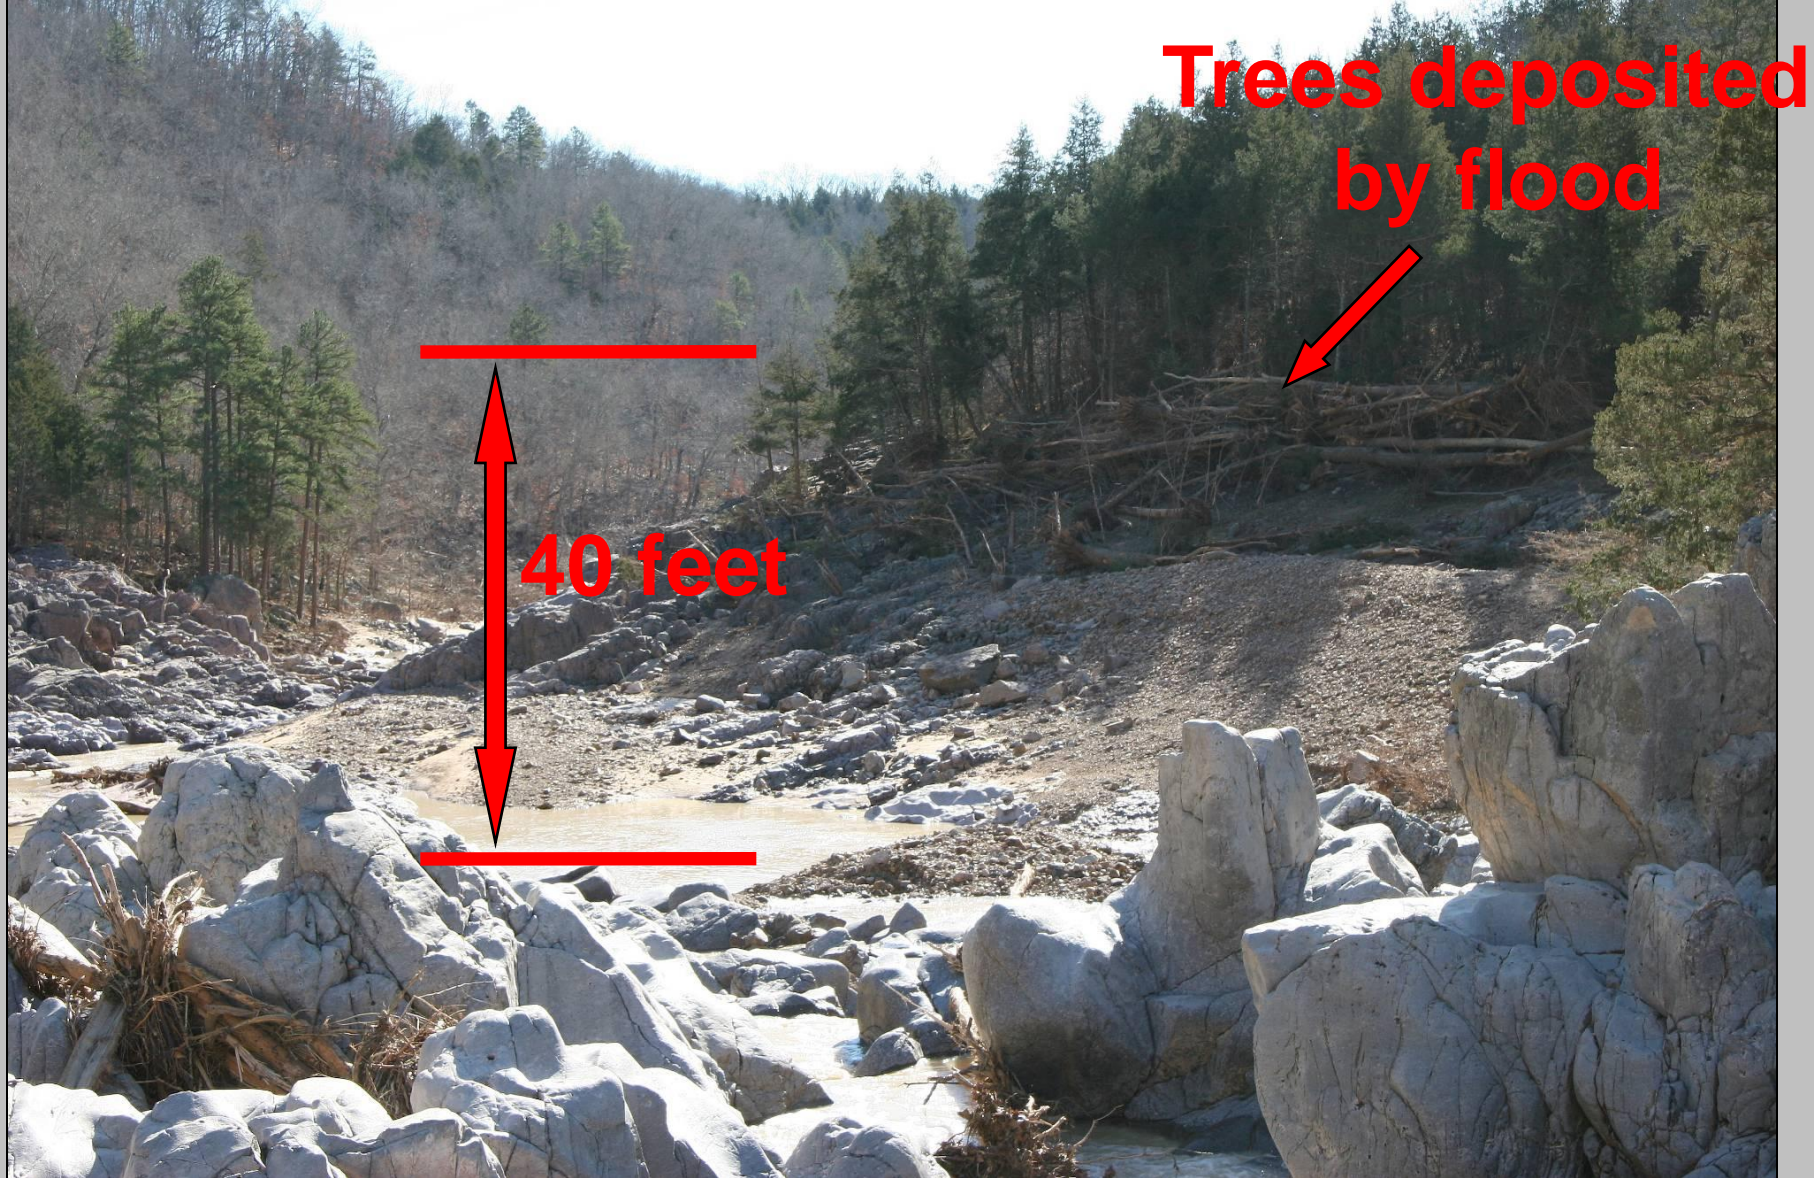
**Trees deposited
by flood**

40 feet

A pile of trees was deposited 40 feet above the main channel by the flood. If anyone had been in the shut-ins at the time of the flood, they probably would not have realized how grave of a predicament they were in until it was too late to get out.

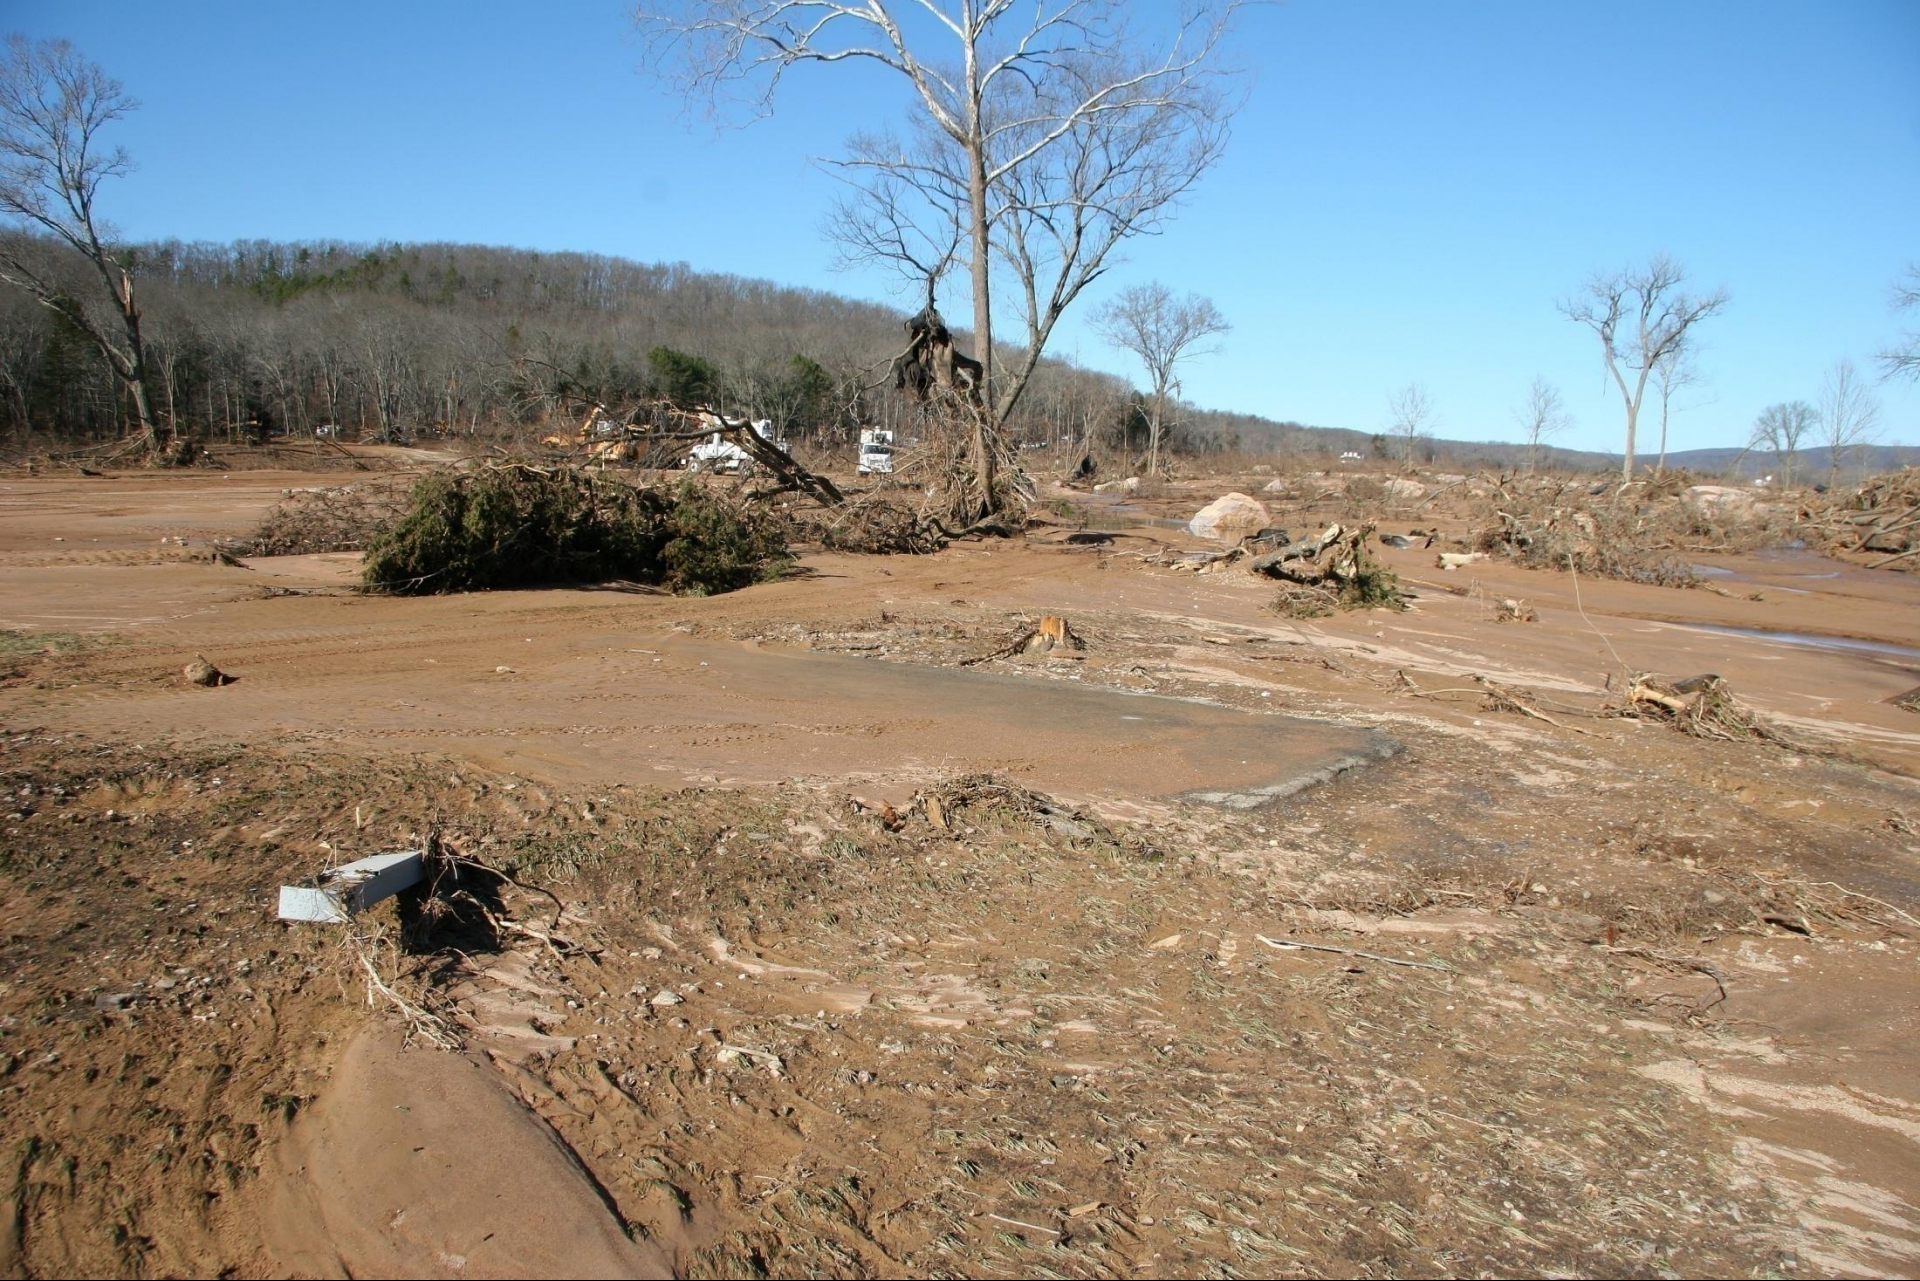
Deposition of boulders, mud, and trees in the campground at Johnson's Shut-ins State Park.

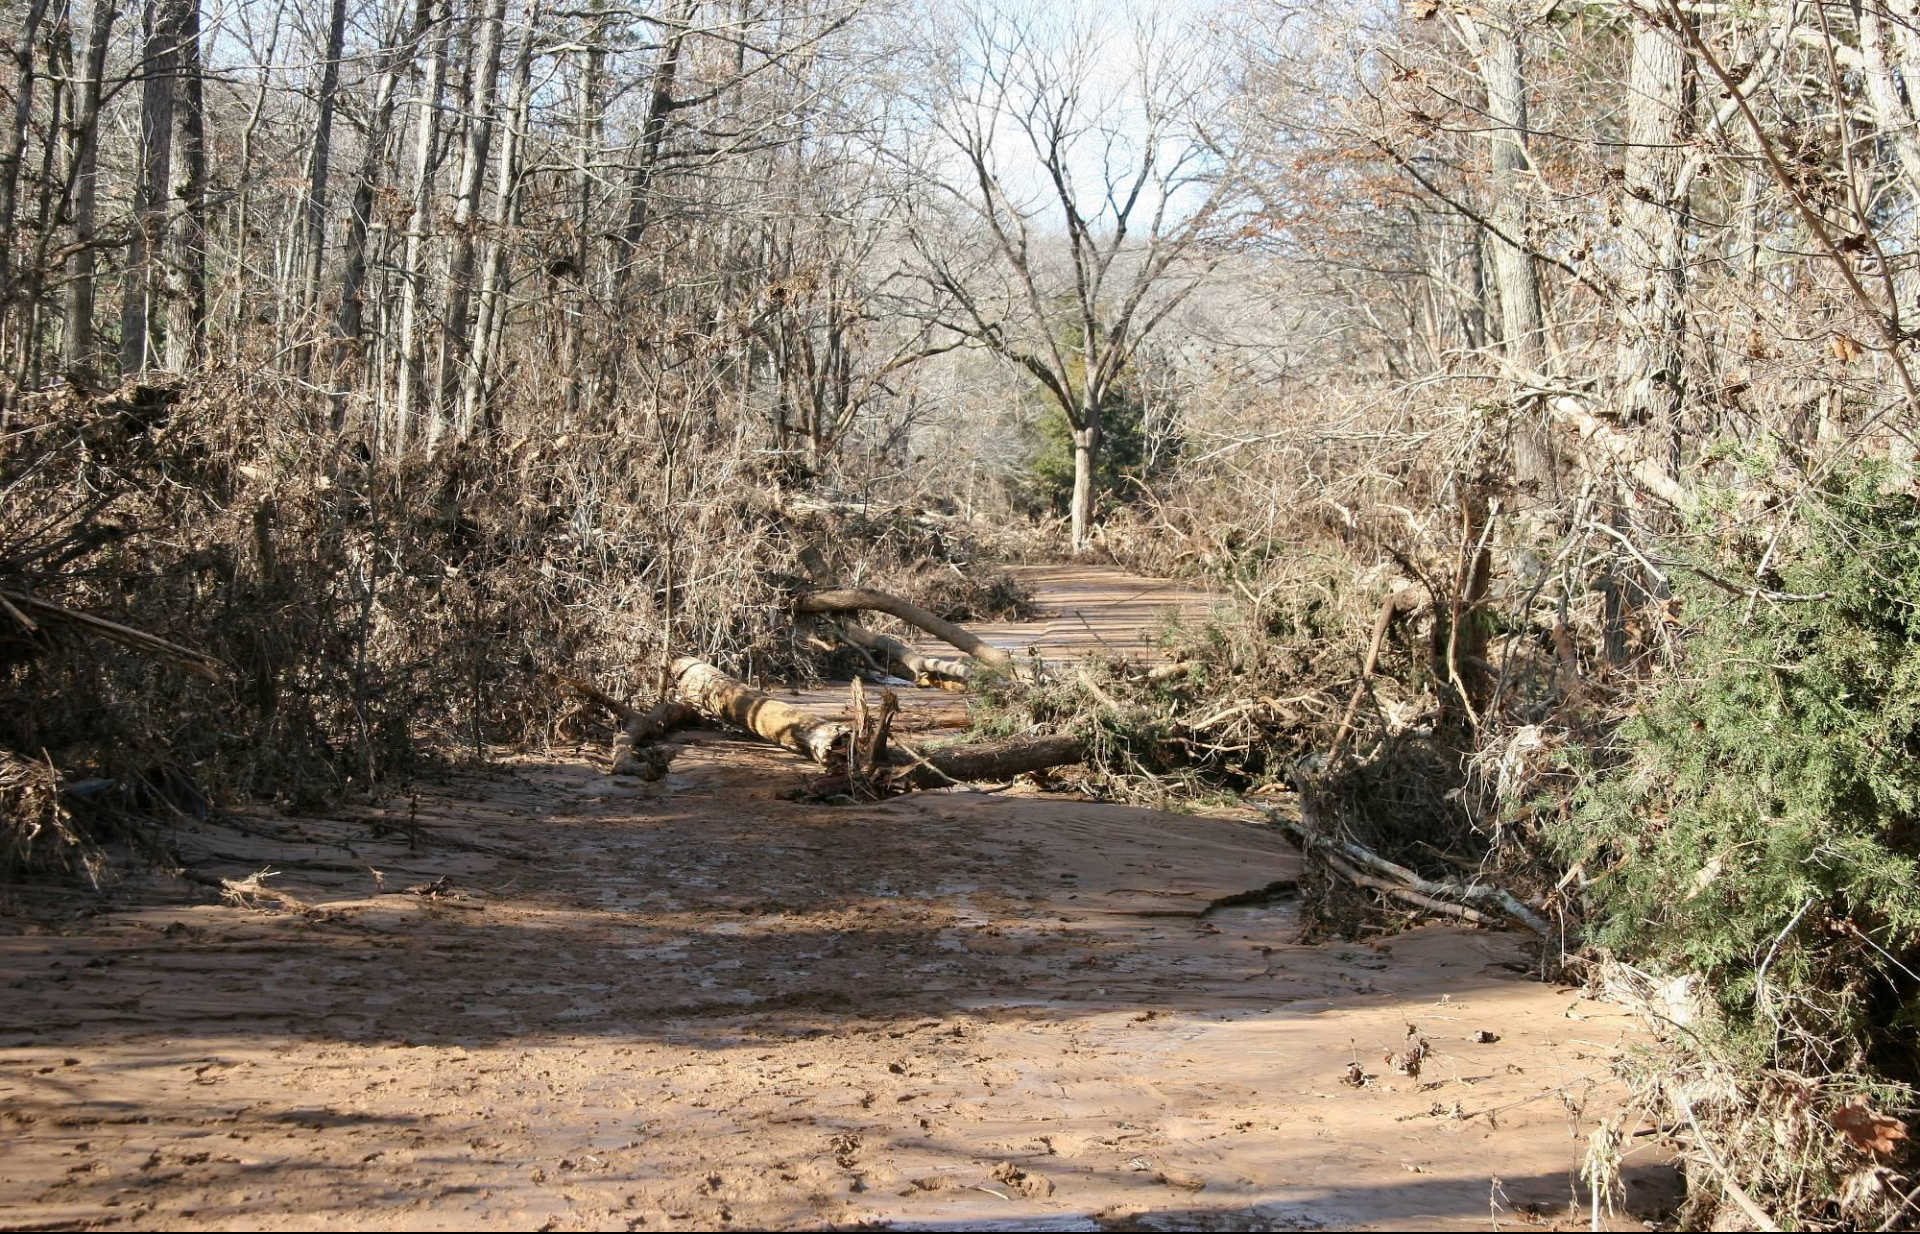
The trail leading to the shut-ins was covered by a thick layer of mud and other debris. The shut-ins below restricted the flow and slowed the waters in this portion of the park.

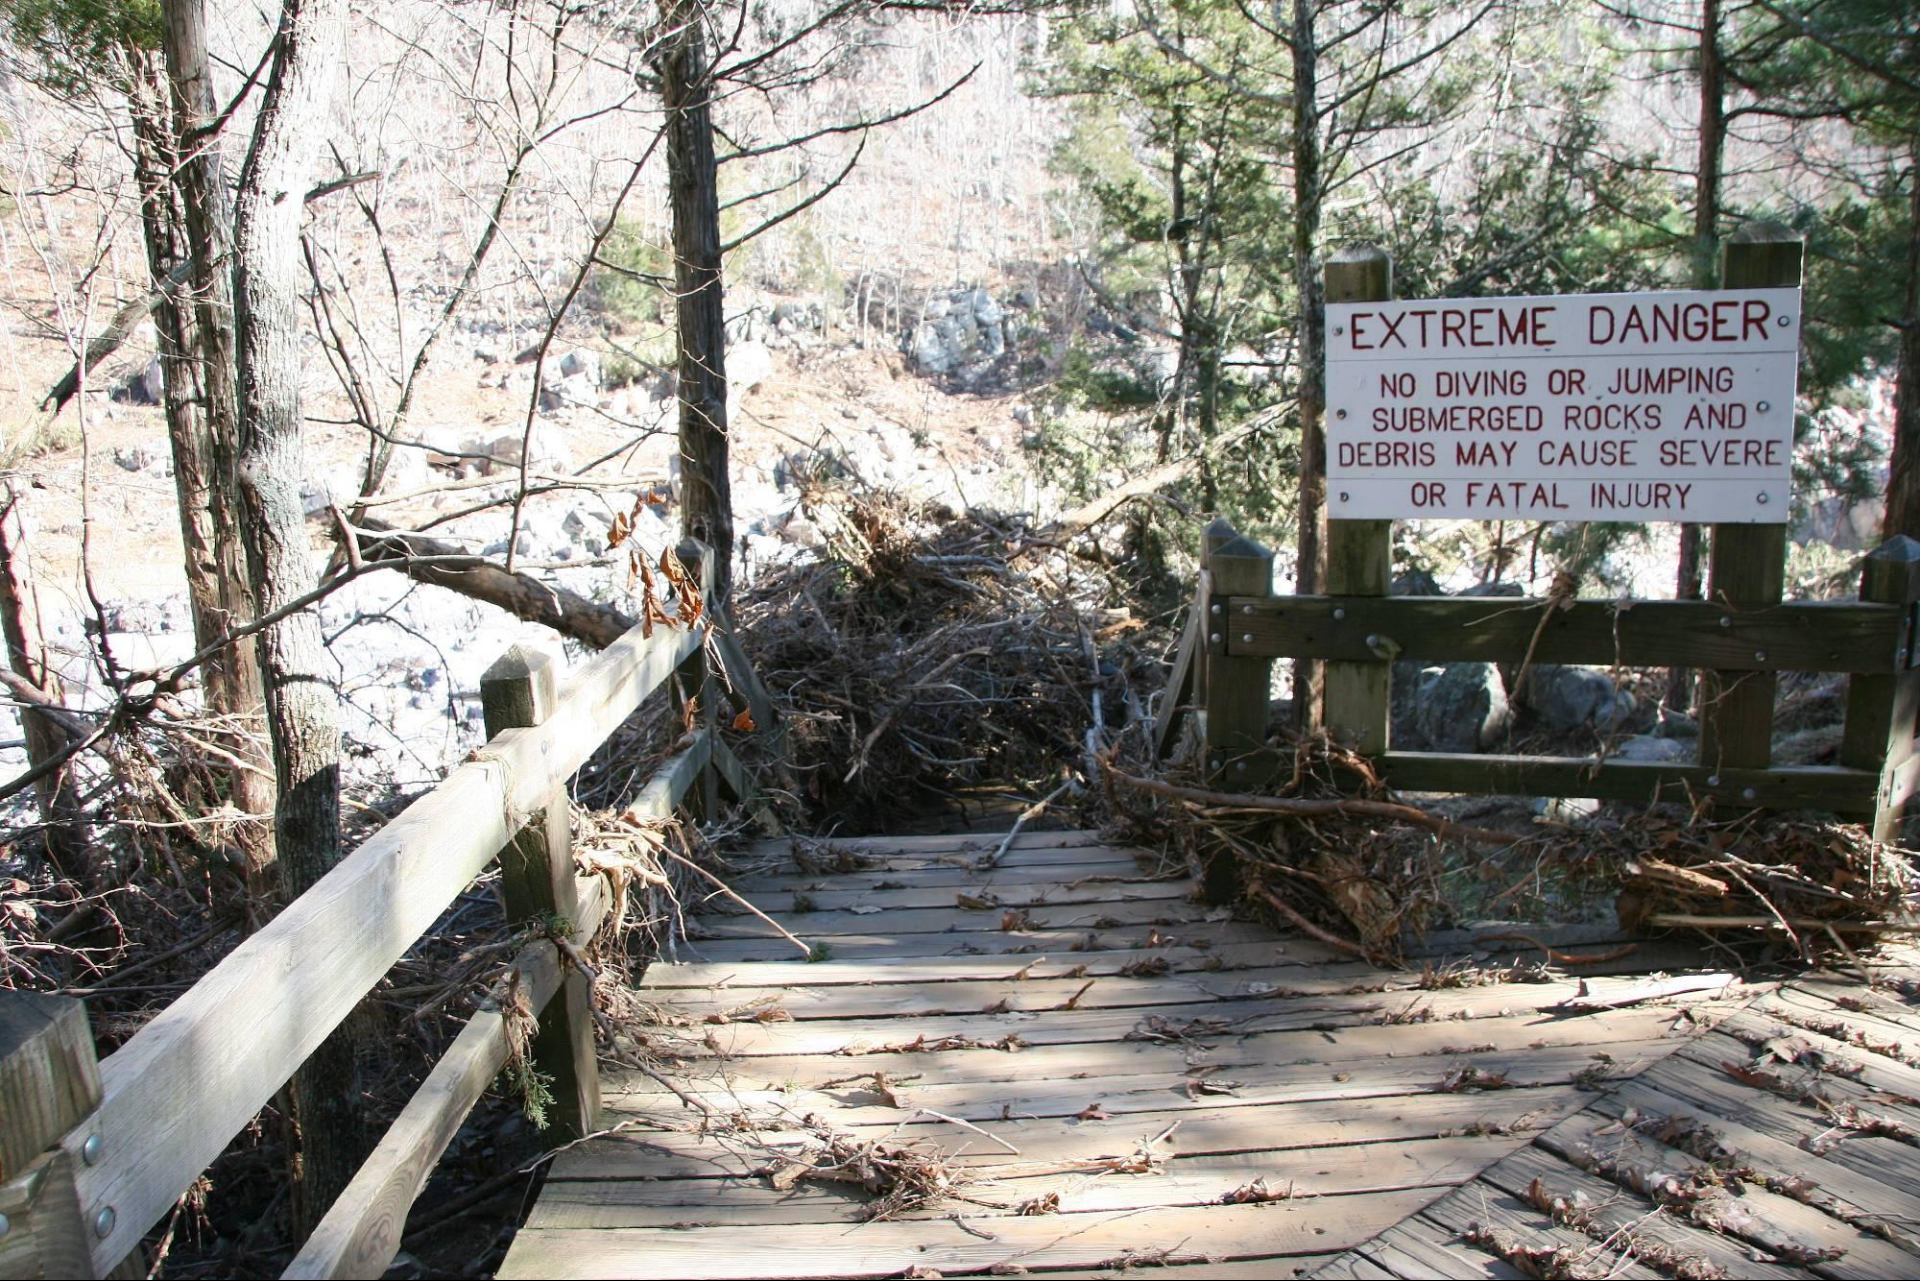
The boardwalks leading to the shut-ins were damaged and covered by debris.
