Overview and History of the Taum Sauk Pumped Storage Project Reynolds County, Missouri

**J. David Rogers, Conor Watkins, and
David J. Hoffman**

Missouri University of Science and Technology – Rolla, MO

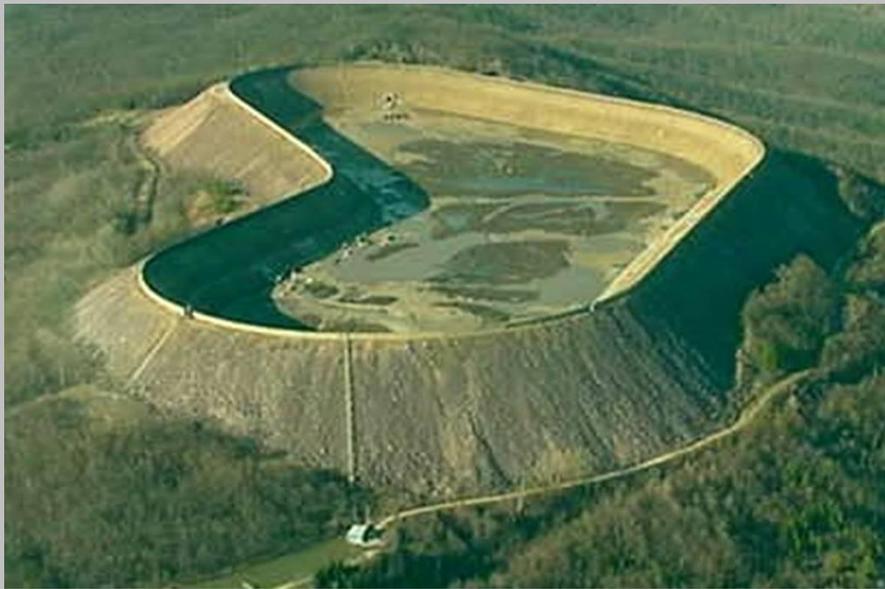
**DIFFERENTIAL
SETTLEMENT
OF THE
RING DIKE**

Settlement of the rockfill embankment during first five years of operation

- The Taum Sauk embankment settled 0.50 to 0.8 ft in the first 4-1/2 years; between 0.53% and 0.73% of the embankment height.
- In 1967, J. Barry Cooke noted that the observed settlements were without precedent for a rockfill embankment, concluding that *“frequent zones of soft weathered rock”... “could not have been selectively wasted”* and that *“I believe that a fill of 100% competent rock would have stabilized and that the percentage of weathered rock in the Taum Sauk is the cause.”*
- According to Cooke’s 1967 review, the average settlement of 0.1 ft/year during the first 4-1/2 years was unexpectedly high and without precedent (10x higher than any other project).

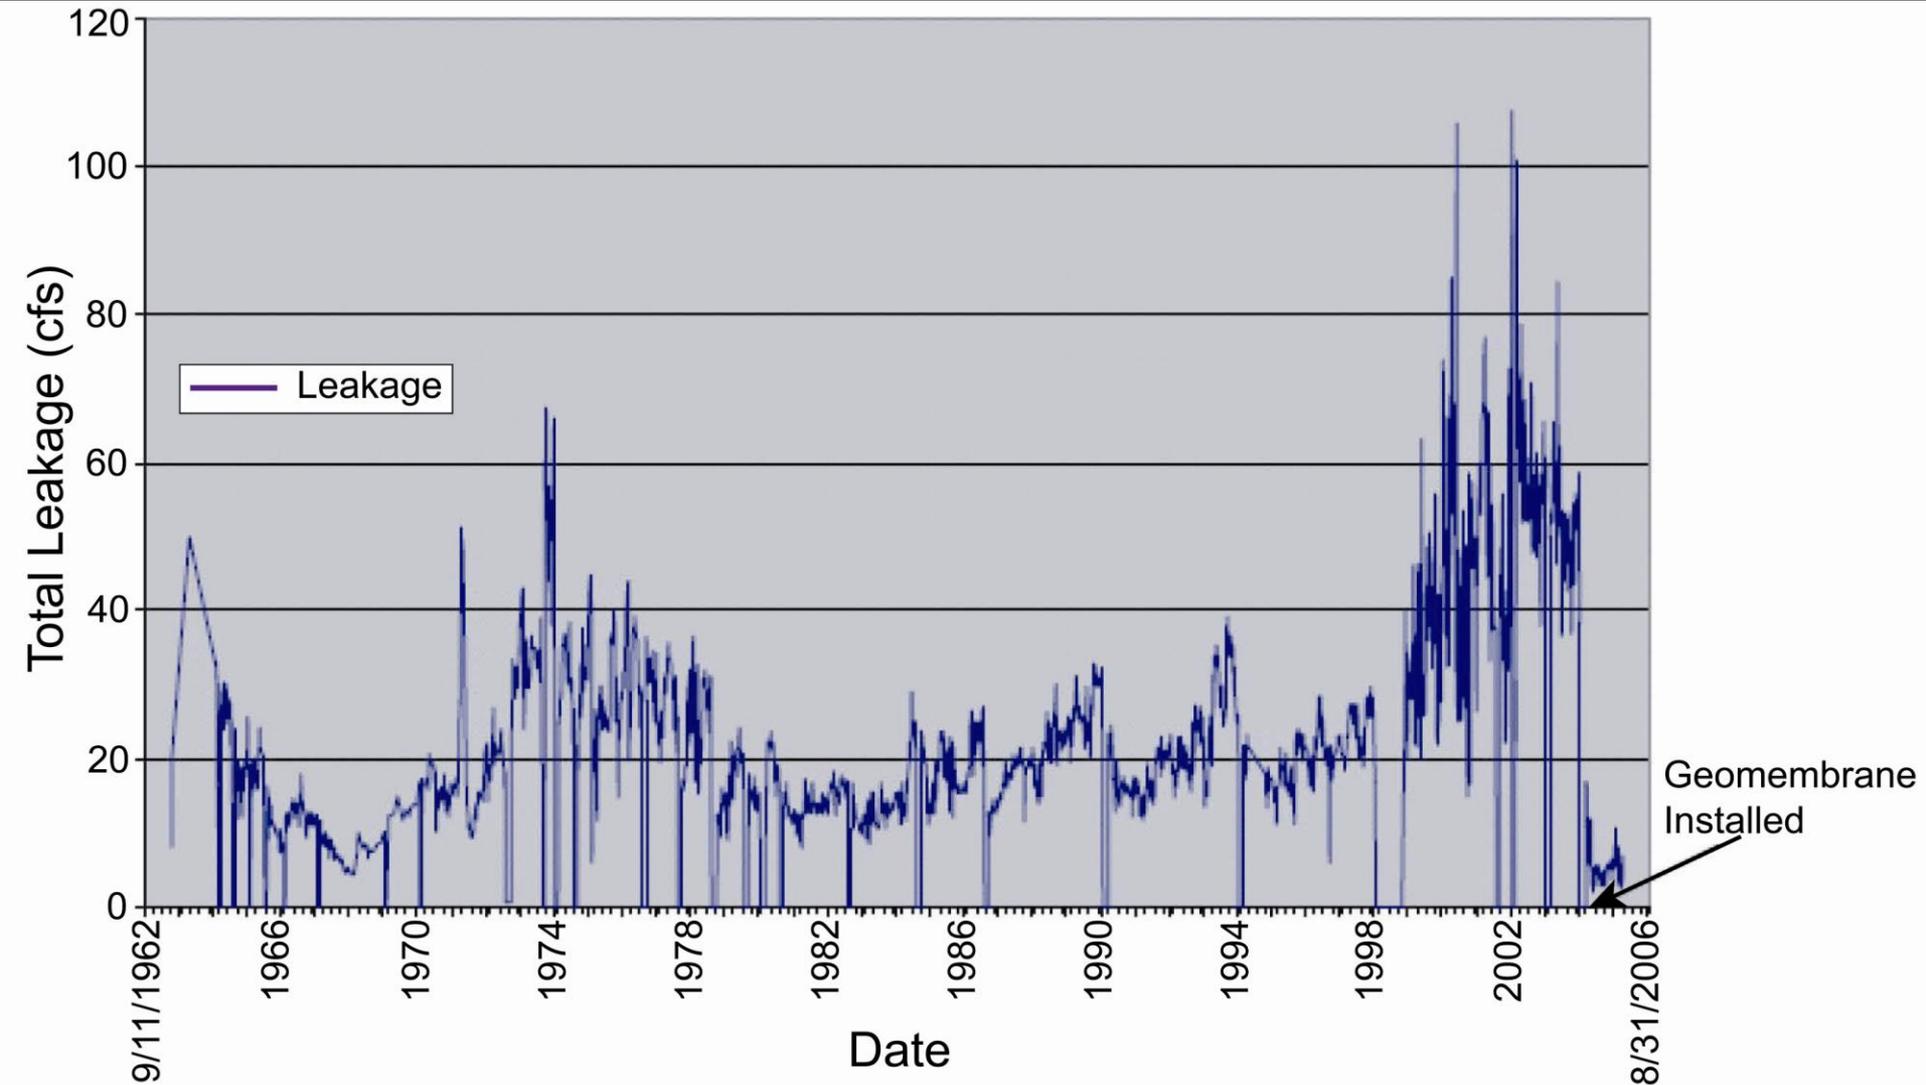
Leakage Rates Increased Throughout Project Life

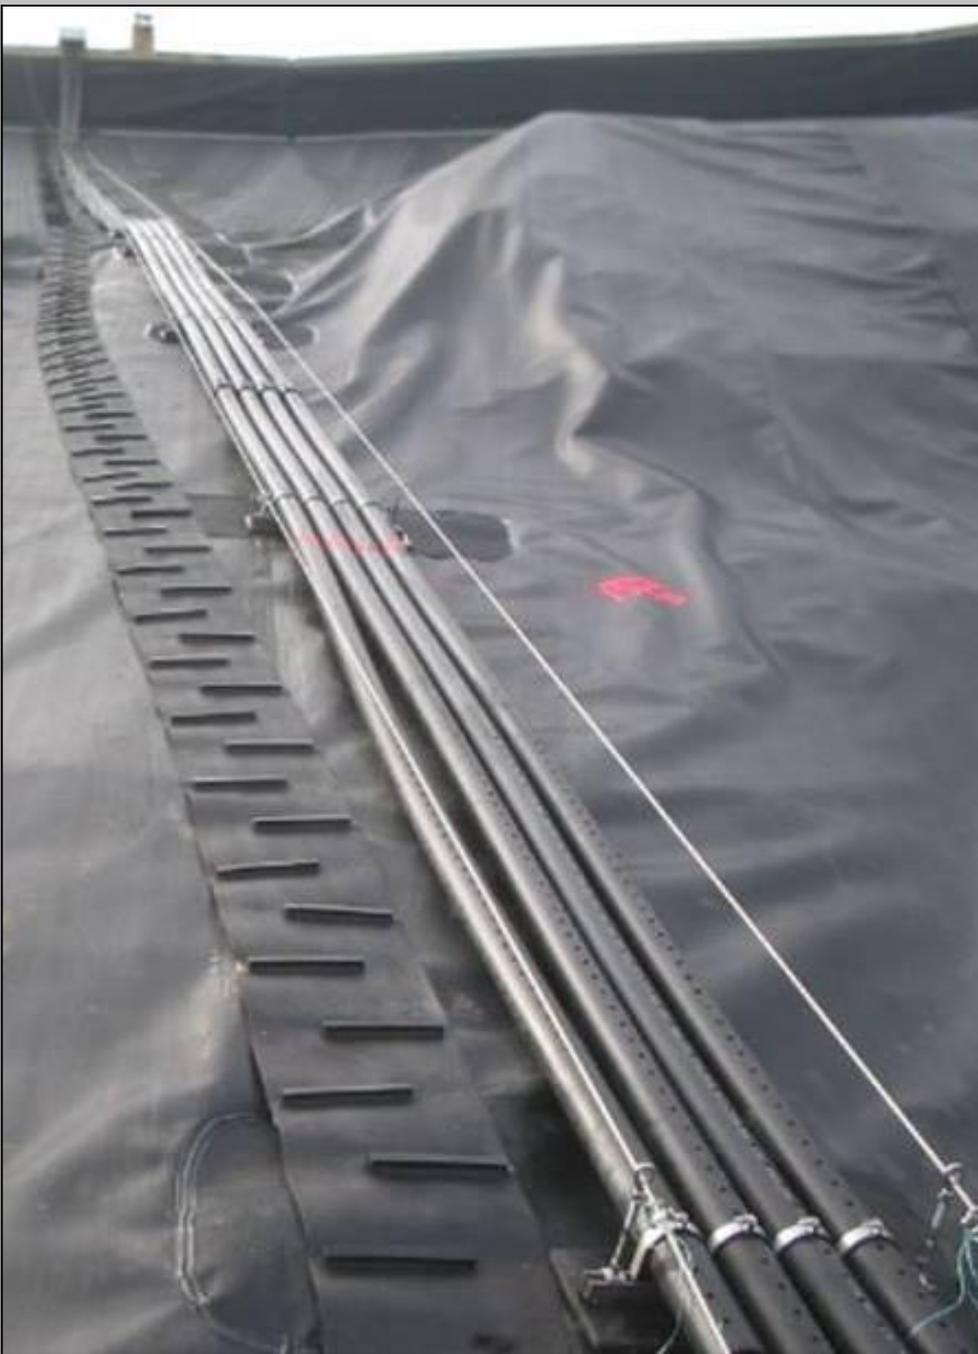
**CHANGES TO
RESERVOIR STAGE
SENSOR SYSTEM
DURING 2004
LINING/UPGRADE**

- The sensor network was comprised of 4 perforated HDPE conduits; two were to hold pressure transducers, one was an extra, and one was to be filled with concrete as ballast. This was to be anchored to the liner using welded HDPE straps.
- The liner contractor pointed out that this design would reduce the performance and life of the liner and changes should be made.

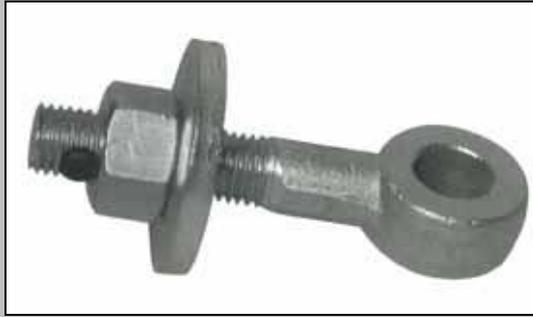
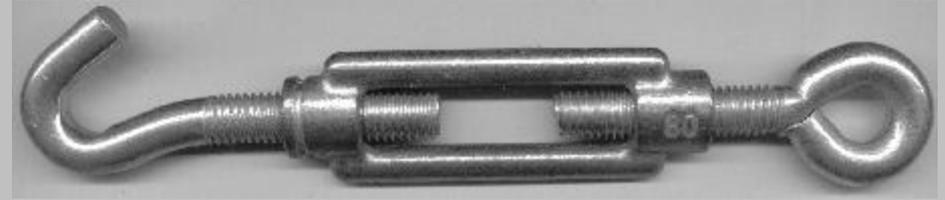
- **An untensioned steel cable was to be anchored to the top and bottom portions of the concrete lining with eye bolts, like that shown left above. The concrete ballast pipe was removed. Since a fourth pipe was already on site, it was installed as a spare, without anything inside.**
- **During placement, the eye bolts were discarded in favor of turnbuckles (right above), so the steel cable could be tensioned.**
 - 1. The turnbuckles loosened during cyclic loading caused by the filling and emptying to the reservoir, allowing the tubes to work themselves free.**
 - 2. The omission of a ballast pipe allowed the sensor tubes to move and deflect much more easily.**
- **These attachment details were not subjected to external peer review. Last minute connection details often prove to be problematic.**

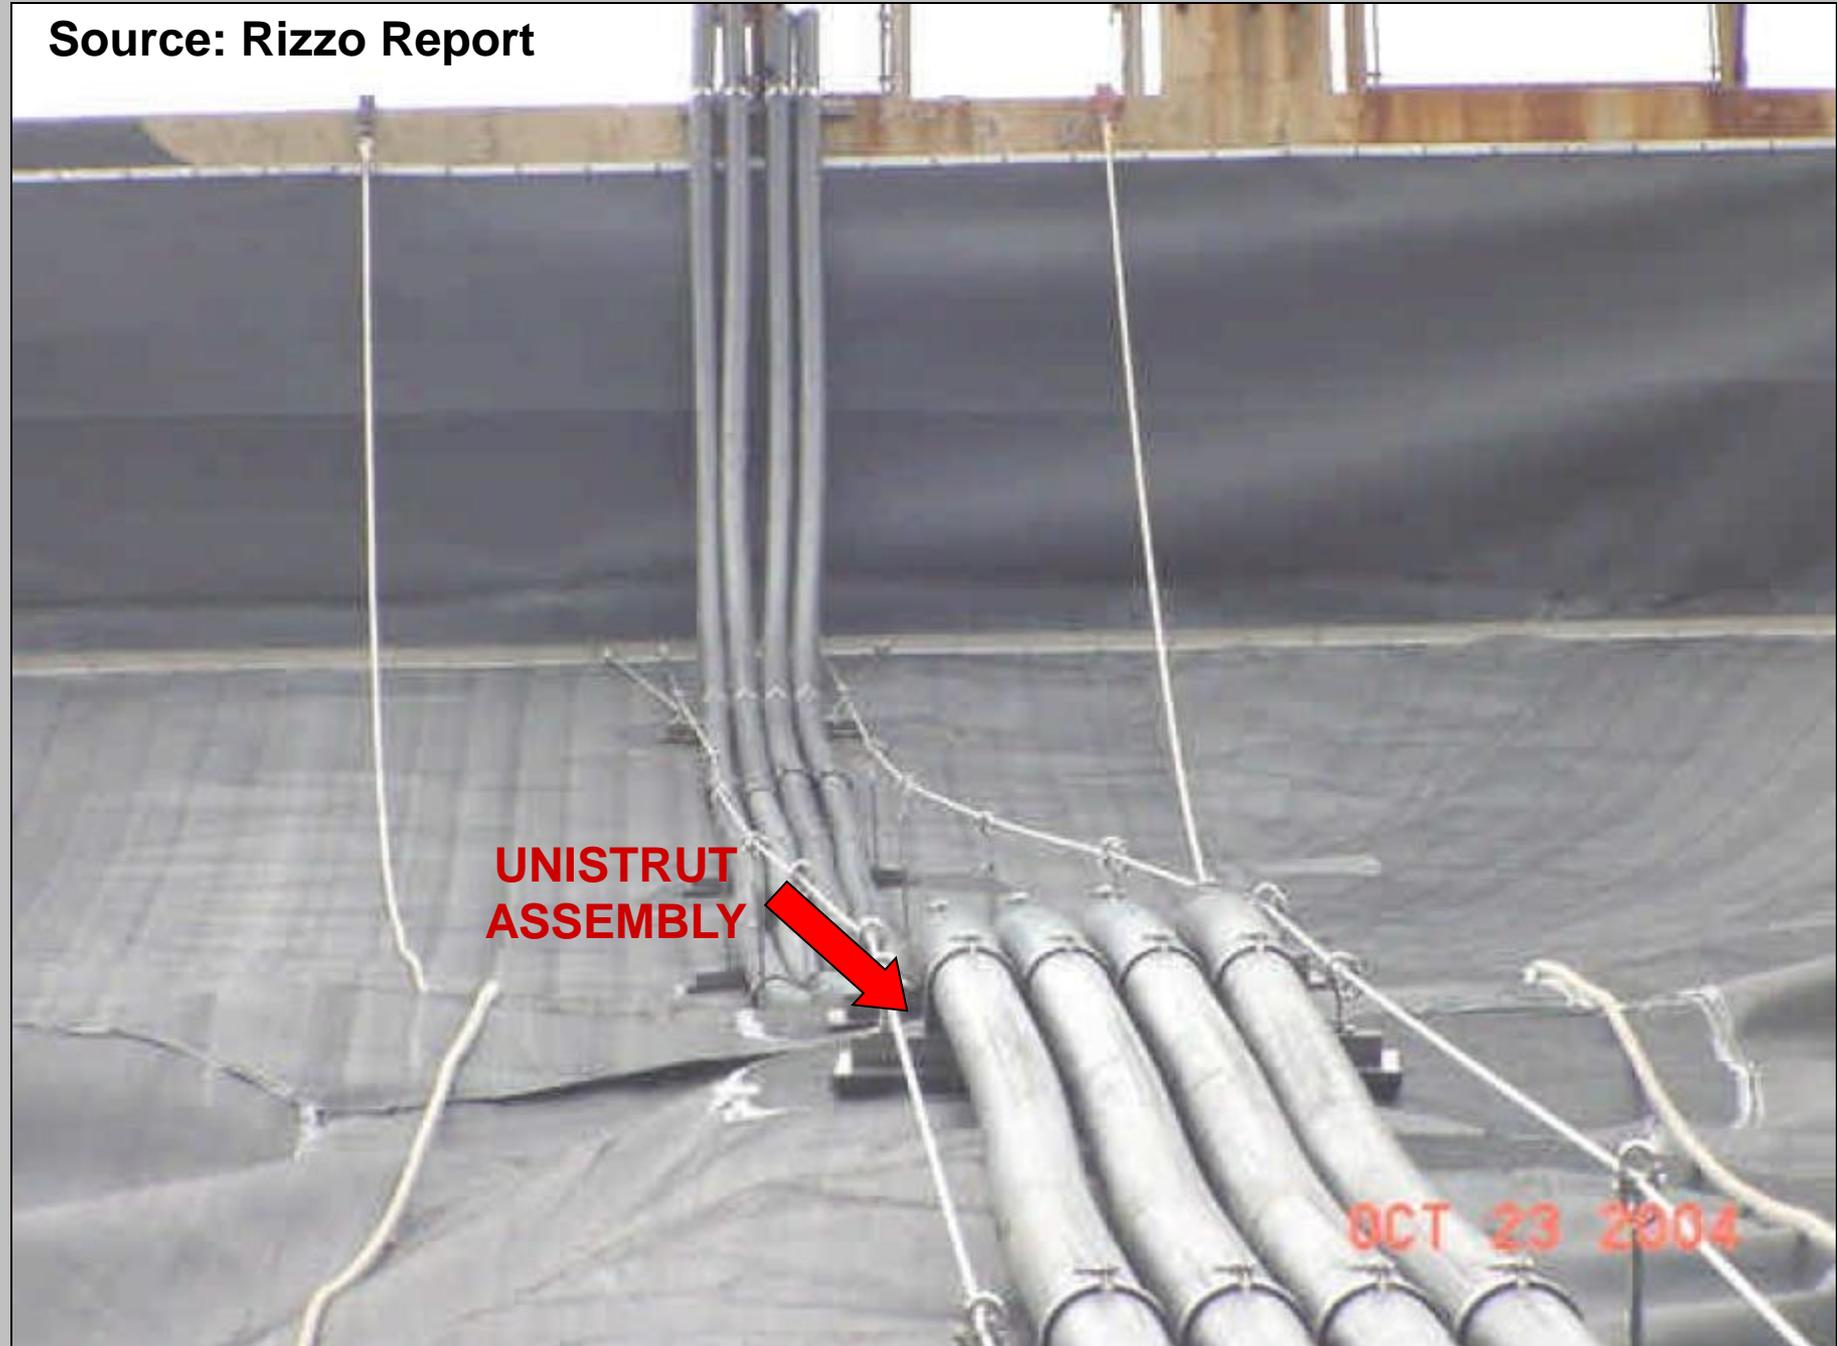
Sensor conduits as constructed at Taum Sauk Upper Reservoir in 2004

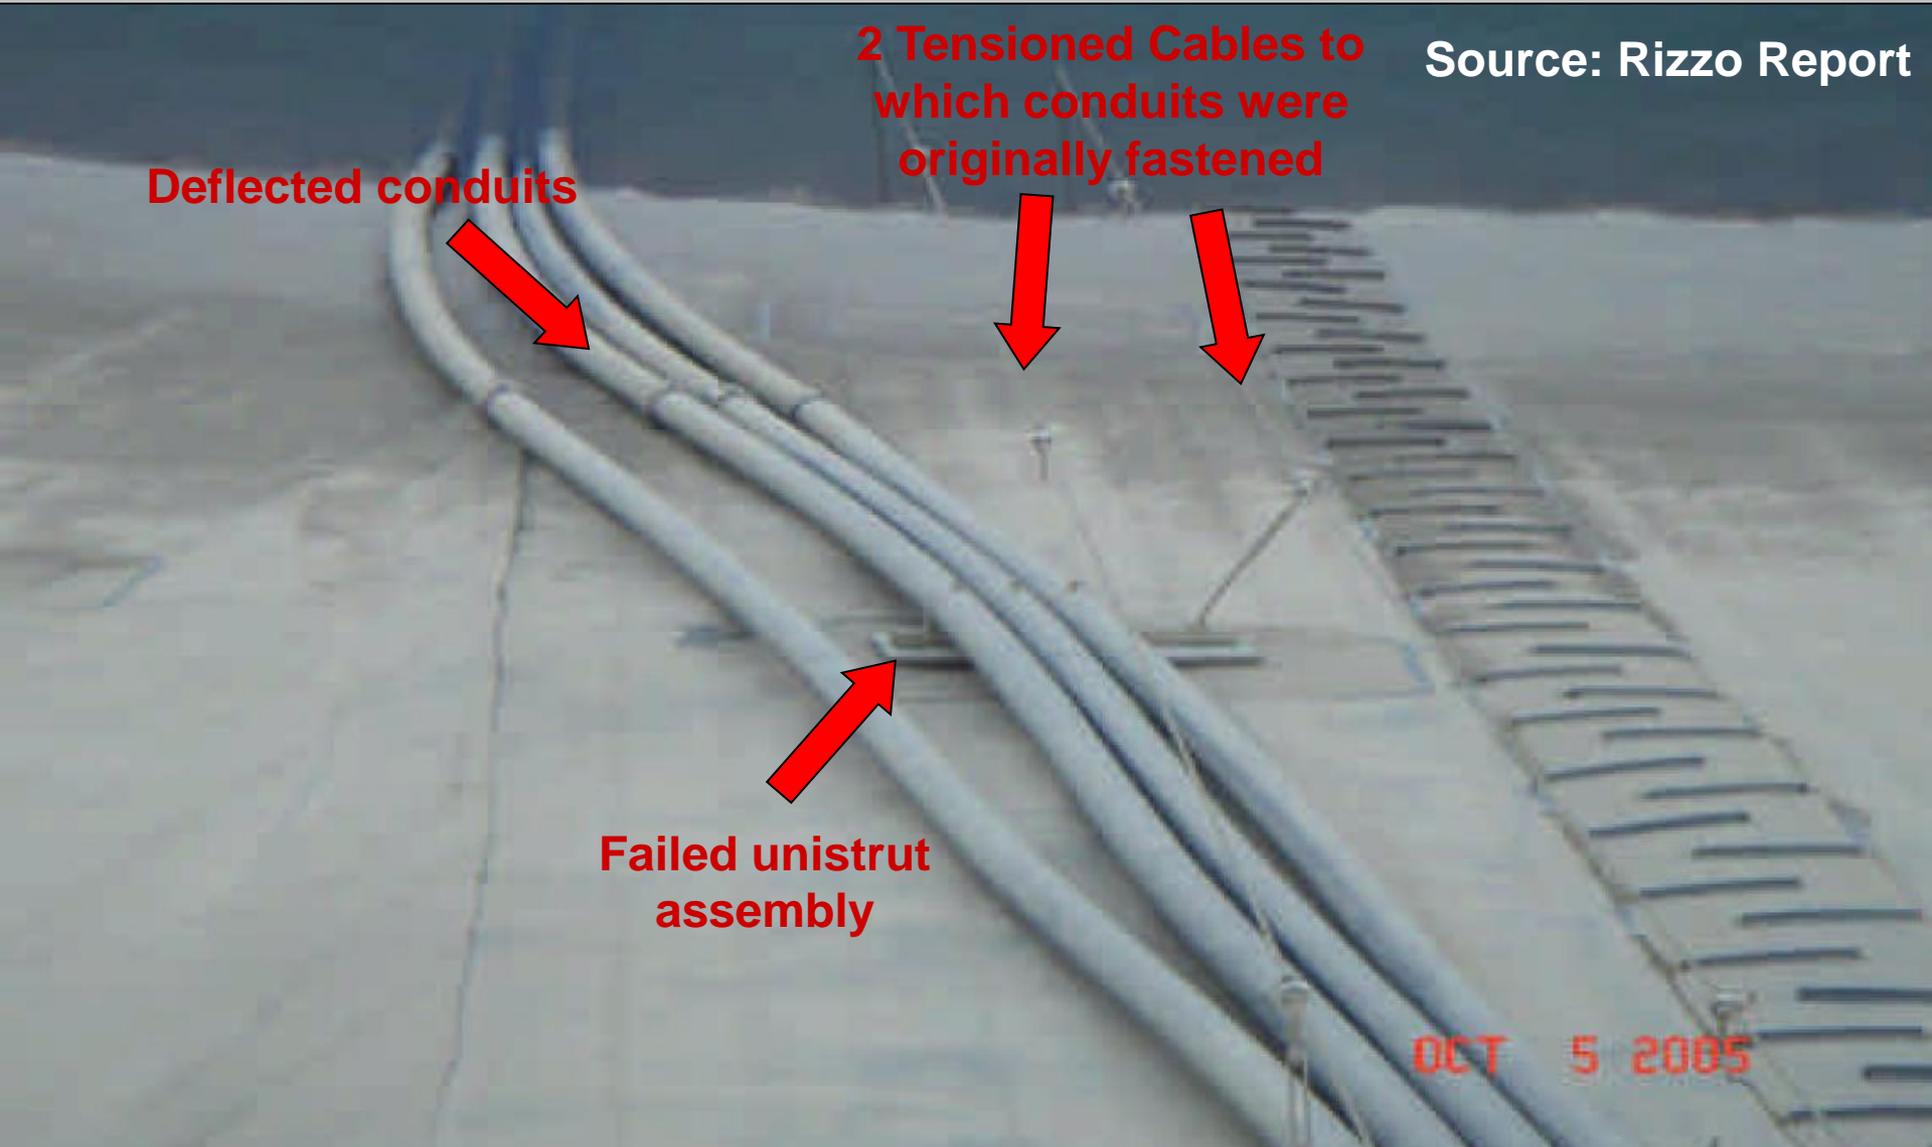
FAILED UNISTRUT ASSEMBLY AND DEFLECTED SENSOR CONDUITS

Deflected conduits

2 Tensioned Cables to
which conduits were
originally fastened

Failed unistrut
assembly

- Divers were called in and determined that the sensors were loose at the bottom of the reservoir. Maximum water levels in the reservoir were reduced by 3 feet to provide a margin of error. Permanent repairs would be postponed until other regular scheduled maintenance to avoid an additional shutdown of the facility.
