PANAMA CANAL: THE WORLD'S LANDSLIDE LABORATORY

J. David Rogers, Ph.D., P.E., P.G.

2007 Annual Meeting

Association of Environmental and Engineering Geologists

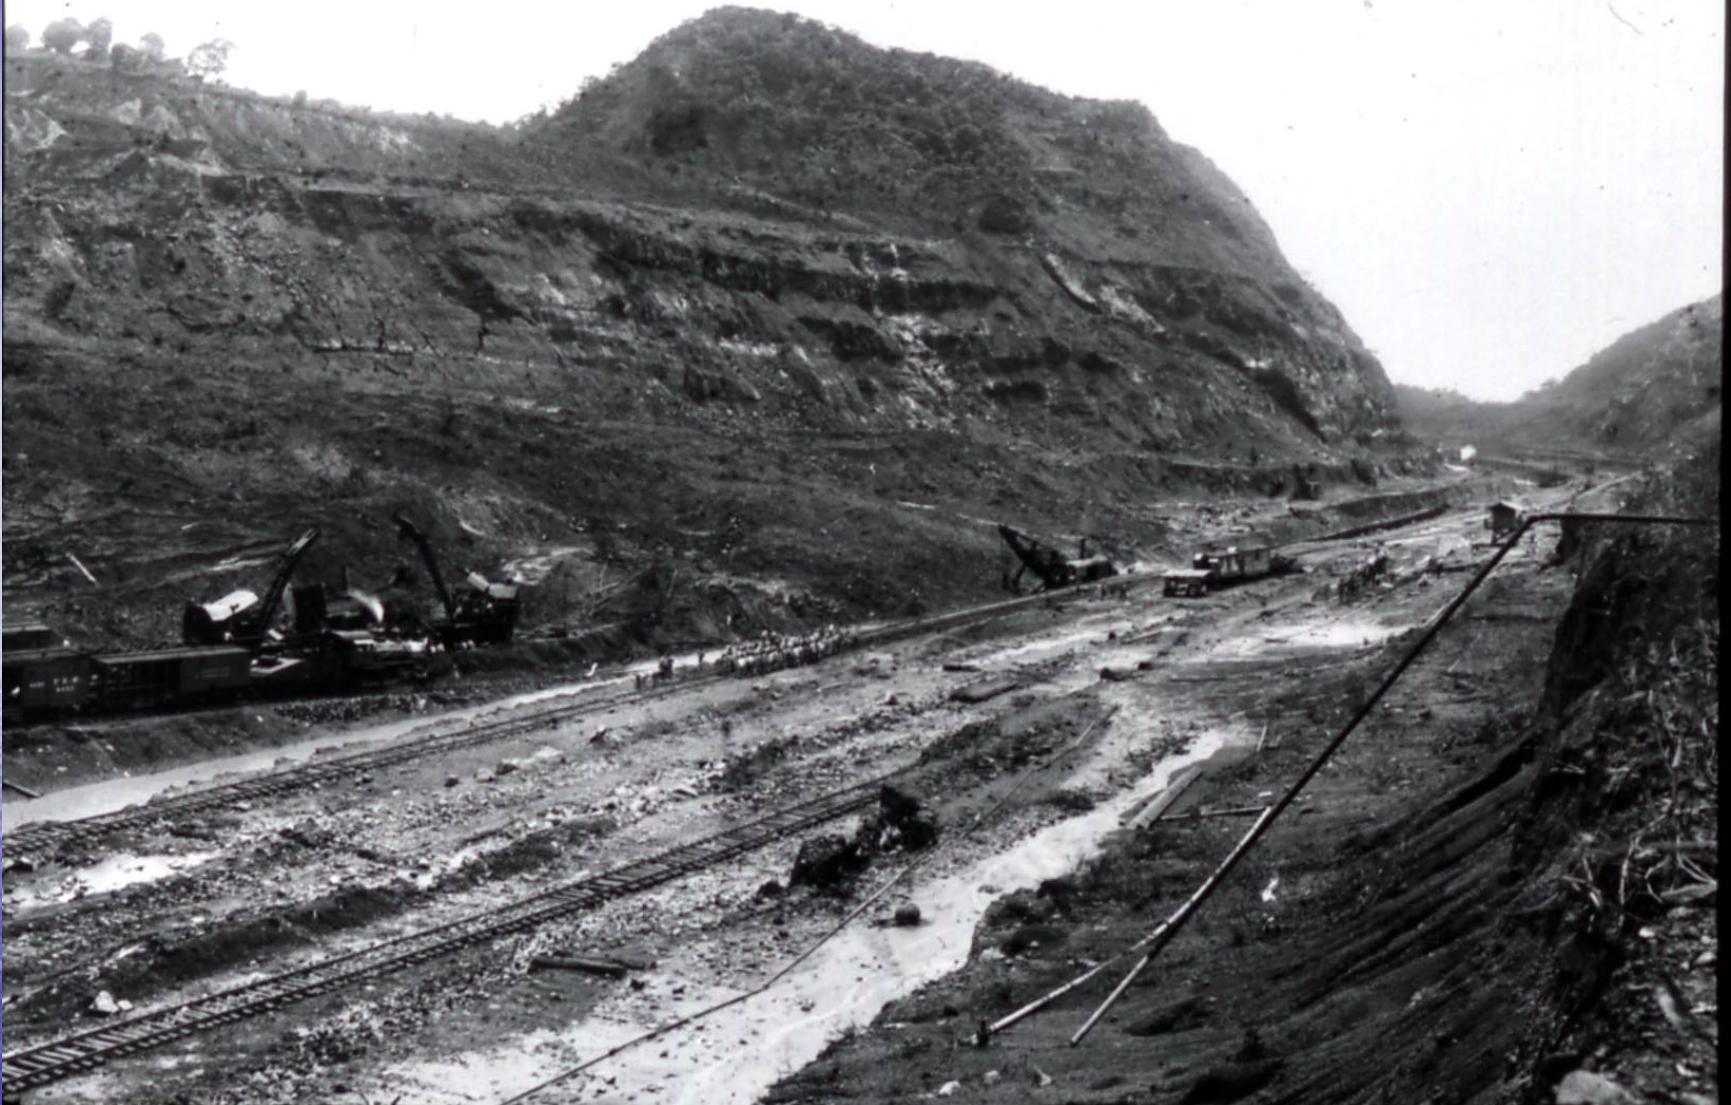
- As the excavation deepens, the side slopes started caving in on the main excavation. This shows the beginning of the East Culebra side

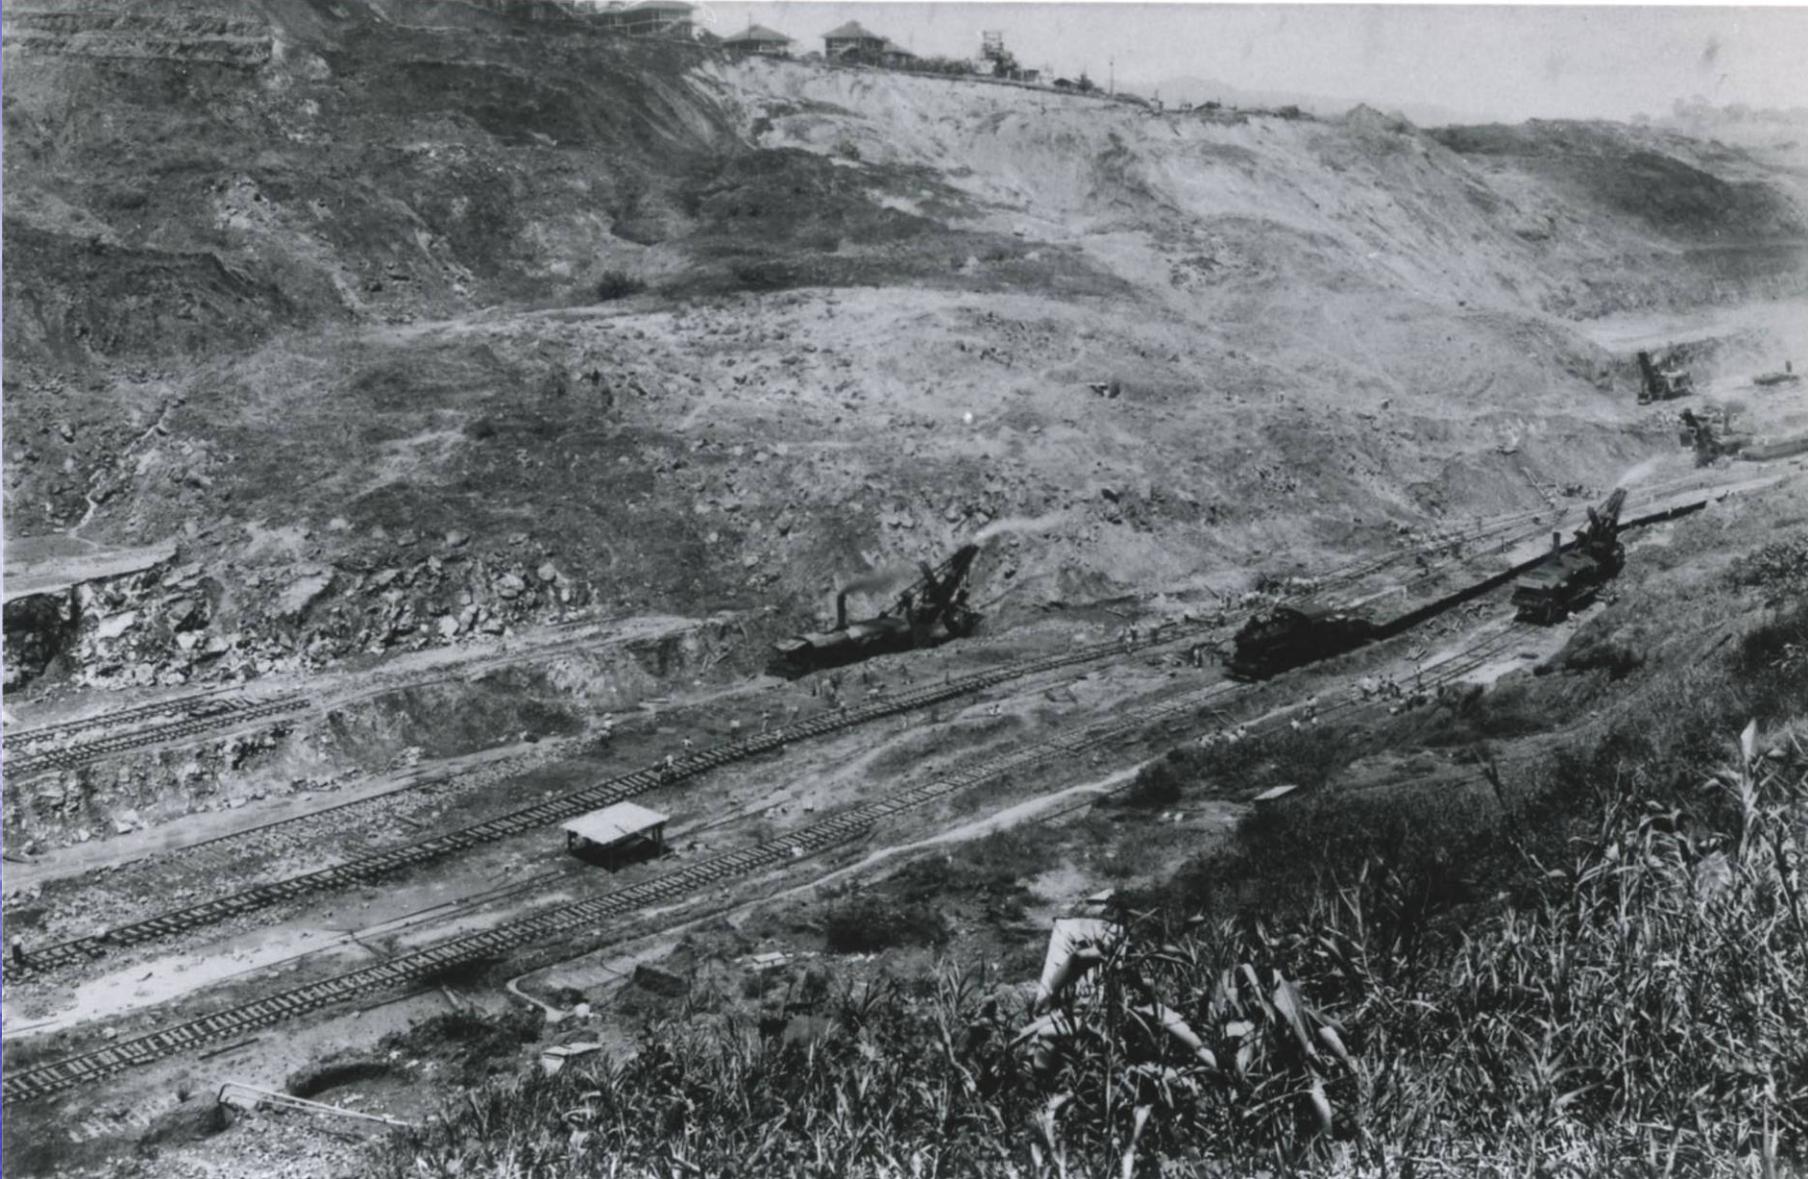
- Shovels begin attacking a similar problem, which they name the **West Culebra Slide**, on September 12, 1912

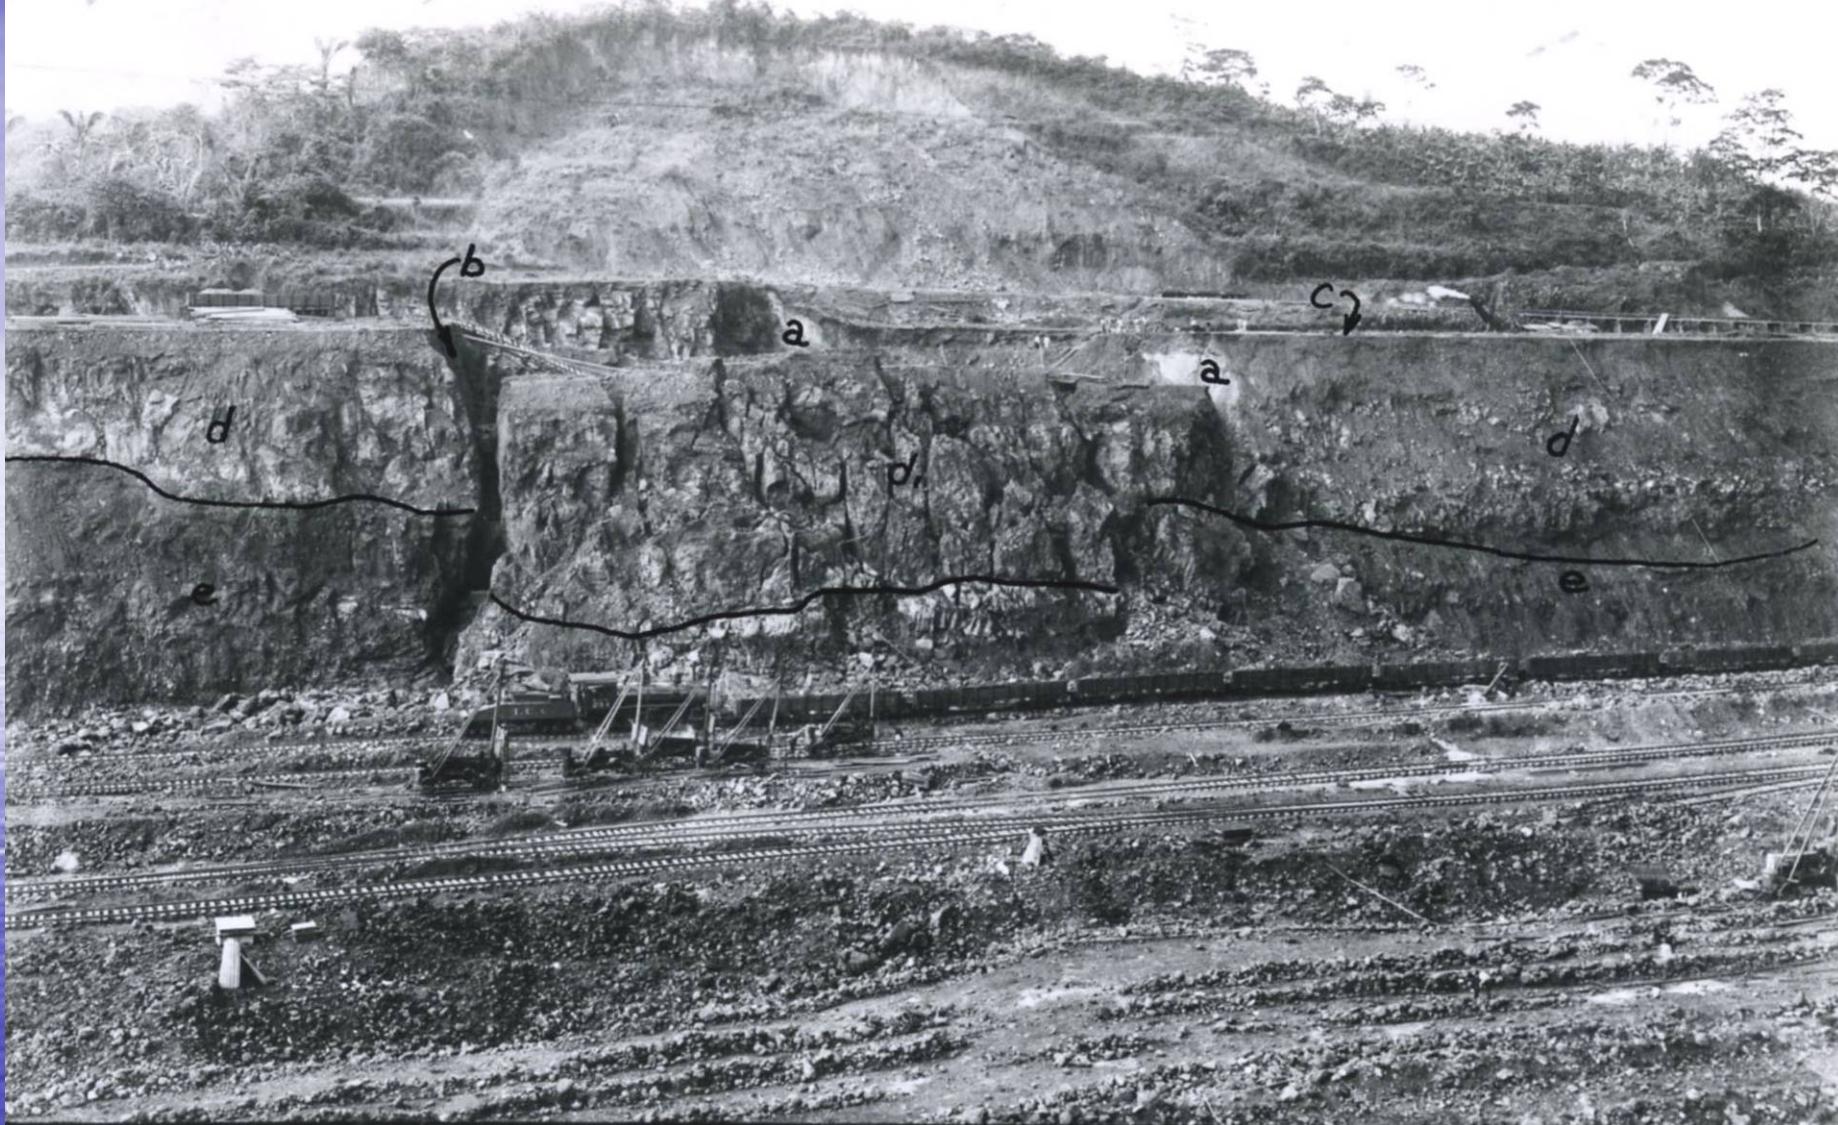
- Block glide day-lighting into canal excavation in May 1910. This is one of the earliest slides that was scientifically evaluated by Army Engineers.

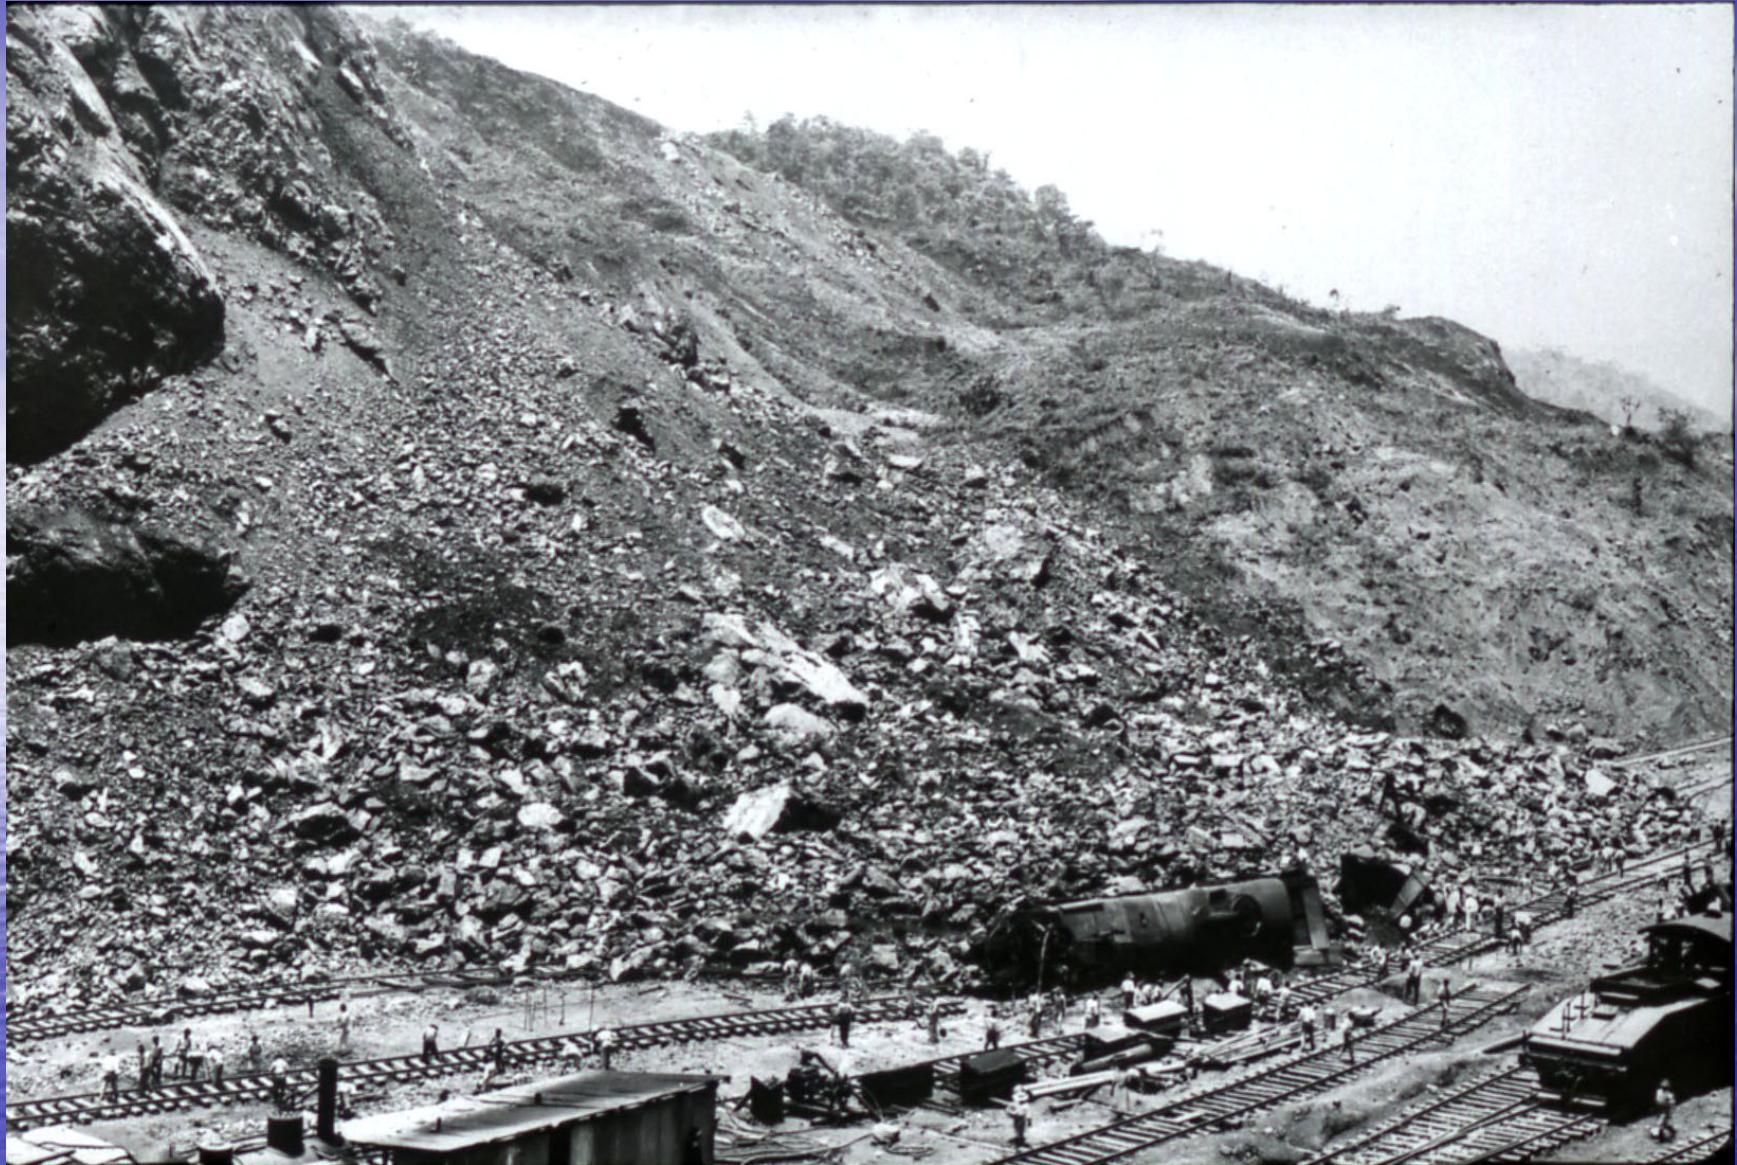
- One of the early landslides at Cucaracha, on the south side of Gold Hill, near the Continental Divide, on July 5, 1911.

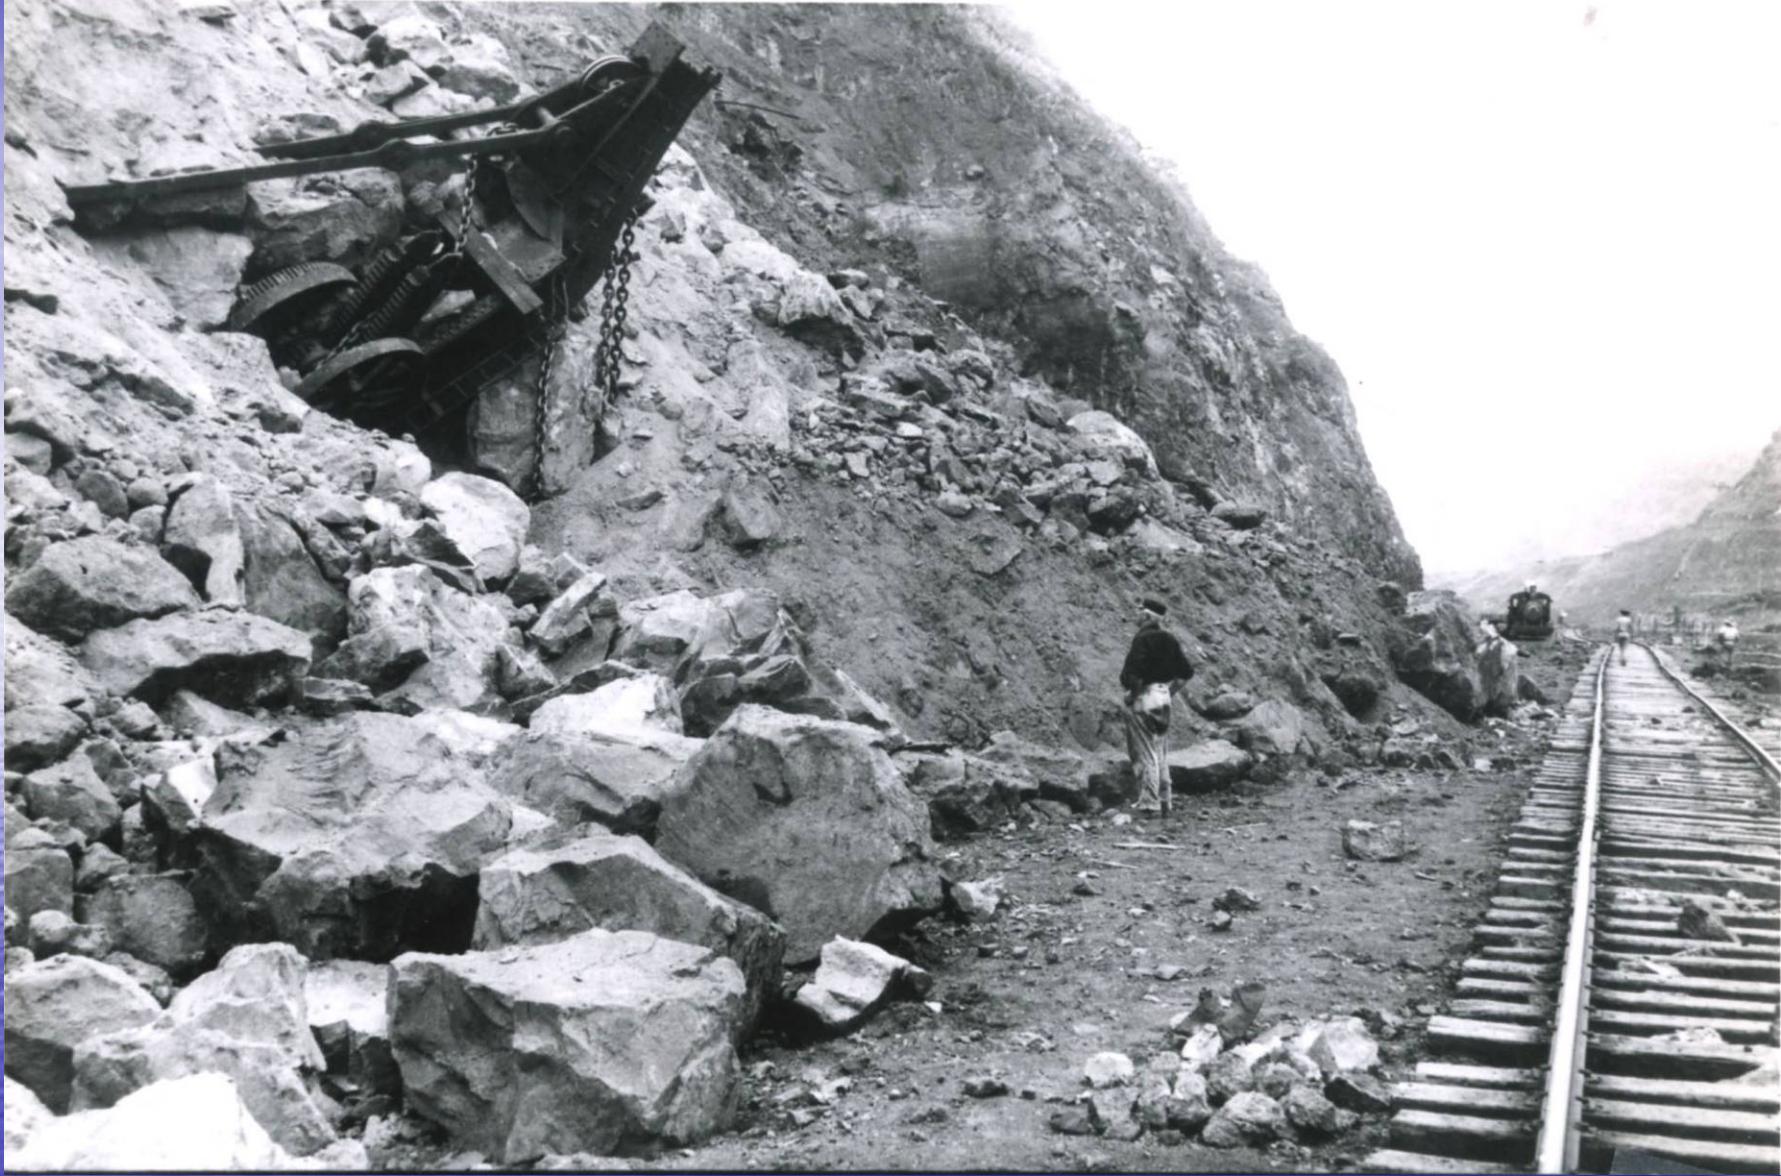
- Ground view of the same slide of July 5, 1911 at Cucaracha, showing buried steam shovel.

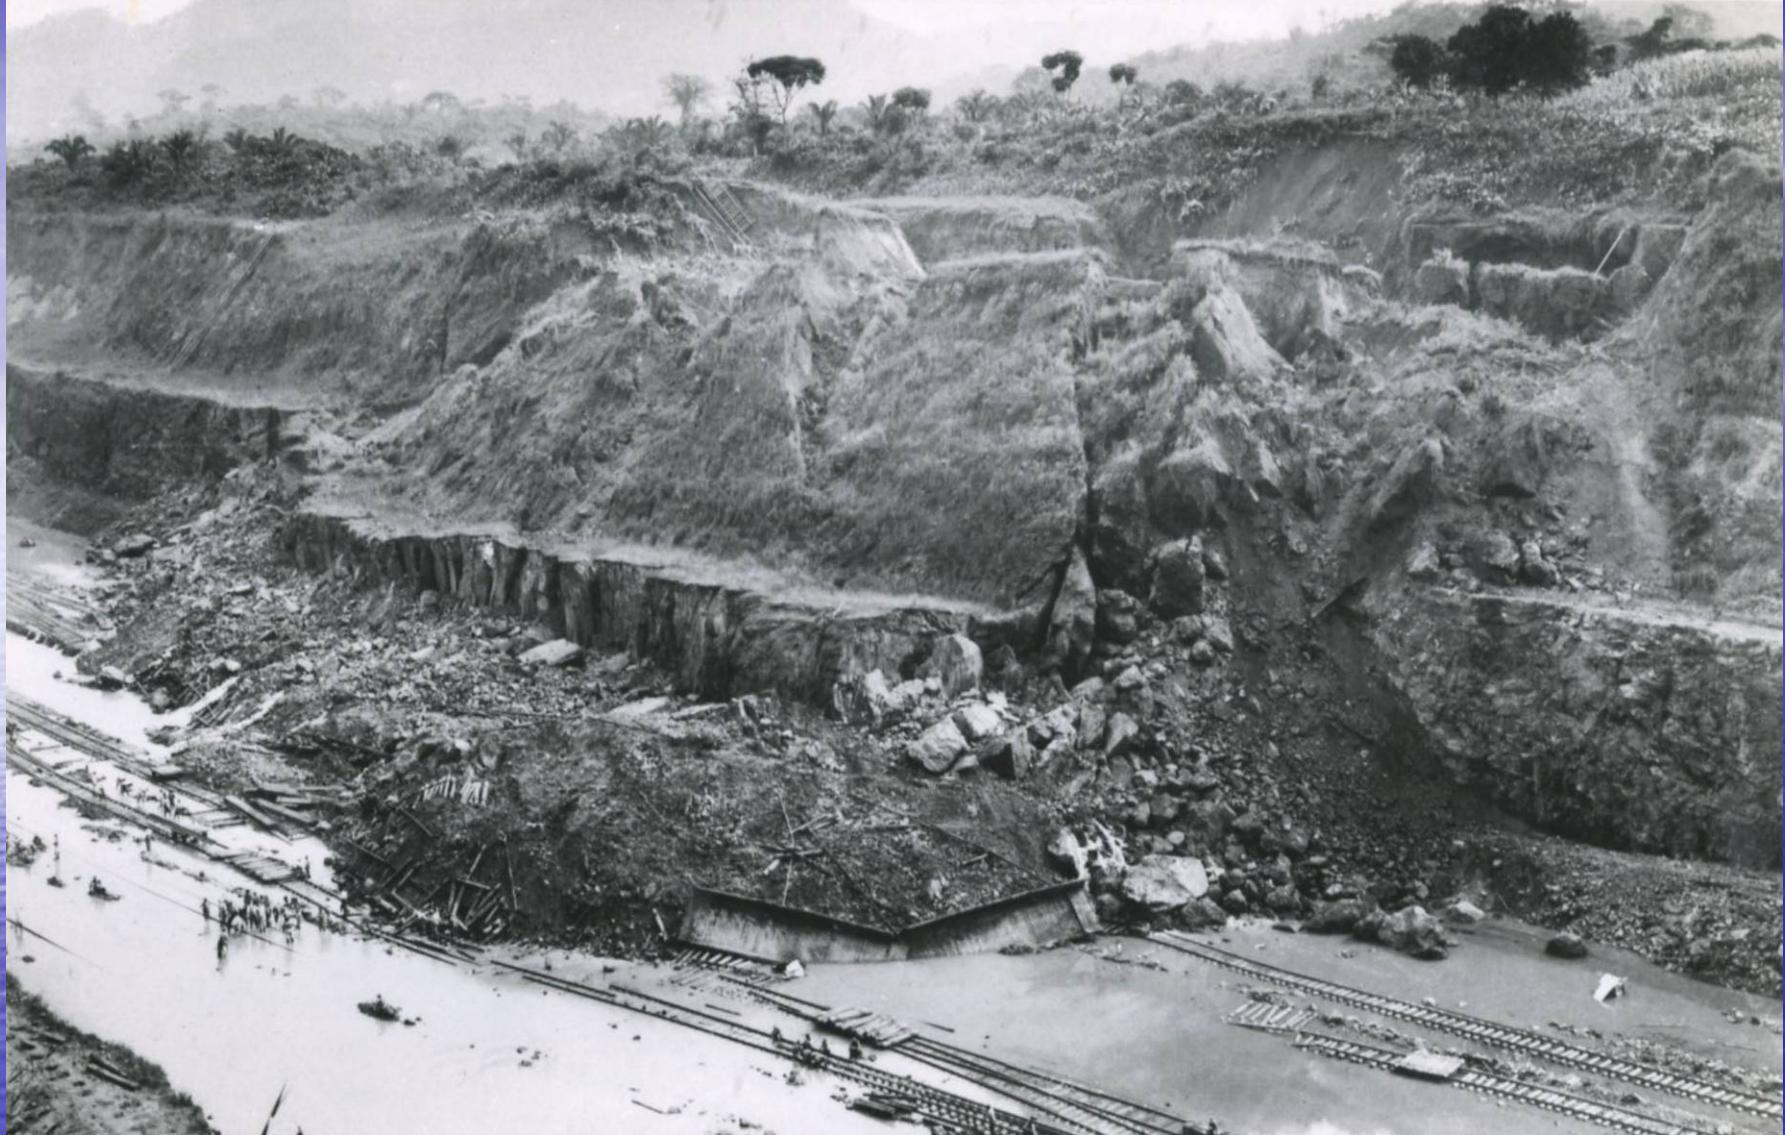
- Cut slope failure on the Obispo Division on August 21, 1912. Note ponded water.

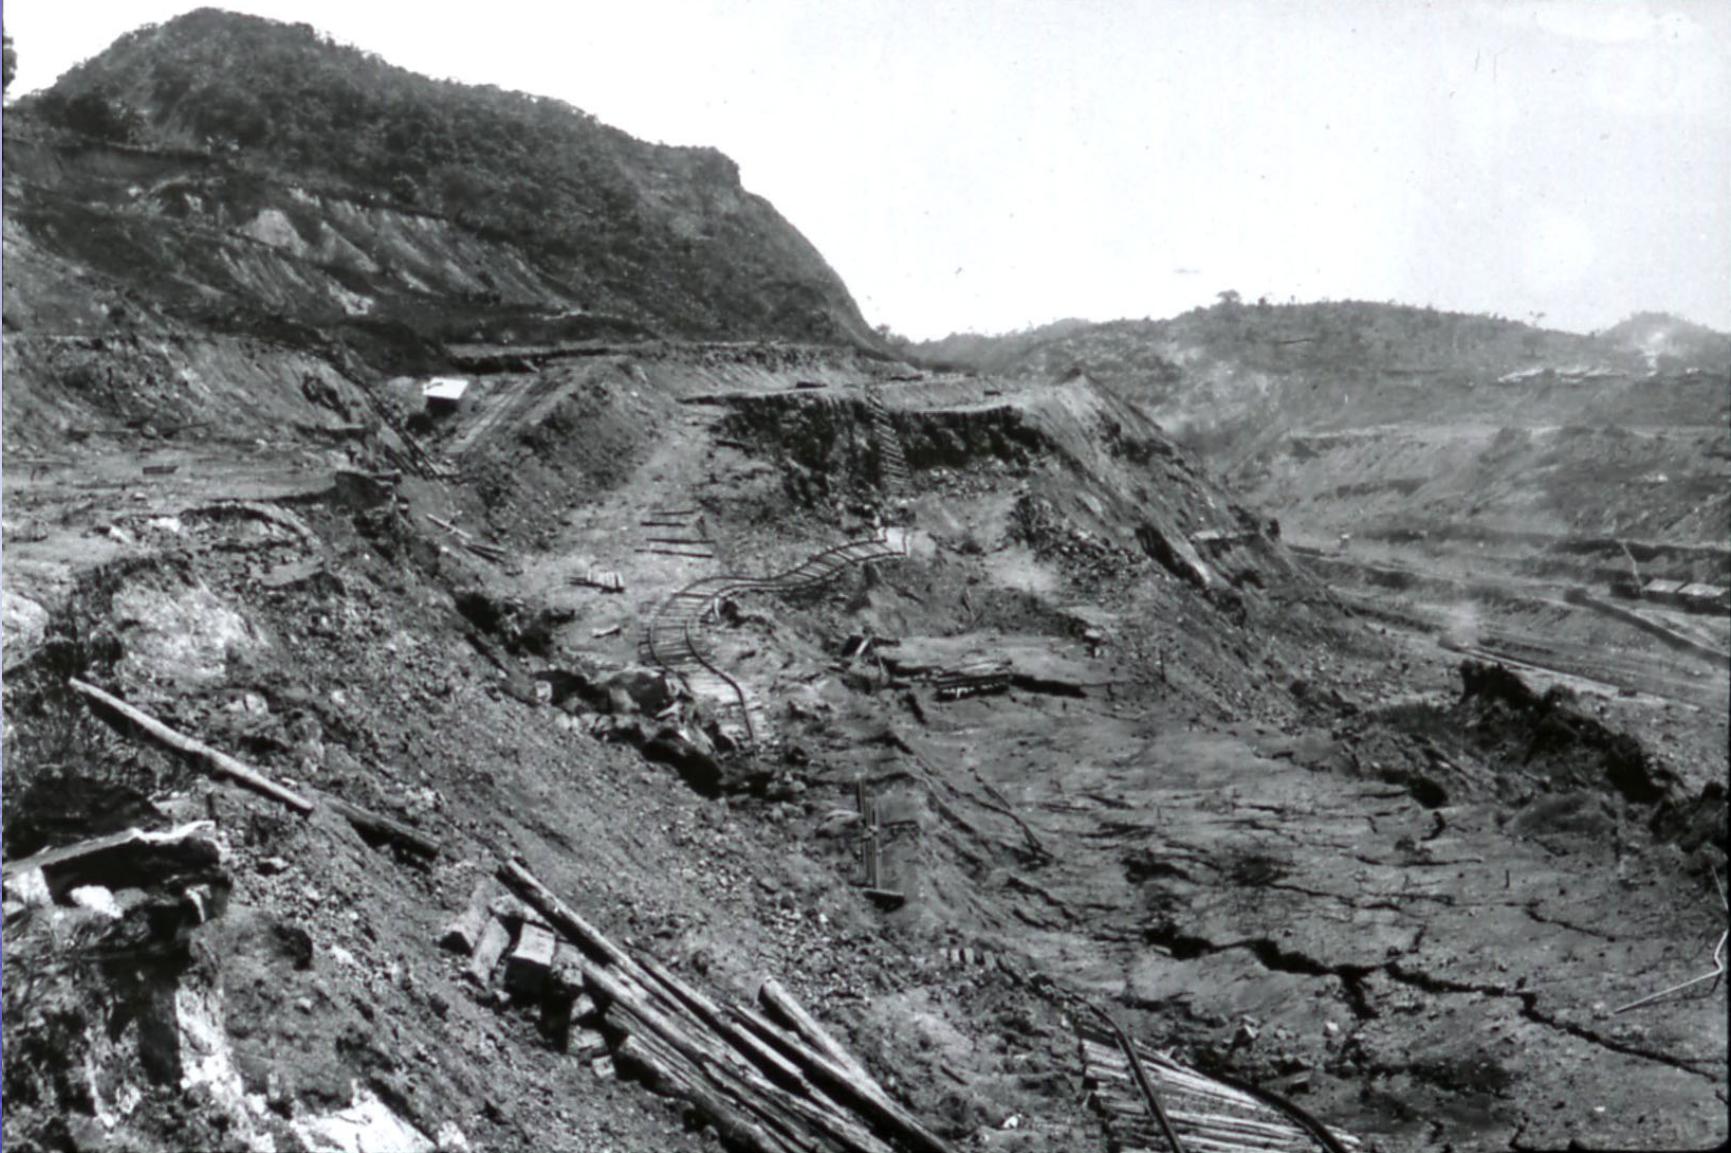
- Crown scarp of the East Culebra Slide on September 19, 1912, looking south.

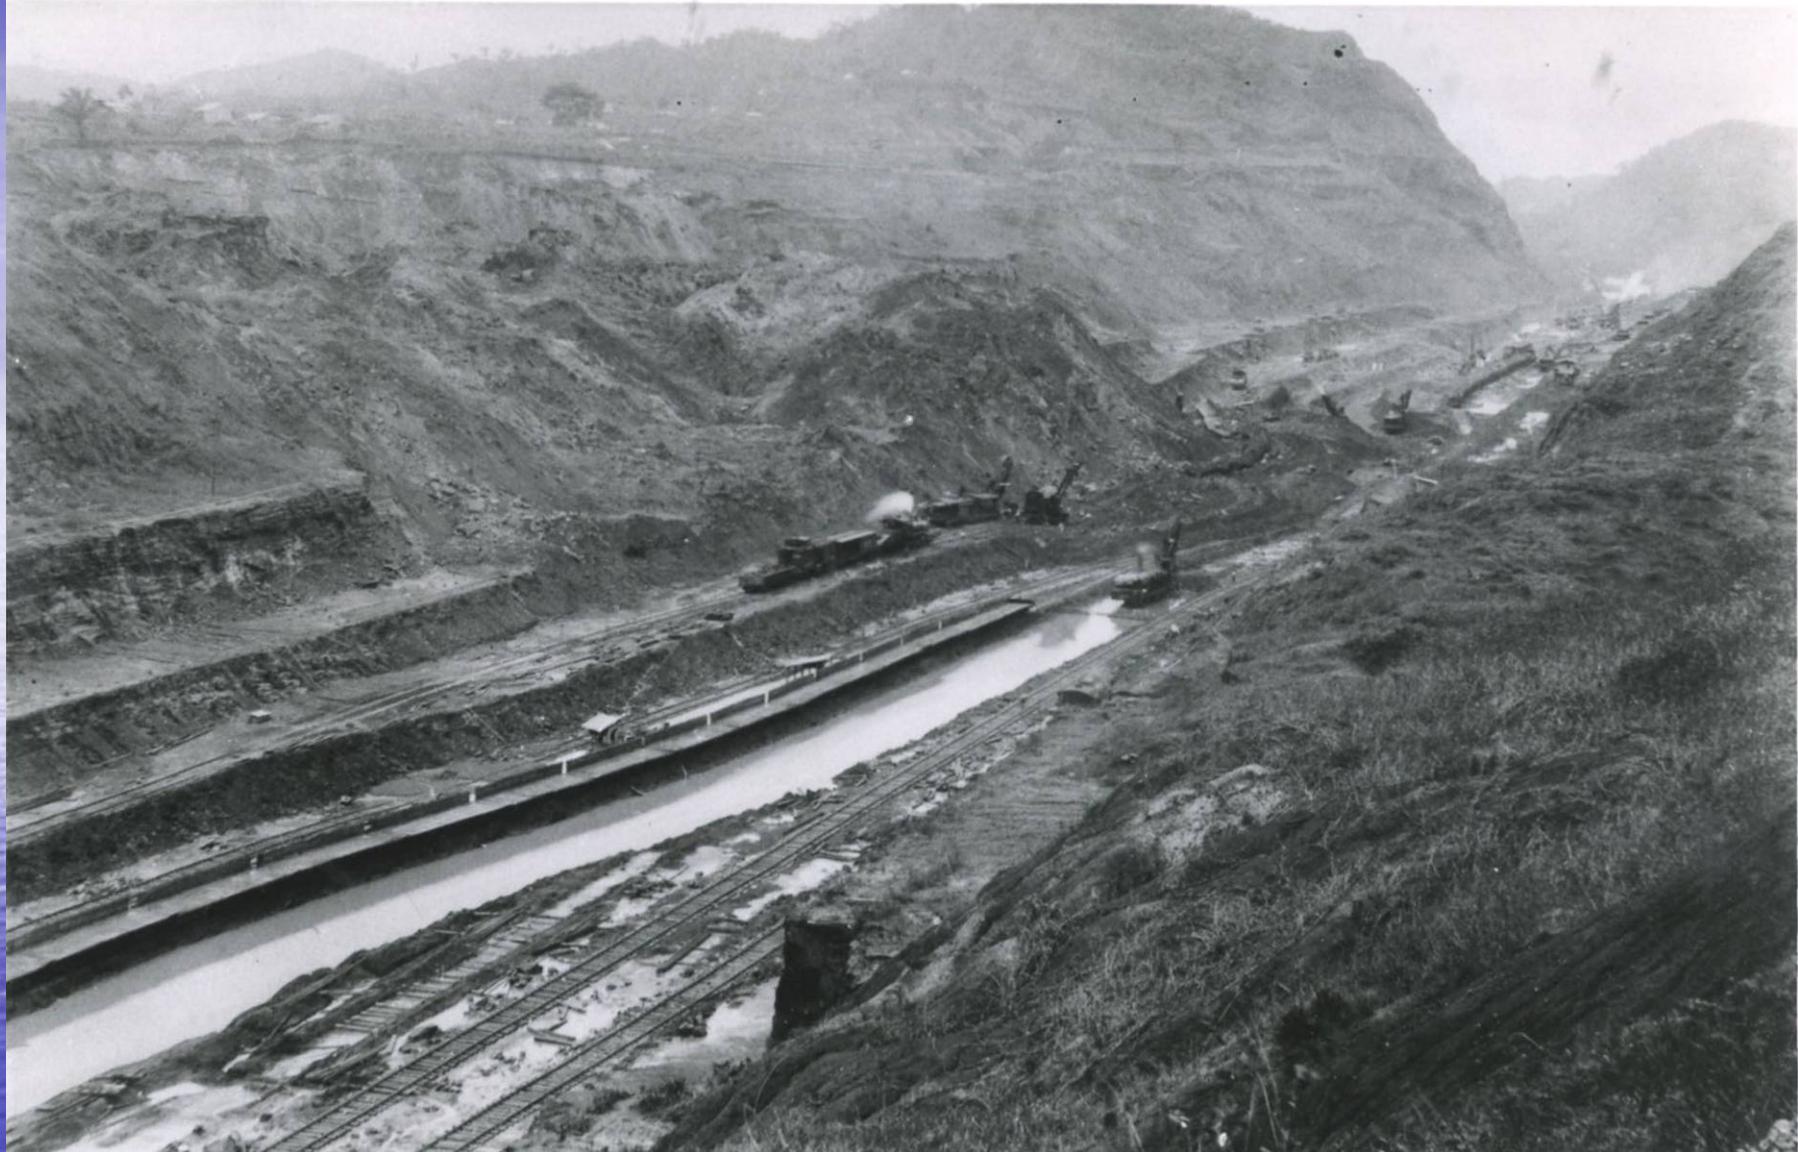
- Large deep-seated slump on the East Culebra Slide blocks the canal excavation, May 27, 1913.

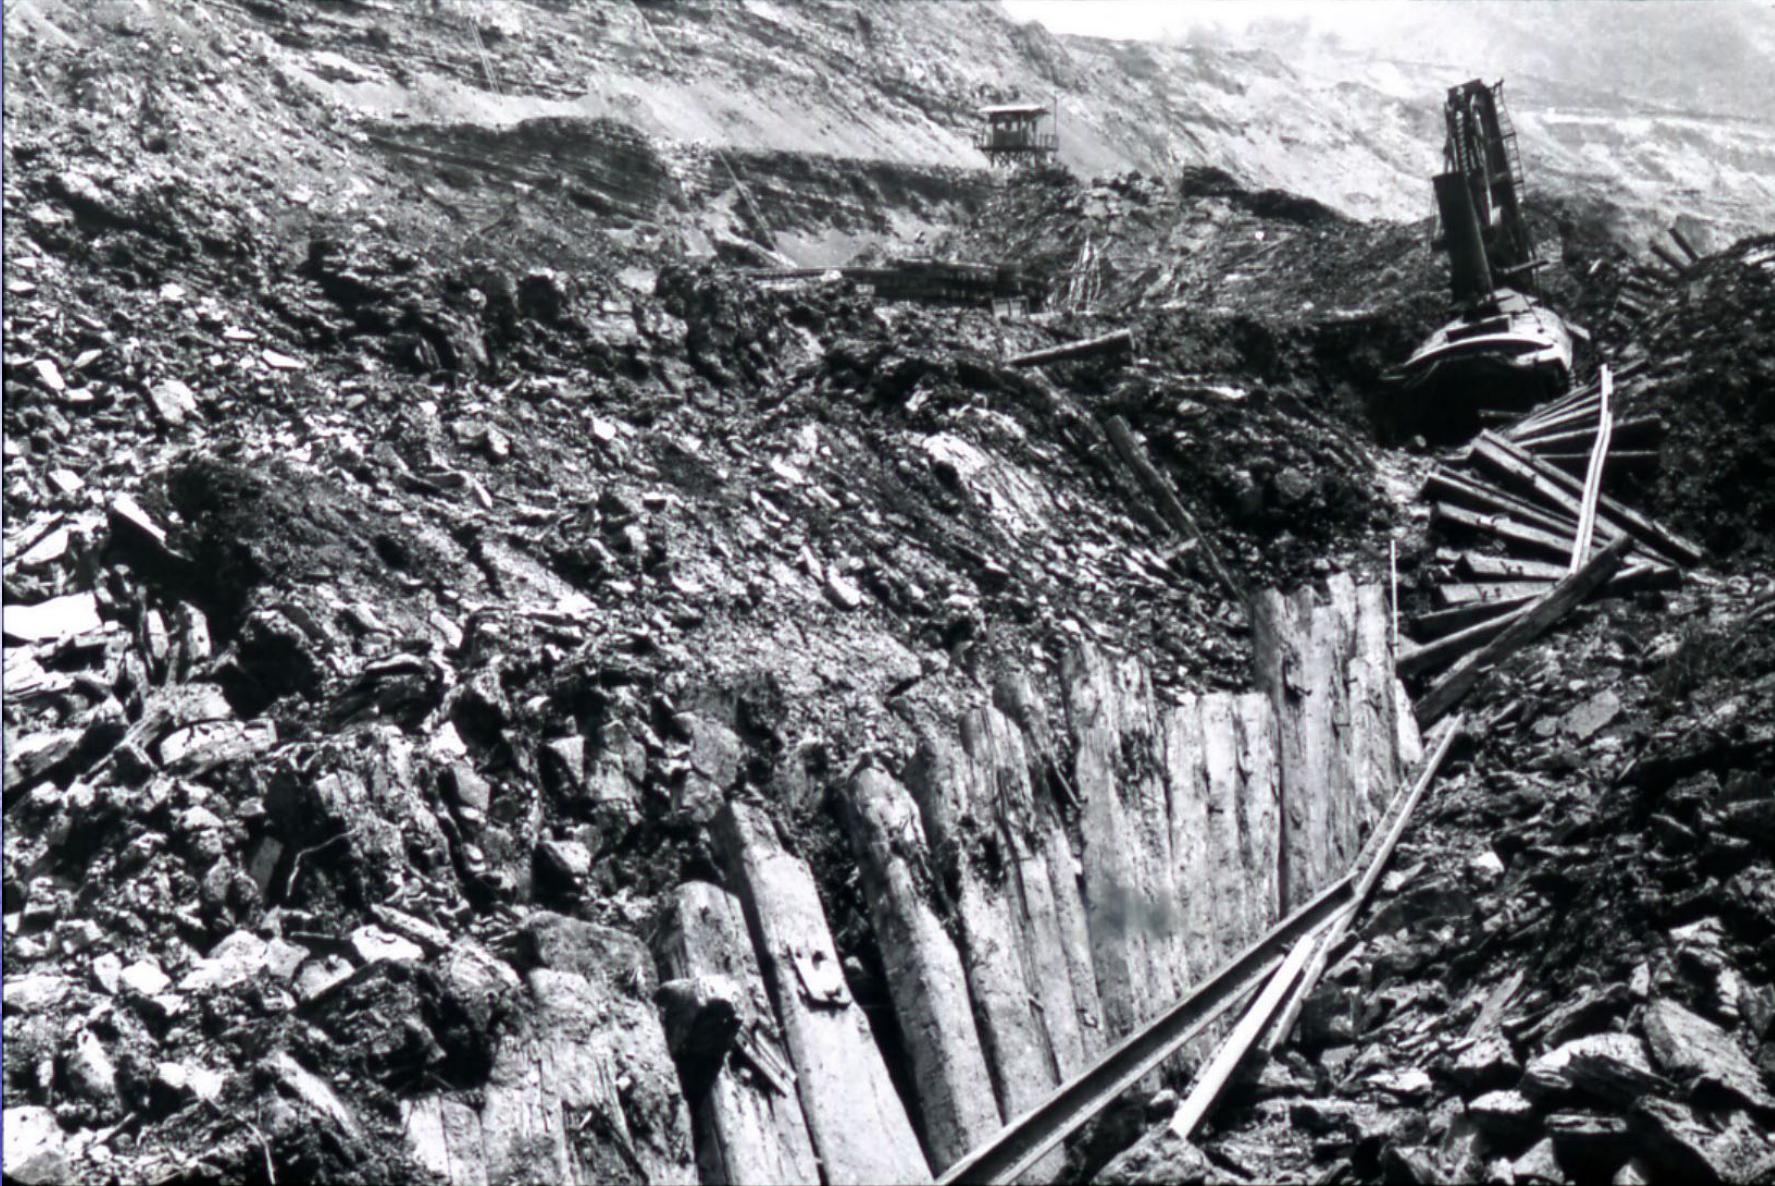
- Buried steam shovel and shredded tracks at East Culebra.

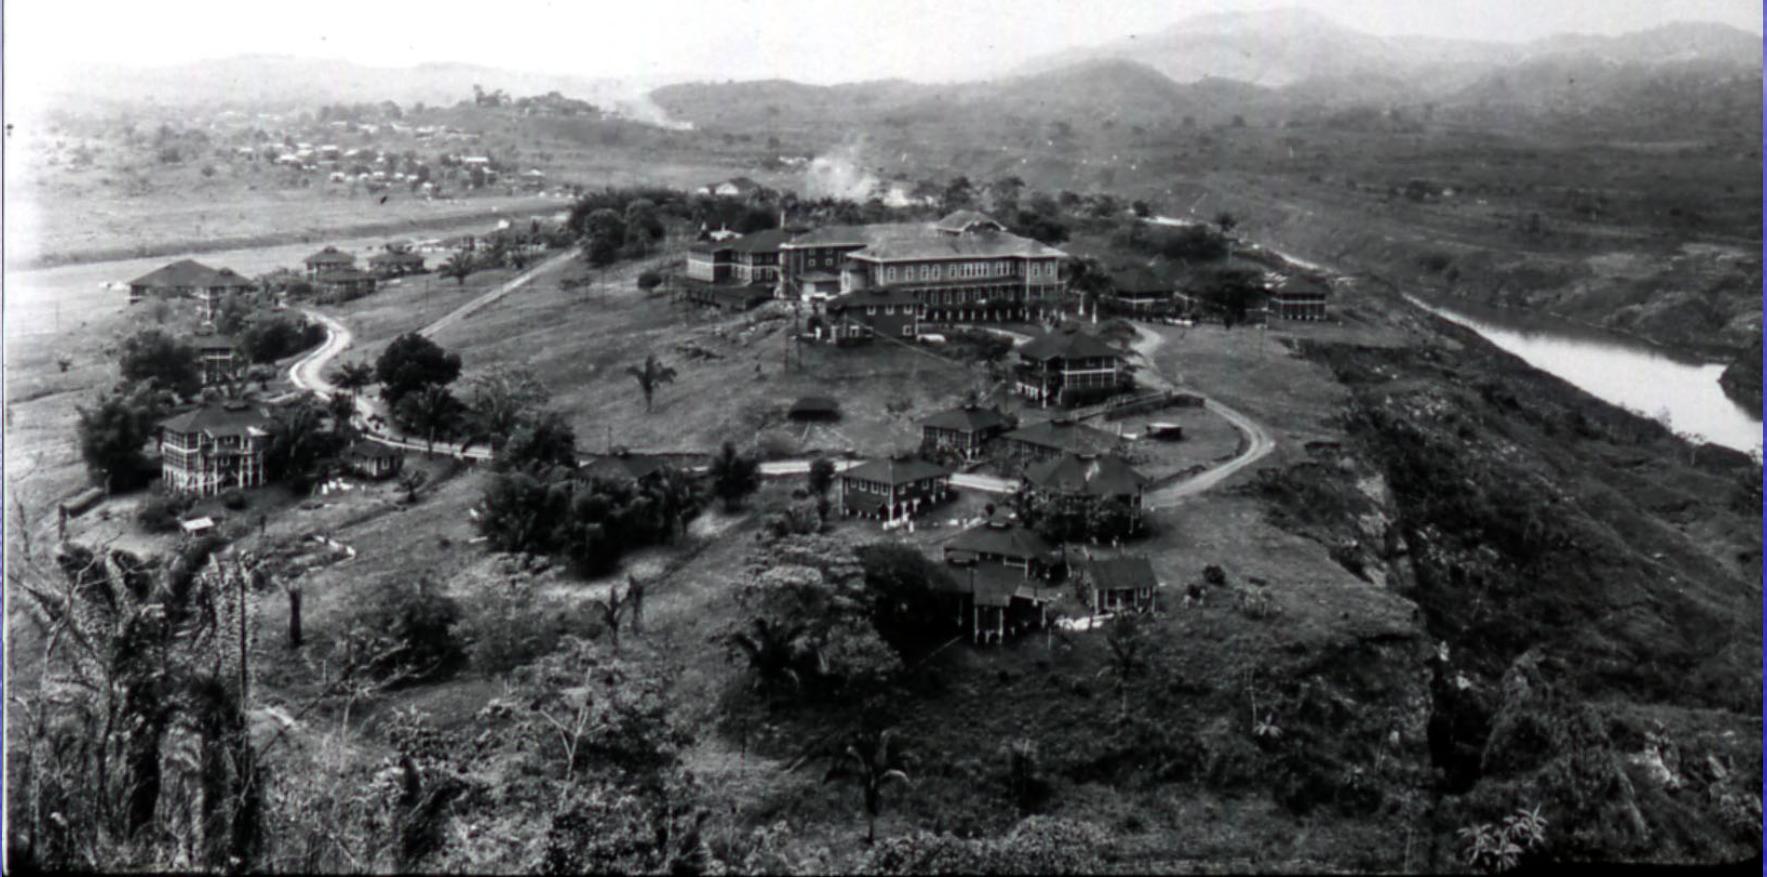
- The headscarp of the West Culebra Landslide swallowed up part of the town of Culebra

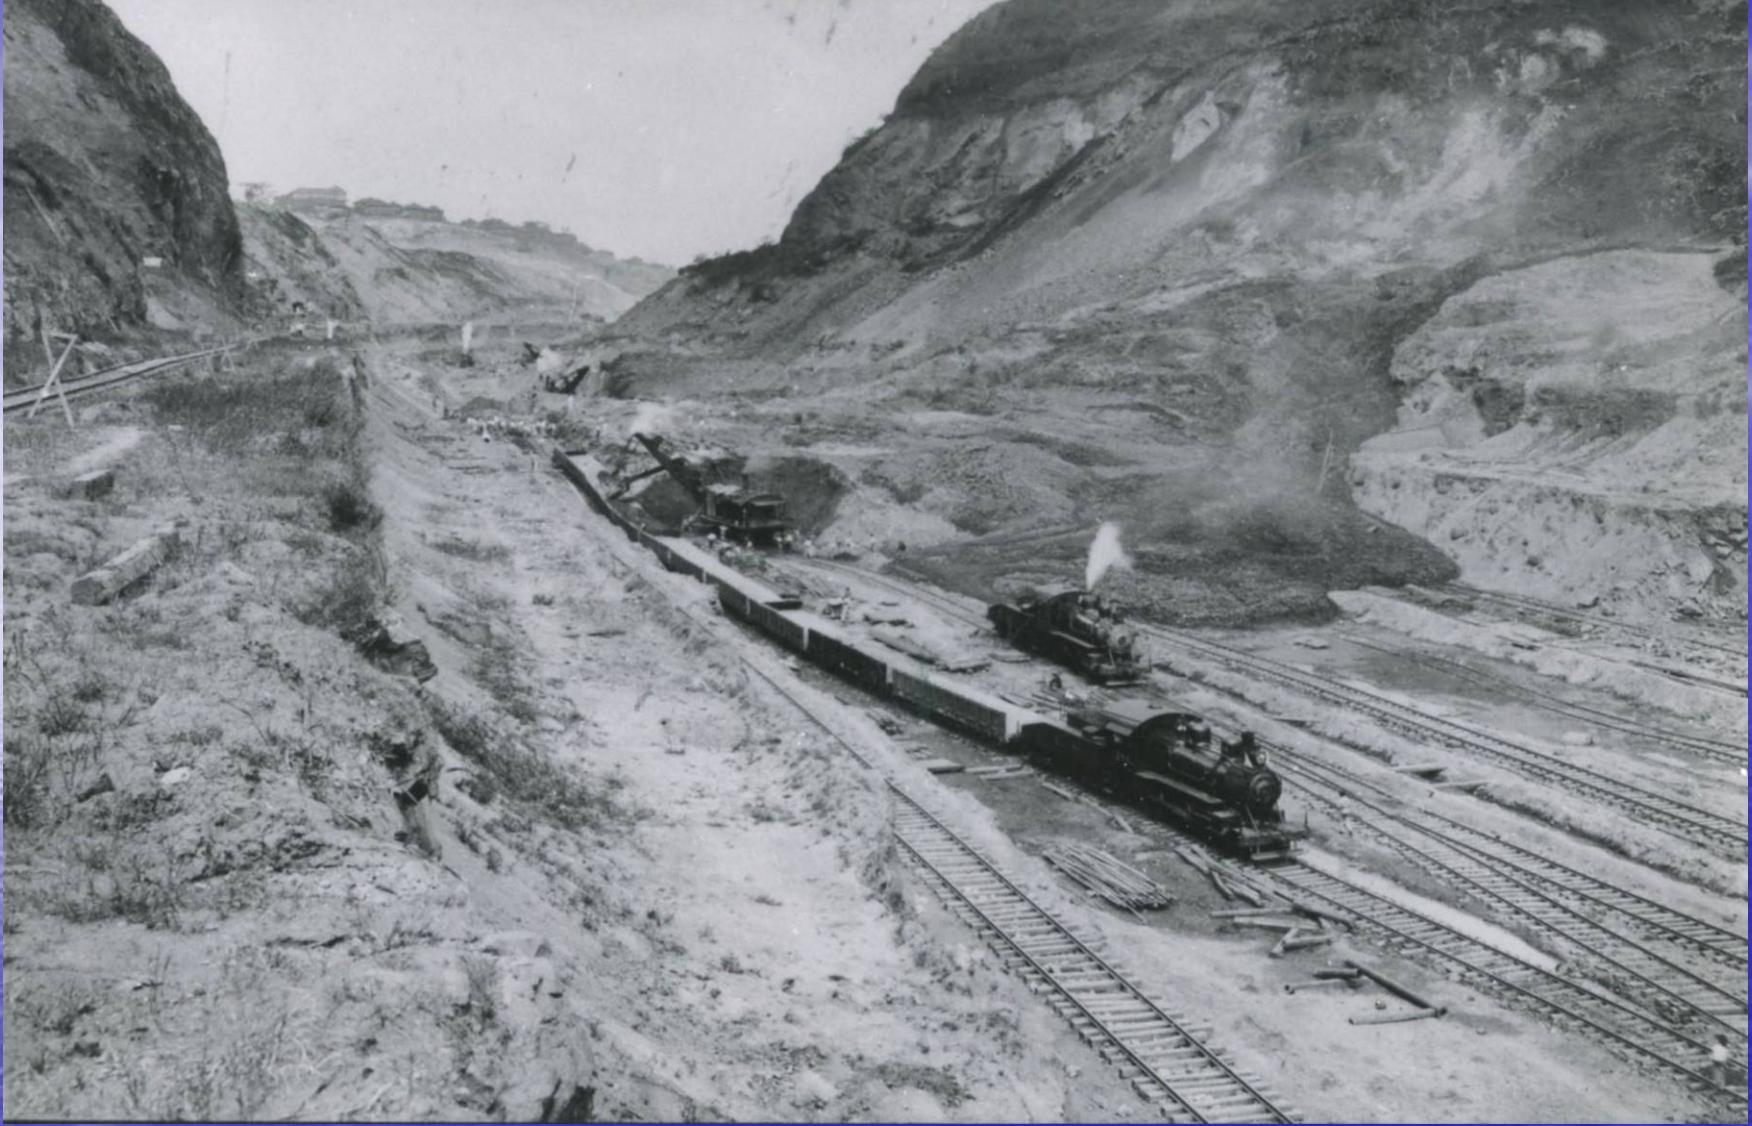
- Flowage off the Cucaracha Landslide on February 2, 1913. A harbinger of what was to come...
