PANAMA CANAL: THE WORLD'S LANDSLIDE LABORATORY

J. David Rogers, Ph.D., P.E., P.G.

2007 Annual Meeting

Association of Environmental and Engineering Geologists

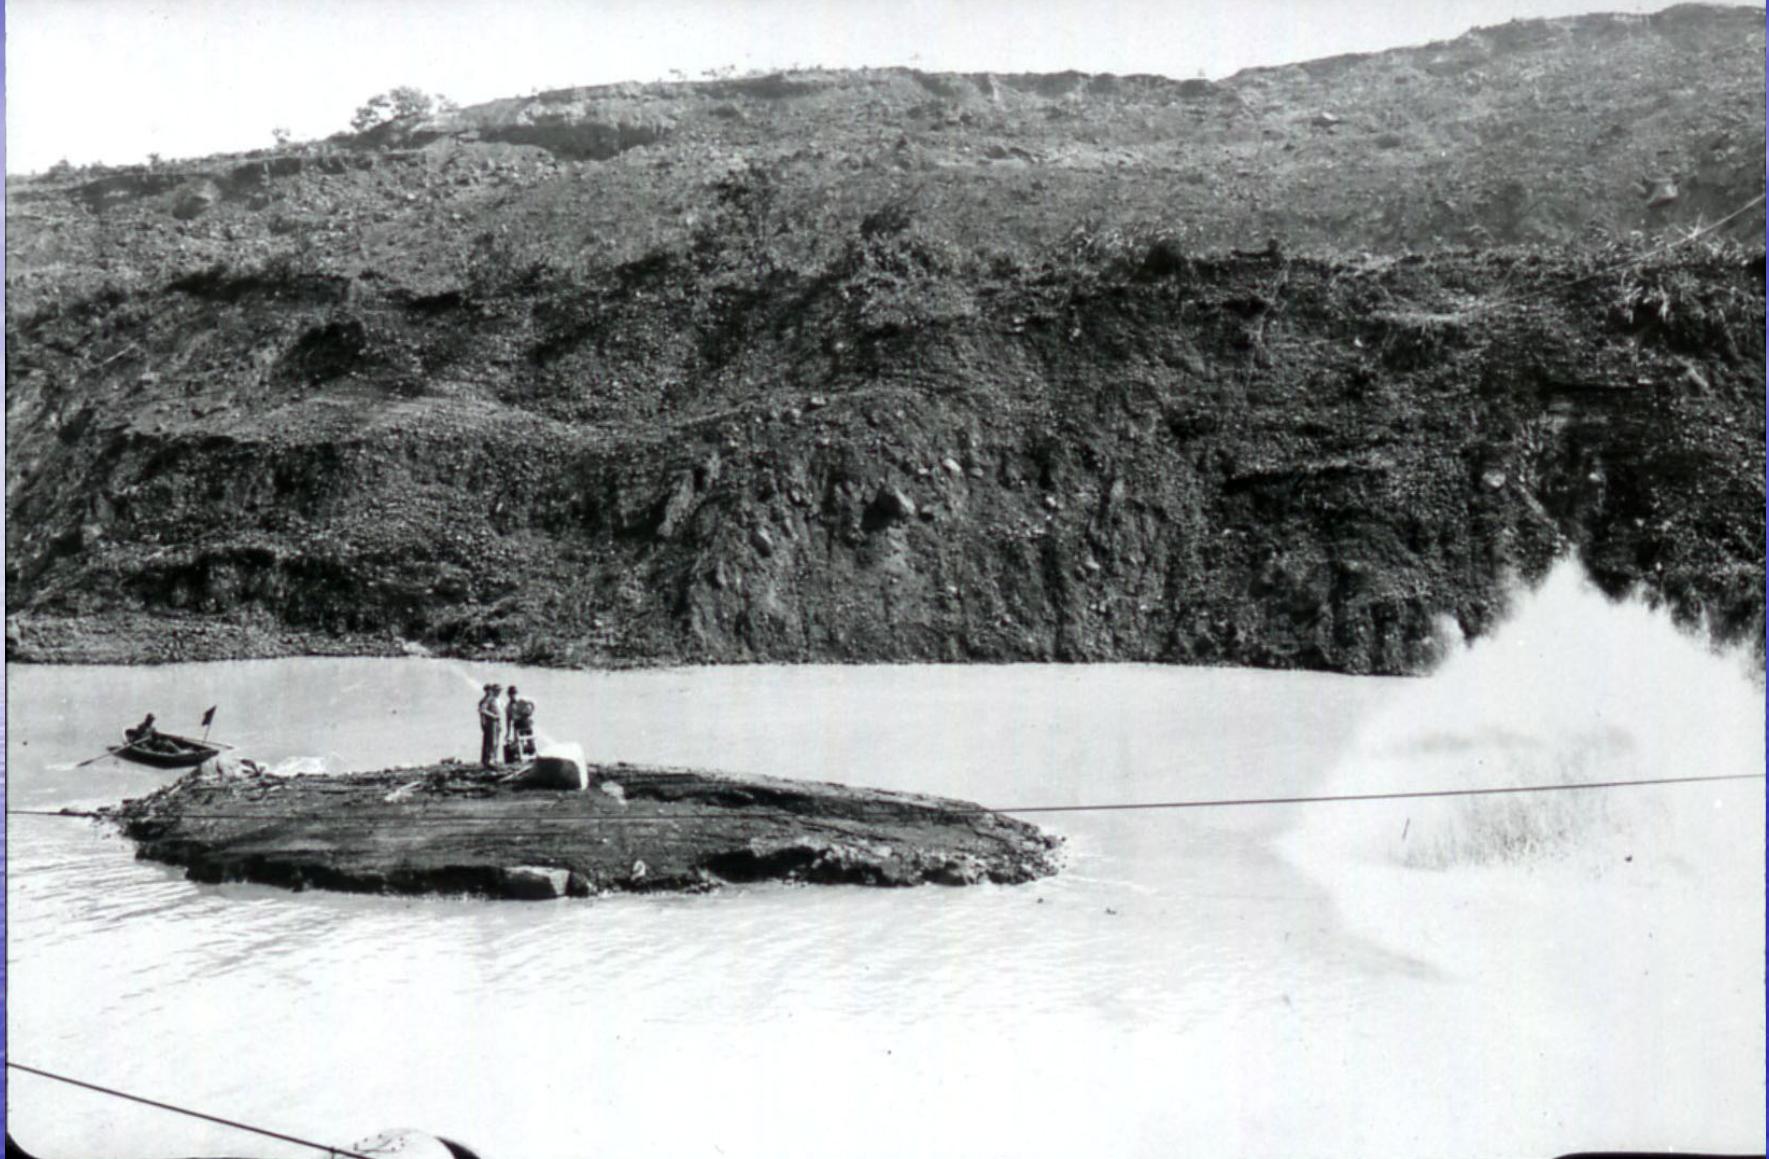
- Toe heave that protruded upward through 30 feet of water on September 19, 1915.

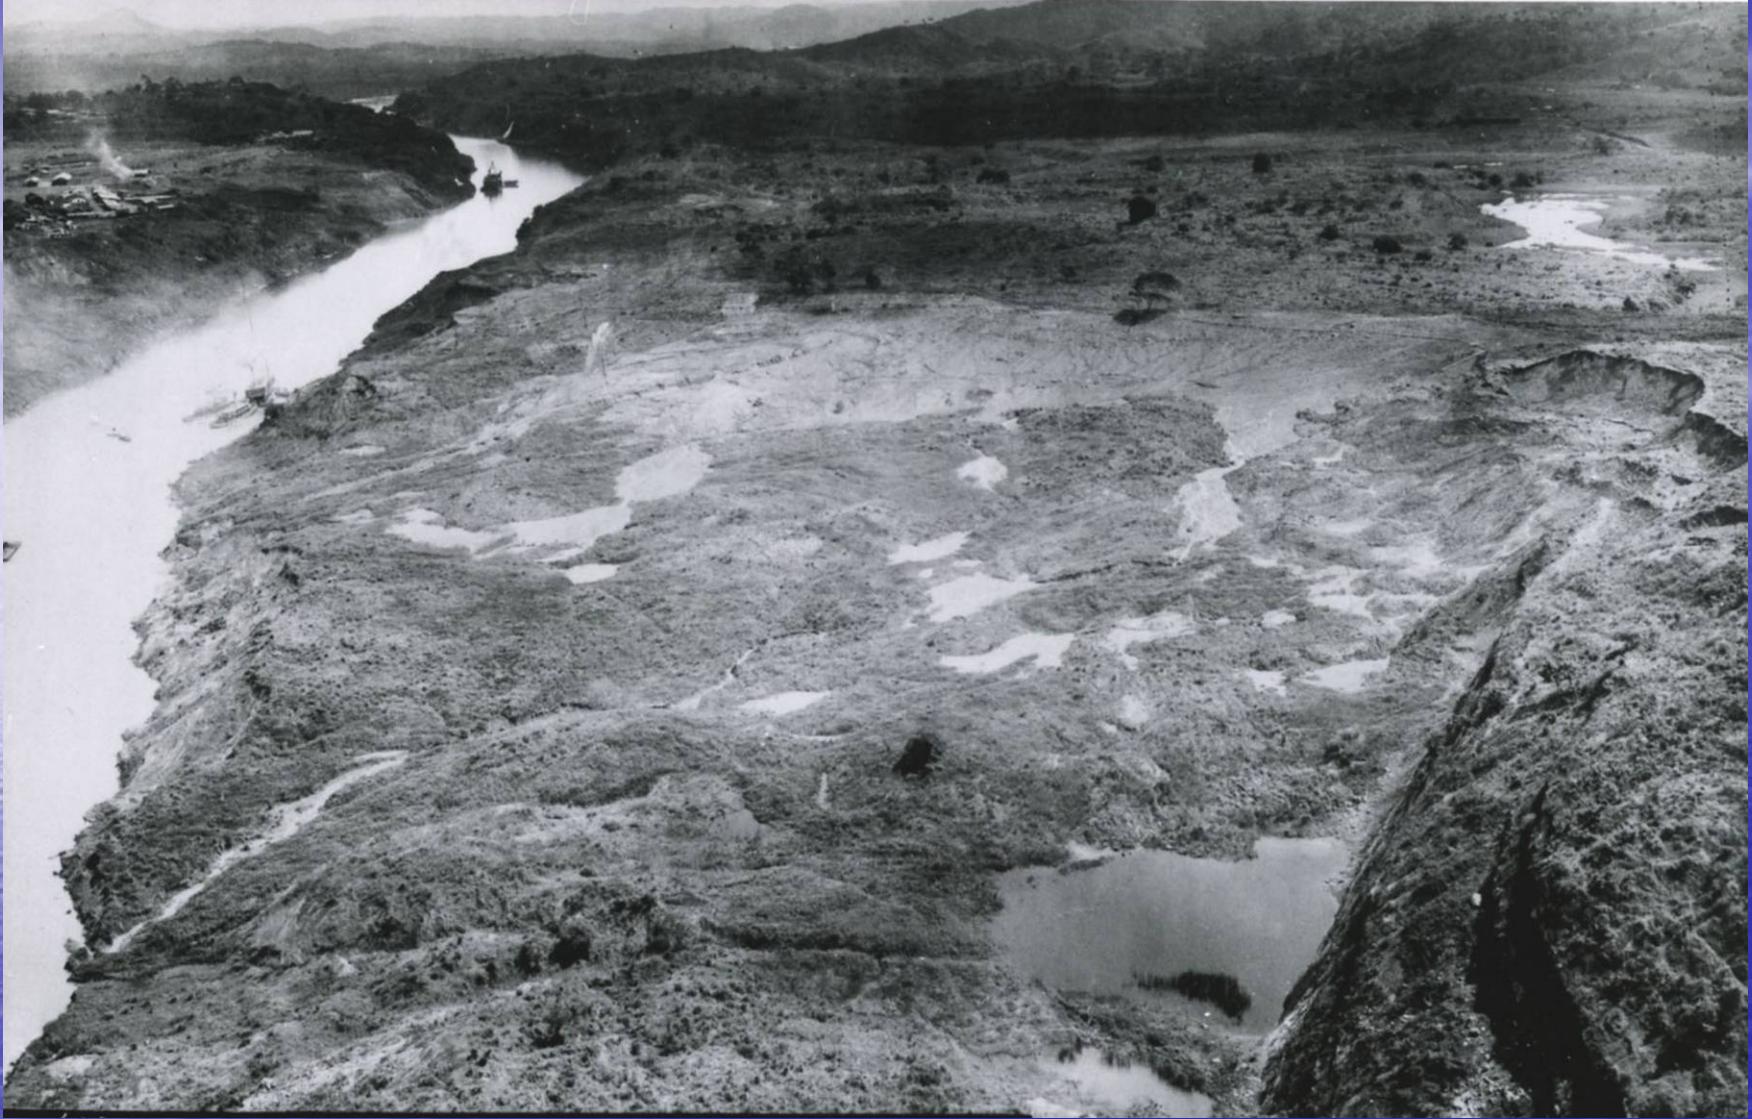
- **East Culebra Slide as seen from the crest of Gold Hill on June 19, 1923. The shear strength of the slide debris had obviously been transformed to a much lower value.**

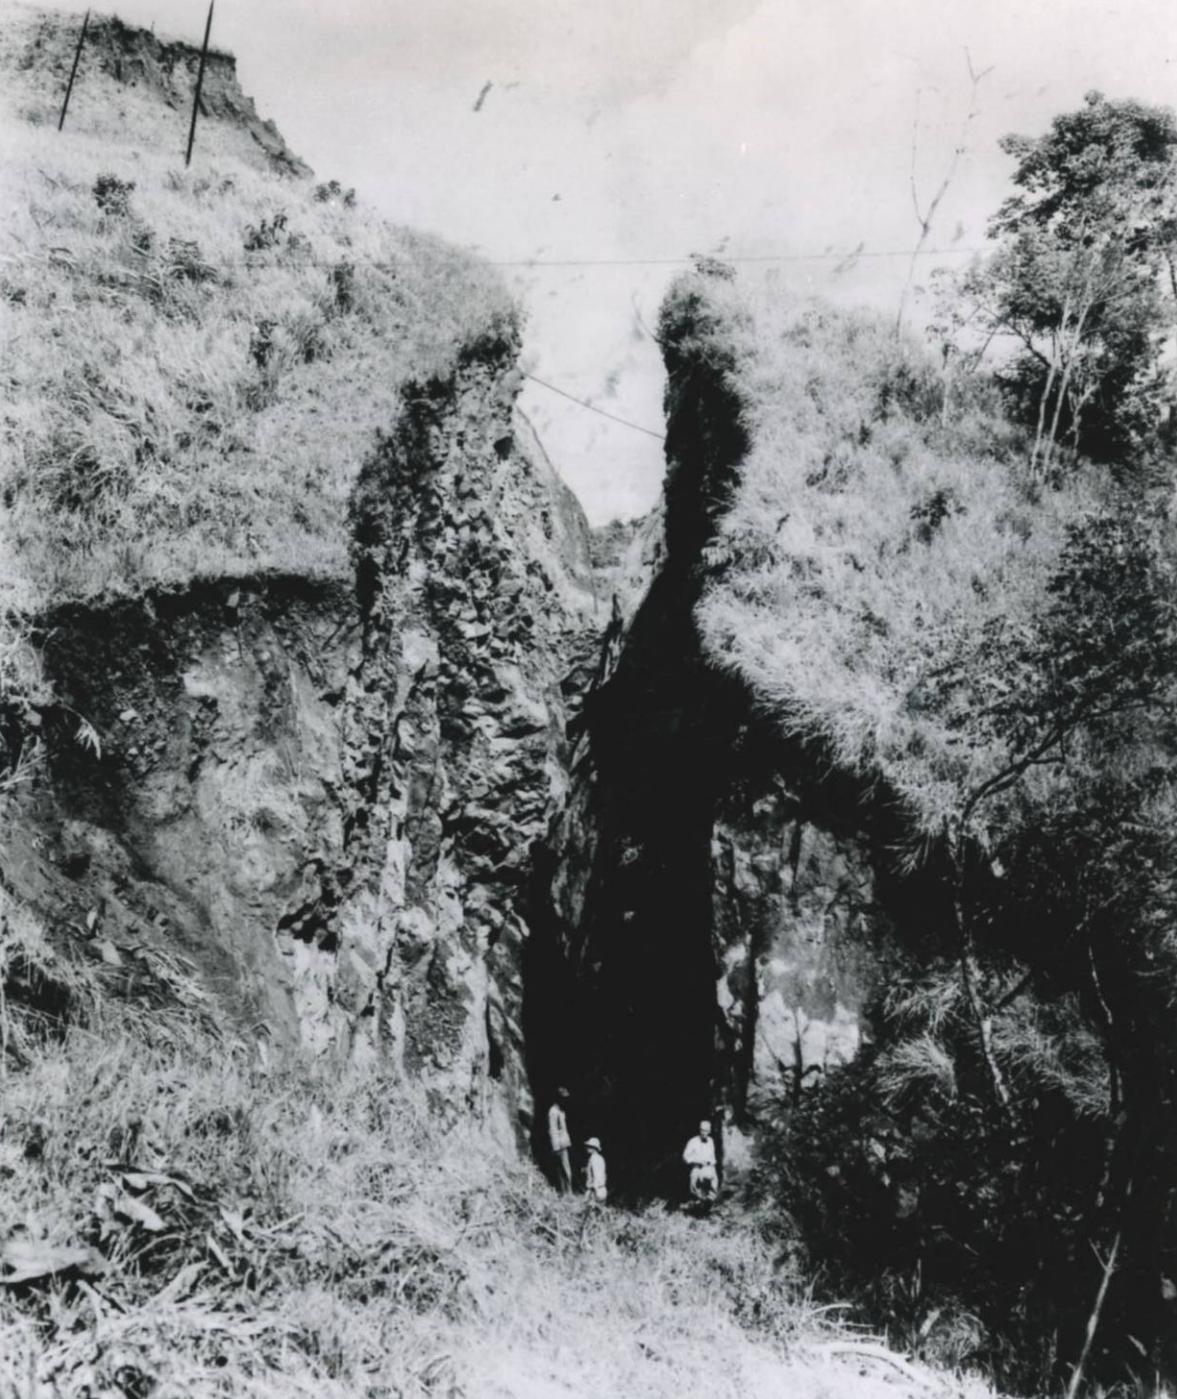
- Massive tension crack opening above the West Culebra Landslide on October 22, 1936

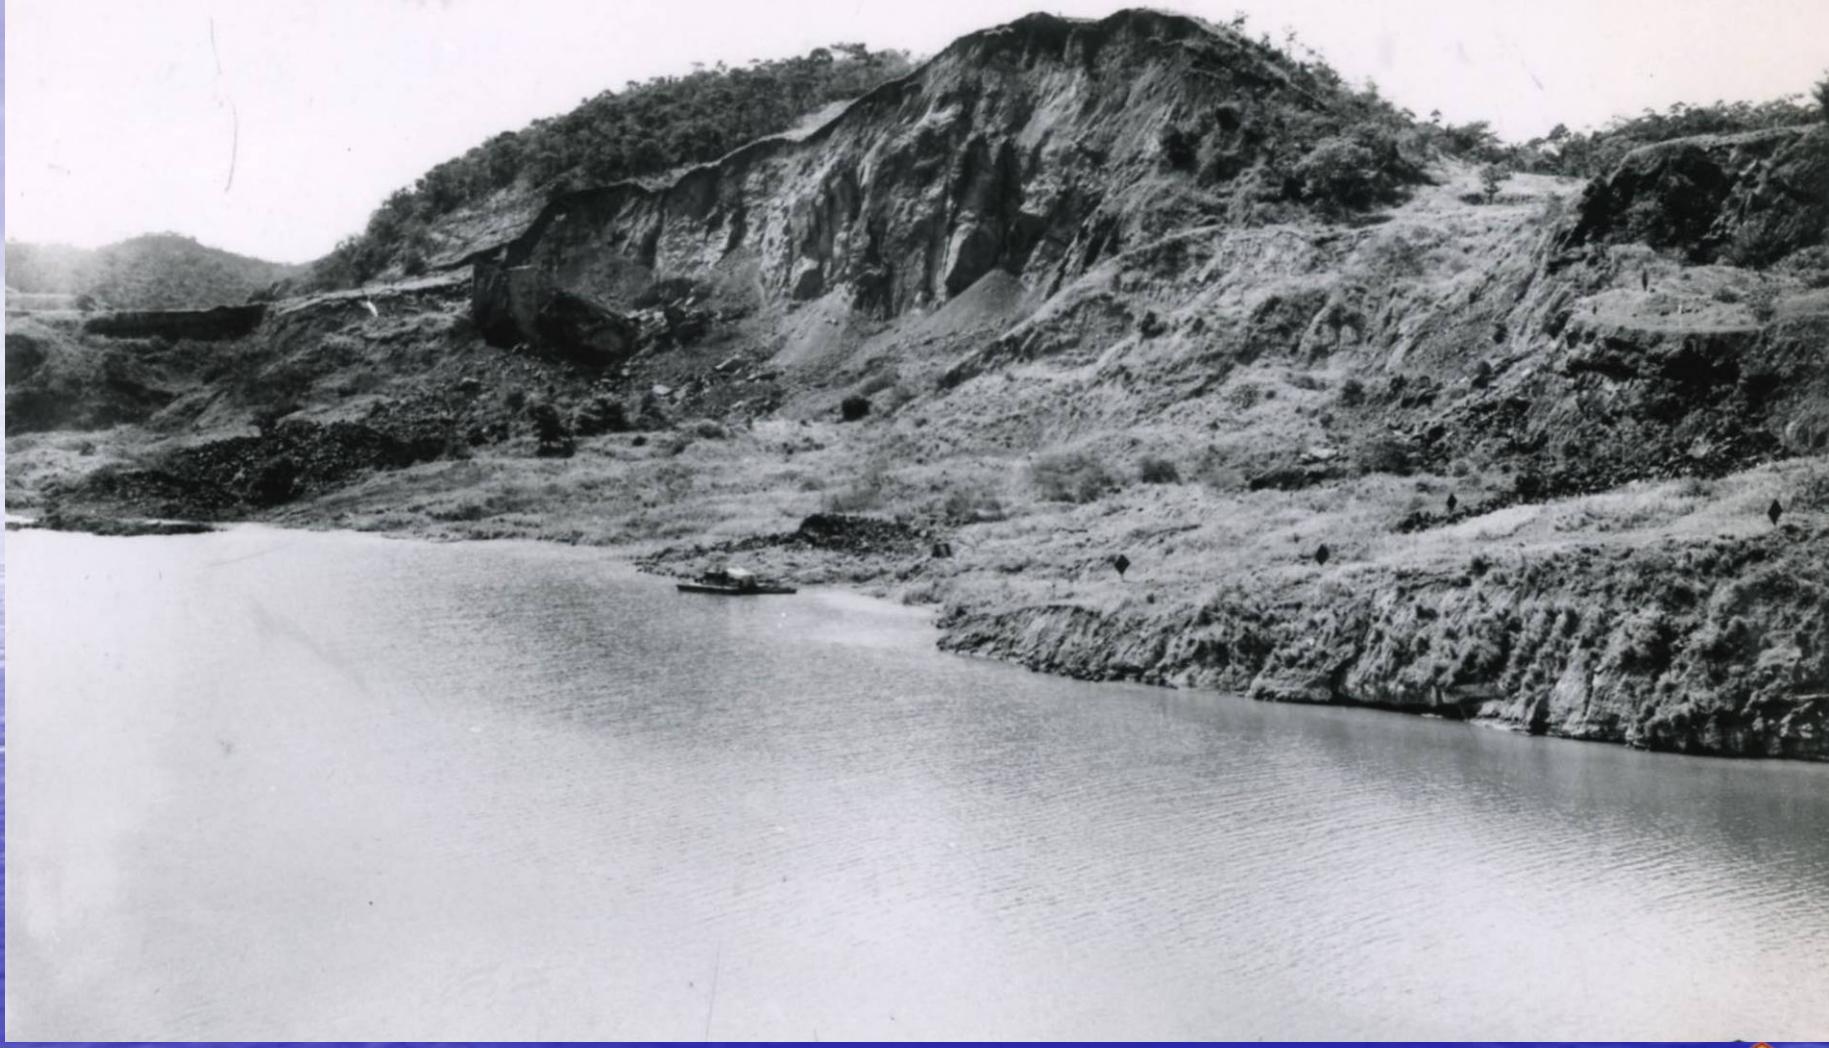
- Head scarp of the West Culebra Slide, 25 years later, on January 26, 1937

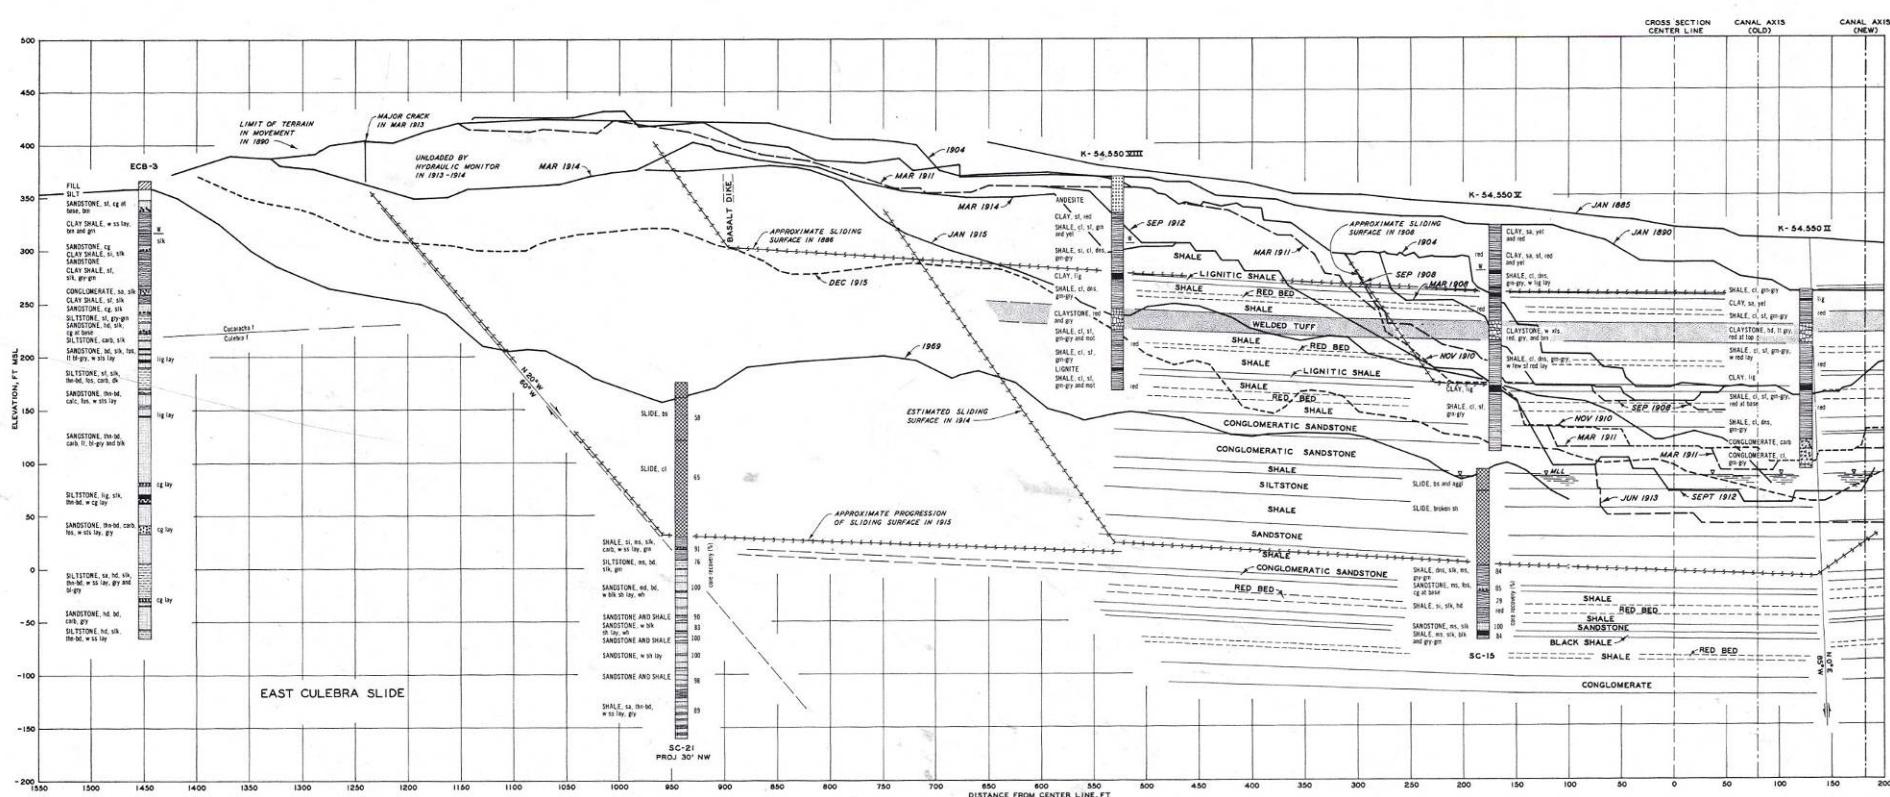
- By the early 1970s the Corps had amassed 60 years of data. This shows a section through the East Culebra Landslide, showing retrogression of the head scarp, progressive deflation, and controlling stratigraphy.
