New Orleans and Hurricane Katrina.

IV: Orleans East Bank (Metro) Protected Basin

DOI: 10.1061/(ASCE)1090-0241(2008)134:5(762)

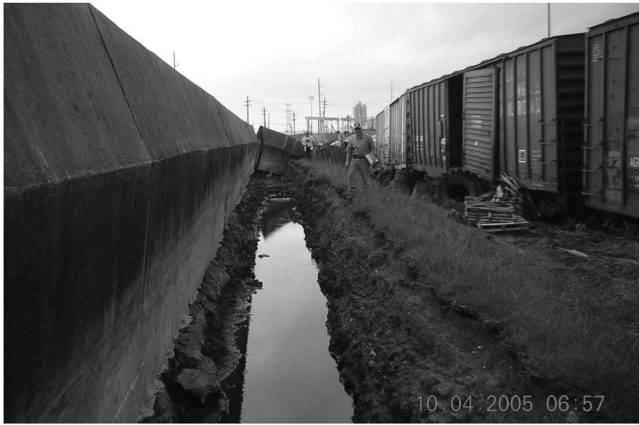
Fig. 2. View of the I-wall failure at the Port of New Orleans, from the inboard side, showing the trench scoured behind the I-wall by overtopping flows

The next failure to the south was the failure of a sheetpile-supported I-wall section atop a relatively low-rise earthen levee embankment section (Fig. 2), and a full description is presented in ILIT (2006). This failure was the result of overtopping of the concrete floodwall by the elevated waters of the IHNC, which resulted in erosion of a trench behind the wall. This served to reduce the lateral bracing of the concrete I-wall and its supporting sheetpile curtain, and the lateral pressures of the elevated canal

waters then pushed the floodwall sideways, opening a water-filled gap between the sheetpile curtain and the outboard side of the earthen levee embankment. The gap allowed water pressures to act against both the I-wall and its supporting sheetpile curtain, and these lateral water pressures then pushed the I-wall (and its supporting sheetpiles) to the inboard side, rupturing the concrete I-wall and producing the breach as shown in the center of the photograph.

The breach itself represented the separation of two adjacent concrete I-wall panels, and then flow through this opening further widened the feature (but only to a width of approximately 40 ft). It is interesting to note that this overtopping failure produced only a localized failure, and that it did not scour a path to below sea level, so that although flow passed through this breach for several hours, this inflow eventually ceased as the storm surge within the IHNC channel subsequently subsided.

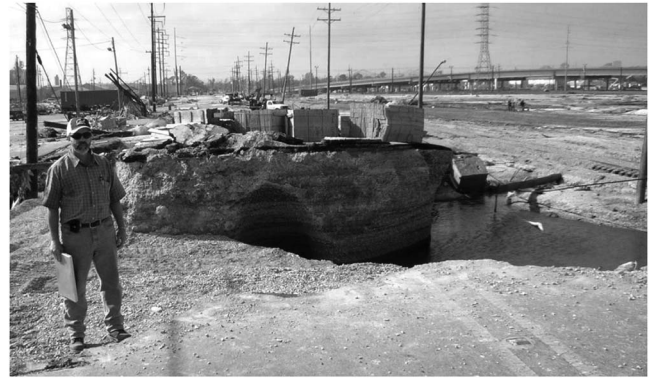
Fig. 3. Southernmost breach along the west bank of the IHNC, showing the lightweight shell-sand fill of the remaining intact levee embankment section adjacent to the eroded breach

Two additional failures (and breaches) occurred farther to the south, along the west bank of the IHNC. Both of these breaches occurred at locations where the earthen embankment sections were comprised primarily of highly erodeable lightweight shell-sand fills. Fig. 3 shows a close-up view of the southernmost of these two breaches. In Fig. 3 the highly erodeable shell-sand fill can be seen at the rear of the photo (i.e., the striated exposed face of the end of the intact embankment at the rear of the breach in this photo). The use of this same shell-sand fill for the partially completed interim breach repair (in the foreground of the photo) can also be seen (i.e., the material upon which the person is standing). In addition, kicked up by passing foot traffic, some of the lightweight small (fine gravel-sized) mollusk shells that comprise a large fraction of this material are visible atop the asphalt pavement section.

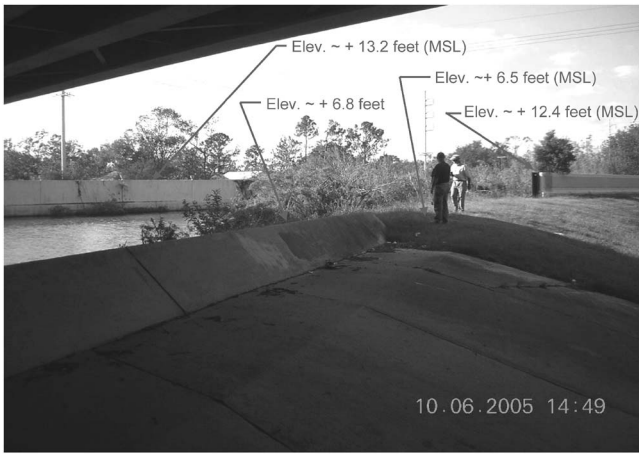
Fig. 4. Side view of the “gap” in the flood defenses at the south end of the Orleans canal

A third difference was the fact that the flood protection system around the perimeter of the Orleans Canal was incomplete at the time of Katrina’s arrival. A gap had been left in the system, at the south end of the canal (see Fig. 4). At the south end of the canal, on the east bank, the final 200 ft of concrete floodwall were never installed. Instead, as an interim measure, a concrete spillway section (visible in the left foreground of Fig. 4) was installed so that water flowing through this gap would not cause catastrophic erosion. This gap in the defenses provided an opening with a crest height approximately 6 ft lower than the adjacent levee/floodwall sections, so that at the peak of the hurricane-induced storm floodwaters simply flowed freely through this gap into the heart of the main (Metro) New Orleans protected basin.

The reason for the existence of this gap in the defenses occurs just to the left of the photo in Fig. 4 (just out of the photo), where an old brick building (constructed in 1903) crosses the south end of the canal as a “T,” forming the southern boundary of the lined canal. That building houses several large Woods pumps, used by the Water Board to pump waters out of New Orleans into the drainage canal for transit north into Lake Pontchartrain. The ability of that old brick building to hold back high water is questionable; at canal water levels of more than about +5 ft (MSL) water seeps through the brick wall of the building and enters the structure. It is apparent that higher water levels against the front of this structure could potentially imperil the building. To complete the perimeter defenses for the Orleans Canal, either (1) the Water Board needed to construct a protective frontage wall to both pro-

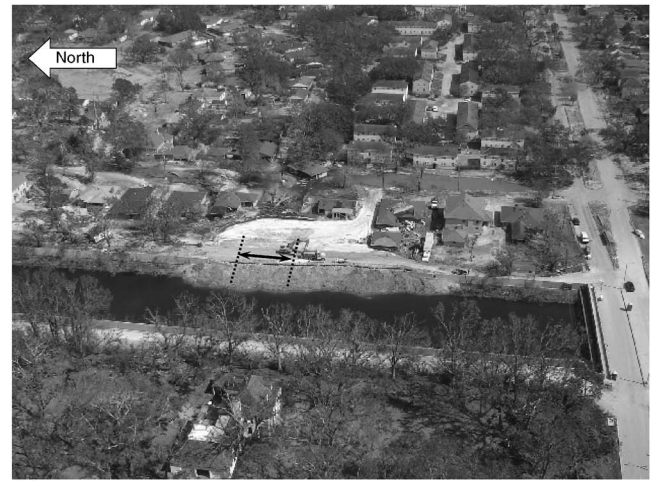
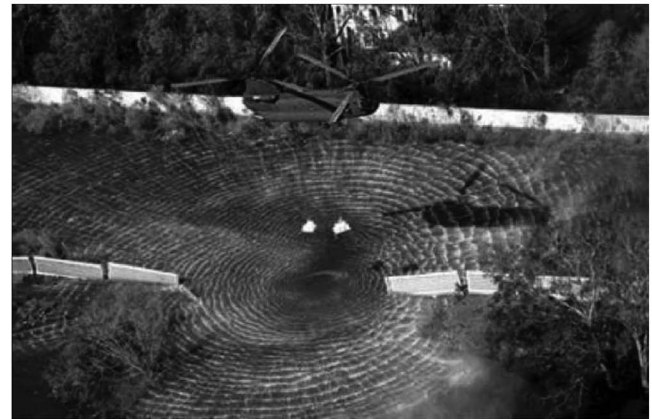
Fig. 5. (a) Oblique aerial view of the breach section near the south end of the London Avenue drainage canal, on the east bank. The interim repair has been largely completed, but the arrows indicate the location of the original breach location; (b) Aerial view of initial breach closure at the London Avenue South Breach, showing the narrow breach width and the I-wall panels at each end toppling inwards toward the scoured breach opening. (IPET 2007).

Fig. 5(a) shows an oblique aerial view of this breach, which occurred on the east bank of the canal just to the north of the Mirabeau Bridge (the bridge at the right of this photo). At the time of this photo, the interim repair embankment section was largely in place, and so it obscures the details of the original failure. Accordingly, Fig. 5(a) has been annotated by the addition of a pair of dashed lines, and arrows, indicating the location of the now obscured deep, narrow scoured opening that appears to have been the initial failure location. Fig. 5(b) shows a second view of this feature, during early stages of emergency breach repairs. In this photo, the narrow nature of the original breach can be seen. The breach was initially only three concrete I-wall panels in width (a width of less than 60 ft), and in this photo (despite the floodwaters) it can be seen that the concrete I-wall panels at both ends of the narrow breach are toppling into a deep, trench-like feature.

It should also be noted that significant vegetation, including mature trees, had been allowed to grow along the inboard side toes of the levees along this canal as shown in Figs. 5 and 7.

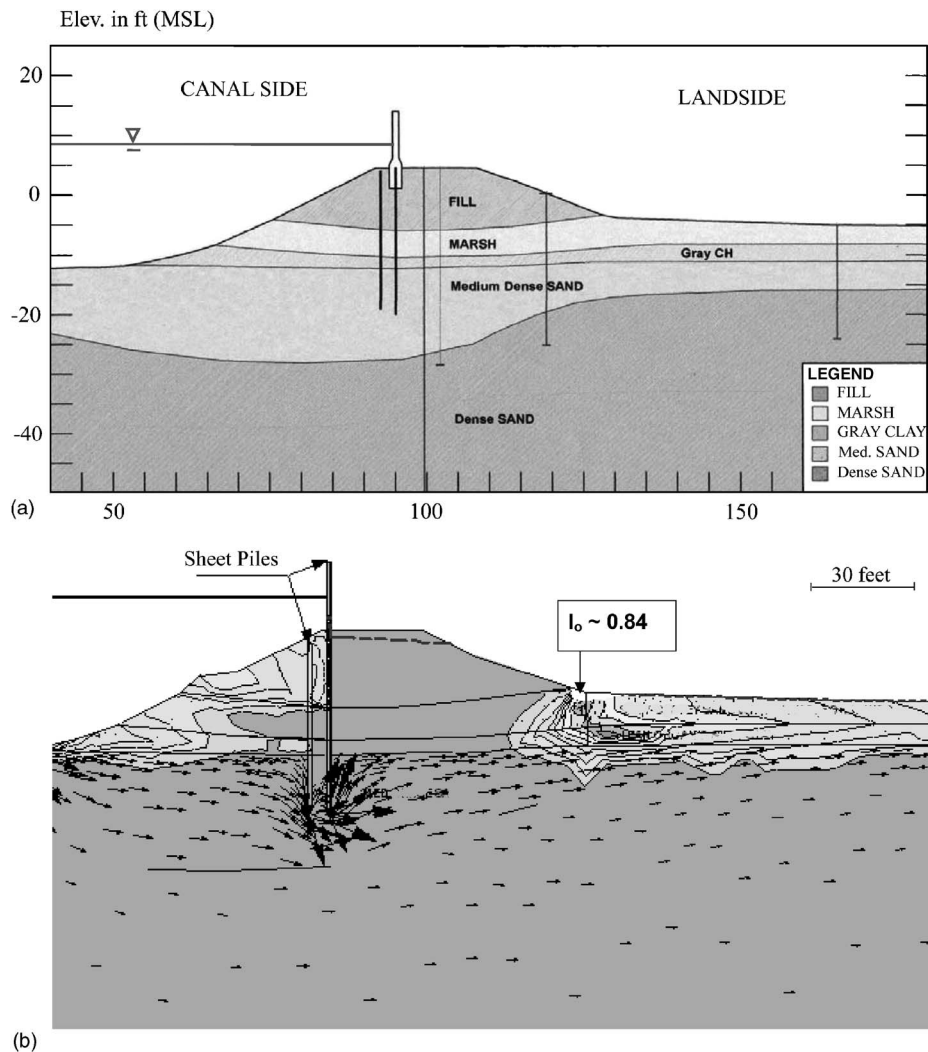
Fig. 6. (a) Cross section through the South Breach, on the east bank near of the London Avenue drainage canal, near the south end; (b) Hydraulic gradients (and flow vectors) for storm surge at +9 ft (MSL) at the South Breach on the east bank of the London Avenue drainage canal (maximum exit gradient, $i_0 \approx 0.84$)

Instead, this failure appears to have been the result of underseepage and piping erosion. Fig. 6(b) shows flow vectors and exit gradients calculated using the finite-element program SEEP/W (Krahn 2004) to perform transient seepage analyses modeling the full time-dependent rise of canal water levels over the 24 h that preceded the failure. Table 1 shows the principal parameters used to model the various key strata in these analyses (ILIT 2006). Underseepage flow passed through the pervious foundation sands, and it also passed beneath the relatively shallowly embedded sheetpile curtain which did not extend deeply enough as to represent an effective underseepage “cut-off.”

Field evidence at this site is consistent with these findings. The deep, narrow erosional failure had all the characteristics of a classic underseepage and piping failure in which underseepage initiated at the inboard toe region (likely accelerated by initial uplift or blowout), and then tunneled progressively back beneath the levee crest, producing a deep, narrow trench-like feature into

which the concrete I-wall sections would topple. This was one of only two major breaches during Hurricane Katrina that appeared to be the result of underseepage-induced piping (and possible blowout). The other such feature was the North Breach at the east bank of the IHNC, at the west end of the Lower Ninth Ward. As discussed in Seed et al. (2008b), that feature was also a deep, narrow breach feature. Both of these piping-induced breaches were less than 90 ft in width, even after scouring inflows through the open breaches. The other major breaches on the three drainage canals, and at the west end of the Lower Ninth Ward, were judged by these studies to have been the result of lateral/semirotational levee embankment instability failures, and each of those stability-related breaches were more than 400 ft in width. This mode of underseepage-induced piping was also judged by the USACE’s IPET investigation to represent the most likely mode of failure at this South Breach (IPET 2006).

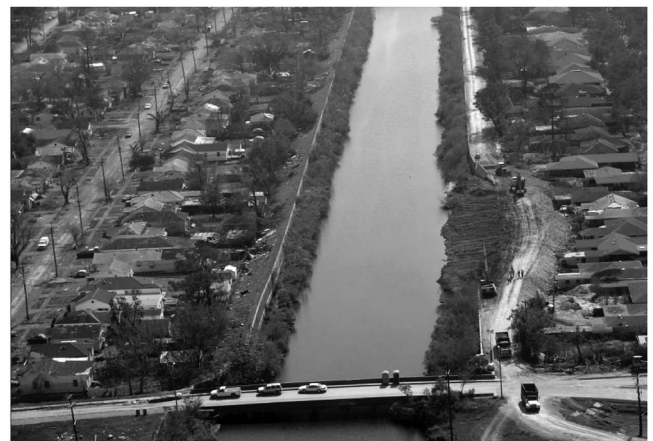
Fig. 7. Oblique aerial view of the breached (North Breach) section on the west bank of the London Avenue Canal (on the right side of the photo, which is taken looking to the south), and the distressed section on the east bank (on the left in this photo)

The second breach that occurred along the drainage canals occurred near to the north end of the London Avenue drainage canal, on the west bank (Fig. 1). Fig. 7 is an oblique aerial view of this site, looking toward the south. The failure section is on the right of this photograph (on the west bank), just to the south of the Robert E. Lee Bridge. If one looks closely, it can also be noted in this photograph that the concrete I-wall on the opposite bank of the canal (on the east bank, on the left side in this photograph) has been laterally displaced between 1 and 3 ft, and is leaning slightly away from the canal toward the inboard (land) side.

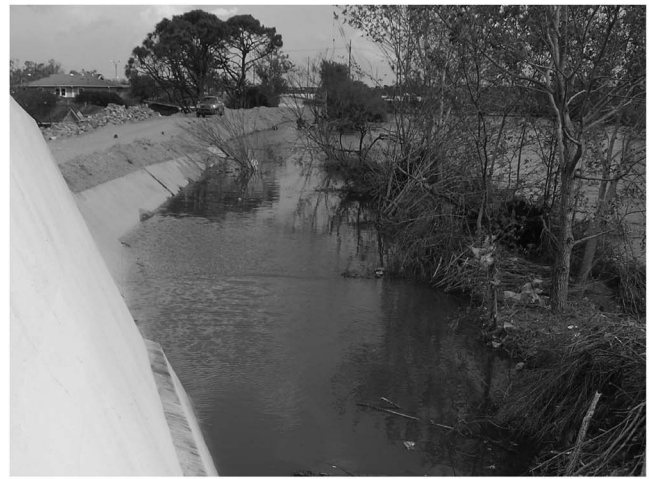
Fig. 8(a) shows conditions at the outboard side of the concrete I-wall on the west bank, at the breach location. In this photograph, it is clear that a “water-filled gap” has opened between the sheetpiles/I-wall and the outboard side of the levee embankment, peeling back the I-wall but leaving the top of the outboard side (canal side) of the earthen levee embankment in place (at the right of this photo).

Fig. 8. (a) View of the west bank breach near the north end of the London Avenue canal, taken from the south end, showing the top of the outboard side of the earthen embankment section still in place (at the right of the photo); (b) water-filled gap at the outboard side of east bank distressed section; London Avenue Canal

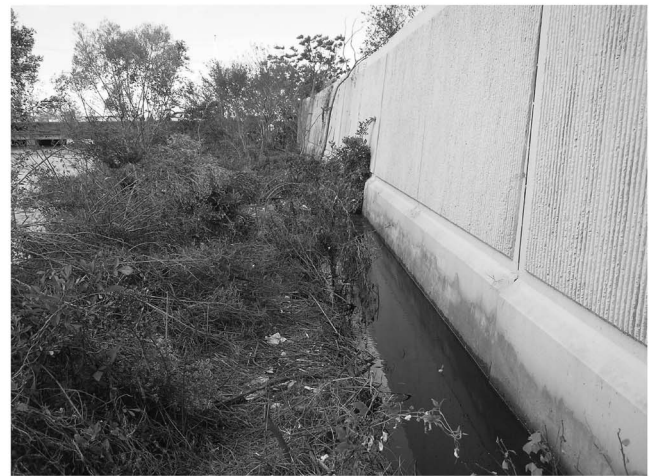
(b)

Fig. 8(b) shows conditions at the outboard side of the concrete I-wall on the east bank (at the distressed section). In Fig. 8(b), it can be clearly seen that a water-filled gap has opened between the slightly laterally displaced I-wall (and its supporting sheetpile curtain) and the outboard side of the earthen levee embankment. The maximum width of this gap was measured to be 2.6 ft at the location of maximum movement. On the landside of the floodwall on the distressed east bank, several sand boils were found along the toe of the levee. In addition, several sinkholes were found on the levee crown immediately landward of the floodwall. These signs of seepage distress were situated in the area where the floodwall had moved the most.

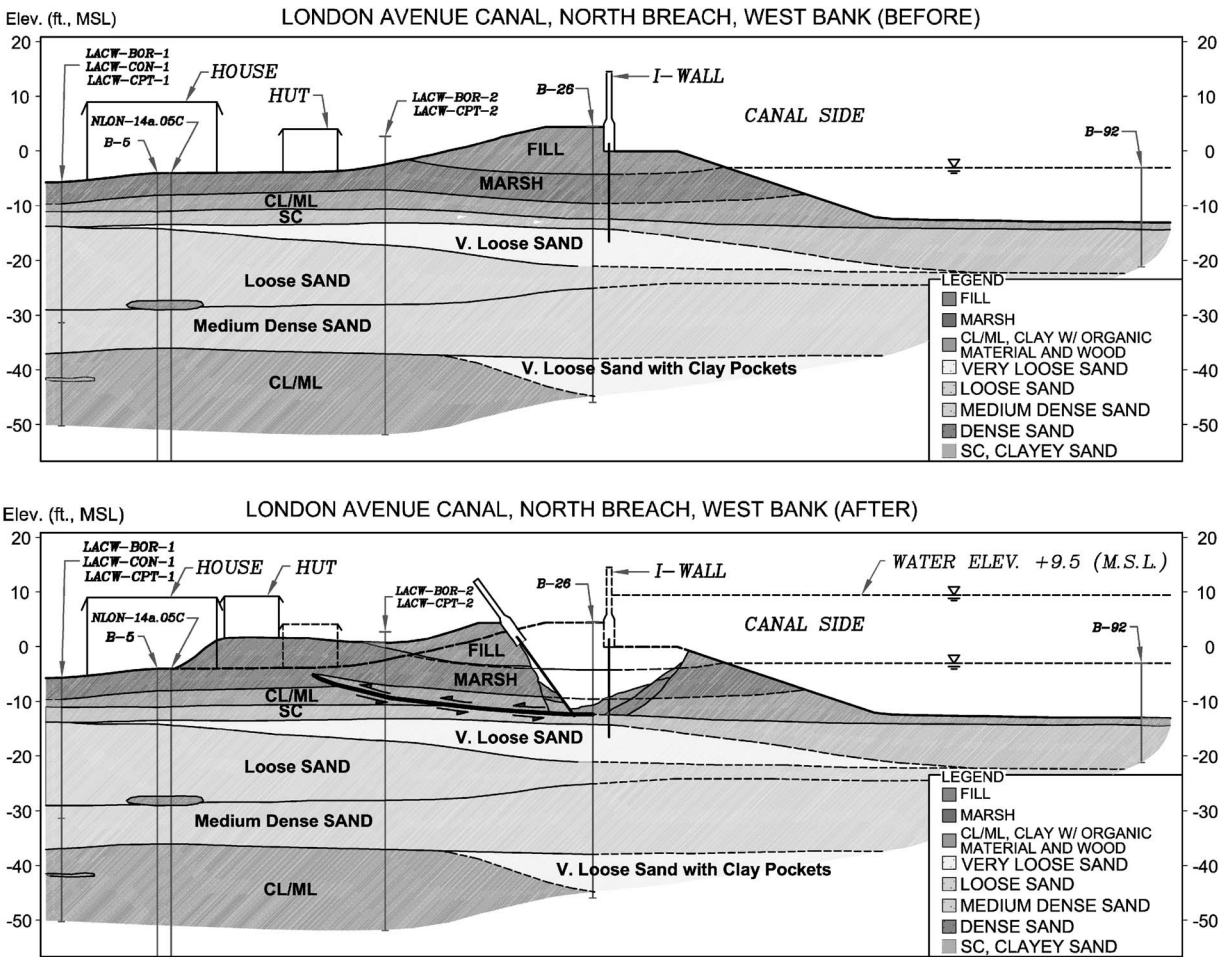
Fig. 9 shows a pair of cross sections through the west bank breach section, illustrating conditions before and after the failure occurred. The failure at this site was a translational failure of the inboard half of the earthen levee embankment, pushed laterally by elevated canal water pressures acting against both the upper concrete I-wall, and also against the lower sheetpile curtain (from within a water-filled gap that opened on the outboard side of these sheetpiles, as shown in Fig. 8). The shear slippage within the foundation soils was apparently fomented by reductions in the strengths of these soils due to underseepage-induced pore pressures that passed beneath the inadequately deep sheetpile curtain. Removal of some of the foundation sands by underseepage piping could also have played a role, as suggested by the evidence of seepage distress found on the opposite side of the canal.

Fig. 9. Cross section of conditions before and after the failure at the North Breach on the West Bank of the London Avenue drainage canal

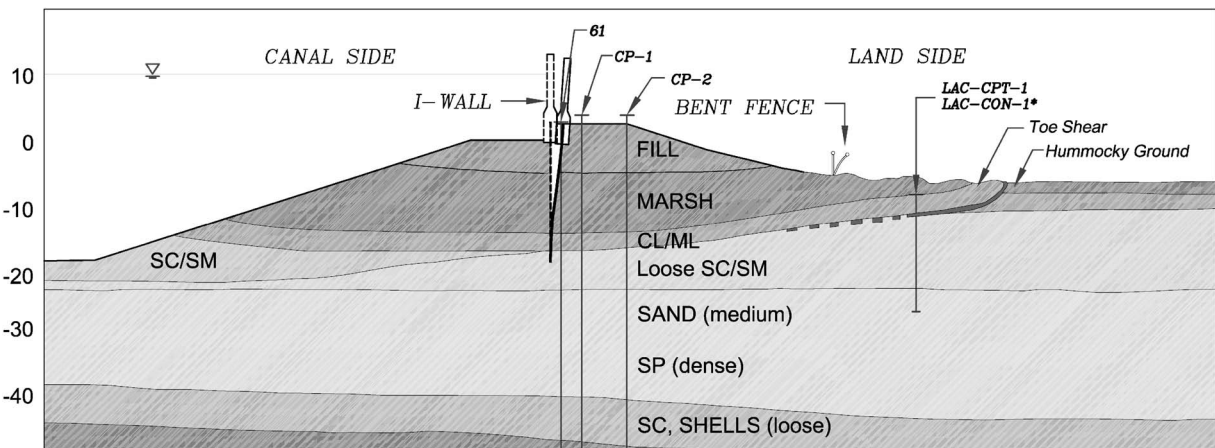
Fig. 10 presents a cross section showing the similar soil conditions at the east bank distressed section. As displacements were small, both the “before” and “after” displacements are shown in Fig. 10 for clarity. Conditions at this east bank section represent an incipient failure (or distress condition), but the movements were arrested when the west bank section failed first (and drew down the canal water elevation to a safer level). The levee embankments consisted of moderately compacted clay fills, and were underlain by local marsh deposits consisting of variably interbedded peaty materials and clays. These marsh deposits were underlain by a relatively thin stratum of gray, paludal clays (CH). As was discussed in the previous section, a prominent “buried sand ridge” underlies these sites at shallow depths, so that the relatively thin veneer of low permeability marsh and clay deposits is underlain by significant thicknesses of more pervious sandy soils on both sides of the canal. Although the marsh deposits and the paludal clays are both relatively weak, these strata do not appear by themselves to have been the cause of the failure (and near-failure) that were observed. Calculated minimum factors of safety for slippage along shear surfaces passing mainly through these marsh and clay strata were significantly higher than for

Fig. 10. Cross section at the “distressed” levee and floodwall section on the east bank of the London Avenue drainage canal, which shows partial wall deflection and minor lateral slippage at the inboard side levee embankment toe

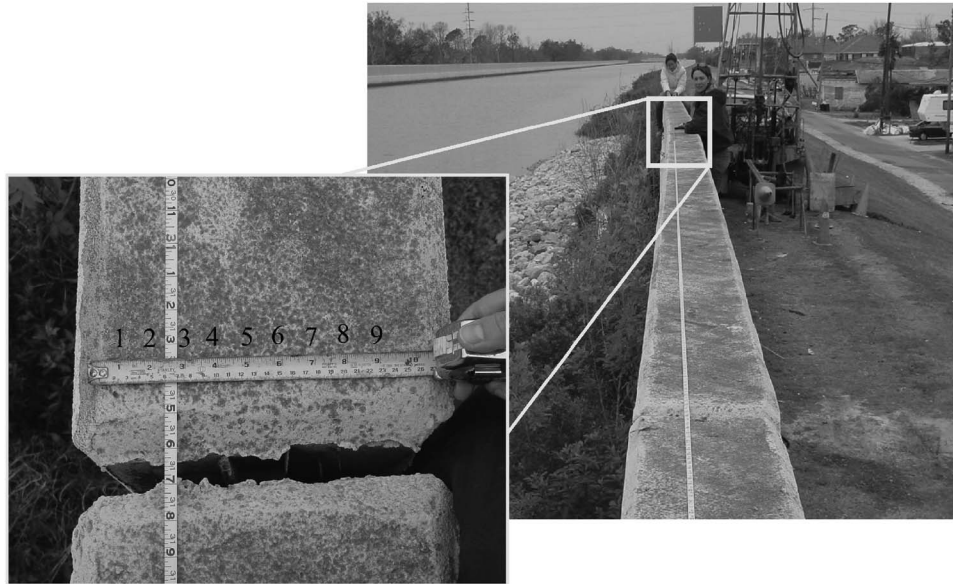
Fig. 15. Lateral displacement of 3 in. at top of distressed I-wall section on the west bank of the 17th Street drainage canal, directly across from the large failure (and breach) on the east bank

One of the important little-recognized events during Hurricane Katrina was the near failure of the levee and floodwall section on the west bank of the 17th Street drainage canal, directly across from the large failure on the east bank that was described earlier. This west bank section suffered lateral displacements of several inches, and our (ILIT) analyses showed that this west bank section also came perilously close to failure. The near failure of this

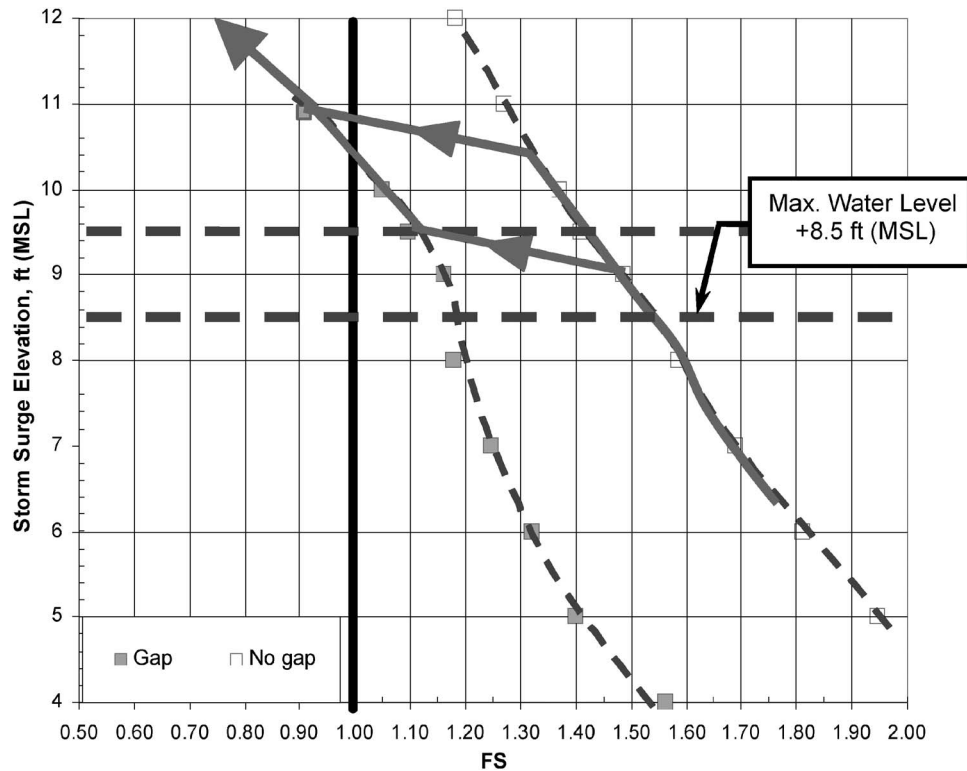
Fig. 17. Evolution of calculated factor of safety versus canal water level for the distressed section on the west bank of the 17th Street drainage canal

Finally, it should also be noted that the design at this west bank distressed section was targeted to produce a minimum factor of safety of at least $FS \geq 1.3$ for a design canal water elevation of at least +12.5 ft (MSL). As shown in Fig. 17, the design failed to achieve this by a considerable margin.
