March/April 2006

Geo-Strata

Lessons Learned from the St. Francis Dam Failure

By J. David Rogers, Ph.D., P.E., P.G., M.A.S.C.E.

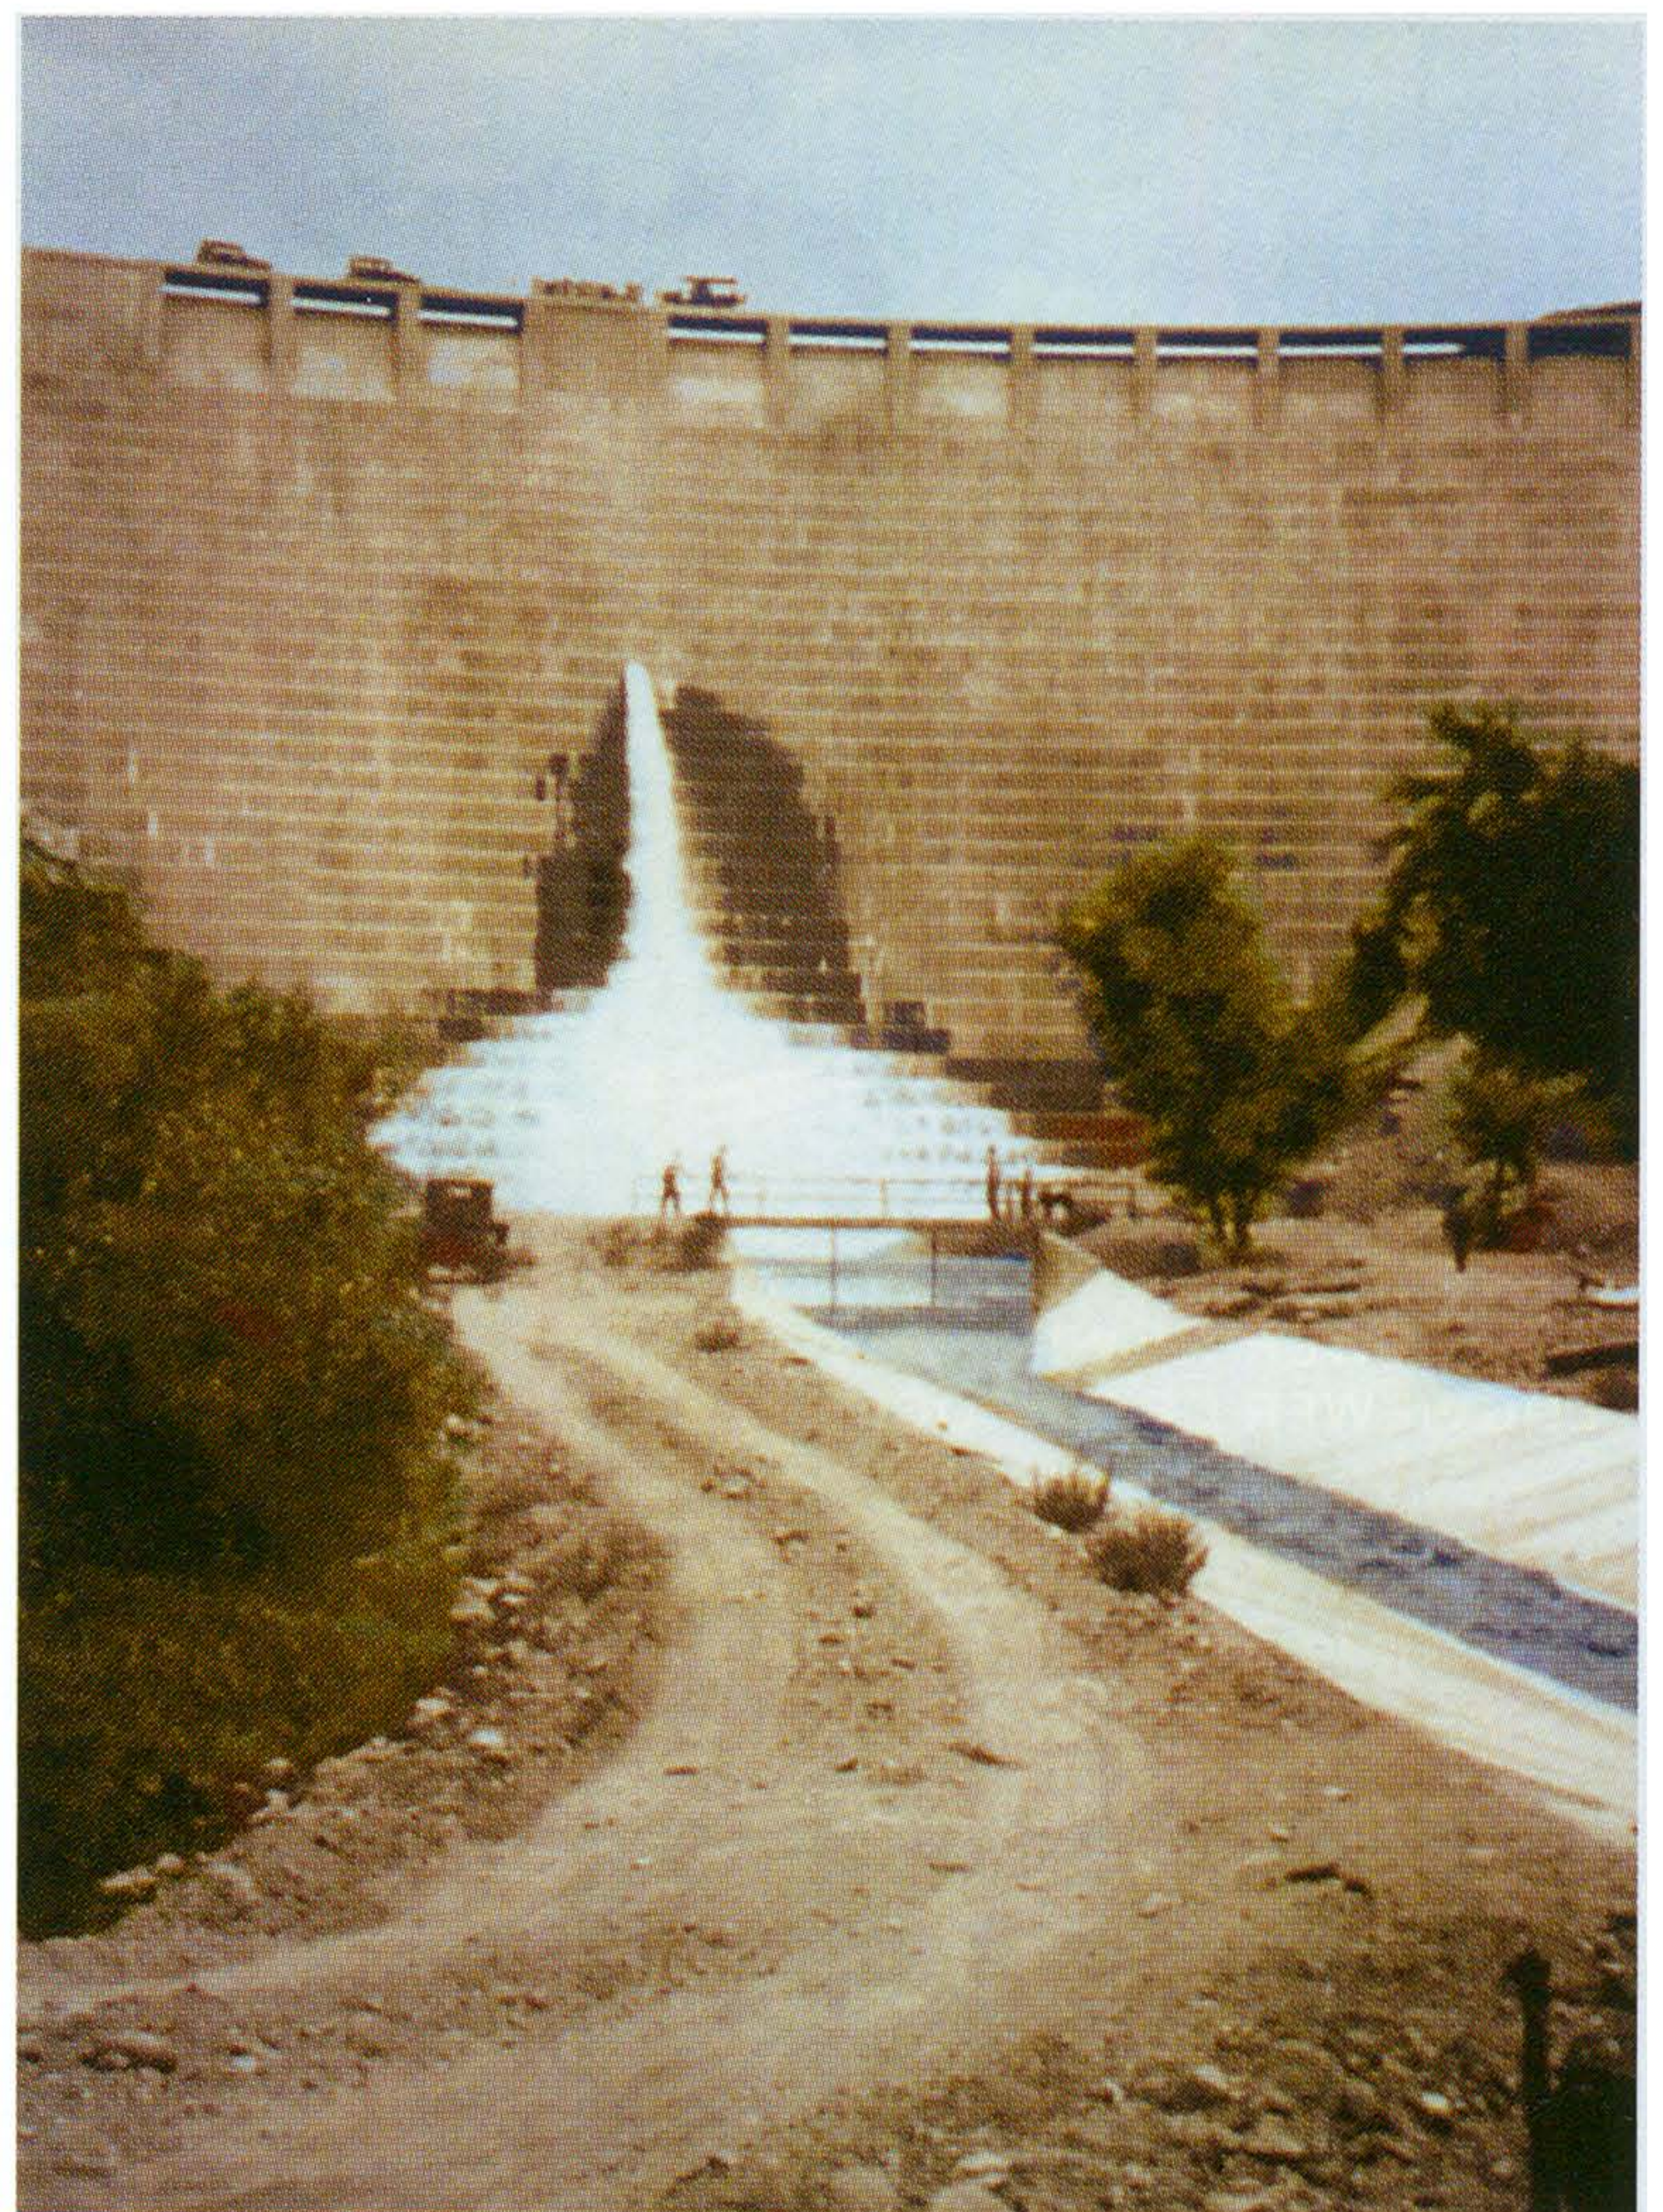
Figure 1. St. Francis Dam was a curved concrete gravity arch structure 209 feet high, constructed between April 1924 and May 1926 (W.L. Huber Collection, U.C. Water Resources Center Archives, Berkeley, colorized by P. Horton).

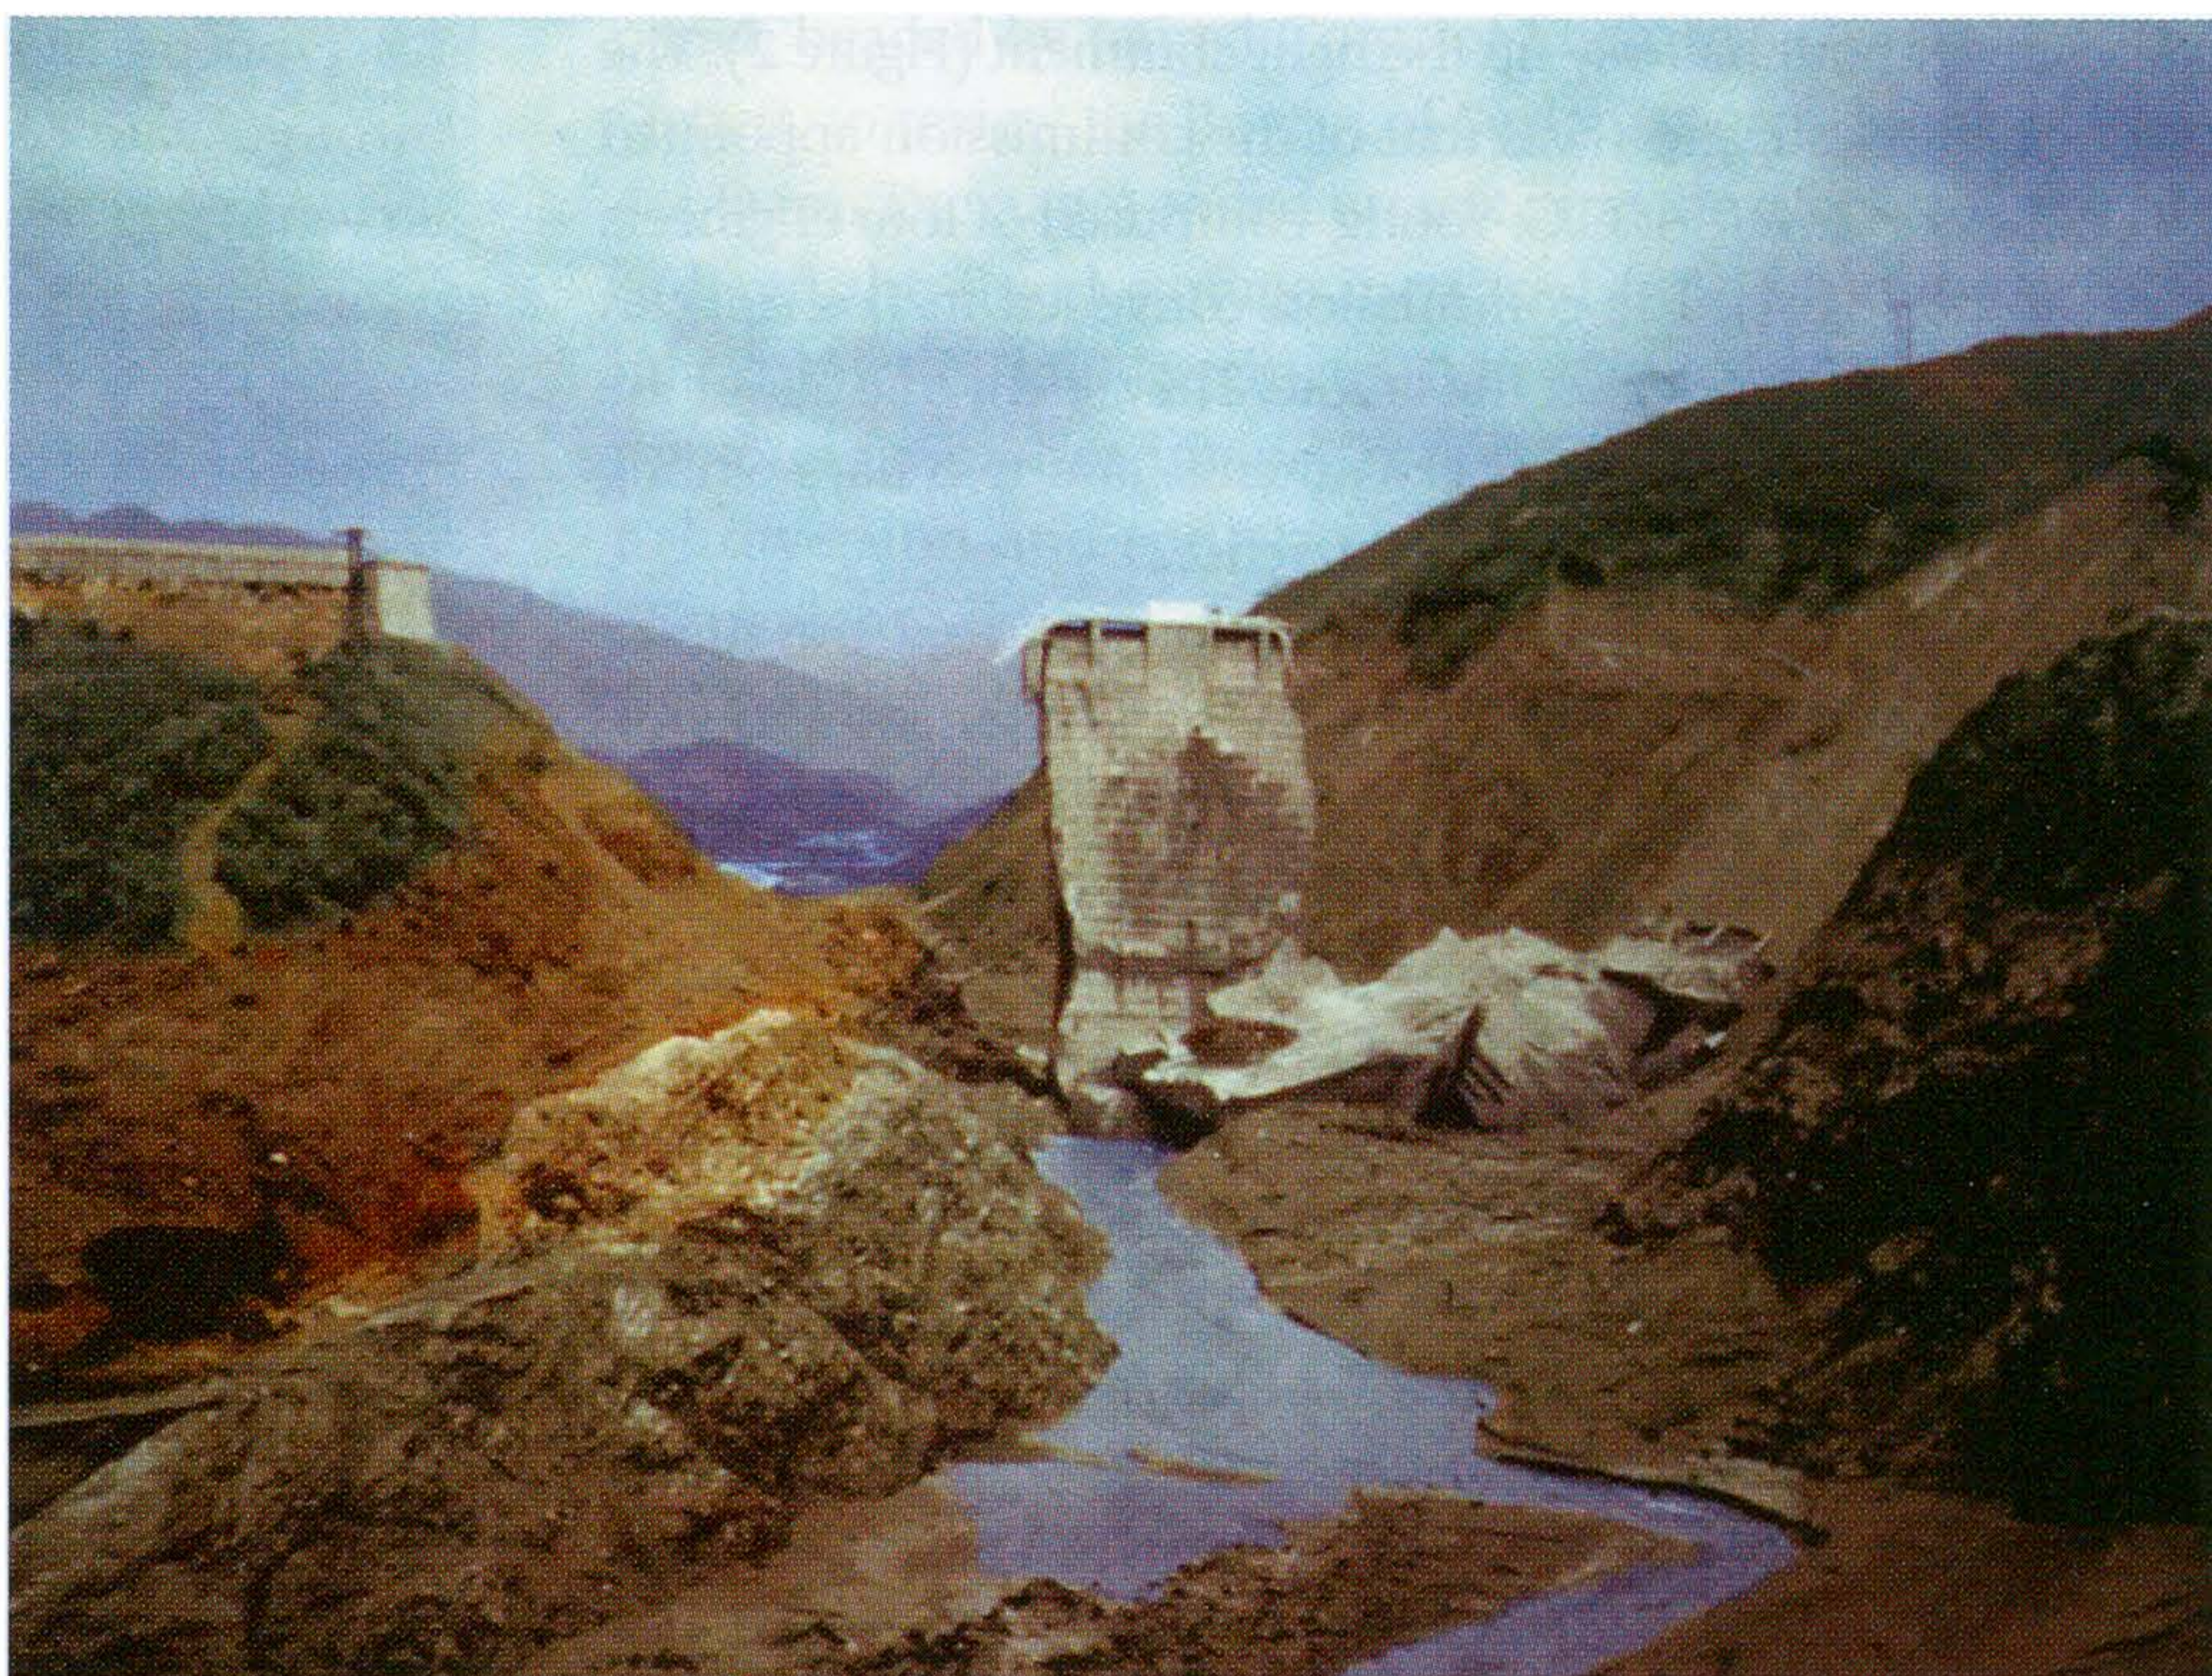
The dam failed catastrophically just before midnight on March 12, 1928, killing nearly 450 people. A dozen panels were appointed to investigate the failure by various agencies and interested parties. They pointed to the dam's inadequate foundation as the culprit—specifically, the tendency of the Vaqueros formation to slake profusely upon saturation, and alleged hydraulic piping of this material along the San Francis-

Figure 2. Ground view looking upstream at remains of the St. Francis Dam after its untimely failure in March 1928. Note the dramatic fault contrast between the Vasquez conglomerate at extreme left with the silvery Pelona Schist. The San Francisquito fault pierced the dam's right abutment and was blamed for the dam's collapse (C.H. Lee Collection, U.C. Water Resources Center Archives, Berkeley, colorized by P. Horton).

quito fault, about halfway up the right abutment (Figure 2). The most cited investigation was that of the commission appointed by California Governor C.C. Young, comprised of four engineers and two geologists. The commission convened in Los Angeles on March 19—a week after the failure. They spent one day at the dam site, two days reviewing documents, and two days writing its report, which was released on March 27.

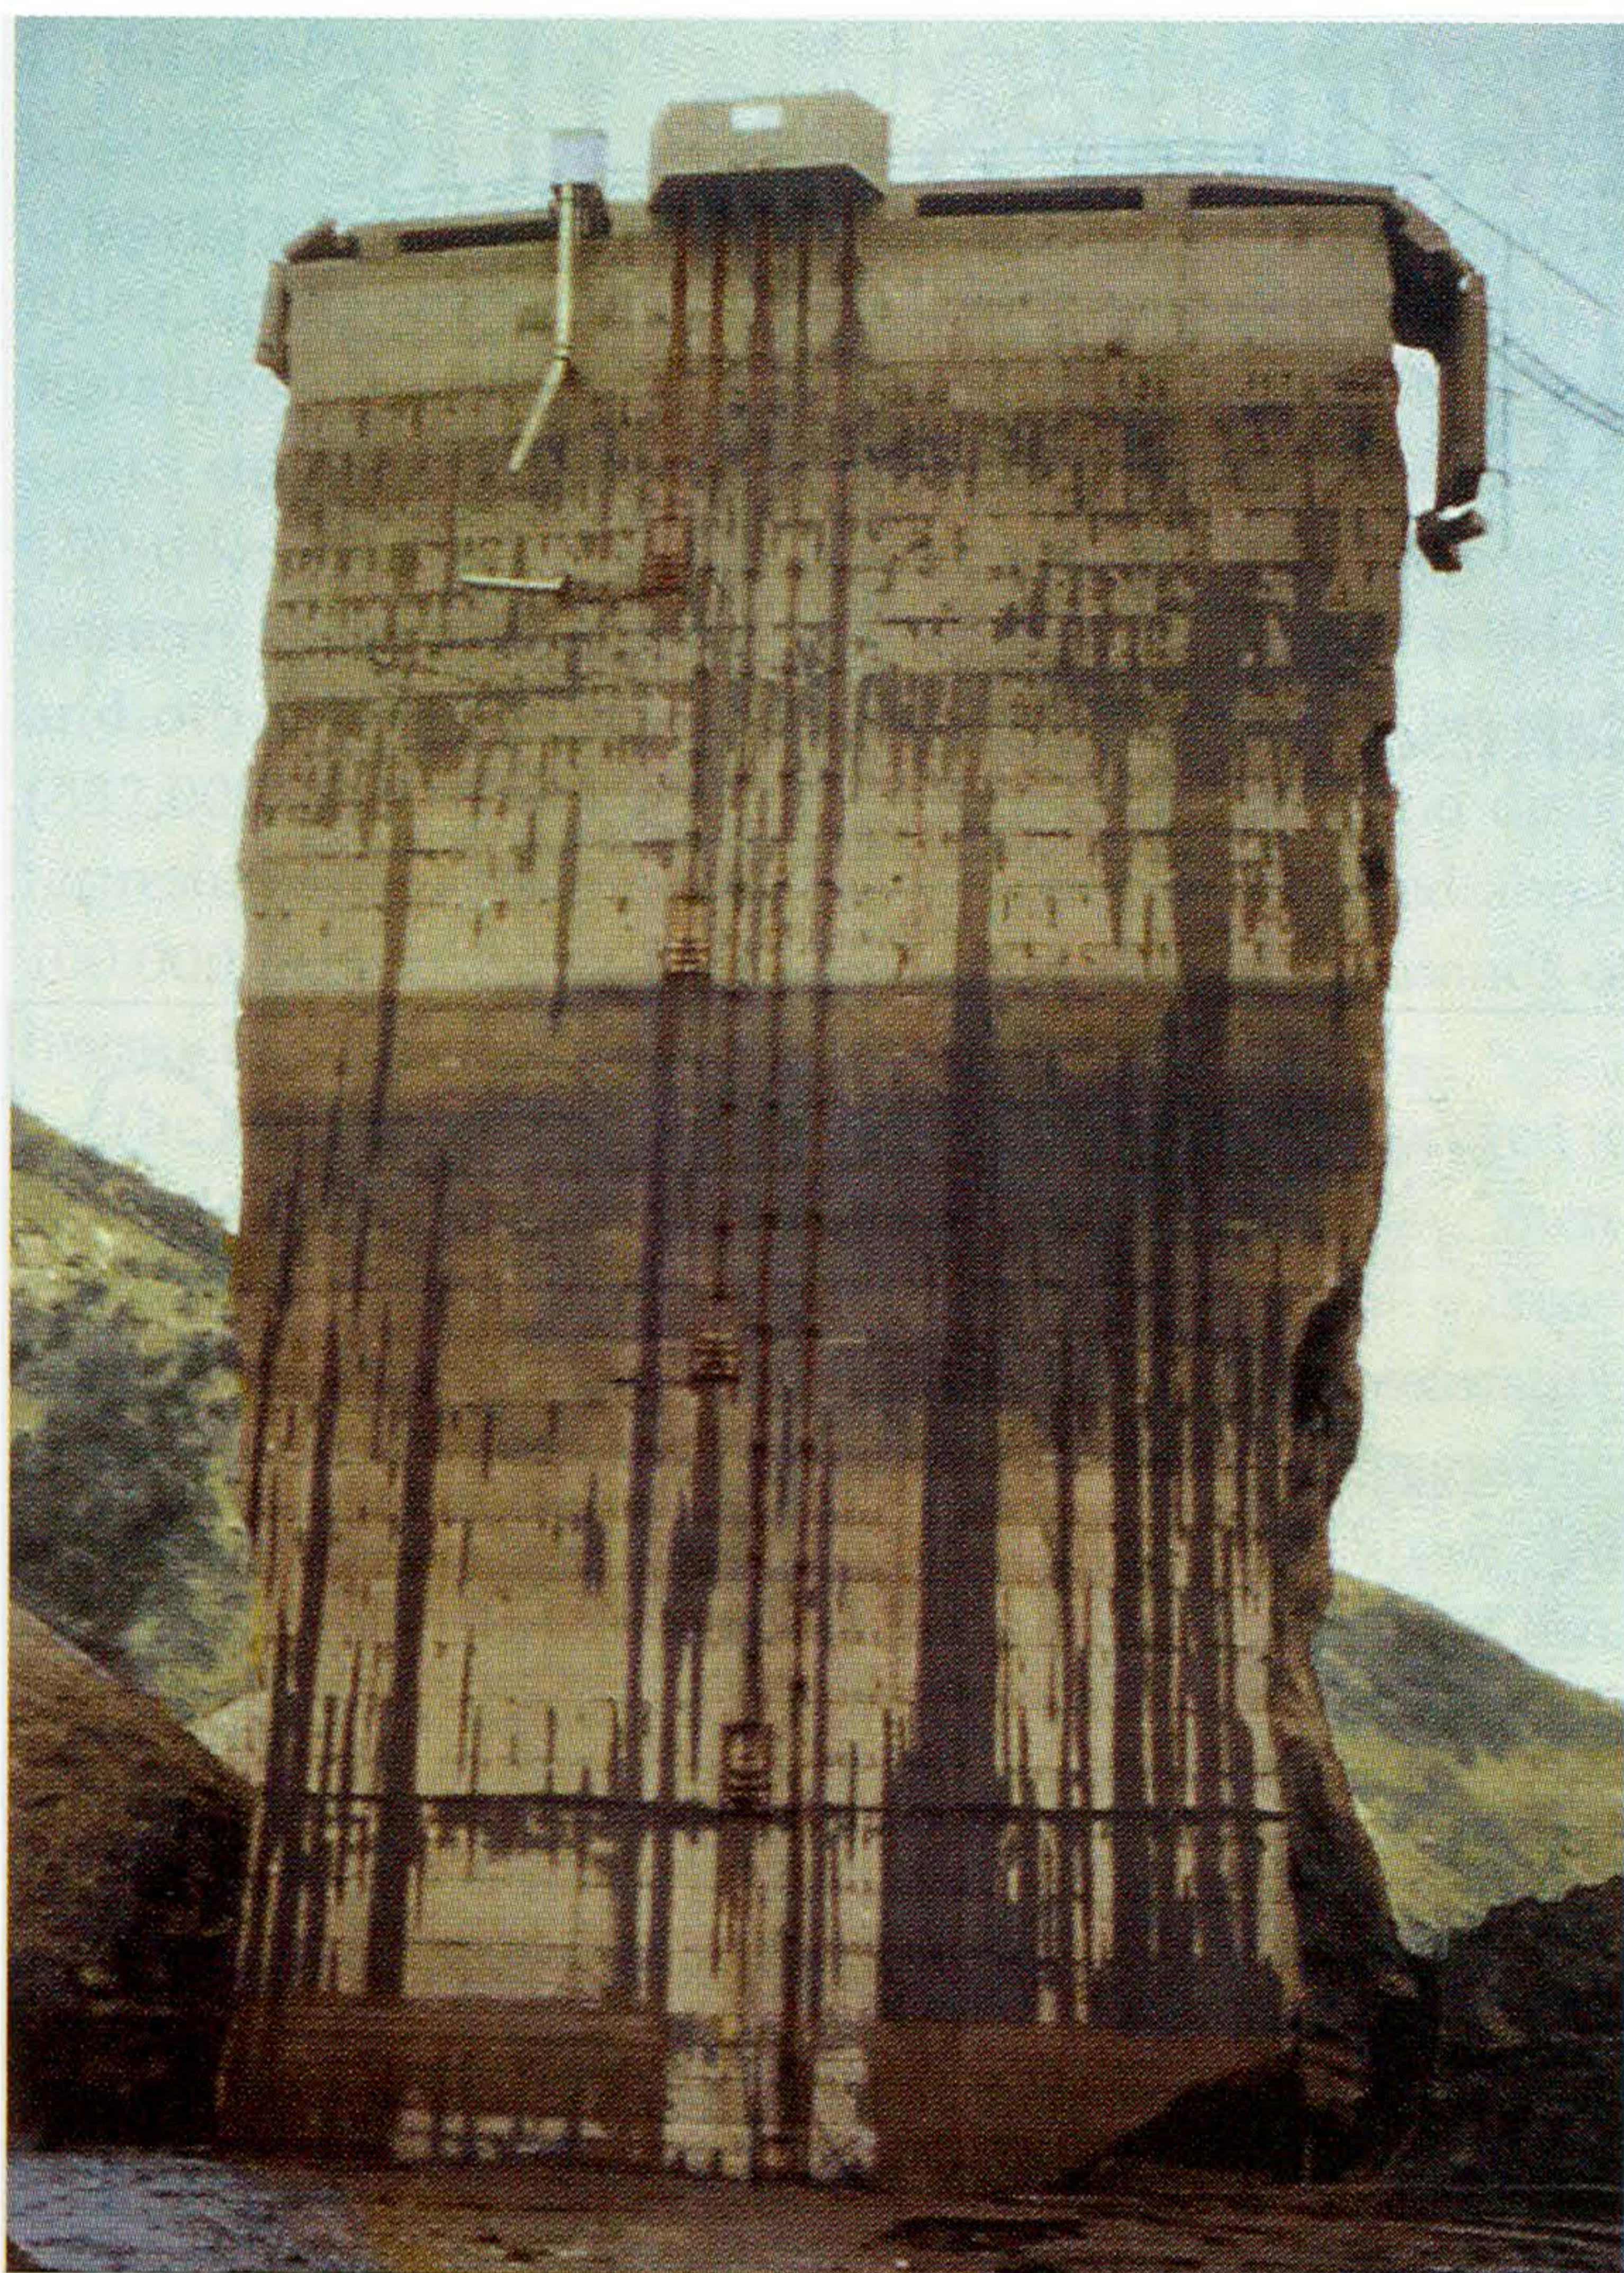
Subsequent studies I have made suggest that the dam's untimely demise was more complex than originally thought, involving the partial reactivation of an ancient bedrock landslide which comprised the dam's entire left abutment. A Stevens Water Stage Recorder on the dam's surviving central block (Figure 3) recorded a slight drawdown of the reservoir pool from 8:00 pm onward, which dropped with increasing severity during the last 40 minutes of the record. The 1928 investigations assumed the gage recorded simple outflow, but post-failure images show a massive tension crack at the dam's upstream heel, containing the gage attendant's wooden access ladder (Figure 3). This suggests that the dam's heel was in tension and tilting downstream when the dam failed. After the failure, Mulholland testified that the factor of safety against overturning "was in excess of 4," but the repeated heightening of the dam without commensurate increases in the base width created a dangerous situation. A simple check of full

reservoir pressure inside the heel crack shows that the overturning factor of safety would have been reduced to 0.77! The Stevens Gage actually recorded a half degree of cantilever tilt, which I confirmed using a 2D finite element model.

Figure 3. Upstream face of the remaining portion of St. Francis Dam, after the failure. The broken Stevens Gage can be seen near the crest, bent towards the left abutment, indicating out-rushing water flow in that direction. A prominent crack up the upstream heel is seen at lower right hand side (C.H. Lee Collection, U.C. Water Resources Center Archives, Berkeley, colorized by P. Horton).

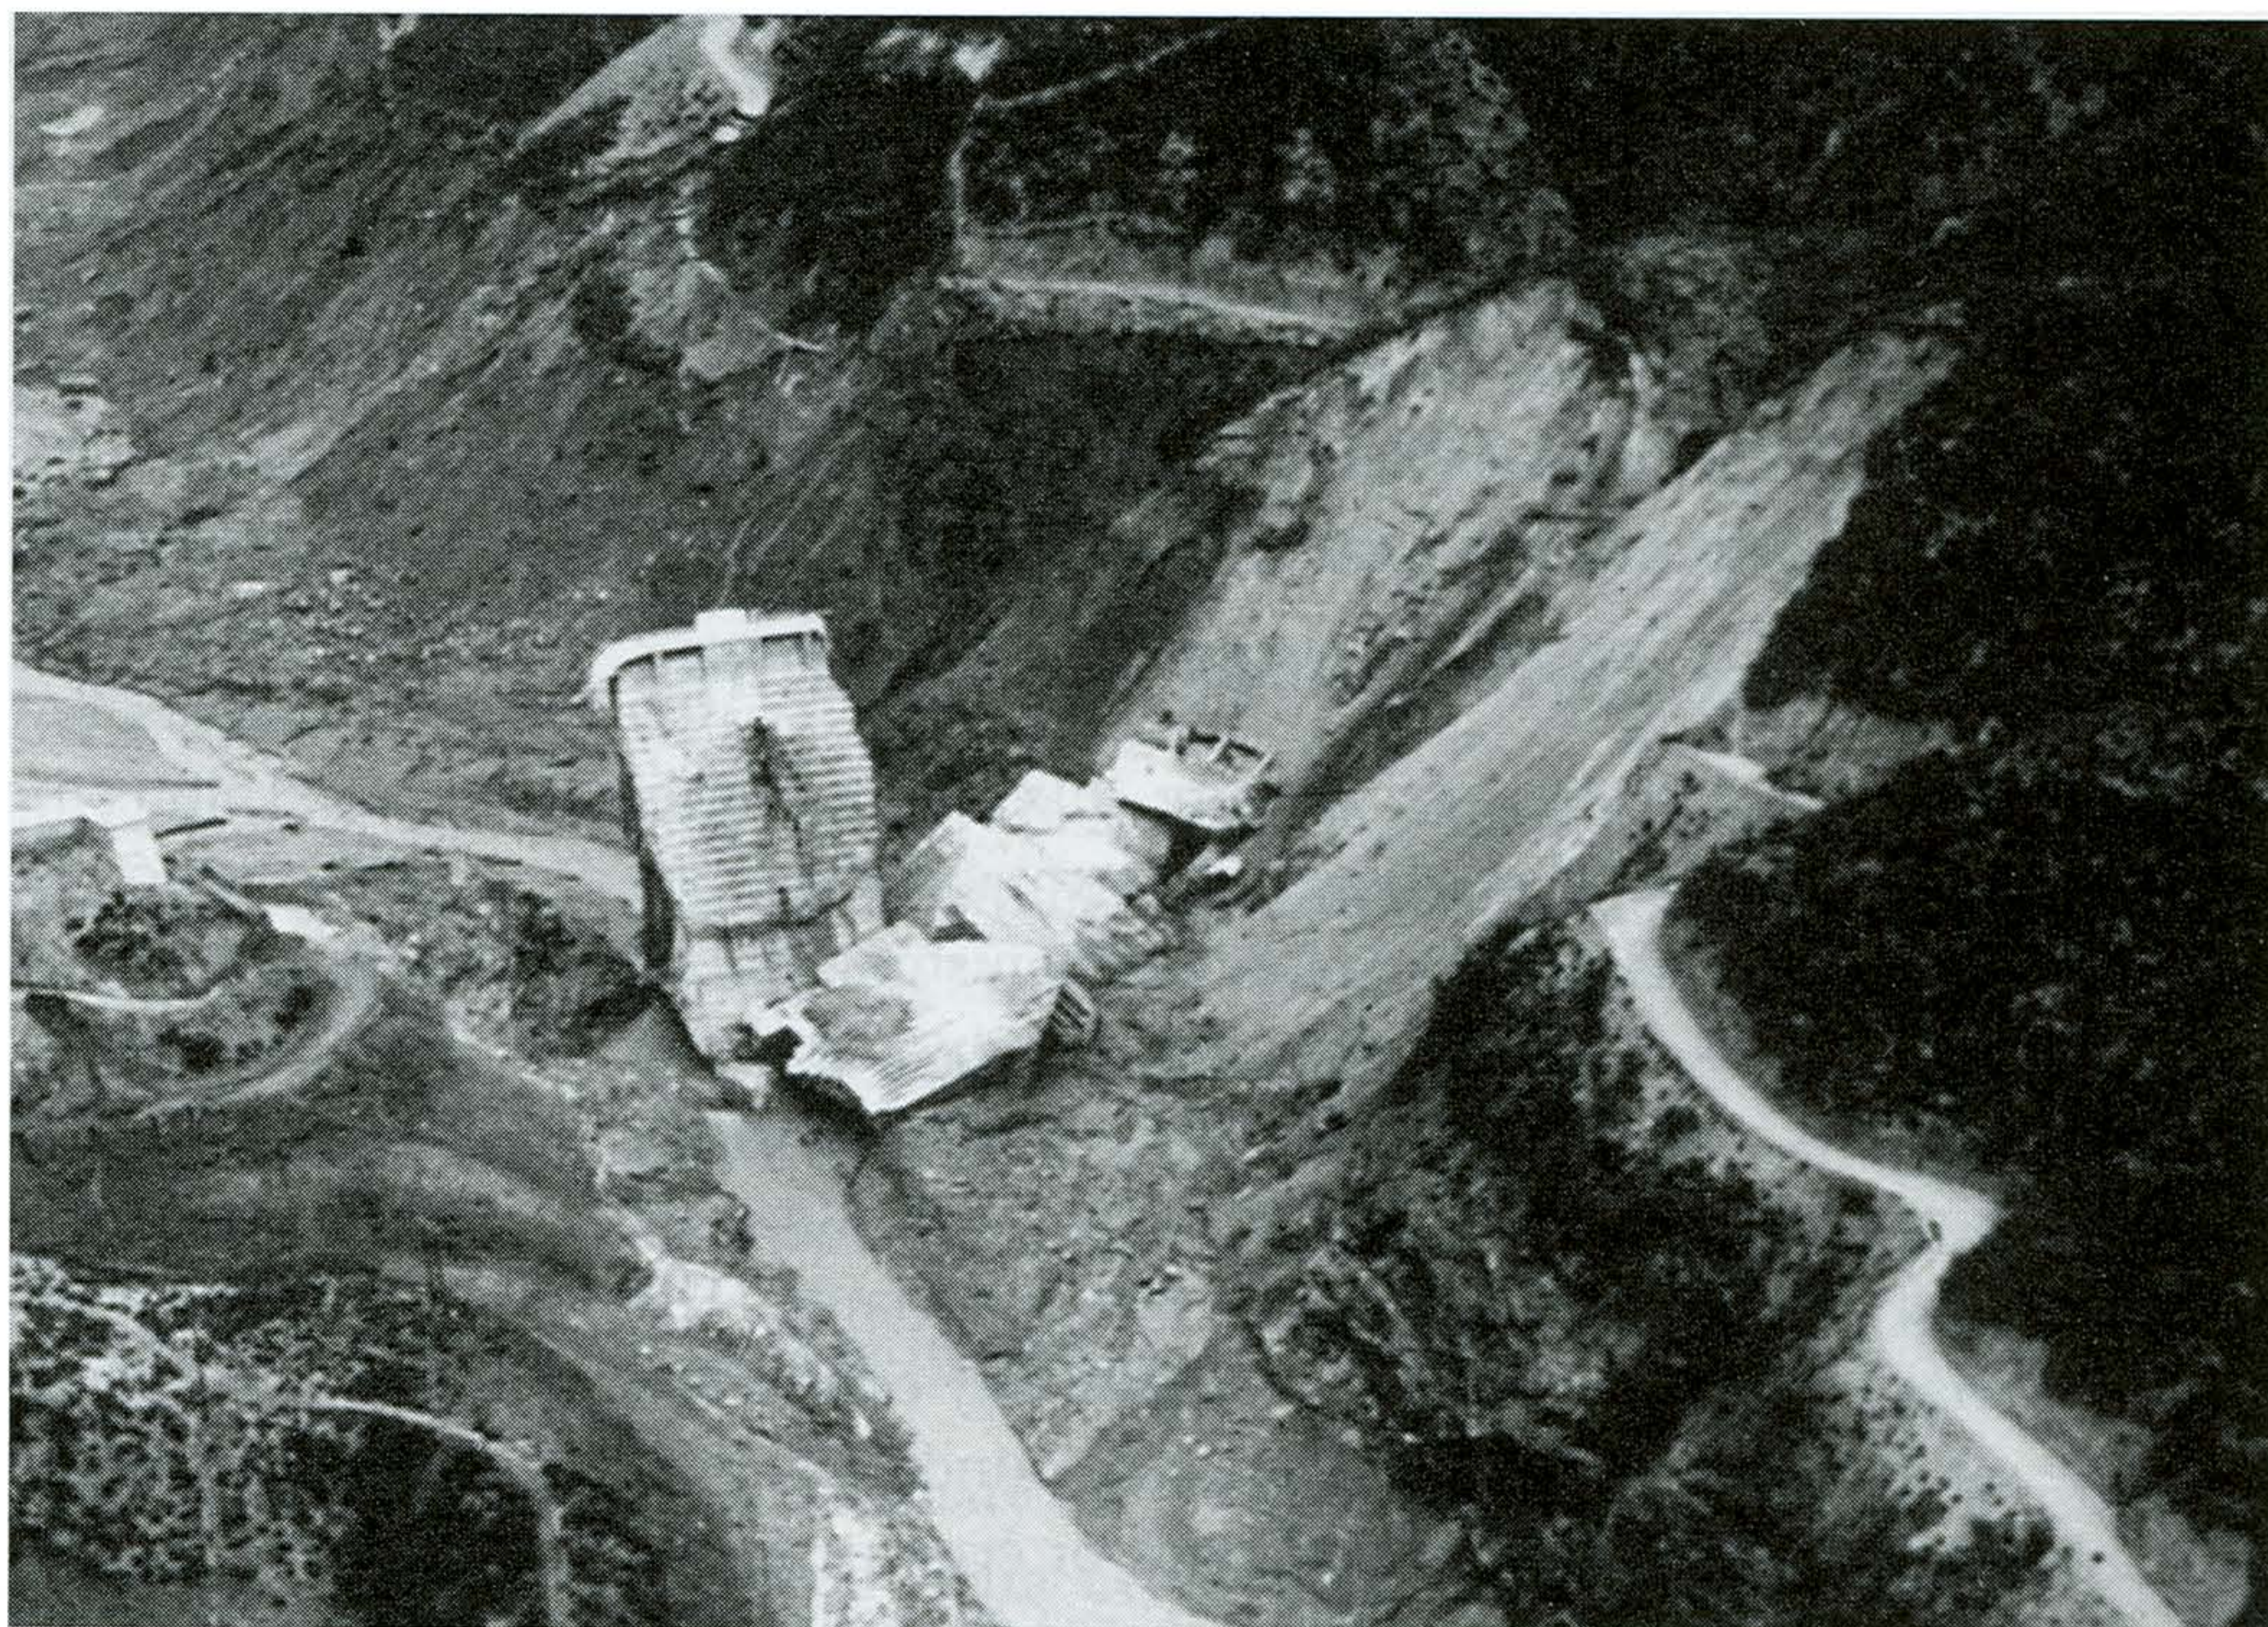
Southern California Edison County's 70 KV Lancaster power line ran along San Francisquito Canyon, past the dam. It was destroyed at 11:57-1/2 pm where it crossed the dam's left abutment 40 ft above the dam crest. Physical evidence suggests that the entire left abutment detached itself as a massive landslide carrying a portion of the dam on 700,000 yd³ of schist (Figure 4). This formed a temporary landslide dam which the outpouring reservoir quickly enlarged, reaching a peak outflow of about 1.7 million cfs.

Figure 4. Aerial oblique view of the St. Francis Dam failure taken the following morning, looking upstream. the left abutment landslide is clearly visible, extending almost 200 feet above the reservoir pool elevation (Spense Aerial Photo Collection, UCLA Geography Department).
