THE ST. FRANCIS DAM FAILURE

**worst American civil engineering
disaster of the 20th Century**

J. David Rogers, Ph.D., P.E., P.G., C.E.G., C.HG.

Shlemon Specialty Conference

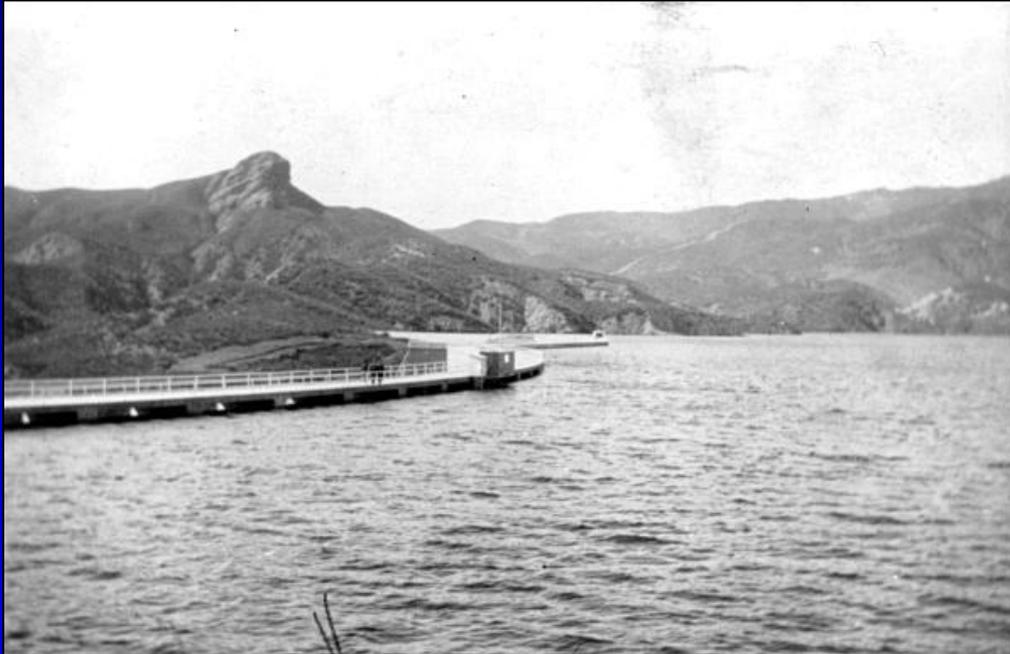
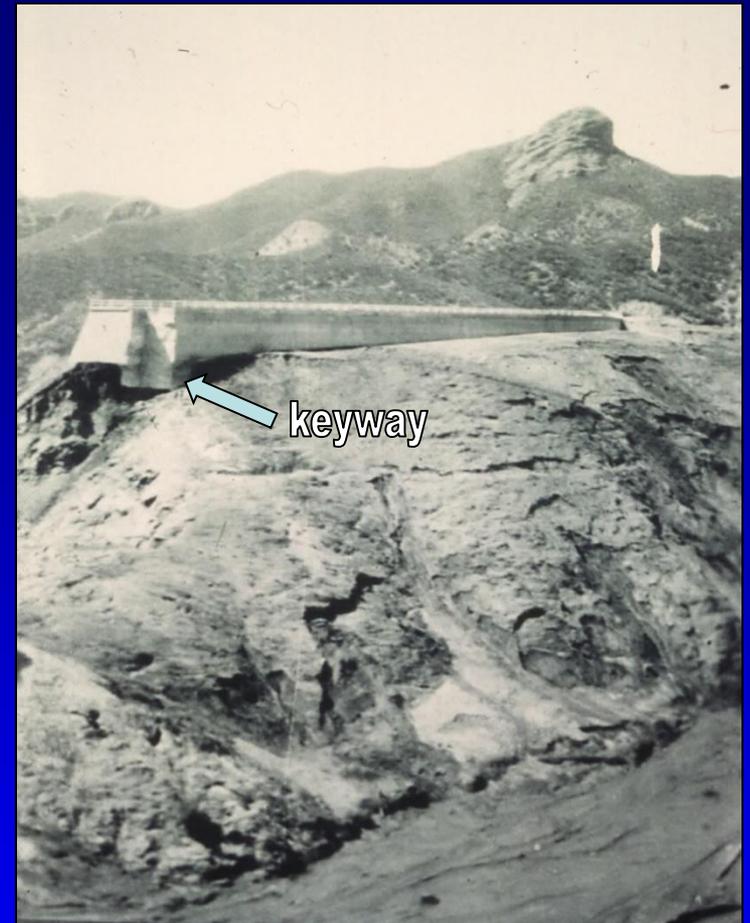
- Comparative views taken of the dam's upstream face looking at the right abutment 12 hours before the failure (at left) and the day after (right)
- Note exposed keyway beneath right abutment dike

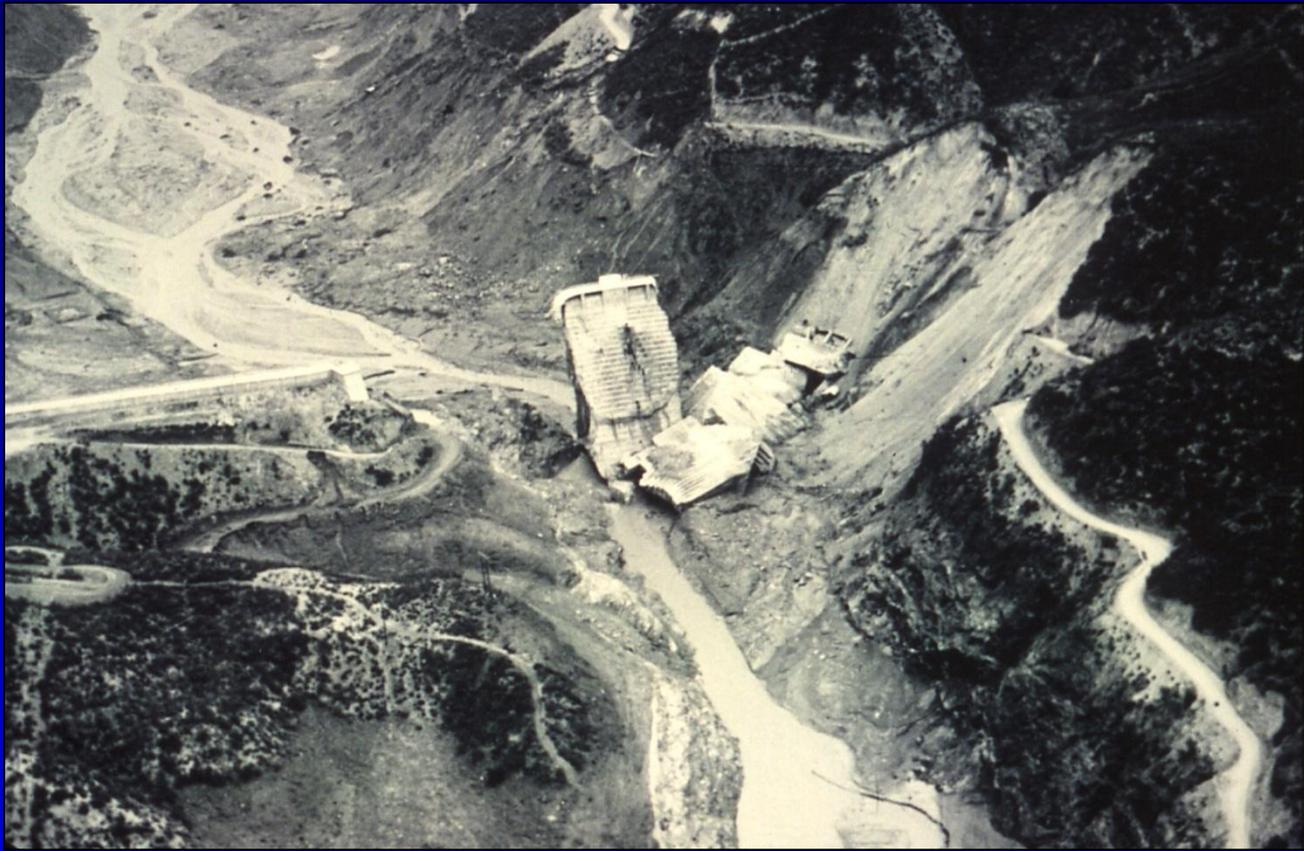
- **Aerial oblique view of the dam site the morning after the failure, taken by Spence Aerial Surveys.**
- **Note the enormous landslide on the dam's left abutment, truncating San Francisquito Canyon Road, at extreme right**

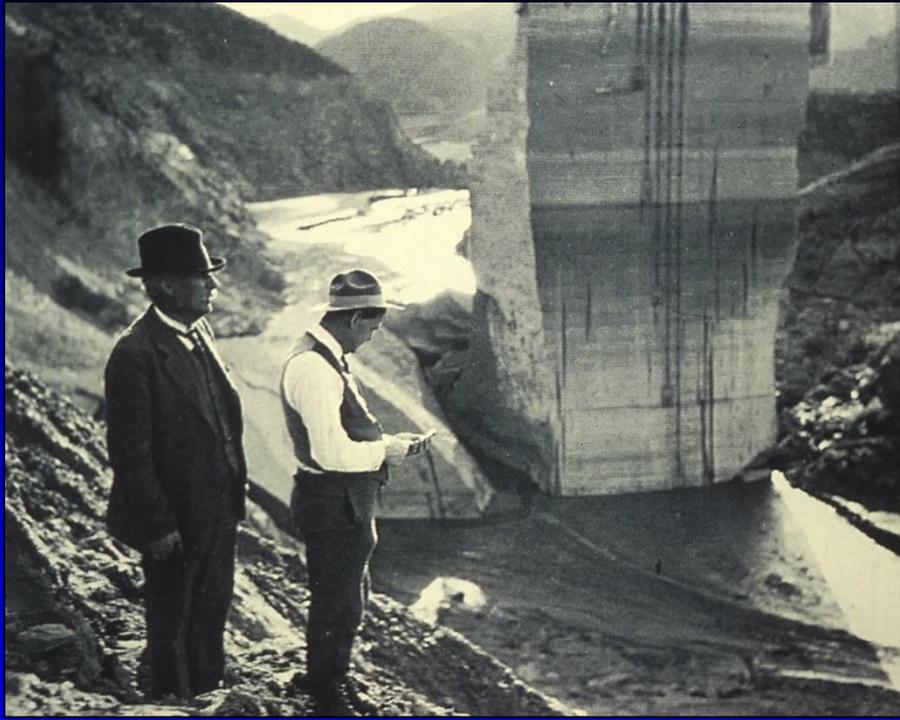
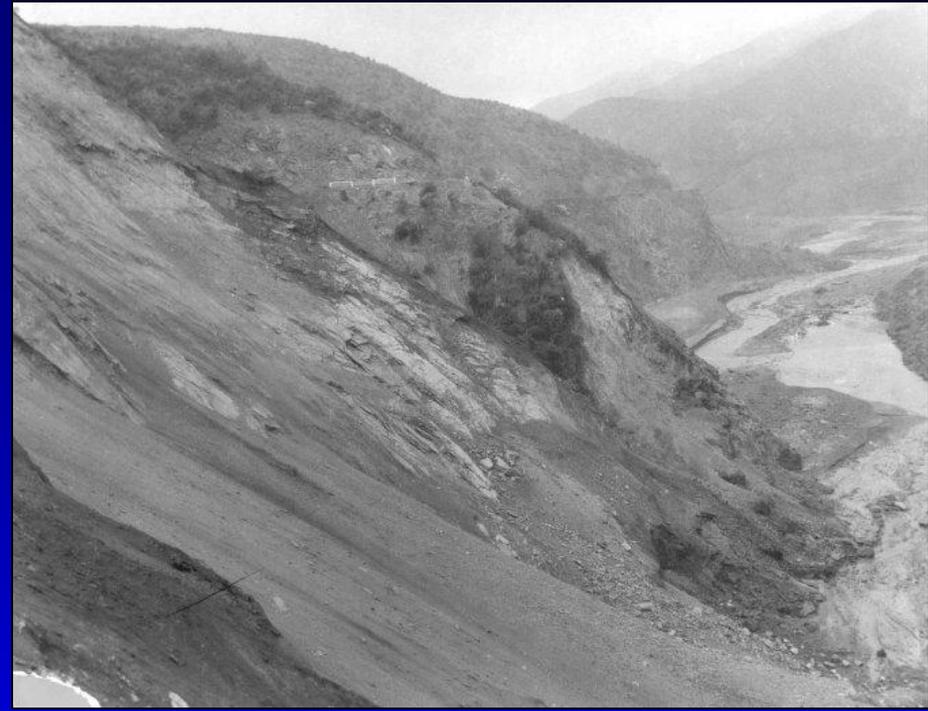
- **William Mulholland and his assistant Harvey Van Norman view the dam site from several hundred yards upstream the morning after the failure (left).**
- **The massive void left by the left abutment landslide is seen at right. Between 40 and 80 vertical feet of the dam's left abutment was eroded by the outpouring waters of the reservoir.**

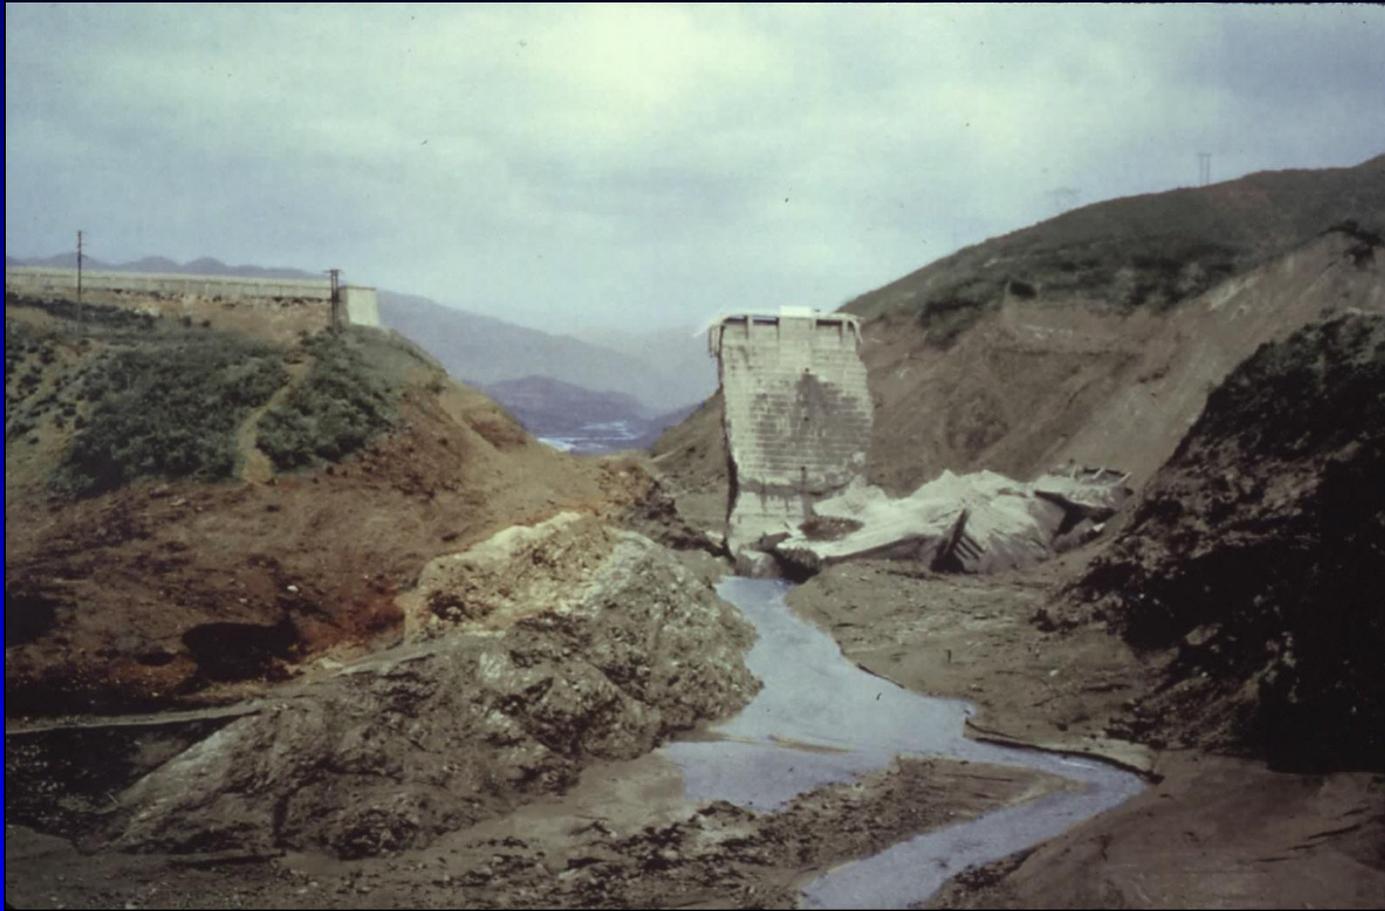
- **A colorized image of the St. Francis failure by Pony Horton, showing the color contrast between the red beds of the Vasquez [Sespe] conglomerate (at left) and the grey colored Pelona Schist (at right)**

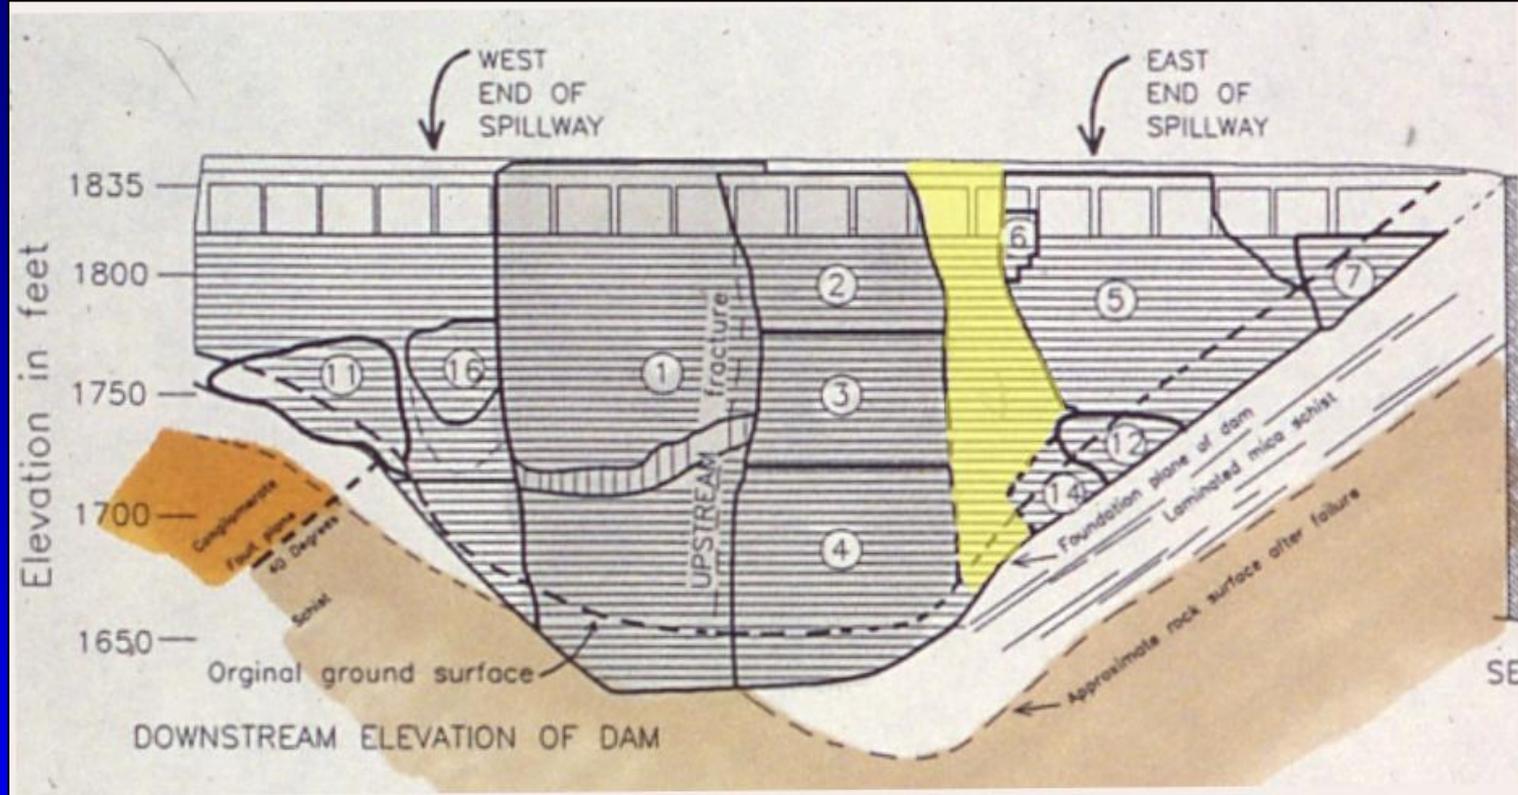
- The portion of the dam between Blocks 2/3/4 and 5/6/7 (shown in yellow) was not identified in the debris field until months later.
- This was referred to as the “*missing section*”

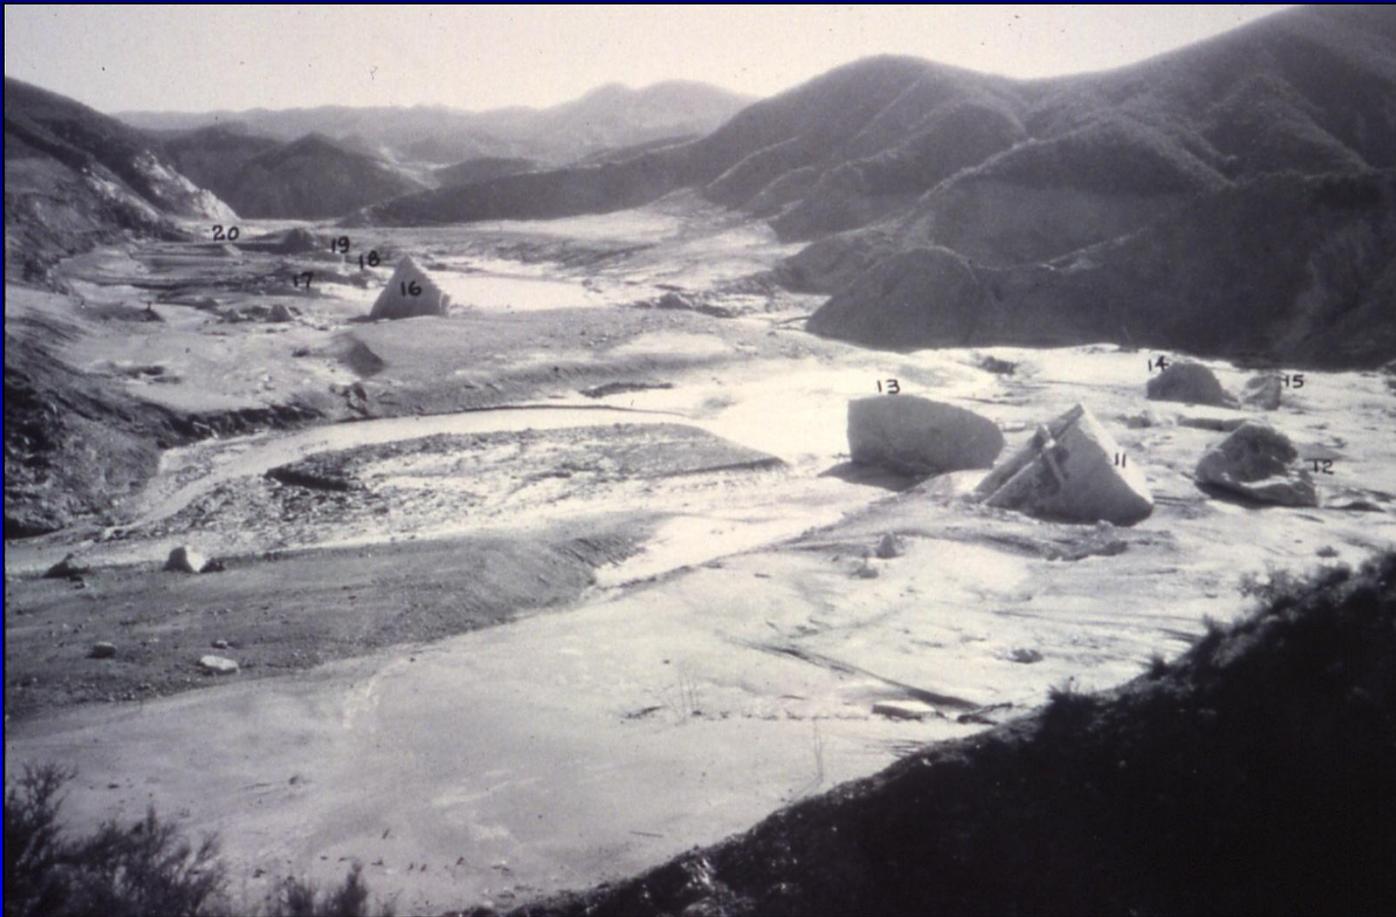
- One of the shortcomings of the plane table map of the displaced blocks was that it *did not include the relative elevations* of the objects. Blocks 12 and 14 from the base of the left abutment were located 26 feet higher than Block 16 and well off the right side of the channel. Block 11 may have helped form a dam with Blocks 12 and 13 that deflected subsequent flows off to the left, where Block 16 was found, further downstream.

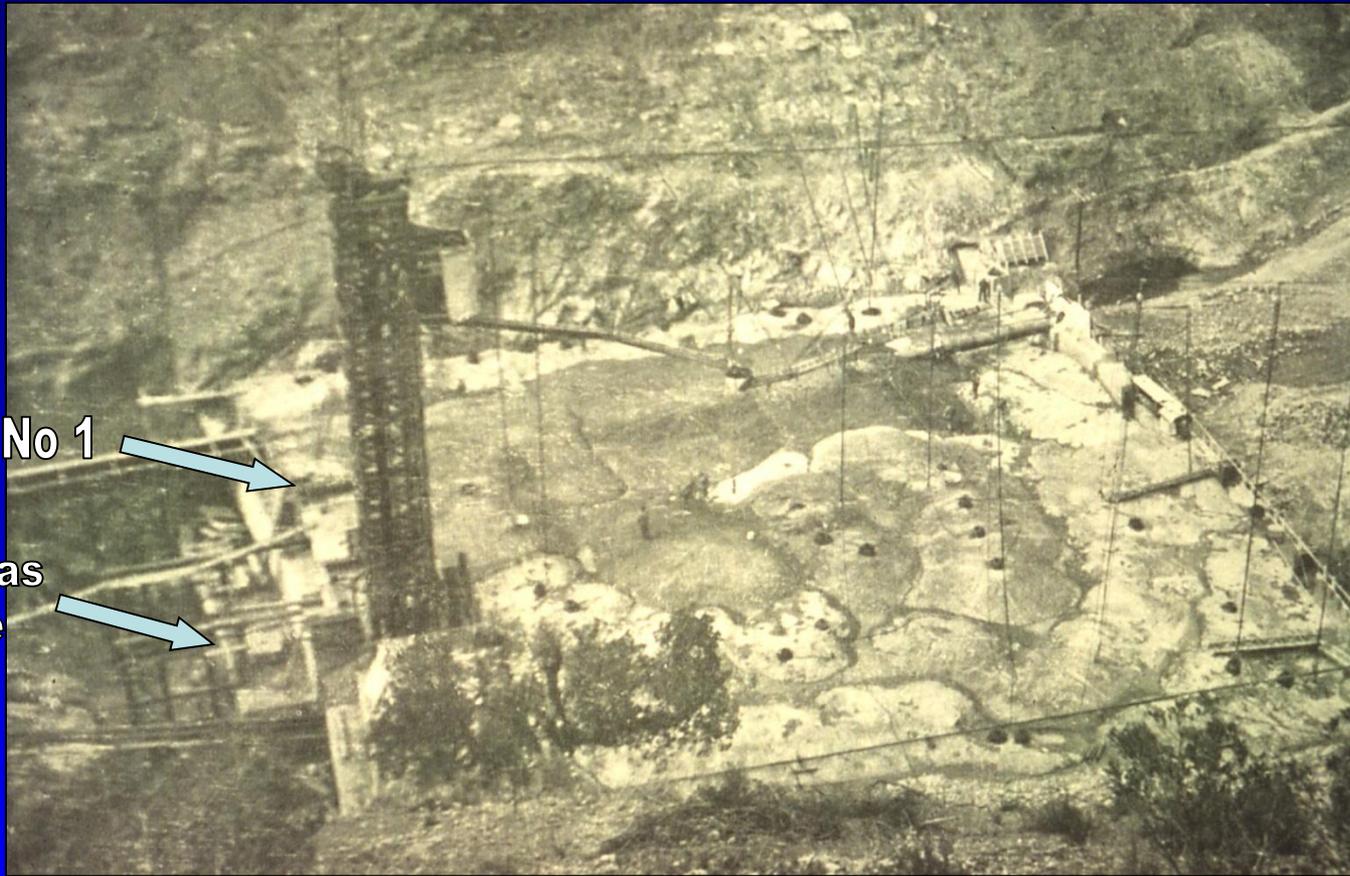
Outlet Pipe No 1

Last step was
very wide

- Charles Outland discovered inconsistencies with the City's official cross section when he examined this construction photo, which clearly shows a 'chopped' downstream toe, beginning at Elevation 1650. This suggests that the base was ~152 ft wide instead of the 176 feet shown on the design section given to the Governor's Commission.

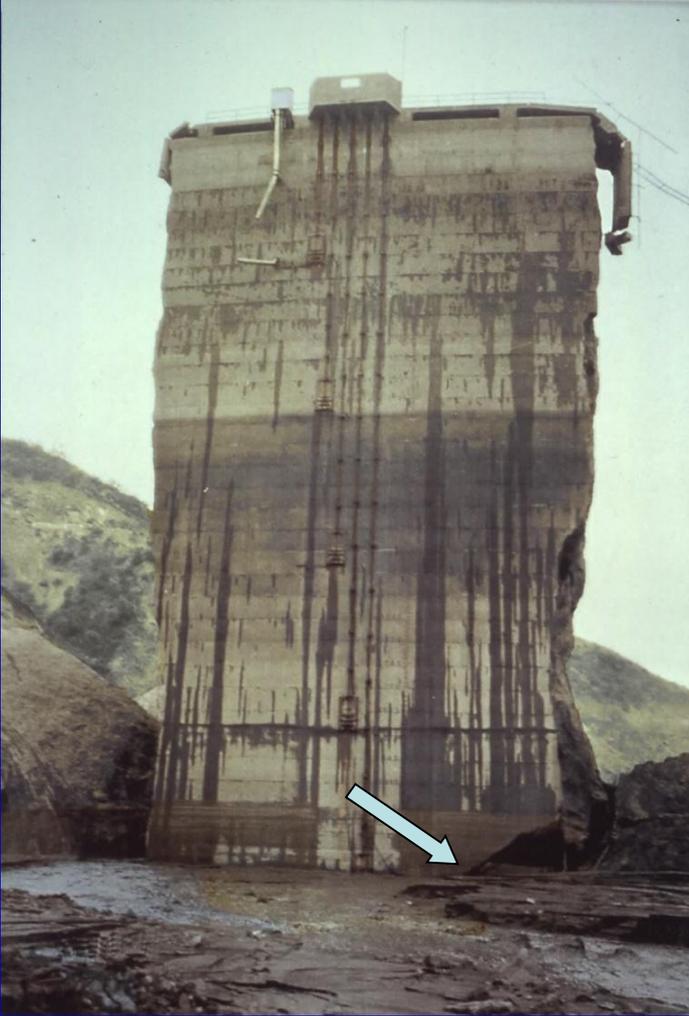
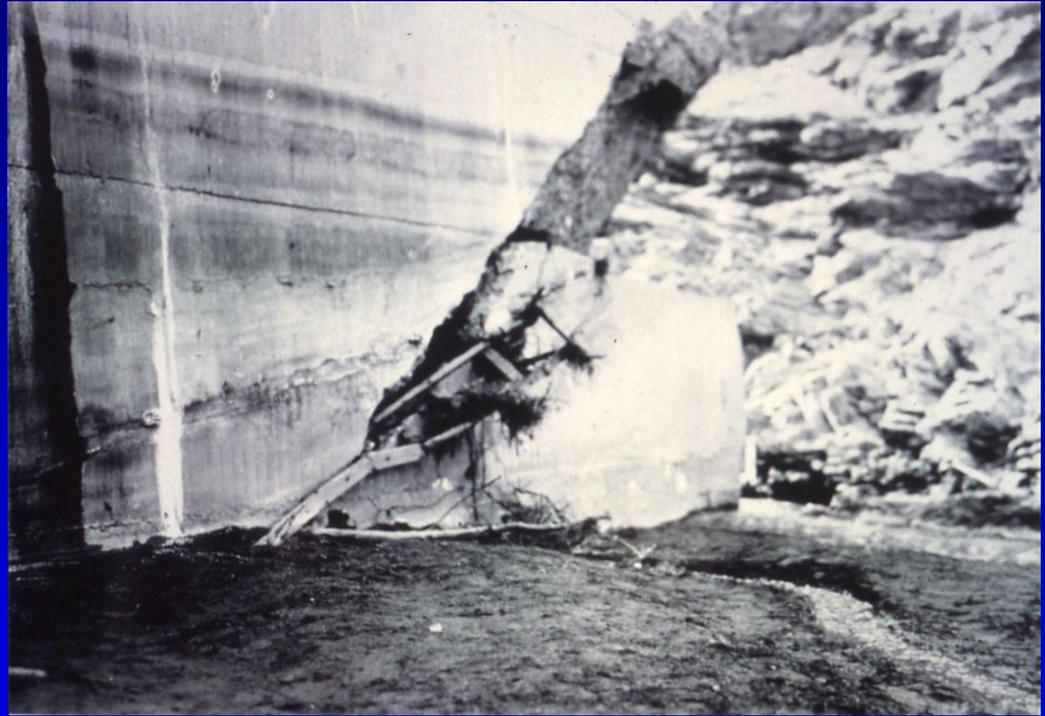
- **San Francisco engineer Carl Grunsky discovered the crushed remains of the wooden stage recorder ladder wedged in a tension crack at the dam's upstream heel. This testifies to the heel having been in tension, which would cause cantilever instability. Grunsky was an engineer of equal, or even greater, renown as Mulholland .**

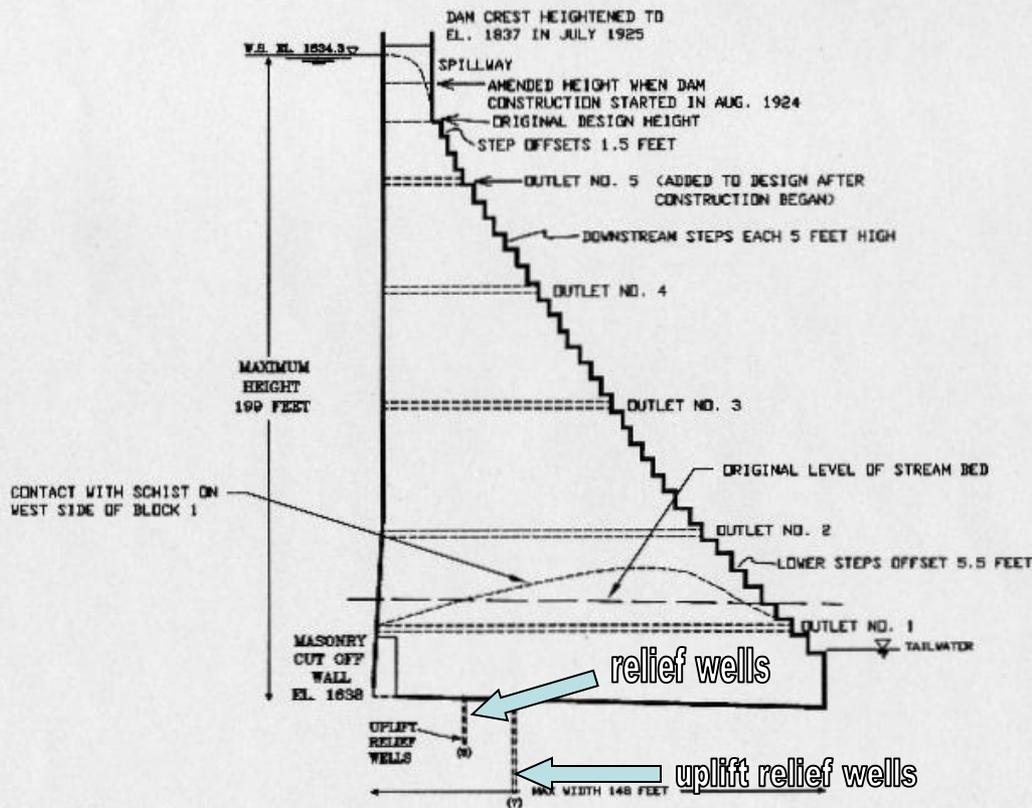
ELEVATION VIEW OF ST. FRANCIS DAM
TAKEN THROUGH SURVIVING BLOCK 1

- The main section of the St. Francis Dam was constructed with 10 uplift relief wells set in two rows, as shown above. This portion of the dam did not fail, only the sloping abutments, which did not have uplift relief wells.

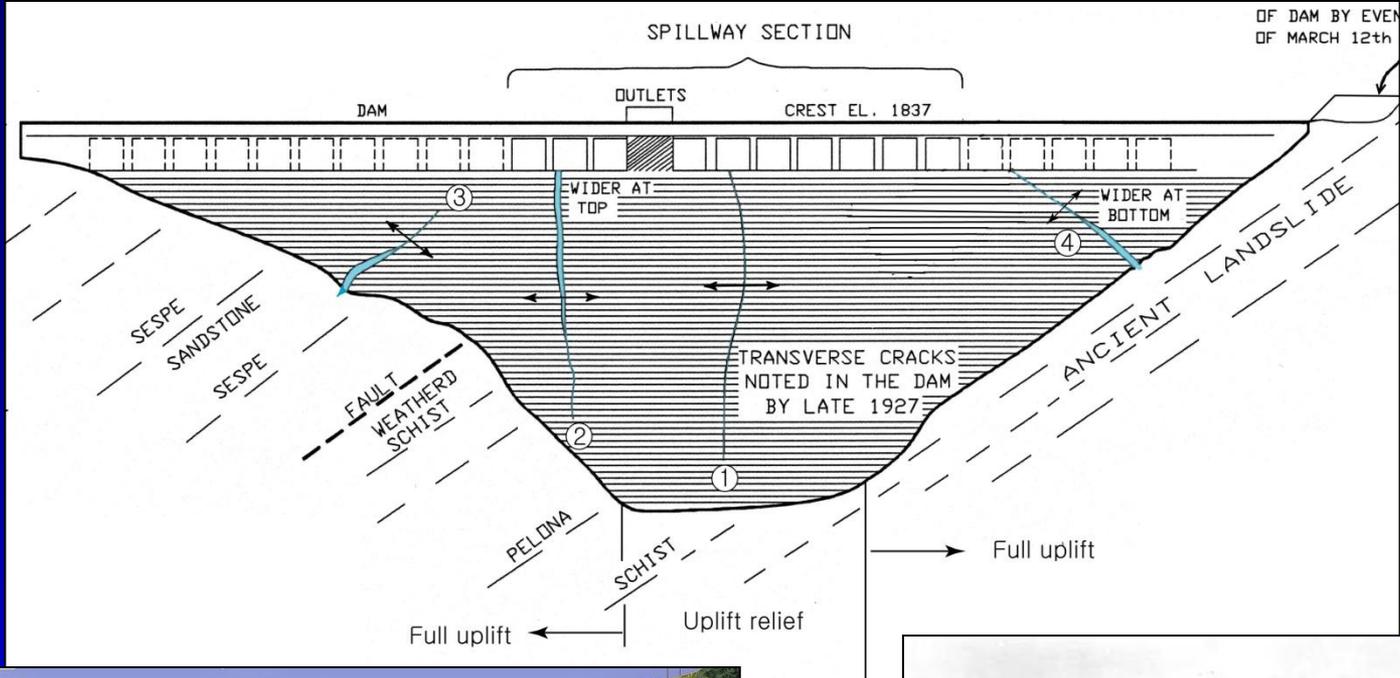
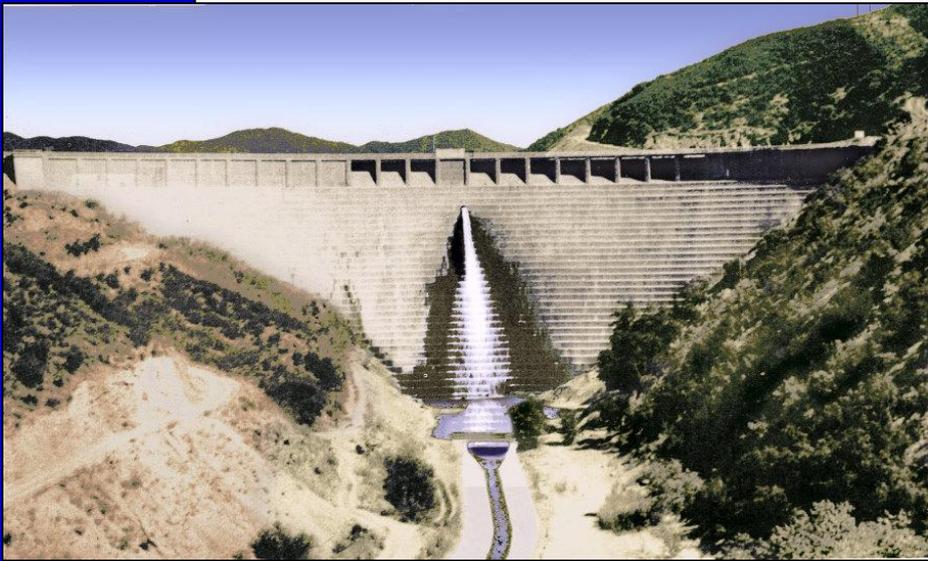
Four prominent contraction joints leaked noticeable volumes of water in the main dam and required grouting

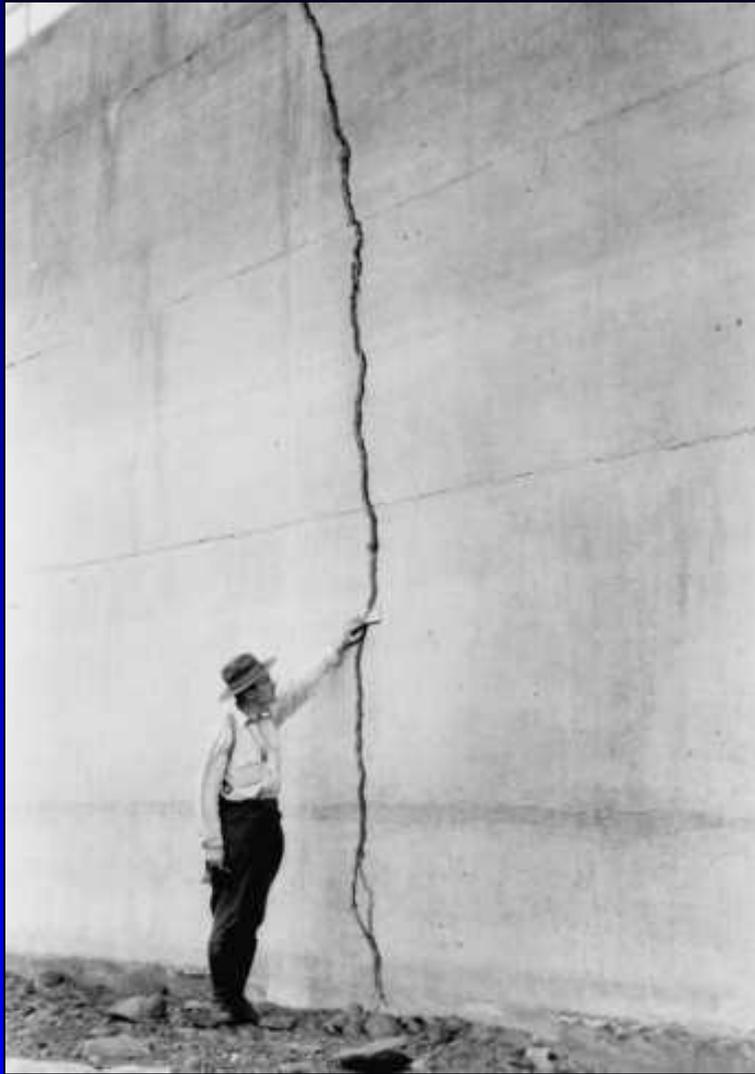
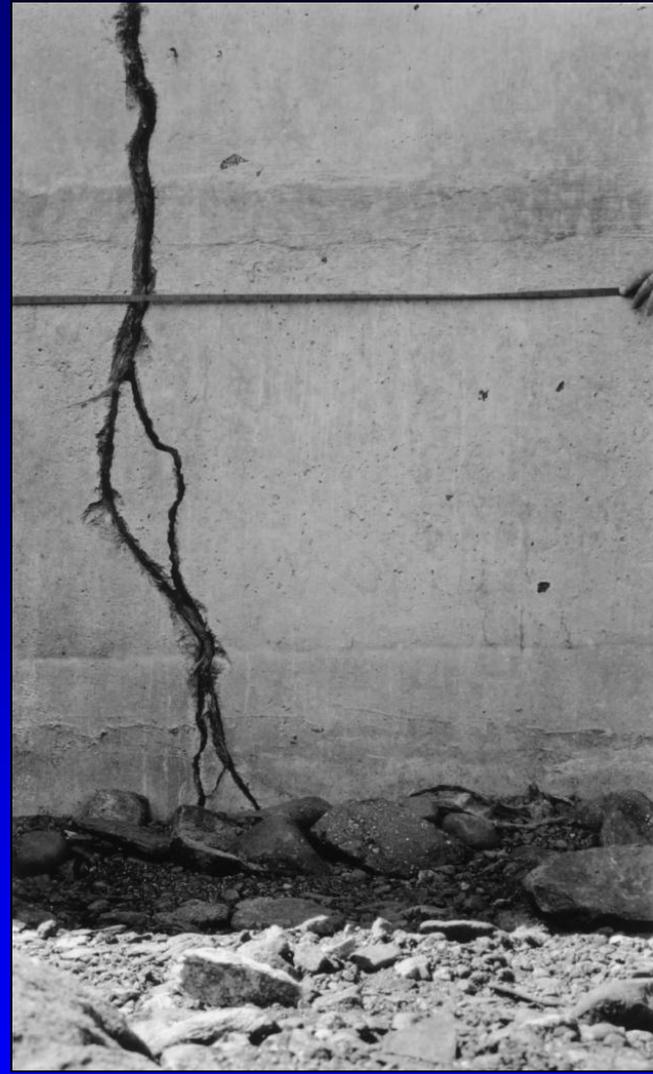
Several tension cracks formed in the concrete dike section during the second year of operation, in 1927-28. These began leaking noticeably in early March 1928.

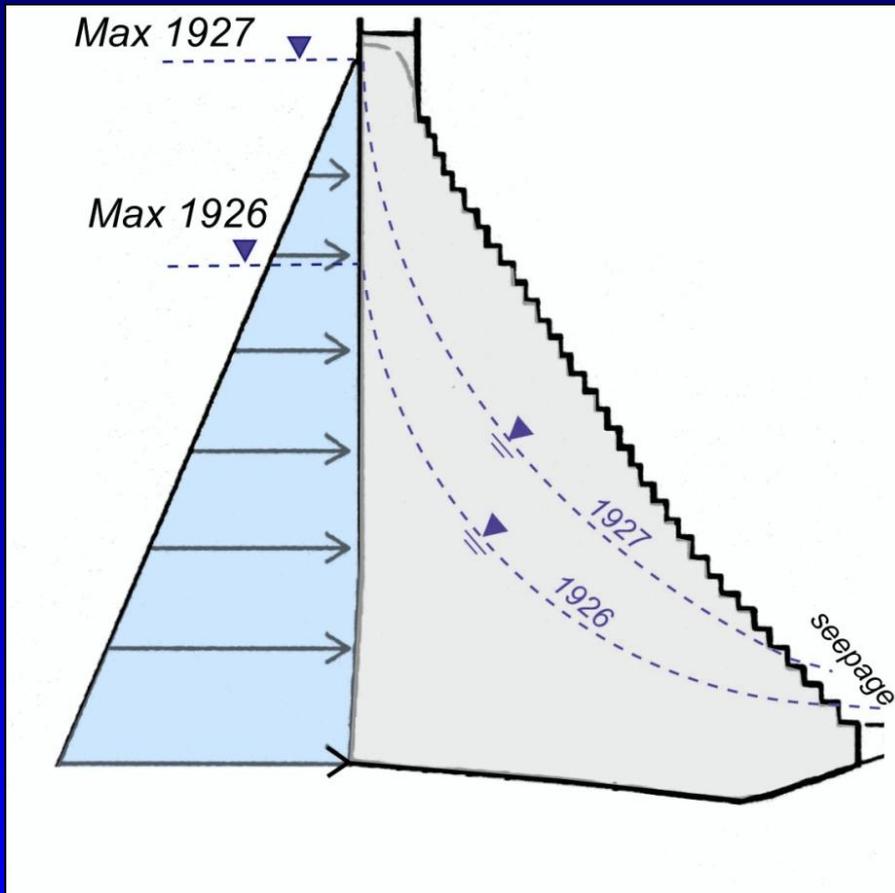
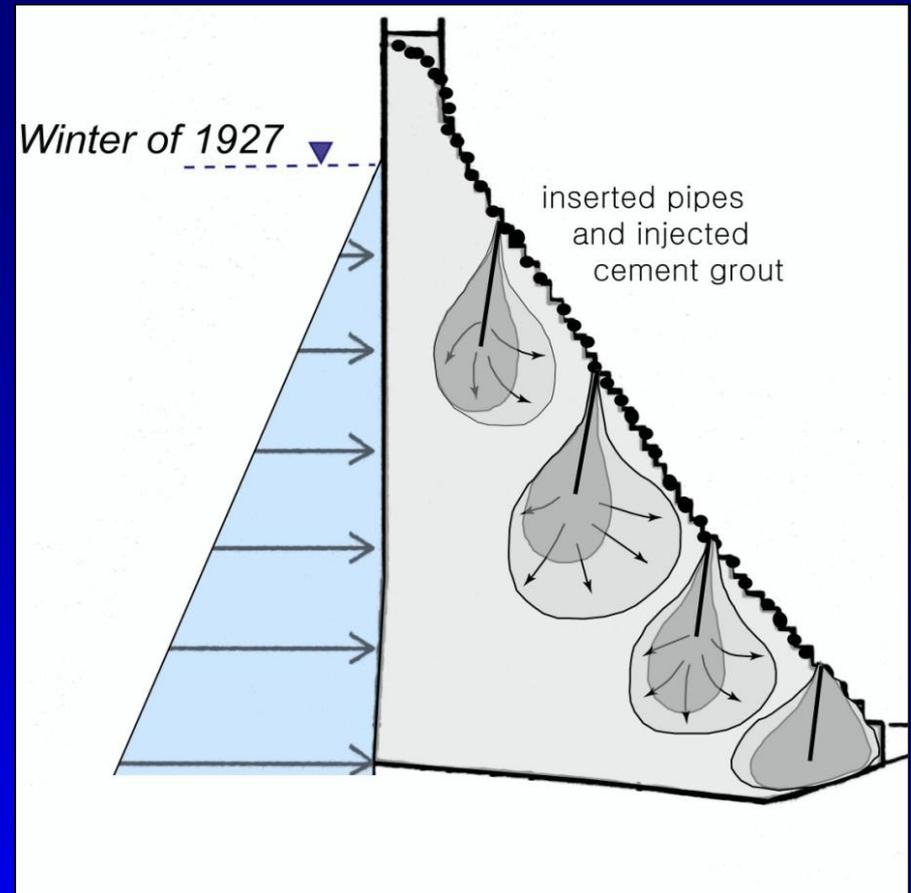
During the high water stand of 1927 seepage increased markedly through the downstream face of the dam. Mulholland ordered the four prominent cracks to be caulked with oakum, to prevent loss of cement grout injected into these cracks.

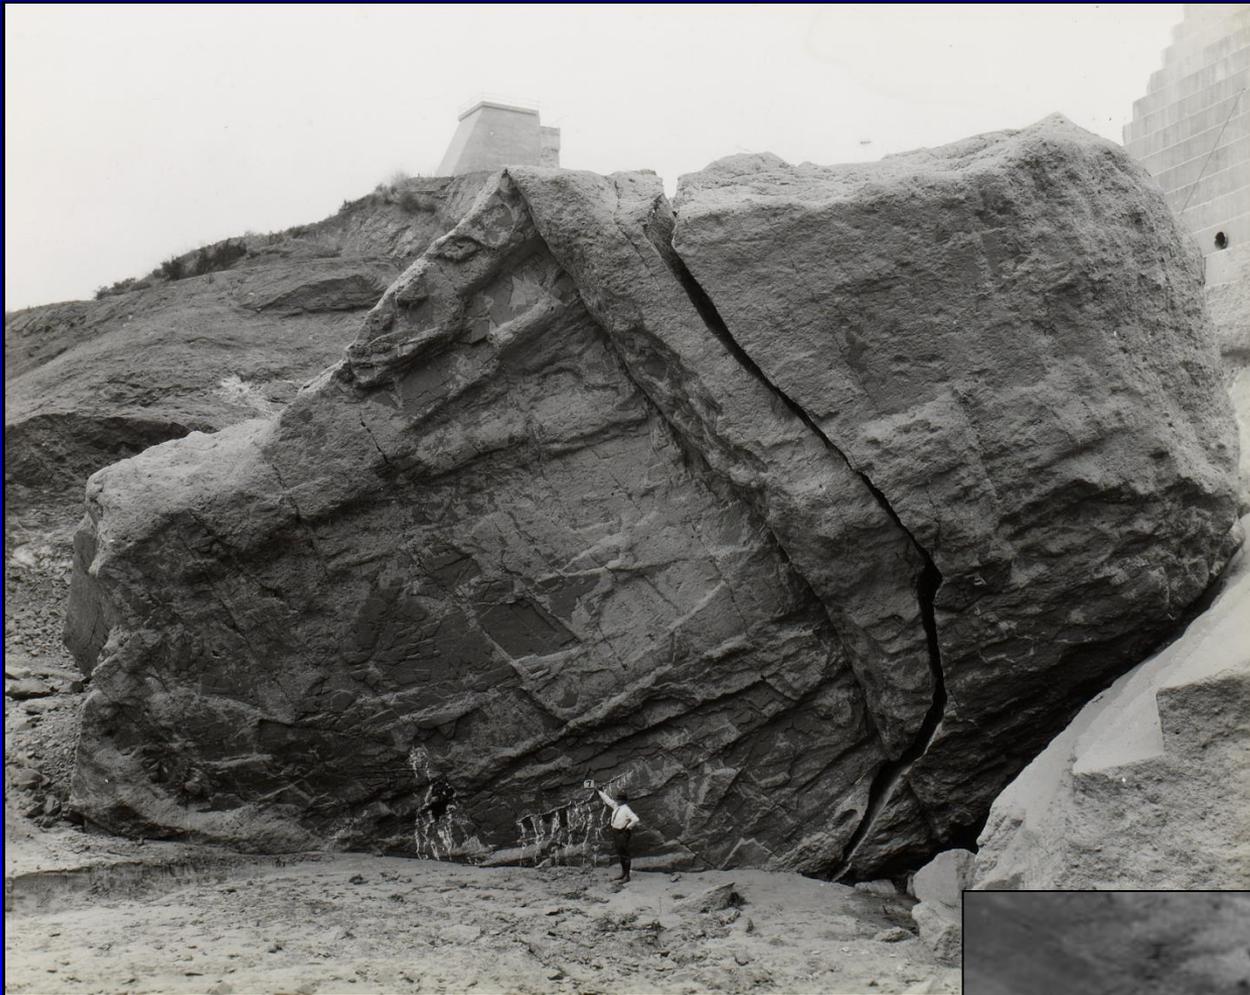
**Prominent
shrinkage
crack
observed
cutting
through
Block 5 after
the failure**

**The oakum caulking can be
discerned on the post-failure
images as dark lines across
the dam's downstream face**

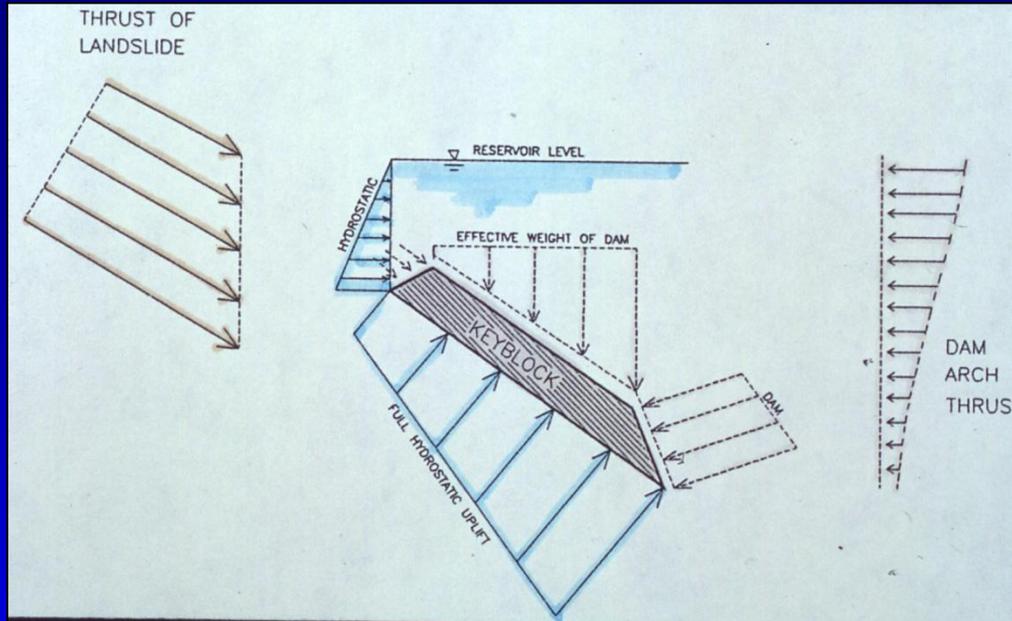
- Full reservoir pressure was applied to Rock Wedges A, B and C identified at the base of the left abutment in the Keyblock program.
- These were found to lift upward, even under the weight of the dam in that area (which diminishes rapidly progressing up the left abutment)
- Such lifting could have destabilized the dam's left abutment

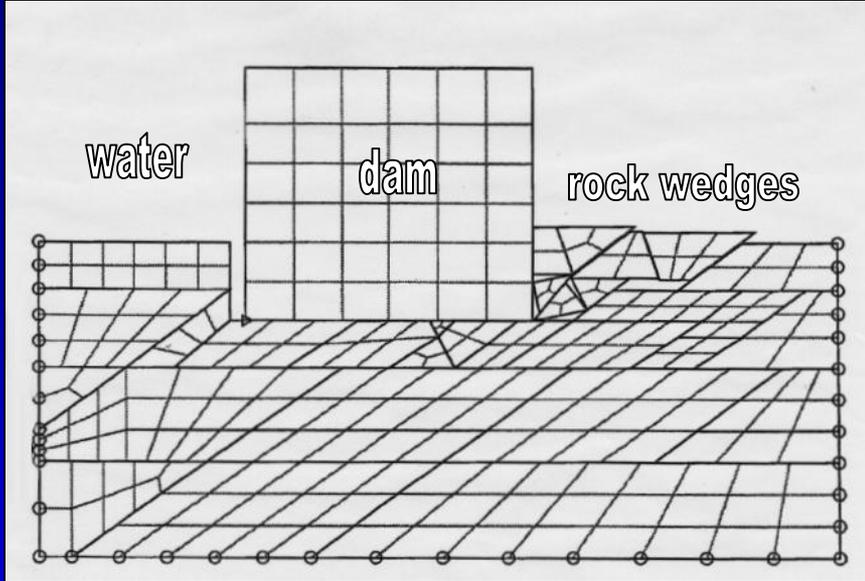
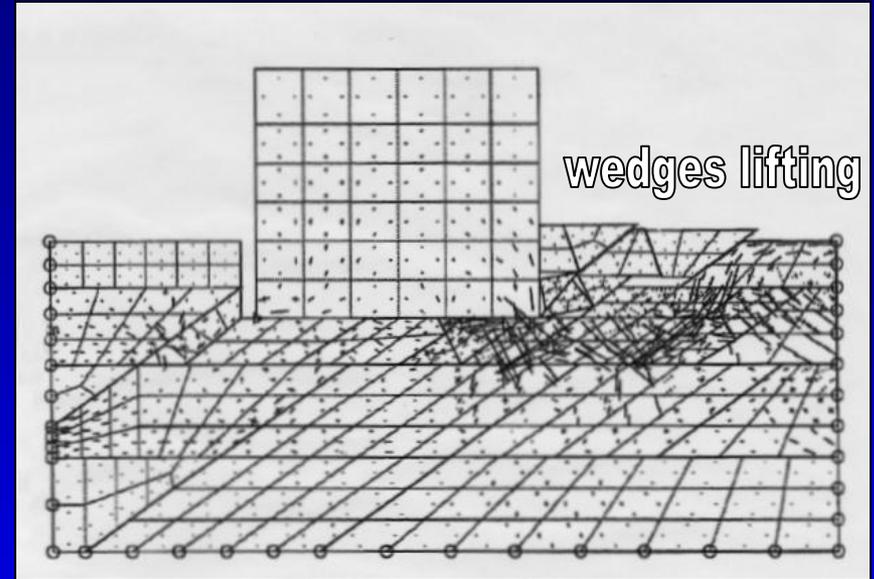
- The DDA simulations suggest that wedges A, B and C would all lift significantly if subjected to pressure head percolating beneath the dam's sloping abutment. This lifting could cause a catastrophic failure of the abutment section, very similar to the mode of failure that subsequently occurred at Malpasset Dam in 1959.

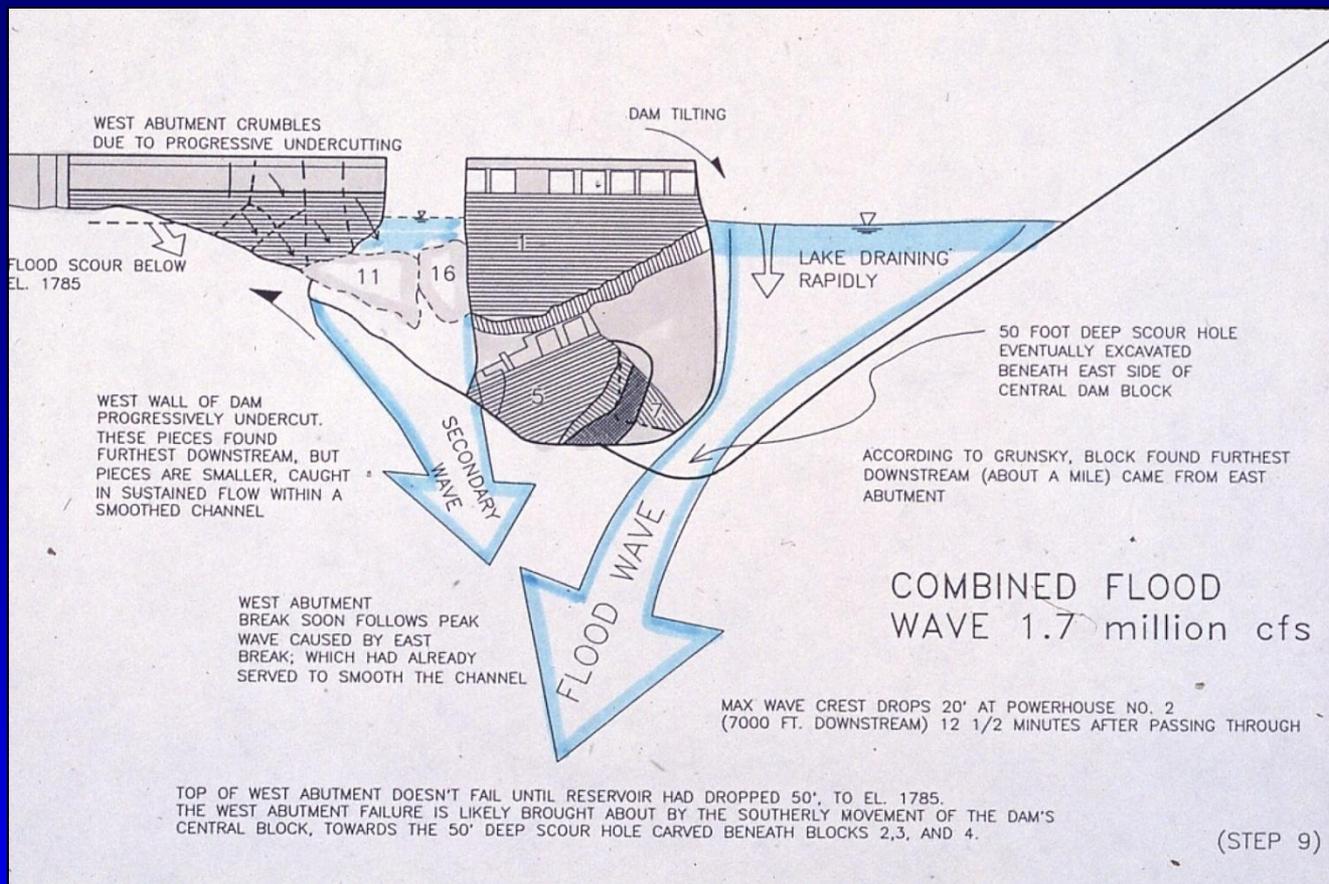
- As the left side of the main dam was undercut, the dam tilted slightly and rotated to that side, allowing water to enter the shrinkage crack on the west side of Block 1
- This triggered a chain-reaction failure of the right abutment, but only after the reservoir had dropped between 70 to 80 feet.

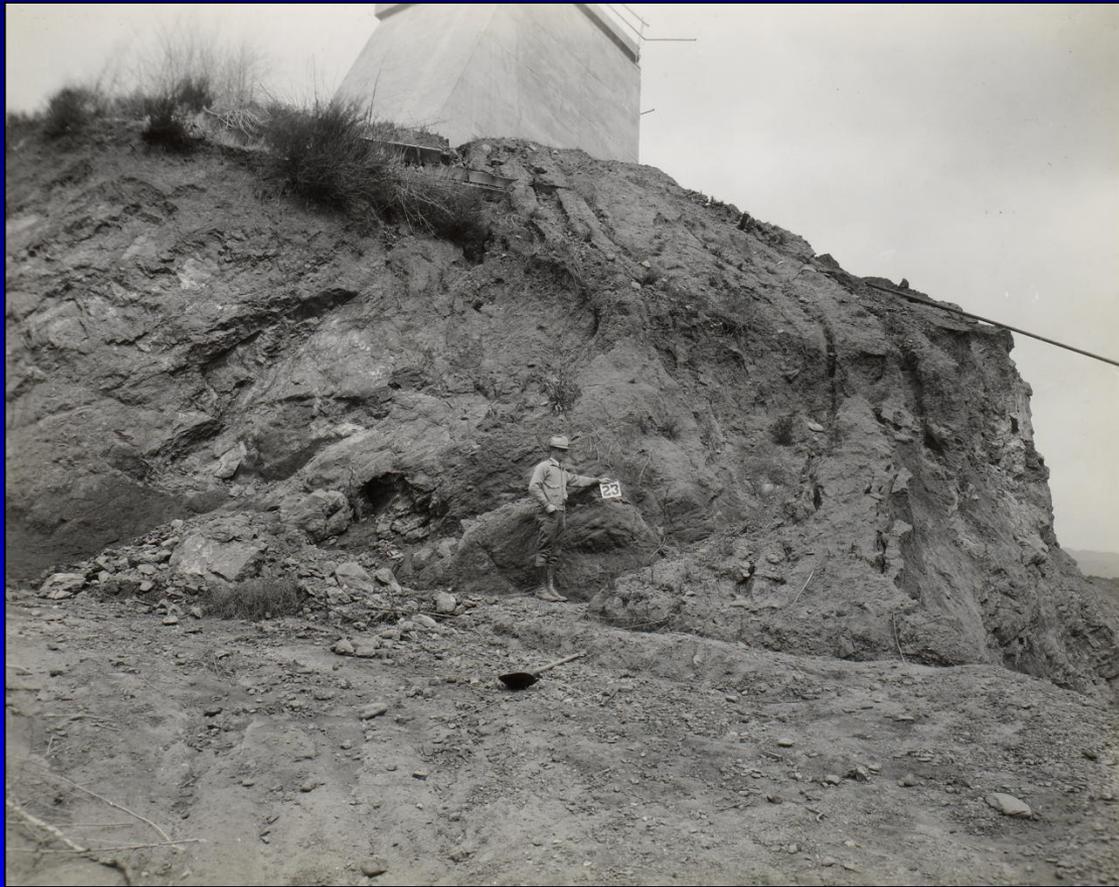
- **Man standing on ‘intact ground’ which was not inundated by outpouring flood waters, at elevation 1765, 70 feet below the reservoir water surface, along the construction access road that traversed the dam’s right abutment.**
- **The loose detritus in foreground suggest that the high water mark may have been 5 to 10 ft lower.**

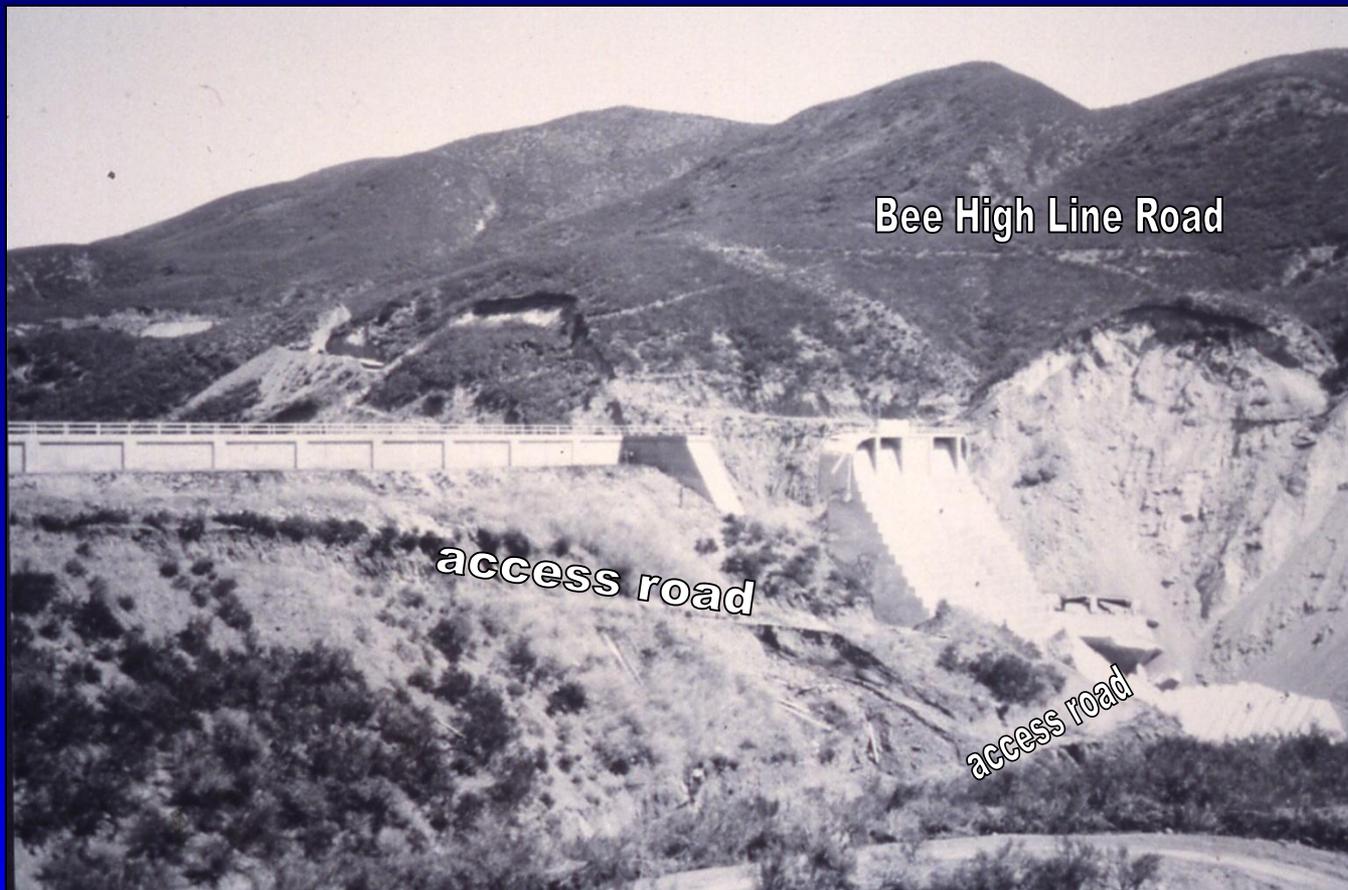
- Looking towards remnant of the main dam from the downstream right abutment, after the failure
- No erosion can be observed to a depth of at least 70 to 80 feet below crest, suggesting that the flooding did not initiate on this side of the dam
