THE ST. FRANCIS DAM FAILURE

**worst American civil engineering
disaster of the 20th Century**

J. David Rogers, Ph.D., P.E., P.G., C.E.G., C.HG.

Shlemon Specialty Conference

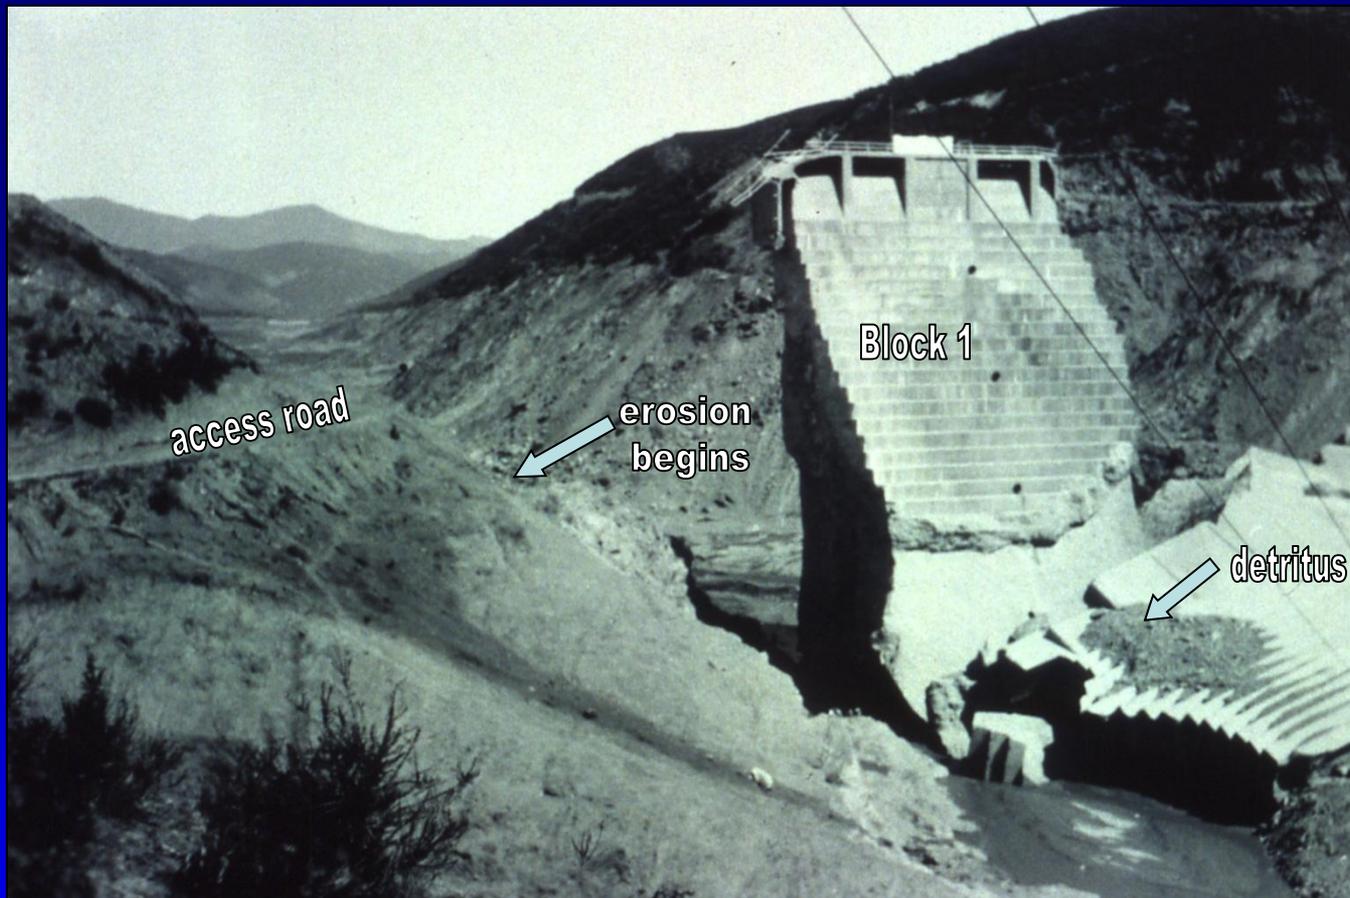
- Loose sidecast fill from construction access road begins about 75 feet below crest (arrow)
- Note schist detritus lying atop Block 5, 30 to 40 feet above the channel. This was left from the landslide that Block 5 rode down, into the canyon.

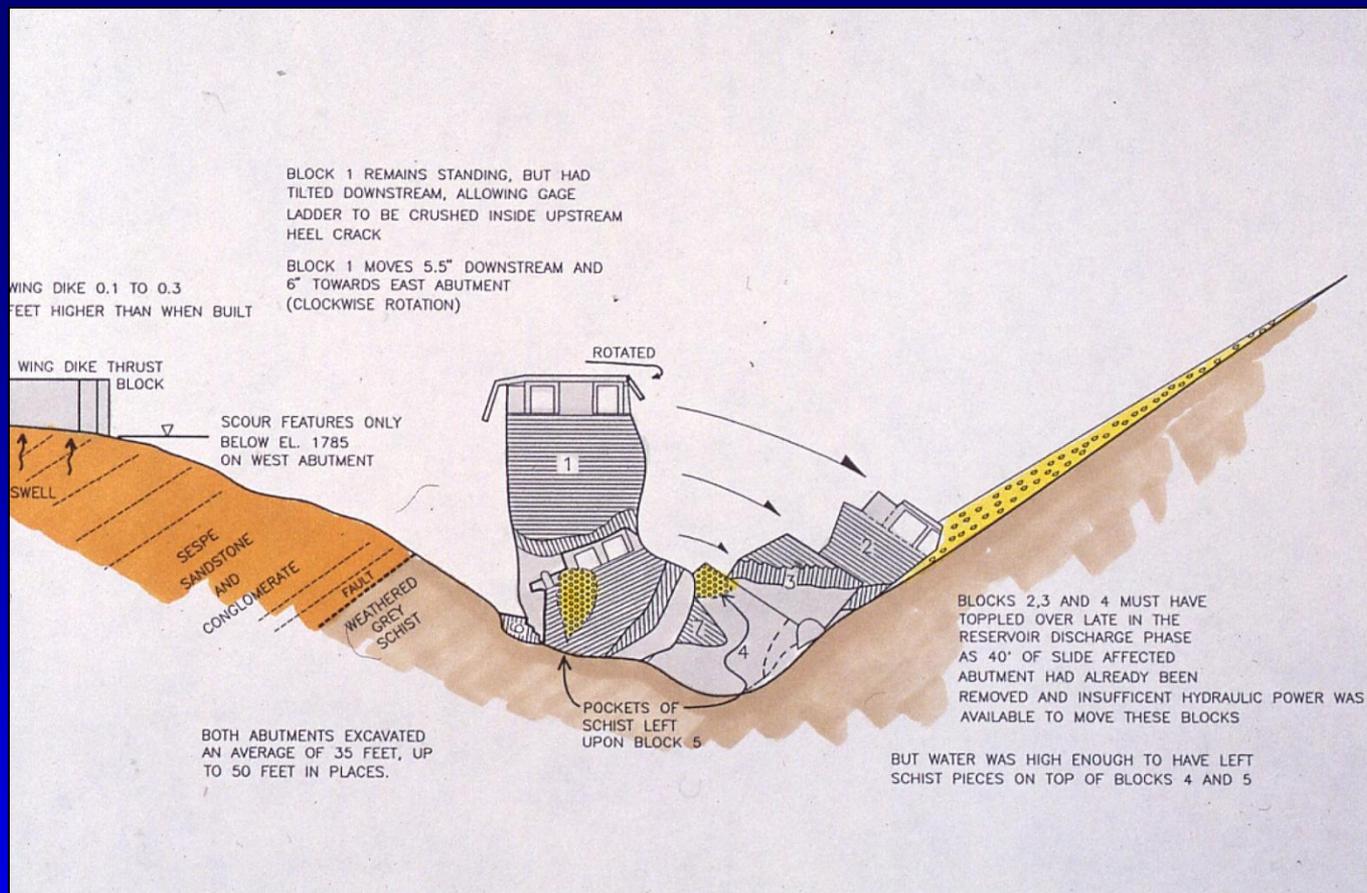
- Towards the end of emptying of the reservoir, the left half of the main dam topped backward at an angle of 54 degrees after being undercut by the outbreak flood waters. The depth of this downcutting was about 35 vertical feet!
- Patches of schist detritus were left upon Blocks 5 and 7 (shown in yellow)

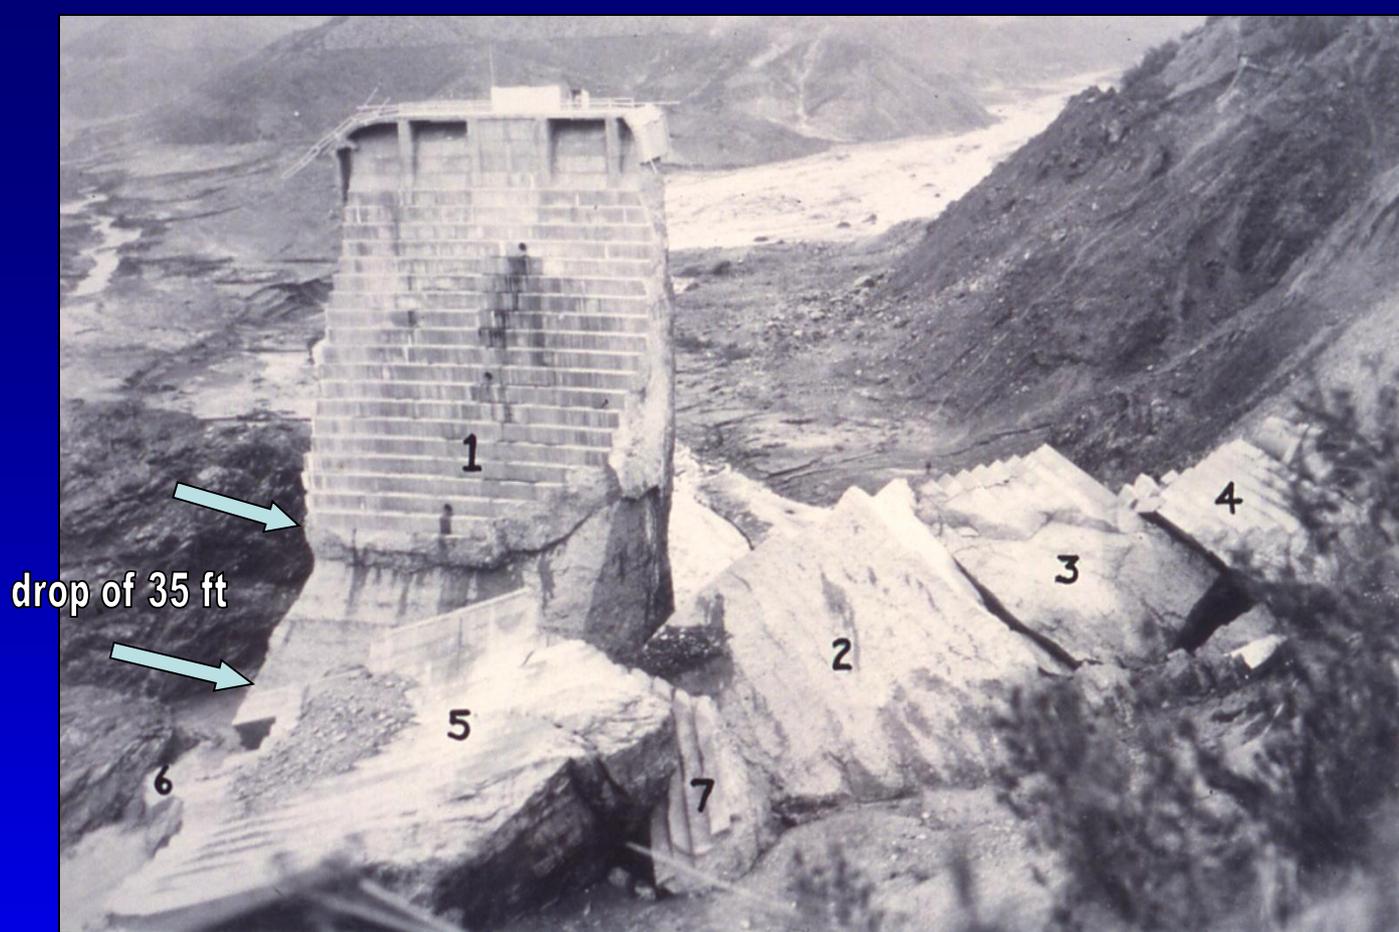
- **Photograph taken after the failure showing the disposition of Blocks 1 thru 7. The left half of the main dam fell into an enormous hole cut beneath its left side, between Elevation 1660 and 1615 ft, a depth of 45 feet!**
- **Note position of Block 5, well below chatter line on downstream face (arrows). Water pouring out of the right abutment breach likely carried off the schist detritus beneath Block 5.**

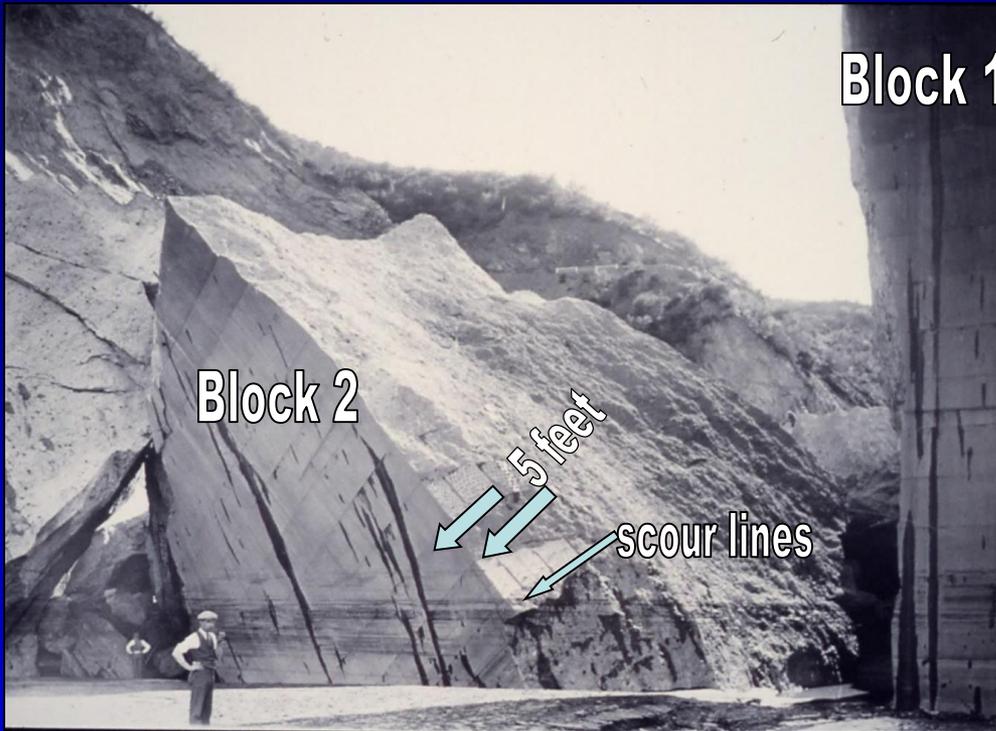
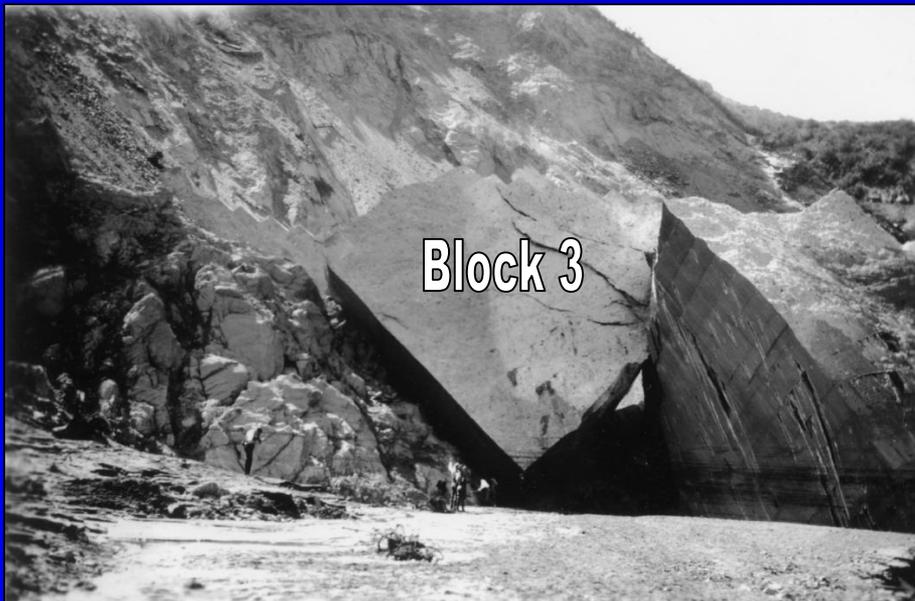
- The elevation of the drained reservoir pool at the time Blocks 2/3/4 topped backward (about 16 ft) was estimated by studying the scour marks left on the tilted blocks and comparing this measurement with the five-foot high concrete lifts, bracketed by the blue arrows
