Levee Failures Along the Inner Harbor Navigation Channel in New Orleans

J. David Rogers, Ph.D., P.E., P.G.

for Technical Session #15 on

New Orleans Levees and Hurricane Katrina

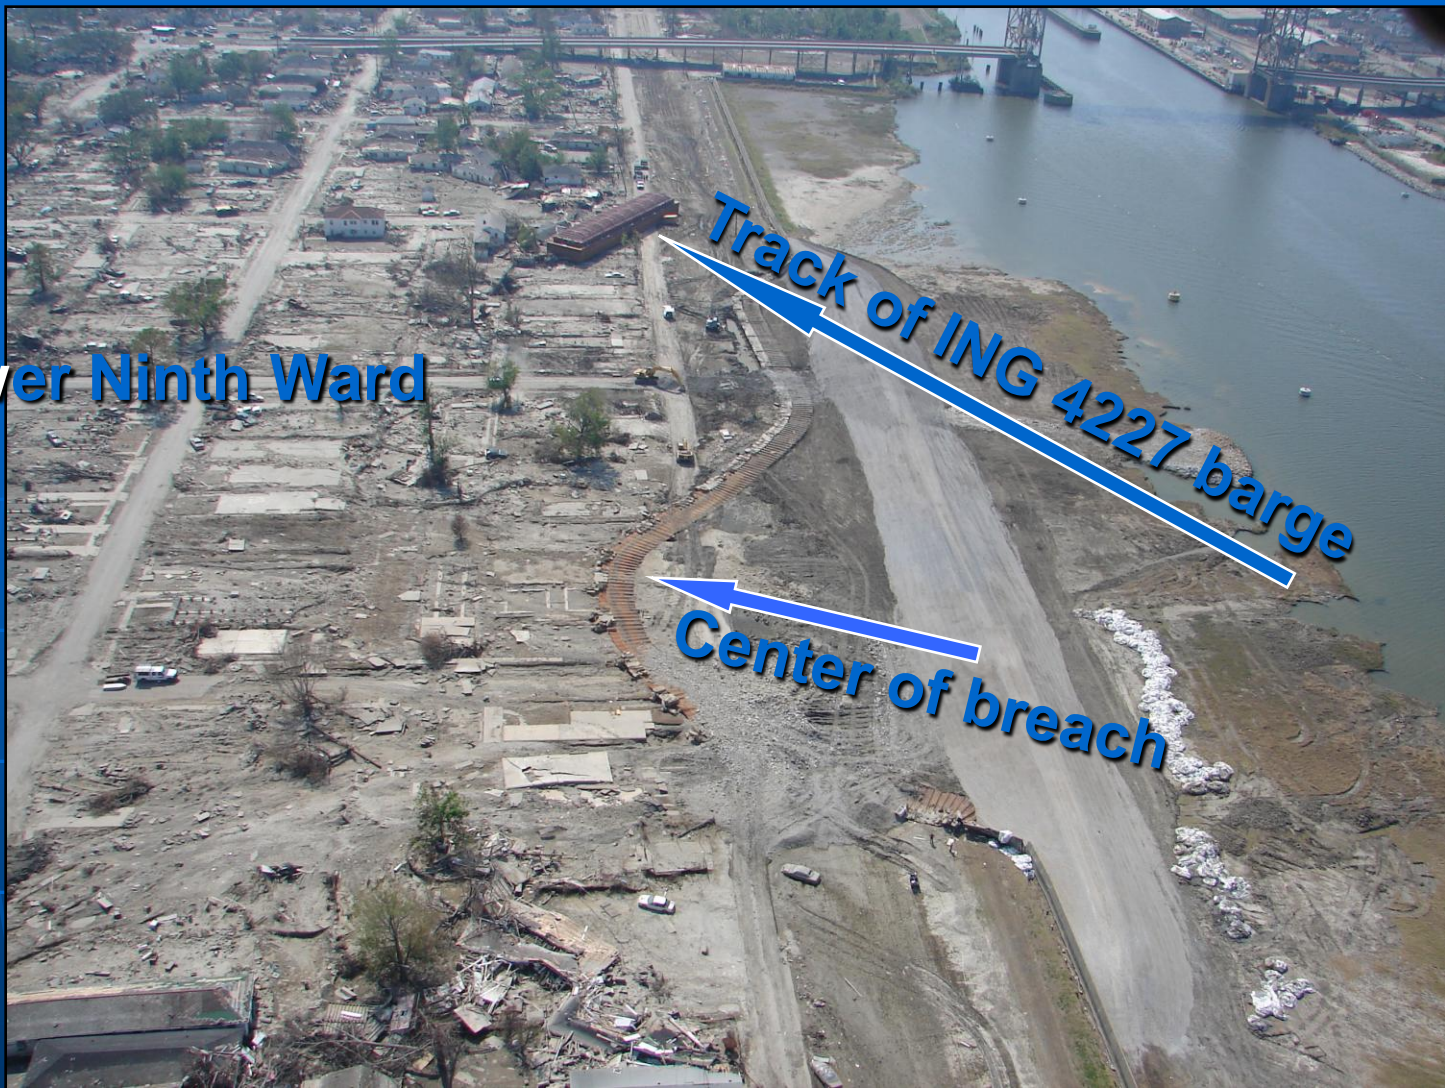
- **Aerial view of the 900 ft long south breach of the Inner Harbor Navigation Channel (IHNC) in the Lower Ninth Ward. View looking south.**

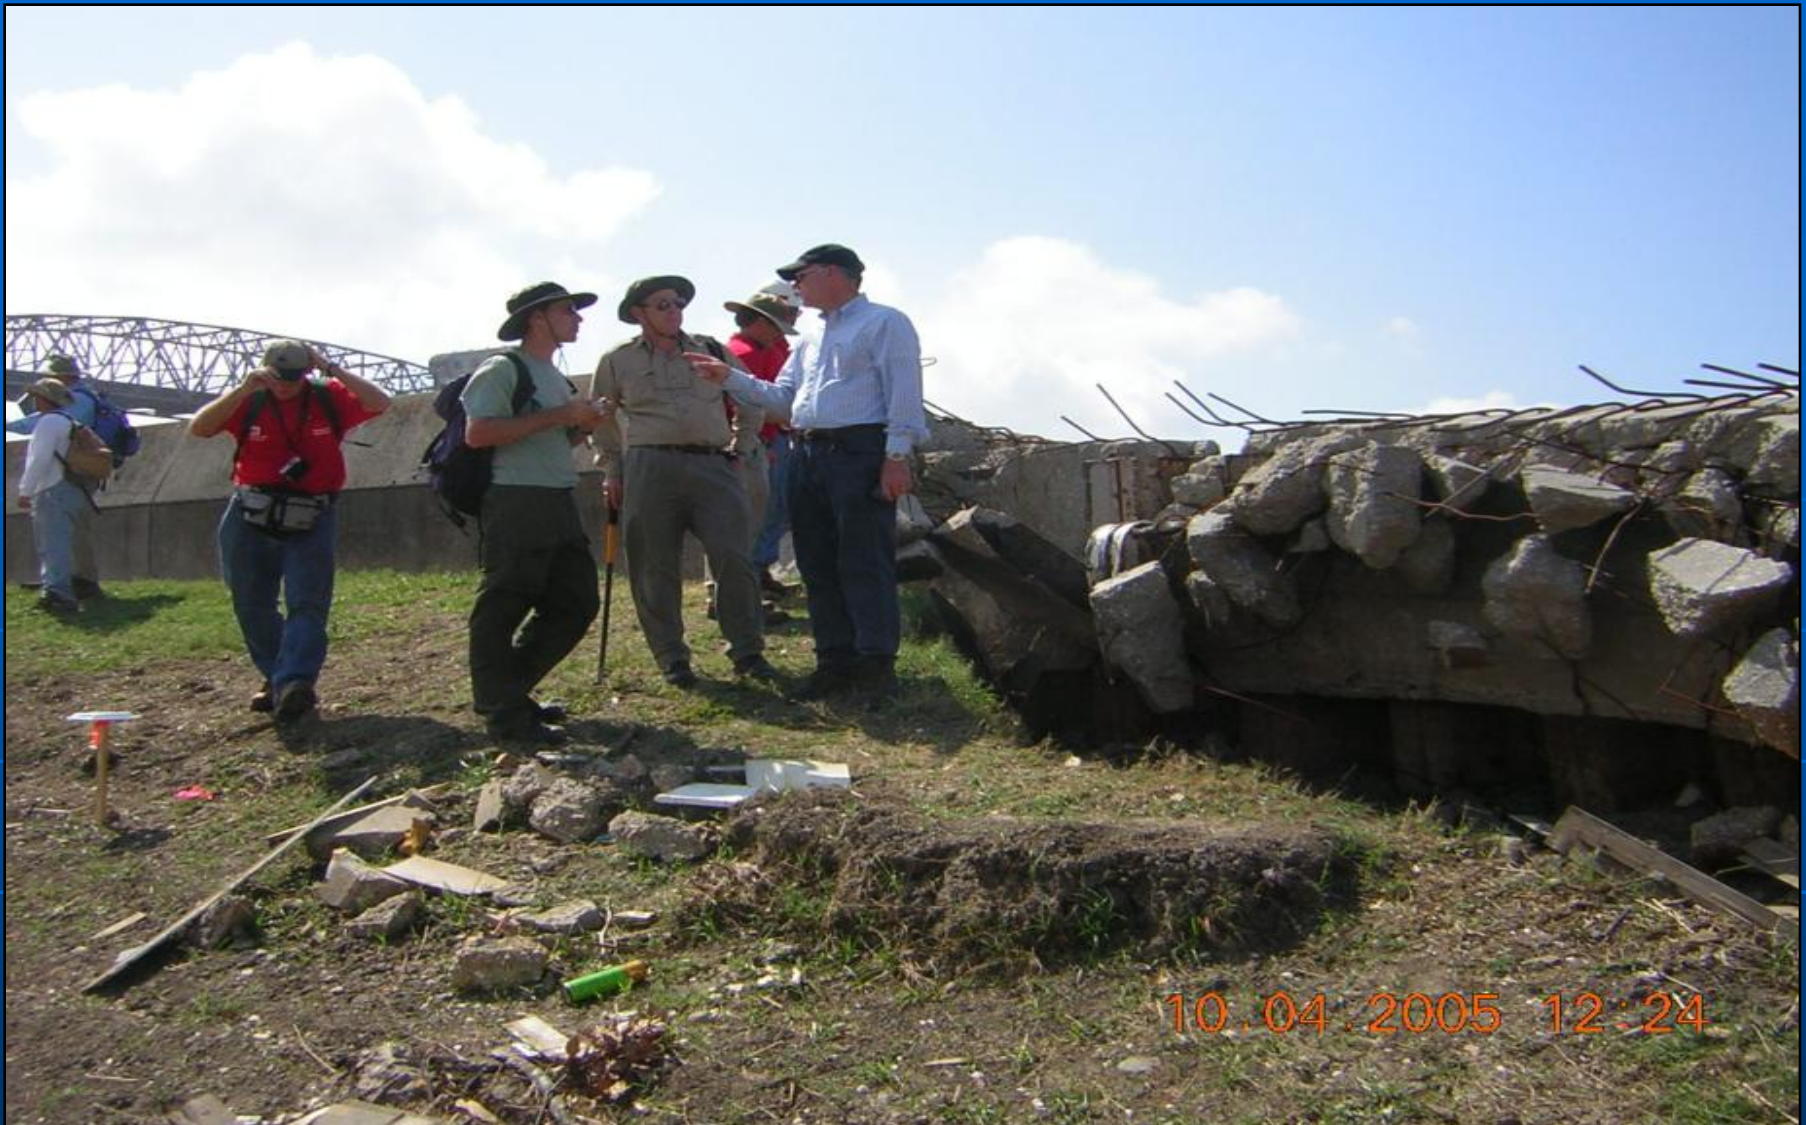
10.04.2005 12:24

- **Damage to concrete flood wall where ING 4727 Barge collided with it, along the south side of the IHNC adjacent to the Lower Ninth Ward**

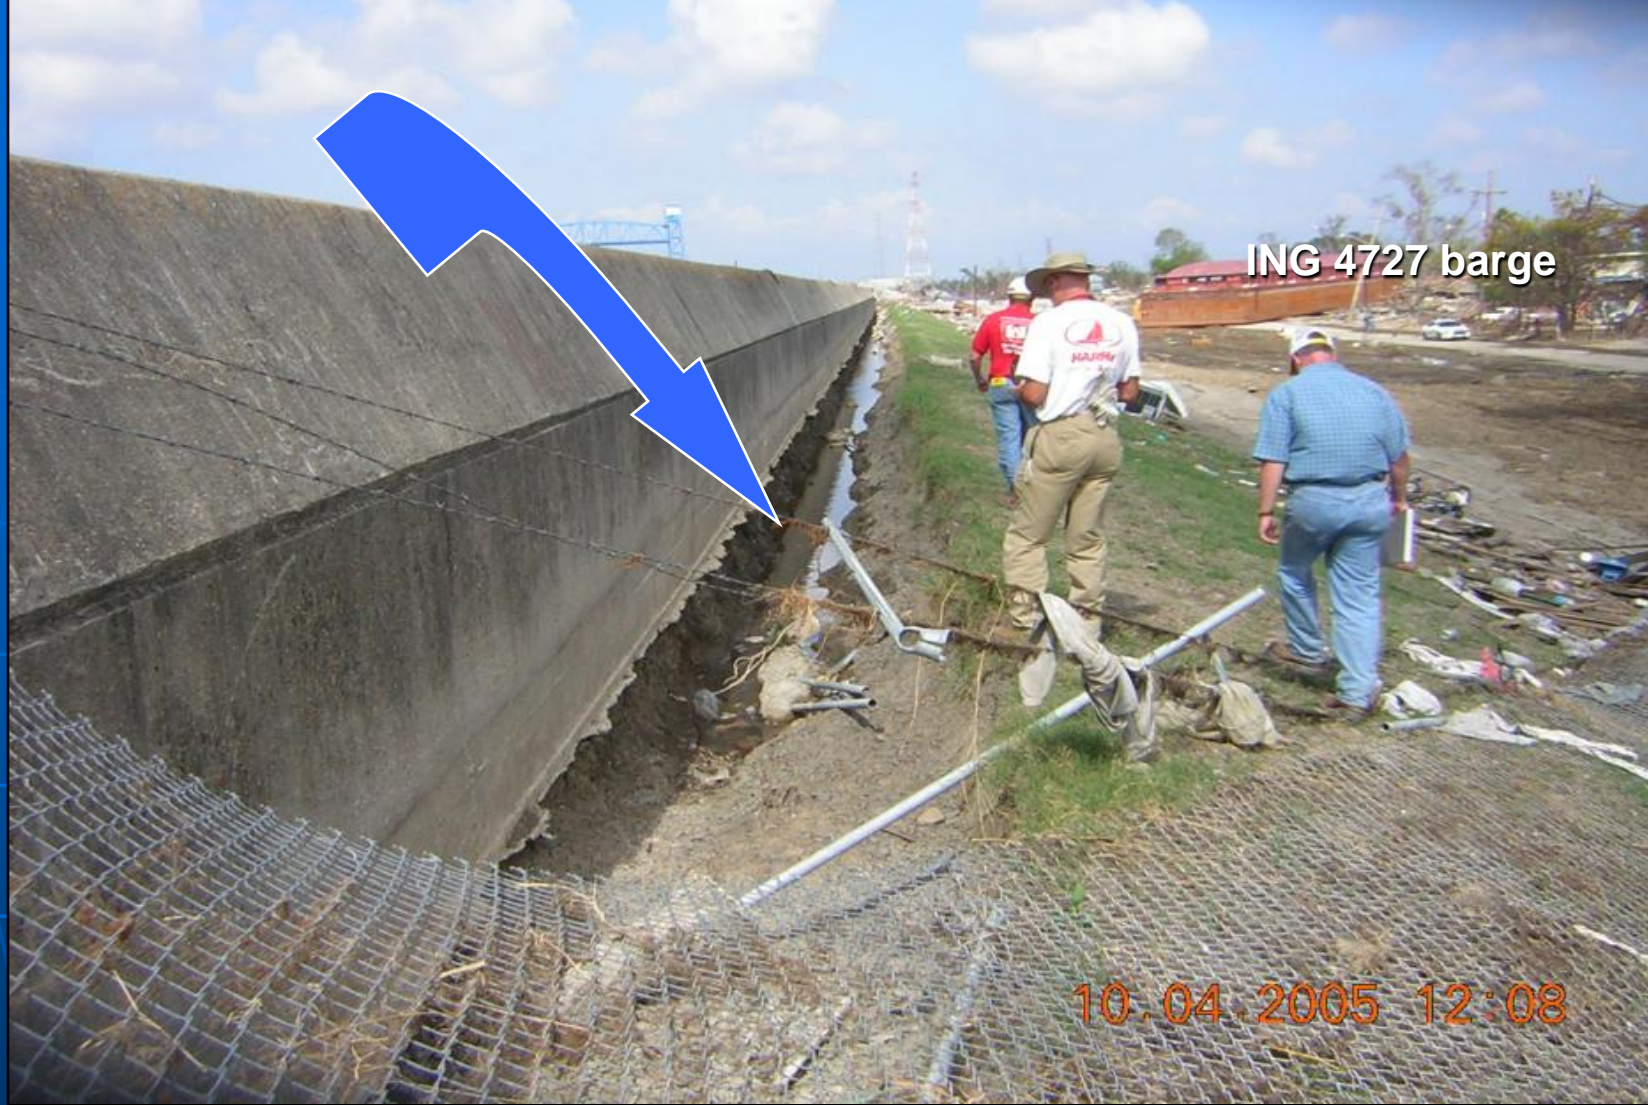
- Evidence of sustained overtopping of concrete flood wall along the IHNC in the Lower Ninth Ward. Scour holes usually limited to 1.5X height of the free fall (7.5 ft). This scour trench deepened to the north, as elevations dropped.

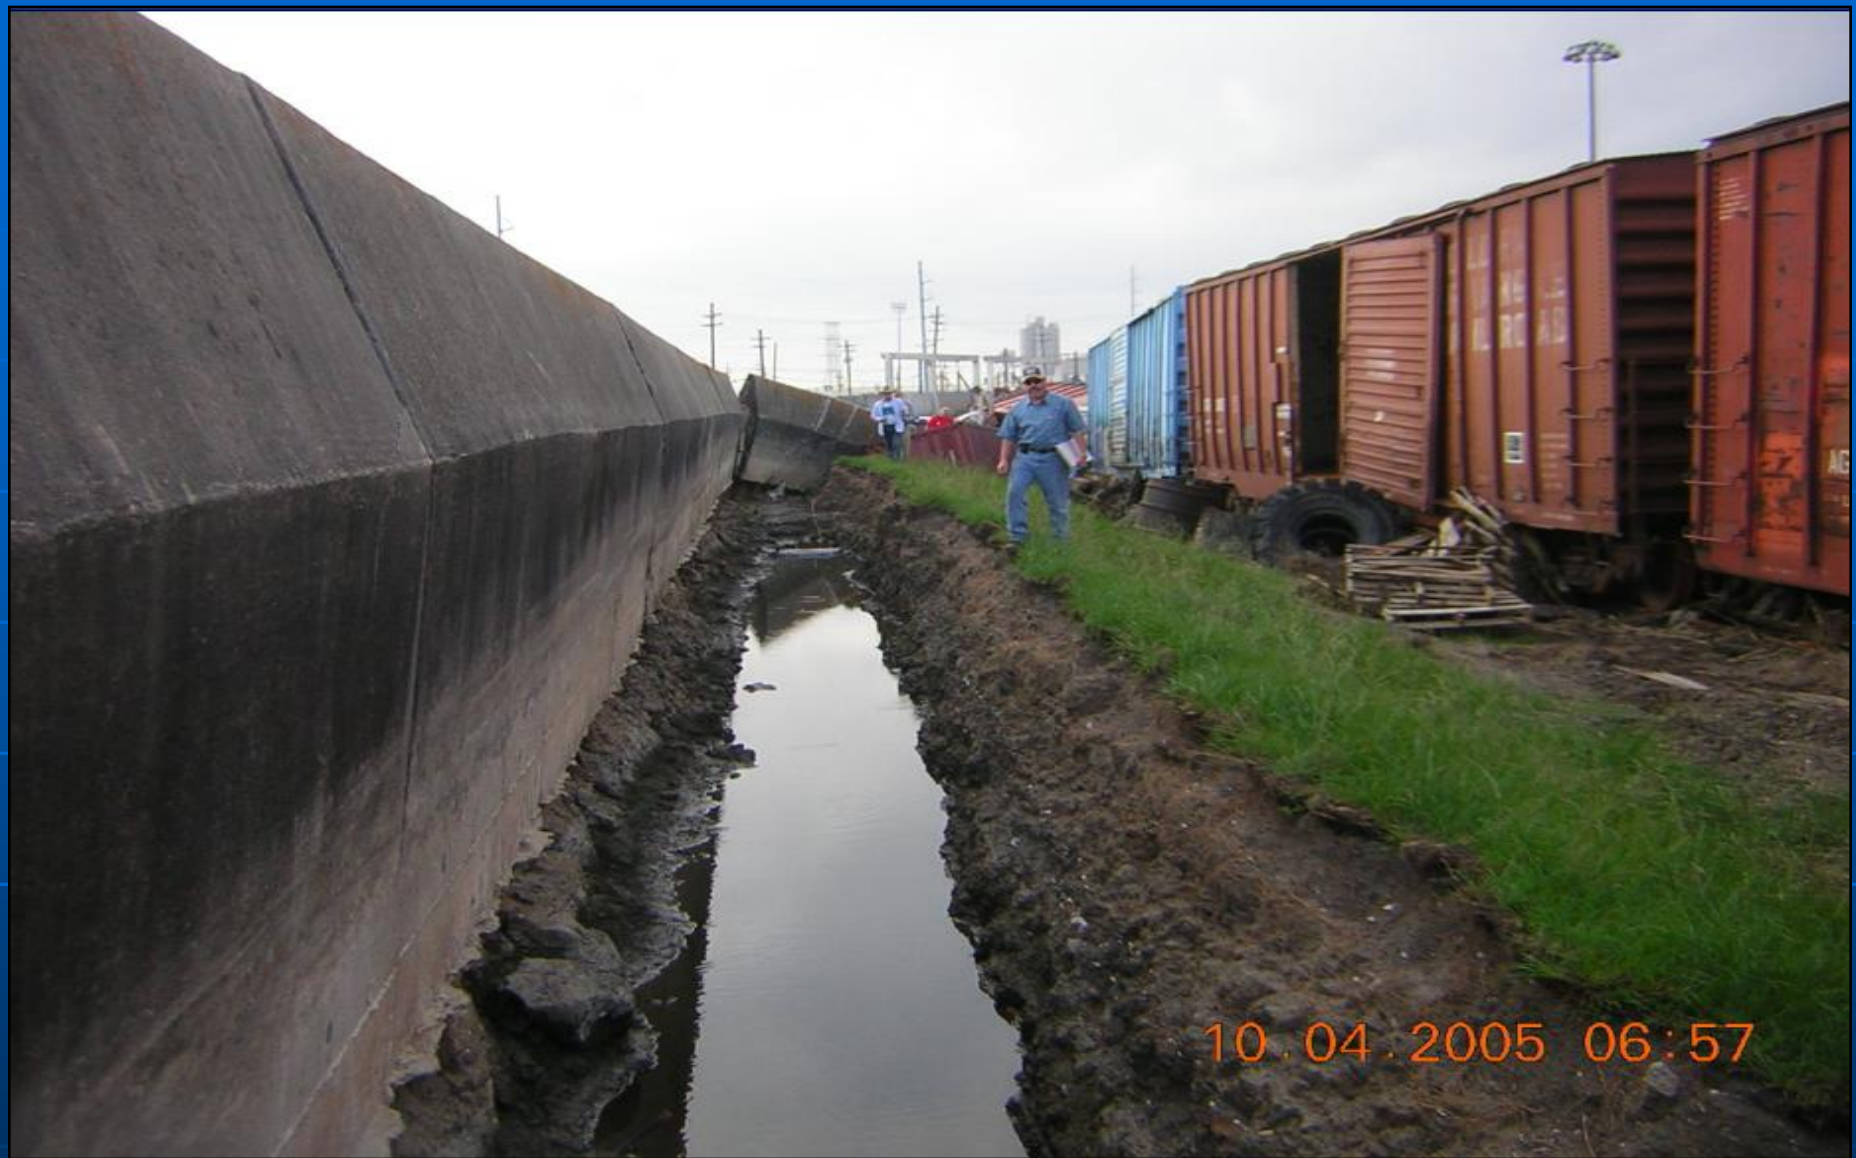
- **Overtopping-induced failure of the flood wall on the west side of the IHNC, north of Florida Ave. This breach was only 65 feet wide.**

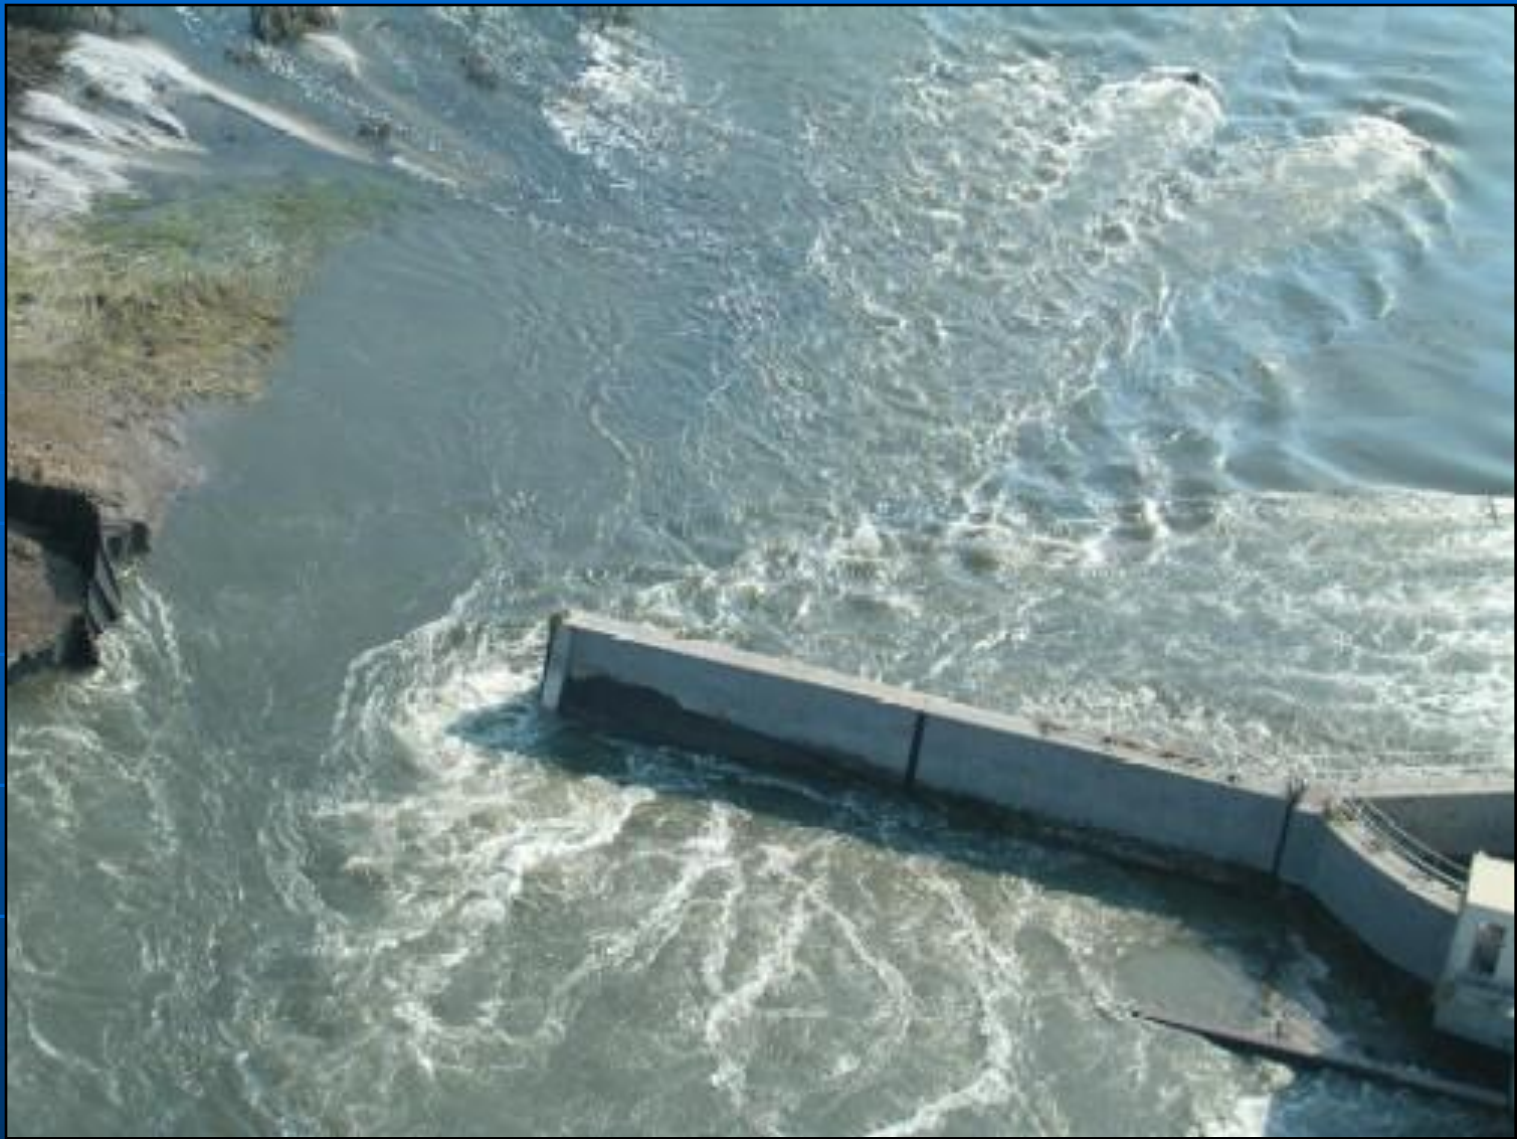
East Side IHNC North Breach, near Florida Ave. bridge and pumping station, during inflow. Note narrow chasm defined by this failure and dramatic flexure of the sheetpiles.

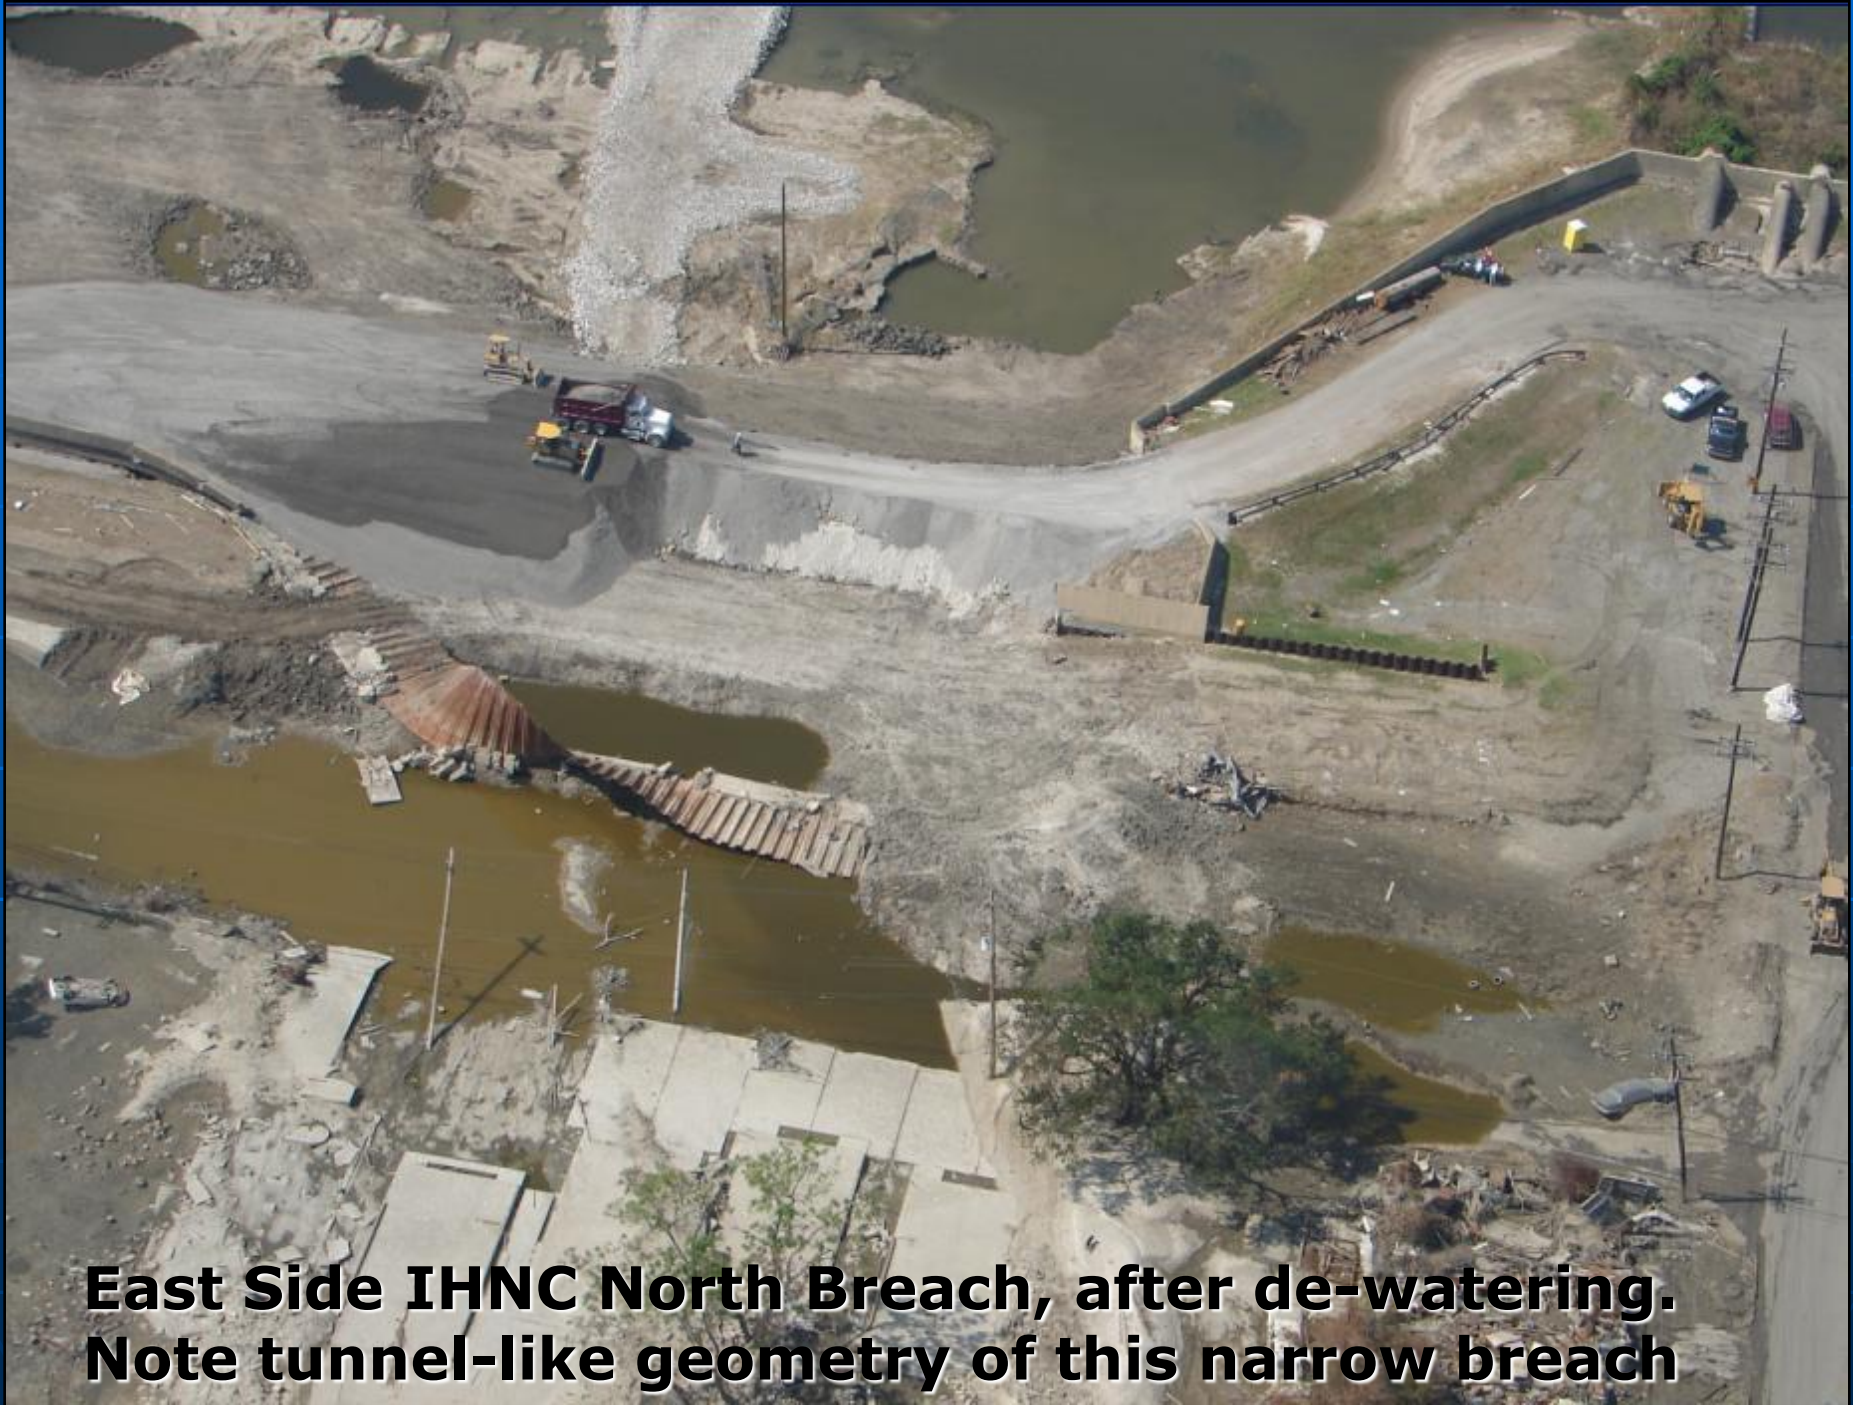
**East Side IHNC North Breach, after de-watering.
Note tunnel-like geometry of this narrow breach**

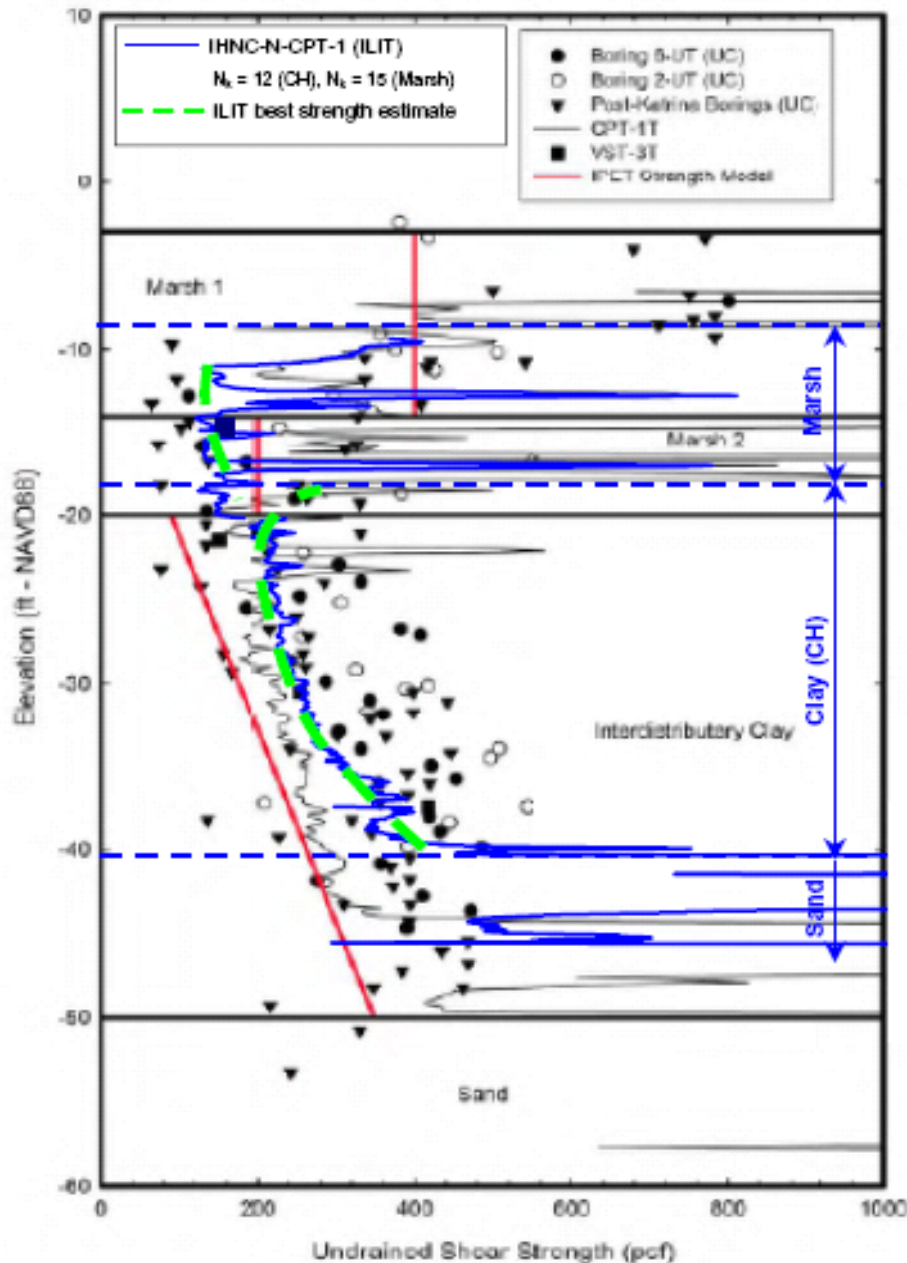
Undrained shear strength vs depth at the East IHNC North Breach

Blue lines shows profile of CPT-1, with NGI tip corrections for the three units encountered

Green line shows strength profile selected by the NSF team

Red lines shows strength profile used by the IPET team; which allows a rotational stability failure sometime between 5:30 and 6:00 AM

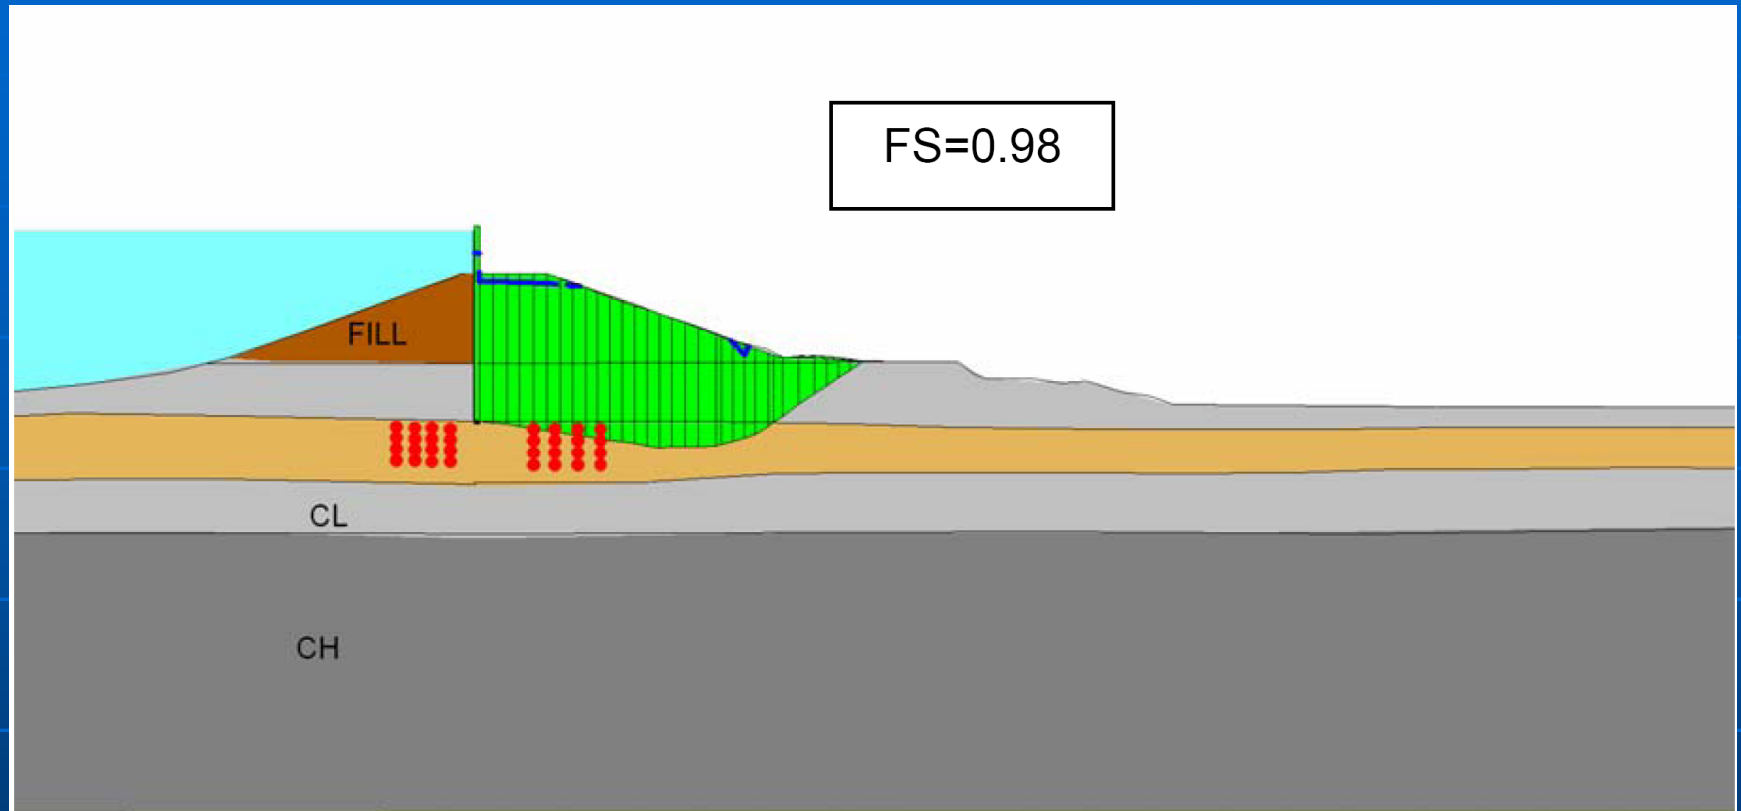
Critical stability conditions for East IHNC North Breach occur when the storm surge reaches +14 feet (MSL), which was not achieved until 9 AM. Note that the presumed failure surface passes through the marsh layer.

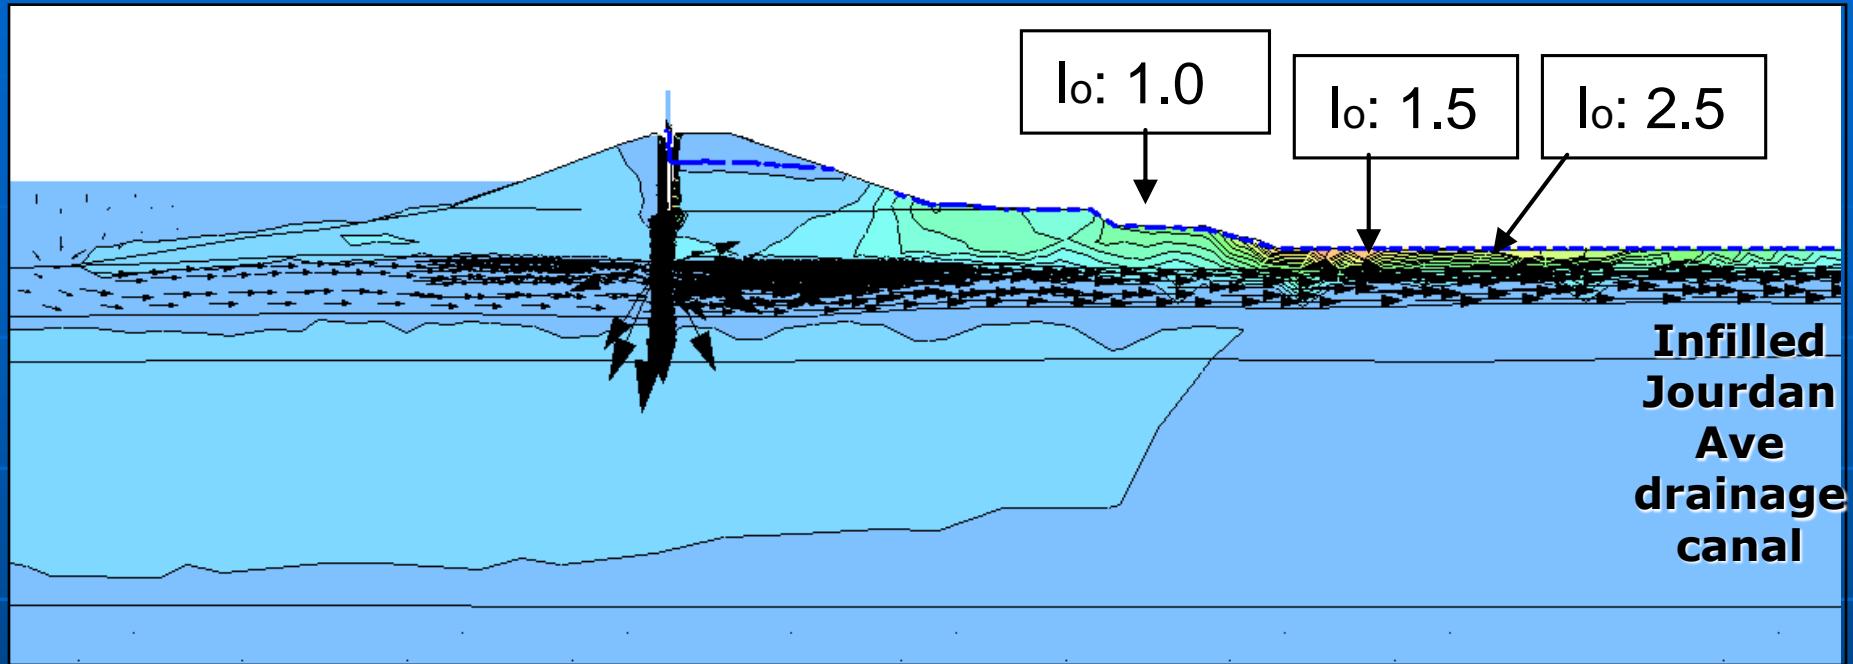
Hydraulic gradients for the north breach on IHNC. Storm surge at +14.4ft (MSL). Maximum exit gradient on the upper levee toe is $i_o \approx 1.0$, and $i_o \approx 1.5$ to 2.5 in the lower toe area. The distal toe value could have been worse, depending on k value of backfill used on Jourdan Ave. drainage canal.

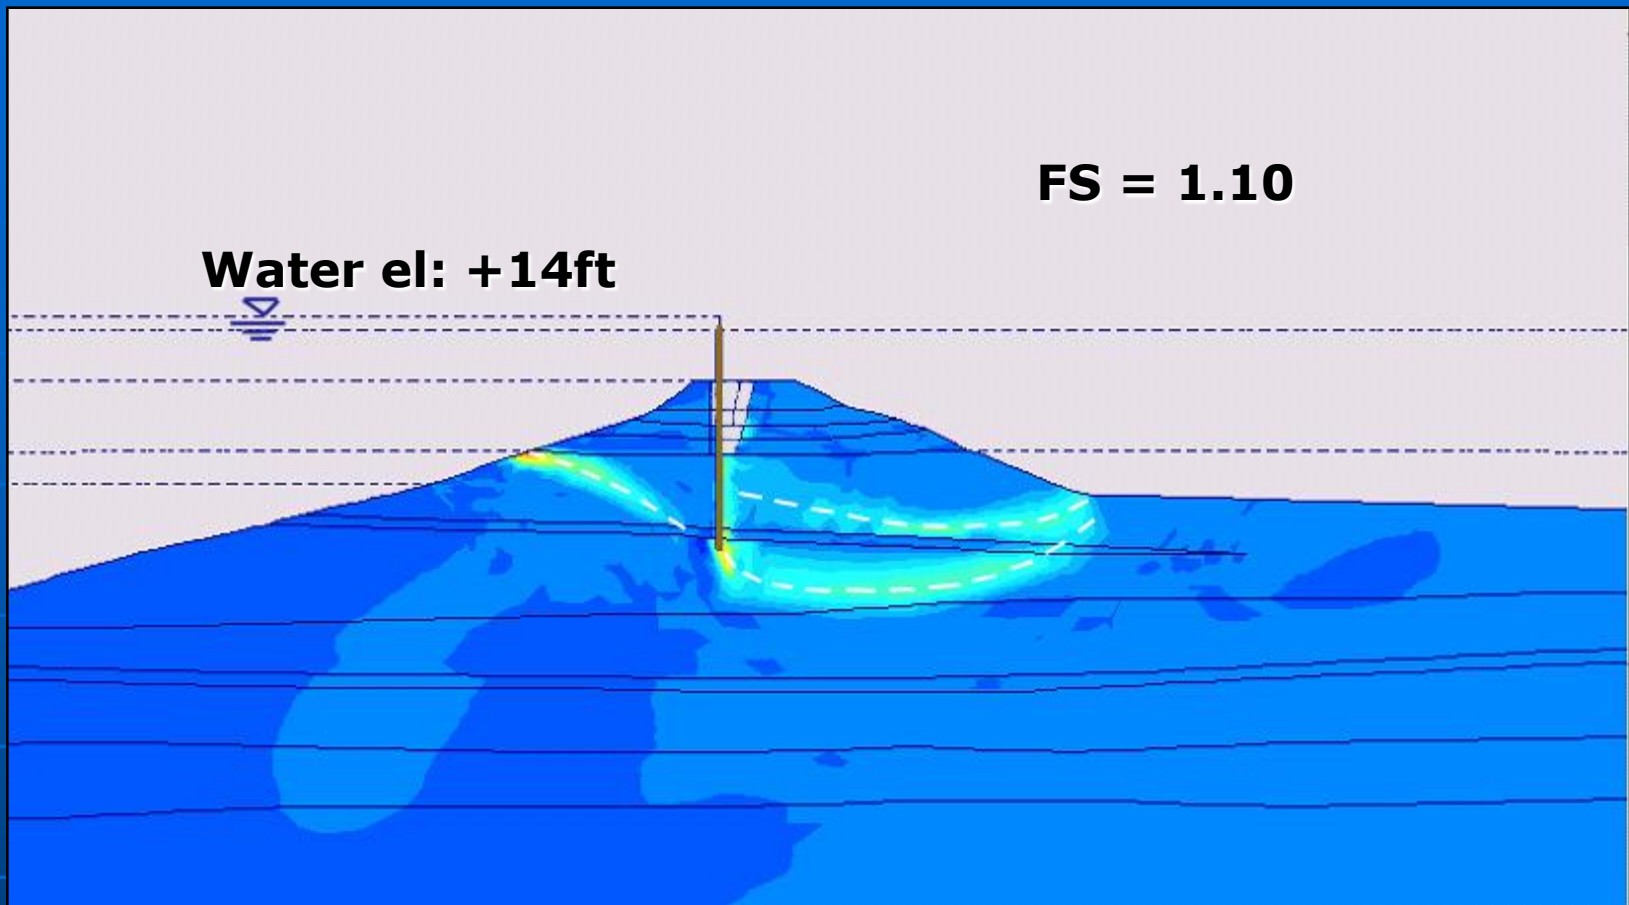
Shear strains predicted by the Plaxis model, assuming a 7.5 ft deep scour trench and 4.5 ft wall gap – using “best estimates” of c and phi – Factor of Safety = 1.10. Underseepage-induced pore pressure trapped along base of less pervious clay stratum, overlying the more pervious marsh deposits.

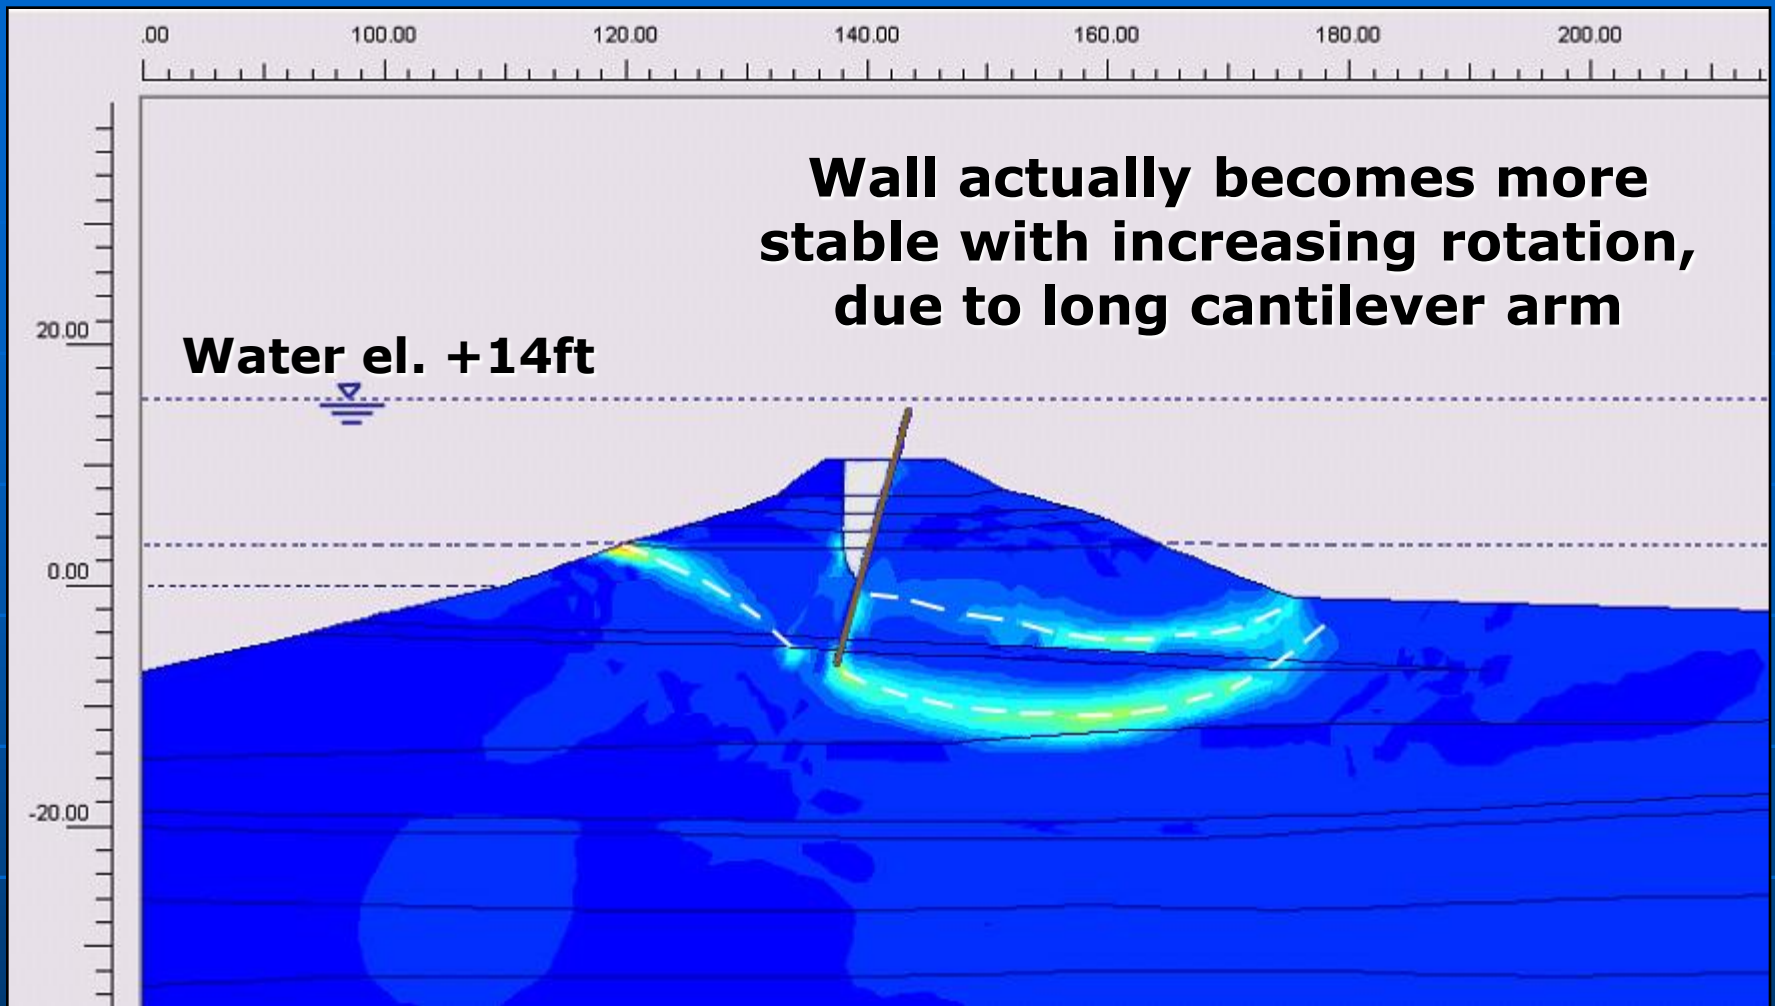
Leaning wall with 8.5 ft of gap. Predicted shear strains using "best estimates" of c and phi. Factor of Safety now = 1.15

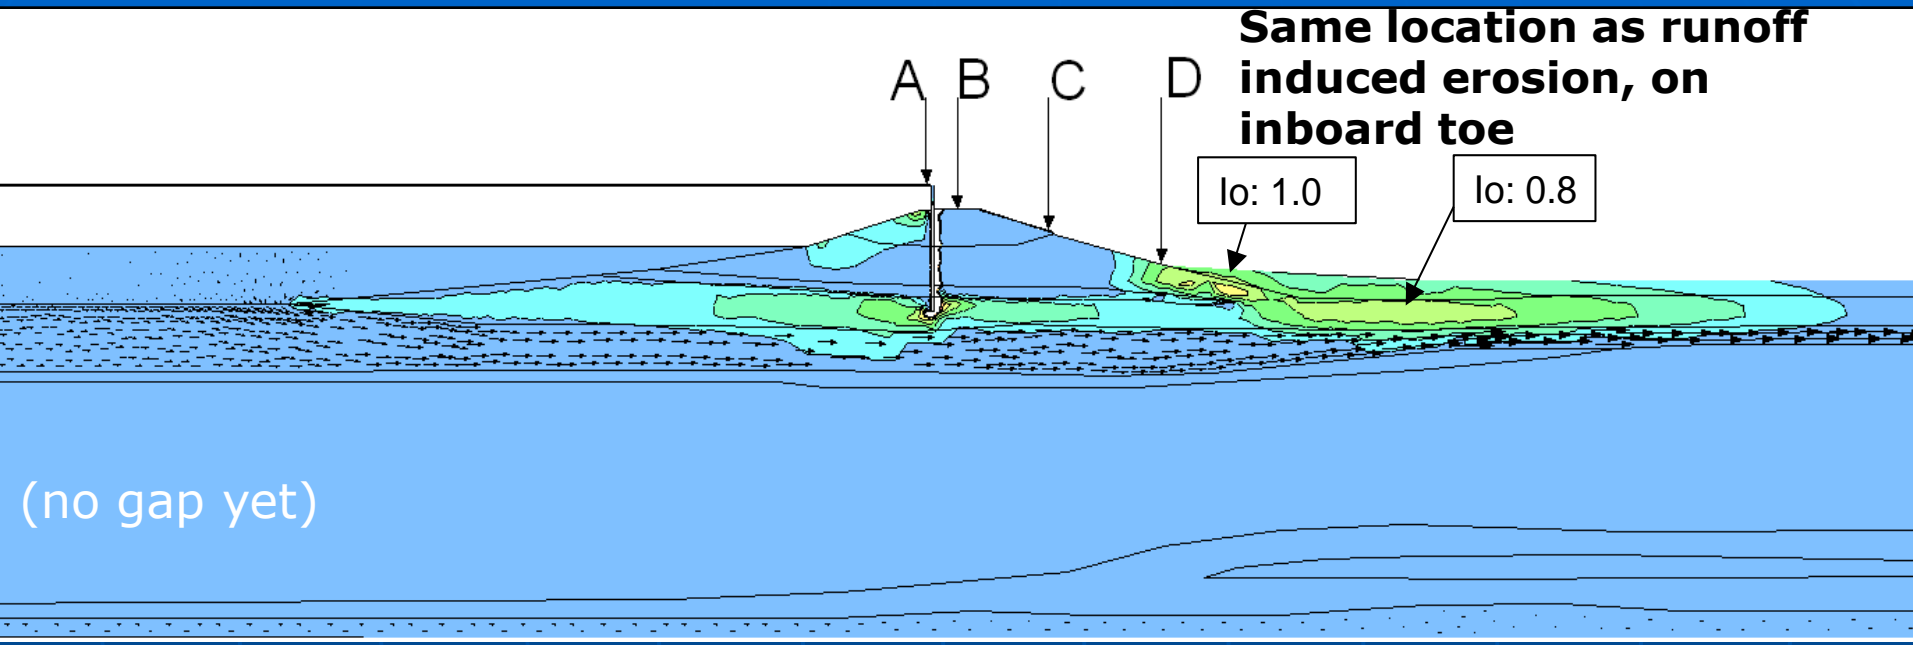
- Hydraulic gradients for the south breach on IHNC east bank; storm surge at 14.4ft (MSL). Maximum exit gradient at the levee toe is $i_o \approx 0.8$ to 1.0, at threshold for hydraulic piping.

- This may help to explain the persistent wet spot noted on the backfill of the Jourdan Avenue conduit backfill for weeks afterward.

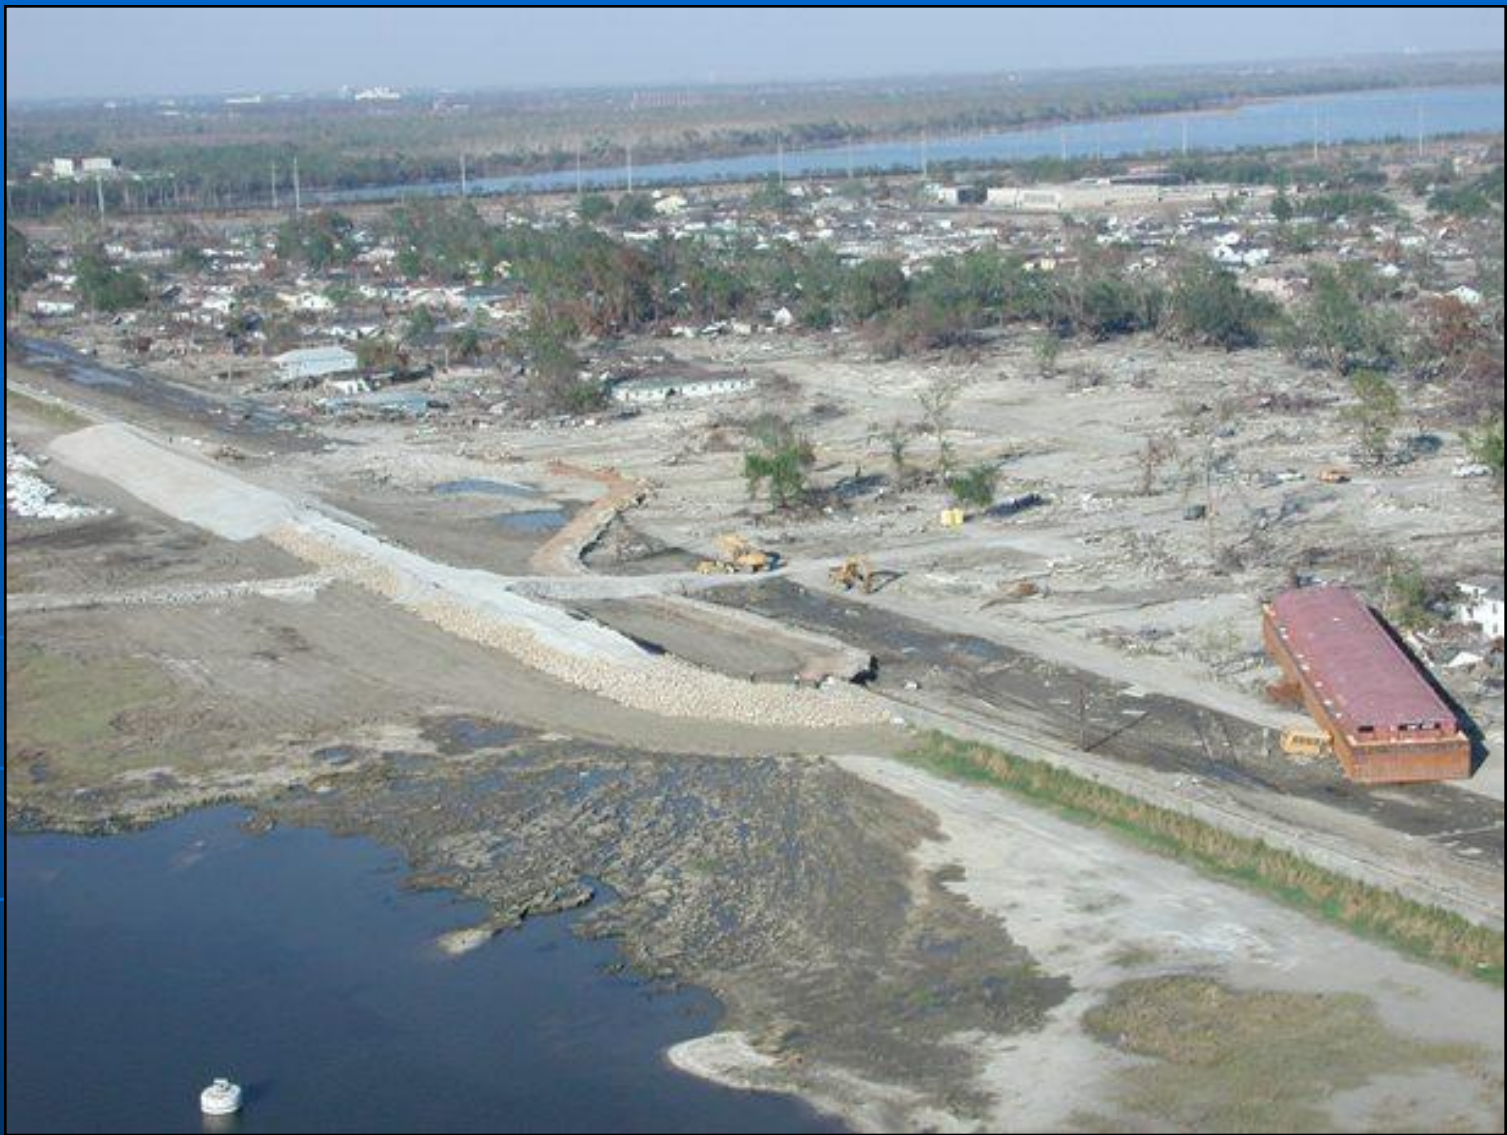
Aerial view of the south breach at the east bank of the IHNC (at the west end of the Ninth Ward), showing the 'wet spot' along the inboard side and the crevasse splay generated by reverse drainage flow. [Photograph by U.S. Army Corps of Engineers]
