Levee Failures Along the Inner Harbor Navigation Channel in New Orleans

J. David Rogers, Ph.D., P.E., P.G.

for Technical Session #15 on

New Orleans Levees and Hurricane Katrina

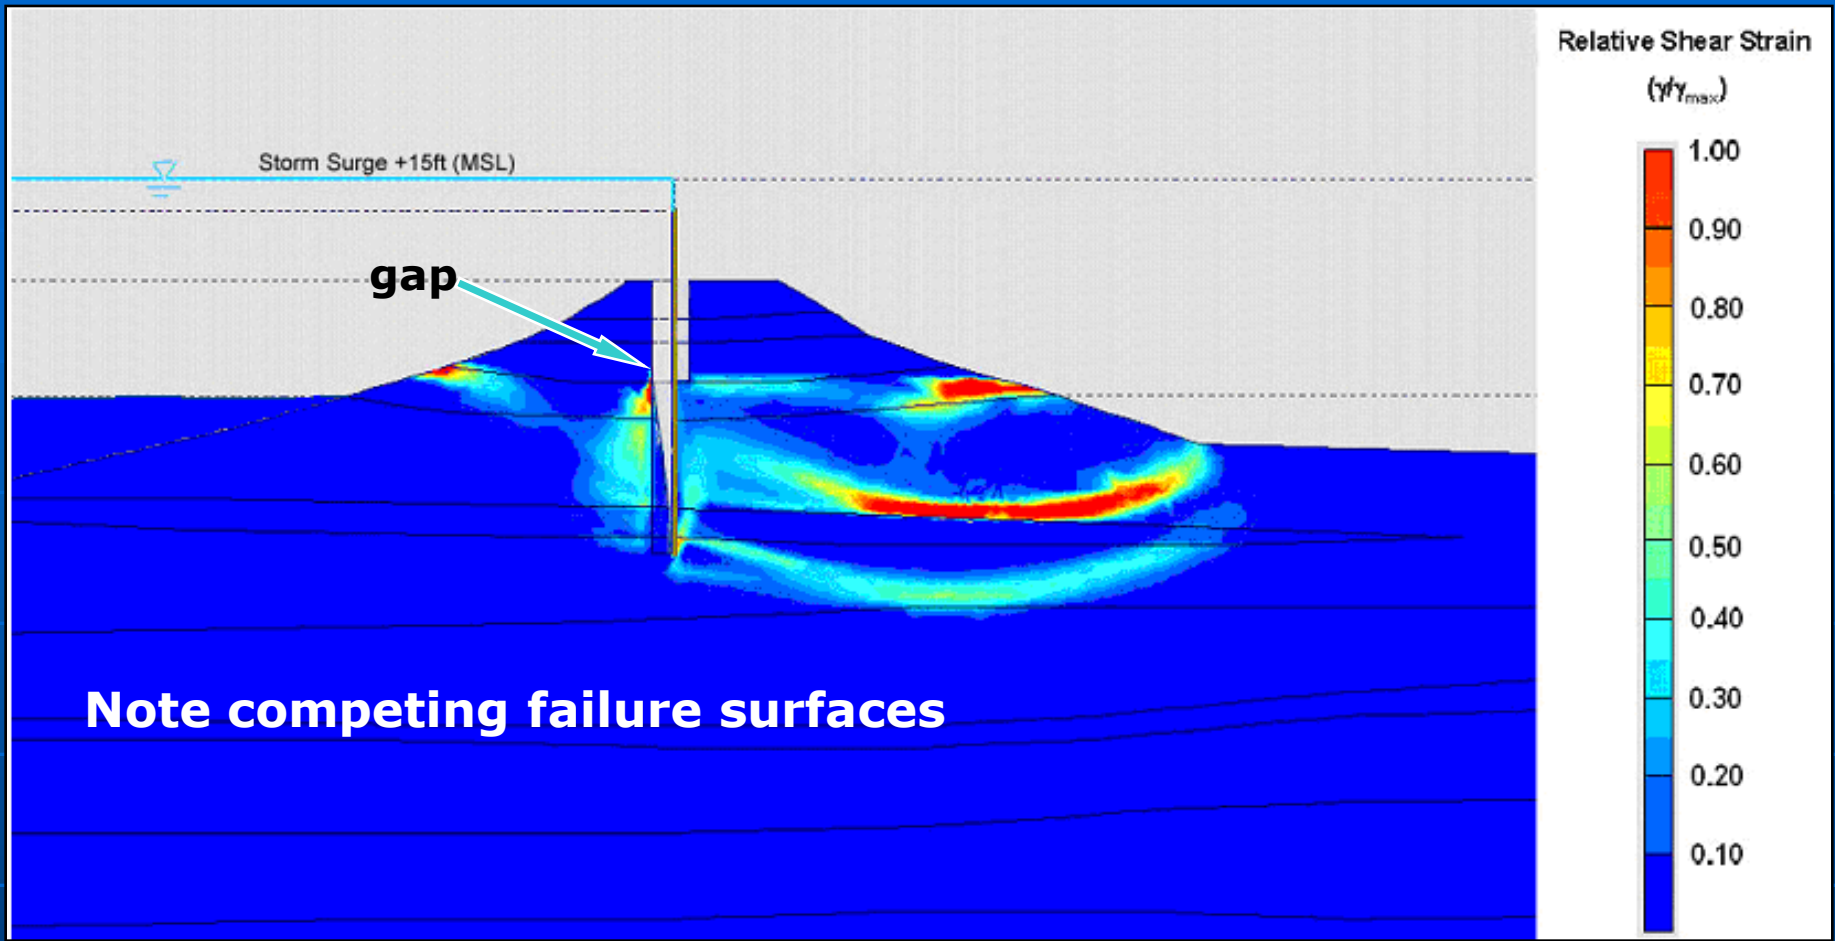
Normalized shear strain contours (shear strain divided by strain to failure) for a storm surge at Elev. + 14 feet (MSL) on the east IHNC south breach; gapping at outboard toe of floodwall is fully developed.

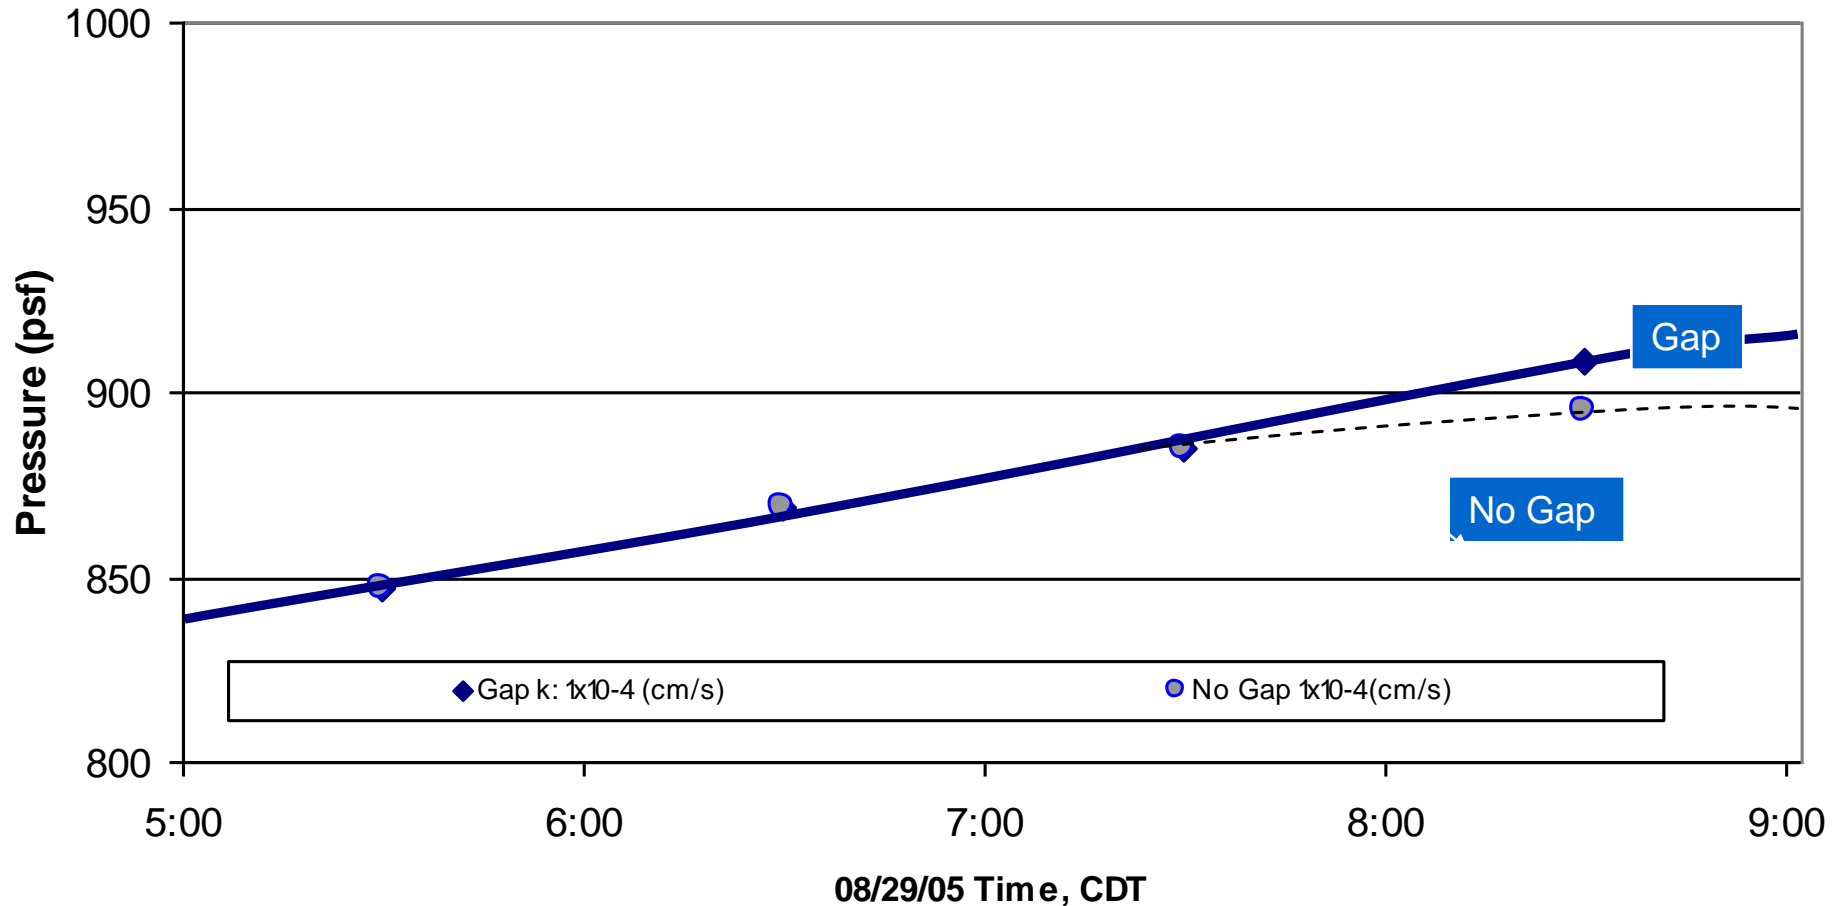
Increase of pore pressure at top of lower marsh unit if the gap on water side of flood wall opened around 7:30 AM. This would have hastened the build-up of pore pressure at this location.

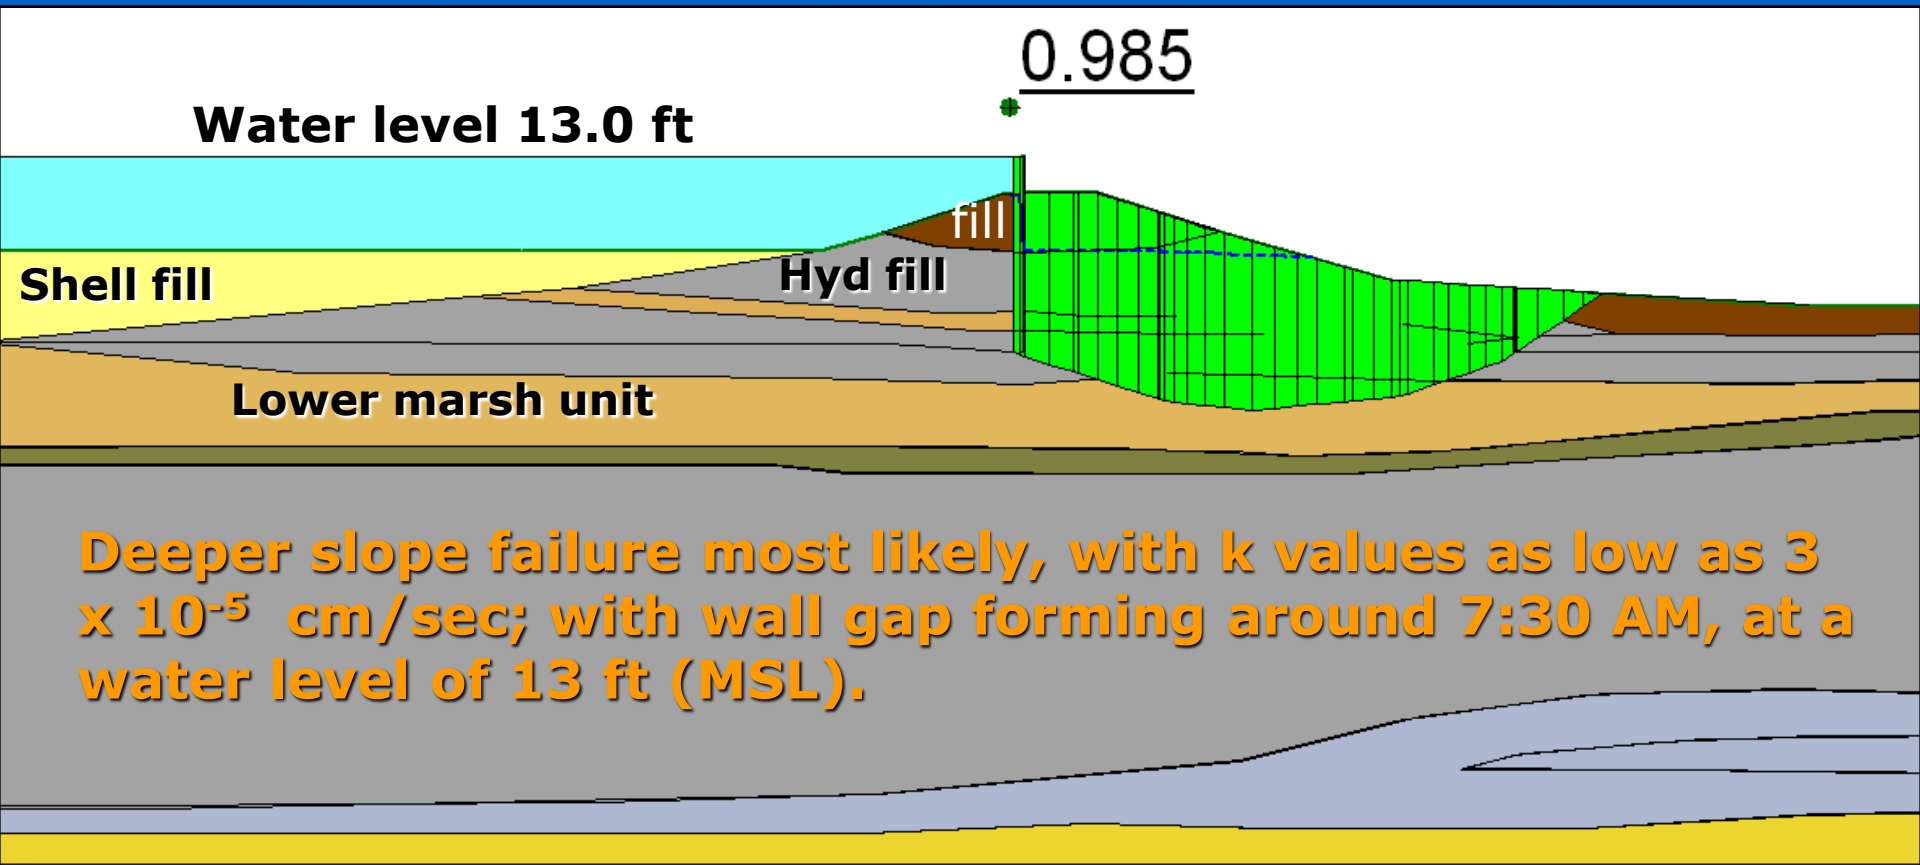
Deep failure mode (in lower marsh) with wall gap- FS=0.985

This would appear to be the best explanation for a massive translational failure, 800 feet long.

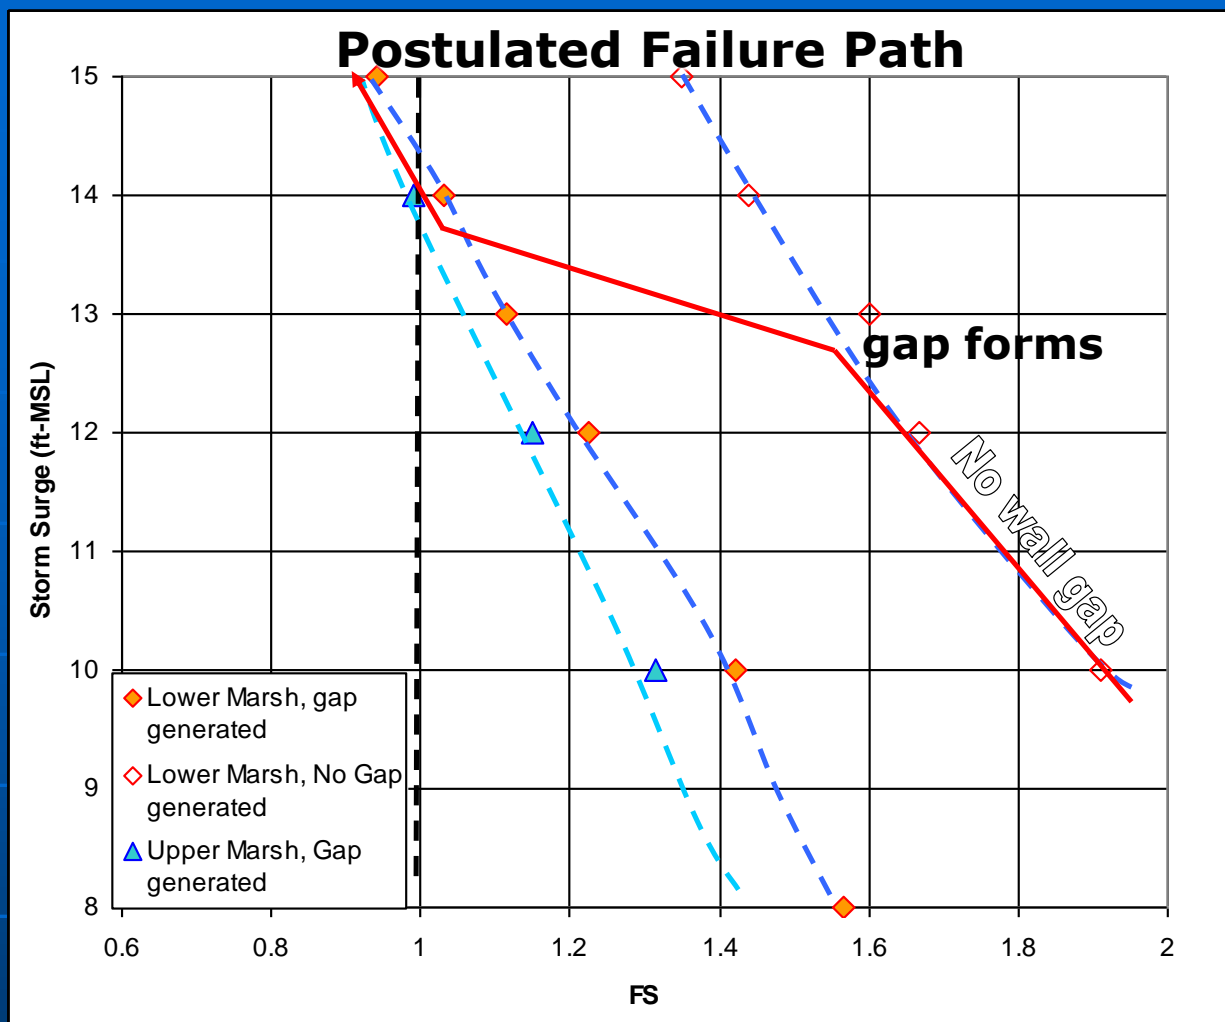
Calculated Factors of Safety for three modes based on SLOPE/W analyses of the East Bank IHNC South Breach site for various surge levels; showing the best-estimated path to failure.
