HALES BAR DAM

POTENTIAL PITFALLS OF CONSTRUCTING DAMS ON KARST FOUNDATIONS

J. David Rogers, Ph.D., P.E., P.G.
Missouri University of Science & Technology
for the symposium on

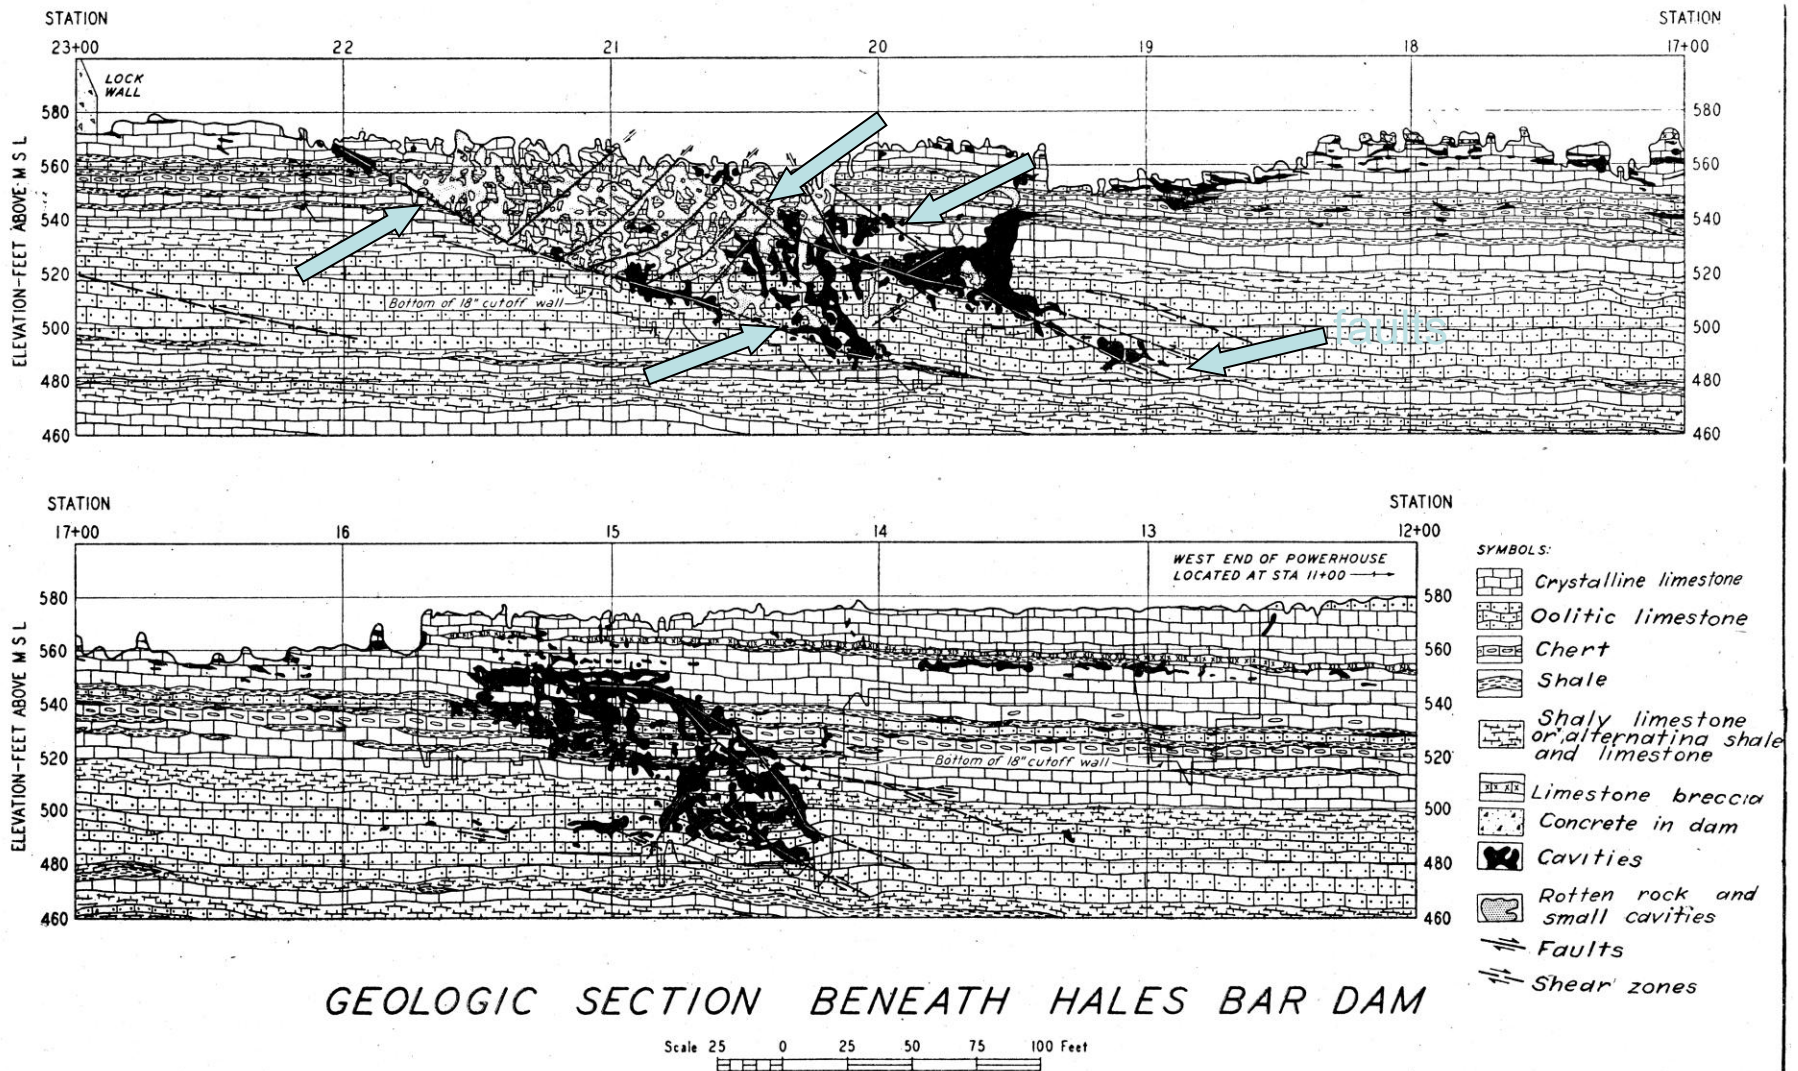
GEOLOGIC SECTION BENEATH HALES BAR DAM

- After 25 years of study, it was learned that the **Bangor limestone** contained numerous **clay-filled cavities** (shown in white) and open **interconnected caverns**, shown in black. The clay-filled cavities proved to be the unsolvable problem, not the open caverns.

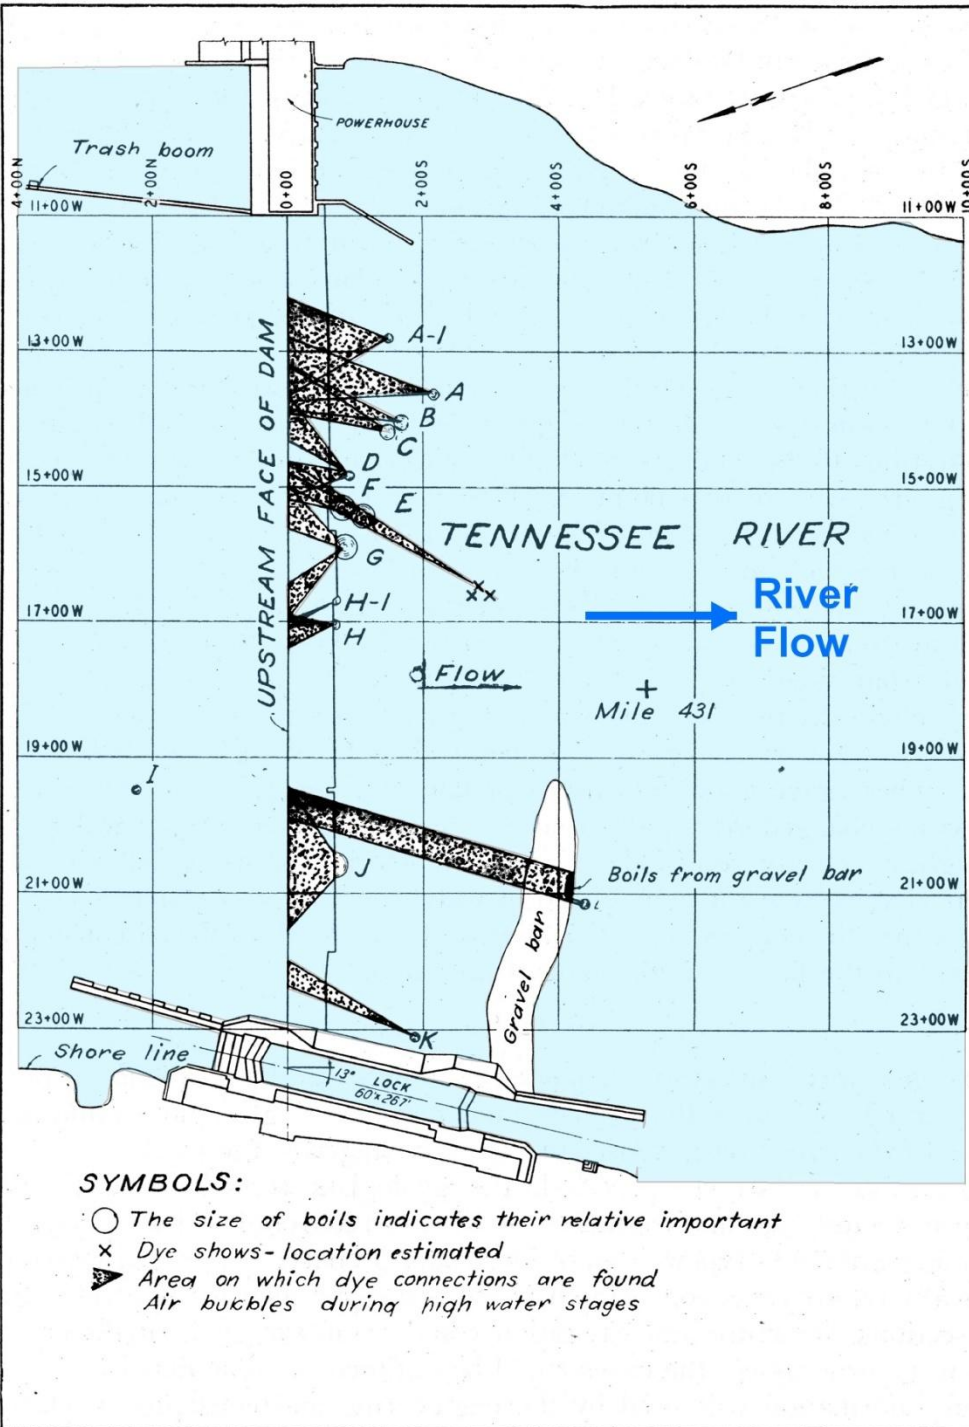
- **Flourescein dyes** were used in measurements of seepage by the USGS and the TVA in **1939**
- These revealed that the leakage beneath the main dam varied between **1720 and 1650 cfs**; about **10%** of the **Tennessee River's normal flow**
- In plan view at left, note seepage **boils** formed in the gravel bar, which increased each year, to **13 known boils** by **mid 1939**

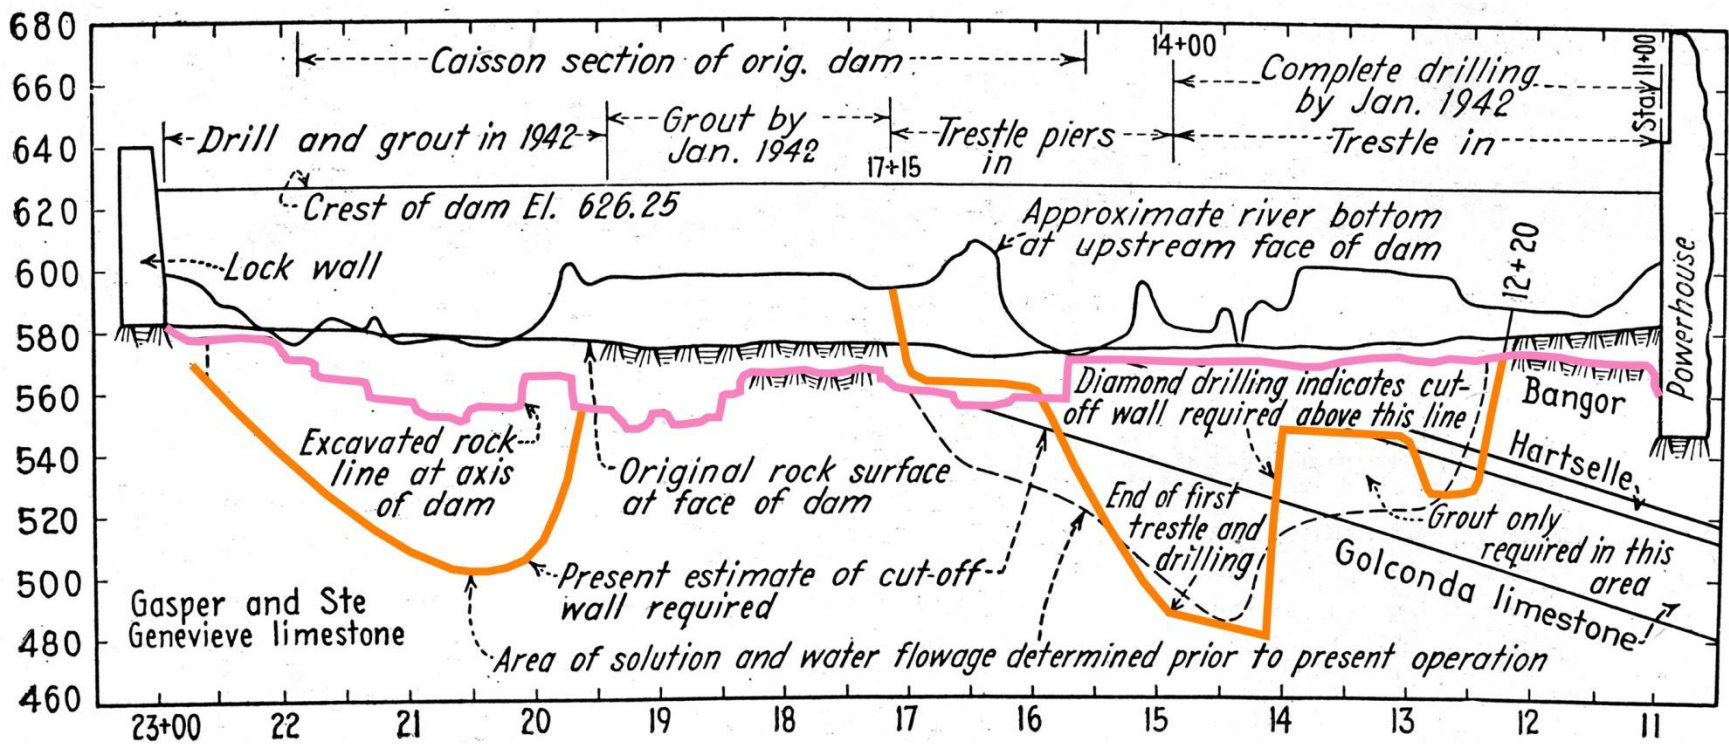
- Profile of **cutoff wall systems** constructed beneath Hales Bar Dam in the cavernous Bangor Limestone
- Note variation between rock surface at upstream heel and toe of the gravity dam
- Note inclination of the **most porous zones**, along a series of **low angles faults**, parallel to the strike of the strata and the river course

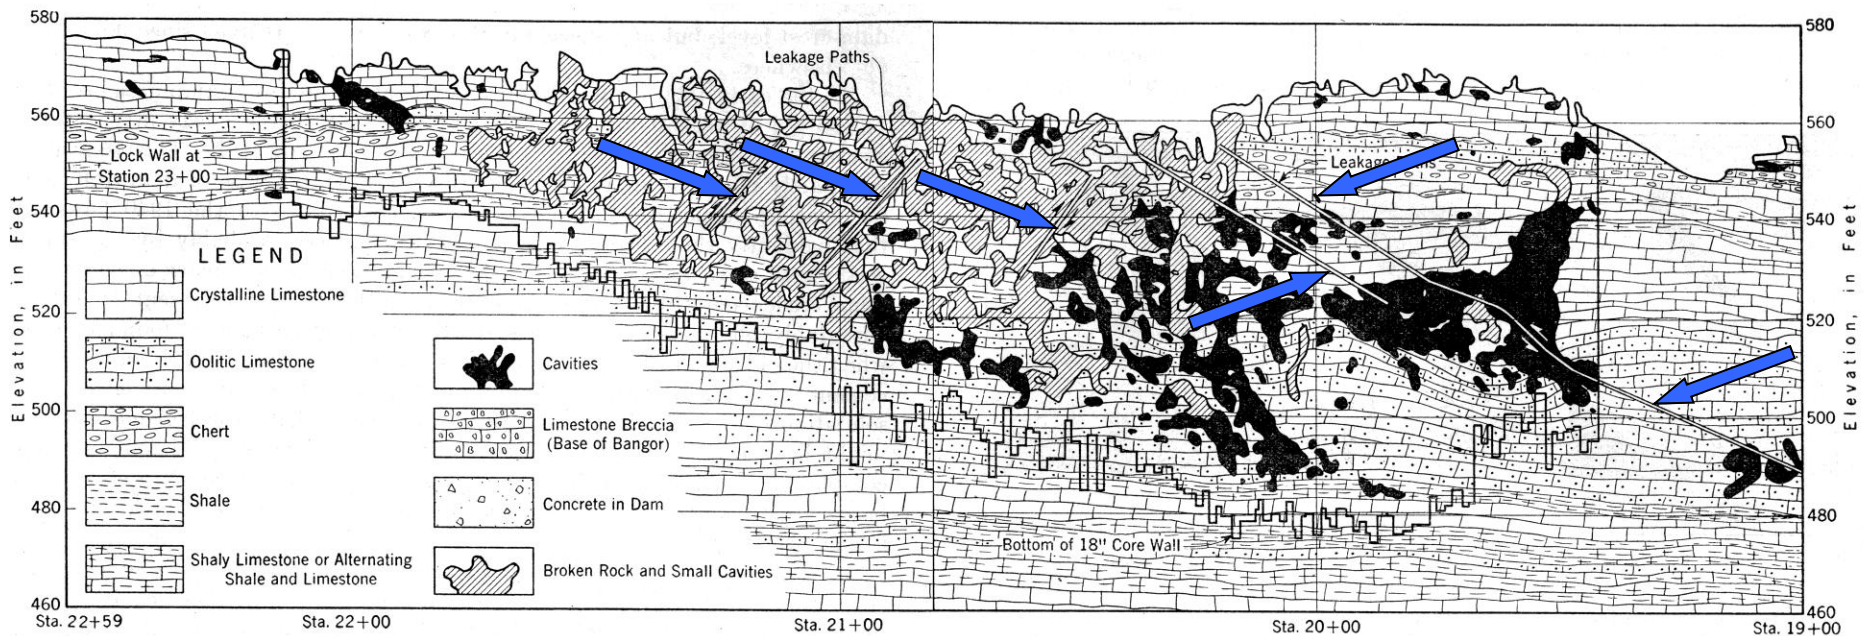
- The **principal leakage paths** (blue arrows) beneath the dam were discerned through **logging of cores**, **current meter measurements**, and **mapping of sand boils** in the channel bed below the dam.
- Note the **extensive interconnected system of cavities**, and the linear nature of these flow conduits.
- Note bottom of the 18" core wall, annotated above

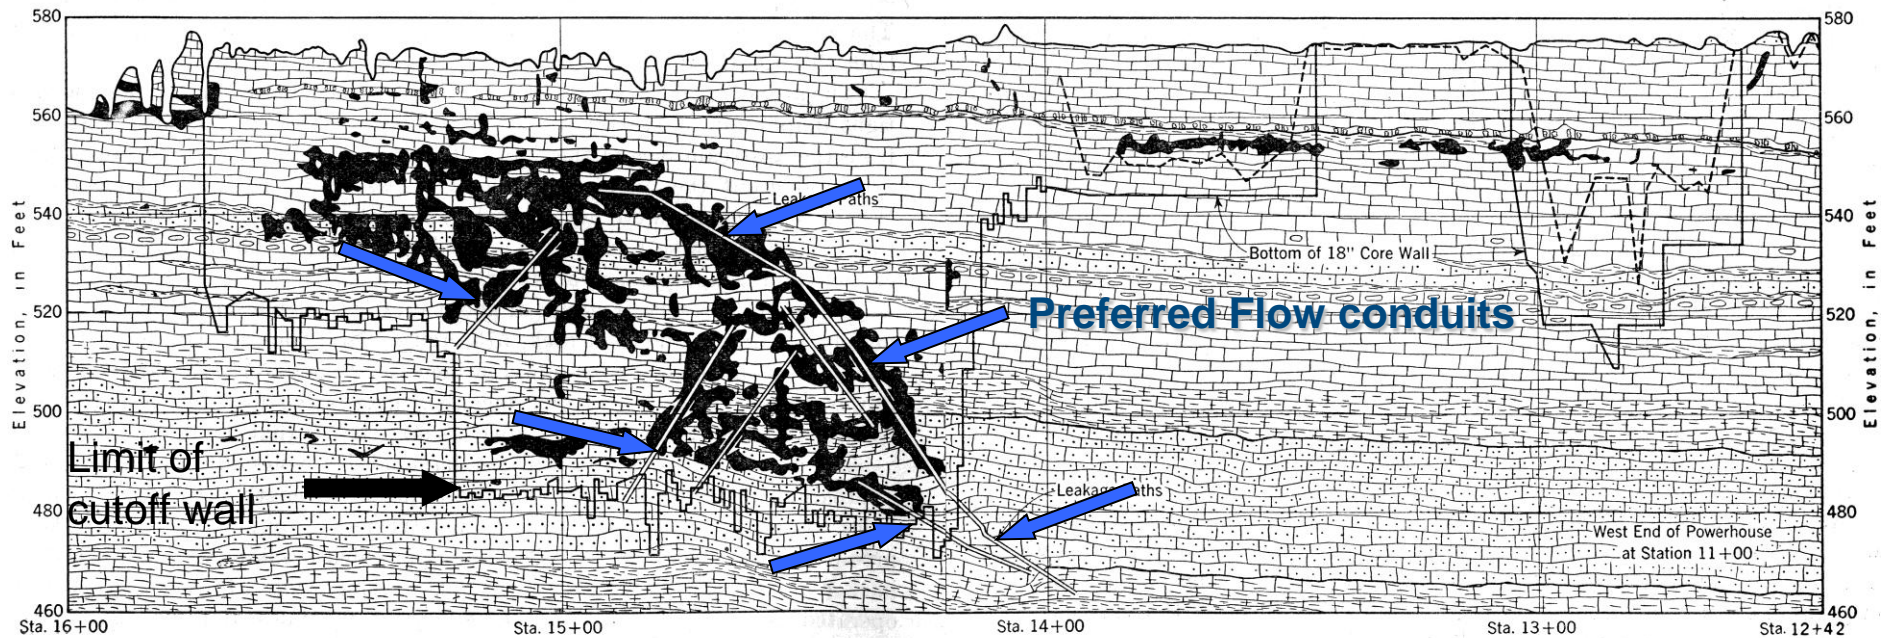
- Another area of filled cavities and **severe underseepage** encountered beneath **Hales Bar Dam**, looking upstream.
- Note the linear nature of the **preferred seepage conduits**, cutting across bedding.
- The limits of the concrete cutoff wall are shown by the solid black line.

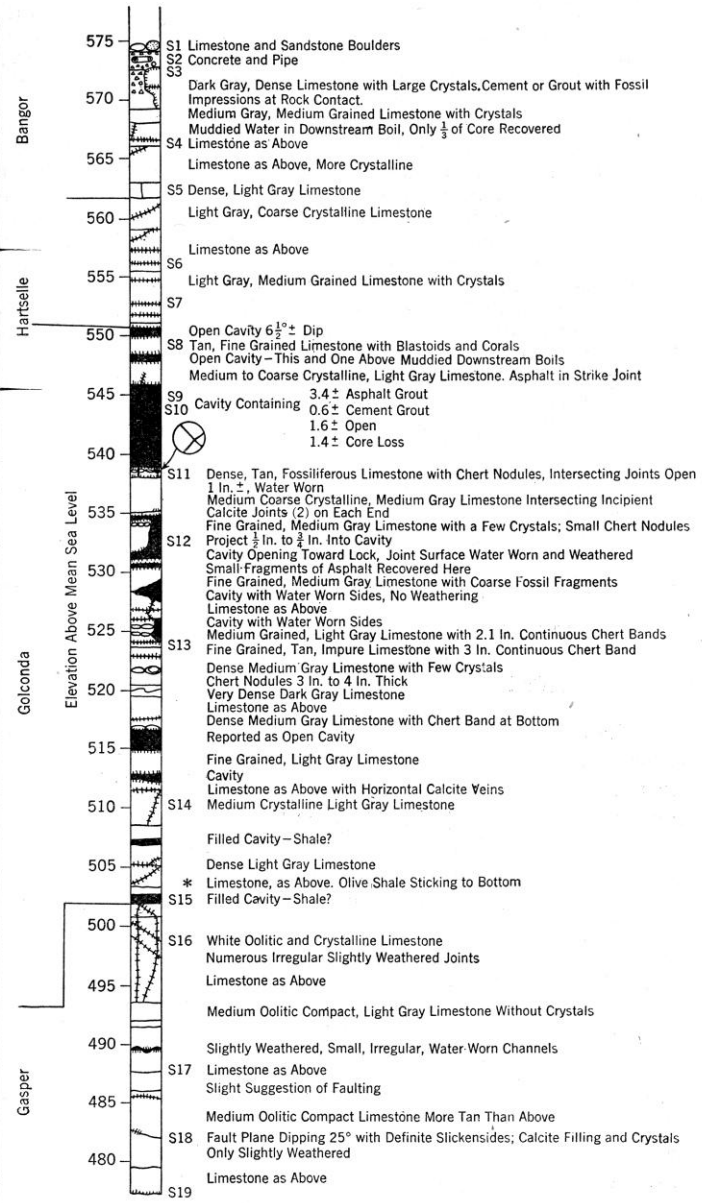
(b) LOG OF TYPICAL DRILL HOLE, HALES BAR DAM

Discrete horizons containing cavities were identified, shown at left in black
