# THE CASE FOR REMOVING MATILIJA DAM

**J. David Rogers, Ph.D., P.E., P.G.**

2007 Annual Meeting

Association of Environmental and Engineering Geologists

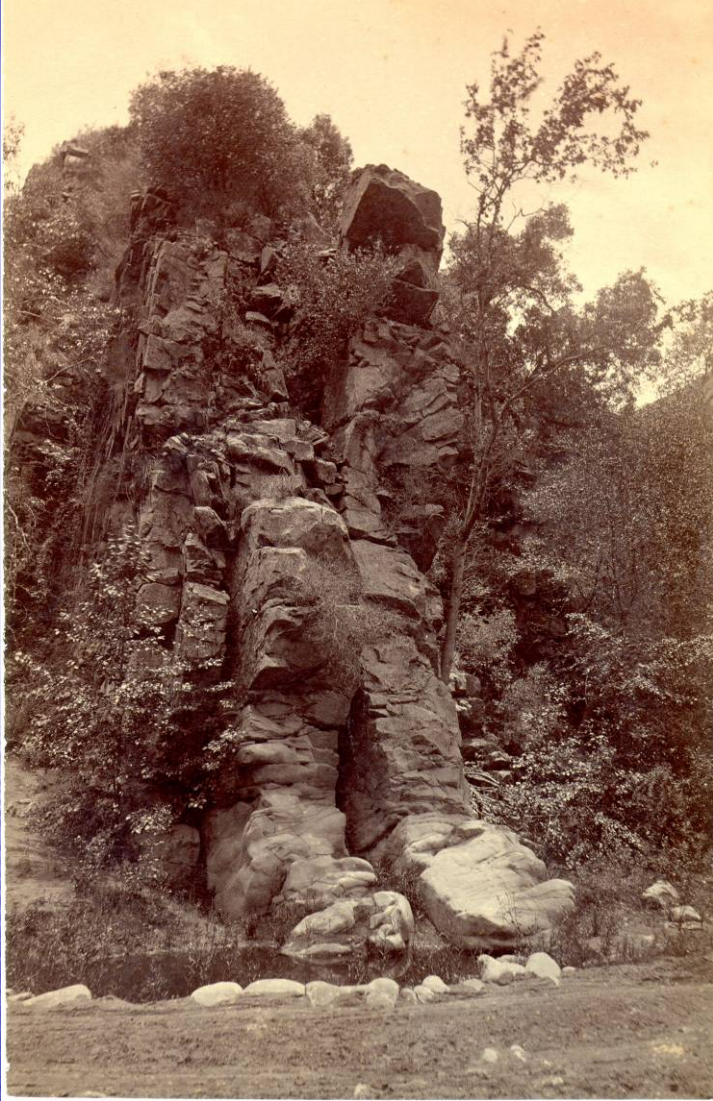
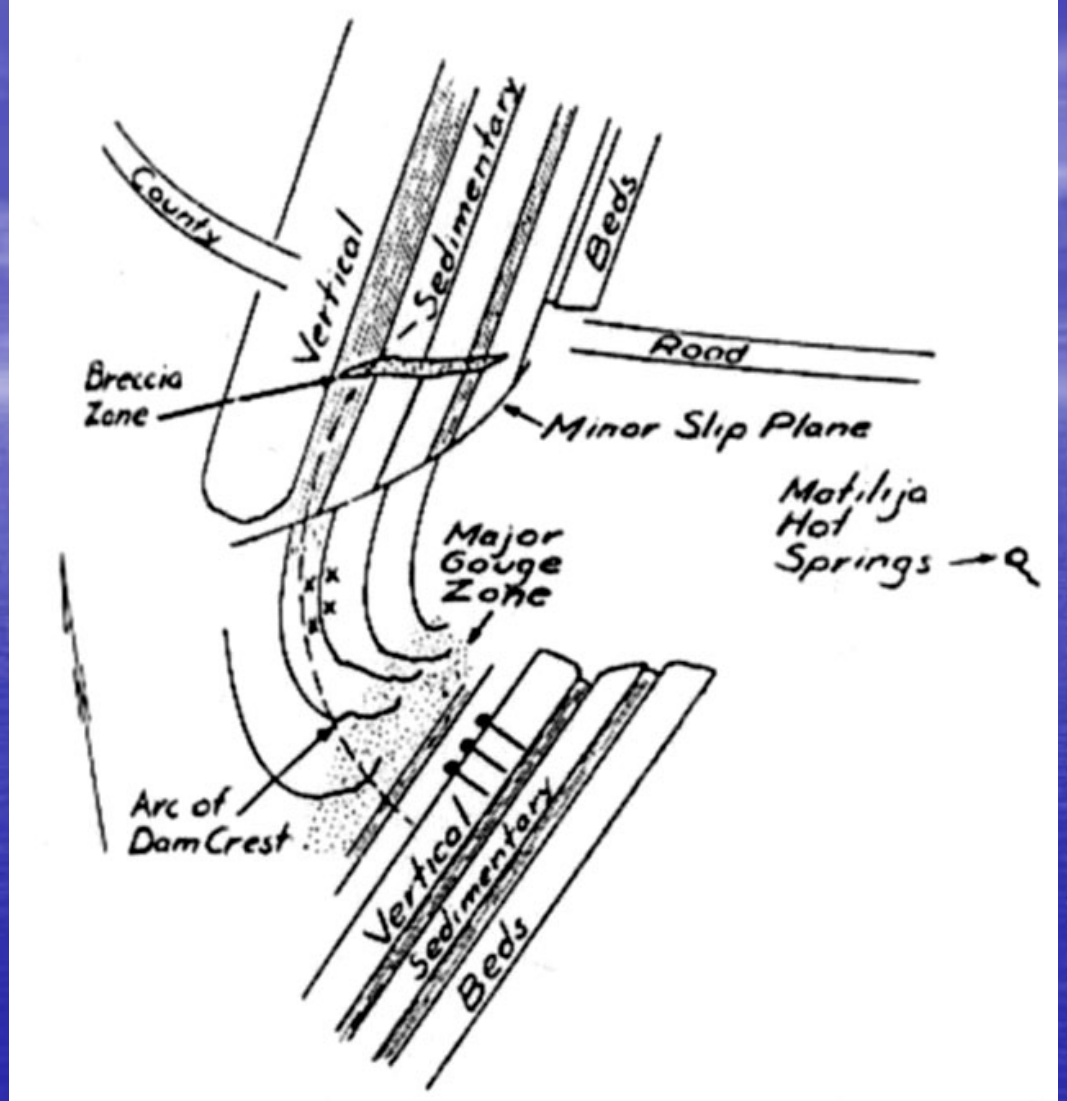
- Soon after construction began, the contractor's geologist discovered a fault in a tightly folded anticline. The fault offsets slightly dissimilar geology on either abutment and the drag folds suggest an offset of ~100 ft. The fault zone is about 150 ft wide.

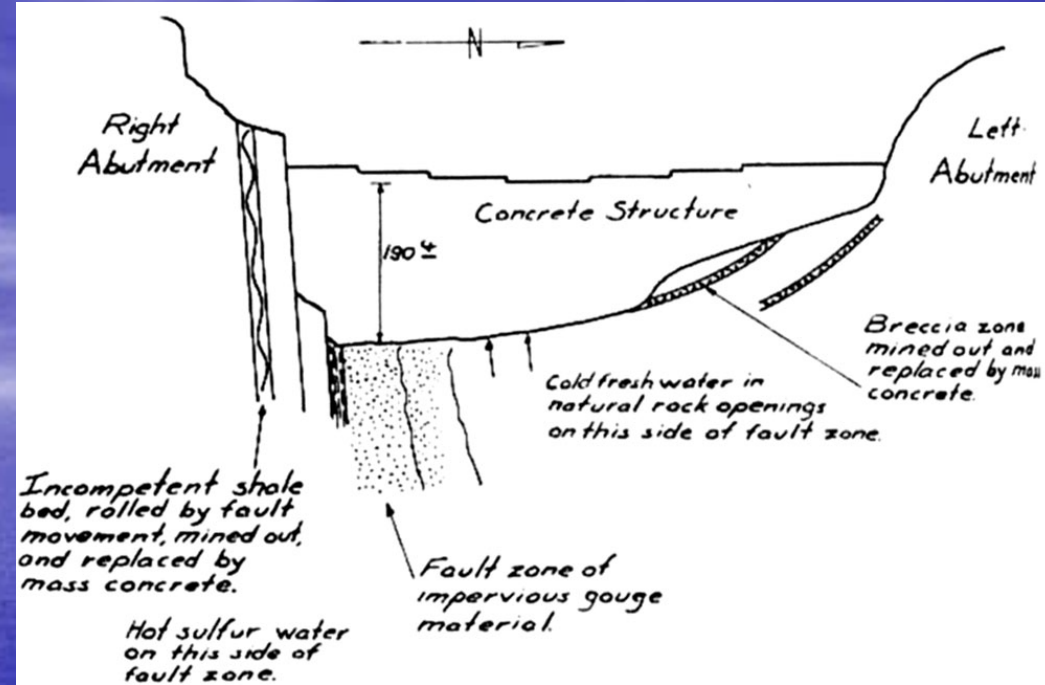
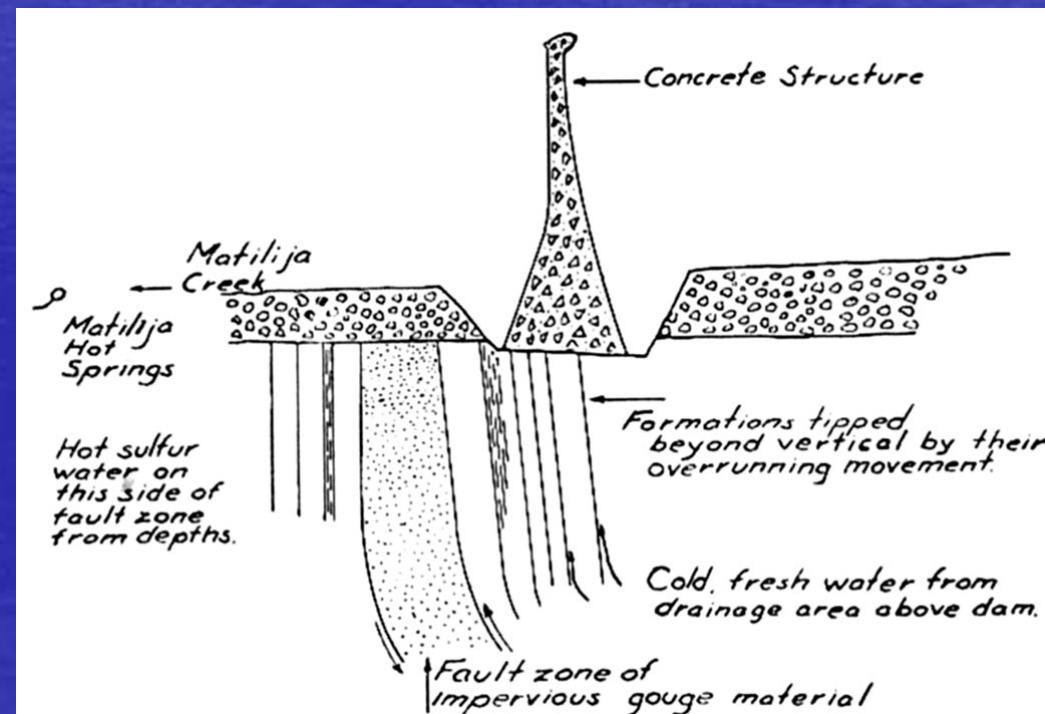
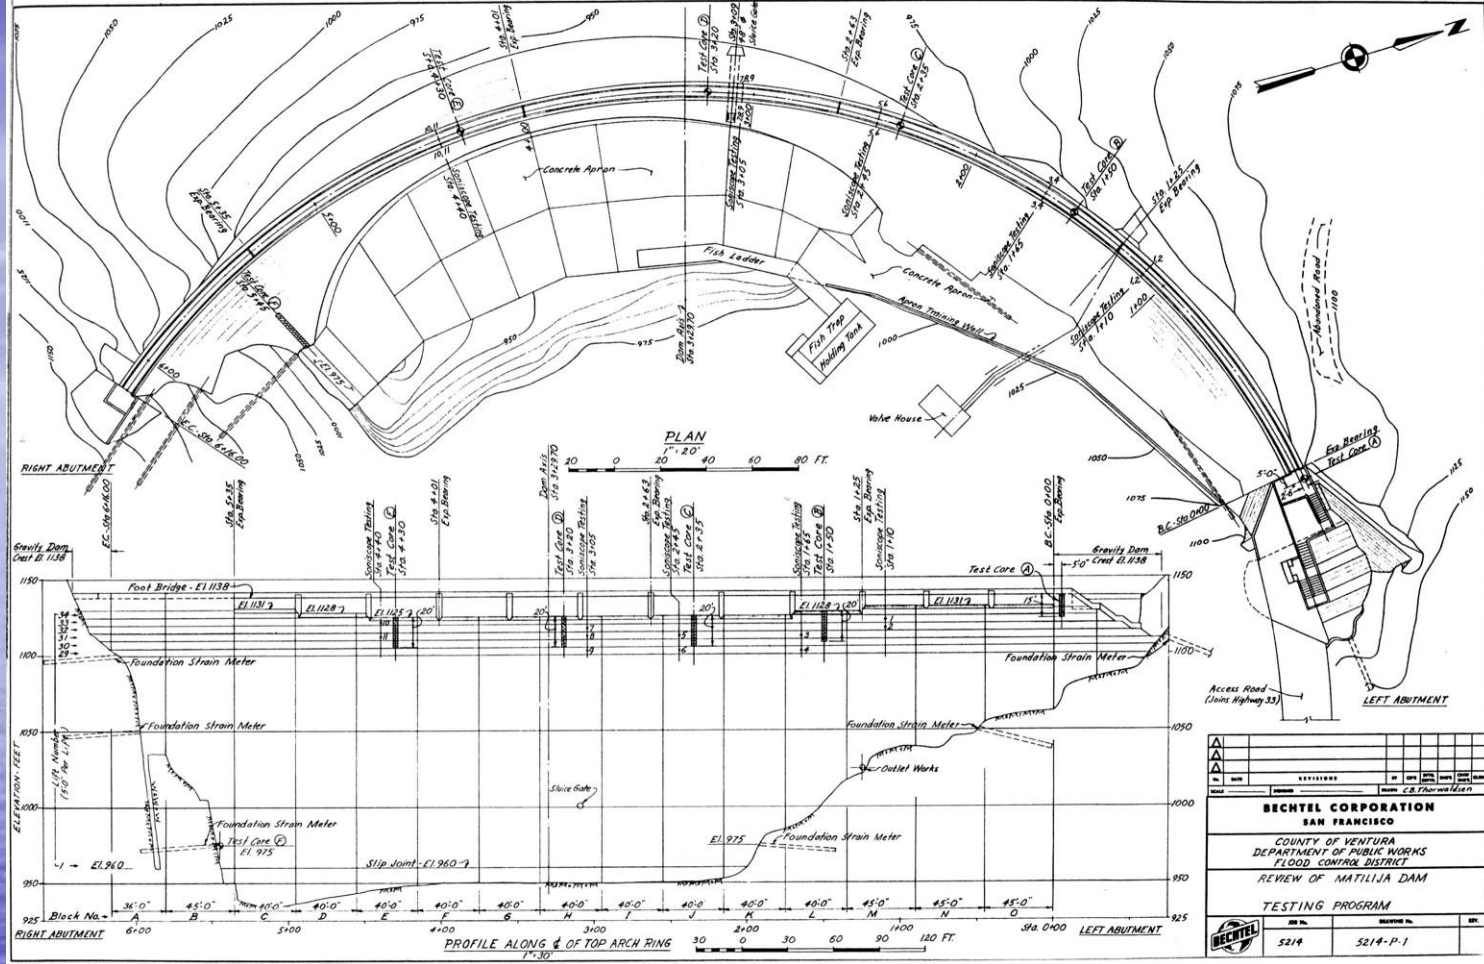
- Special foundation treatment was required for a fault in the southwest abutment
- Prof. Charles Berkey brought in as a consultant, as well as many others

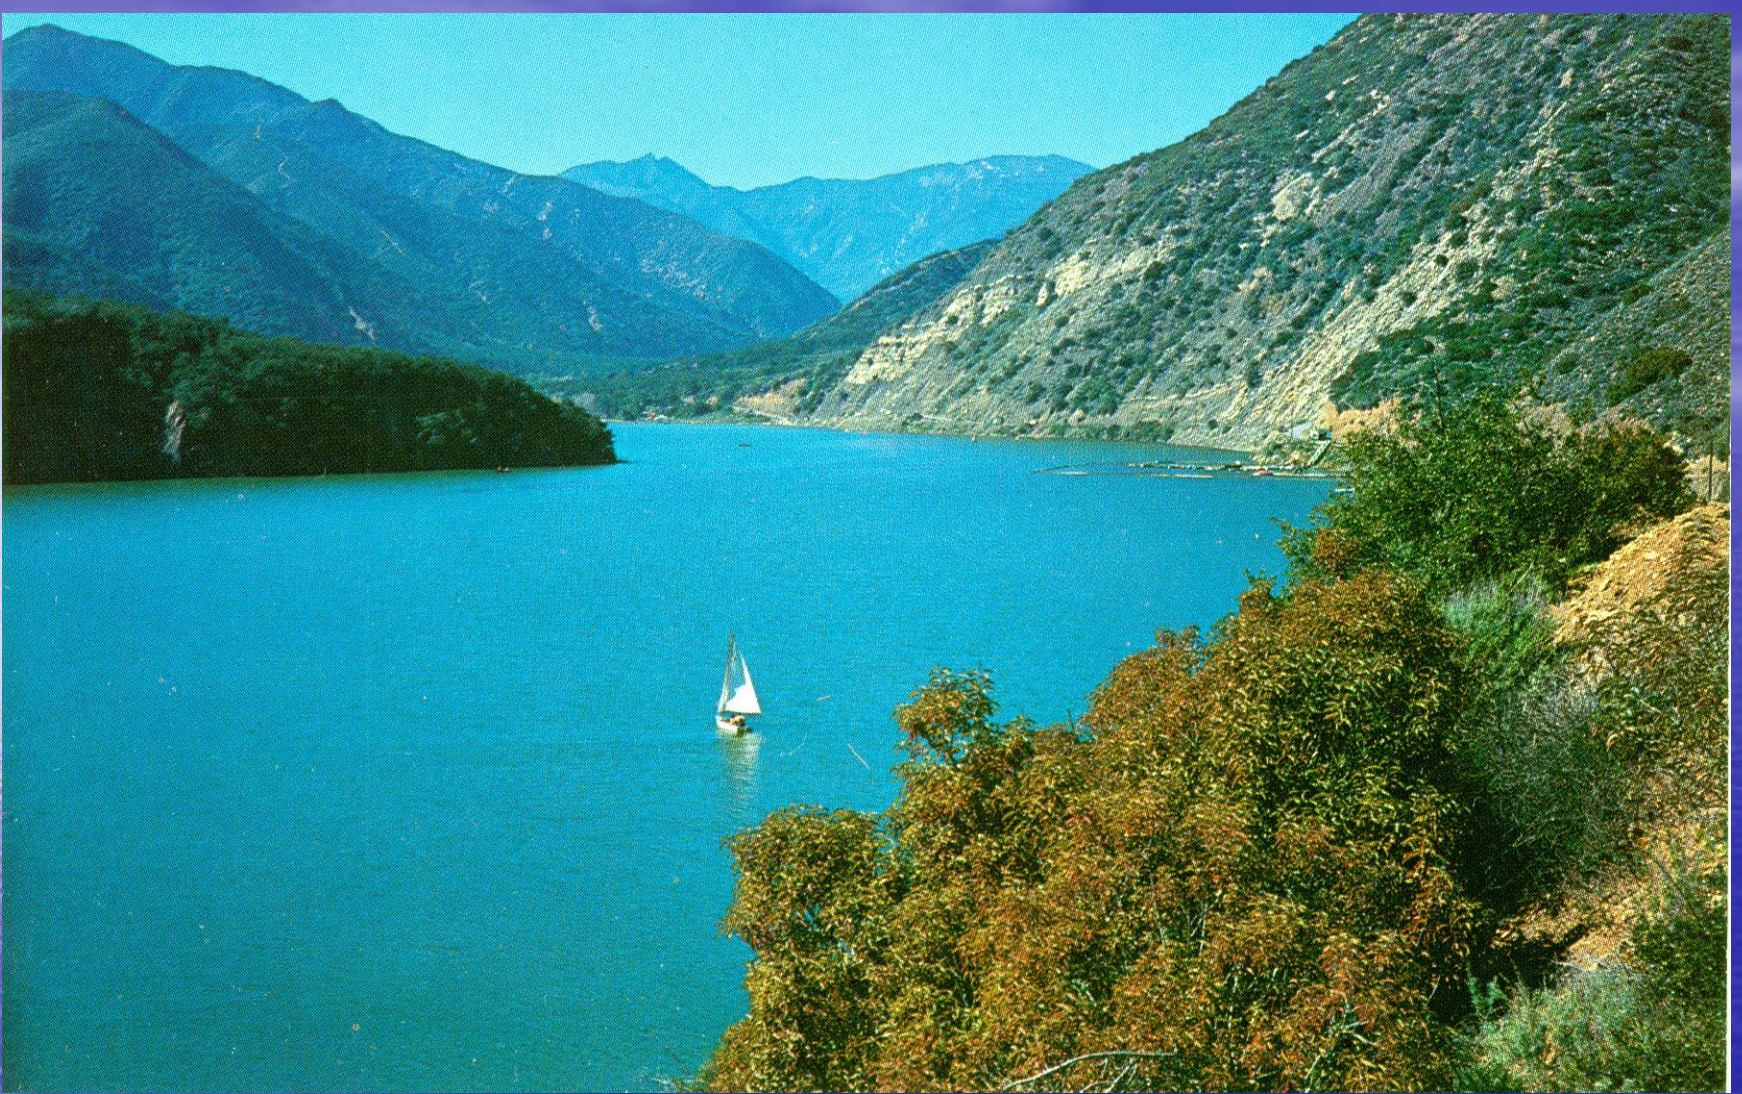
- The only obvious operational problem experienced by the dam during its first decade of service was severe erosion, caused by deflection of spillage on the left side of the spillway, shown here.

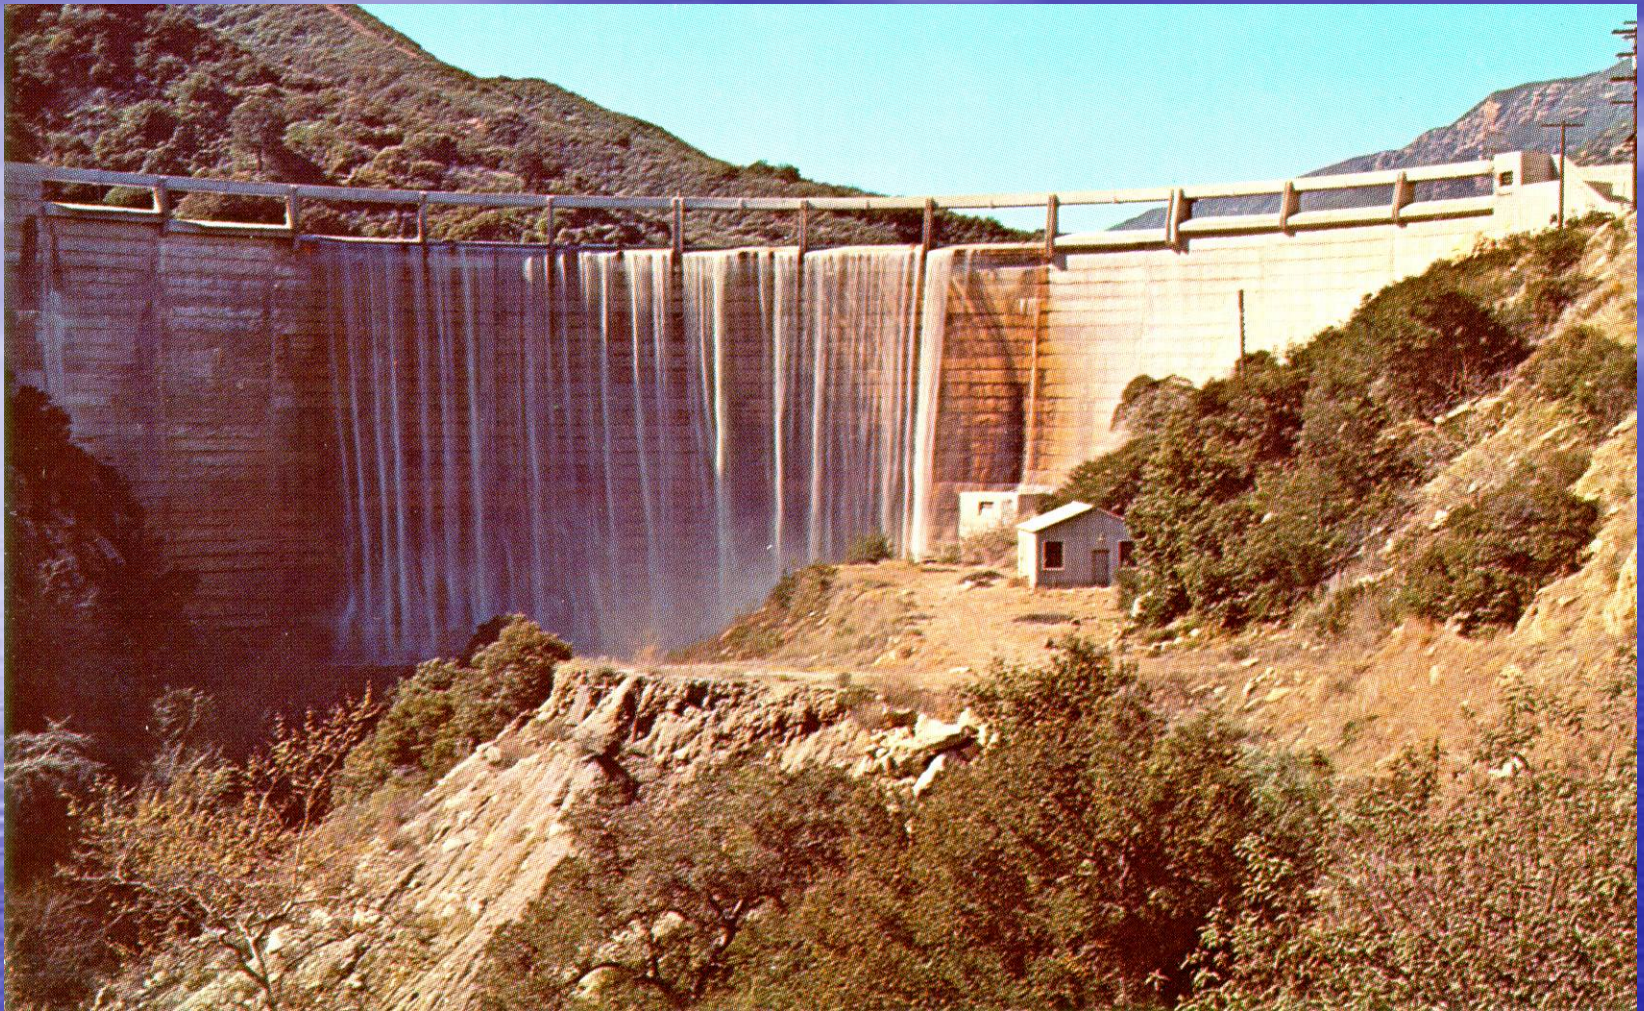
- As the dam got older, the water district started noticing staining and unusual deterioration of the dam's concrete.

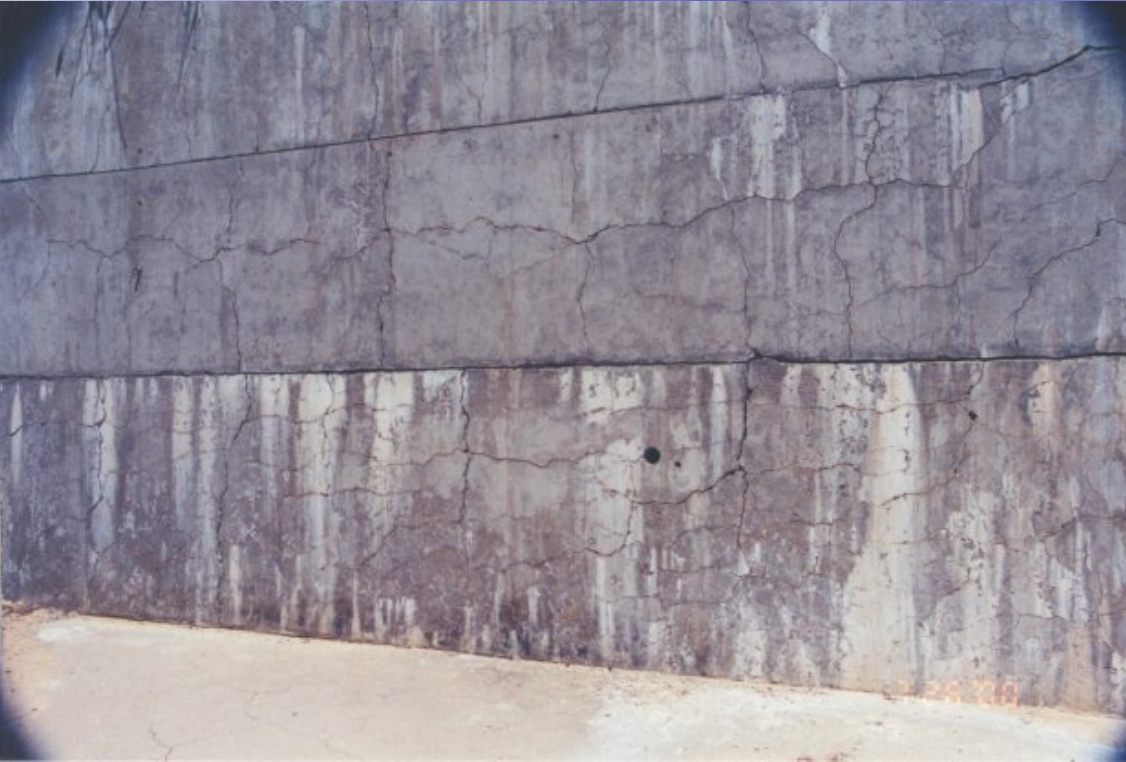
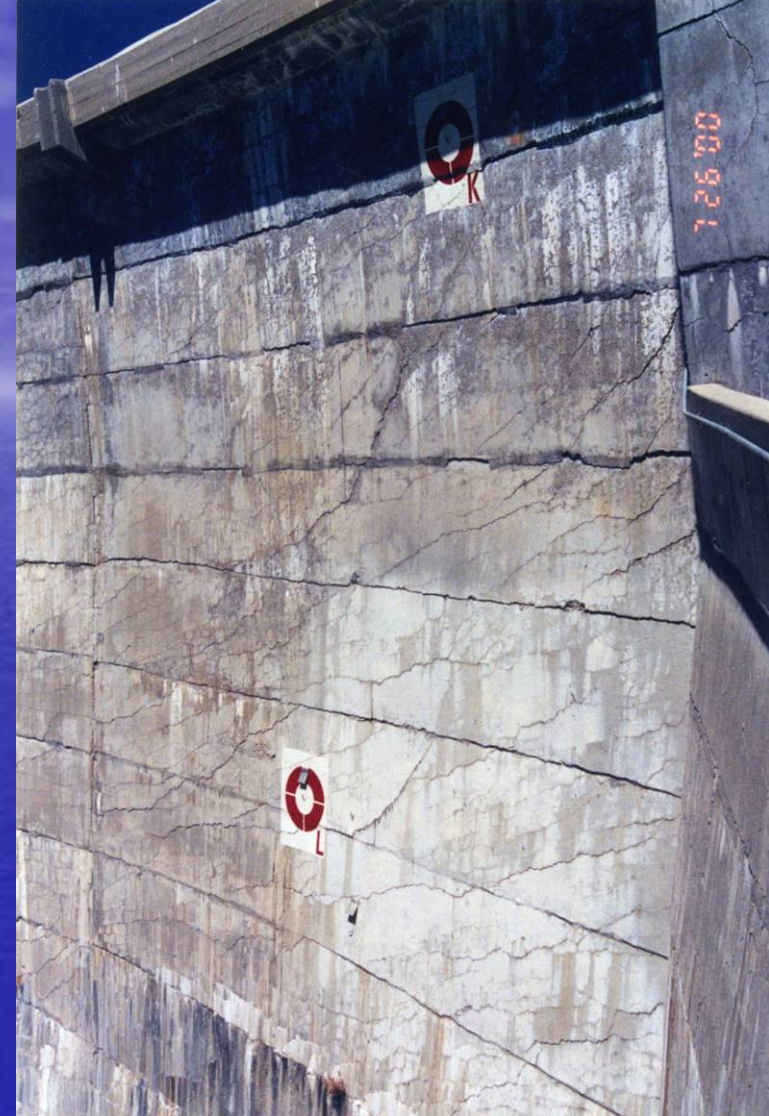
- In 1964 the water district retained Bechtel to evaluate excessive cracking problems in the dam's concrete. The cracking was most severe in the upper 40 feet.

- The alkali aggregate reaction was caused by inclusion of glassy andesite and chalcedonic chert in the fine aggregate fraction.
- Cores from the dam showed concrete strength had deteriorated to between 1,200 and 2,600 psi; while the original tests at time of construction were 4,500 to 5,000 psi.
- The precise mechanism was not ascertained until the mid 1970s; that being a chemical reaction between opaline quartz and the cement paste.

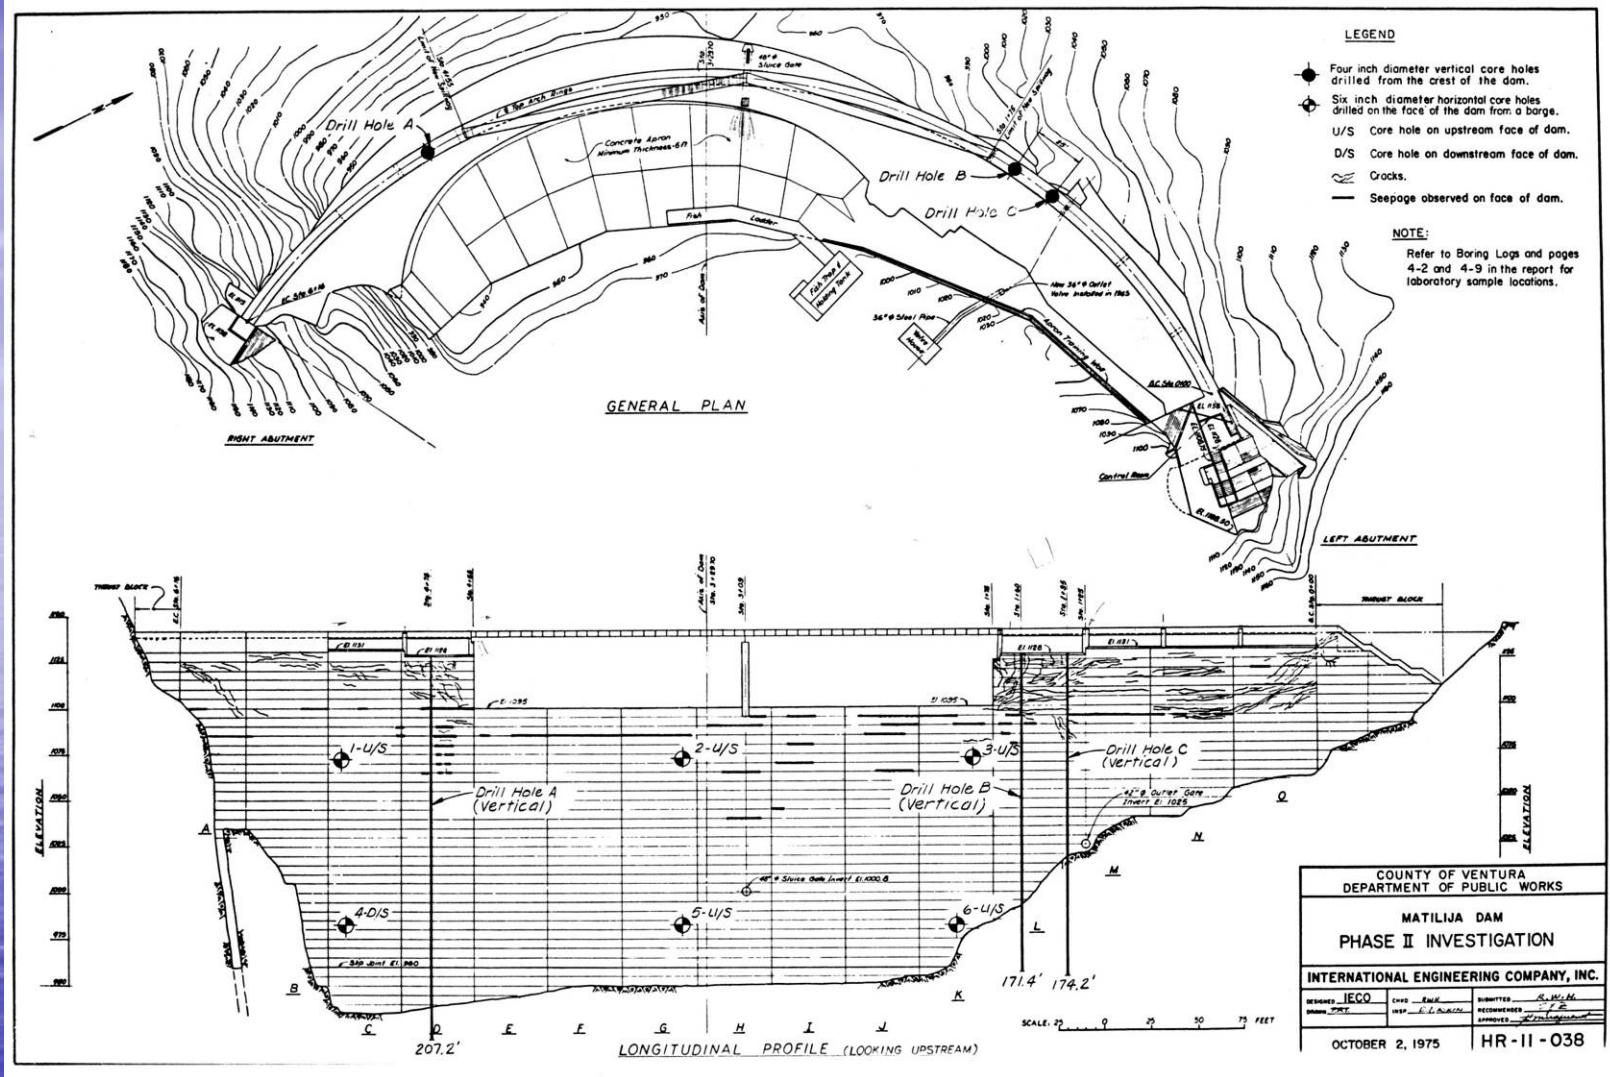
- Bechtel performed a series of structural analyses using the lower strength of the deteriorated interior of the dam's arch
- These structural analyses concluded that lower than normally accepted factor of safety existed.
- This work was reviewed by CA DSOD

- Bechtel recommended lowering the dam crest by 40 feet. This reduced the reservoir storage by 540 ac-ft. Later, the catwalk was also removed.

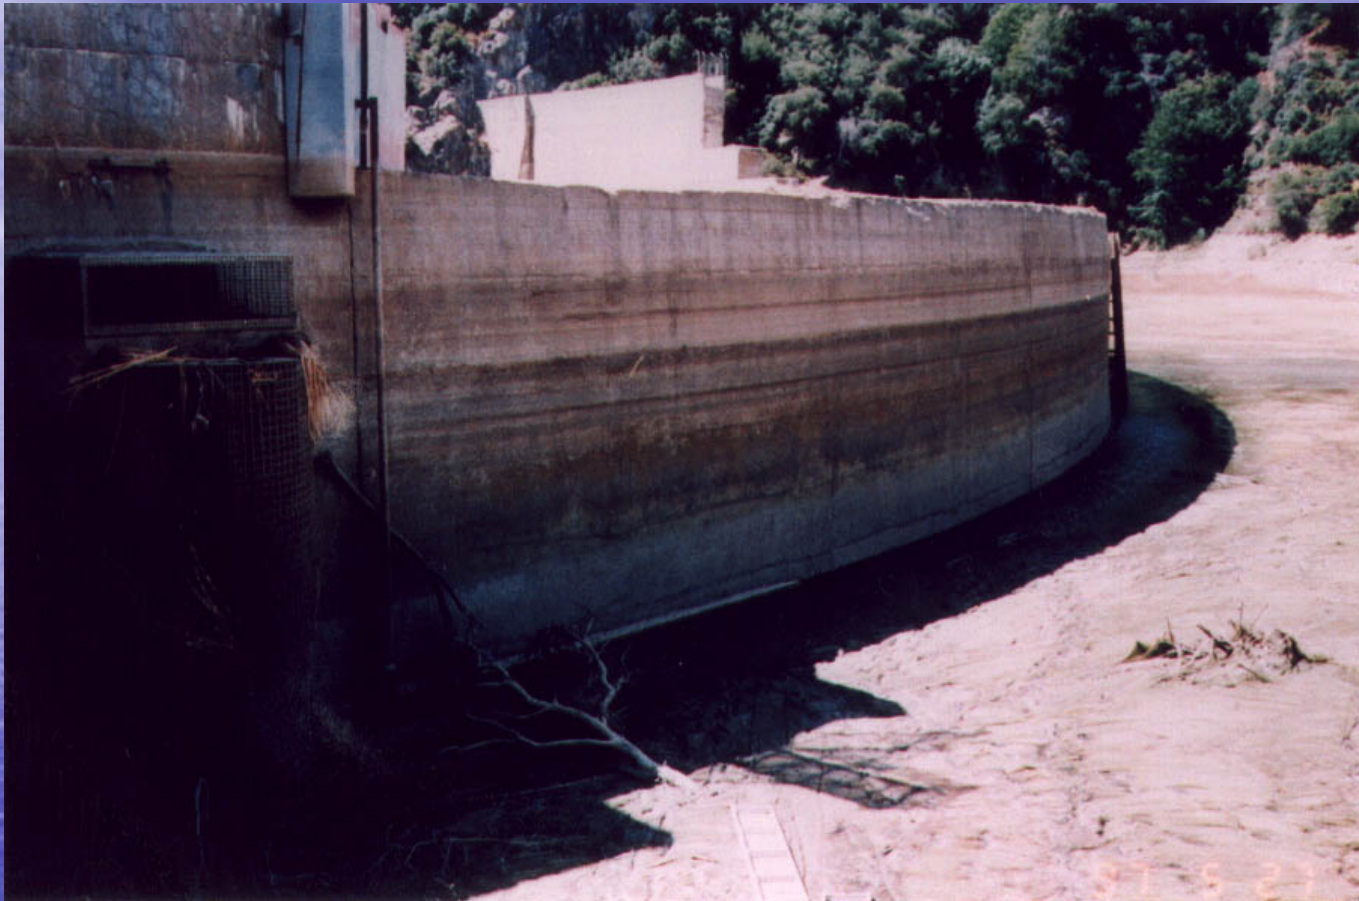
- By 2000, the reservoir was essentially full, with just 400 ac-ft of storage left. Matilija Creek used to support steelhead trout, migrating up Ventura River from Pacific Ocean
- Current plans call for its removal, after studies by USBR, USGS and USCOE are concluded

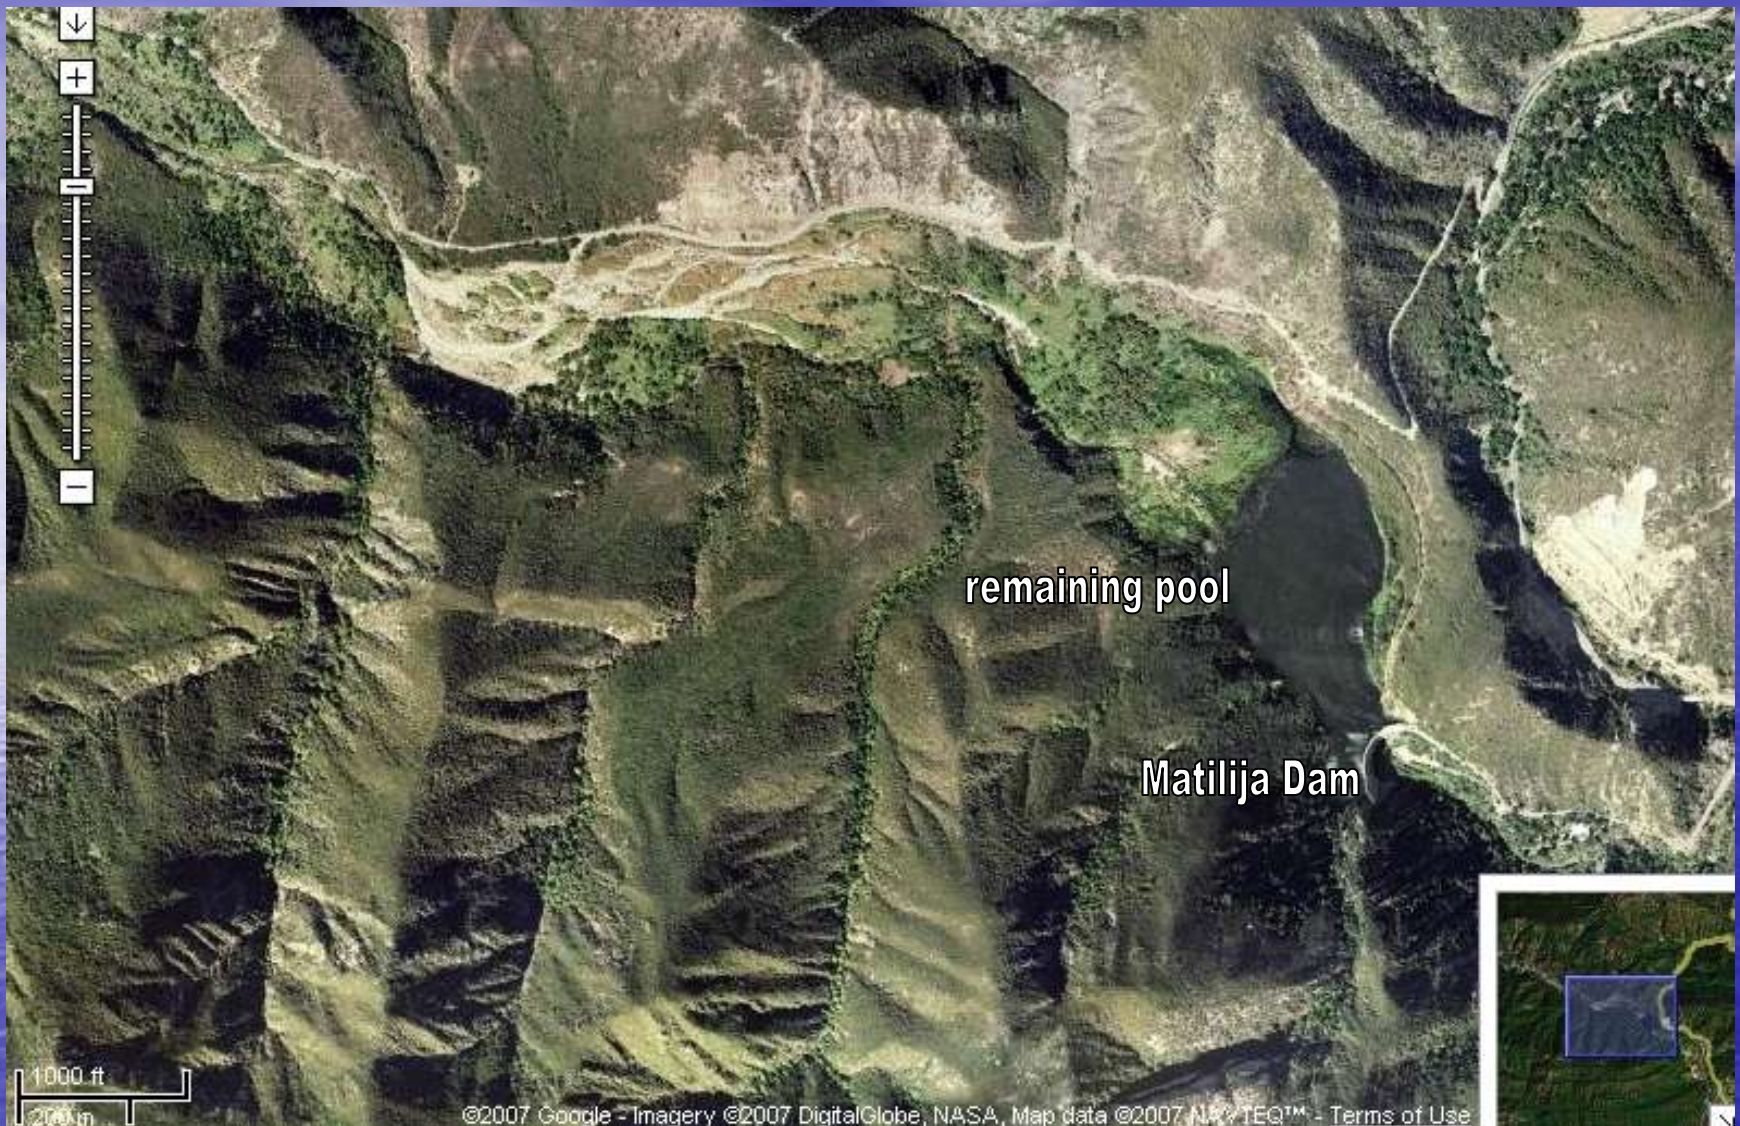
- **NASA image of the almost-filled Matilija Reservoir, as it appeared in 2005**

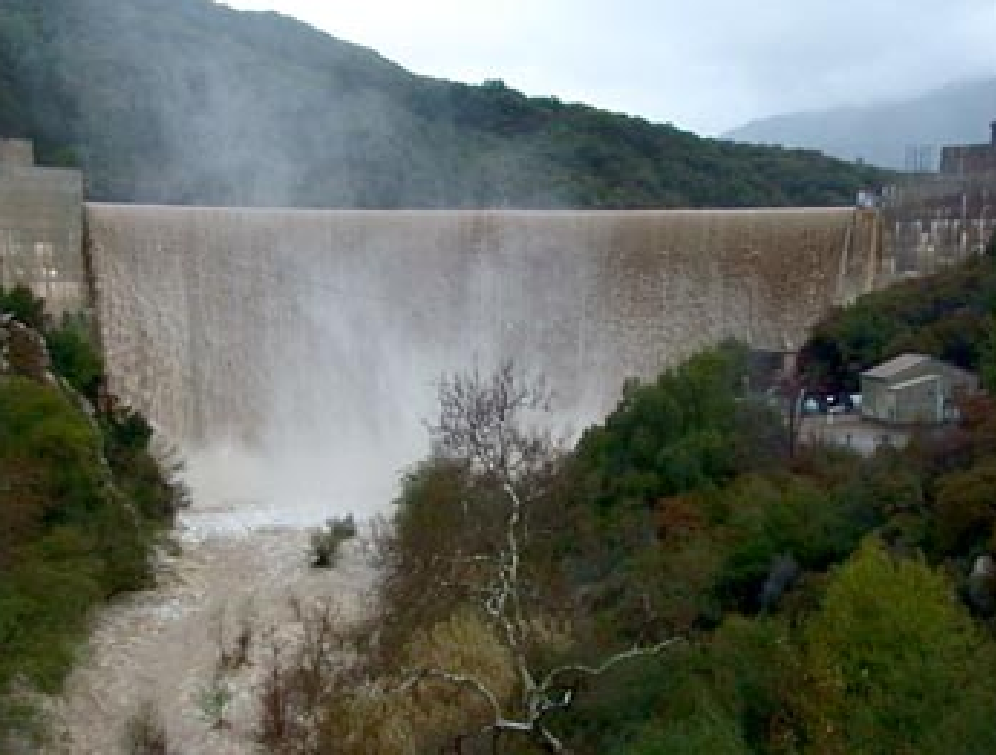
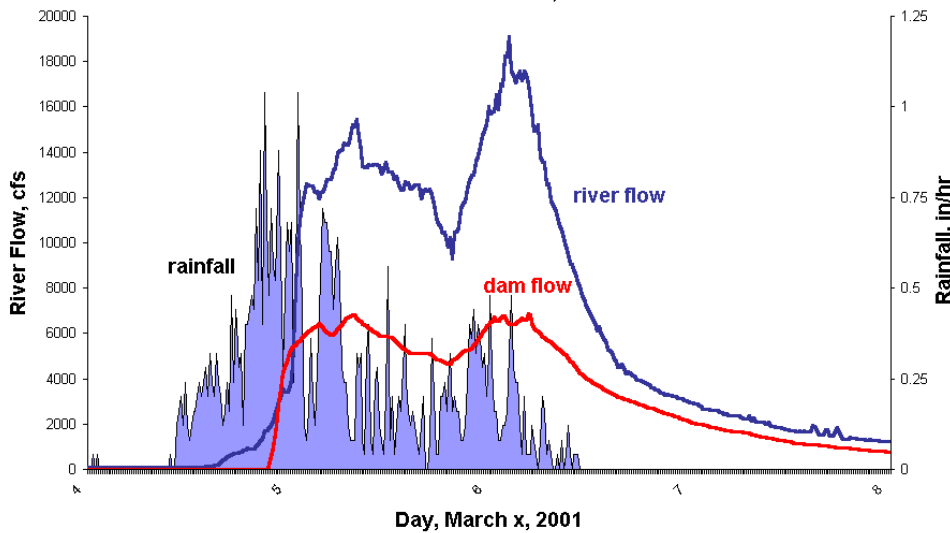
Ventura River  
Flood of March 6, 2001

- The dam spilled up to 6,000 cfs on March 6, 2001, shown here.
- The precipitation and flow hydrograph comparisons for this storm are presented at left.
