OVERVIEW OF THE TAUM SAUK UPPER RESERVOIR FAILURE

December 14, 2005
Reynolds County, Missouri

J. David Rogers, Jae-won Chung,
Conor M. Watkins, and
David J. Hoffman

Missouri University of Science & Technology

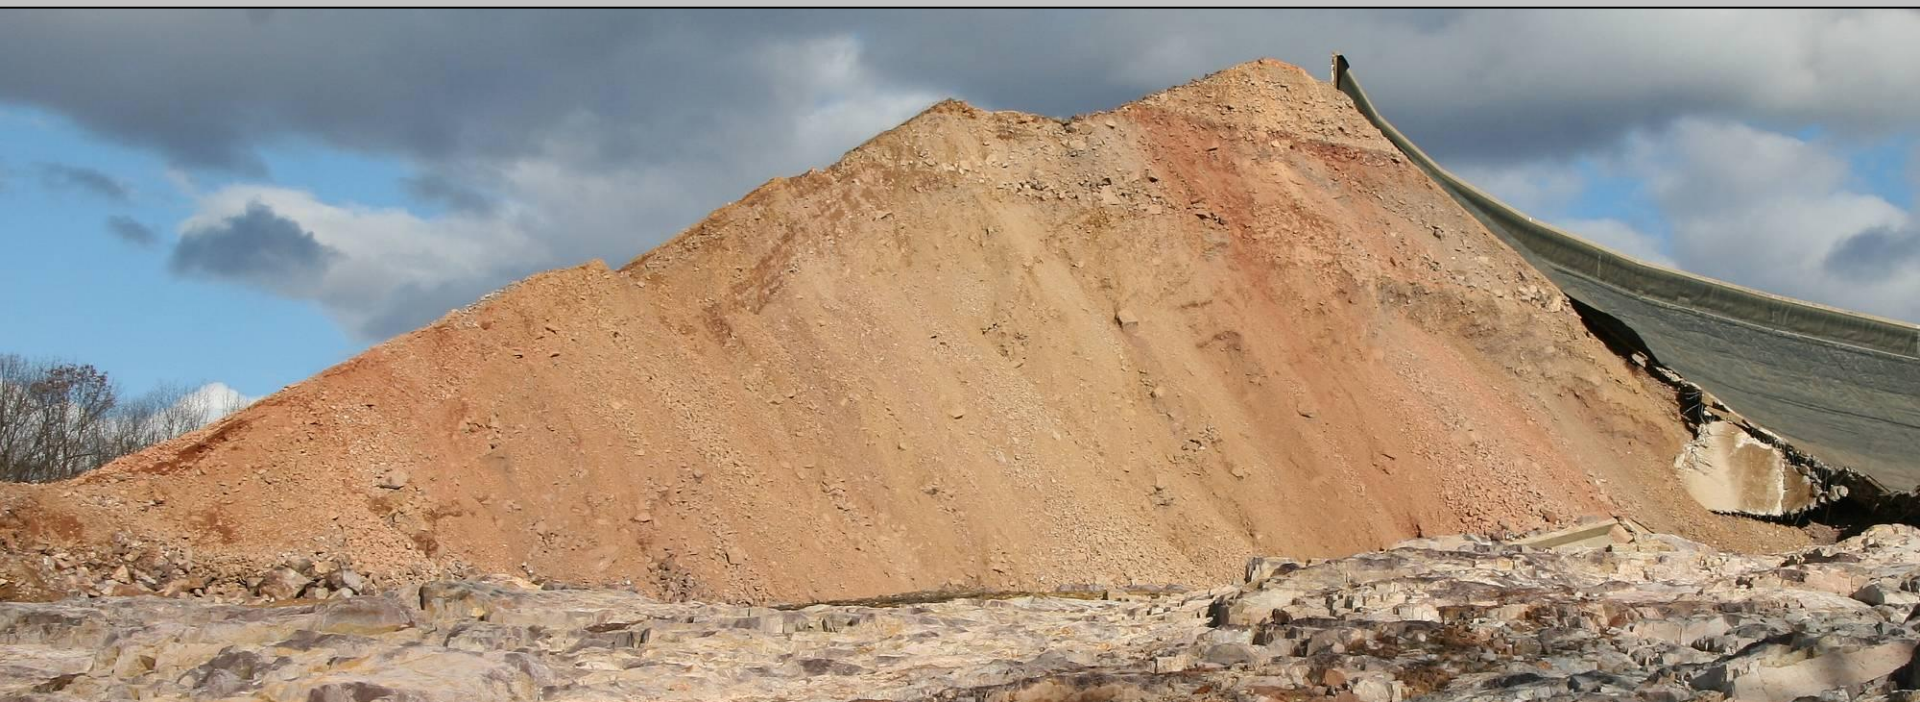
The Upper Reservoir embankment was the last loose dumped (uncompacted) concrete-lined rockfill dike constructed in the U.S. The great majority of the dike was placed by end dumping (tipping) rock fill, and allowing it to stabilize at its angle of internal friction.

The upper 16 feet of the dike was placed as rolled fill, using four 4-foot thick lifts.

Note the three distinct zones, indicative of the different placement techniques.

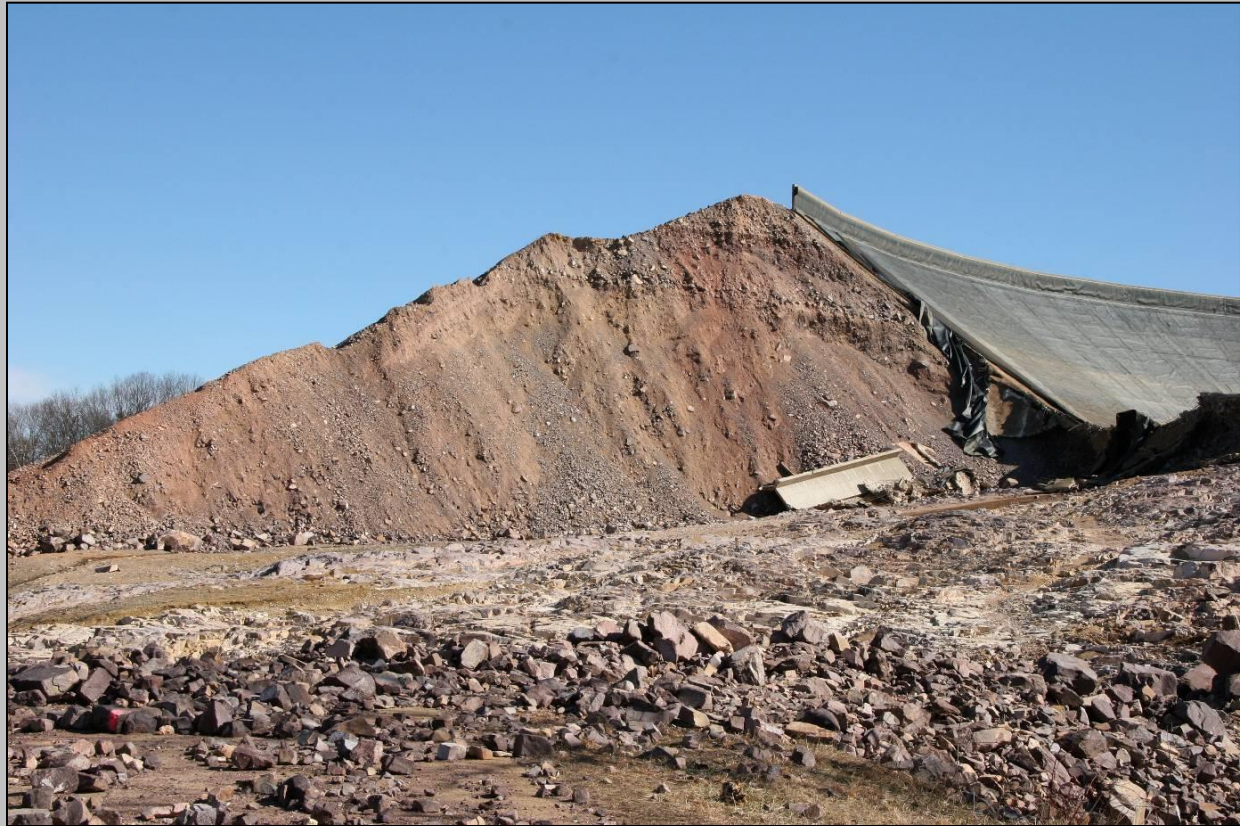
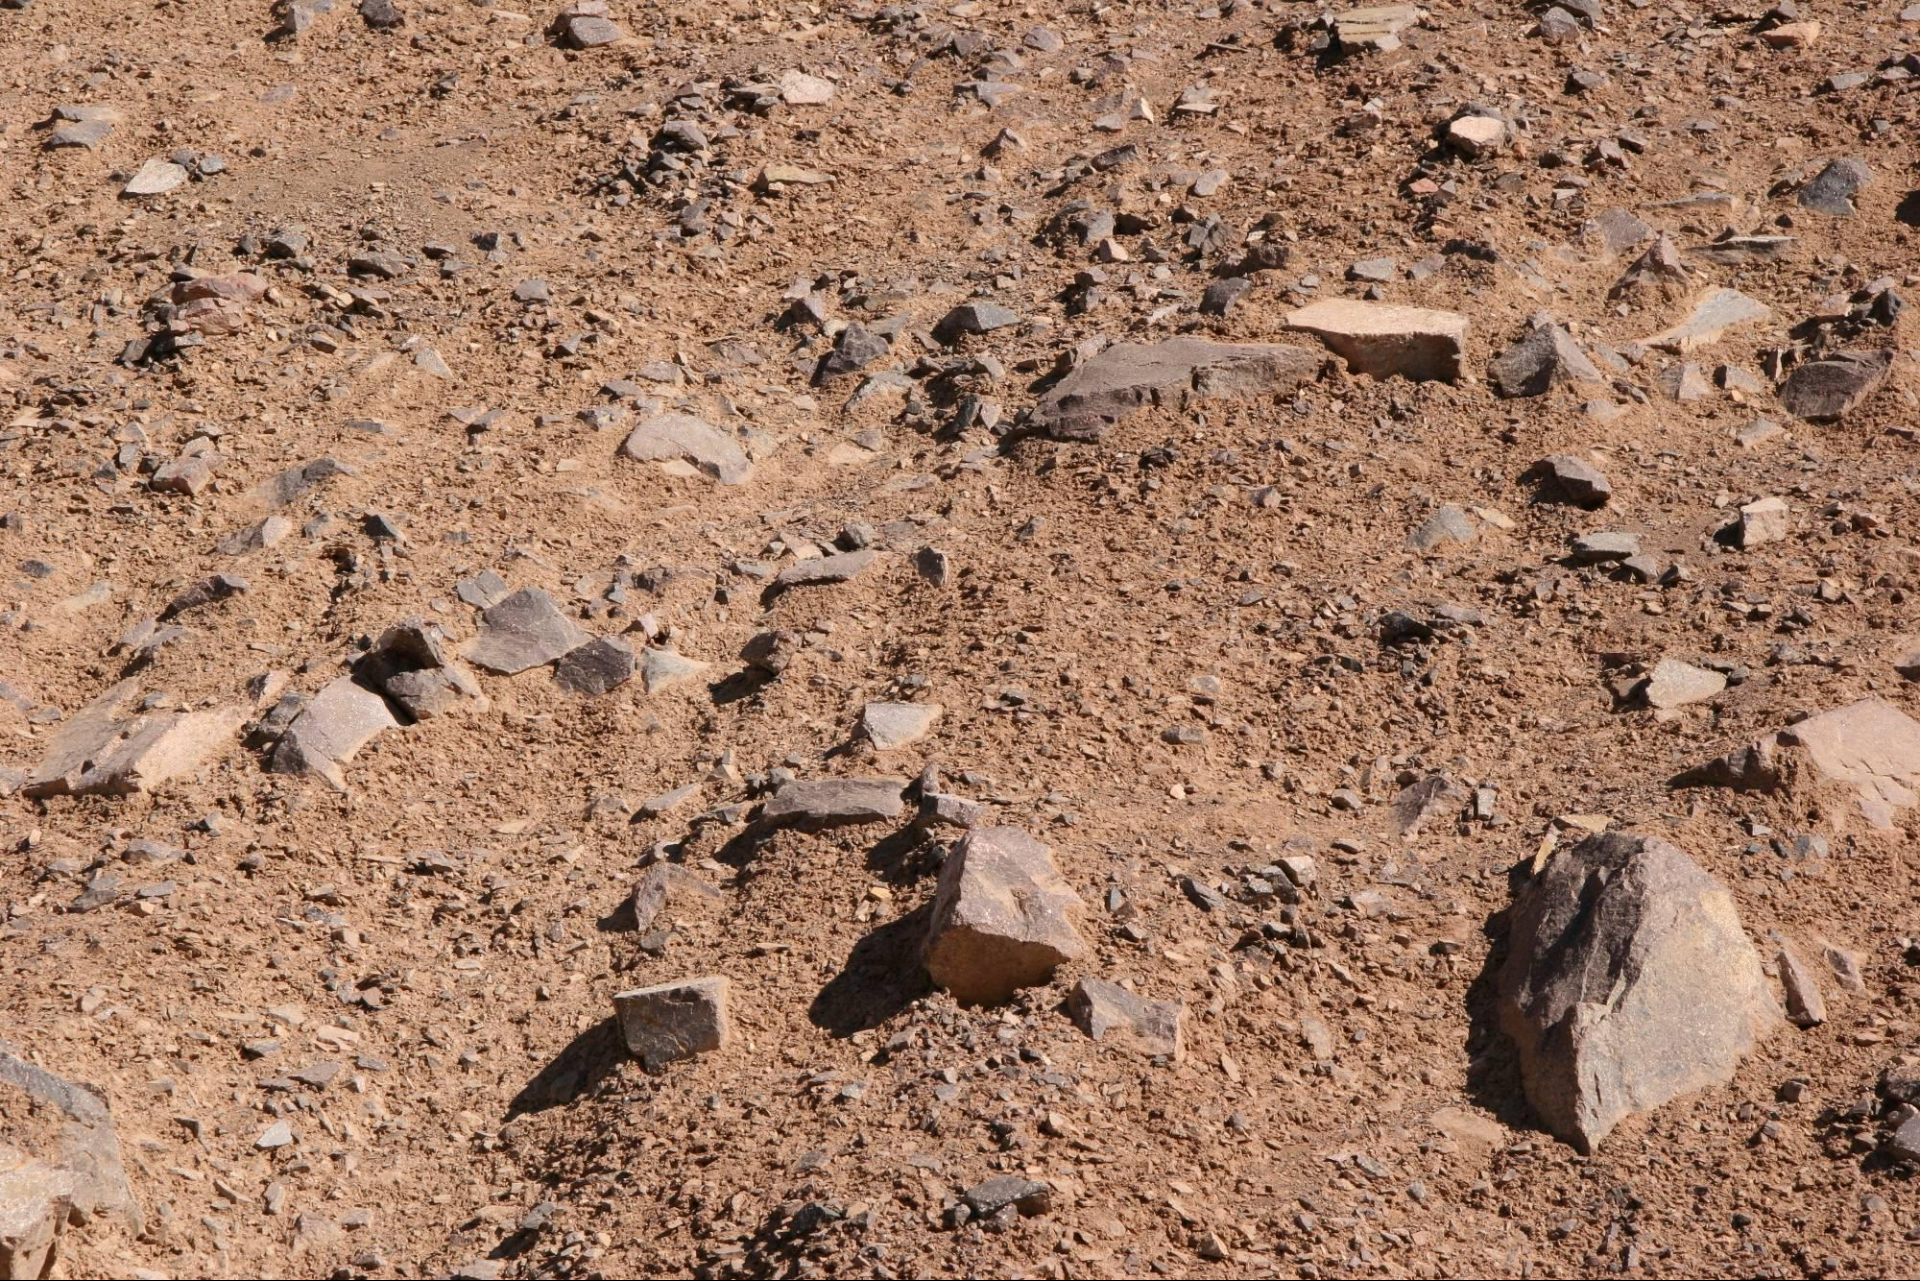
“DIRTY” ROCKFILL

The cross section of the dam exposed by its failure exhibited a high fines content. The rockfill contained up to 28% fines while the project specifications limited the fines to 5% or less.

This contributed to up to 2 feet of differential settlement, shifting of the concrete parapet walls, and cracking of the concrete liner, over the years. These same factors would have degraded the internal stability of the dike

Close up of “dirty” rockfill exposed at failure site. For scale, the large rocks are 10-12” in diameter.

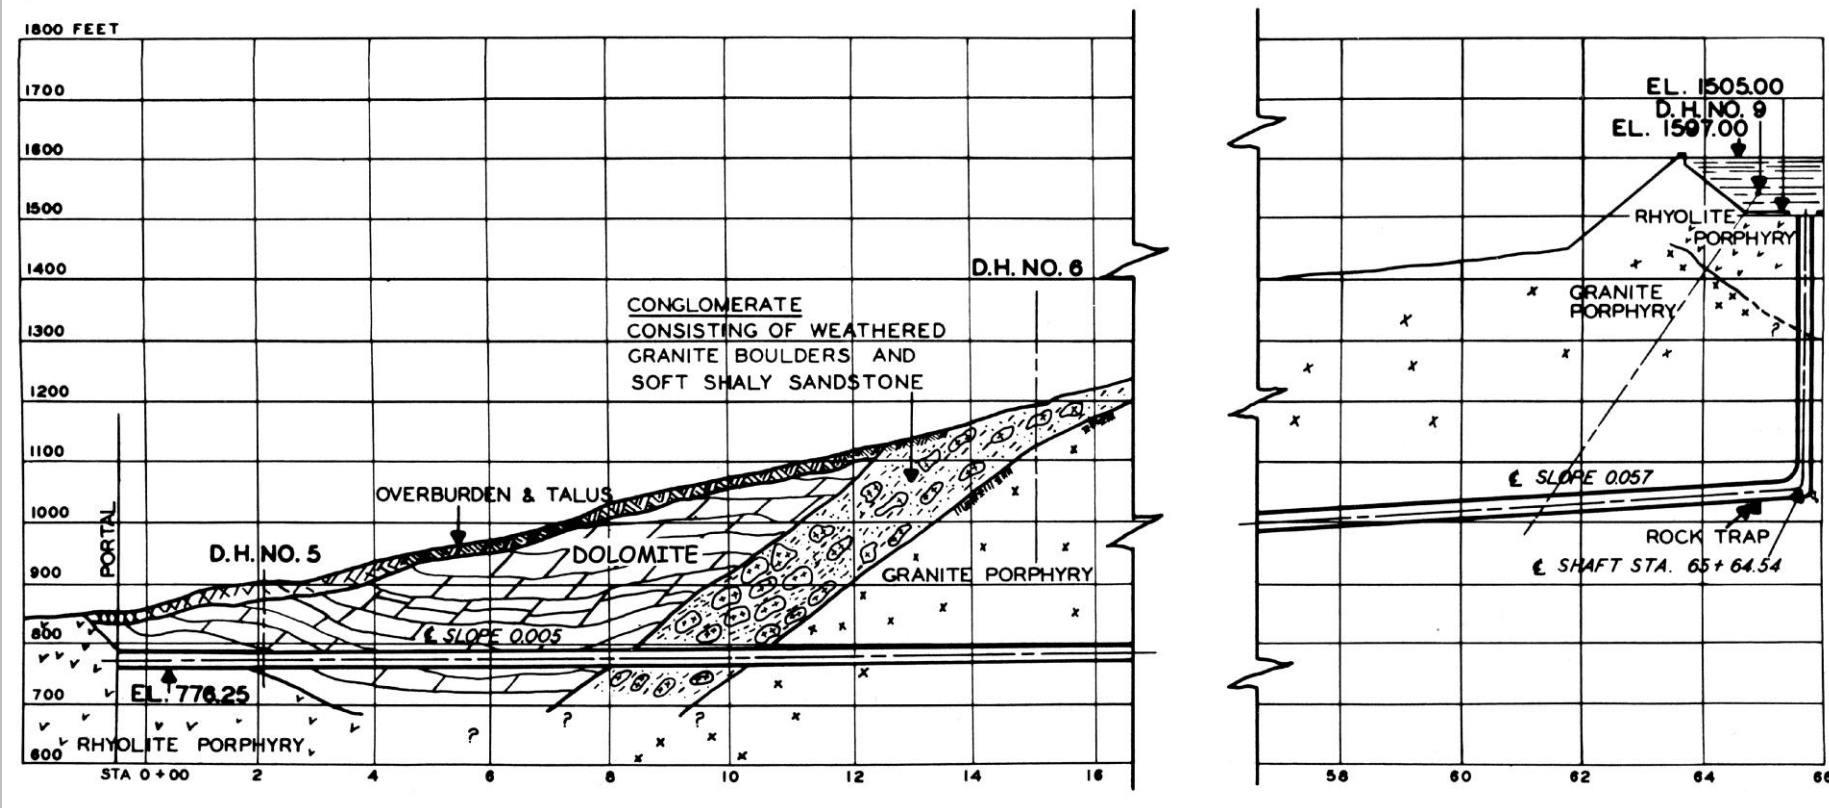
- Partial geologic profiles along the lower and upper portions of the Taum Sauk feed tunnel, excavated in 1960-62.
- The project originally envisioned an inclined shaft, which was explored using a test boring inclined at 55 degrees, shown at right. The unit overlying the granite porphyry is a Precambrian fanglomerate

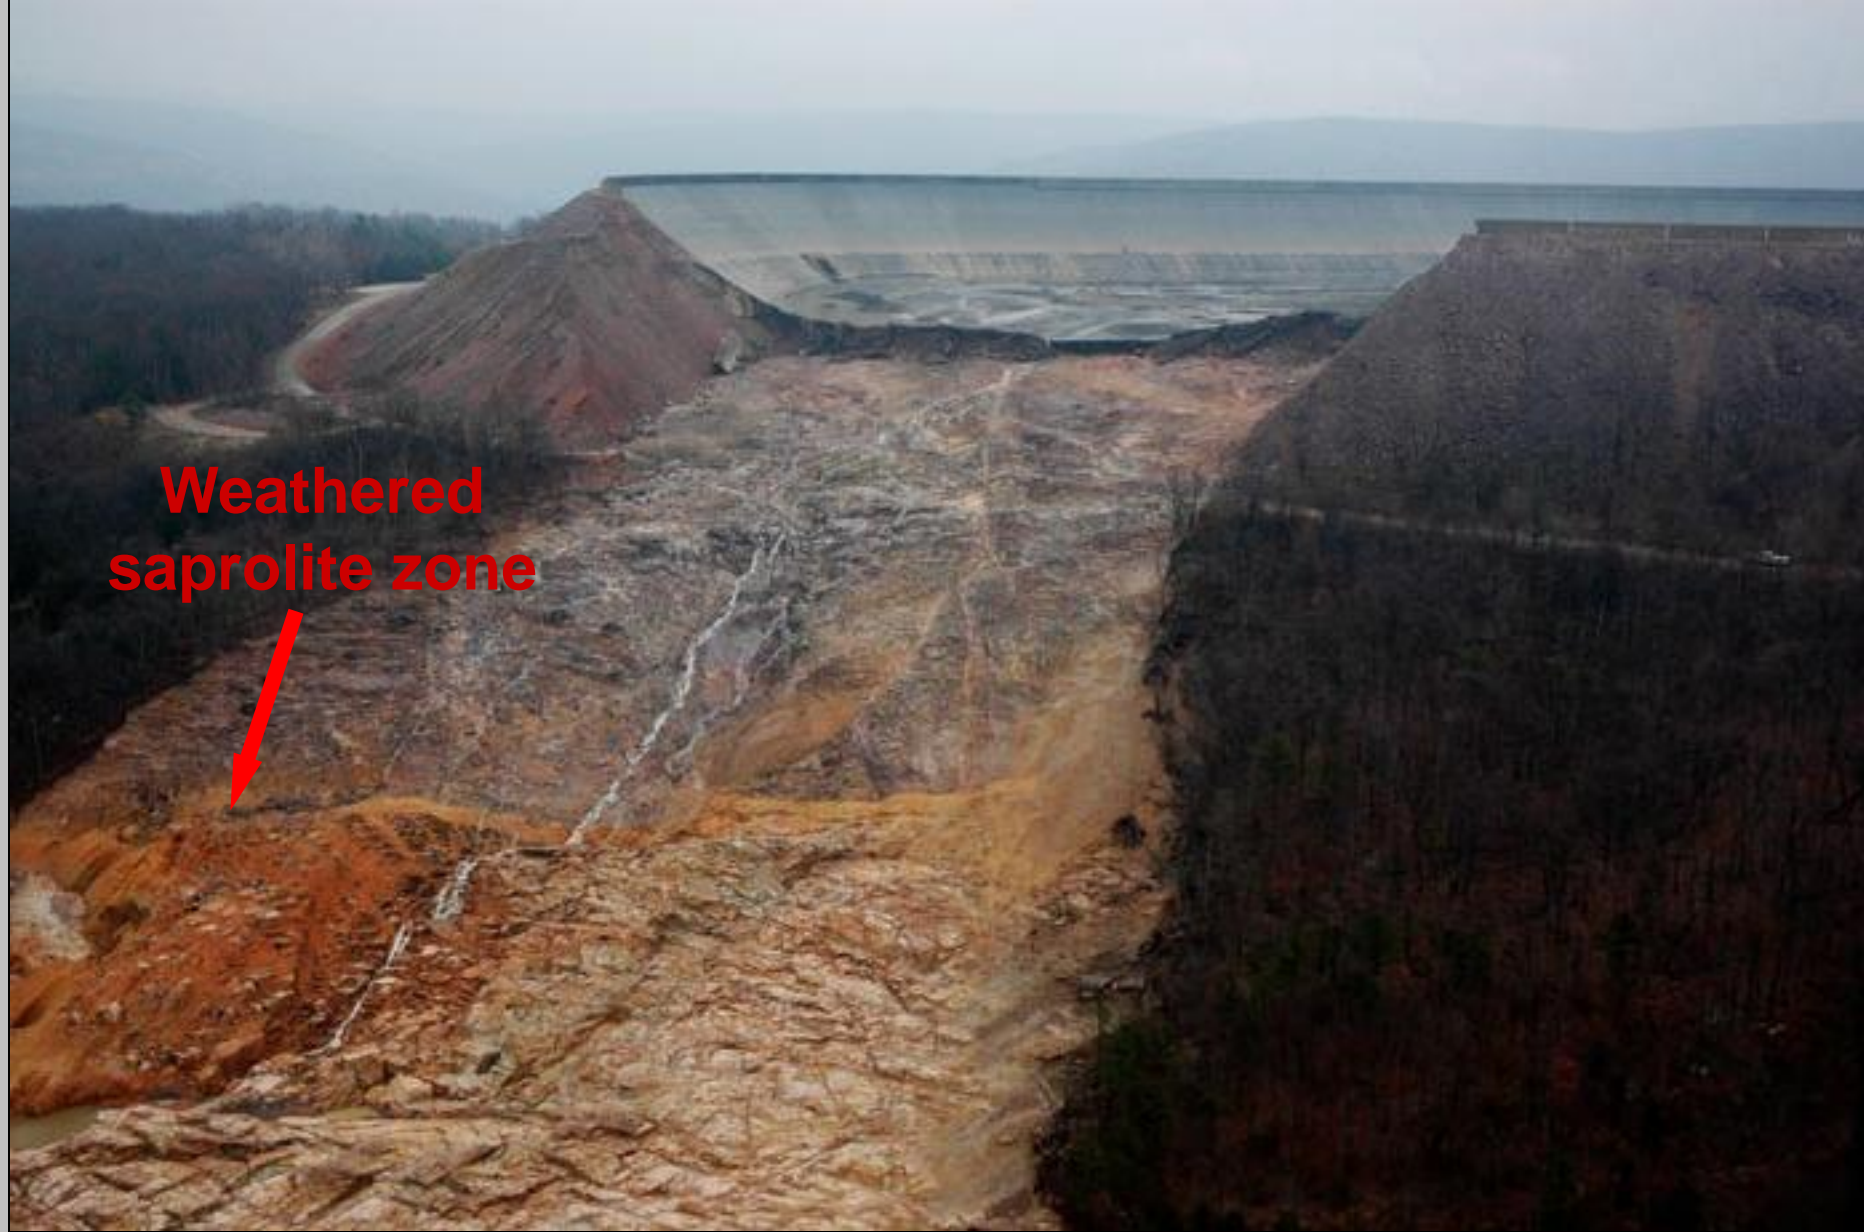
**Weathered
saprolite zone**

**Geologic units exposed by scouring of the outbreak flood.
Note the reddish saprolite. Photo from the Associated Press**

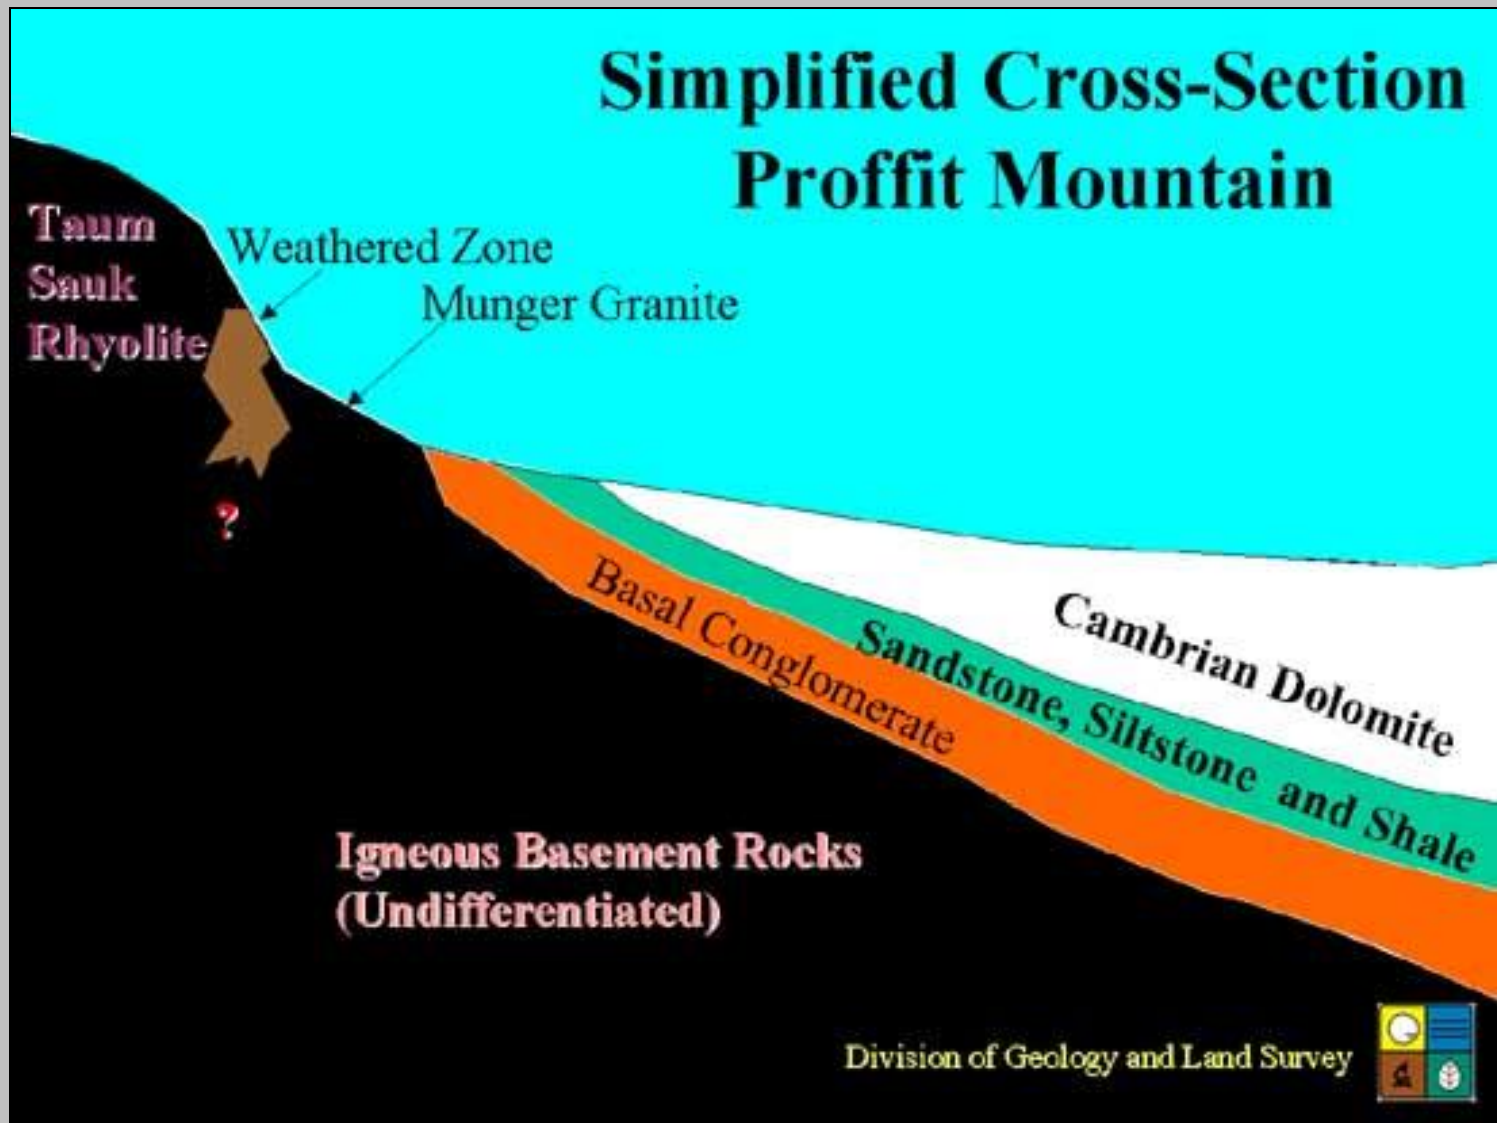
- **Stratigraphic relationships between units exposed along path of outbreak flood, just below the reservoir. Note the weathered zone at the break in slope.**

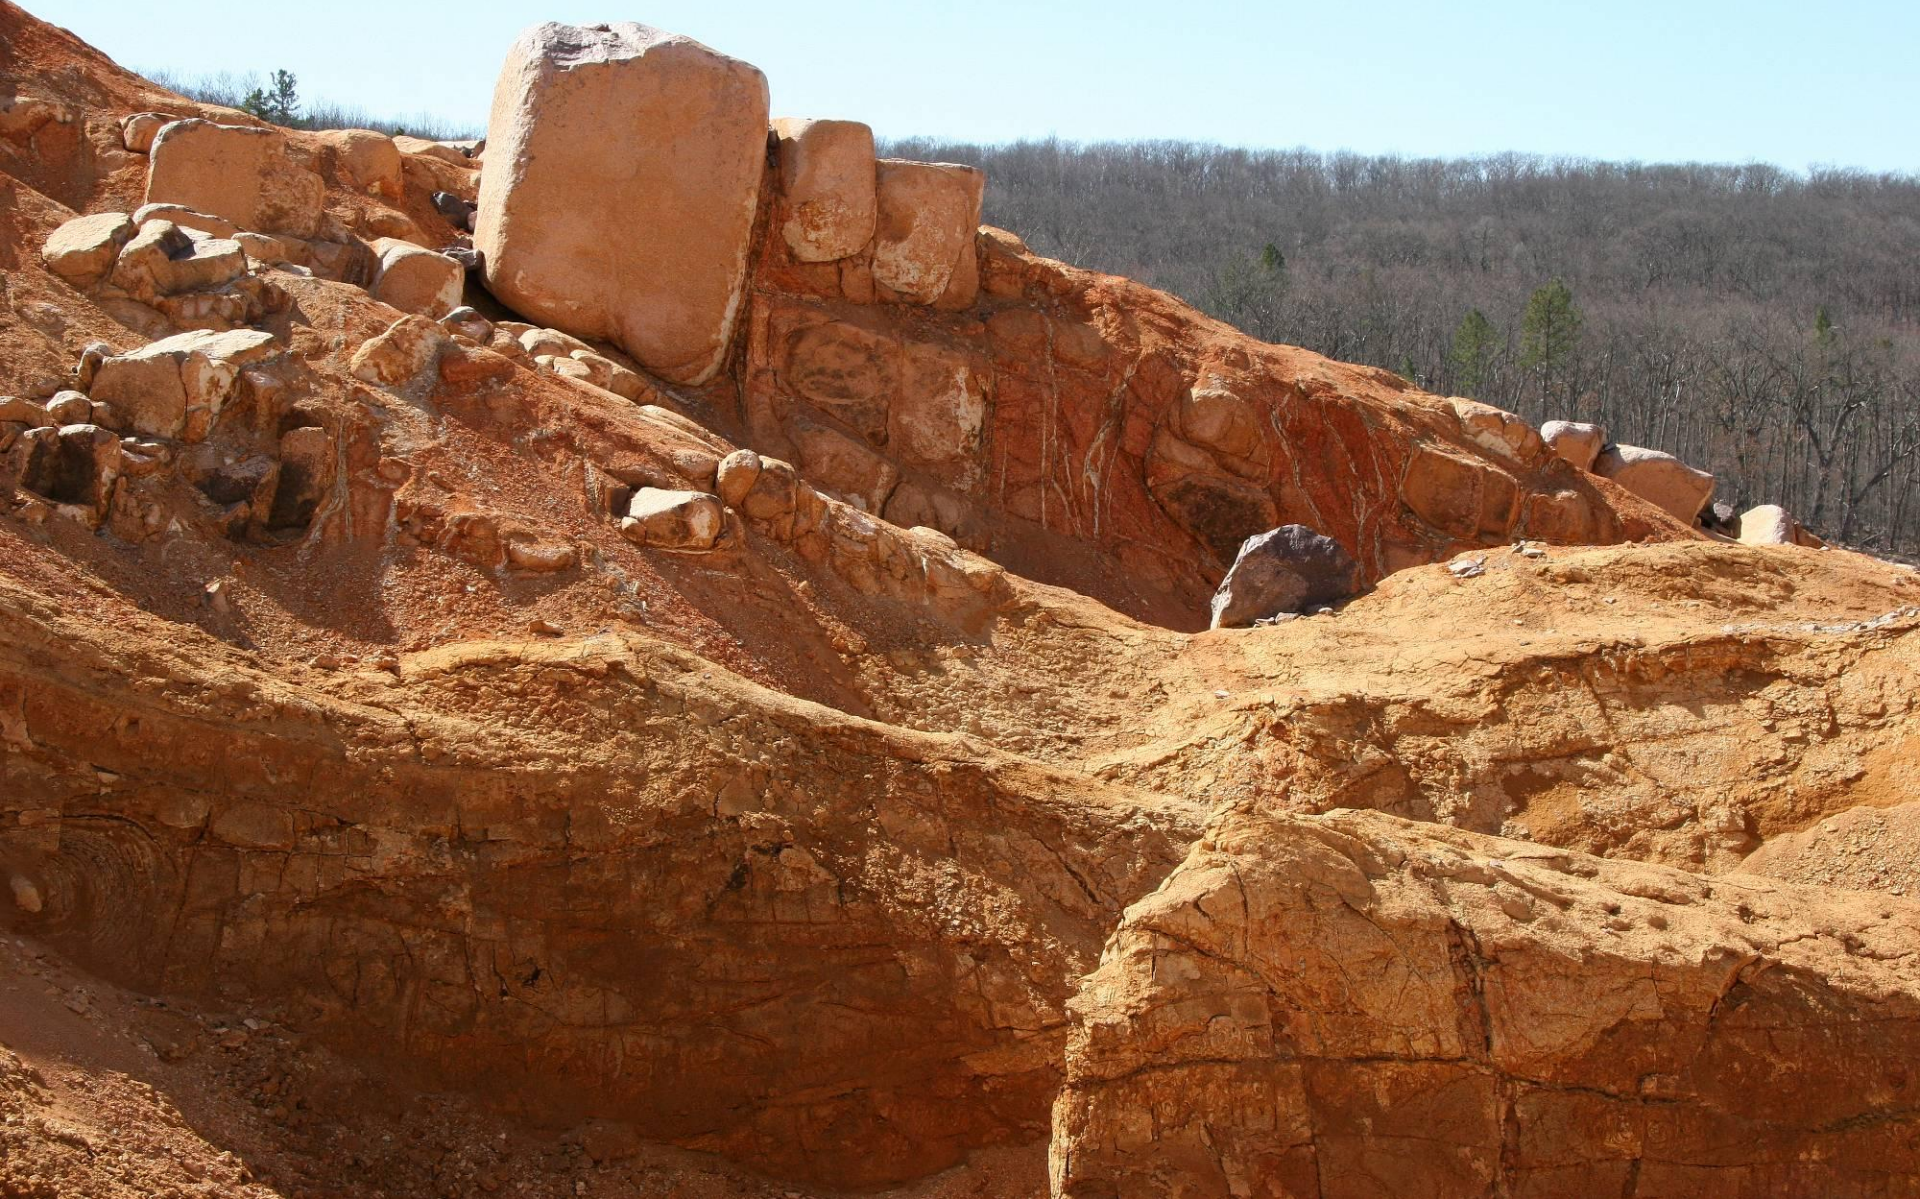
Zones of deeply weathered granite and diabase were exposed on the upper slopes of Proffit Mountain during the flood. Materials similar to this may have ended up in the embankment fill during construction, contributing to its contamination by fines, which led to the high rates of settlement.

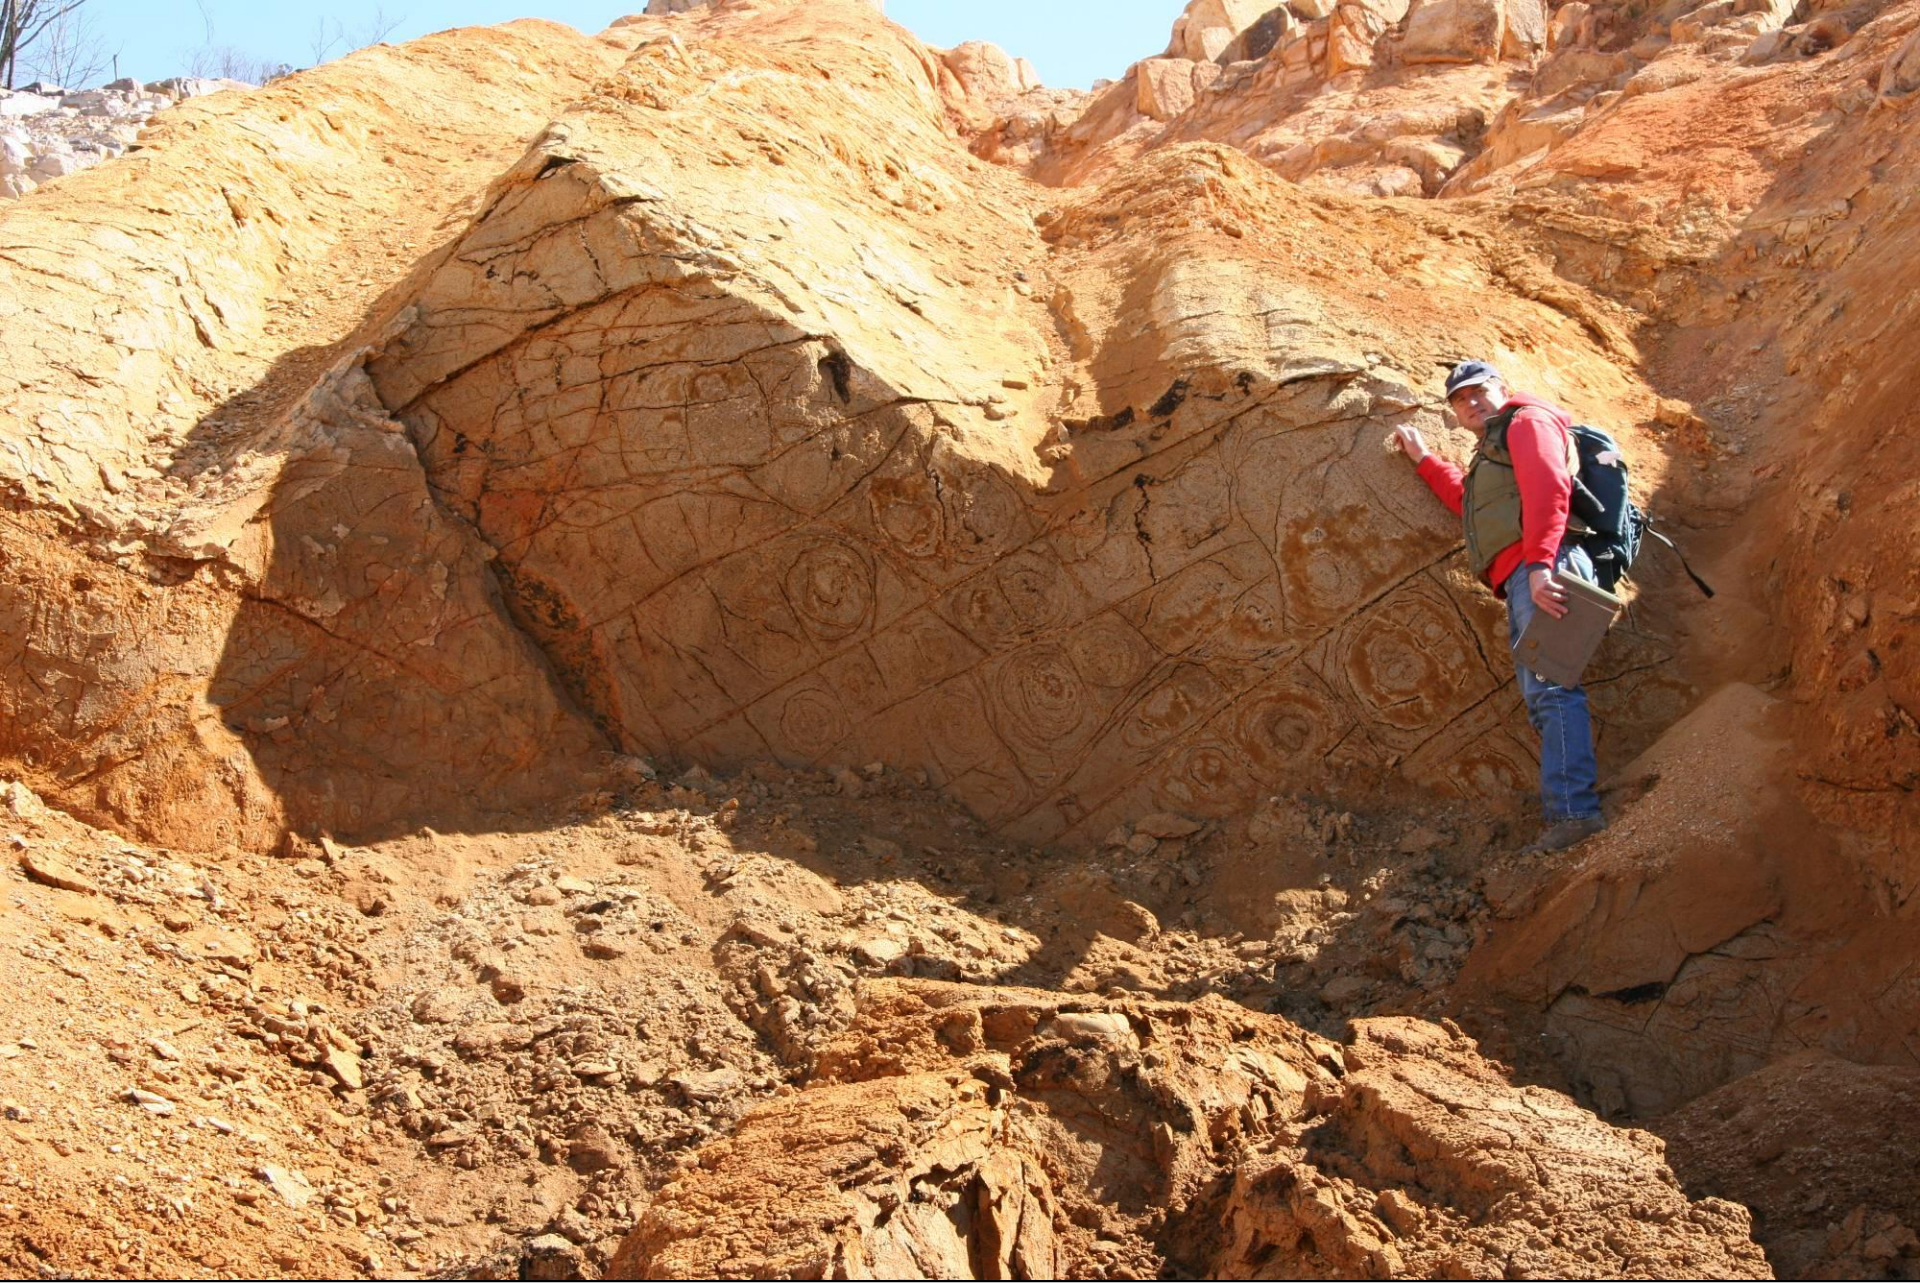
This diabase dike (or sill) on the upper slopes of Proffit Mountain weathered to a weak soil-like material, yet retained the rock's original fabric and fracture pattern.

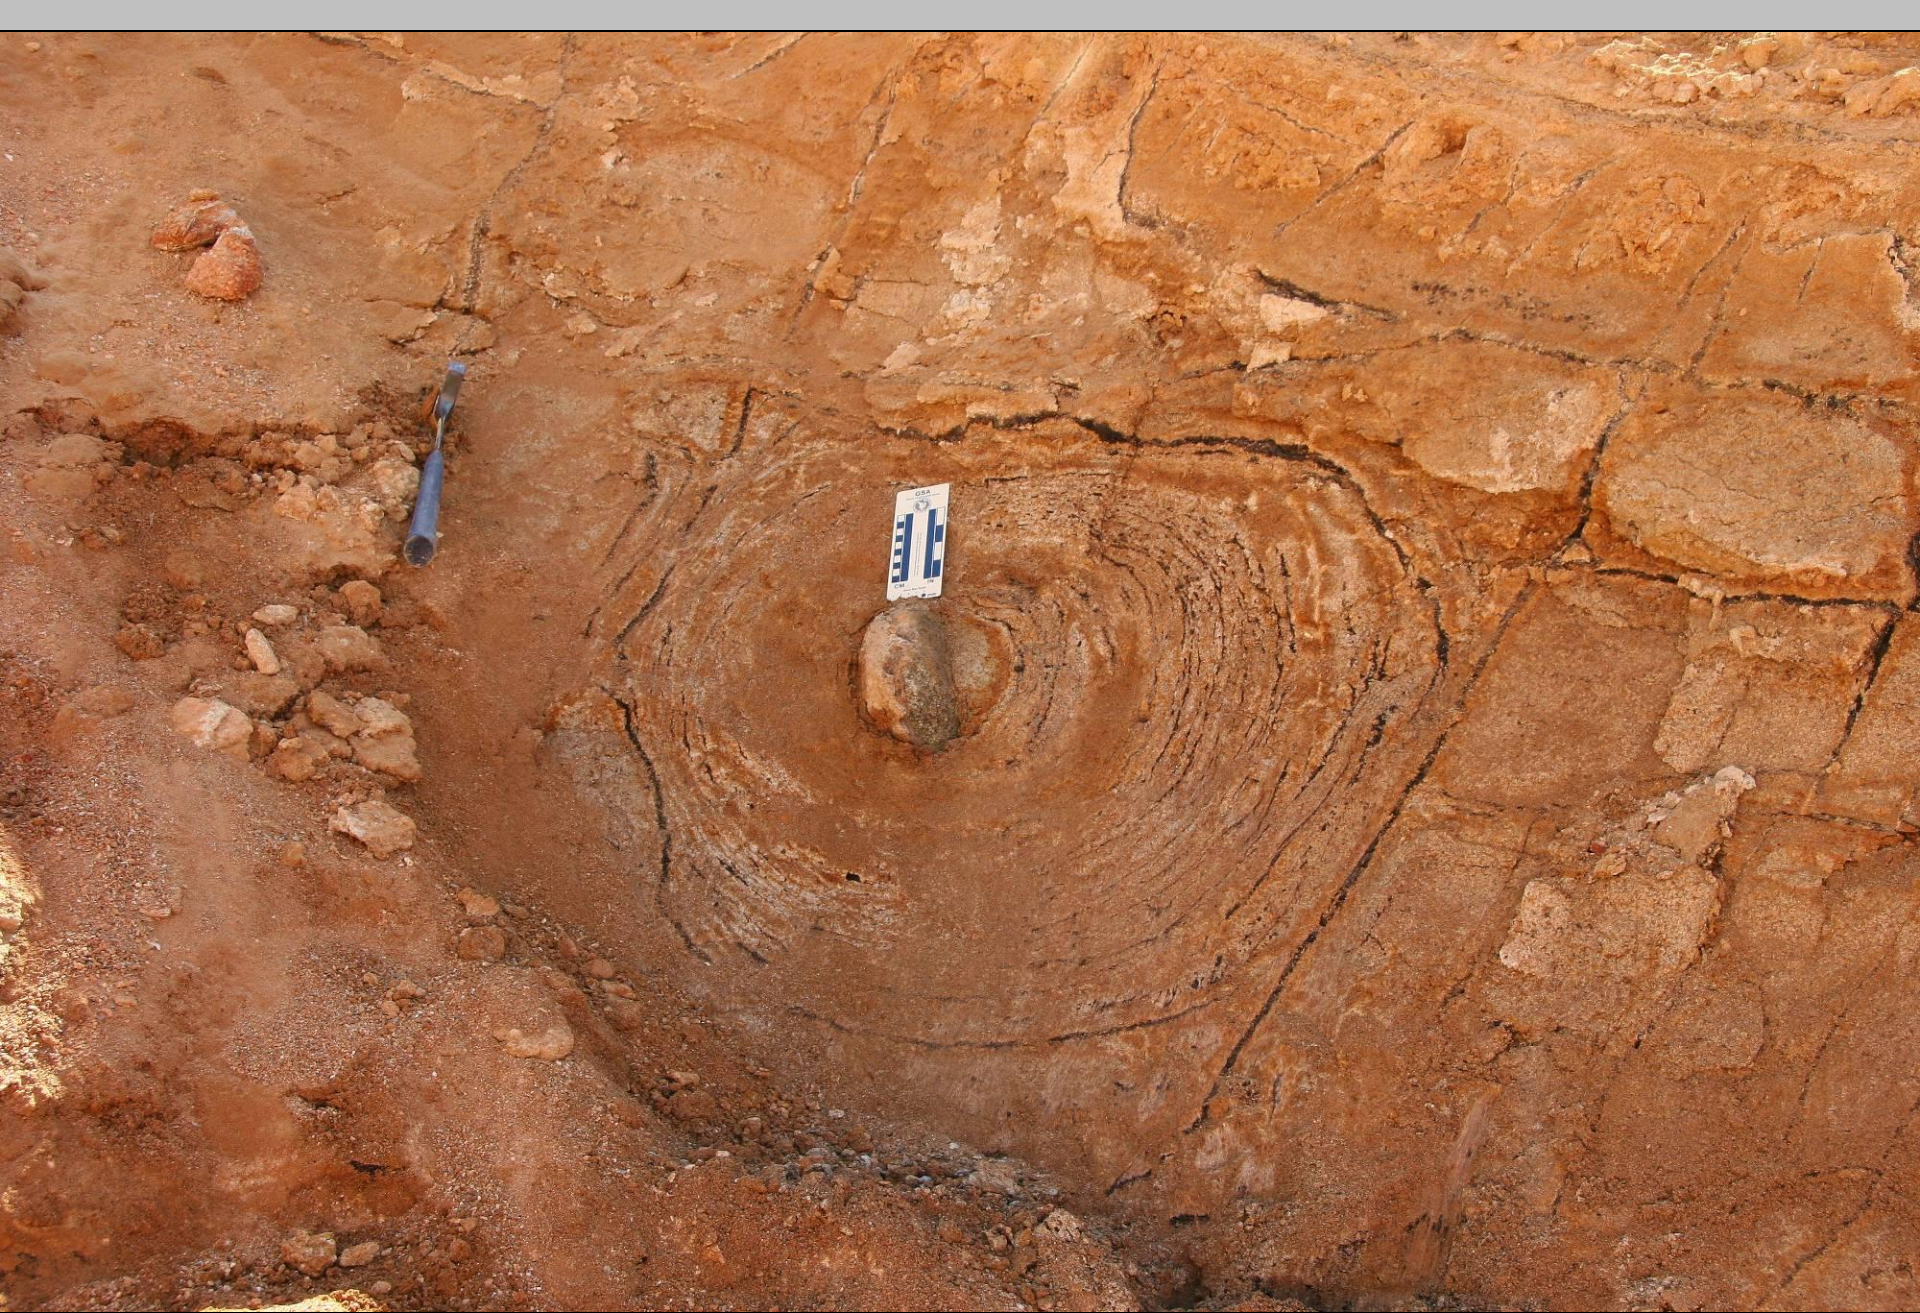
Core stone and remnant spheroidal weathering rind in the saprolite matrix.

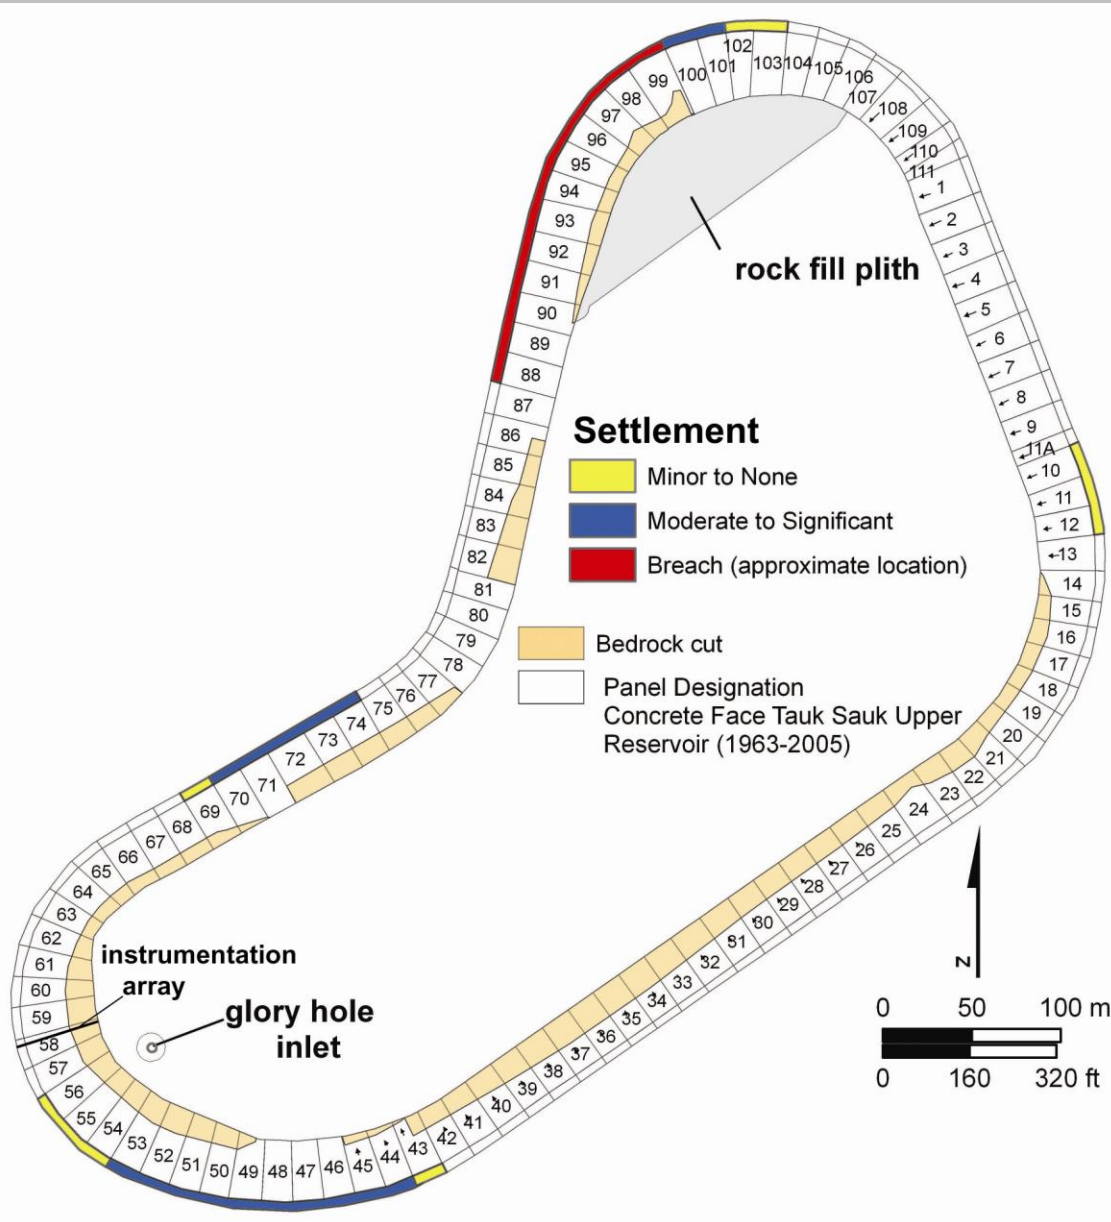
- Specifications called for the **removal of all soil** beneath the rockfill embankment. Any remaining soil should have been no greater than 2 inches in thickness and '*well saturated*' before placement of the rockfill.
- Up to 18" of native residual soil was found beneath the embankment during drilling.
- This may have contributed to the shifting/settlement of the embankment and likely resulted in lower strengths at the rockfill/foundation interface.

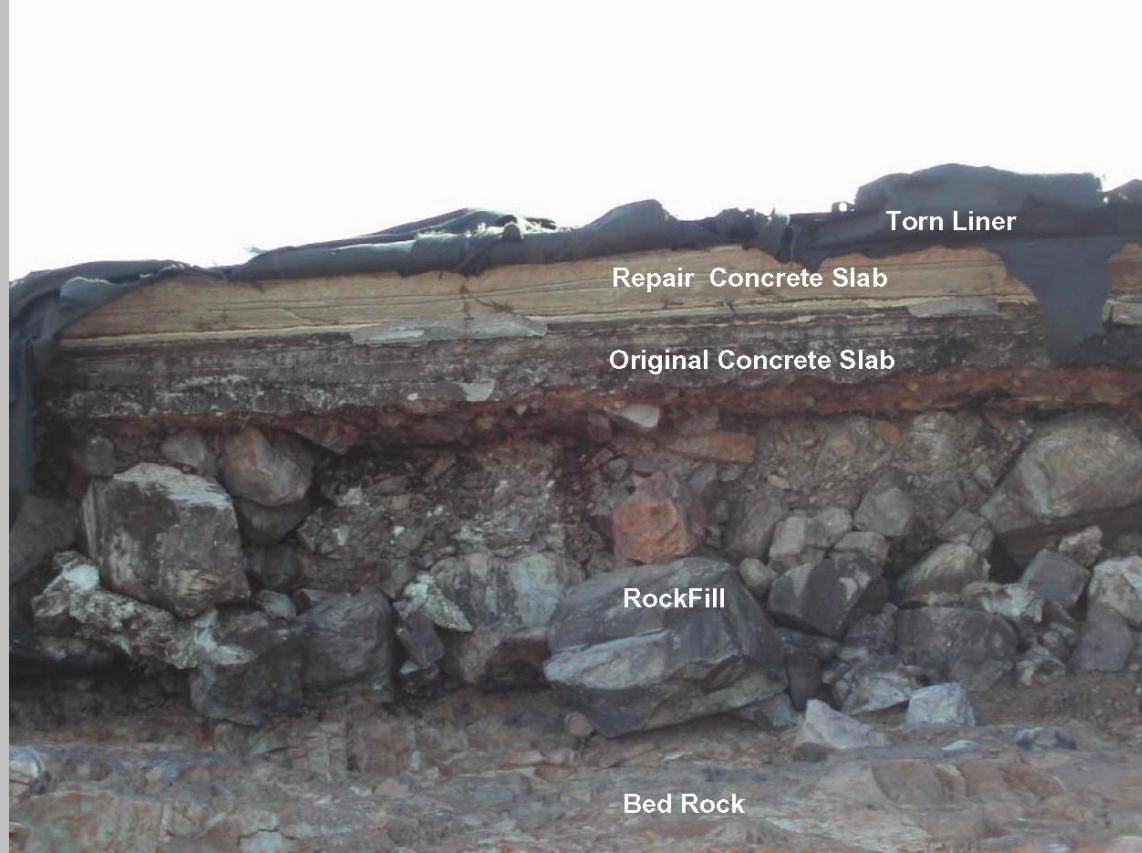
- The most nagging leakage and settlement problems were at Panels 89-107 in 1963-64, in the vicinity of the ‘**rock fill plinth.**’
- The cut-fill wedge at the northwest corner of the reservoir, which experienced extra-normal settlement. This area should have been overexcavated and replaced.

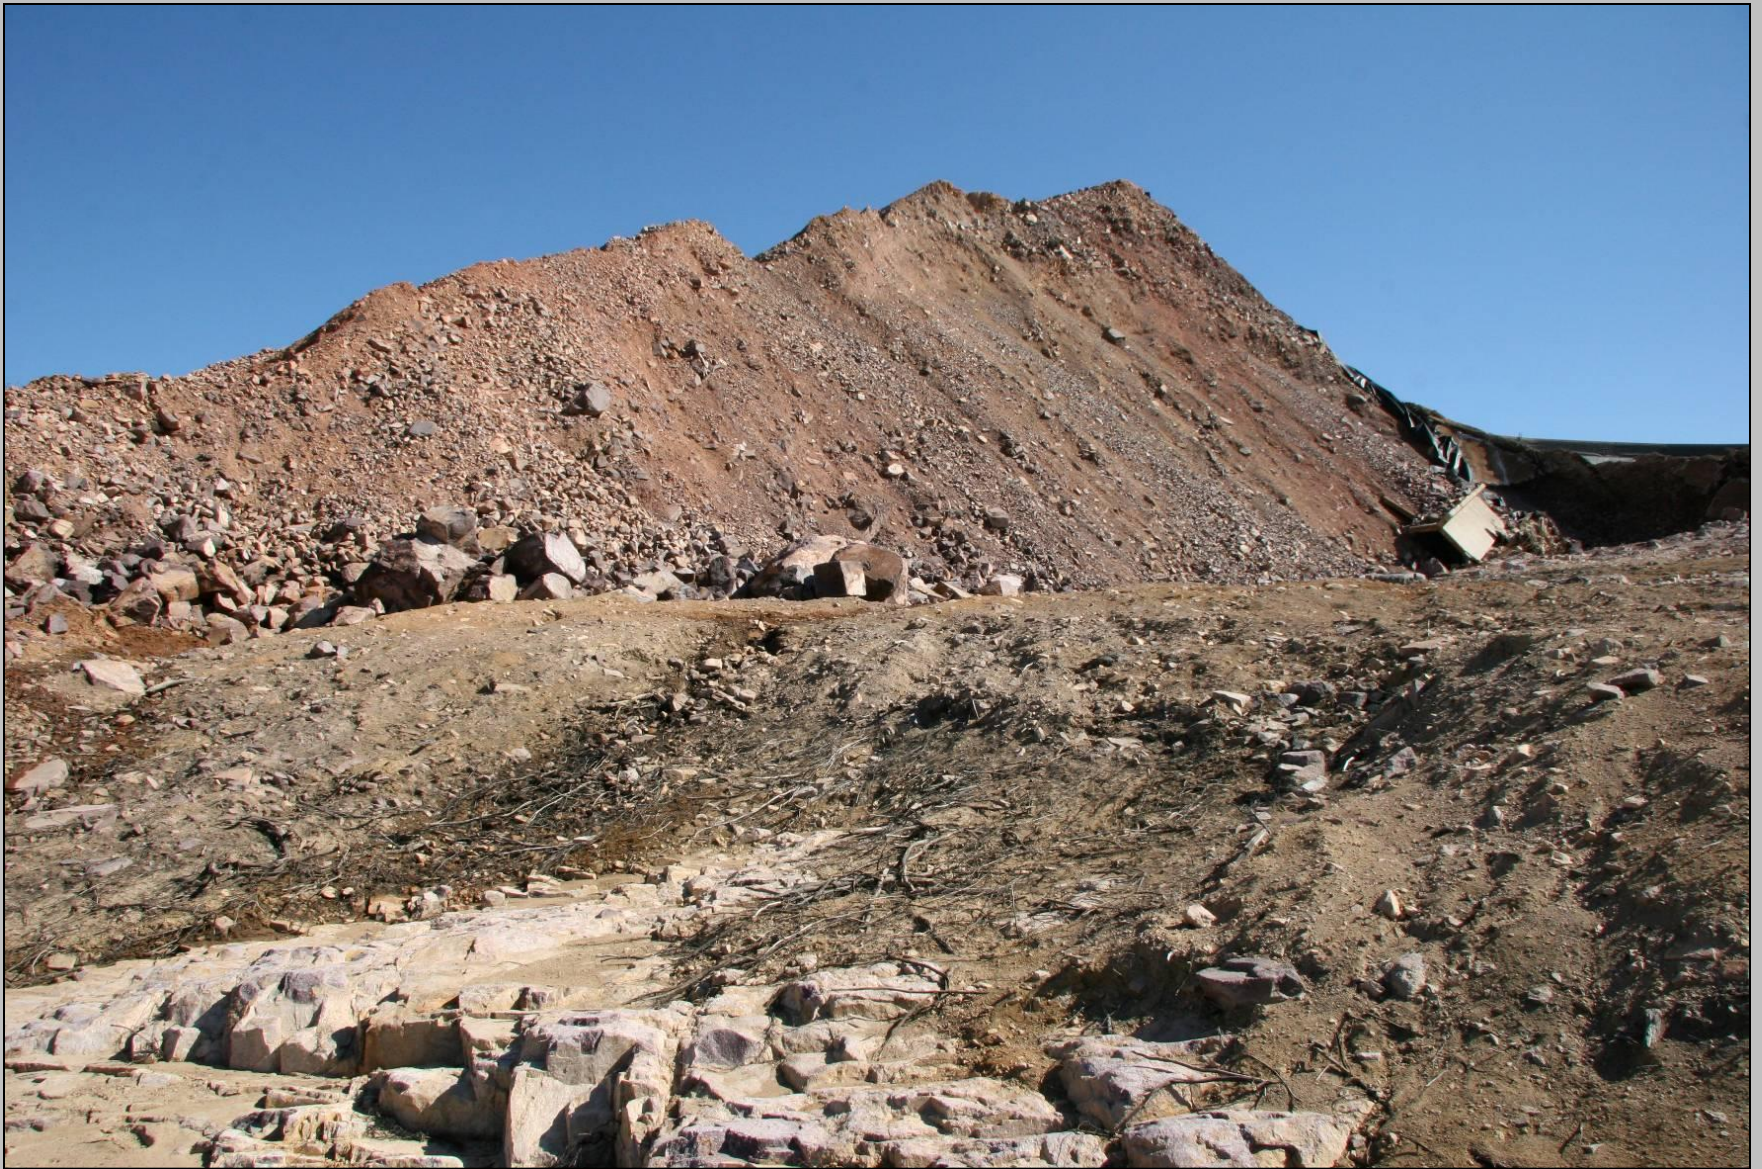
- **Rockfill exposed in the plinth beneath the northwest corner of the Upper Reservoir.**
- **Several feet of clean rockfill were placed over the rhyolite bedrock, then covered with a 4-inch thick asphalt liner, which failed miserably under uplift when the reservoir was initially filled in 1963.**
- **The asphalt was replaced by several generations of reinforced concrete mats in 1963 and 1964, which were subsequently covered by the HDPE geomembrane liner in 2004.**

Much of the residual soil cover and organic debris (shown here) was left in-place, beneath the northwest corner of the reservoir, and exposed *after* the failure.
