OVERVIEW OF THE TAUM SAUK UPPER RESERVOIR FAILURE

December 14, 2005
Reynolds County, Missouri

J. David Rogers, Jae-won Chung,
Conor M. Watkins, and
David J. Hoffman

Missouri University of Science & Technology

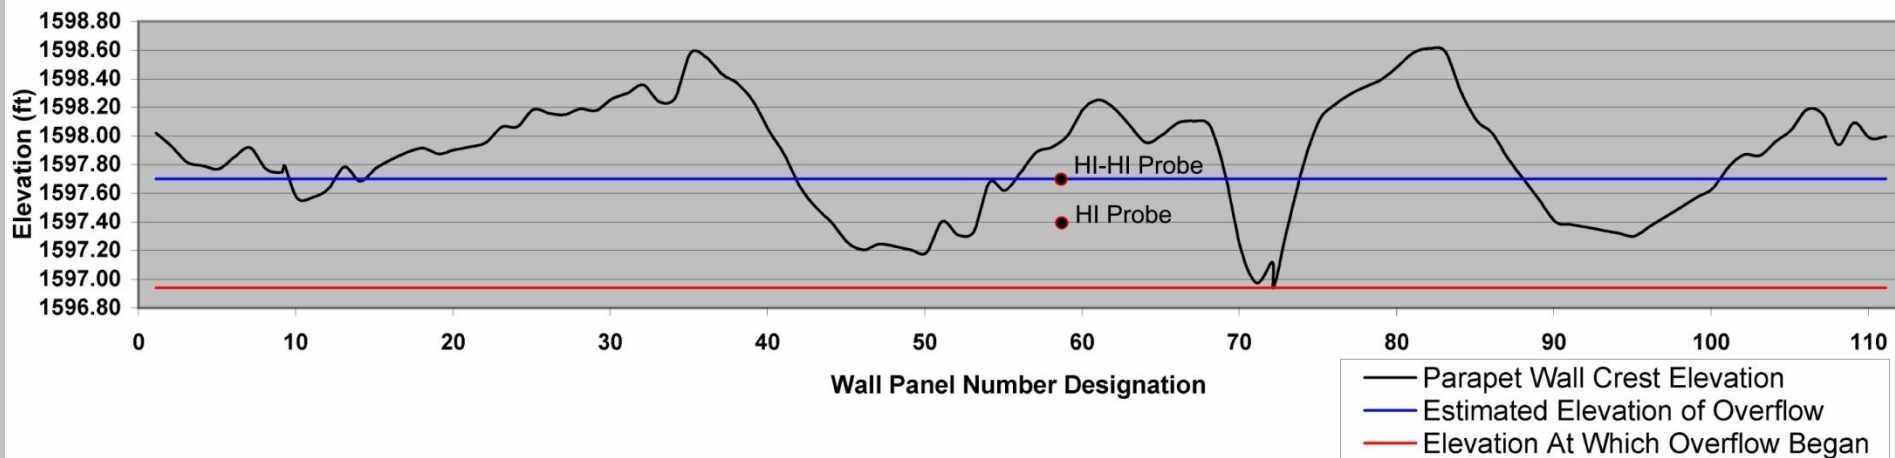
Taum Sauk Upper Reservoir Parapet Wall Crest Elevation

- This figure illustrates the differential settlement along the crest of the upper reservoir parapet wall and the positions of the Warwick probes at the parapet wall at Panel 58.
- Four segments of the parapet wall were almost two feet (61 cm) lower than their original elevation.
- The elevations of the breached Panels (shown here in red) were estimated by AmerenUE after the failure (data from MoDNR, 2006).

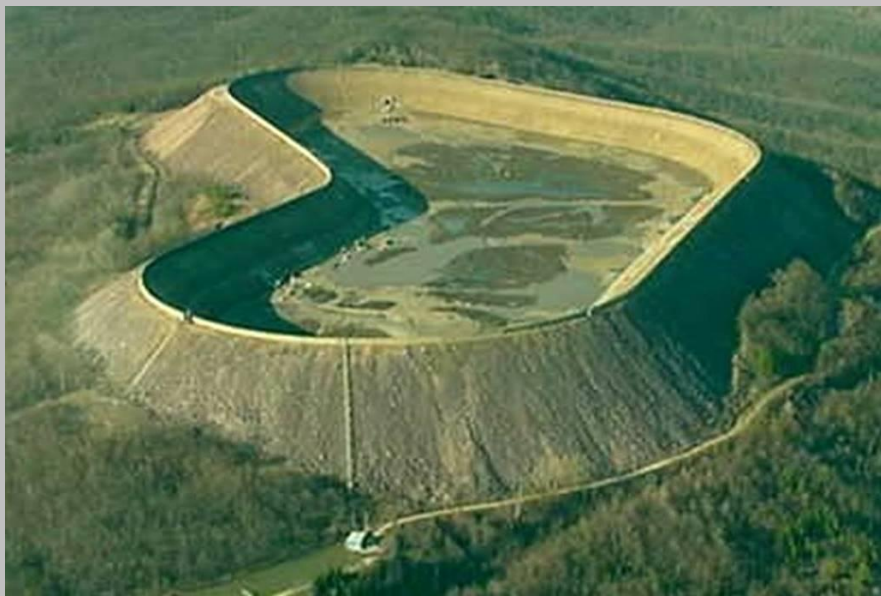
Settlement of the rockfill dike during first five years of operation

- In the first 4.5 years of operation the Taum Sauk embankment settled 0.50 to 0.80 ft; between 0.53% and 0.73% of the embankment height.
- In 1967, J. Barry Cooke noted that the observed settlements were without precedent for a rockfill embankment, concluding that *“frequent zones of soft weathered rock”... “could not have been selectively wasted”* and that *“I believe that a fill of 100% competent rock would have stabilized and that the percentage of weathered rock in the Taum Sauk is the cause.”*
- According to Cooke’s 1967 review, the average settlement of 0.1 ft/year during the first 4-1/2 years was unexpectedly high and *“without precedent.”*

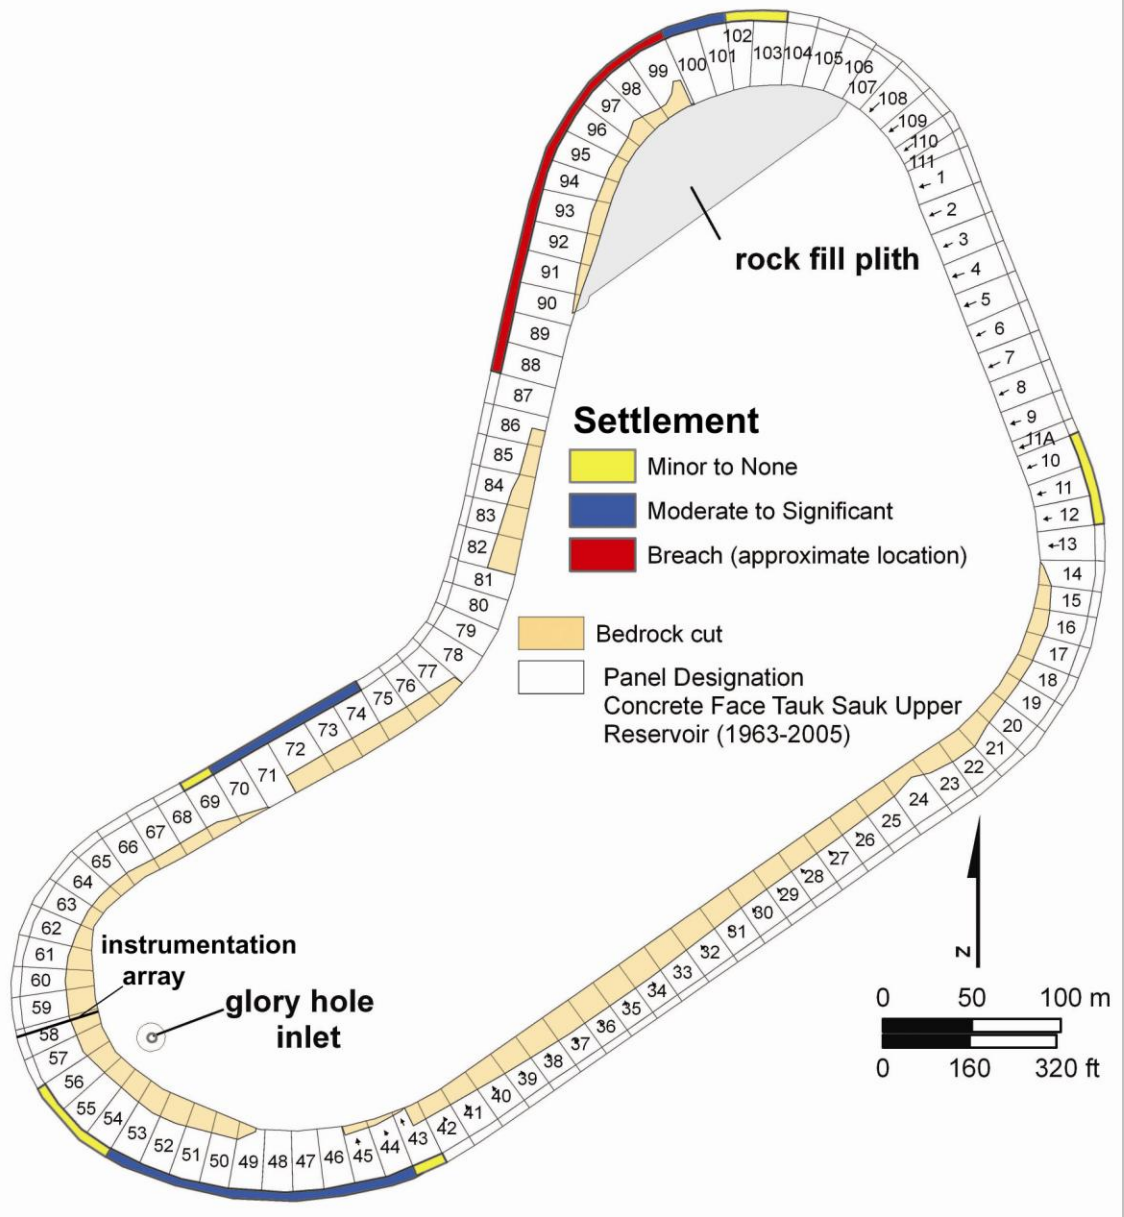
- **Plan view of Taum Sauk Upper Reservoir, showing all 111 concrete panels lining the inside face of the circular dike, which was capped by a 10 ft (3 m) high cantilever retaining wall.**
- **The colored areas denote those portions of the wall that were overtopped on the morning of Dec 14, 2005.**
- **Note the variable height of cut on the inboard toe of the dike and height of embankment, on the outboard side.**
- **The most nagging leakage and settlement problems were at Panels 89-107 in 1963-64, in the vicinity of the ‘rock fill plinth.’**

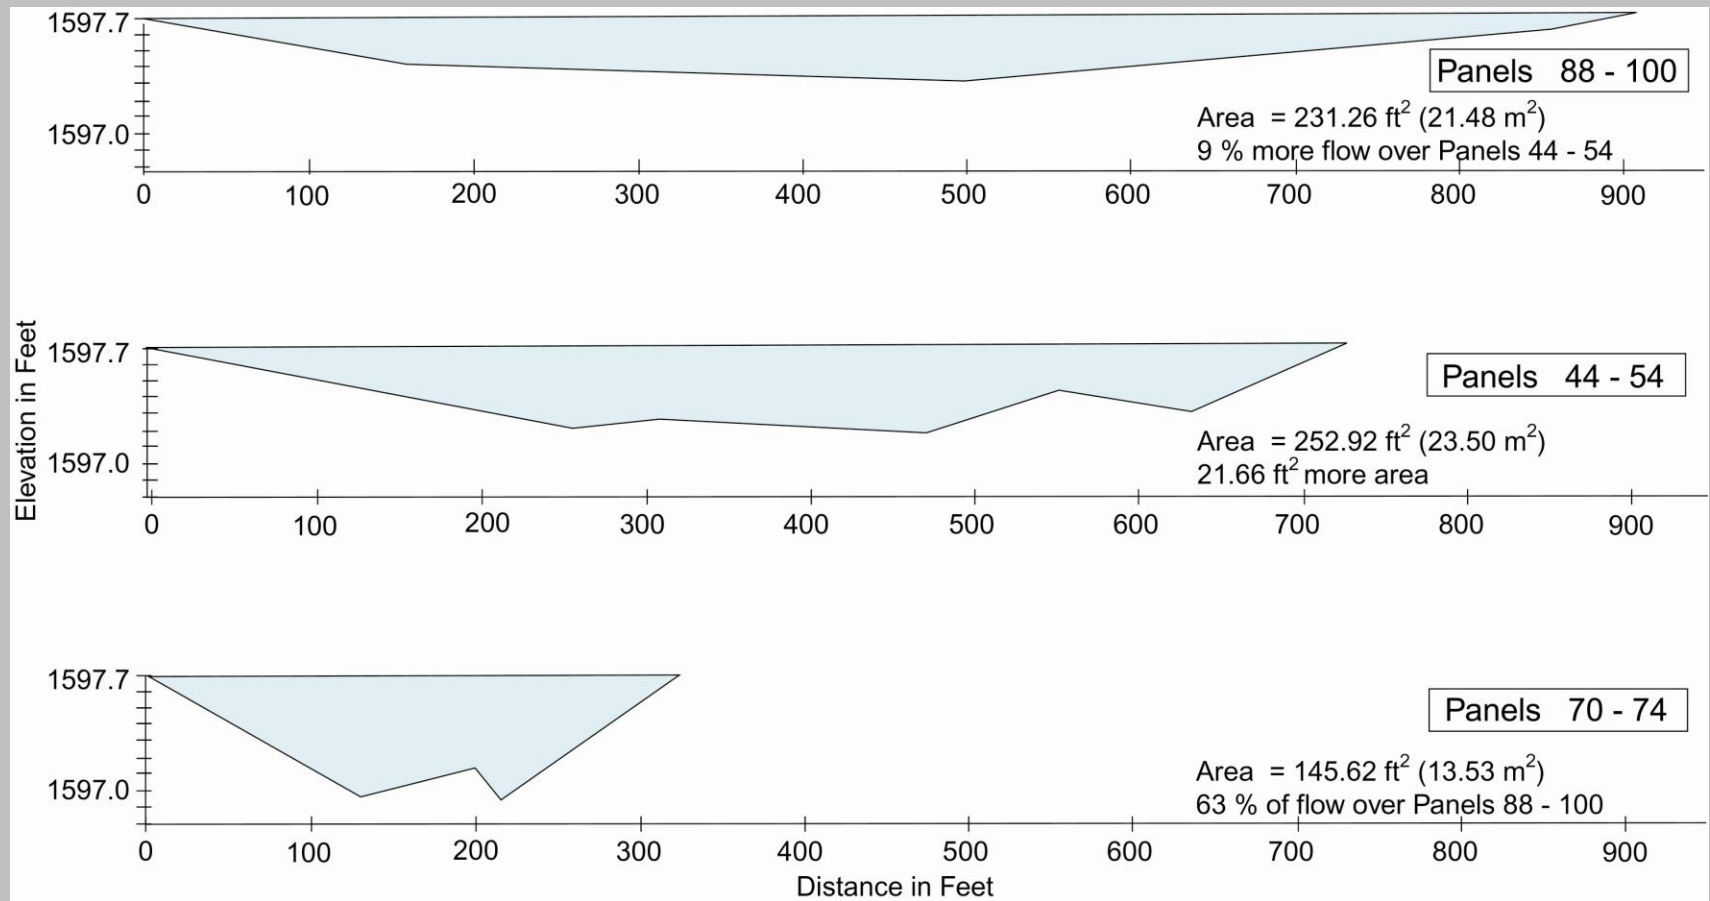
- Comparative cross sections along the crest of the Upper Reservoir between Panels 70-74, 44-54, and 88-101. Note how the **greatest cross sectional area and volume of spillage** appears to have occurred between Panels 44-54, *not* where the breach occurred, between Panels 88-99.**

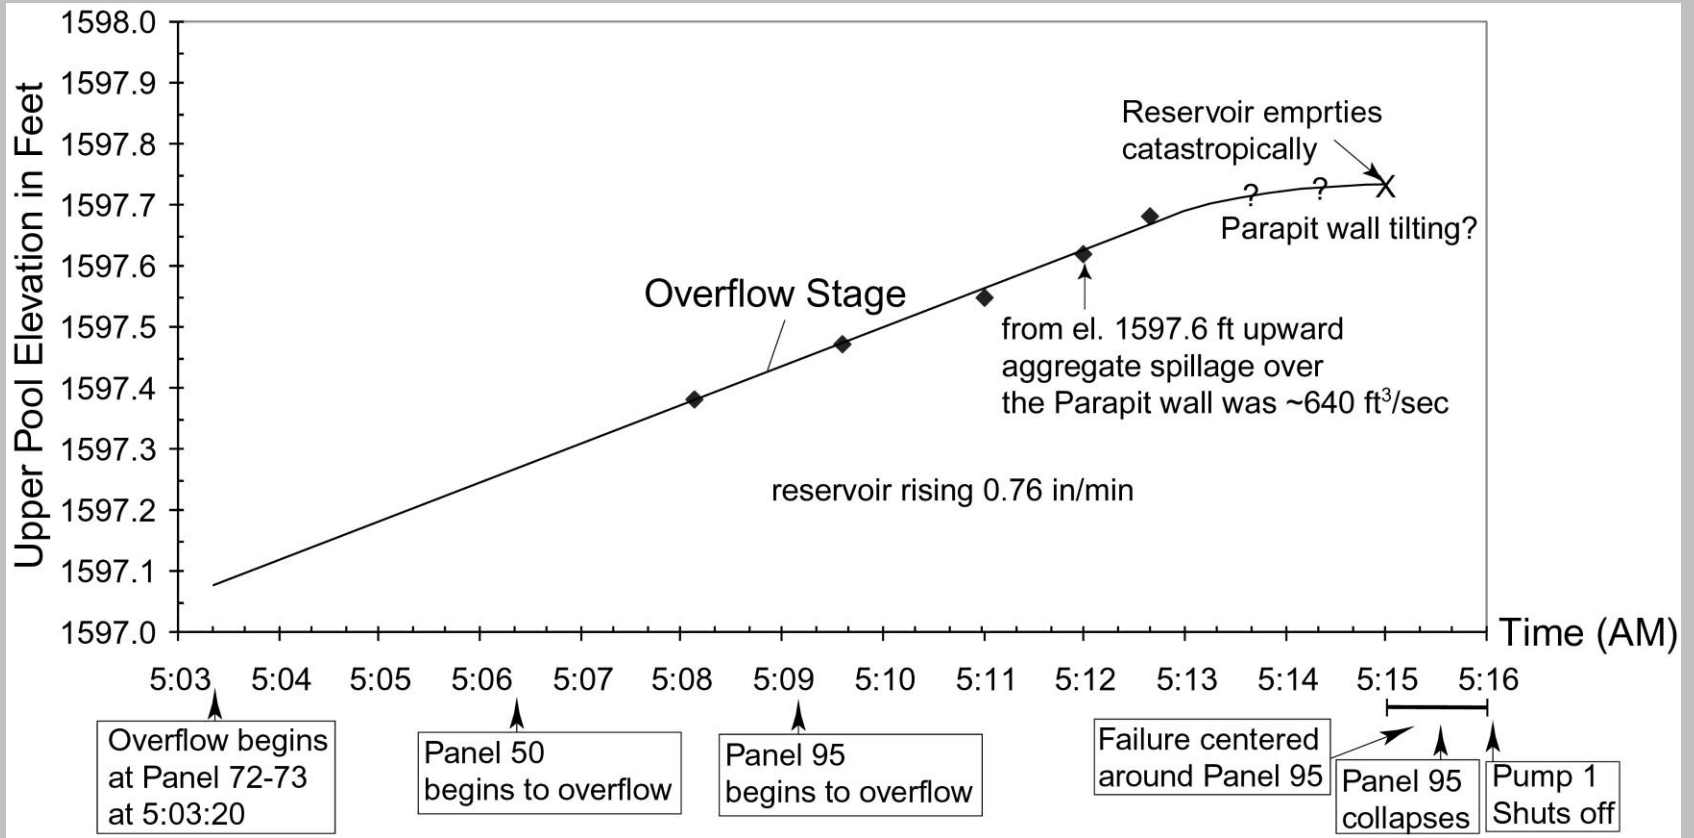
- Reconstruction of **Upper Reservoir stage versus time** during the interval when the reservoir breached, between 5:03 and 5:16 AM on December 14, 2005.
- Note how the three principal zones of spillage began at 5:03, 5:06, and 5:09, with the last zone being the one that undercut the parapet wall first. The wall toppled over just about the same time that the last pump shut down.

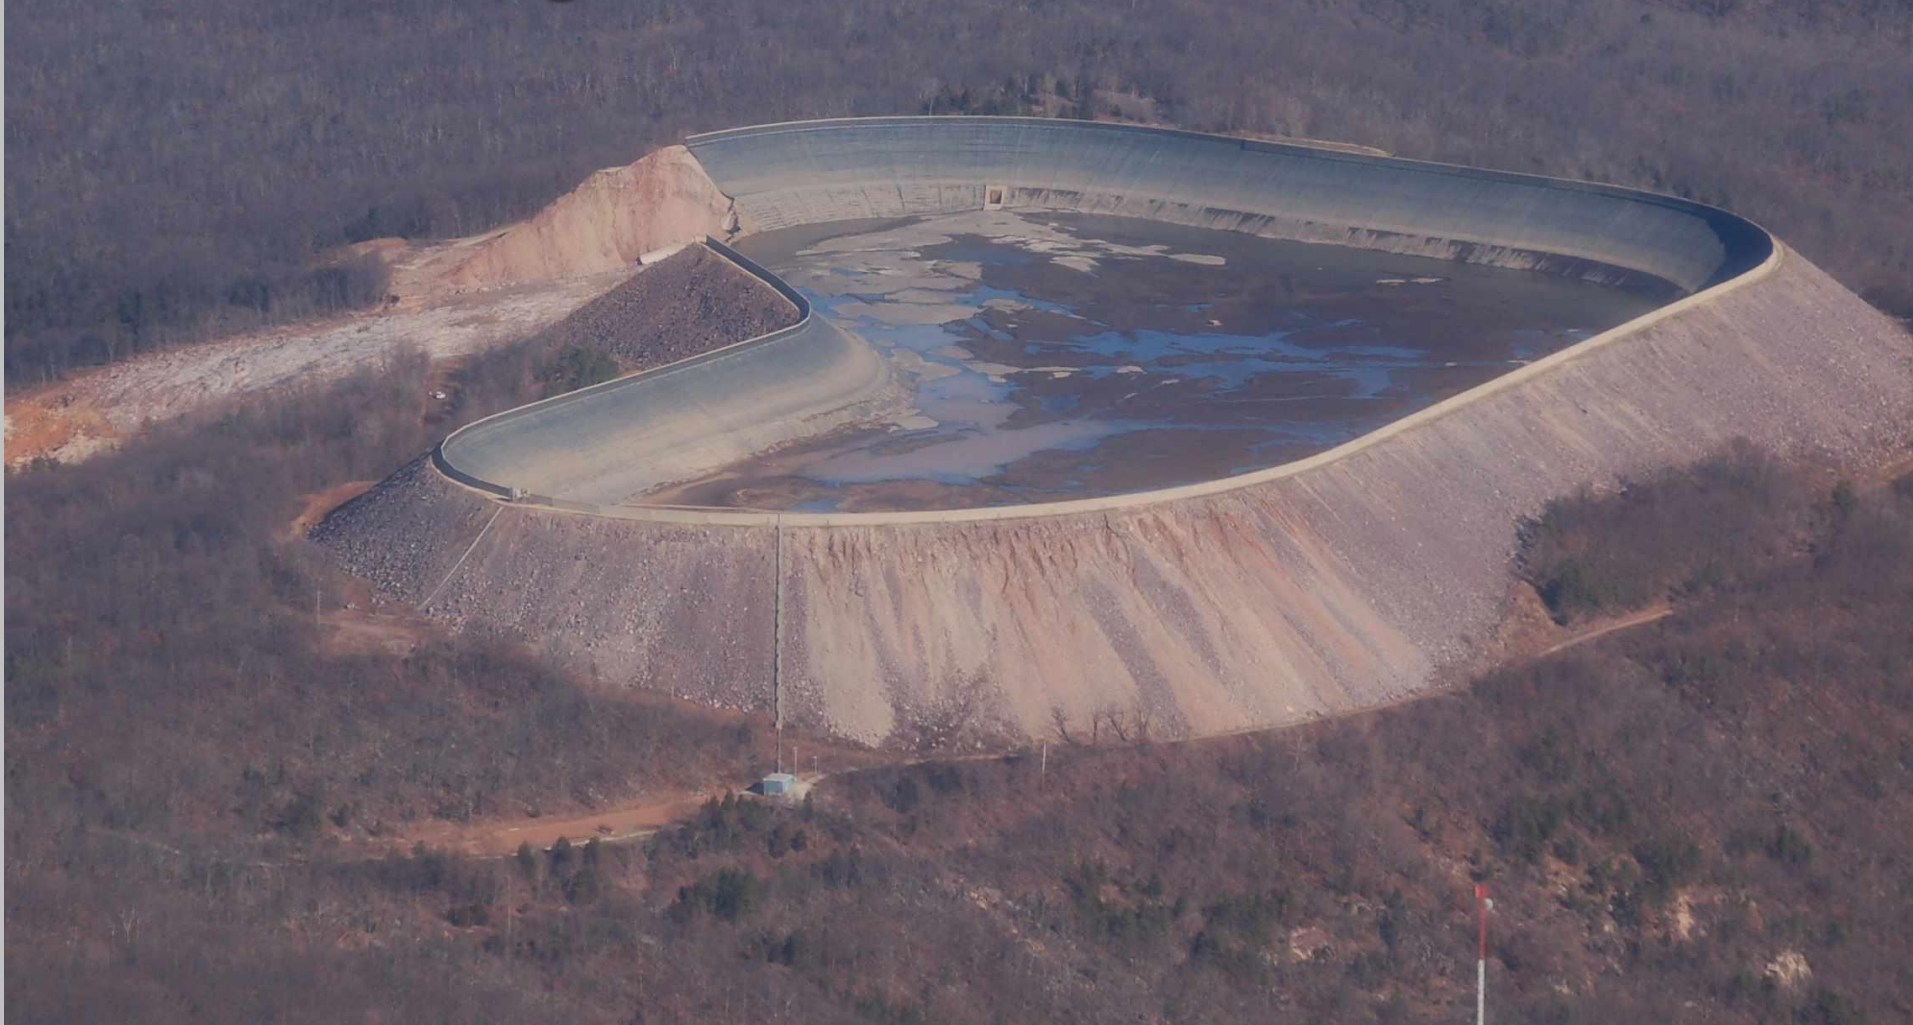
- **Aerial oblique view of the southeastern side of the Upper Reservoir embankment, taken the morning after the failure.**

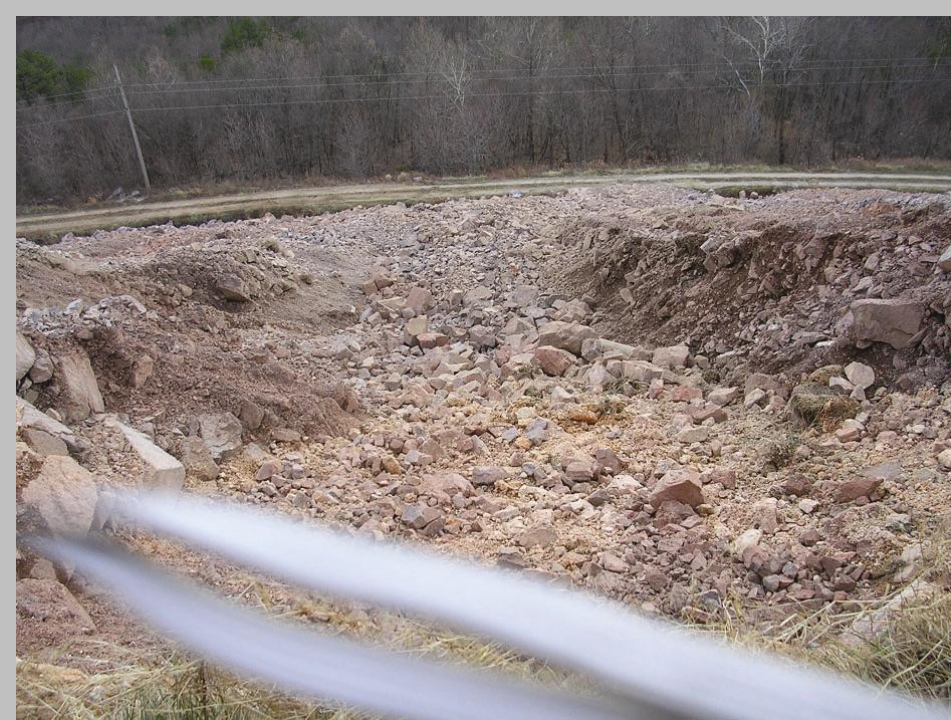
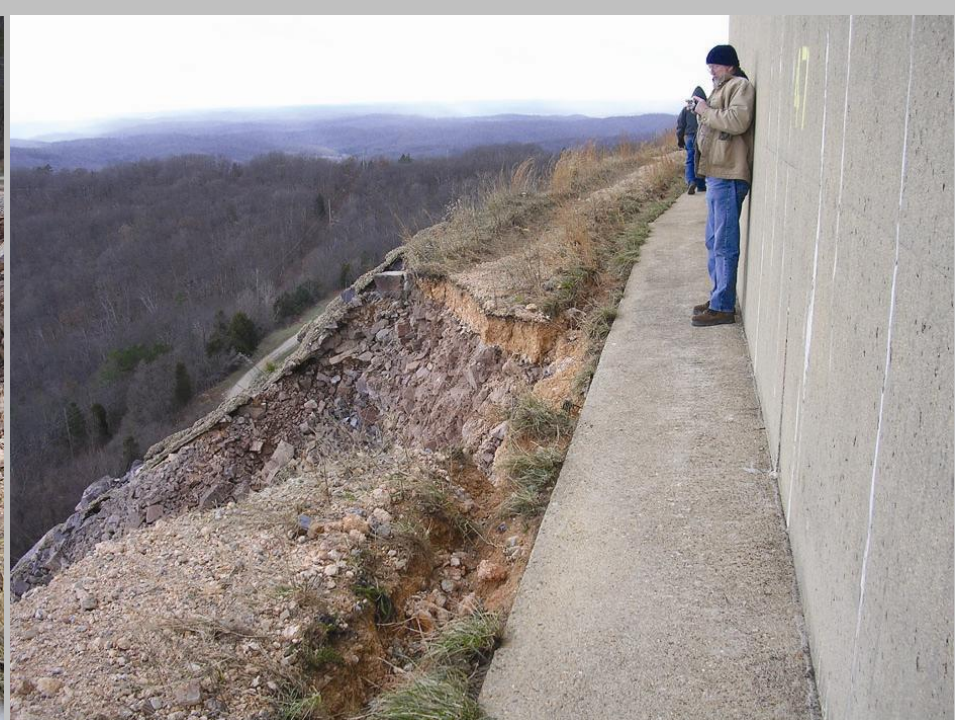
- Extensive erosion of the Upper Reservoir embankment near at Panel 47, on the southeastern perimeter.
- Right view shows erosion of the perimeter road to the footing of the parapet wall. Note gunite facing that had been placed on the upper slope to arrest surficial raveling, prior to the failure.
- Left view shows the extensive gully erosion in this same area, extending to depths of 15 feet. Note the sluicing of finer grained materials by the large volume of runoff.

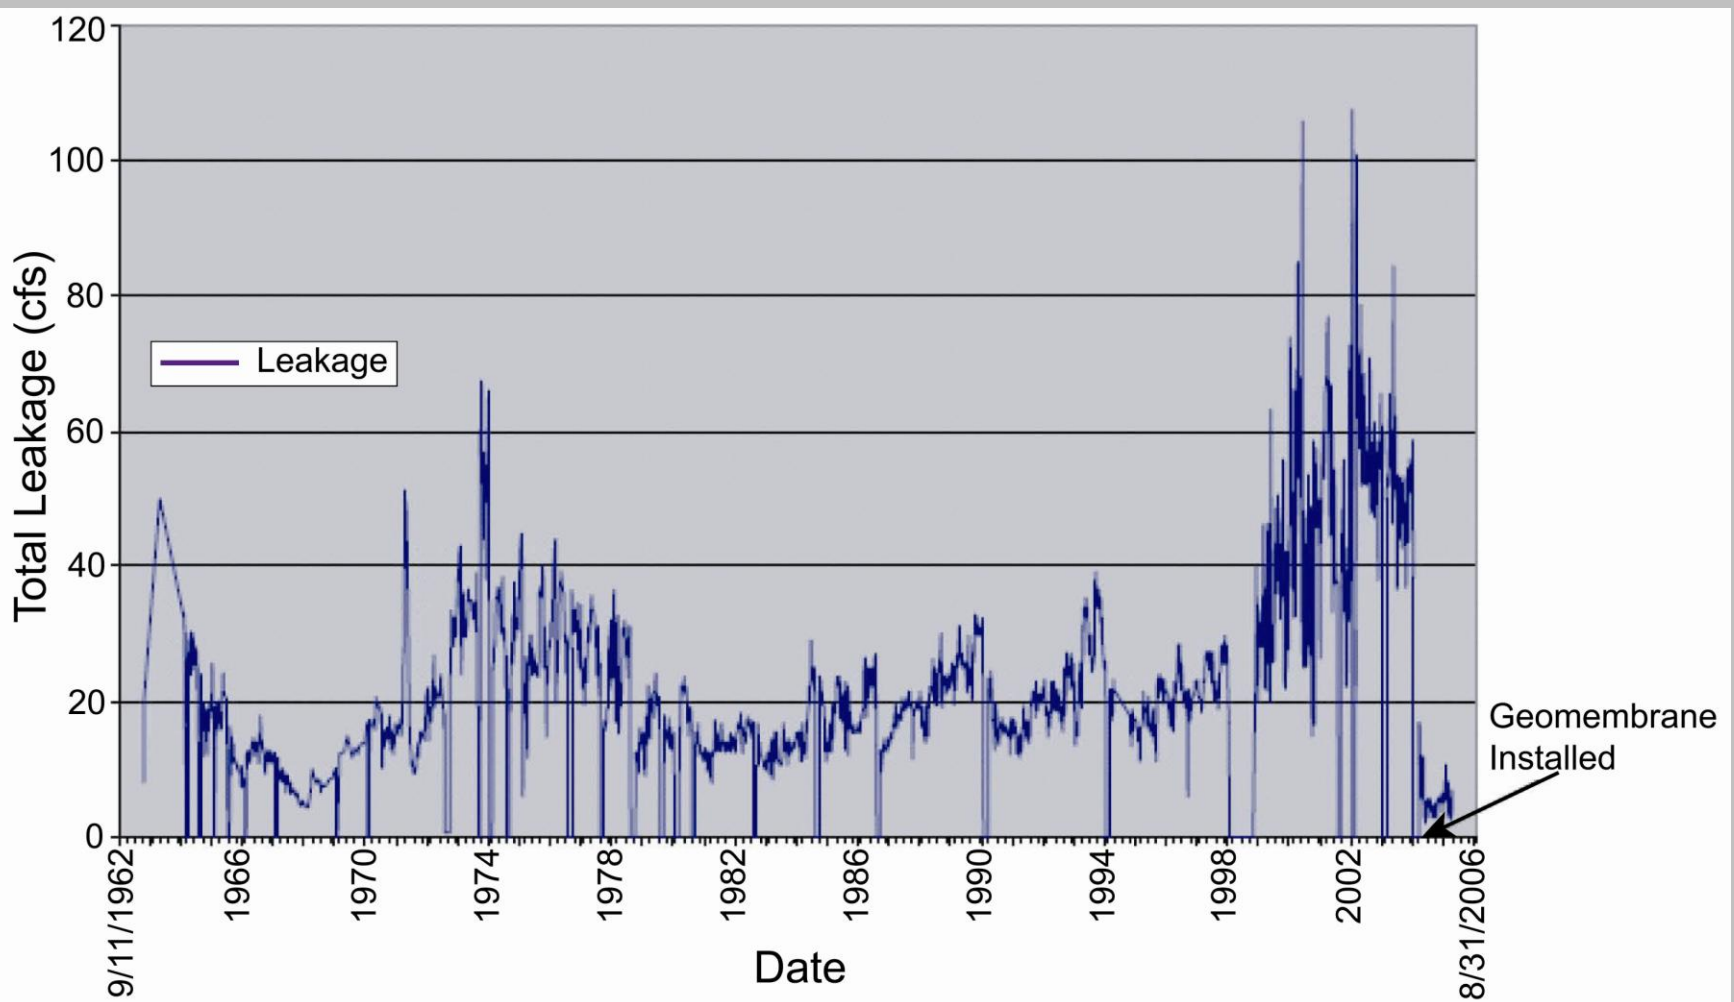
- **Throughout its life, the upper reservoir leaked. This leakage helped provide Johnson's Shut-ins with a steady source of water during dry summers.**
- **Some leaks were serious and resulted in the shut-down of the plant for repairs.**
- **Most leaks were related to the cracking of the reinforced concrete liner as the underlying rockfill settled differentially.**
- **Leakage was reducing the efficiency of the operation by about 2%, so the reservoir was lined with an HDPE geomembrane in fall 2004. This stabilized the seepage losses.**

- **Leakage from the Upper Reservoir exhibits a gradual upward trend until the basin was lined in 2004, dramatically reducing seepage losses (FERC Independent Panel of Consultants Report, 2006).**

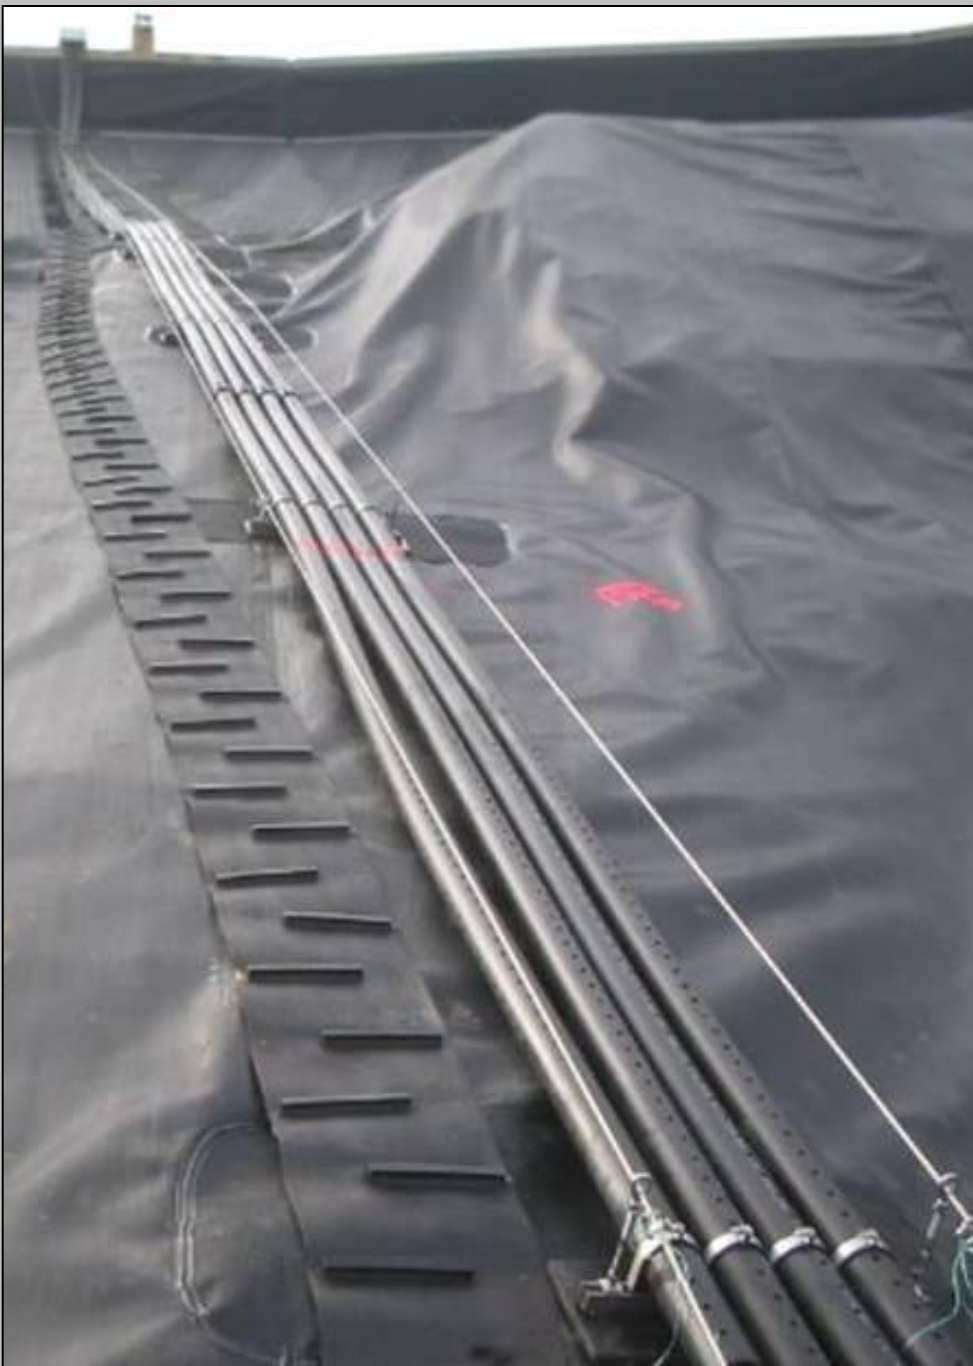
- The reservoir stage sensors were comprised of the four perforated HDPE conduits shown here; two were to hold pressure transducers, one was an extra, and one was to be filled with concrete as ballast. This was to be anchored to the liner using welded HDPE straps.
- The liner contractor pointed out that this design would reduce the performance and life of the liner and suggested that some alterations be made.

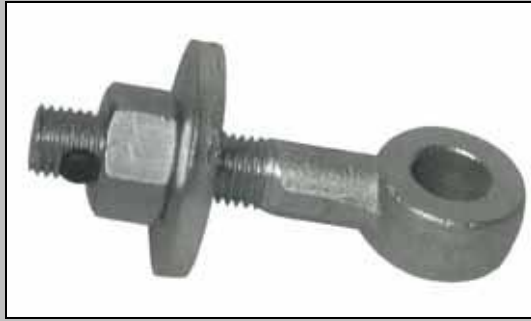
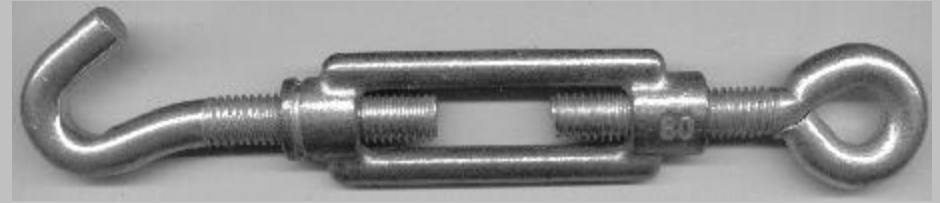
- An untensioned steel cable was to be anchored to the top and bottom portions of the concrete lining with eye bolts, like that shown left above. The concrete ballast pipe was removed. Since a fourth pipe was already on site, it was installed as a spare, without any ballast.
- During placement, the eye bolts were discarded in favor of turnbuckles (right above), so the steel cable could be tensioned. 1). During the twice-daily filling and emptying of the reservoir, the turnbuckles loosened and allowed the sensor tubes to work themselves free. 2). The omission of a ballast pipe allowed the sensor tubes to deflect much more easily.
- These attachment details were not subjected to external peer review. **Last minute connection details often prove to be problematic.**

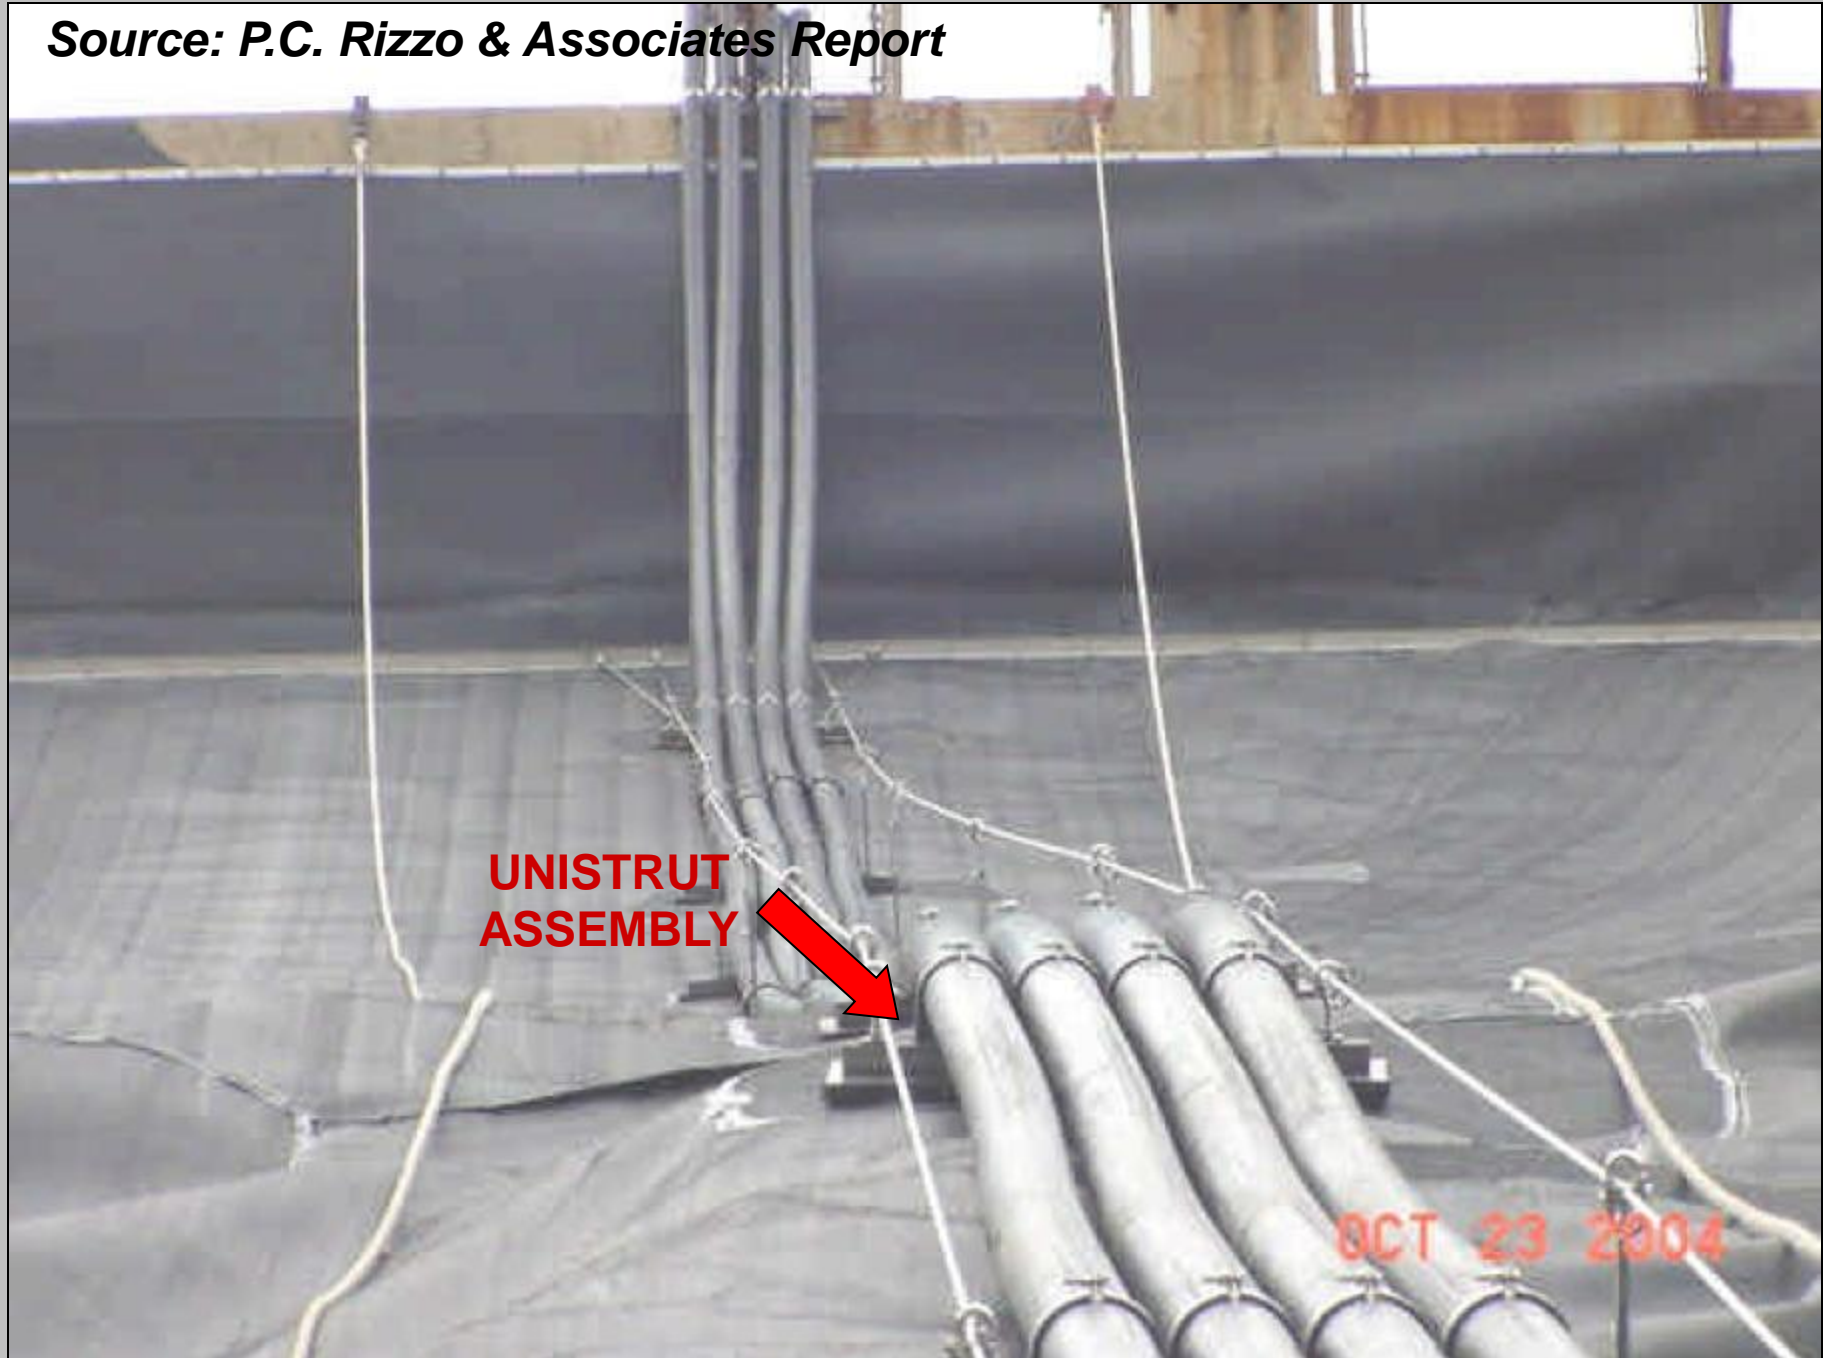
Sensor pipe array emplaced at Taum Sauk Upper Reservoir in 2004

- The four sensor pipes were held bound together by four U-bolts, fastened to a piece of hardware called a *unistrut*. This hardware came apart as the turnbuckles loosened, allowing the pipes to separate. This reduced the cumulative stiffness of the pipe group, allowing them to deflect more easily under the twice-daily cyclic loading of the reservoir filling and draining.

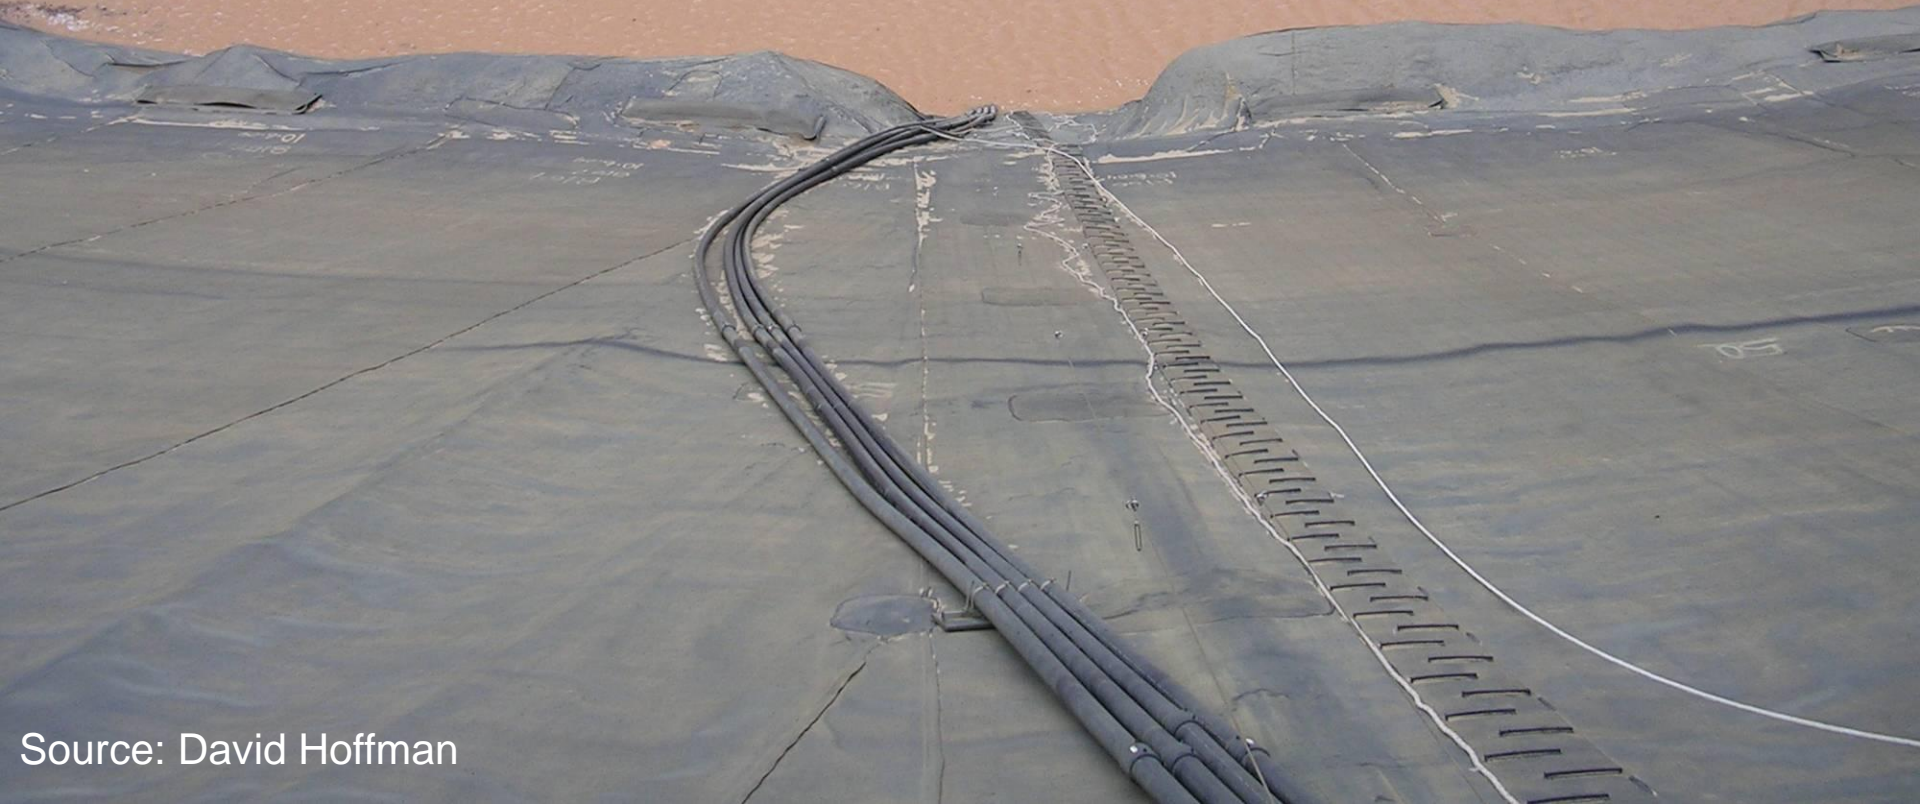
Detached UNISTRUT Assemblies and deflected sensor conduits – as seen after the failure

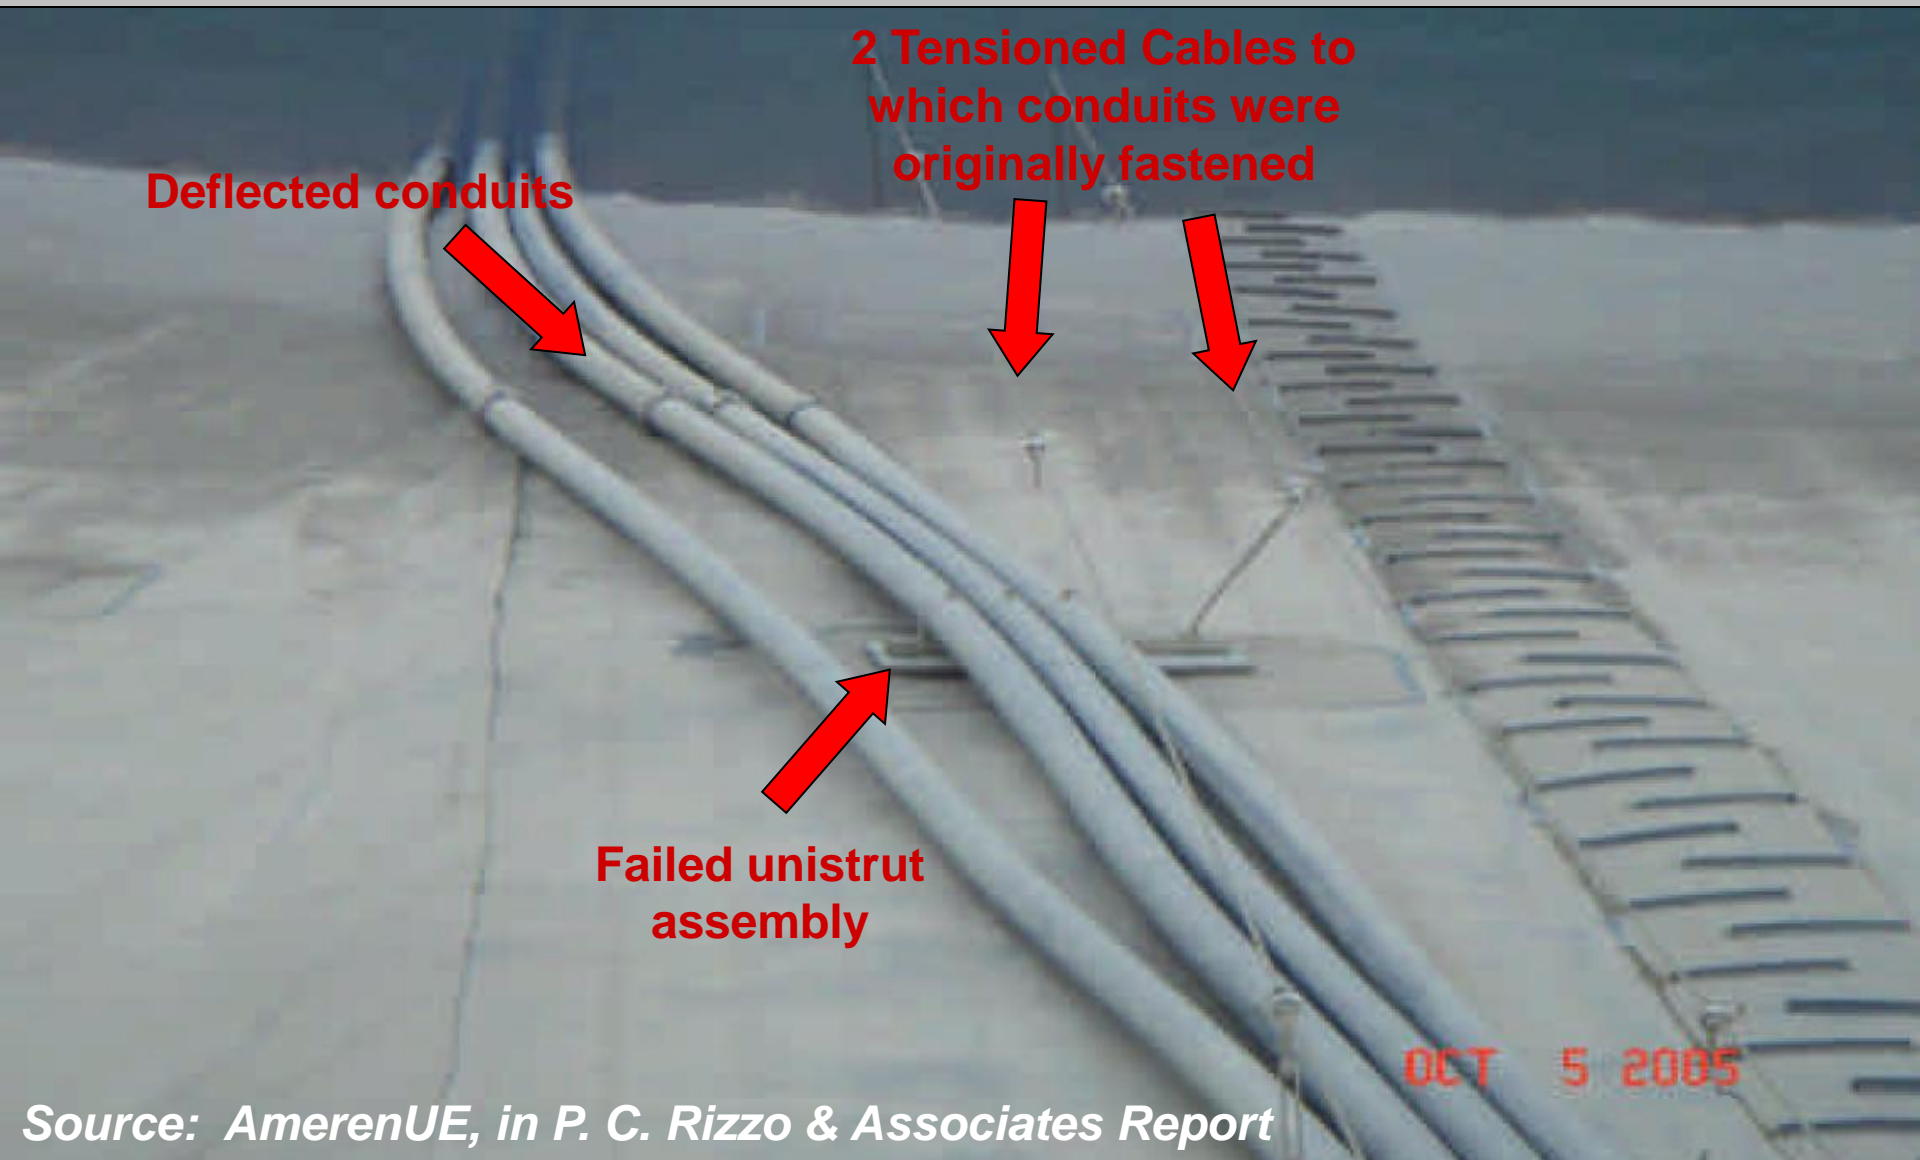
Detached Unistrut assembly and deflected sensor conduits-as seen 2-1/2 months before the failure

Deflected conduits

2 Tensioned Cables to
which conduits were
originally fastened

Failed unistrut
assembly

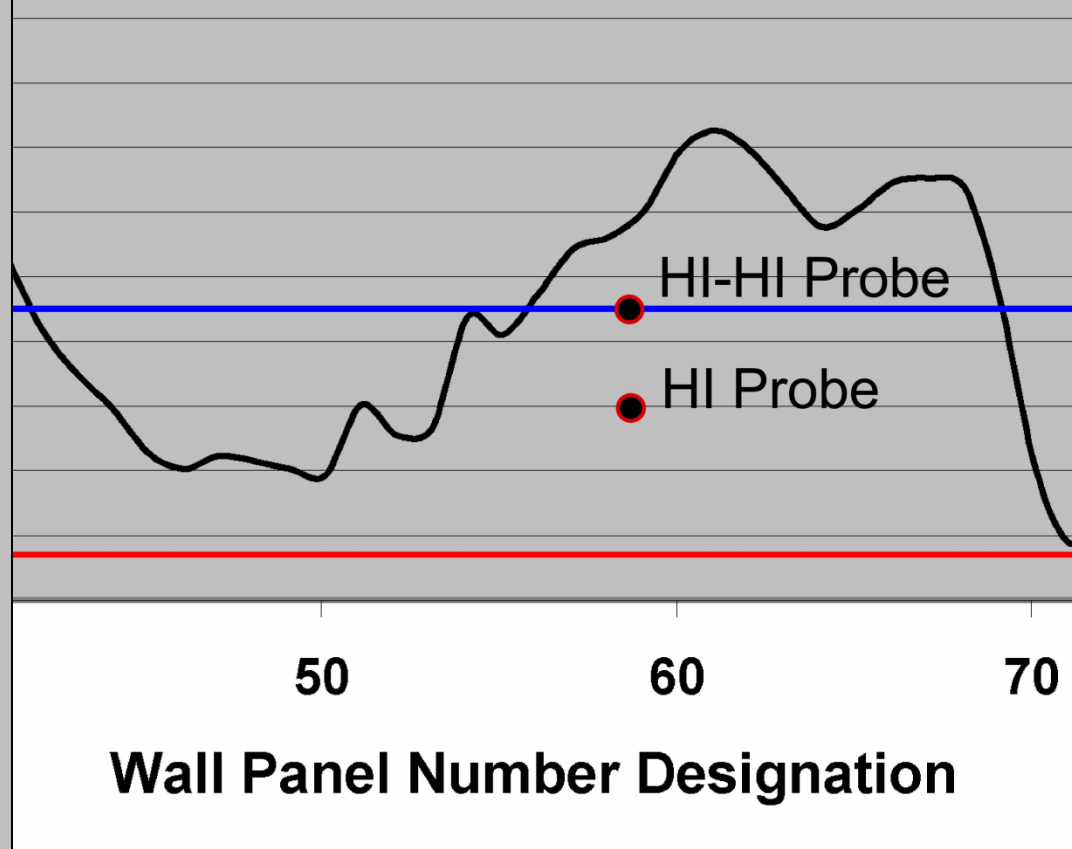
- The upper reservoir included so-called **fail-safe probes**, intended to automatically shut down inflow if the reservoir stage monitoring system in the reservoir malfunctioned.
- Due to the wrong assumed elevation of the parapet wall (due to the differential settlement of the embankment), in 2004 these probes were fixed **ABOVE** the lowest crests of the parapet wall at other locations around the reservoir (which had dropped < 1598 ft).

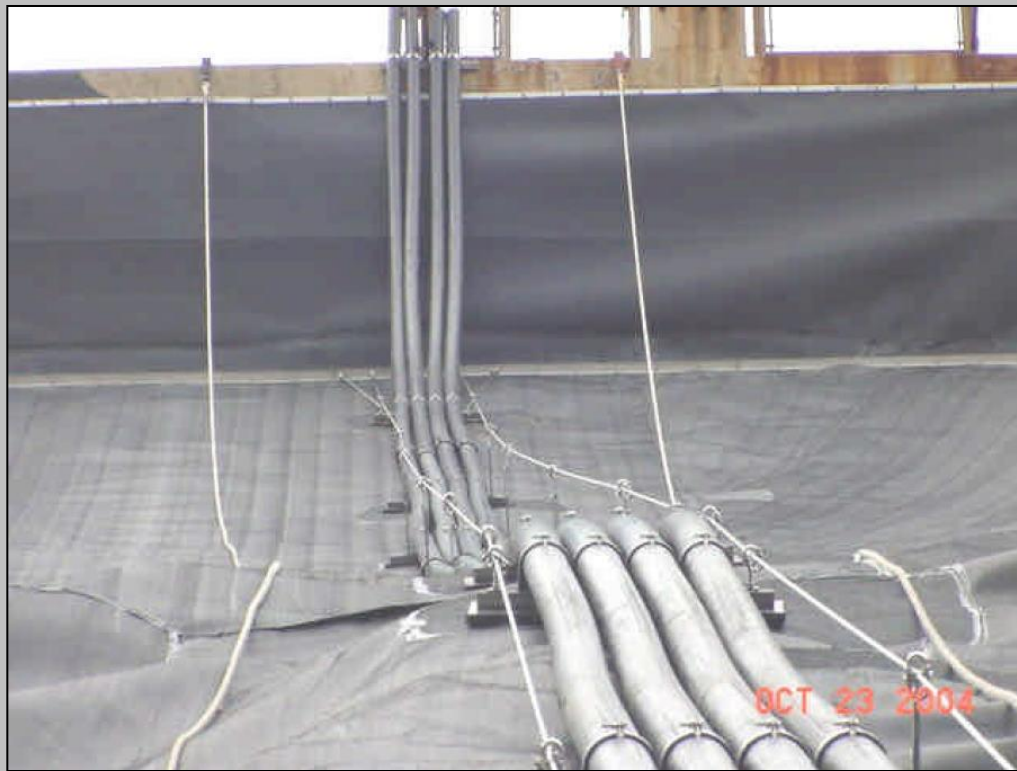
- The reservoir level was observed to have risen within 4 inches of the wall crest two days after the “Niagara Falls” overtopping (Sept 25th), and **the fail-safe shut off probes failed to activate.**
- Some wetness on the parapet walls indicated minor overtopping.
- The maximum level of these fail-safe probes was then lowered, but the reservoir stage conduits continued to deflect, so that sufficient freeboard was lost by the time of the fatal overtopping on Dec. 14th.
