HOOVER DAM:

Grout Curtain Failure and Lessons Learned in Site Characterization

J. David Rogers

**Dams Symposium
Association of Engineering Geologists
Annual Meeting Las Vegas, Nevada
September 22, 2005**

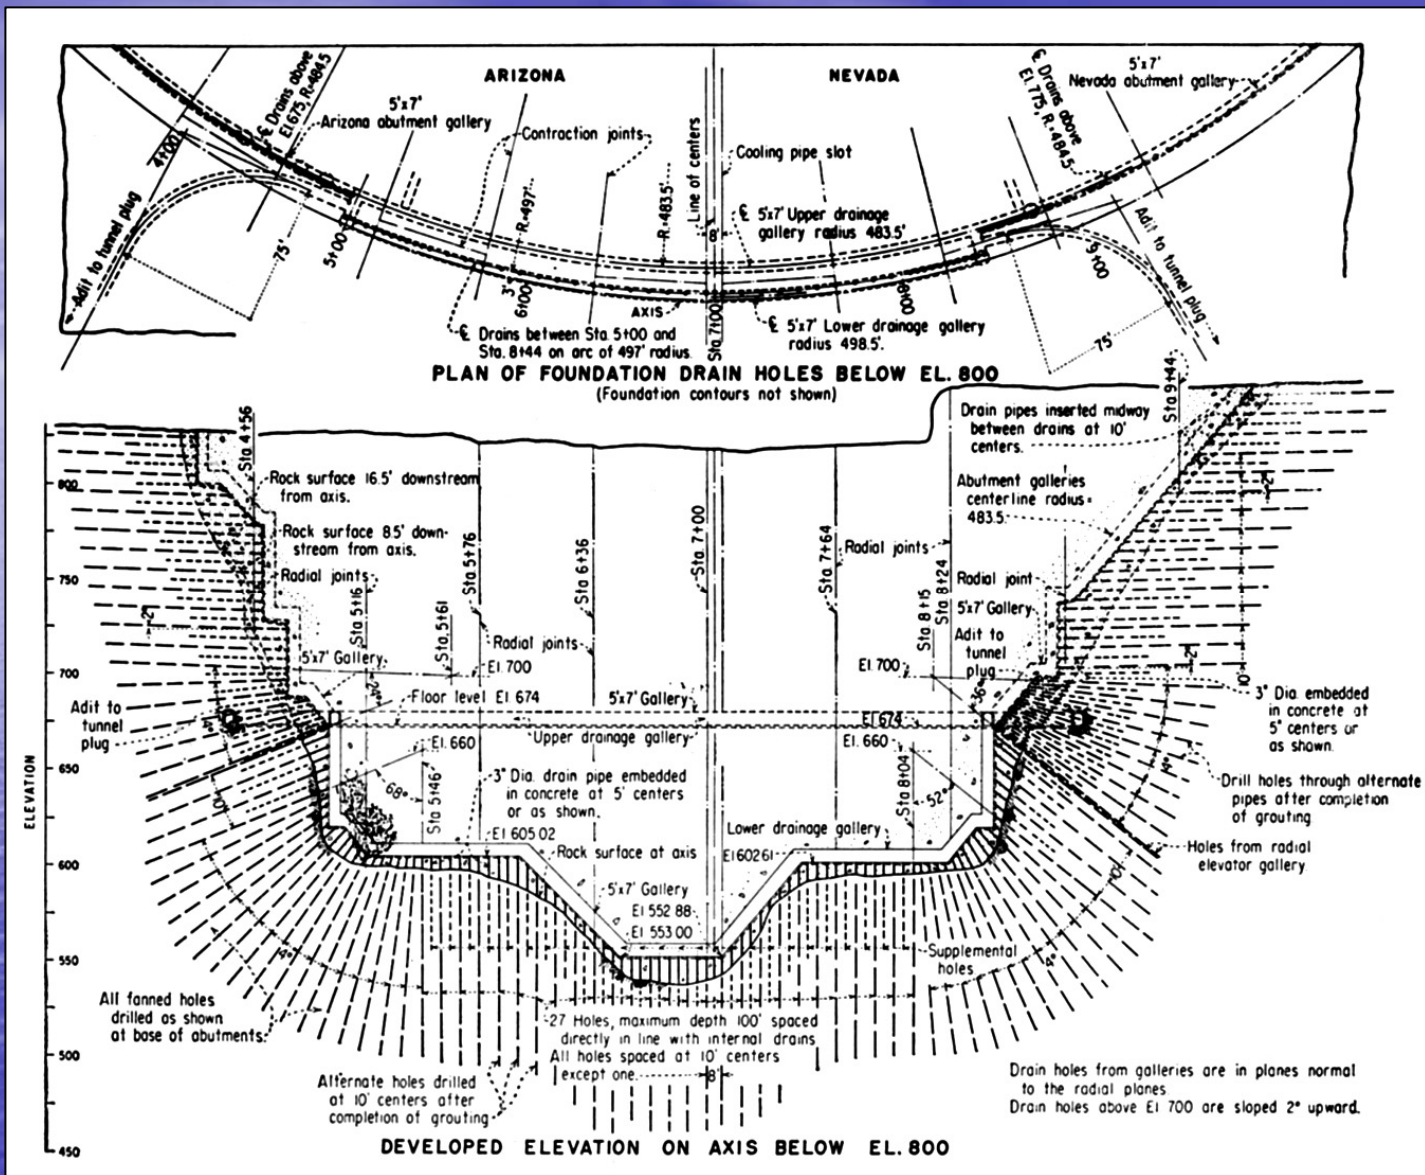
The grout curtain included a single line of holes 100 to 125 feet deep; about 14 to 21% of the dam height.

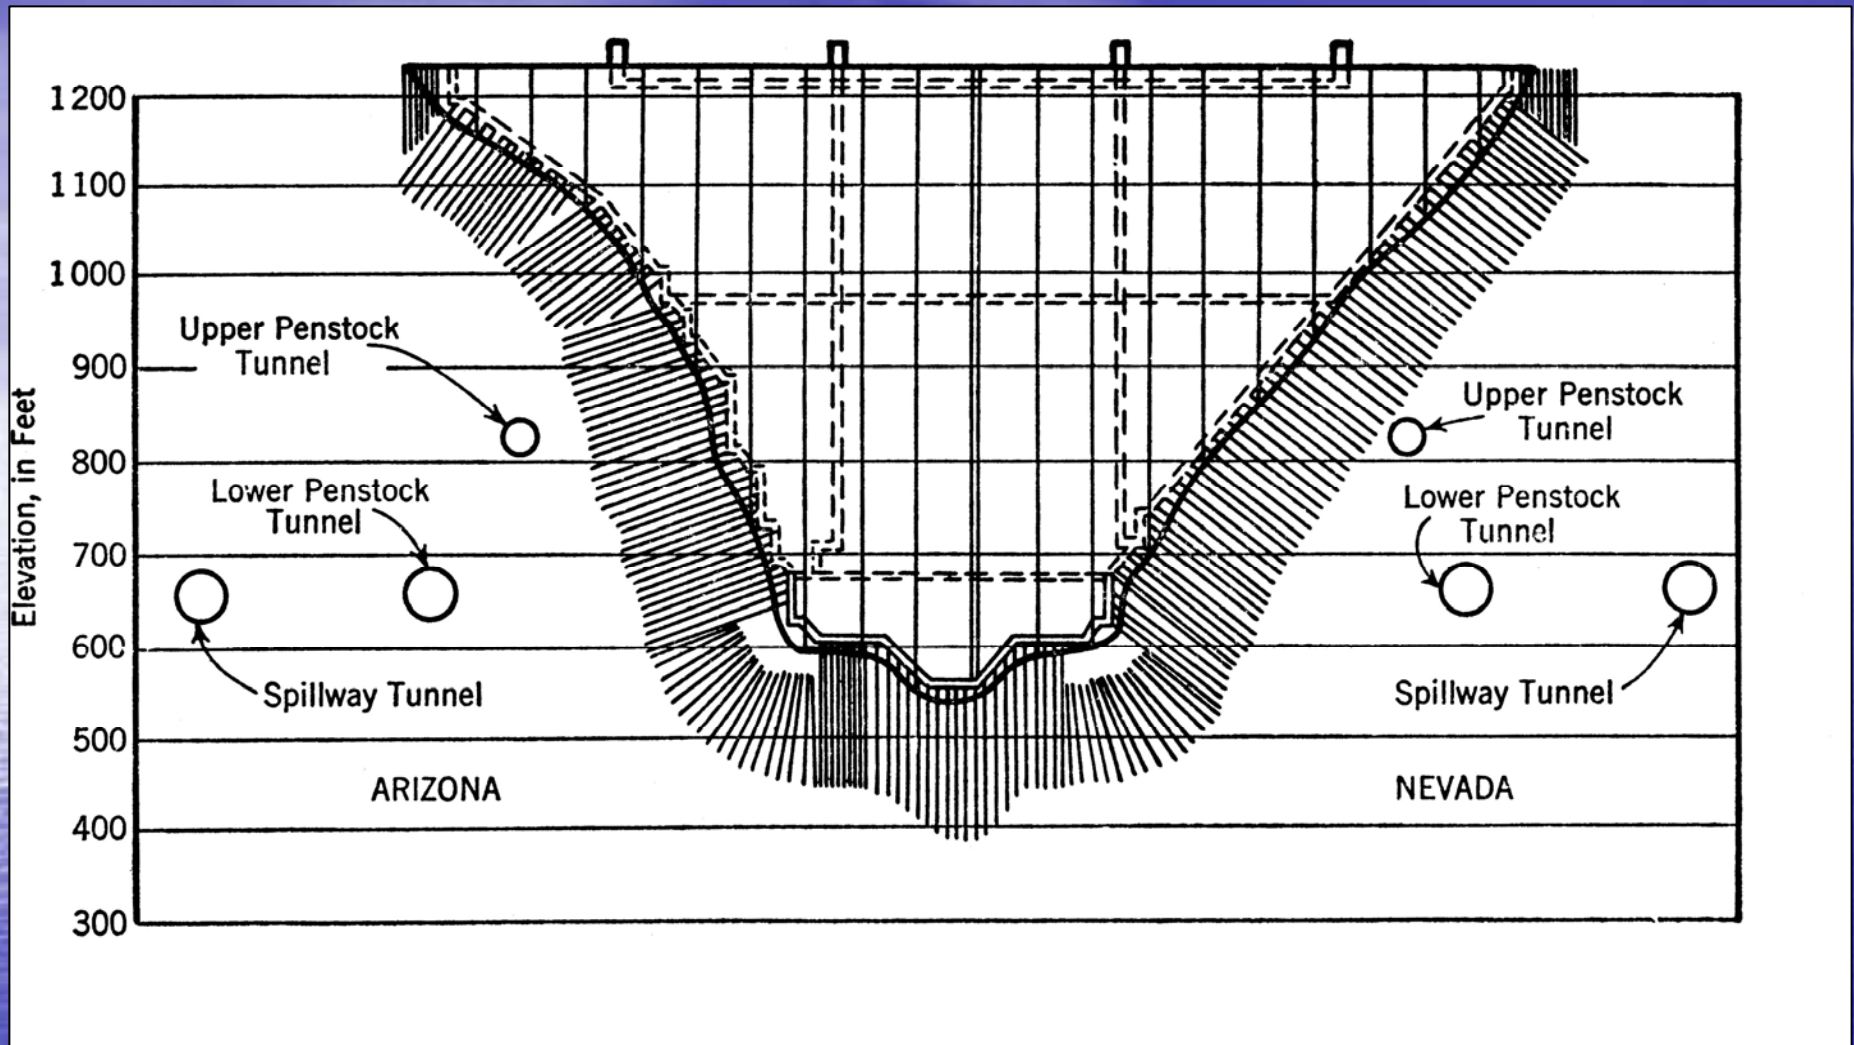
- Profile of dam centerline showing pattern of original grout curtain. Note ratio of dam height to depth of the curtain.

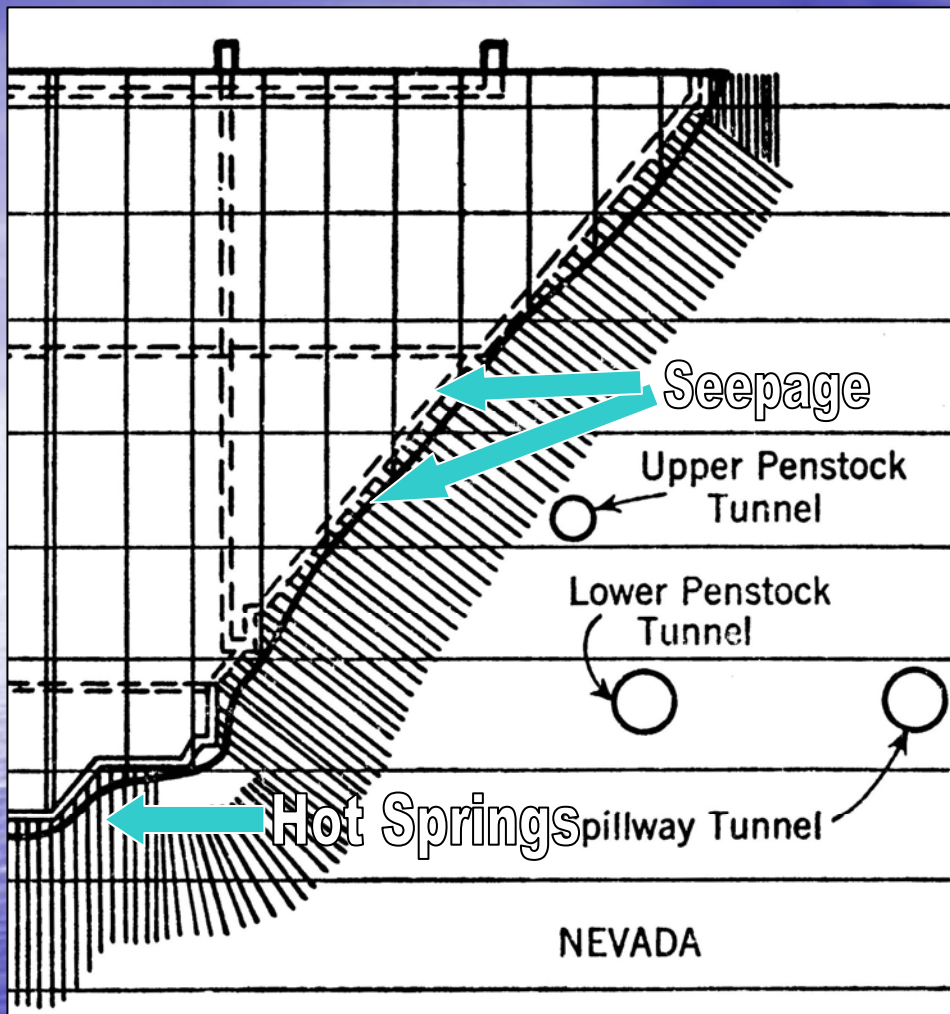
- **On the Nevada abutment** between elevations 840 and 940, several gout holes penetrated two distinct minor faults, and four holes had to be abandoned, because excessive grout take and leaks.
- When the reservoir reached 1100 feet elevation, the faults daylighted in the right abutment, and water began entering the fault zone
- At this time the abutment drains in the Nevada side began discharging cool water.

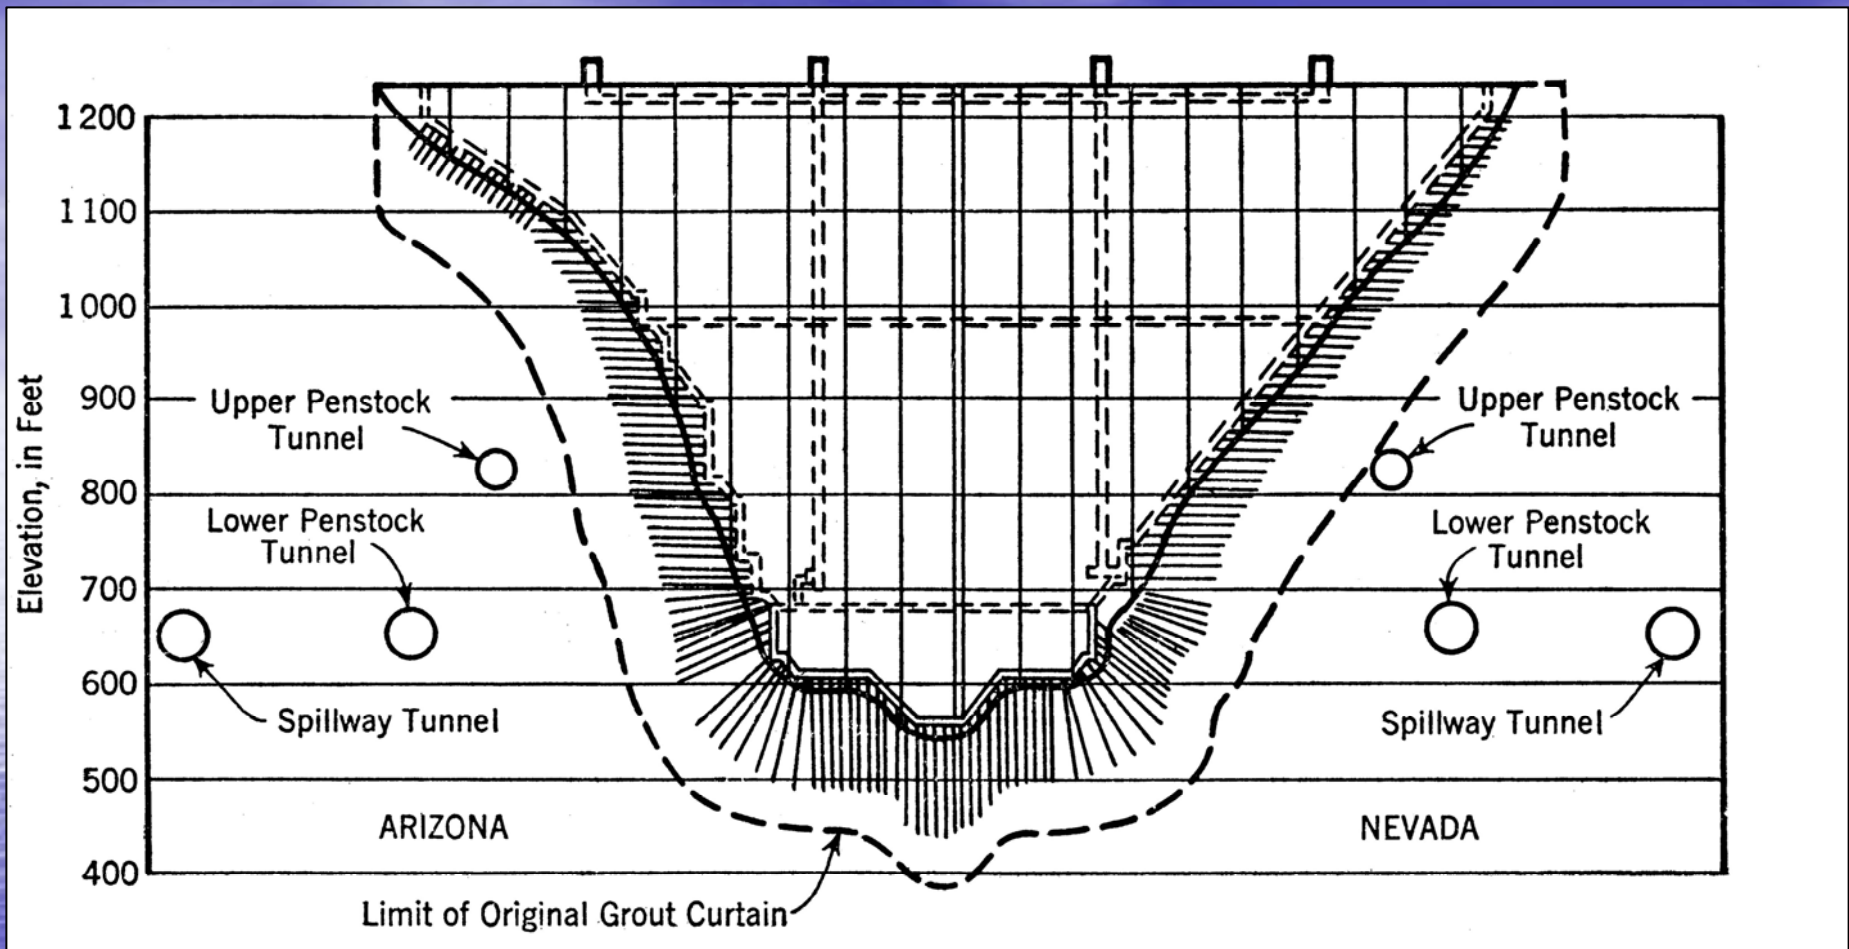
- Profile of dam centerline showing pattern of original drain holes, which extended a maximum of 100 feet. Note ratio of dam height to depth of the uplift relief holes.

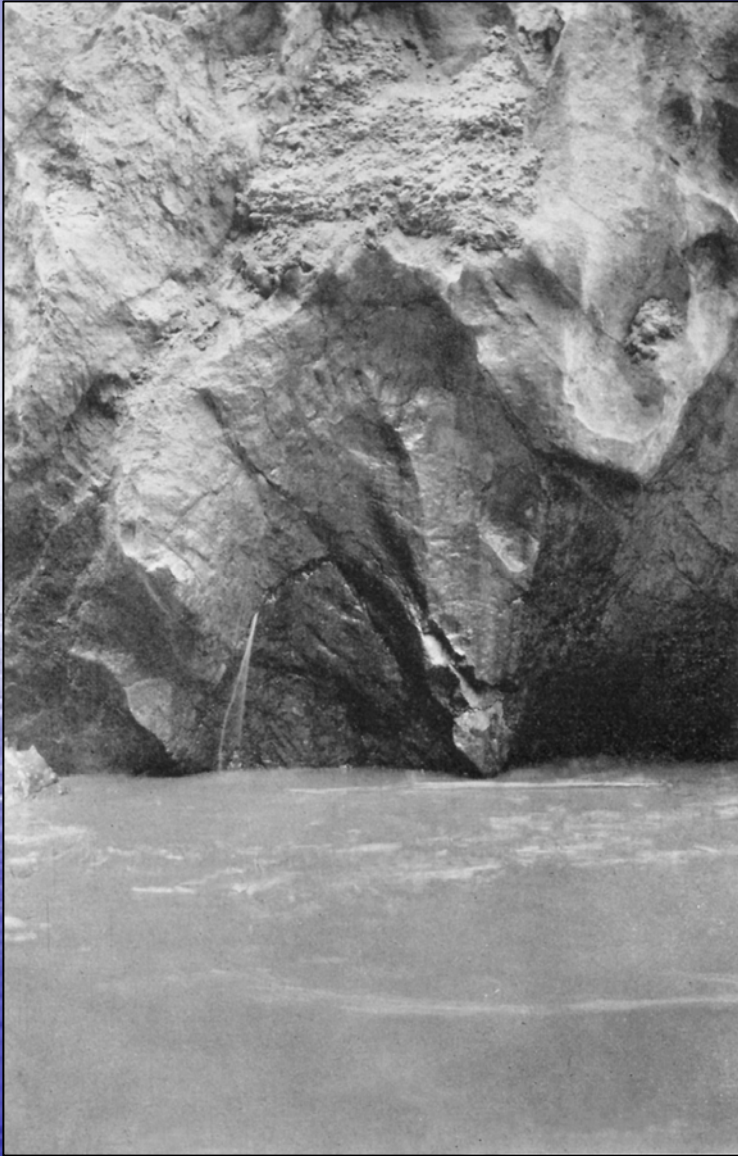
Hot springs on Nevada abutment

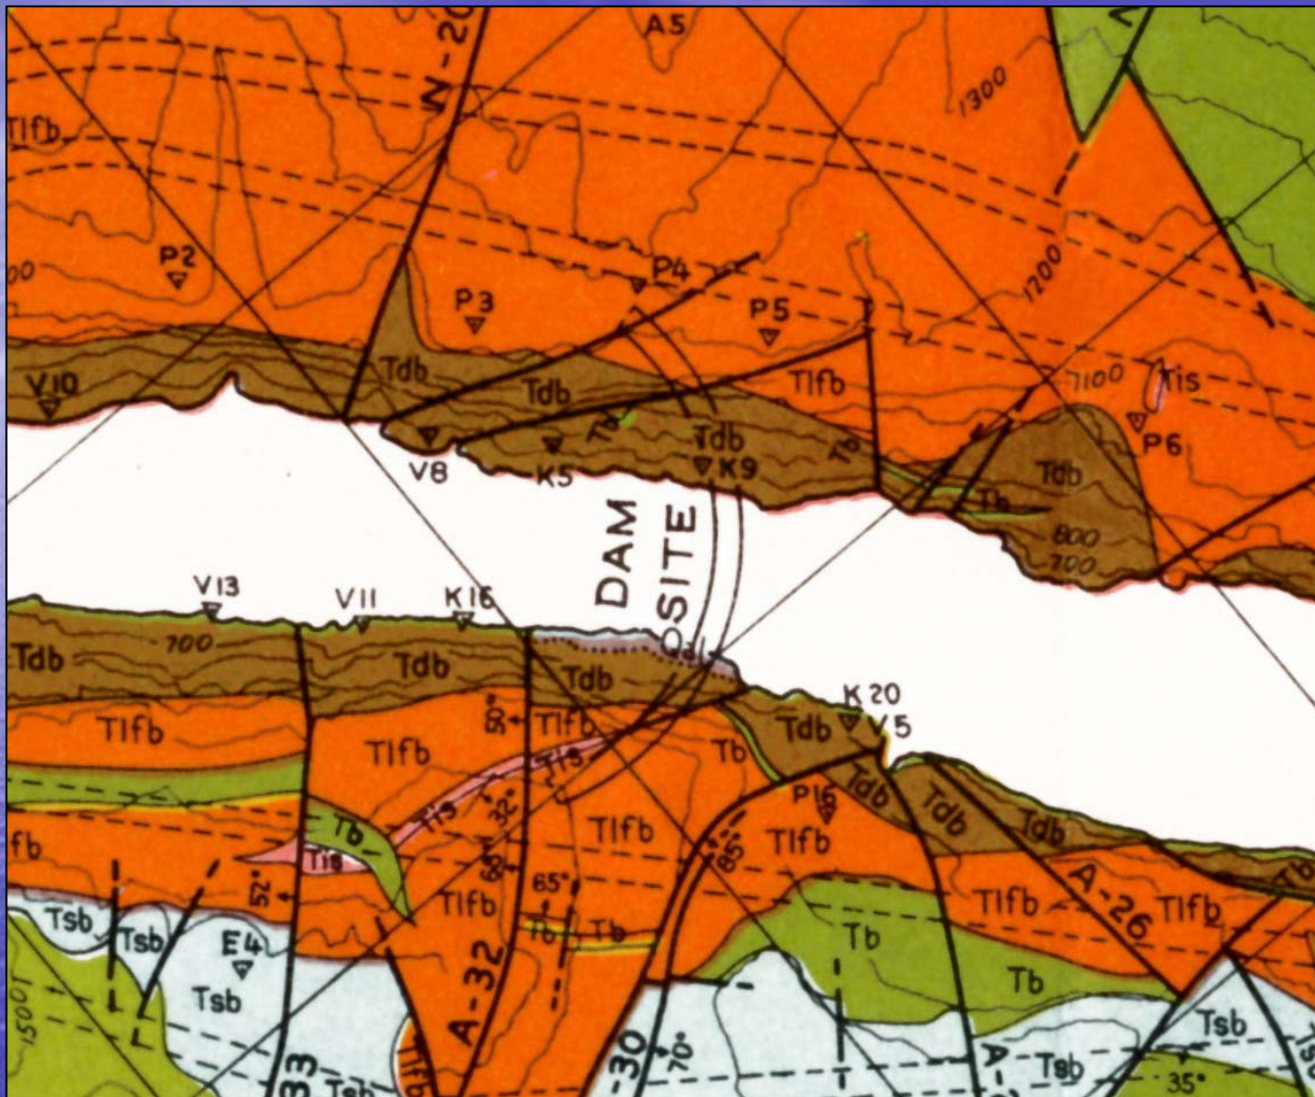
- Excessive seepage also manifests itself along two fault strands through the right abutment when the reservoir reached elevation 1100 feet, 132 feet below crest.

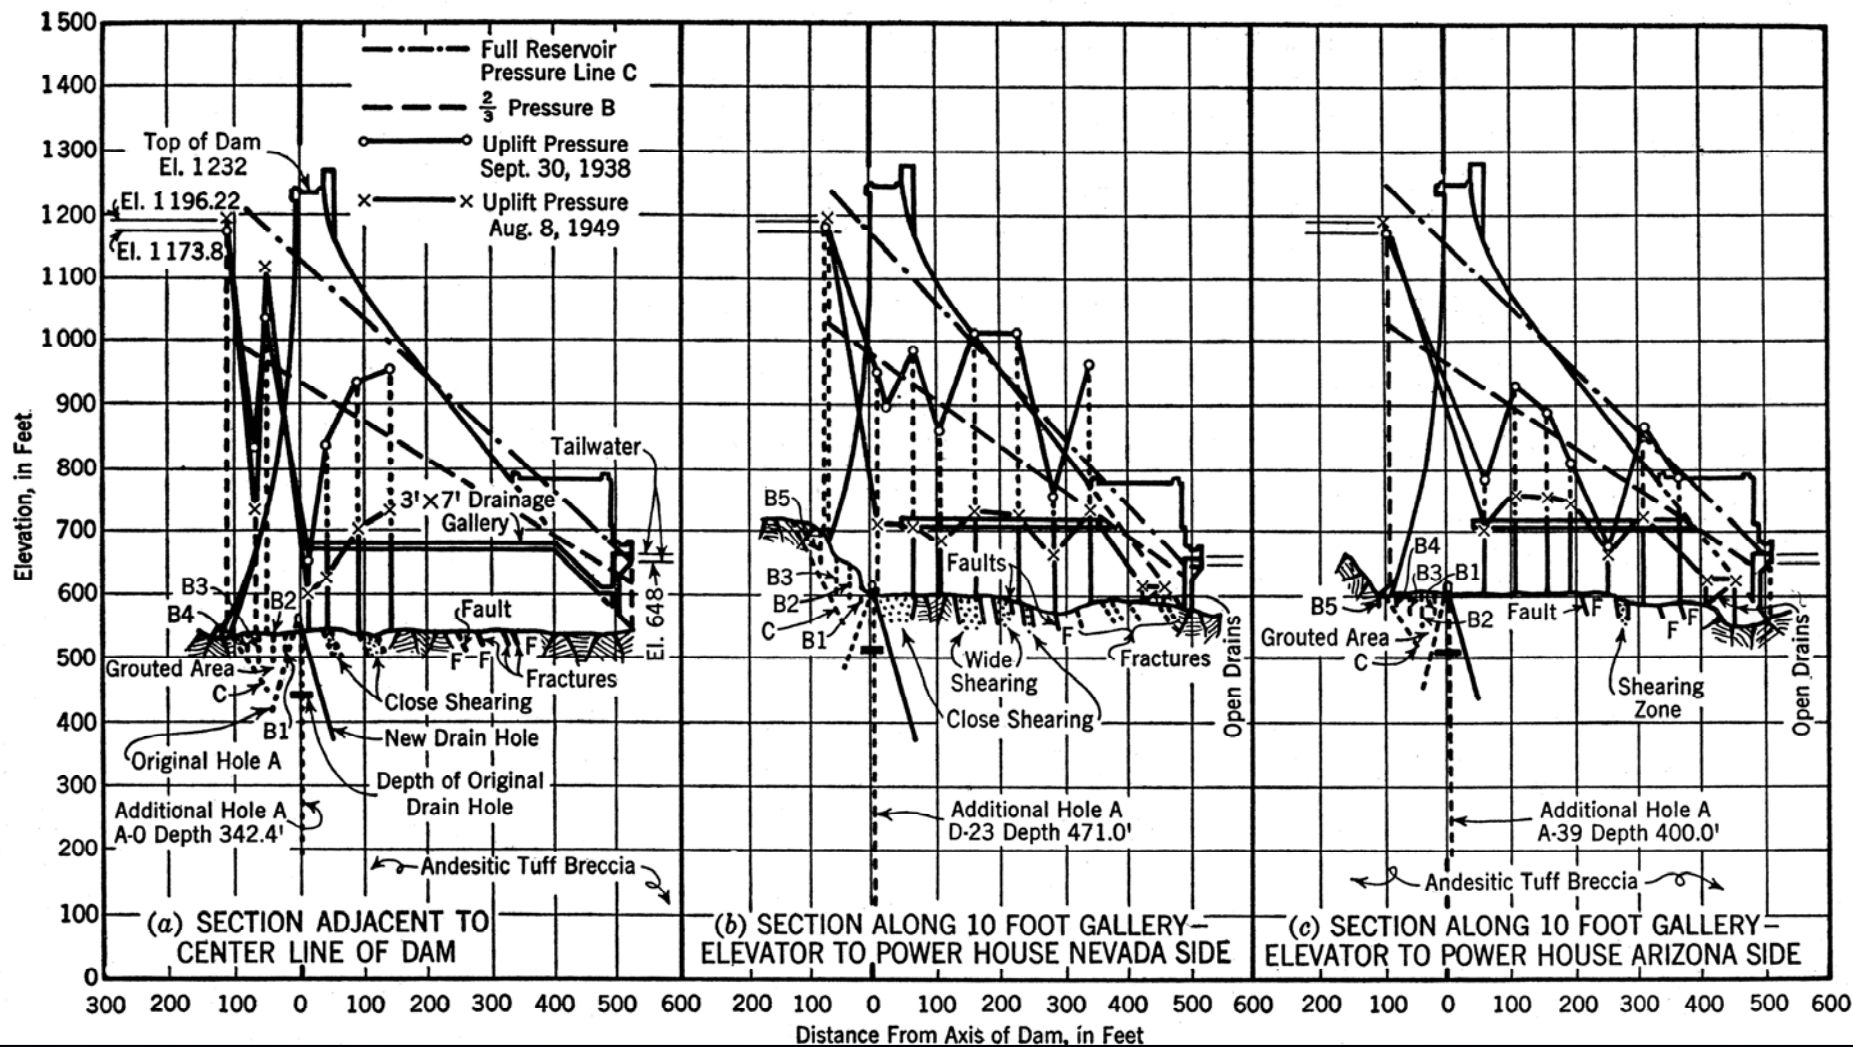
- **Uplift pressure gradient plots:** a) at dam centerline; b) along gallery elevator Nevada side; and c) along gallery elevator on Arizona side

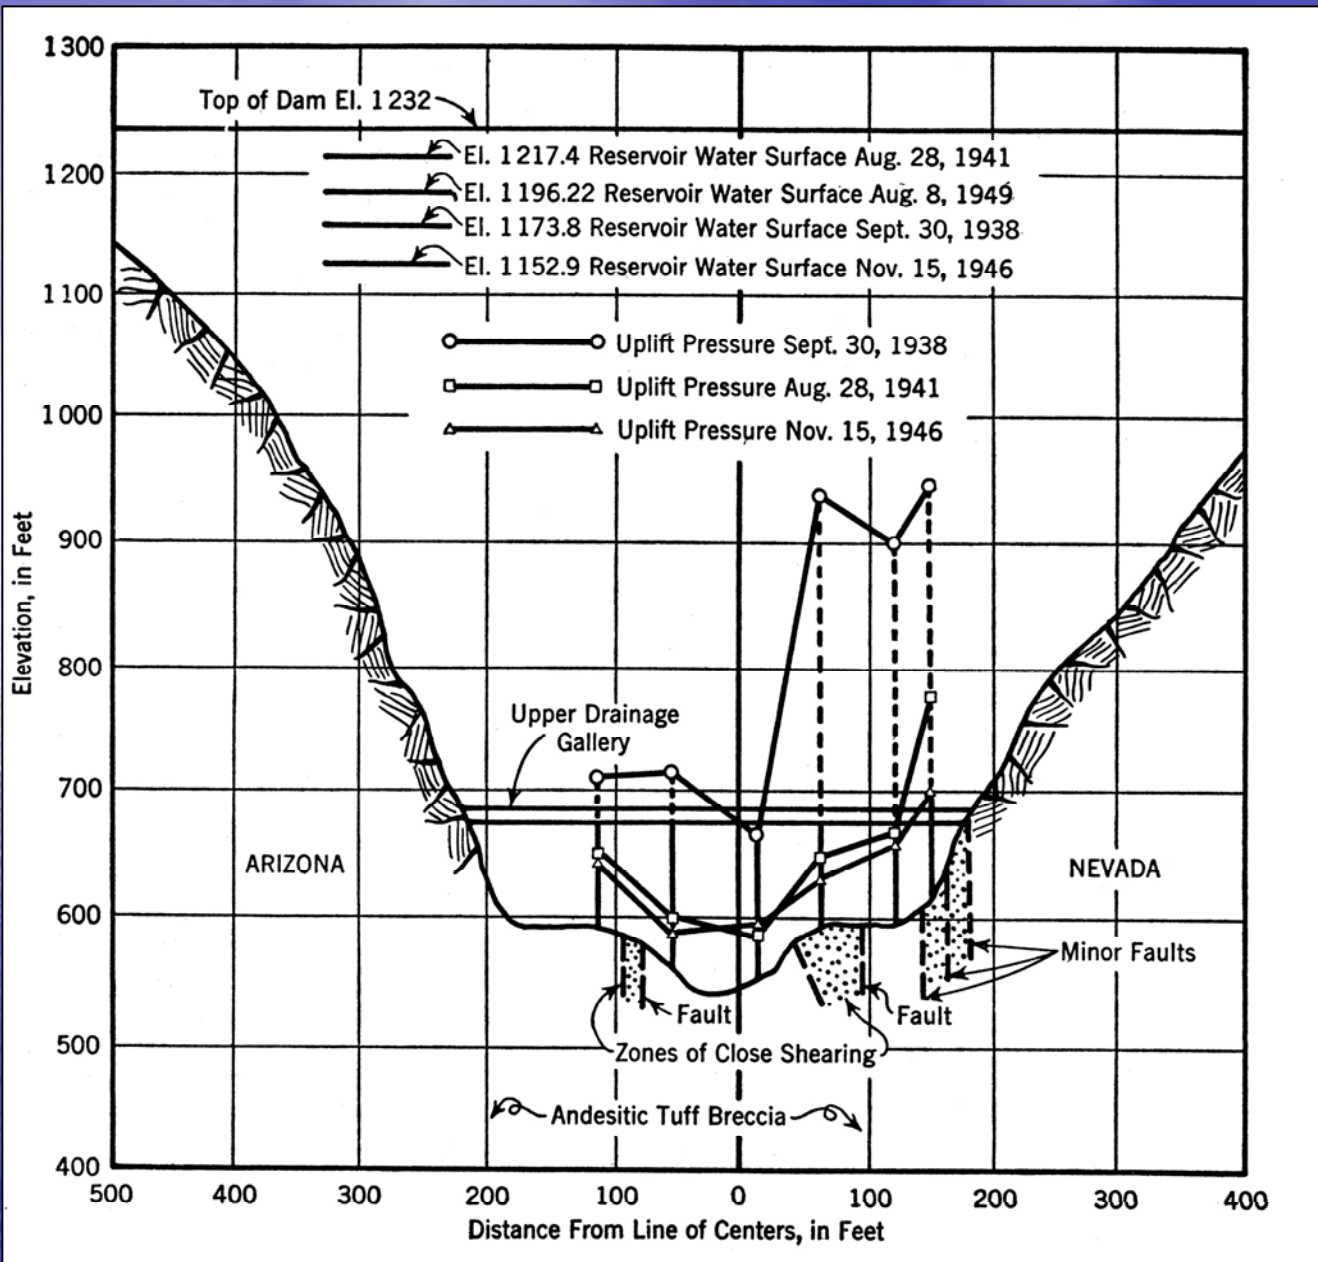
- Uplift pressure gradients along centerline of upper drainage gallery.
- Note increased pressures on Nevada side and fault zones

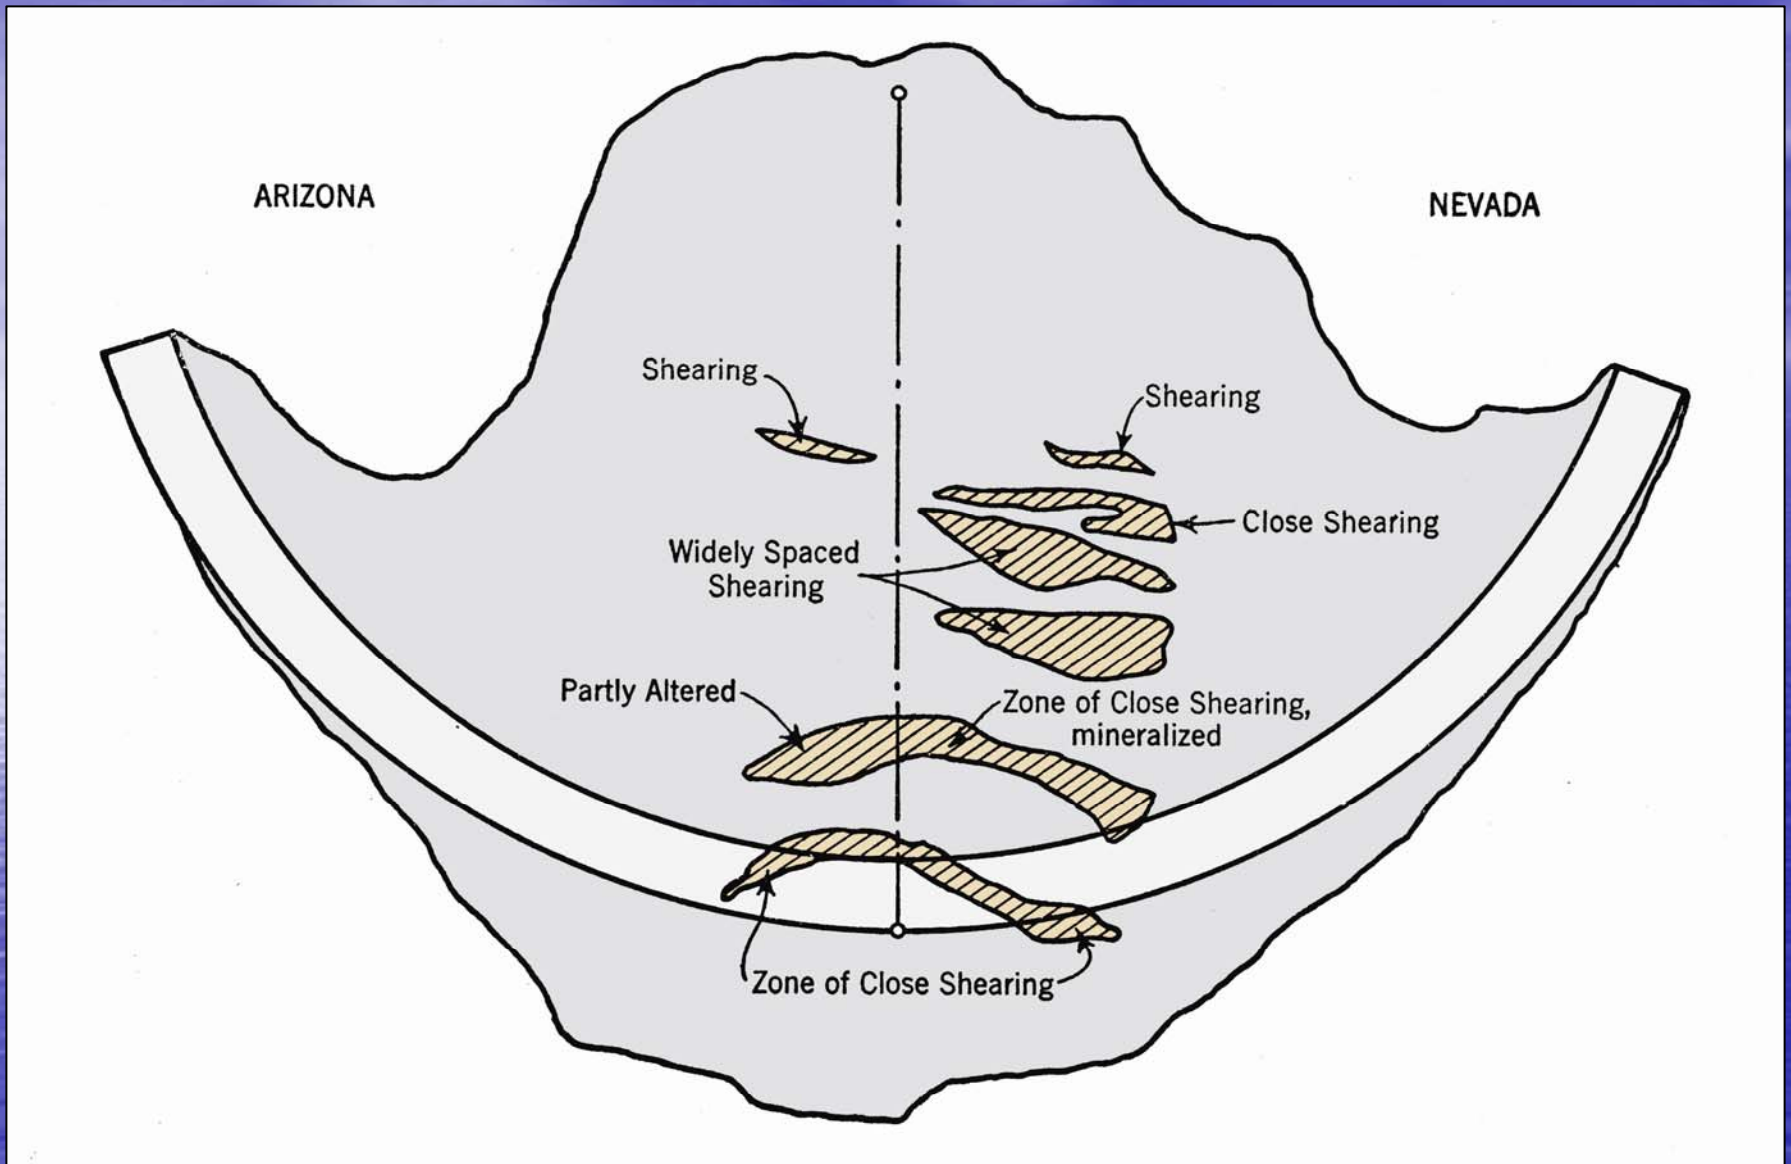
- Reservoir uplift reached its maximum levels in September 1938
- The decision was made to drill a series of BX size cores in the foundation beneath the dam
- The drilling revealed that the grout curtain was much too shallow on the faulted abutments, because 6 zones of intensely sheared rock were feeding water into the foundation and a series of **crisscrossing manganese gouge seams** were perching the underseepage, causing abnormally high pore pressures to develop

Manganese-rich gouge zones discovered in the dam foundation, along faults and shear zones.

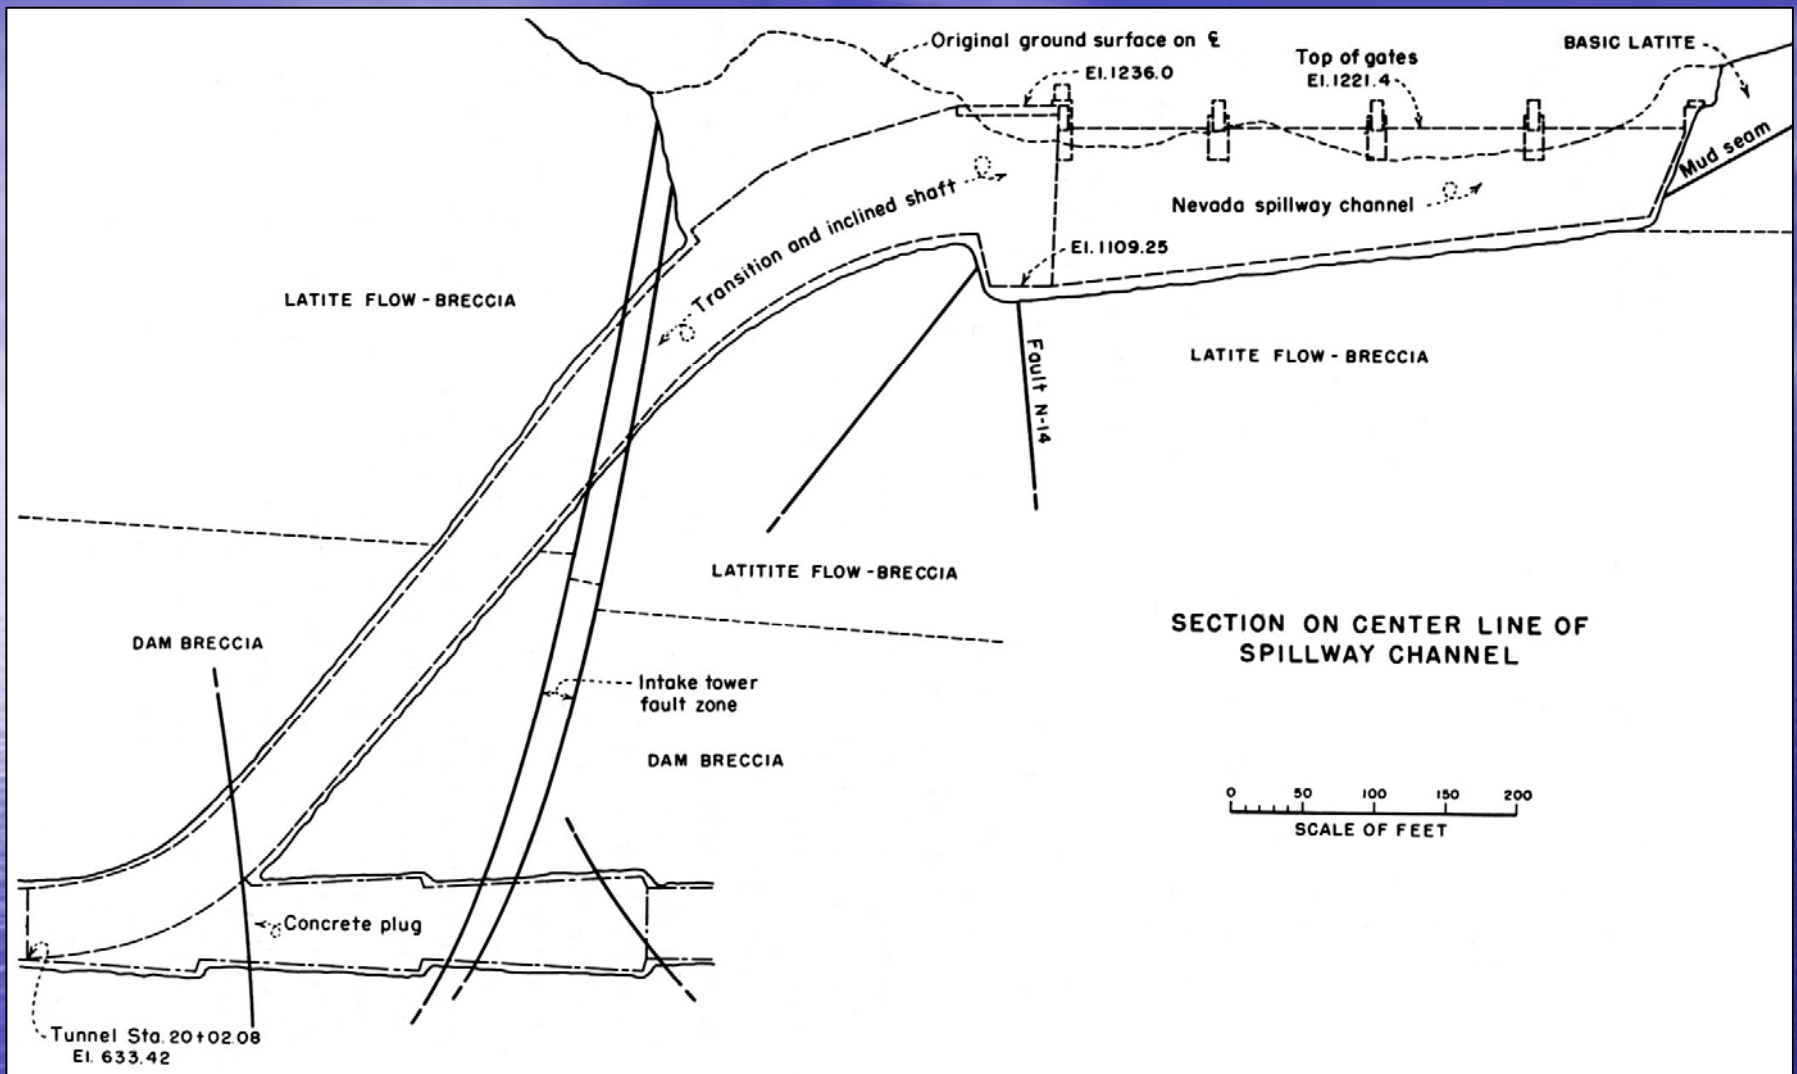
- Faults exposed in Nevada Spillway excavations. Note "mud seam" at upper right. The spillway shaft experienced significant seepage after the reservoir filled, along brecciated zones adjacent to faults.

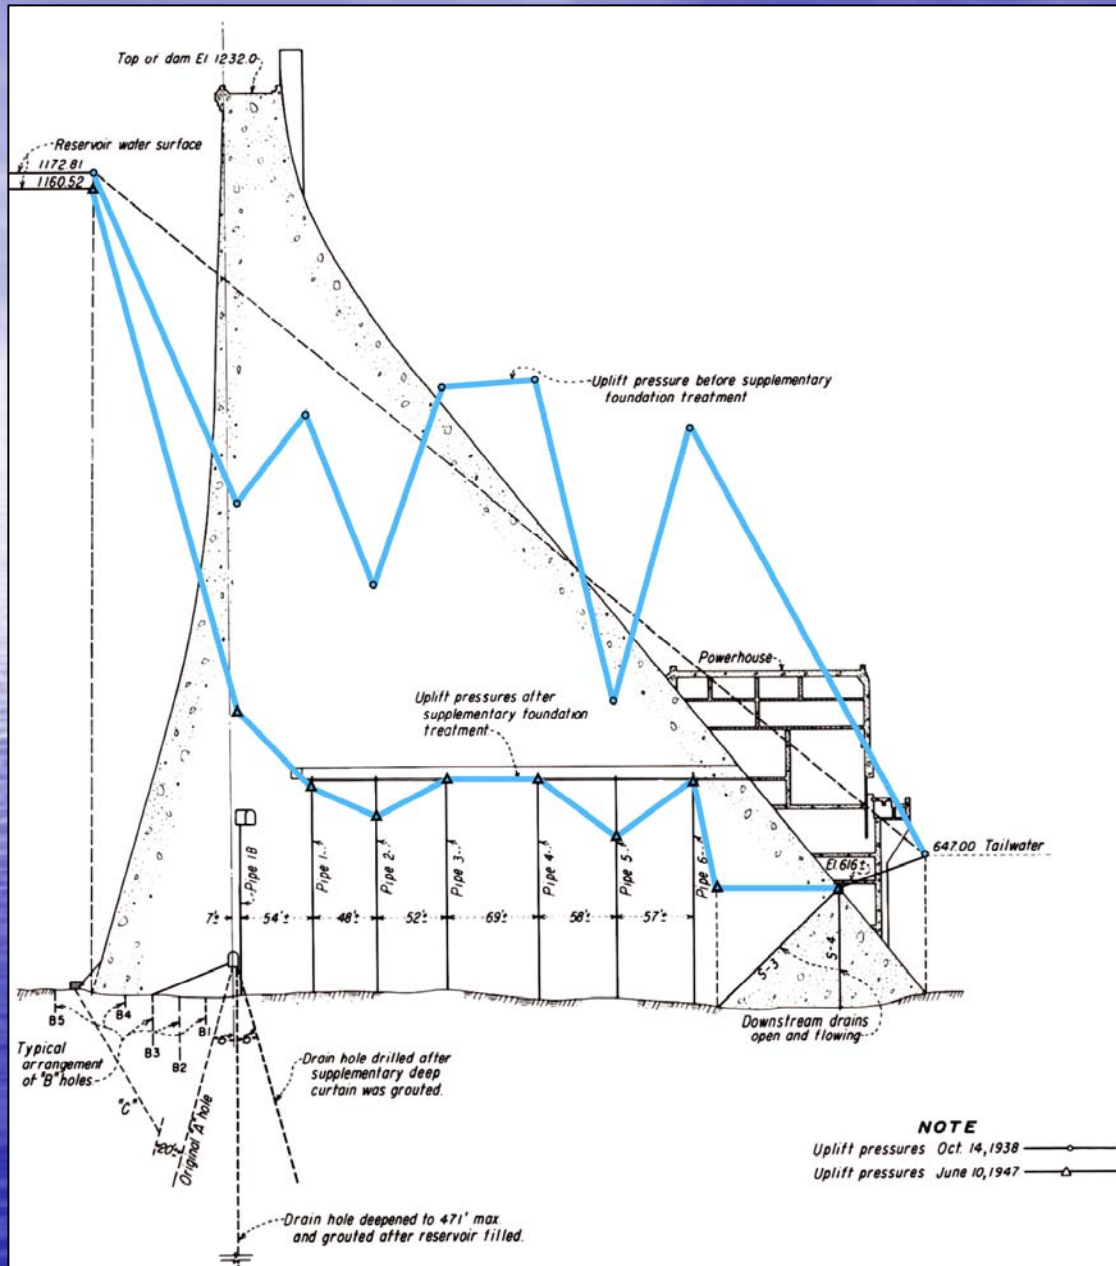
- The 9 year supplemental grouting program eventually succeeded
- Uplift pressures were significantly reduced, shown as the lower blue line in the drawing at left.
