PART 4

**HURRICANE
KATRINA STRIKES
NEW ORLEANS
AUGUST 2005**

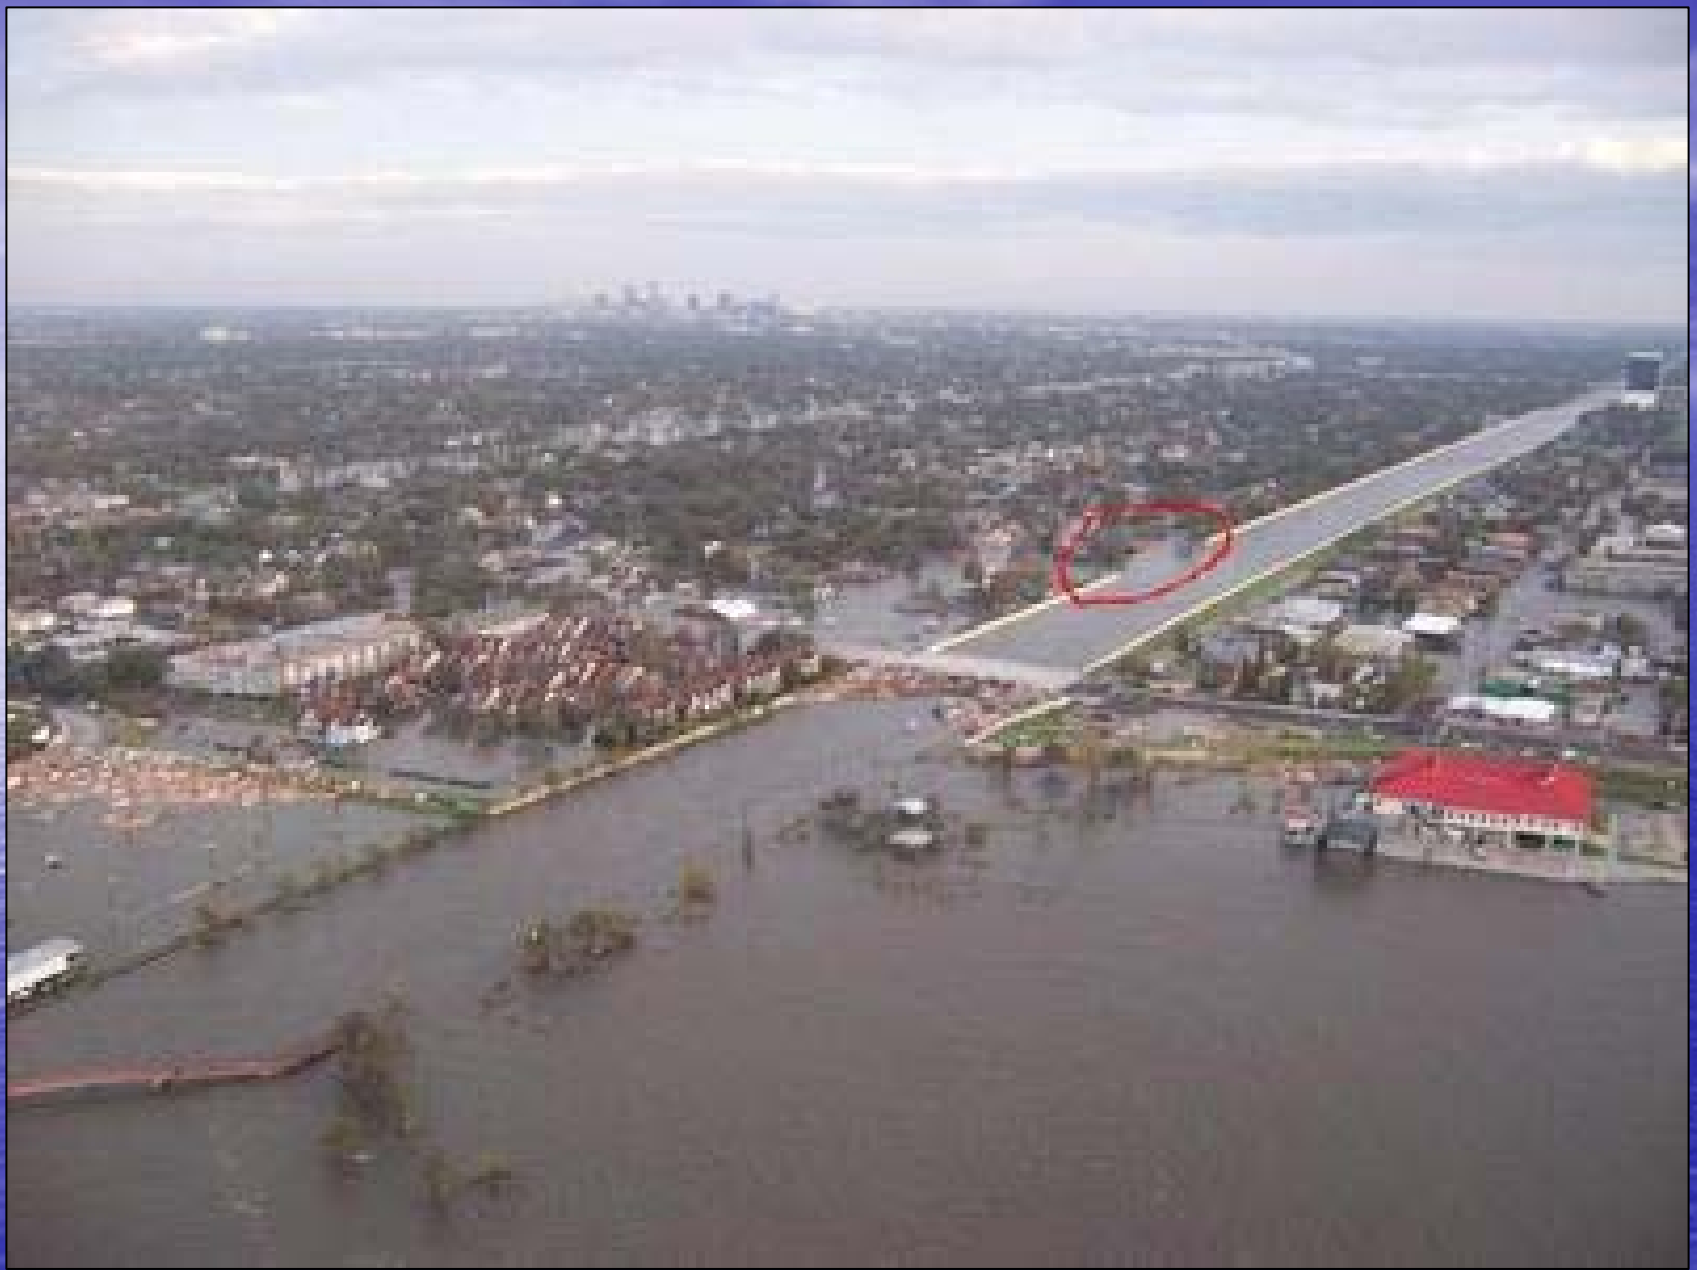
The break on the 17th Street Canal is circled. Note debris piled up against Hammond Highway Bridge in foreground.

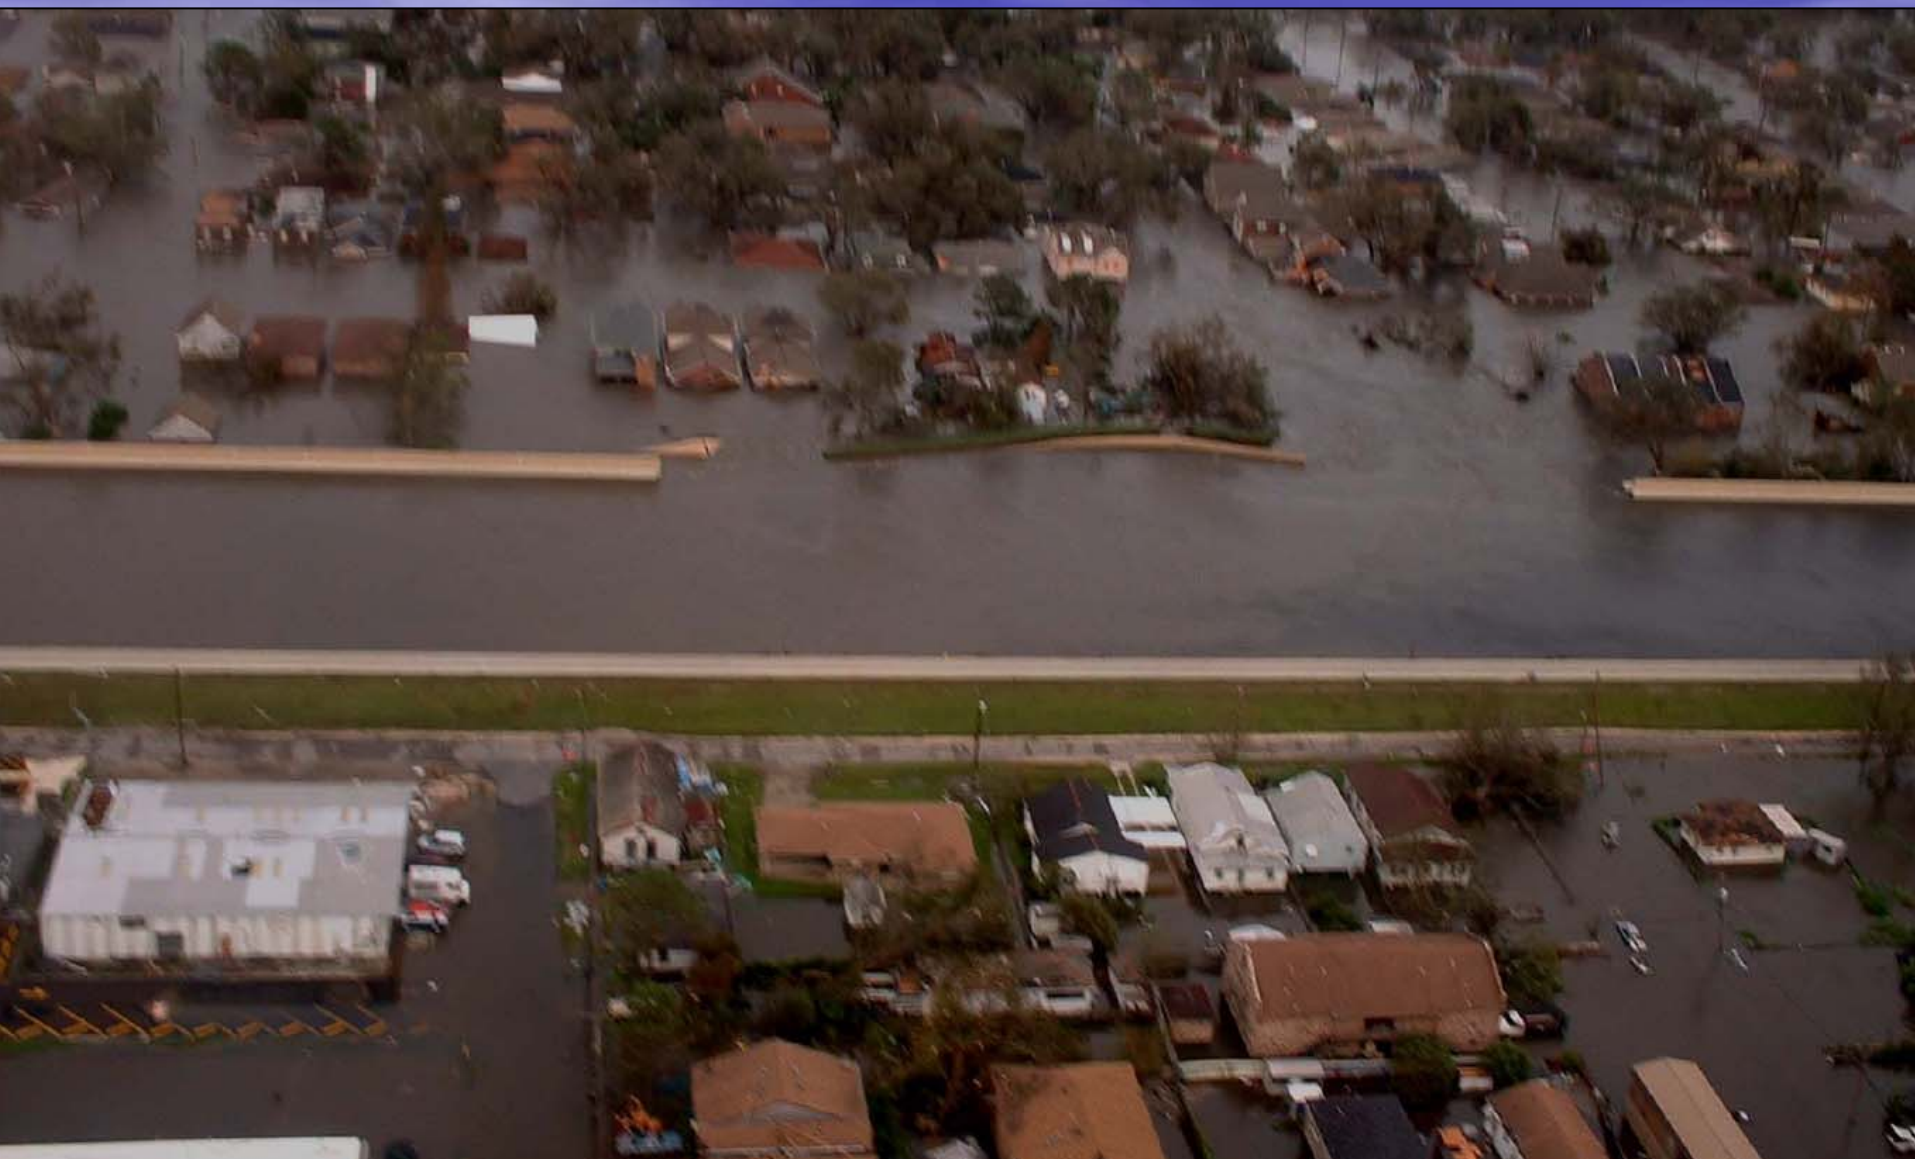
- Aerial oblique view of the 17th Street Canal break, looking east. Note lateral translation of concrete flood wall, between 35 and 50 ft. Photo by Ivor van Heerden.

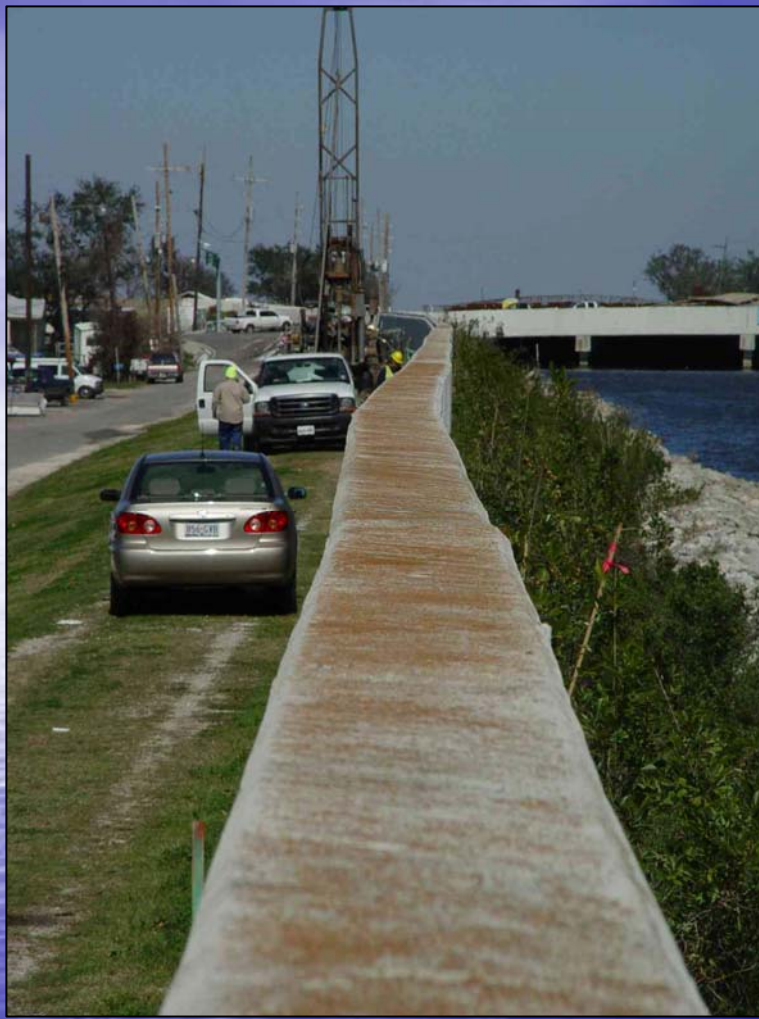
Lateral translation of I-wall

Ground view of displaced concrete flood wall at 17th Street Canal failure. Note slight back rotation of wall. Photo Iver van Heerden.

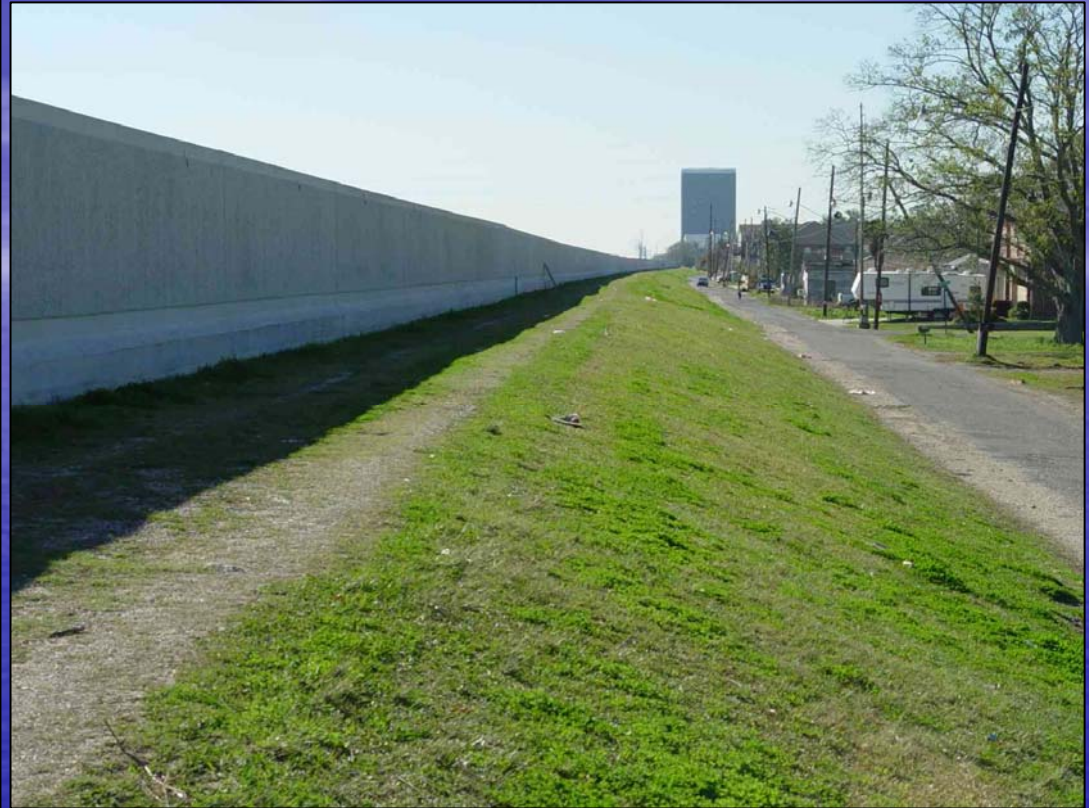
- Apparent displacement of the 17th Street Canal flood wall on the west (Jefferson Parish) side, opposite the 17th Street failure.

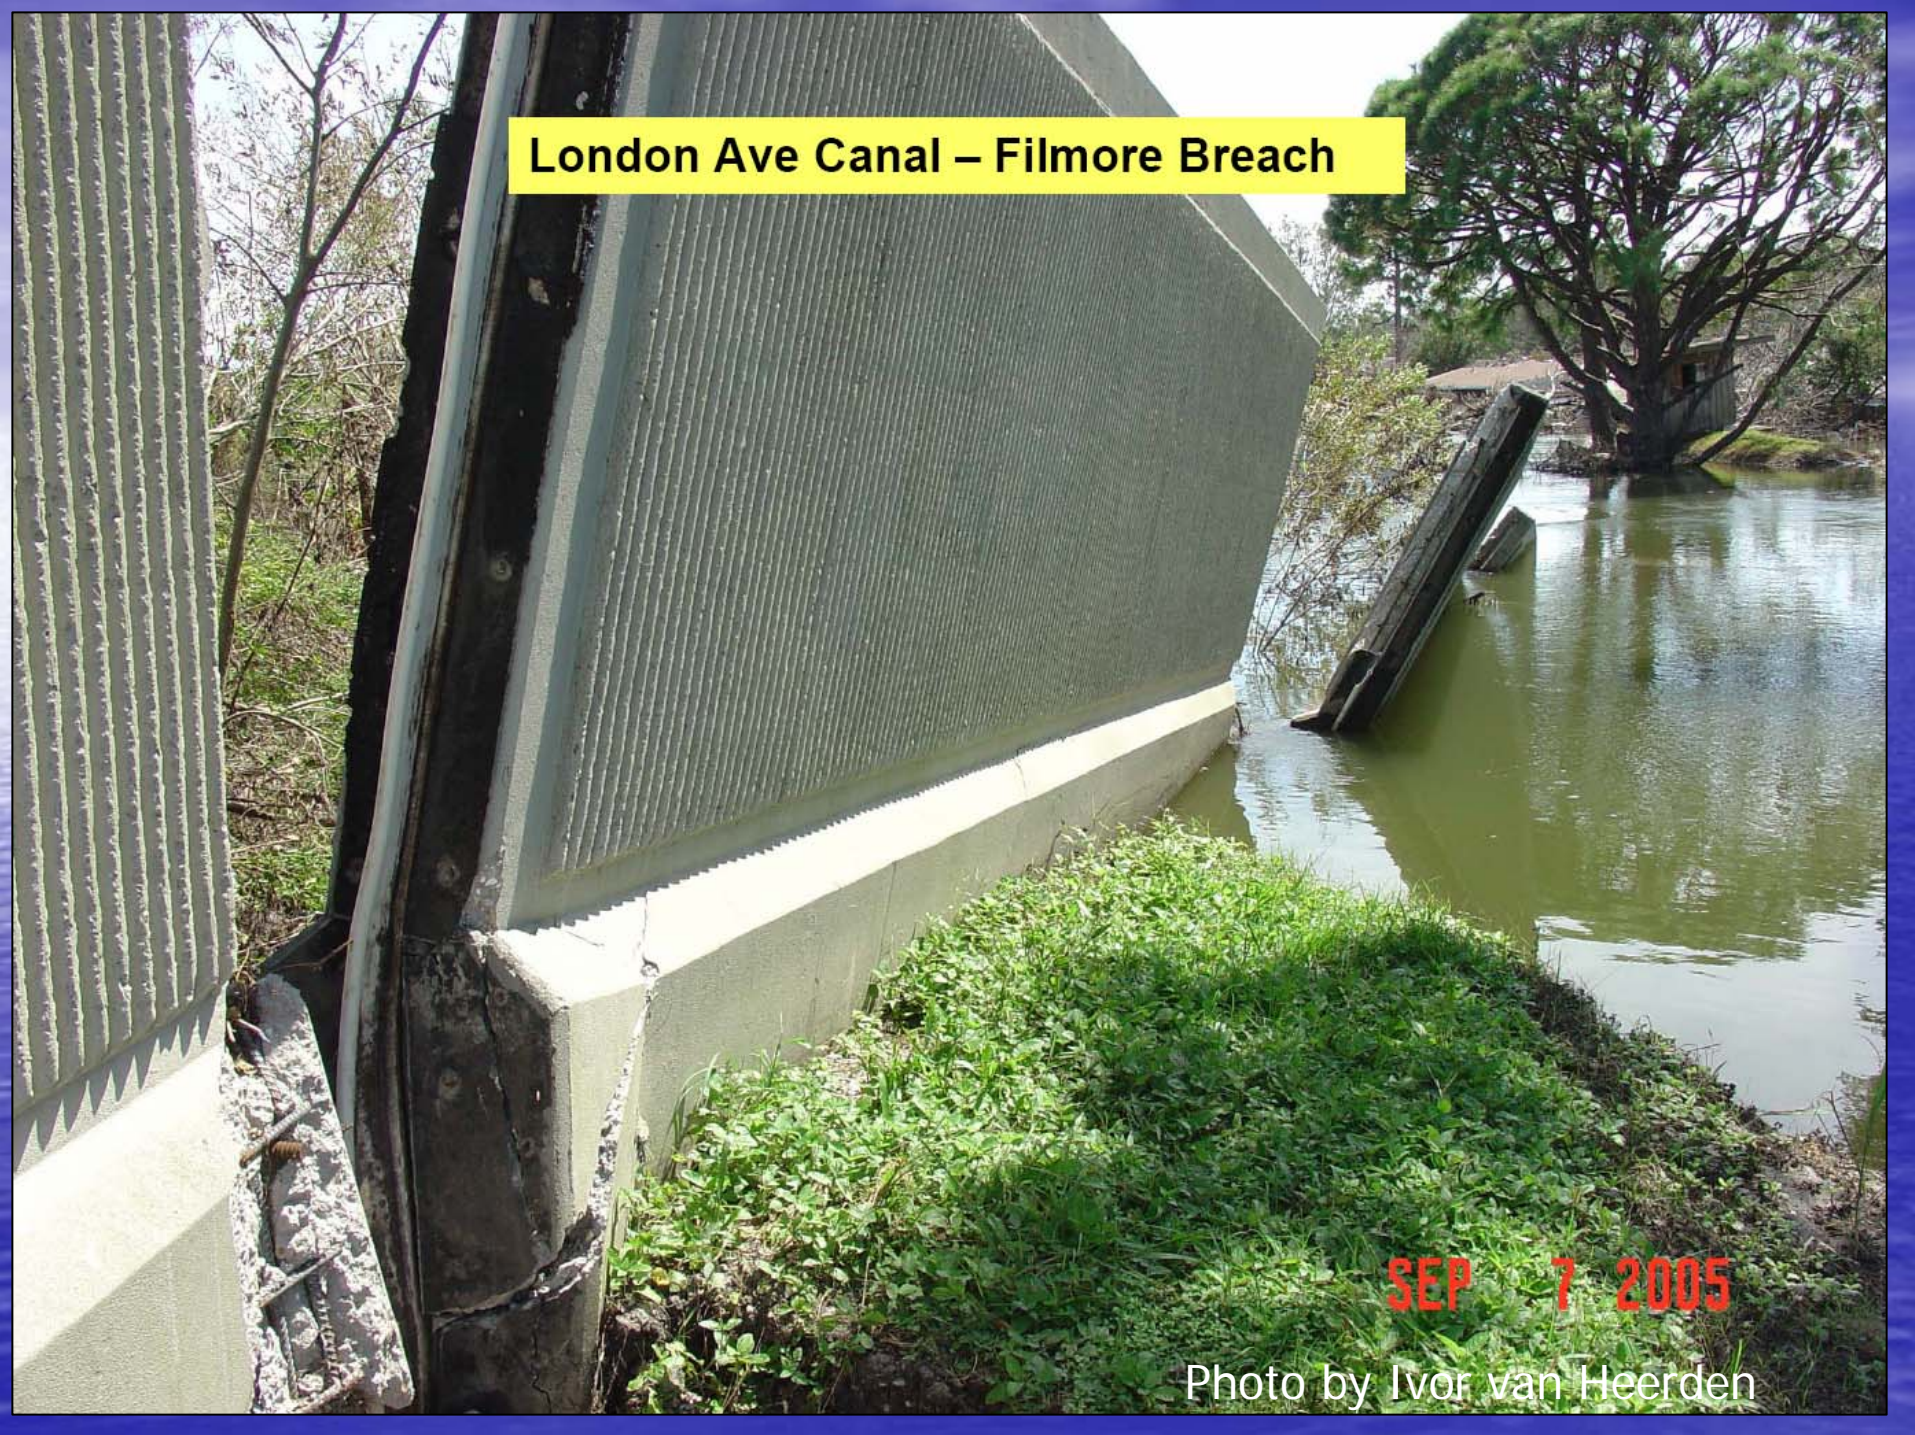
London Ave Canal – Filmore Breach

Deflected flood wall was in process of failing (pushing to the right) when opposite of the north London Canal gave way.

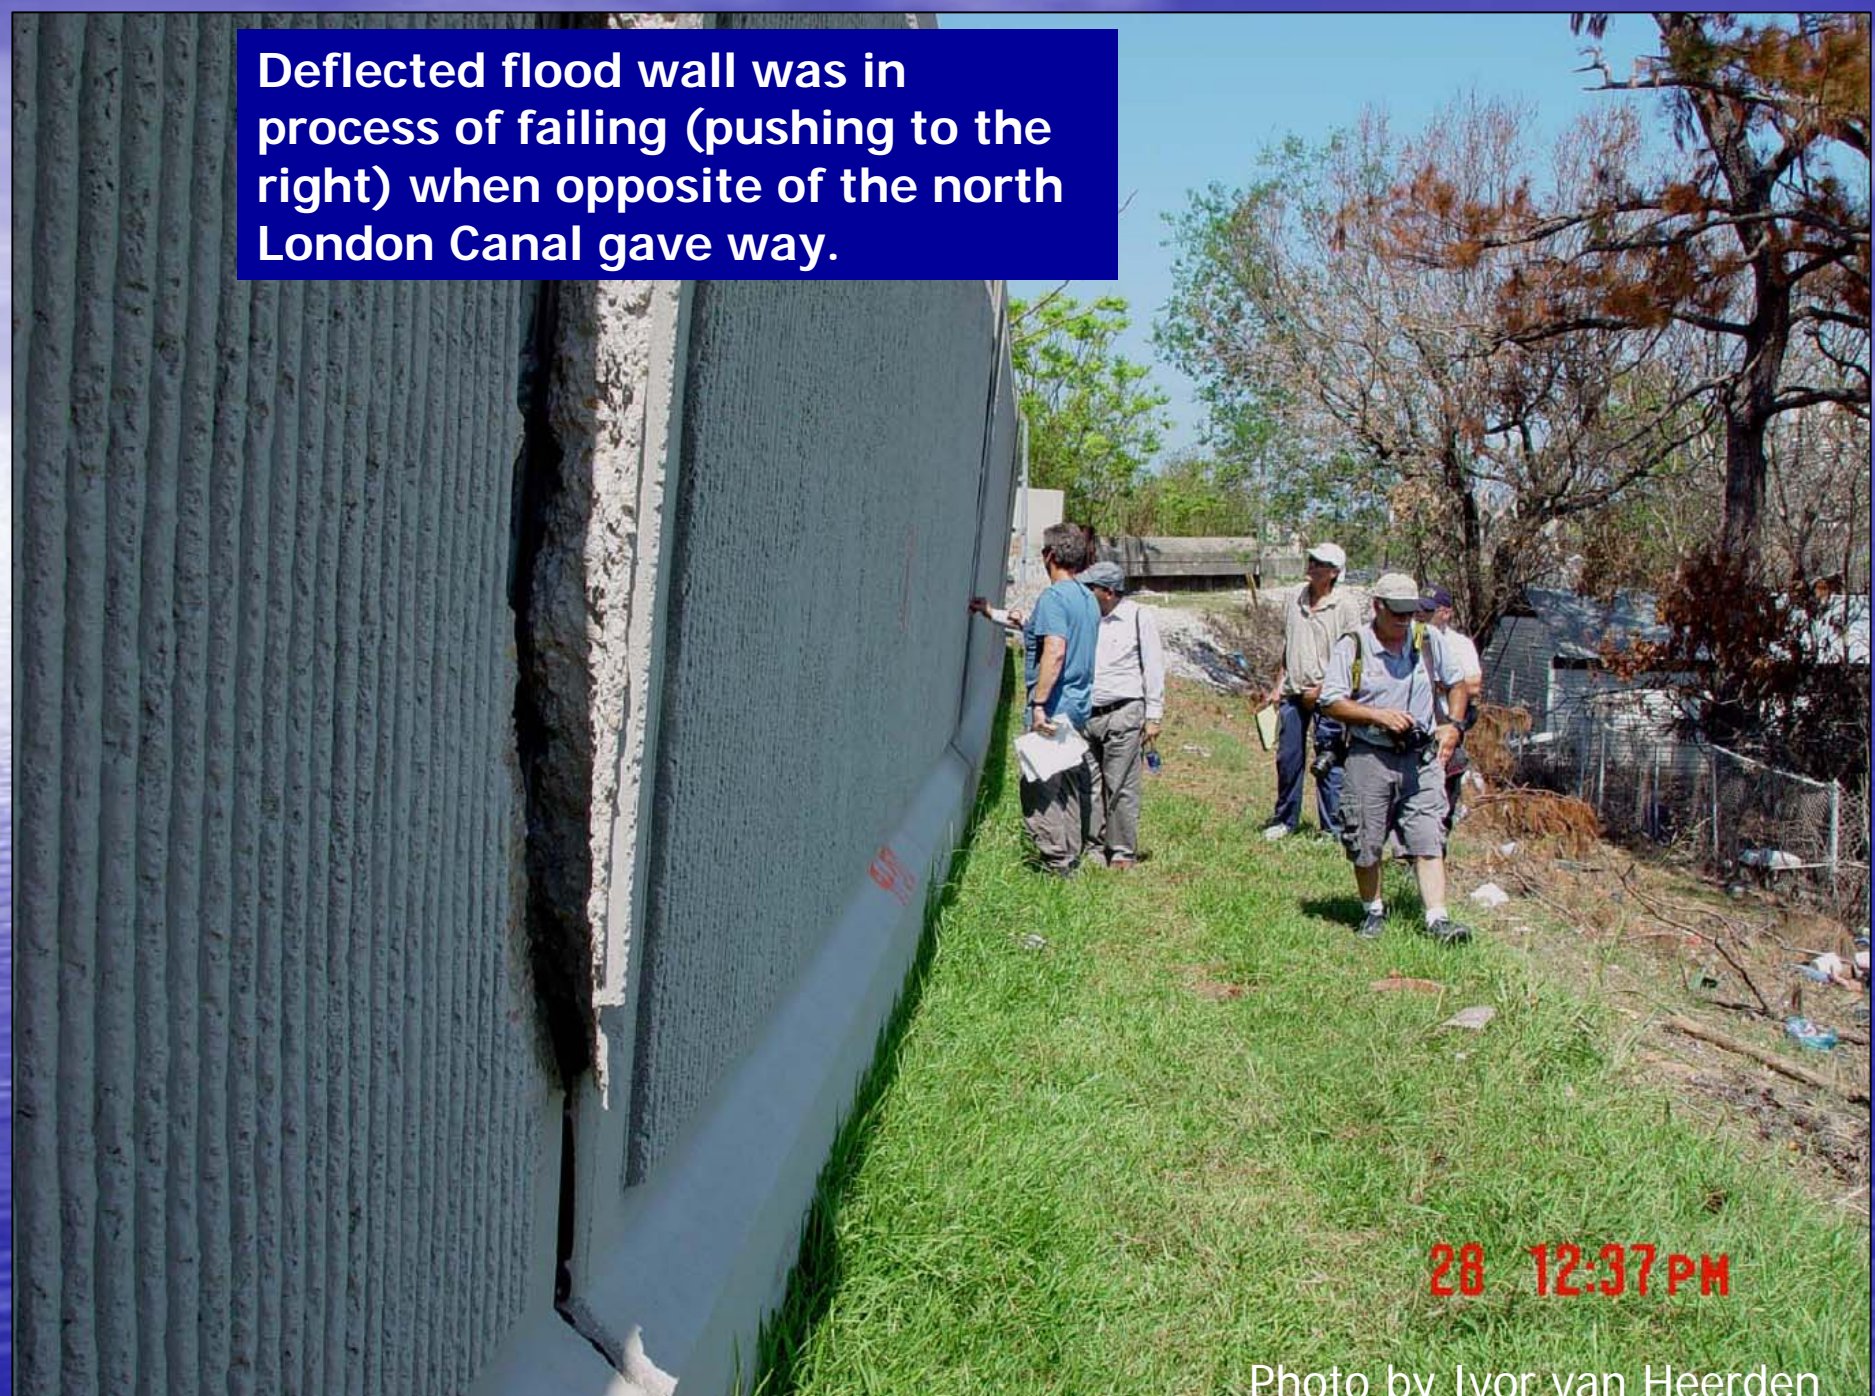
South London Avenue Canal breach, just north of Mirabeau Drive

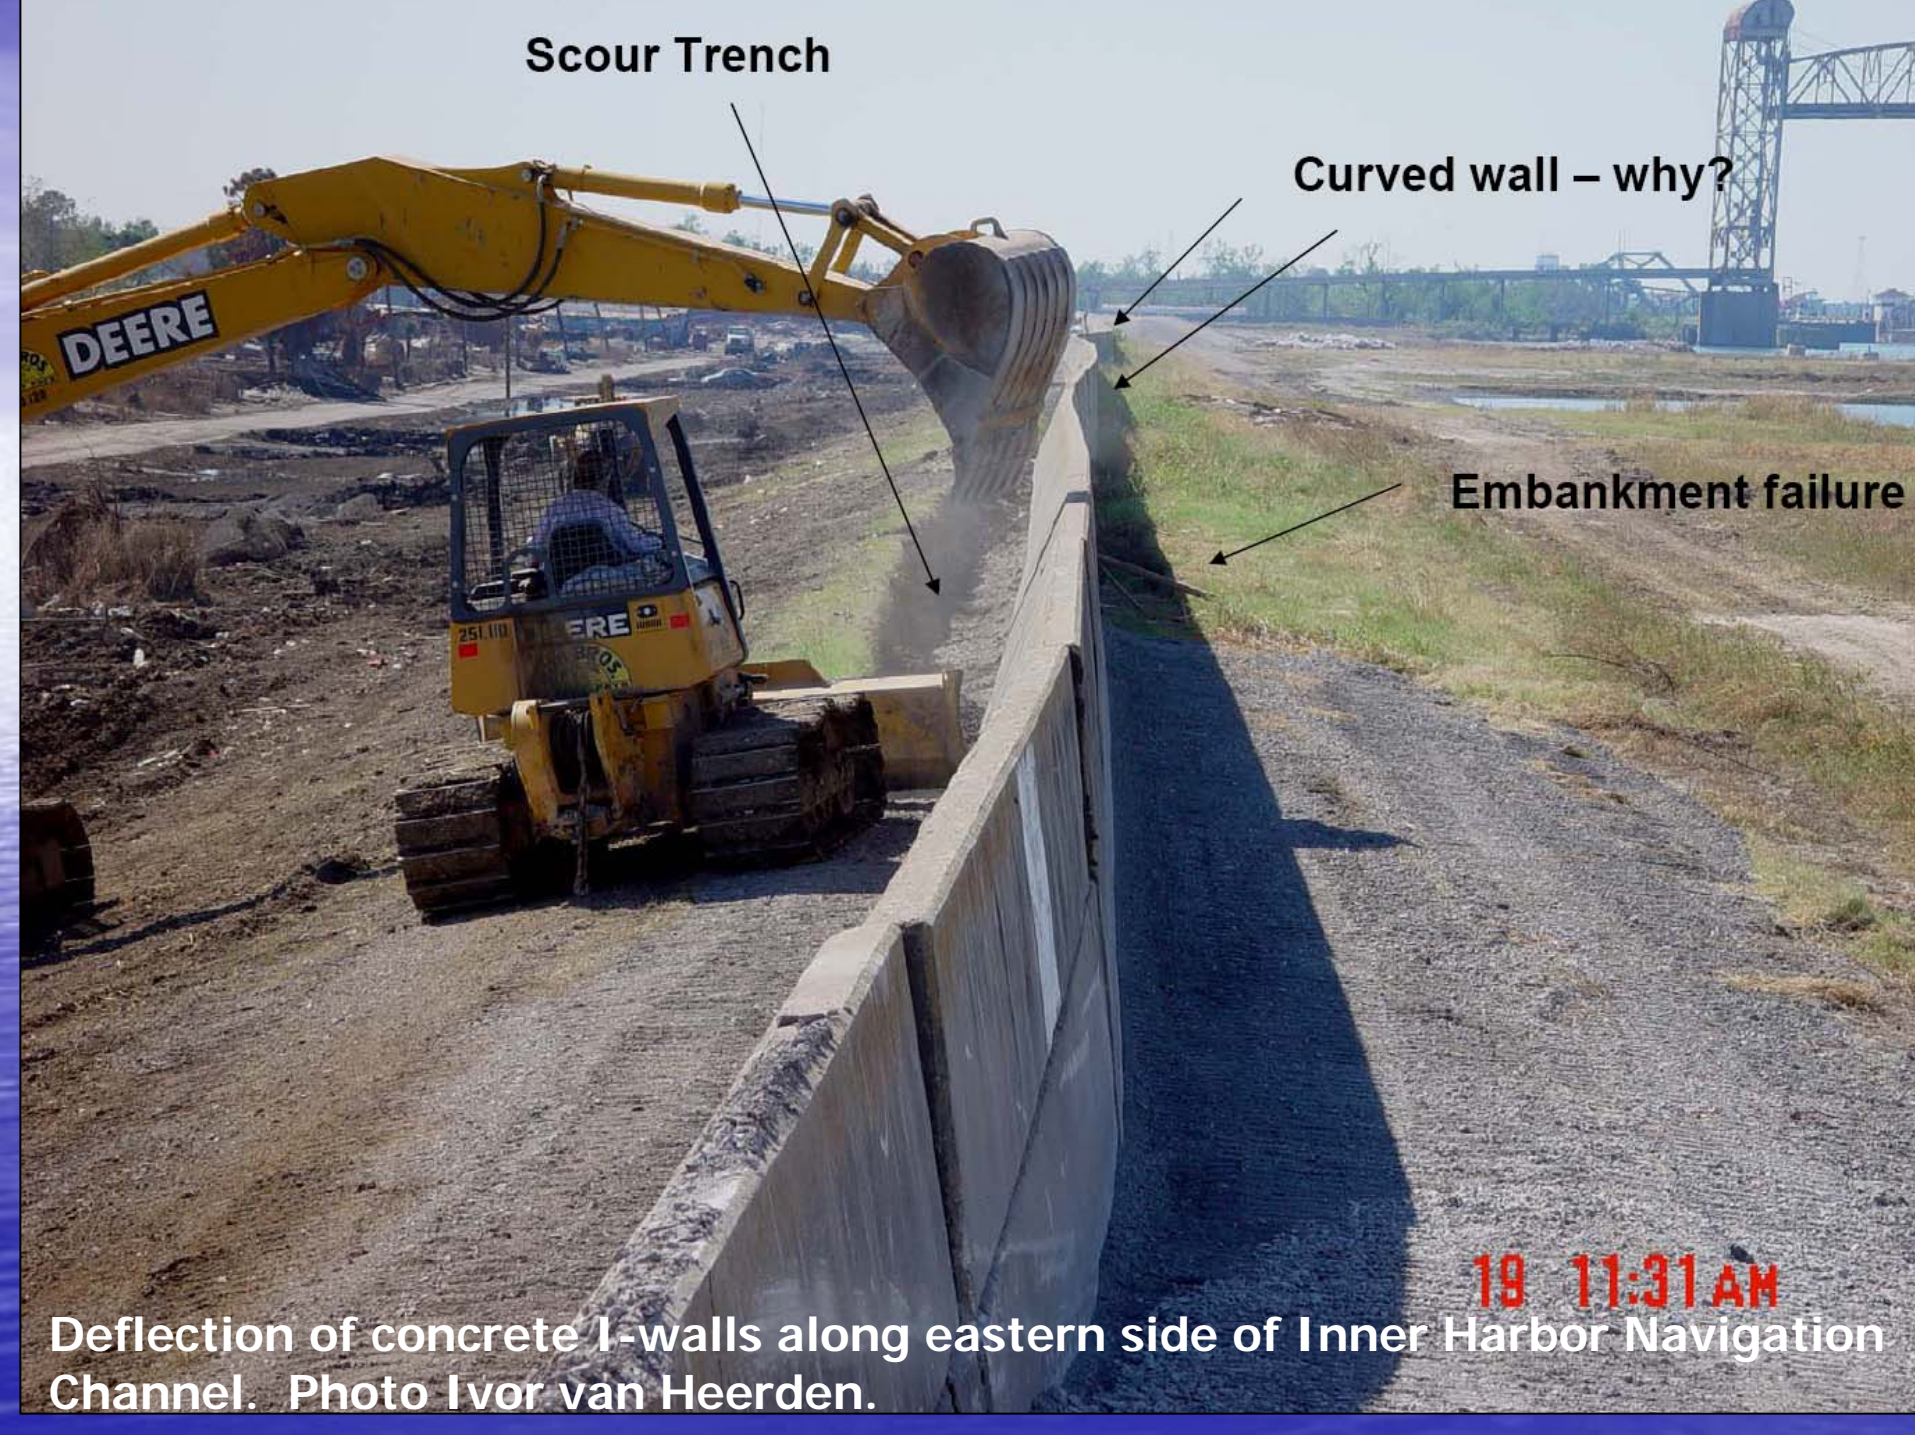
Deflection of concrete I-walls along eastern side of Inner Harbor Navigation Channel. Photo Ivor van Heerden.

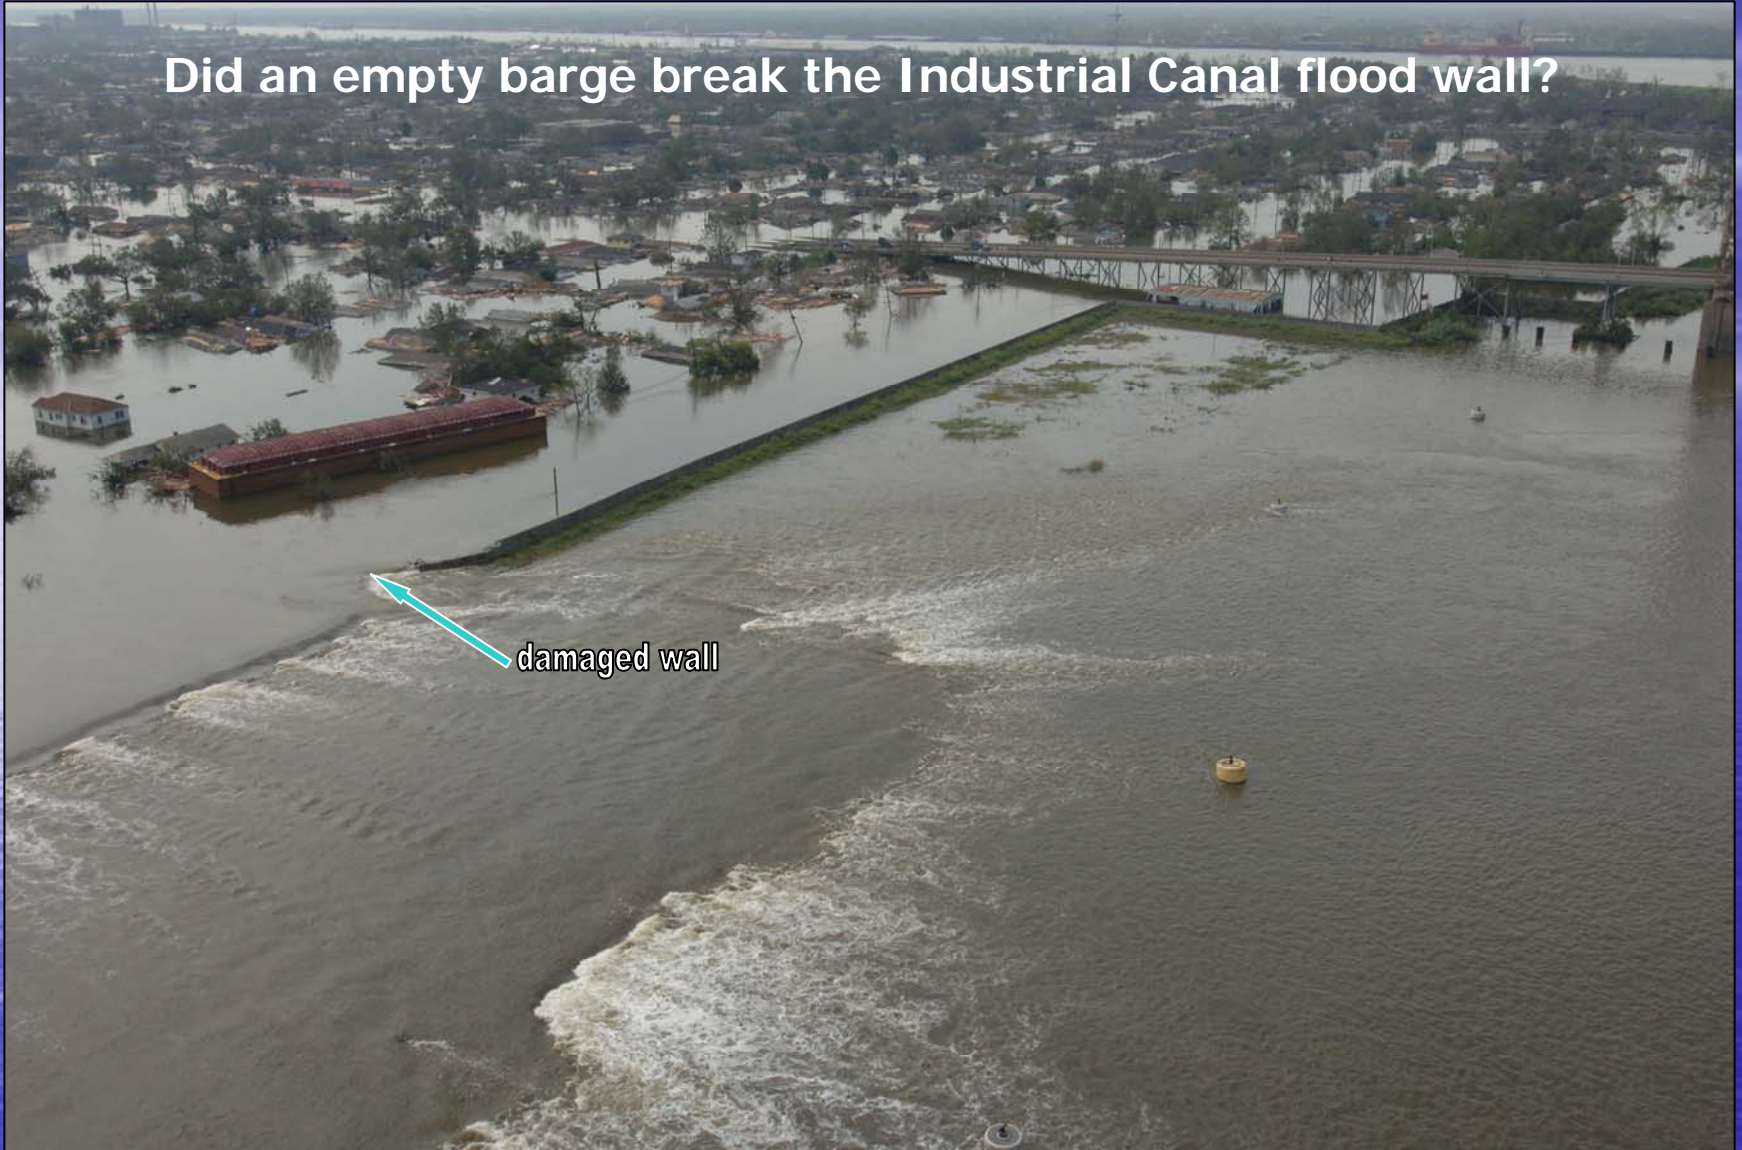
damaged wall

An **empty barge** moored at the Lafarge North America construction materials facility on Lake Pontchartrain tore loose of its moorings and crashed through the levee along the Industrial Canal, coming to rest next to a house, shown here. The barge appears to have bumped the flood wall, but only after it had overtopped and failed.

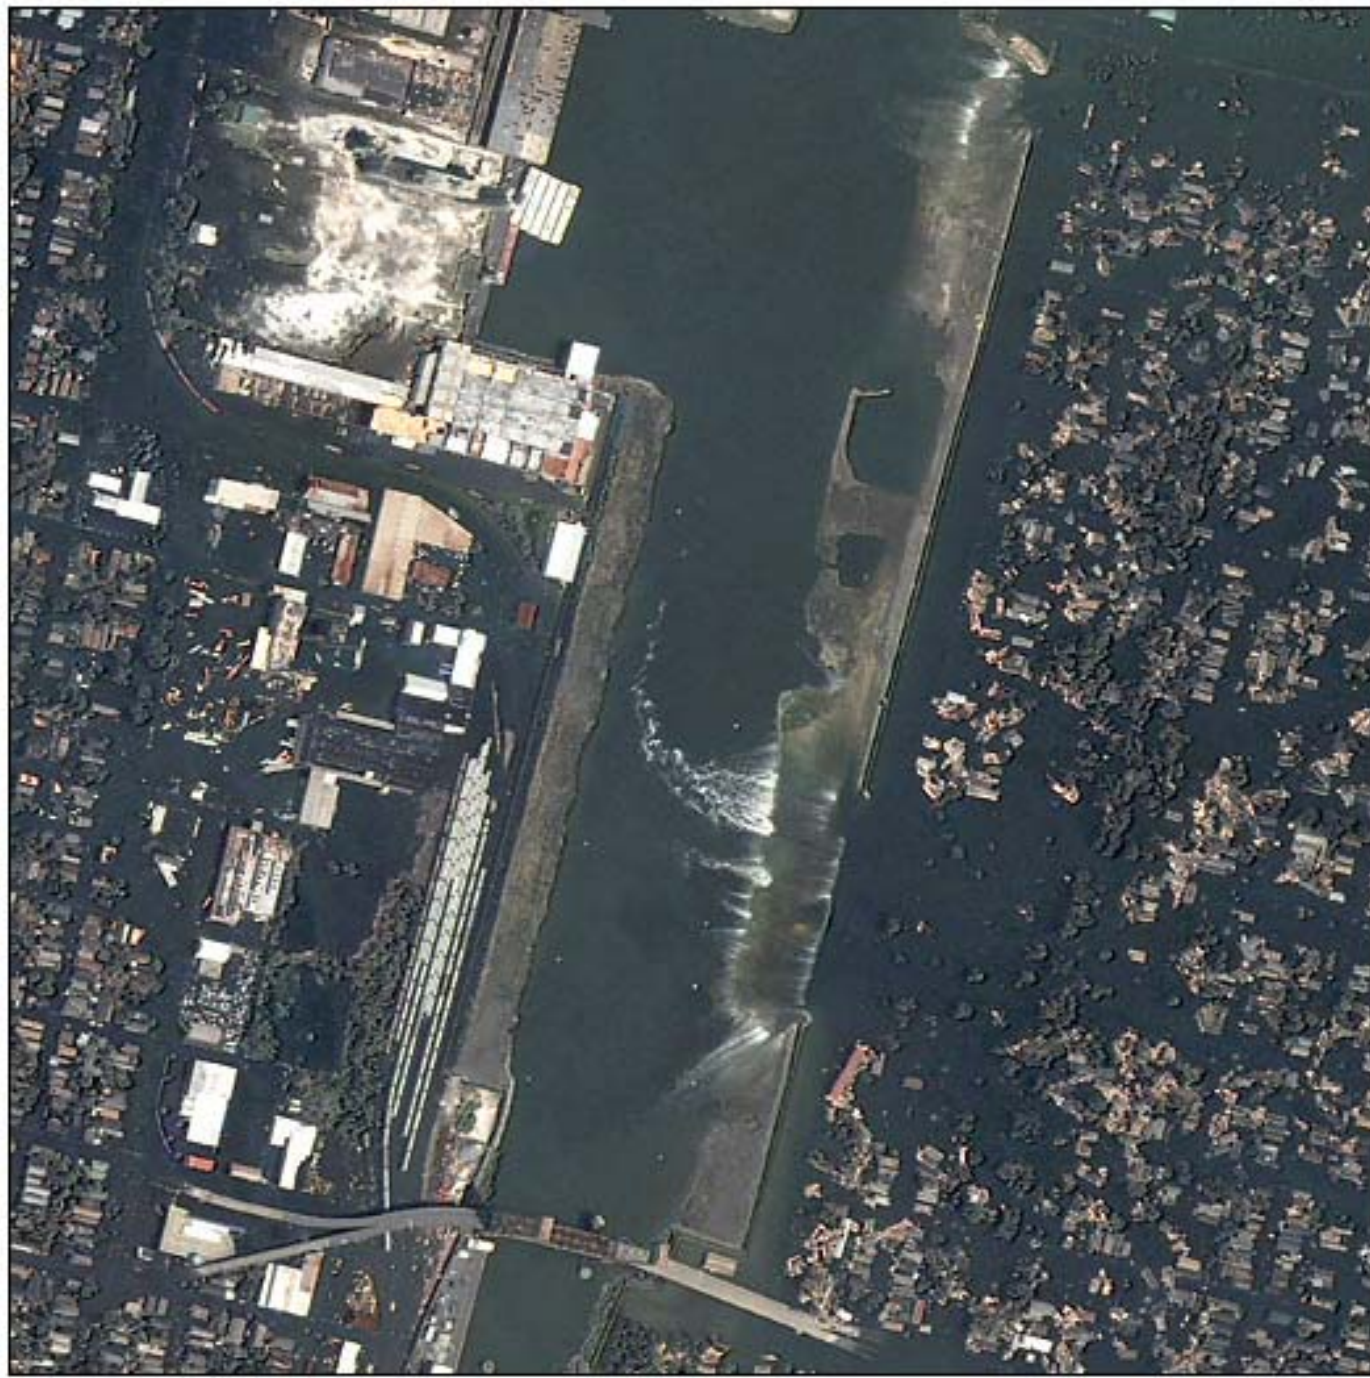
This aerial view shows an example of reverse flow, back into the Inner Harbor navigation Channel.

Note the absence of the concrete flood wall capping the earthen levee, removed by toe scour of the supporting levee embankment when it was initially overtopped

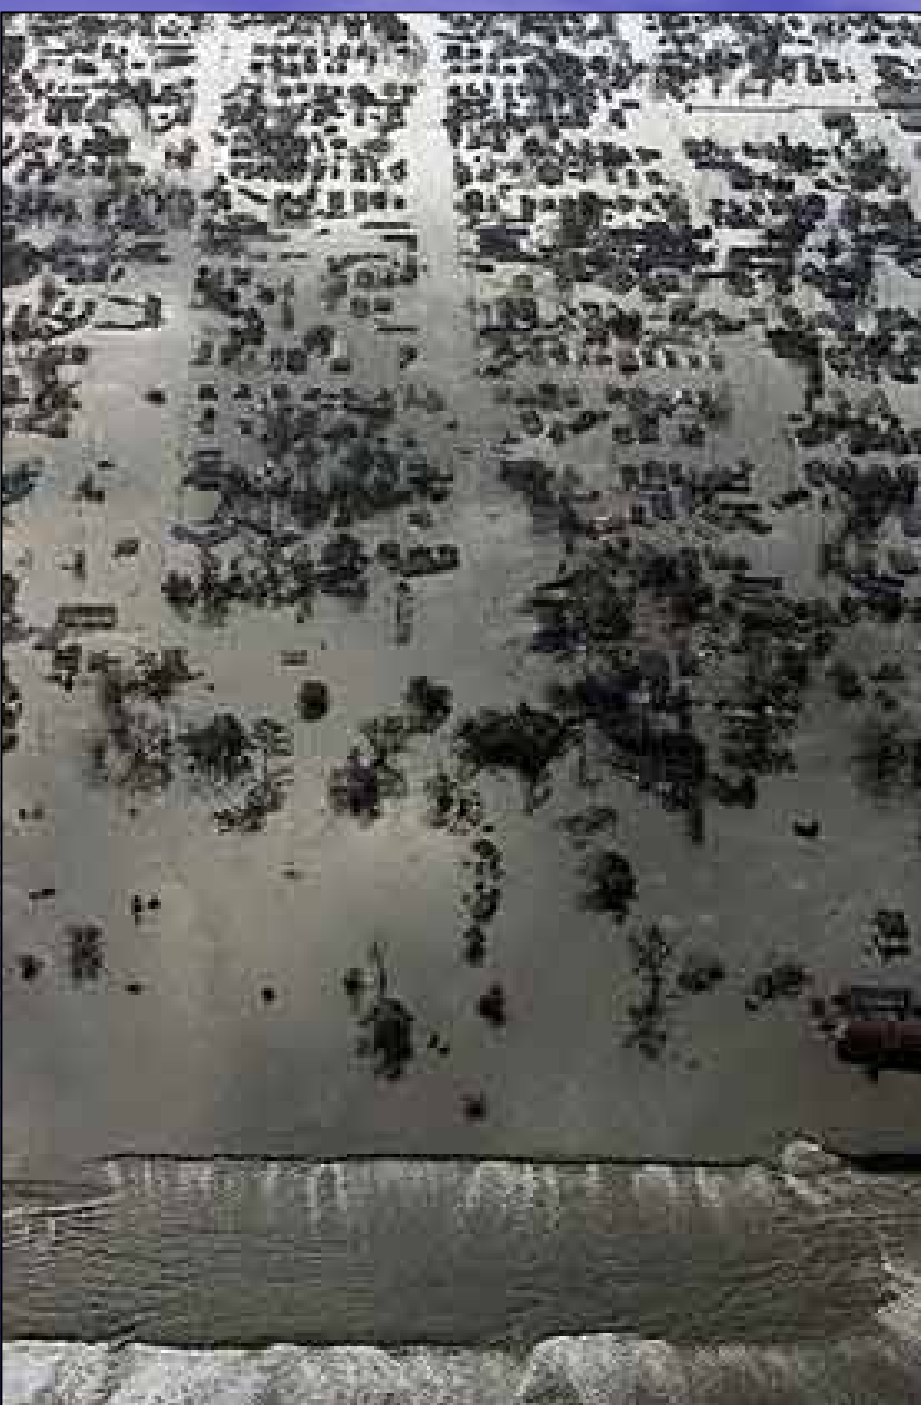
Once flood waters overtop an embankment they quickly scour the land-side toe of the embankment, and deep scour holes develop on either side of the "hydraulic jump" that forms at the point of overflowage, enlarging the breach, as shown here.

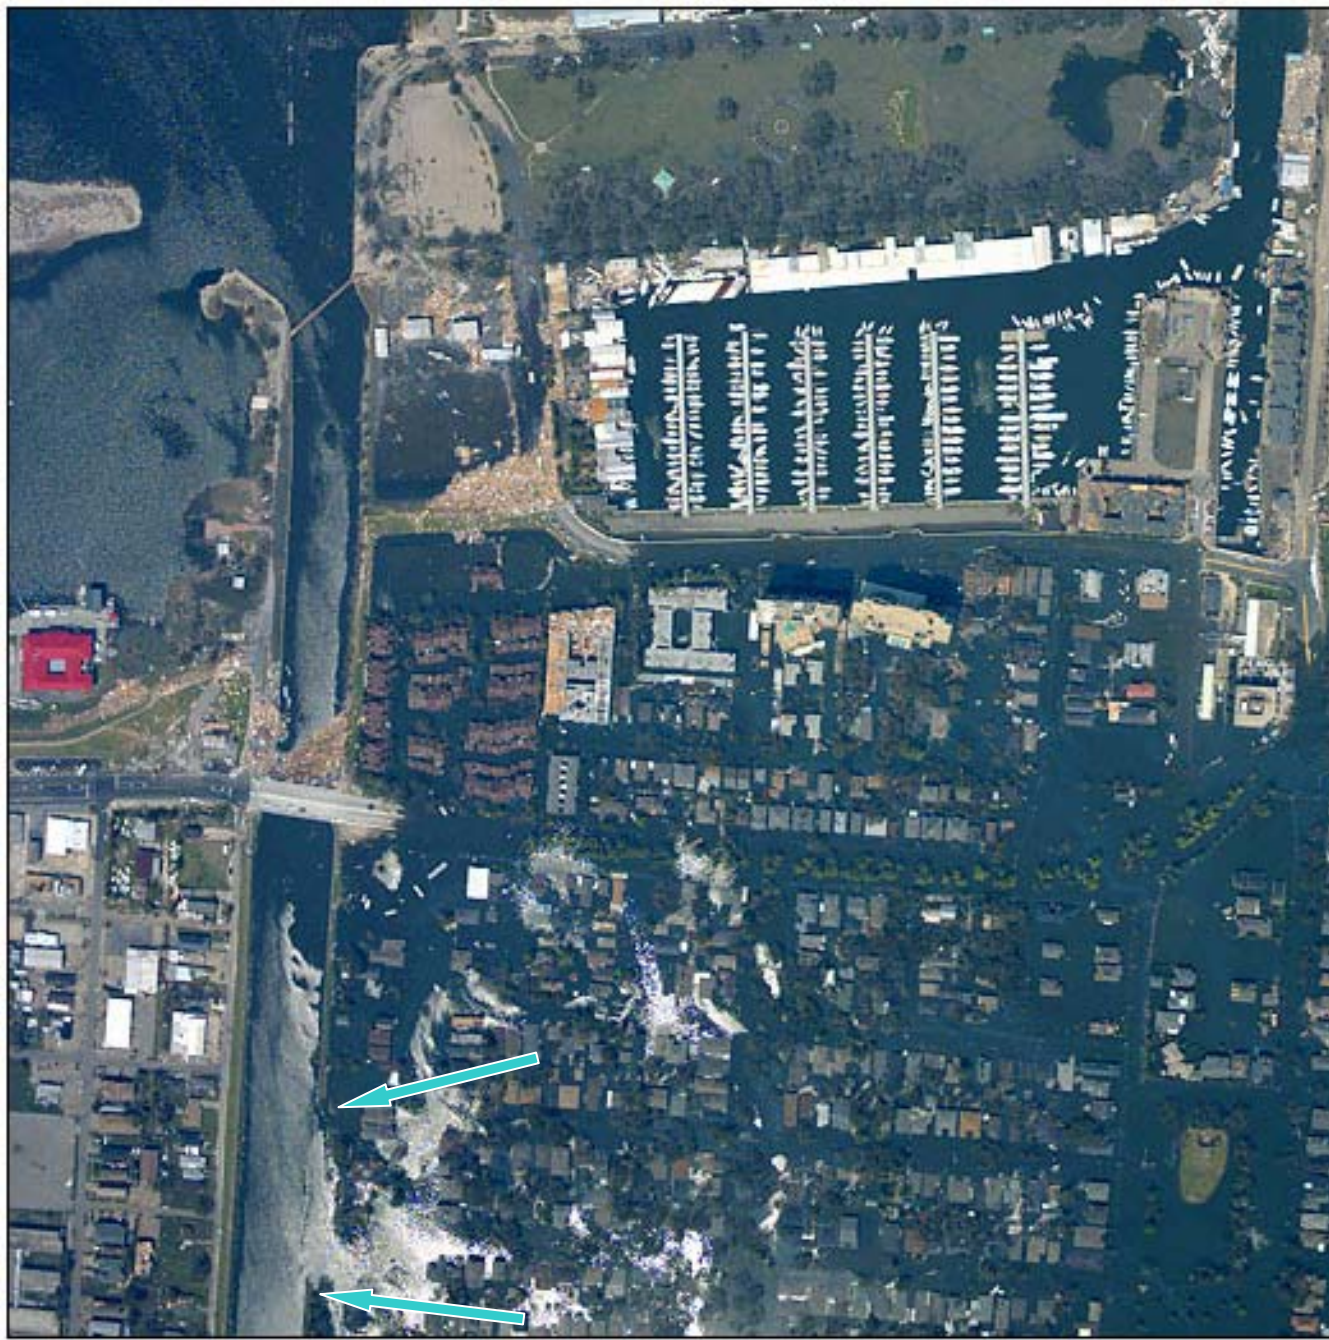
Lower 17th Street Canal

The eastern side of 17th Street Canal I-wall and embankment shifted 50 feet laterally, between arrows, spilling water into the Lakeside neighborhood at right. The Eastern Jefferson Parish (left of the canal) was spared inundation.
