New Orleans and Hurricane Katrina.

II: The Central Region and the Lower Ninth Ward

Abstract: The failure of the New Orleans regional flood protection systems, and the resultant catastrophic flooding of much of New Orleans during Hurricane Katrina, represents the most costly failure of an engineered system in U.S. history. This paper presents an overview of the principal events that unfolded in the central portion of the New Orleans metropolitan region during this hurricane, and addresses the levee failures and breaches that occurred along the east–west trending section of the shared Gulf Intracoastal Waterway/Mississippi River Gulf Outlet channel, and along the Inner Harbor Navigation Channel, that affected the New Orleans East, the St. Bernard Parish, and the Lower Ninth Ward protected basins. The emphasis in this paper is on geotechnical lessons, and also broader lessons with regard to the design, implementation, operation, and maintenance of major flood protection systems. Significant lessons learned here in the central region include: (1) the need for regional-scale flood protection systems to perform as systems, with the various components meshing well together in a mutually

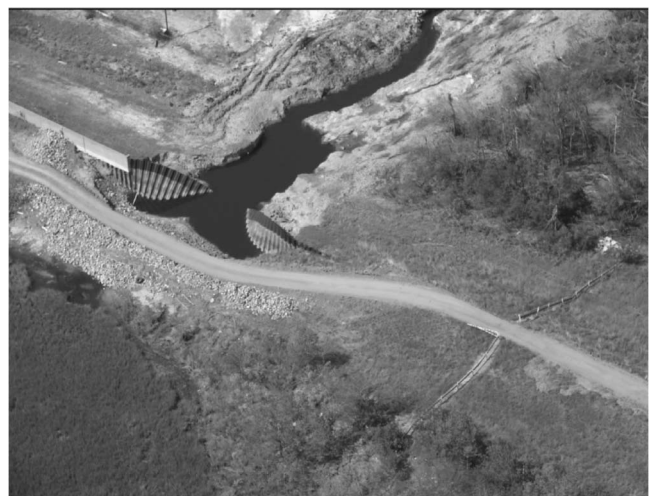
Fig. 3 shows a straightforward example of a transition between a full height earthen levee embankment section adjoining a half-height earthen embankment section topped by a sheetpile-supported concrete I-wall (floodwall). The elevation of the top of the I-wall shown on the left of Fig. 3 is approximately 1 ft higher than the top of the adjoining full-height earthen levee section. It was observed that the sections with significant “structural components” (e.g., concrete floodwalls, concrete gate structures with steel floodgates) consistently had slightly higher top elevations than adjoining earthen embankment sections (Baumy, private communication, 2005; ILIT 2006). The two adjoining and well-performing sections (levee reaches) in Fig. 3 are connected by a transition section that consists of a simple sheetpile wall section. The height of the top of this sheetpile wall is lower than either of the two adjoining levee or levee/floodwall sections, and overtopping thus occurred preferentially at this low spot. This overtopping flow eroded (scoured) a trench behind the back side of the

sheetpile wall, and the lateral force of the floodwaters then pushed back against the now inadequately laterally supported sheetpile wall and produced the failure shown.

Fig. 3. An example of one of the numerous failures (breaches) that occurred at “transitions” between disparate, adjoining flood system elements. (From left to right: concrete floodwall, sheet pile wall, and earthen levee.)

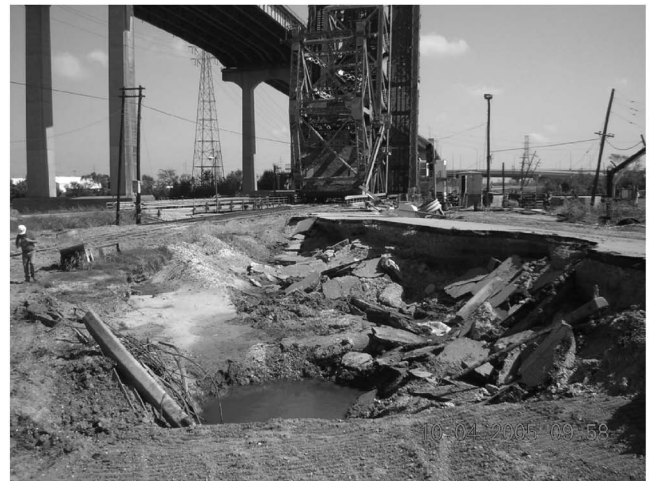
The main failure and breach at this site occurred as a result of adverse interaction between the rail line and the adjacent port access roadway. The low spot at this site with regard to passage of water was the base of the pervious gravel ballast beneath the railroad tracks. Flow through this ballast appears to have eroded

Fig. 4. (a) Breach at a complex “penetration” through the federal levee system at the west bank crossing of the IHNC waterway by the CSX rail line; (b) concrete floodgate structure at the west bank IHNC crossing of the CSX Rail line

the soils beneath the adjacent port roadway. These soils consisted of poorly compacted, and highly erodeable, lightweight shell sands as evidenced by the eroded detritus strewn back behind the breach and by the material still in place beneath the partially destroyed asphalt cement pavement section shown in the photograph of Fig. 4(a) (ILIT 2006). As discussed in a companion paper (Seed et al. 2008a), these lightweight shell sand mixes, comprised of small mollusk shells and fine sands, are highly erodeable and represent an intrinsic hazard, especially when they are not provided with slope face protection to prevent risk of erosion due to frontal wave attack and overtopping and internal cut-offs to prevent through-flow. Conversely, the main (federal) levee embankment section was built with superior materials (compacted clay), but the USACE did not appear to have control of the selection of fill immediately beneath the roadway section.

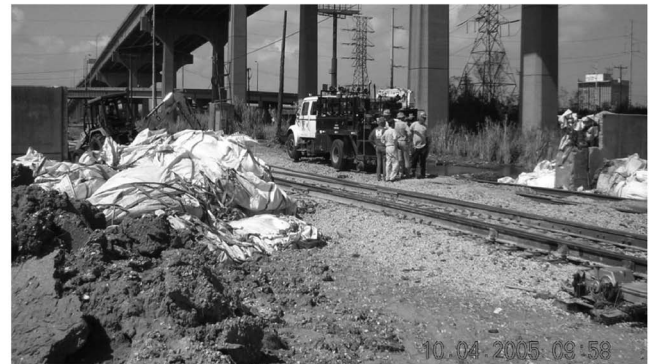
(b)

A second problem occurred just to the left of the photograph of Fig. 4(a), immediately to the left of the person in Fig. 4(a), where the rail line passes through a concrete gateway with a rolling steel floodgate. This location is shown in Fig. 4(b), this time looking west (away from the IHNC). The rail line passes through a concrete gateway structure, and the people in this image are standing in the center of the gateway. A rolling steel floodgate is supposed to close this opening, but the steel floodgate had been damaged by a minor rail accident several months prior to Hurricane Katrina's arrival and had been taken away for repairs. An emergency levee

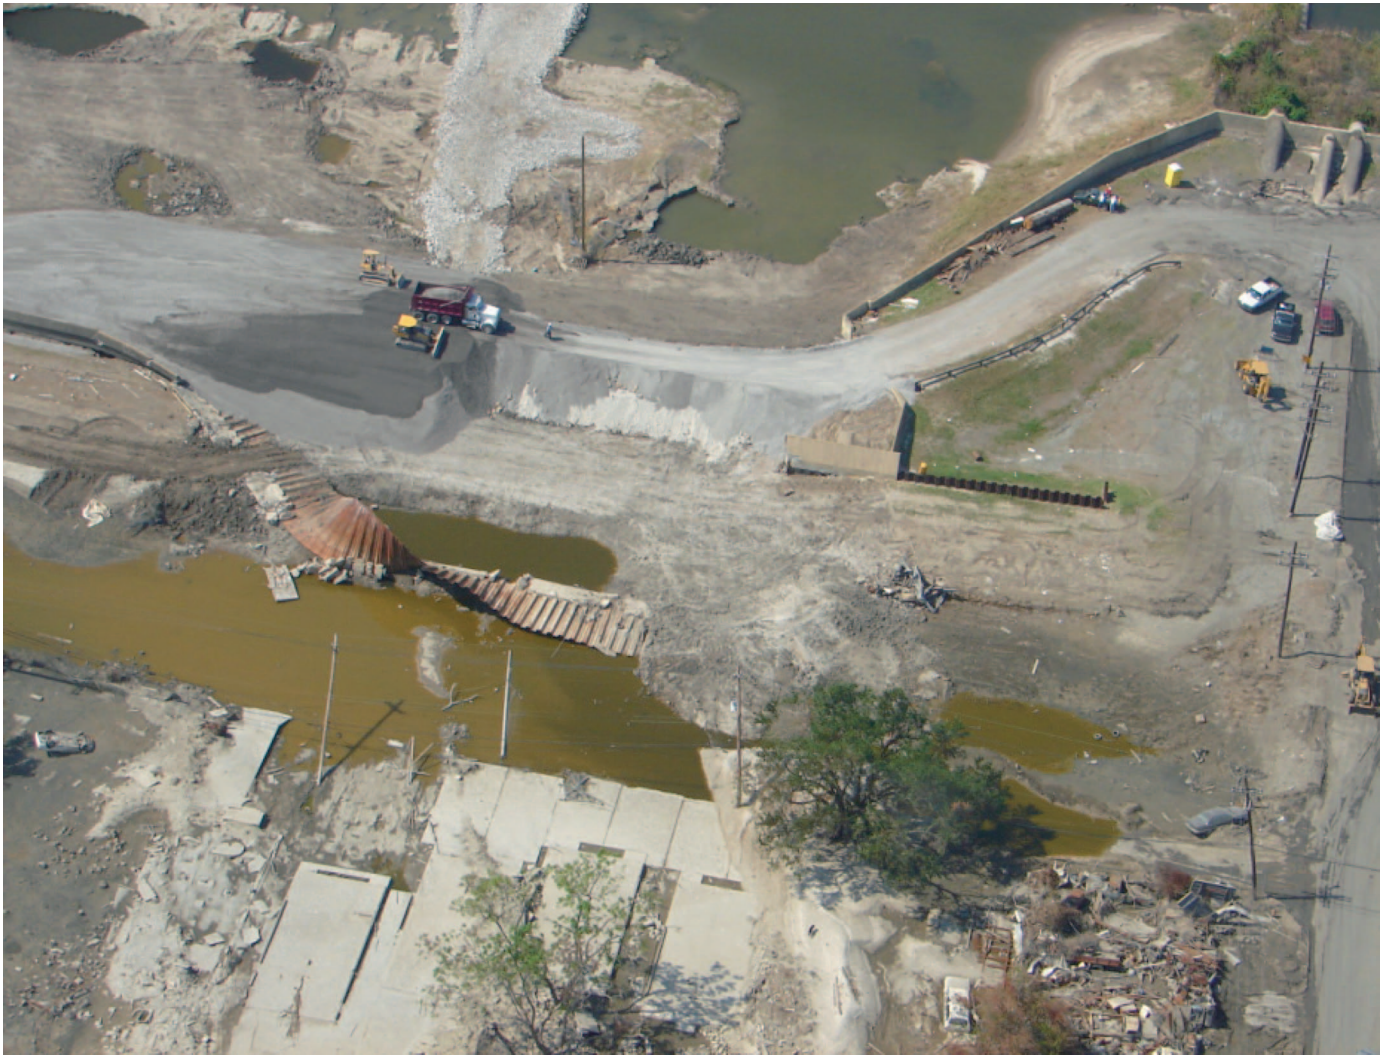
Fig. 5 shows an aerial view of this feature. The levee runs from left to right across this photograph and the inboard side (landside) is at the bottom. This photograph was taken on October 5, 2006, and the interim outboard side repair embankment is nearing completion. The narrow, trench-like erosional channel through the breach has also been largely infilled at the time of this photograph. The toppled sheetpiles that had supported the concrete I-wall at this location can be seen just behind the nearly

completed interim repair section. This was a relatively narrow feature, less than 90 ft in width, and unlike the more massive second failure that occurred approximately 3,000 ft to the south (as discussed in the section that follows) there was no evidence of sustained overtopping adjacent or near to this feature (ILIT 2006). The full depth of the breach feature was not determined prior to the commencement of emergency repairs.

Fig. 5. (Color) Aerial view of the north breach on the east bank of the IHNC, at the west end of the Lower Ninth Ward

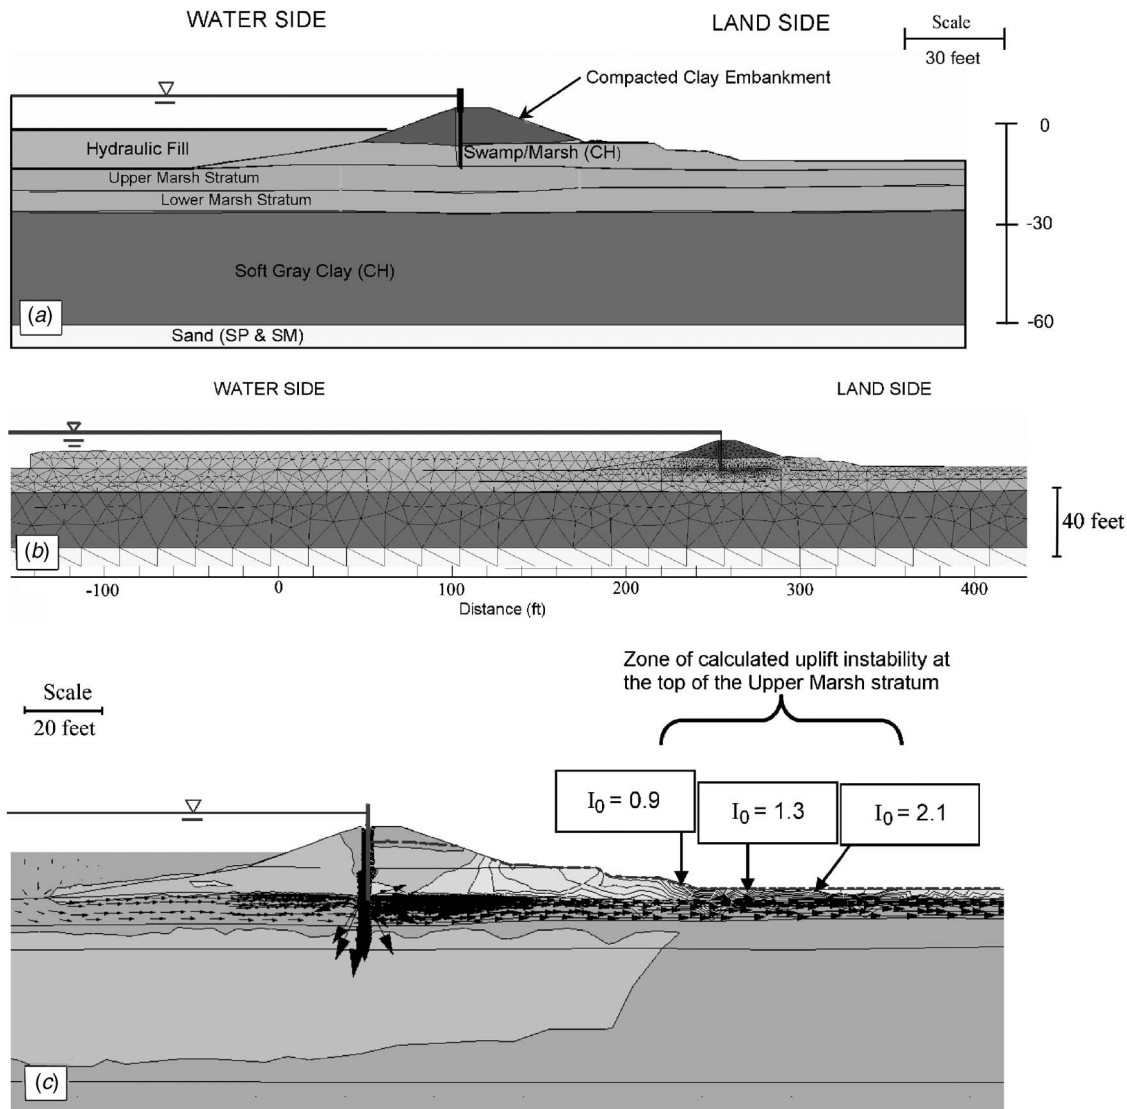
As shown in Fig. 6, the relatively short sheetpiles supporting the concrete floodwall along this frontage had been designed as cantilever support for the floodwall, and not as an underseepage cut-off, as it was assumed that the permeabilities of the foundation soils were sufficiently low that there would not be significant transmission of pore pressures beneath the floodwall during the relatively short duration of a hurricane-induced storm surge in the IHNC channel (USACE 1966). As a result, the sheetpiles did not extend deeply enough to cut off potential flow through the variably peaty upper marsh stratum.

These transient flow analyses modeled the progressive rise in storm surge levels over the 24 h preceding the failure. Fig. 6(c) shows a close-up view of calculated seepage exit gradients as they would have existed at approximately 5:30 a.m. (with a canal water level of Elev. +10.5 ft, MSL) if the representative lateral hydraulic conductivity of the peaty marsh stratum had been $k_h=10^{-4}$ cm/s. This figure also shows the seepage gradient vectors; indicating that the principal passage of flow/pressure is through the marsh stratum, with high gradient vectors occurring around the base of the sheetpile curtain. For this particular scenario, exit gradients had become unsafe with regard to initiation of erosion and piping at an earlier stage of this analysis, with exiting gradients at and near to the inboard side levee toe reaching values greater than 0.6 (sufficient to begin piping for some of the lightweight soils in the toe region) as early as 4:30 to 5:00 a.m. In addition, the pore pressures beneath the thin surficial clay stratum

Fig. 6. (a) Cross section for analysis of the north breach, IHNC at the west end of the Lower Ninth Ward; (b) finite-element mesh for analysis of the north breach, IHNC at the west end of the Lower Ninth Ward; and (c) transient flow seepage analysis results showing equipotential lines (1 ft contours), seepage flow vectors, and exit gradients at 5:30 a.m., based on a lateral coefficient of permeability of the upper marsh strata of $k_h = 10^{-4}$ cm/s

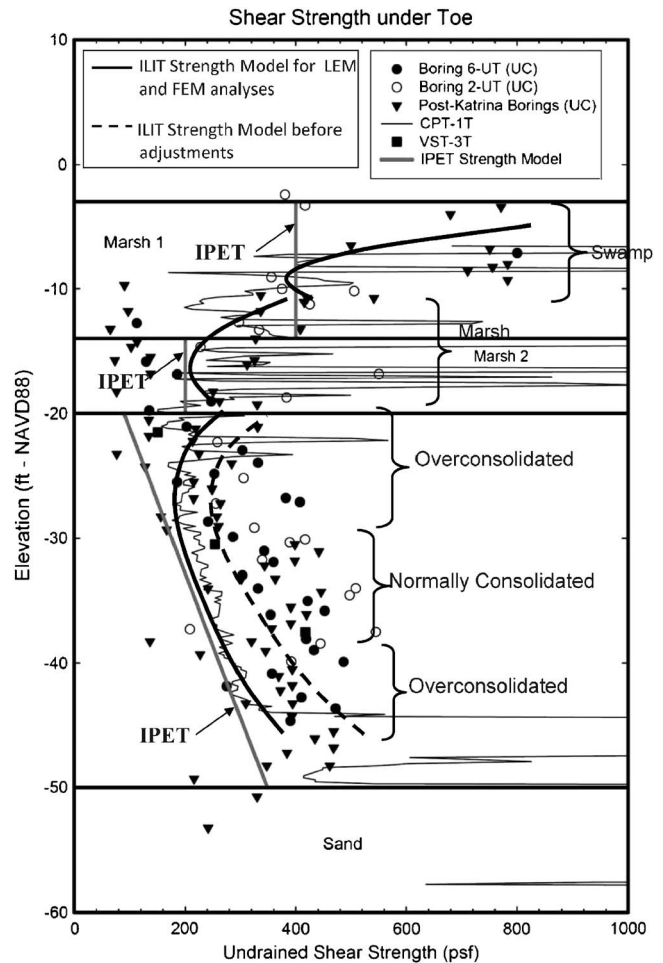
Fig. 7. ILIT model for shear strengths beneath the inboard side levee toe; north breach, IHNC at the west end of the Lower Ninth Ward (adapted from IPET 2007, Vol. V)

The heavy black line in Fig. 7 shows a profile of $(s_u/\sigma'_v)_{DSS}$ used at a lateral location directly beneath the contact of the inboard side levee toe and the nearly horizontal adjacent ground surface within this critical clay stratum in our own studies [these profiles continued to vary somewhat further beneath the levee, and further toward the inboard (free field) side, as a function of varying overburden stresses]. The heavy dashed line in Fig. 7 shows the profile of s_u versus depth determined by our studies (prior to adjustments for DSS shear conditions); this increases linearly versus depth in the middepth region where the clays are normally consolidated, but this profile shows higher strengths at the top and bottom of this clay stratum representing the variable OCR profiles in these zones. This strength profile is in good agreement with the available UU-TX data. The heavy solid line then shows the final profile of s_u versus depth, after empirical adjustments (reductions), that was actually used for the limit equilibrium stability analyses performed (and also for finite-element analyses as well). The adjacent linear trend, showing strength increasing linearly versus depth, was the alternate interpreted strength profile used in the corresponding IPET (2006) analyses.

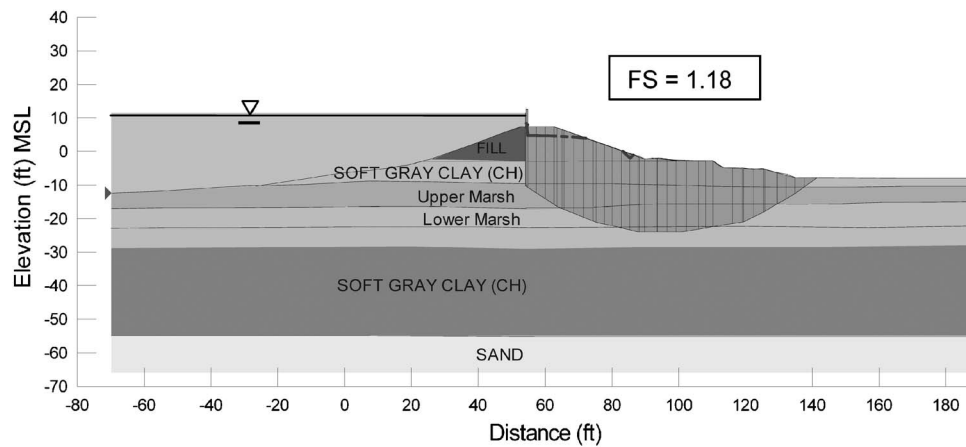
Fig. 8 shows the most critical potential failure surface found by our analyses for this potential deep, semirotational failure mode, and for an IHNC water level of Elev. +10.5 ft (MSL); the conditions present at approximately 5:30 a.m. when the actual failure occurred. The critical failure surface shown in Fig. 8 is similar to the most critical failure surface found by the IPET studies (IPET 2007). Although both studies found similar geometries for the most critical potential failure surface, the calculated levels of stability differed somewhat between the two investigations. Our characterization of strengths within the soft gray clays and overlying marsh and swamp strata, including the additional strength due to the overconsolidation profiles found within these strata, resulted in a somewhat higher calculated FS values when compared to the IPET findings. We computed the factor of safety for the most critical failure surface of Fig. 8 to be approximately FS = 1.18, for a canal water level of +10.5 ft, whereas IPET found the FS to be 1.03 for that same canal water level.

In addition, we note that these are two-dimensional plane strain analyses, and that they likely significantly underestimate the actual three-dimensional (3D) factor of safety due to the unusually narrow and deep shape of the actual field failure (low aspect ratio) and the cohesive strength that would have been mobilized along the sides of this narrow feature. Our best estimate of the actual factor of safety is therefore approximately 5–10% higher, in order to account for these 3D effects, resulting in a best-estimated overall FS \approx 1.24–1.30. This represents an apparently stable condition, but we acknowledge that uncertainties might still have permitted the occurrence of such a deep rotational failure at this IHNC water level. Nevertheless, even if we consider only the two-dimensional FS of 1.18 for the critical failure

Fig. 8. Calculated minimum factor of safety for deep, semirotational failure at the north breach, IHNC at the west end of the Lower Ninth Ward with surge height at Elev. +10.5 ft (MSL)

surface for this mechanism, we judge this to be less likely than the underseepage and piping mode of Hypothesis No. 1.

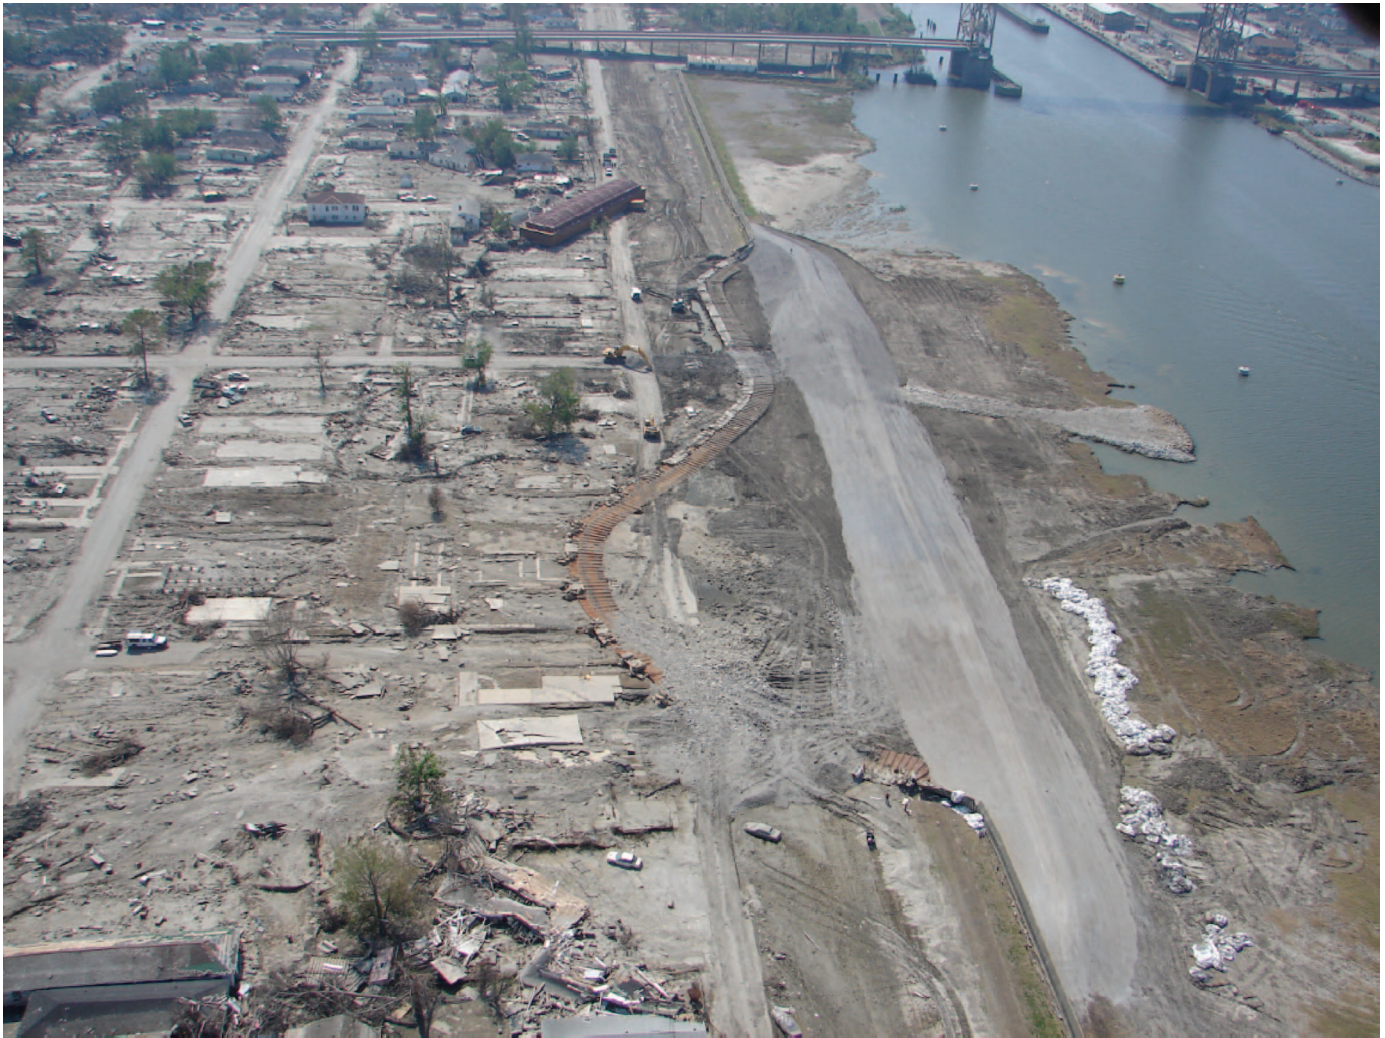
Fig. 9. (Color) Oblique view of the (south) levee breach at the Inner Harbor Navigation Canal into the lower Ninth Ward

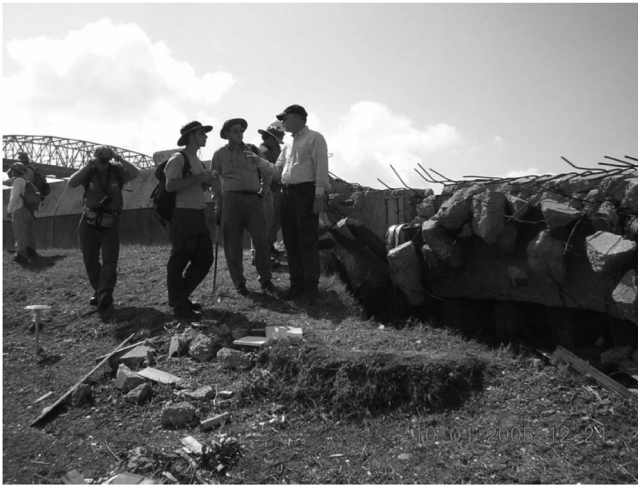
The first question to answer was whether the barge caused the breach or was it drawn in through a breach that was already open. Fig. 10 shows a close-up view of the top of the concrete floodwall at the south end of the breach. The concrete floodwall along the top of the sheetpile curtain across the full rest of the width of this large breach was largely spalled off of the tops of the sheetpiles in extension as the sheetpiles were pulled by extensile/tensile forces. The south end of the breach (Fig. 10) was the only location where the concrete floodwall was crushed by compressive impact. In addition, a large dent on the left side of the barge, near the bow, and a scrape on its base at that location, appeared to correlate well

Fig. 10. Close-up view of crushed (impacted) concrete floodwall at the south end of the south breach at the east bank of the IHNC at the west end of the Lower Ninth Ward

with the south end impact site shown in Fig. 10. Finally, as described later, geo-forensic studies performed as part of our investigation show that this section would have been expected to fail without barge impact. It was concluded by this investigation that the barge was most likely drawn in through a breach that was already open, and that it impacted at the extreme south end of the breach as it passed inland through the (already open) breach.

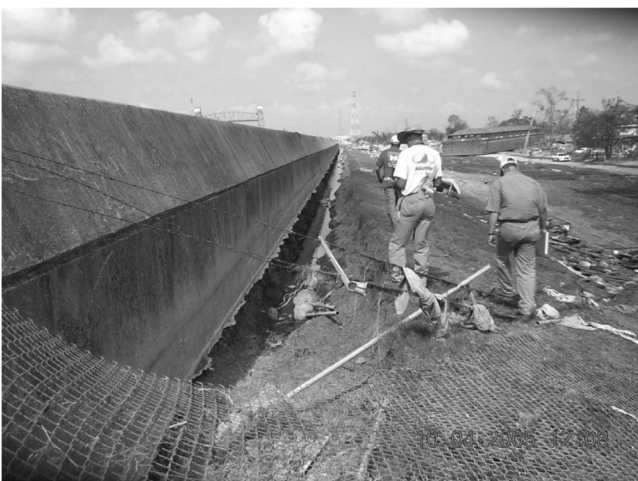
Fig. 11. Eroded trench at the rear (inboard) side of the floodwall at the south end of the south breach at the east bank of the IHNC at the west end of the Lower Ninth Ward

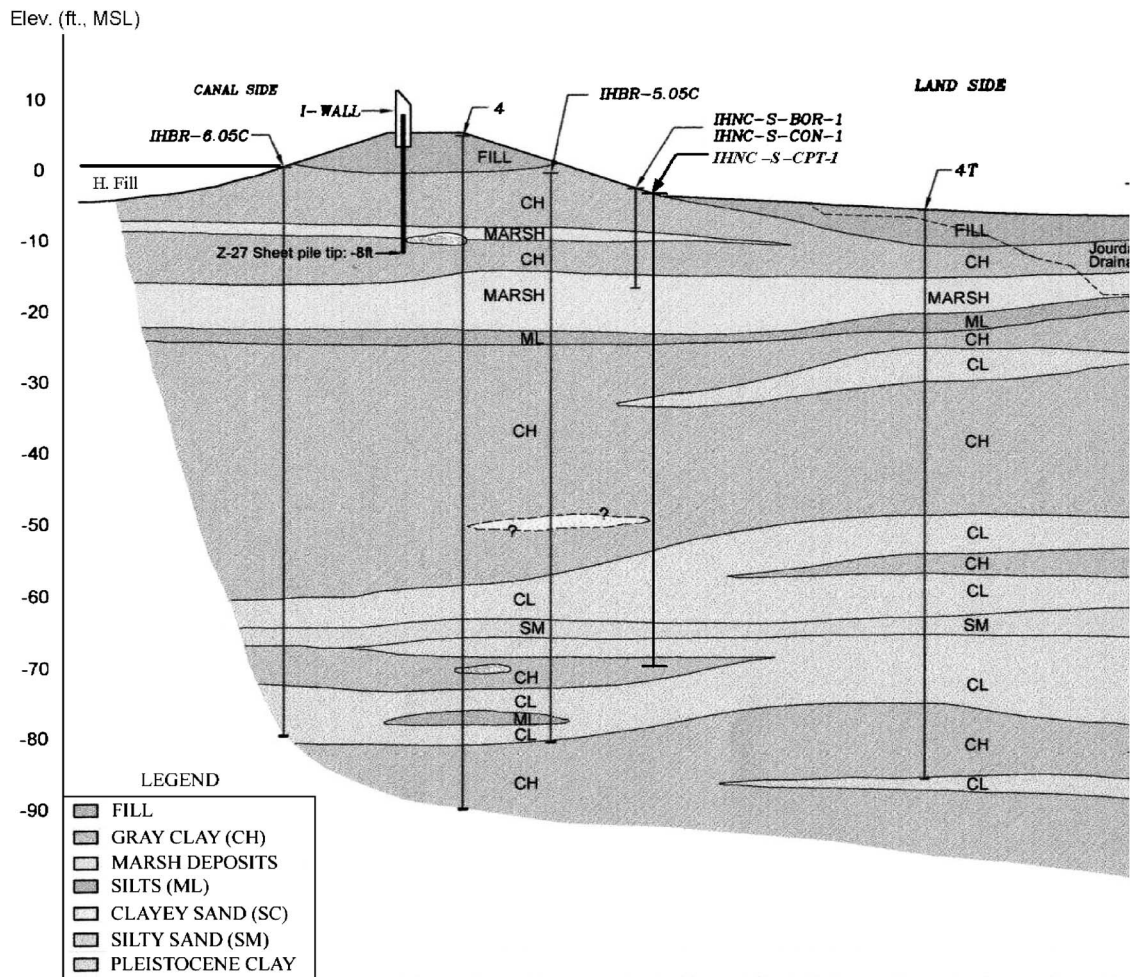
Fig. 12 shows a cross section through the breach section. The top of the concrete floodwall at this location is at approximately Elev. +12.7 ft (MSL). The foundation stratigraphy at this section

is similar to that of the north breach discussed previously in this paper. The clayey levee embankment sits atop primarily gray swamp/marsh clays (CH) with occasional plastic silt strata, but there are two significant marsh deposits in the upper foundation as well. As shown in Fig. 12, the sheetpile curtain supporting the concrete floodwall is again very short, with its base at Elev. -8 ft (MSL), and fails to cut off flow through the second (main) marsh layer. As with the nearly adjacent north breach, the marsh layer is a variably interbedded layer of organic silts, clays, and peats. The k_h of this ensemble is variable, and there is a well-established history of underseepage problems along this overall levee frontage (ILIT 2006; Van Heerden et al. 2006; Consolidated Litigation 2008).

Fig. 12. Cross section through the large south breach on the east bank of the IHNC, at the west end of the Lower Ninth Ward

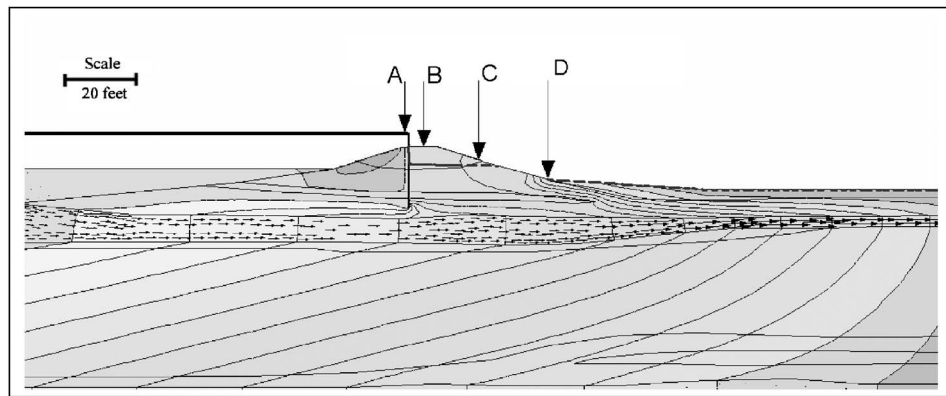
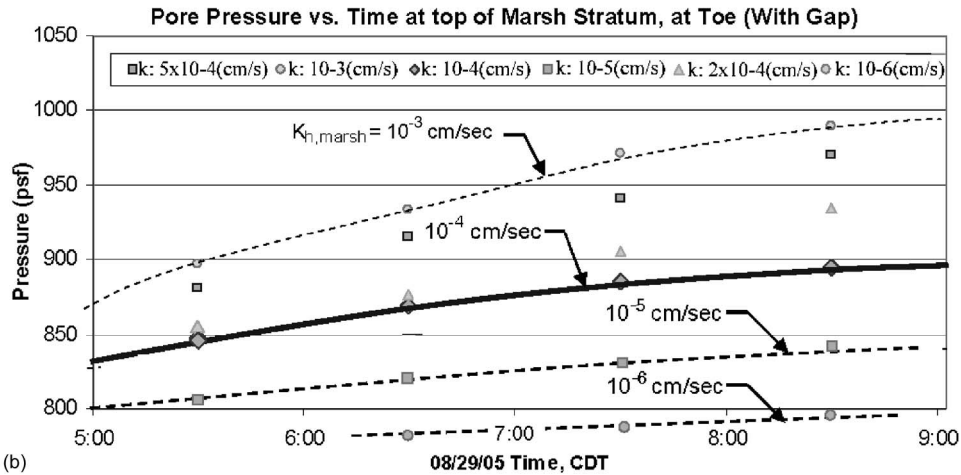
Fig. 13(b) shows porewater pressures calculated over the last 4 h before the surge peaked at about 8:45 a.m. As shown in this figure, the fraction of the steady state pore pressure that actually accrues at this location is affected by the k_h of the marsh stratum. For values of $k_h = 10^{-3}$, 10^{-4} , 10^{-5} , and 10^{-6} cm/s, the fraction of the full steady state pore pressure achieved by transient flow at this location would have been on the order of 92, 84, 78, and 73% of the steady state pore pressures, respectively. This overstates the degree of pore pressure transmission due to the transient rise in canal water level, however, as the pore pressures shown in Fig. 13(b) also include the initial pore pressure present at this location prior to the final storm surge rise. Subtracting out the initial pore pressure as it existed approximately 24 h before the final storm surge rise, the fraction of the steady state pore pressure change (due to storm surge rise) transferred to the top of the marsh beneath Point D was calculated to be on the order of 83, 61, 49, and 38% for values of $k_h = 10^{-3}$, 10^{-4} , 10^{-5} , and 10^{-6} cm/s, respectively.

It should also be noted that the pore pressures shown in Fig. 13(b) correspond to the gapped case, wherein it is assumed that a gap opens between the sheetpiles and the levee embankment soils on the waterside as the canal water reaches an elevation of approximately +10 to +11 ft (MSL), as such gapping was suggested by finite-element analyses performed to model the behavior of this section (ILIT 2006). The effect of this opening of a gap, in part, was to permit direct entry of high water pressures at the base of the sheetpile curtain during the later stages of the storm surge rise, and this also adds a bit to the calculated overall pore pressure rise beneath the inboard side of the levee embankment.

Fig. 13. (a) Equipotential contours at the time when canal water levels reached Elev. +14 ft (MSL). Contours are at 1 ft intervals; (b) pore pressure versus time at the top of the marsh stratum directly beneath Location D of Fig. 13(a), as a function of the lateral permeability of the marsh stratum.

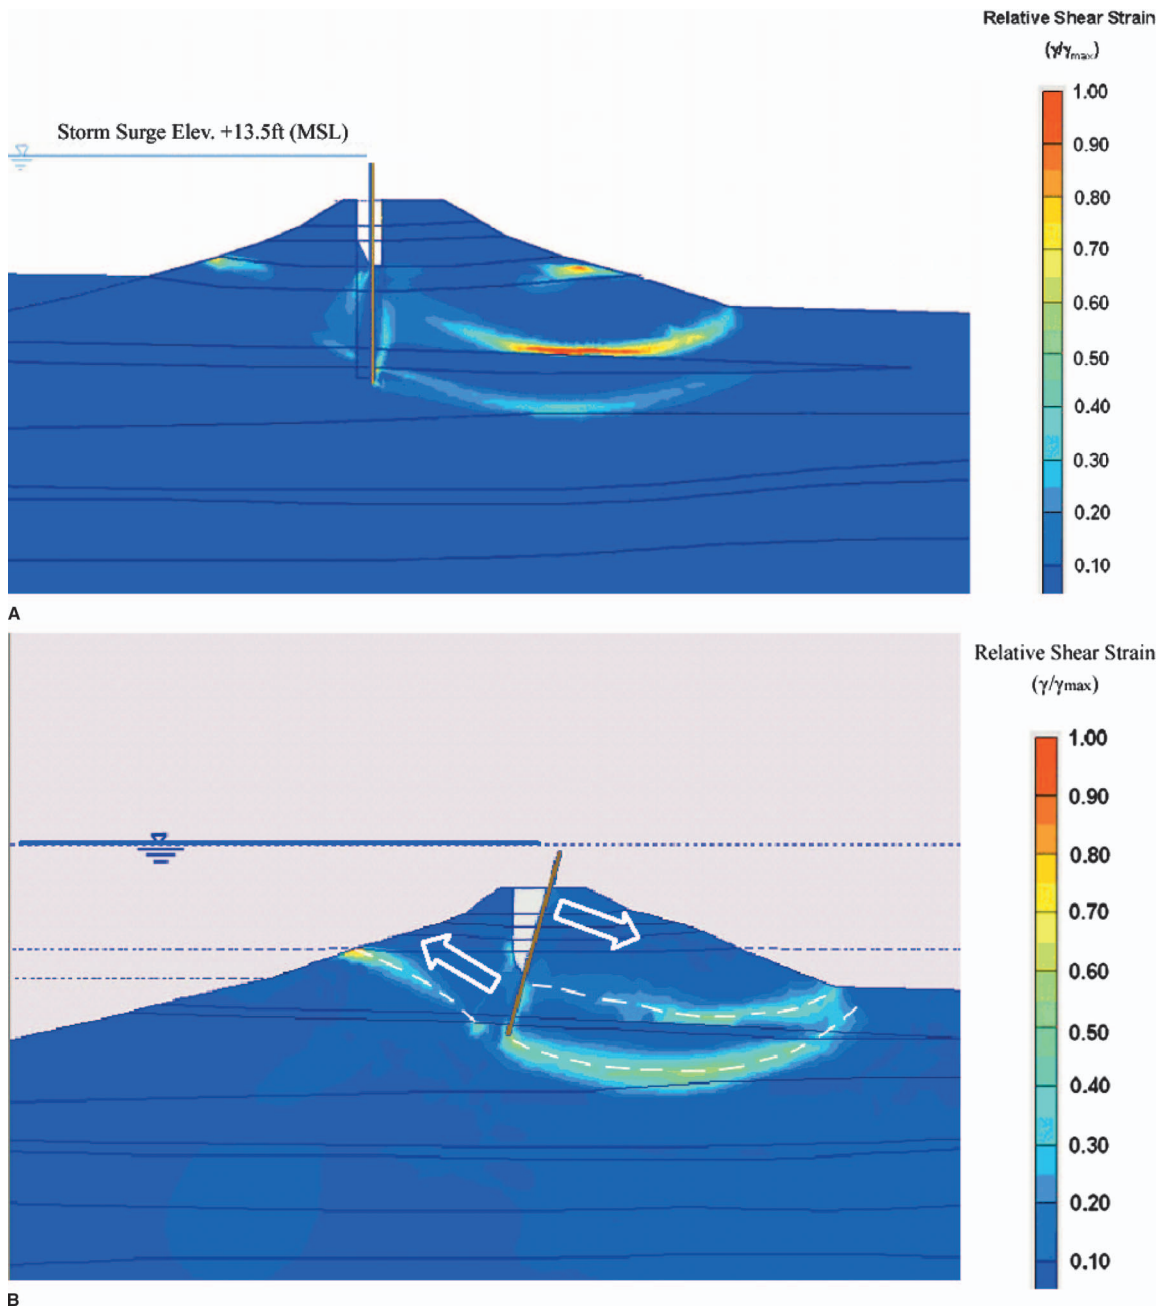
The lower mode was found to be slightly more critical in the finite-element analyses, and the upper mode was found to be slightly more critical in the coupled seepage/limit equilibrium analyses. The calculated FS for the lower semirotational mode was calculated in the specific analysis shown in Fig. 14(a) to be FS=1.08 (by the SSR method), for conditions when the IHNC water level was at +13.5 ft (just short of its eventual peak at approximately +14.5 ft, MSL), and FS=1.13 was calculated for

Fig. 14. (Color) (a) Finite-element analysis results showing the two most critical potential failure surfaces for the south breach with the IHNC water level at Elev. $\approx +13.5$ ft (MSL), and for pore pressure and underseepage conditions at 8:45 a.m., based on $k_{h,marsh} \approx 10^{-5}$ cm/s; (b) finite-element analysis results showing stable “cradling” of a partially topped I-wall and sheetpile curtain, south breach section, IHNC at the west end of the Lower Ninth Ward

the lower mode. It should be noted that the analyses of Fig. 14(a) represent just one canal water elevation, and are based on $k_h = 10^{-5}$ cm/s.

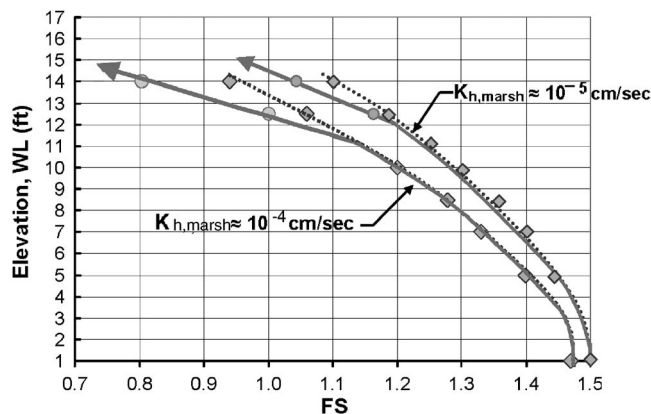
Fig. 15 shows the calculated evolution of the overall FS for this potential failure mode as a function of progressively rising water levels (over time) in the IHNC, and for two sets of modeled k_h levels within the peaty marsh strata. The results shown are for finite-element analyses, but the results of more conventional seepage/limit equilibrium analyses were similar for the later stages of water rise (generally within 10% or less for most com-

Fig. 15. Evolution of factor of safety as IHNC water levels rose; plot of overall factor of safety for lateral translation versus water elevation (south breach on the IHNC, at the west end of the Lower Ninth Ward)

binations of water level and modeled marsh k_h). In Fig. 15, the dashed lines and diamond symbols are calculated FS values without the opening of a water-filled gap on the outboard side of the sheetpiles (from analyses where the development of the gap was prevented), and the solid lines (and filled circles) are the calculated FS values when such gapping is allowed to occur naturally. As shown in this Fig. 15, these finite-element analyses showed that such a gap would begin to open at a canal water level of between +11 and +12.5 ft (MSL). For other ranges of stiffness parameters also considered reasonable, this gap began to open at water elevations of between about +10 to +13 ft (MSL).

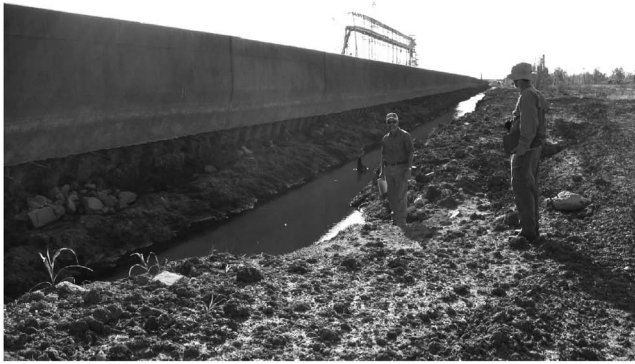
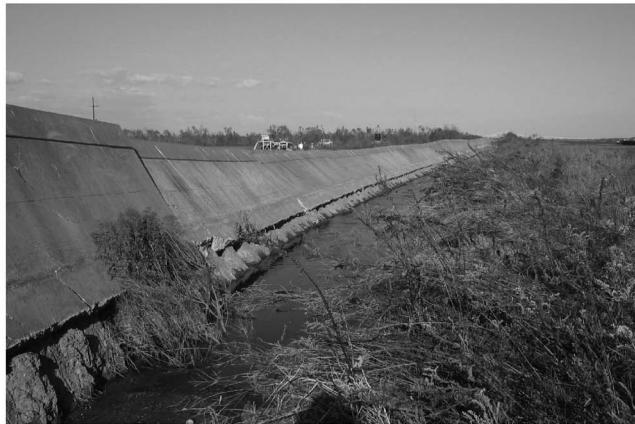
This is supported by observations of the performance of I-walls at other locations in the region. Fig. 16 shows two examples, at two sections of the Citrus Back Levee (and floodwall) described previously. Fig. 16(a) shows a deeply eroded (scoured) trench on the inboard side of the floodwall, at one of the deepest

Fig. 16. (a) Significant lateral deflection of the Citrus Back Levee floodwall, seen from the inboard (protected) side. Note the soil heave adjacent to the displaced sheetpiles; (b) deflection and tilting of another section of the Citrus Back Levee floodwall, this time viewed from the outboard side. Note the gap between the outboard side levee embankment and the sheetpile curtain.

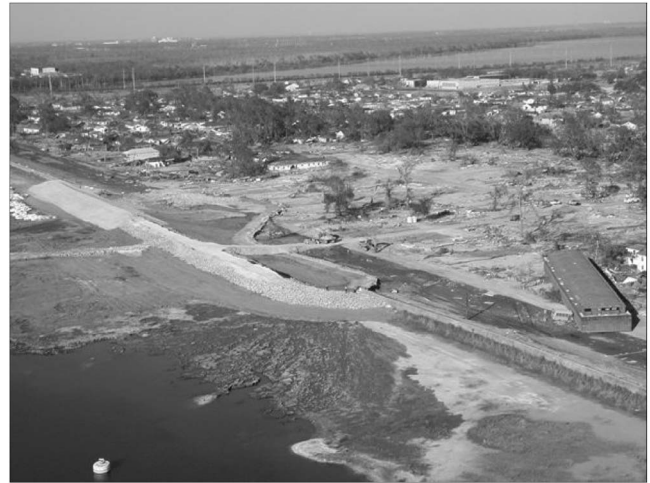
Fig. 17. Reverse crevasse splay produced by reverse drainage out through the foundation soils beneath the interim repair embankment section; south breach IHNC at the Lower Ninth Ward (IPET 2006)

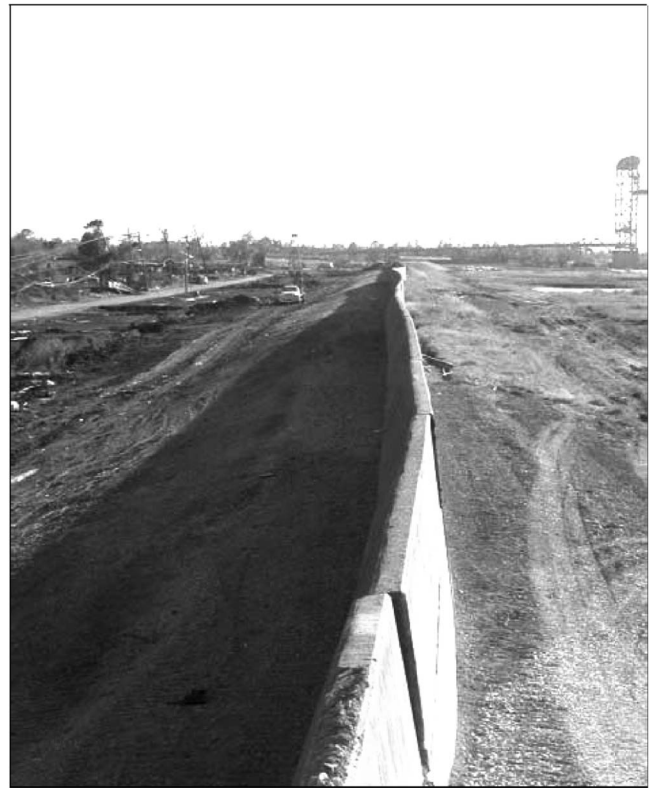
One final piece of evidence is the relatively minor, but noticeable, lateral displacement of a considerable portion of the levee and floodwall along the frontage section between the north and south breaches along this IHNC frontage; as shown in Fig. 18. This photograph shows the I-wall along the frontage between the two major breaches, and is taken from the north breach looking toward the south. The two concrete I-wall panels in the immediate

foreground mark the south end of the north breach, and the large barge that passed in through the large south breach can be seen (dimly) in the background; just behind and above truck on the left of the I-wall. As shown in Fig. 18, the I-wall is significantly misaligned between these two major breach features in the wake of Hurricane Katrina. This misalignment did not appear to be associated with significant overtopping-induced trench scour behind the floodwalls; in fact many of the displacements occurred at

Fig. 18. View of lateral misalignment along the I-wall between the north and south breach features; IHNC at the west end of the Lower Ninth Ward (IPET 2007)

locations that exhibited little or no scour of that sort. Instead, the misalignment appears to have been due to deeper-seated movements; movements that could apparently only be explained as partial or incipient lateral translational displacement of the levee embankment itself.
