# UNRAVELLING THE LEVEE FAILURES IN NEW ORLEANS DURING HURRICANE KATRINA – WHAT WE ALL SHOULD KNOW

**J. David Rogers, Ph.D., P.E., R.G.**

Member, National Science Foundation Independent Levee Investigation Team and  
Karl F. Hasselmann Chair in Geological Engineering  
University of Missouri-Rolla

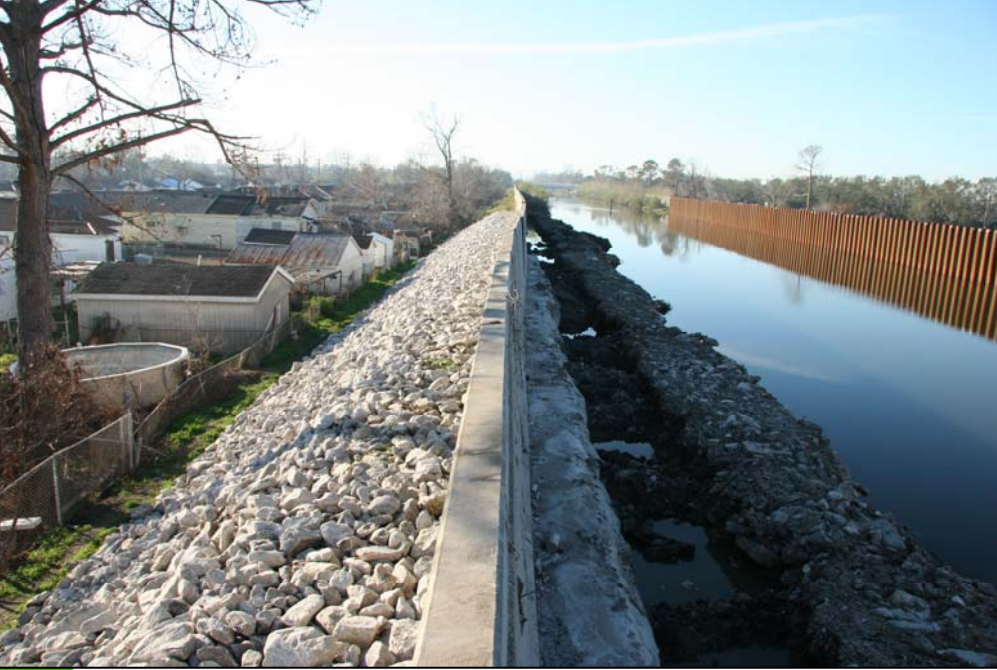
- View looking up the east side of the London Avenue Canal near Robert E. Le Boulevard crossing showing the **encroachment of homes against the slope of the levee**. This situation was common across New Orleans

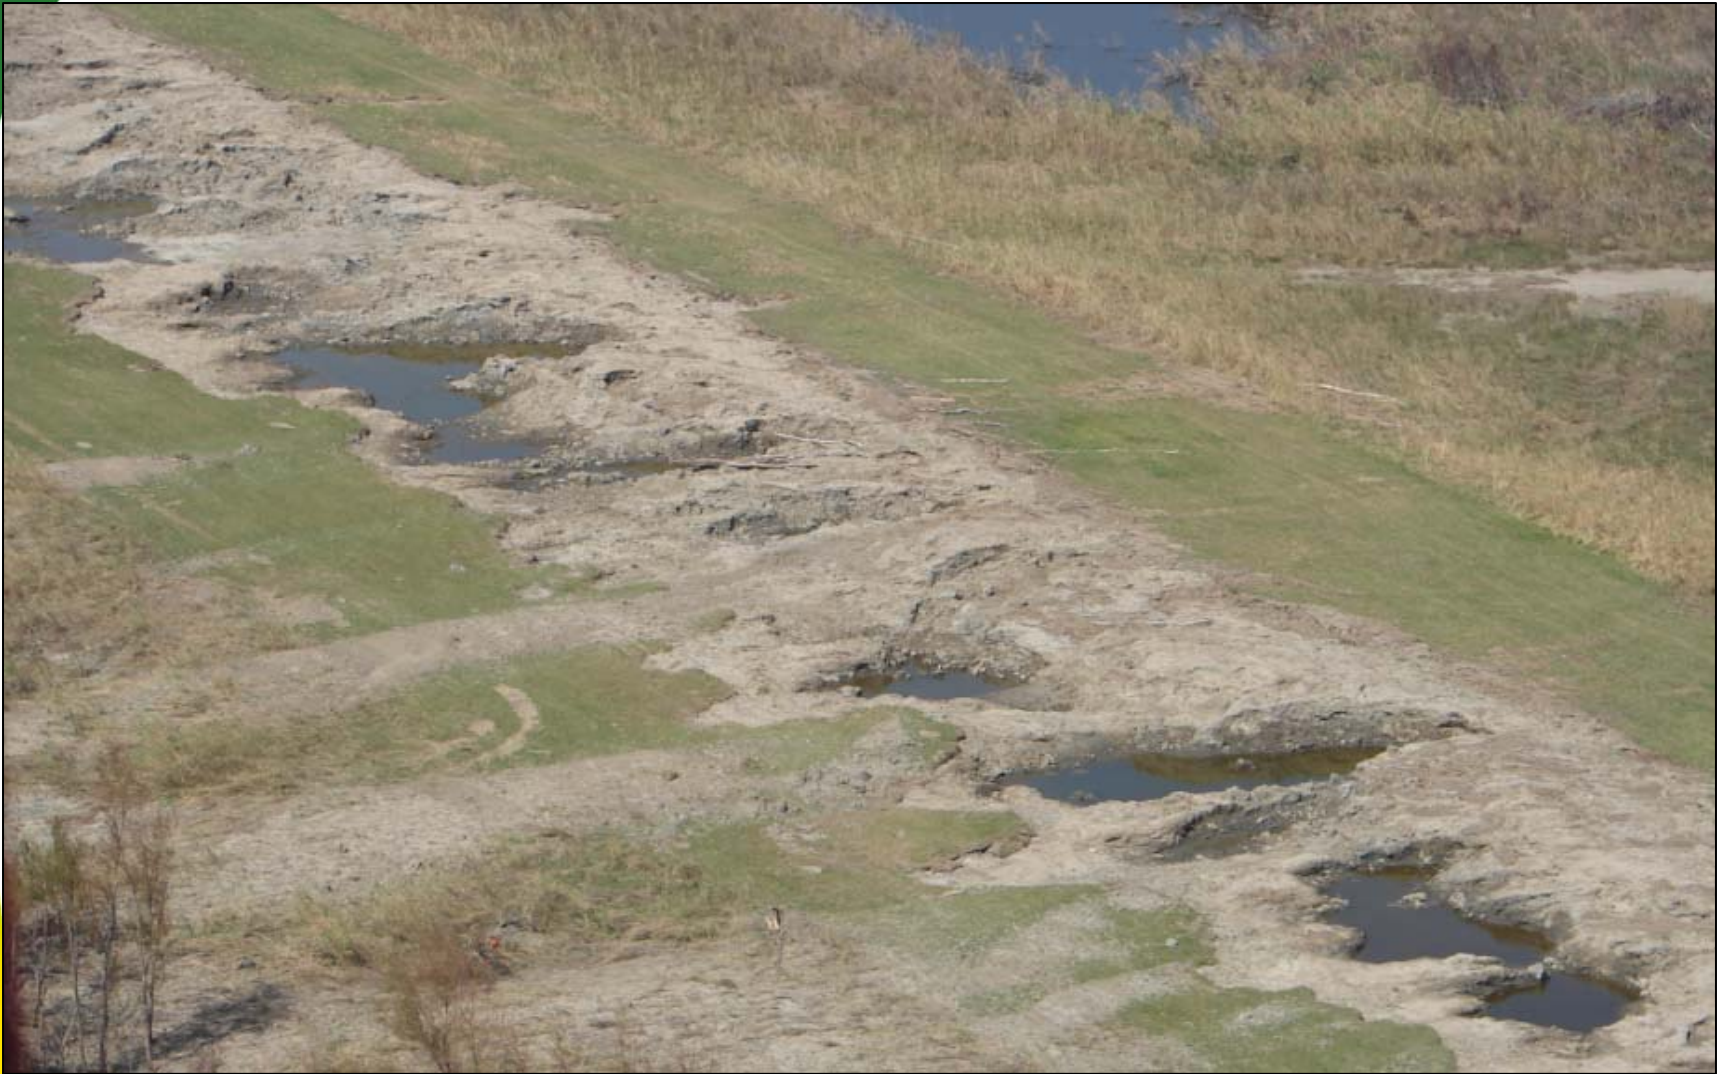
- **Miles of levees just disappeared: MRGO levee completely washed away about two miles southeast of Bayou Dupree.**

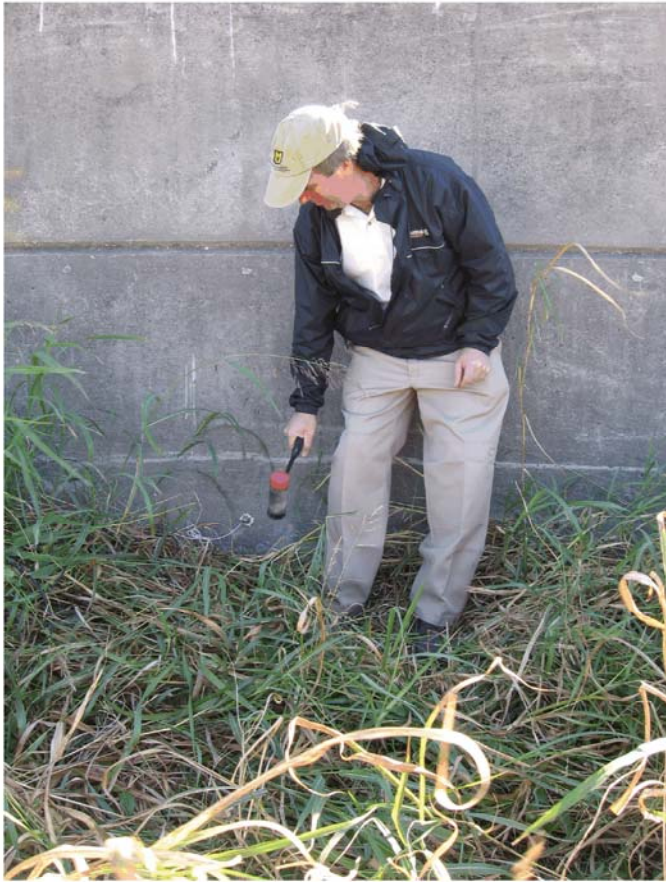
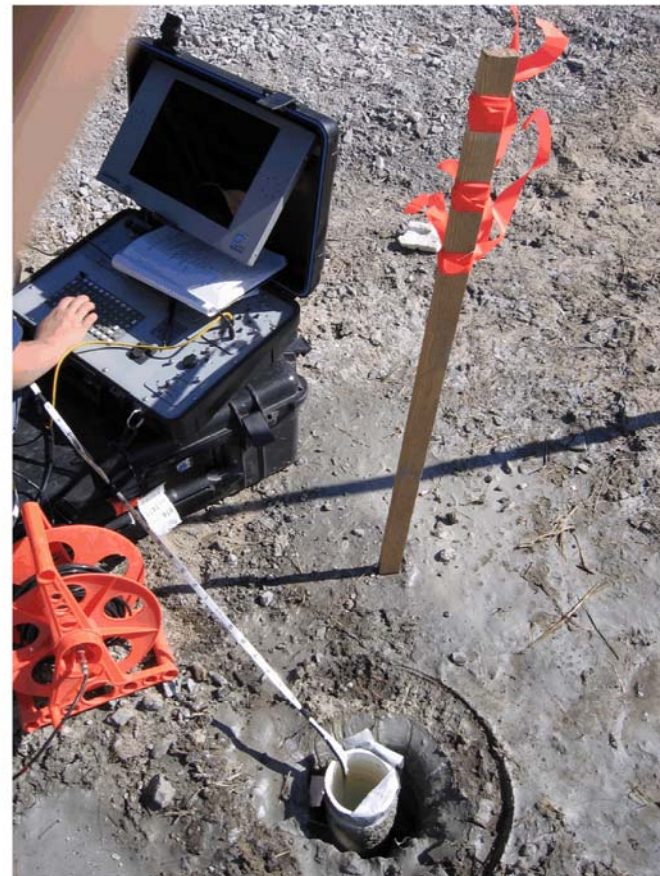
**Figure 2** - Photographs of impacting Wall of IHNC Levee at South Borehole of South Breach and Freedom Data PC at Cased Borehole with Hydrophone Receiver Downhole

- **Photo showing energy being tapped into base of one of the concrete I-walls by a consultant in October 2005. These tests were complicated by a very weak signal making it through the concrete shell into the top of the sheetpiles, and down to the supposed sheetpile tips.**

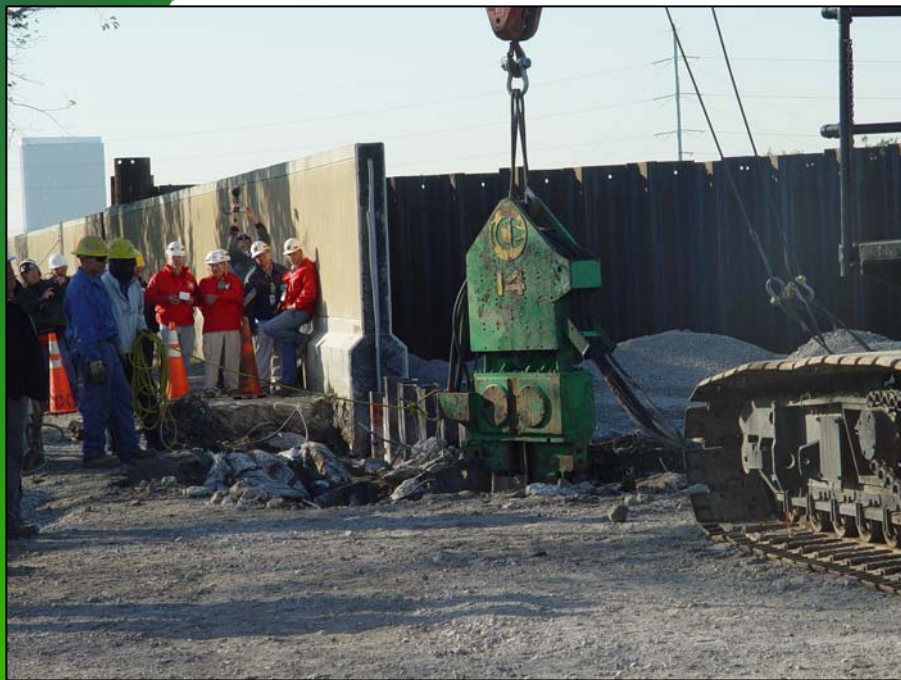
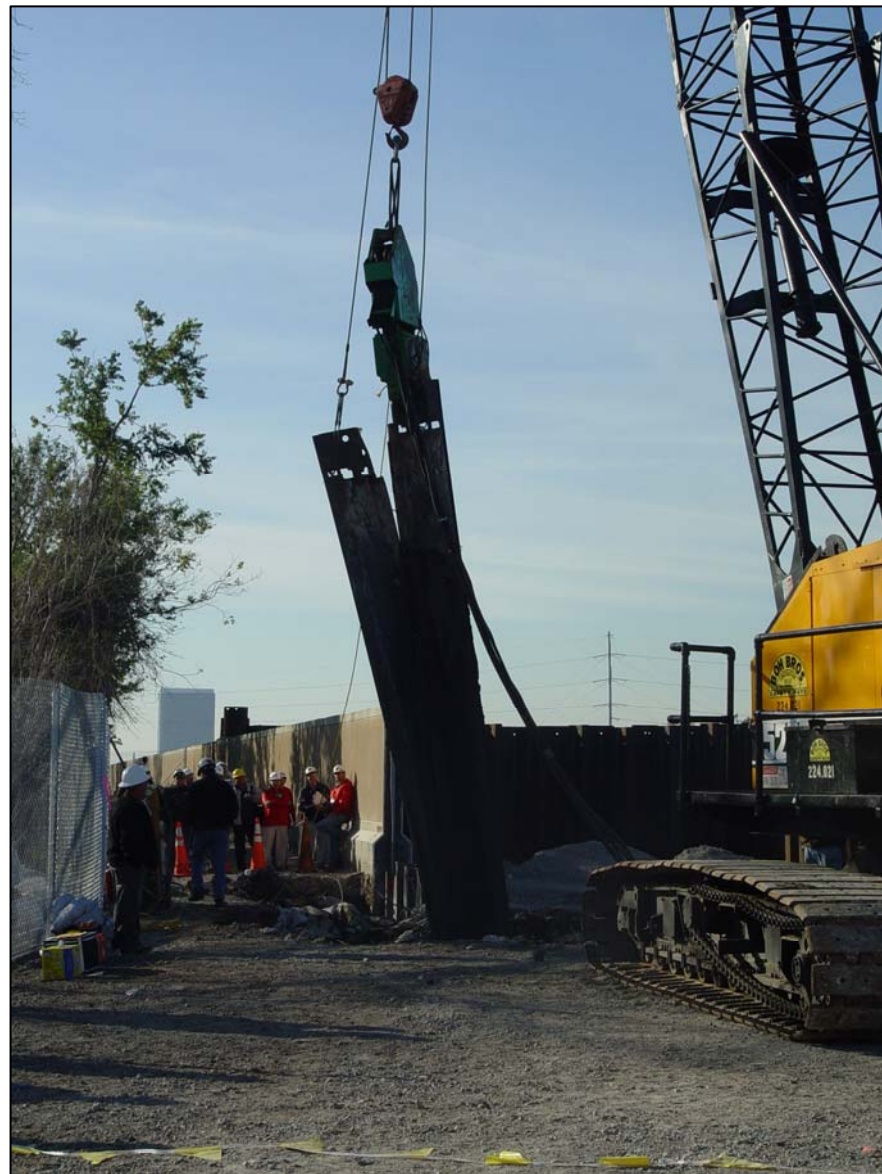
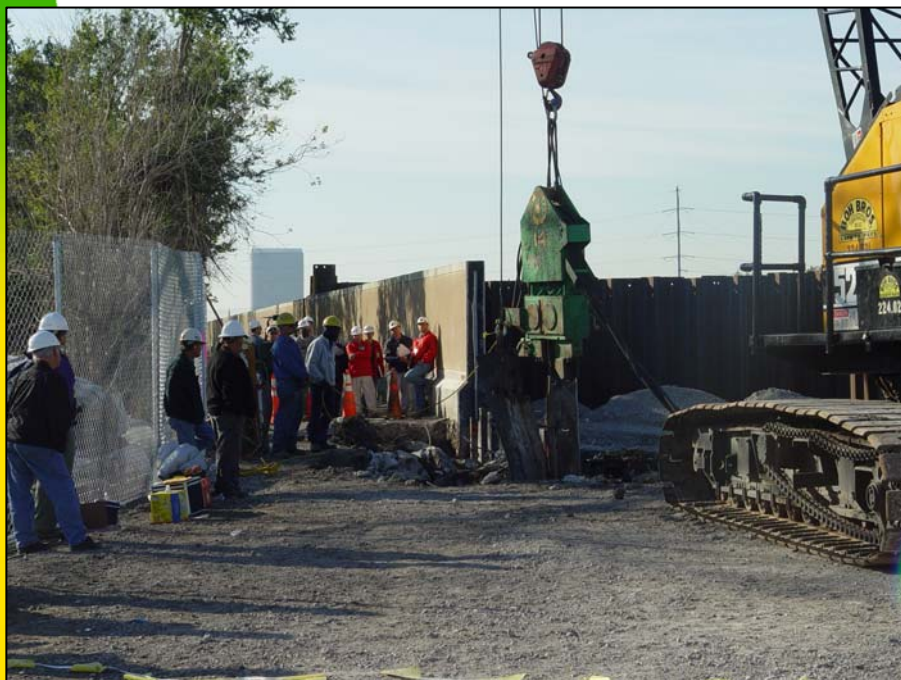
- **Pulling sheetpiles at south end of 17<sup>th</sup> Canal breach on December 13, 2005**

- The sheetpiles turned out to be 23'-6" long, slightly longer than required in the 1993 construction documents

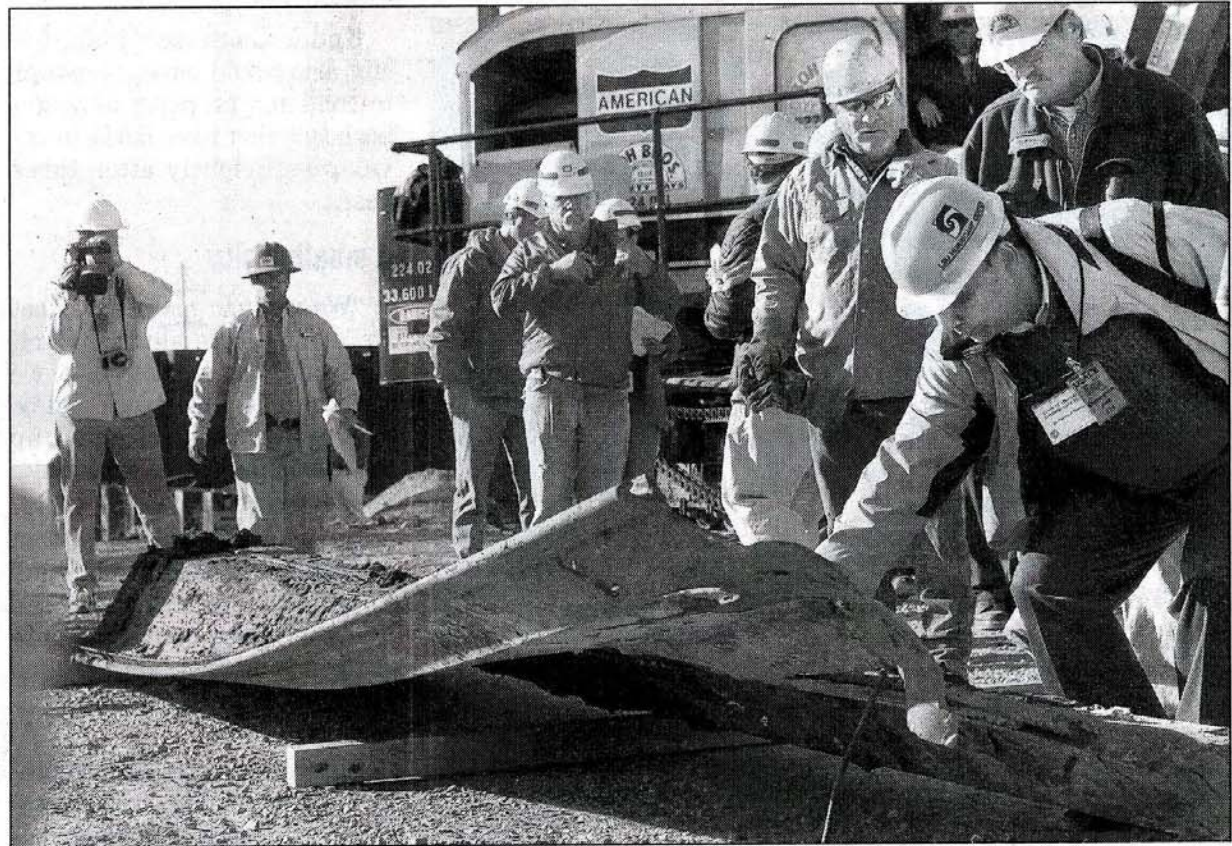
Investigators from various agencies inspect the second section of sheet piling removed from the 17th Street canal. 'We need to check every foot of the levees,' said Michael McCrossen, acting chairman of the Orleans Levee District. 'Random tests are not enough.'

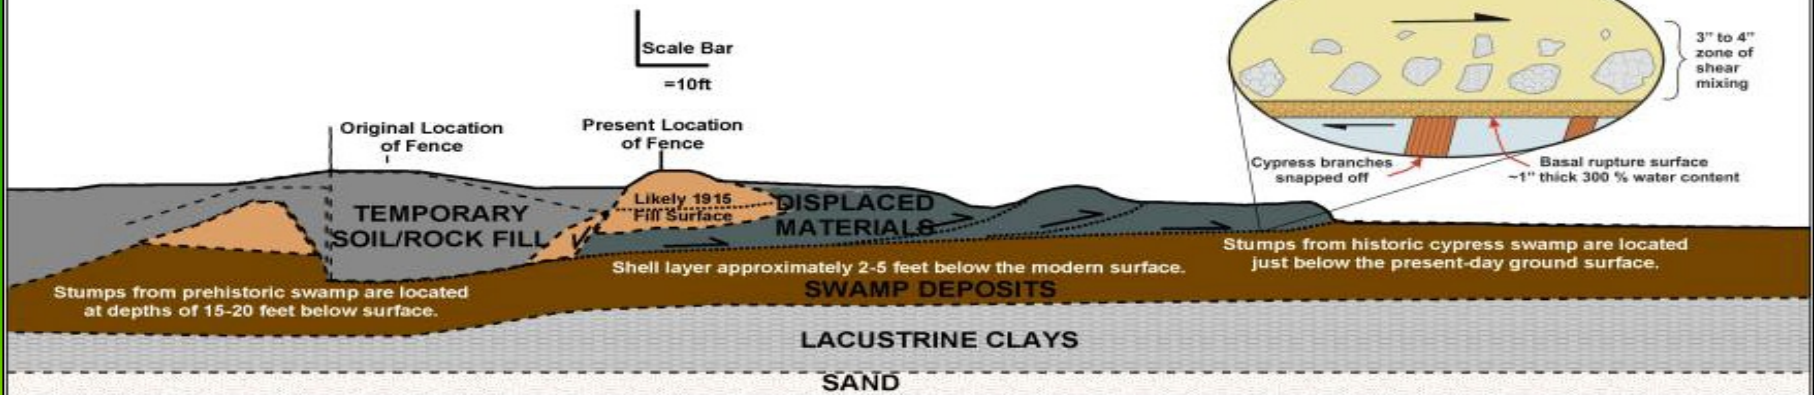
- **West-to-east geologic cross section through the 17<sup>th</sup> Street Canal failure approximately 60 feet north of Spencer Avenue. A detailed sketch of the basal rupture surface is shown above right.**
- **The slip surface was about one inch thick with a high moisture content (watery ooze). A zone of mixing 3 to 4 inches thick lay above this. Numerous pieces of cypress wood, up to 2 inches diameter, were sheared off along the basal rupture surface.**

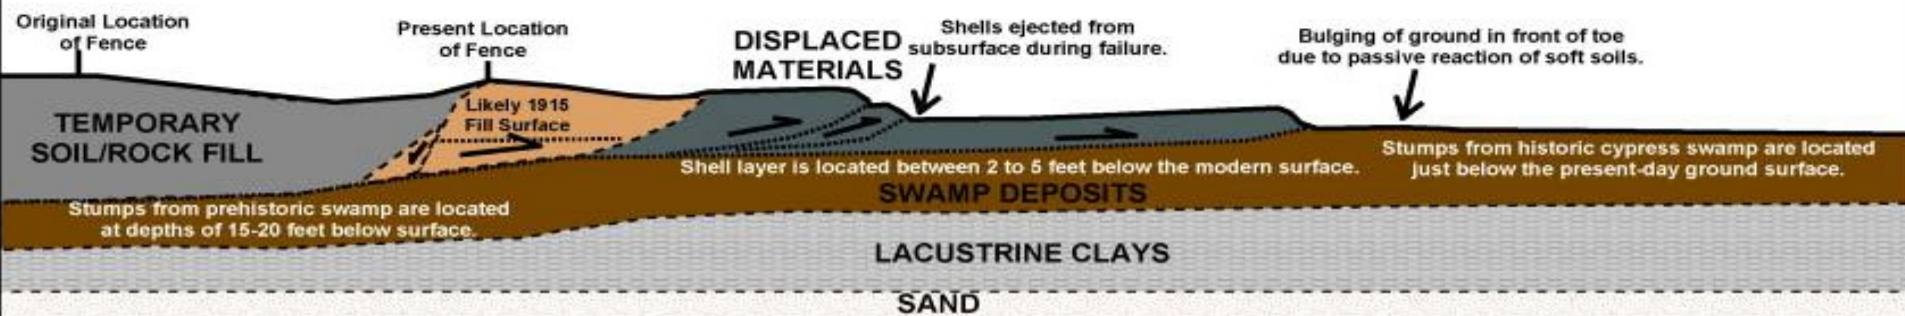
- **West-to-east geologic cross section through the 17<sup>th</sup> Street Canal failure approximately 140 feet north of the northern curb of Spencer Avenue.**
- **Large quantities of bivalve shells were extruded by high water pressure along the advancing toe thrusts. Note the slight back rotation of the distal thrust sheet.**

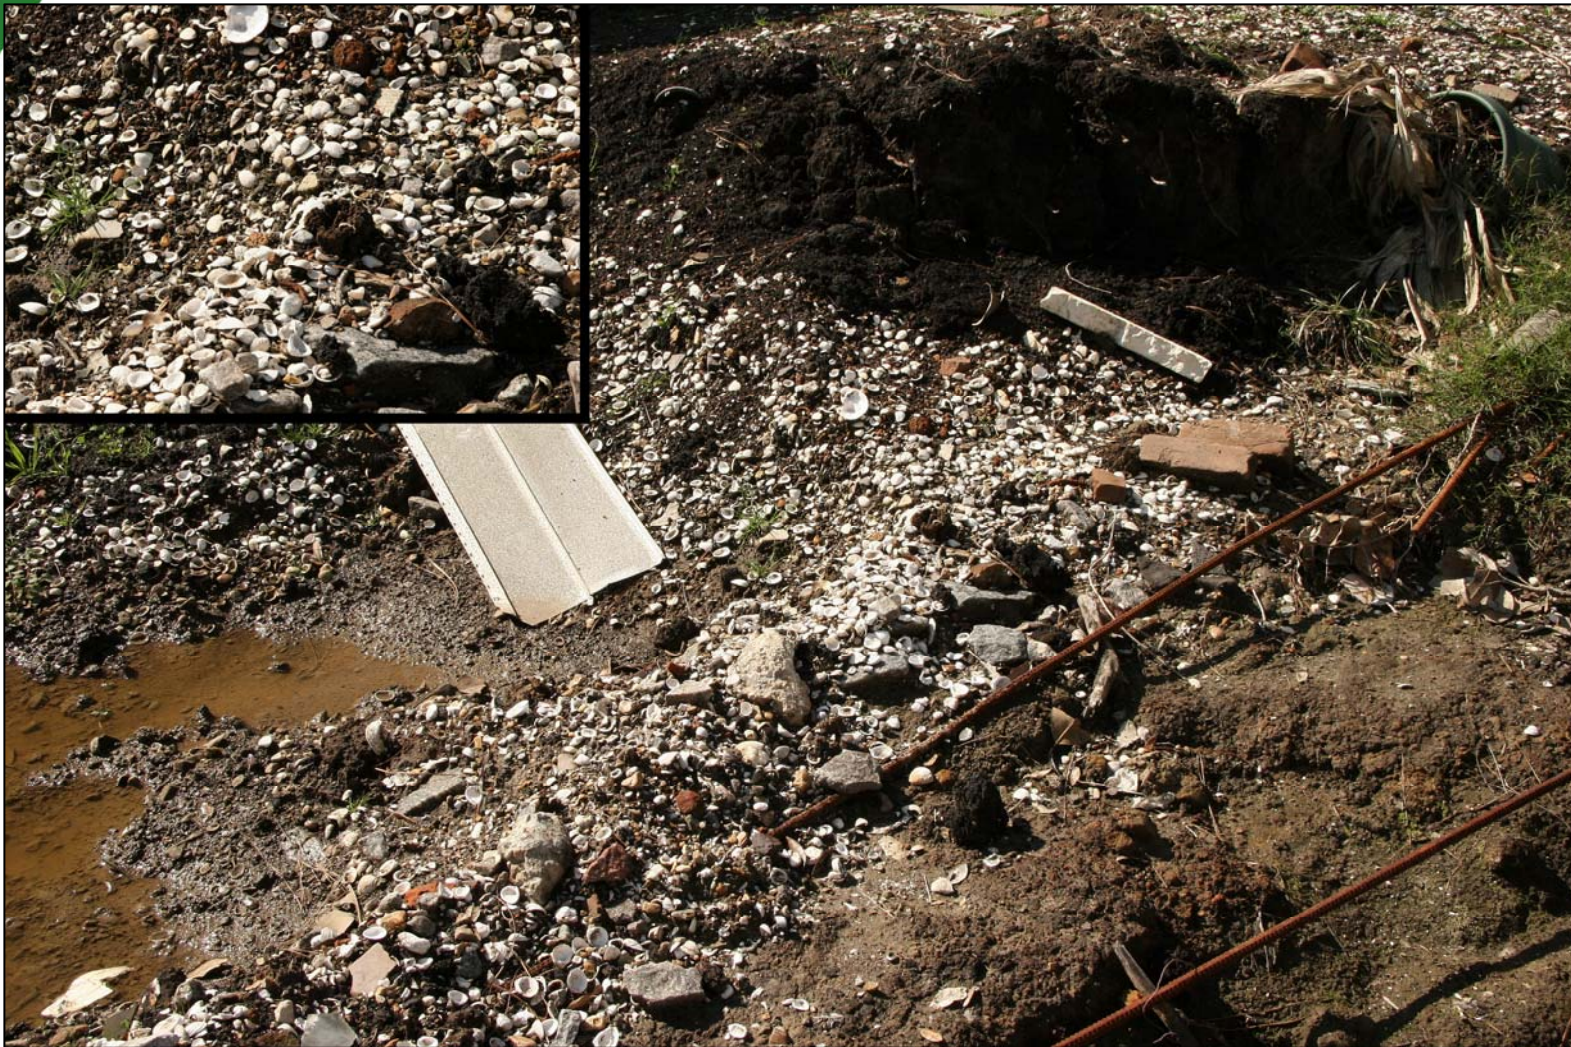
- **Bivalve shells ejected by high pore pressures emanating from toe thrusts on landside of failed levee at the 17 Street Canal (detail view at upper left). These came from a distinctive horizon at a depth of 2 to 5 feet below the pre-failure grade.**

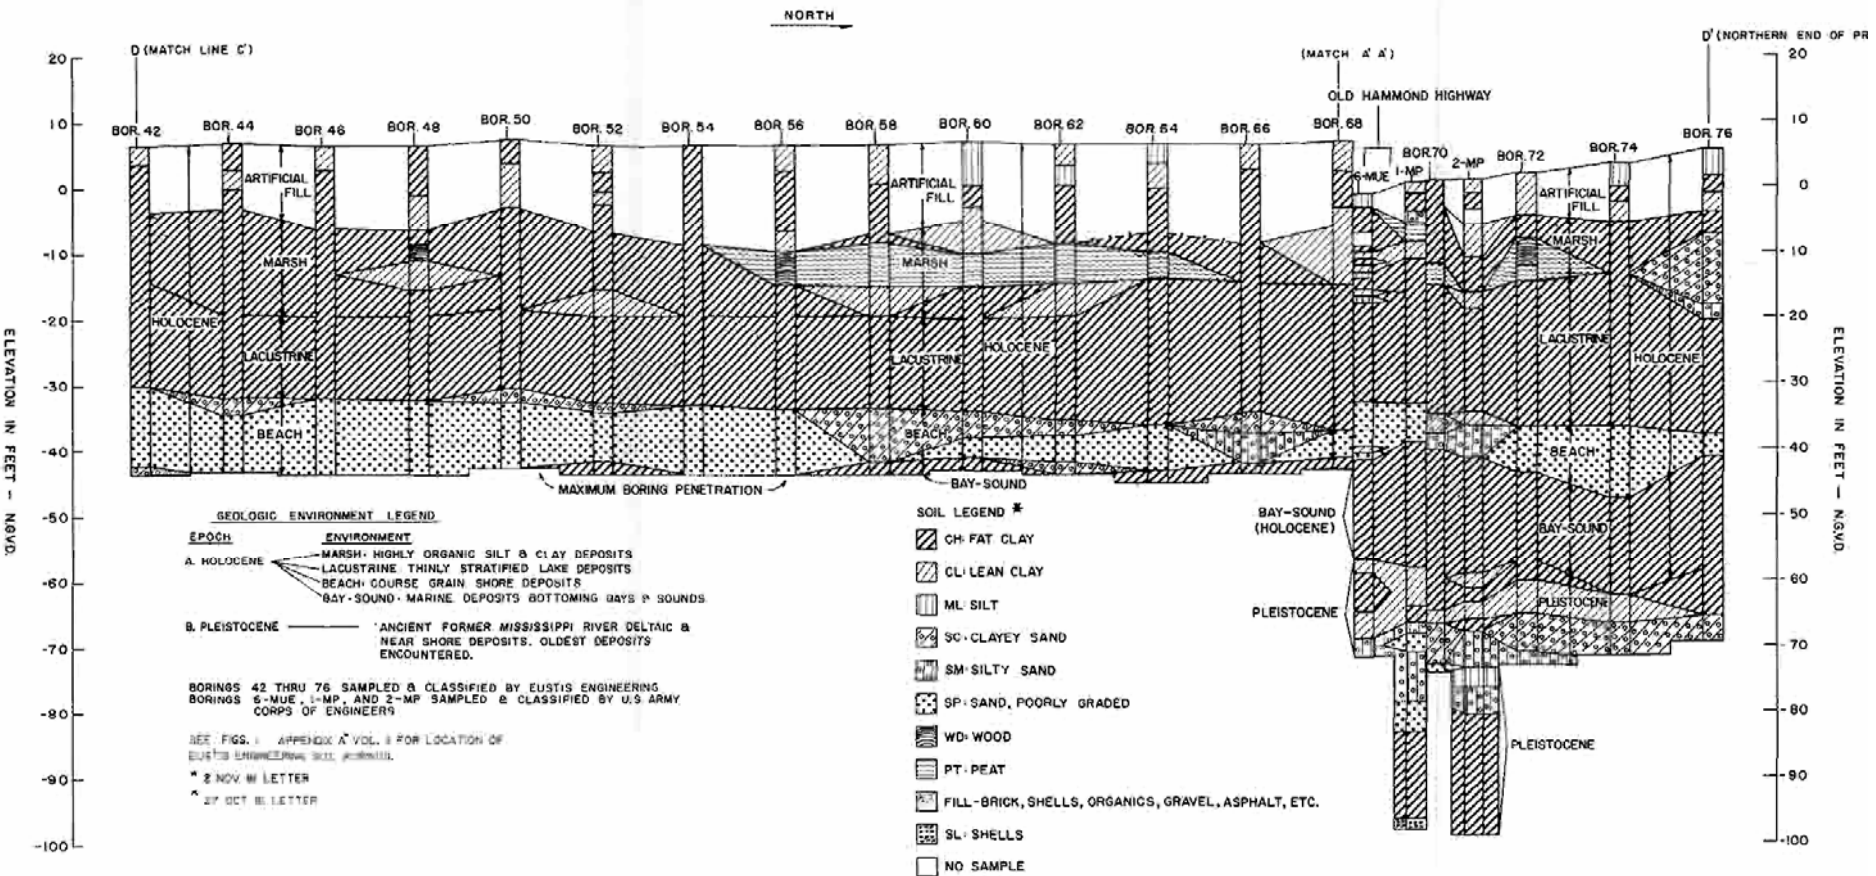
**Geologic profile for the 17<sup>th</sup> St Canal flood wall prepared by Corps' New Orleans District office in 1990. Three of four holes in vicinity of the 2005 failure (spaced 500 ft apart) had zero sample recovery. These contacts were projected and sheet pile tips designed, accordingly.**

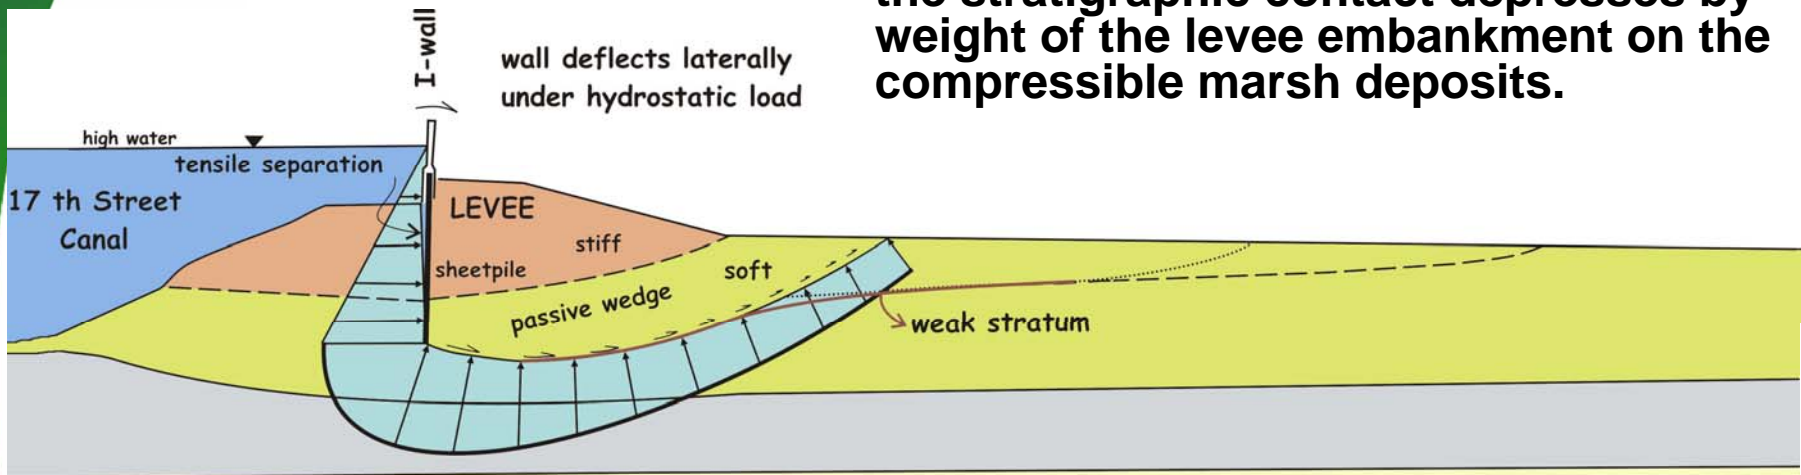
**Initial loading conditions, Storm surge rose to within 4 feet of flood wall crest. Hydrostatic pressures on sheetpile supported I-wall highlighted in blue.**

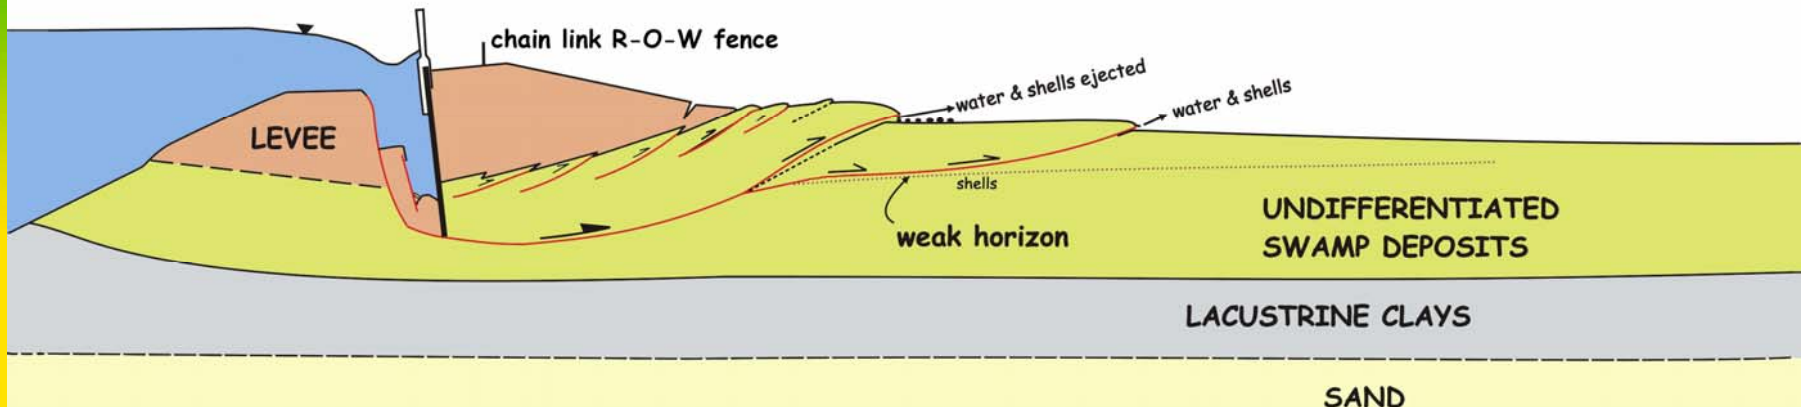
**Translational failure begins. Traction shears noted along base of embankment. Note initial back rotation component of motion and development of planar thrusting.**

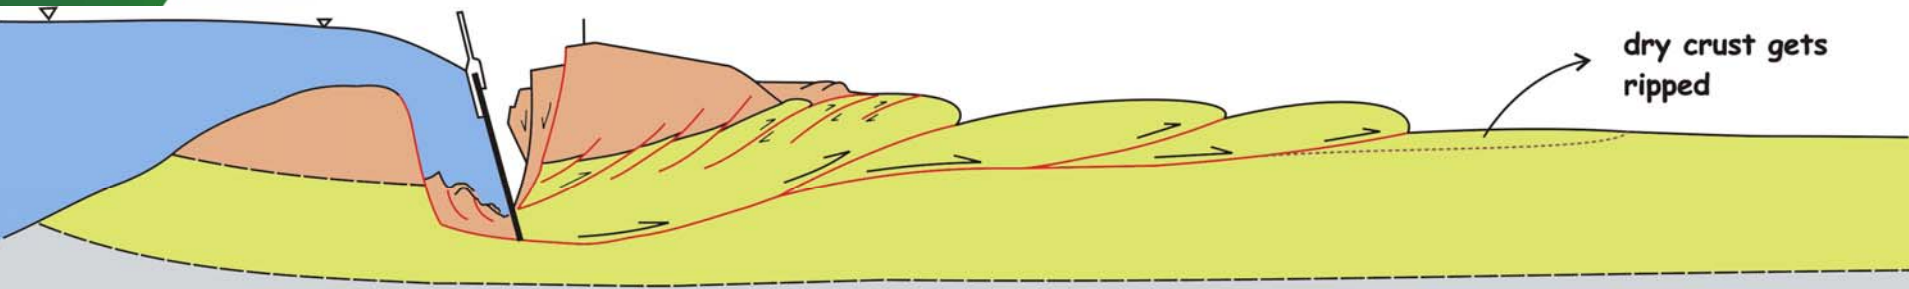
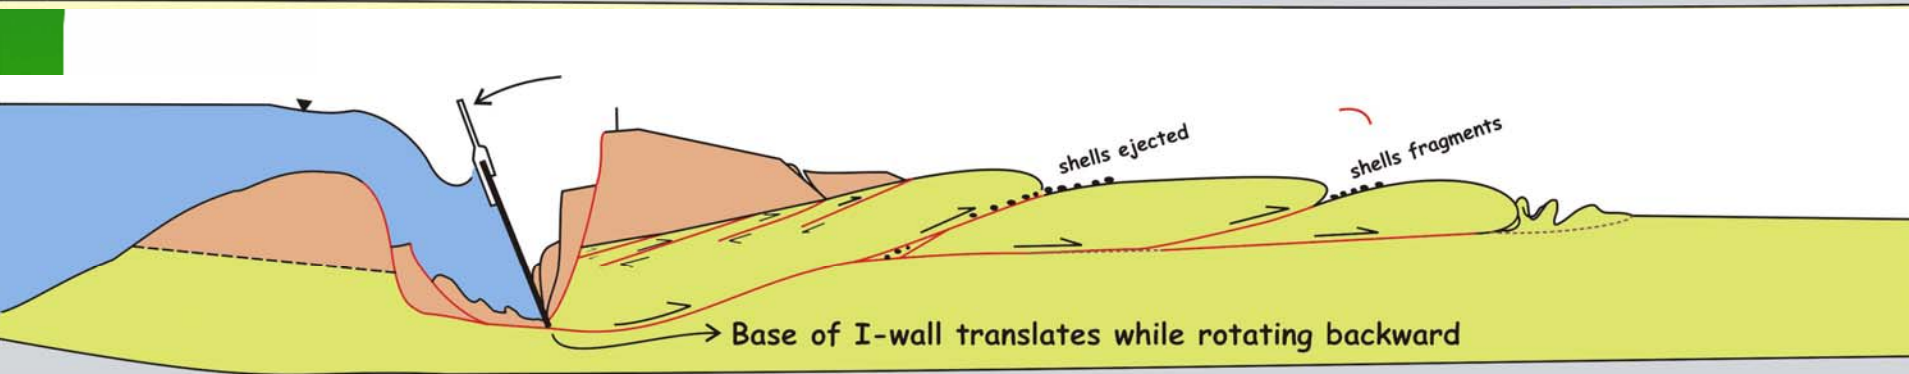
- **Progression of translational failure sequence. Multiple thrust sheets develop in partially saturated crust, comprised of sandy fill over organic cypress swamp deposits. Buckles like a rug being rolled up.**

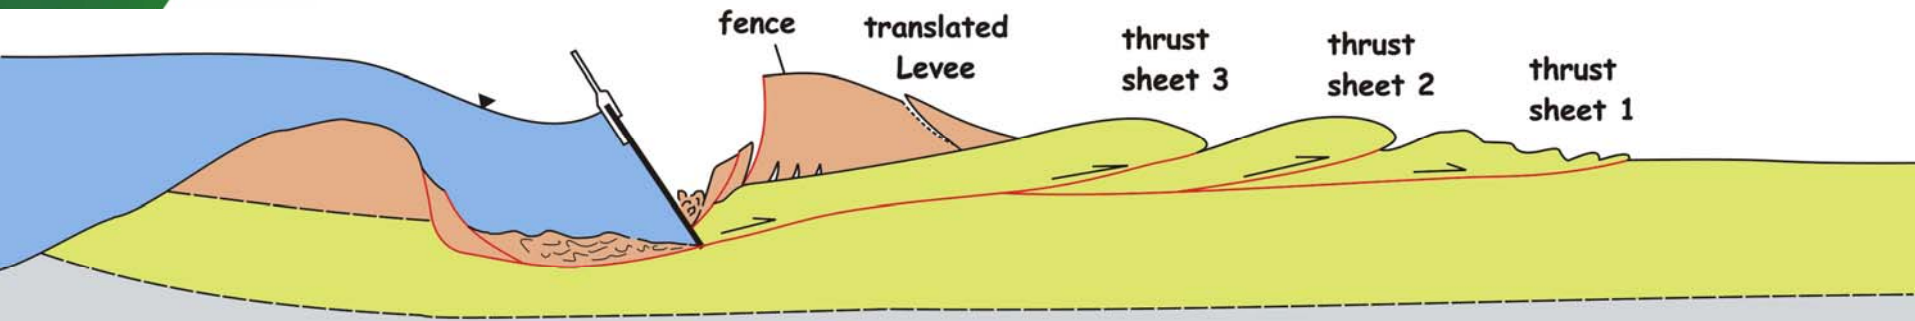
**Some sheetpile supported I-walls fell backward; others fell forward**

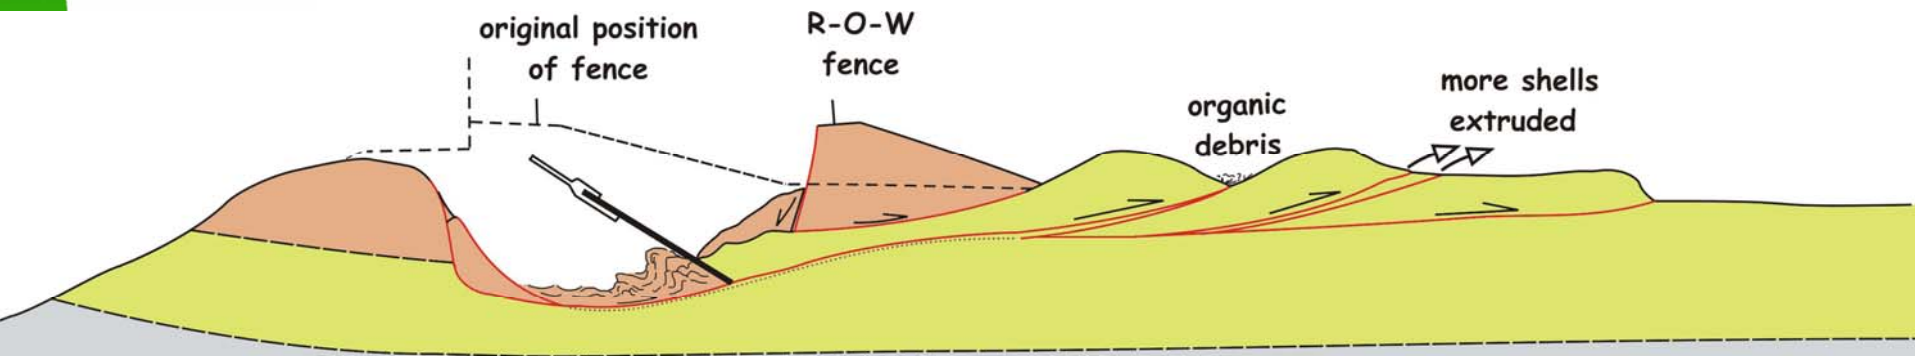
- **Final stages of translational failure sequence. Lower section shows failed levee after 51 feet of displacement. The void was quickly backfilled with gravel as part of sealing the breach.**

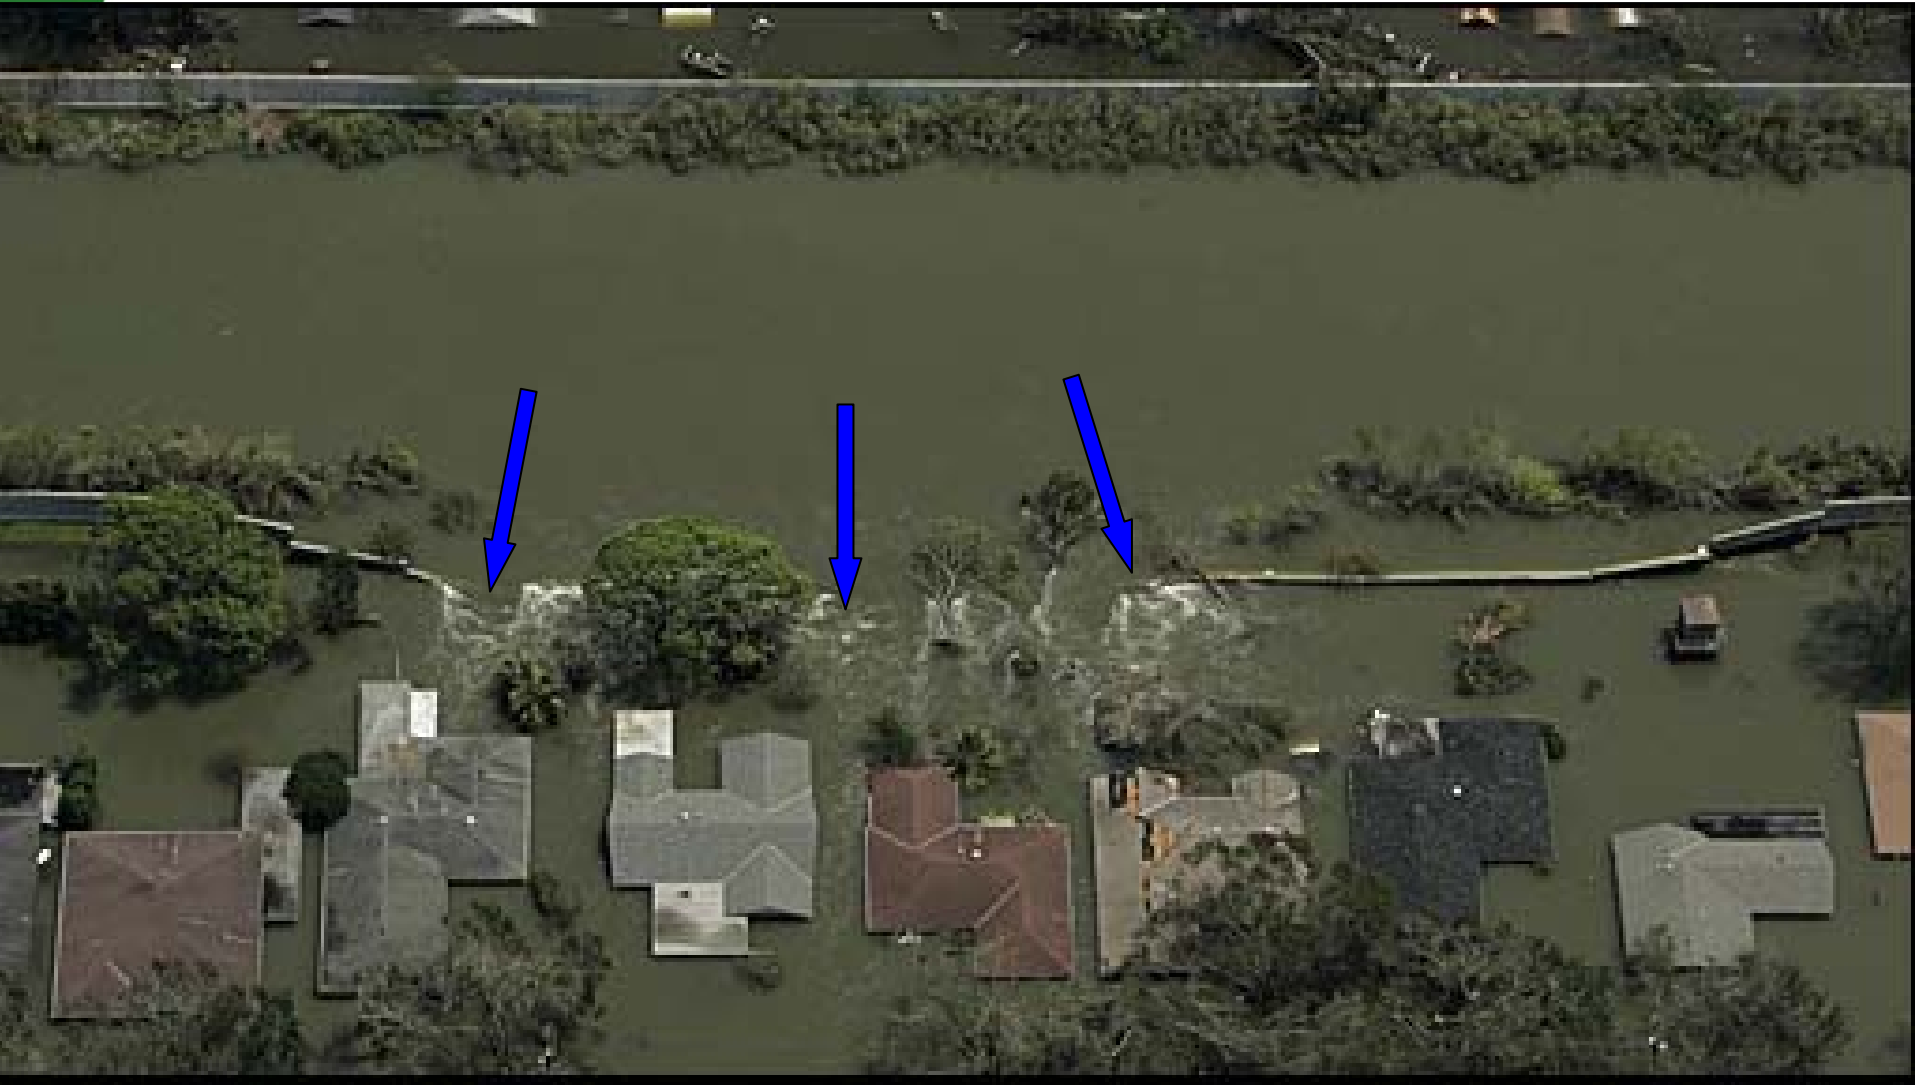
# London Avenue (North) breach

**Similar failure mechanism as 17<sup>th</sup> St Canal**

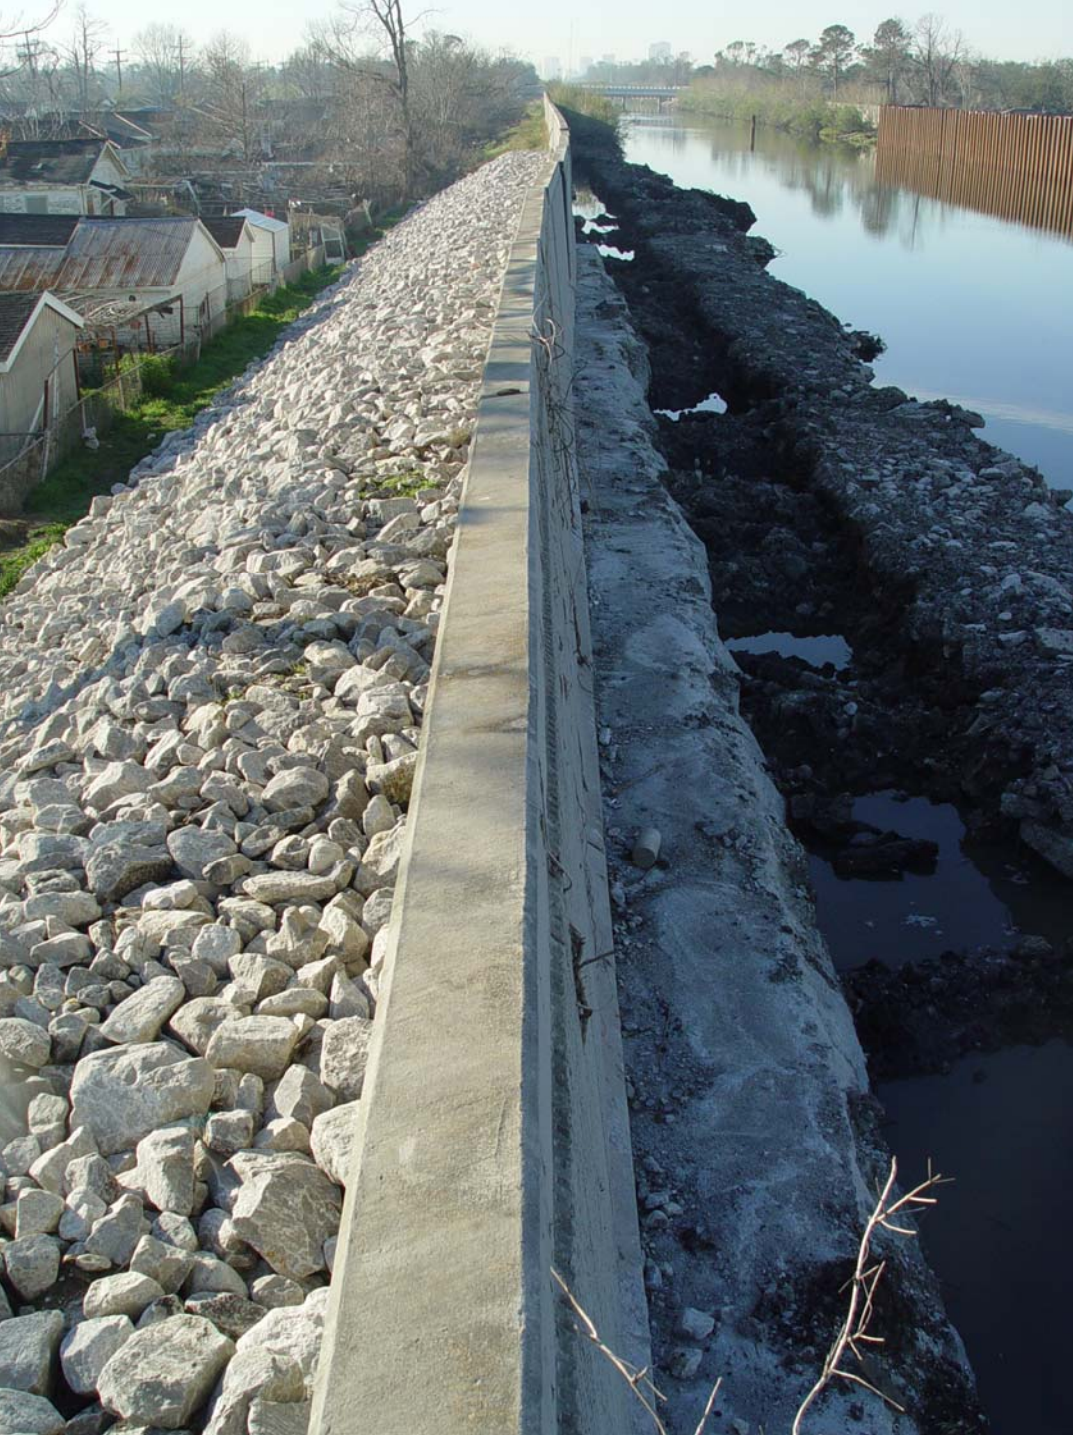
- **Tilted flood wall opposite the London Avenue North breach, at Robert E. Lee Blvd.**
- **Forensic scientists learn more from a partial failure than a complete one, because much of the critical evidence remains**
