# UNRAVELLING THE LEVEE FAILURES IN NEW ORLEANS DURING HURRICANE KATRINA – WHAT WE ALL SHOULD KNOW

**J. David Rogers, Ph.D., P.E., R.G.**

Member, National Science Foundation Independent Levee Investigation Team and  
Karl F. Hasselmann Chair in Geological Engineering  
University of Missouri-Rolla

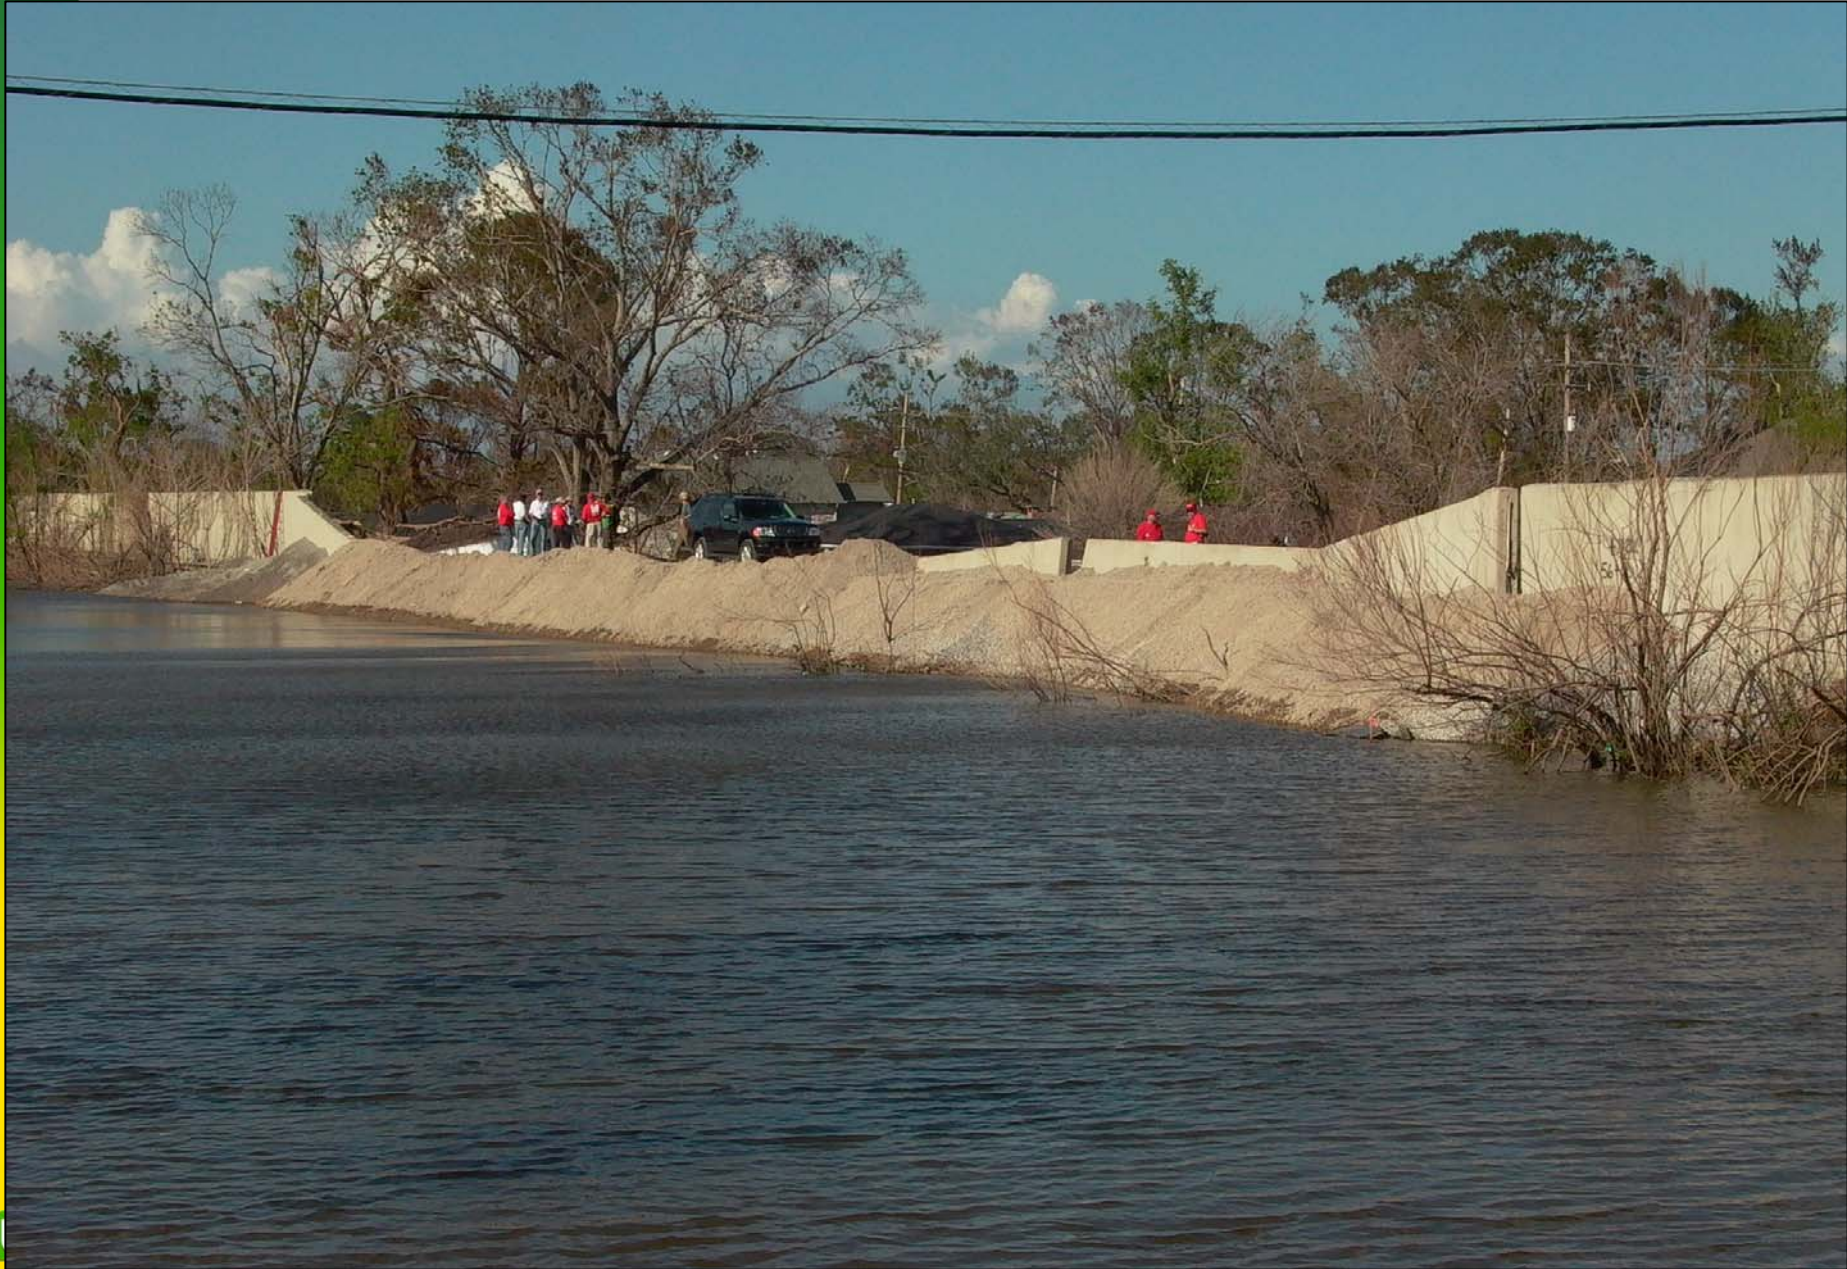
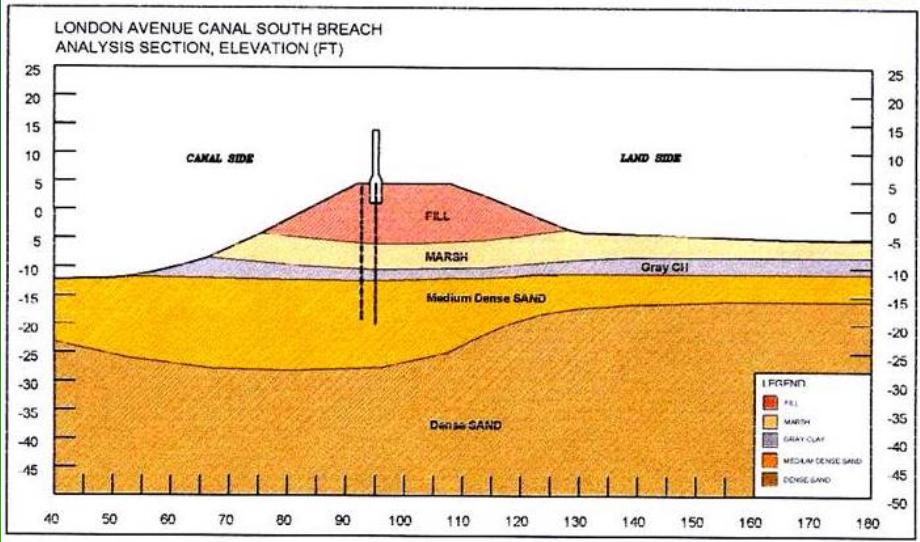
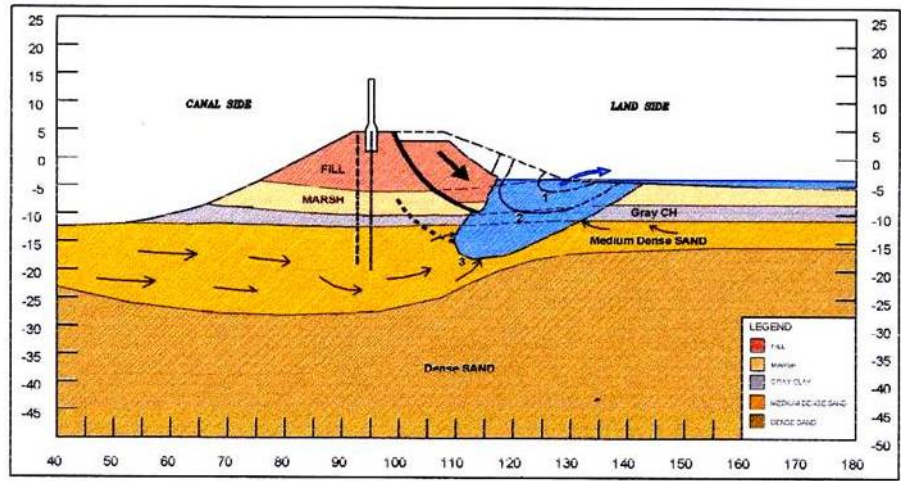
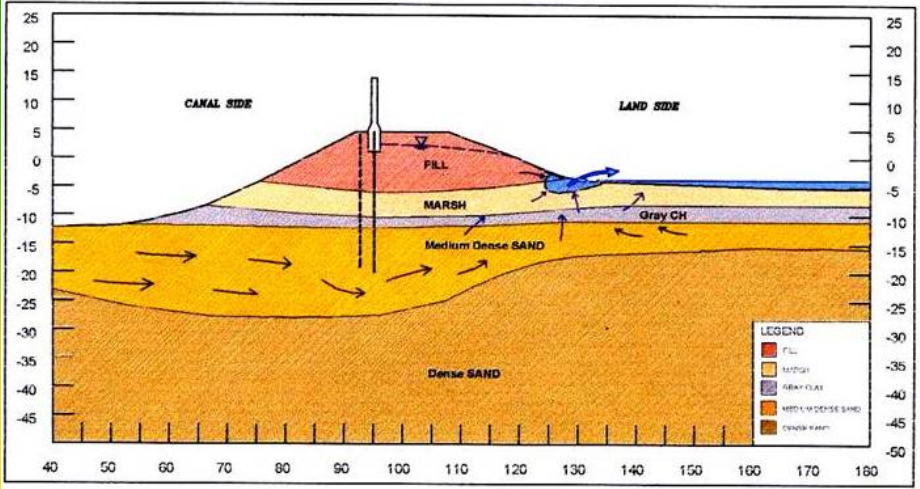
# London Avenue (South) breach

The South Breach of the London Avenue Canal was caused by **excess seepage pressures** developed in the sand underlying the canal, which had been dredged

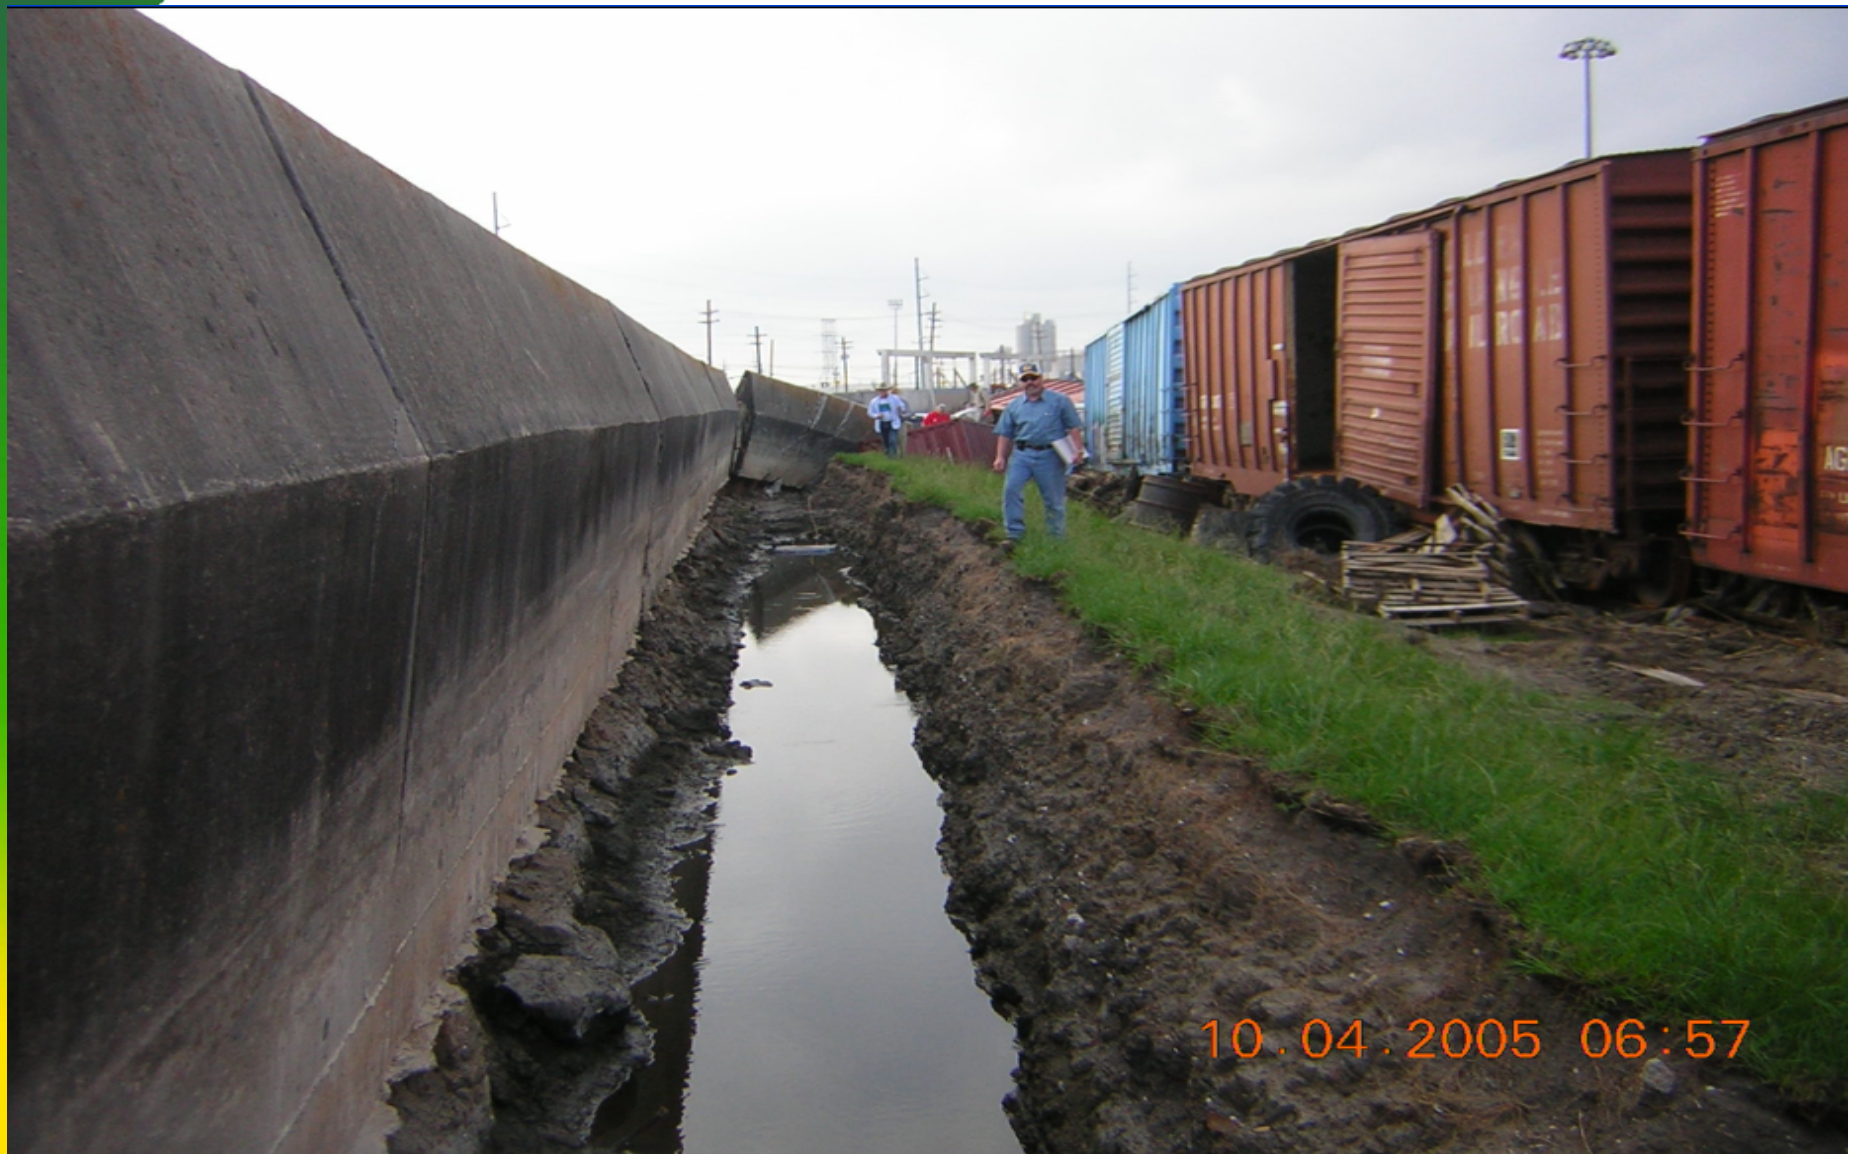
- **Overtopping scour holes along landside of flood wall on west side of the IHNC. Note broken wall in background. A splash pad on inboard side could have prevented this failure mode.**

Protective **concrete splash pads** would have protected the I-walls for about 0.5 % of the I-wall construction cost. They are being retrofitted to the flood walls. This is a cost-effective measure.

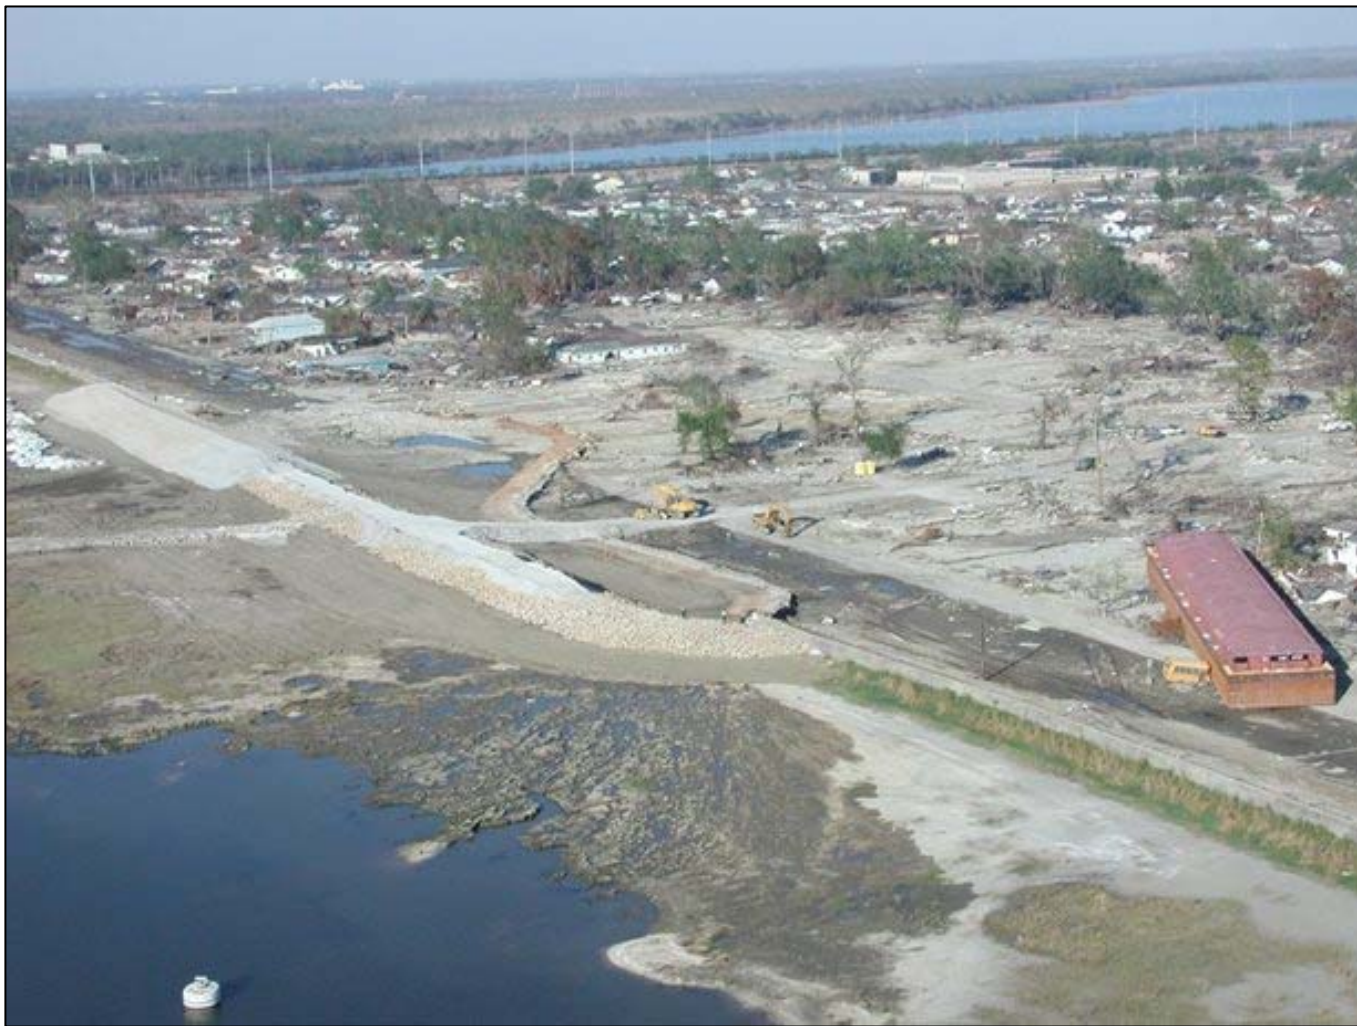
- **Seepage crevasse splay** exposed on the water side of the east levee of the IHNC breach after Hurricanes Katrina and Rita. **This same section of the IHNC levee failed in 1965 during Hurricane Betsy.**
- Note the **anomalous seepage** in lower foreground, which suggests much higher permeability in this particular portion of the dike, close to the south end of the failed section.
