# **Levee Design Issues revealed by Post- Katrina Studies in Louisiana**

**J. David Rogers, Ph.D., P.E., P.G.**

**American Society of Civil Engineers**

**Central Pennsylvania Geotechnical Conference**

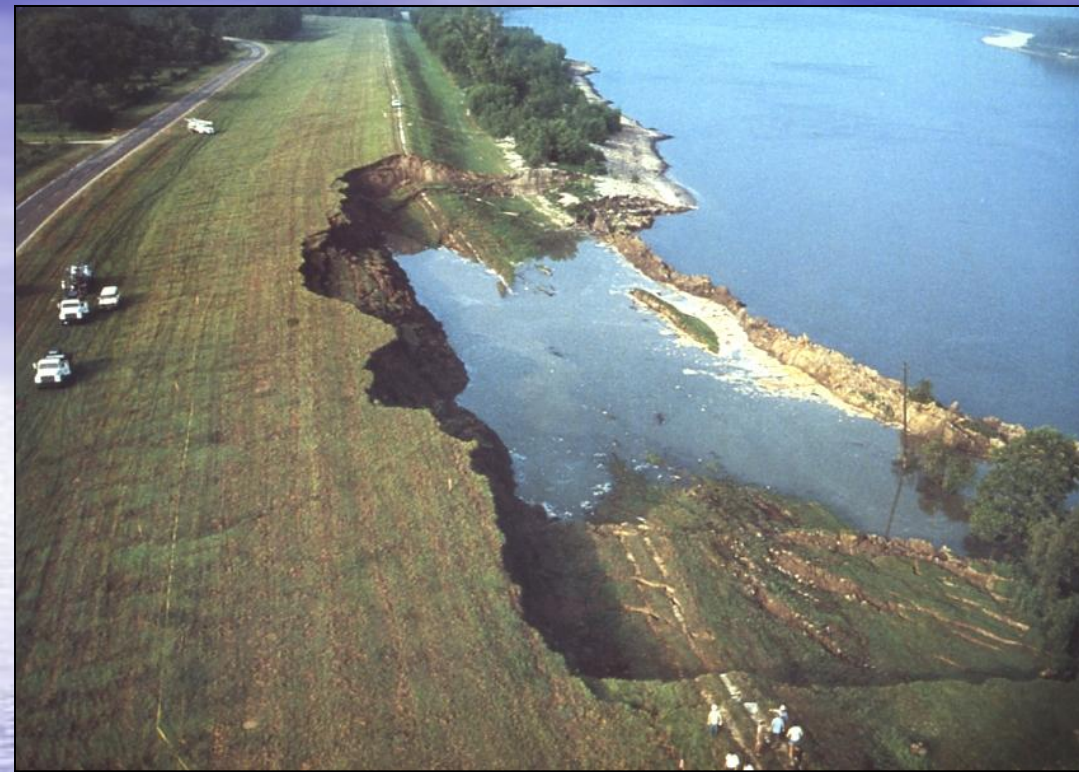
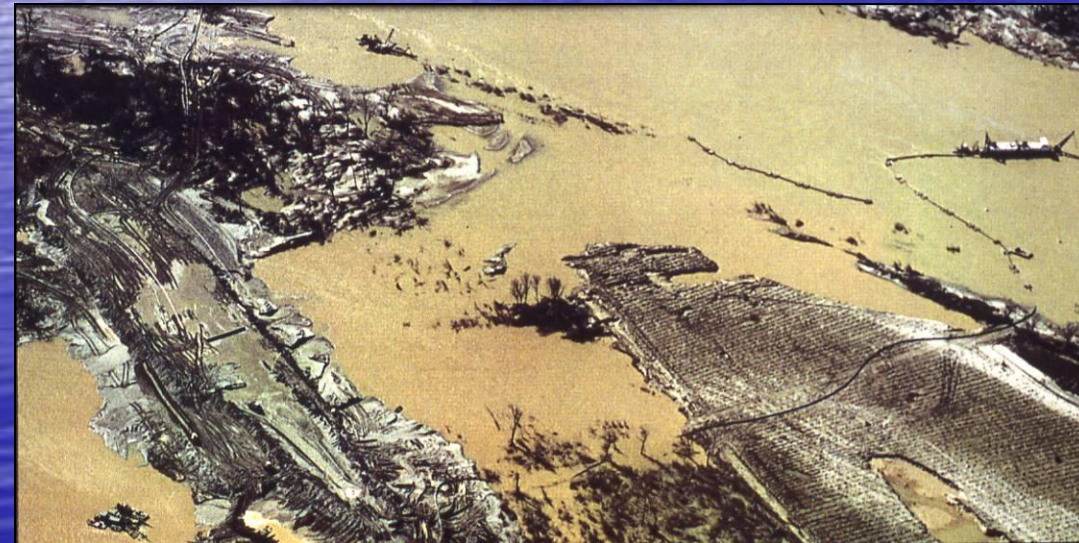
- 700 ft section of levee that slid into the Mississippi River on August 23, 1983 at Darrow, in Ascension Parrish, LA. The slide occurred shortly after a high water stage had receded, suggesting that toe undercutting & rapid drawdown likely contributed to the failure.
- After the MR&T Project was quasi completed in 1960, occasional levee failures have occurred because of **underseepage problems, toe scour, and overtopping**

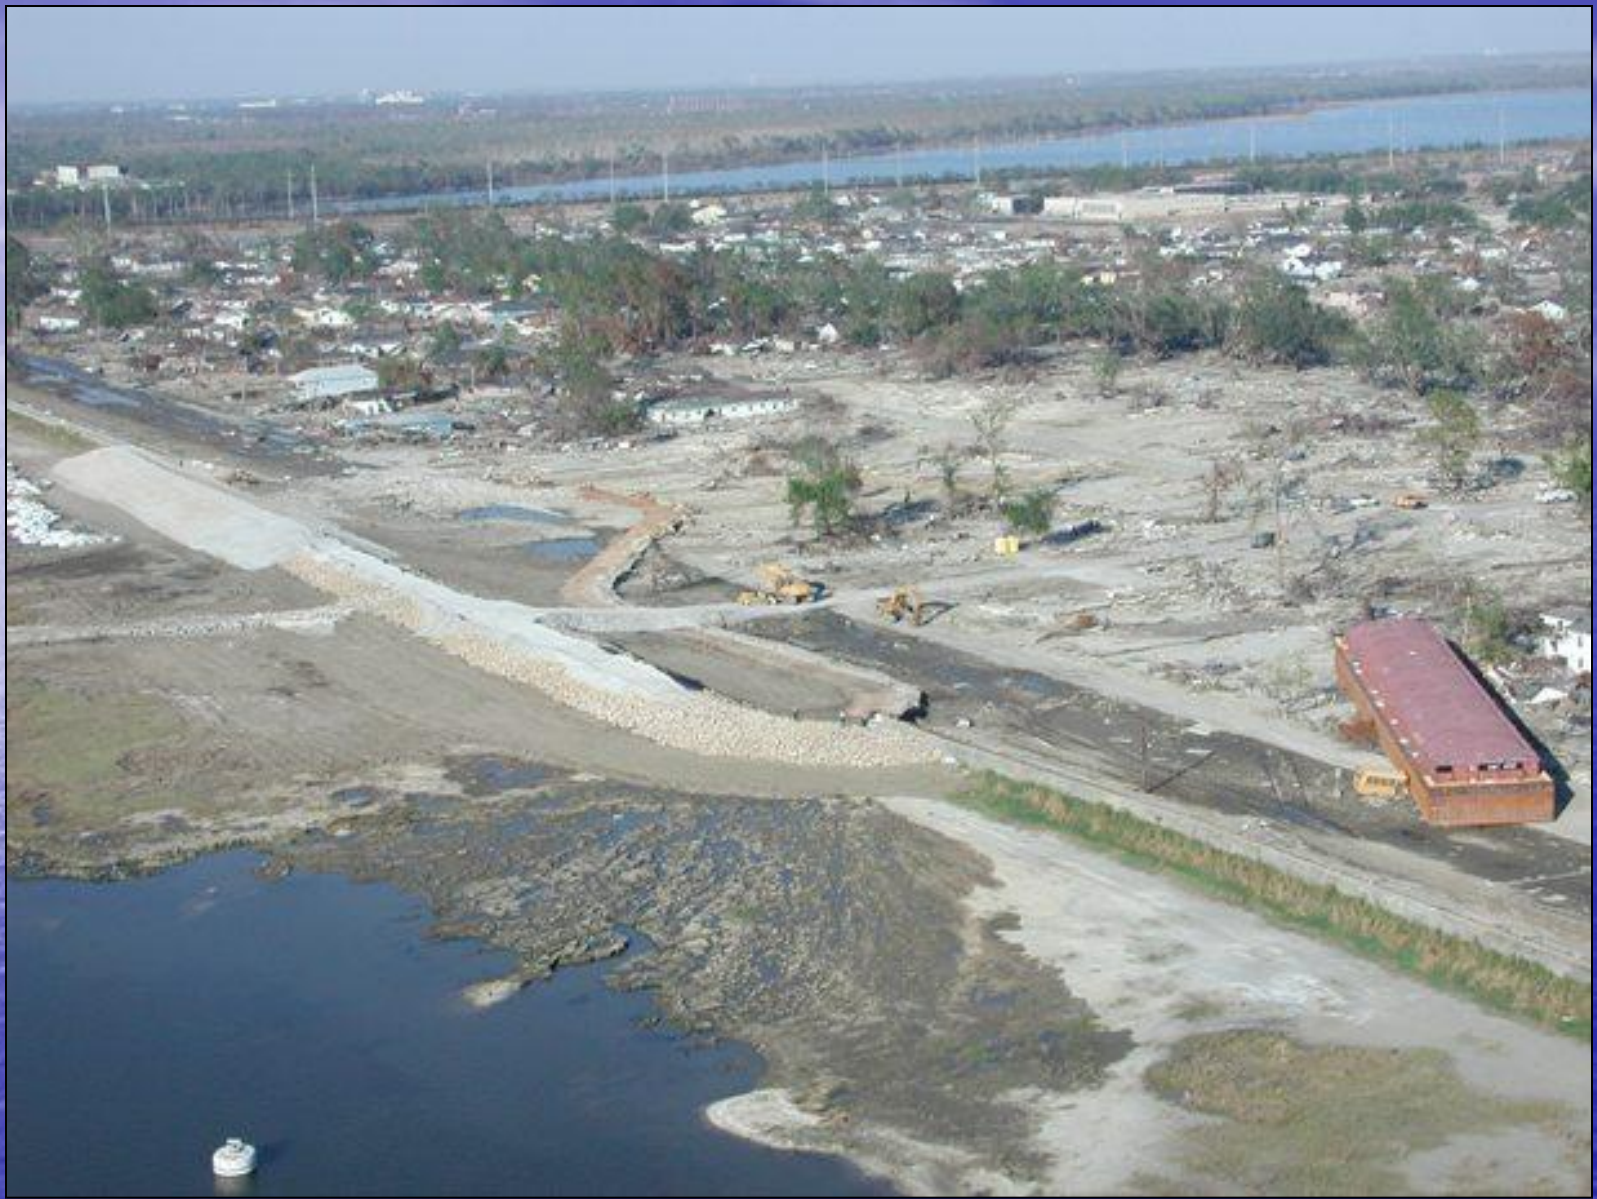
**Seepage crevasse** exposed at the east levee of the IHNC breach after Hurricanes Katrina and Rita

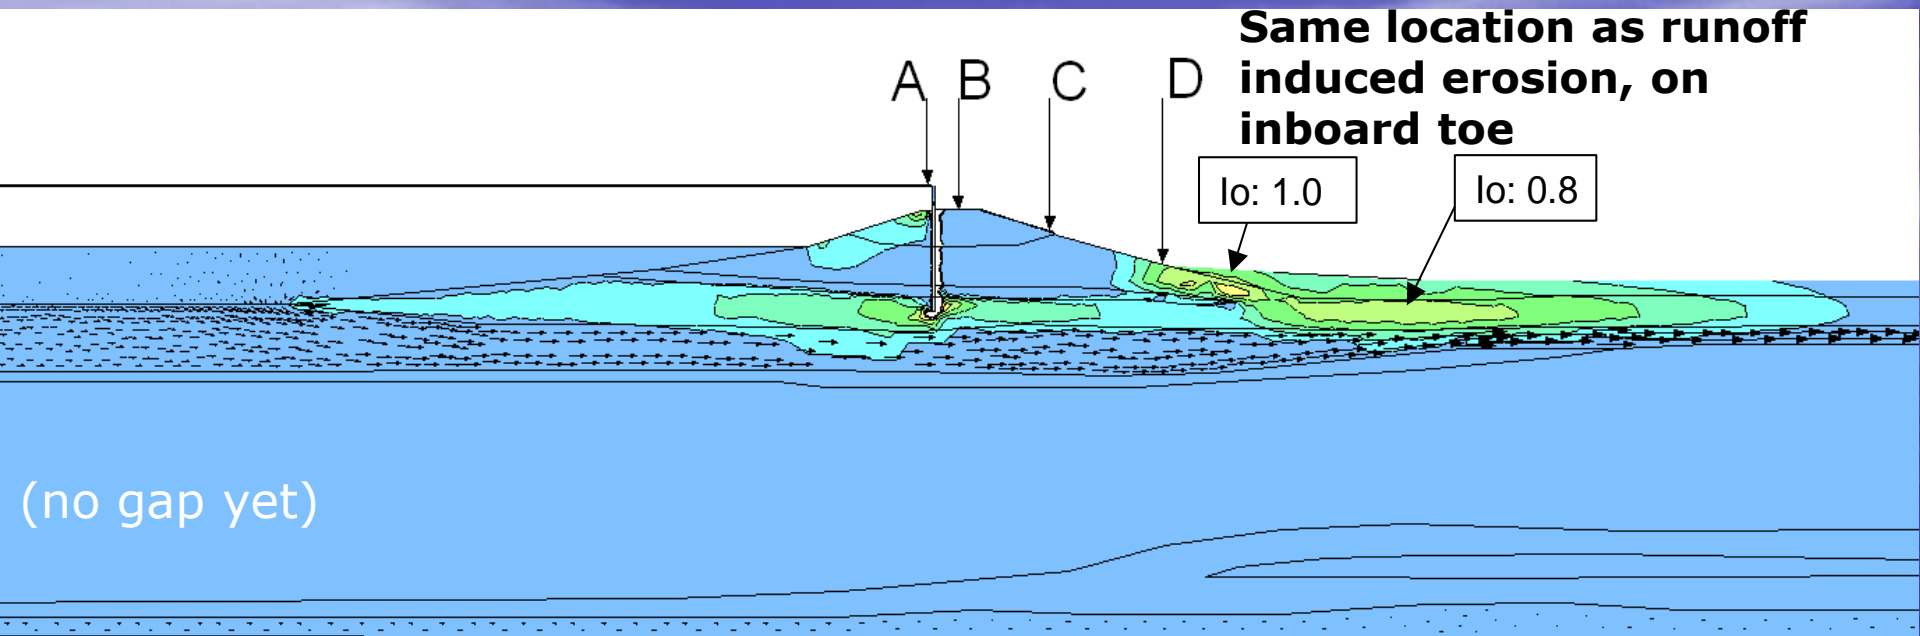
- Hydraulic gradients for the south breach on IHNC east bank; storm surge at 14.4ft (MSL). Maximum exit gradient at the levee toe is  $i_o \approx 0.8$  to 1.0, at threshold for hydraulic piping.
- This may help to explain the persistent wet spot noted on the backfill of the Jourdan Avenue conduit backfill for weeks afterward.

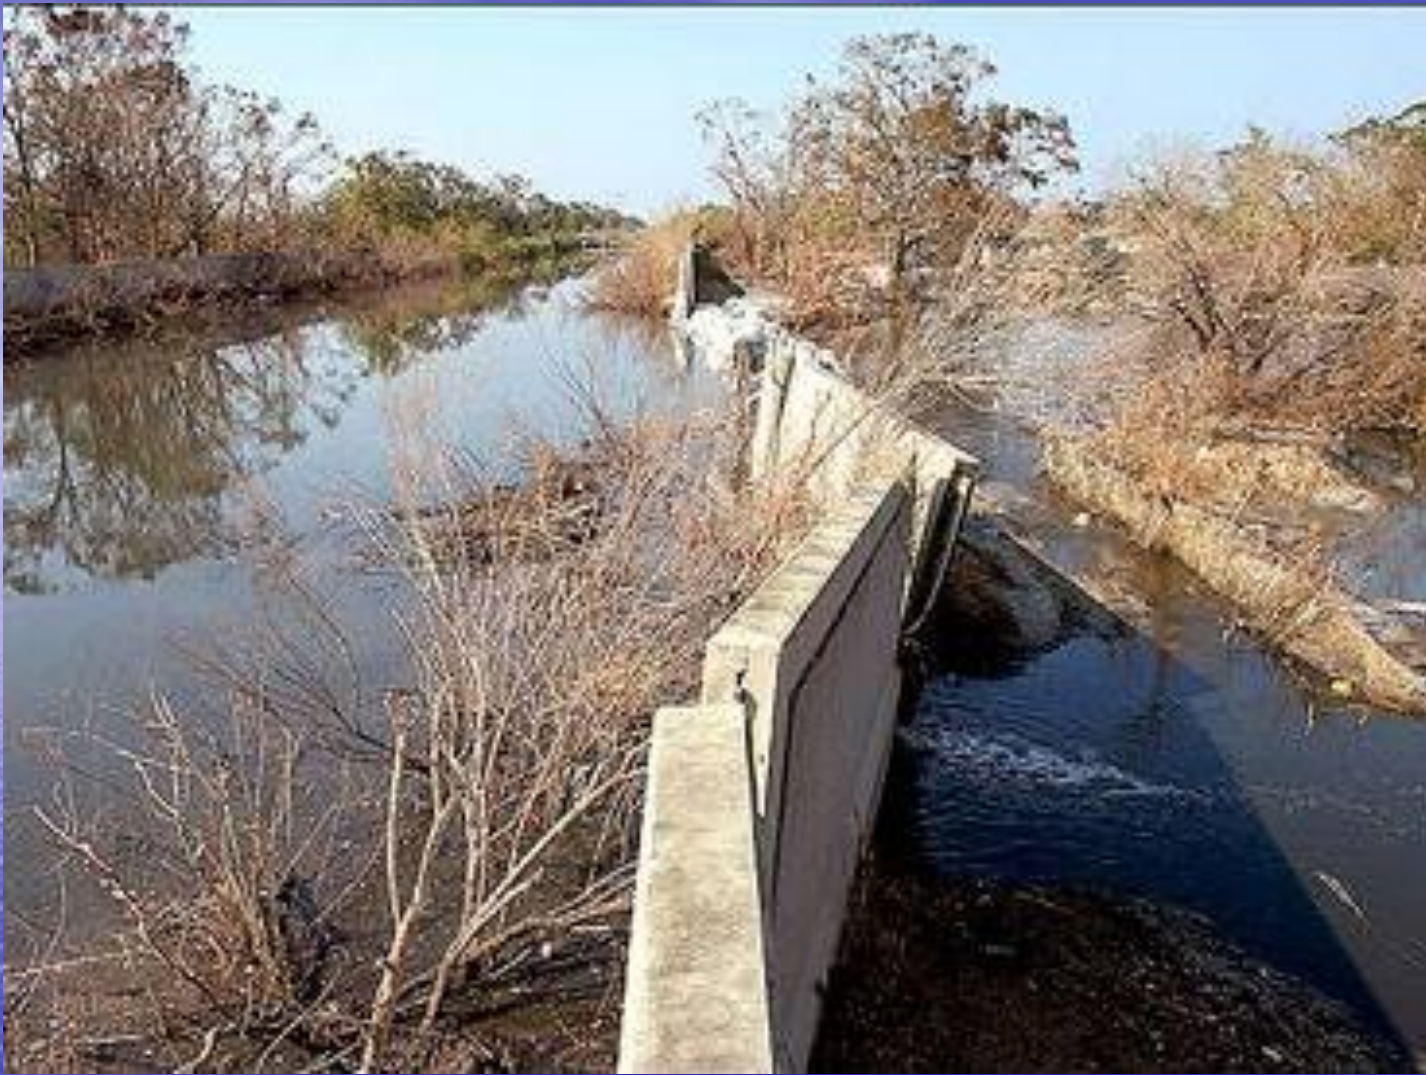
**London Ave Canal – Filmore Breach**

**Deflected flood wall along the London Avenue Drainage Canal in New Orleans. This failure was driven by excessive transient pore pressures developed in the underlying Pine Island Sands.**

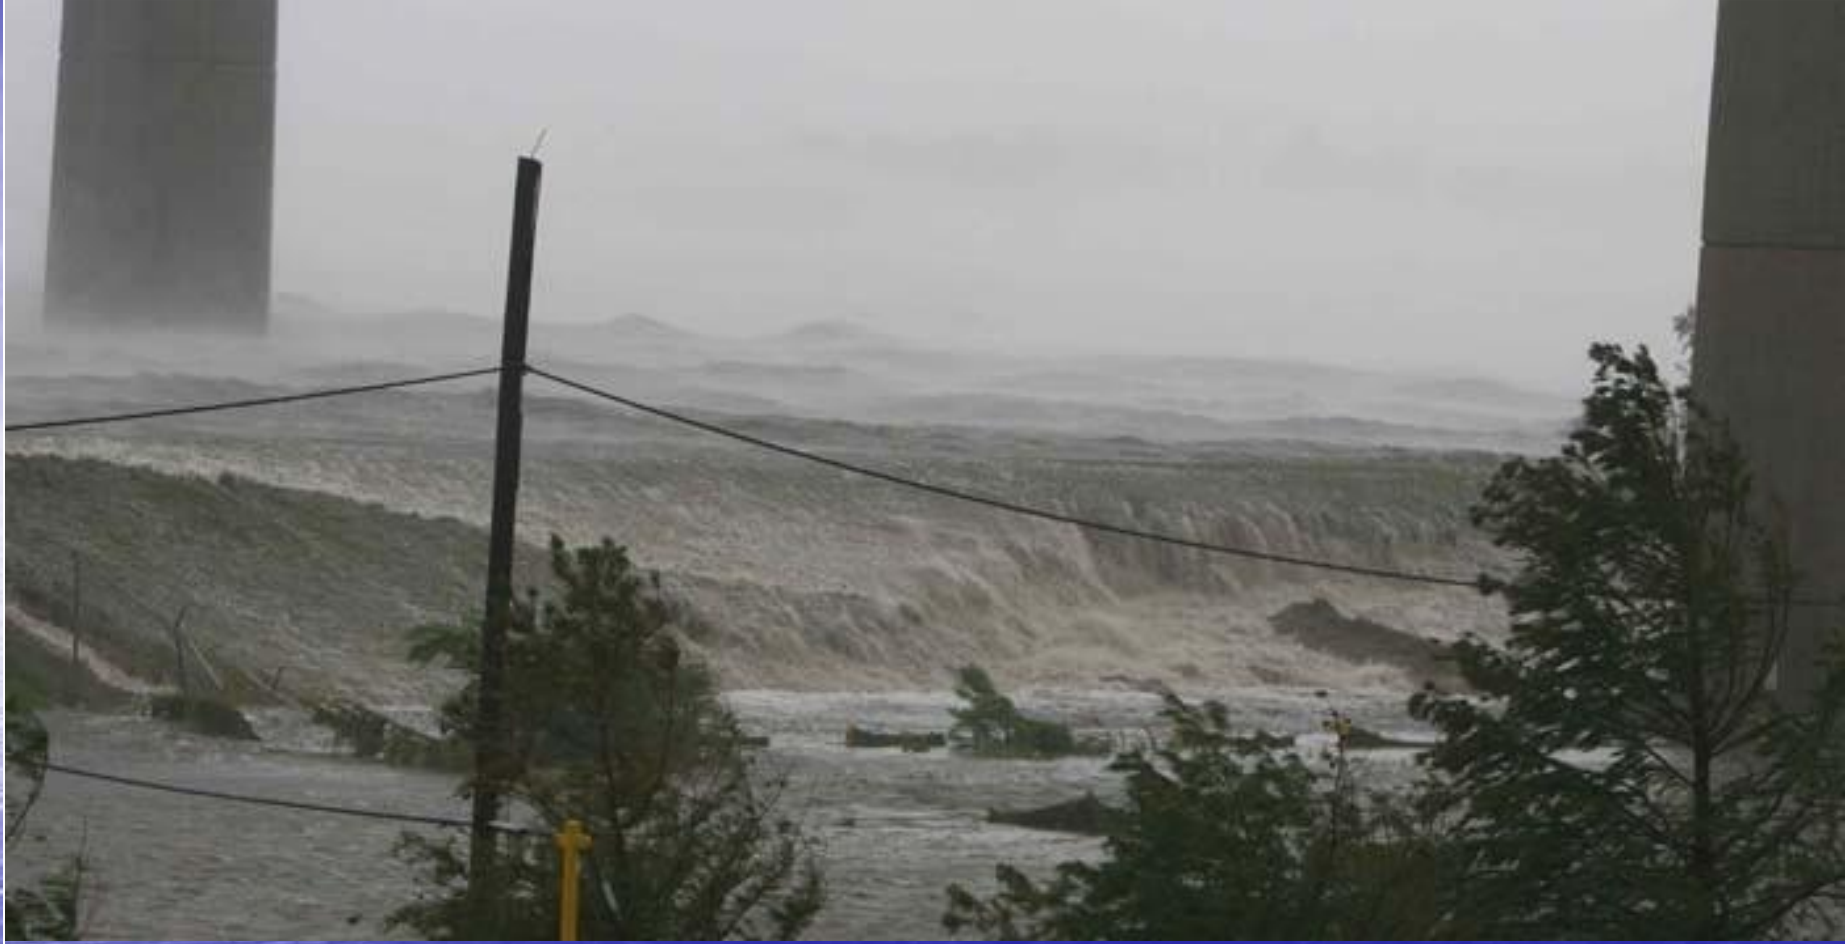
- **Overtopping:** Earthen levee being overtopped at the Entergy Power Plant along the MRGO/ICWW channel. This began around 6 AM on August 29<sup>th</sup>, 2005. 9 ft storm surge with crest heights up to 17 ft.

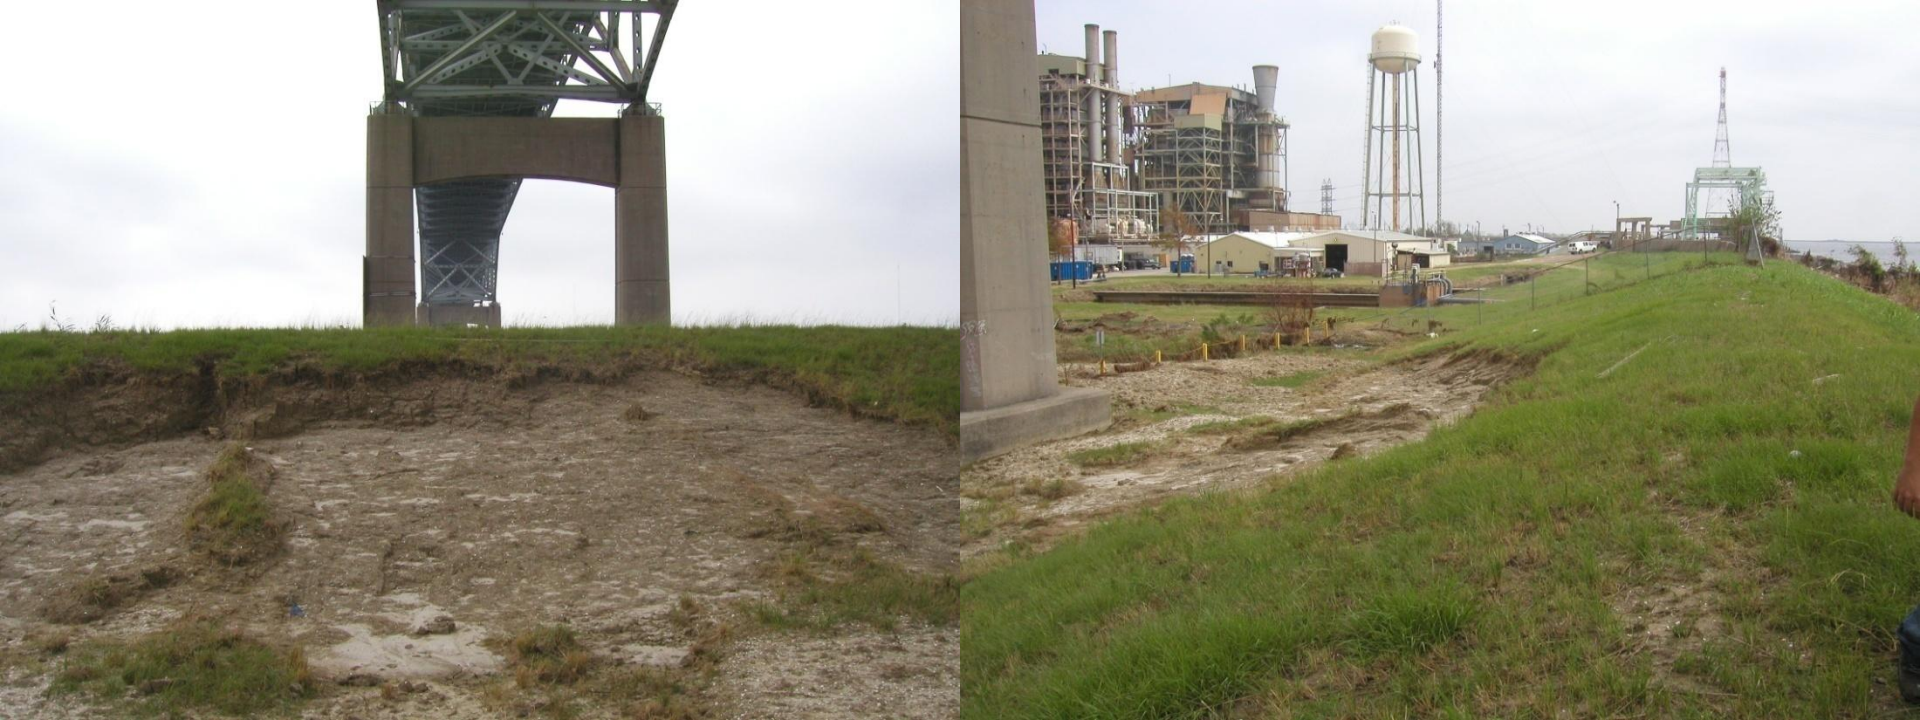
- **Resilient structures:** The levee protecting the Entergy Power Plant beneath the Route 47/Interstate 310 viaduct over the MRGO/ICWW channel at Michoud survived 8+ hours of overtopping with only moderate erosion.

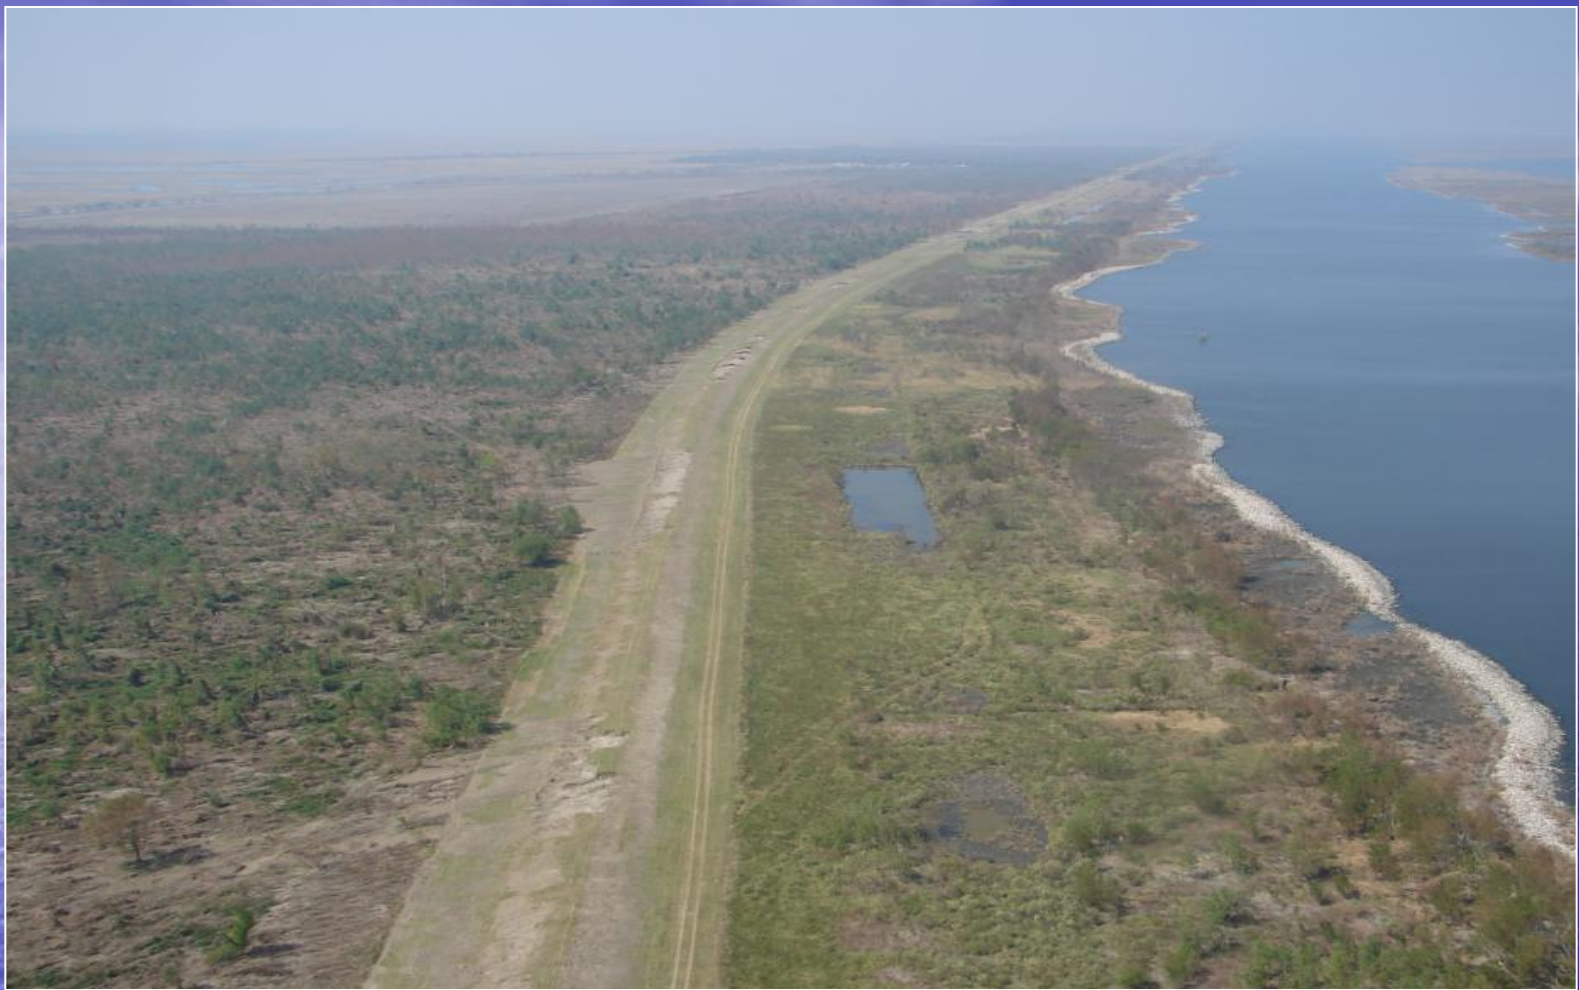
- **Good performance:** some portions of the **Mississippi River Gulf Outlet (MRGO) Channel** survived waves as high as 17 feet, triggered by a 9+ foot storm surge off Lake Borgne (to the right)

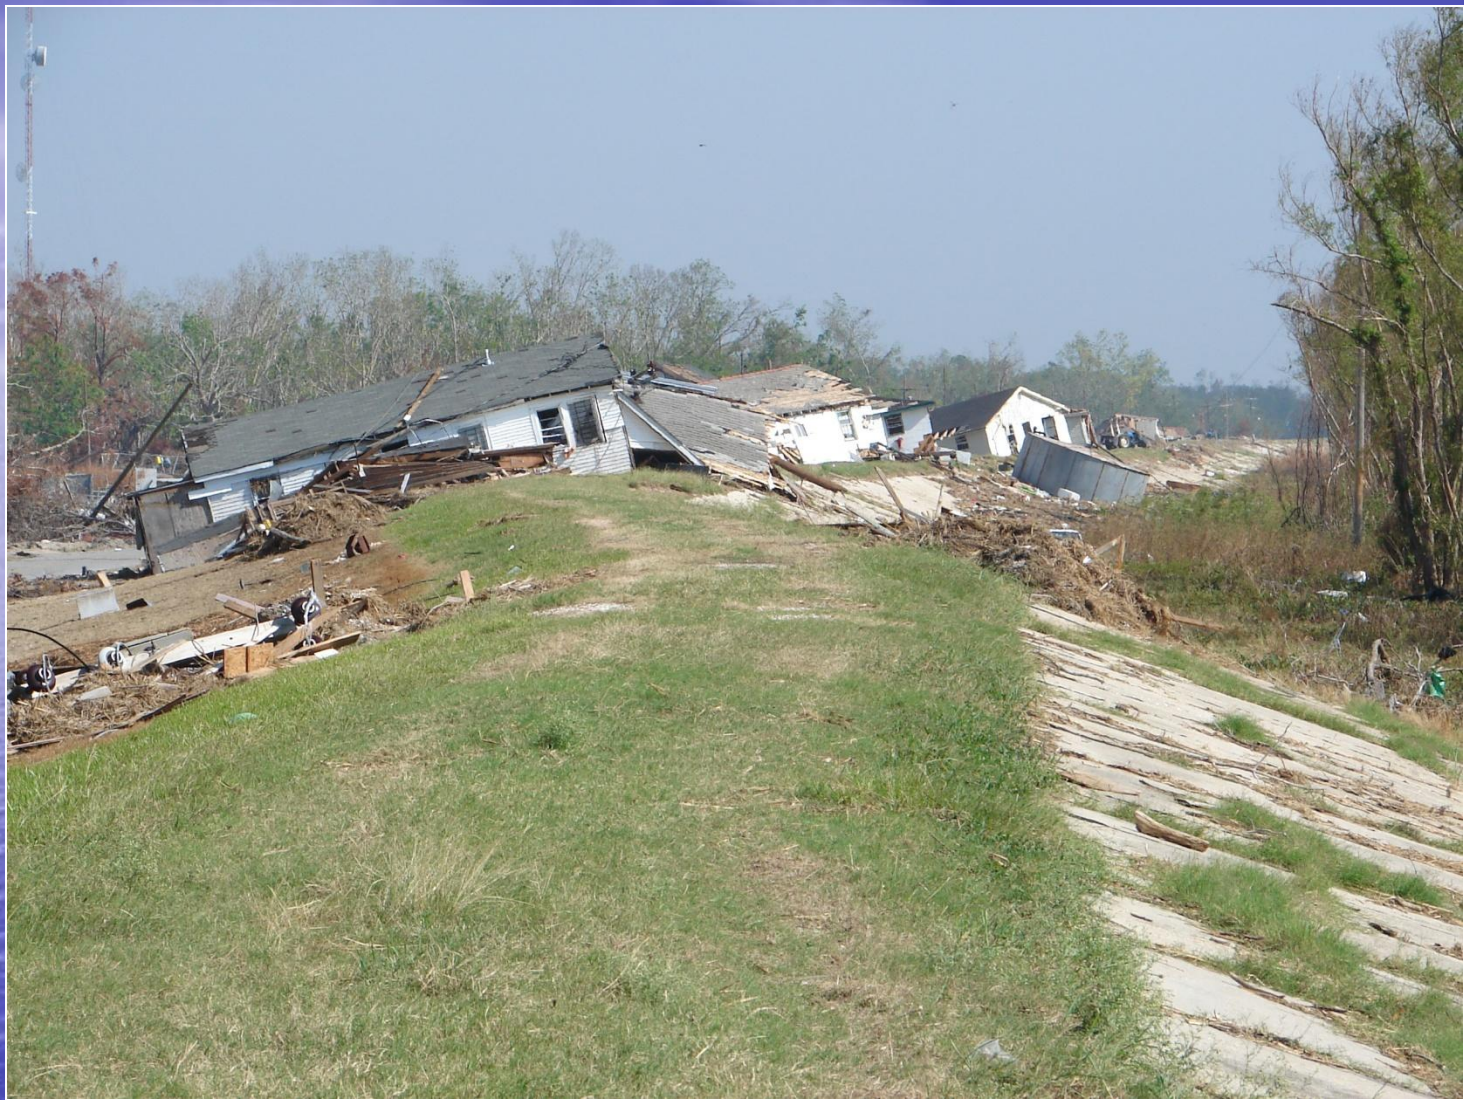
- **Survivable levees:** The storm surge pushed houses up on top of some levees, leaving them scattered about ...

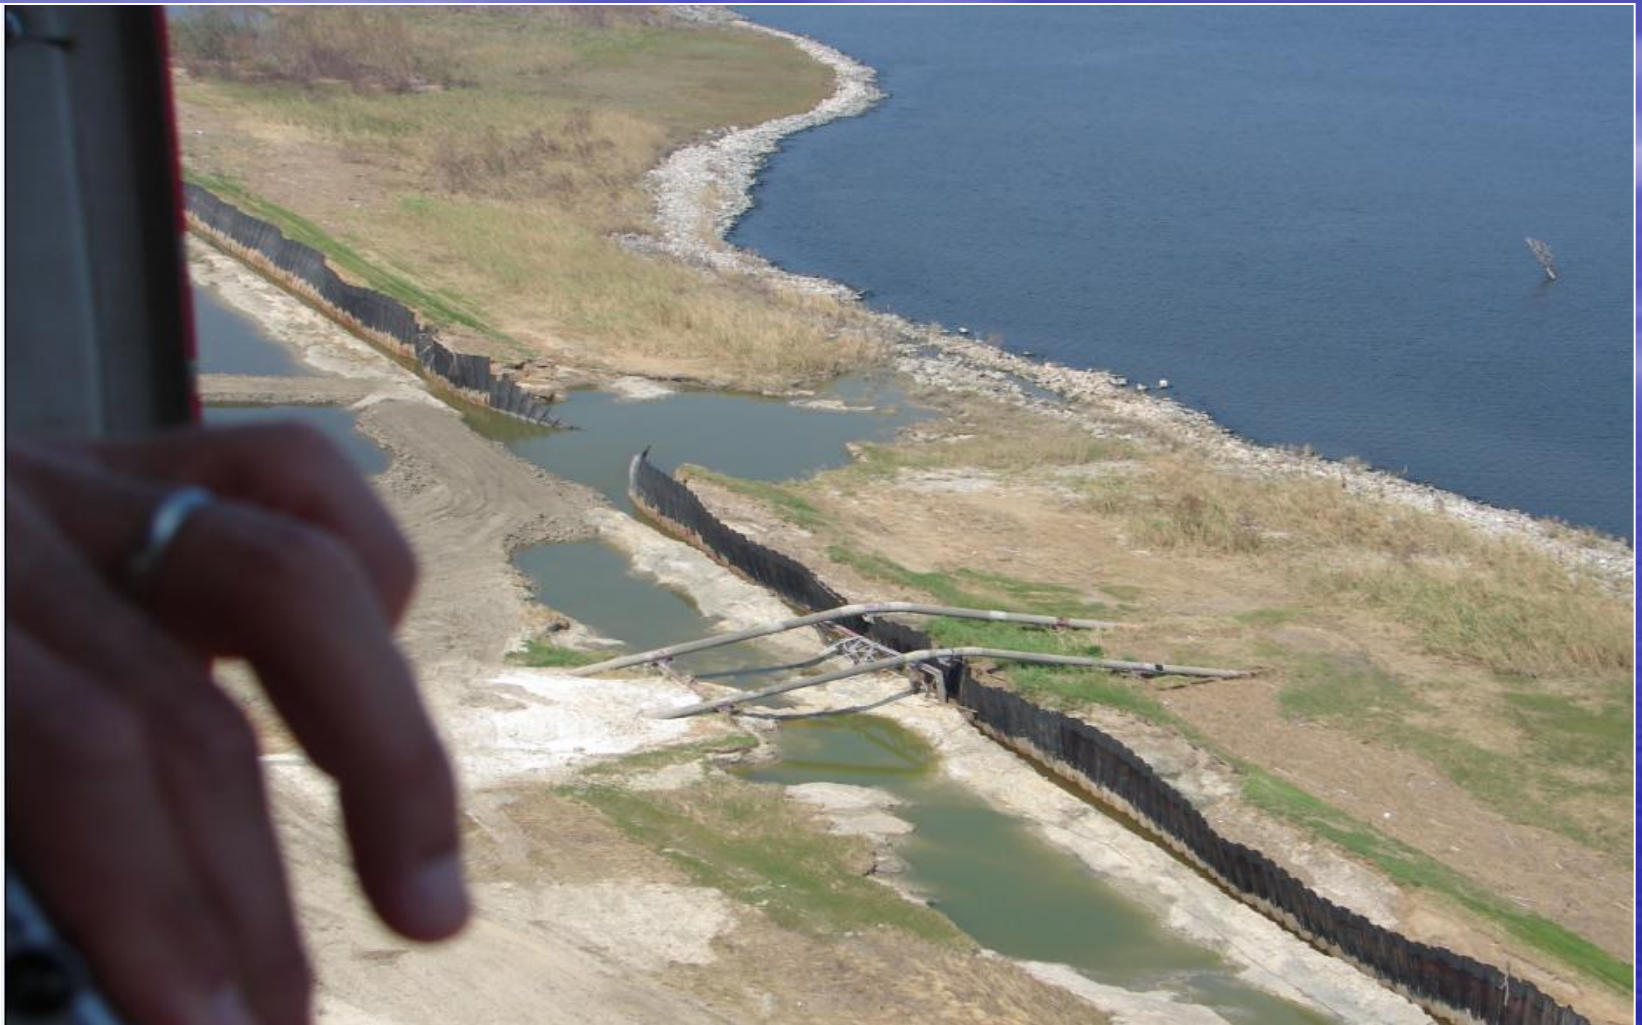
- **Poor performance:** Skeleton of **steel sheetpile cutoff walls** is all that remains of the **MRGO levee** between Bayou Bienvenue and Bayou Dupree

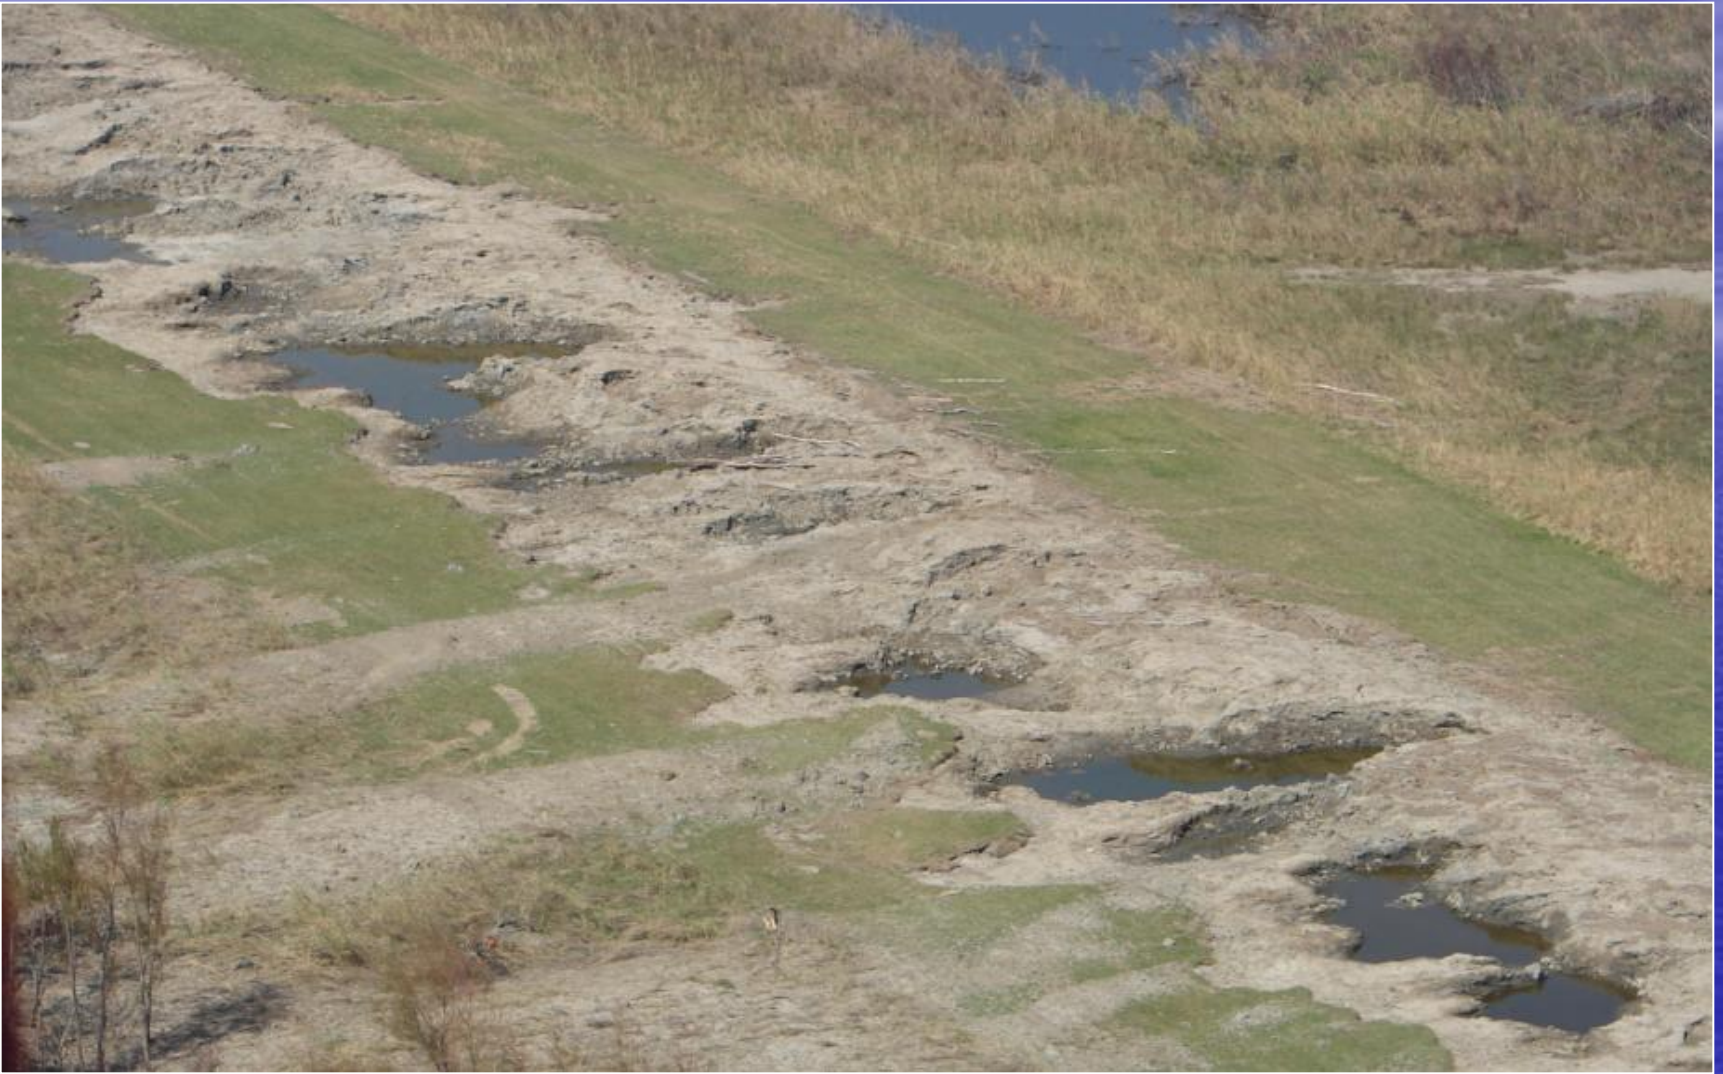
- **Poor performance:** MRGO levee completely washed away, about two miles southeast of Bayou Dupree.

**Cohesionless shell fill is easily eroded by moving water**

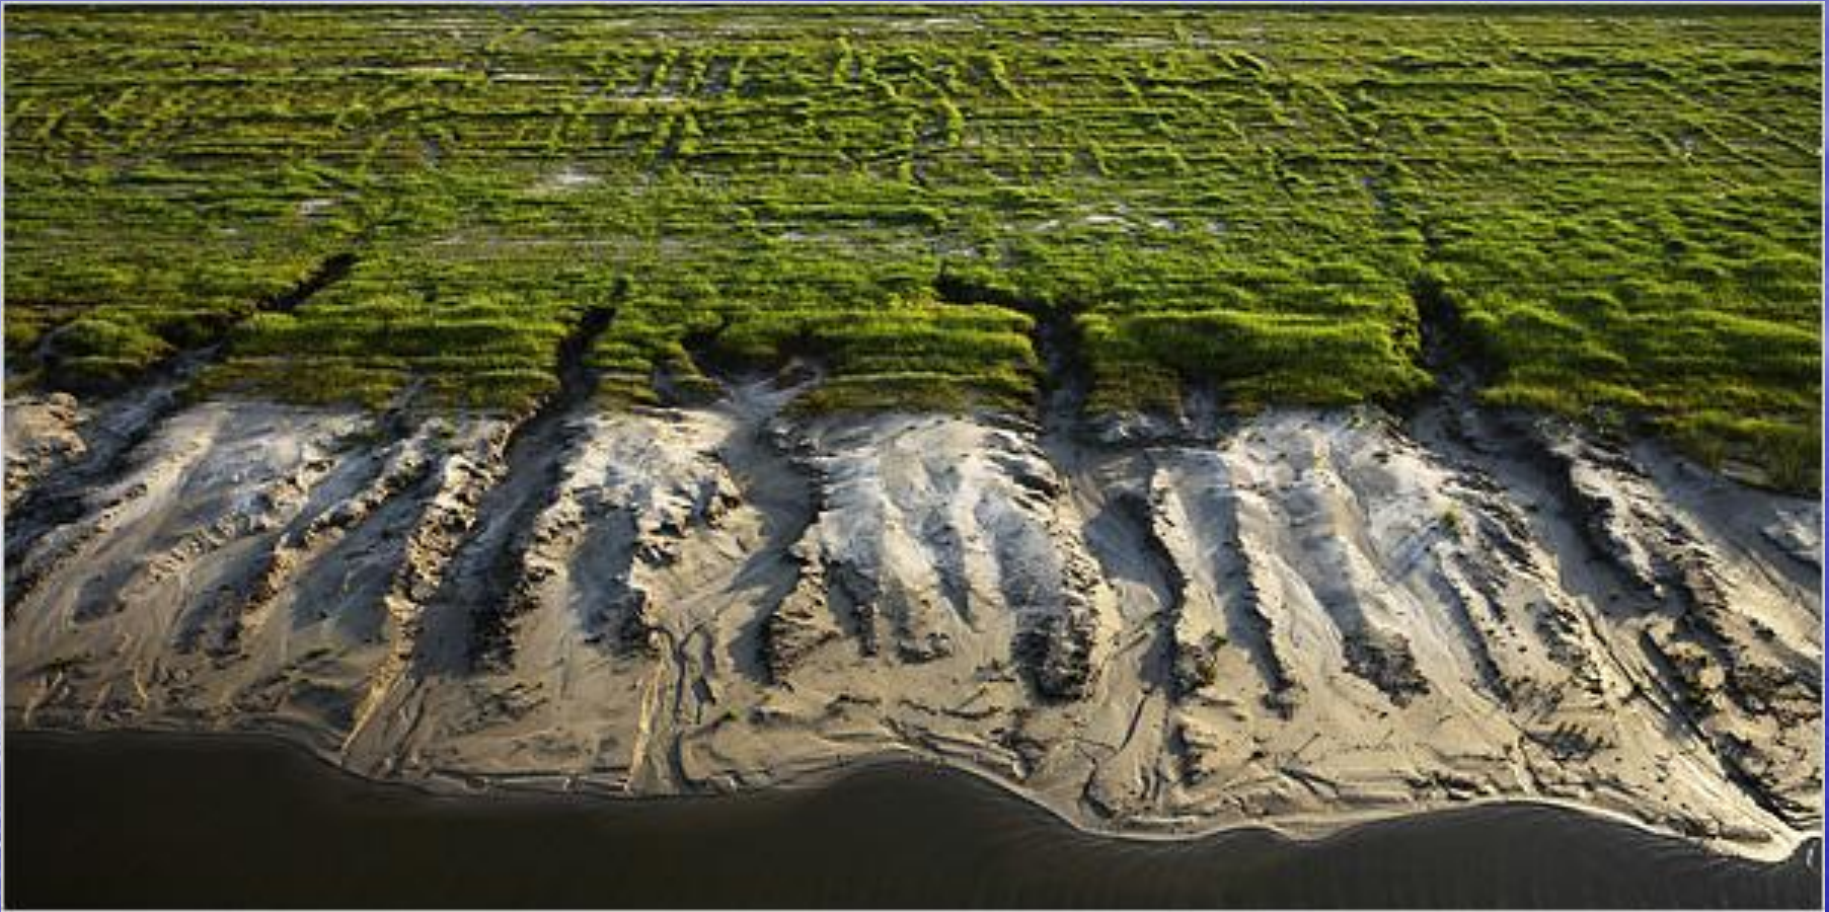
- **Surficial erosion of the outboard toe of embankment bordering a borrow area along the western side of the reconstructed MRGO channel; as seen in 2007. This is suggestive of low cohesion fill.**

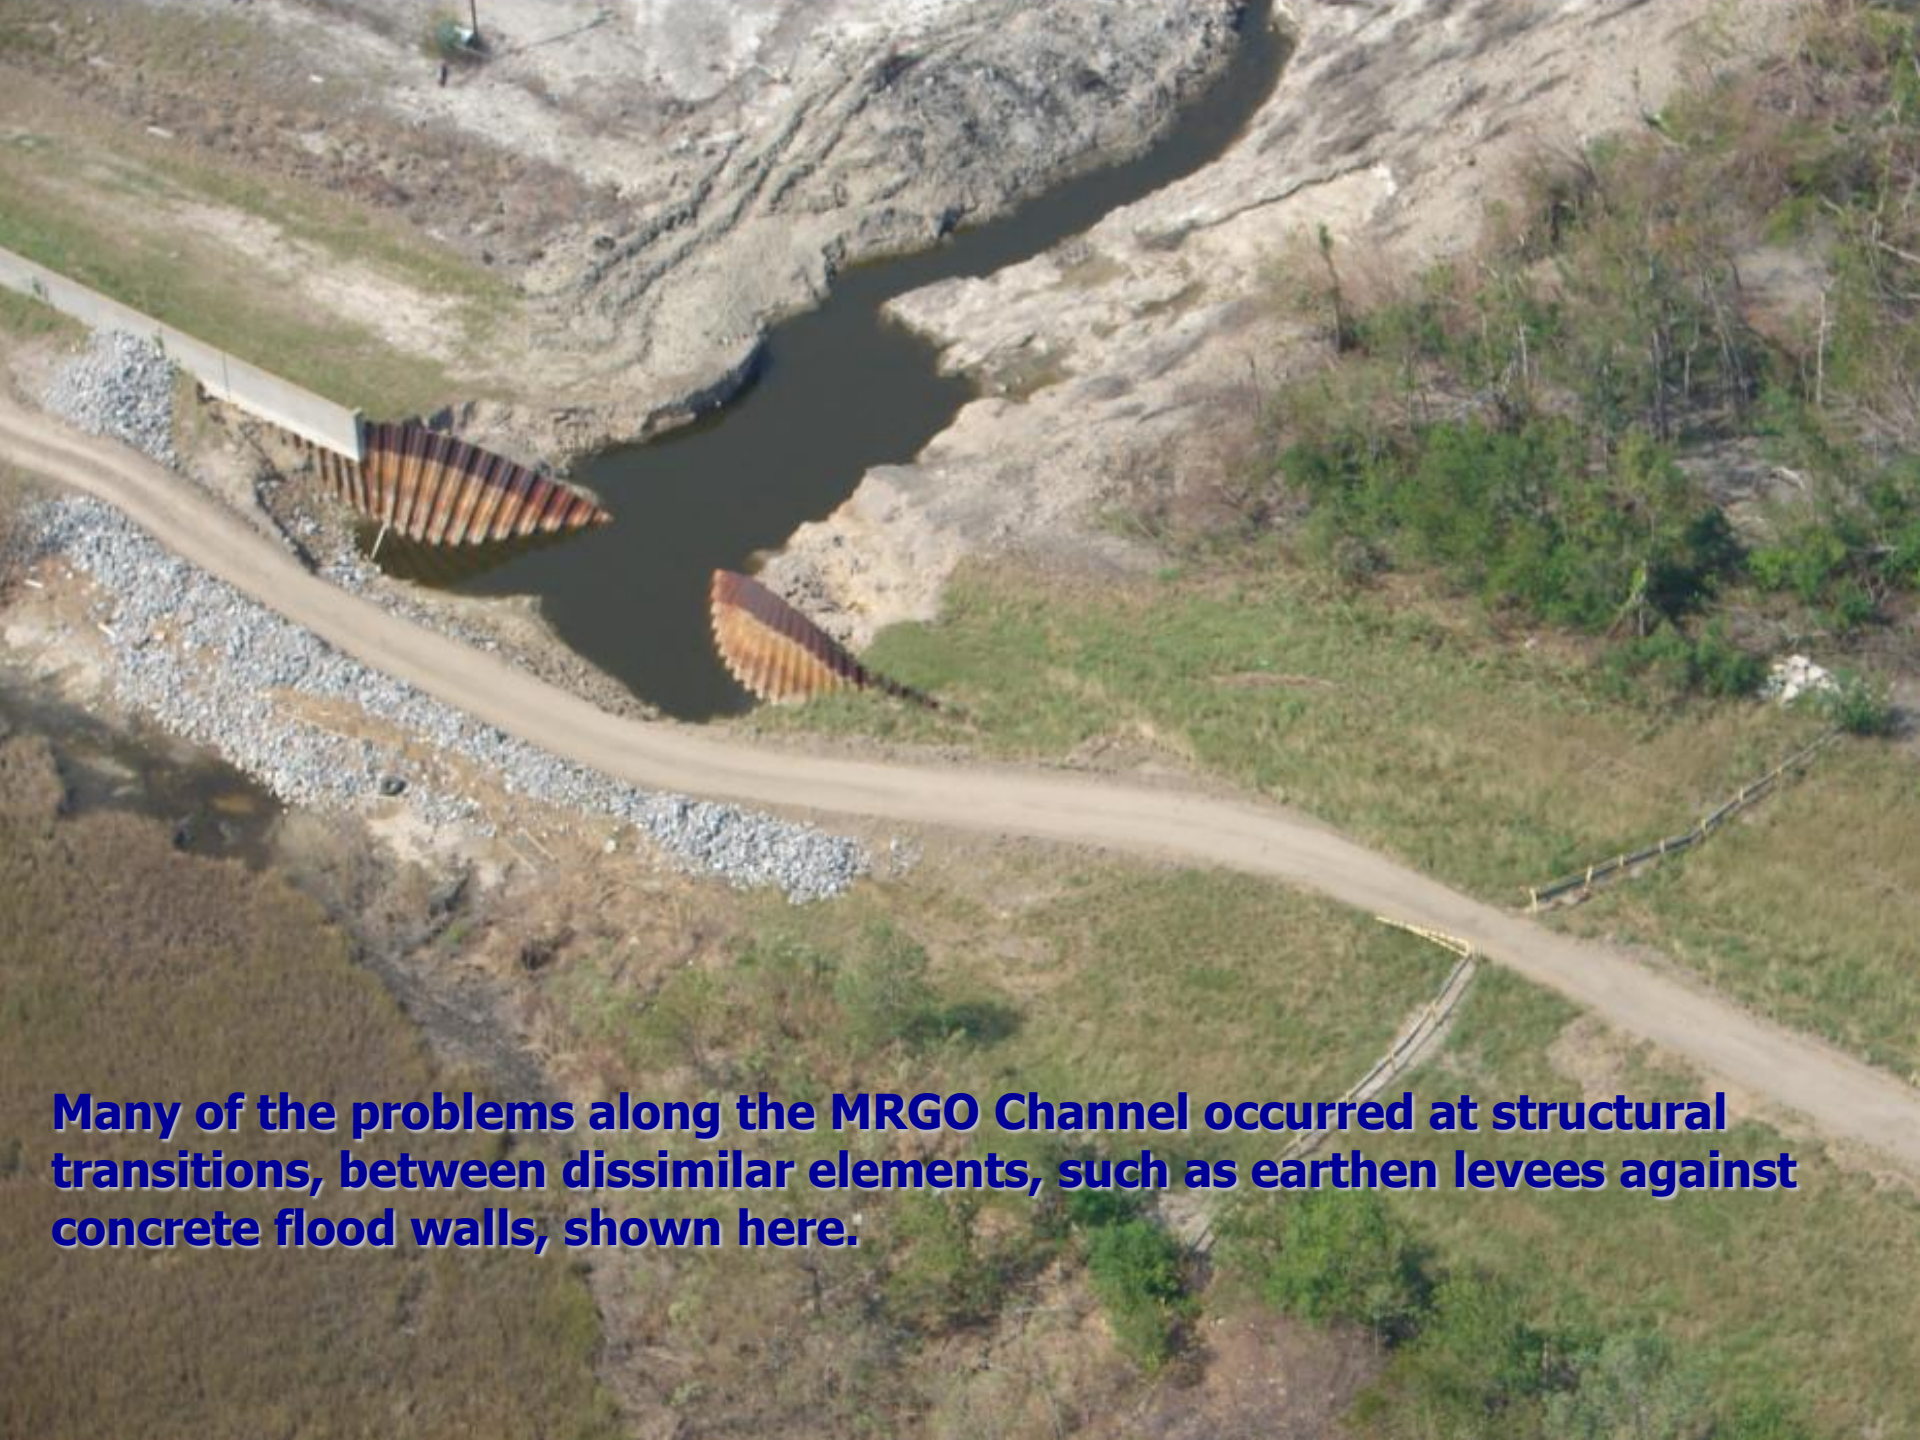
**Many of the problems along the MRGO Channel occurred at structural transitions, between dissimilar elements, such as earthen levees against concrete flood walls, shown here.**

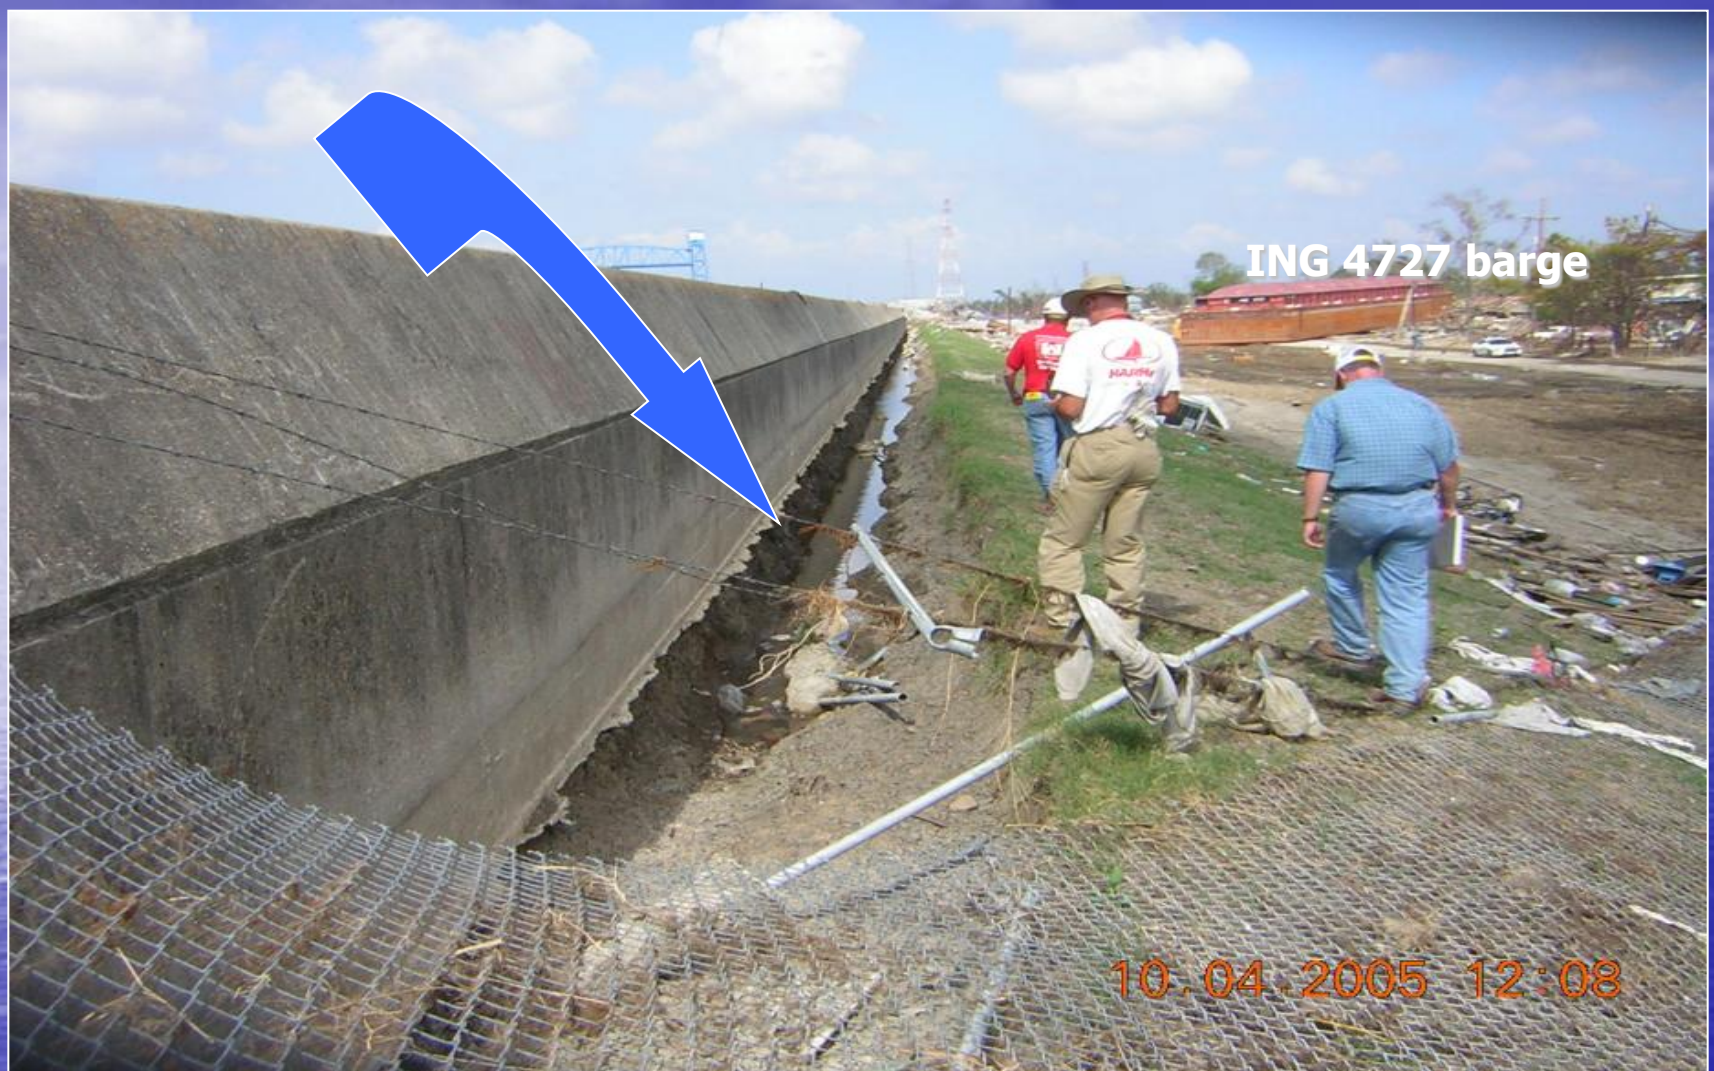
- **Some sections survived:** Evidence of sustained overtopping of concrete flood wall along the IHNC in the Lower Ninth Ward.
