# **Levee Design Issues revealed by Post- Katrina Studies in Louisiana**

**J. David Rogers, Ph.D., P.E., P.G.**

**American Society of Civil Engineers**

**Central Pennsylvania Geotechnical Conference**

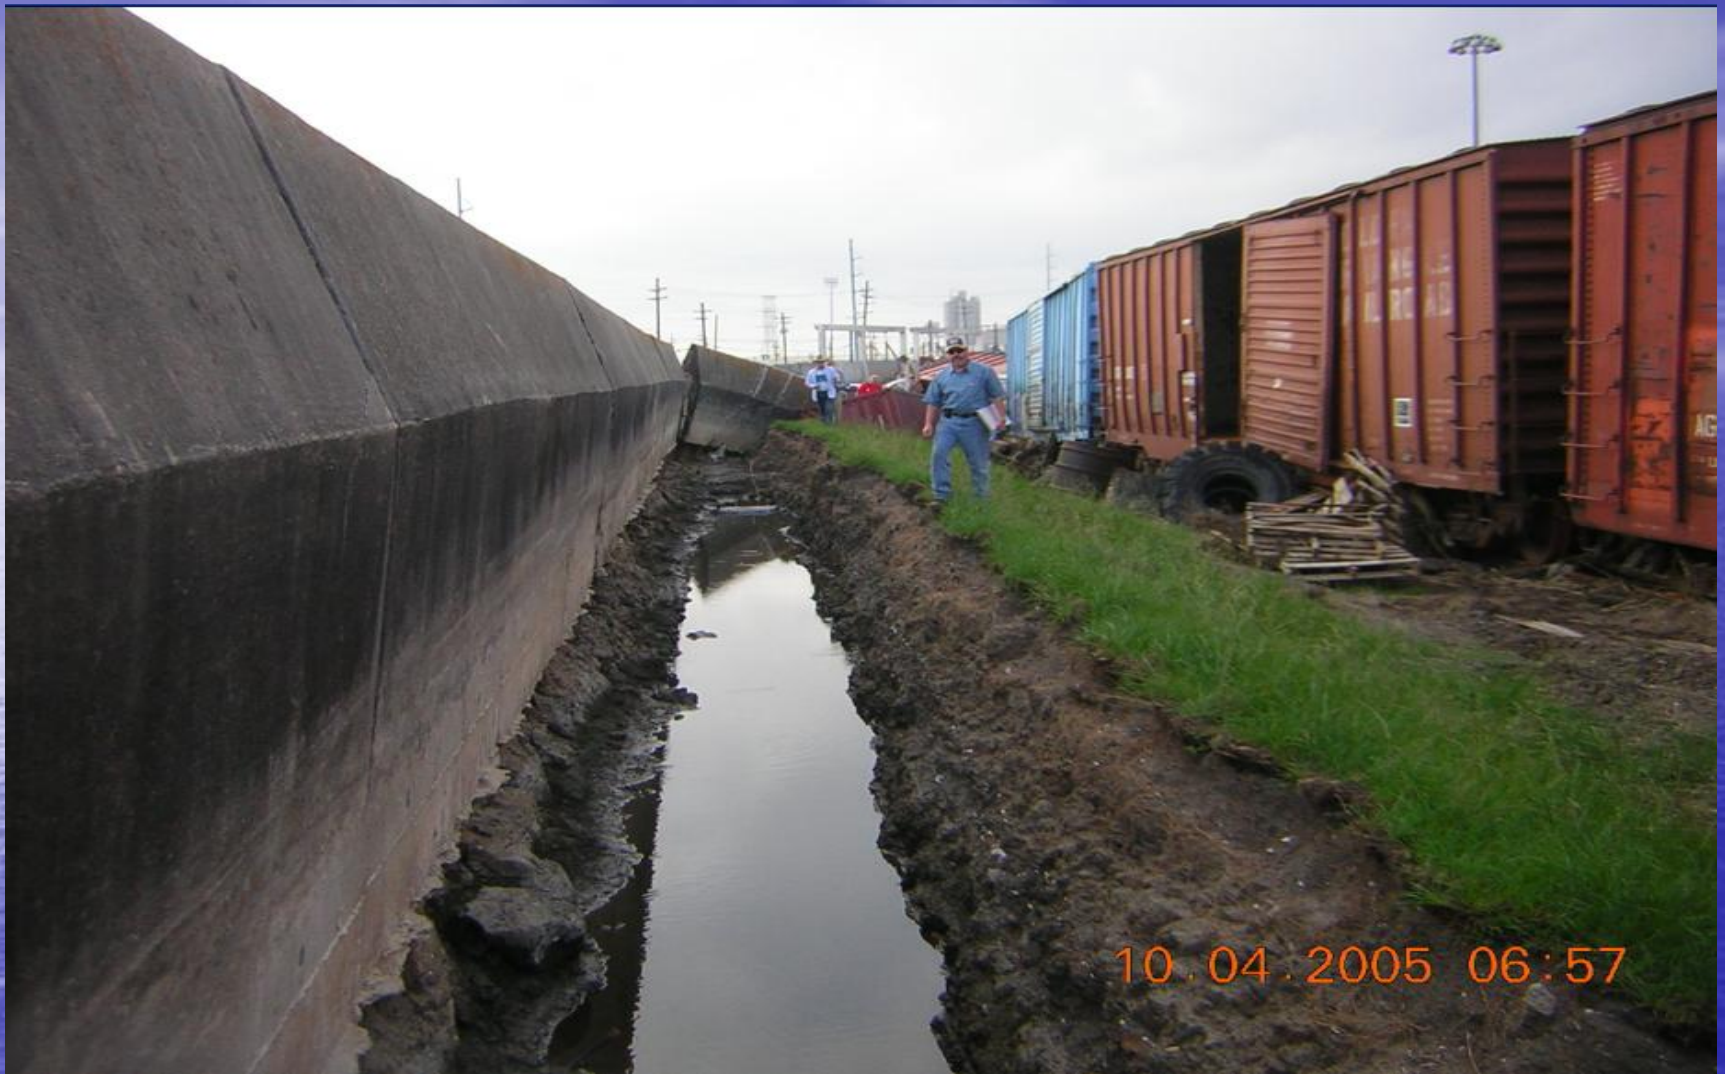
- Overtopping scour holes along landside of flood wall on west side of the IHNC. Note broken wall in background. A splash pad on inboard side could have prevented this undercutting for less than 0.5% of the flood wall cost, making the structure **“Class 3 survivable.”**

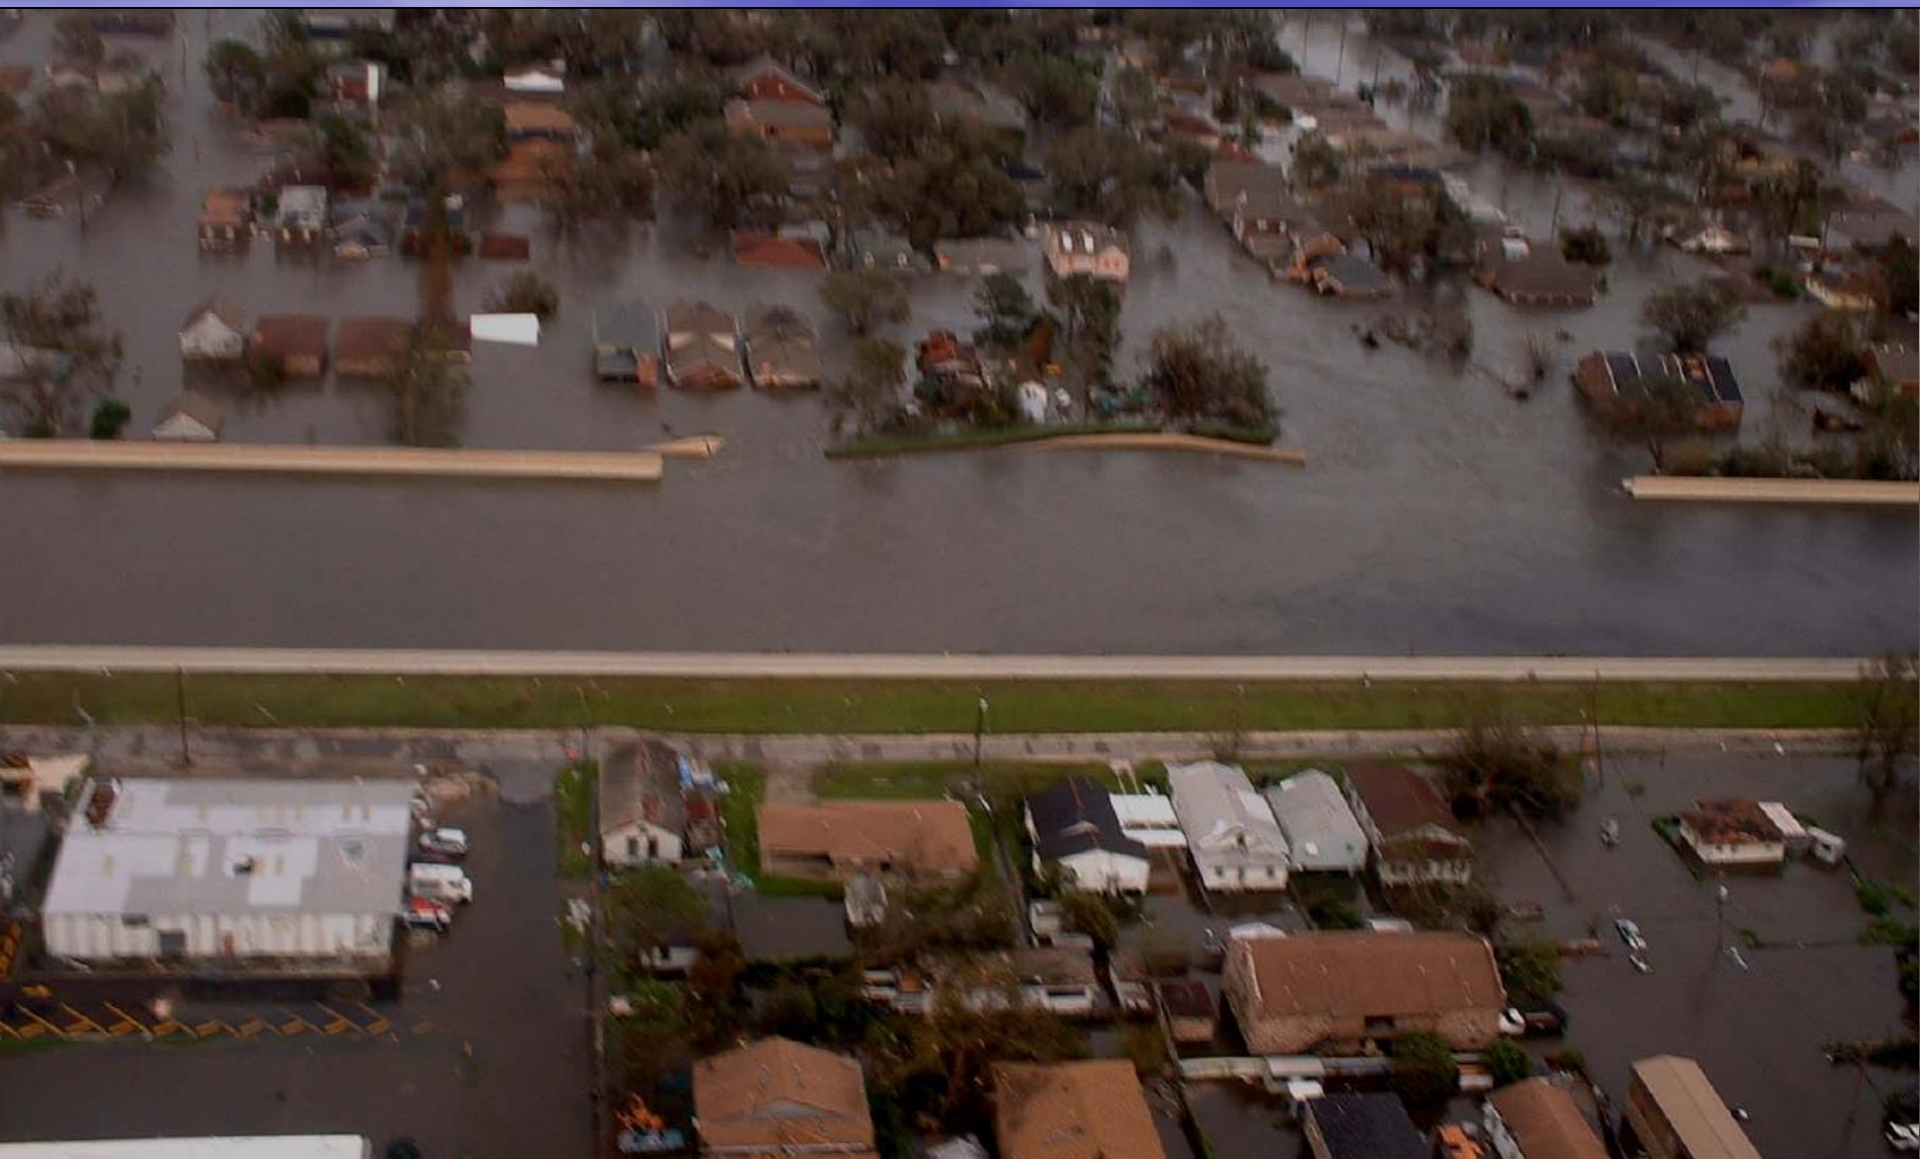
- **Aerial oblique view of the 17<sup>th</sup> Street Canal break, looking east. Note lateral translation of concrete flood wall, between 35 and 50 ft. Photo by Ivor van Heerden.**

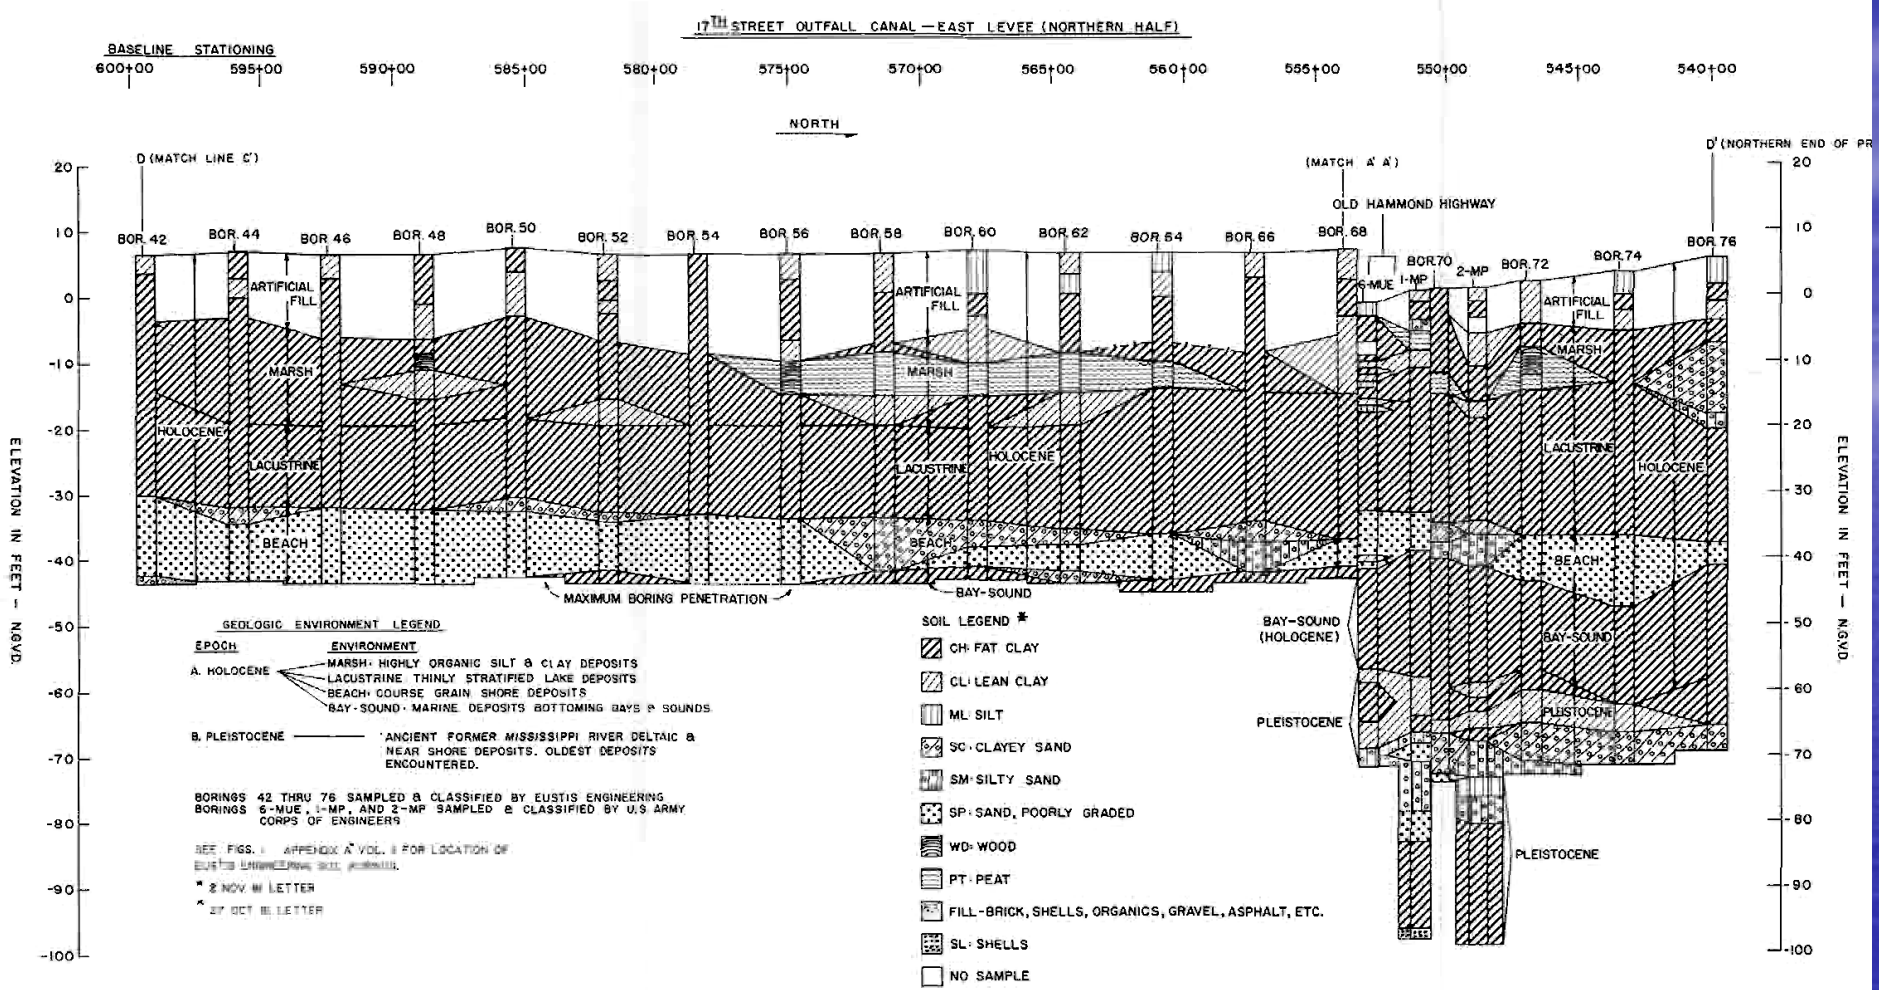
Geologic profile for the 17<sup>th</sup> St Canal flood wall prepared by Corps' New Orleans District office in 1990. Three of four holes in vicinity of the 2005 failure (spaced 500 ft apart) had **zero sample recovery**. These contacts were projected and the sheet pile tips designed, accordingly.

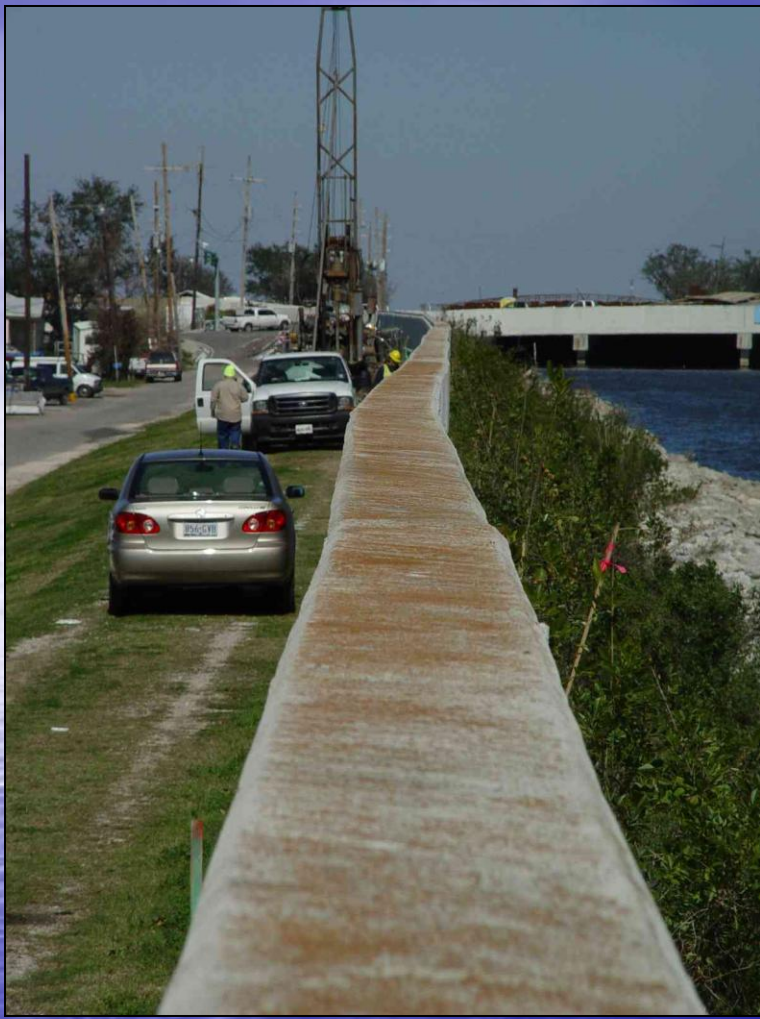
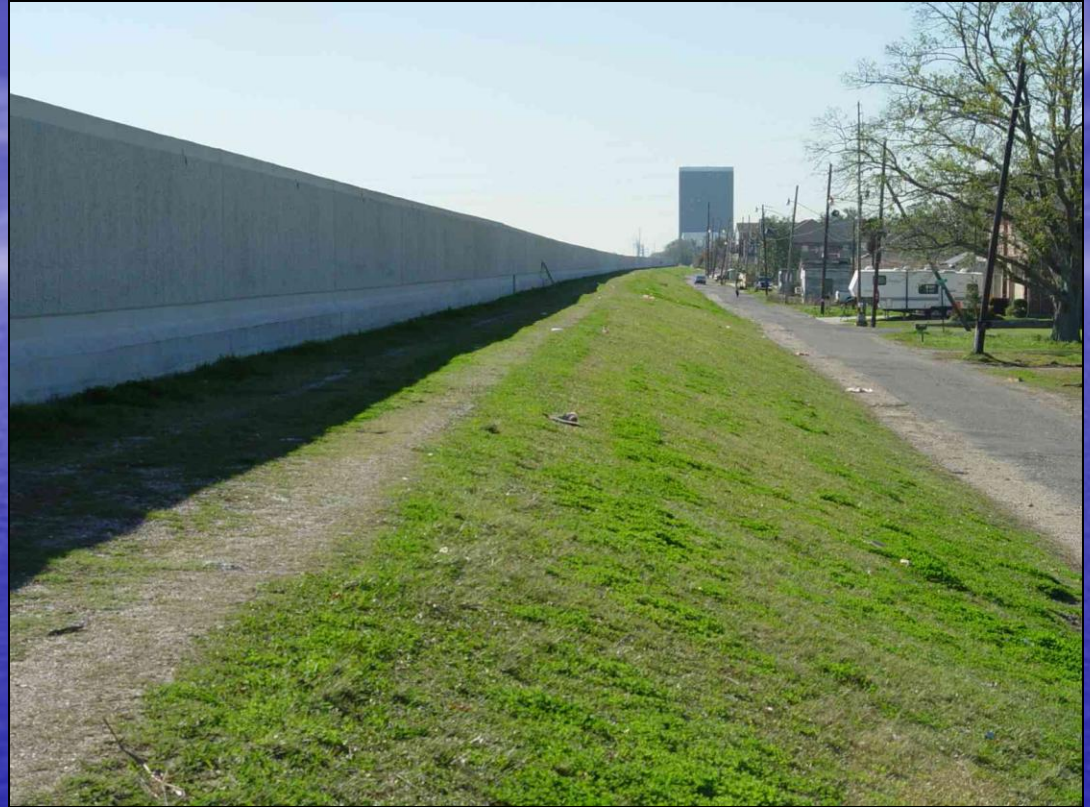
- **Apparent displacement of the 17<sup>th</sup> Street Canal flood wall on the west (Jefferson Parish) side, opposite the 17<sup>th</sup> Street failure.**

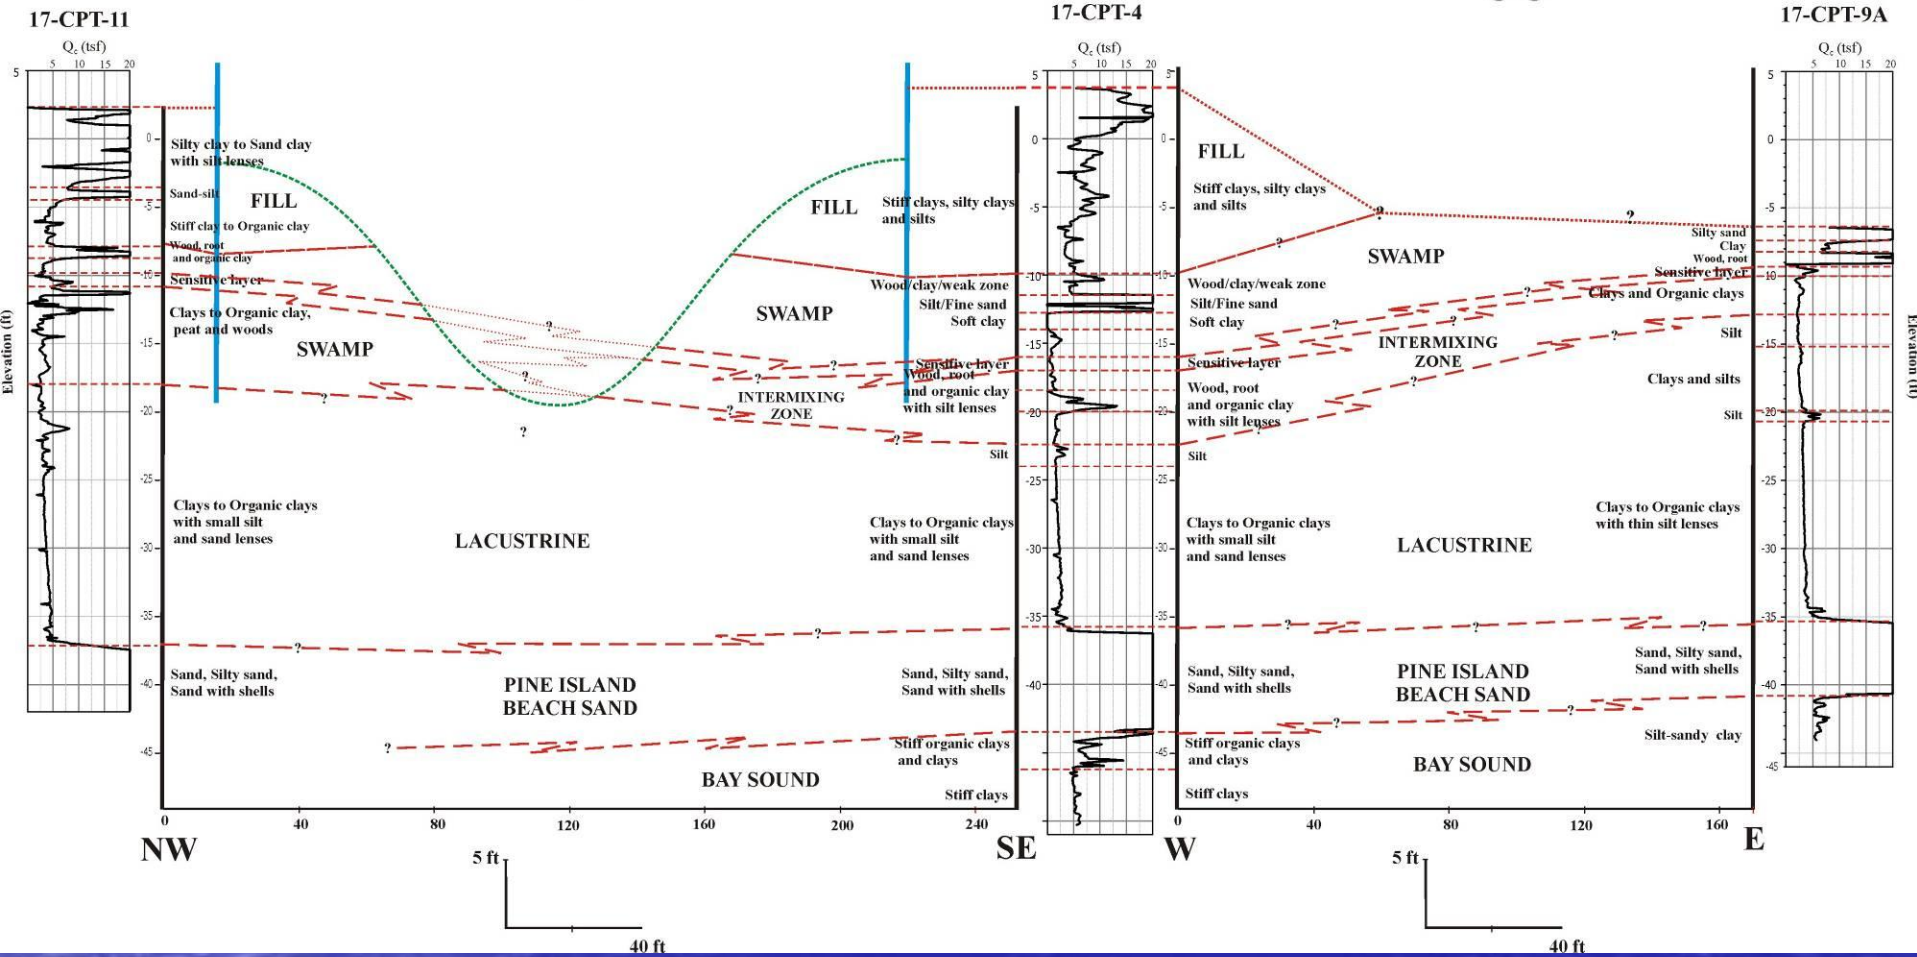
- Stratigraphic interpretations across the 17<sup>th</sup> Street Canal breach. The swamp much appeared to be thinning northerly, as does the underlying **Pine Island Beach Trend**. The lacustrine clays appear to thicken southward, as shown.
- The approximate positions of the flood walls (light blue) and canal bottom (dashed green) are based on information provided by the Corps of Engineers.

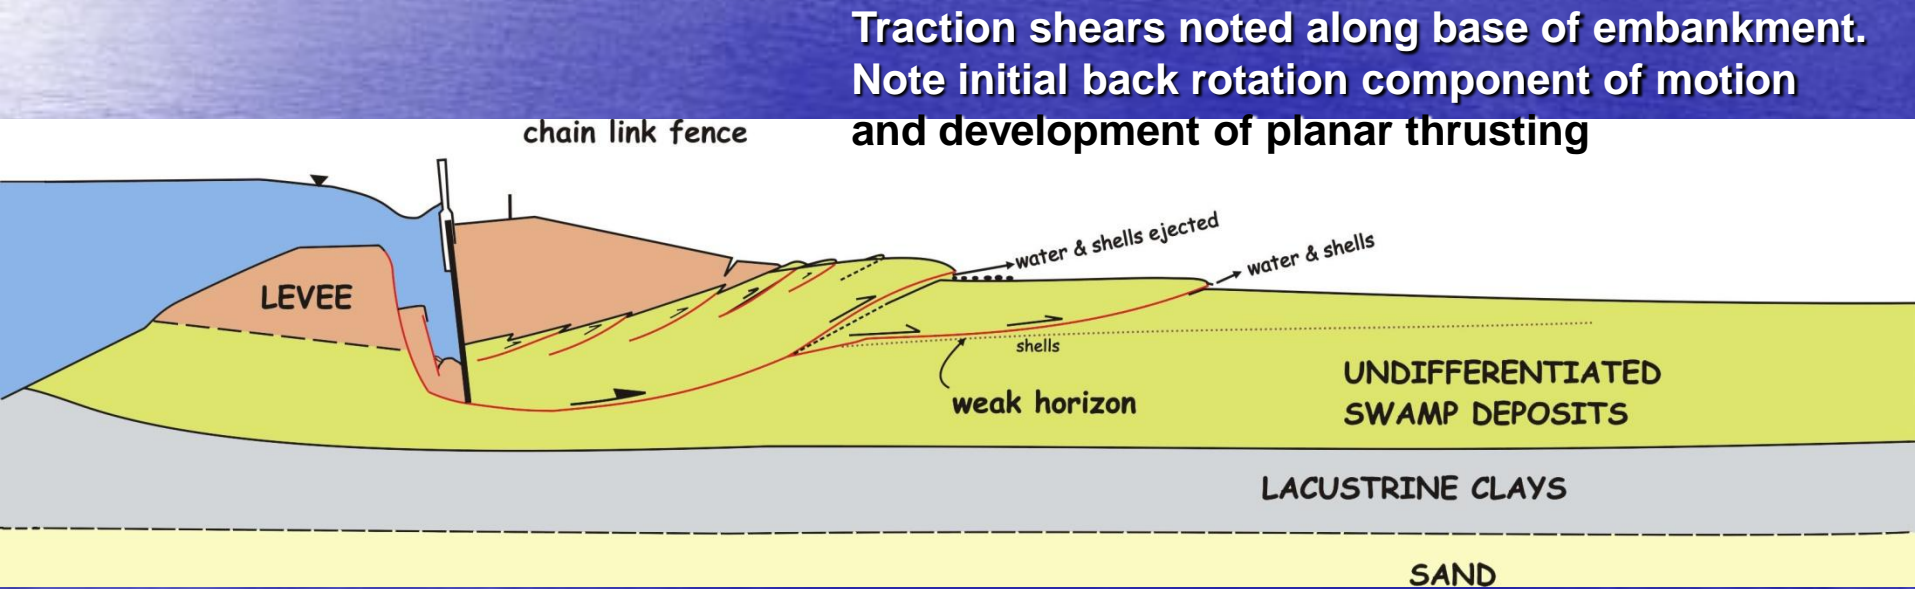
Initial loading conditions. Storm surge rises to within 4 feet of flood wall crest. Hydrostatic pressures on sheetpile supported I-wall highlighted in blue. Translational failure begins.

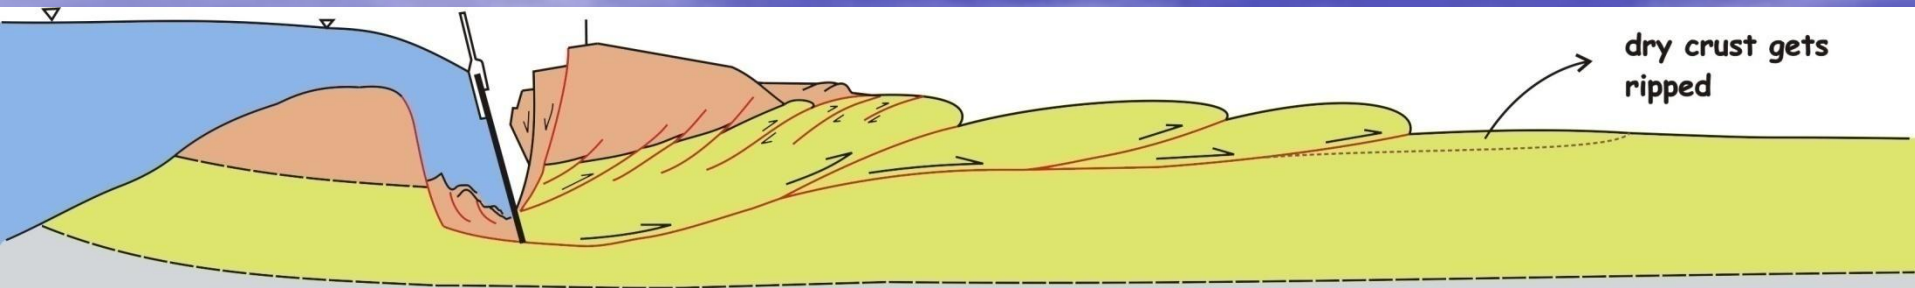
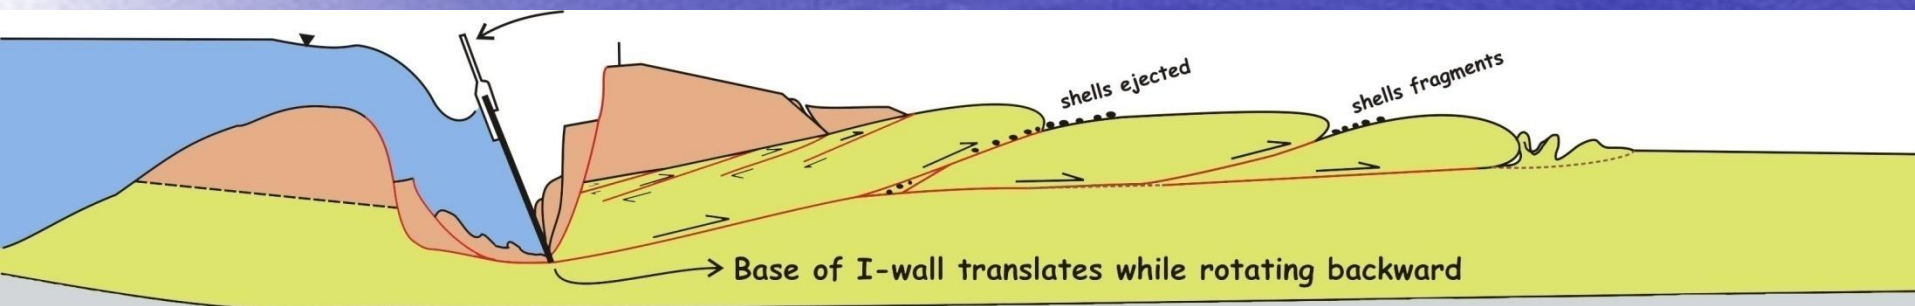
**Progression of translational failure sequence. Multiple thrust sheets develop in partially saturated crust, comprised of sandy fill over organic cypress swamp deposits. The upper crust buckles like a rug being rolled up.**

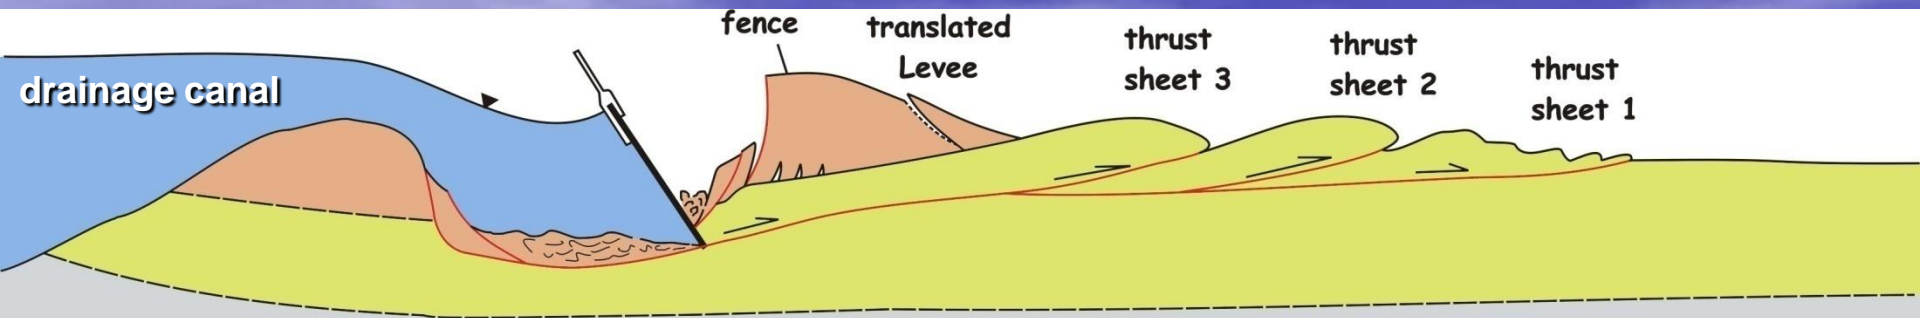
Some sheetpile supported I-walls fell backward; others fell forward

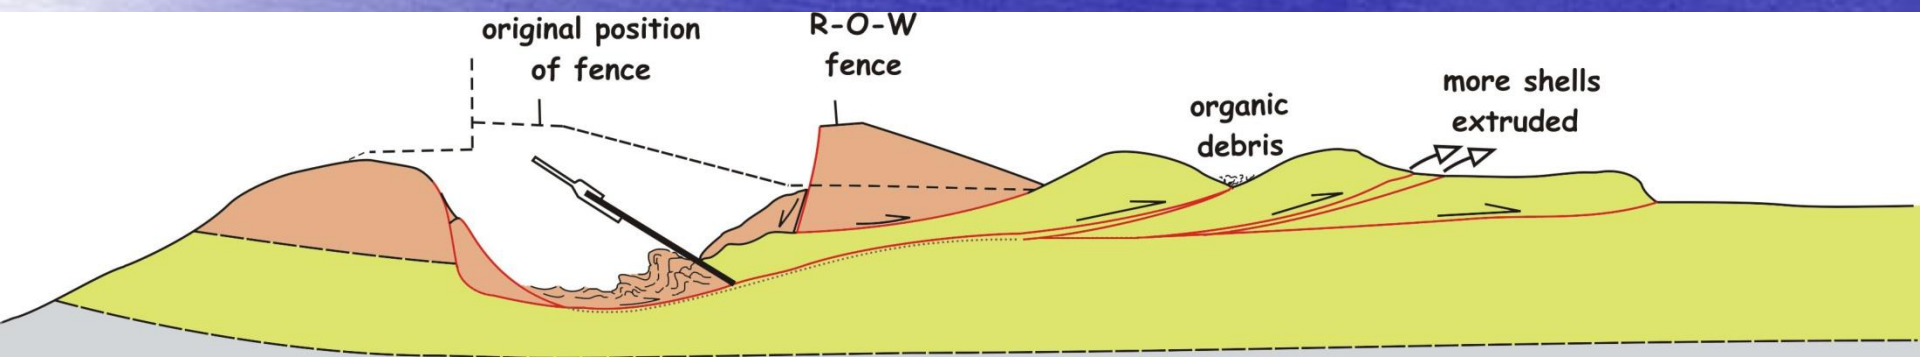
**Final stages of translational failure sequence. Lower section shows failed levee after 51 feet of displacement. The void was quickly backfilled with gravel as part of sealing the breach.**
