POST-FLOOD RECONNAISSANCE: UPPER MISSISSIPPI RIVER FLOODING OF 2008

J. David Rogers, Ph.D., P.E., R.G.

Natural Hazards Mitigation Institute

November 11, 2008

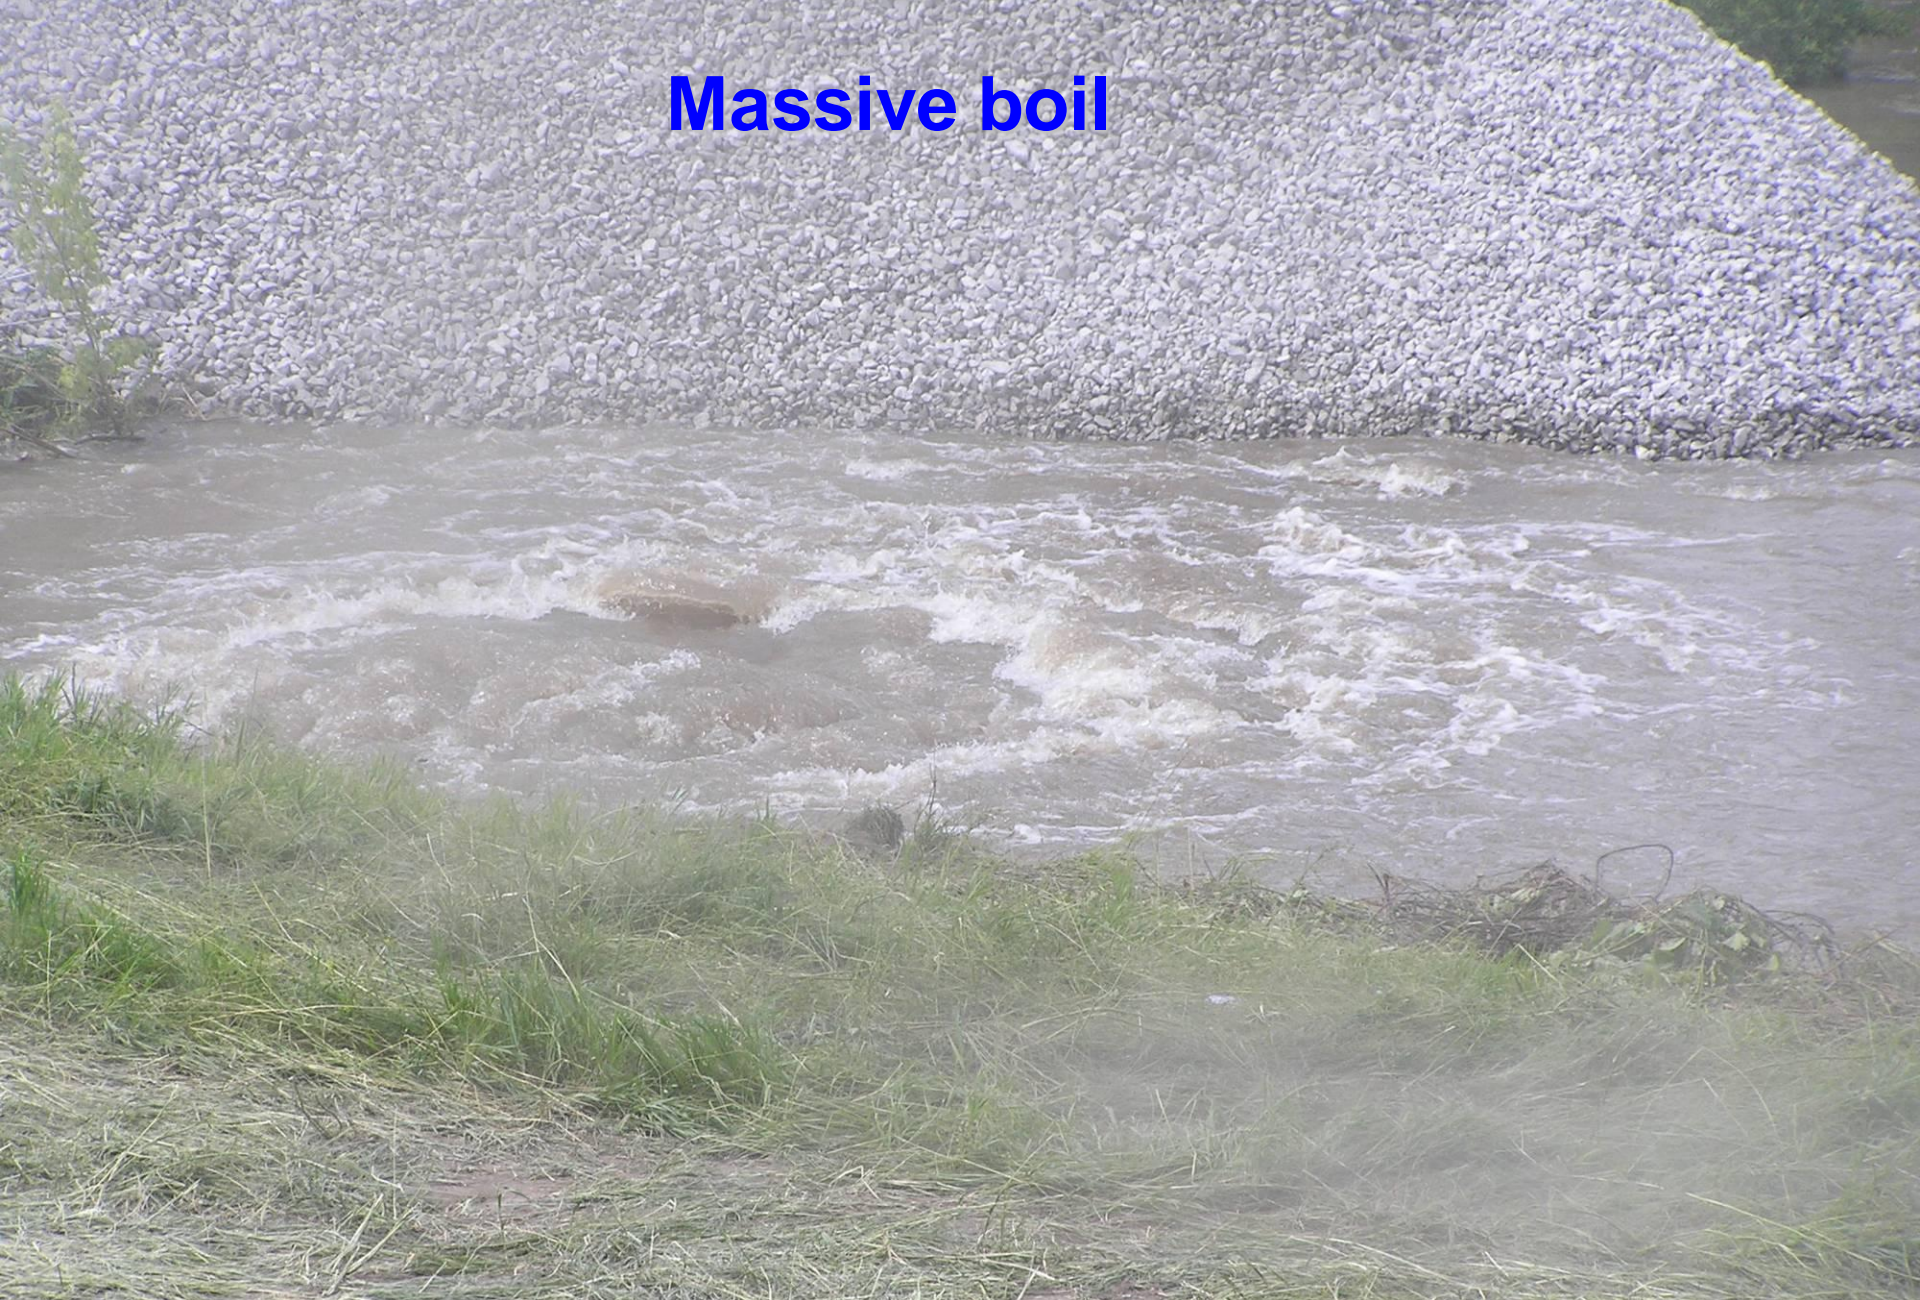
Massive boil

When hydraulic gradients > 1.0 , piping of fine grained soils ensues.

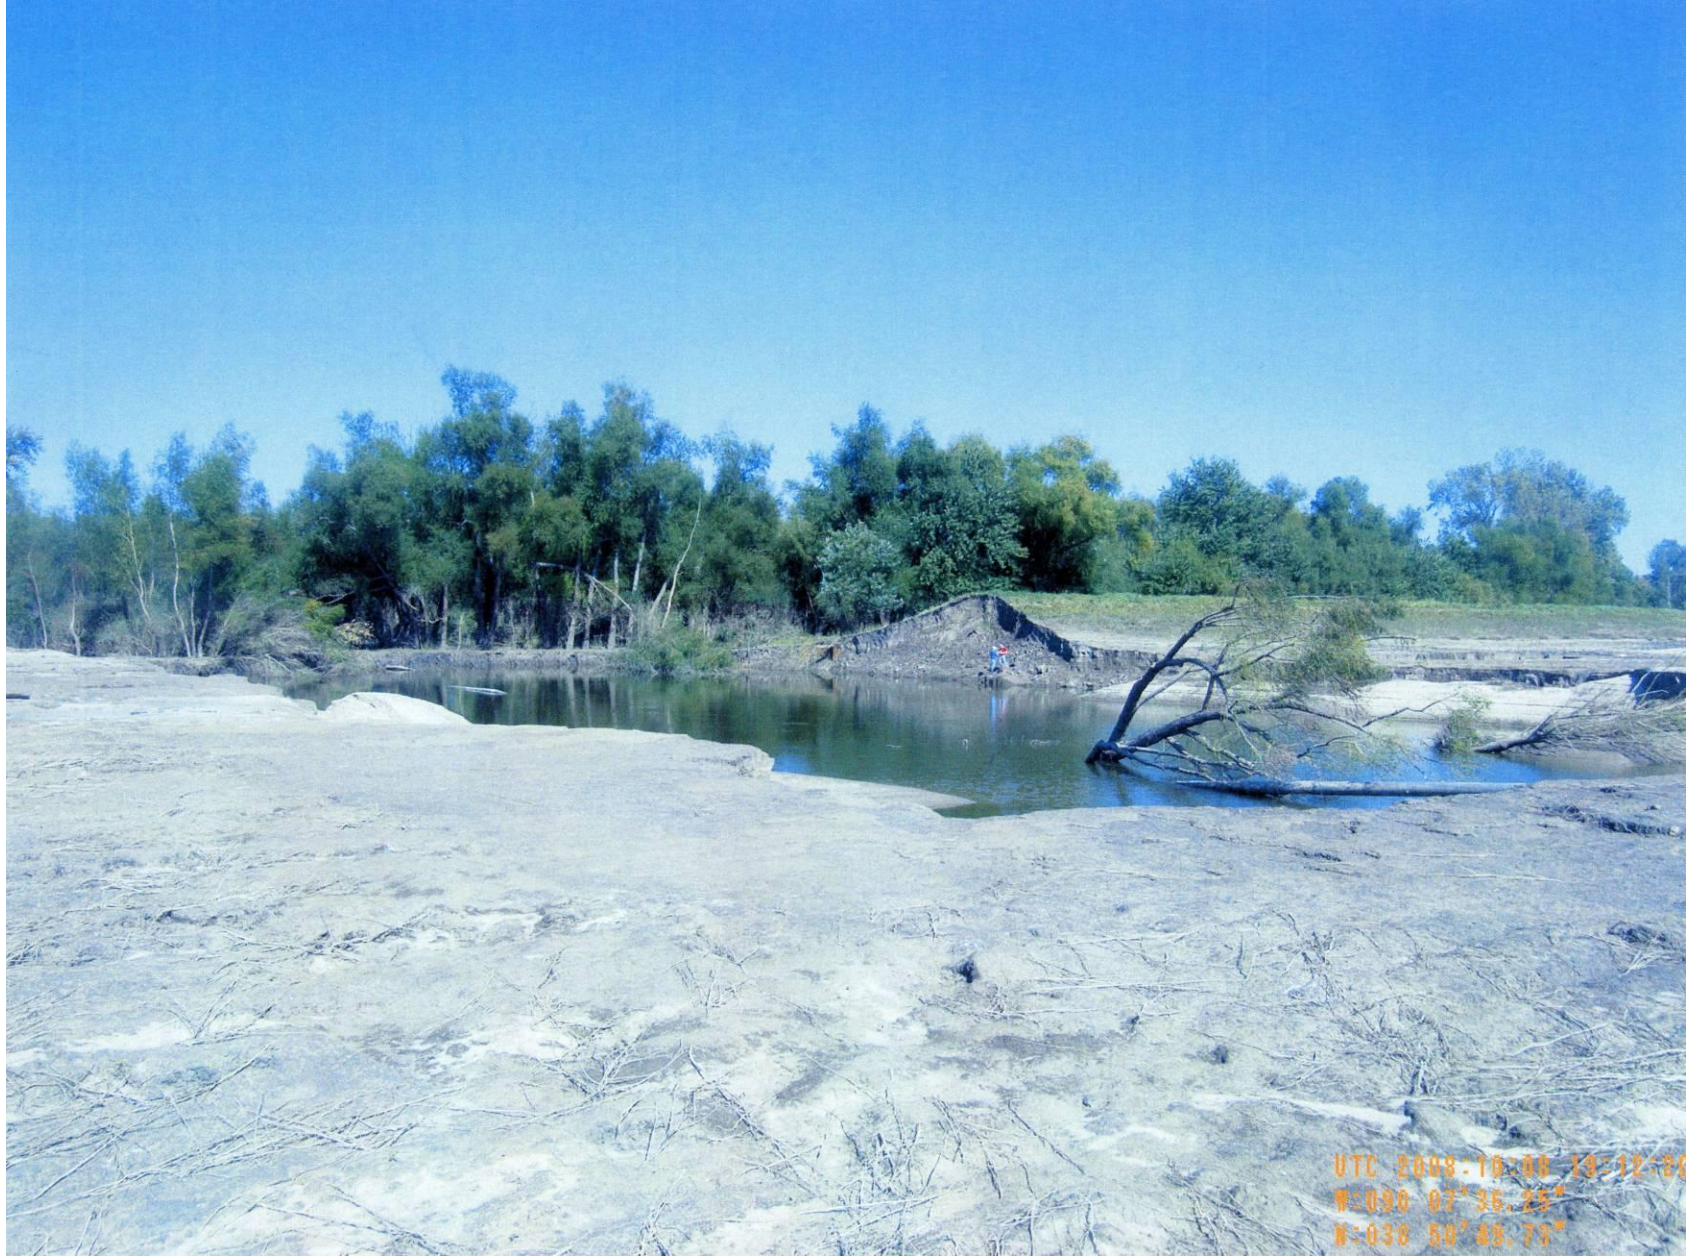
- **Breach at confluence point likely influenced by seepage along pipeline trenches. Failures here in 1993 and 2008.**

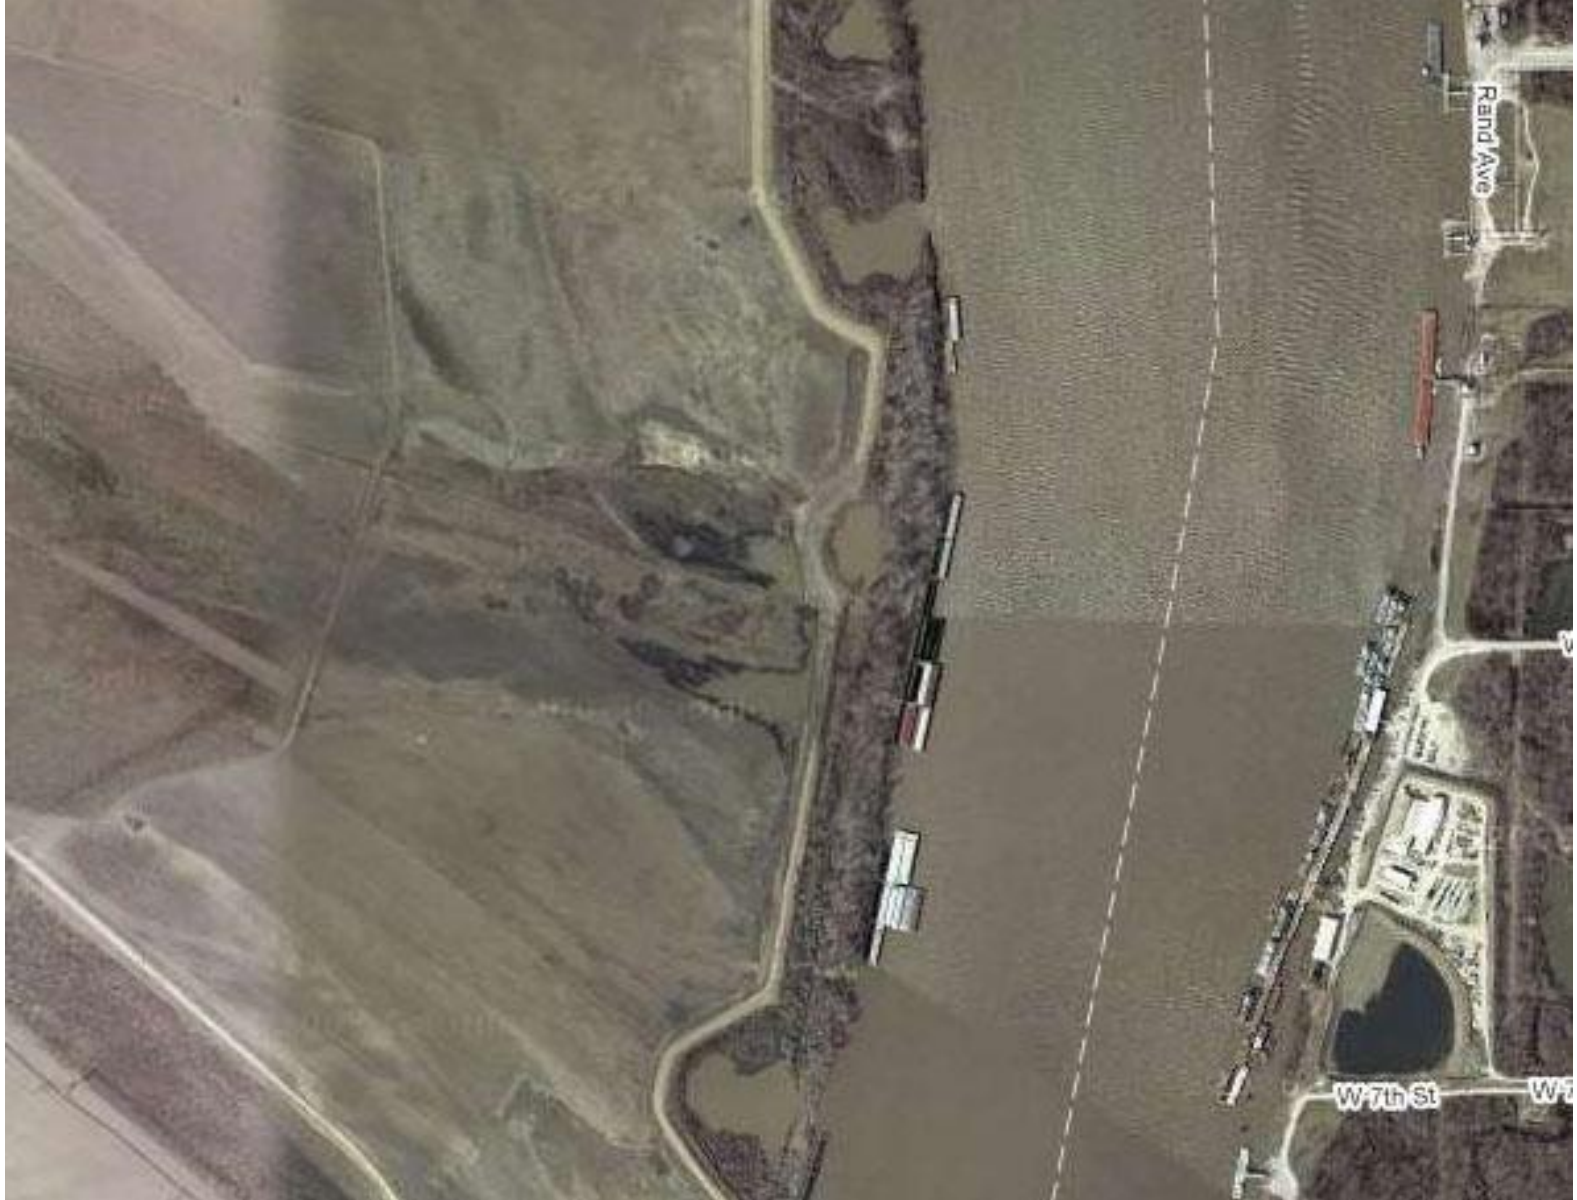
- Pipeline breaks near Confluence Point. Note duck ponds and pipelines

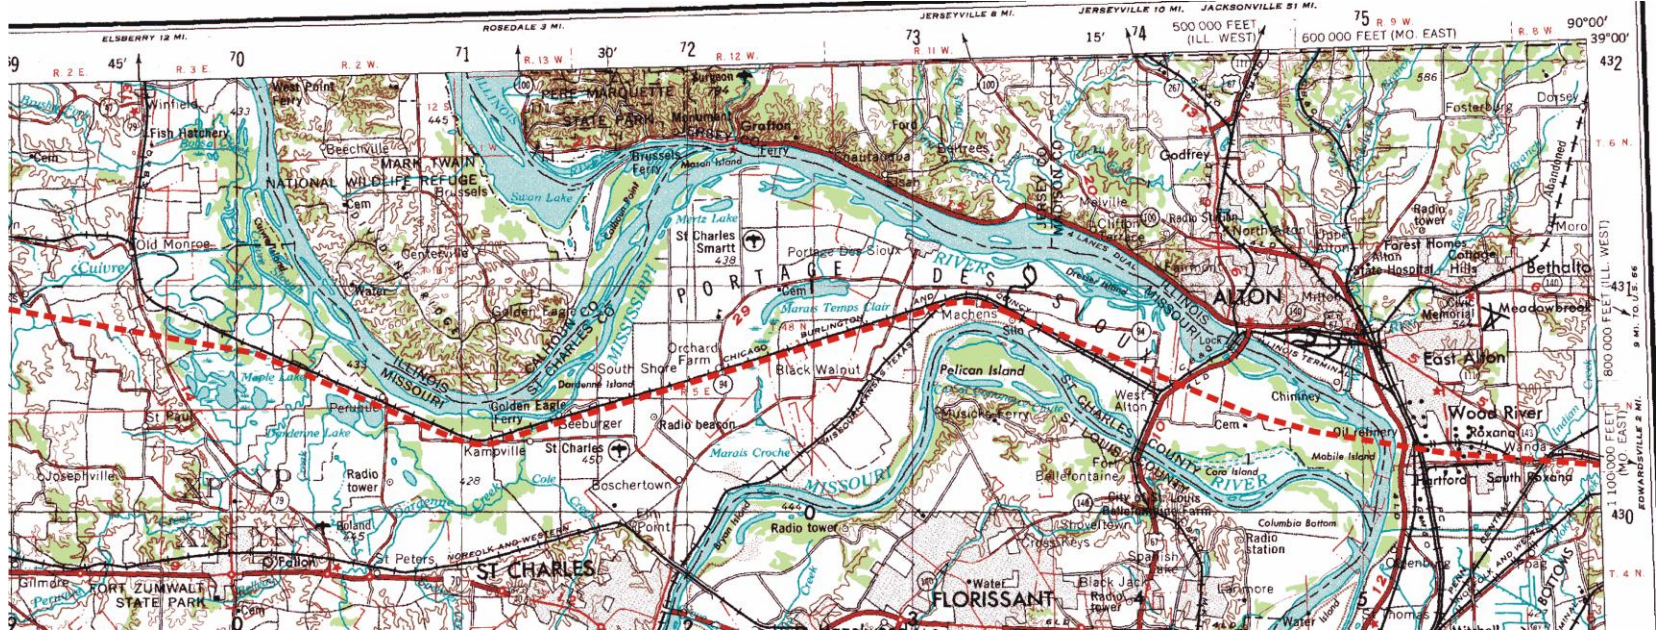
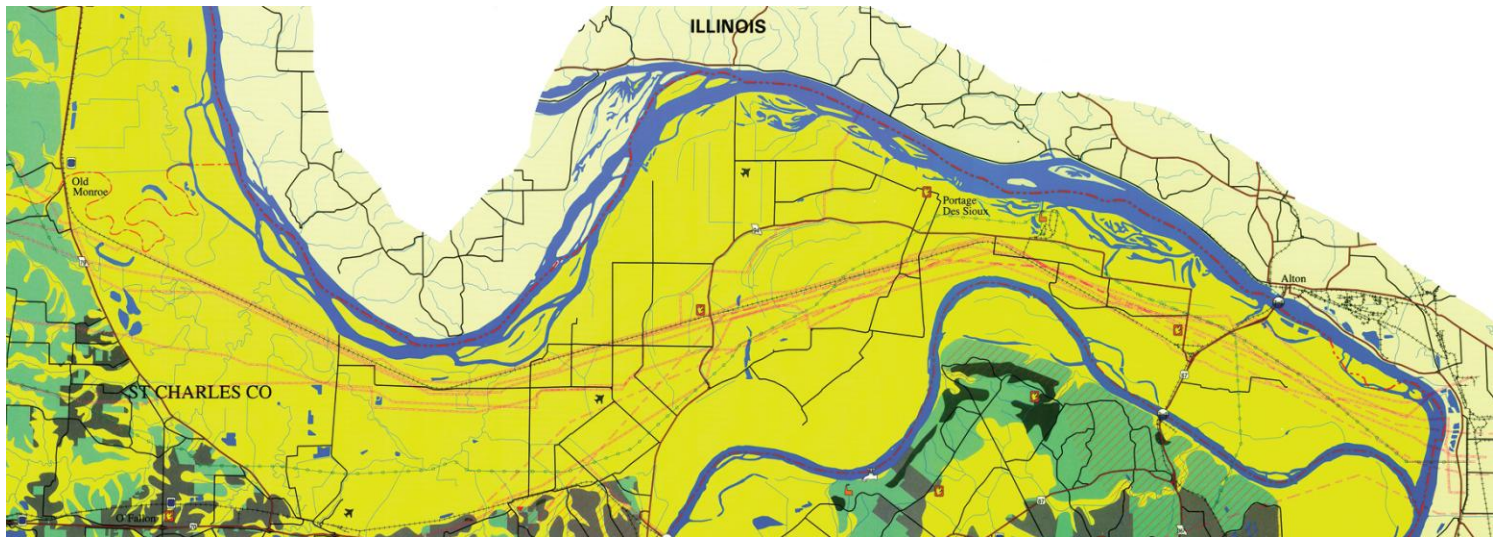
- **Buried pipelines are corridors of potential vulnerability, for floods and earthquakes**

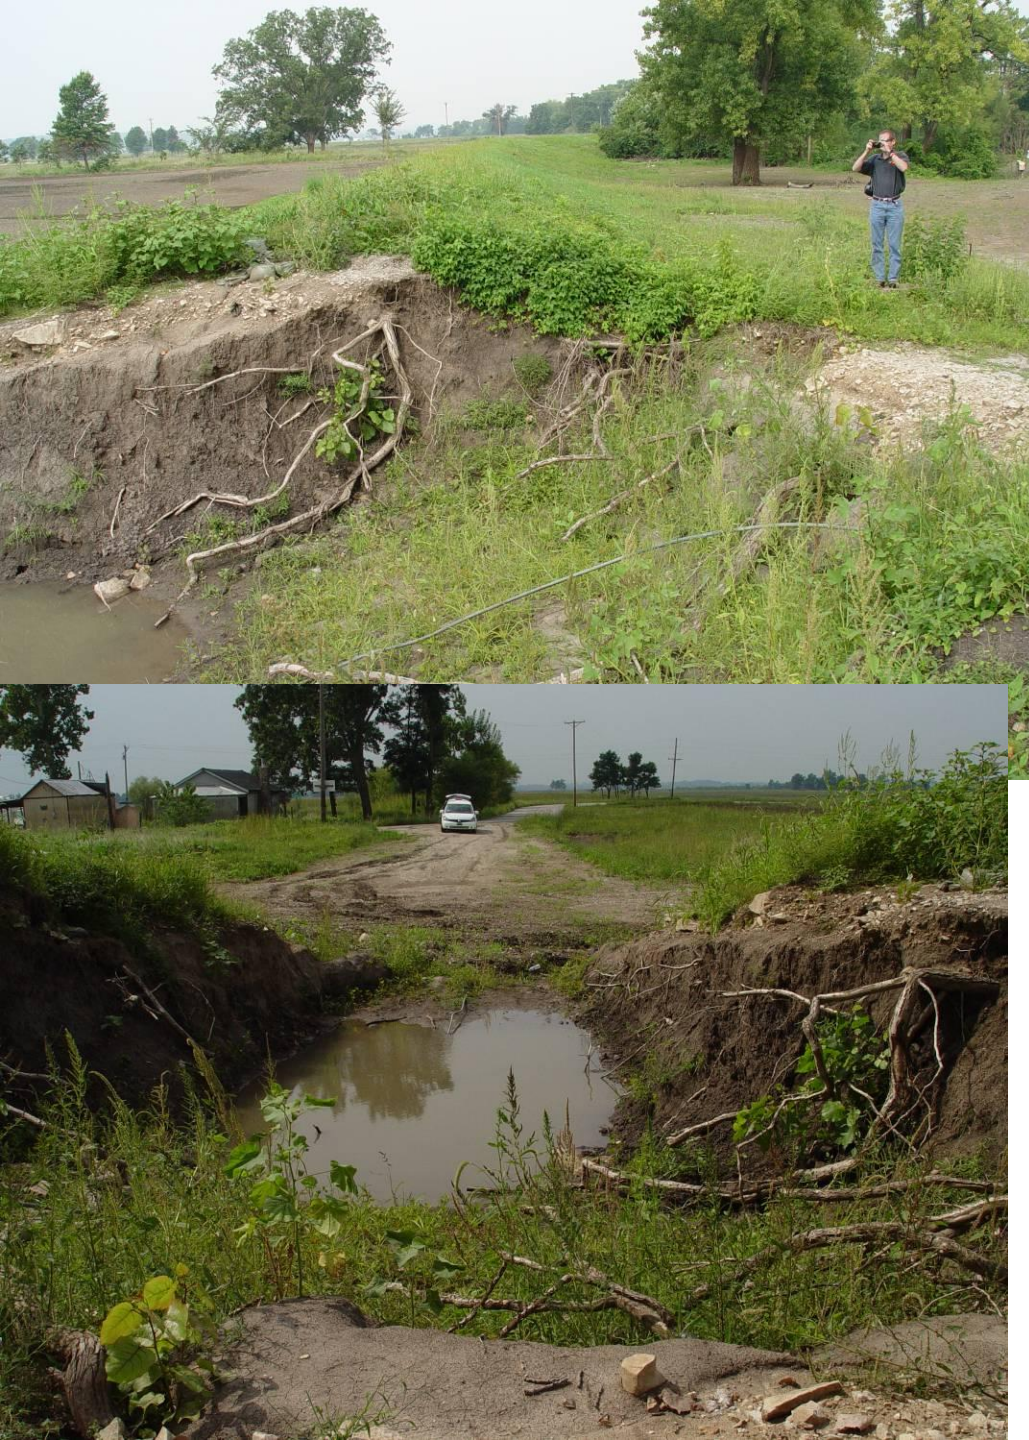
Crossovers

- **Just about every place where a gravel-paved road crossed an agricultural levee, failure ensued by seepage through the gravel, even with sandbagging**

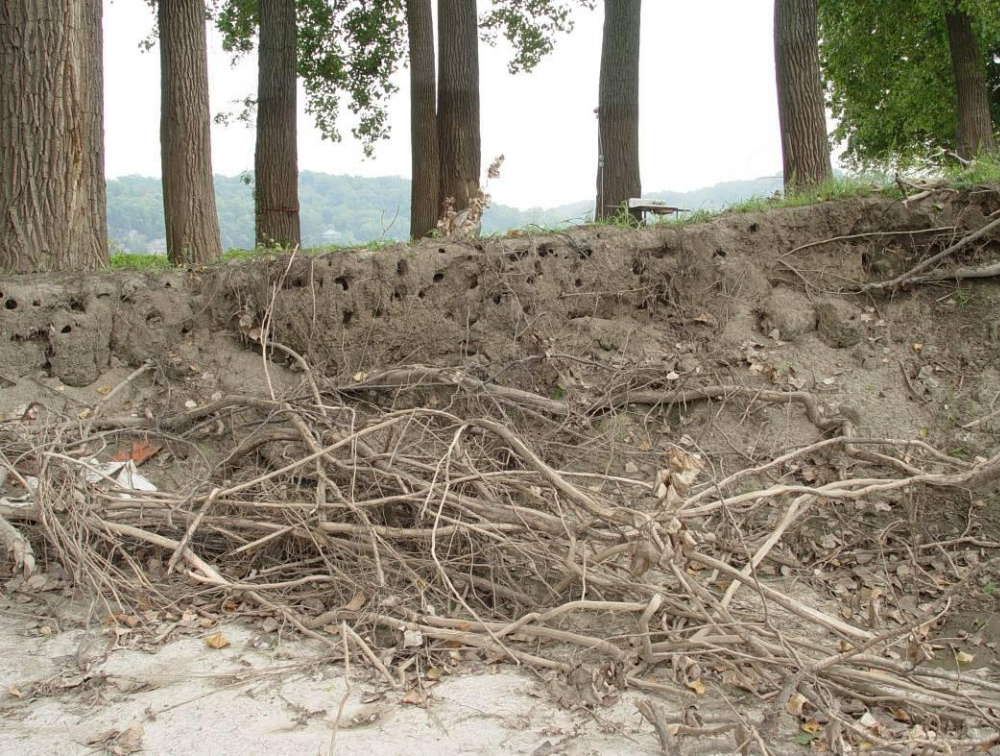
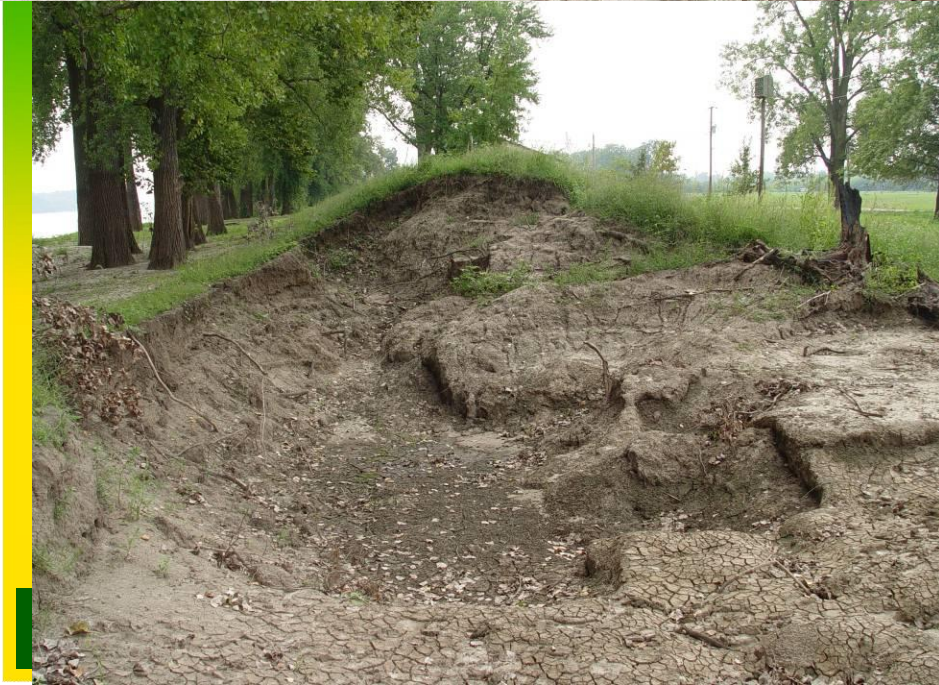
- **Seepage paths** often influenced by features such as tree root tracks, crayfish and/or ground squirrel burrows
- **Permeability** of silty earthen dikes close to the modern channel is about 1×10^{-3} cm/sec, or about 3 ft/day

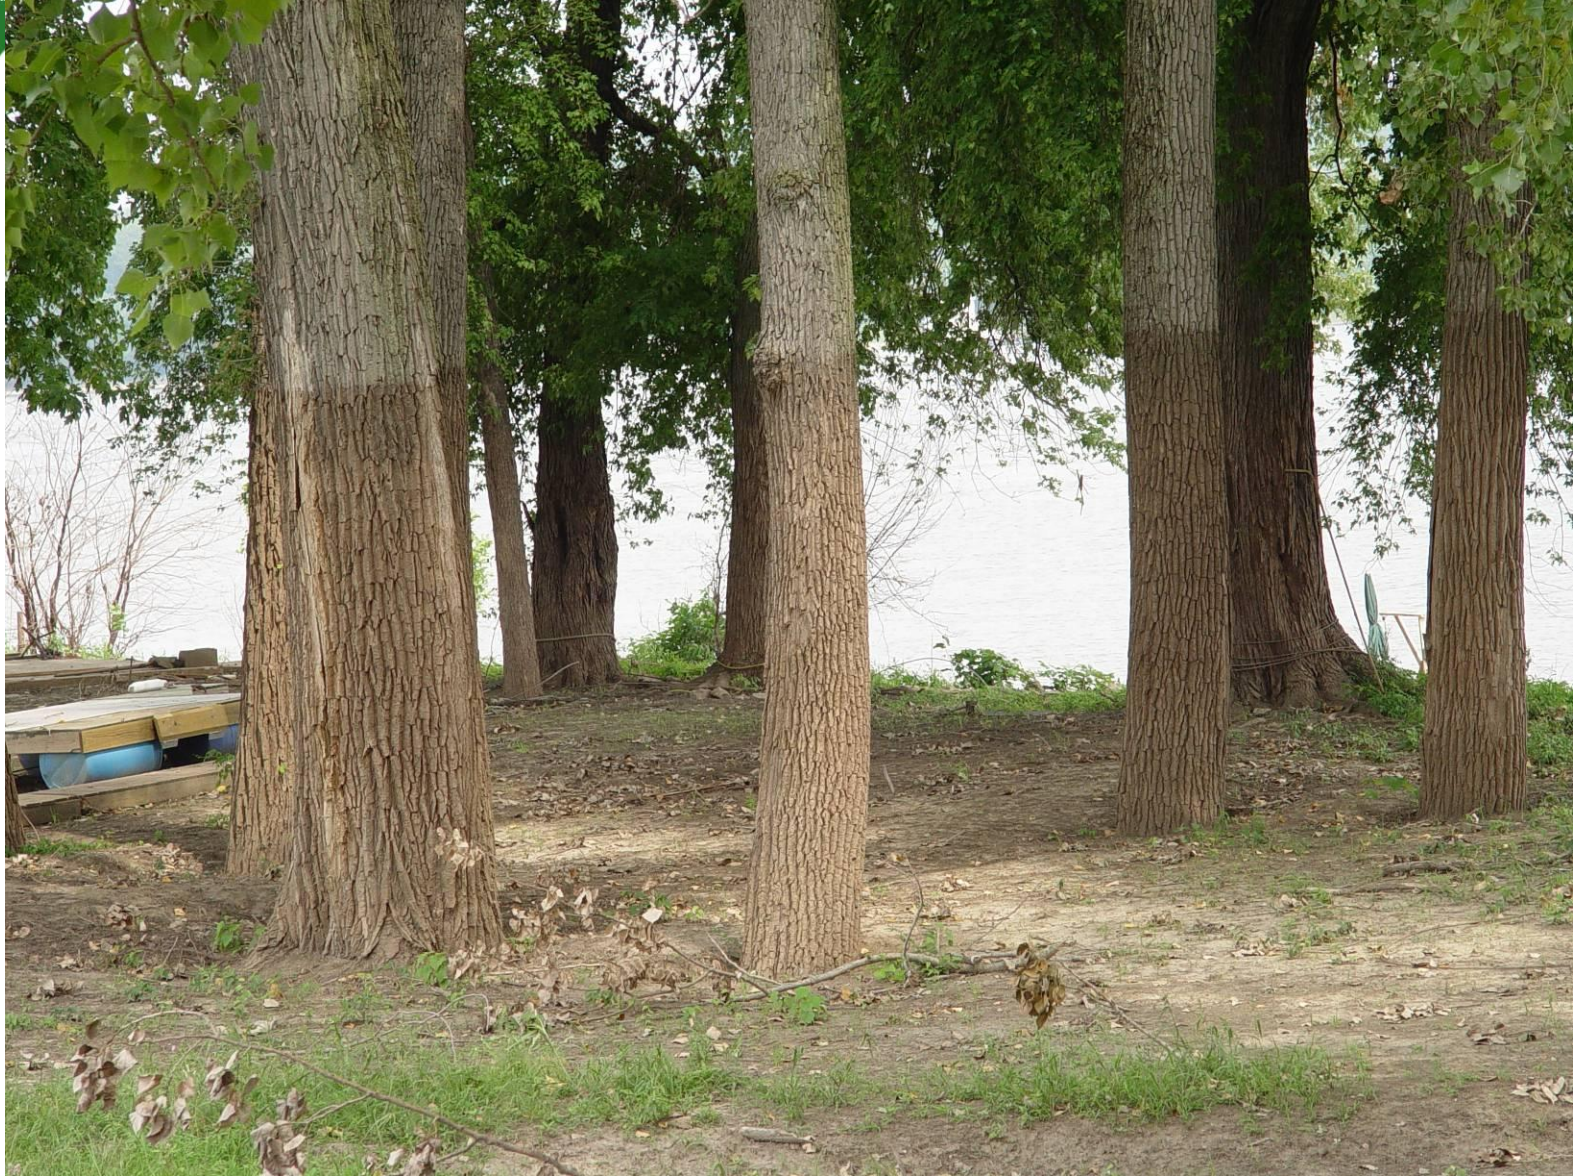
- **Mud lines on tree trunks record the maximum flood levels adjacent to dikes that were breached**

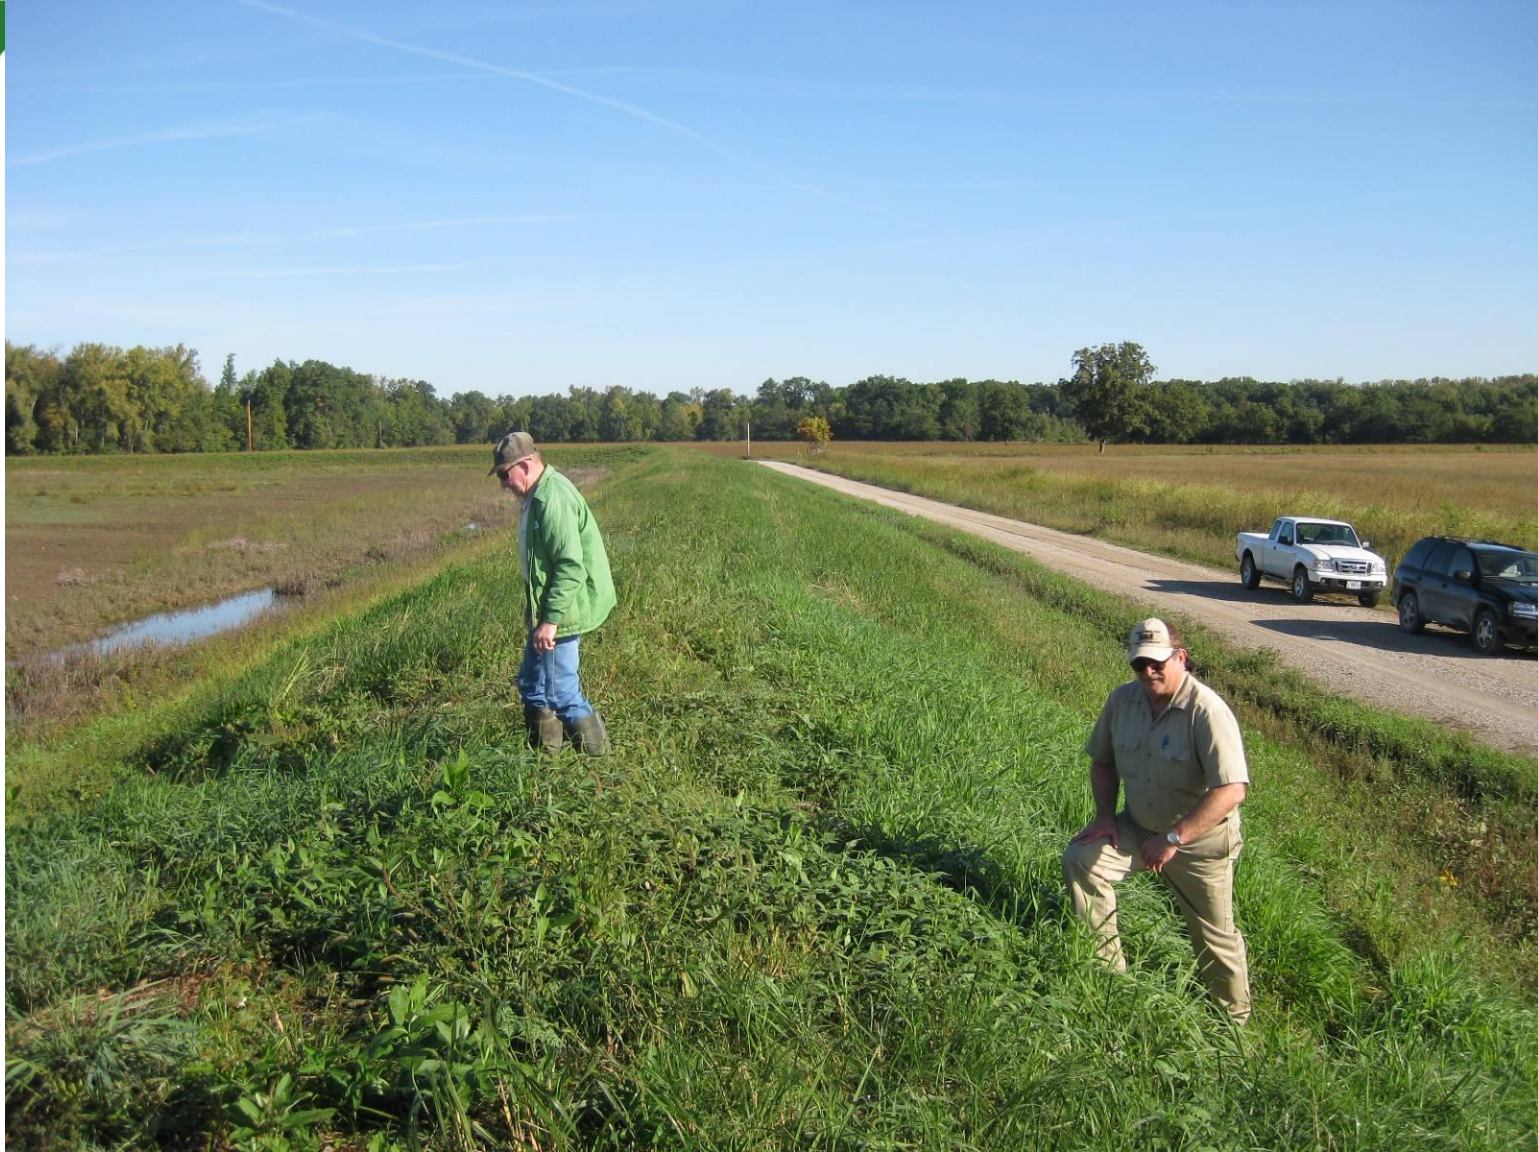
- **The Brevator District levees near Winfield survived 14 days of near-continuous overtopping, without failing**

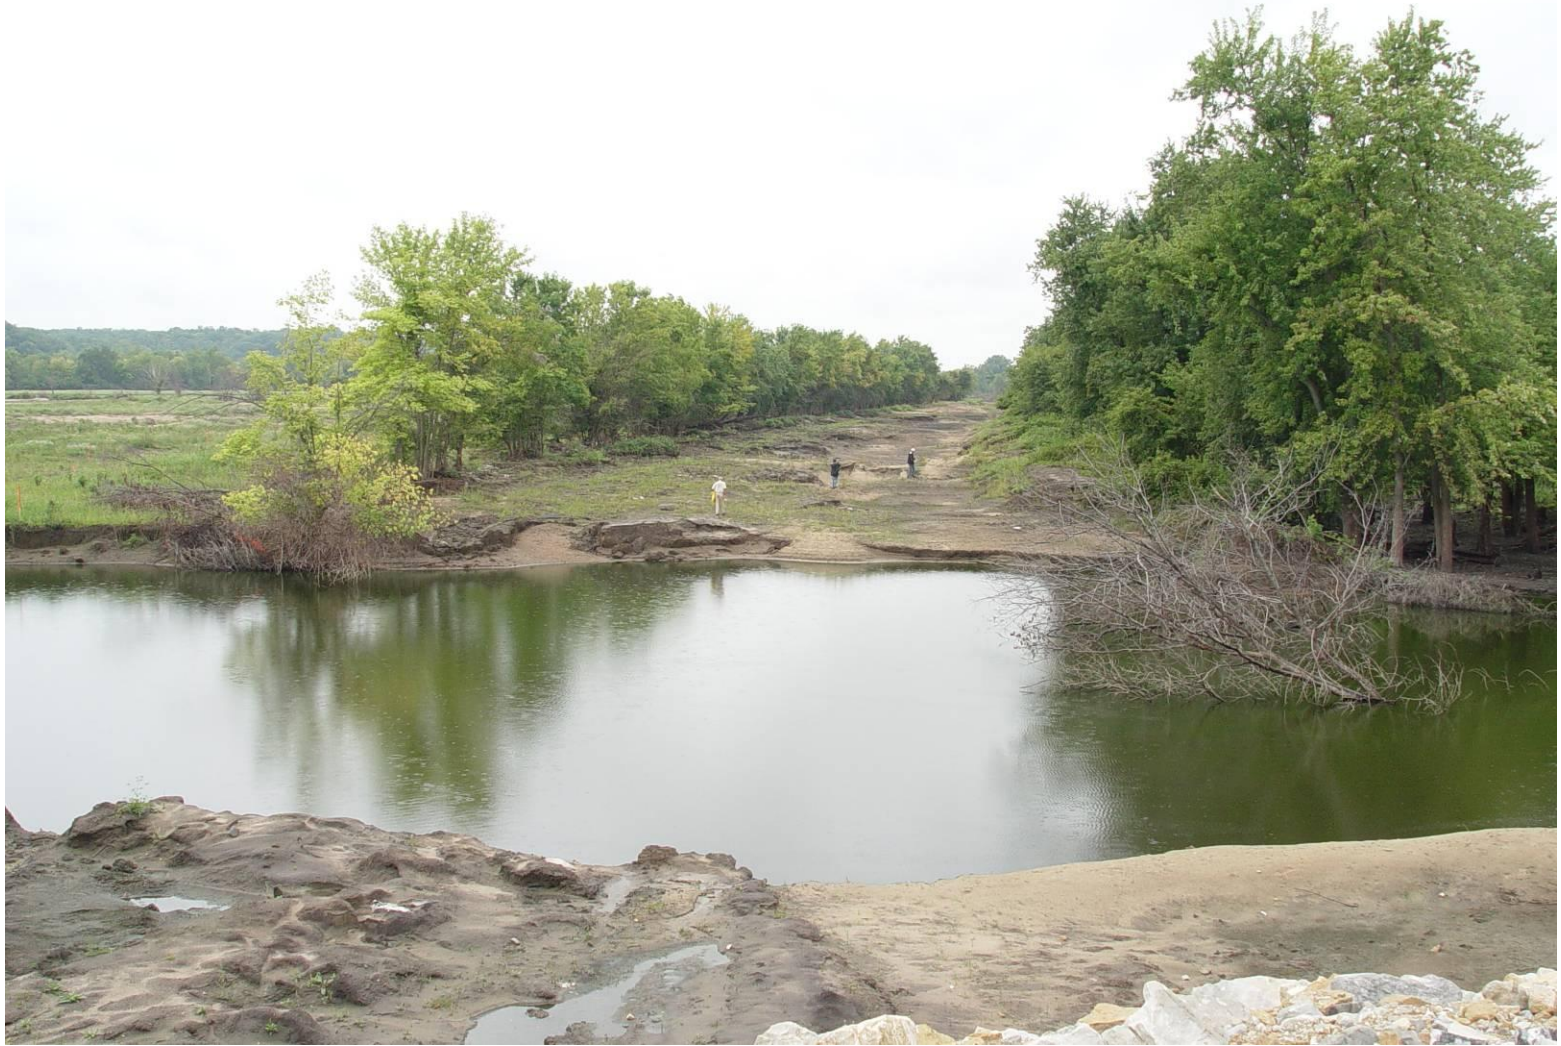
- The breach along the southern bank of the lower Iowa River in the Two Rivers area southeast of Wapello, IA was one mile long. This break was a result of another break about 10 miles upstream, where US Hwy 61 crosses the river, which bifurcated the maximum flow, which re-joined at this location.

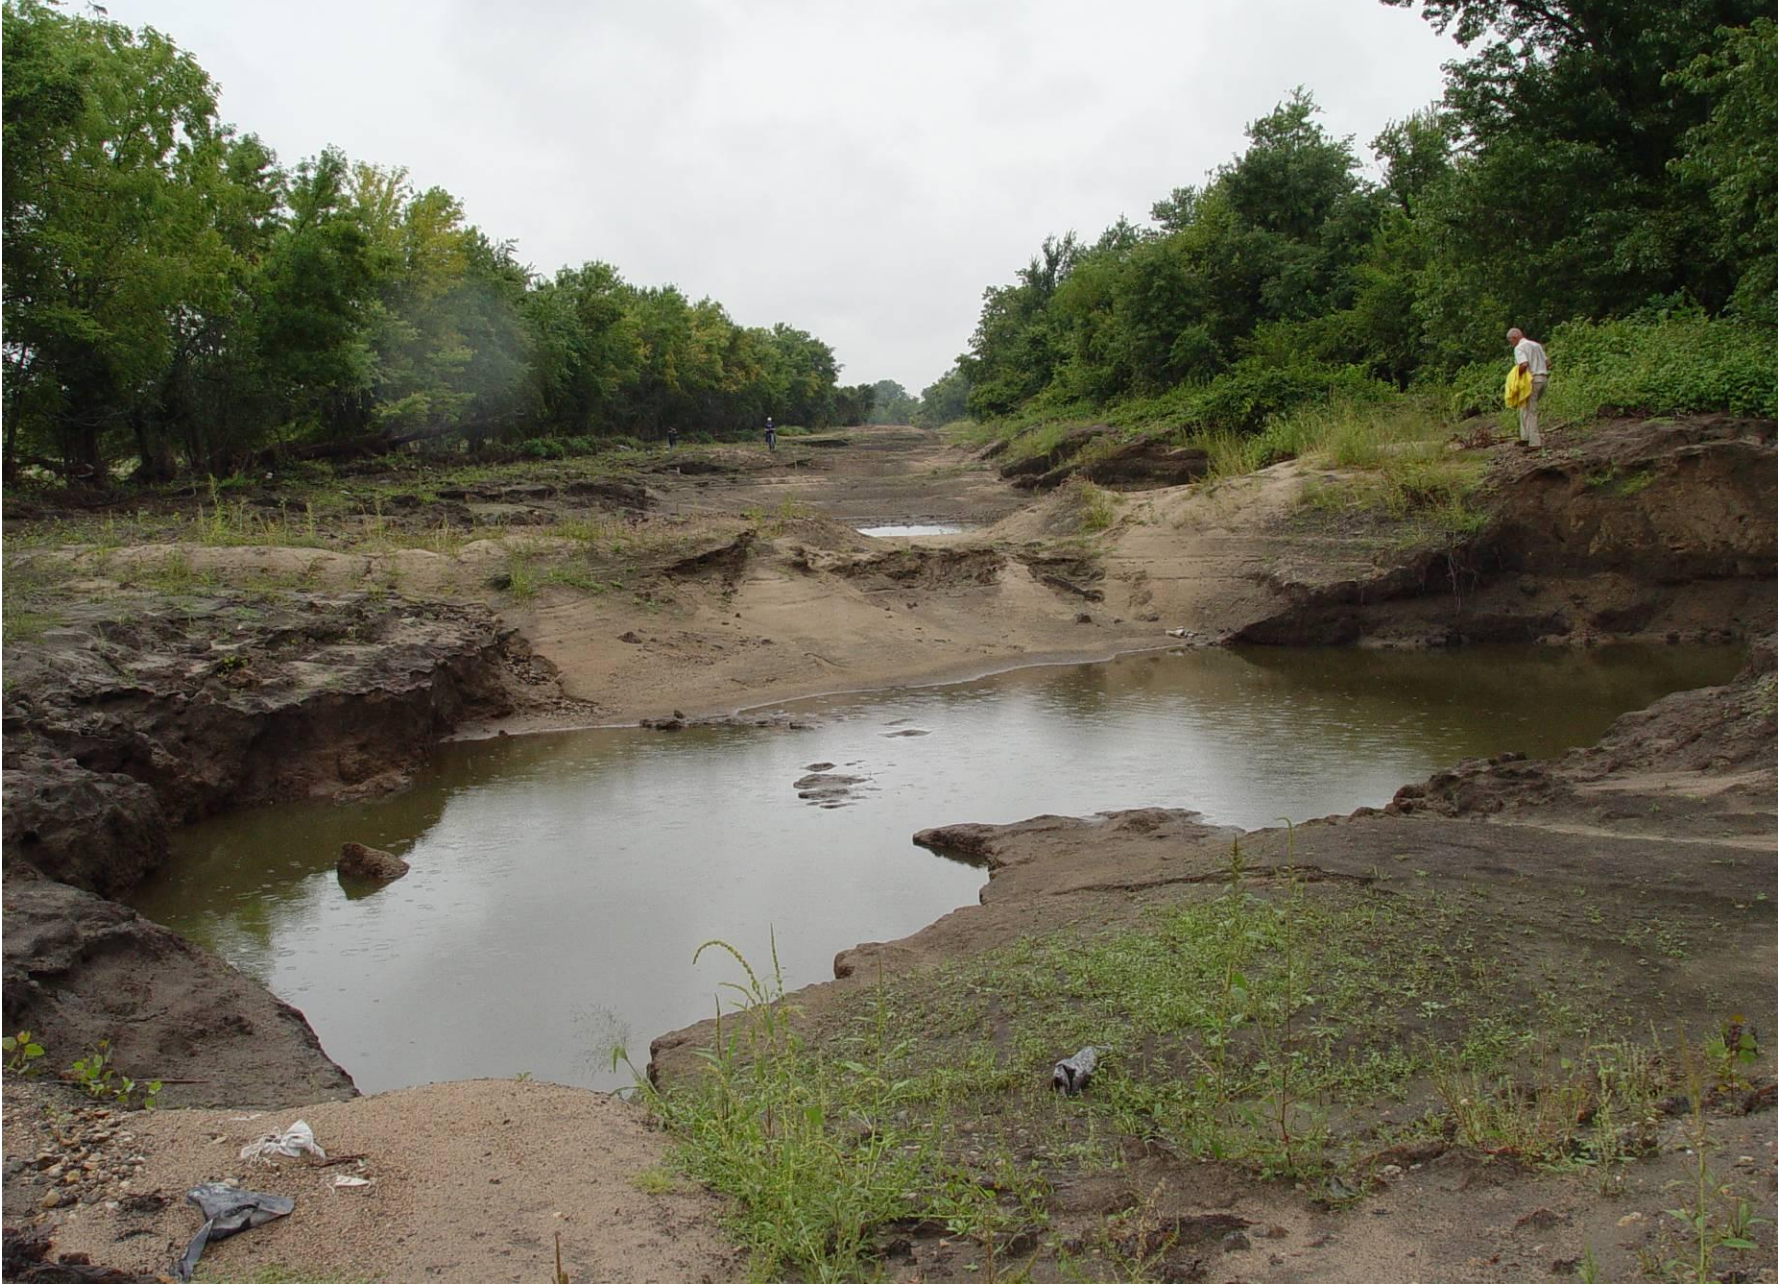
- **View looking westerly, down the former axis of the right bank levee of the Iowa River, in the Two Rivers Levee & Drainage Association. This was the worst levee breach that occurred in the 2008 Midwest floods.**

Scour holes in a shale foundation testified to a large volume of water sweeping through, leaving almost no trace of the levee behind

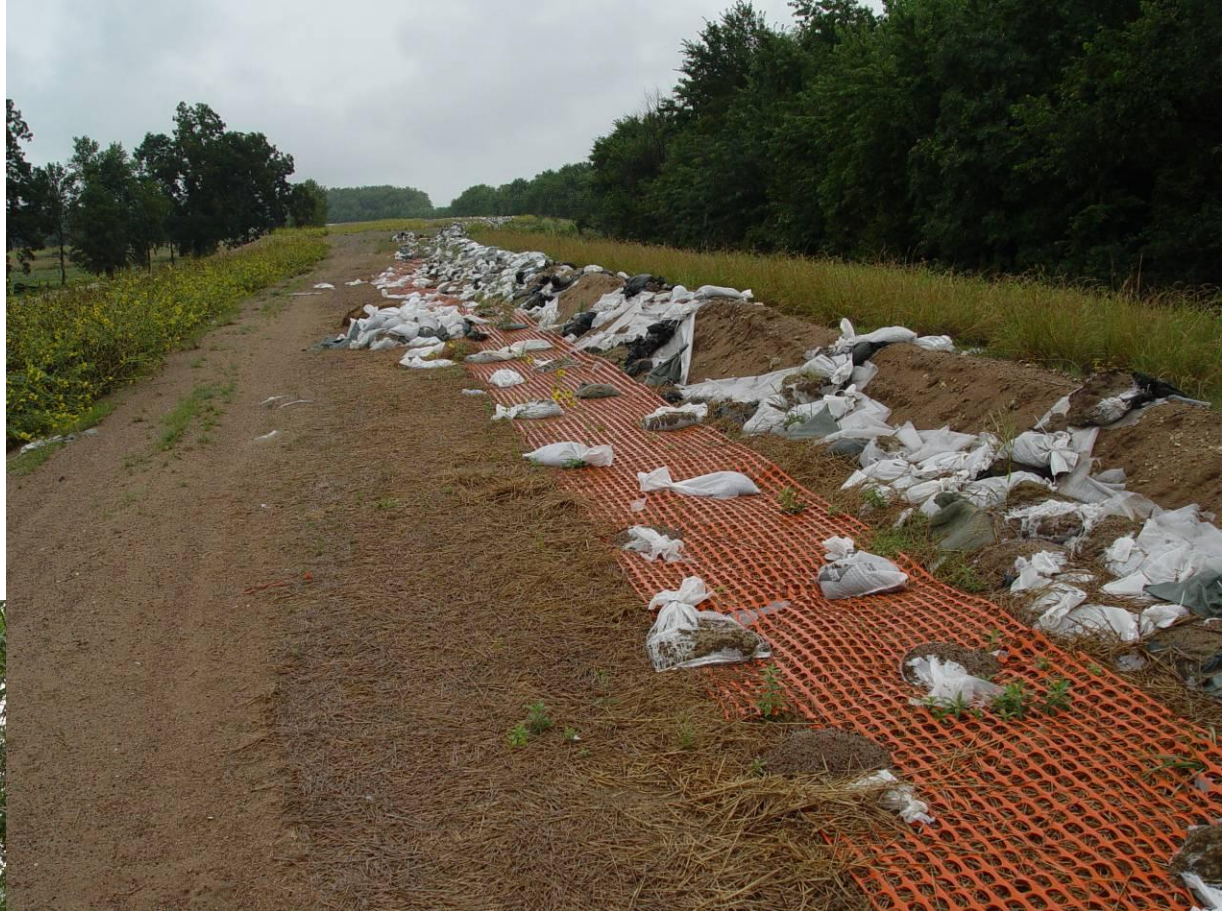
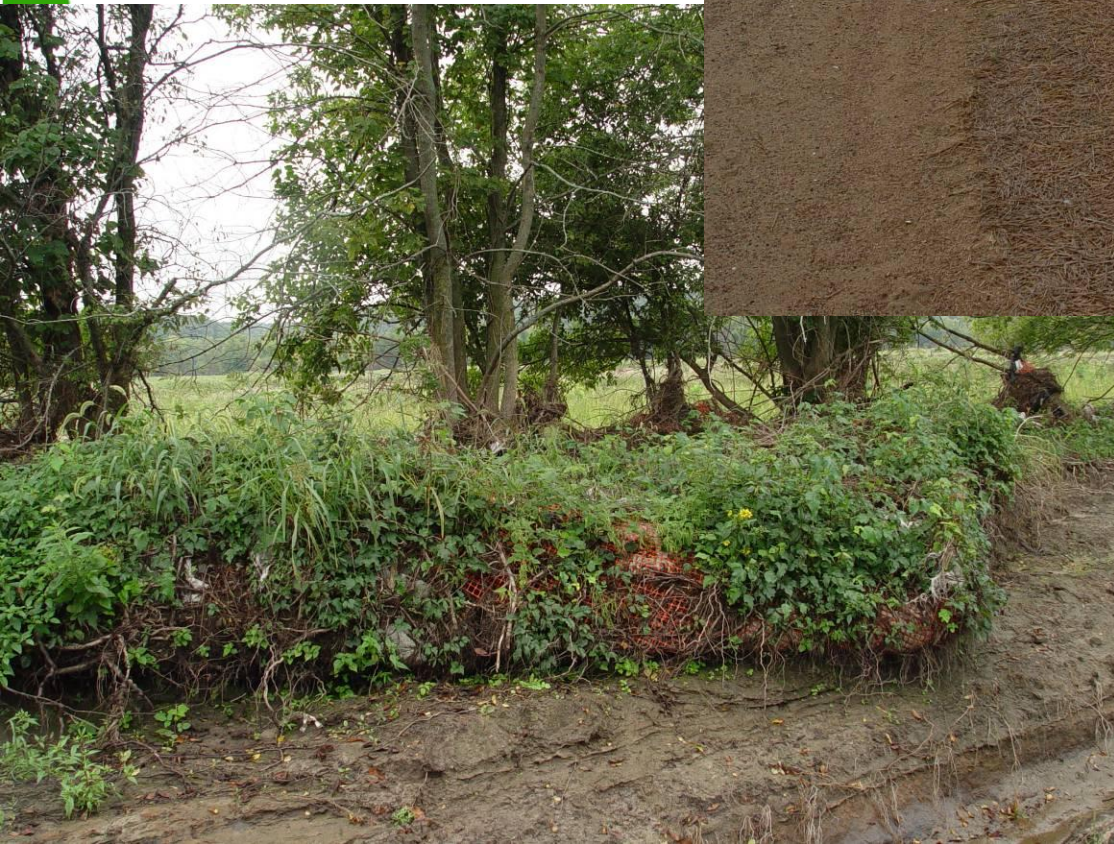
Two Rivers Blow-out

- **Sand push-ups were used to raise the Iowa River dike about 3 feet.**
