POST-FLOOD RECONNAISSANCE: UPPER MISSISSIPPI RIVER FLOODING OF 2008

J. David Rogers, Ph.D., P.E., R.G.

Natural Hazards Mitigation Institute

November 11, 2008

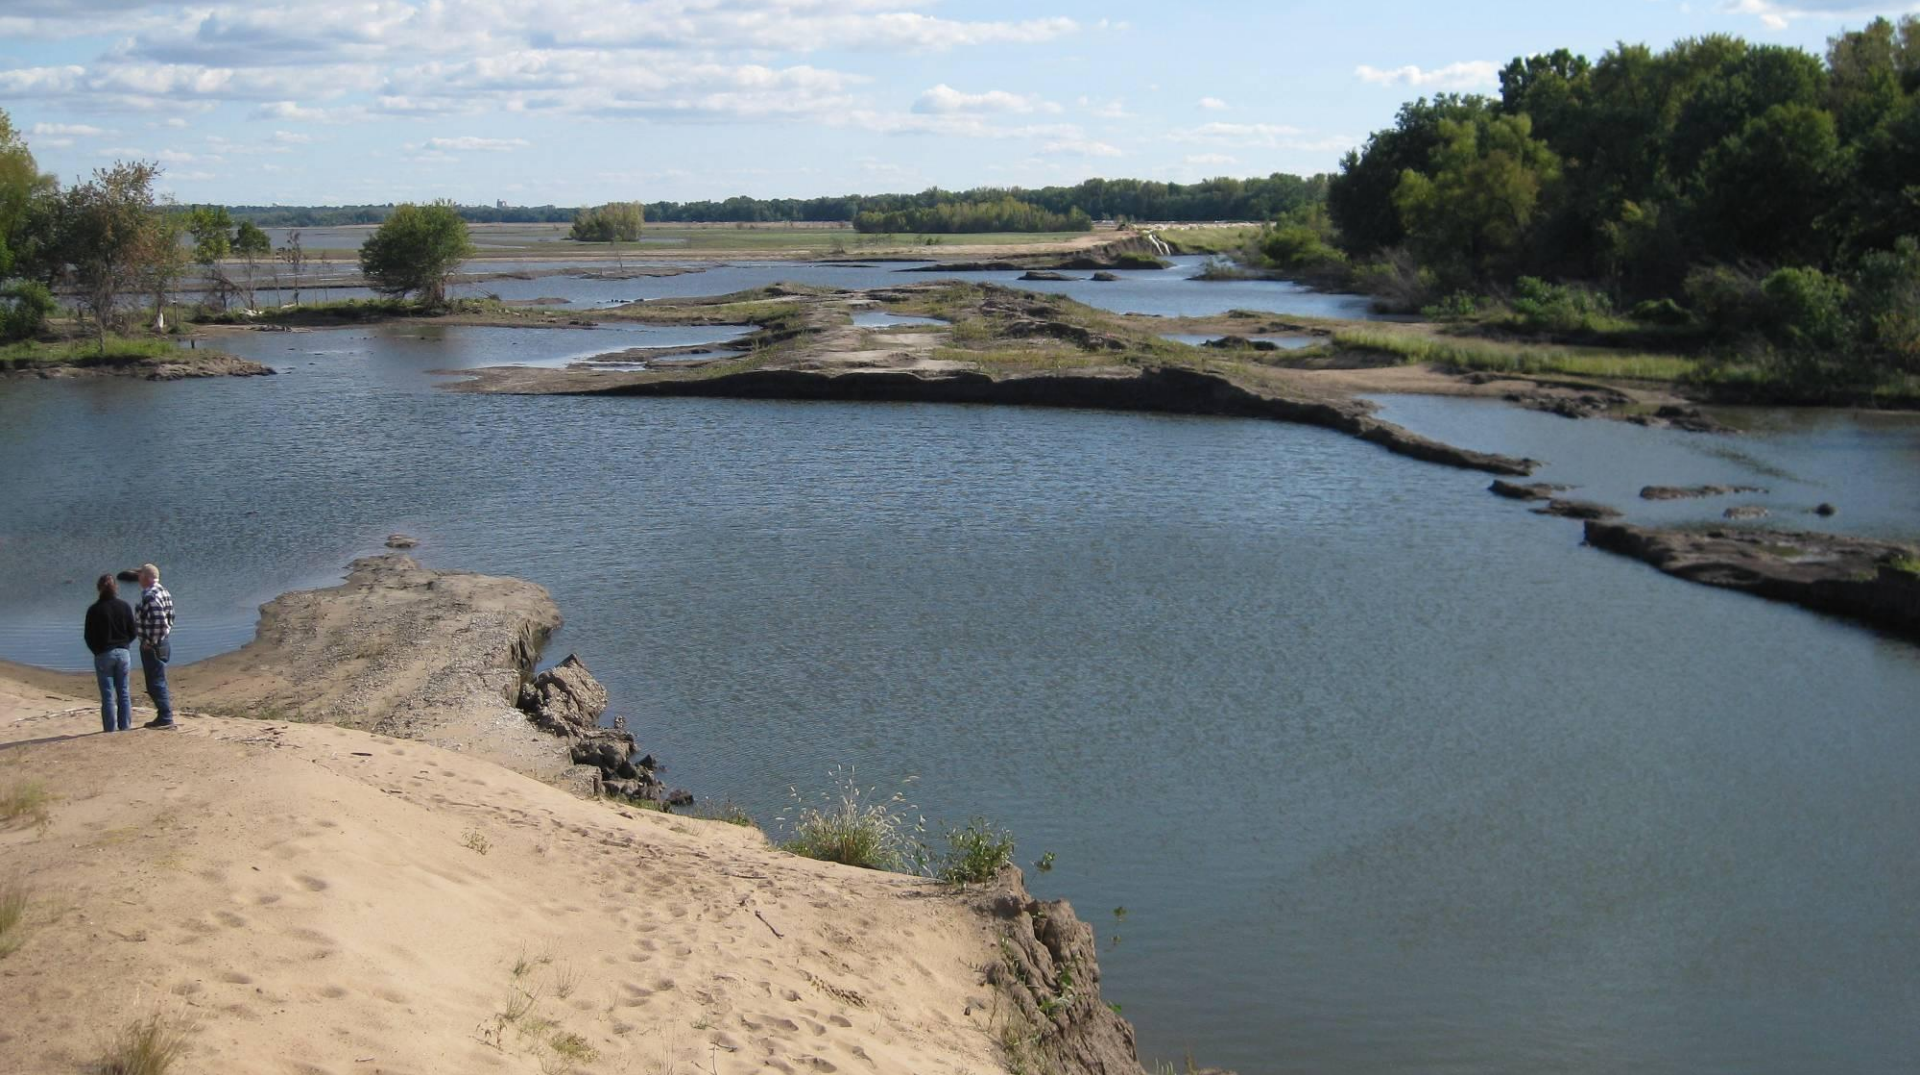
- **1300 ft wide breach at Indian Grave, near Quincy, IL. Failures have occurred here in 1947, 1965, 1993, and 2008. Four floods in 61 years is once every ~15 yrs. These agricultural levees are rated by the Corps of Engineers as 14-yr flood protection structures.**

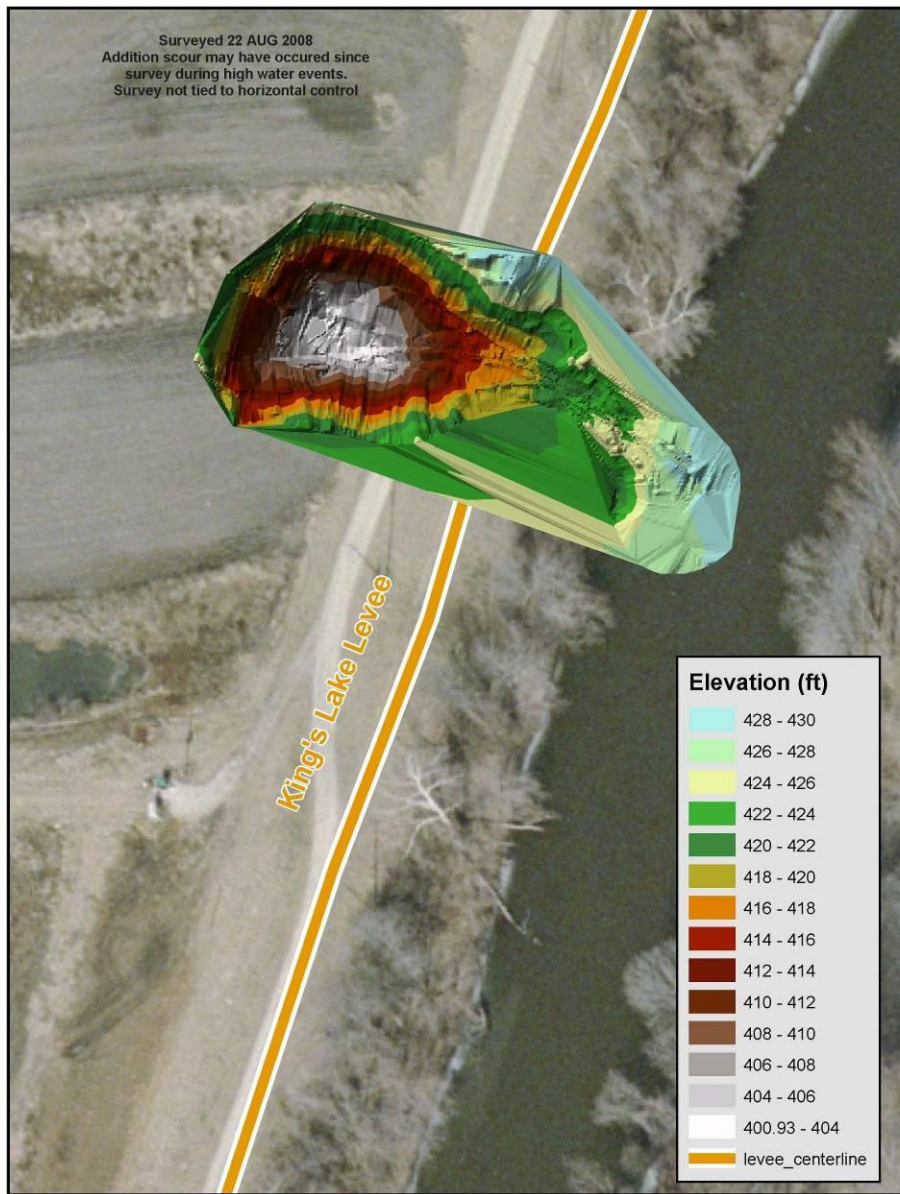
Biggest Repair Problem

- Deep scour holes are perhaps the biggest engineering challenge in repairing dikes.
- These hole can be up to 40 ft deep and are backfilled with dredged sand
- A 5 ft thick clay cap is compacted over the sand fill to provide a semi-impervious seepage 'blanket'
