ENGINEERING GEOLOGIC CHARACTERIZATION OF LEVEE FAILURES IN NEW ORLEANS DURING HURRICANE KATRINA

J. David Rogers, Ph.D., P.E., R.G.

**2007 Annual Meeting
Association of Environmental and Engineering Geologists
Los Angeles, California
September 28, 2007**

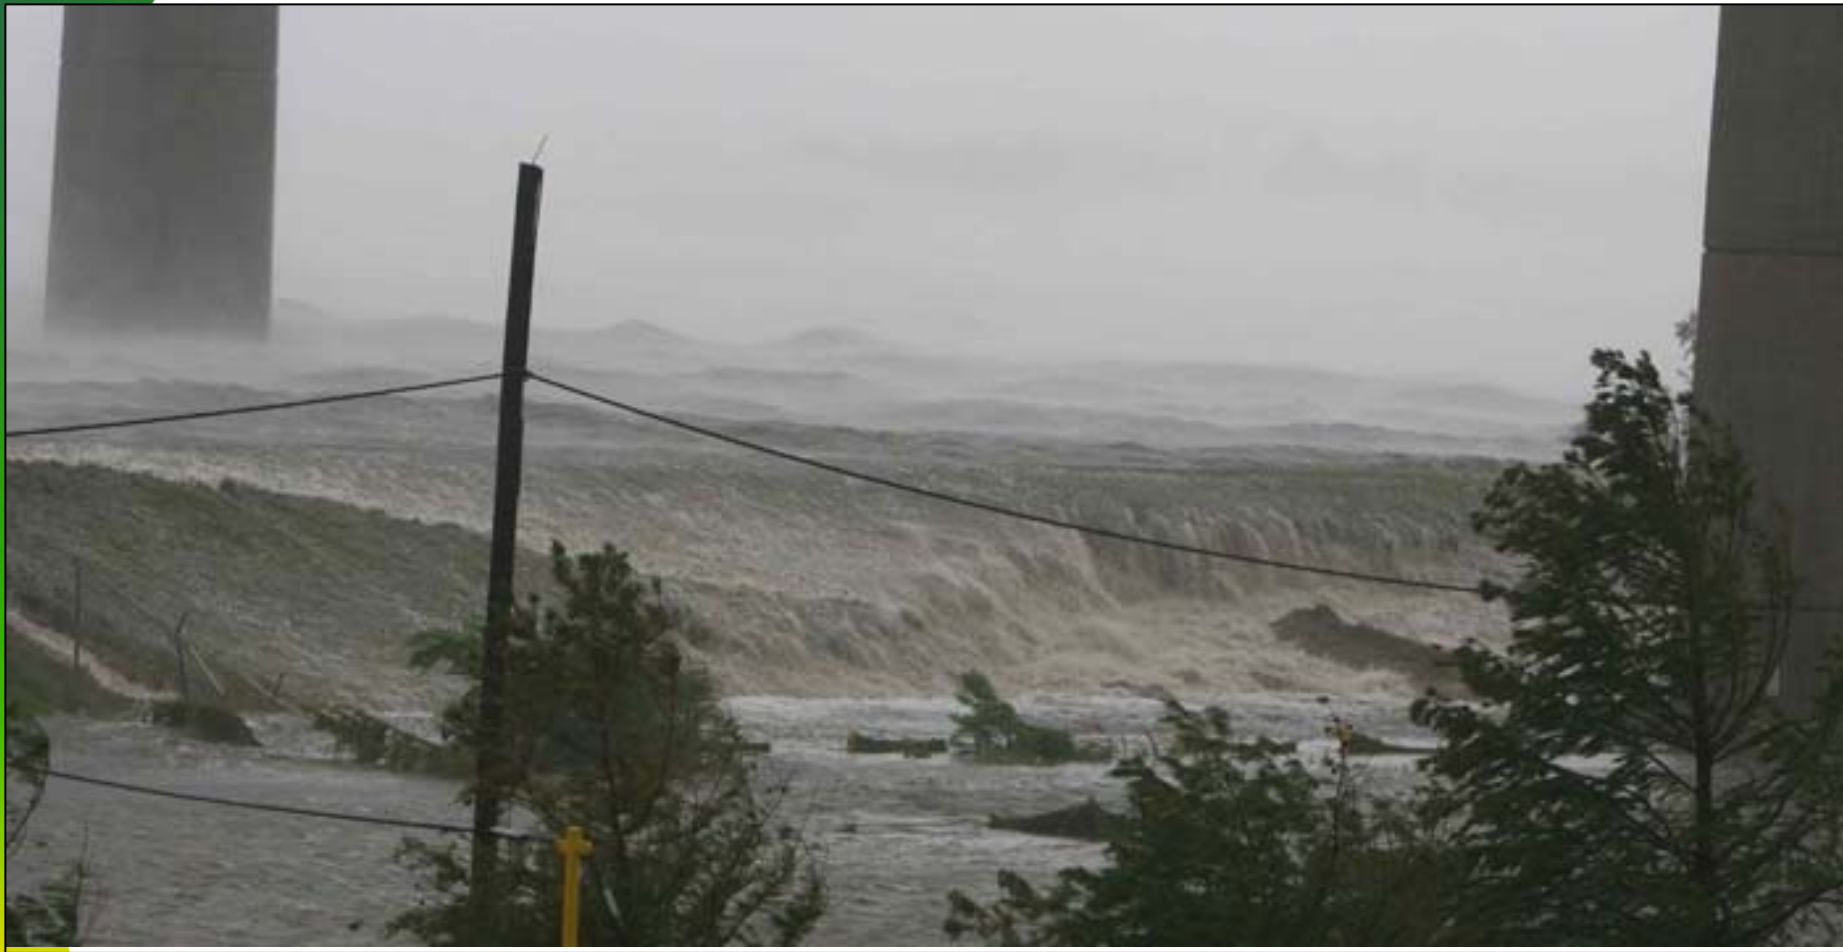
- **Around 6 AM on August 29th the 9 ft storm surge swept into the Inner Harbor Navigation Canal area, engulfing the Entergy Power Plant area with waves up to 17 ft high.**

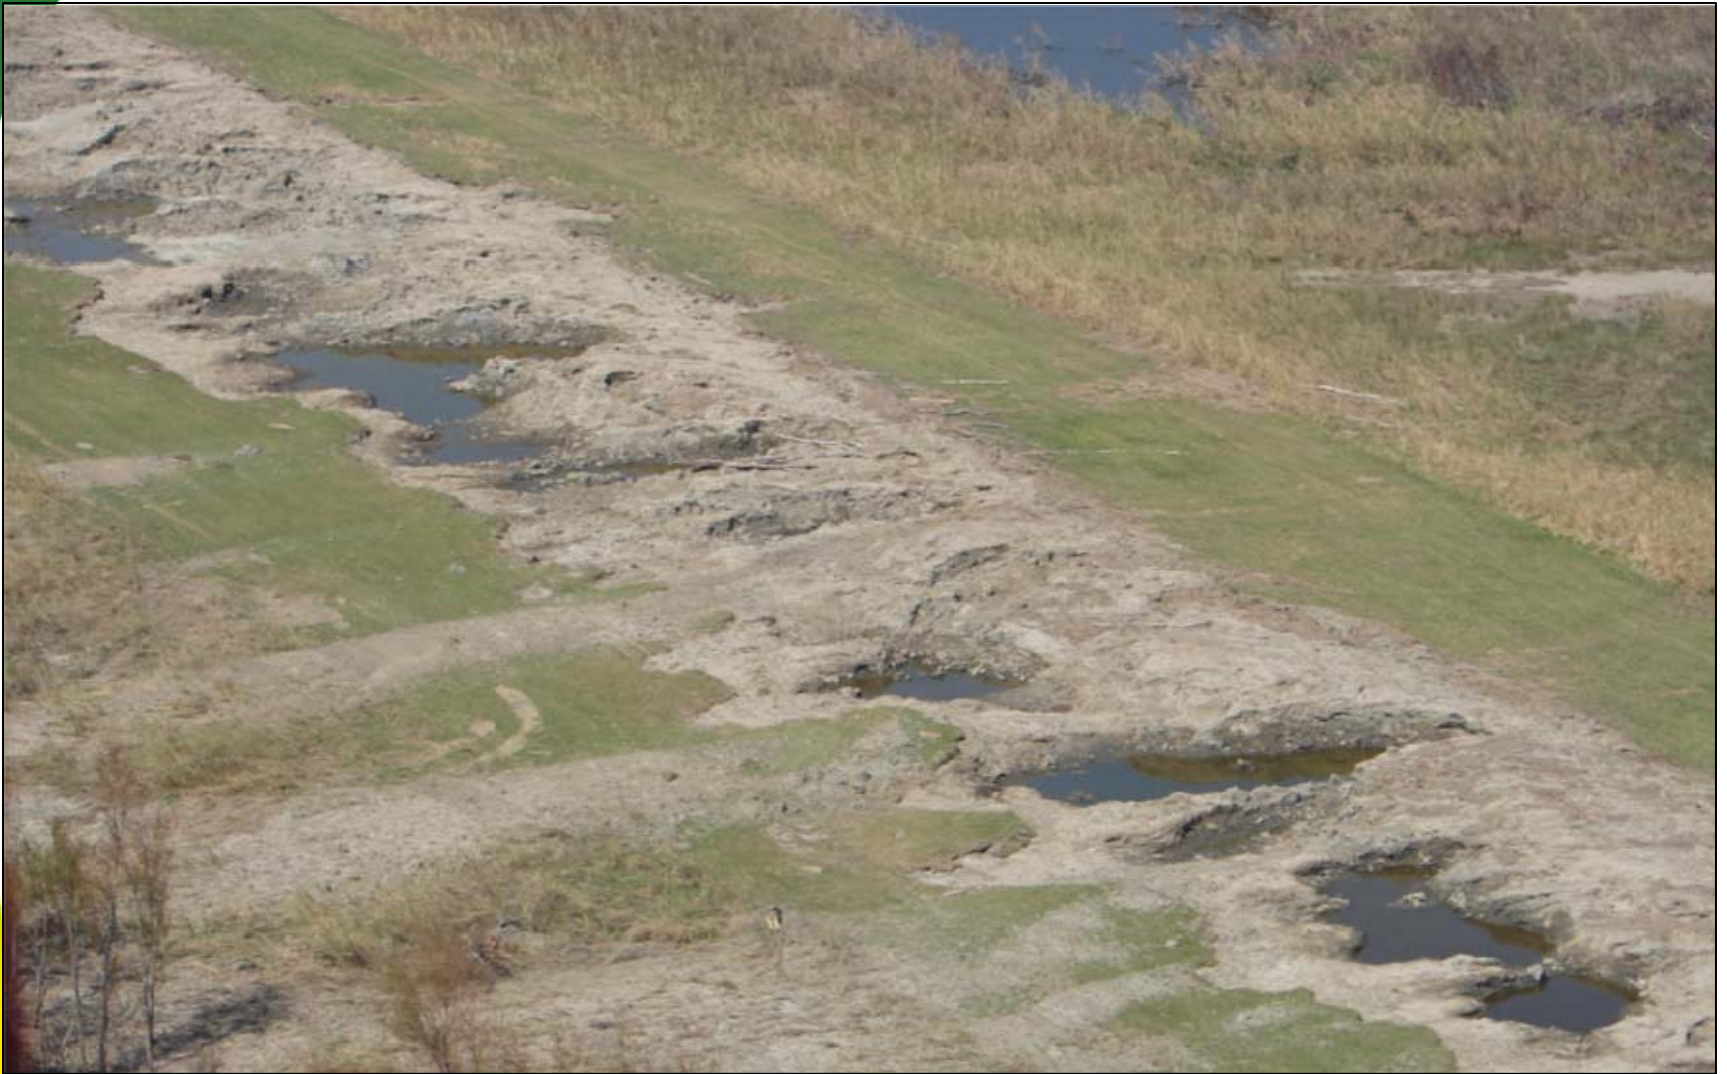
- **Miles of levees just disappeared: MRGO levee completely washed away about two miles southeast of Bayou Dupree.**

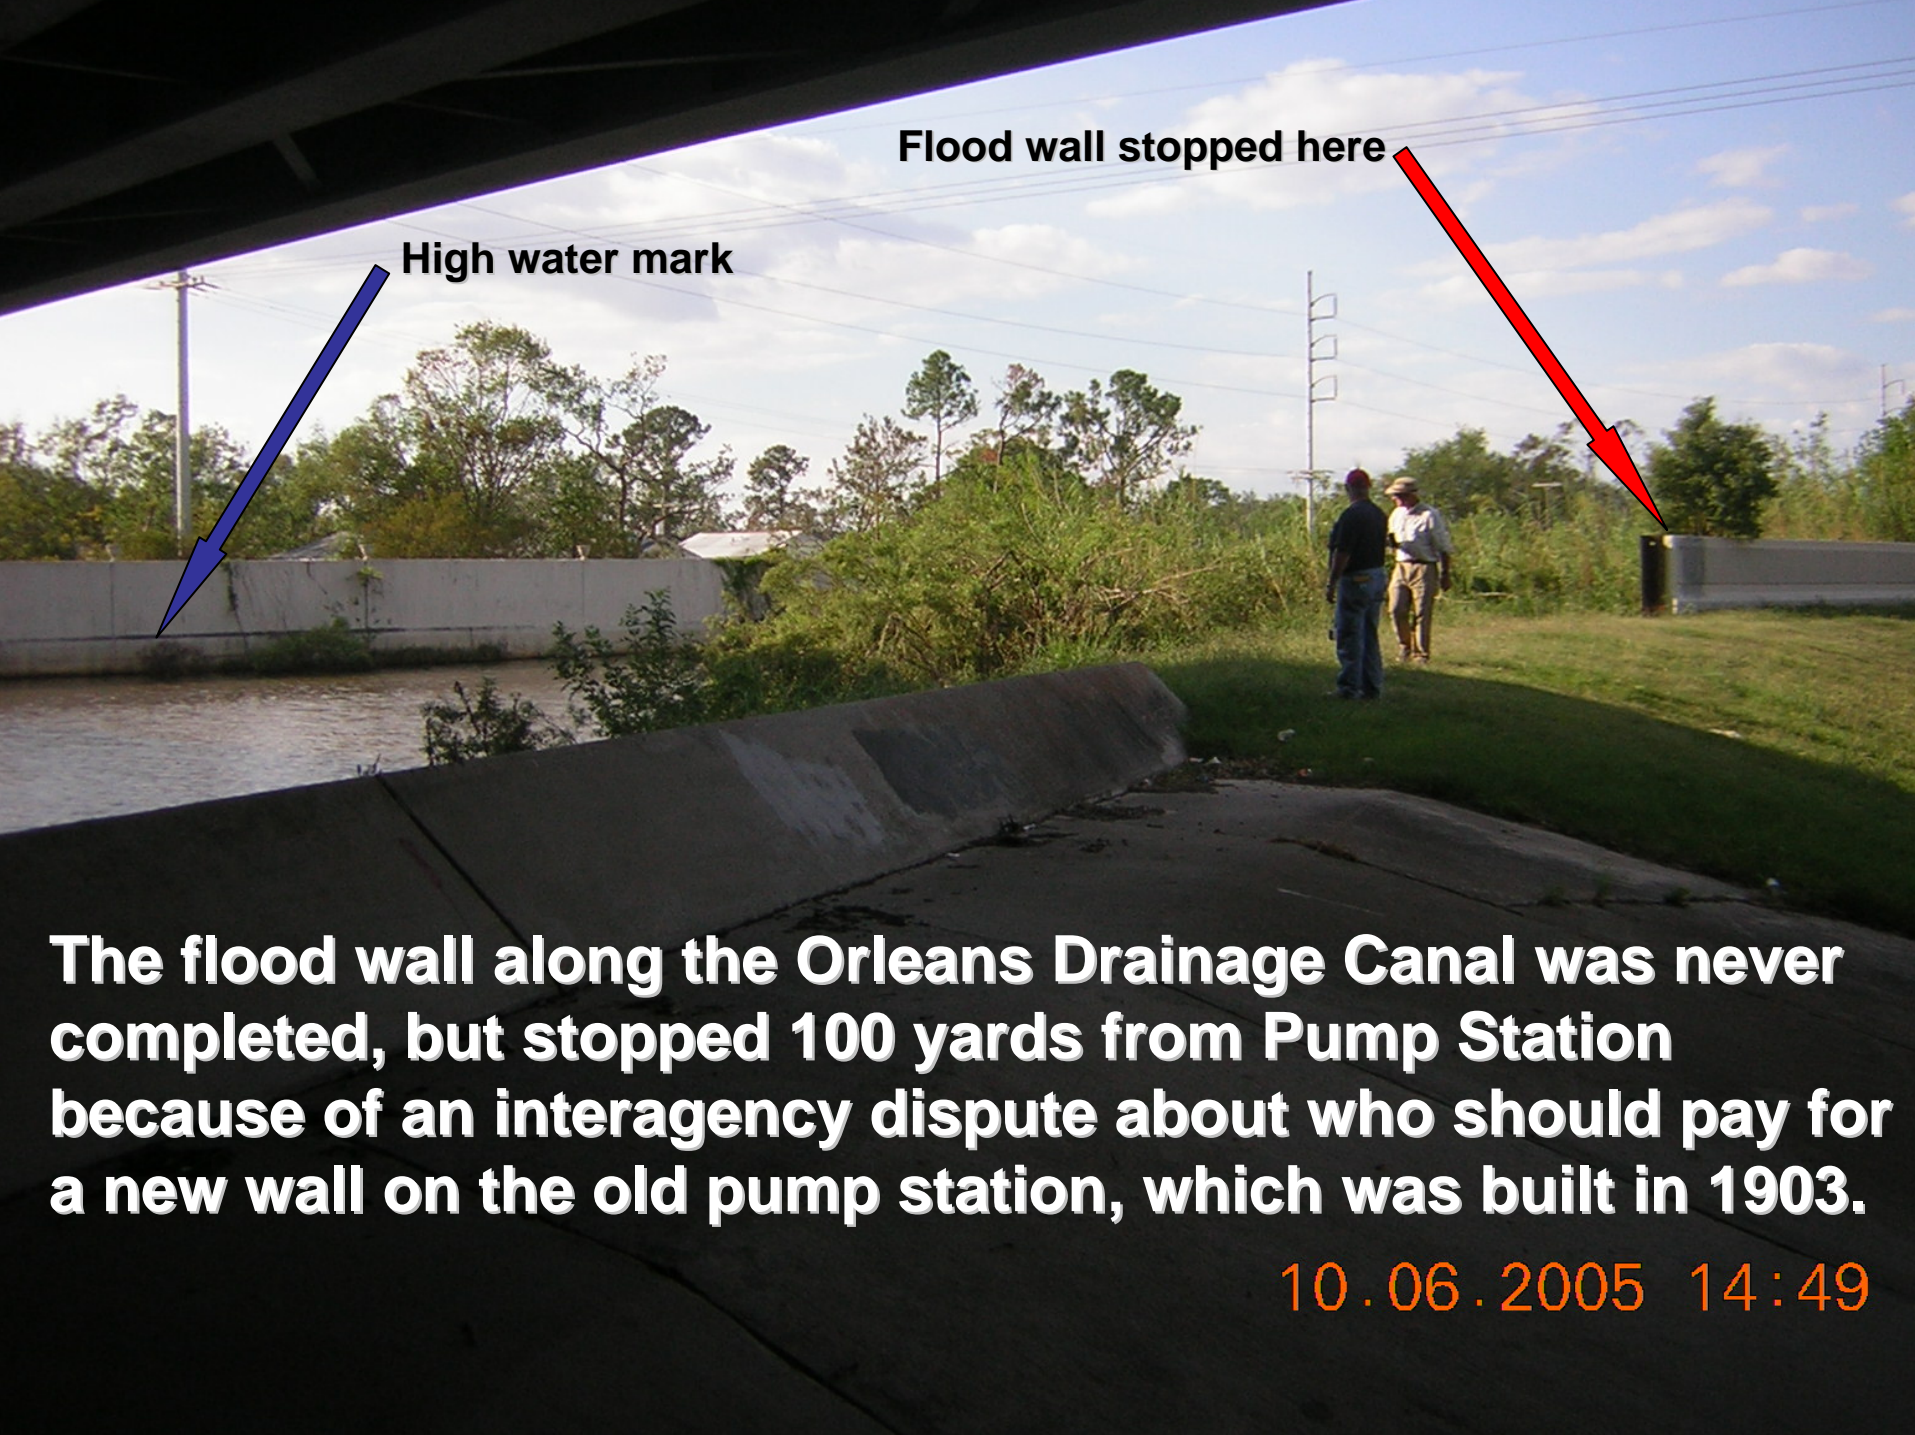
Flood wall stopped here

The flood wall along the Orleans Drainage Canal was never completed, but stopped 100 yards from Pump Station because of an interagency dispute about who should pay for a new wall on the old pump station, which was built in 1903.

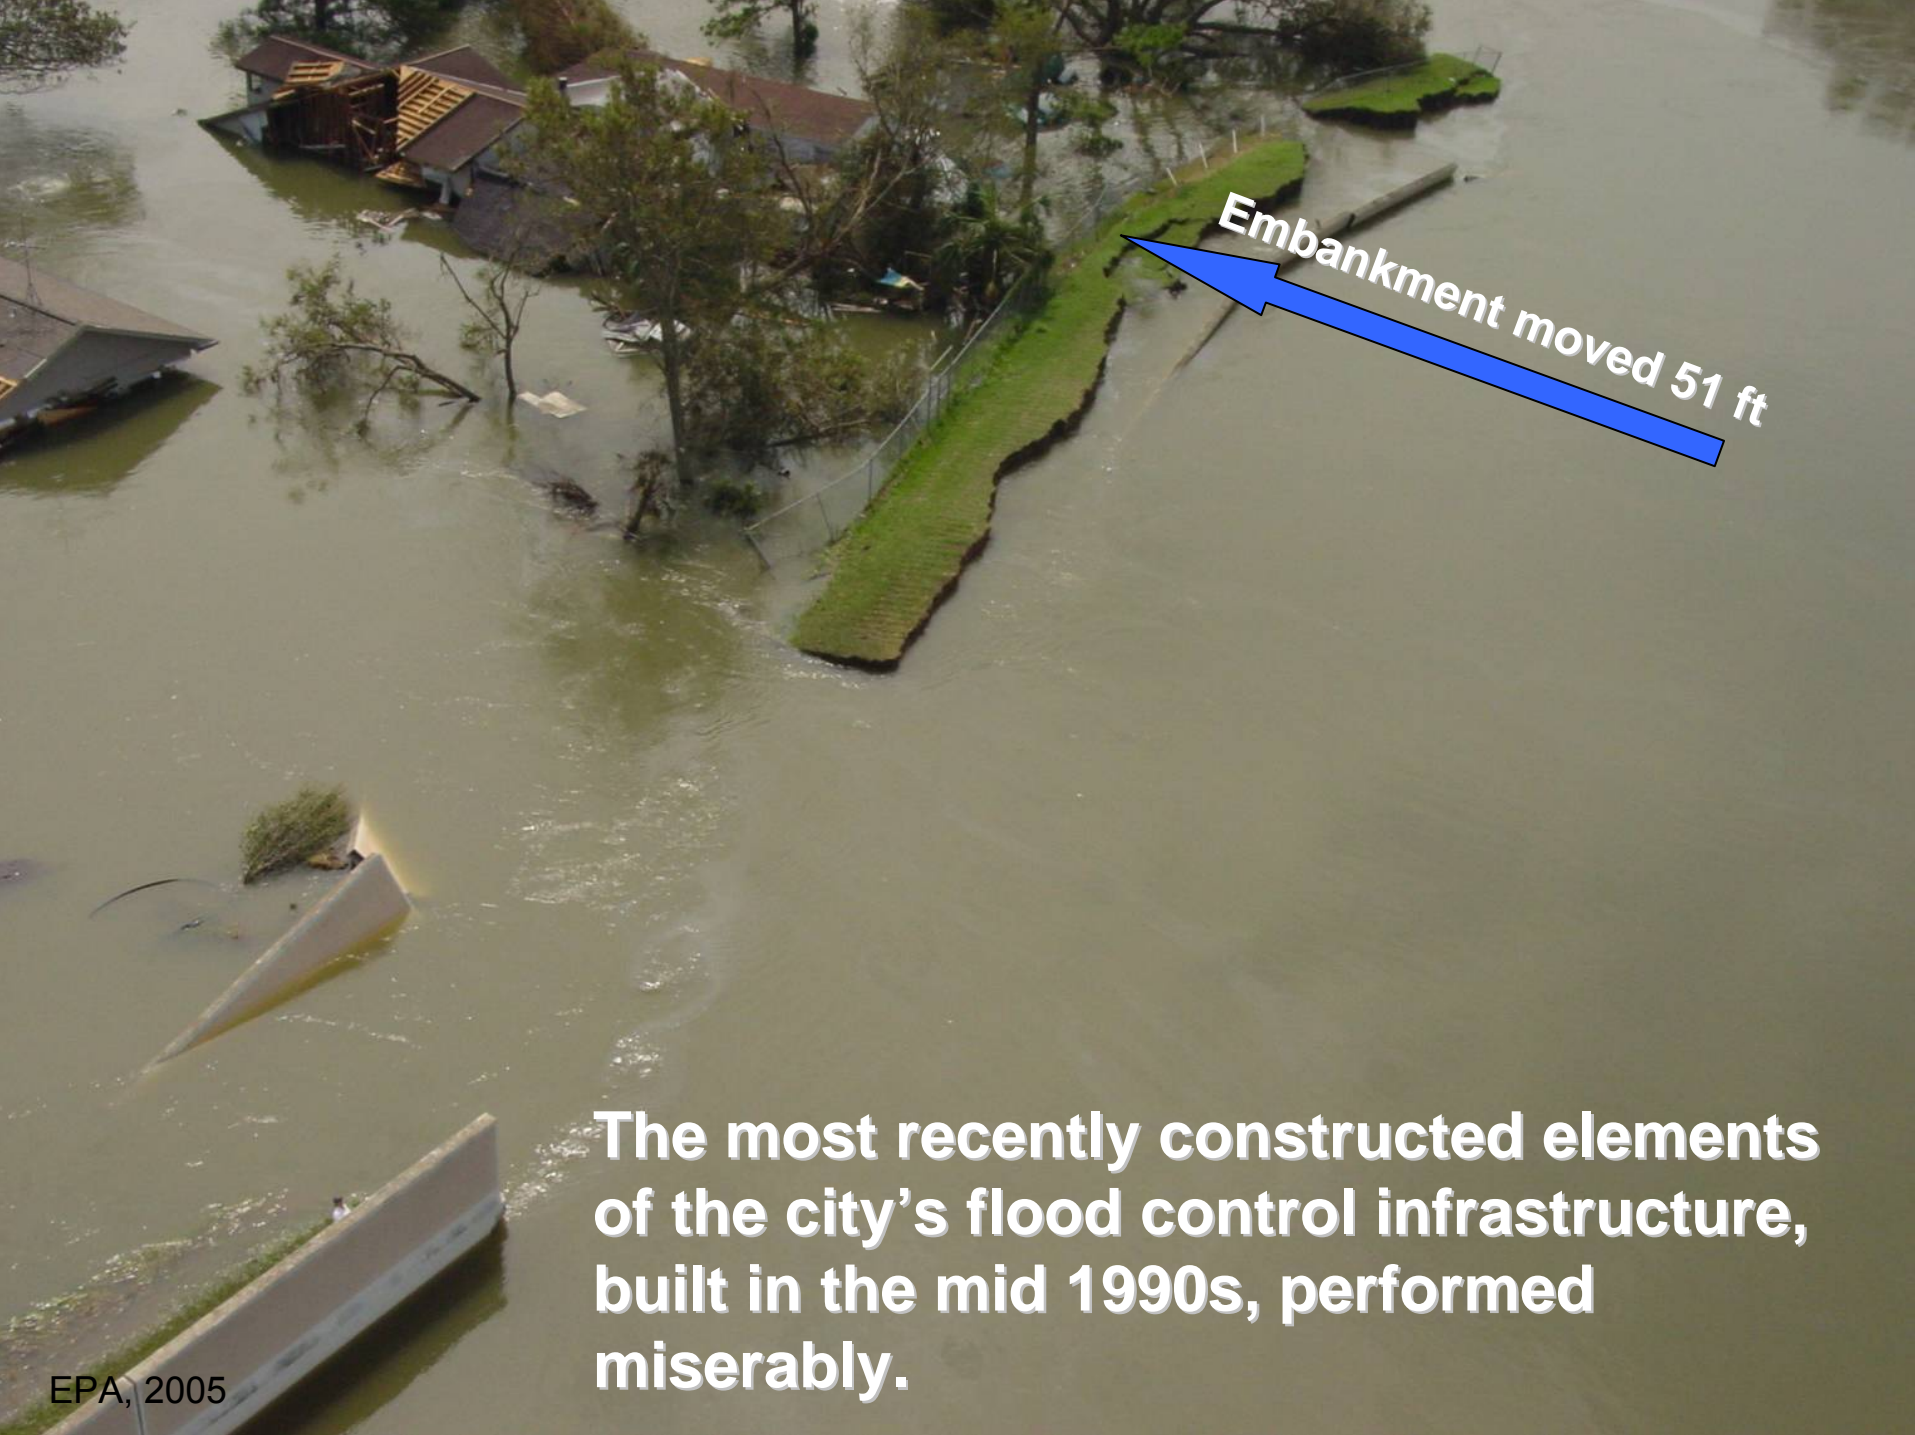
Embankment moved 51 ft

The most recently constructed elements of the city's flood control infrastructure, built in the mid 1990s, performed miserably.

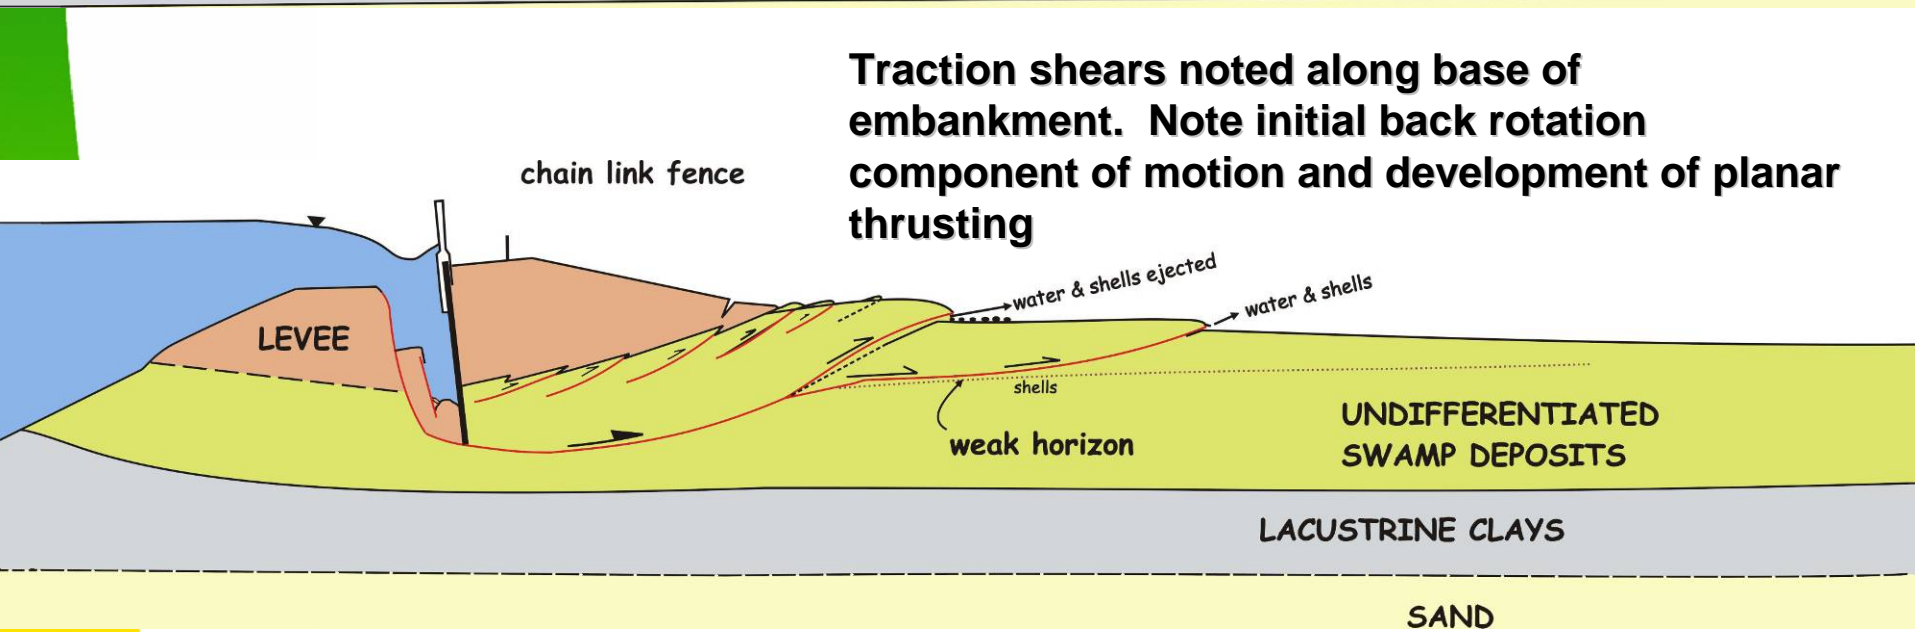
Passive reaction wedge coincided with stratigraphic horizon depressed by weight of the levee embankment on the compressible cypress marsh deposits

Traction shears noted along base of embankment. Note initial back rotation component of motion and development of planar thrusting

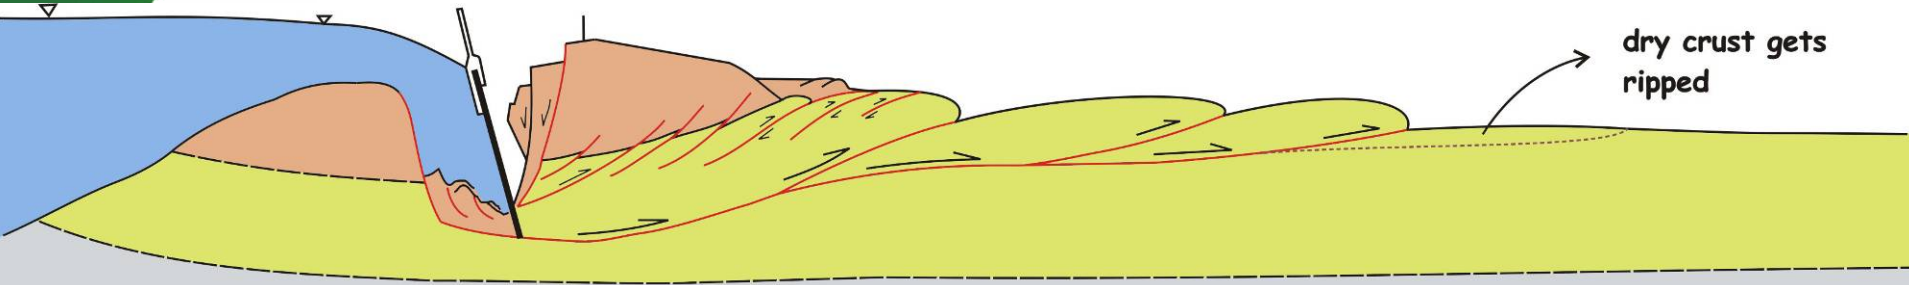
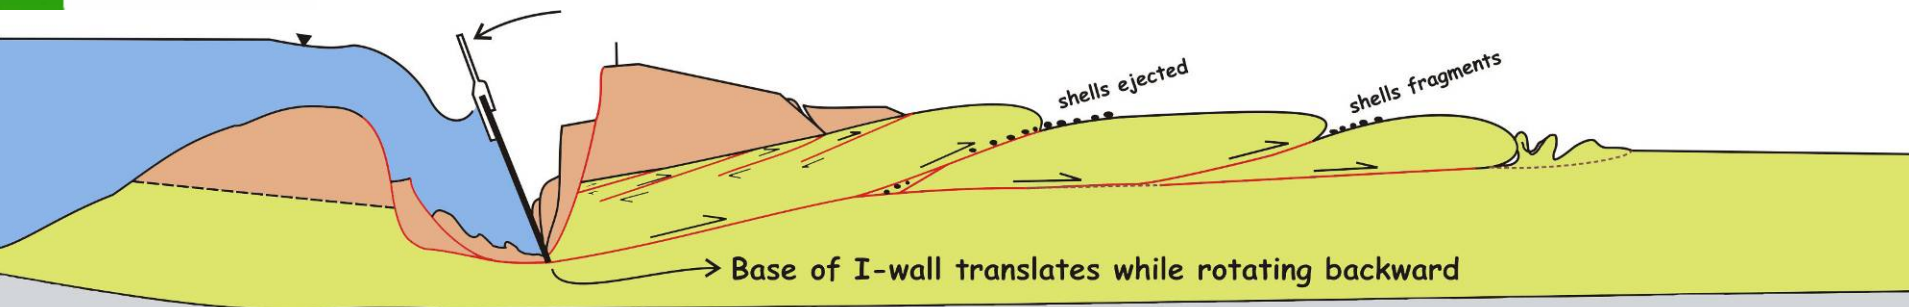
Initial loading conditions. Storm surge rises to within 4 feet of flood wall crest. Hydrostatic pressures on sheetpile supported I-wall highlighted in blue. Translational failure begins.

Progression of translational failure sequence. Multiple thrust sheets develop in partially saturated crust, comprised of sandy fill over organic cypress swamp deposits. The upper crust buckles like a rug being rolled up.

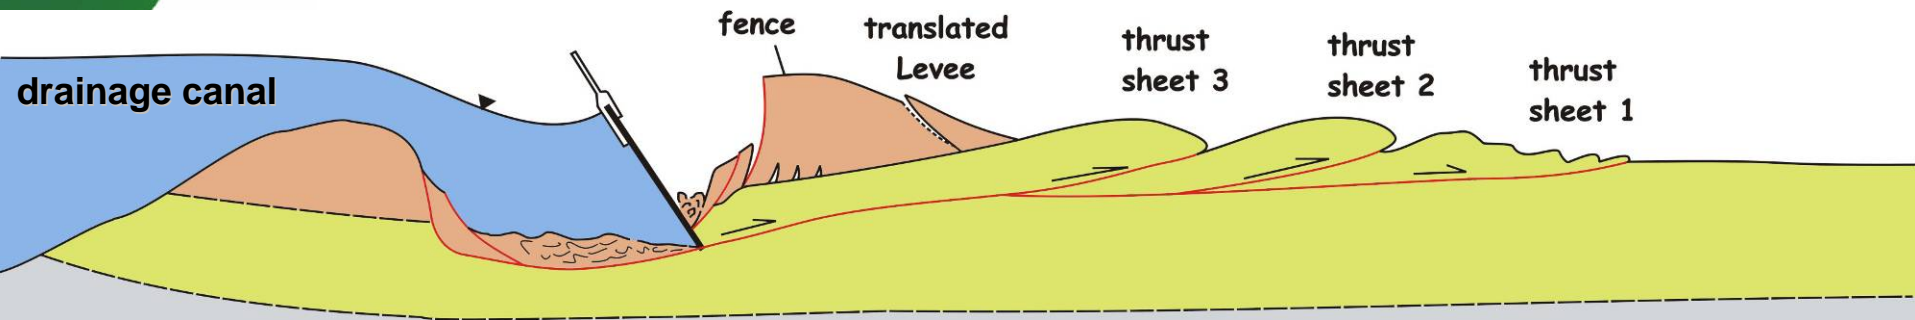
Some sheetpile supported I-walls fell backward; others fell forward

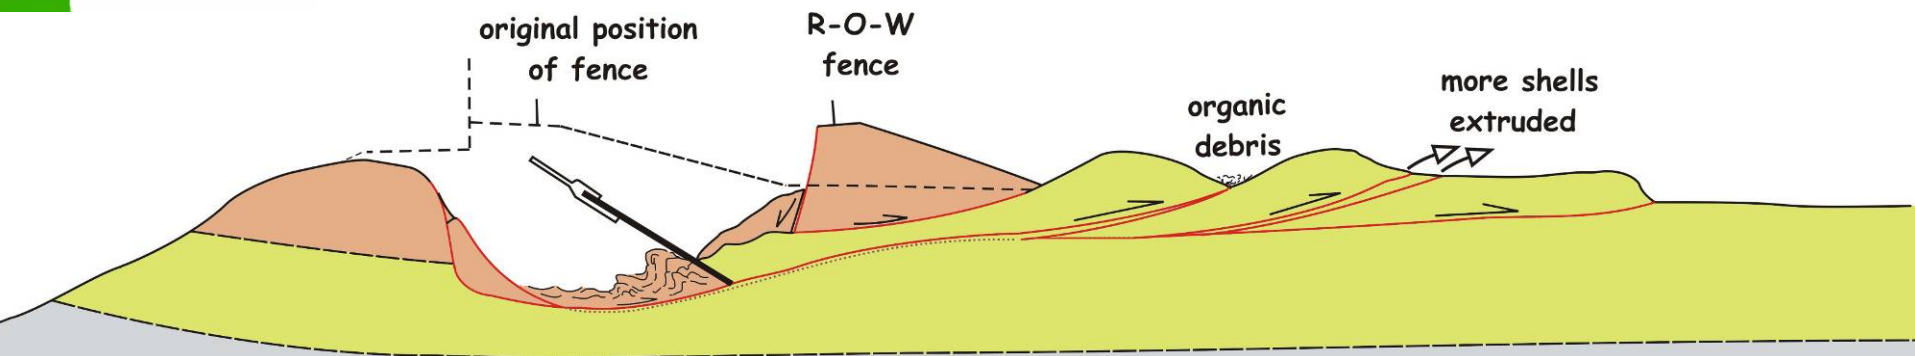
Final stages of translational failure sequence. Lower section shows failed levee after 51 feet of displacement. The void was quickly backfilled with gravel as part of sealing the breach.

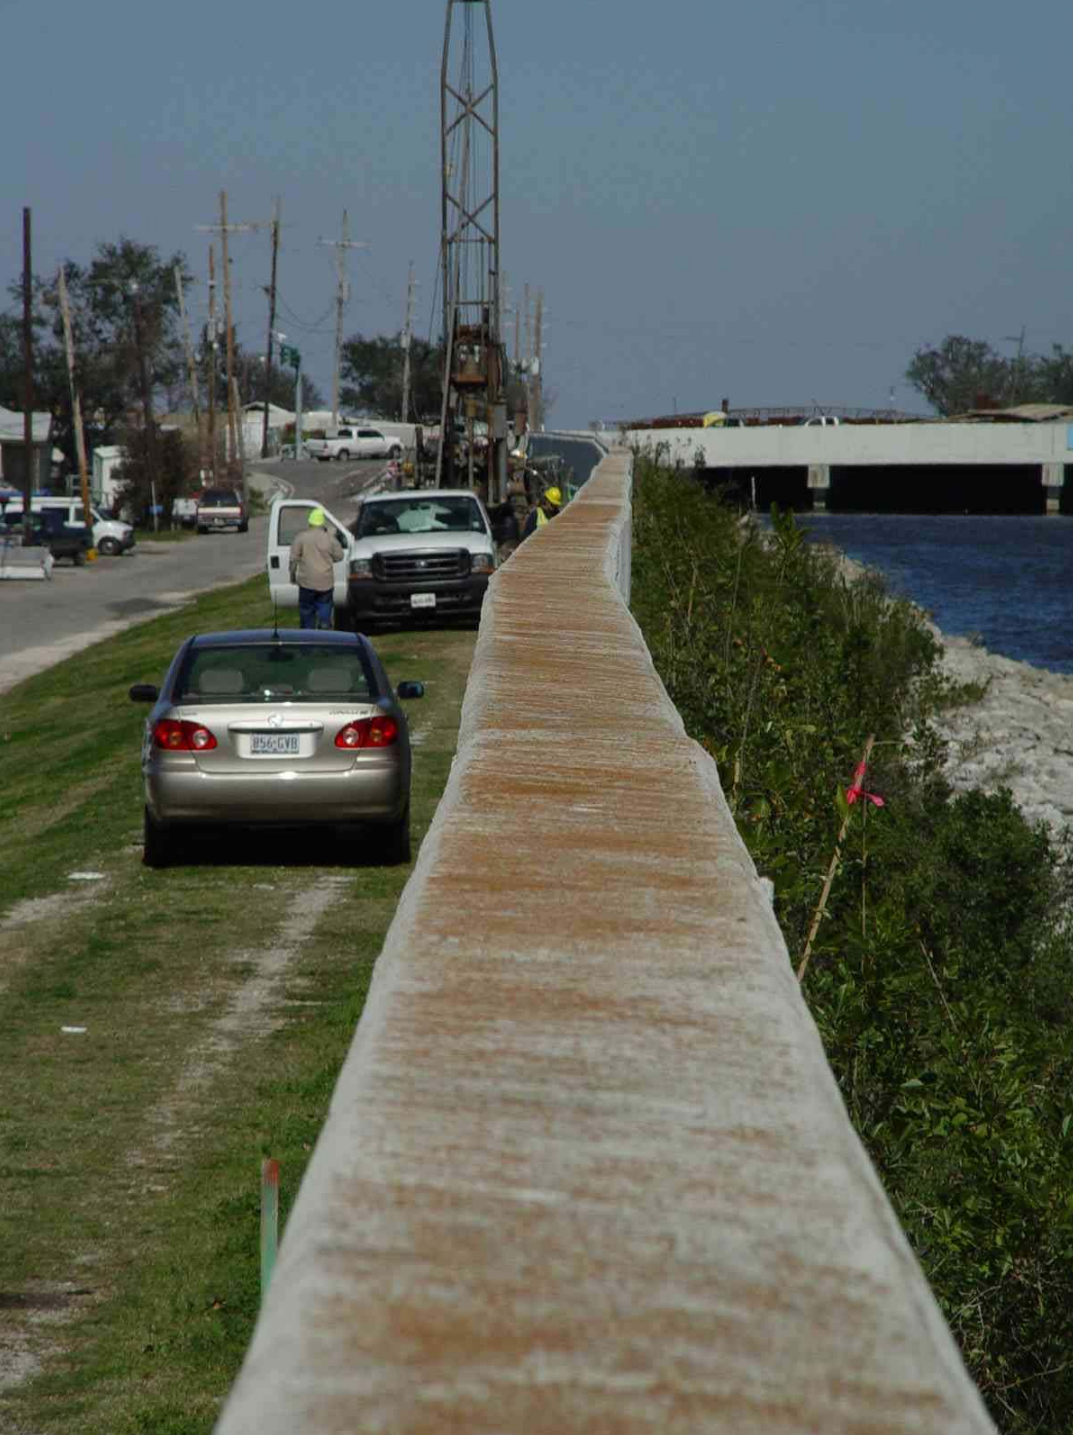
The tilting wall controversy

- The NSF team assuaged that the bend in the flood wall on the west (unfailed) side of the 17th St Canal was evidence of an incipient failure
- The Corps didn't initially agree publicly

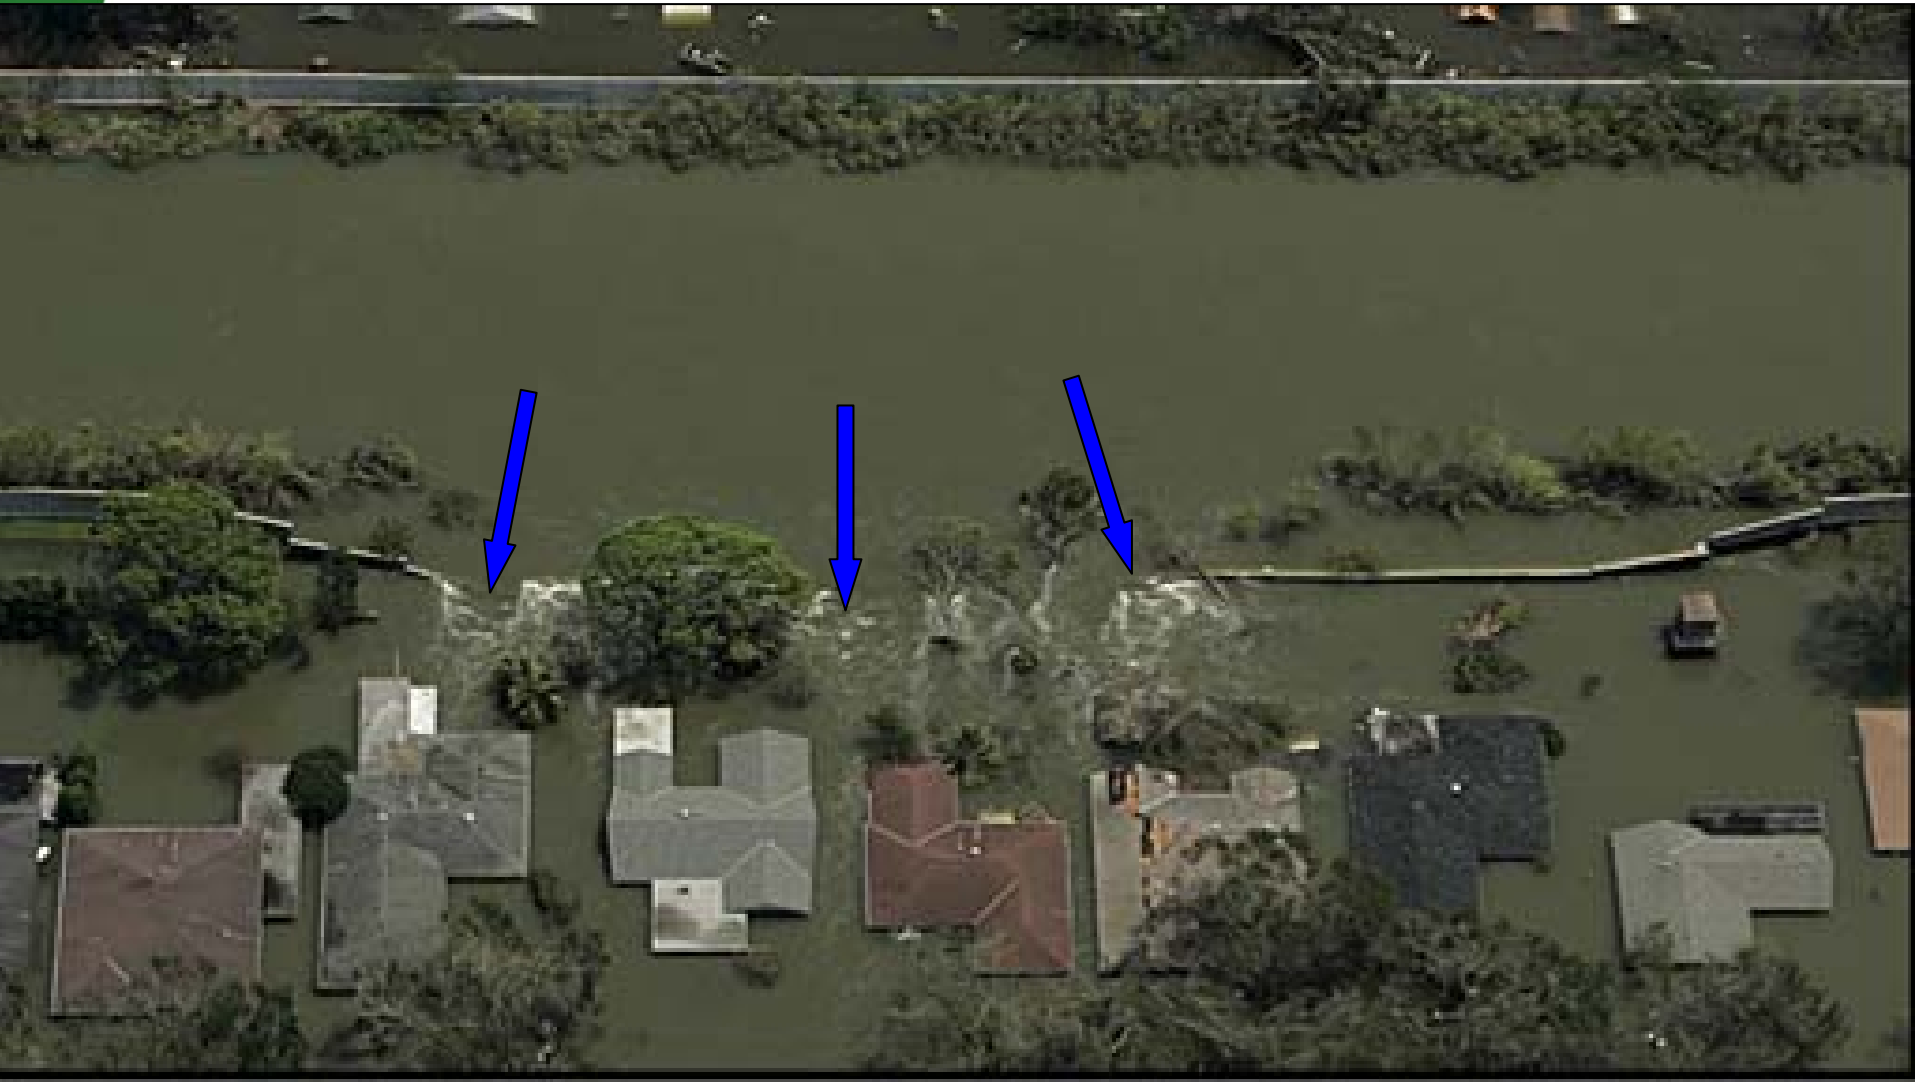
London Avenue (North) breach

Similar failure mechanism as 17th St Canal

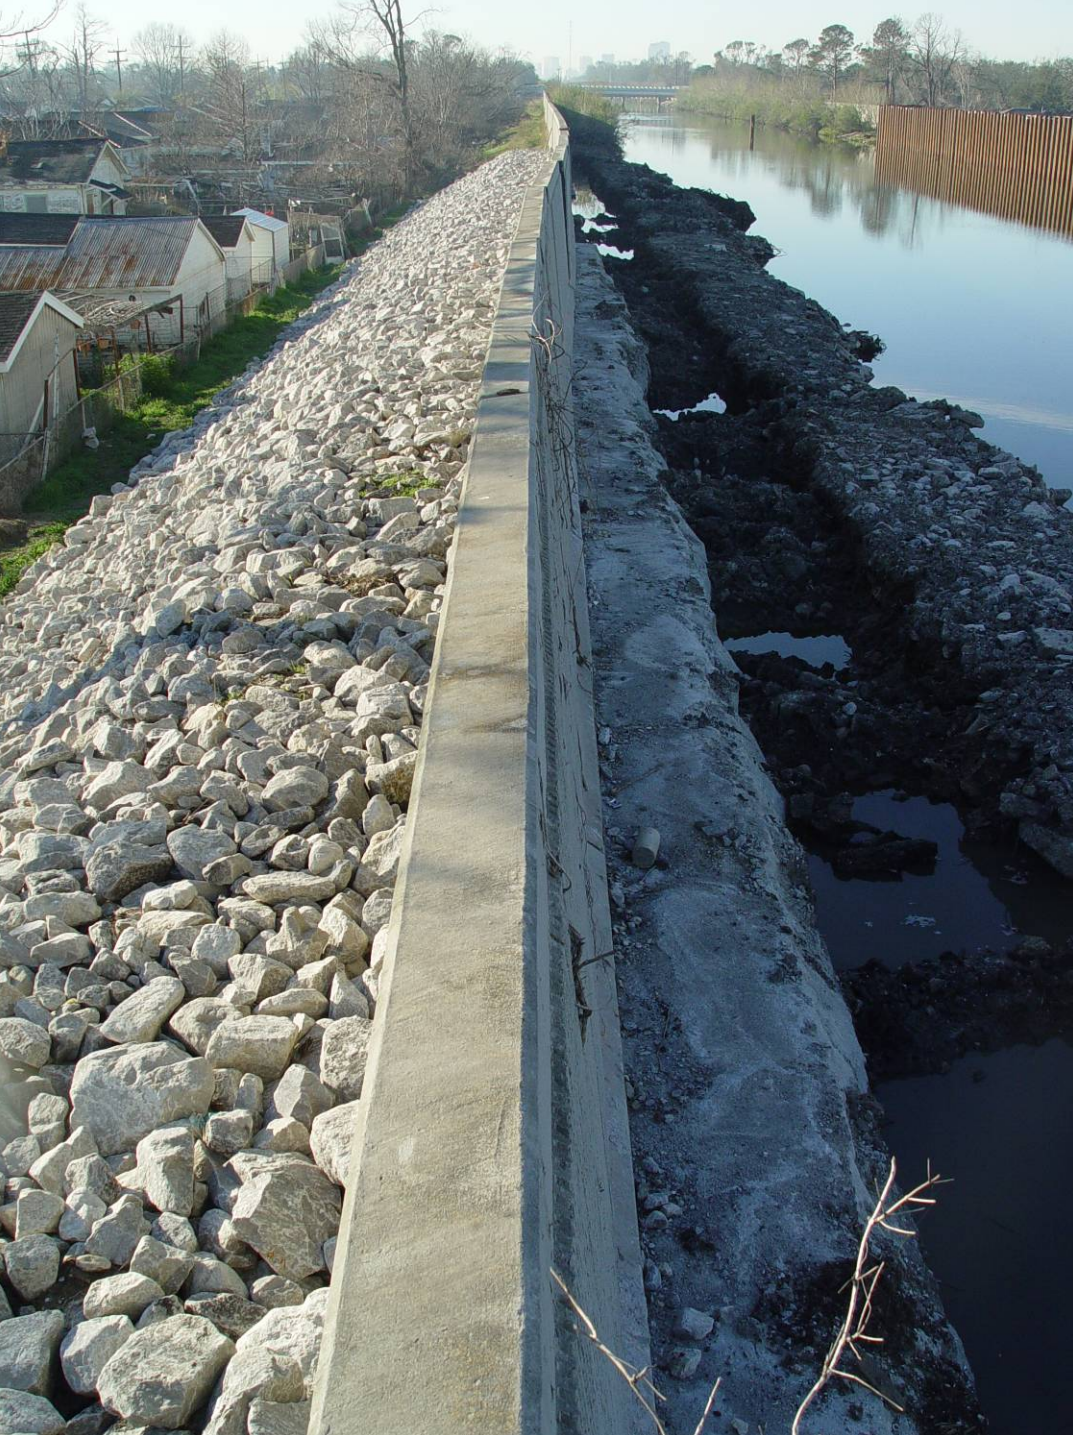
Incipient failure

- **Tilted flood wall opposite the London Avenue North breach, at Robert E. Lee Blvd.**
- **Forensic scientists learn more from a partial failure than a complete one, because much of the critical evidence remains**

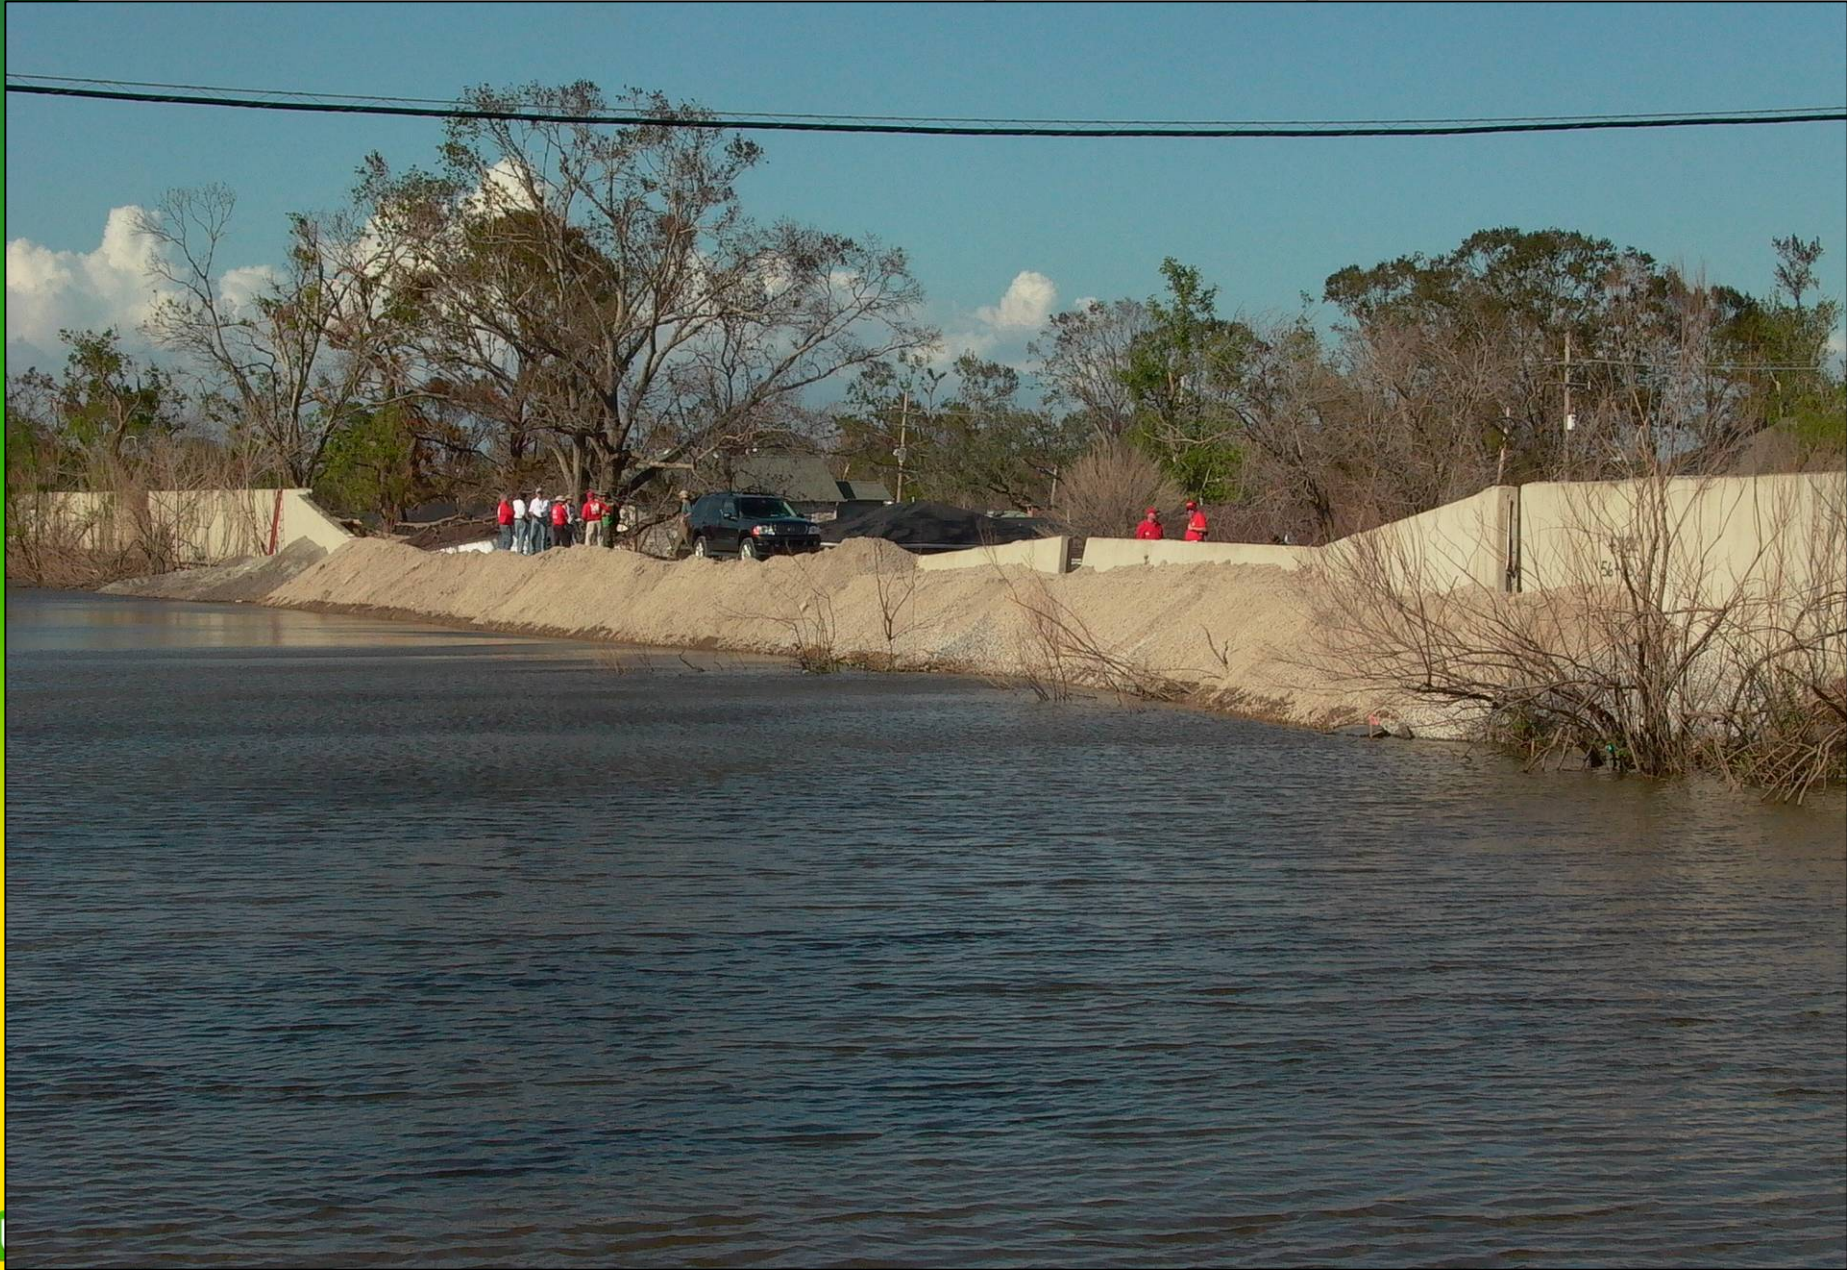
London Avenue (South) breach

The South Breach of the London Avenue Canal was caused by **excess seepage pressures** developed in the sand underlying the canal, which had been dredged

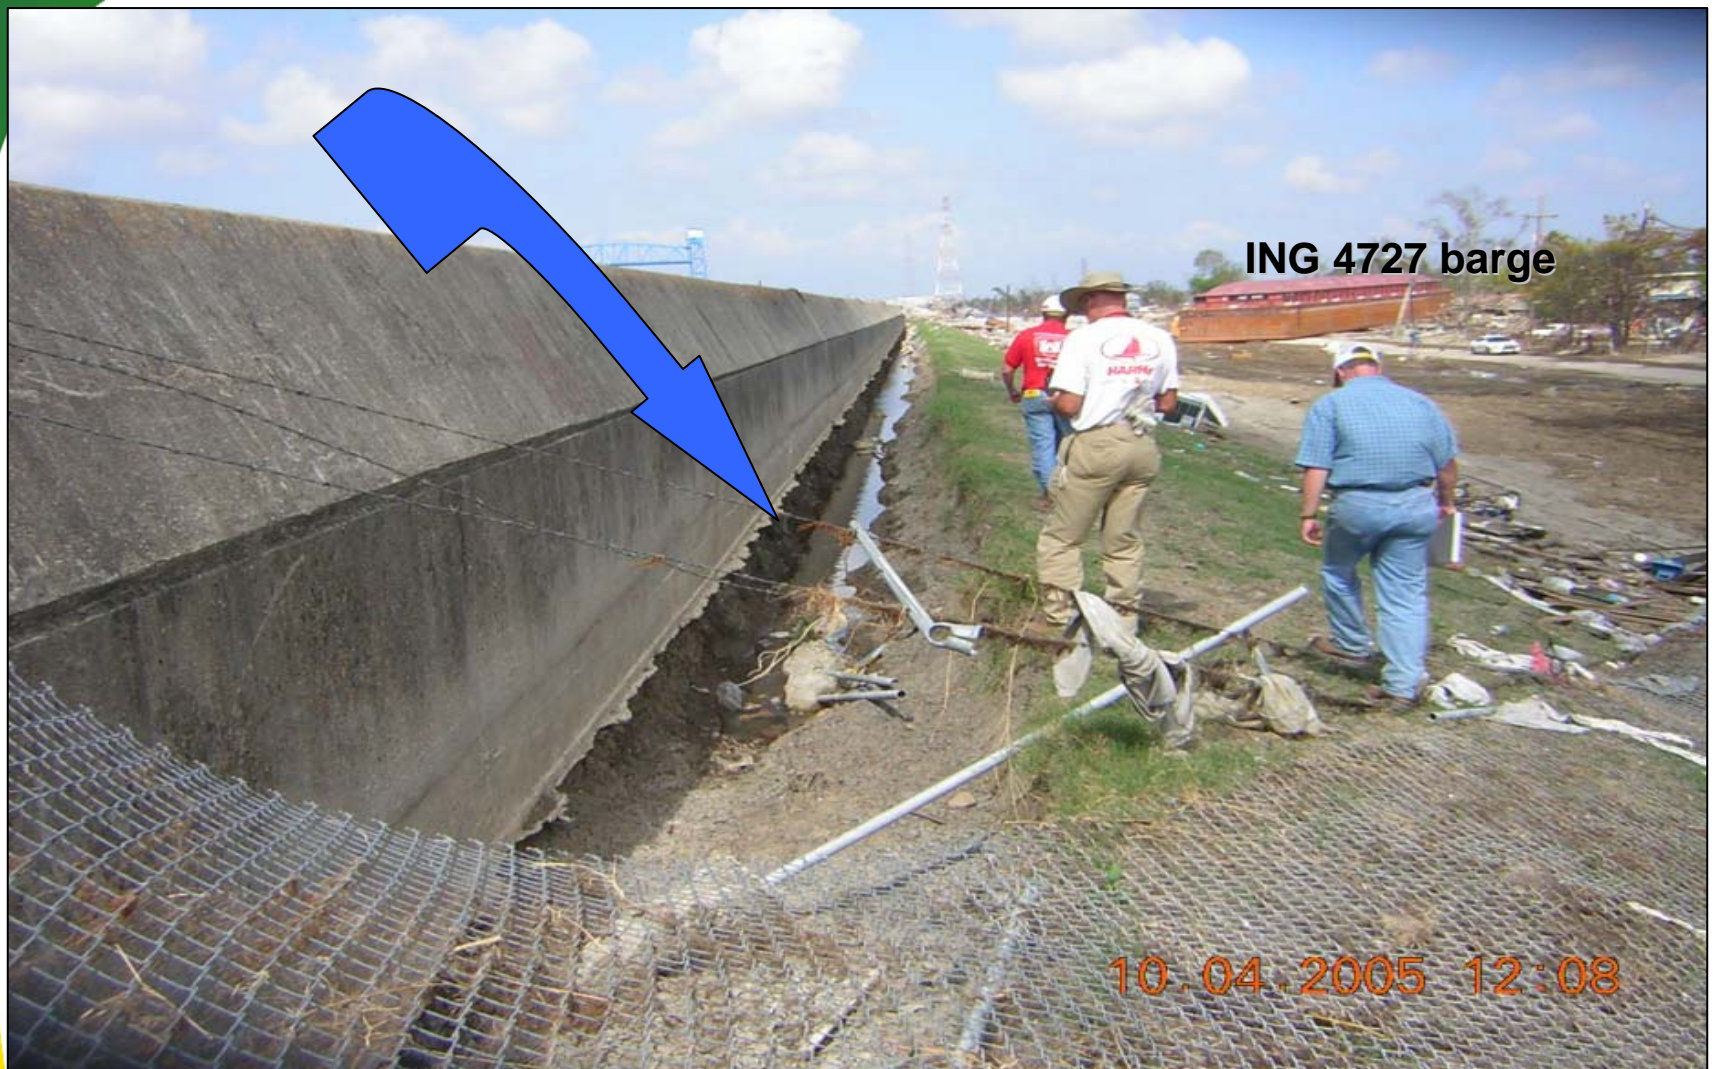
- **Some sections survived:** Evidence of sustained overtopping of concrete flood wall along the IHNC in the Lower Ninth Ward.
