ENGINEERING GEOLOGIC CHARACTERIZATION OF LEVEE FAILURES IN NEW ORLEANS DURING HURRICANE KATRINA

J. David Rogers, Ph.D., P.E., R.G.

**2007 Annual Meeting
Association of Environmental and Engineering Geologists
Los Angeles, California
September 28, 2007**

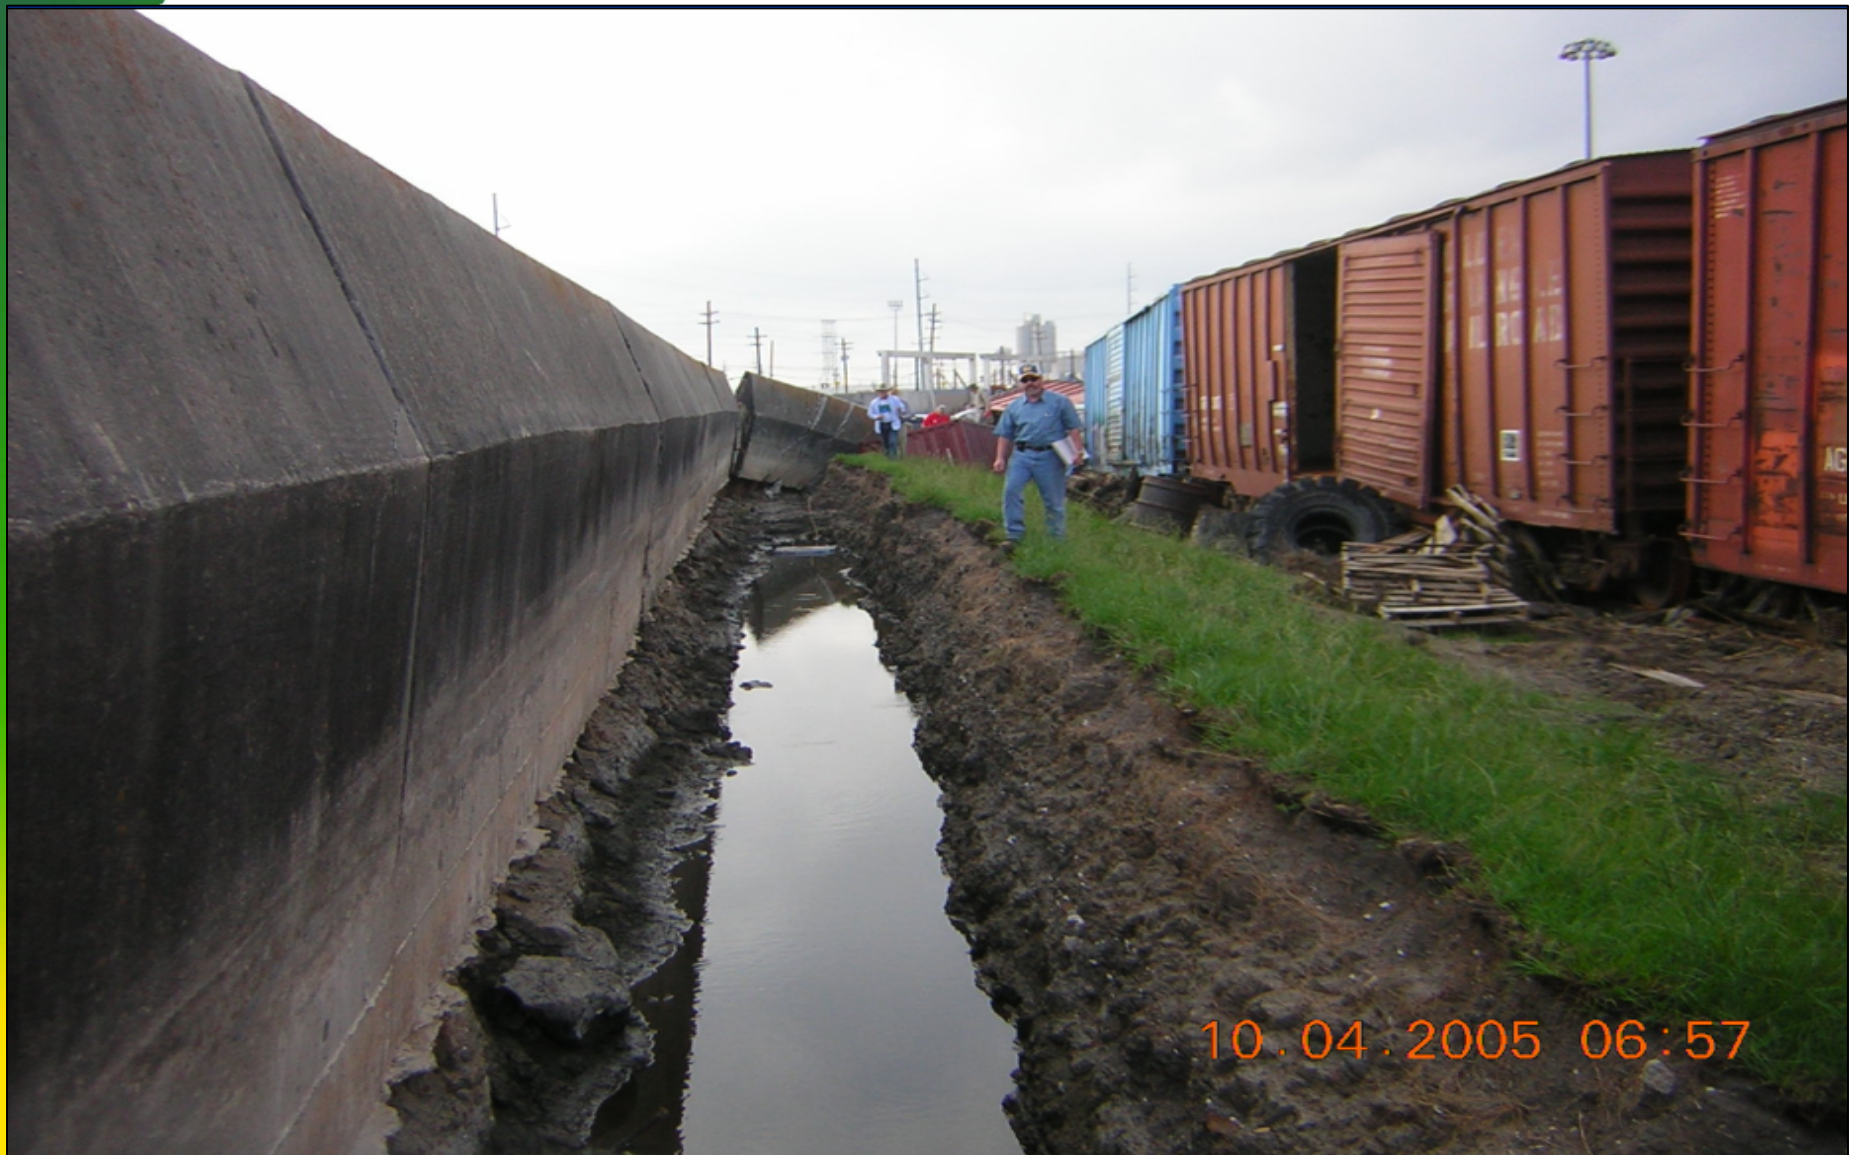
- **Overtopping scour holes along landside of flood wall on west side of the IHNC. Note broken wall in background. A splash pad on inboard side could have prevented this failure mode.**

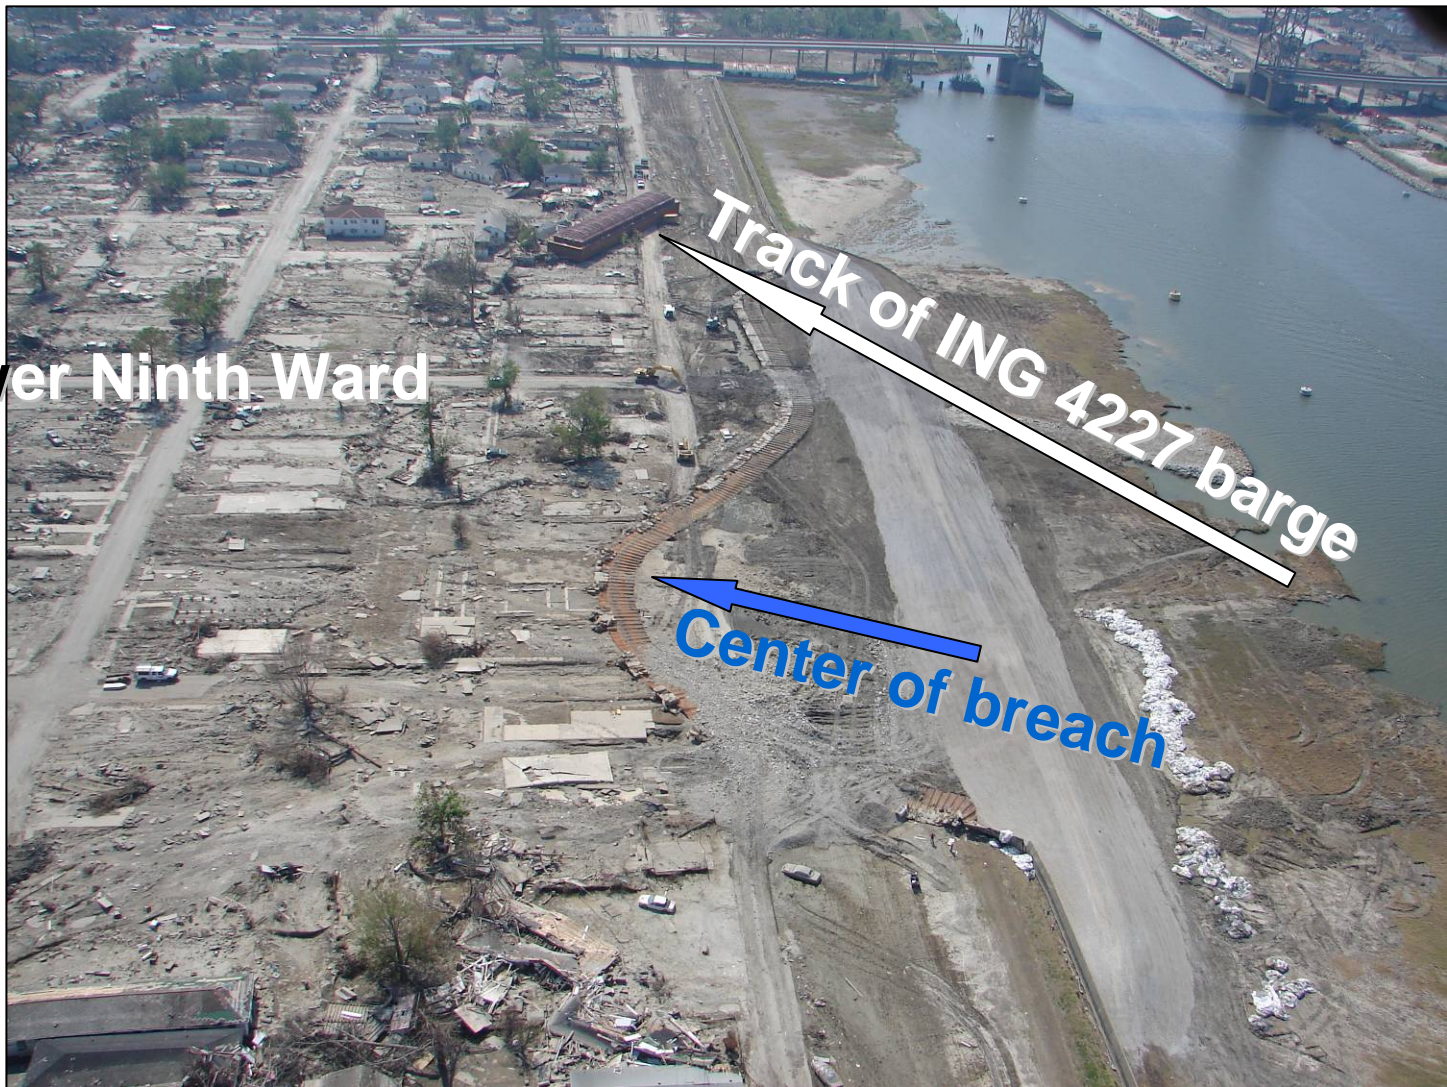
- Aerial view of the south breach of the Inner Harbor Navigation Channel (IHNC) in the Lower Ninth Ward of New Orleans.

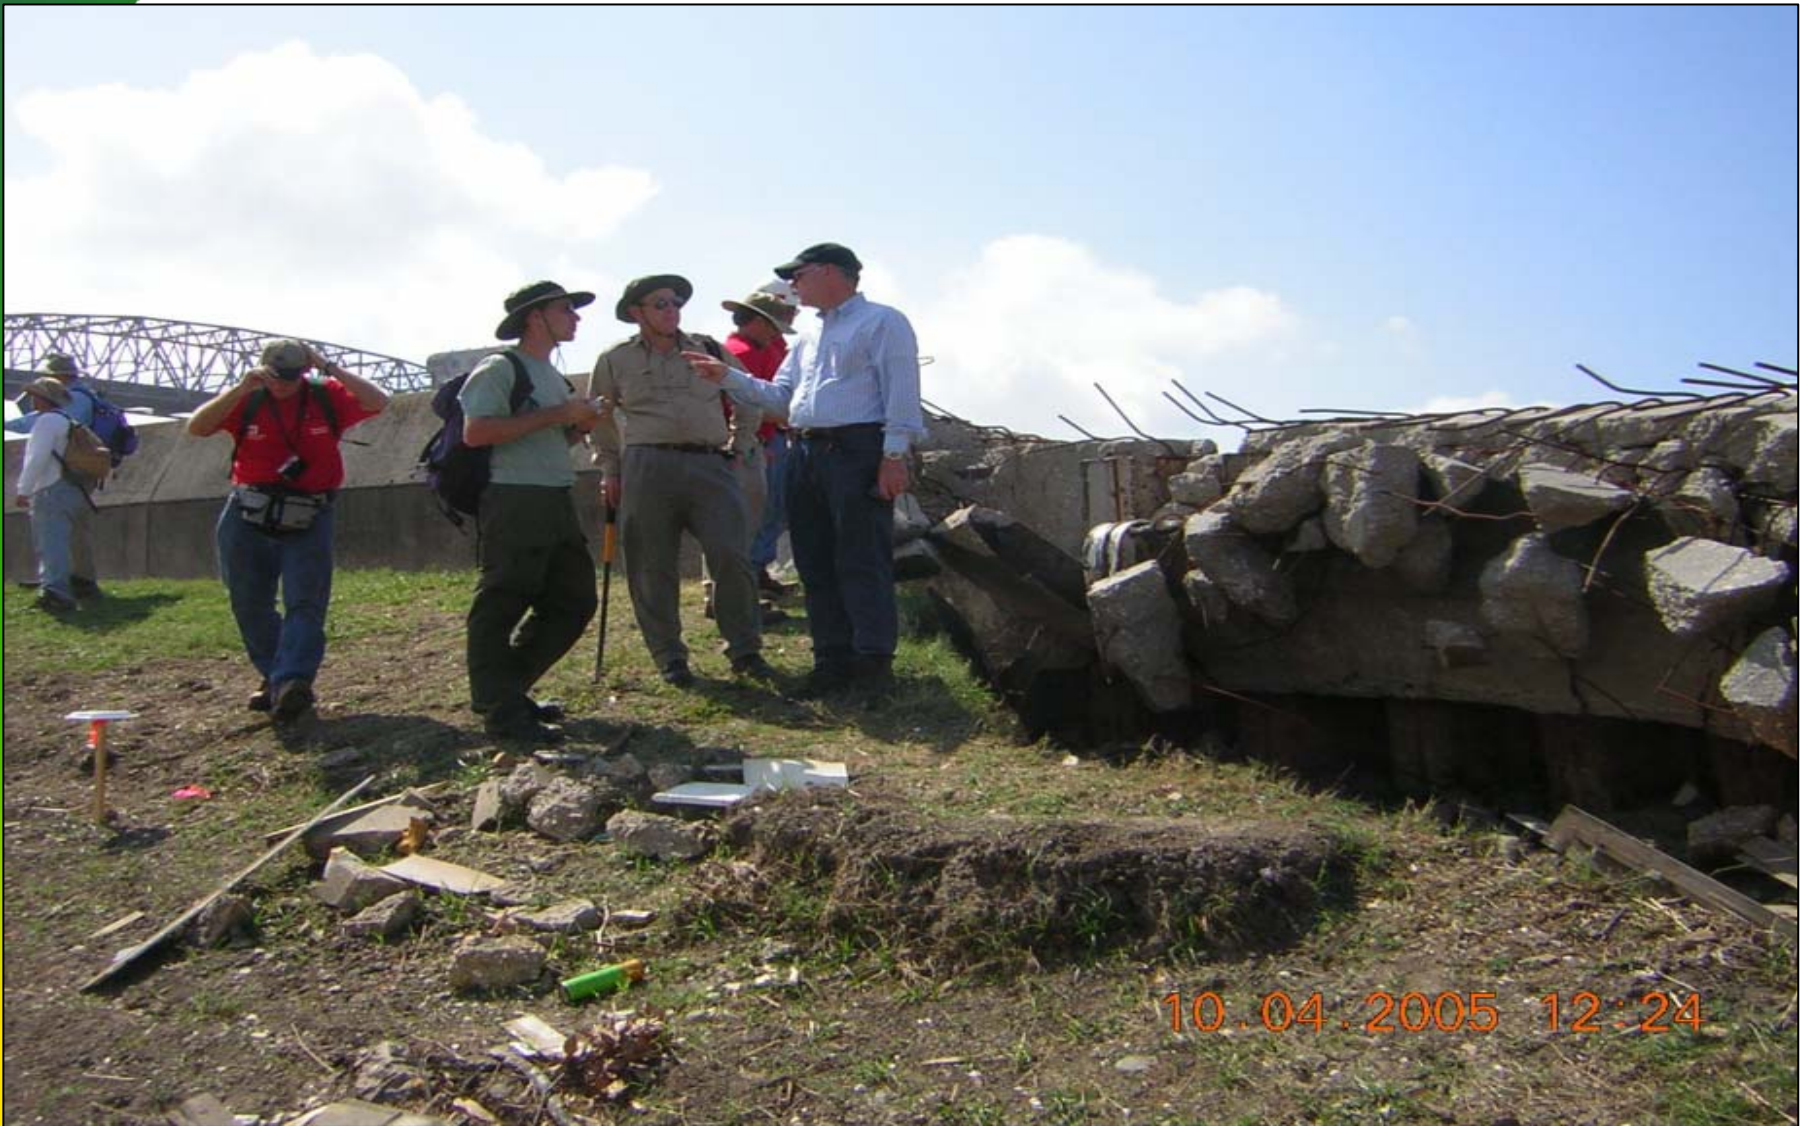
- **Damage to concrete flood wall where ING 4727 Barge collided with it, along the south side of the IHNC adjacent to the Lower Ninth Ward**

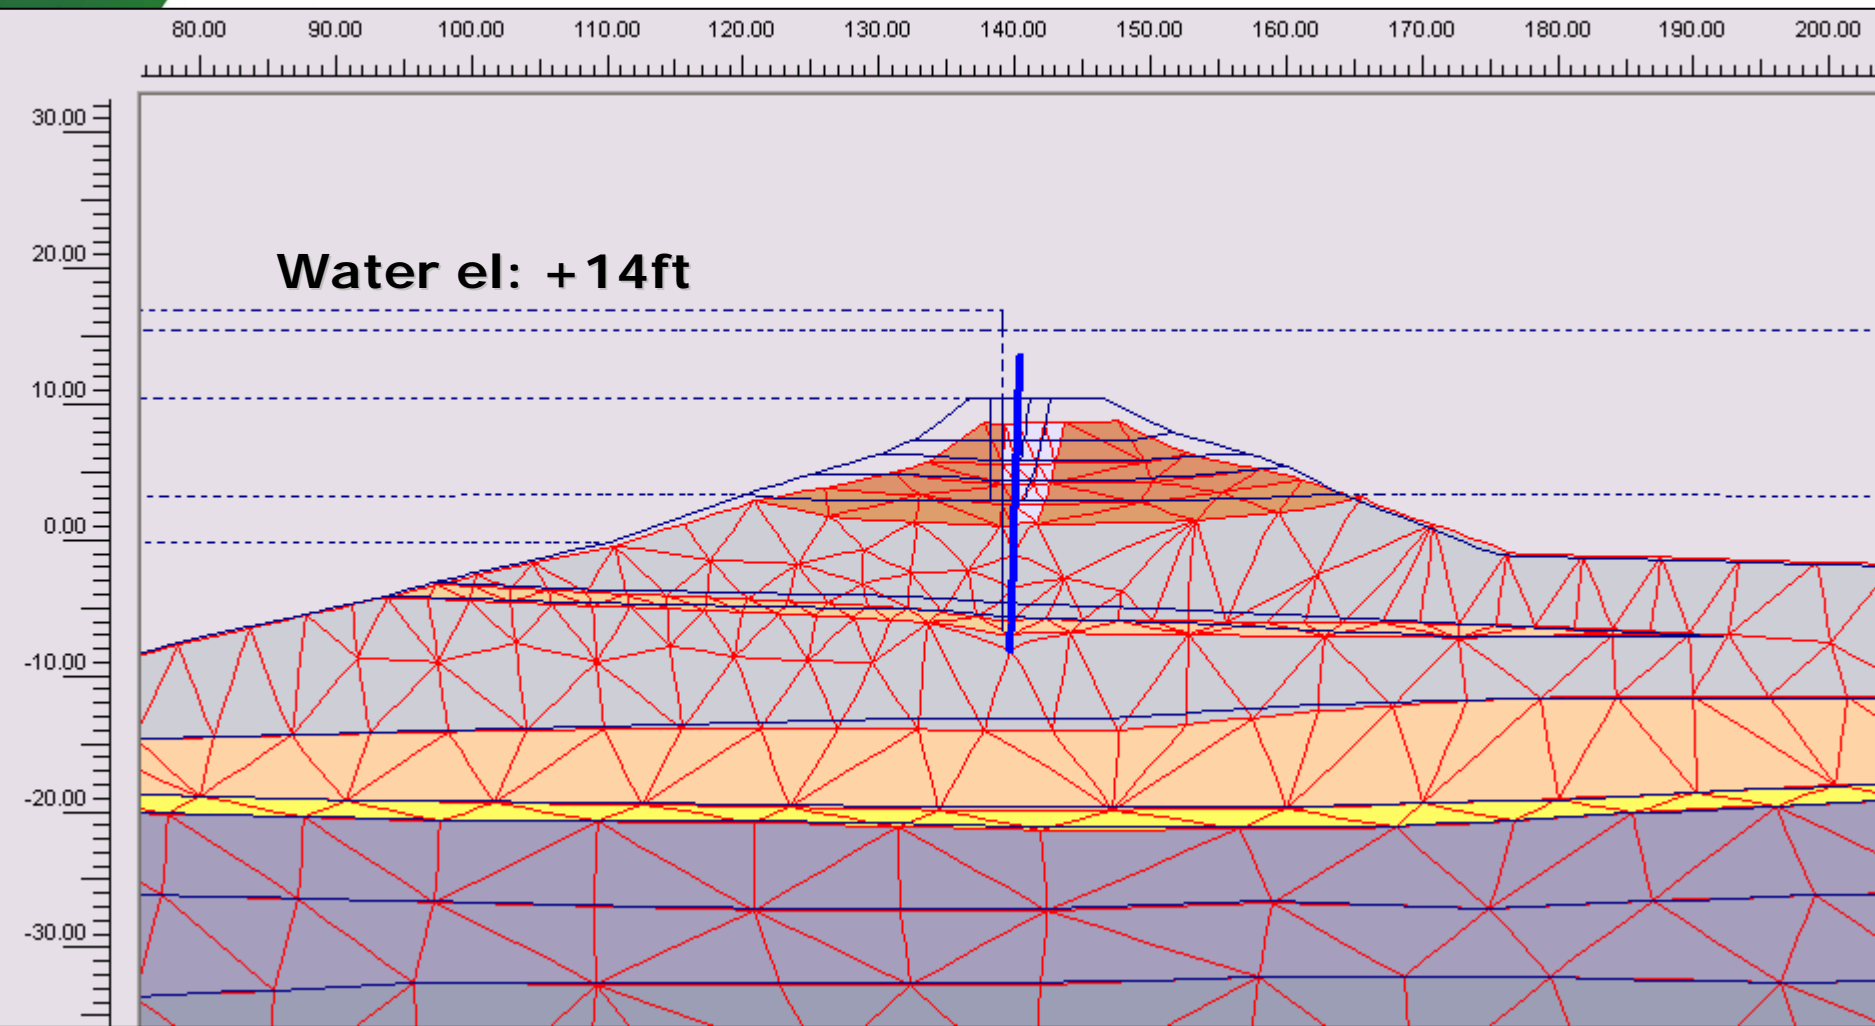
Plaxis soft soil constitutive modeling of 7.5 ft deep scour trench and 4.5 ft gap – deformed mesh – true scale (max displacement of embankment crest = 1.2 ft)

Shear strains predicted by the Plaxis model, assuming a 7.5 ft deep scour trench and 4.5 ft wall gap – using “best estimates” of c and ϕ – Factor of Safety = 1.10. Underseepage-induced pore pressure trapped along base of less pervious clay stratum, overlying the more pervious marsh deposits.

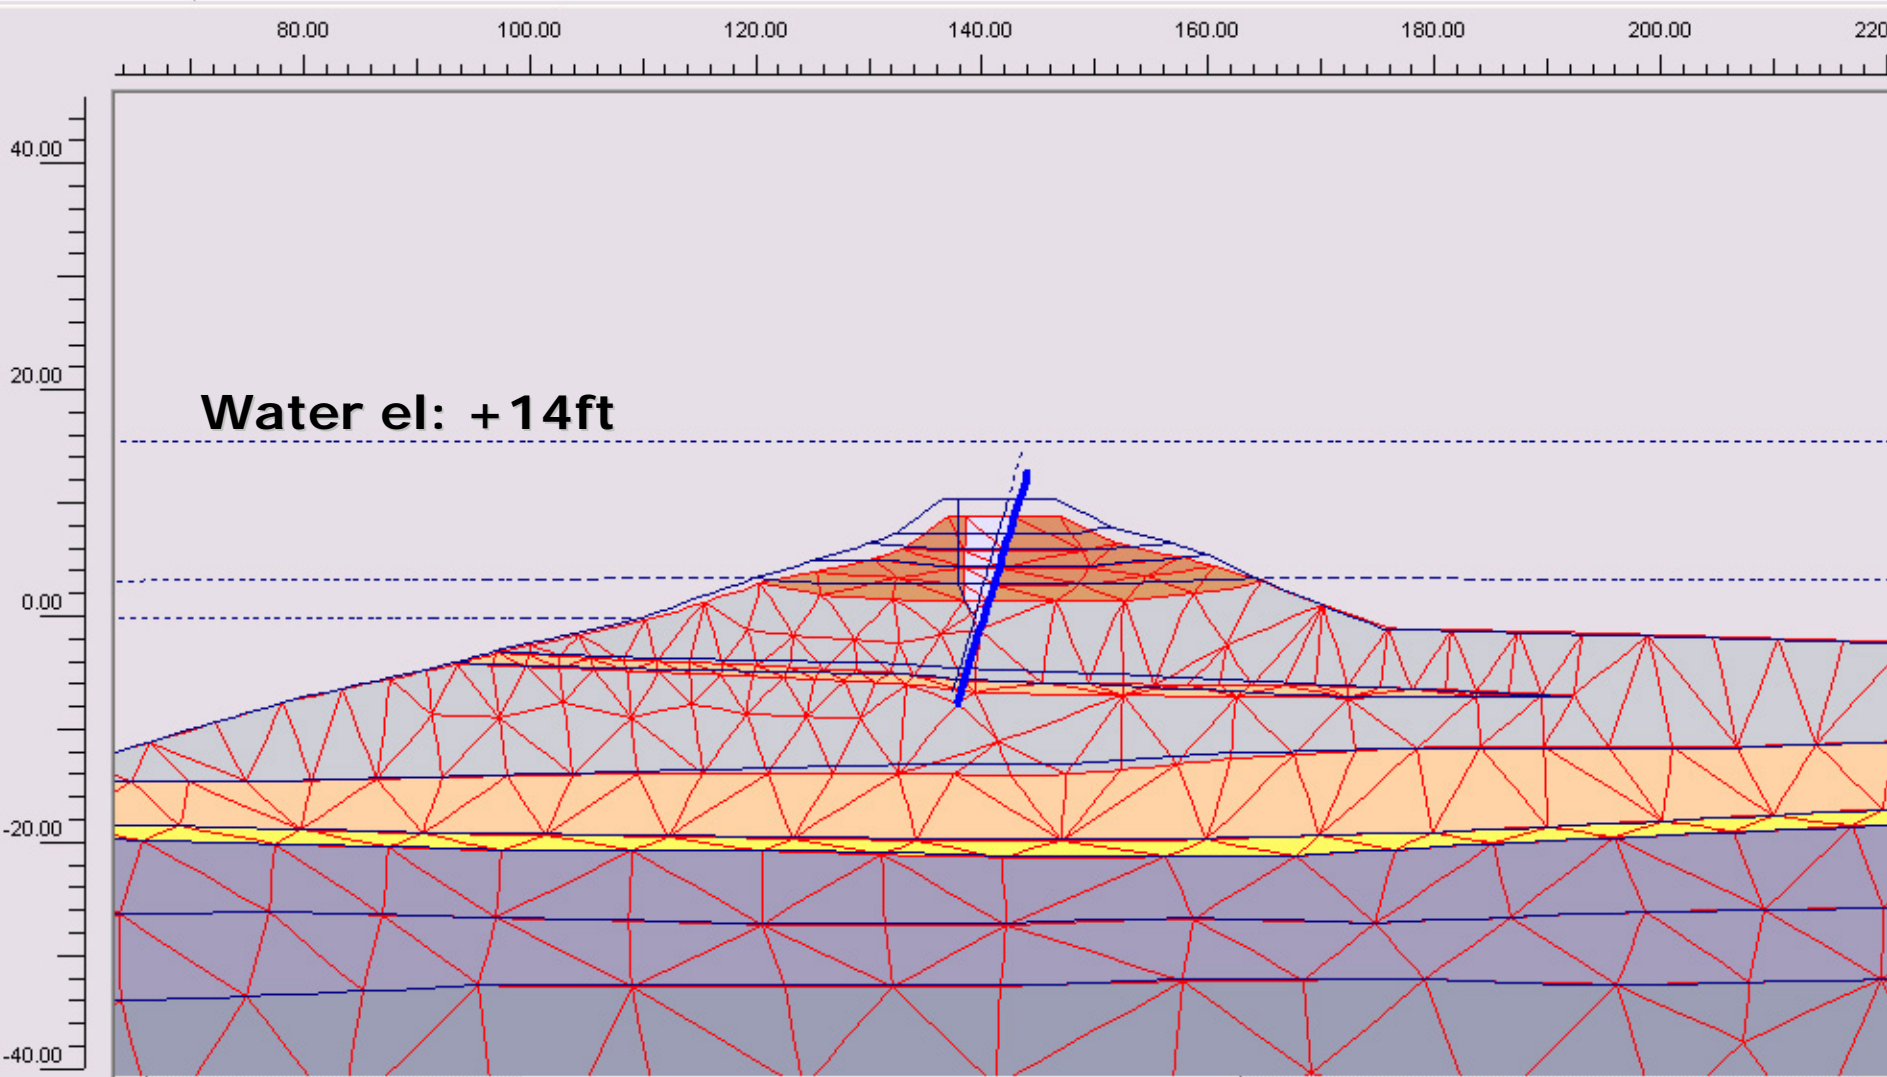
Leaning wall with 8.5 ft of gap – deformed mesh – true scale (max displacement = 1.71 ft)

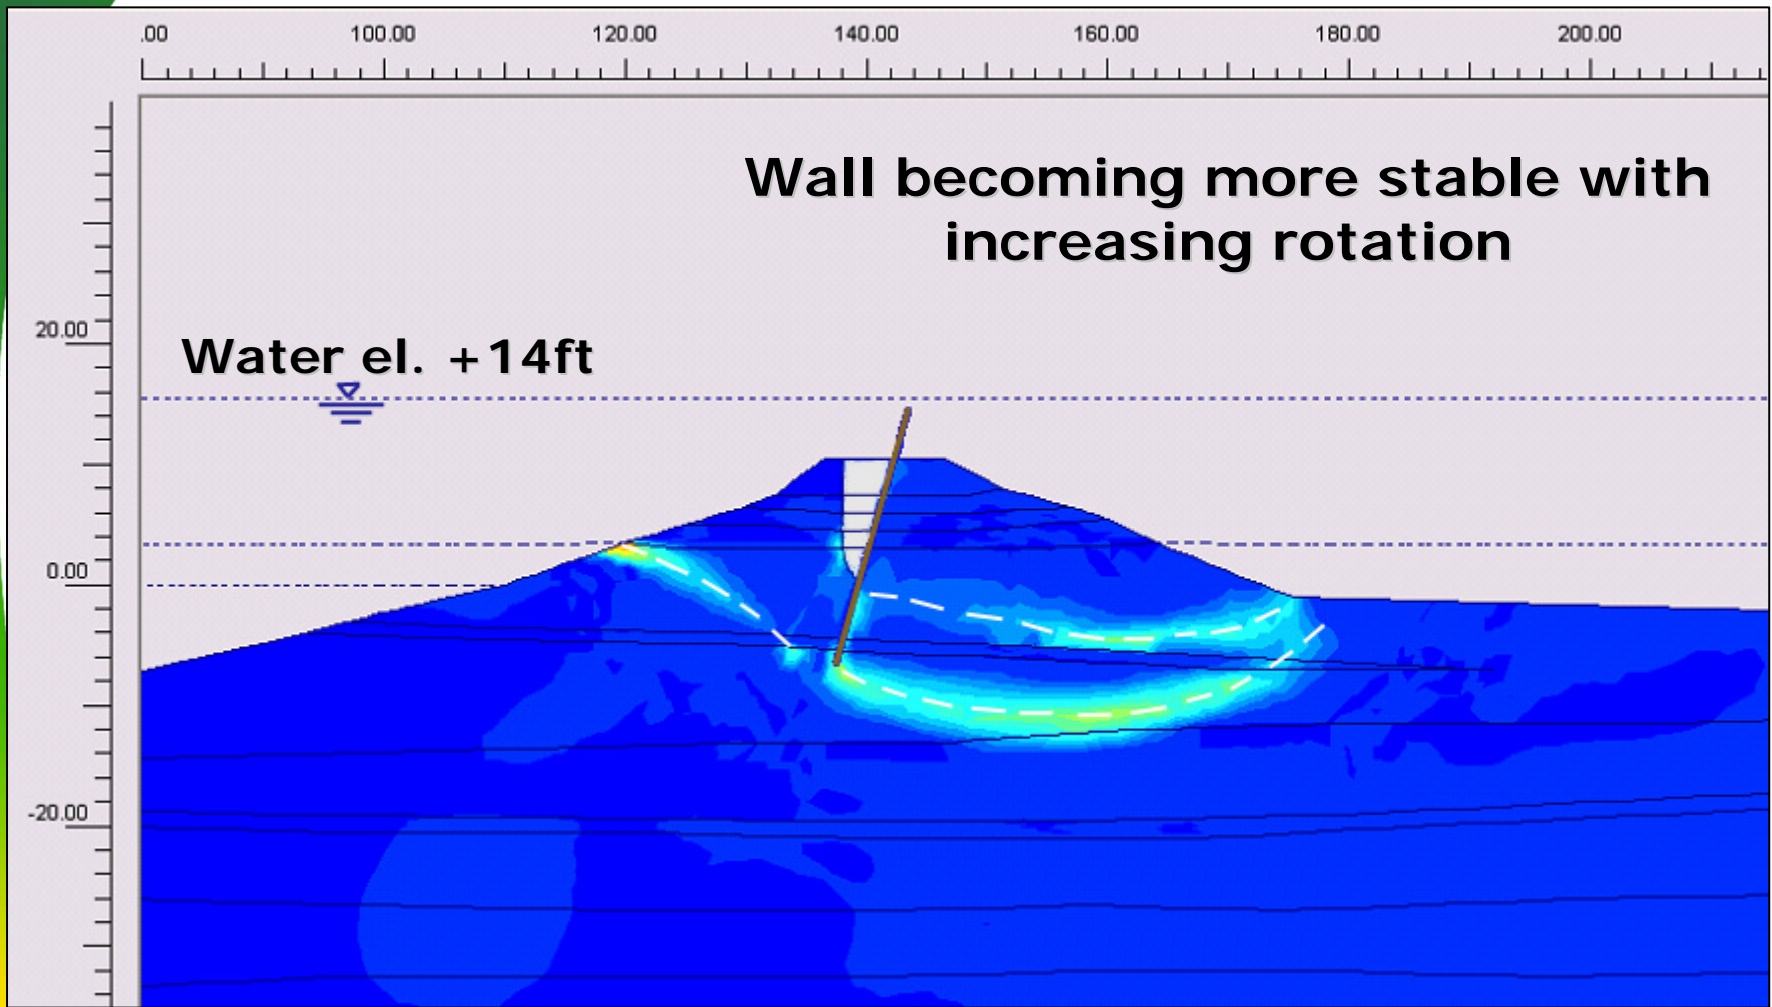
Leaning wall with 8.5 ft of gap. Predicted shear strains using "best estimates" of c and phi. Factor of Safety now = 1.15

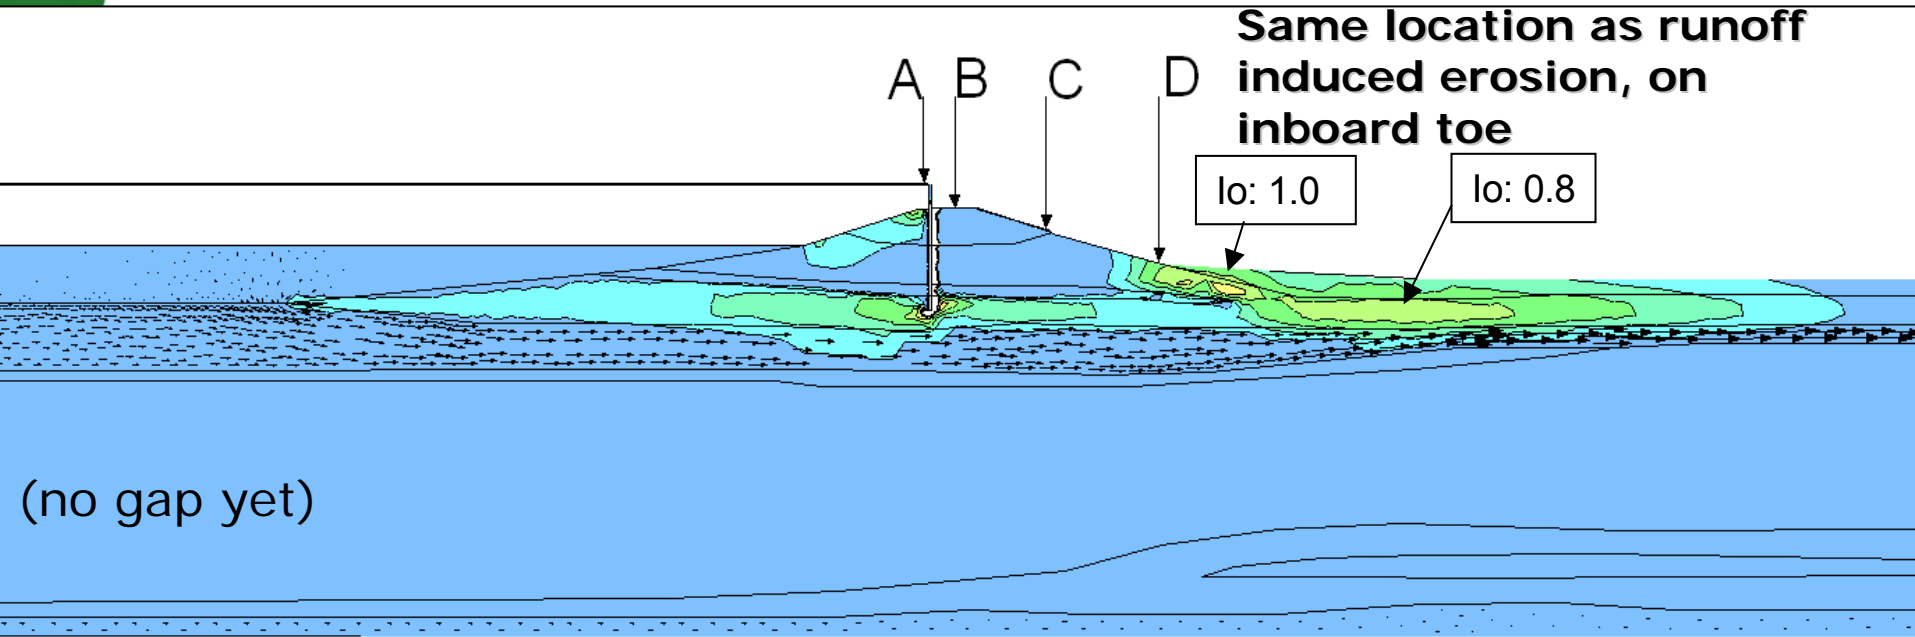
- Hydraulic gradients for the south breach on IHNC east bank; storm surge at 14.4ft (MSL). Maximum exit gradient at the levee toe is $i_o \approx 0.8$ to 1.0, at threshold for hydraulic piping.
- This may help to explain the persistent wet spot noted on the backfill of the Jourdan Avenue conduit backfill for weeks afterward.

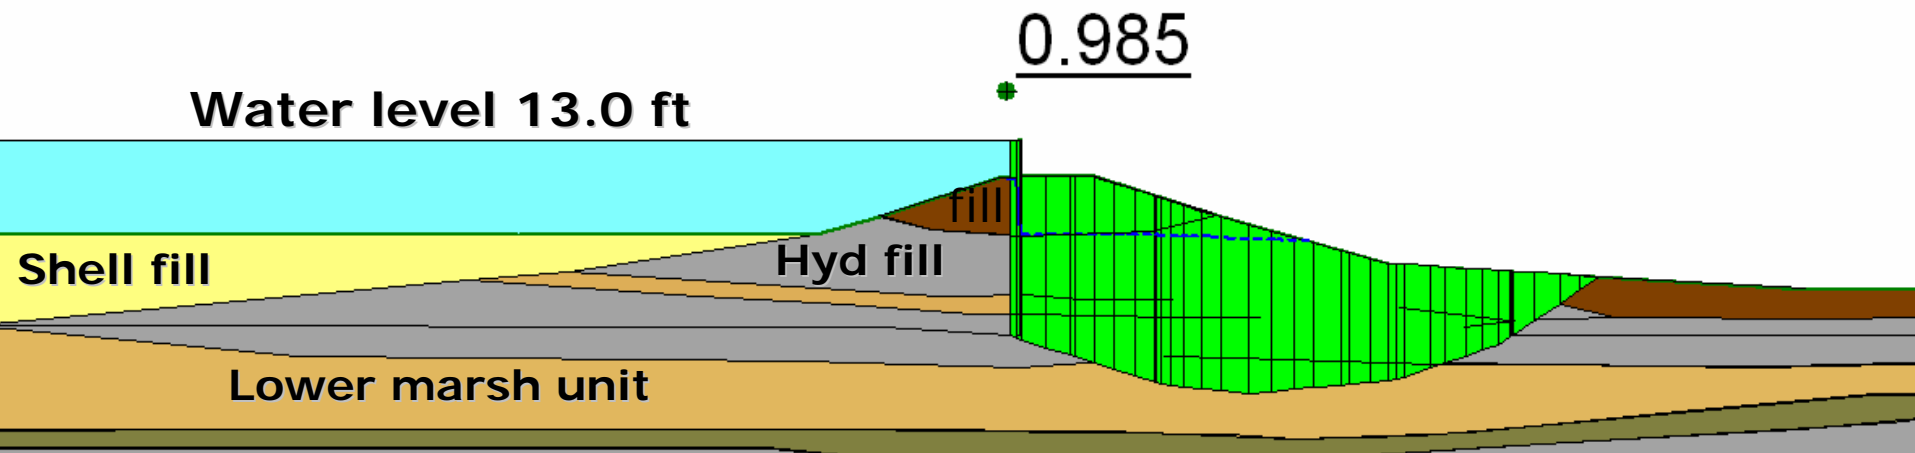
Deep failure mode (in lower marsh) with wall gap– FS=0.985

Deeper slope failure most likely, with k values as low as 3×10^{-5} cm/sec; with wall gap forming around 7:30 AM, at a water level of 13 ft (MSL).

This would appear to be the best explanation for a massive translational failure, 800 feet long.

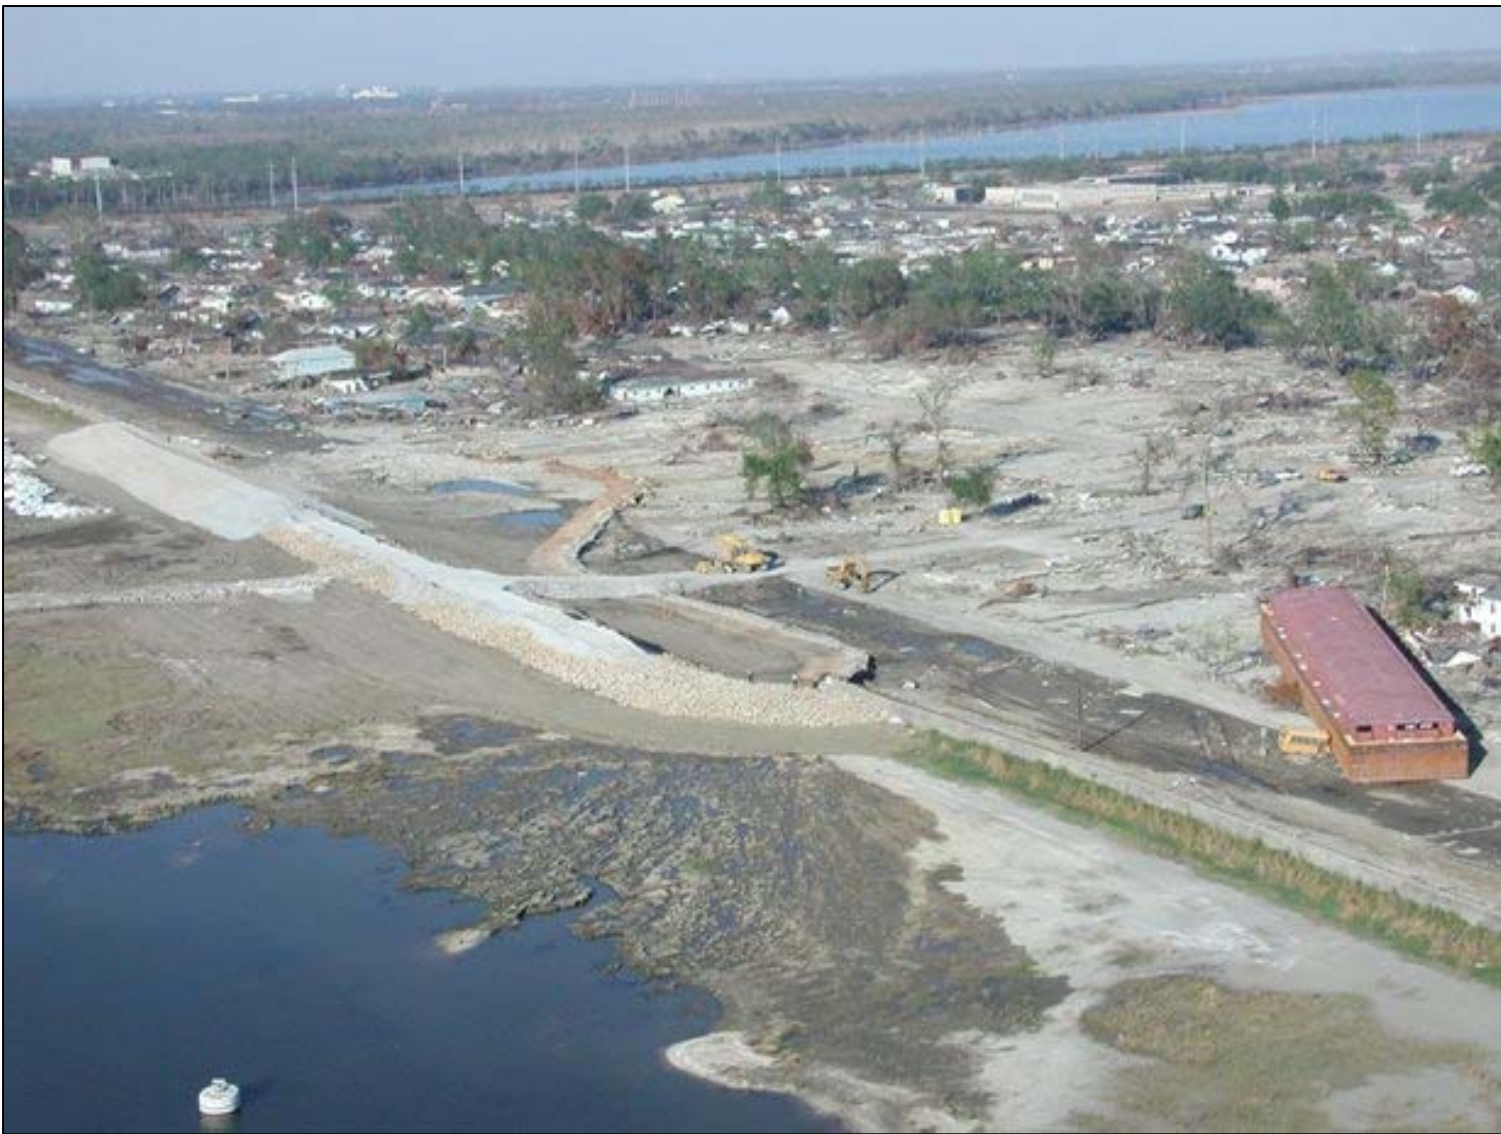
Aerial view of the south breach at the east bank of the IHNC (at the west end of the Ninth Ward), showing the 'wet spot' along the inboard side and the crevasse splay generated by reverse drainage flow. [Photograph by U.S. Army Corps of Engineers]
