Part 2

OVERTOPPING OF FLOOD CONTROL STRUCTURES

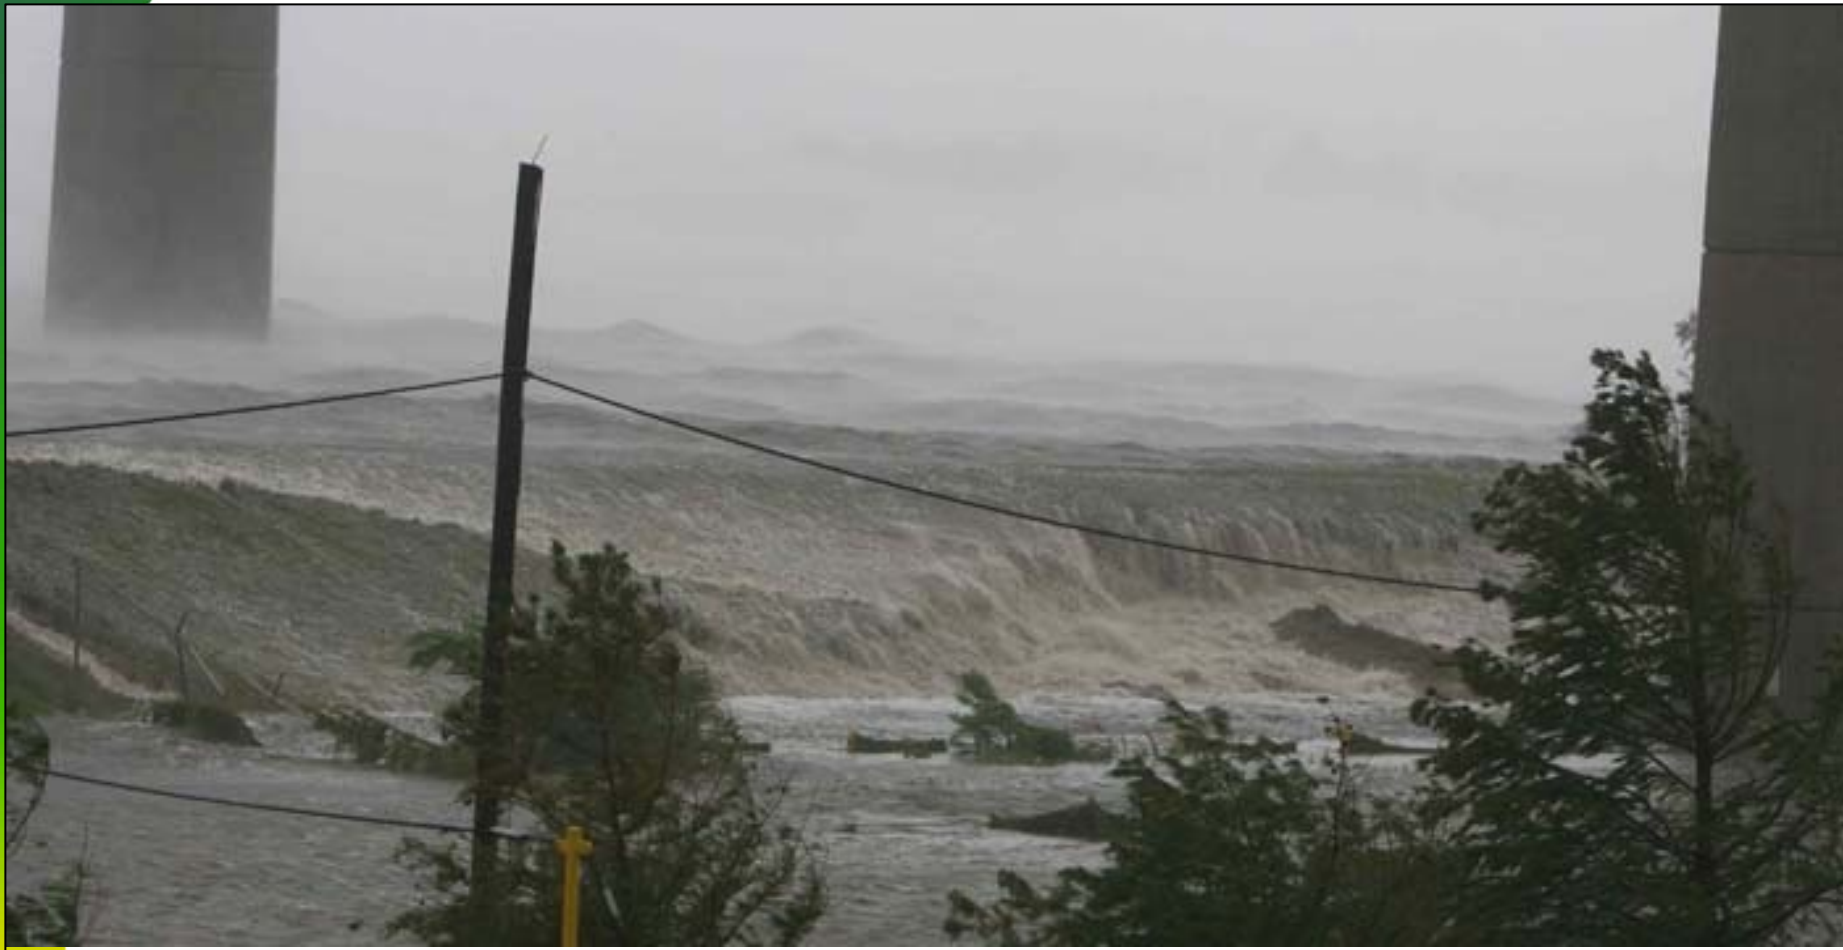
- **Overtopping:** Earthen levee being overtopped at the Entergy Power Plant, Inner Harbor Navigation Channel. This began around 6 AM on August 29th. 9 ft storm surge with crest heights up to 17 ft

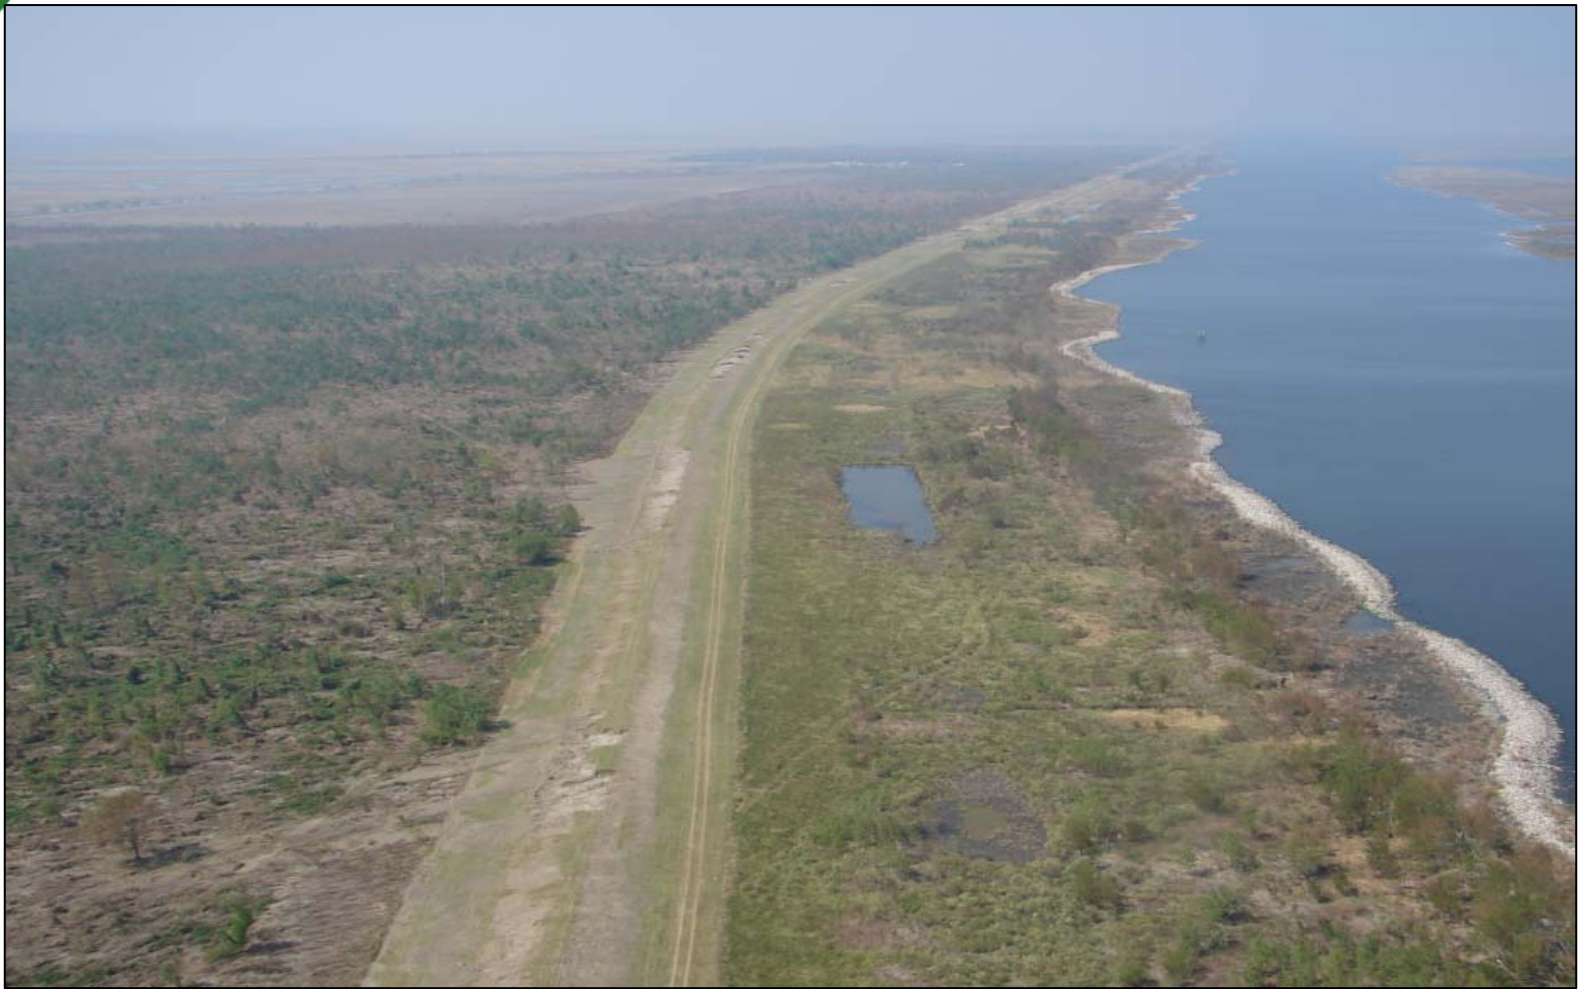
- **Good performance:** some portions of the **Mississippi River Gulf Outlet (MRGO) Channel** survived waves as high as 17 feet, caused by a 9 foot storm surge off Lake Borgne (to the right)

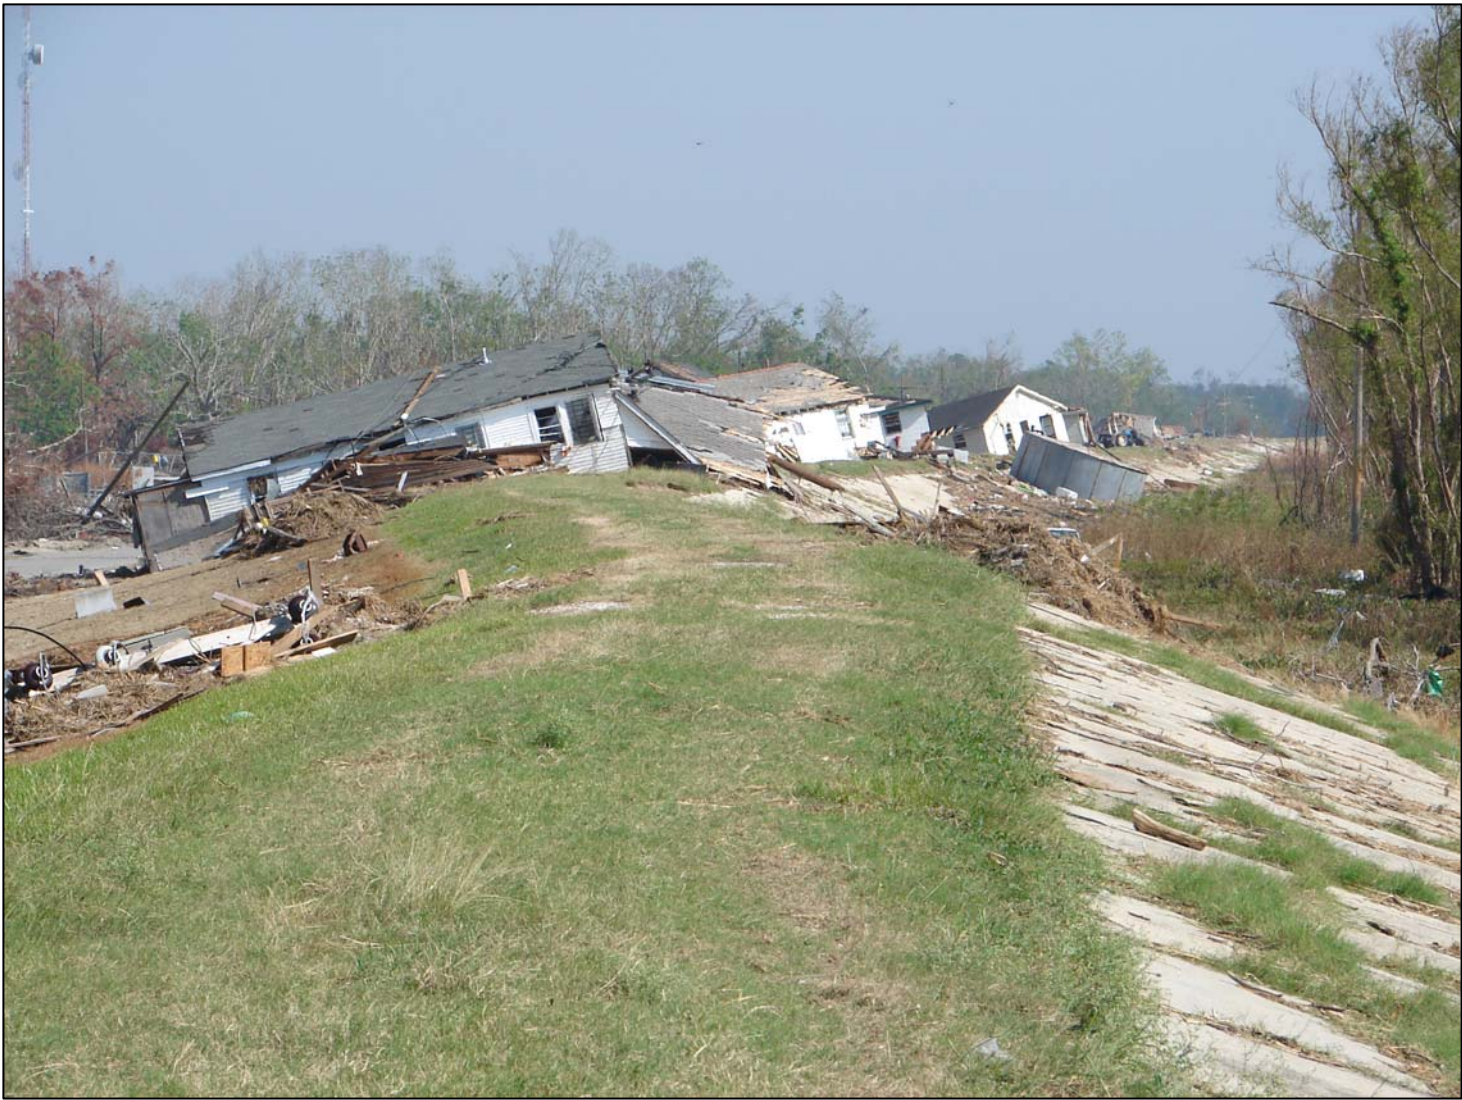
- **Survivable levee:** The storm surge pushed houses up on top of some levees, leaving them scattered about

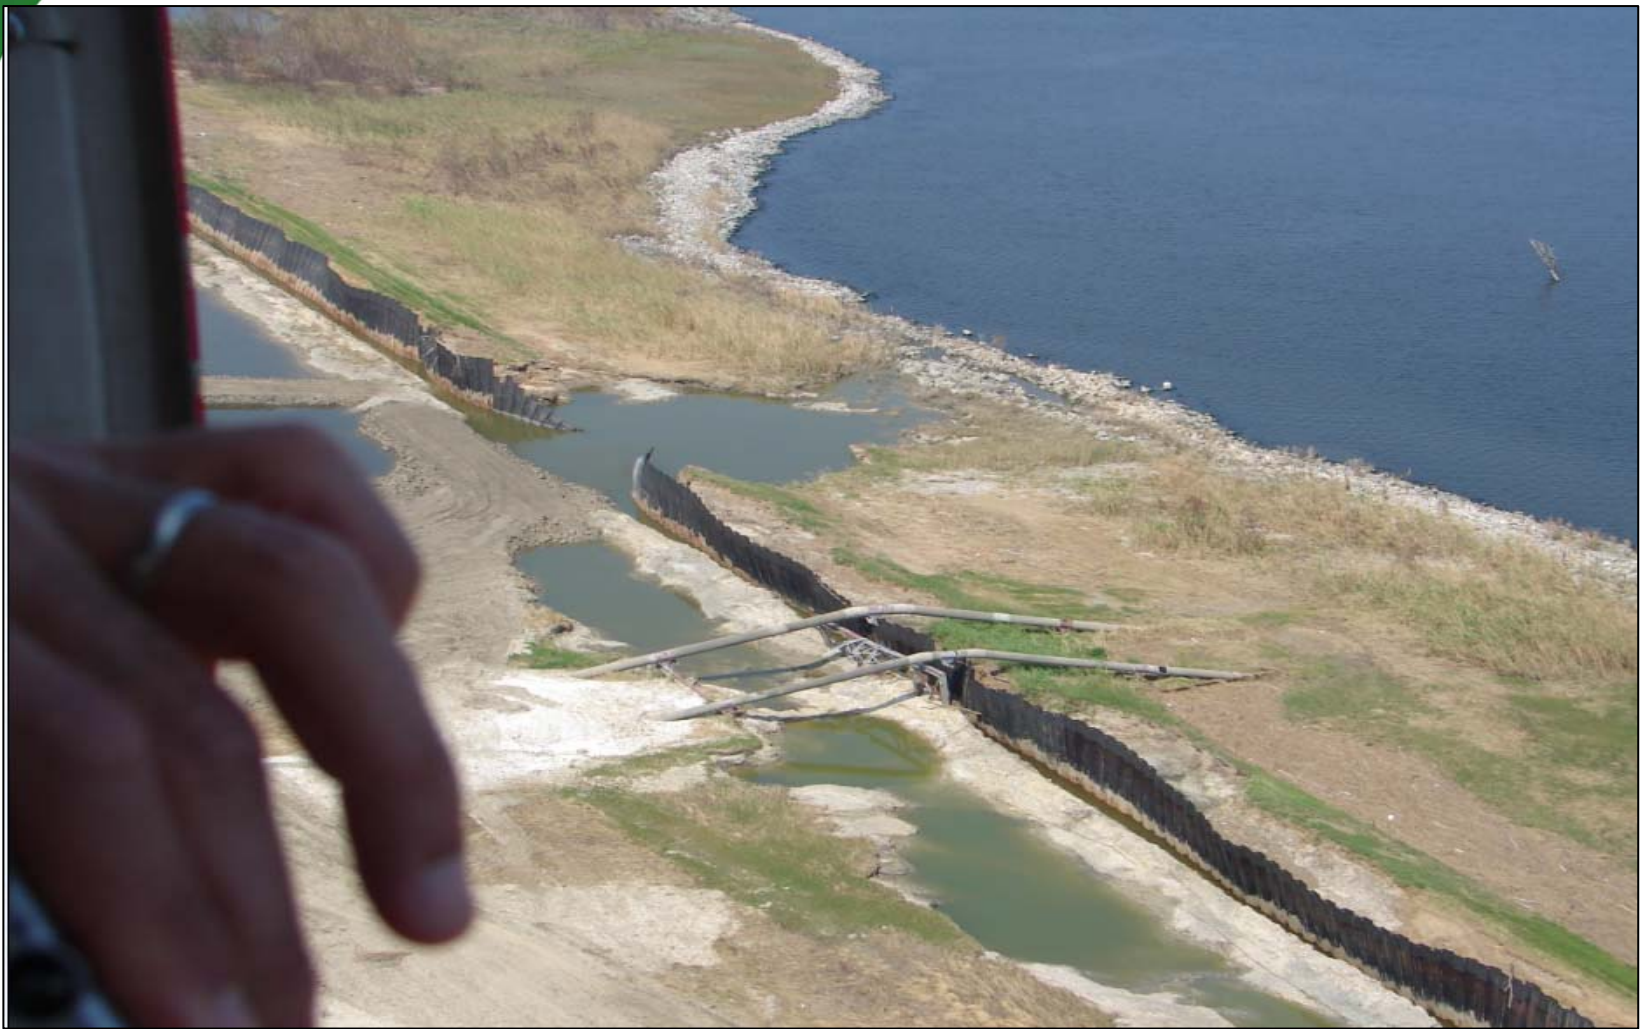
- **Poor performance:** Skeleton of steel sheetpile cutoff walls is all that remains of the **MRGO levee** between Bayou Bienvenue and Bayou Dupree

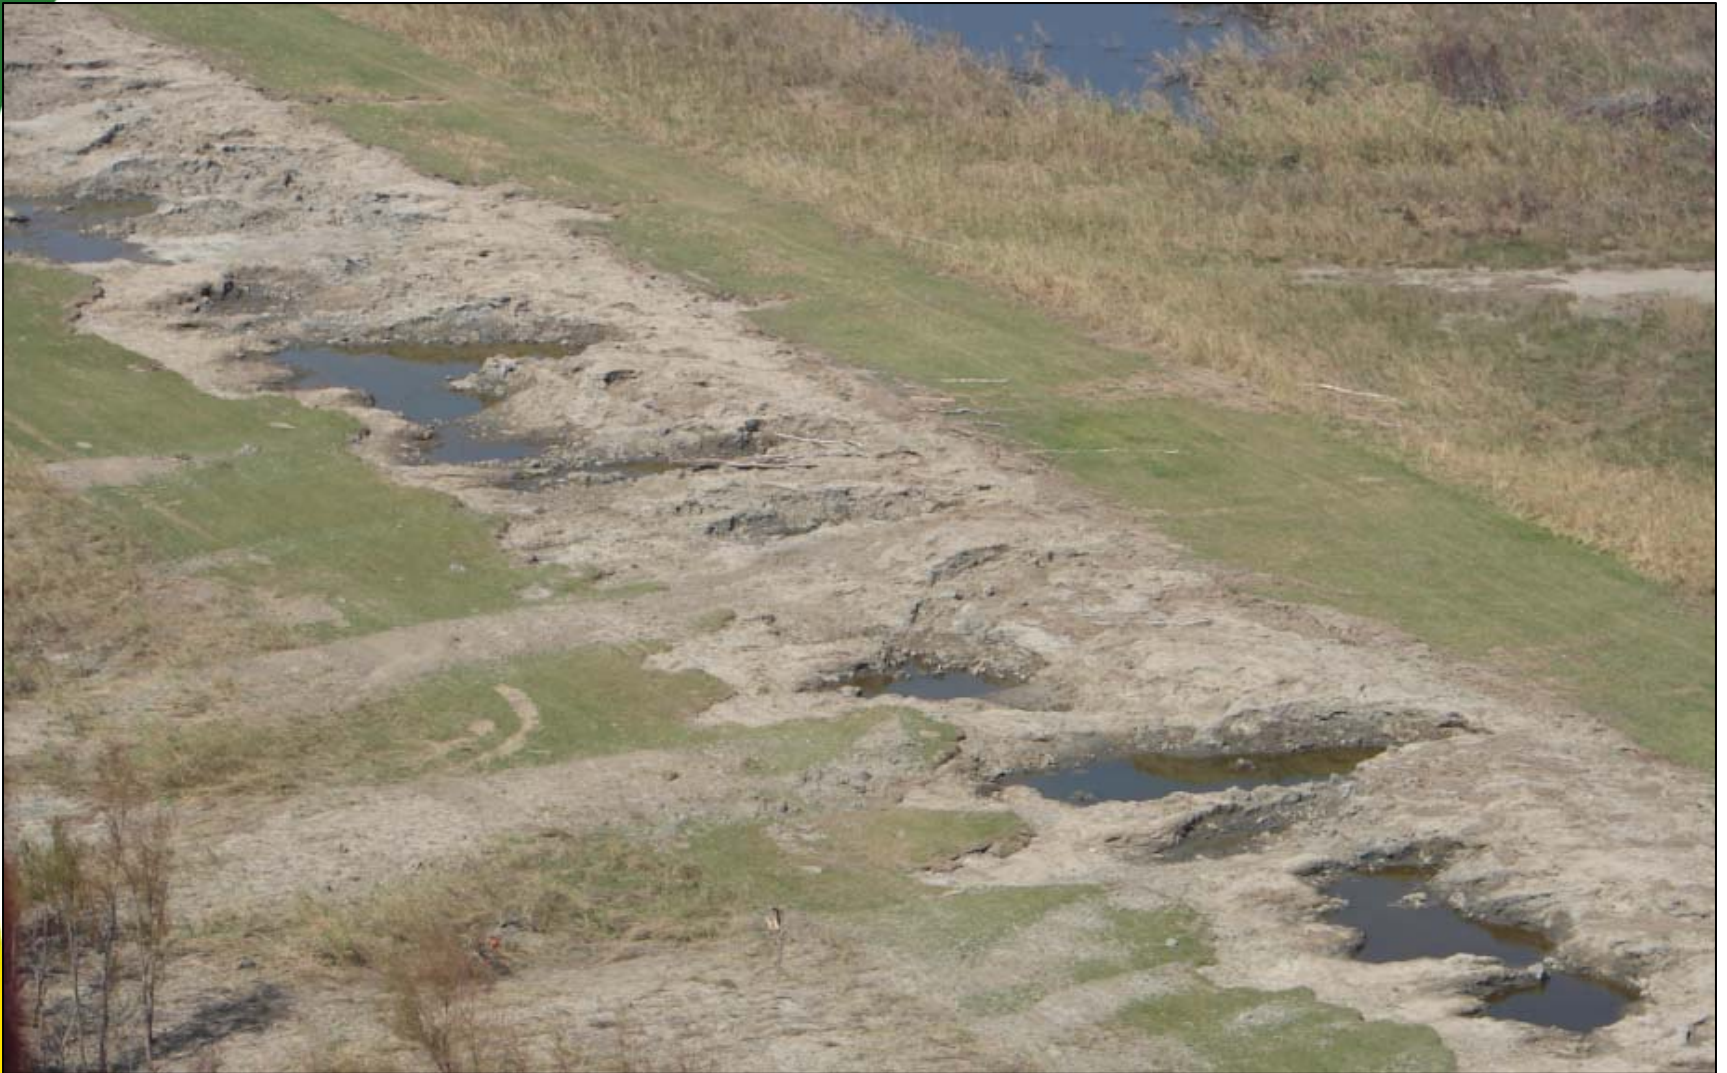
- **Poor performance: MRGO levee** completely washed away about two miles southeast of Bayou Dupree.

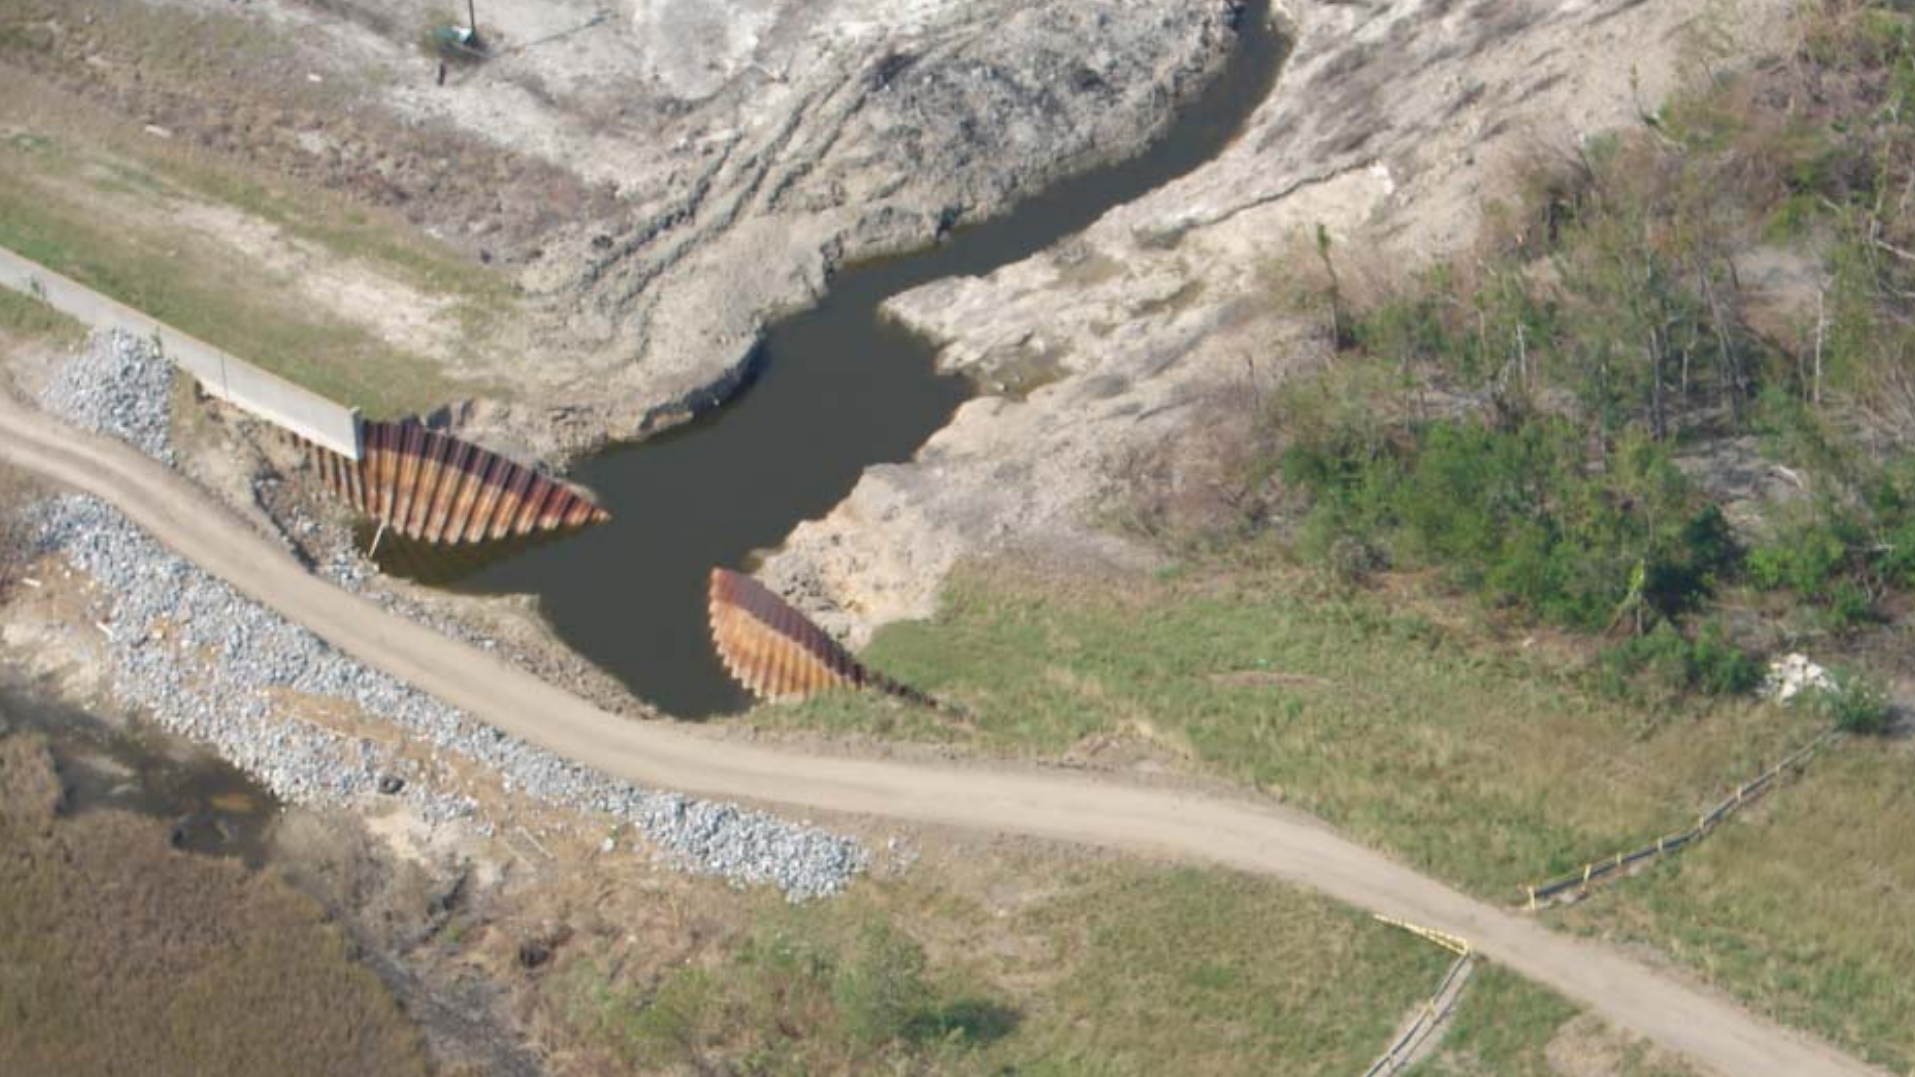
Many of the problems along the MRGO Channel occurred at structural transitions, between dissimilar elements, such as earthen levees against concrete flood walls, shown here.

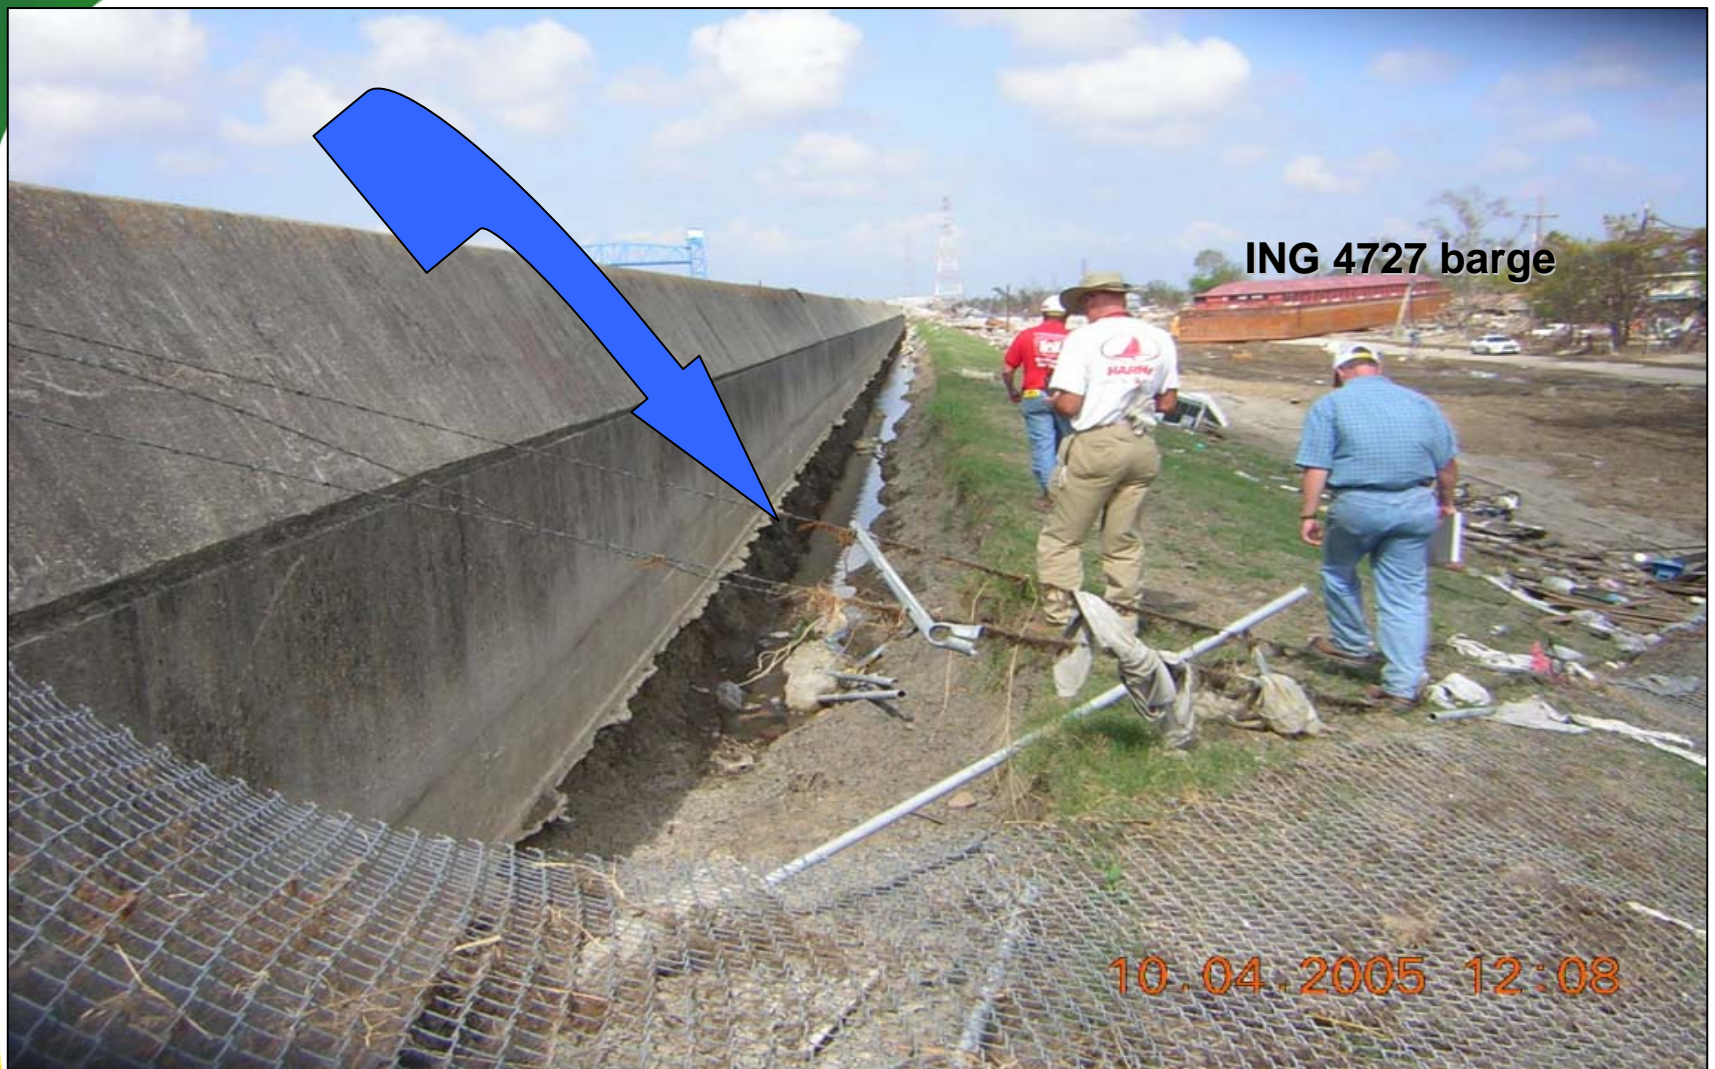
- **Some sections survived:** Evidence of sustained overtopping of concrete flood wall along the IHNC in the Lower Ninth Ward.

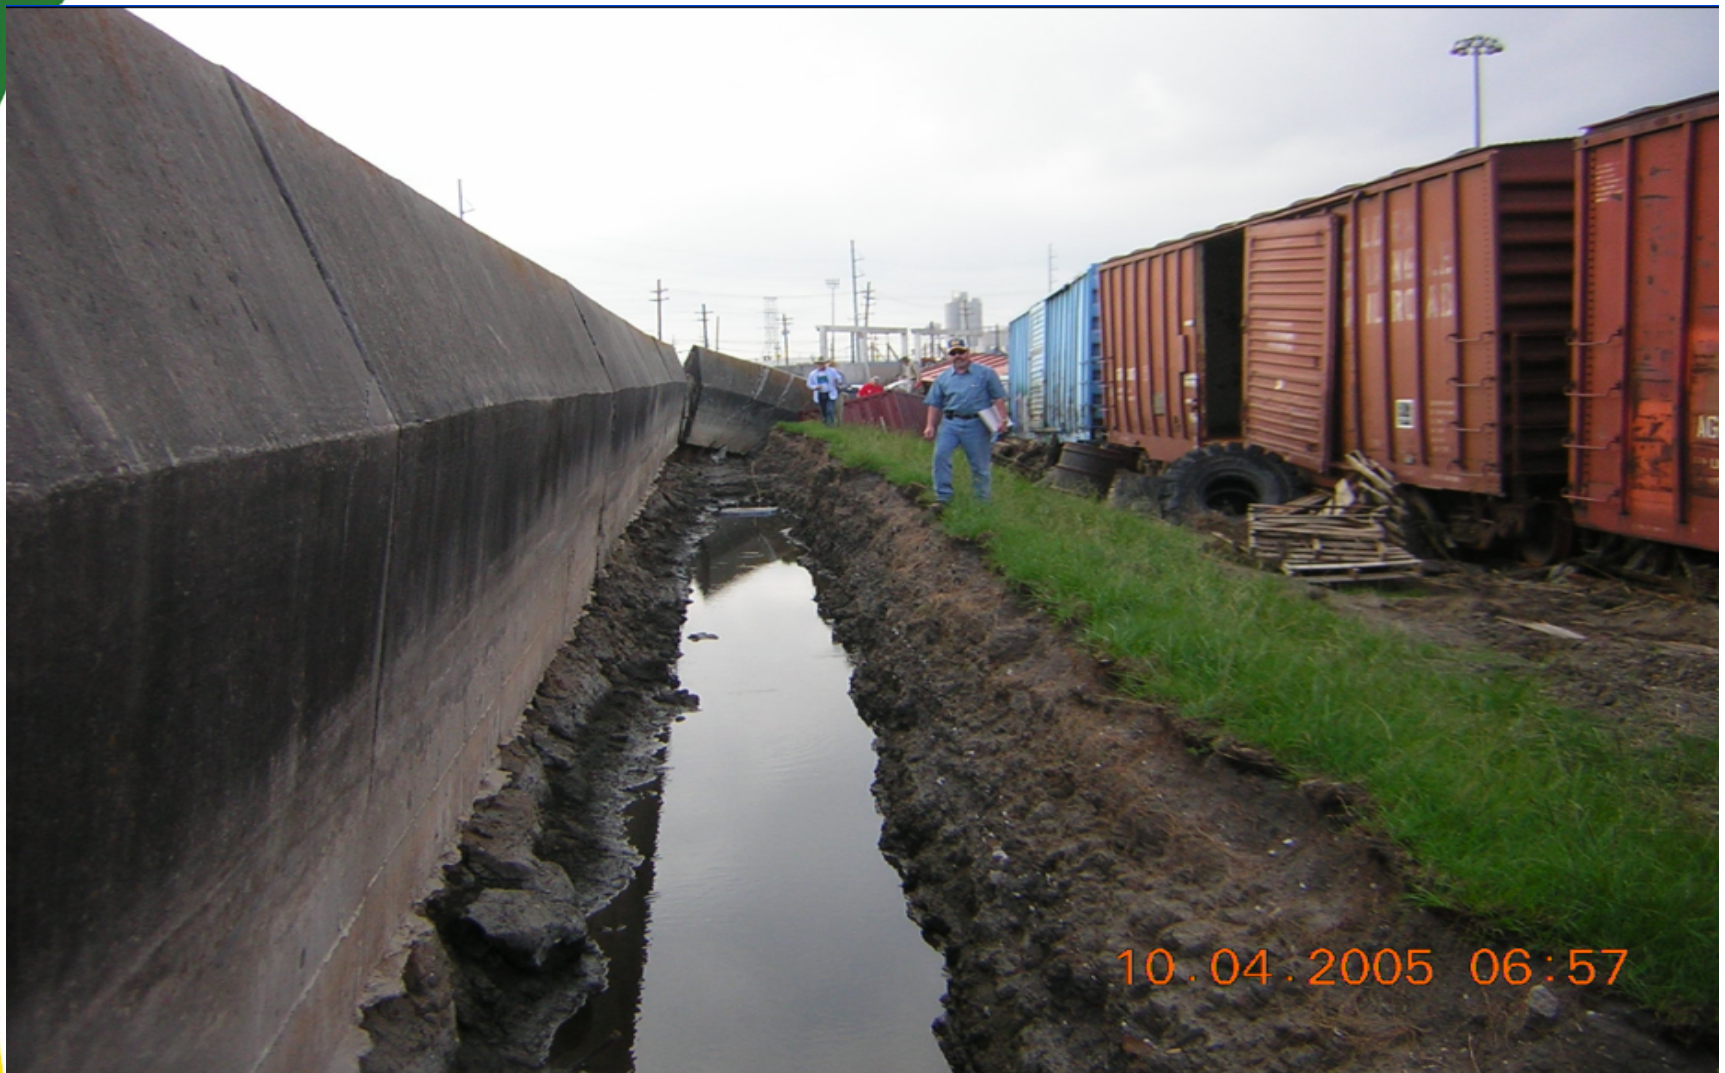
- **Overtopping scour holes along landside of flood wall on west side of the IHNC. Note broken wall in background. A splash pad on inboard side could have prevented this undercutting for less than 0.5% of the flood wall cost, making the structure “Class 3 survivable.”**

Structures must be Class 3 survivable
