Part 3

SYSTEMIC FAILURES OF FLOOD CONTROL INFRASTRUCTURE

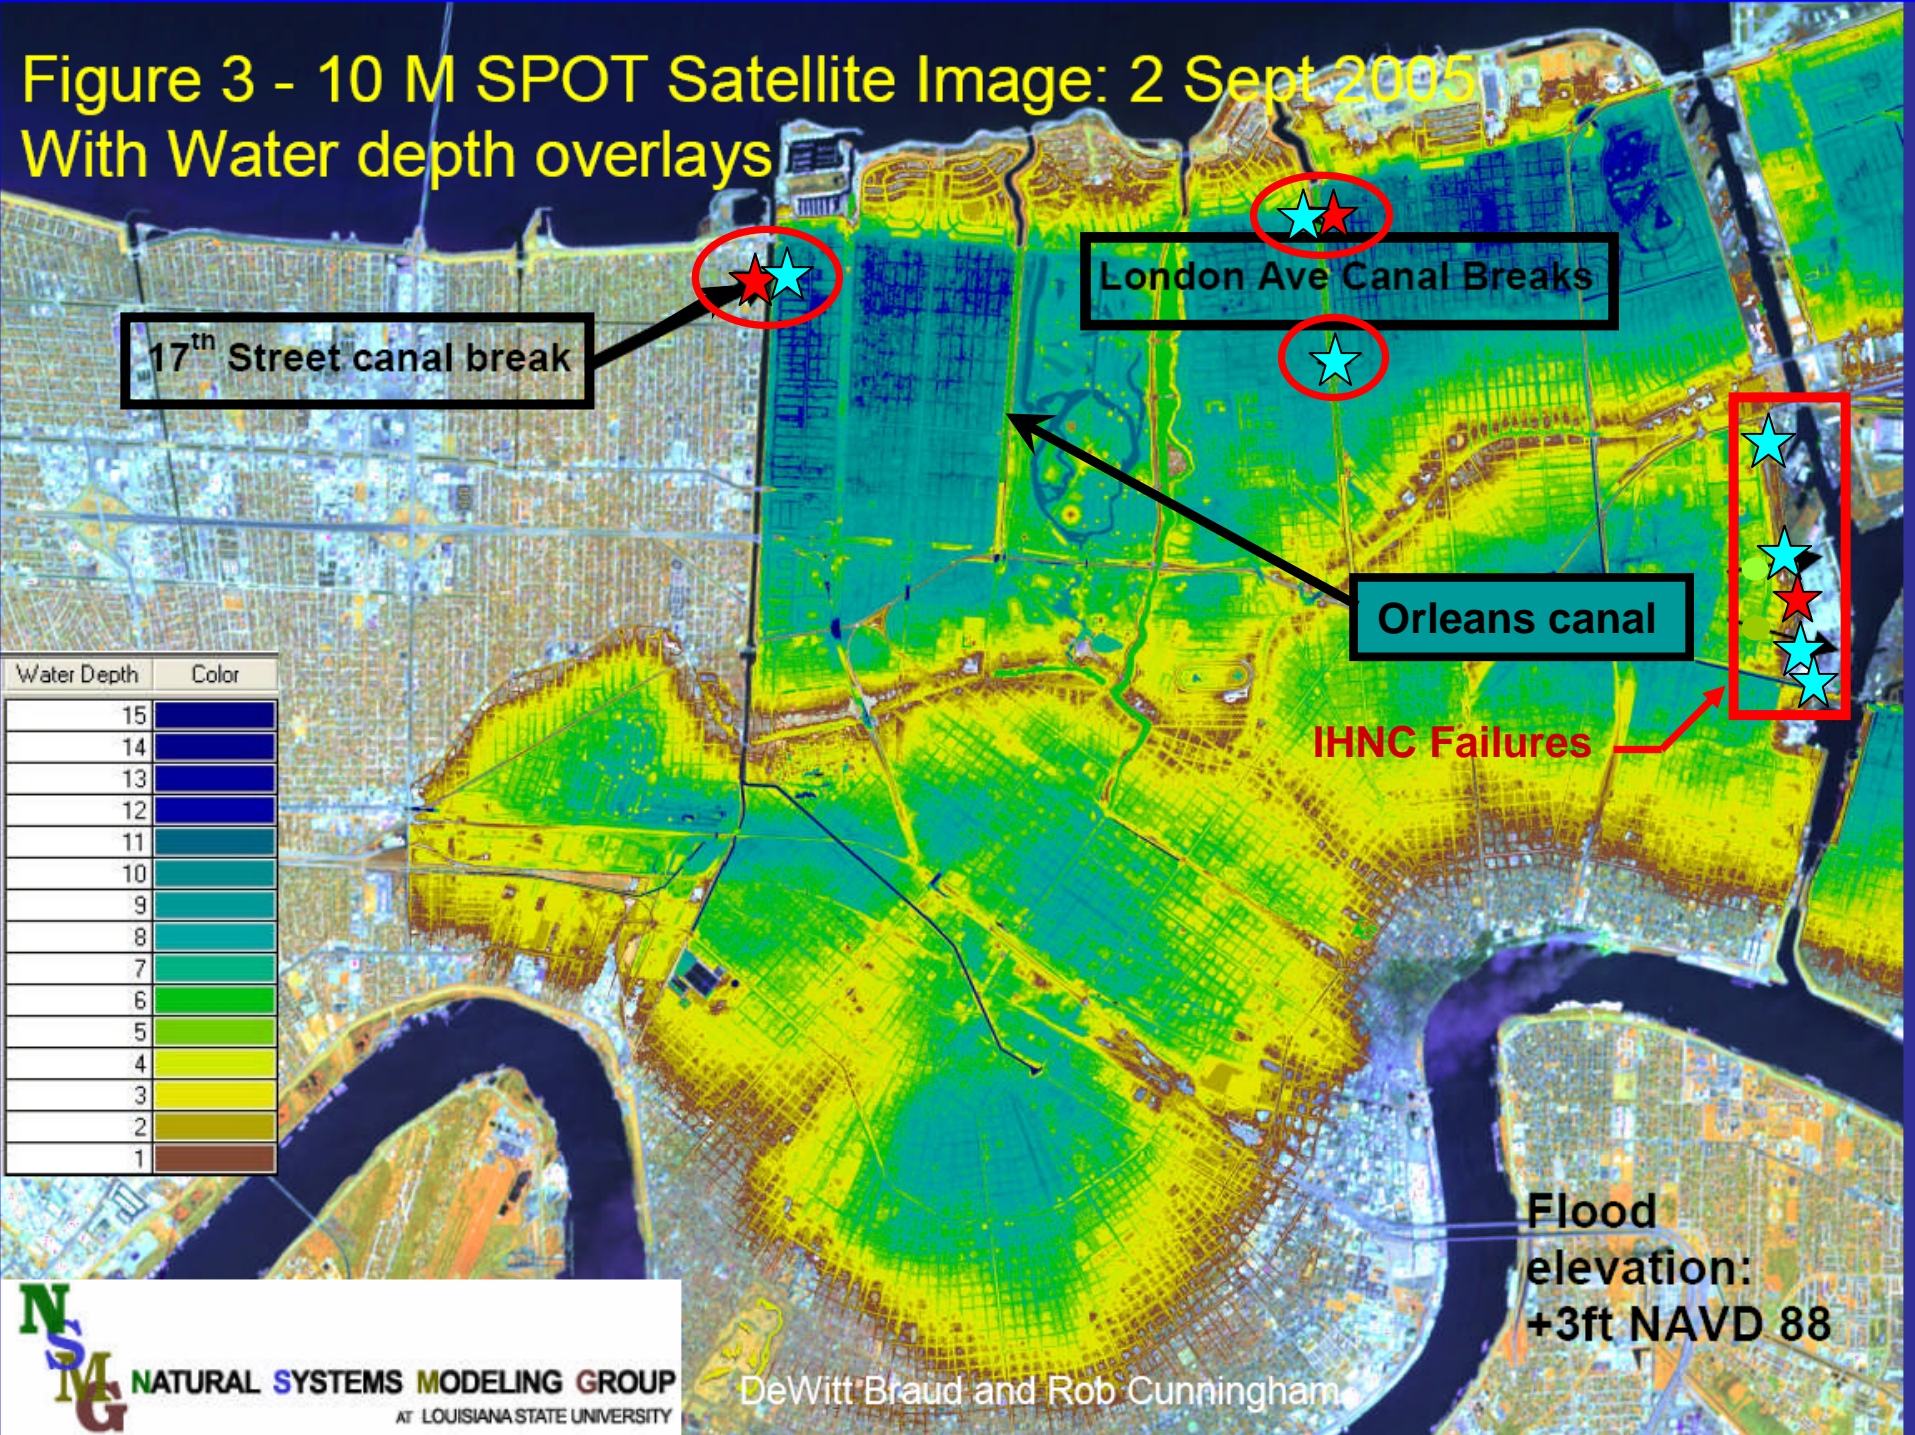
Figure 3 - 10 M SPOT Satellite Image: 2 Sept 2005
 With Water depth overlays

- **New Orleans neighborhoods were filled with as much as 12 feet of water, for up to 6 weeks**

17th Street canal break

London Ave Canal Breaks

Orleans canal

IHNC Failures

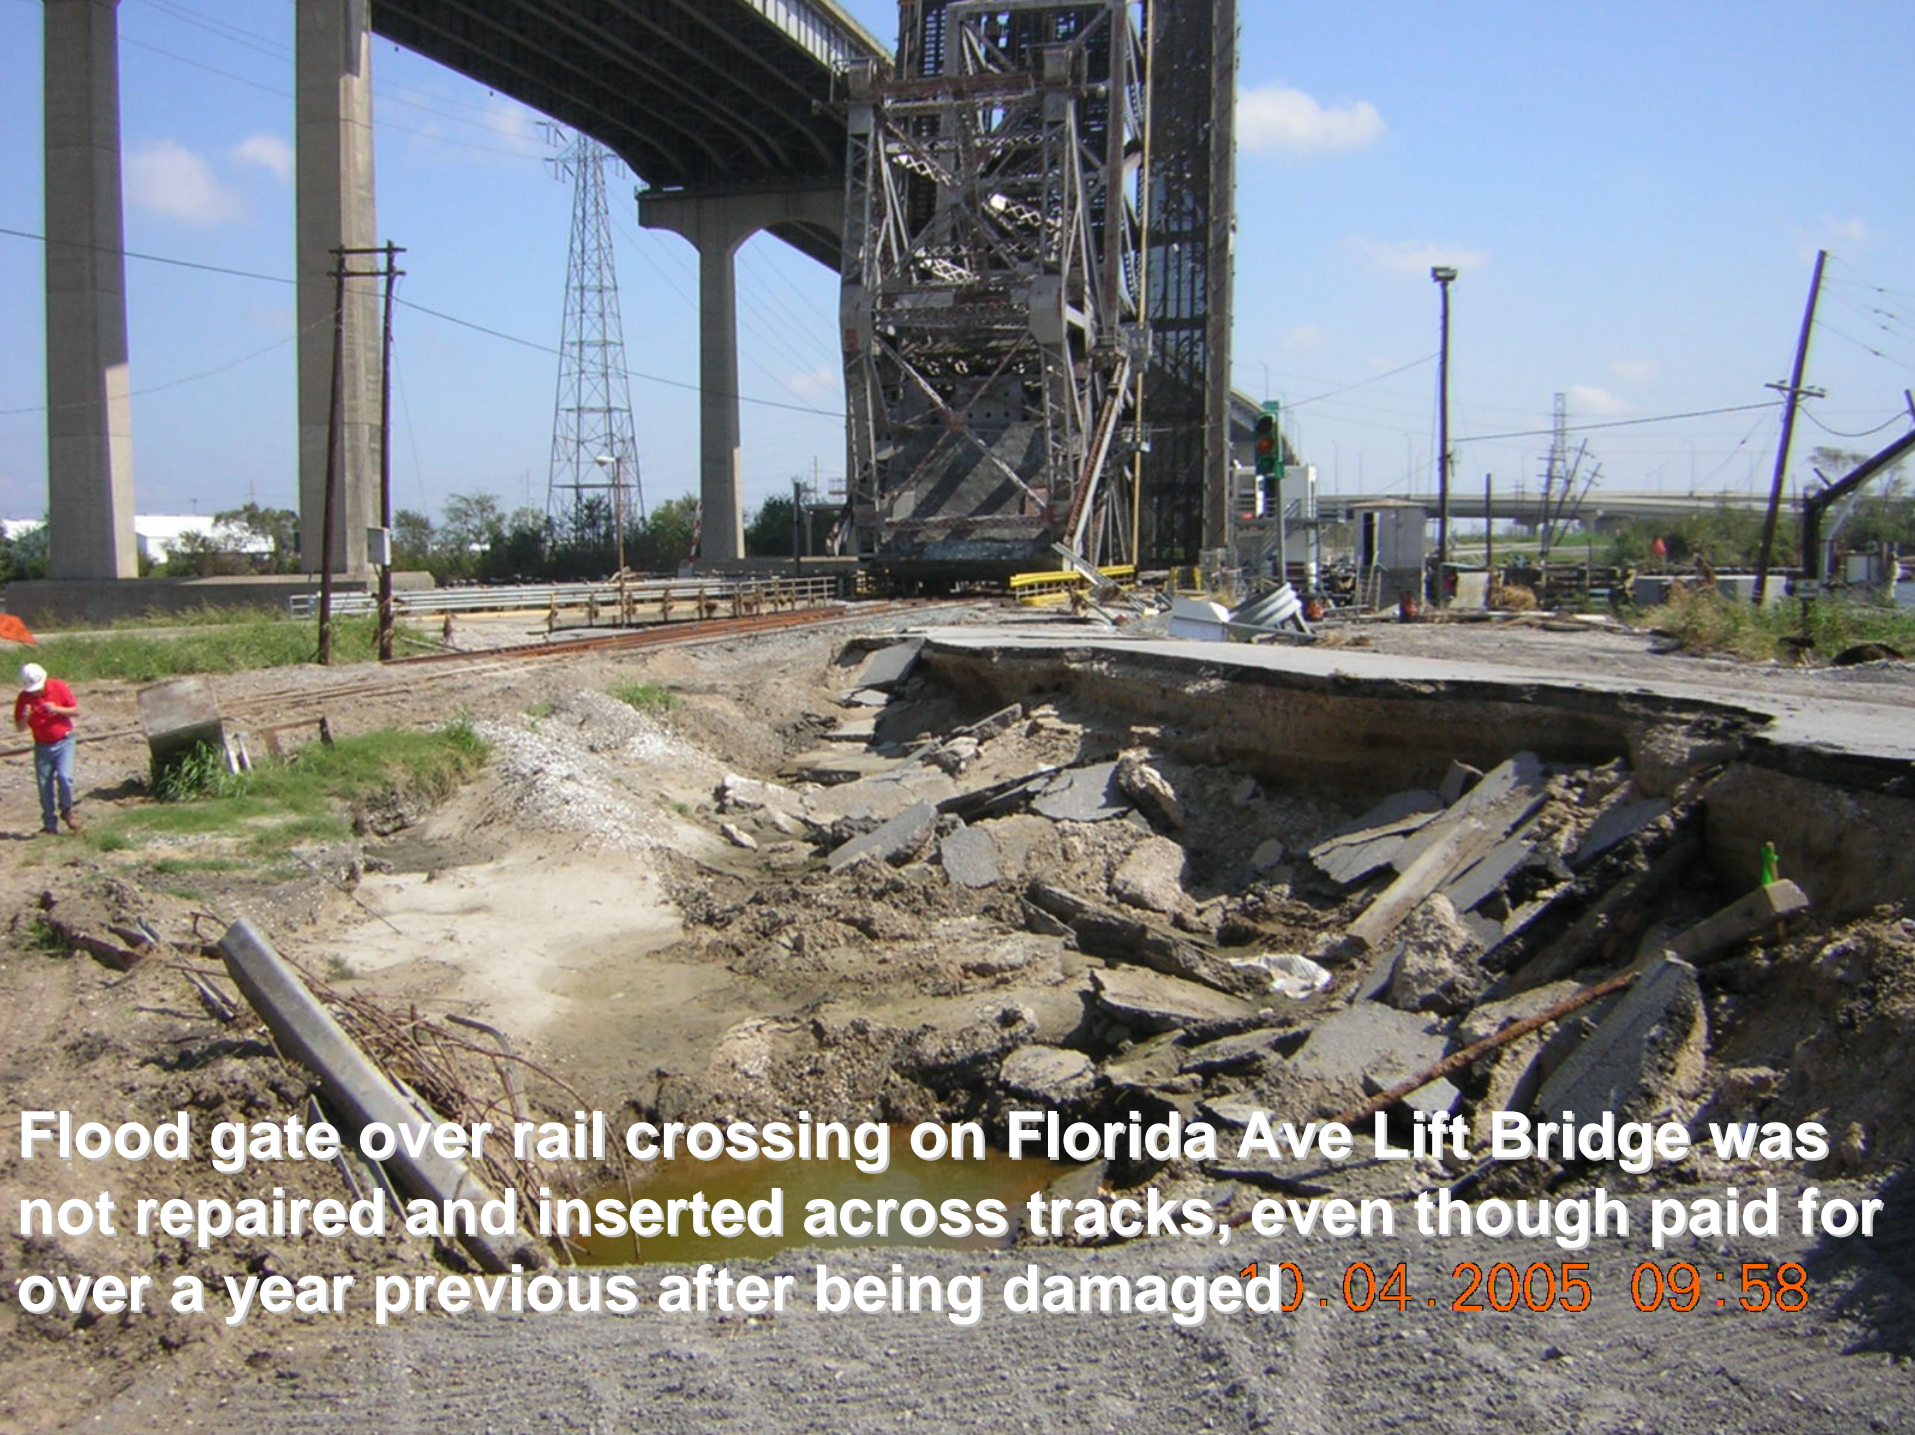
Flood gate over rail crossing on Florida Ave Lift Bridge was not repaired and inserted across tracks, even though paid for over a year previous after being damaged 10.04.2005 09:58

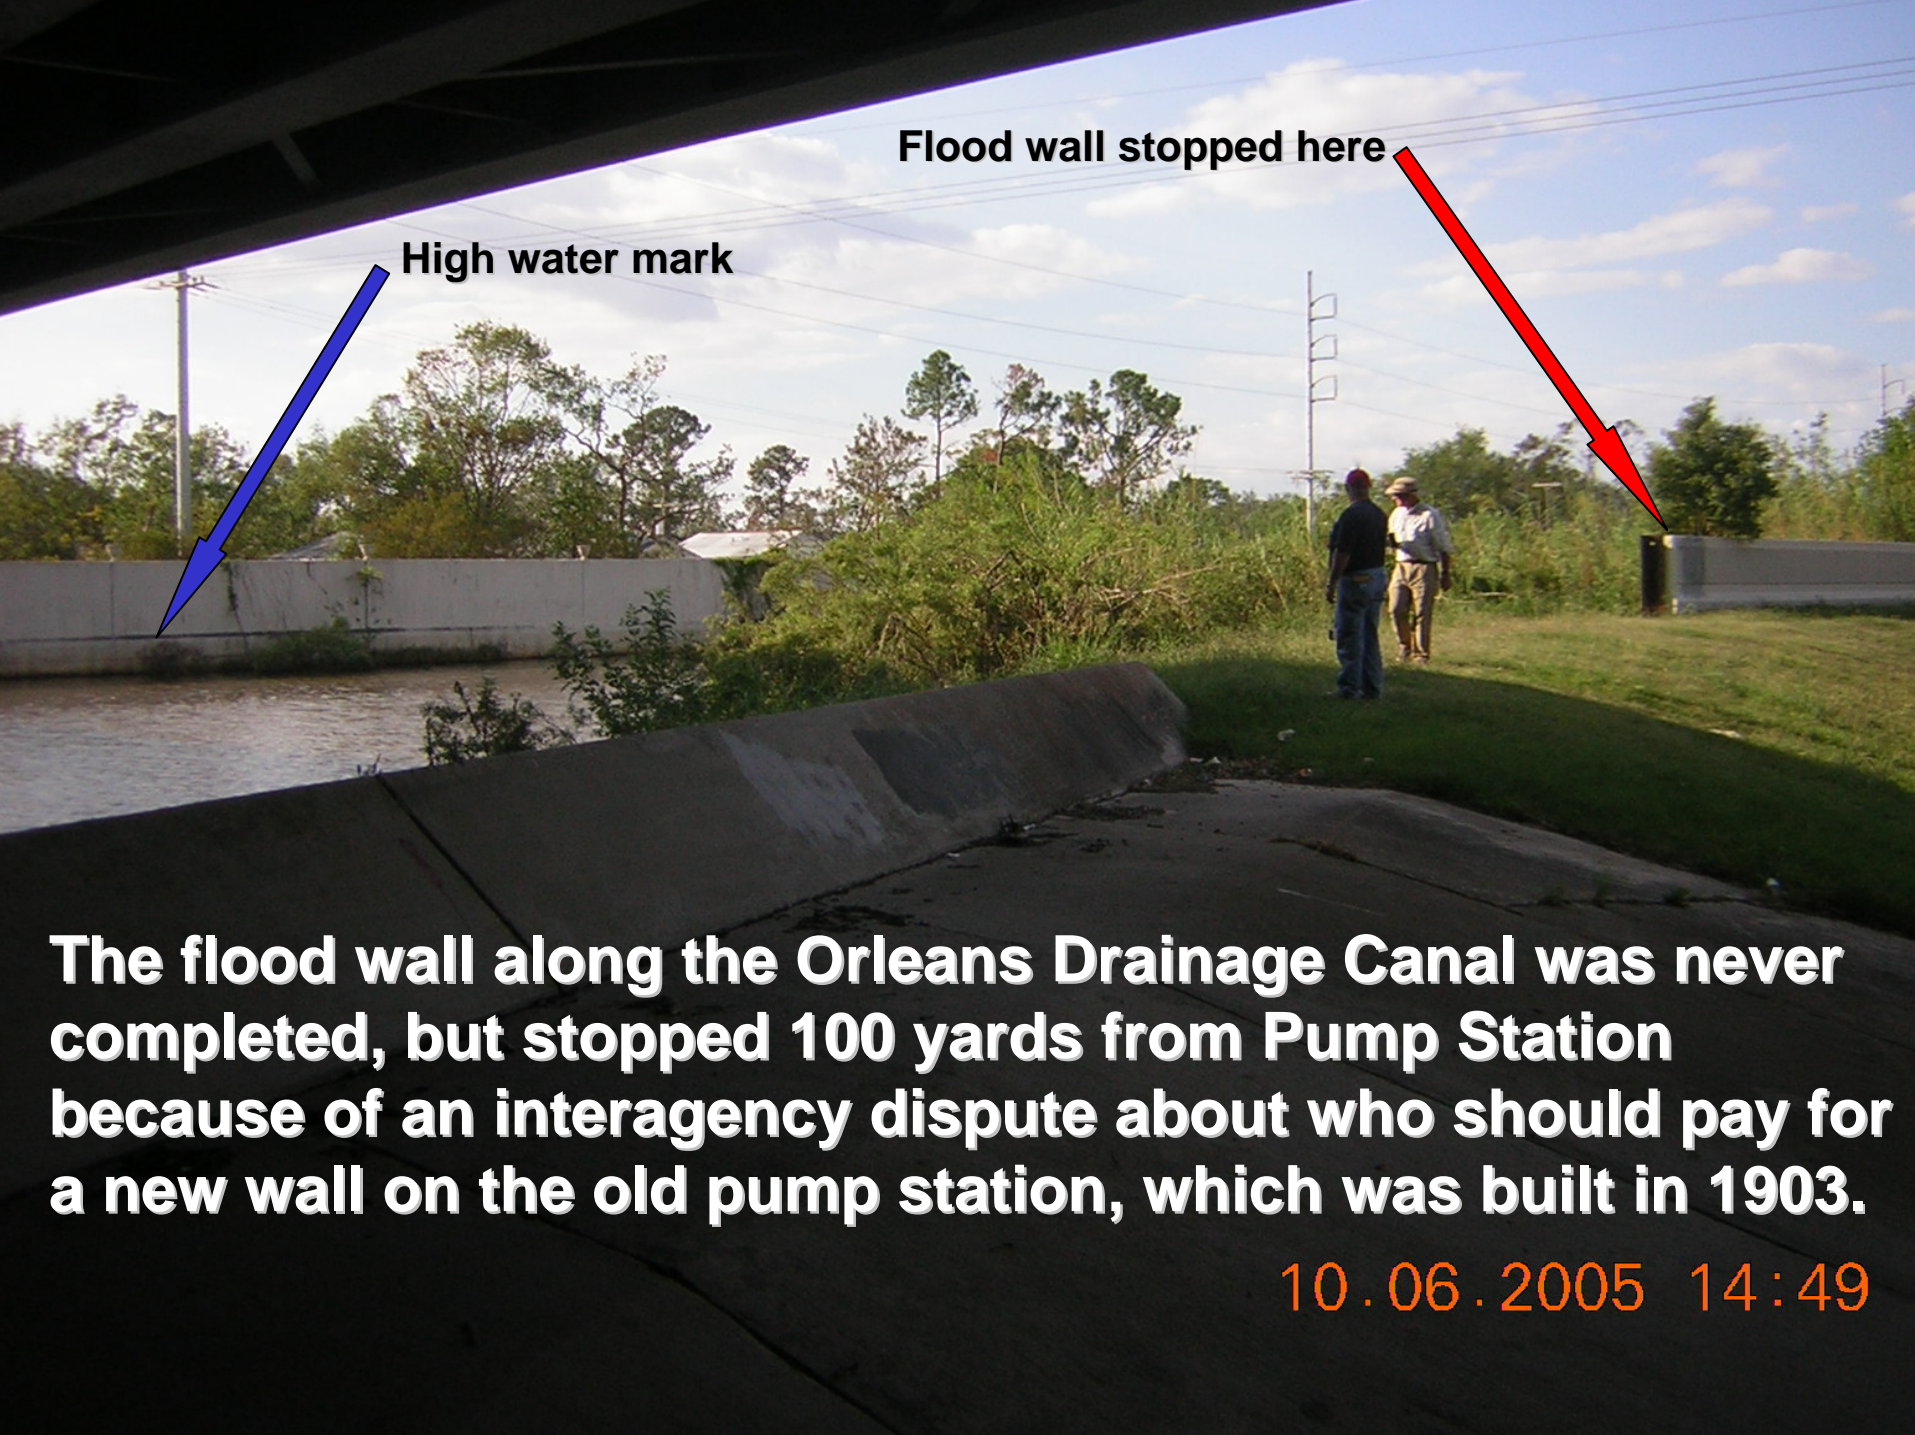
Flood wall stopped here

High water mark

The flood wall along the Orleans Drainage Canal was never completed, but stopped 100 yards from Pump Station because of an interagency dispute about who should pay for a new wall on the old pump station, which was built in 1903.

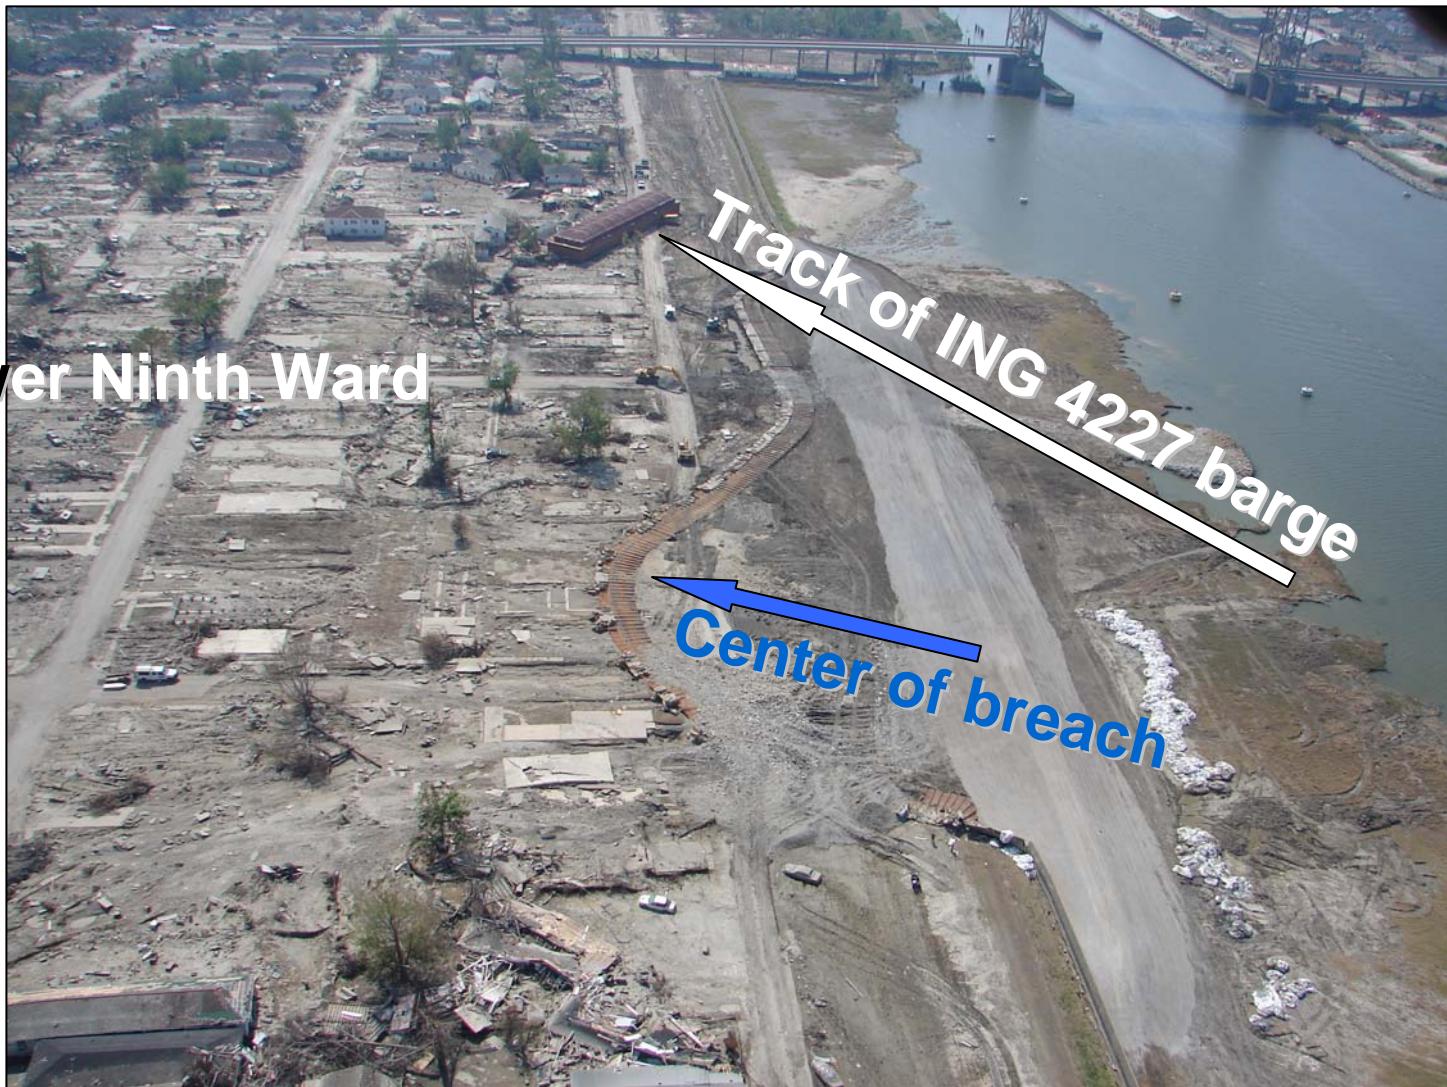
- **Aerial view of the south breach of the Inner Harbor Navigation Channel (IHNC) in the Lower Ninth Ward of New Orleans.**

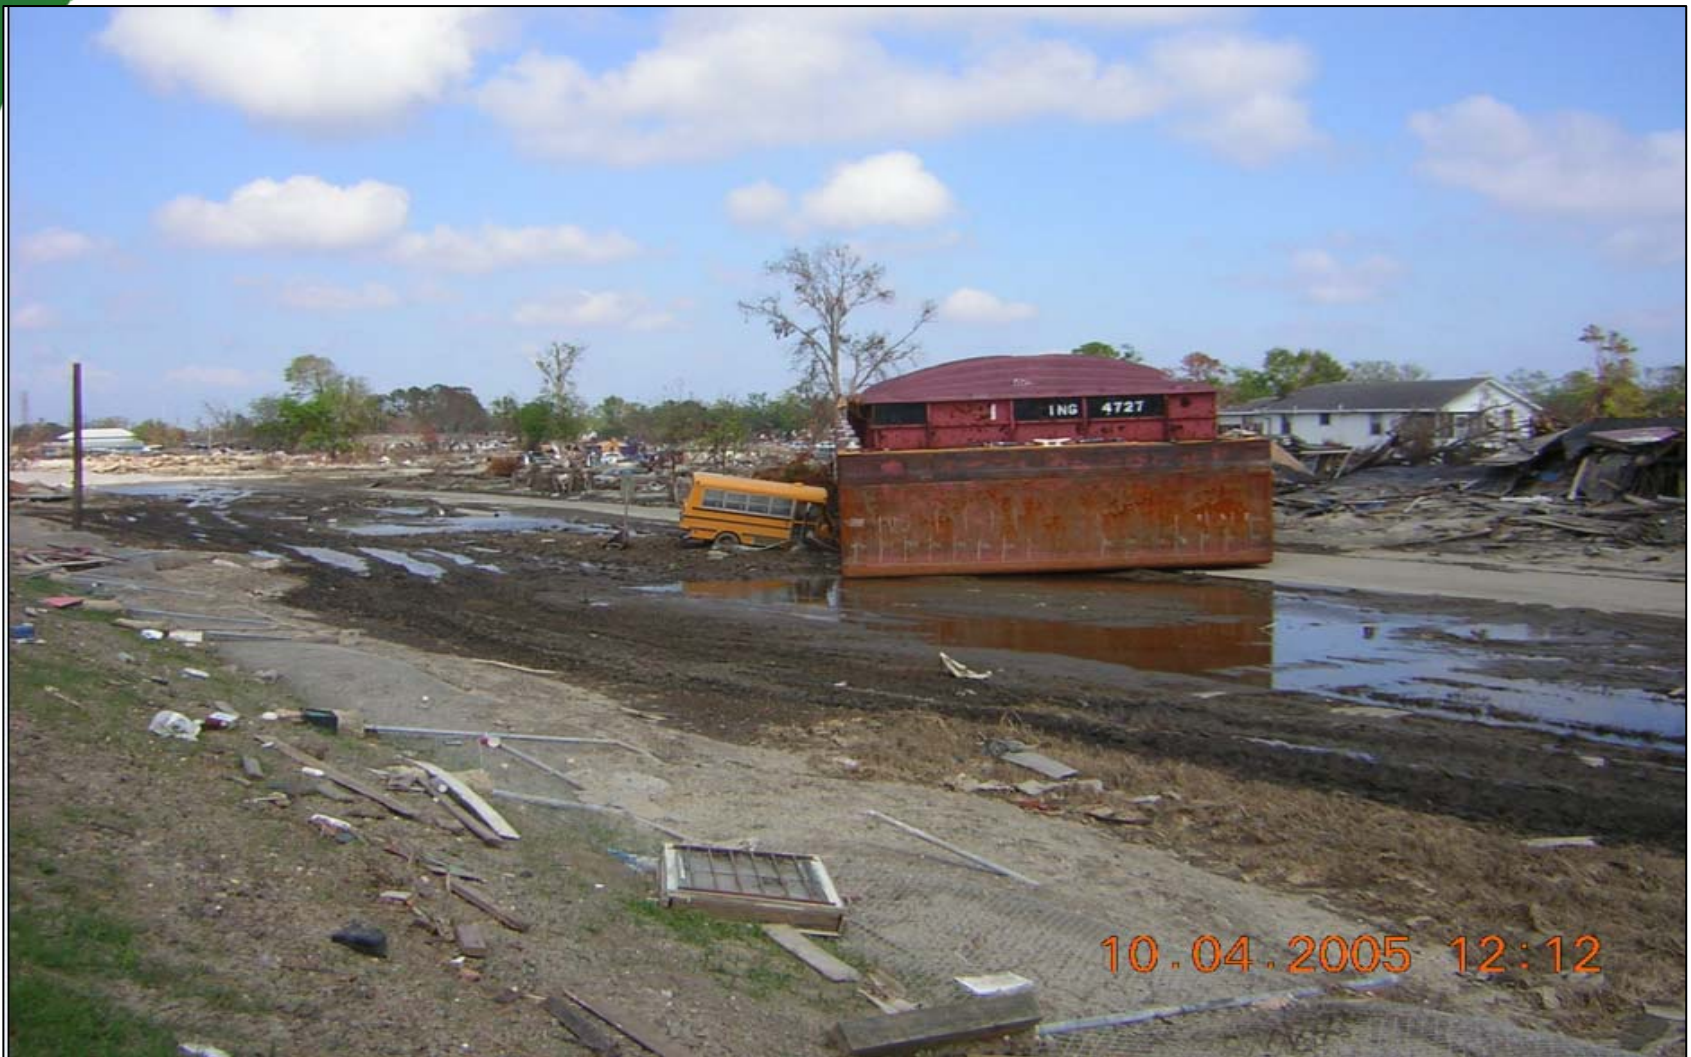
- **ING 4727 was built in 1990 as a dry cargo cover-top barge with a steel hull. It was 200 feet long, 35 feet wide, and 12 ft high, with a cargo volume of 84,659 ft³ (1877 tons). It was being leased to Lafarge North America, and was tied up along the MRGO channel.**

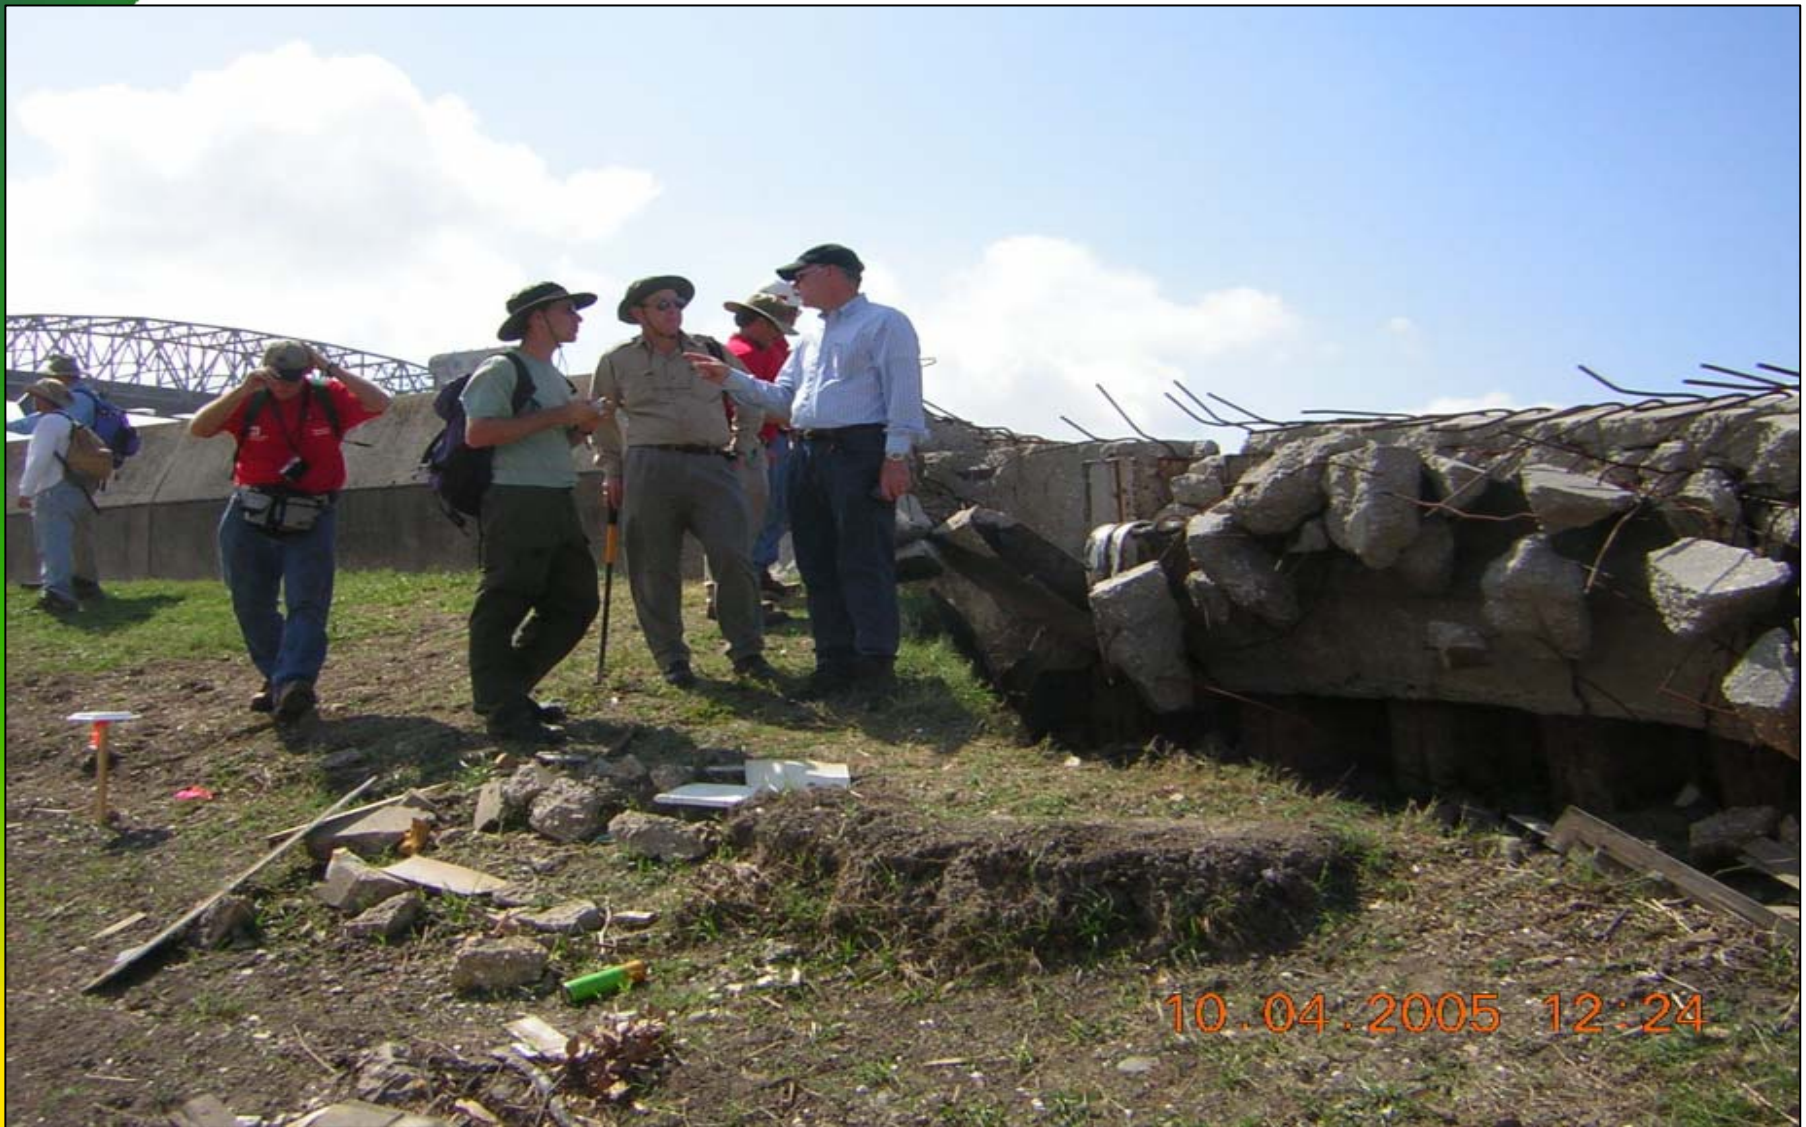
- **Damage to concrete flood wall where ING 4727 Barge collided with it, along the south side of the IHNC adjacent to the Lower Ninth Ward**

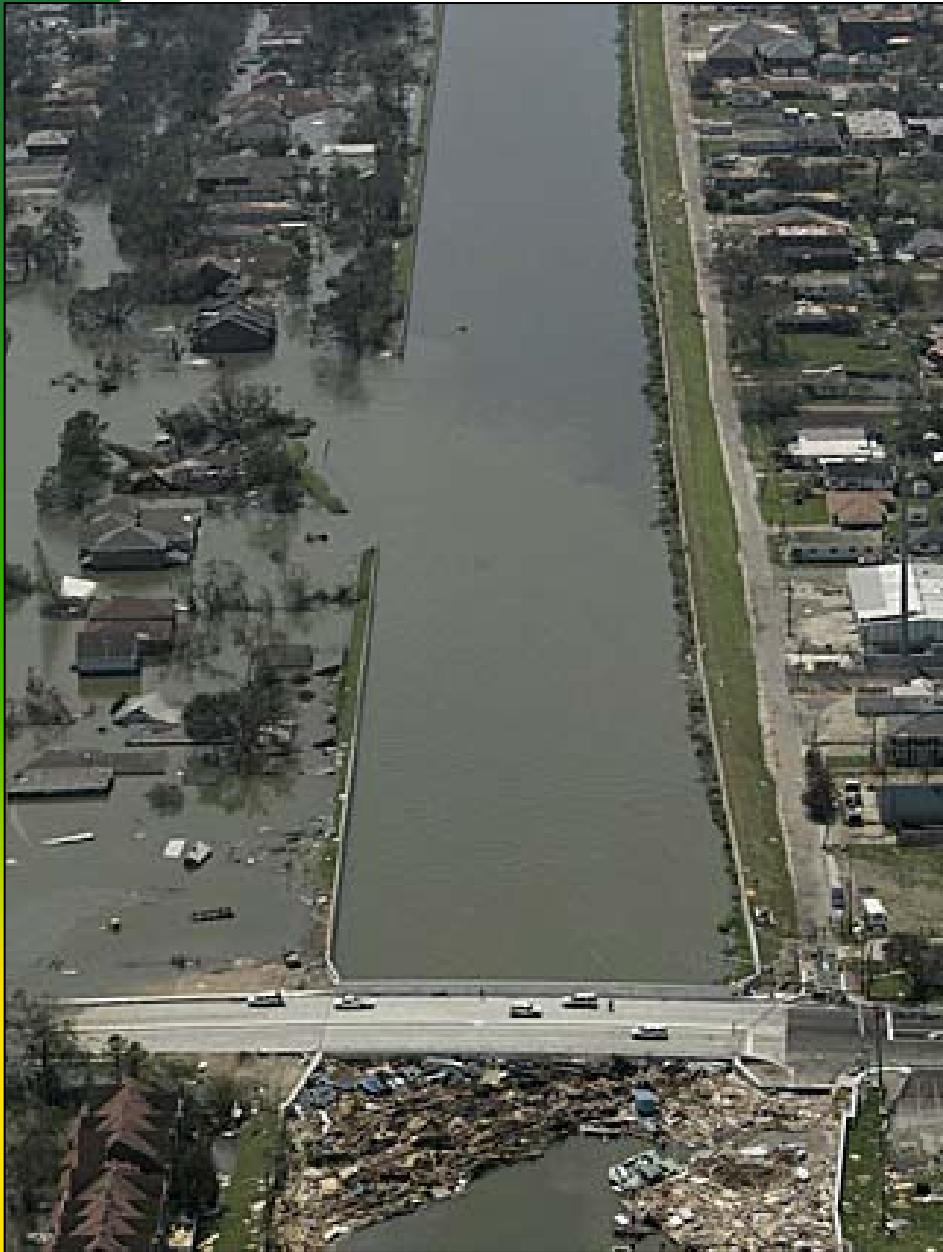
17th Street Drainage Canal breach

- The 17th Street canal had walls 14 ft above MGL
- The highest flow it had ever experienced was between 6 and 7 ft
- It began failing when water got to 8.5 ft.

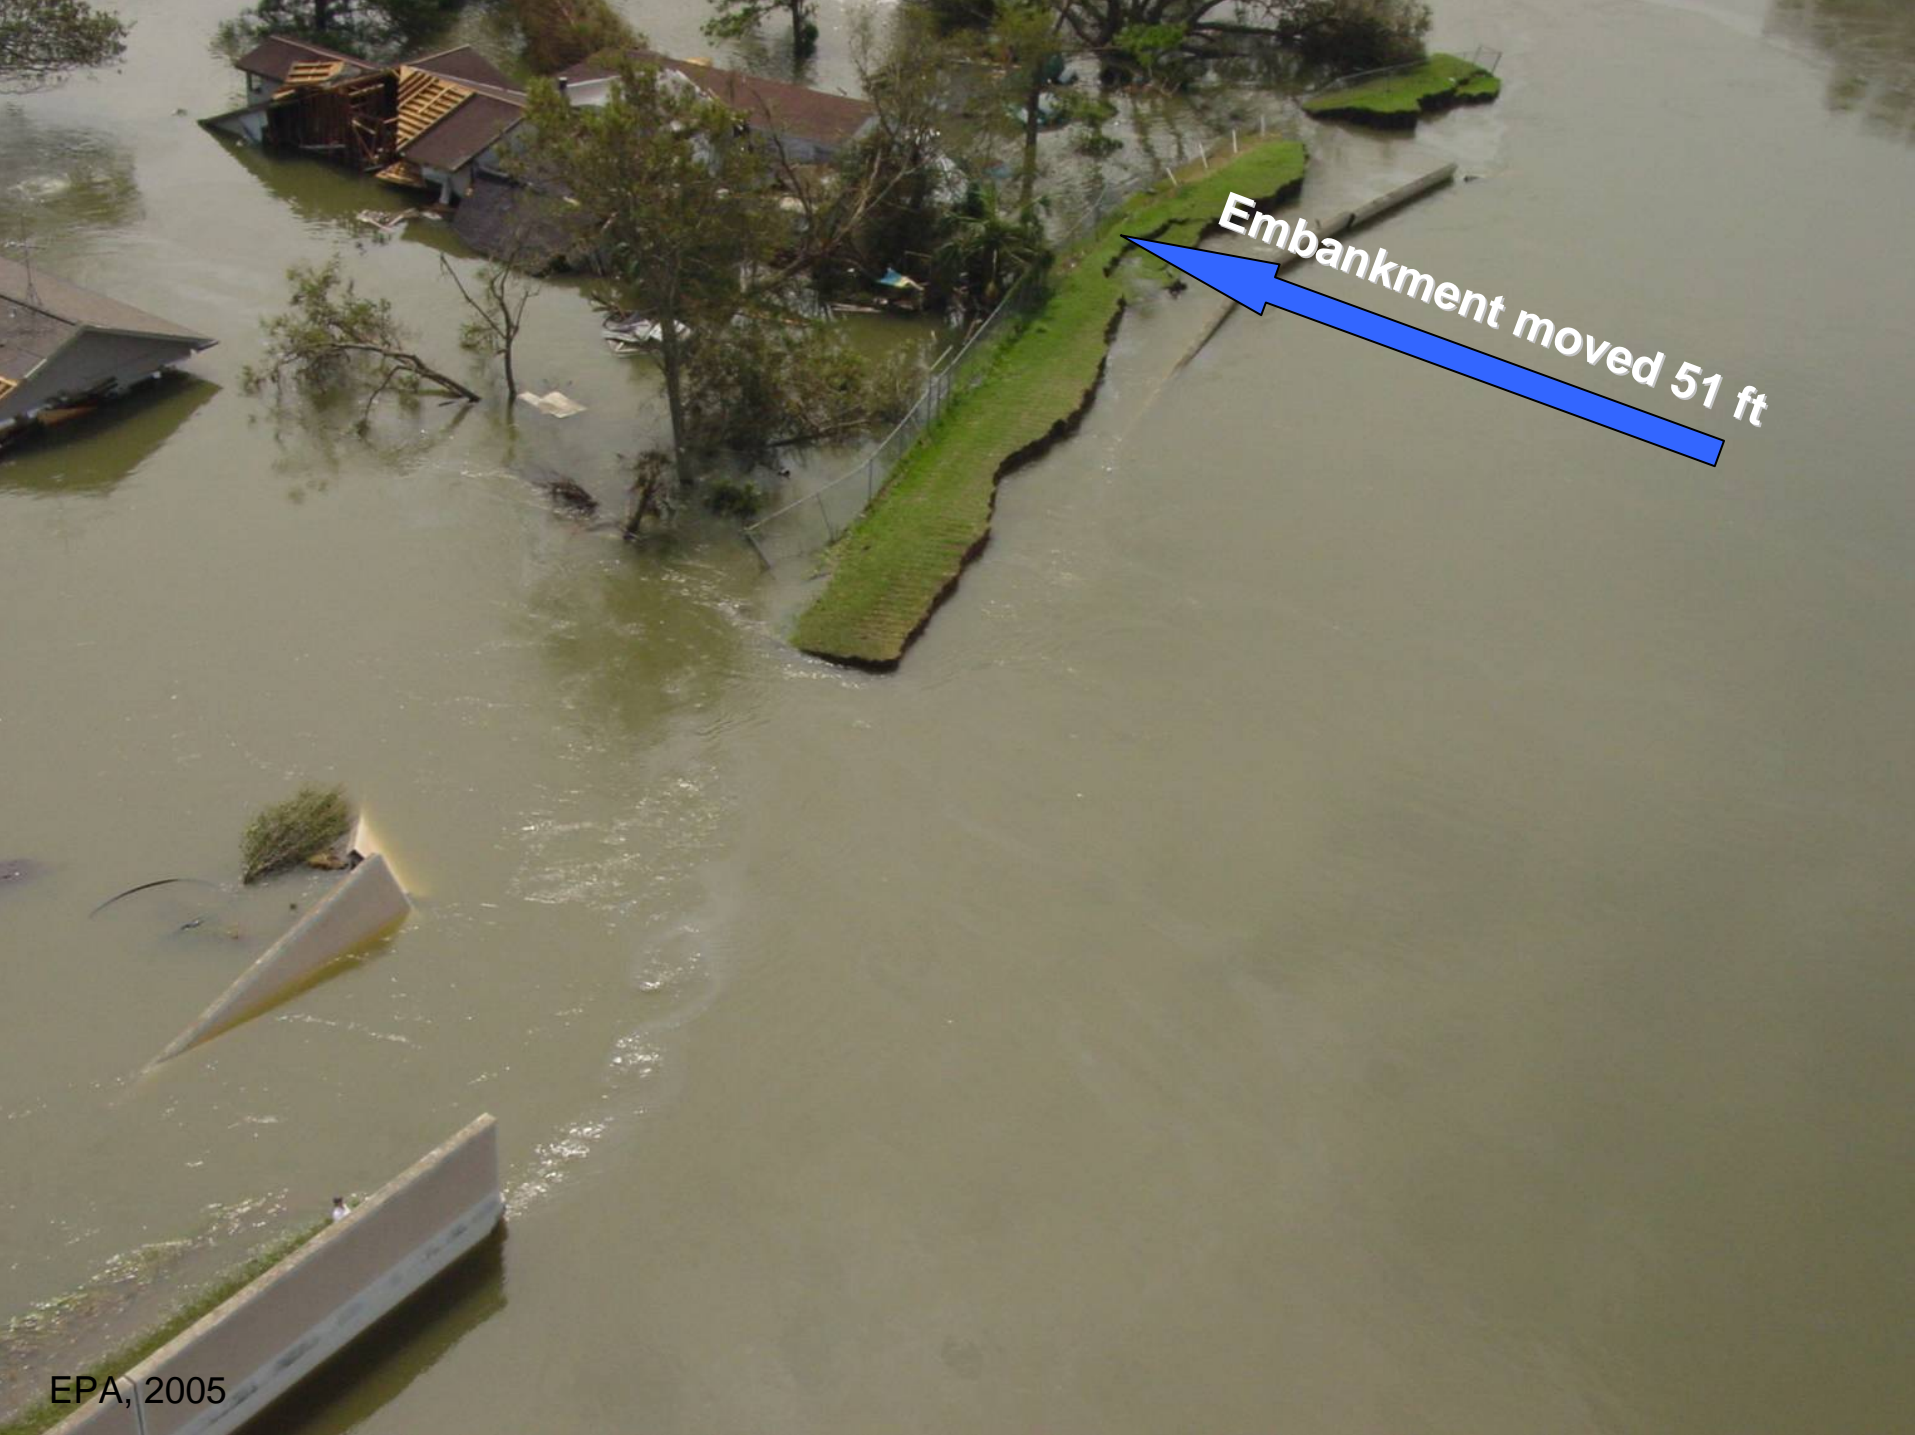
Embankment moved 51 ft

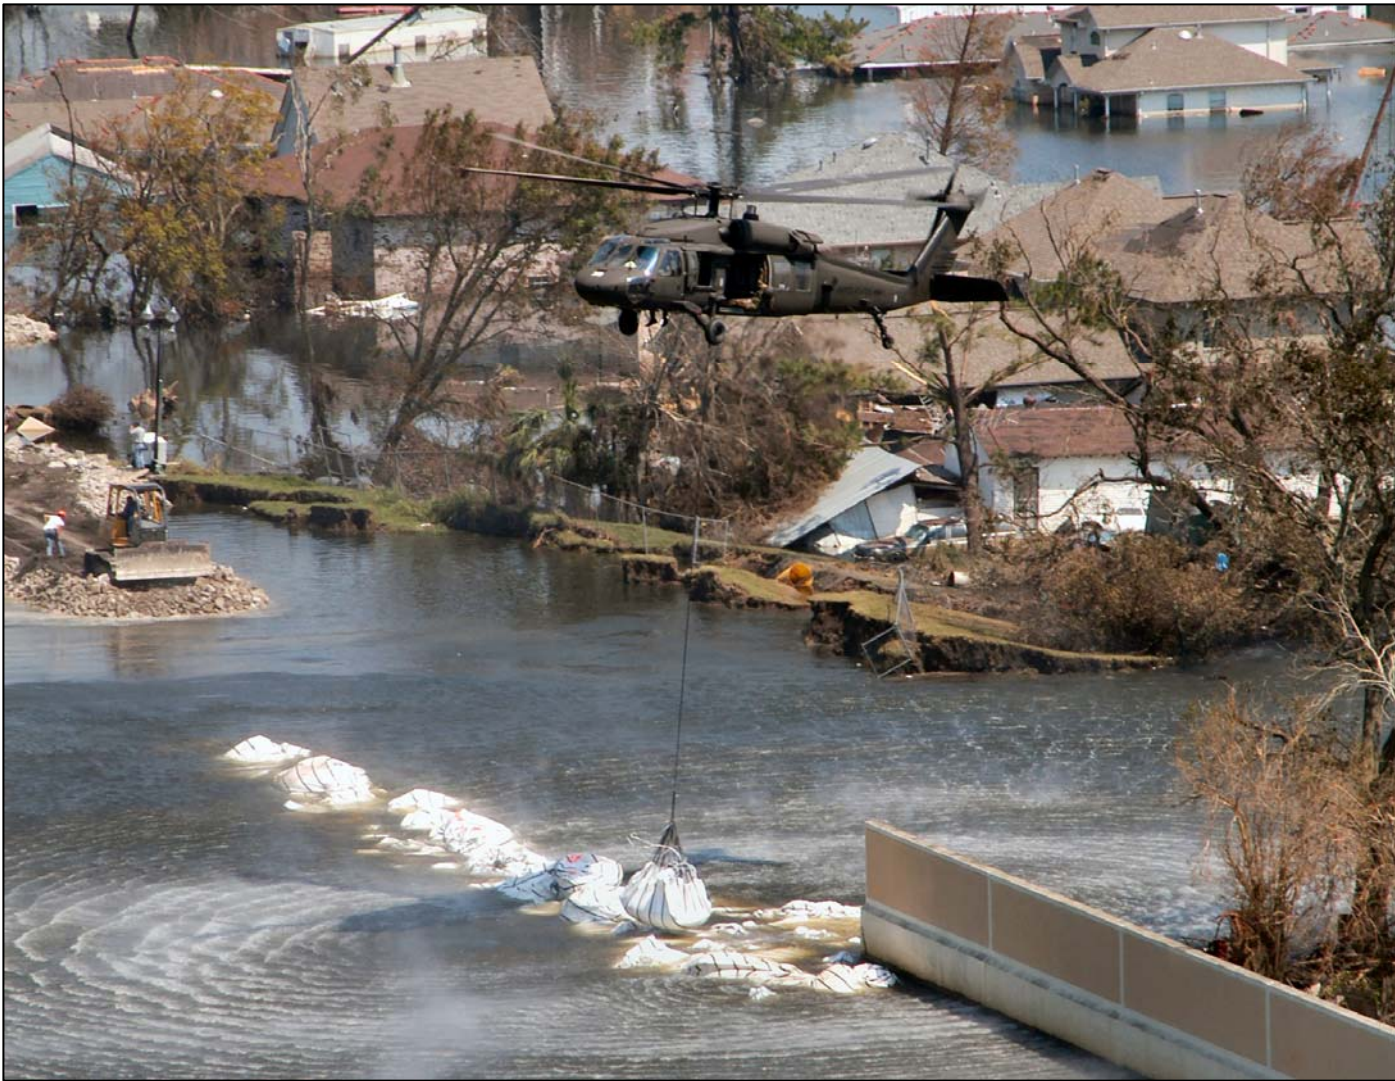
- **Army helicopters and contractors worked for weeks to fill the enormous gaps in the levee system, BEFORE pumping could begin.**

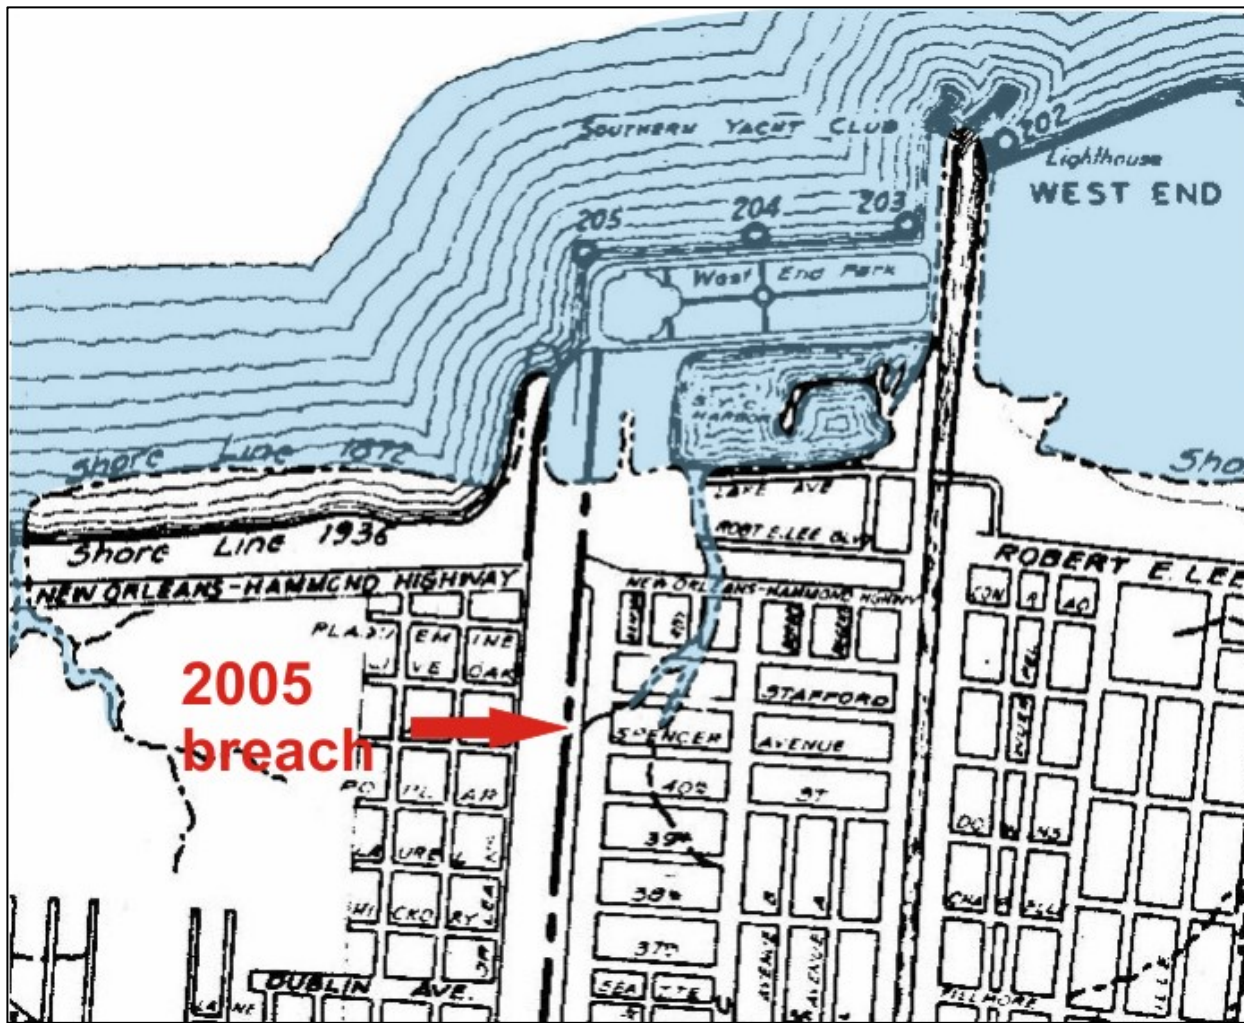
- Overlay of 1872 map by Valery Sulakowski on the 1937 WPA map, showing the 1872 shoreline and sloughs (in blue) along Lake Pontchartrain. The position of the 2005 breach along the east side of the 17th Street Canal is indicated by the red arrow.

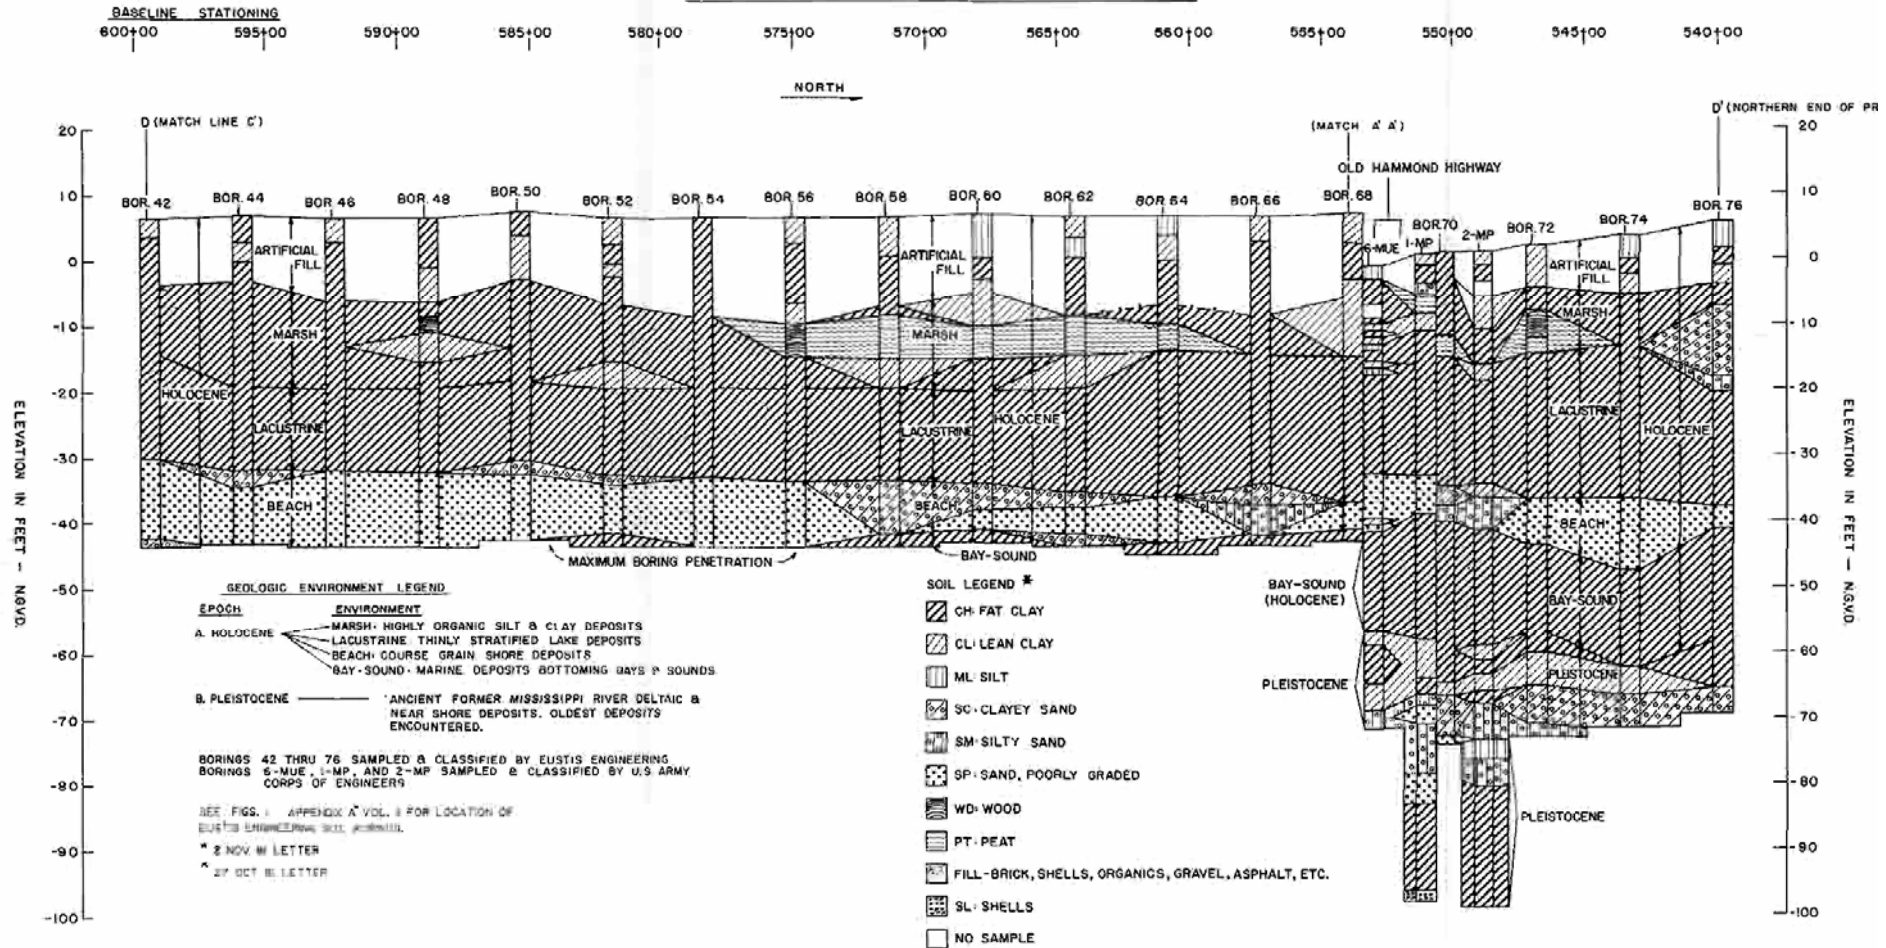
17TH STREET OUTFALL CANAL - EAST LEVEE (NORTHERN HALF)

Geologic profile for the 17th St Canal flood wall prepared by Corps' New Orleans District office in 1990. Three of four holes in vicinity of the 2005 failure had zero sample recovery. These contacts were projected and sheet pile tips designed accordingly.
