Part 3

SYSTEMIC FAILURES OF FLOOD CONTROL INFRASTRUCTURE

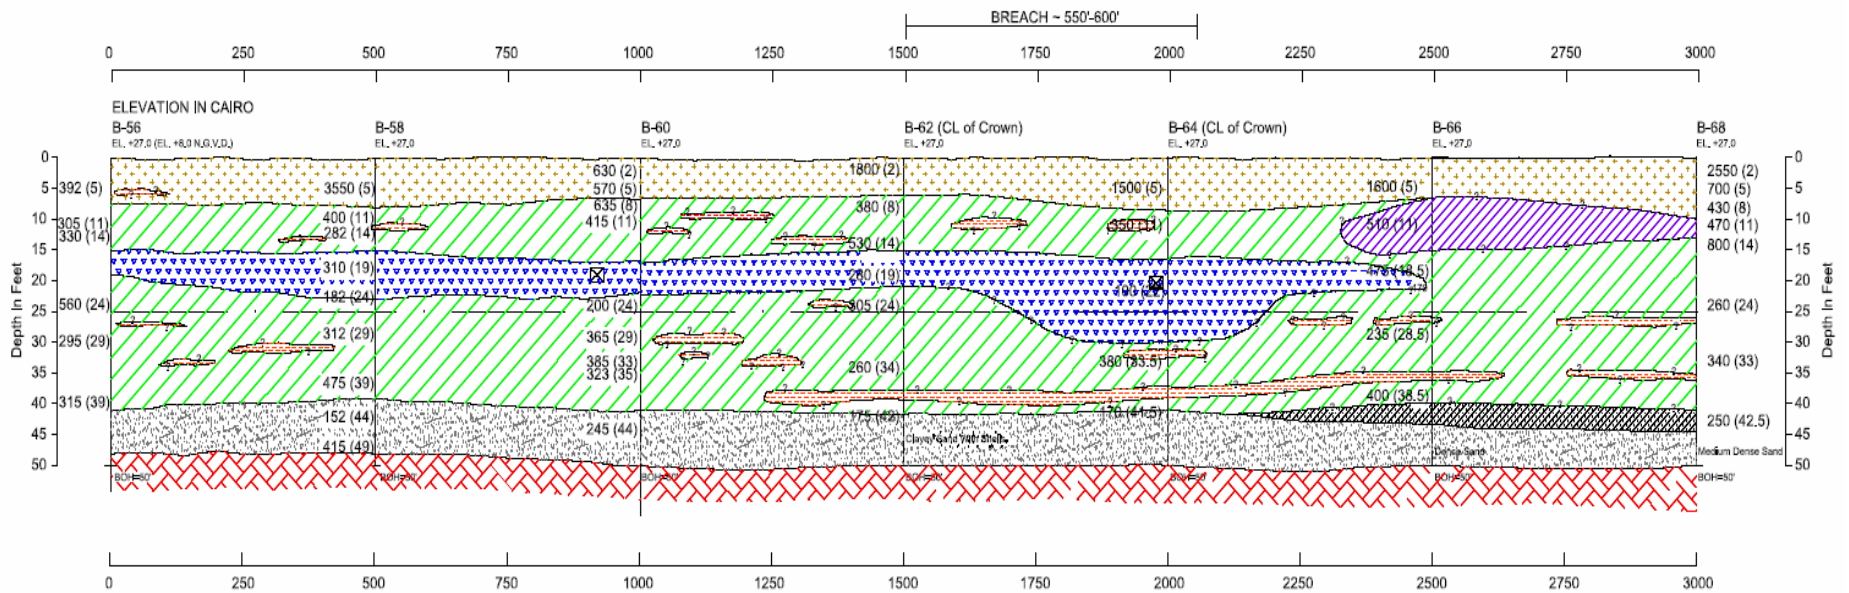
17th Street Canal East Levee- Draft Soil Profile
New Orleans, Louisiana

- Alternative interpretation of the Eustis 1982 borings for the 17th Street Canal East Levee, near the 2005 break. In this case the swamp deposits would extend beneath the sheetpile tips over a zone 300 feet long, where the break occurred.

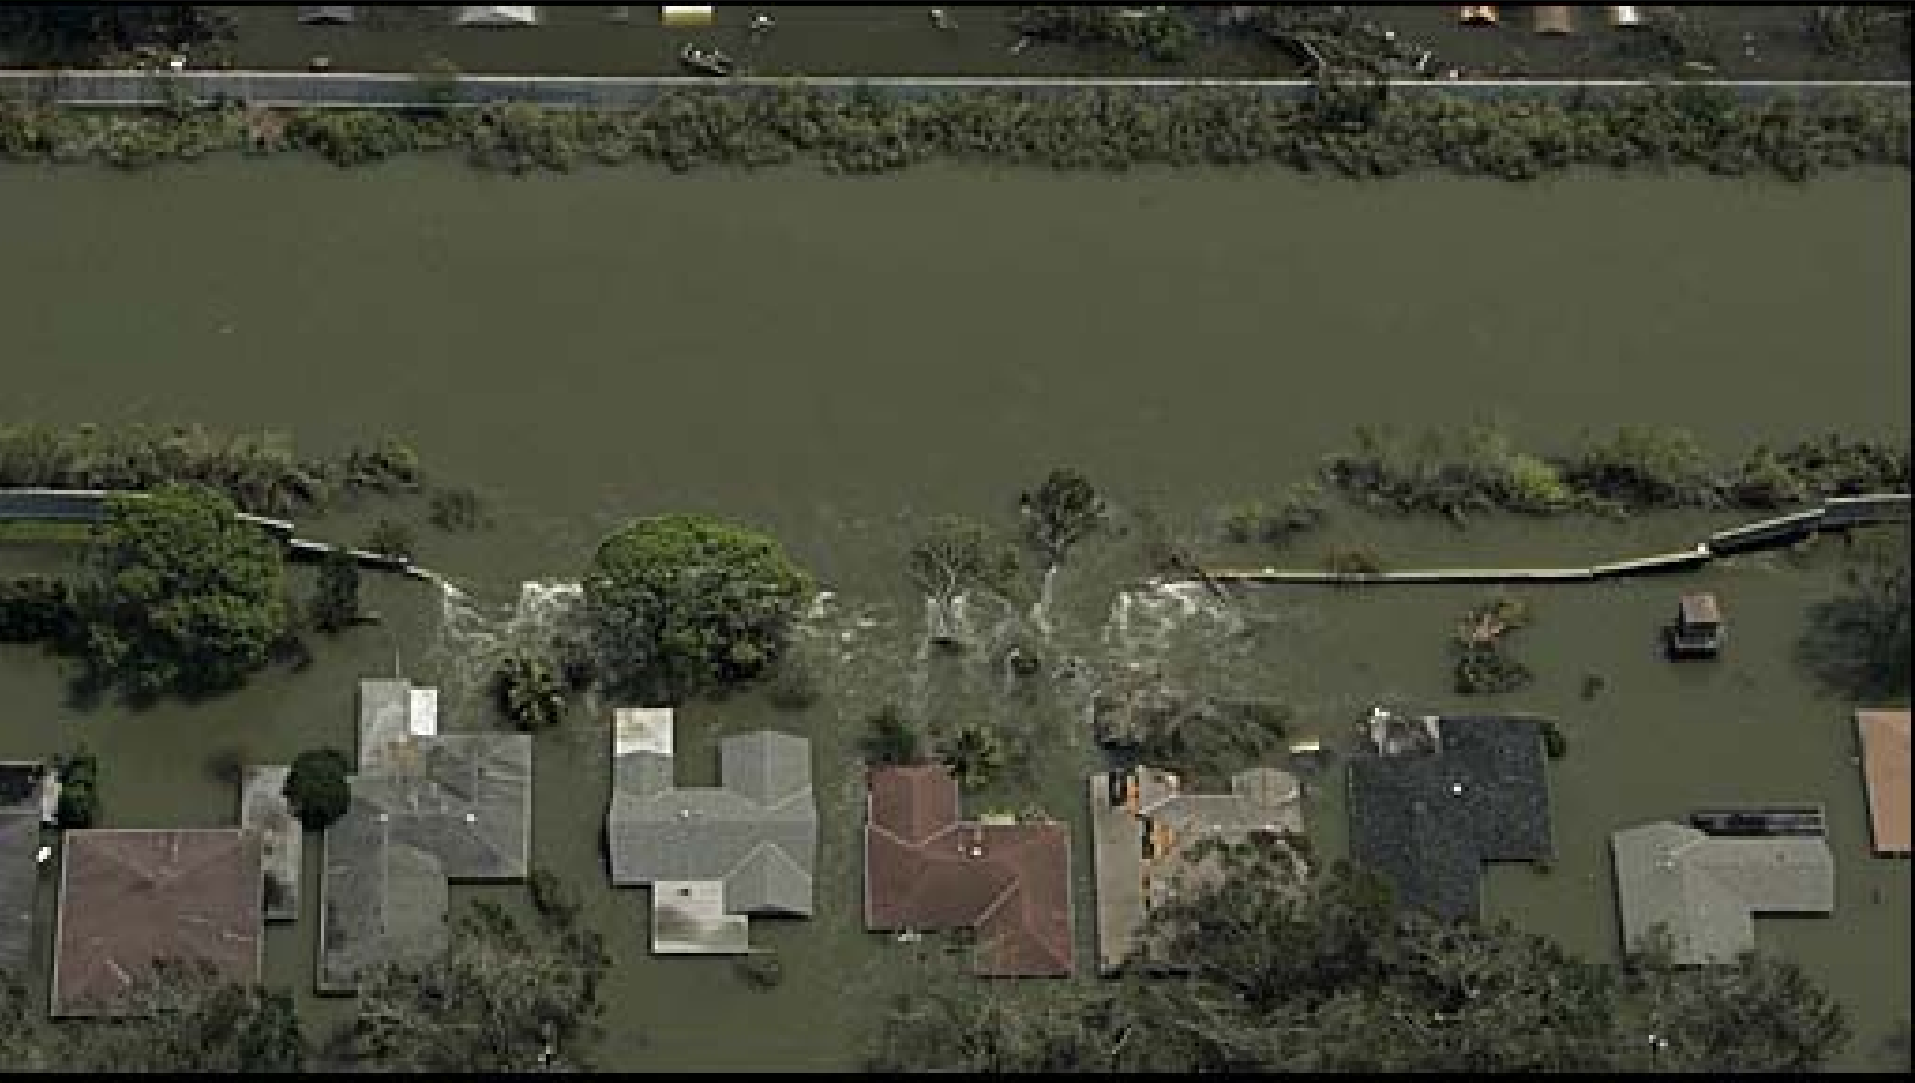
London Avenue (North) breach

Similar failure mechanism as 17th St Canal

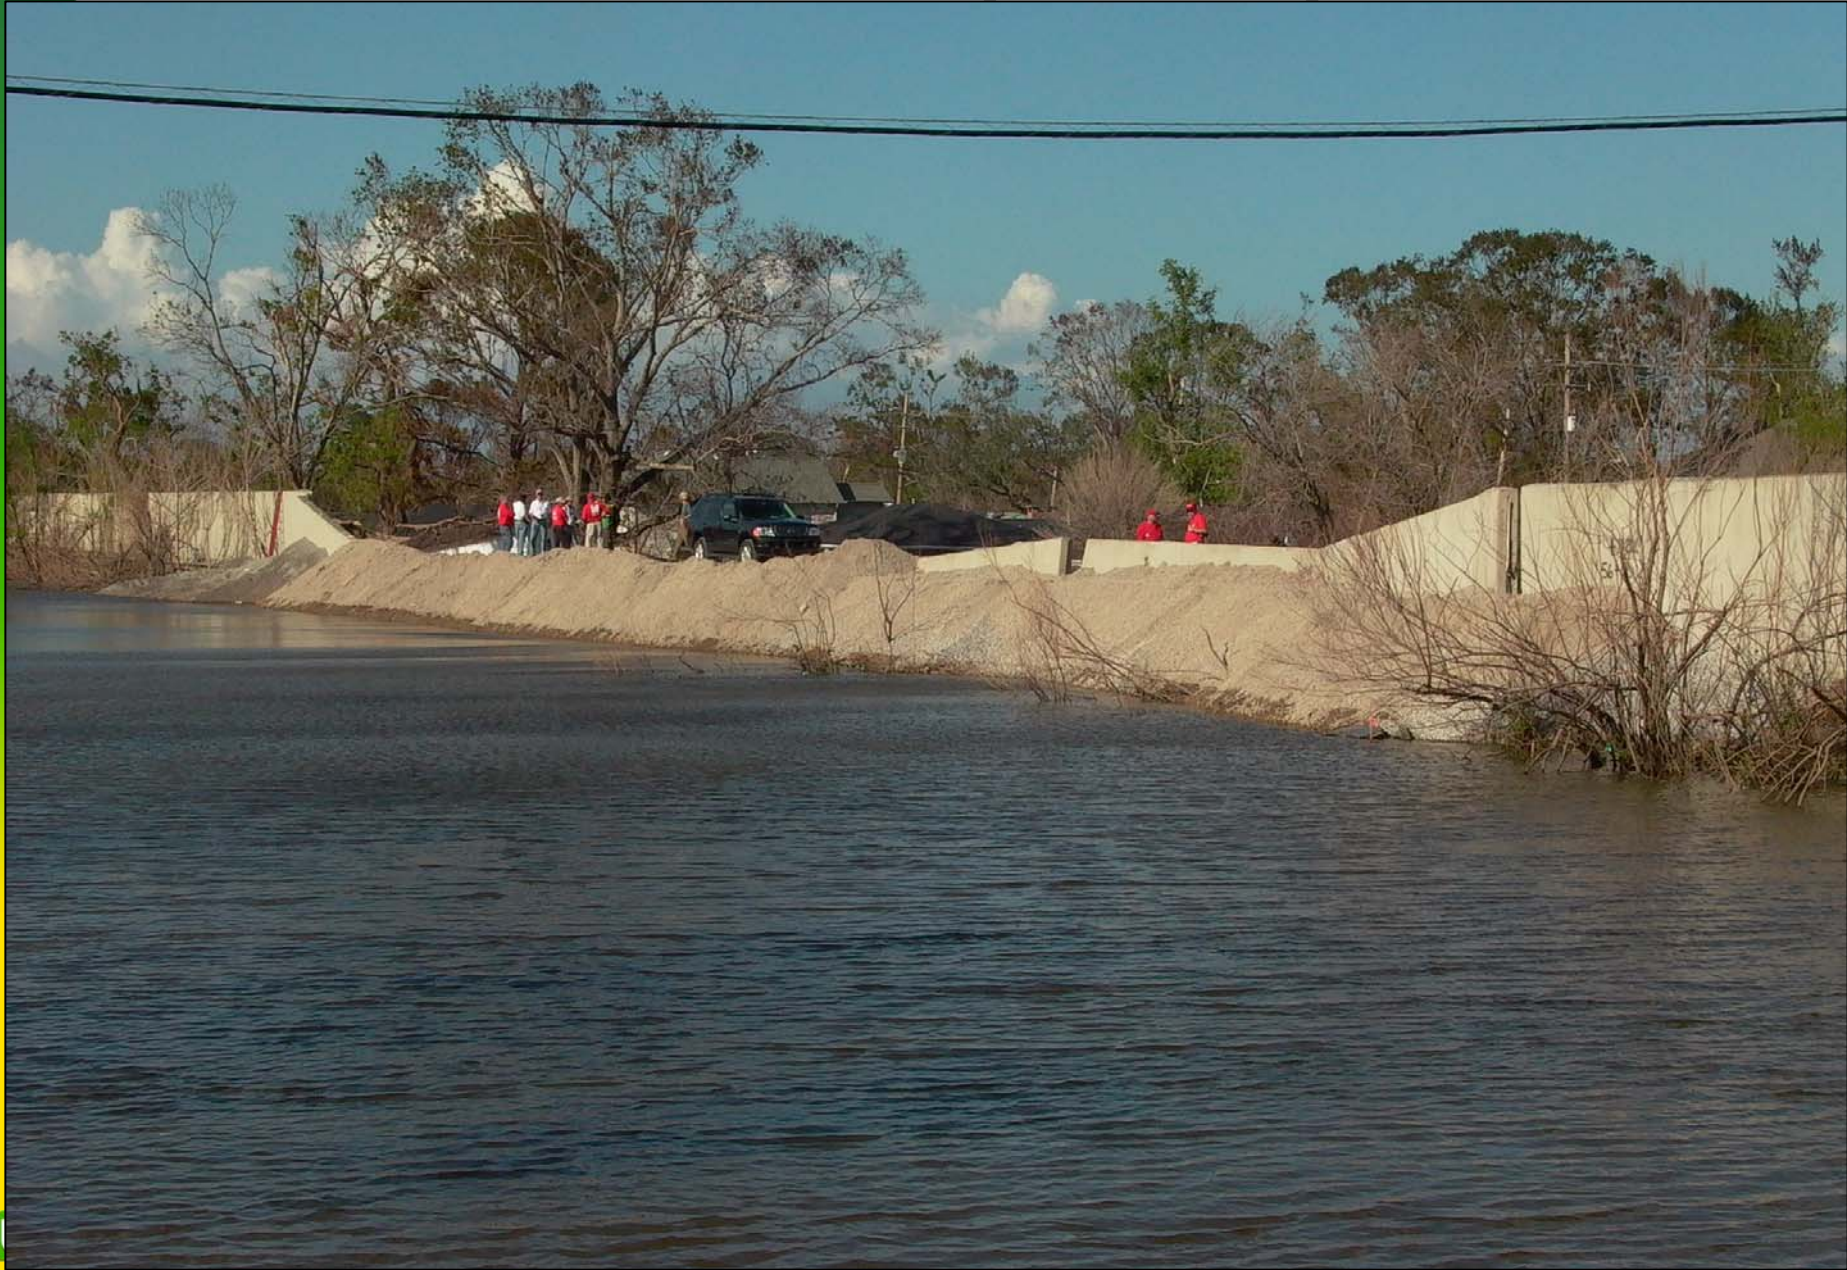
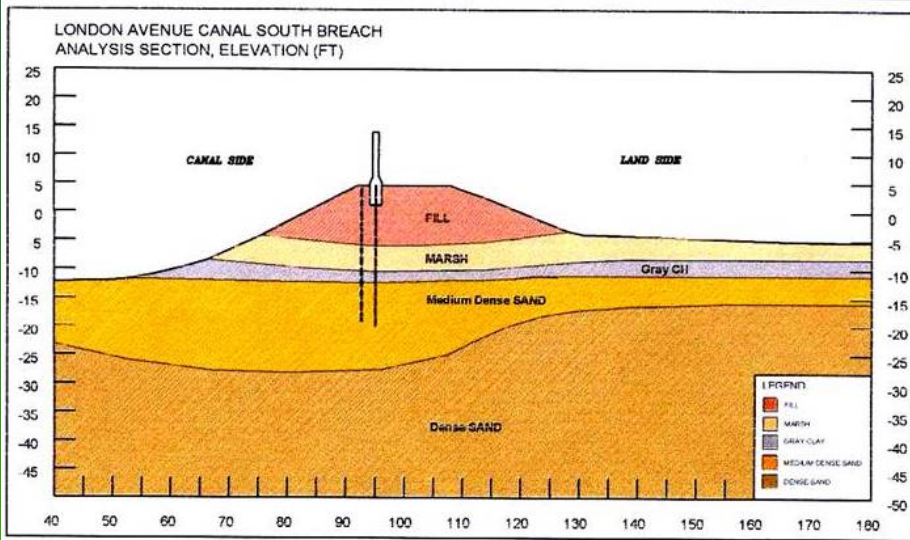
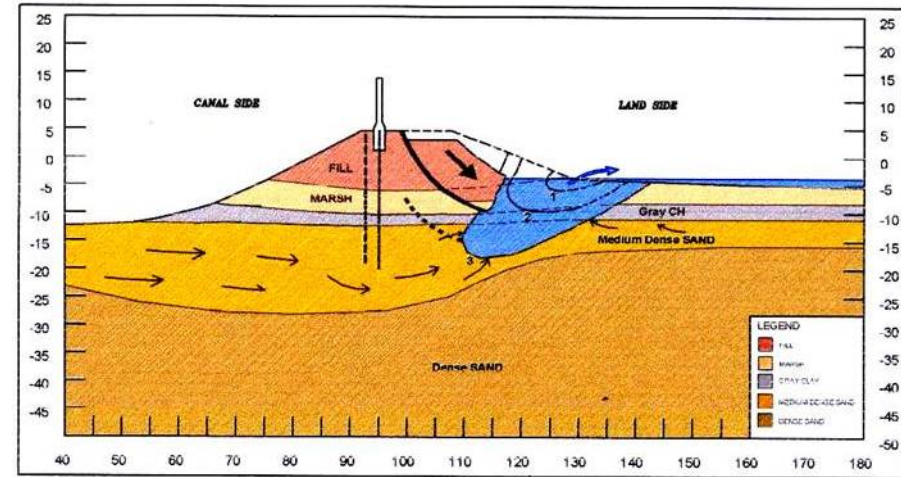
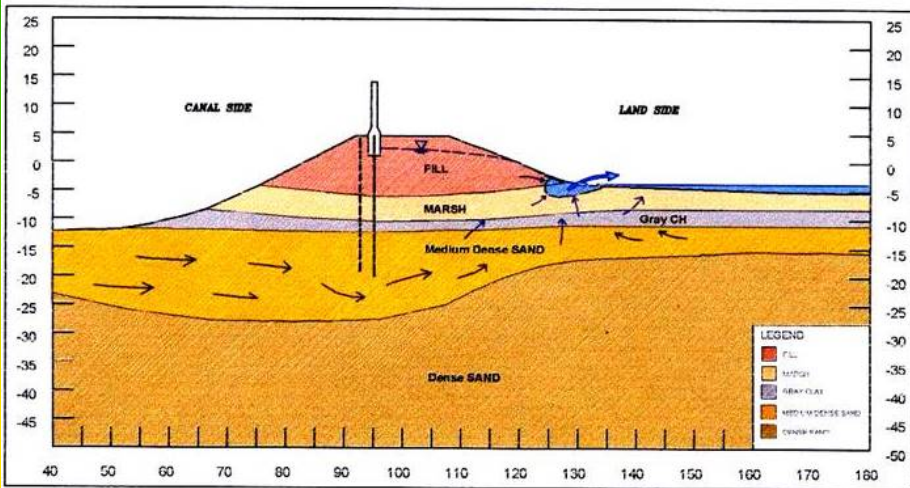
London Avenue (South) breach

The South Breach of the London Avenue Canal was caused by **excess seepage pressures** developed in the sand underlying the canal, which had been dredged
