SITE CHARACTERIZATION AND FAILURE MODELS FOR THE PATERNO et al vs STATE OF CALIFORNIA FLOOD CASE

J. David Rogers, Ph.D., P.E., P.G.

Richard L. Meehan, P.E., G.E.

2007 Annual Meeting

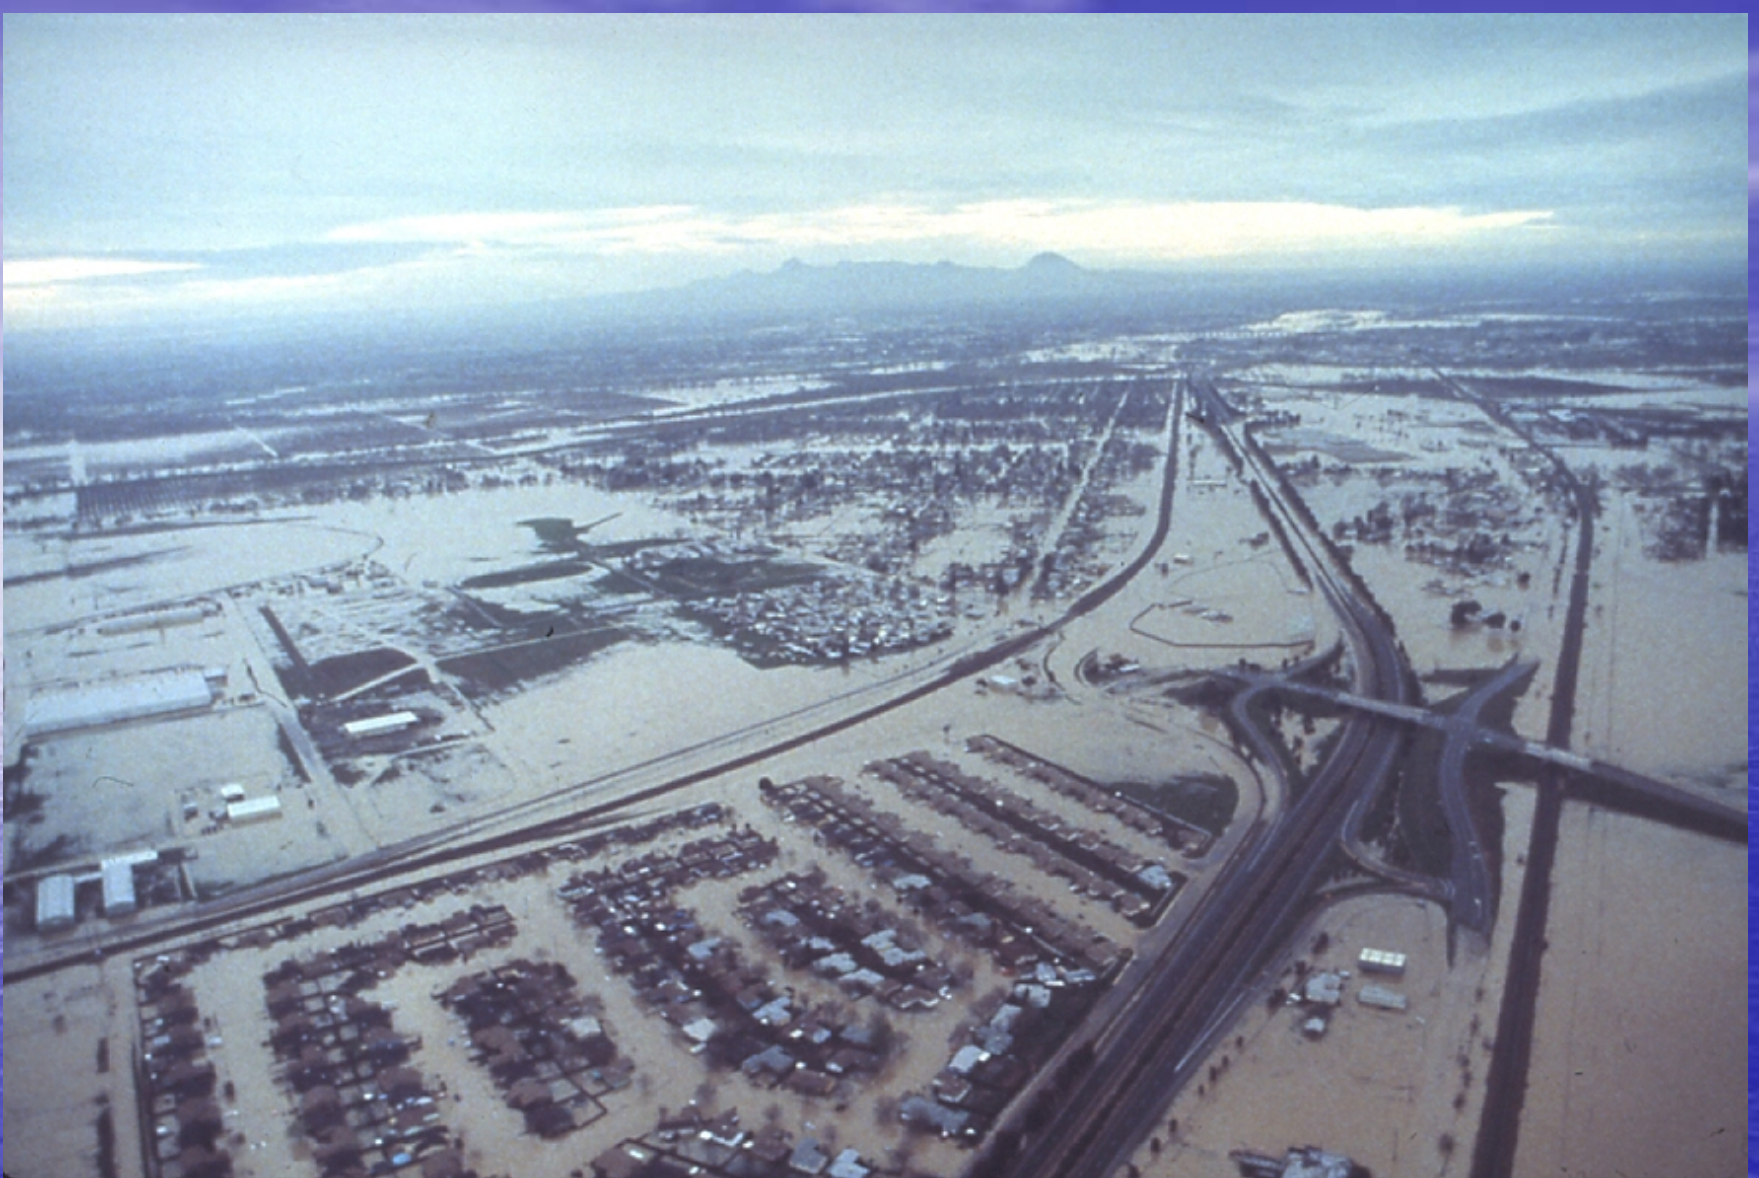
- Around 6 PM on February 20, 1986 the Linda Levee on the south side of the Yuba River, about half a mile above its mouth, suddenly disintegrated.

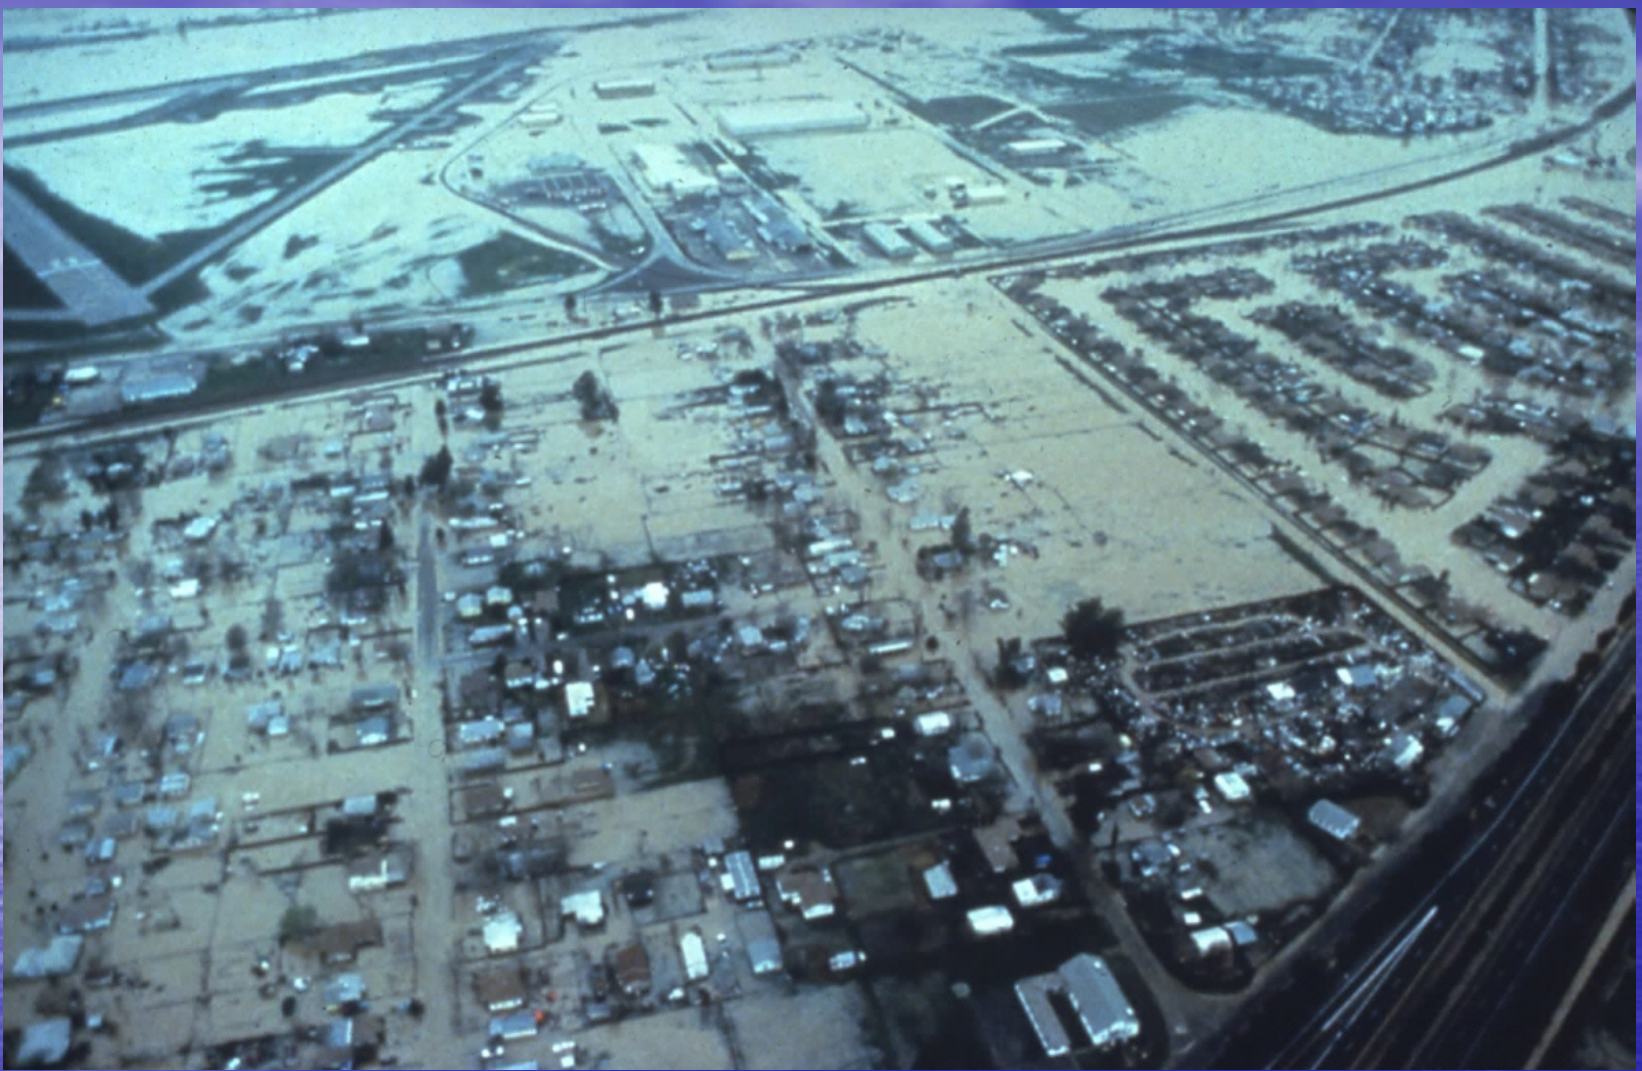
- The flooding spread through the area, inundating the communities of Linda and Olivehurst, causing >\$1.5 billion damage.

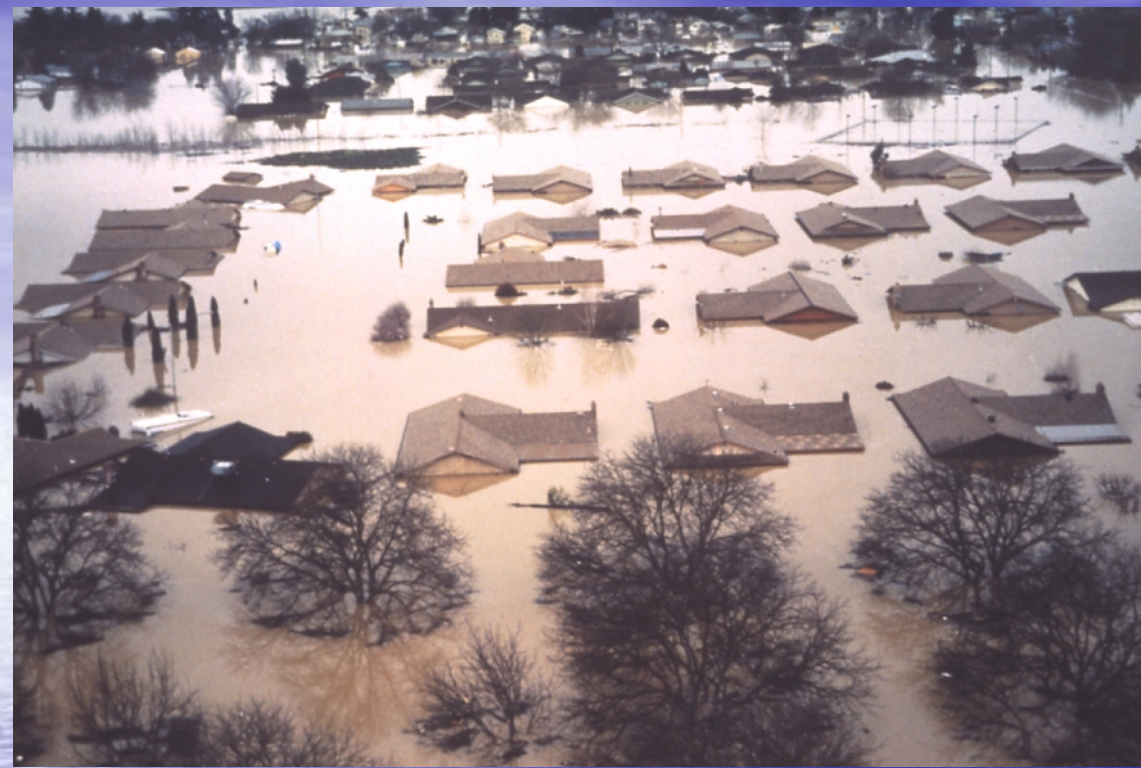
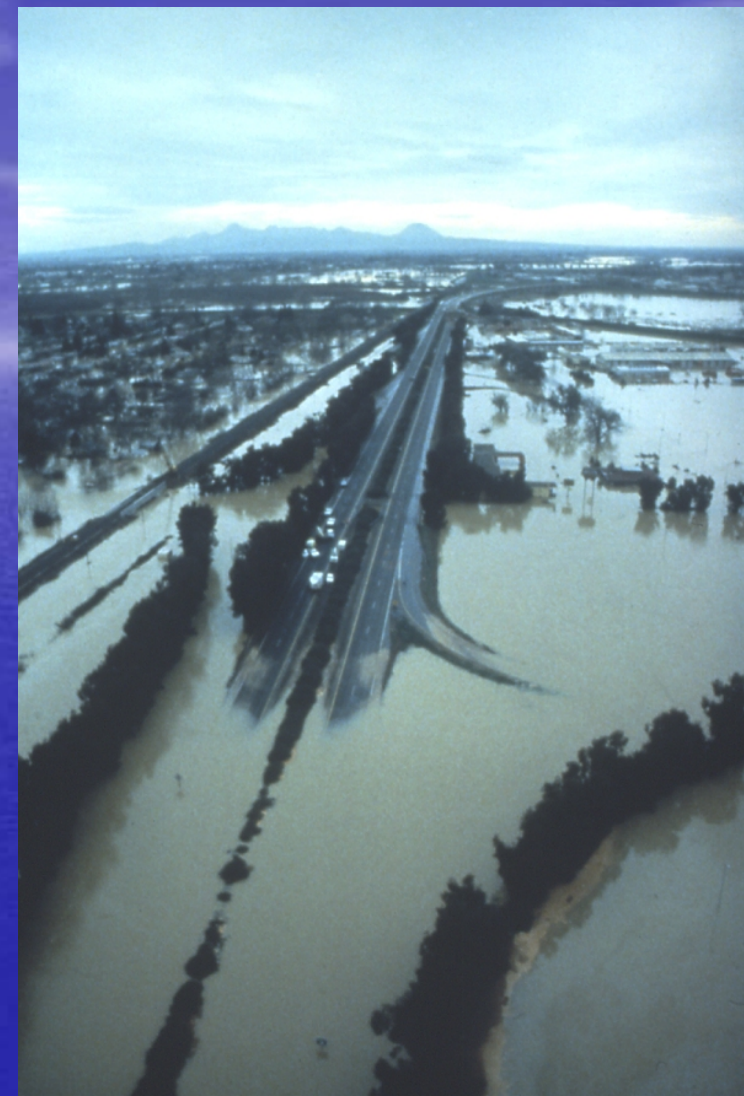
- Entire neighborhoods were flooded, and relief efforts were complicated by the loss of Highway 70, shown here, which is the main access corridor serving the area.

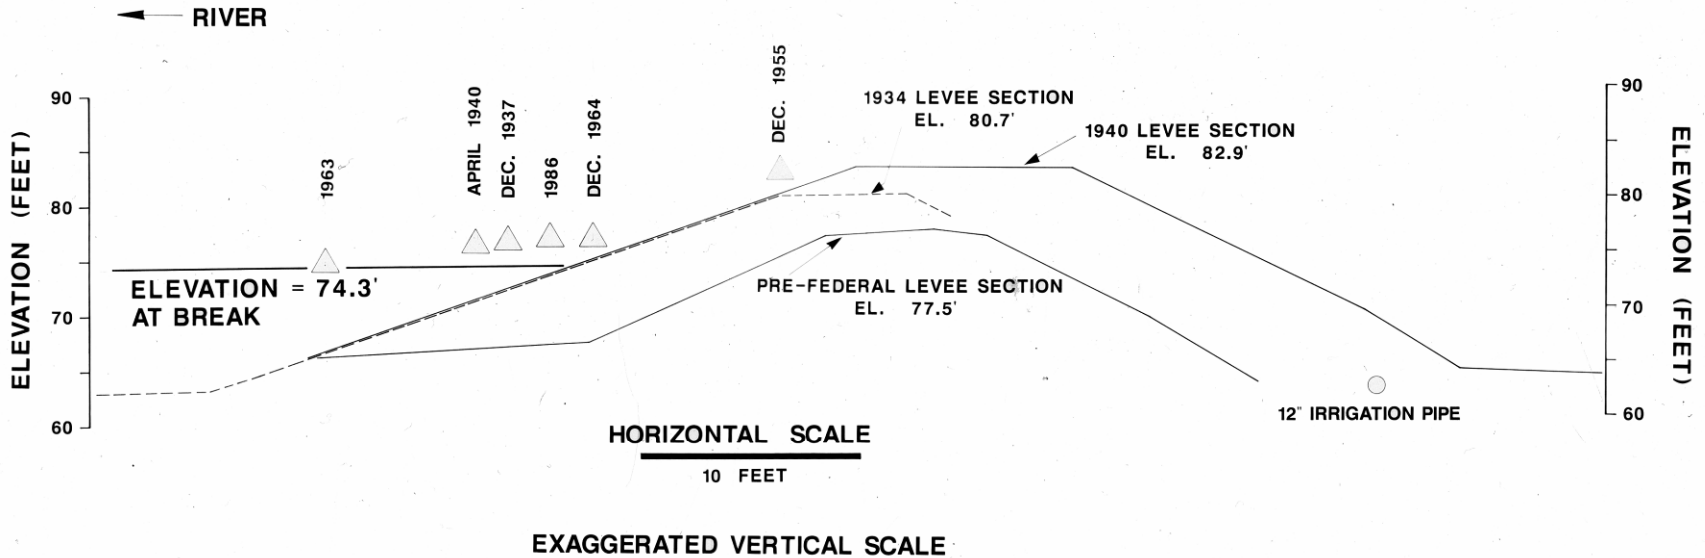
HISTORIC LEVEE SECTIONS

- The February 20th failure occurred *after* the flood had crested, 9 feet *below* the levee crown.

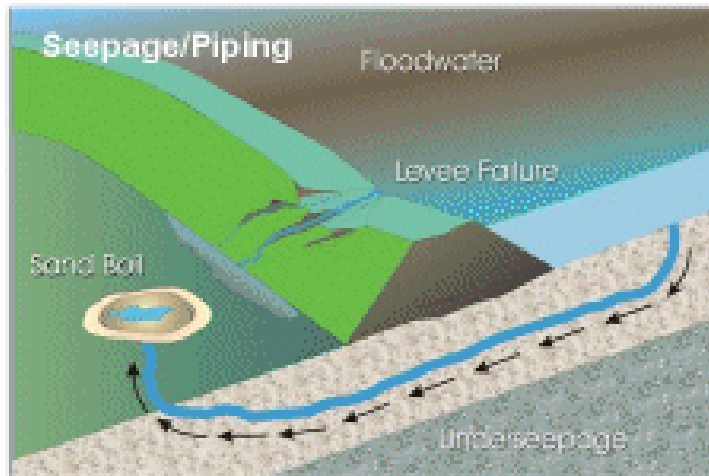
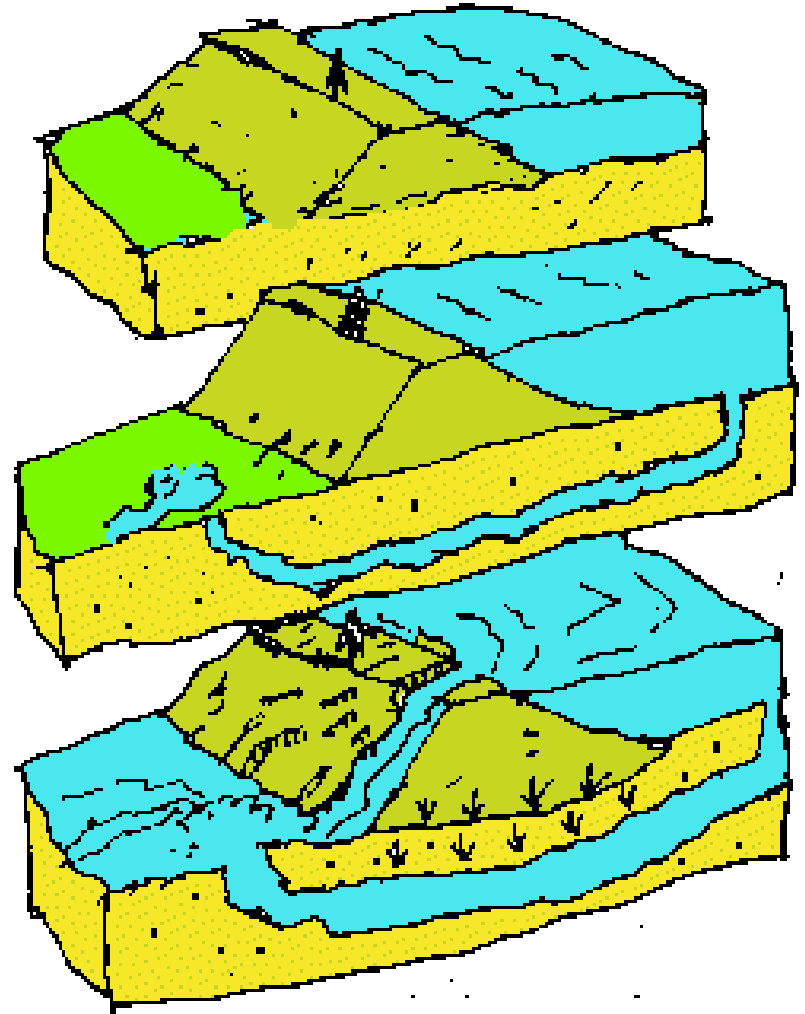
- The precise mode of failure remained a major mystery. Eyewitness accounts described “bubbling” near the levee toe, followed by the land-side of the levee “disintegrating” and “falling into a hole”. The failure was catastrophic.

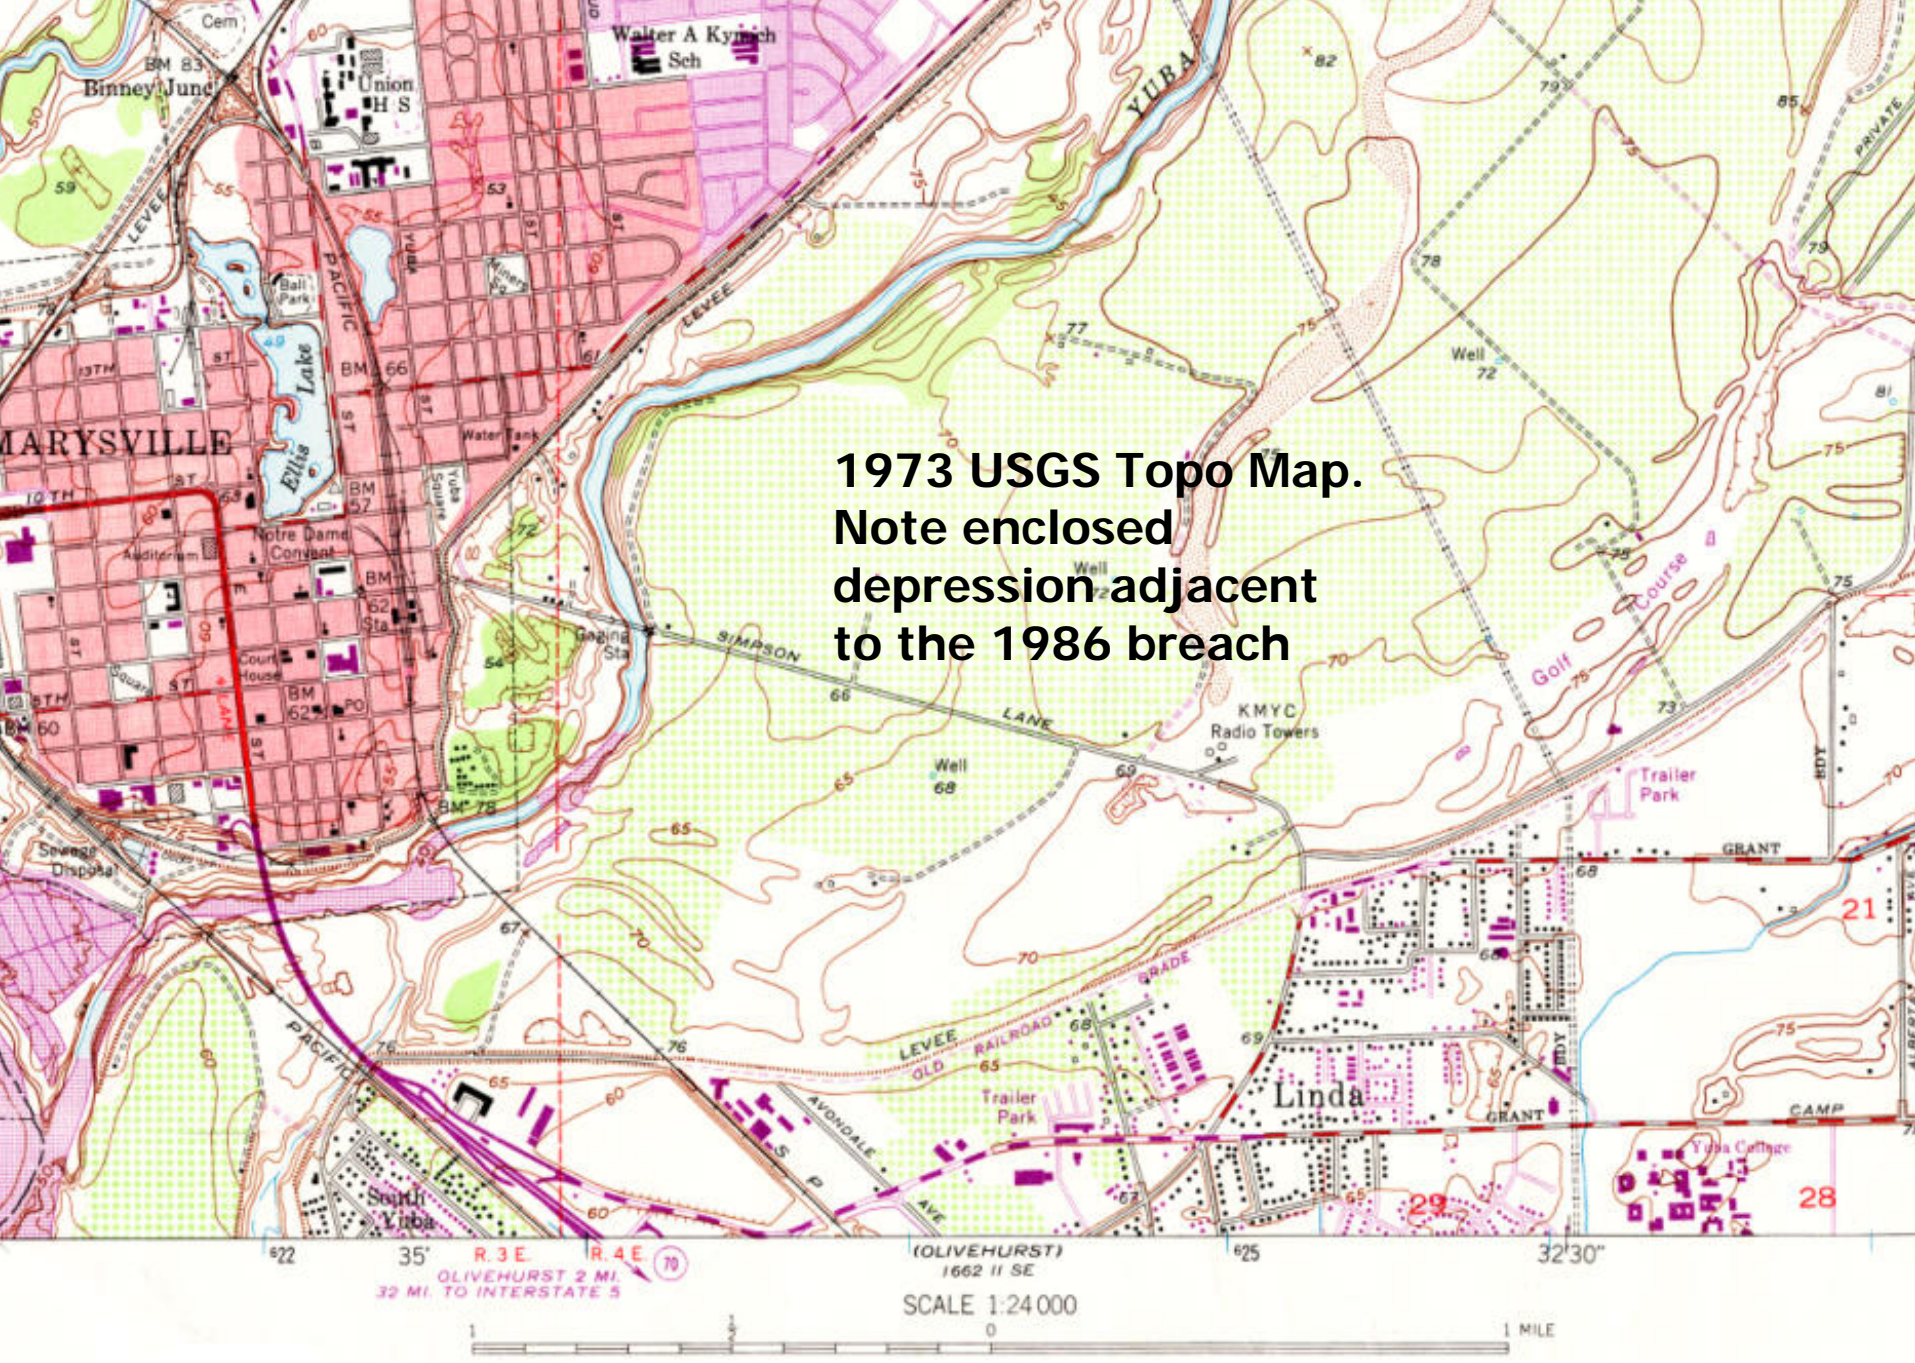
1973 USGS Topo Map.
Note enclosed
depression adjacent
to the 1986 breach

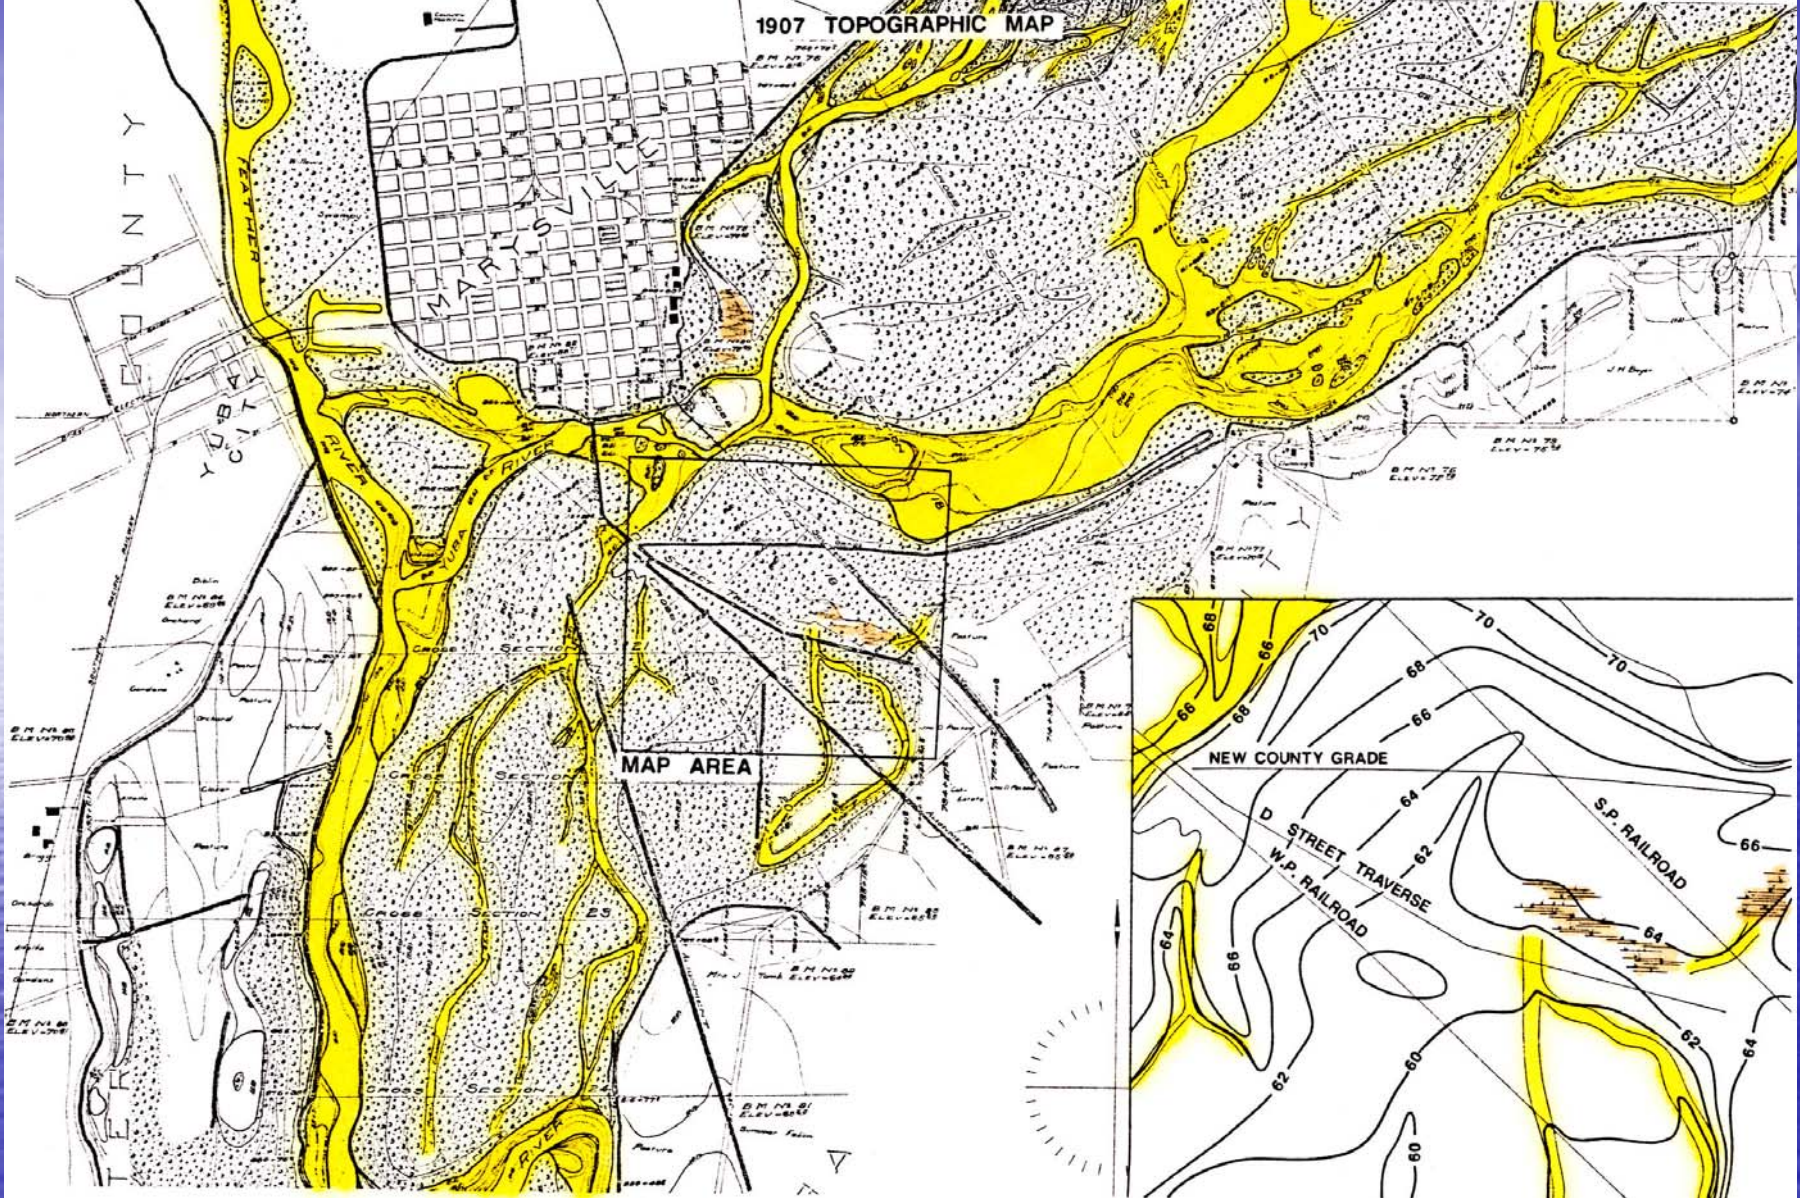
- This is a map of the lower Yuba River prepared by the California Debris Commission in 1907. Inset shows 1986 breach area. Note contours of small swale, coinciding with location of breach.

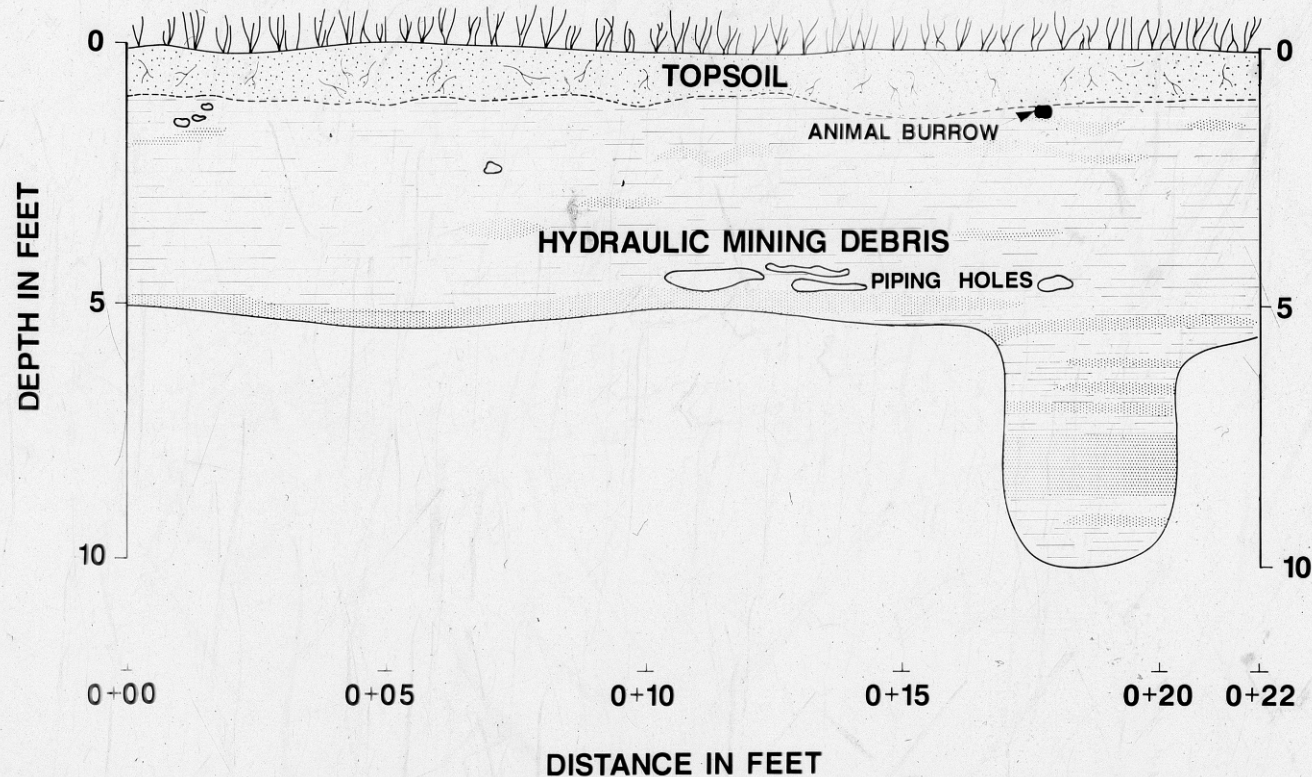
EROSION GULLEY WALL LOG

- Our subsurface exploration commenced with a series of trenches along the bounding walls of the channel scoured by the breach outflow. There was some evidence of piping holes at a depth of ~5 feet.

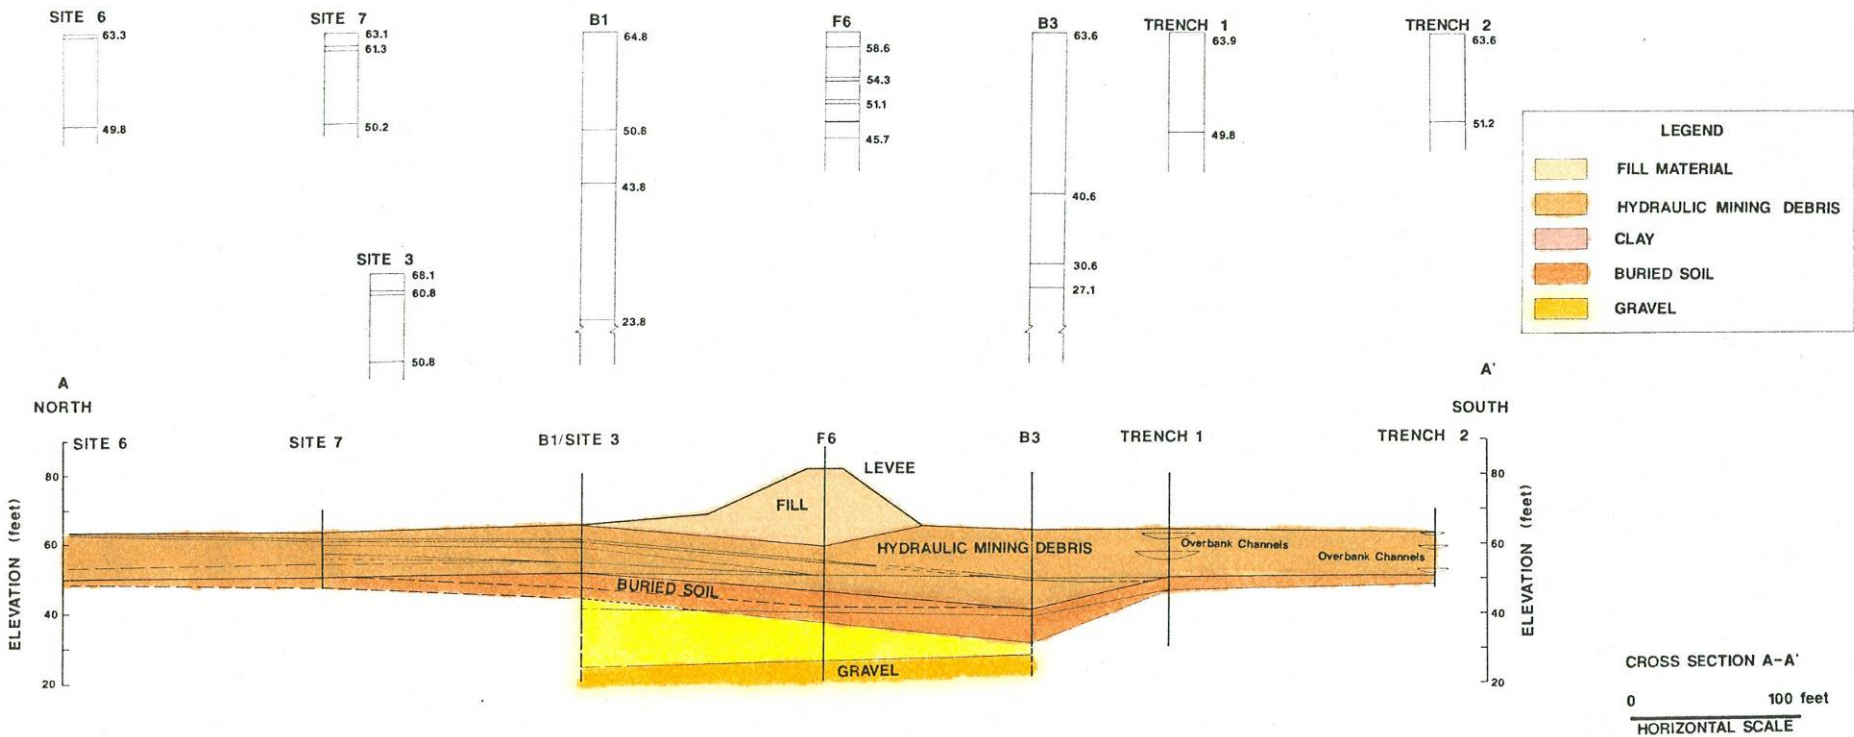
- Preliminary Section A-A' highlighted what might be a serious problem: highly conductive channels feeding *upward*, into a lower permeability cap, deposited in previous overflow channels.
- This is a classic "leaky aquifer" condition.

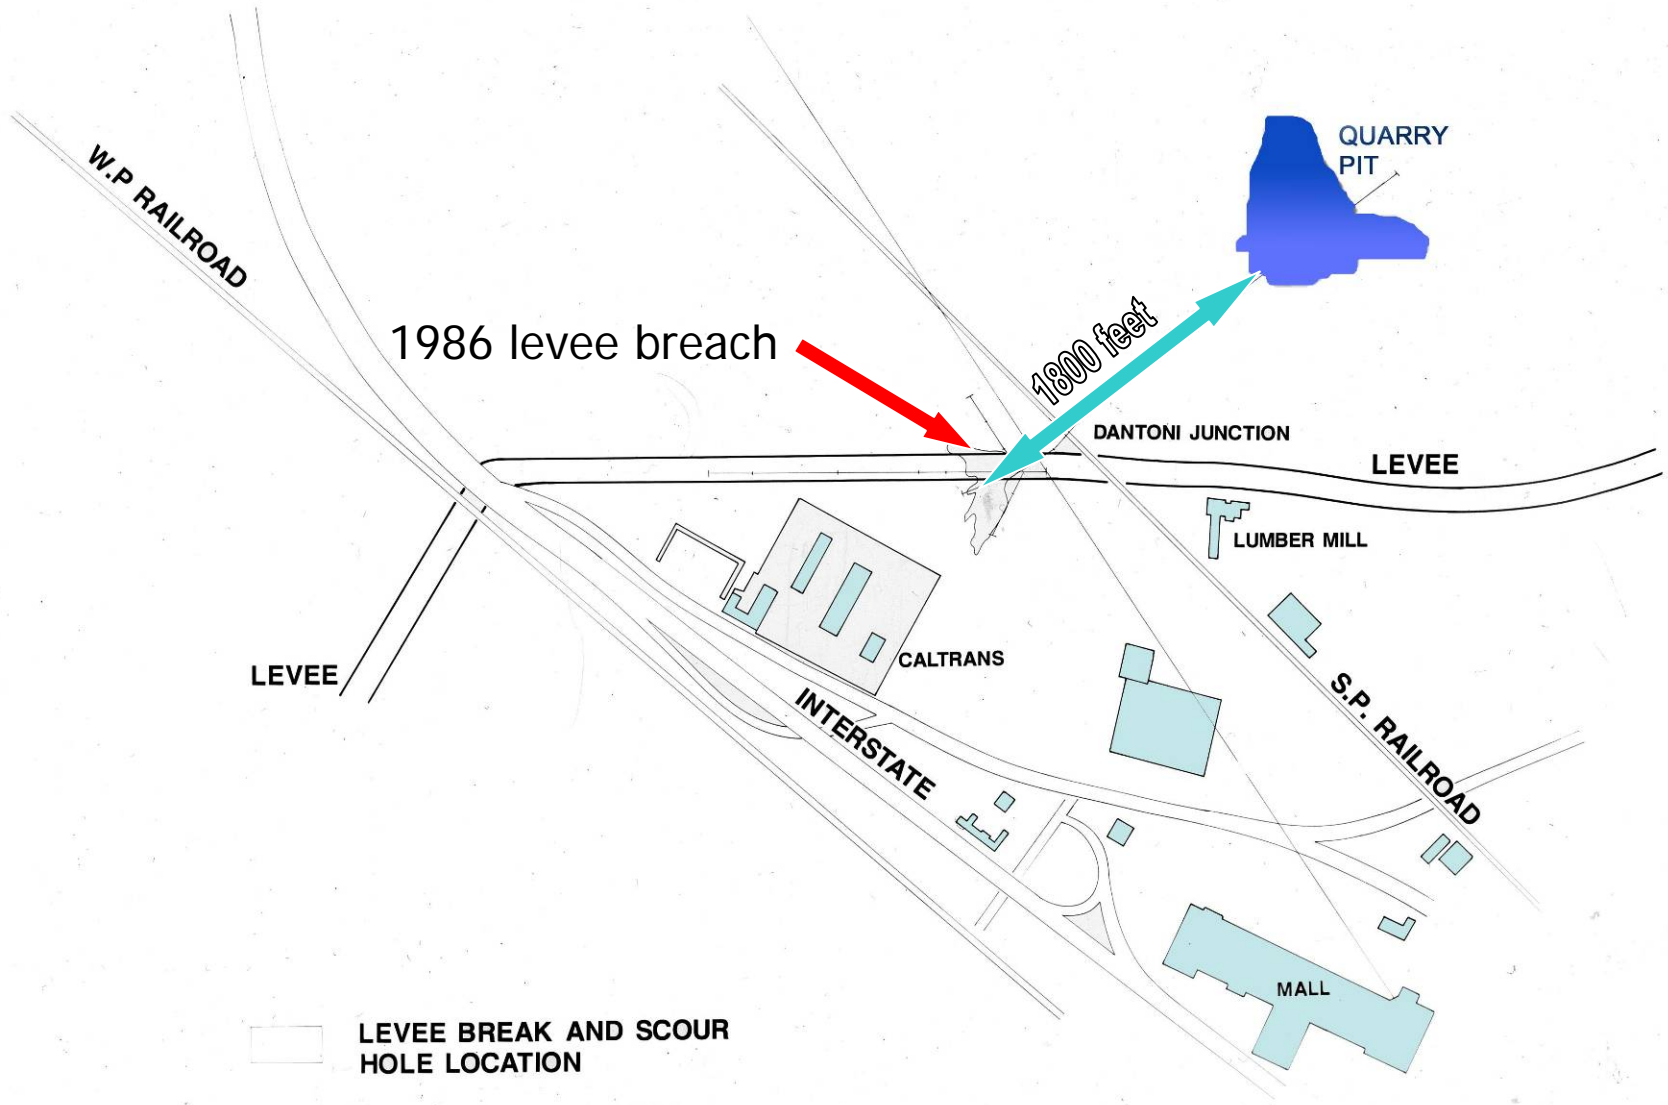
1986 levee breach

- A pump test of the well on the Dhillon Orchard close to the 1986 breach revealed a hydraulic conductivity, $k = 0.2 \text{ cm/sec}$
- This would correspond to 23.6 ft/hr, and 567 ft/day
- Under 15 ft of driving head, the wetting front could have reached the land side of the levee breach area in 3.2 days.
- The breach suddenly occurred 7.5 days after flood stage brought water up against the levee

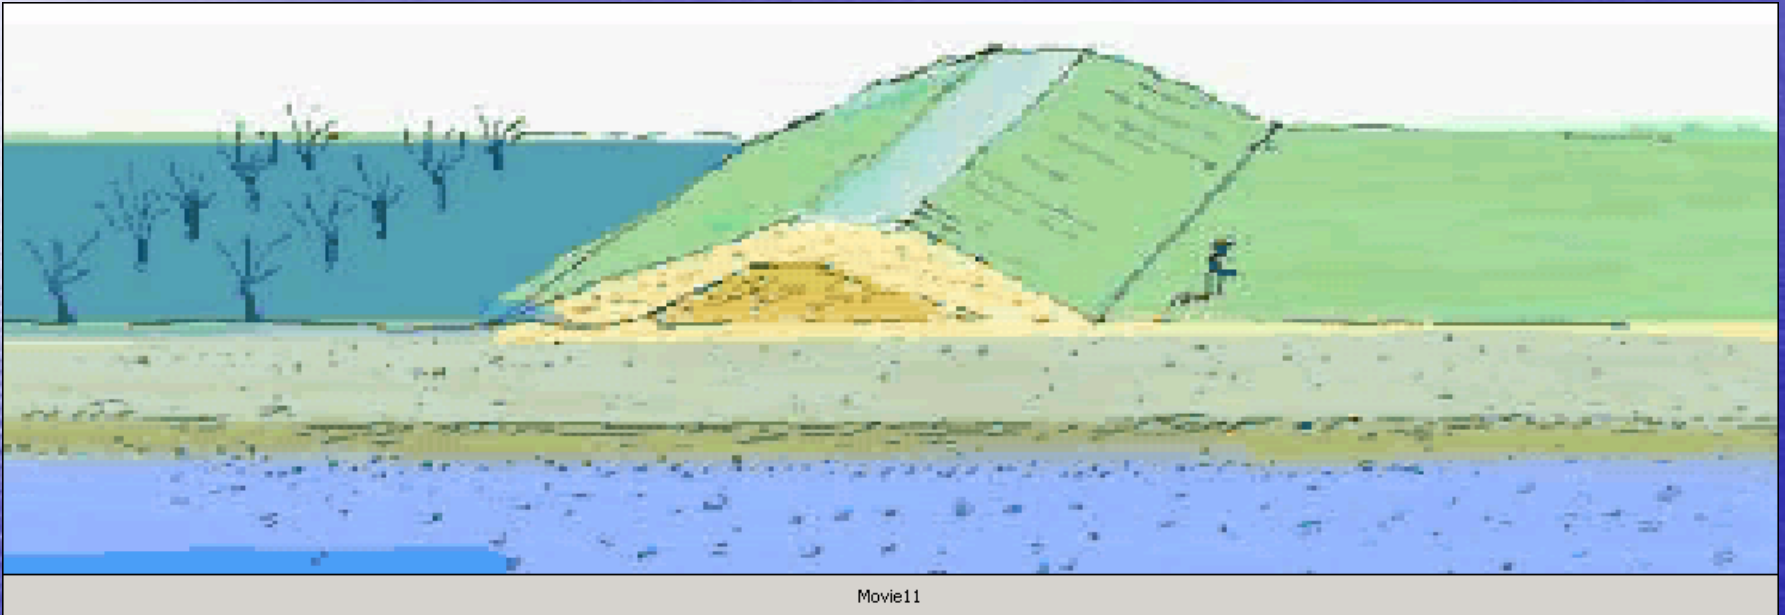
Three wetting fronts assail the levee simultaneously
