**GROUNDWATER CONTAMINATION AND SINKHOLE COLLAPSE
INDUCED BY LEAKY IMPOUNDMENTS
IN SOLUBLE ROCK TERRAIN**

By Thomas J. Aley
James H. Williams
James W. Massello

MISSOURI GEOLOGICAL SURVEY AND WATER RESOURCES

Aley, Thomas J., James H. Williams and James W. Massello, 1972, Groundwater contamination and sinkhole collapse induced by leaky impoundments in soluble rock terrain: Mo. Geol. Survey and Water Resources, Engineering Geology Series No. 5, 40 p., 10 figs., 1 tbl.

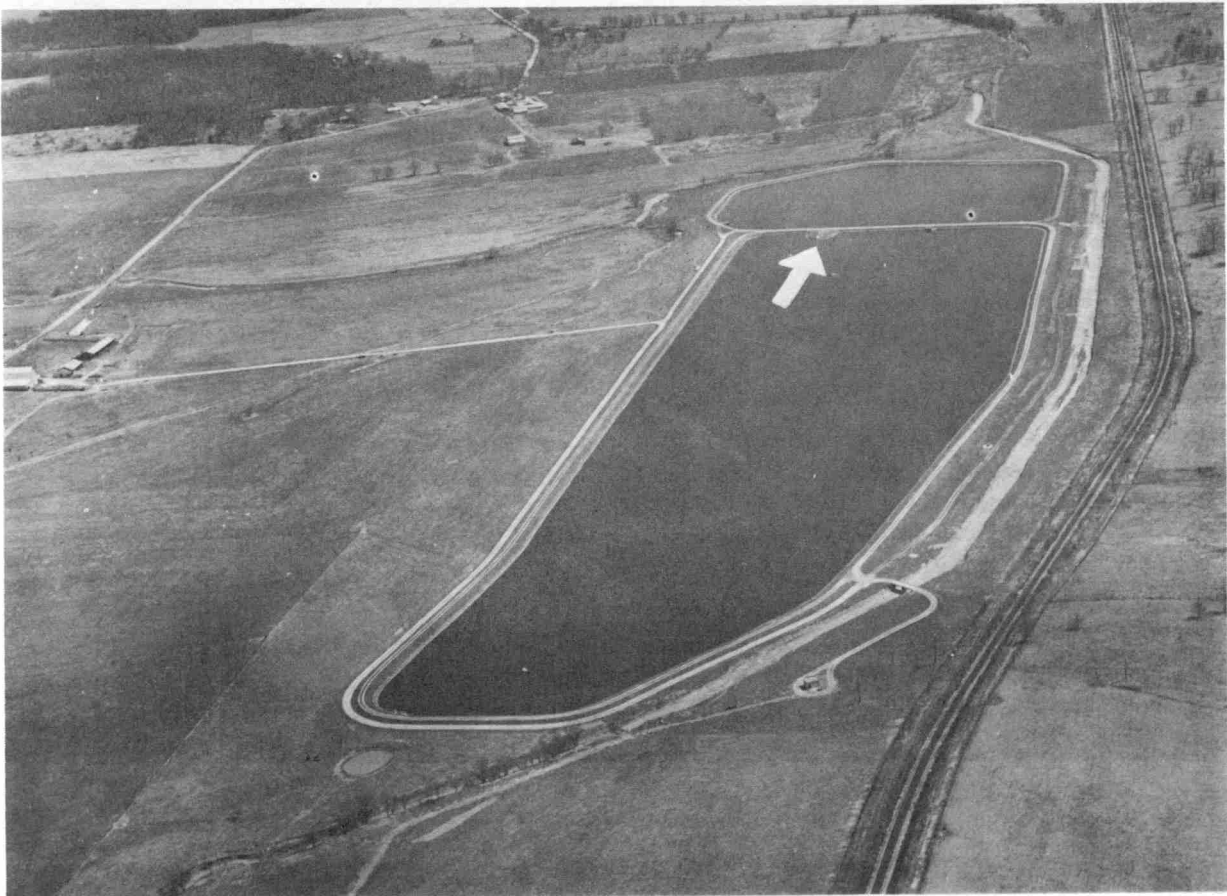
Figure 2

Collapse within sewage lagoons has also occurred at West Plains, Howell County, Missouri (fig. 2). The

Aerial view of the West Plains sewage lagoon as it appeared in 1971. The area which collapsed in 1966 is shown by the arrow. Photo by Jerry D. Vineyard.

The lagoon system was constructed in 1964 and reached full operation in 1966. The smaller cell, which occupies about seven acres, collapsed in two points in 1964. The larger of these collapses was about 17 feet in diameter and probably 10 to 20 feet deep; the sinks were plugged with cement, clay, and bentonite and reportedly no longer leak.

about 136 acre-feet of effluent at the time of collapse; all the water drained out within 52 hours. Mr. Pace, City of West Plains, reports that the collapse and leakage created a vortex of such size that he was unwilling to get close to it with a boat. This is hardly surprising; the average leakage rate for the 52 hours was 29 cubic feet per second.

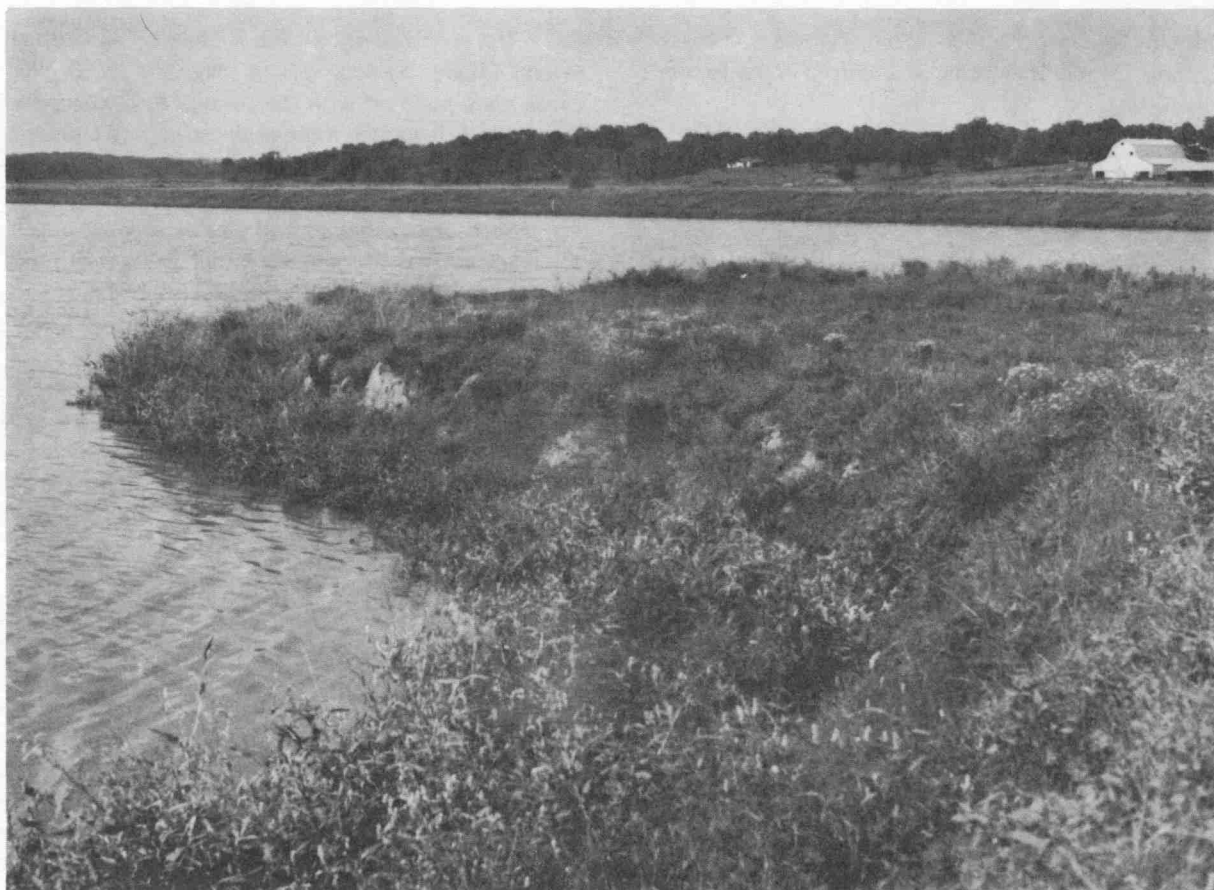
Figure 3

The large cell of the West Plains sewage lagoon. A catastrophic sink occurred in 1966 beneath the peninsula shown in the foreground. Subsequent to the collapse the sink was filled with clay and bentonite and the lagoon was returned to use. Photo by James W. Massello.

The 1966 collapse at the West Plains lagoon was about 34 feet in diameter, and probably 10 to 20 feet deep. This hole was filled with clay and bentonite to the level of the dike wall and the lagoon was returned to use. Mr. Renfrow, formerly Assistant City Engineer of West Plains, reported that he walked about 4 miles of the Howell Creek channel below the lagoon collapse, but found no evidence of lagoon water. There were no reports of well contamination

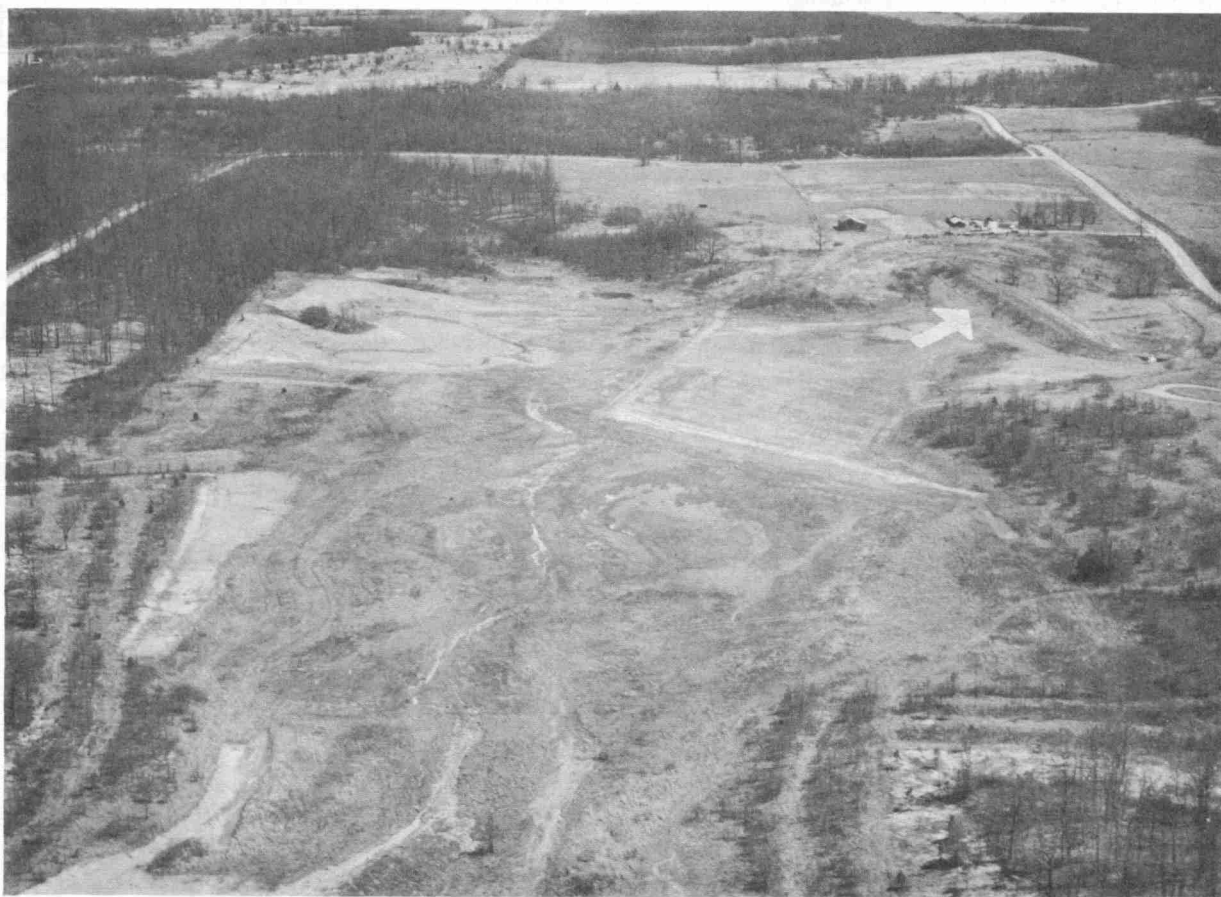
Figure 4

impoundment held a substantial volume of water. Unfortunately, a sinkhole suddenly formed in the floor of the impoundment and drained all the water from the reservoir. Substantial efforts were made to stop the leakage, but they have failed. Personnel of the Missouri Geological Survey report seeing flows of 10 cubic feet per second disappearing underground within the impoundment area.

Aerial view of a portion of the planned impoundment area of the Dean W. Davis Reservoir near Pomona. The arrow indicates the dam. A catastrophic sink formed within 75 yards of the dam and totally drained the impoundment overnight. Extensive attempts to seal the impoundment were unsuccessful. Photo by Jerry D. Vineyard.

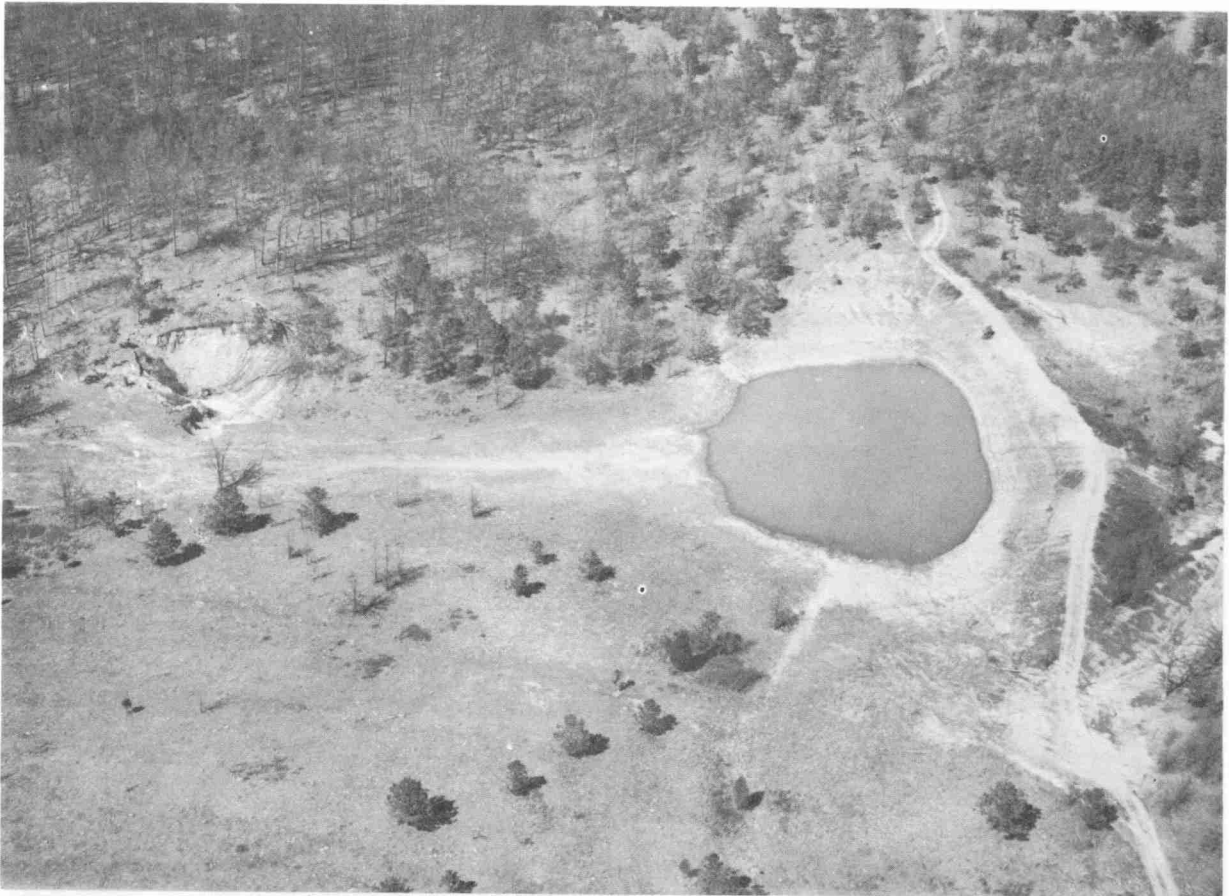
Figure 5

A most spectacular group of collapses induced by construction of an impoundment is found at Norton Dam, 2 miles south of Winona in Sec. 30, T. 27 N., R. 3 W., Shannon County, Missouri (fig. 5). The dam was built on an intermittent stream tributary to Pike Creek. The impoundment site is underlain by deep Roubidoux residuum; there are no bedrock exposures near the impoundment site.

The Norton Dam has been unsuccessful in producing a permanent lake. During storm periods the impoundment will temporarily fill, but the water level falls rapidly to about the original stream

Aerial view of Norton Dam and a portion of the impoundment area. The largest of the four catastrophic sinkholes induced by this impoundment is shown above, in the left-center of the photo. The other three sinkholes lie upstream of the area pictured. Photo by Jerry D. Vineyard.

We are convinced that the Norton impoundment led to the formation of the sinks. The dam has had four effects on water regimens in the valley. The first effect has been to spread flood water over the entire valley floor. The second effect, since the impoundment site leaks, is to induce recharge of groundwater from the impoundment area. This recharge tends to be localized in the more permeable areas, which in turn tends to move fine materials into underlying solution channels and voids. The third effect of the dam has been to make the residuum in

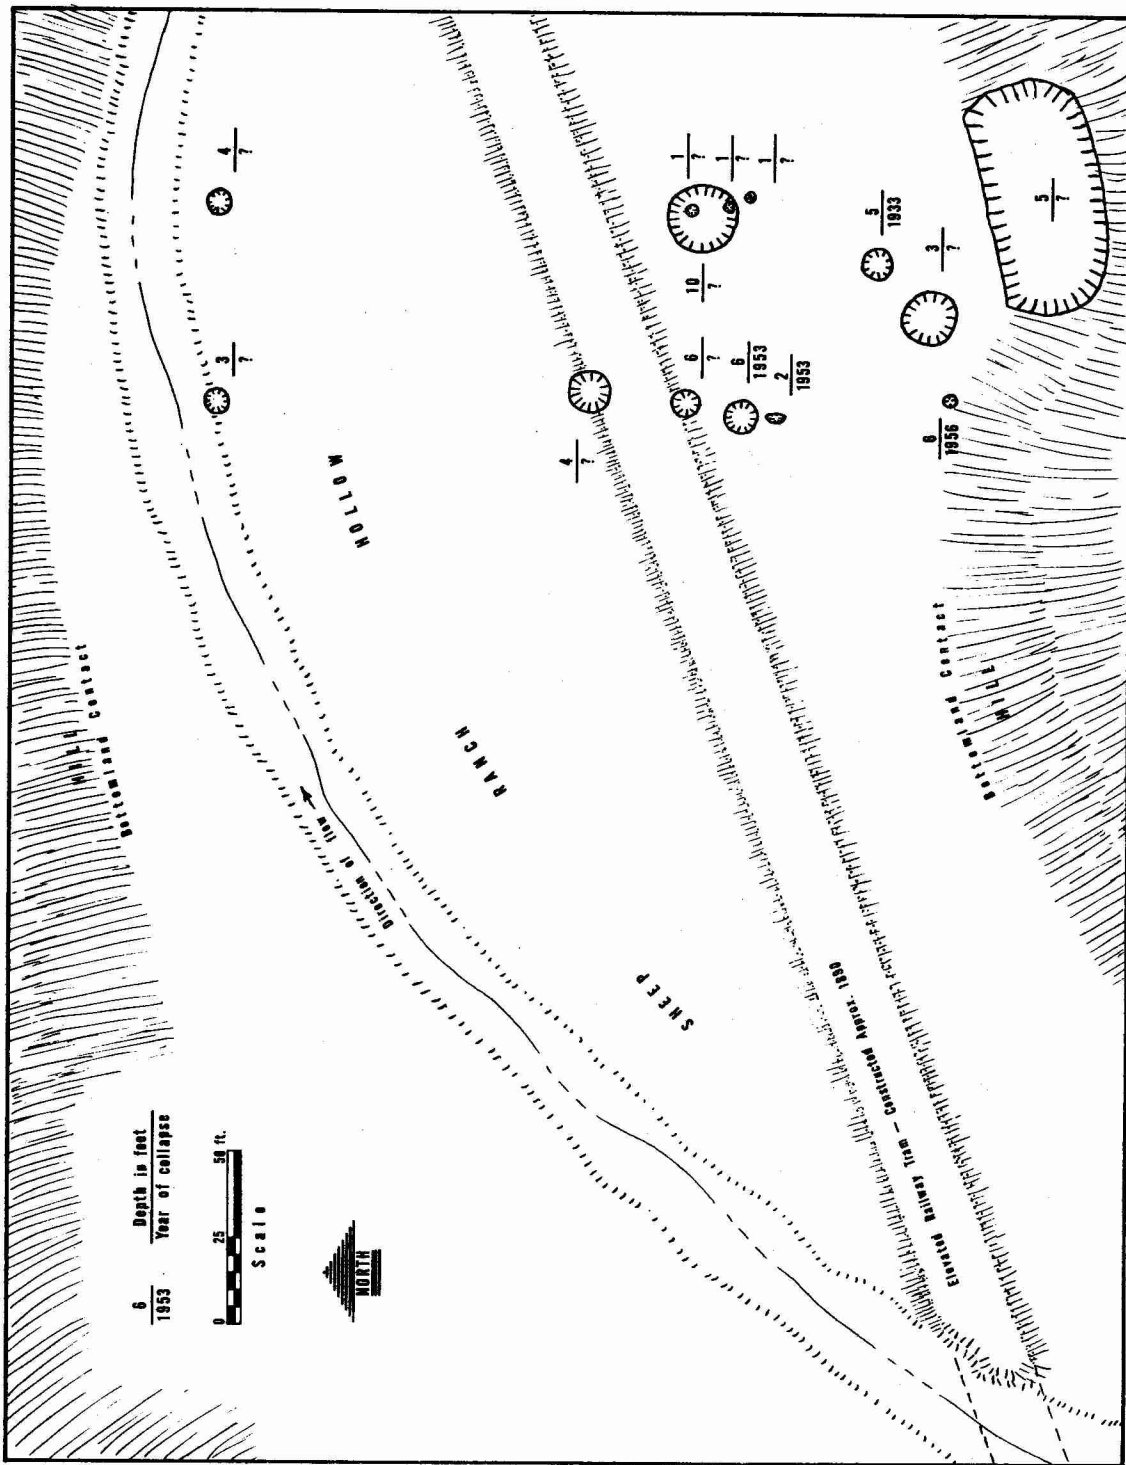
Figure 6

The catastrophic sinkhole collapses which have occurred in Sheep Ranch Hollow (fig. 6) provide an

Sinkhole collapses in Sheep Ranch Hollow induced by construction of a logging tramway in about 1890. Sinkhole sizes were measured in January 1971. (Illustration courtesy of Mark Twain National Forest)

The sinks are found in two clusters within a ten-acre area. The illustration (fig. 6) shows only the downstream cluster consisting of 13 sinks of recent origin. The upstream cluster includes five recent sinks. Not all of the sinks formed immediately after construction of the tramway. One formed in 1933, two

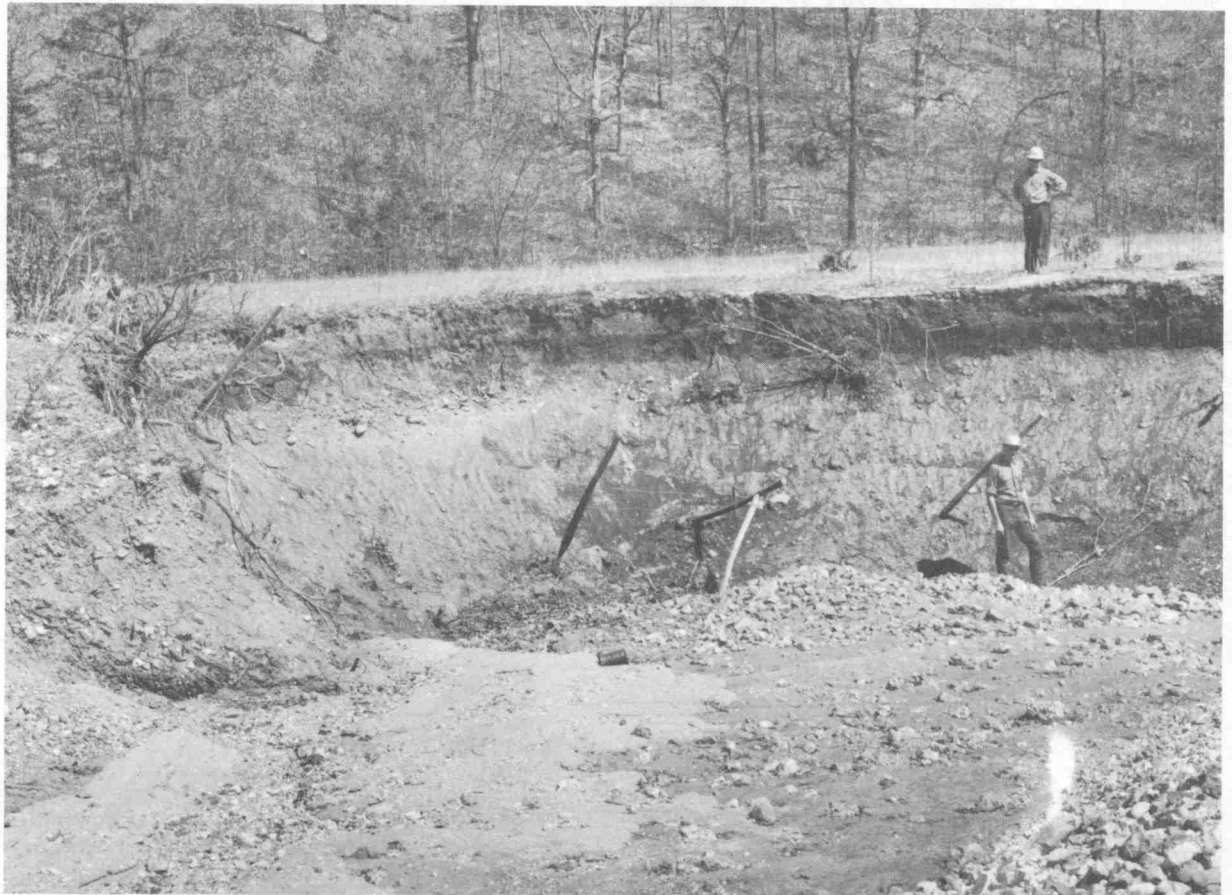
Figure 8

The sink was visited about two weeks after it formed, and at that time it was about 25 feet in diameter, 60 feet deep, and nearly cylindrical in shape. By 1968 (fig. 8) stream gravels had nearly filled the sink; in a few years most, if not all, of the topographic expression of the sink will have disappeared.

Sycamore Creek Sink two years after its formation. The sinkhole has been nearly filled with sand and gravel transported by Sycamore Creek. Photo by James W. Massello.

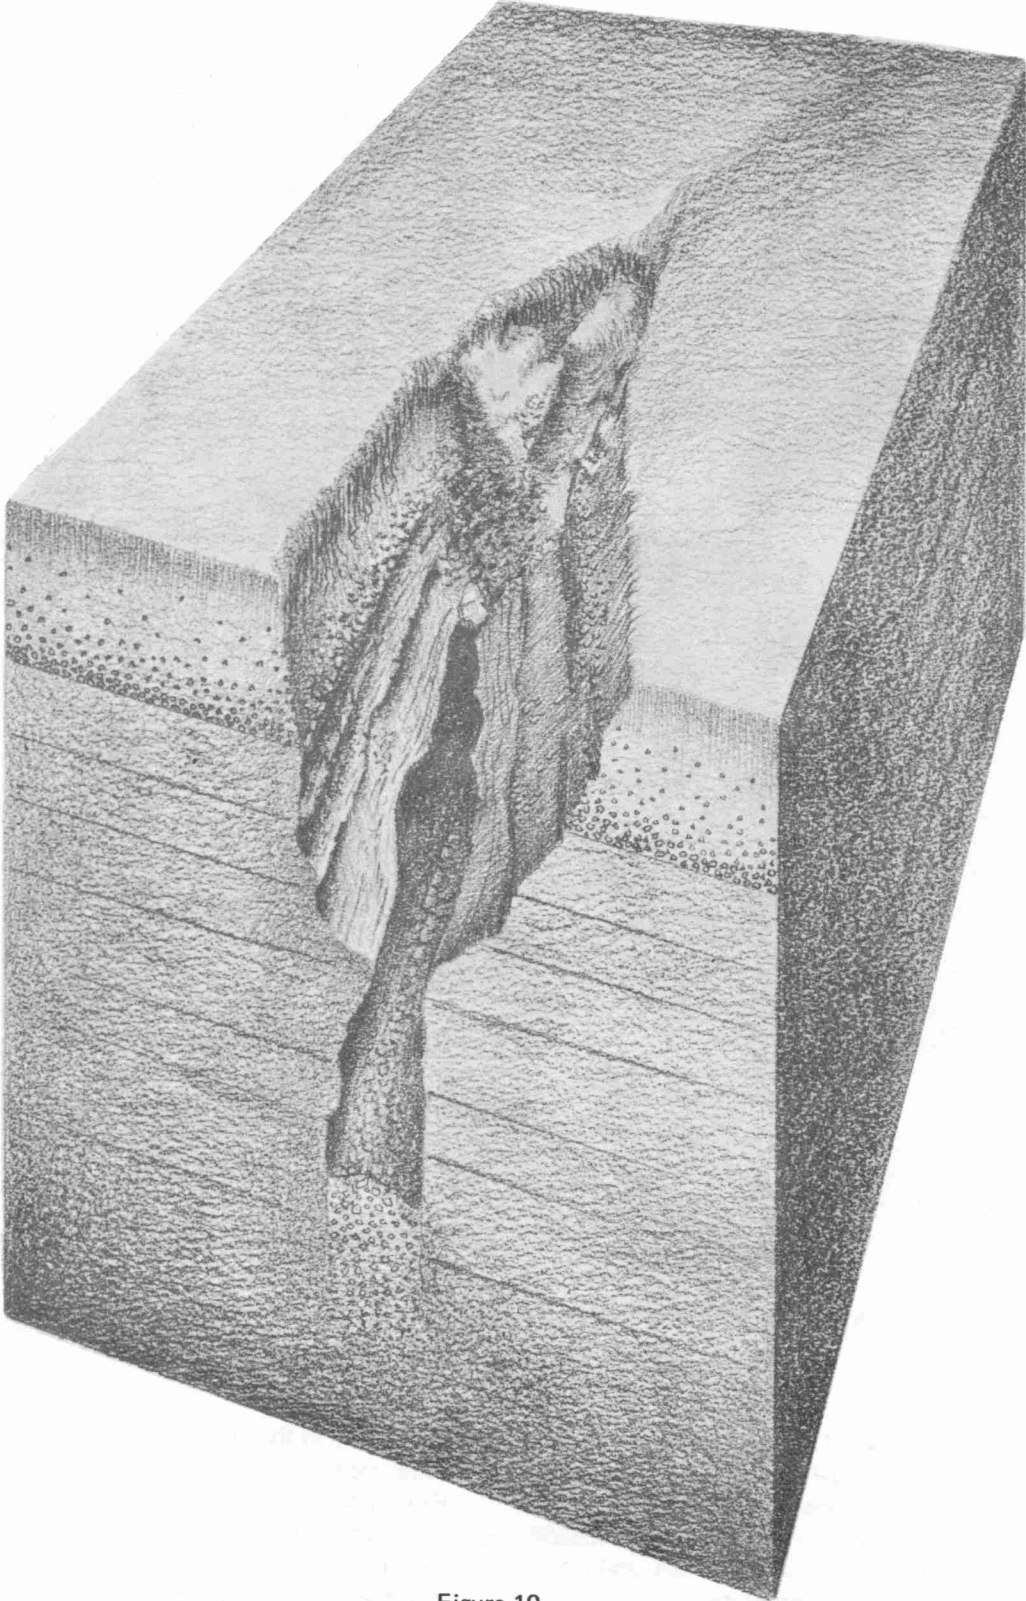
Figure 10

A third example of sinkhole collapse apparently unrelated to man's activities is the Racetrack Ridge collapse near Rueter, Taney County, Missouri, in Sec. 8, T. 22 N., R. 17 W. The sink formed in the 1960's and is about 80 feet long, 40 feet wide, and 60 feet deep. Its orientation is identical with the trend of the losing stream beneath which it has formed (fig. 10). The sink is in an area with shallow soils and numerous rock outcrops assigned to the Jefferson City-Cotter

formation; in this regard it differs from most of our other case histories, with the exception of those at Farmington. Although bedrock is exposed on the sides of the sink, there is no bedrock exposed at the ends of the sink. The senior author has explored several caves in the vicinity which also have residuum ceilings. The caves are typically narrow, vertical passages 2 to 20 feet wide and up to 60 feet high. The Racetrack Ridge sink is apparently an unroofed cave of this type.

Racetrack Ridge collapse. This sinkhole was formed by the collapse of residuum into a solutional void in the bedrock. A portion of the original void still exists and can be entered from the bottom of the sink for about 20 feet. Drawing by Douglas R. Stark from photos by Thomas J. Aley.
