OVERVIEW OF THE TAUM SAUK PUMPED STORAGE POWER PLANT UPPER RESERVOIR FAILURE, REYNOLDS COUNTY, MO

J. David Rogers

ABSTRACT

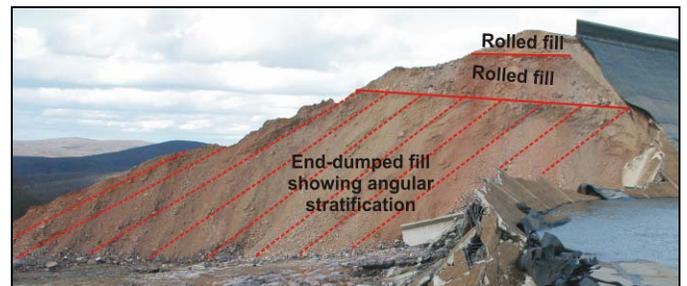
The majority of the upper reservoir's rockfill embankment appears to have been constructed through simple end dumping of the excavated material. The fill was allowed to tumble down the side of the embankment, lying near its natural angle of repose. The embankment materials were not mechanically compacted until the upper 16 feet of fill, which was compacted in four separate 4-foot thick lifts. According to FERC (2006), this was the last uncompacted concrete faced rockfill dam constructed in the United States. The boundaries between the different methods of fill placement were easily observed in the breached section of the embankment after the failure (see Fig. 2).

Fig. 2. – North side of the breached embankment shows the lower three quarters was end-dumped while the upper quarter was placed into two sequences of rolled filling. There does not appear to have been any significant effort made to mechanically compact the embankment because it was assumed to be a clean rockfill.

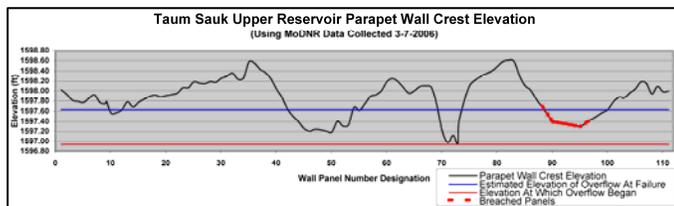
Settlement continued up to the time of failure in December 2005, with differential settlements approaching two feet along the crest of the reservoir's parapet wall (see Fig 3). This differential settlement also led to a cracking of the concrete lining and continual problems with leakage. Leakage became so severe in 1963, only months after operations began, it necessitated shutdown of the facility and additional grouting of the reservoir floor in the northwest portion near where the reservoir failed in 2005 (FERC Independent Panel, 2006).

Fig. 3. – This figure illustrates the differential settlement along the crest of the upper reservoir parapet wall. Four segments of the parapet wall were almost two feet lower than their original elevation. The elevations of the breached panels (shown here in red) were estimated by AmeronUE after the failure and may not be accurate. (Data: MoDNR (2006))

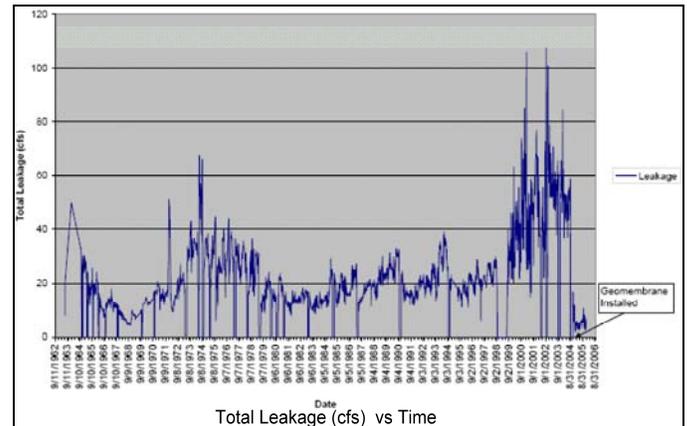
Fig. 4. – This figure from FERC's Independent Panel of Consultants Report (2006) shows a gradual upward trend in leakage rates until it was lined in 2004, dramatically reducing seepage.

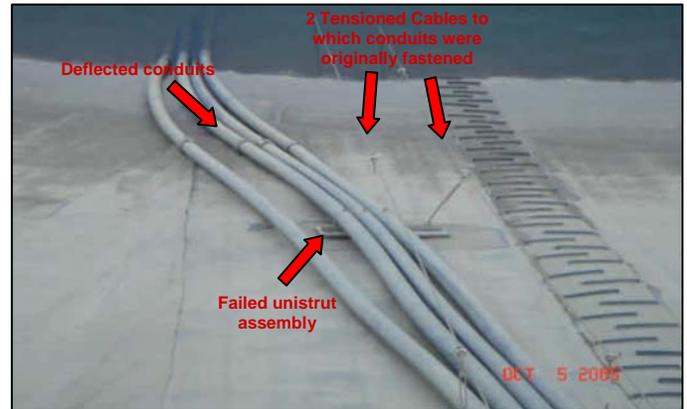
Divers were summoned and they ascertained that the new sensor conduits had become detached from their mountings along the sloping concrete face of the reservoir. Maximum water levels in the reservoir were re-programmed to reduce the operating level by two feet to provide a temporary “margin of error.” Unfortunately, permanent repairs were postponed until regularly-maintenance the following spring (FERC Taum Sauk Investigation Team, 2006) to avoid an additional shutdown of the facility. Fig. 5 shows a Photo taken by AmeronUE on Oct 5th, 2005 when the reservoir pool was drawn down. This shows the sensor conduits have detached from their anchorages.

Fig. 5. – This photo taken on October 5, 2006 by AmeronUE shows the gross deflection of the reservoir’s instrumentation array (photo from Rizzo Associates, 2006).

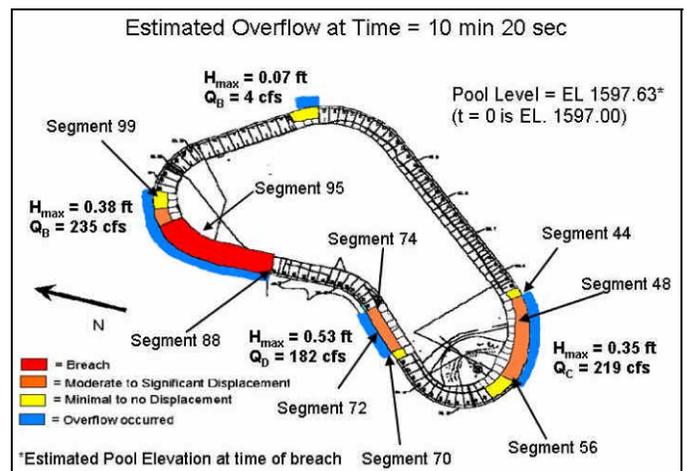
Fig. 6. – This graphic from Rizzo Associates, Inc. (2006) shows panel locations where overflow and failure occurred.

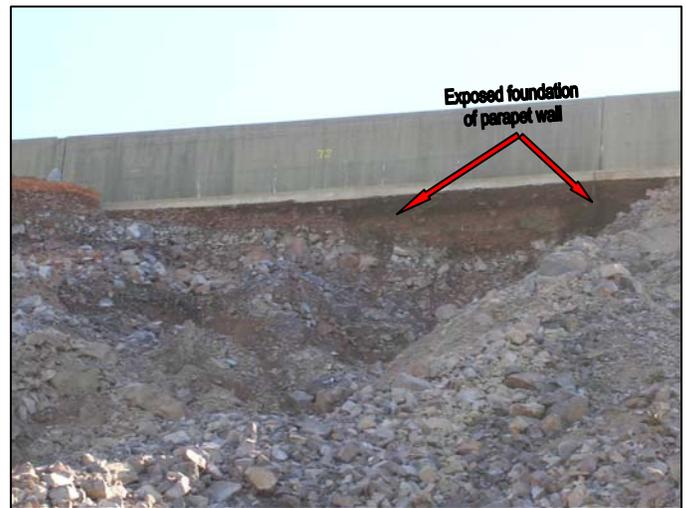
Fig. 7. – This photo taken below panels 71-72 show the deep plunge pool that developed and subsequent undercutting of the parapet wall. (Photo courtesy of David Hoffman).

At 5:15 AM, only six minutes after overtopping is believed to have initiated, the 60-foot long segment near wall panel 95 toppled, unleashing 15 feet of flowing water over the remaining embankment and concrete liner (Figure 7).

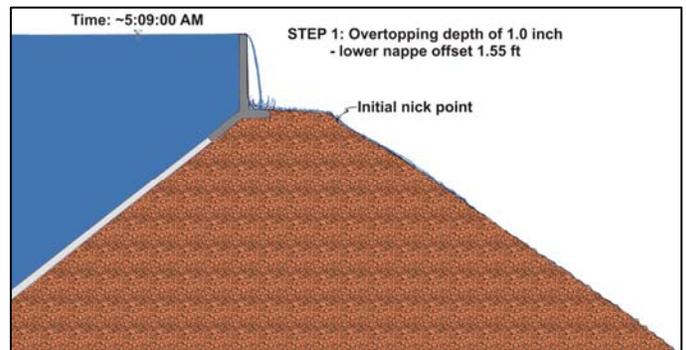
Fig 8. – The first figure from the reconstructed failure sequence shows the initiation of overtopping around 6 minutes prior to failure. Water is spilling onto the 3 foot wide parapet wall footing and just beginning to erode crest of the embankment.

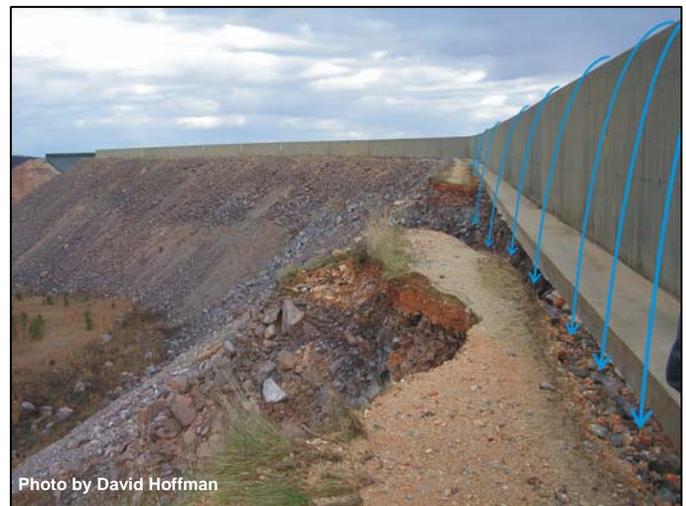
Fig 9. – This photograph shows arrows representing the overflow nappe once it extended beyond the 3 foot wide wall footing and directly onto the underlying rockfill. The rate of scour and erosion increased dramatically once this occurred.

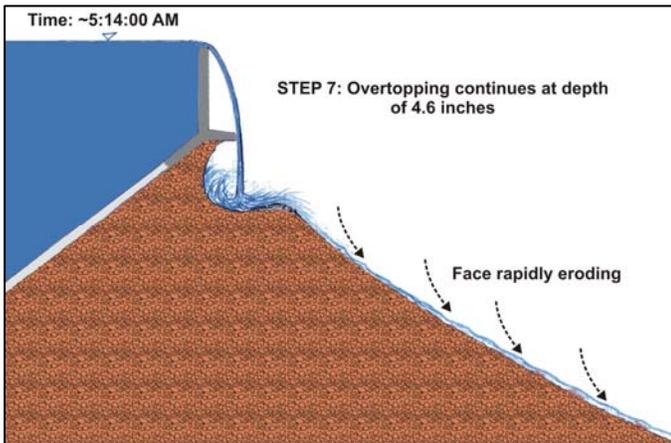
Fig 10. – This step of the reconstructed failure sequence illustrates the undermining of the parapet wall and rapid erosion of the embankment. The wall remained standing at this point due to the hydrostatic load on the inclined portion of the wall footing and 3-dimensional effects from surrounding wall panels.

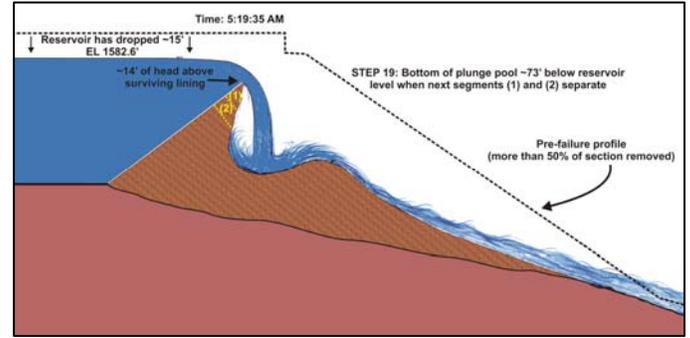
Fig. 13. – The embankment and concrete liner are progressively removed by the outflow. About one half the embankment remains at this stage.

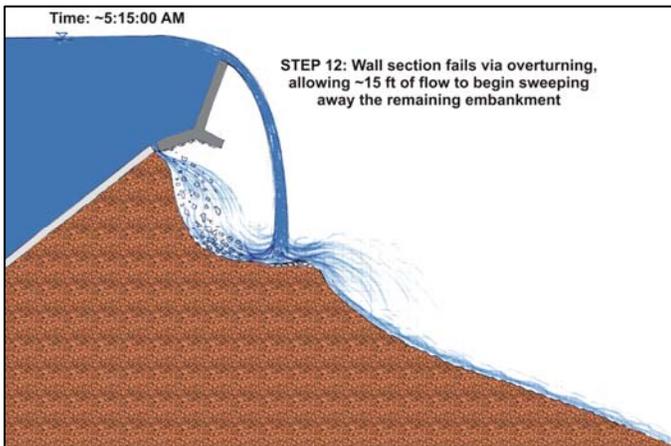
Fig. 11. – This step portrays how the parapet wall toppled in vicinity of panel 95, initiating the catastrophic failure of the reservoir by unleashing ~15 feet of flow over the remaining embankment.

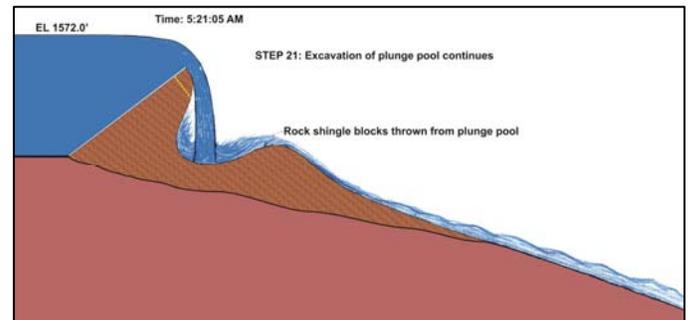
Fig. 14. – A continuation of the sequence show deepening of the plunge pool and ejection of large shingle blocks/boulders.

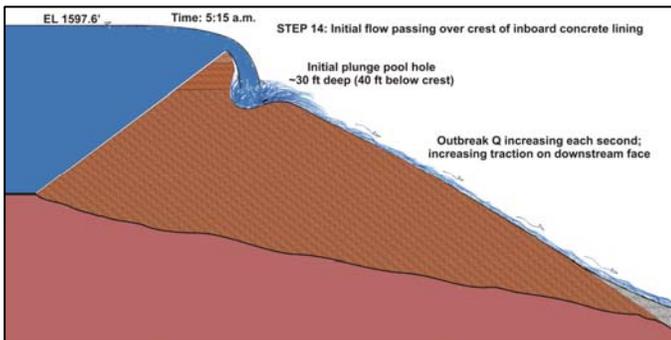
Fig. 12. – This figure illustrates ~15 feet of water overflowing

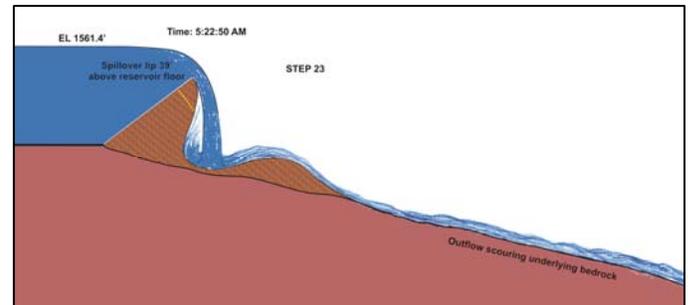
Fig. 15. – The plunge pool deepens towards the foundation interface and outflow has exposed much of the underlying bedrock, which is then scoured.

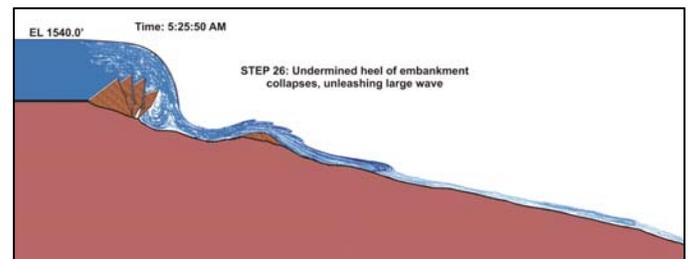
Fig. 16. – The embankment undergoes one final large collapse involving the concrete liner, sending one final surge down the slope.

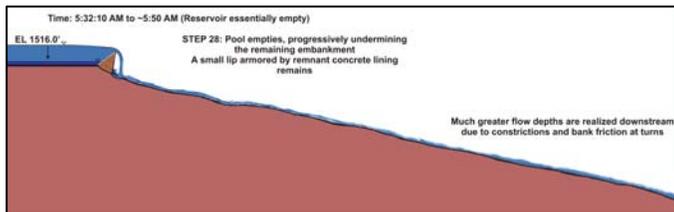
Fig. 17. – A small lip formed by the concrete liner armored the final last remnants of the embankment. Only a small amount of water remained in the reservoir.

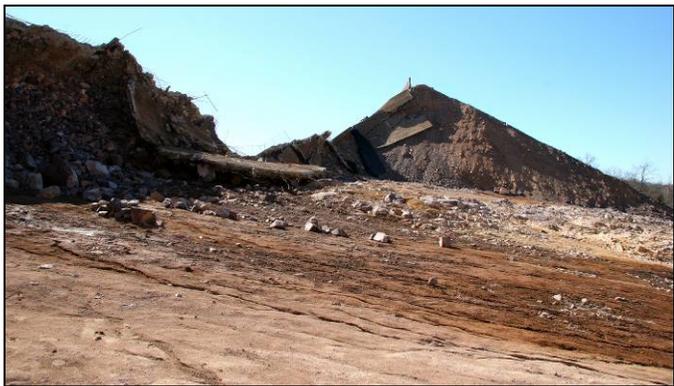
Fig. 18. – The remnant lip as seen at the failure site.

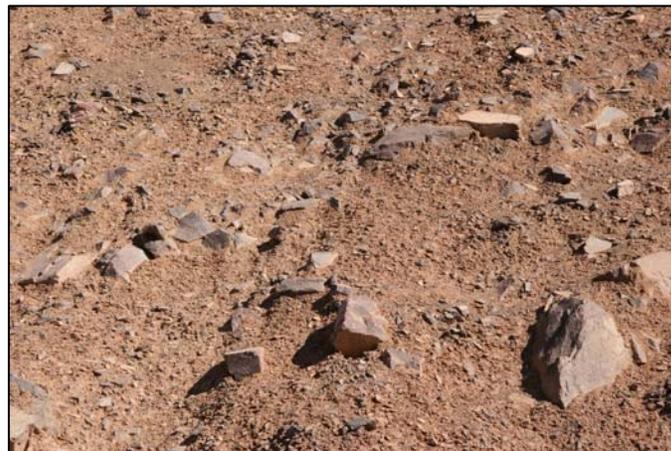
After the reservoir failure, The Federal Energy Regulatory Commission (FERC) and the Missouri Department of Natural Resources, Dam and Reservoir Safety Division (MoDNR-GSRAD) conducted investigations into the failure. Although the embankment was intended to be clean rockfill (less than 5% passing the No. 200 sieve) an excessive amount of fine-grained material was visually recognized in the exposed dike one day after the failure (Leonard, 2005). Forensic analyses by FERC's Taum Sauk Investigation Team (2006), FERC's Independent Panel (2006), and by Rizzo Associates, Inc. (2006) confirmed a fines content of between zero and 20% in the exposed embankment bordering the breach (shown in Figs. 2 and 19). In addition, the percentage of sand sized material

within the embankment was as great as 45% in certain locations, creating a far more erodable mixture than normally expected of clean rockfill (FERC Independent Panel, 2006). This problem was manifest by the unusual level of surficial erosion during the project's 42 year life, from rainfall-induced runoff (FERC Independent Panel, 2006). Cooke (1967) surmised that the dike could not have been clean rockfill because the observed settlement was almost an order of magnitude greater than those recorded on other concrete-faced rockfill dams (prior to 1967).

Fig. 19. - Close up of "dirty" rockfill exposed on lateral margins of the breach. The large clasts are 10-12 inches diameter.

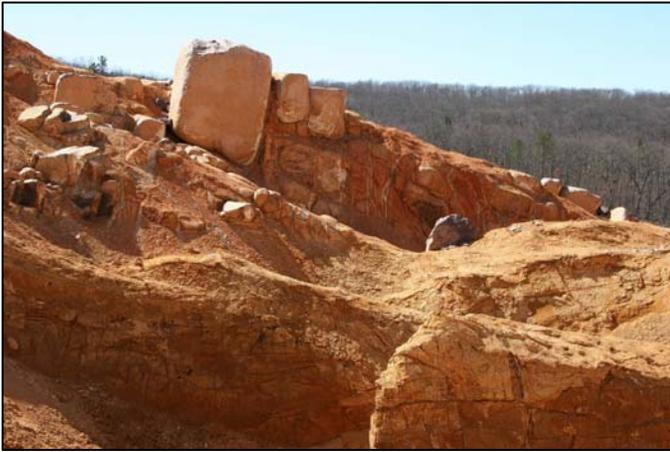
The December 2005 outbreak flood exposed deeply weathered zones in the bedrock slopes of Proffit Mountain. A seam of weathered rhyolite was observed beneath the breached section of the embankment. The upper slopes of Proffit Mountain also contains a zone of deeply weathered diabase saprolite, which appears to be the remnant of a disintegrated dike or sill (see Fig. 20). Adjacent granites and rhyolites also exhibited a high degree of weathering, likely from hydrothermal alteration associated with intrusion of the diabase. The weathered diabase exhibits a soil-like texture, though retaining the rock's original fabric and fracture patterns. Core stones and remnant spheroidal weathering rinds are also visible.

Fig. 20. – A zone of deeply weathered bedrock (saprolite) on the upper slopes of Proffit Mountain appears to have formed due to the disintegration of a diabase dike or sill and nearby hydrothermally altered granites.

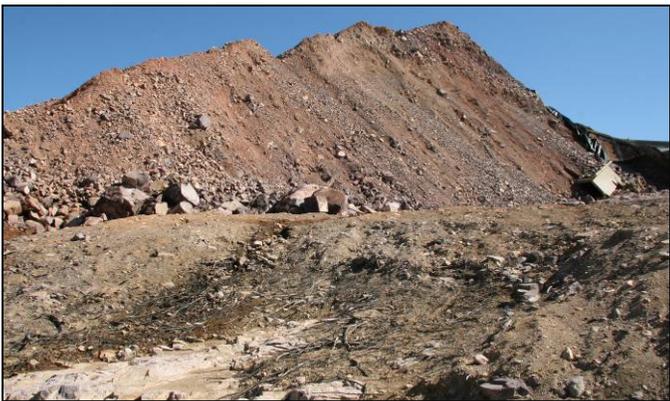
Post-failure investigations included exploratory drilling through the embankment-foundation interface to ascertain the character of the contact. These borings revealed that up to 18 inches of residual soil were not stripped off prior to placement of the rock fill. Soils containing tree roots and other organic matter were also observed beneath the breached section of the embankment (see Fig. 21). This may have contributed to the increased settlement and shifting of the embankment in this area, due to the high fines content, poor drainage, and higher compressibility of the un-stripped residual soil cap, as well as the 'dirty' rockfill.

Fig. 21. – Residual soils, including tree roots and other organic matter, were observed left in place beneath the failed portion of the upper reservoir embankment.
