# **OVERVIEW OF THE TAUM SAUK UPPER RESERVOIR FAILURE**

**December 14, 2005**

**Reynolds County, Missouri**

**University of Missouri-Rolla**

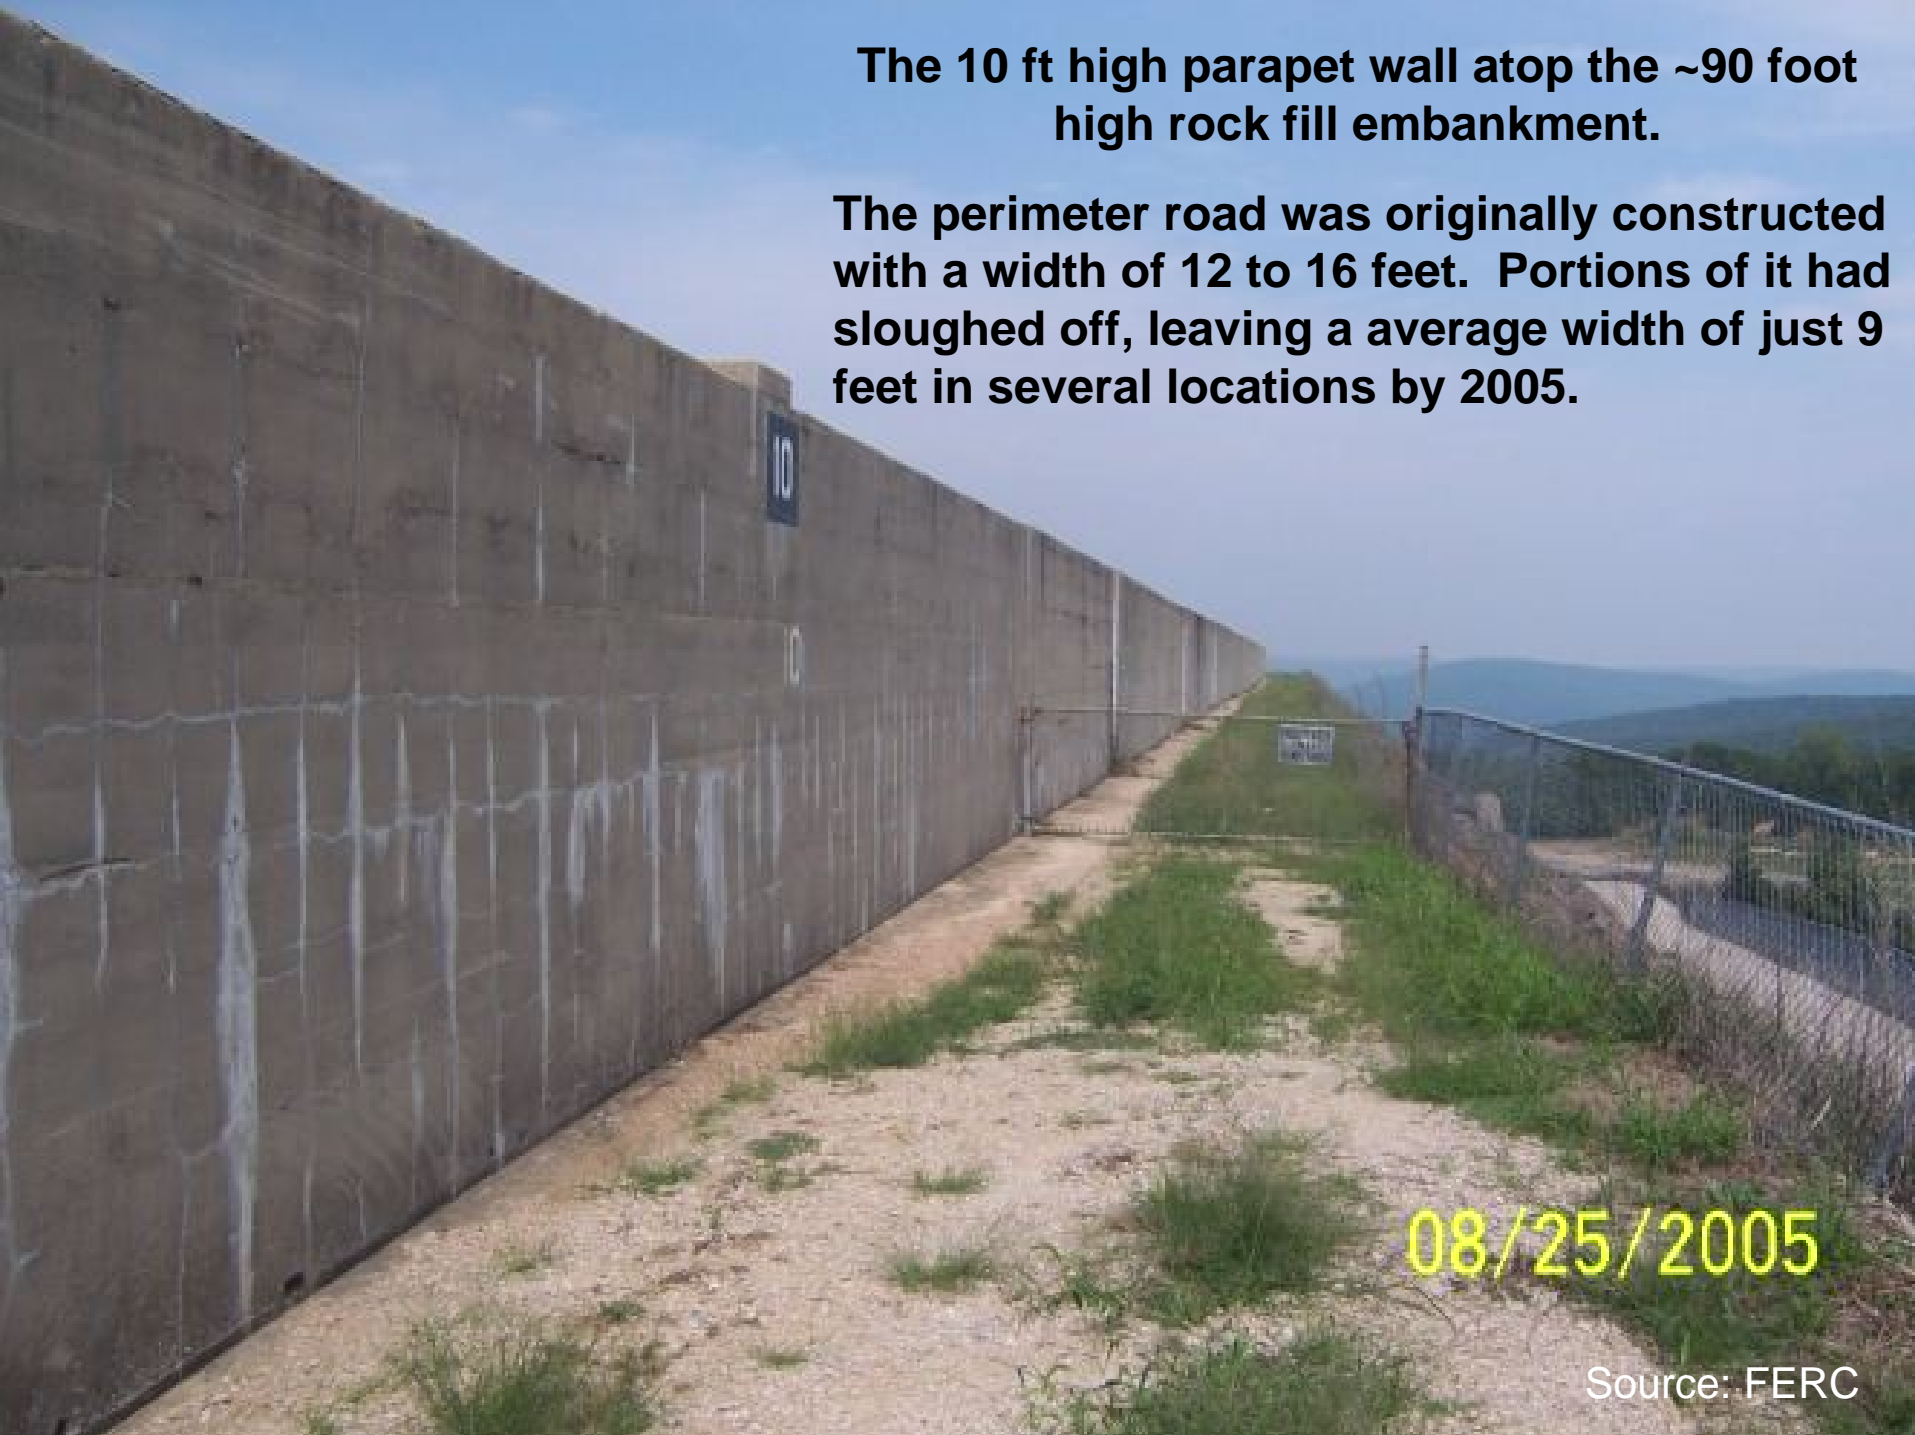
**The 10 ft high parapet wall atop the ~90 foot high rock fill embankment.**

**The perimeter road was originally constructed with a width of 12 to 16 feet. Portions of it had sloughed off, leaving a average width of just 9 feet in several locations by 2005.**

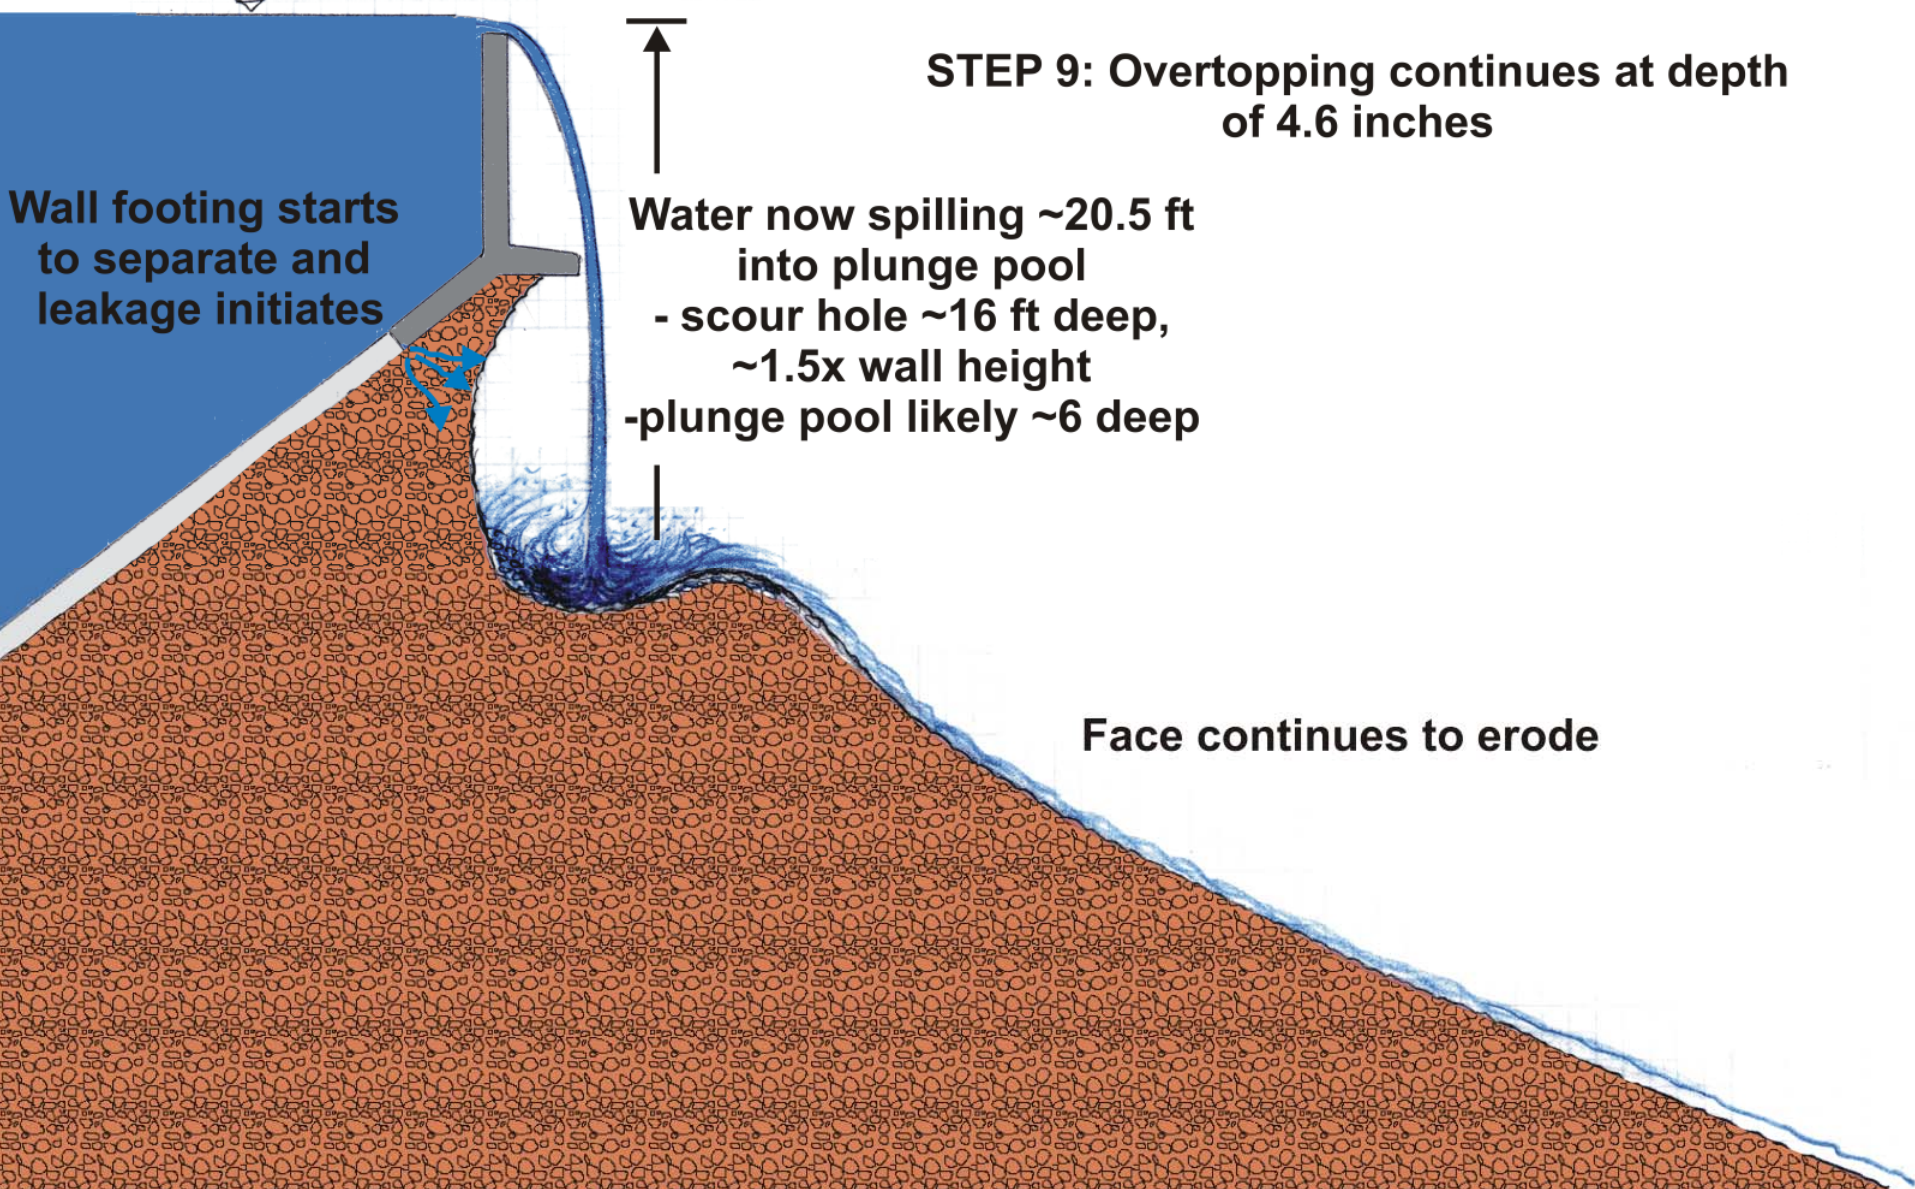
**Wall footing starts to separate and leakage initiates**

**STEP 9: Overtopping continues at depth of 4.6 inches**

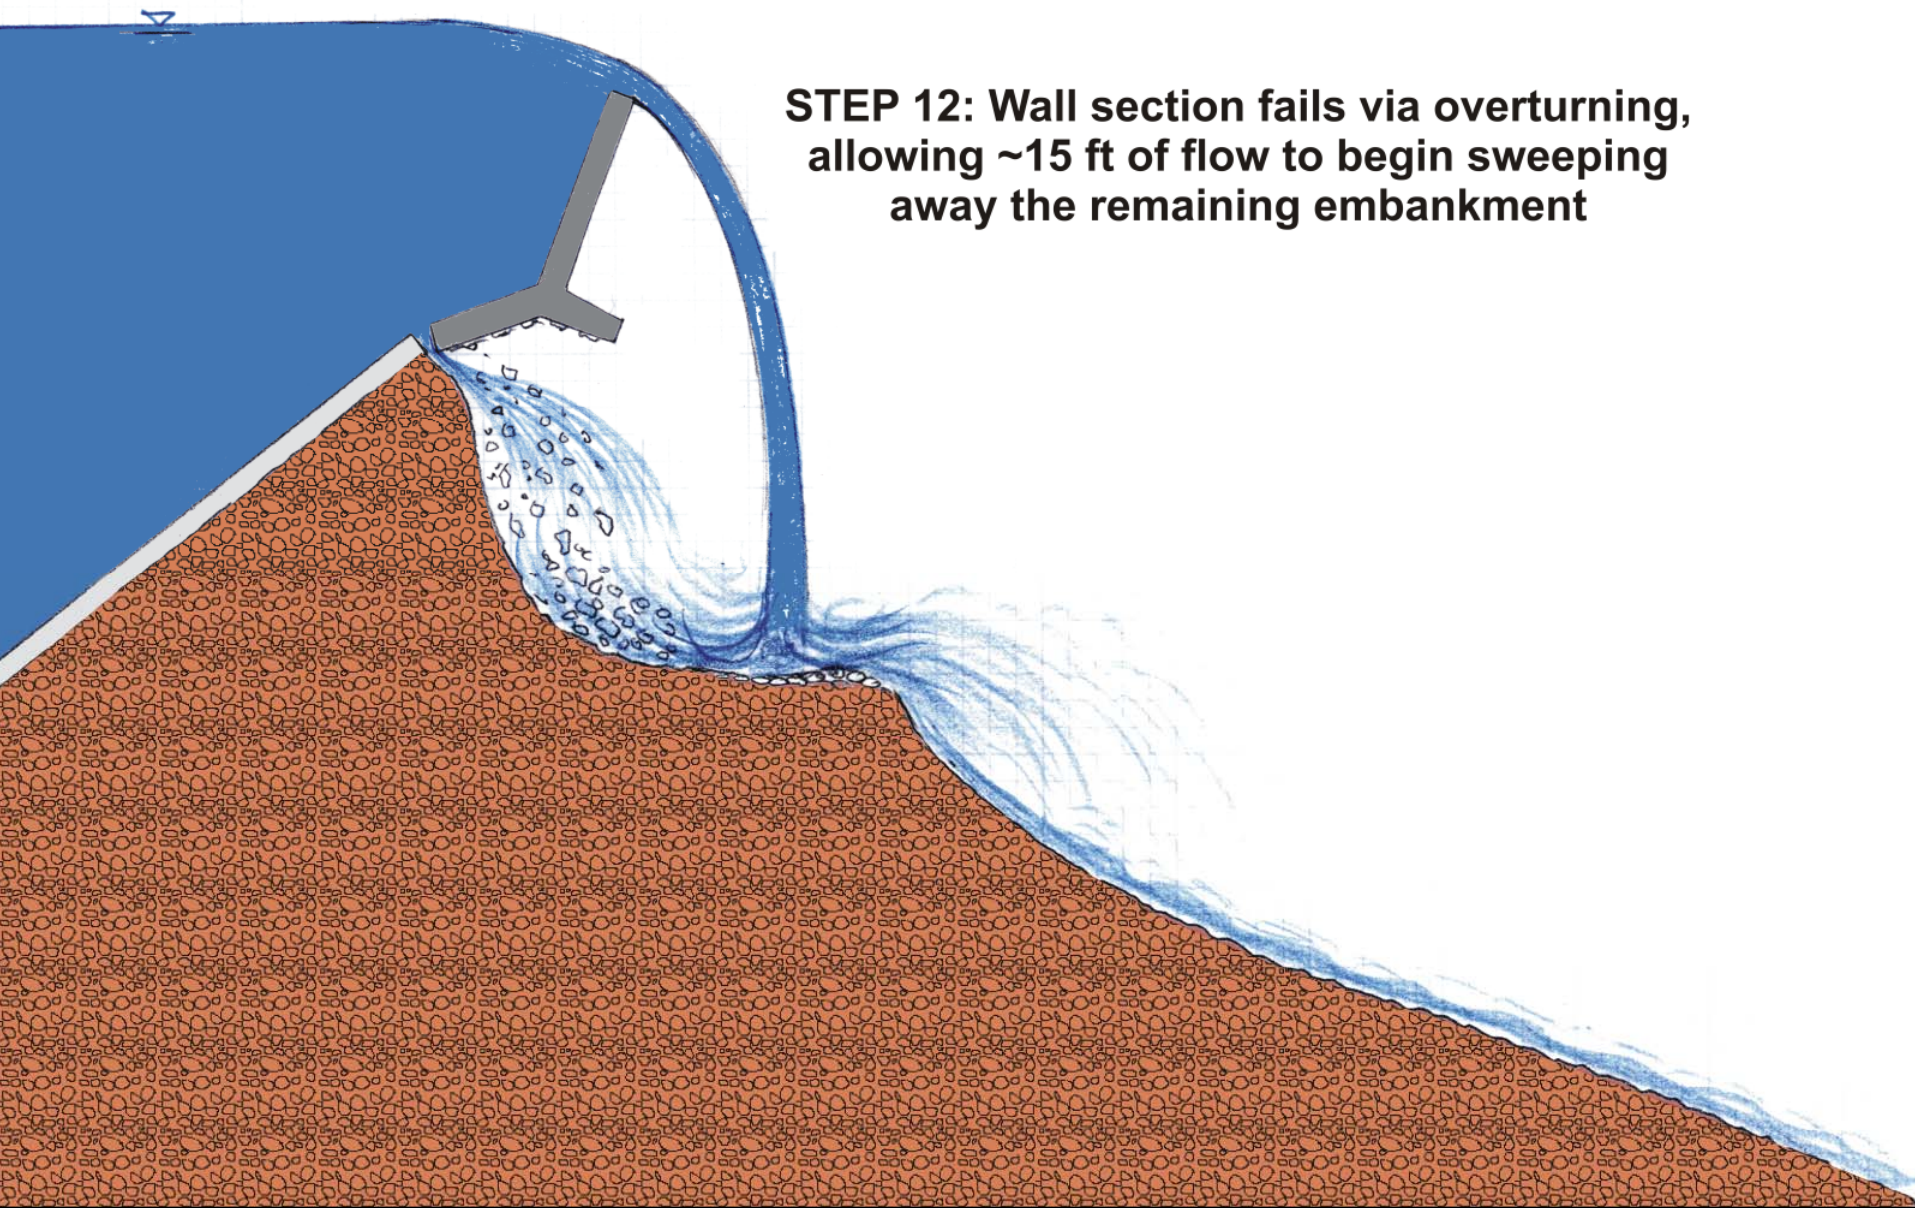
**STEP 12: Wall section fails via overturning,  
allowing ~15 ft of flow to begin sweeping  
away the remaining embankment**

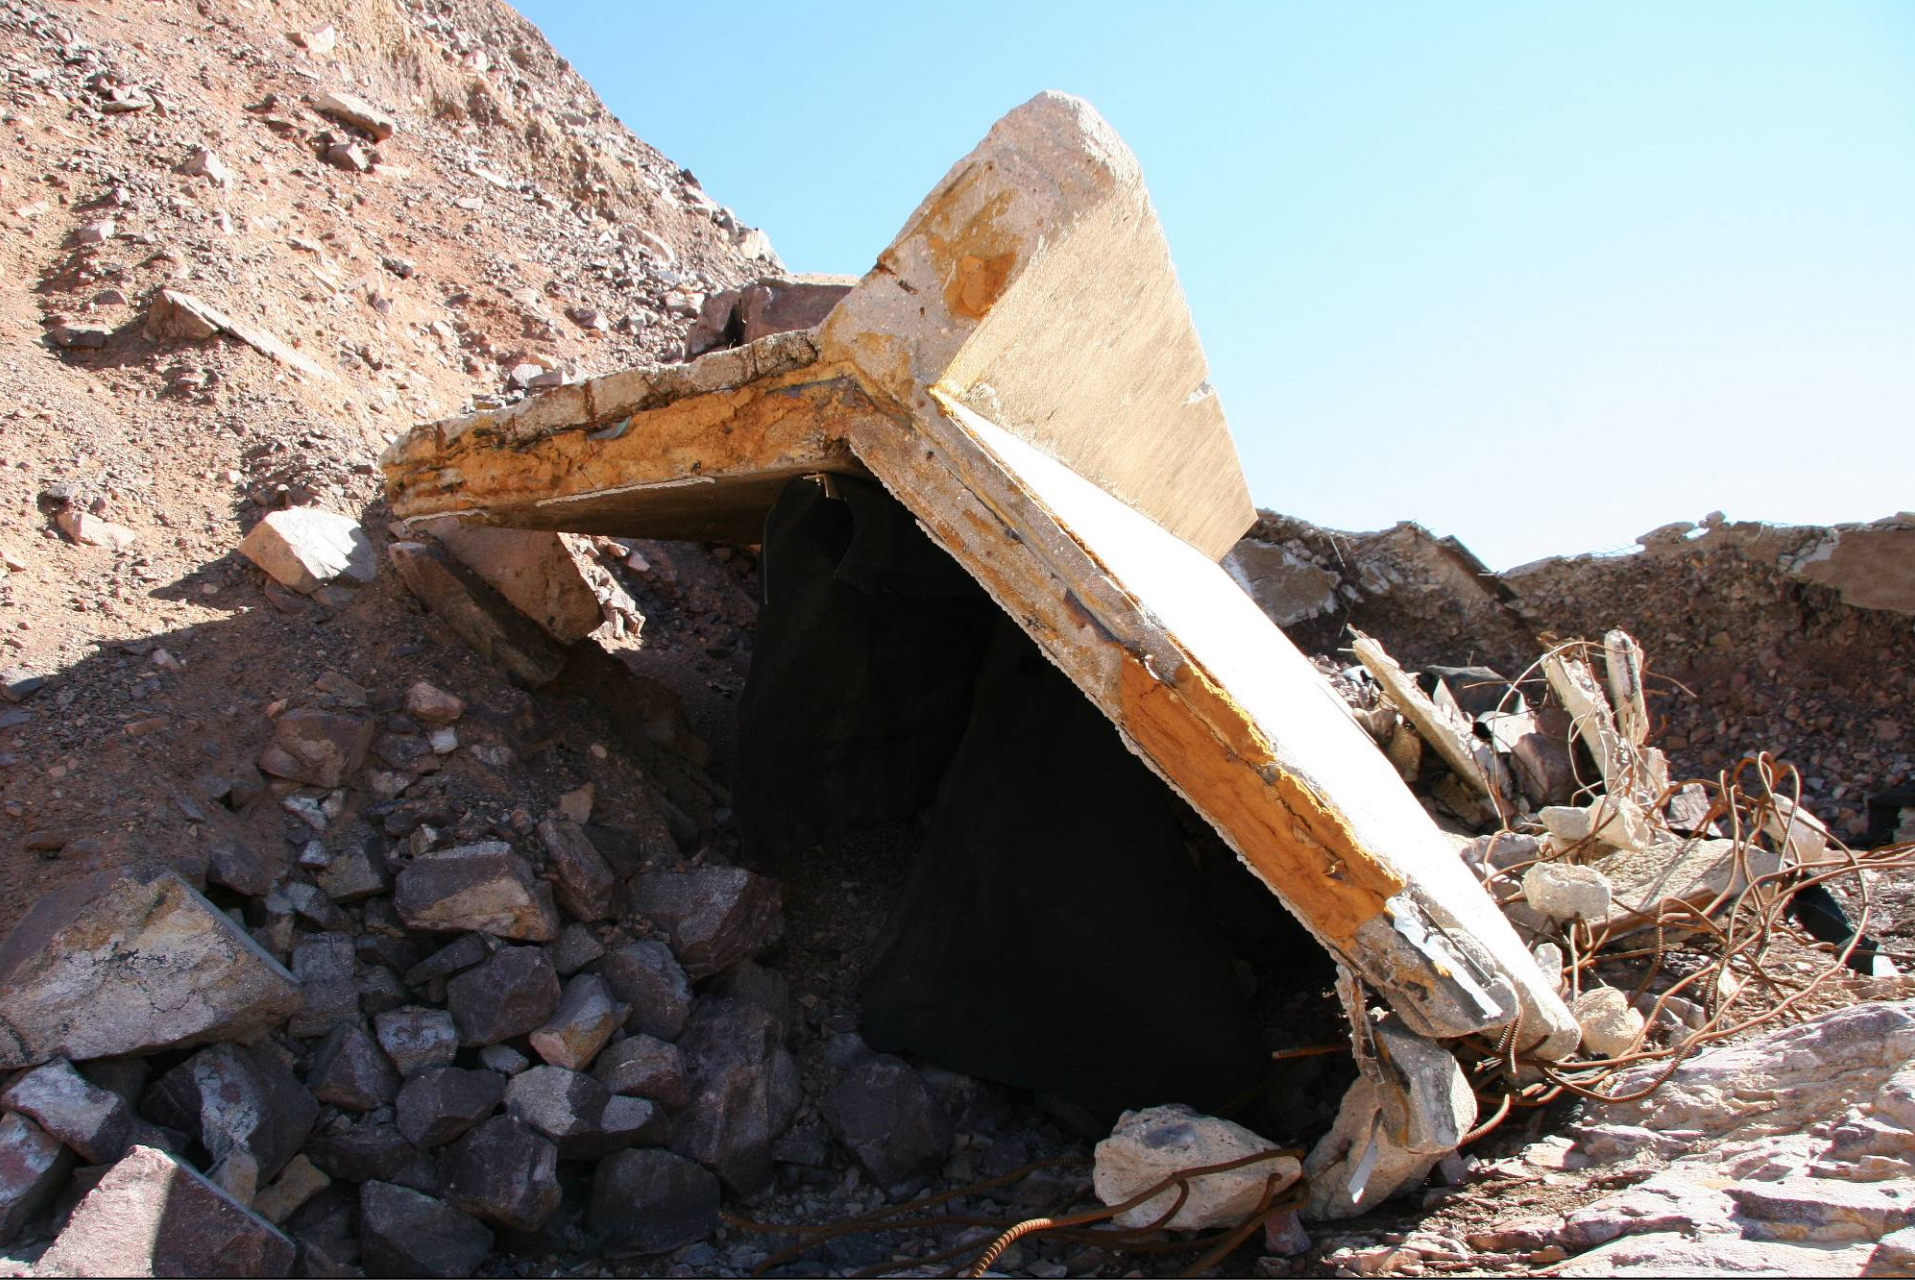
**Wall panels toppled over after extensive undercutting, initiating the catastrophic failure sequence.**

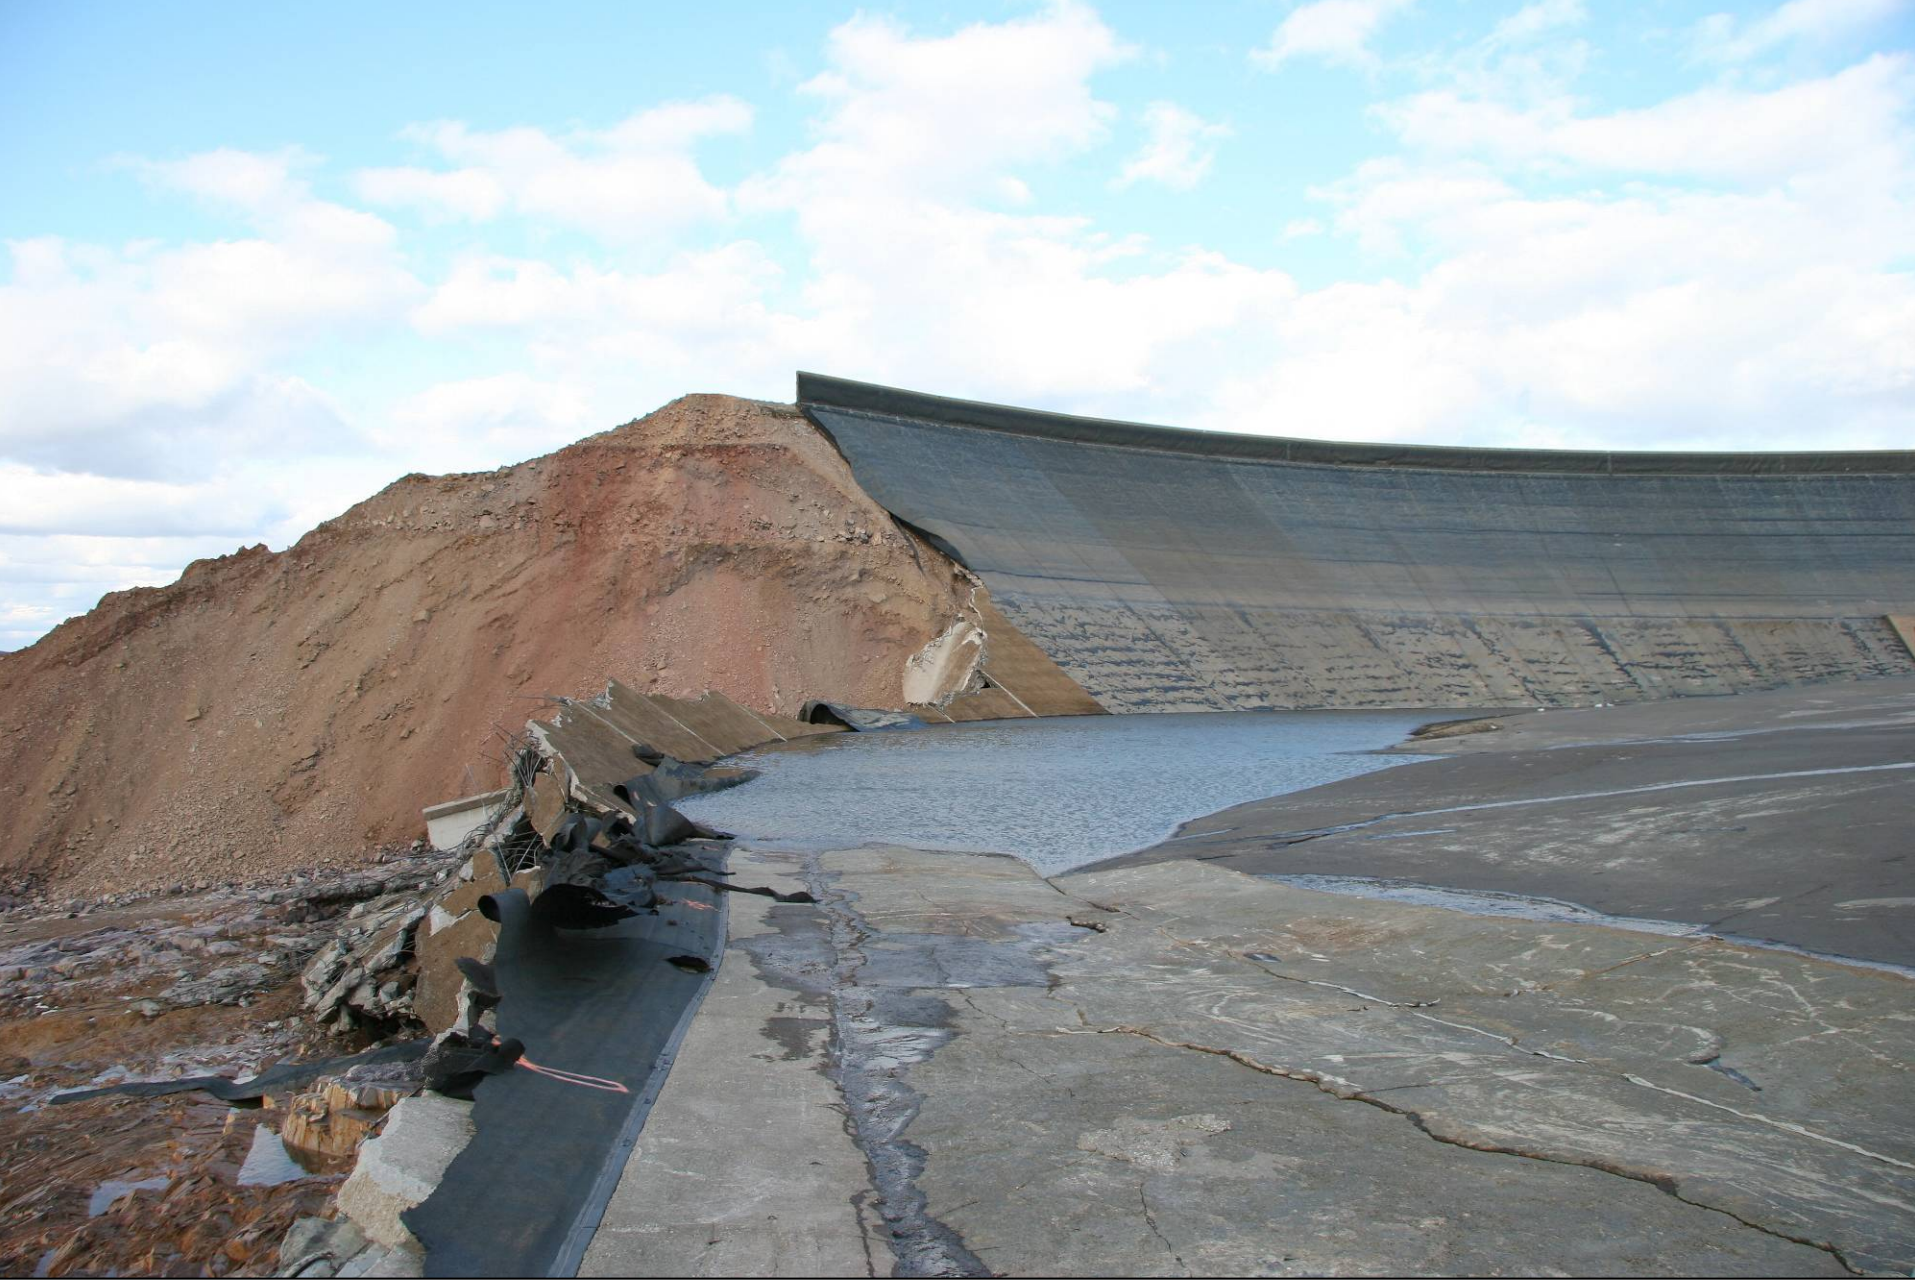
**A small lip of material armored by portions of the concrete liner remained in a few locations at the breach site.**

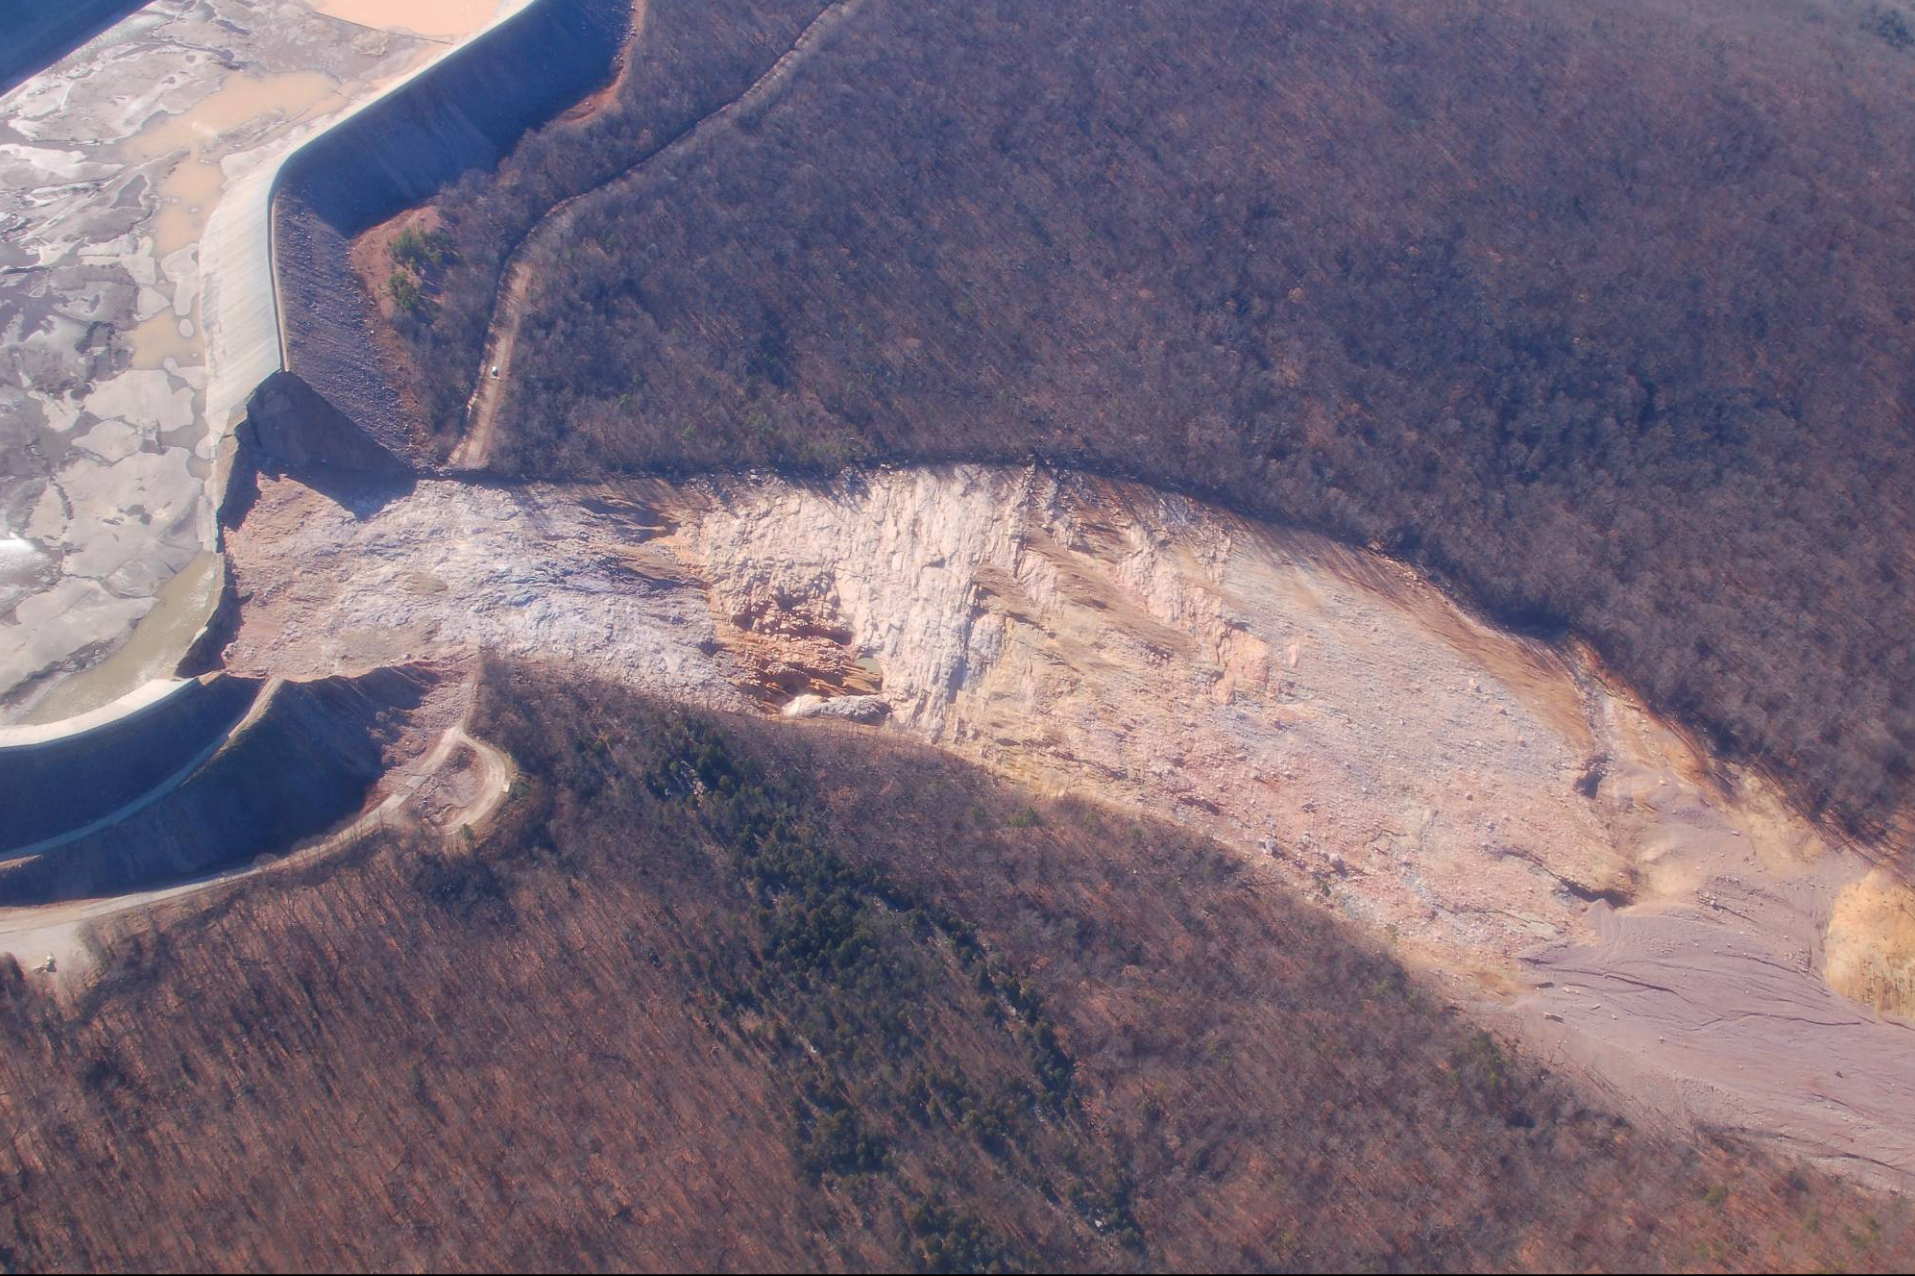
**The flow path down the slope of Proffit Mountain was stripped down to the underlying bedrock (photo by Jeff Spooner (USGS)).**

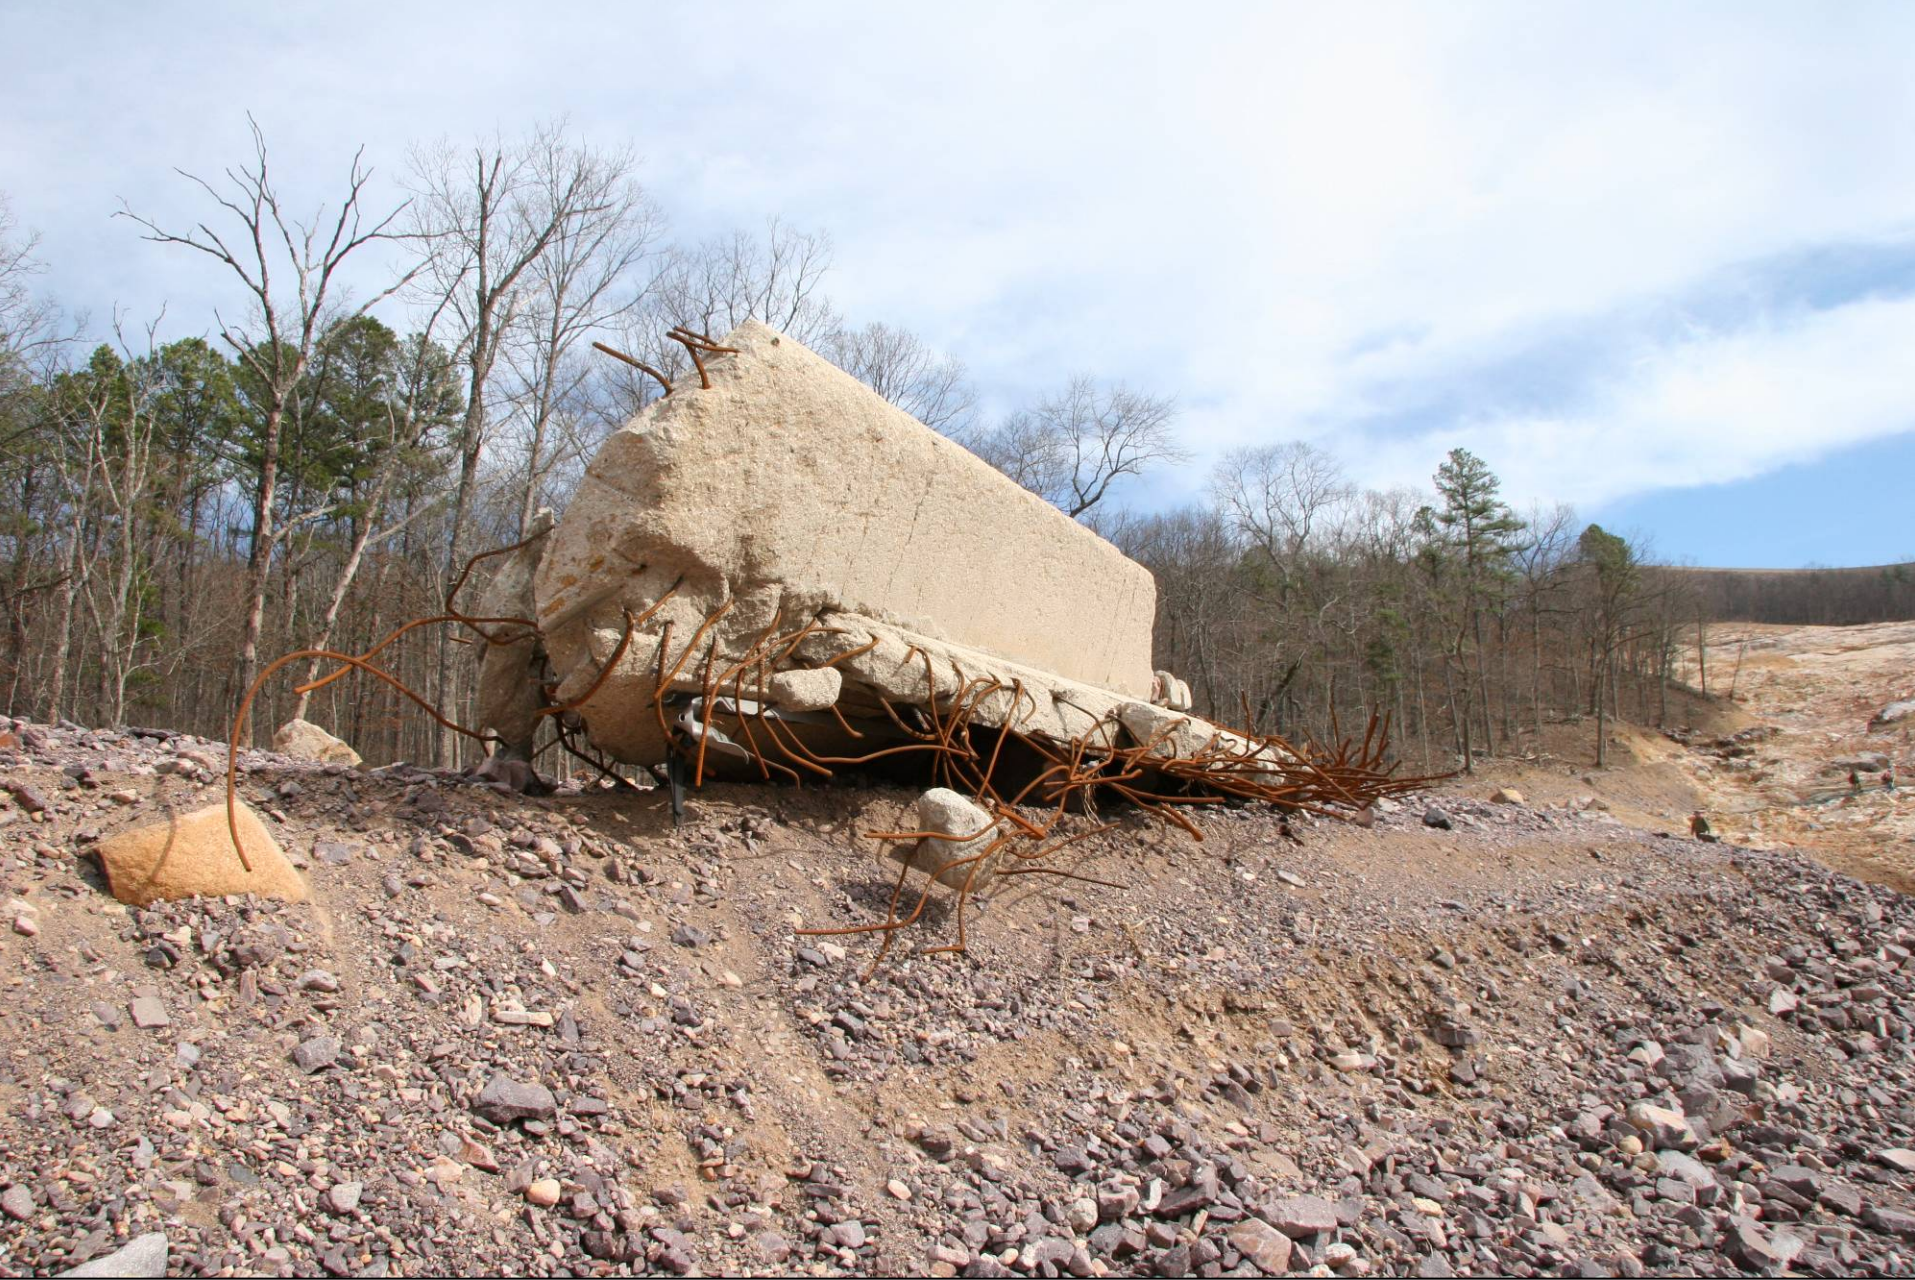
**Huge pieces of rock and concrete were carried down the slope by the turbid debris flow. A large section of a concrete wall panel is shown here.**

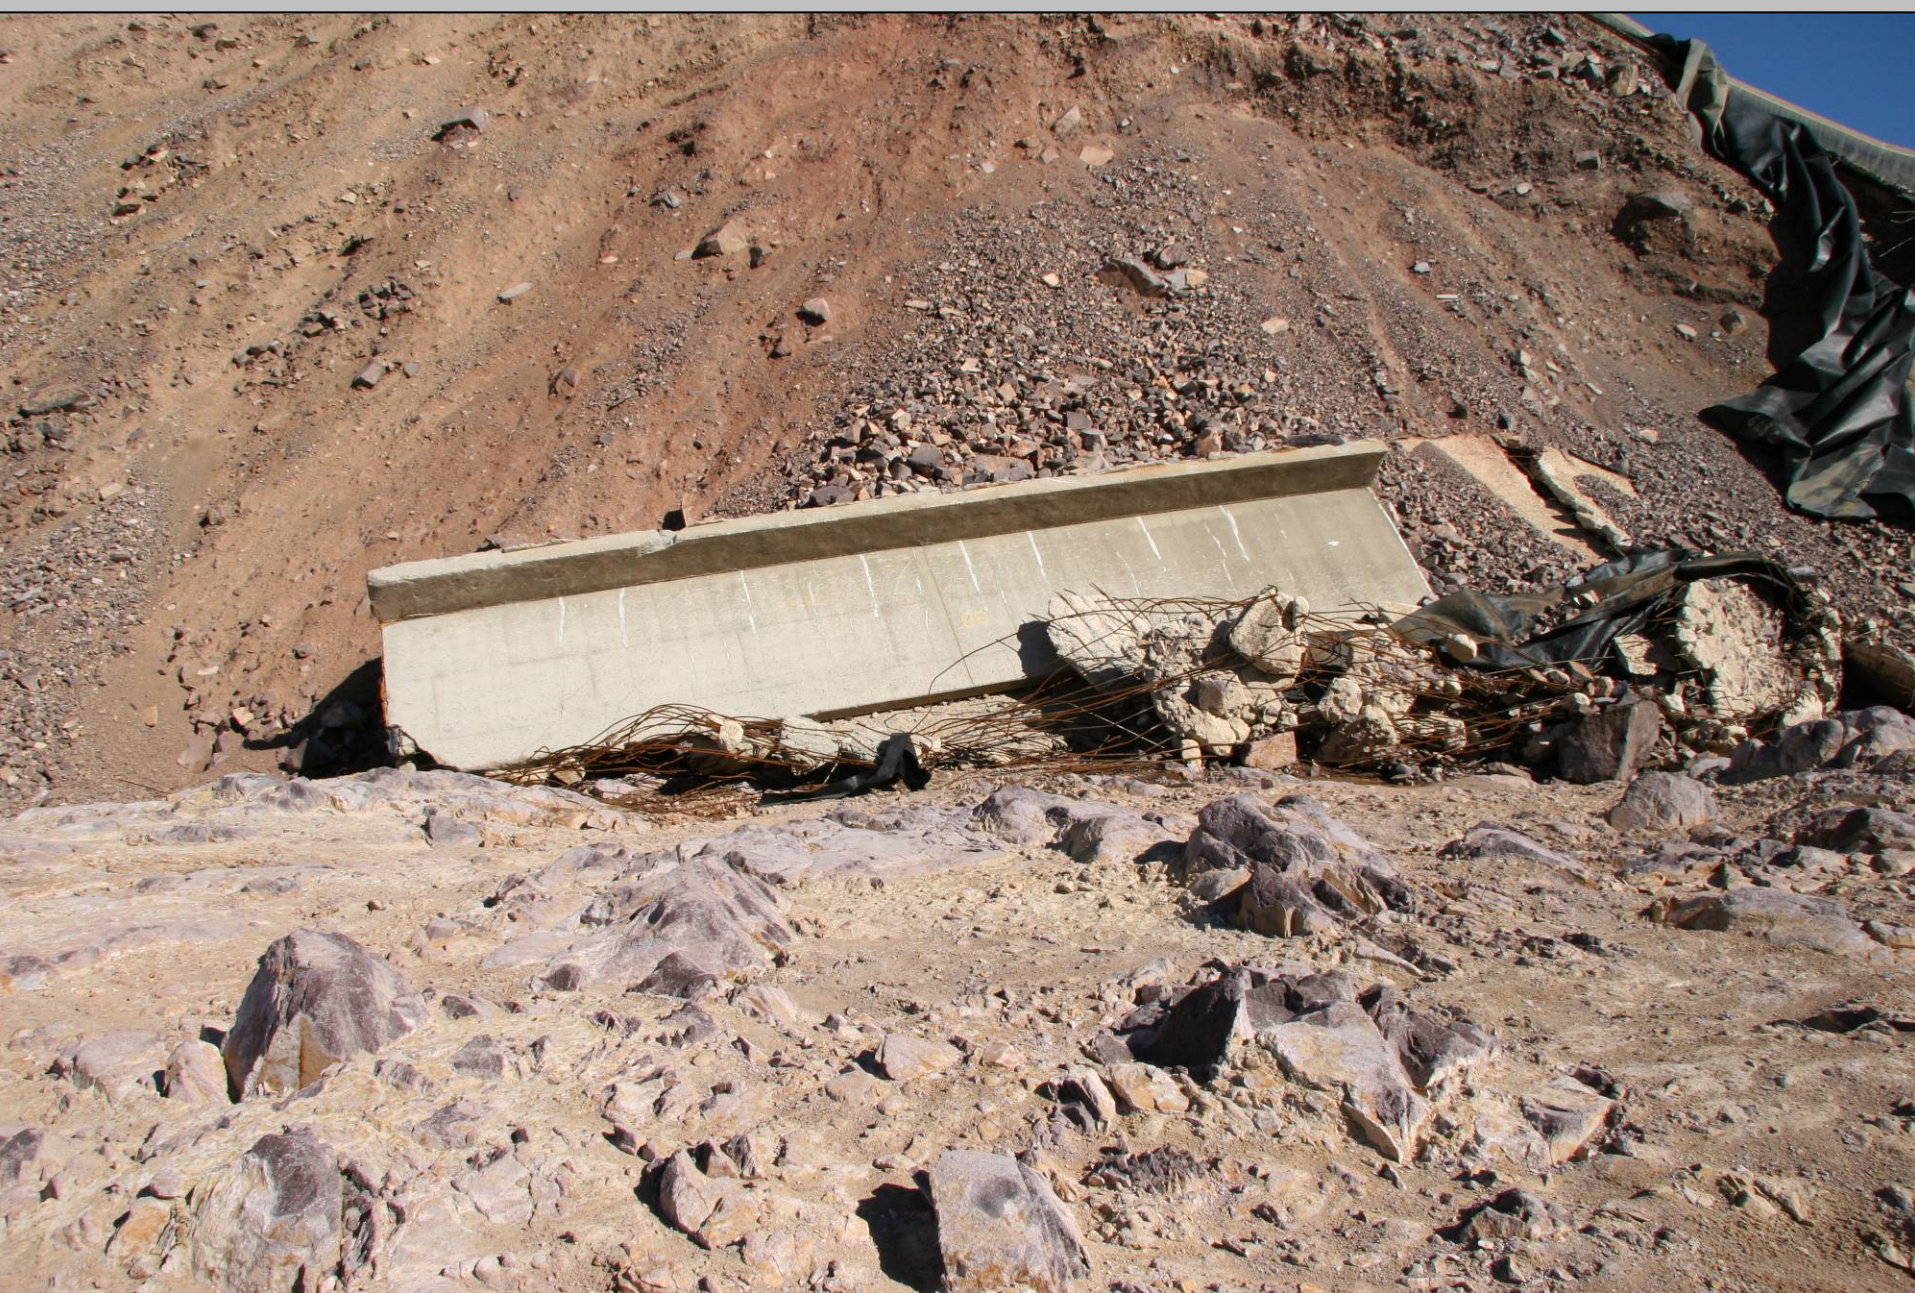
**Toppled wall panel at north end of breach. The stem was 10 feet high.**

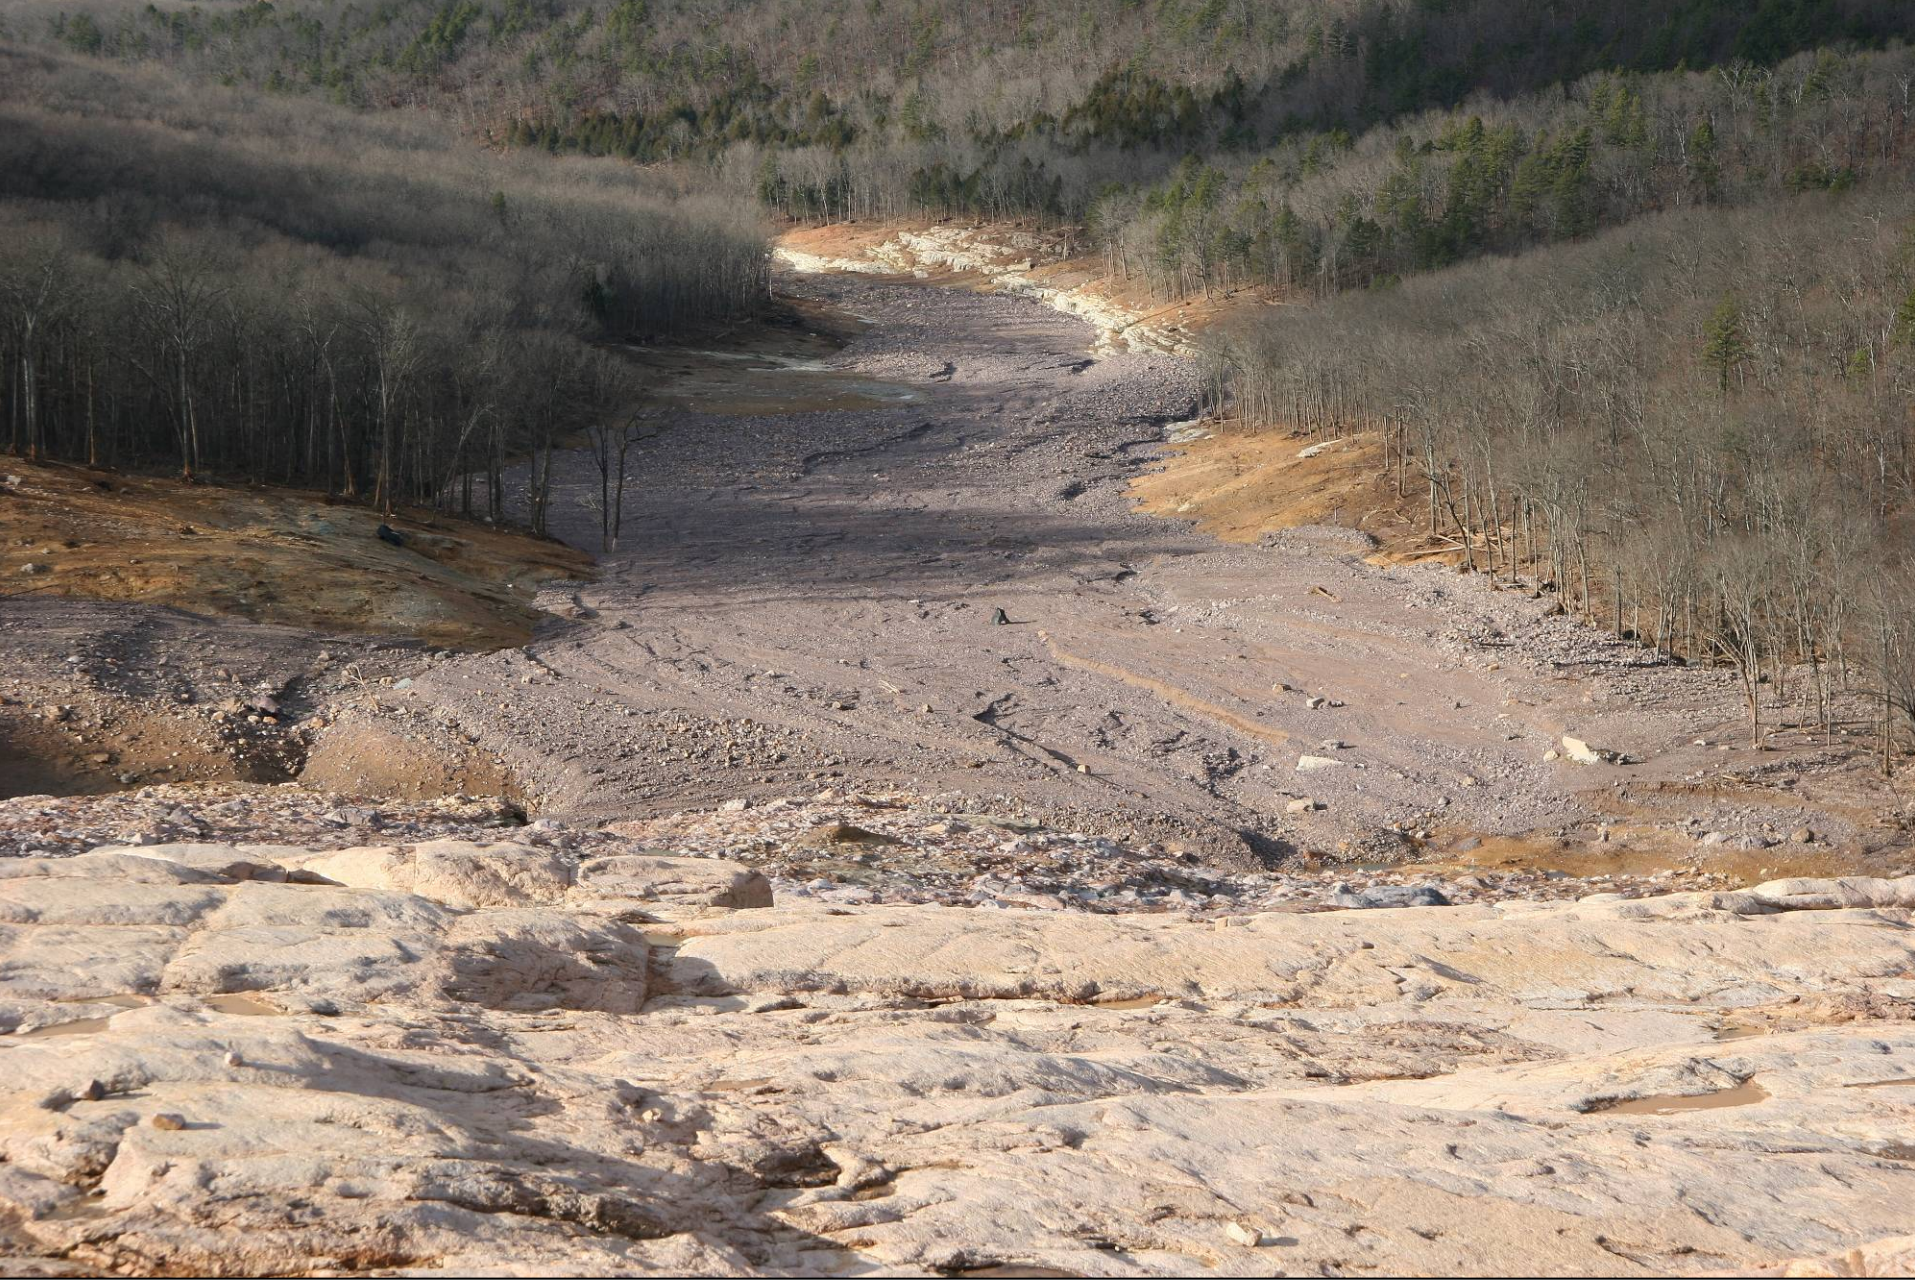
**Lower portion of the scour channel and precipitous drop, immediately below the reservoir.**
