# **OVERVIEW OF THE TAUM SAUK UPPER RESERVOIR FAILURE**

**December 14, 2005**

**Reynolds County, Missouri**

**University of Missouri-Rolla**

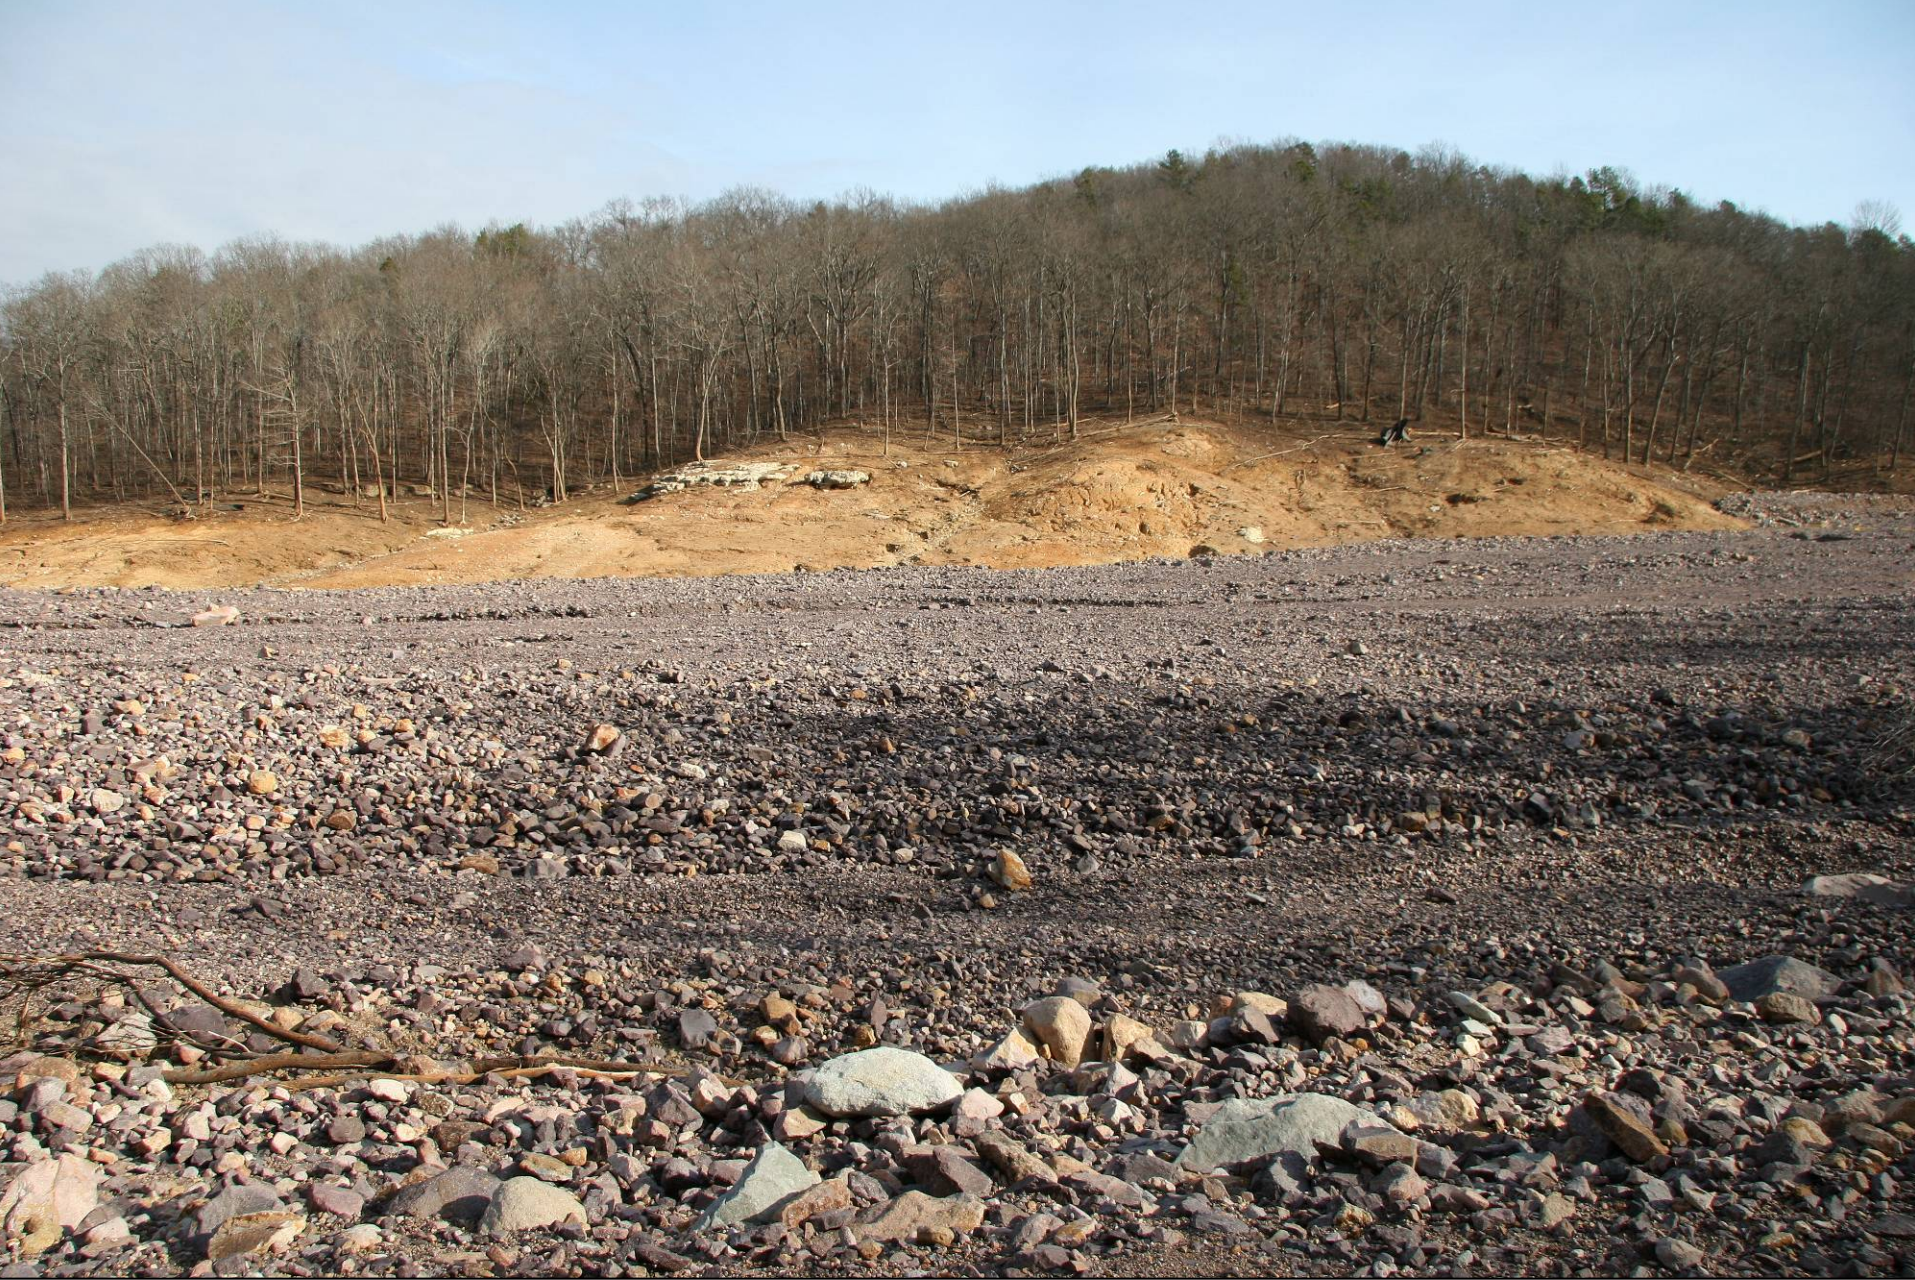
**Reworked boulders, cobbles, and gravel fill the lower portion of the scour channel along with twisted remnants of concrete and rebar.**

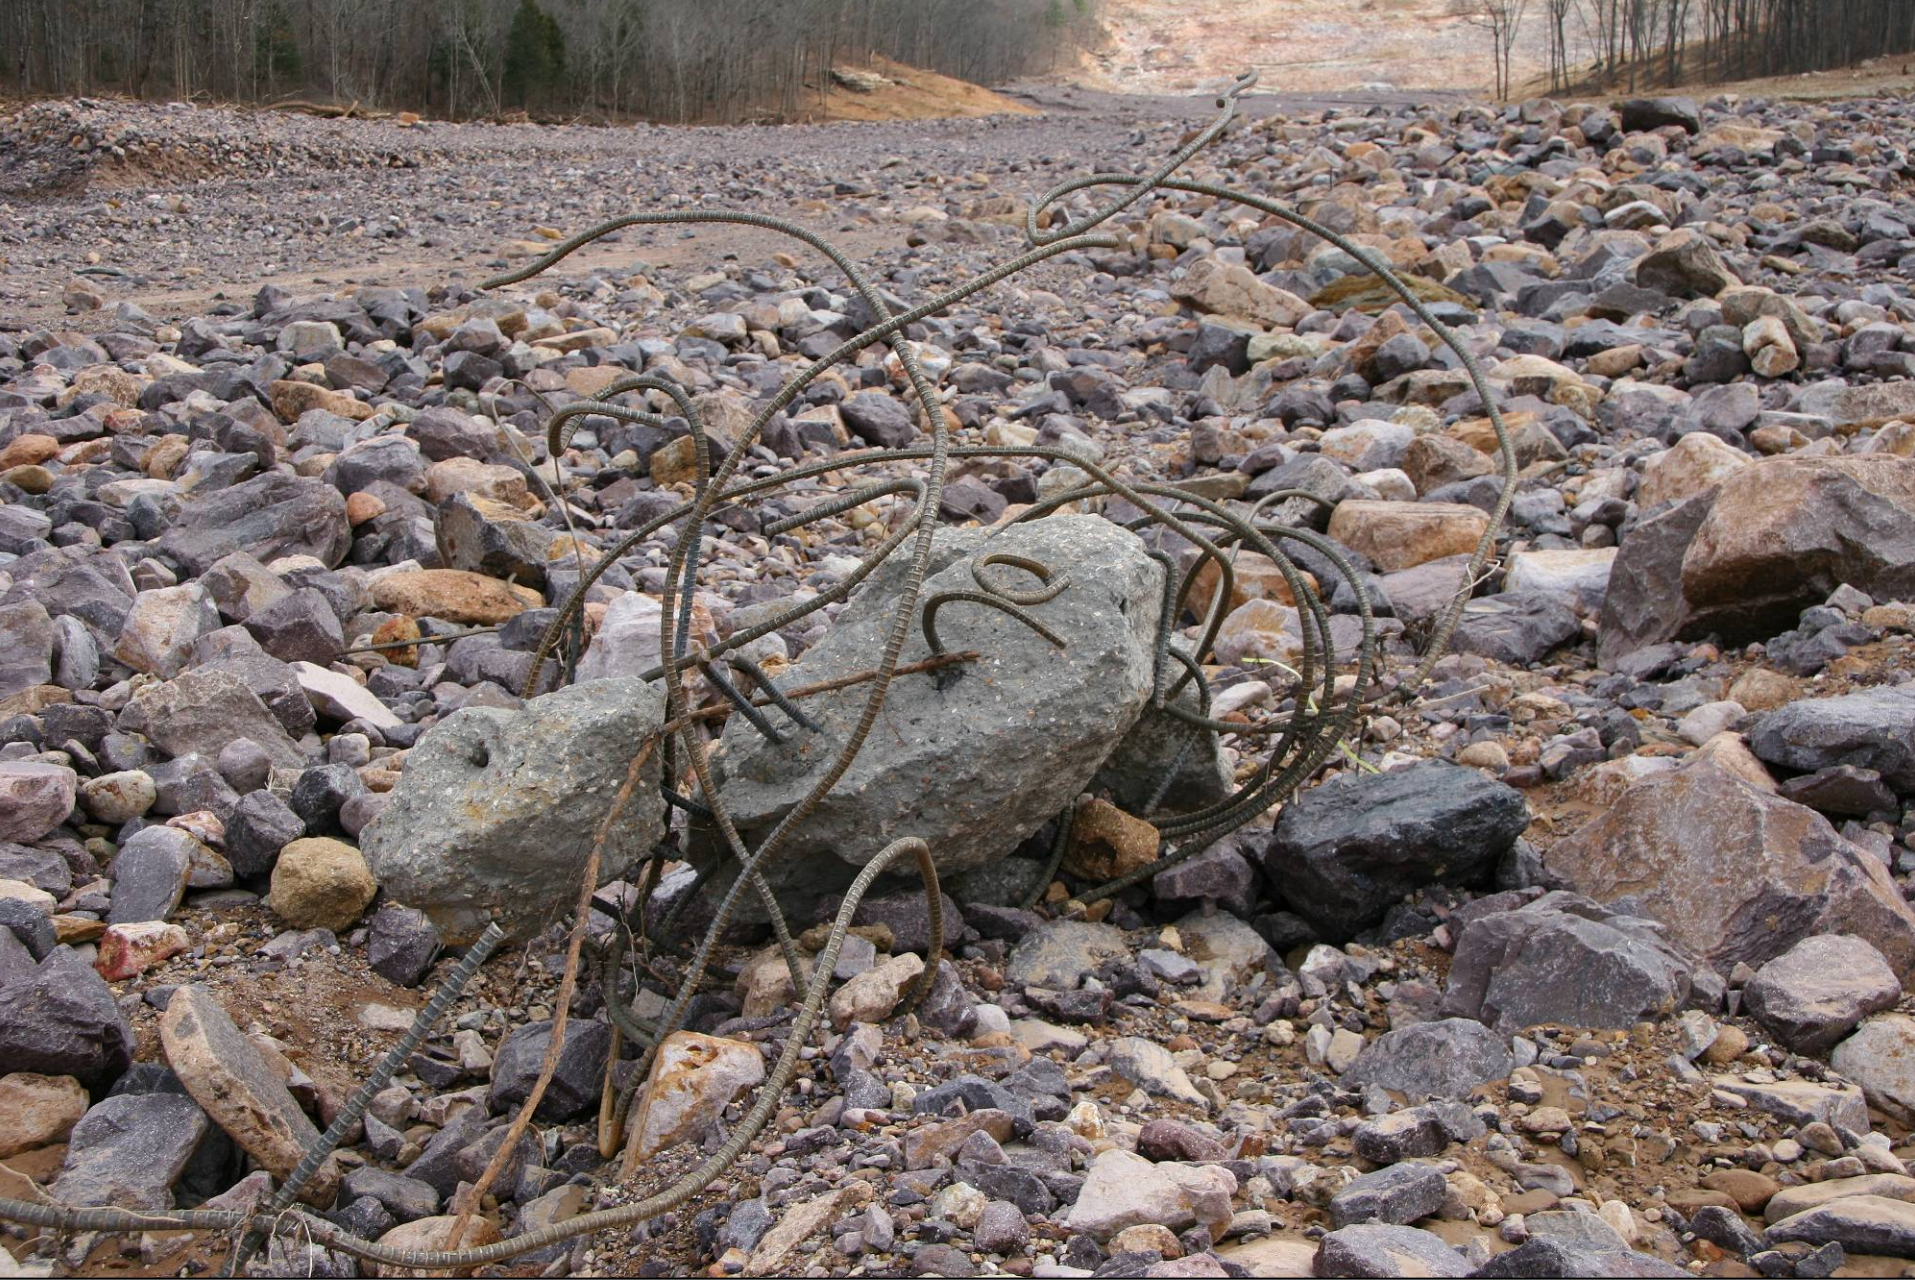
**Concrete and rebar from the dam littered the scour channel.**

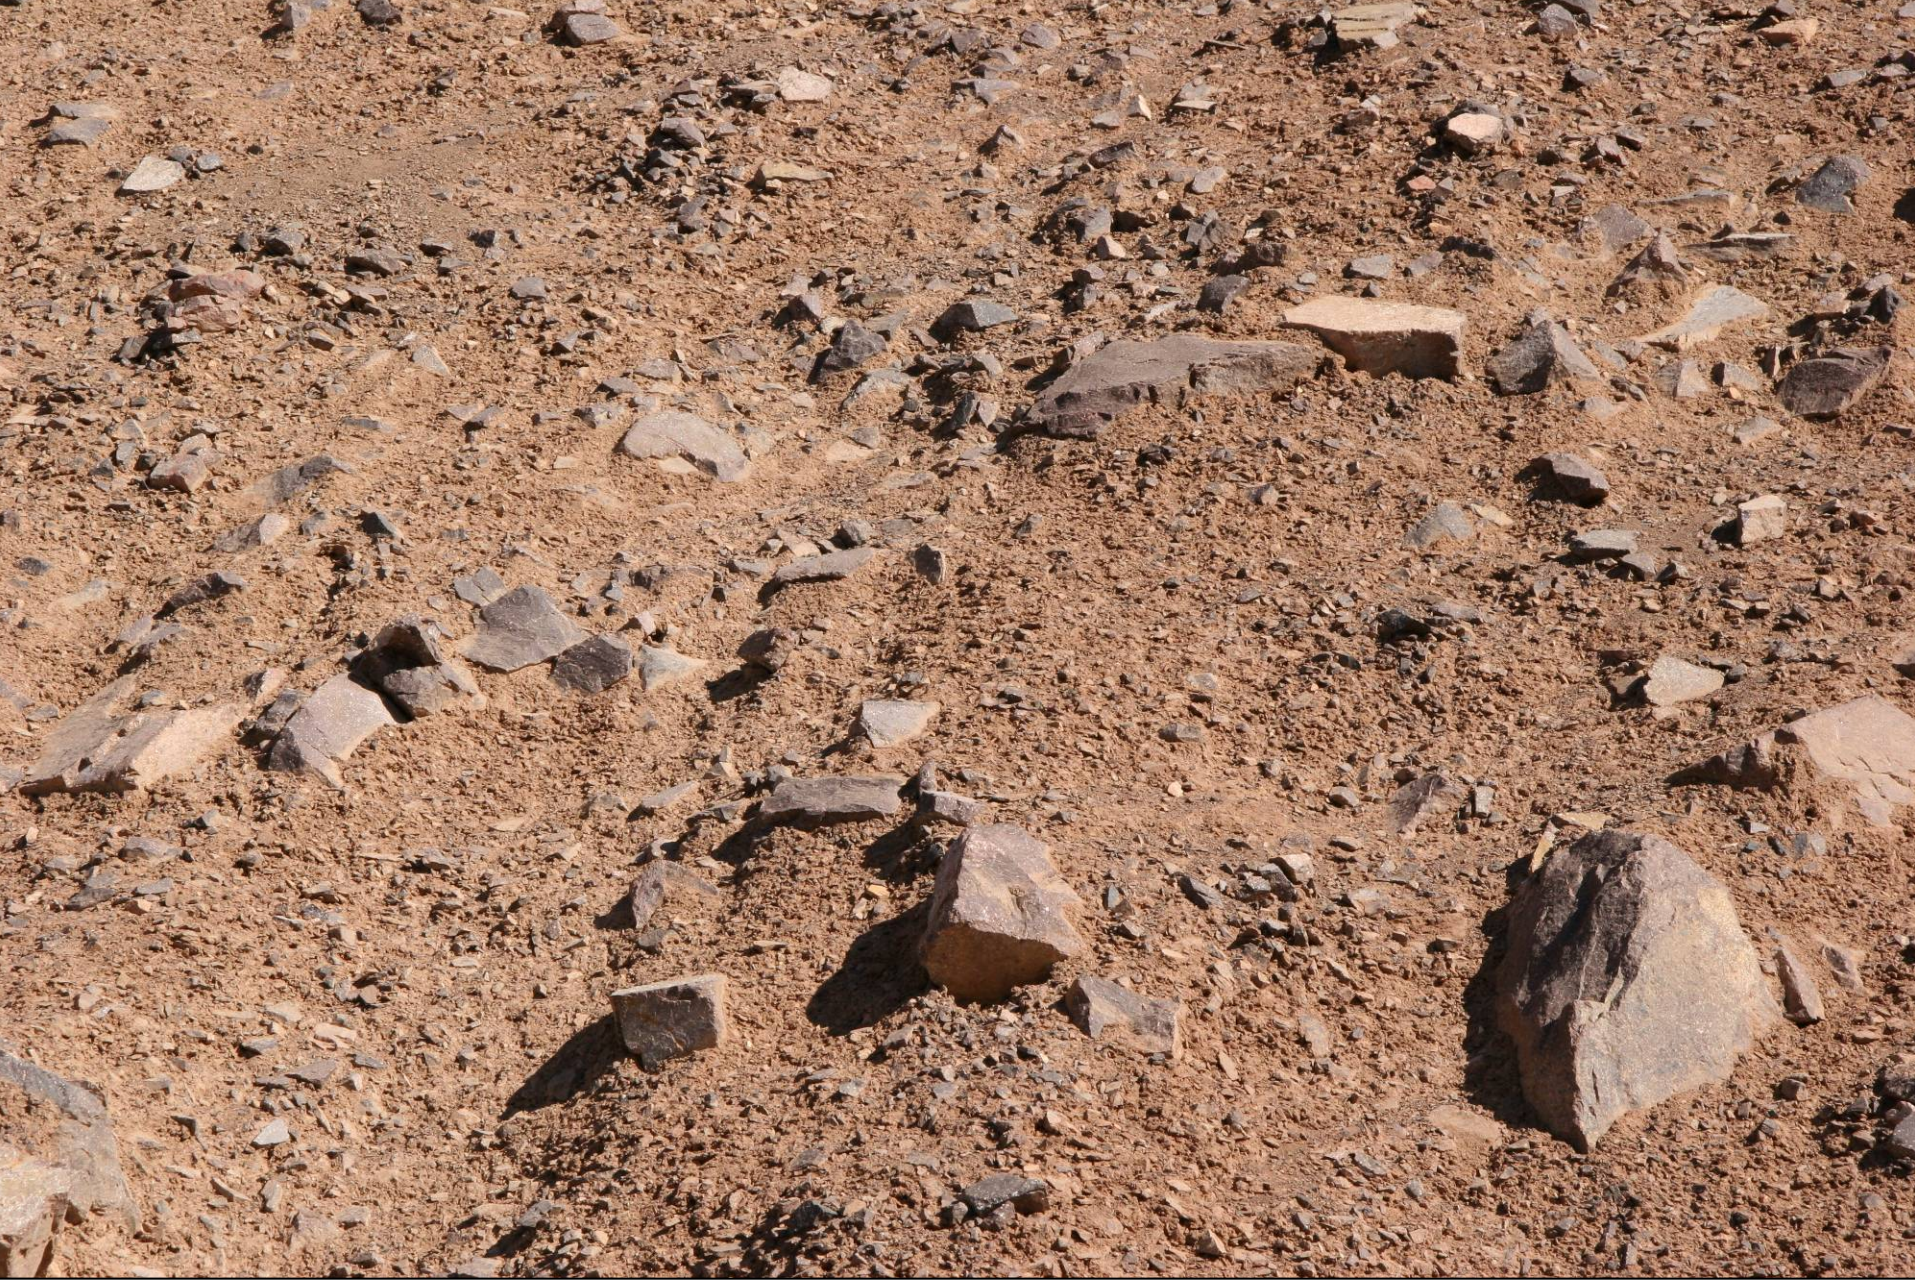
- The cross section of the dam exposed by its failure exhibited a high fines content. The rockfill contained about 20% fines while the project specifications limited the fines to 5% or less.
- This contributed to up to 2' of differential settlement, shifting of the concrete parapet walls, and a cracking of the concrete liner over the years. This also reduced drainage and thus, internal stability of the dam.

**Close up of “dirty” rockfill exposed at failure site. For scale, the large rocks are 10-12” in diameter.**

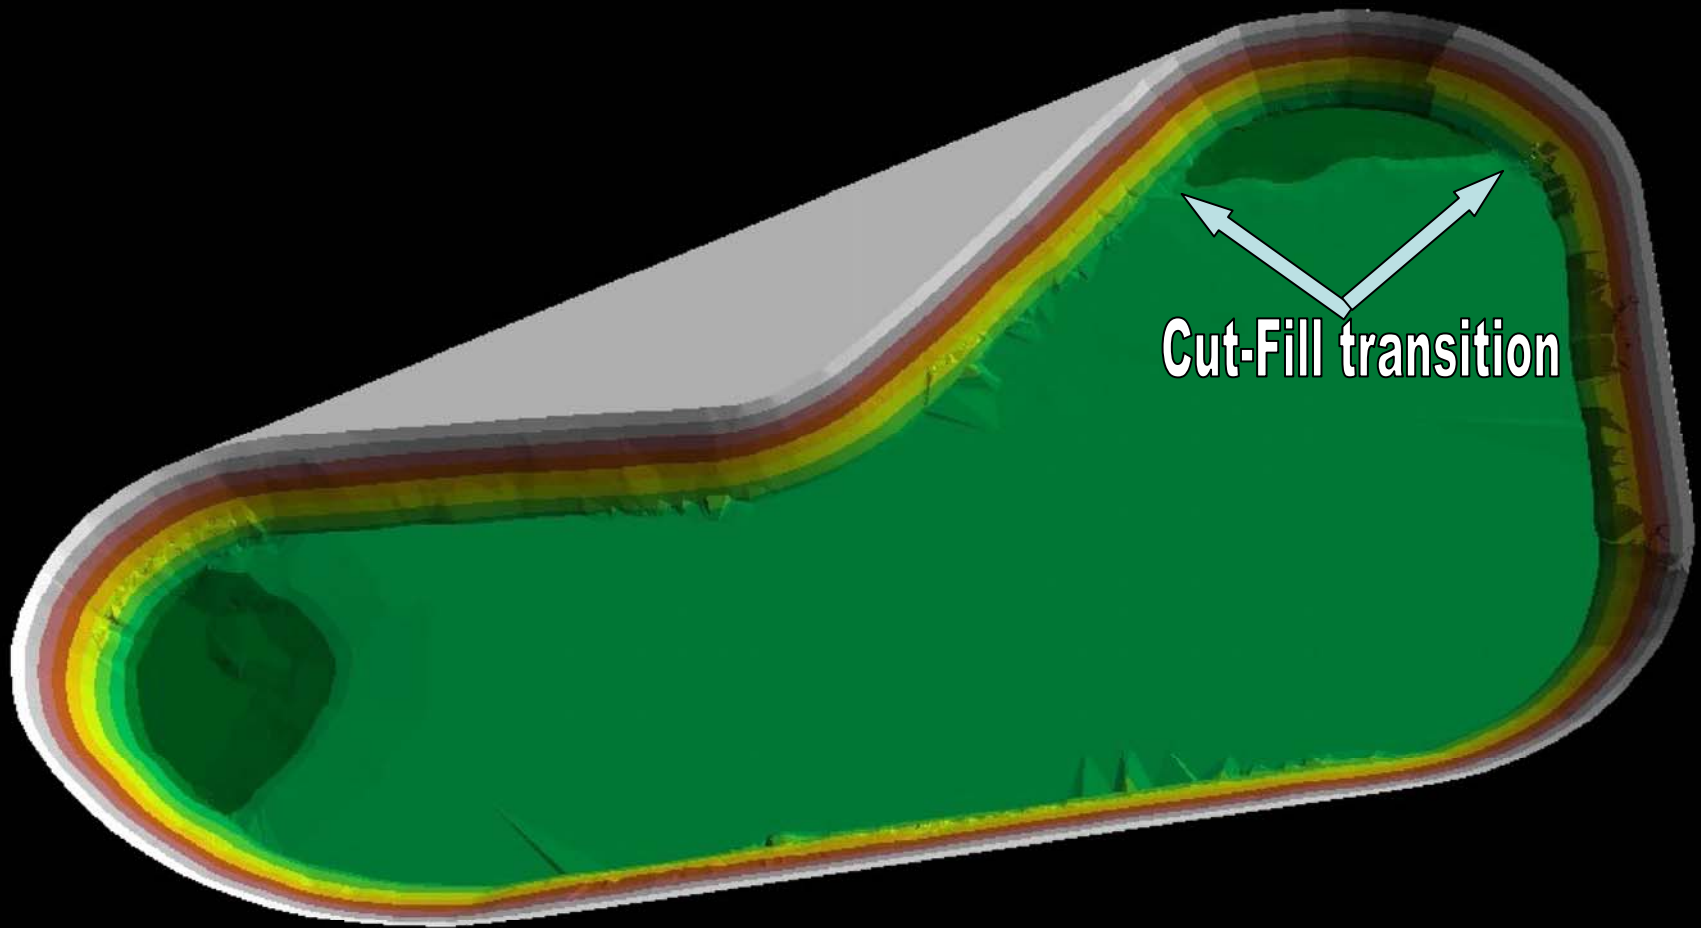
**Figure 8.4 – Aerial Survey of empty upper reservoir**

- **The cut-fill wedge at the northwest corner of the reservoir, which experienced extra-normal settlement.**

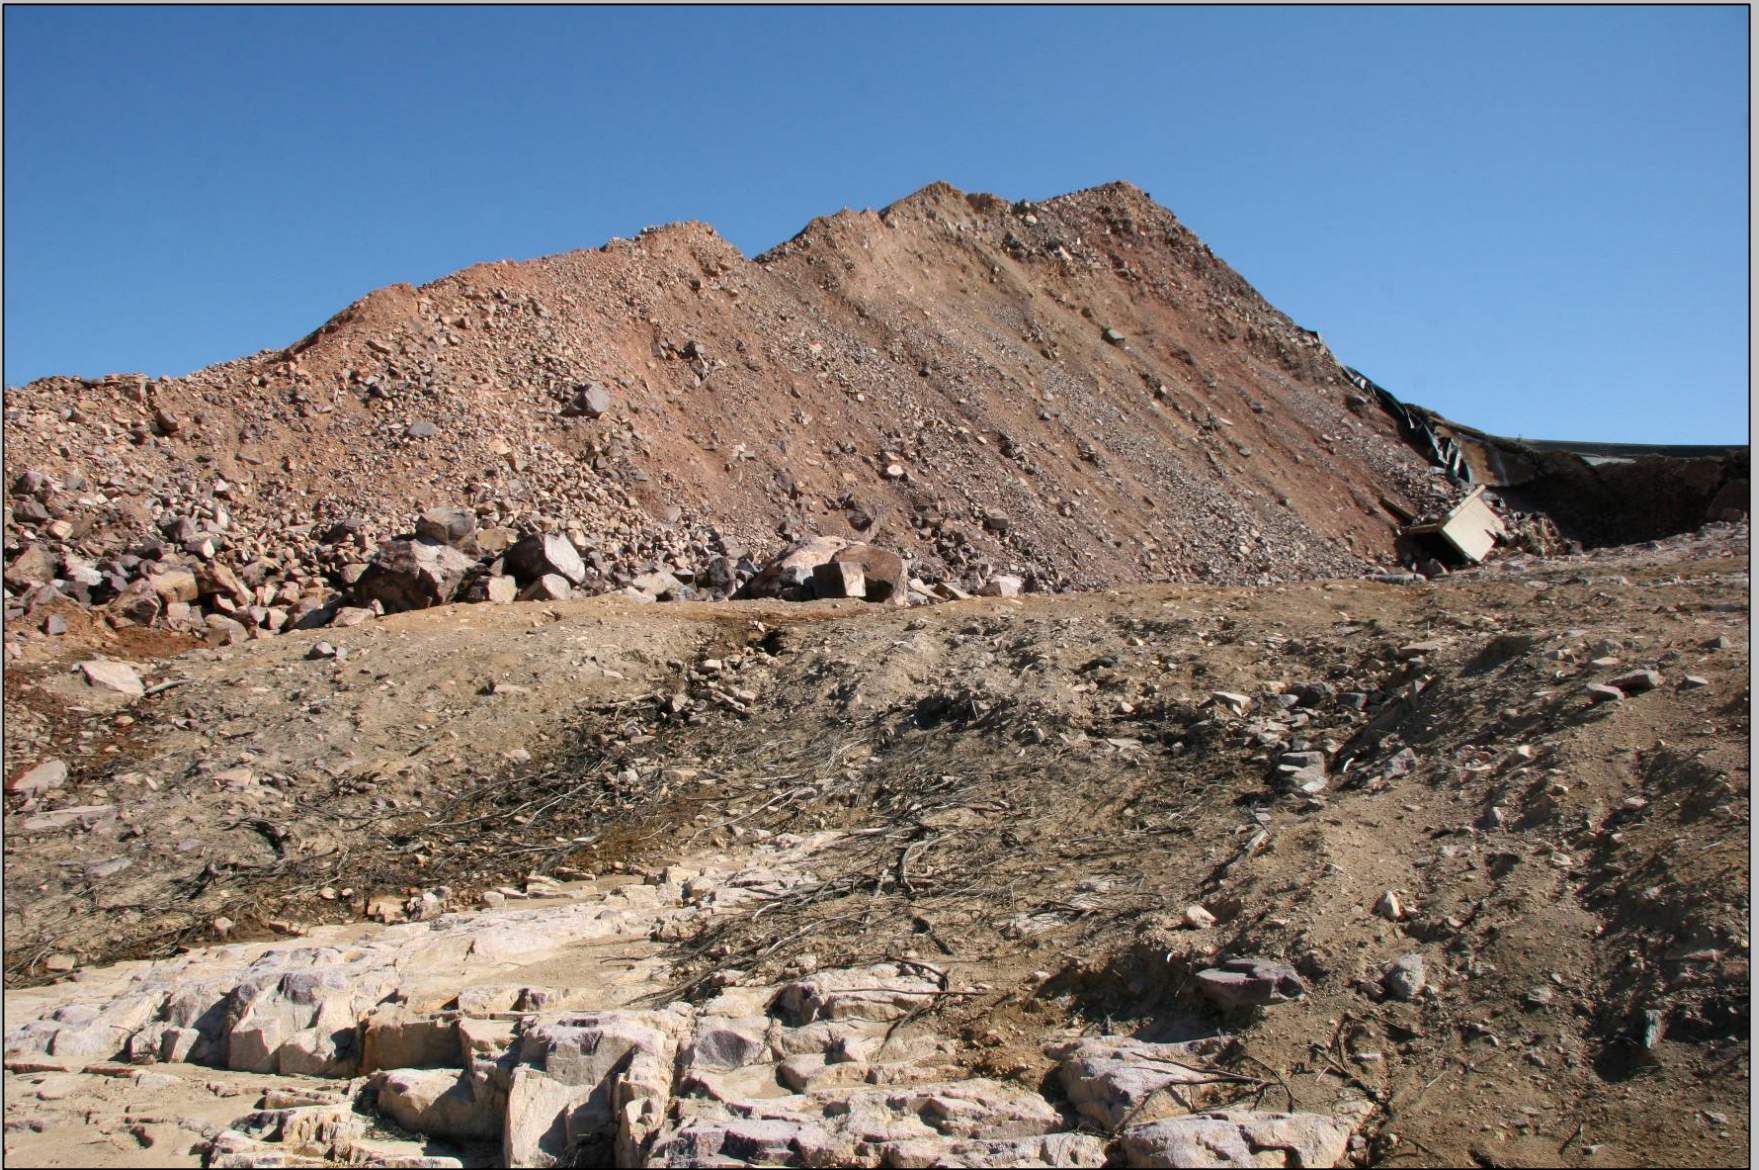
- **Specifications called for the removal of all soil beneath the rockfill embankment. Any remaining soil should have been no greater than 2 inches in thickness and well saturated before placement of the rockfill.**
- **Up to 18” of native residual soil was found beneath the embankment during drilling.**
- **This may have contributed to the shifting/settlement of the embankment and resulted in lower strengths at the foundation interface.**

**Much of the residual soil cover and organic debris (shown here) was left in place beneath the northwest corner of the reservoir, and exposed after the failure.**

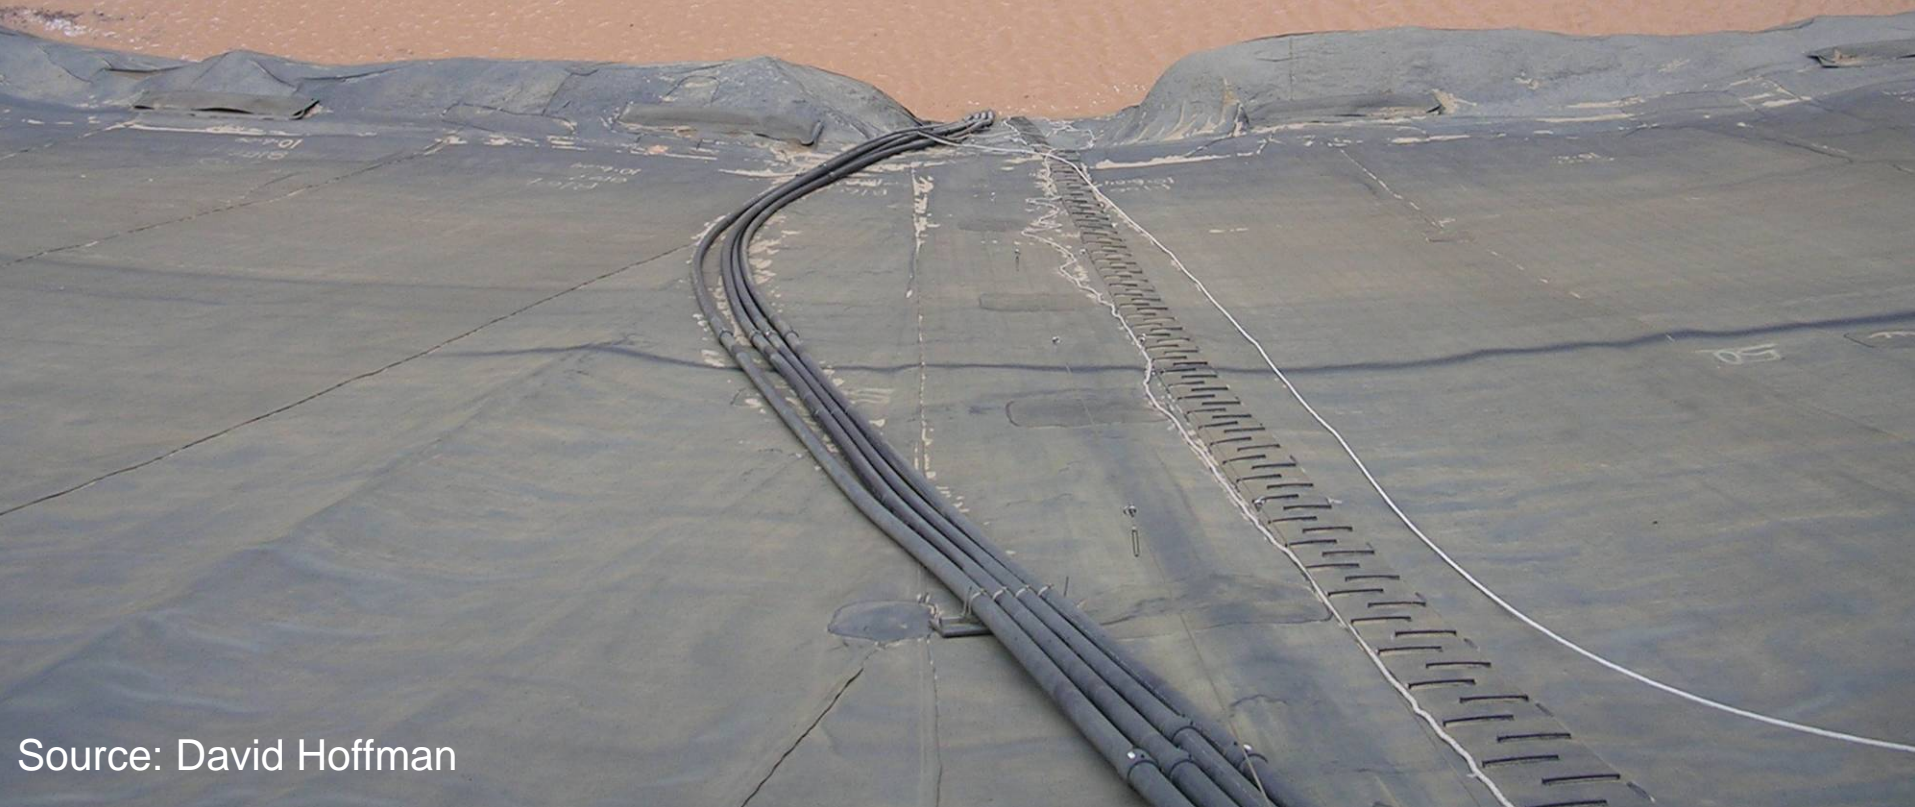
- The four pipes were held bound together by four U-bolts fastened to a piece of hardware called a unistrut. This hardware came apart as the turnbuckles loosened, allowing pipes to separate. This reduced the cumulative stiffness of the pipes, allowing them to deflect easier under the cyclic loading of reservoir filling/draining.

# **FAILED UNISTRUT ASSEMBLIES AND DEFLECTED SENSOR CONDUITS**

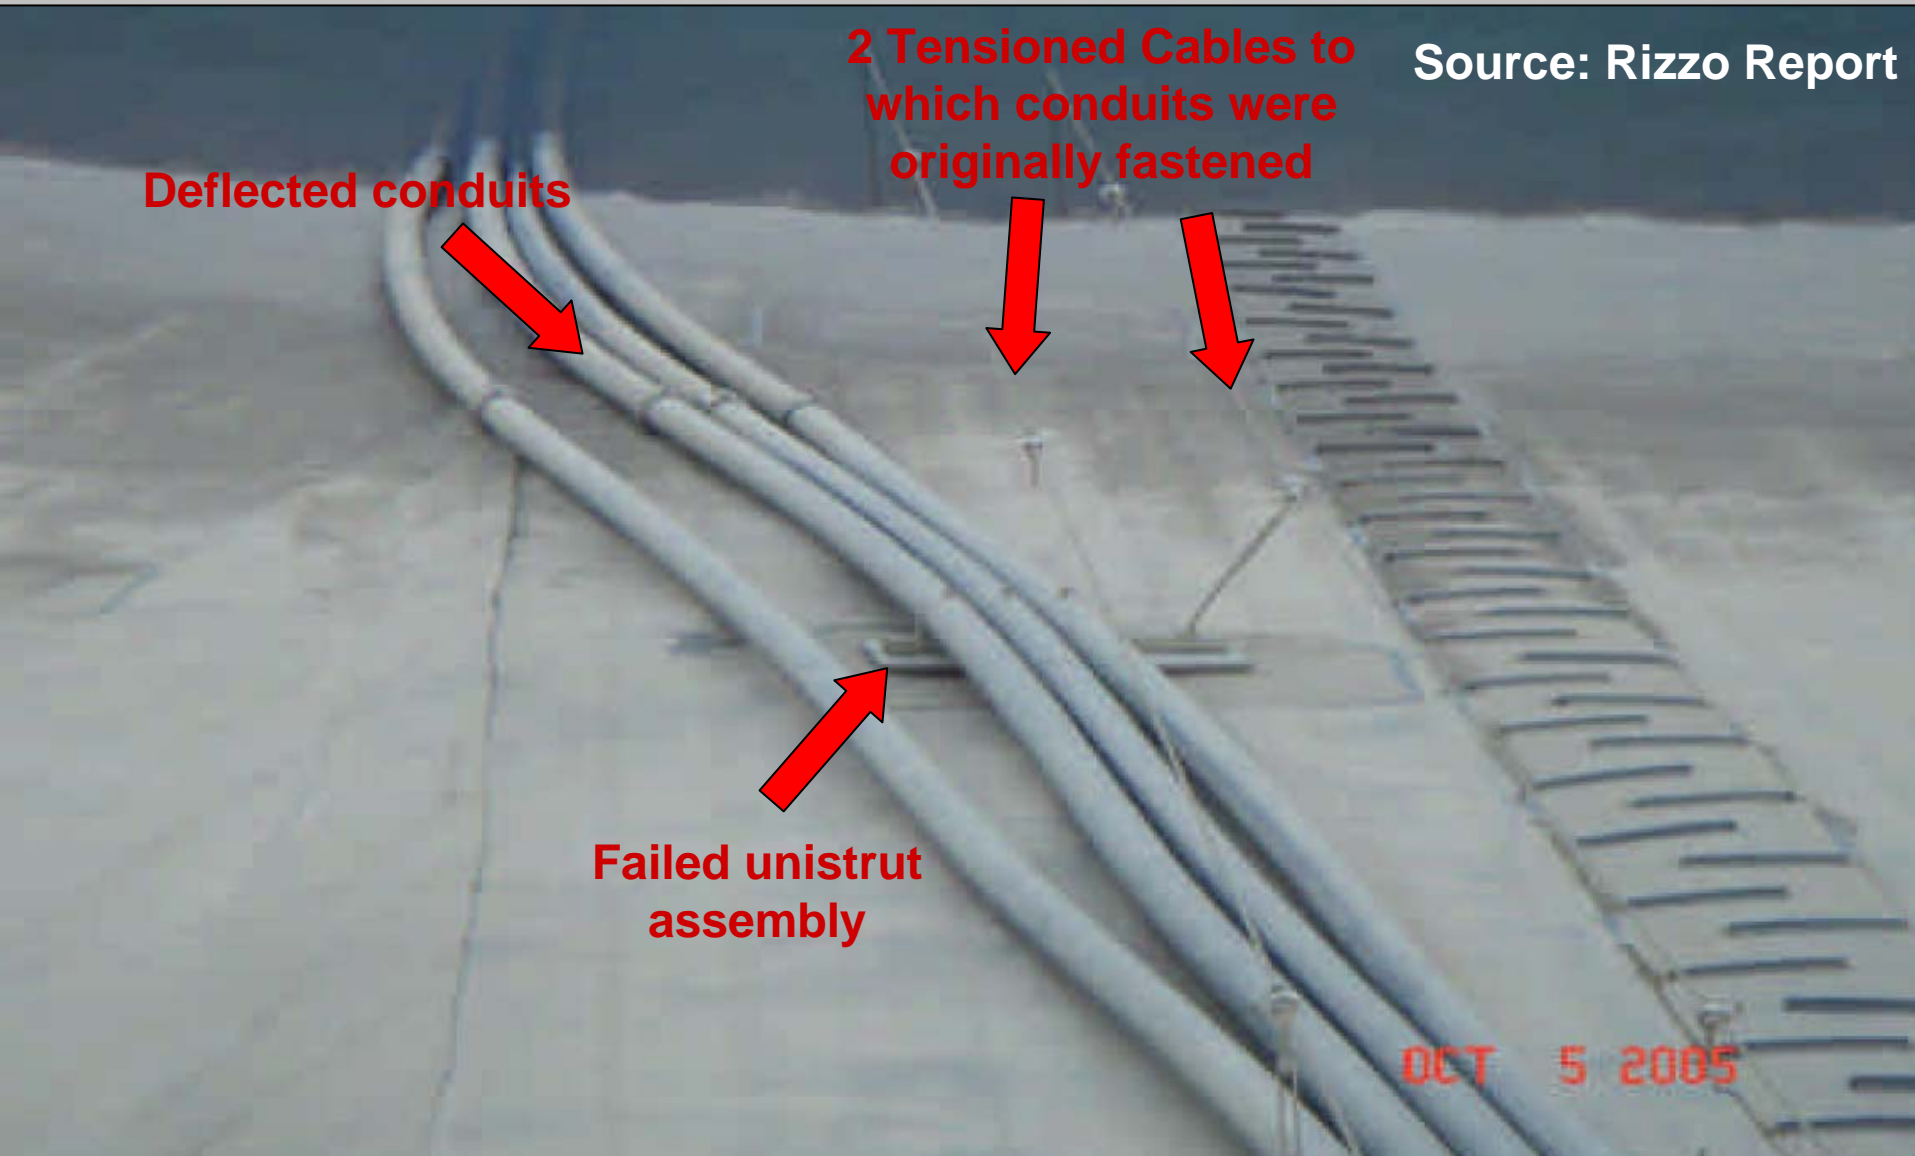
OCT 5 2005

# FAILED UNISTRUT ASSEMBLY AND DEFLECTED SENSOR CONDUITS

Failed unistrut  
assembly

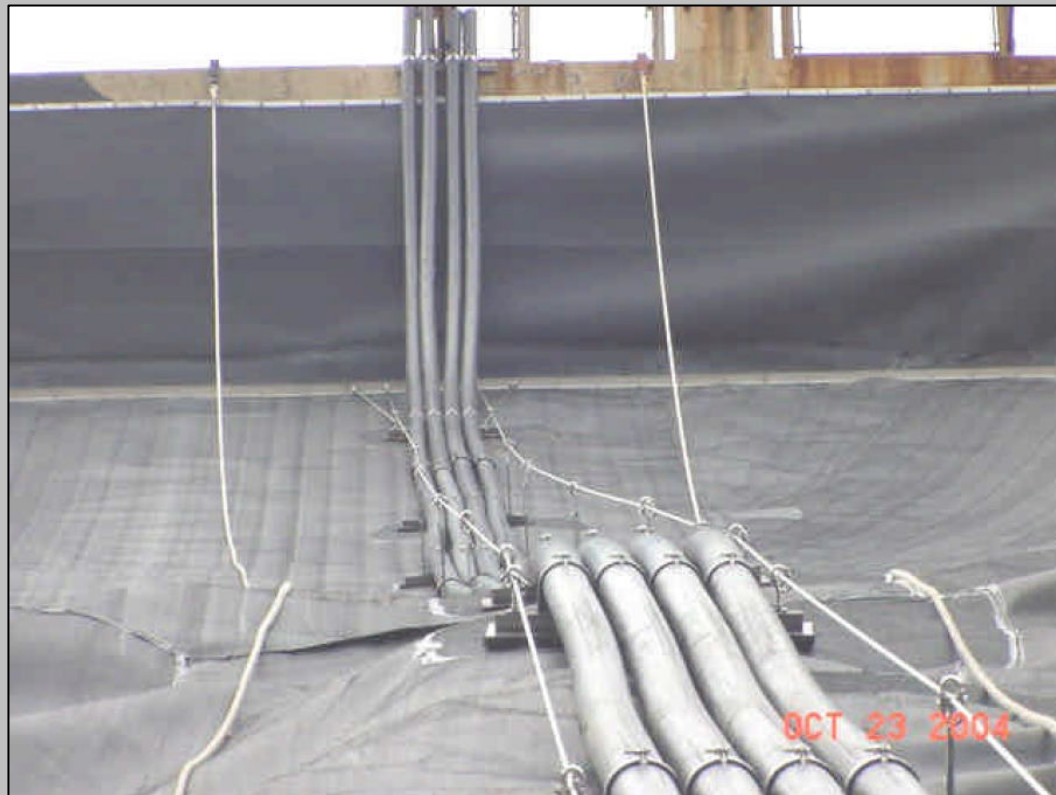
# 7. “FAIL SAFE” PROBES LOCATED TOO HIGH

- The upper reservoir included fail-safe probes to automatically shut down inflow in case the water level indicators within the reservoir malfunctioned.
- Due to the differential settlement of the embankment and parapet wall, these probes were located **ABOVE** the lowest points along the crest of the parapet wall at other locations.
- The reservoir level was observed to have risen within 4 inches of the wall crest two days after the “Niagara Falls” overtopping, but the auto-stop probes failed to activate. Some wetness on the parapet walls indicated minor overtopping. The maximum level of these fail-safe probes was then lowered, but the conduits likely continued to deflect, so that sufficient freeboard was lost by the time of the fatal overtopping on Dec. 14th.
