The 2005 Upper Taum Sauk Dam Failure: A Case History

J. DAVID ROGERS¹

Key Terms: *Dam Failure, Residuum, Fill Contamination, Overtopping-Induced Erosion*

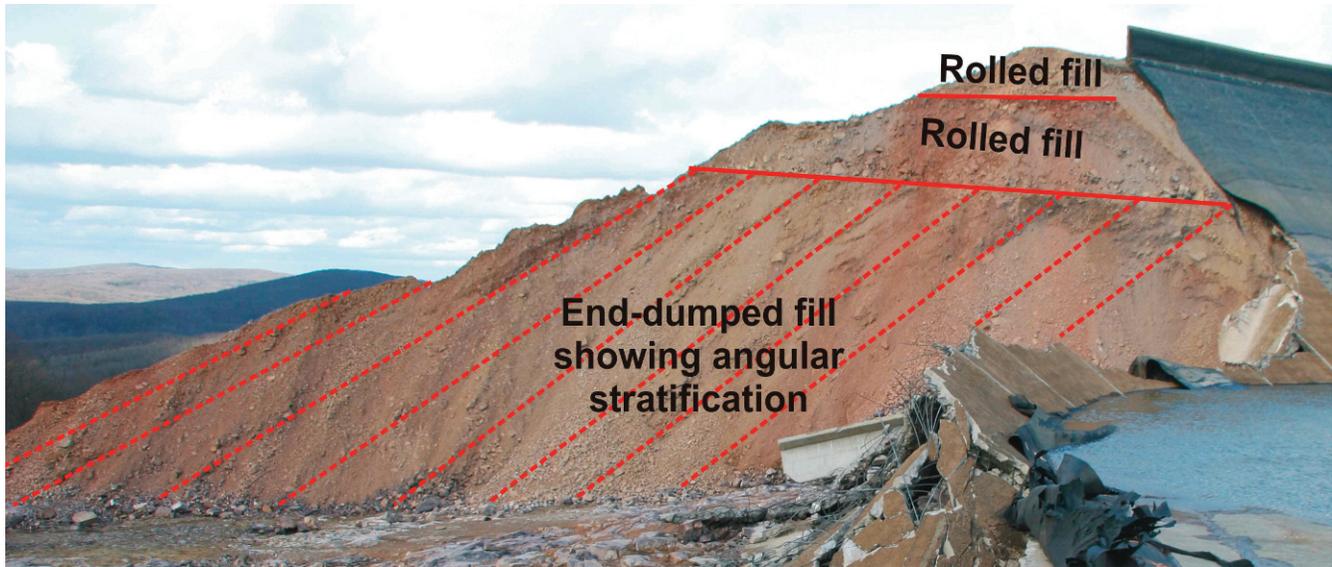
sprayed with a jet of water to help consolidate the mass and fill in voids. The embankment materials were not mechanically compacted until the upper 16 ft (4.9 m) of fill, which was compacted in four separate 4-ft-thick (1.2 m) lifts. According to the report by the Federal Energy Regulatory Commission (FERC, 2006), this was the “last uncompacted concrete-faced rock-fill dam” constructed in the United States. The boundaries between the different methods of fill placement were easily observed in the breached section of the embankment after the failure (see Figure 7).

Figure 7. North side of the breached embankment reveals that most of the fill was end-dumped while two sequences of rolled fill capped the embankment. There does not appear to have been any significant effort made to mechanically compact the embankment because everyone assumed it would be a relatively clean rock fill.

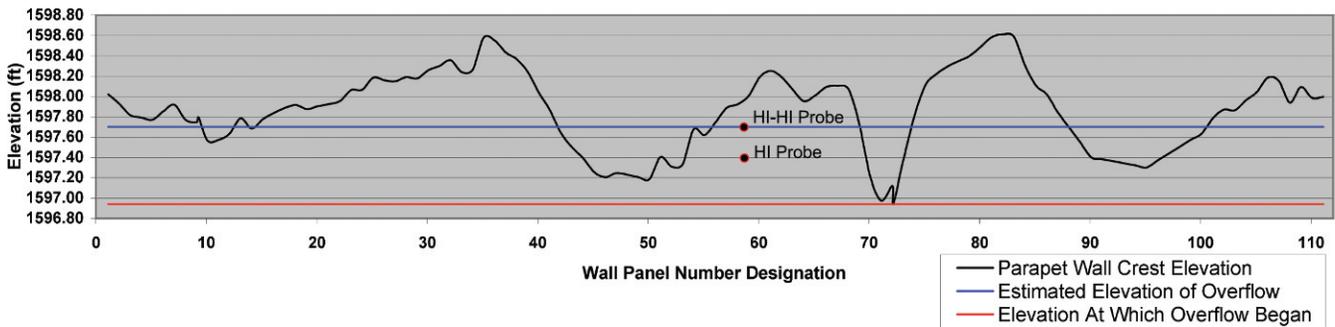
Taum Sauk Upper Reservoir Parapet Wall Crest Elevation
(Using MoDNR Data Collected 3-7-2006)

Settlement continued at a diminishing rate up to the time of failure in December 2005, at which time differential settlements were approaching 2 ft (0.6 m), reducing the crest height of the reservoir's parapet wall (Figure 8). The differential settlement also caused cracking of the concrete lining, which exacerbated ongoing problems with leakage, which also worsened with time (until the geomembrane liner was placed in 2004, described next).

Figure 8. This figure illustrates the differential settlement along the crest of the Upper Reservoir parapet wall and the positions of the Warwick probes at the parapet wall at panel 58. Four segments of the parapet wall were almost 2 ft (61 cm) lower than their original elevation. The elevations of the breached panels (shown here in red) were estimated by AmerenUE after the failure (data from MoDNR, 2006).

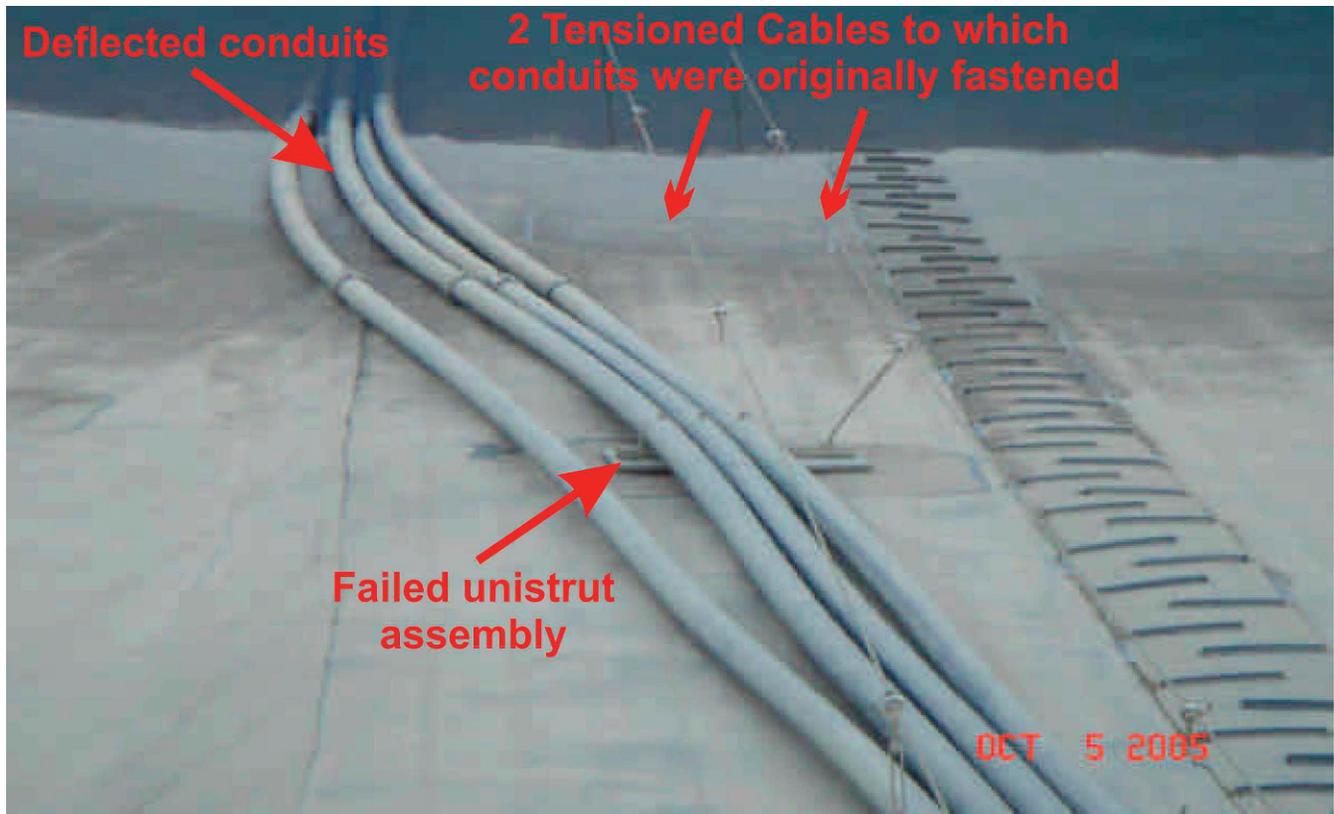
Figure 10. Photo showing the linear distortion of the four reservoir stage instrumentation array conduits after they detached from the unistrut anchors (taken on December 15, 2005, by David J. Hoffman).

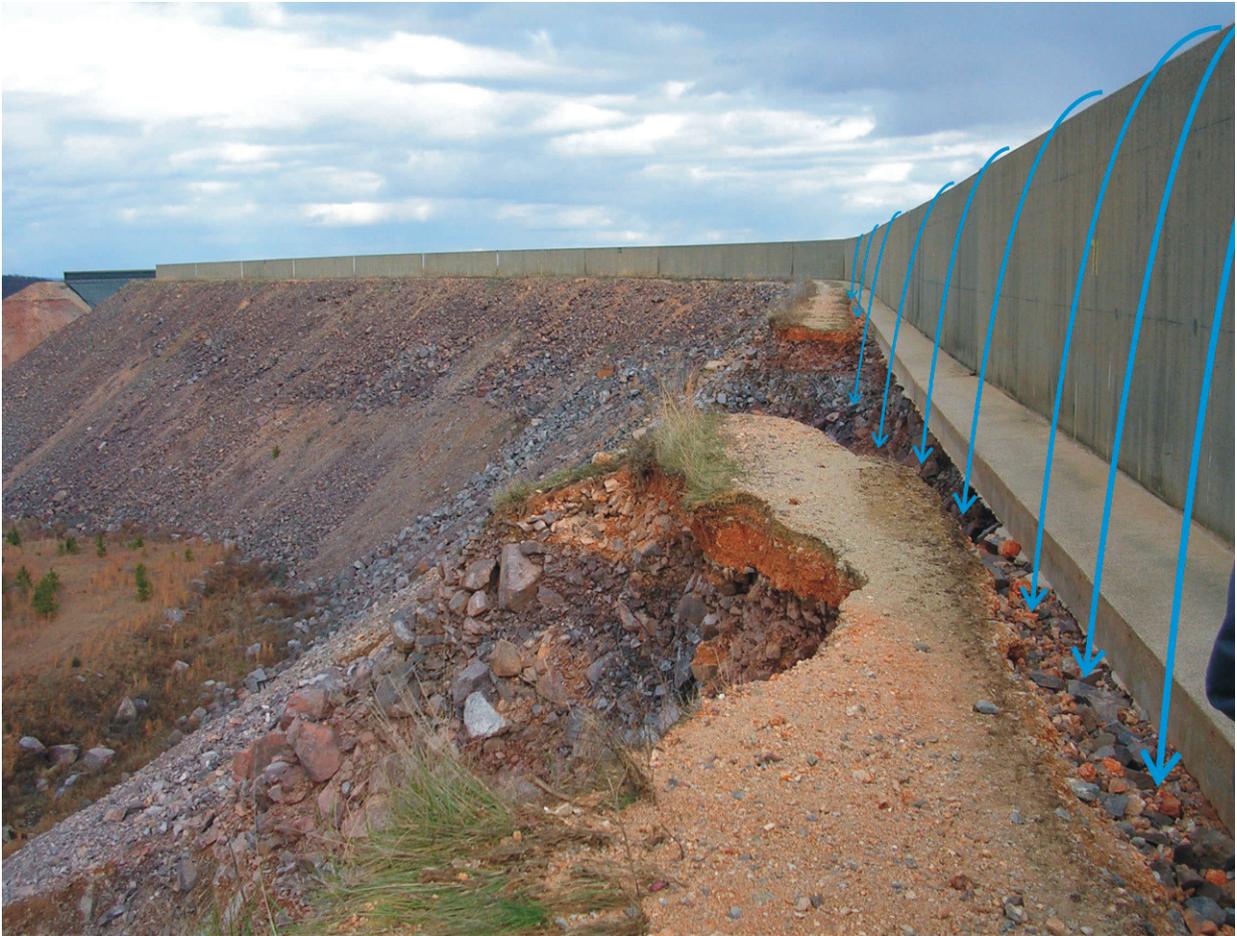
Figure 12. Blue arrows representing the overflow nappe when it began extending beyond the 3-ft-wide (91.44 cm) wall footing and directly onto the underlying rock fill. The rate of scour and erosion increased dramatically at this juncture. At 5:15 AM, only 6 minutes after overtopping initiated, the 60-ft-long (18.3 m) segment near wall panel 95 toppled, unleashing a 15-ft-deep (4.6 m) mass of flowing water over the remaining embankment and concrete liner (Figure 17). Photo courtesy of David J. Hoffman.

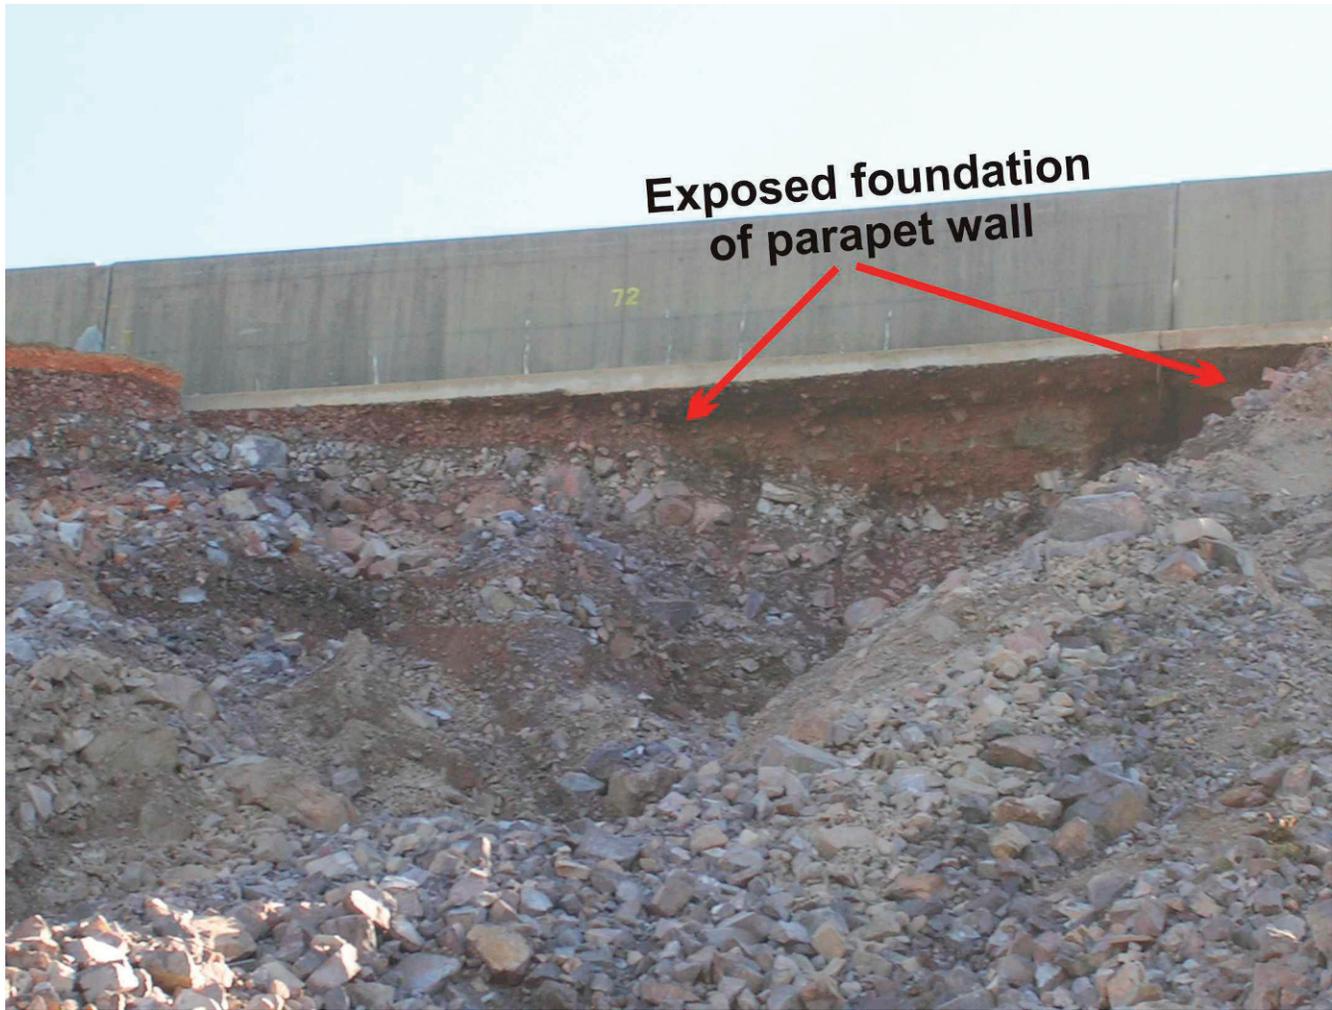
Post-failure observations at panels 10–12, 44–53, and 70–74 suggest that the water quickly scoured deep plunge pools where it poured directly onto the contaminated rock fill, which contained a fine-grained matrix. The eroded debris was rapidly transported downslope and deposited in debris fans just beyond the toe of the embankment. The plunge pool deepened itself within a matter of minutes, displacing the largest clasts onto the rim of the plunge pool. Plunge pools normally excavate themselves to a depth of 1.5 times the free-fall height on level ground, but the steep descending face of the dike (1.3:1, horizontal to vertical) would have exacerbated this situation, allowing for the lateral removal of blocks along the descending slope. This would have allowed a much deeper plunge pool to develop. This inference is drawn from post-failure observations below panels 71–72, shown in Figure 13.

Figure 13. This photo, taken below panels 71–72, shows the plunge pool excavated beneath the parapet wall, which completely undermined the wall and is the basis for Figure 16 (photo courtesy of David J. Hoffman).

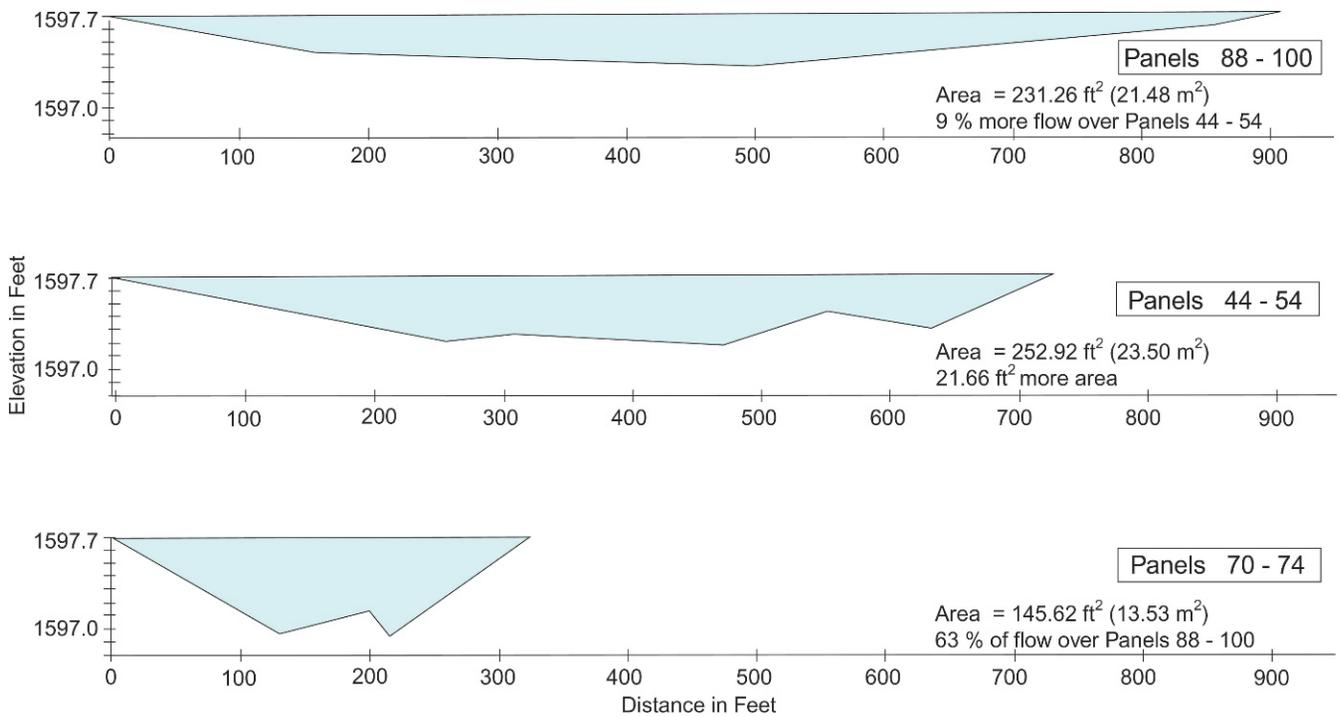
An intriguing aspect of the Taum Sauk overtopping was the apparent contrasts in erodibility between various locations about the embankment. Figure 14 compares the cross-sectional areas of overflowage in the three zones that allowed the greatest volume of water to pass onto the rock-fill embankment. As shown in Figure 11, spillage initiated around 5:03:20 AM at panels 72–73, where the parapet wall had settled the most, to a crest elevation of just 1,596.95 ft (486.73 m). This zone was the most restricted of the three largest spill zones, being only 322 ft wide at the time of failure, when the water reached a level of 1,597.7 ft (486.96 m). Water next began pouring over panel 50 (elevation 1,597.15 ft) about two minutes later (5:06:20 AM). By 5:14 AM, when the water level

Figure 14. Comparative cross sections along the crest of the Upper Reservoir between panels 70 and 74, 44 and 54, and 88 and 101. Note how the greatest cross sectional area and volume of spillage appears to have occurred between panels 44 and 54, not where the breach occurred between panels 88 and 99.

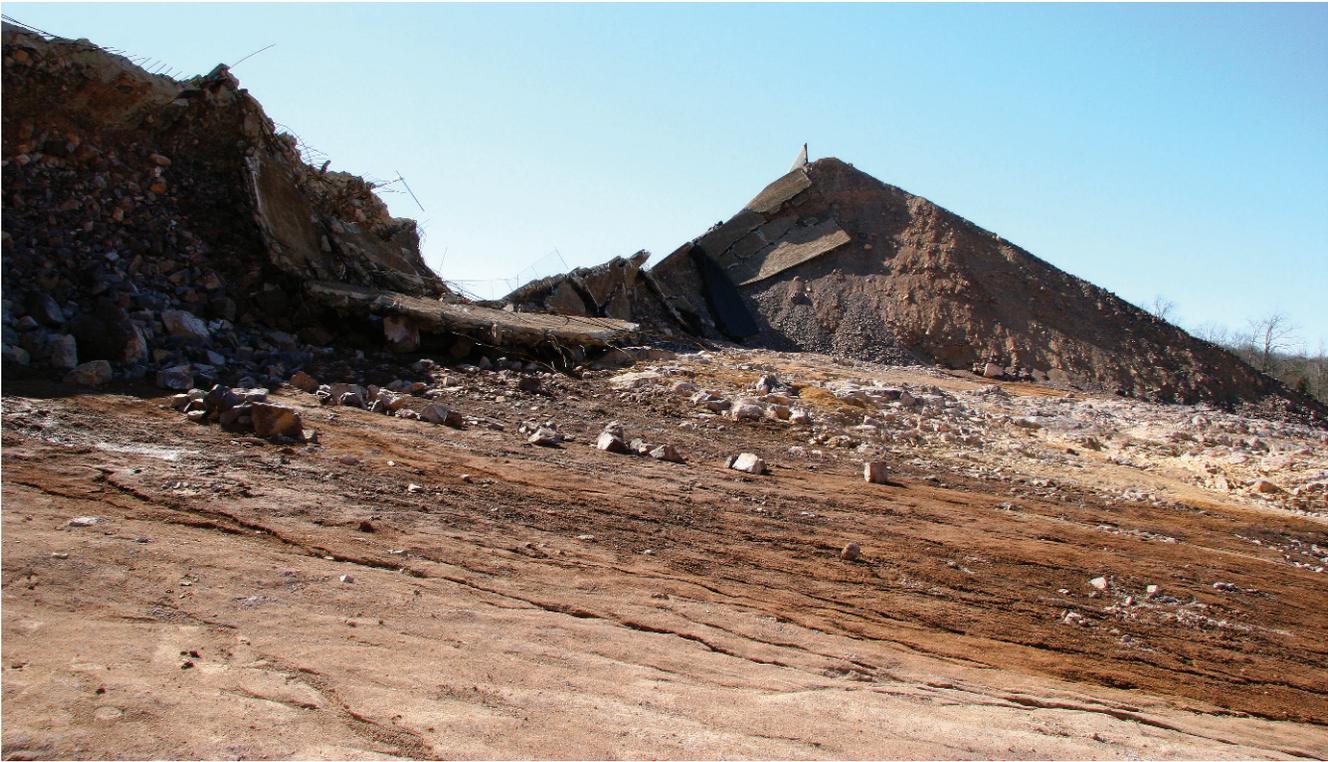
Figure 24. The remnant lip as seen from immediately downslope, the day after the failure.

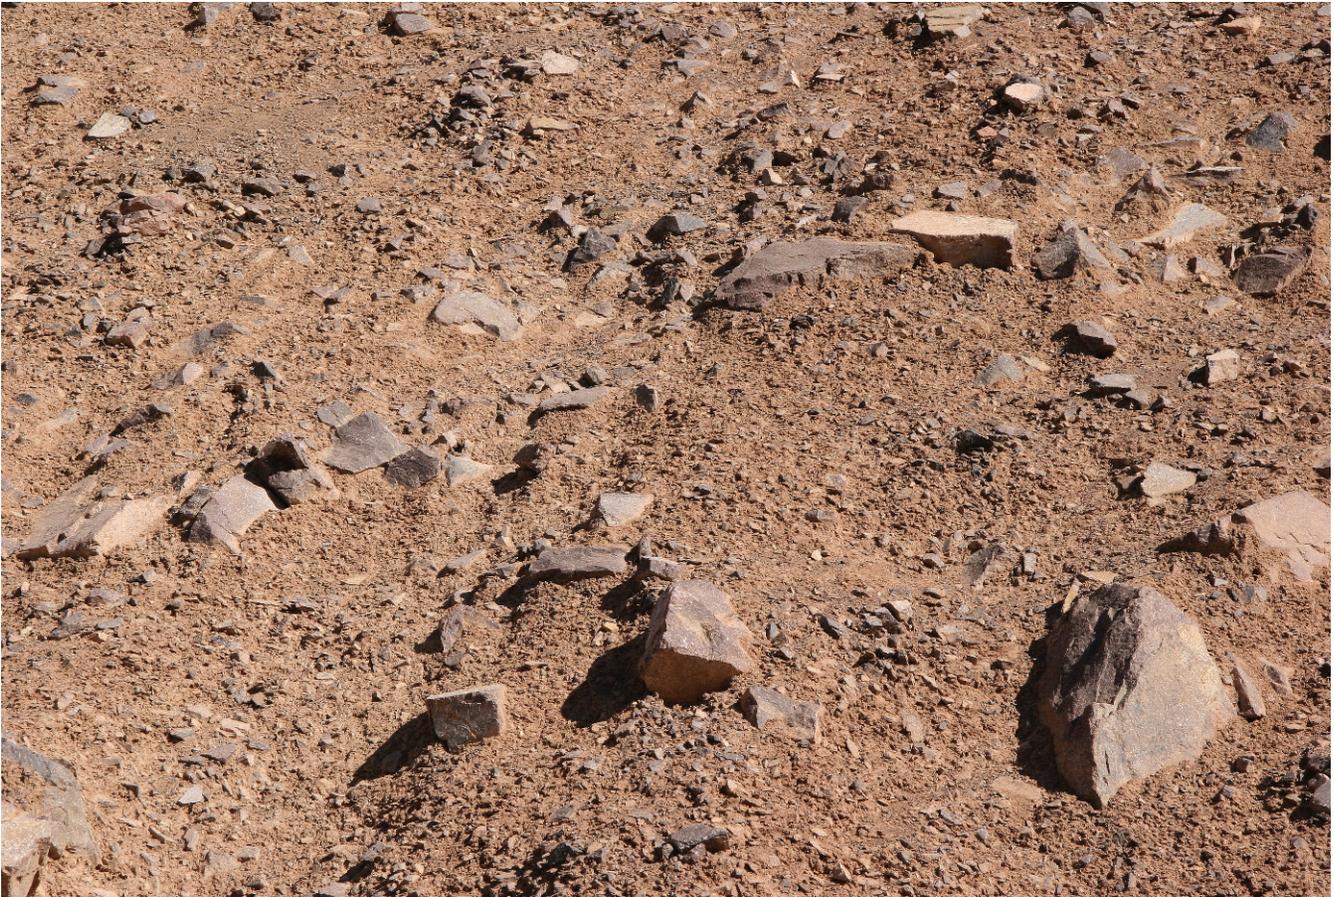
Figure 25. Close-up of the contaminated “dirty rock fill” exposed on lateral margins of the breach. The larger clasts are between 10 and 12 in. (25.4 to 30.5 cm) in diameter.

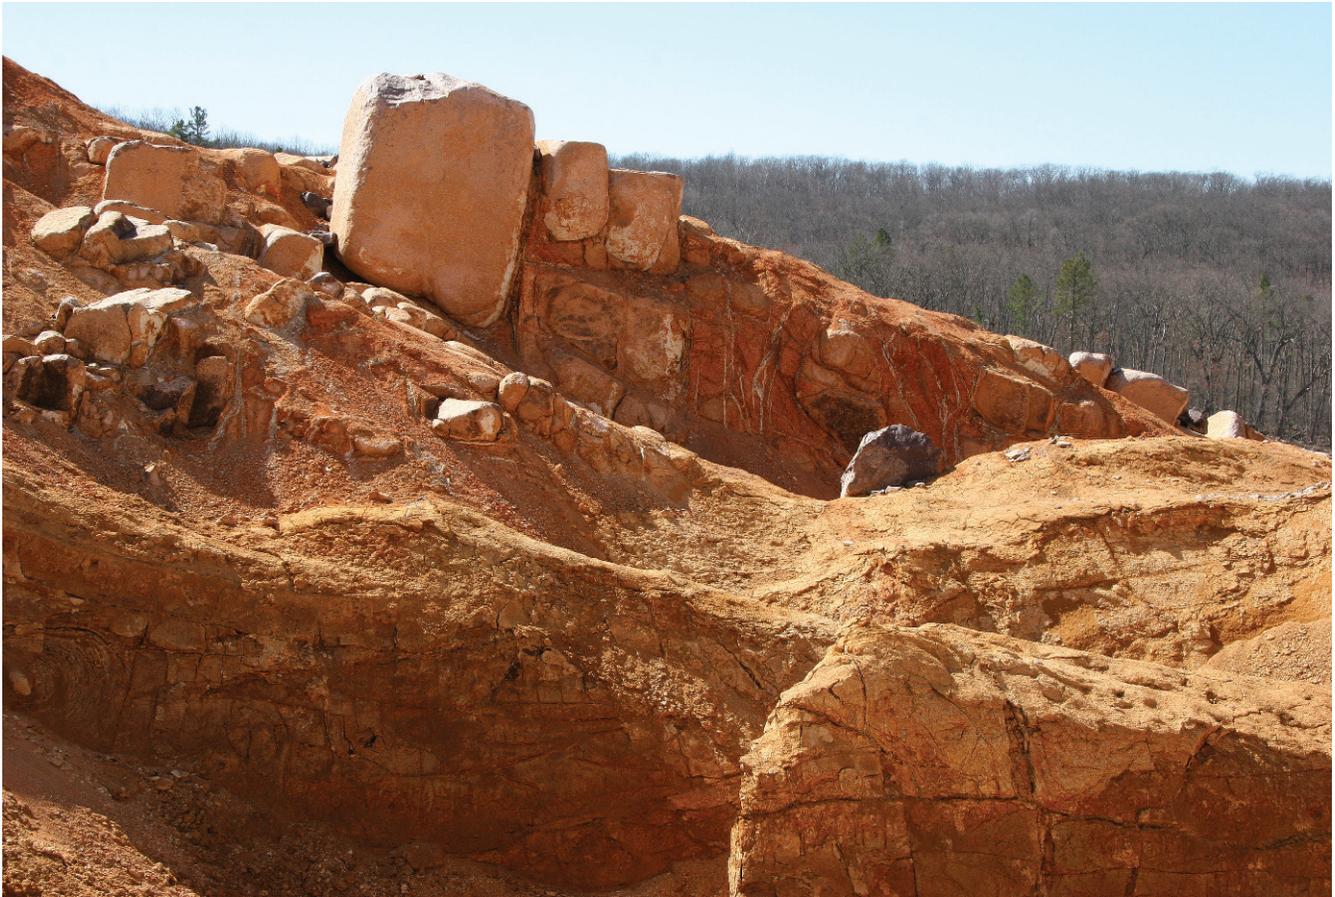
provide adequate bearing for the rock-fill dike. The December 2005 outbreak flood exposed deeply weathered zones in the upper slope of Proffit Mountain. The breach area was underlain by a zone of deeply weathered diabase saprolite, the likely remnant of a disintegrated dike swarm (see Figure 27). Adjacent core stones of granite and rhyolite also exhibited a high degree of weathering, likely from hydrothermal alteration associated with intrusion of the diabase. The weathered diabase exhibited a soil-like texture, though it retained the rock's original fabric and fracture patterns. Core stones and remnant spheroidal weathering rinds were also visible (Figure 27).

Figure 27. A zone of deeply weathered bedrock (saprolite) on the upper slopes of Proffit Mountain appears to have formed due to the disintegration of a diabase dike or sill and nearby hydrothermally altered granites.

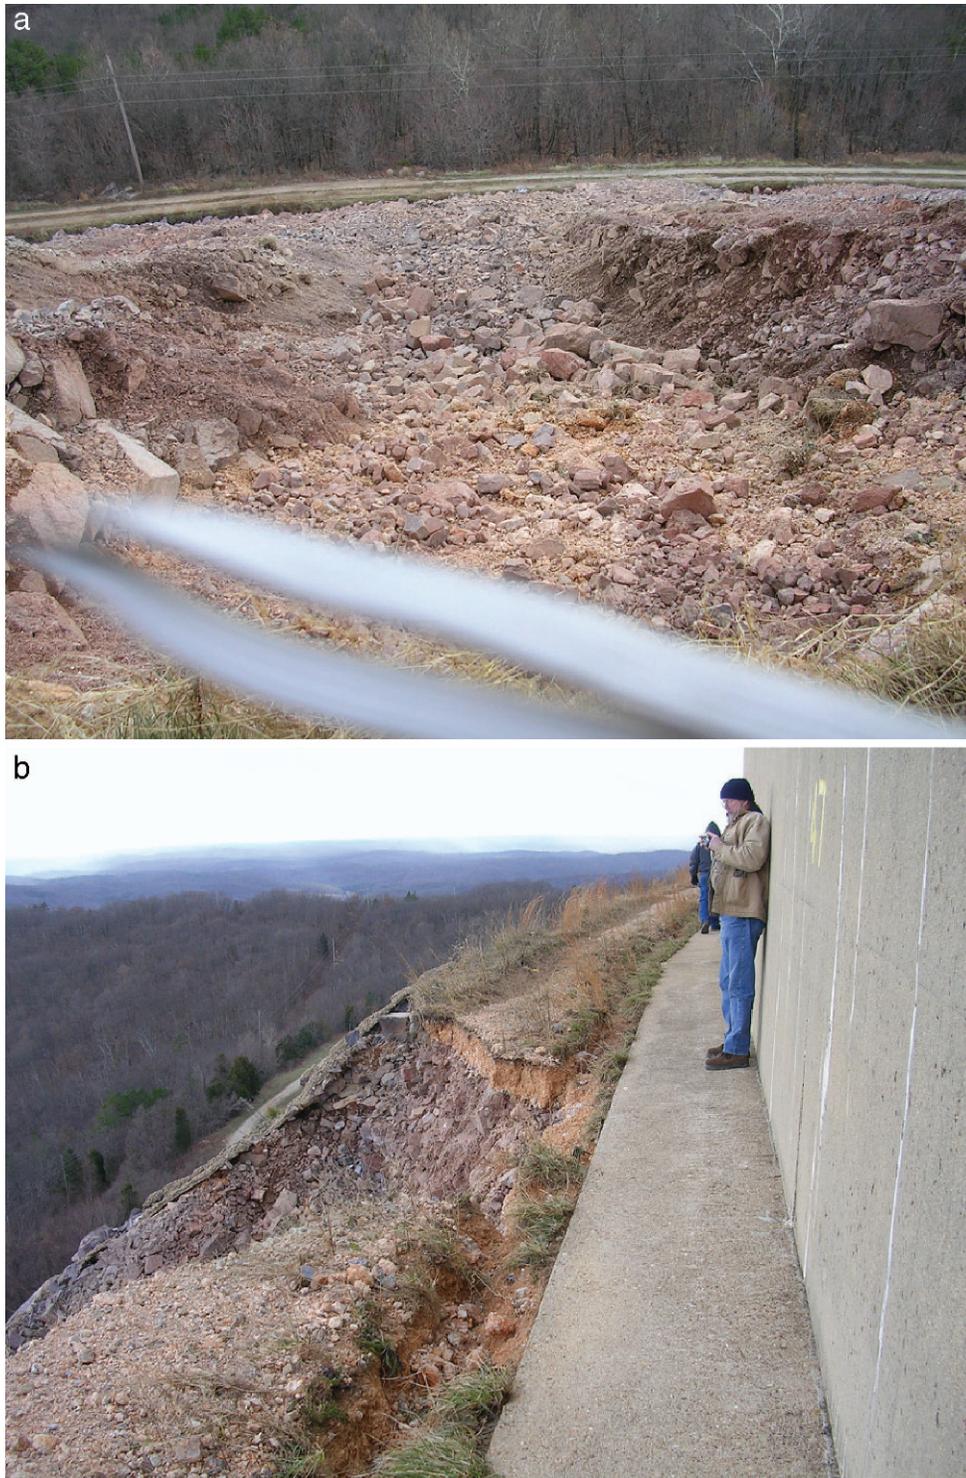
A somewhat less intuitive aspect is the erosion of the embankment face, known as rill erosion, which is shown to good effect in Figure 30. Rills are erosion gullies caused by the running water when velocities exceed the critical shear stress of those materials. These contrasts can be clearly seen at the toe of the slopes at panels 70–74 (Figure 13) versus those at the toe of panels 44–54, which exhibited 1- to 8-ft-deep (0.30 to 2.44 m) rills (Figure 30). It would appear that eroded materials were being rapidly deposited along the lower quarter of the embankment, approaching the toe of the slope and transition to the native grade. Materials were being deposited in this area so rapidly that a massive rotational slump began to translate along the lower third of the embankment slope. This incipient slumping was likely being promoted by the sudden deposition of so much material, and excessive pore pressures developing in the lower slope due to the accretion of the infiltrated seepage, likely perched on the embankment-bedrock contact. This situation was also exacerbated by the diminishing cross-sectional area of the embankment in this same area, where the rock fill was placed over a steeply inclined descending slope. This slope would likely have collapsed within a few minutes had the embankment between panels 88–99 not failed first.

Figure 30. a: Embankment erosion at panel 47, on the southeast side of the Upper Reservoir, the day after the failure. After the spillage penetrated the cohesive road-base cover (light pink color) for the crest road, it rapidly eroded the underlying rhyolite rock fill (lavender color) in a series of deep rills, caused by coalescing flows. The upper slopes in this area had been armored with shotcrete to abate excessive erosion from rainfall-induced runoff (photo by David J. Hoffman). b: Deep rill erosion below panel 46, on the southeast side of the Upper Reservoir, the day after the failure. This rill was about 40 ft (12.2 m) wide and 8 to 10 ft (2.4 to 3 m) deep. Note the contamination of the rock fill by 3 to 15 percent fines, seen in the exposed shoulders of the rill. These fines had been sluiced out of the fill within the rill by the high-velocity discharge (photo by David J. Hoffman).

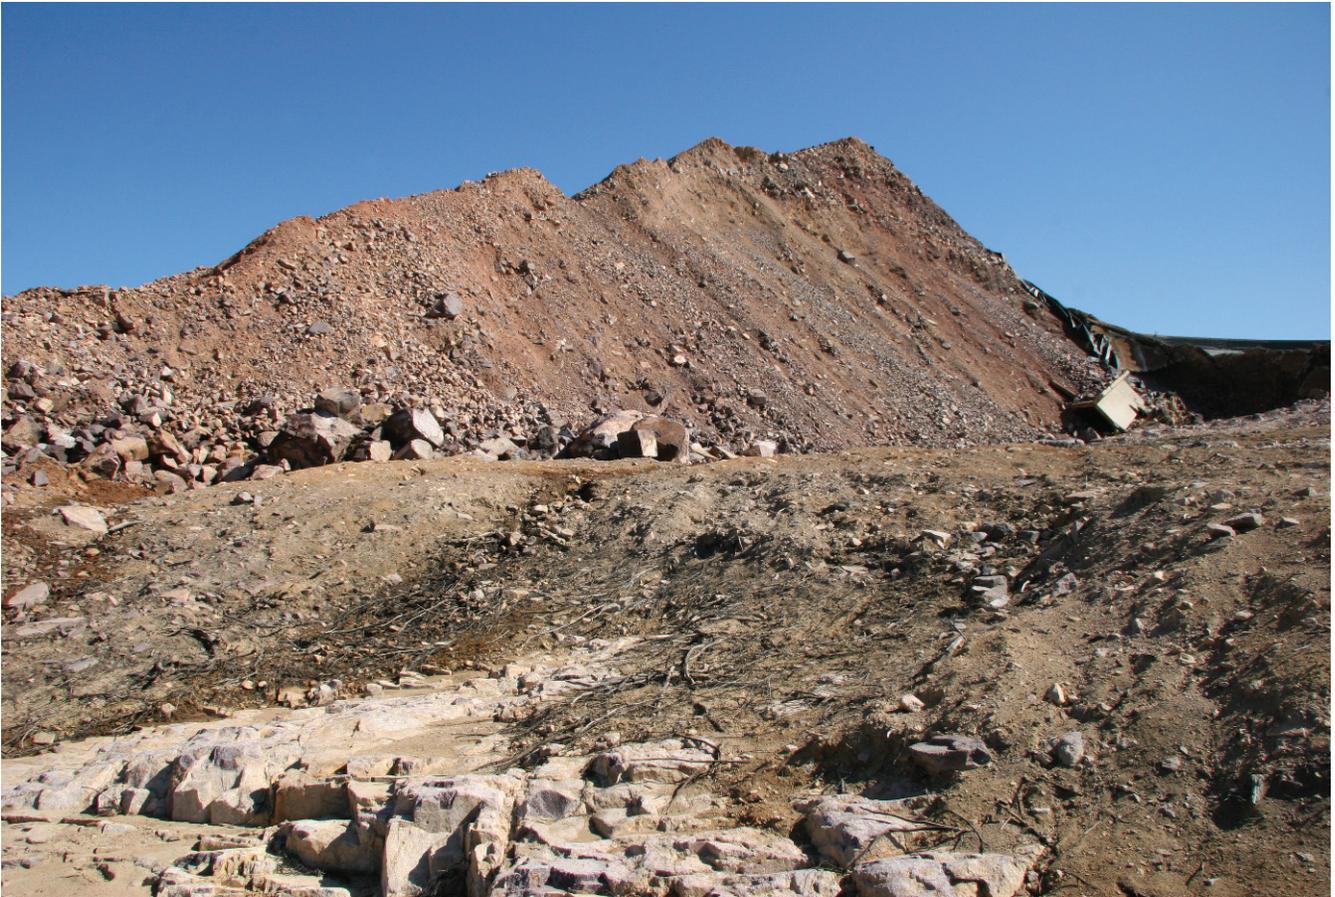
Figure 31. Residual soils, including tree roots, were observed in-place beneath the “plinth area” in the northwest corner of the Upper Reservoir, where a portion of the embankment was founded on as much as 10 to 16 ft (3 to 4.9 m) of residuum and a thin layer of rock fill.

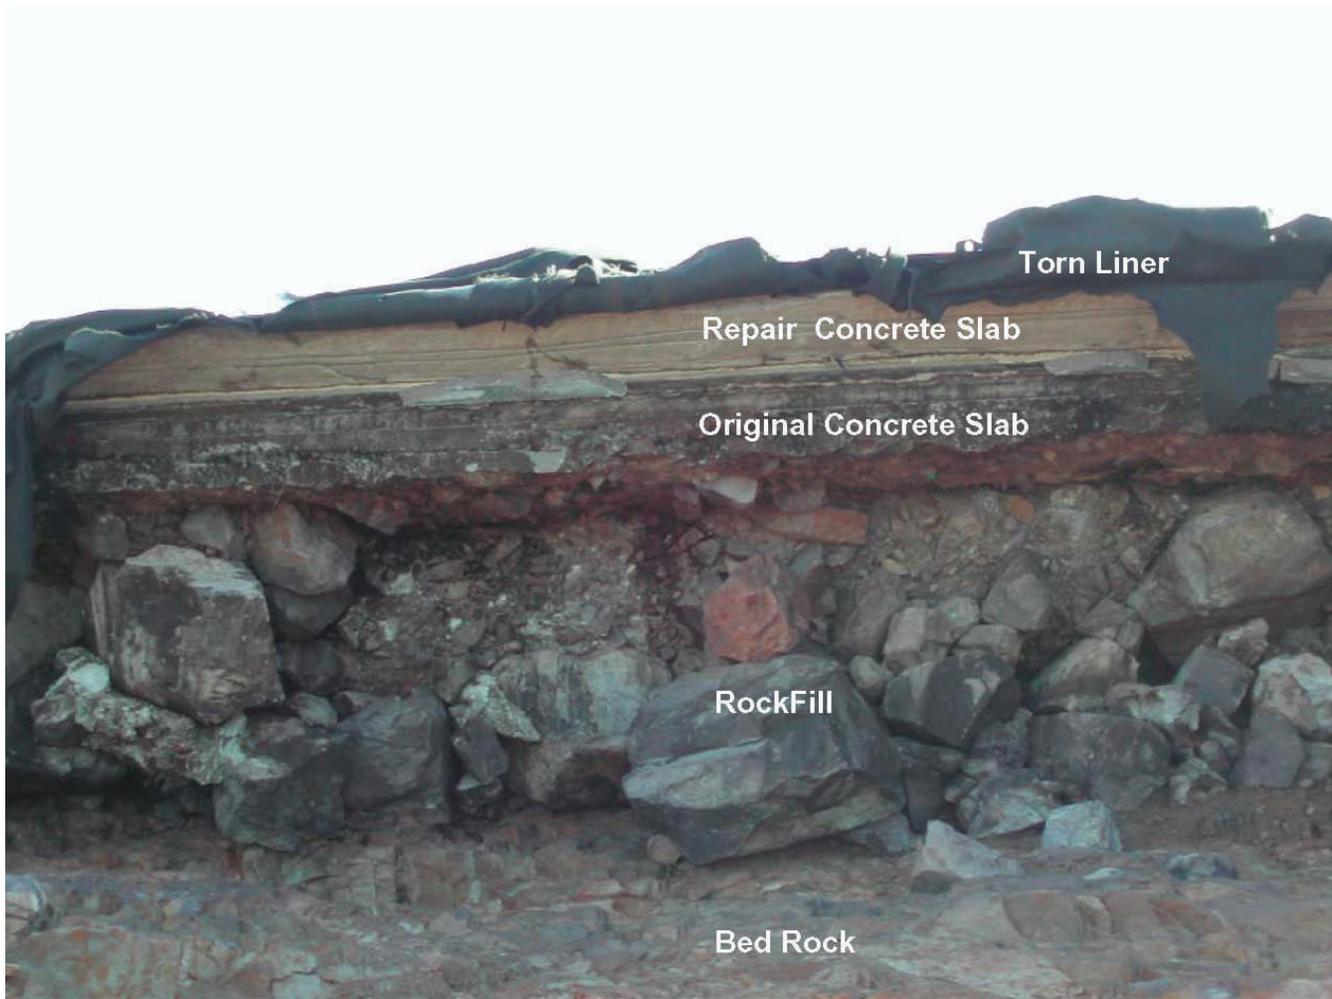
Figure 32. Rock fill exposed in the plinth beneath the northwest corner of the Upper Reservoir. Several feet of clean rock fill was placed over the rhyolite bedrock, and then covered with a 4-in.-thick asphalt liner, which failed miserably under uplift when the reservoir was initially filled in 1963. The asphalt was replaced by several generations of reinforced concrete mats in 1963 and 1964, which were subsequently covered by the HDPE geomembrane liner in 2004 (taken from FERC Taum Sauk Investigation Team, 2006).
