# INVESTIGATION OF LEVEE PERFORMANCE IN HURRICANE KATRINA: Levee Failures Along the Inner Harbor Navigation Channel

J. David Rogers, Ph.D., P.E., R.G., C.E.G., C.HG.

**OVERVIEW:  
East Side IHNC  
Failures  
During Hurricane  
Katrina**

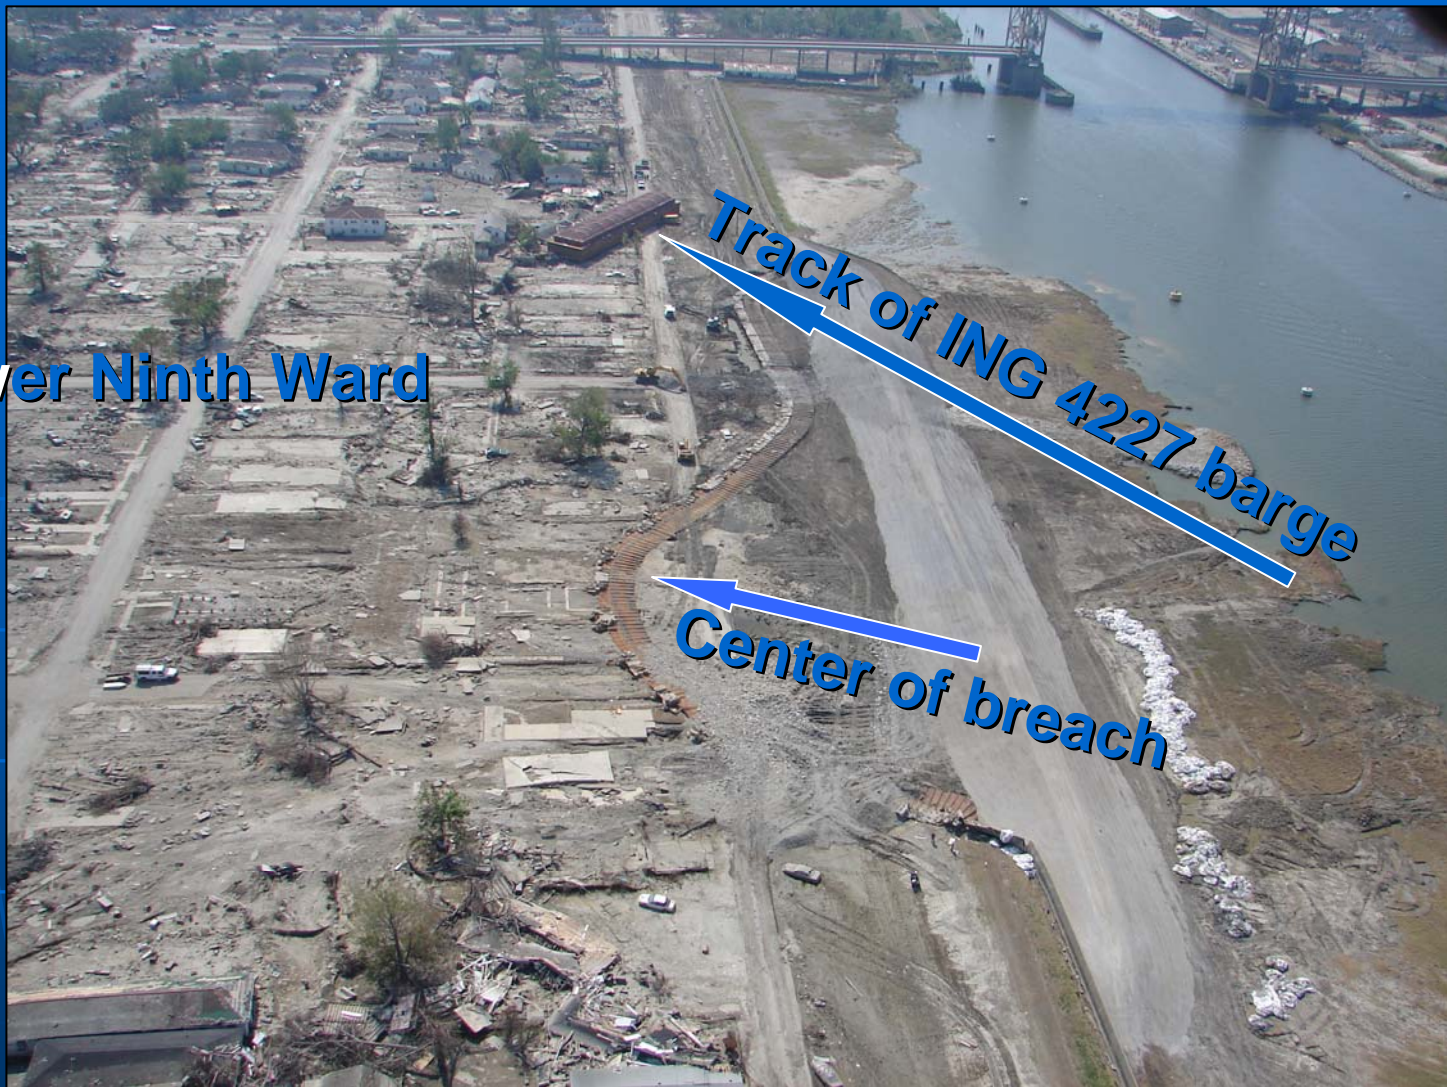
- **Aerial view of the 900 ft long south breach of the Inner Harbor Navigation Channel (IHNC) in the Lower Ninth Ward. View looking south.**

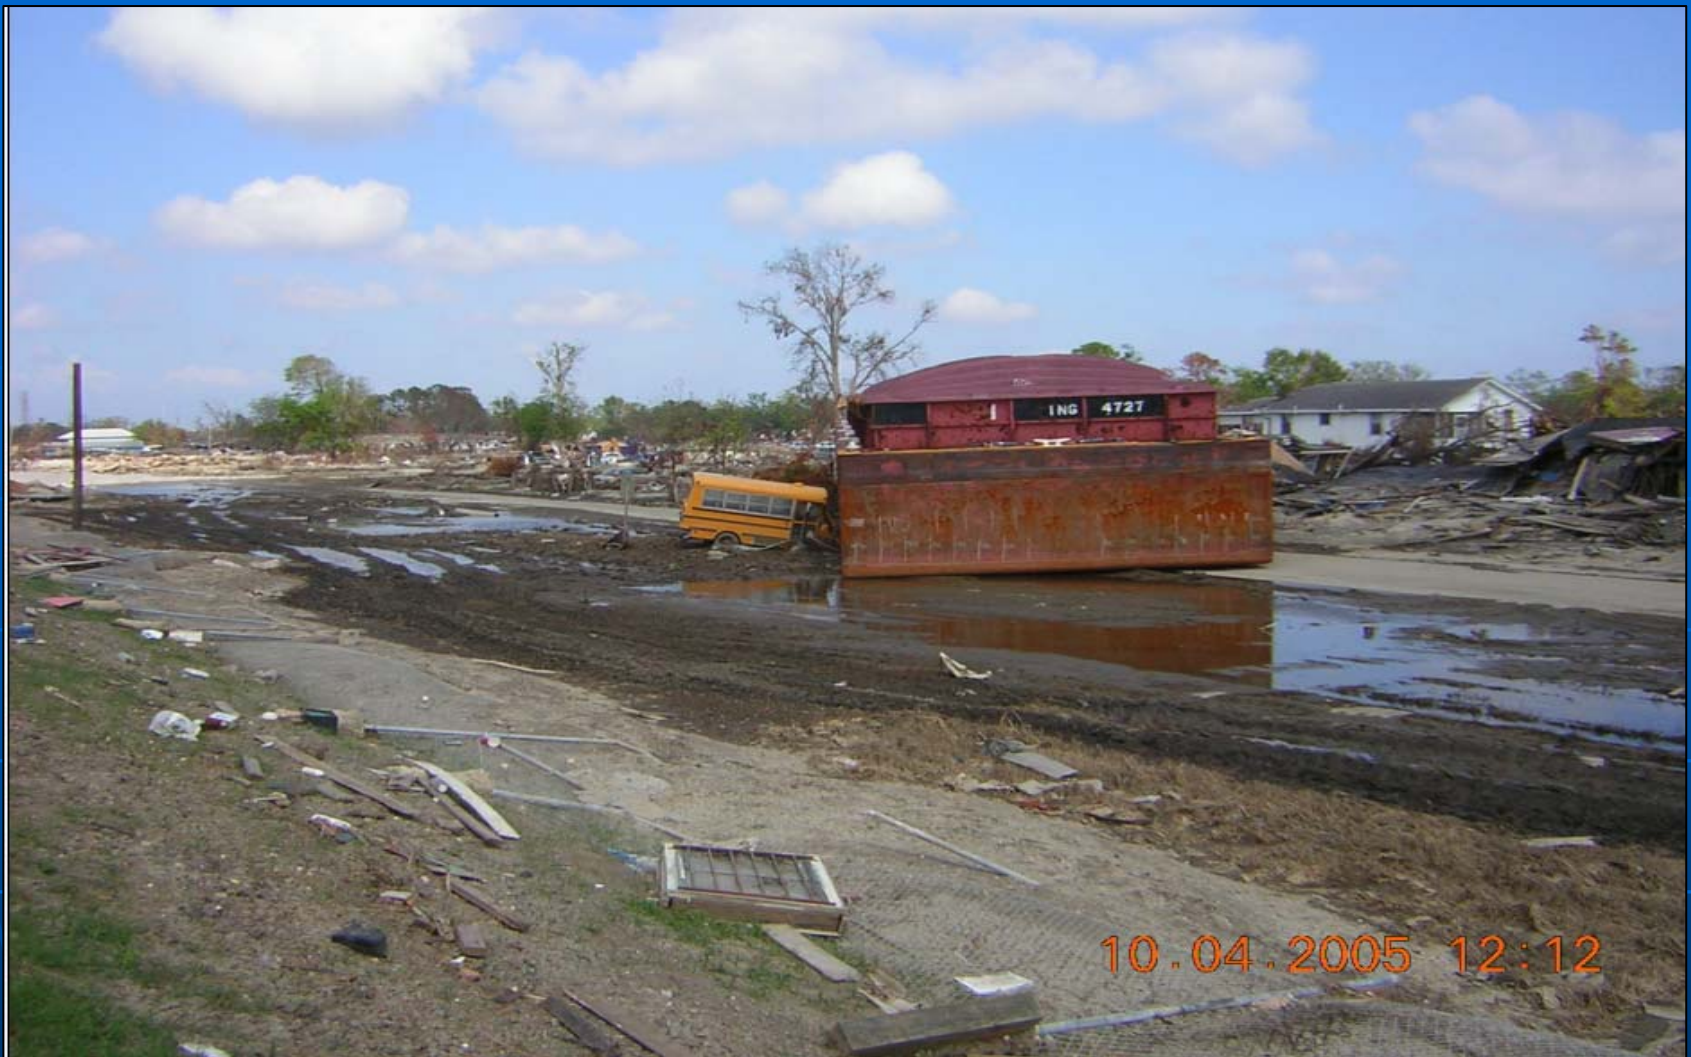
- **ING 4727** was built in 1990 as a dry cargo cover-top barge with a steel hull. It was 200 feet long, 35 feet wide, and 12 ft high, with a cargo volume of 84,659 ft<sup>3</sup> (1877 tons). It was being leased to Lafarge North America and was tied up along the MRGO-IGWW channel.

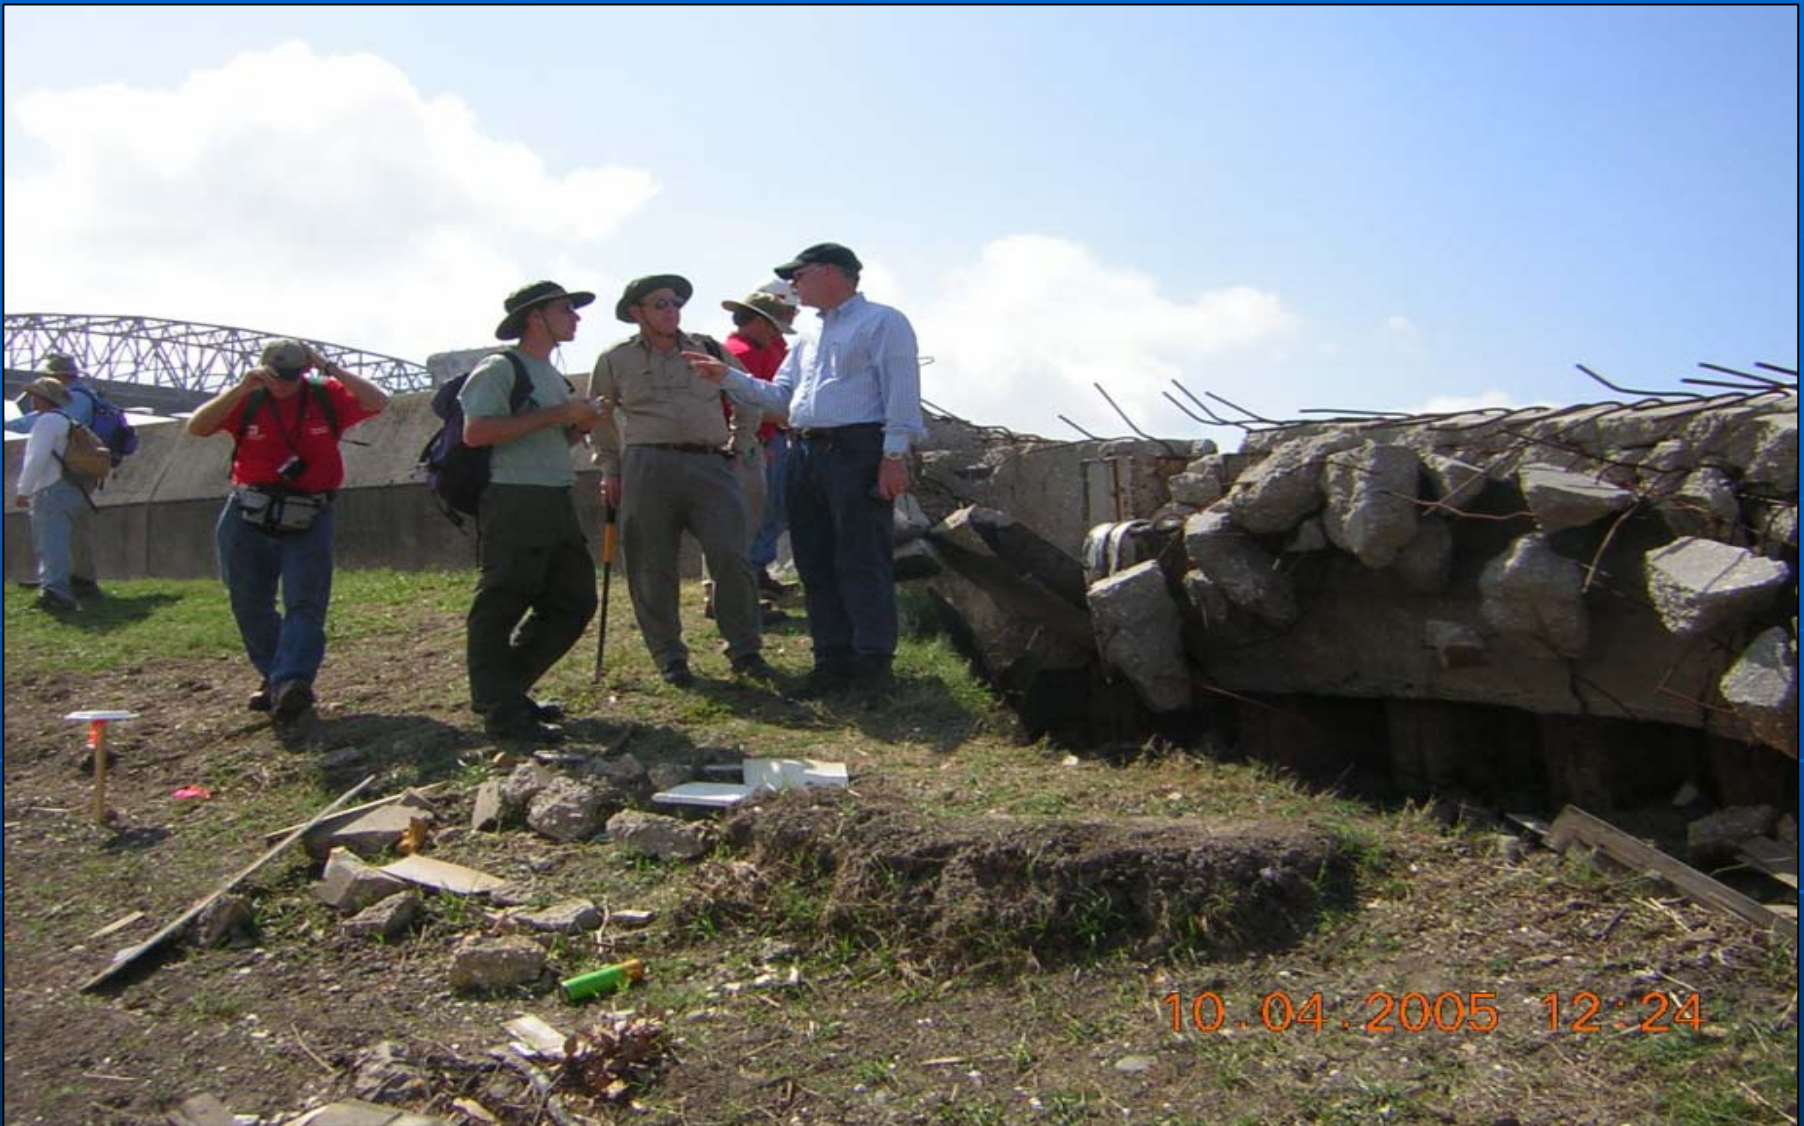
- **Damage to concrete flood wall where ING 4727 Barge collided with it, along the south side of the IHNC adjacent to the Lower Ninth Ward**

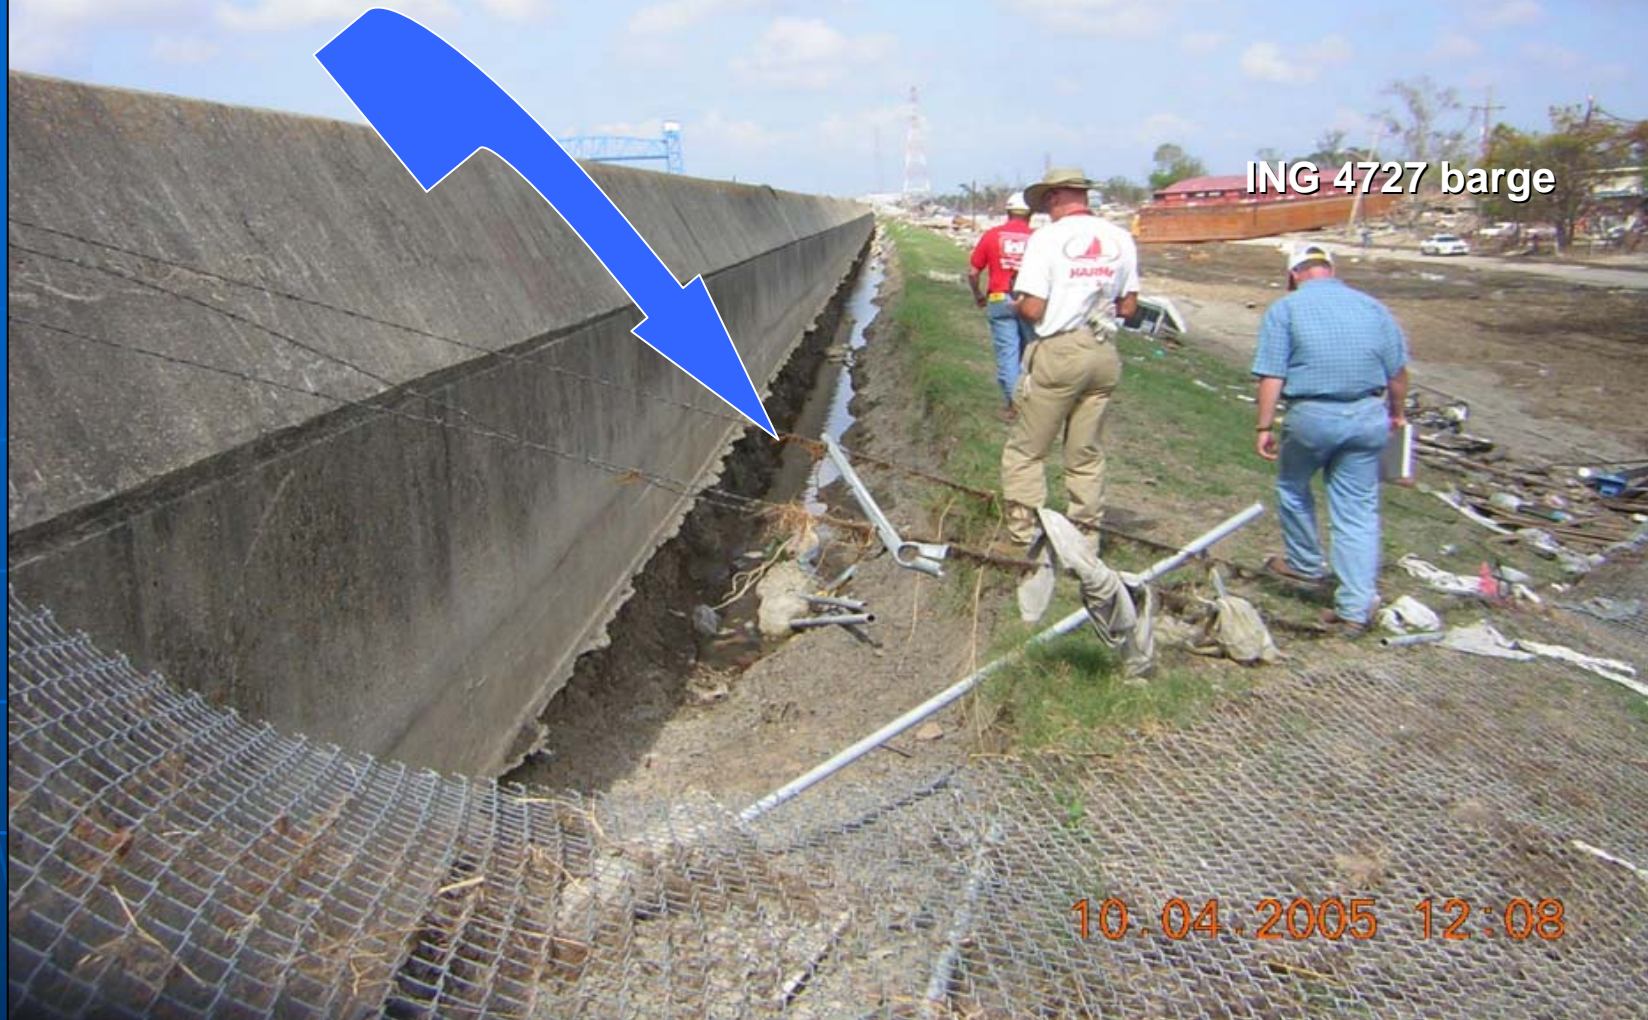
- Evidence of sustained overtopping of concrete flood wall along the IHNC in the Lower Ninth Ward. Scour holes usually limited to 1.5X height of the free fall (7.5 ft). This scour trench deepened to the north, as elevations dropped.

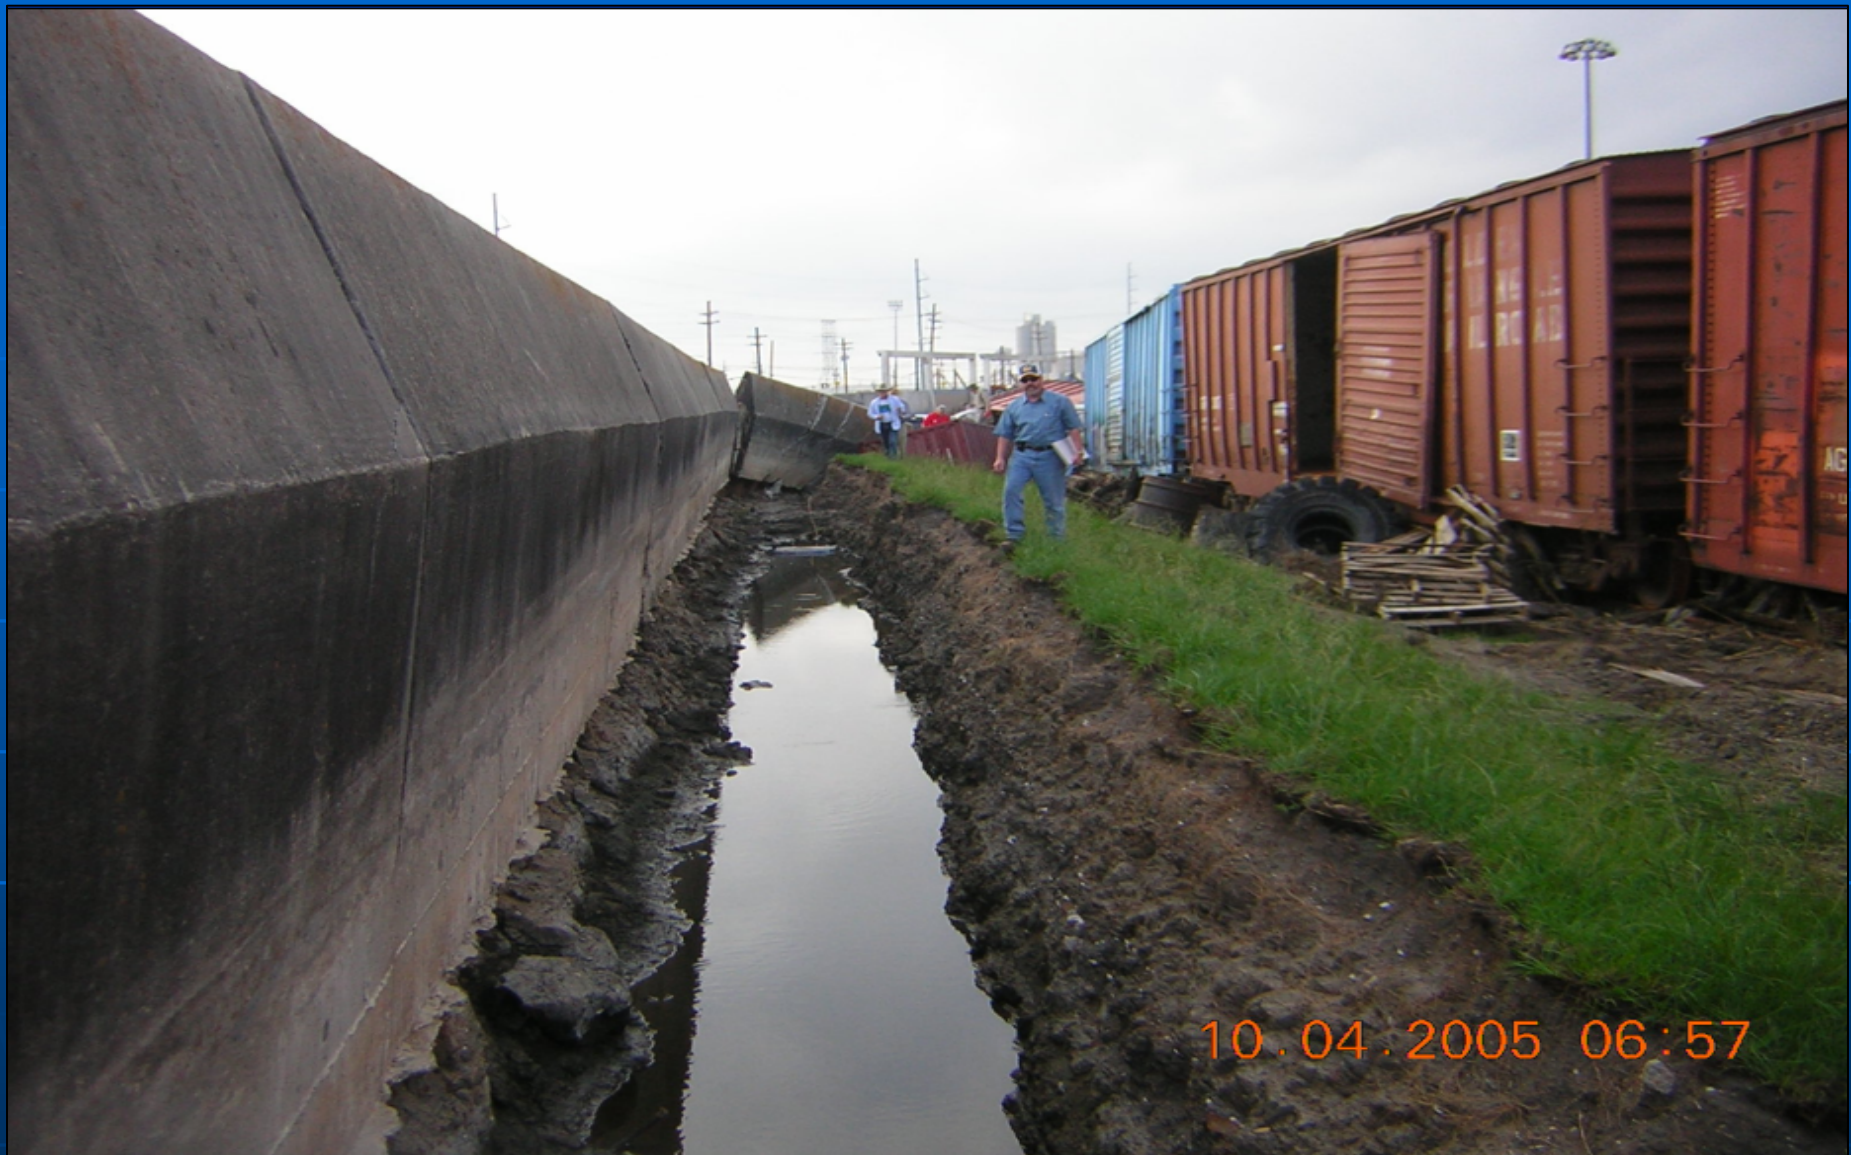
- Overtopping-induced failure of the flood wall on the west side of the IHNC, north of Florida Ave. This breach was only 65 feet wide.

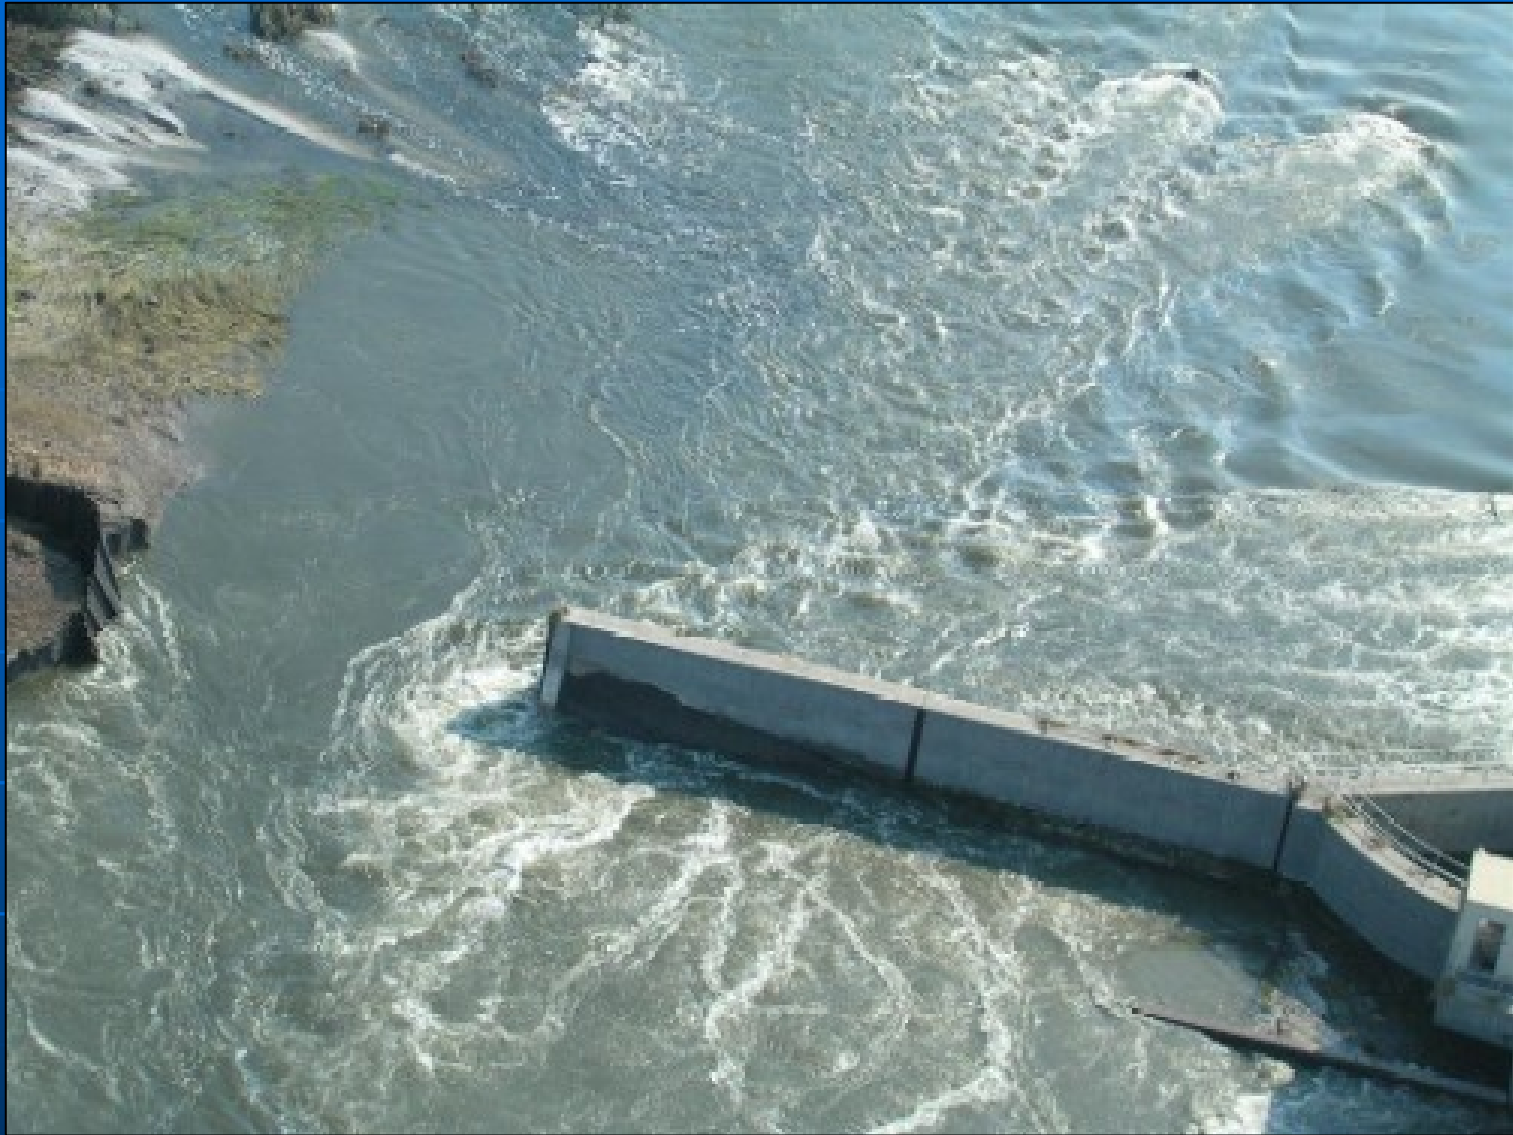
**East Side IHNC North Breach, near Florida Ave. bridge and pumping station, during inflow. Note narrow chasm defined by this failure and dramatic flexure of the sheetpiles.**

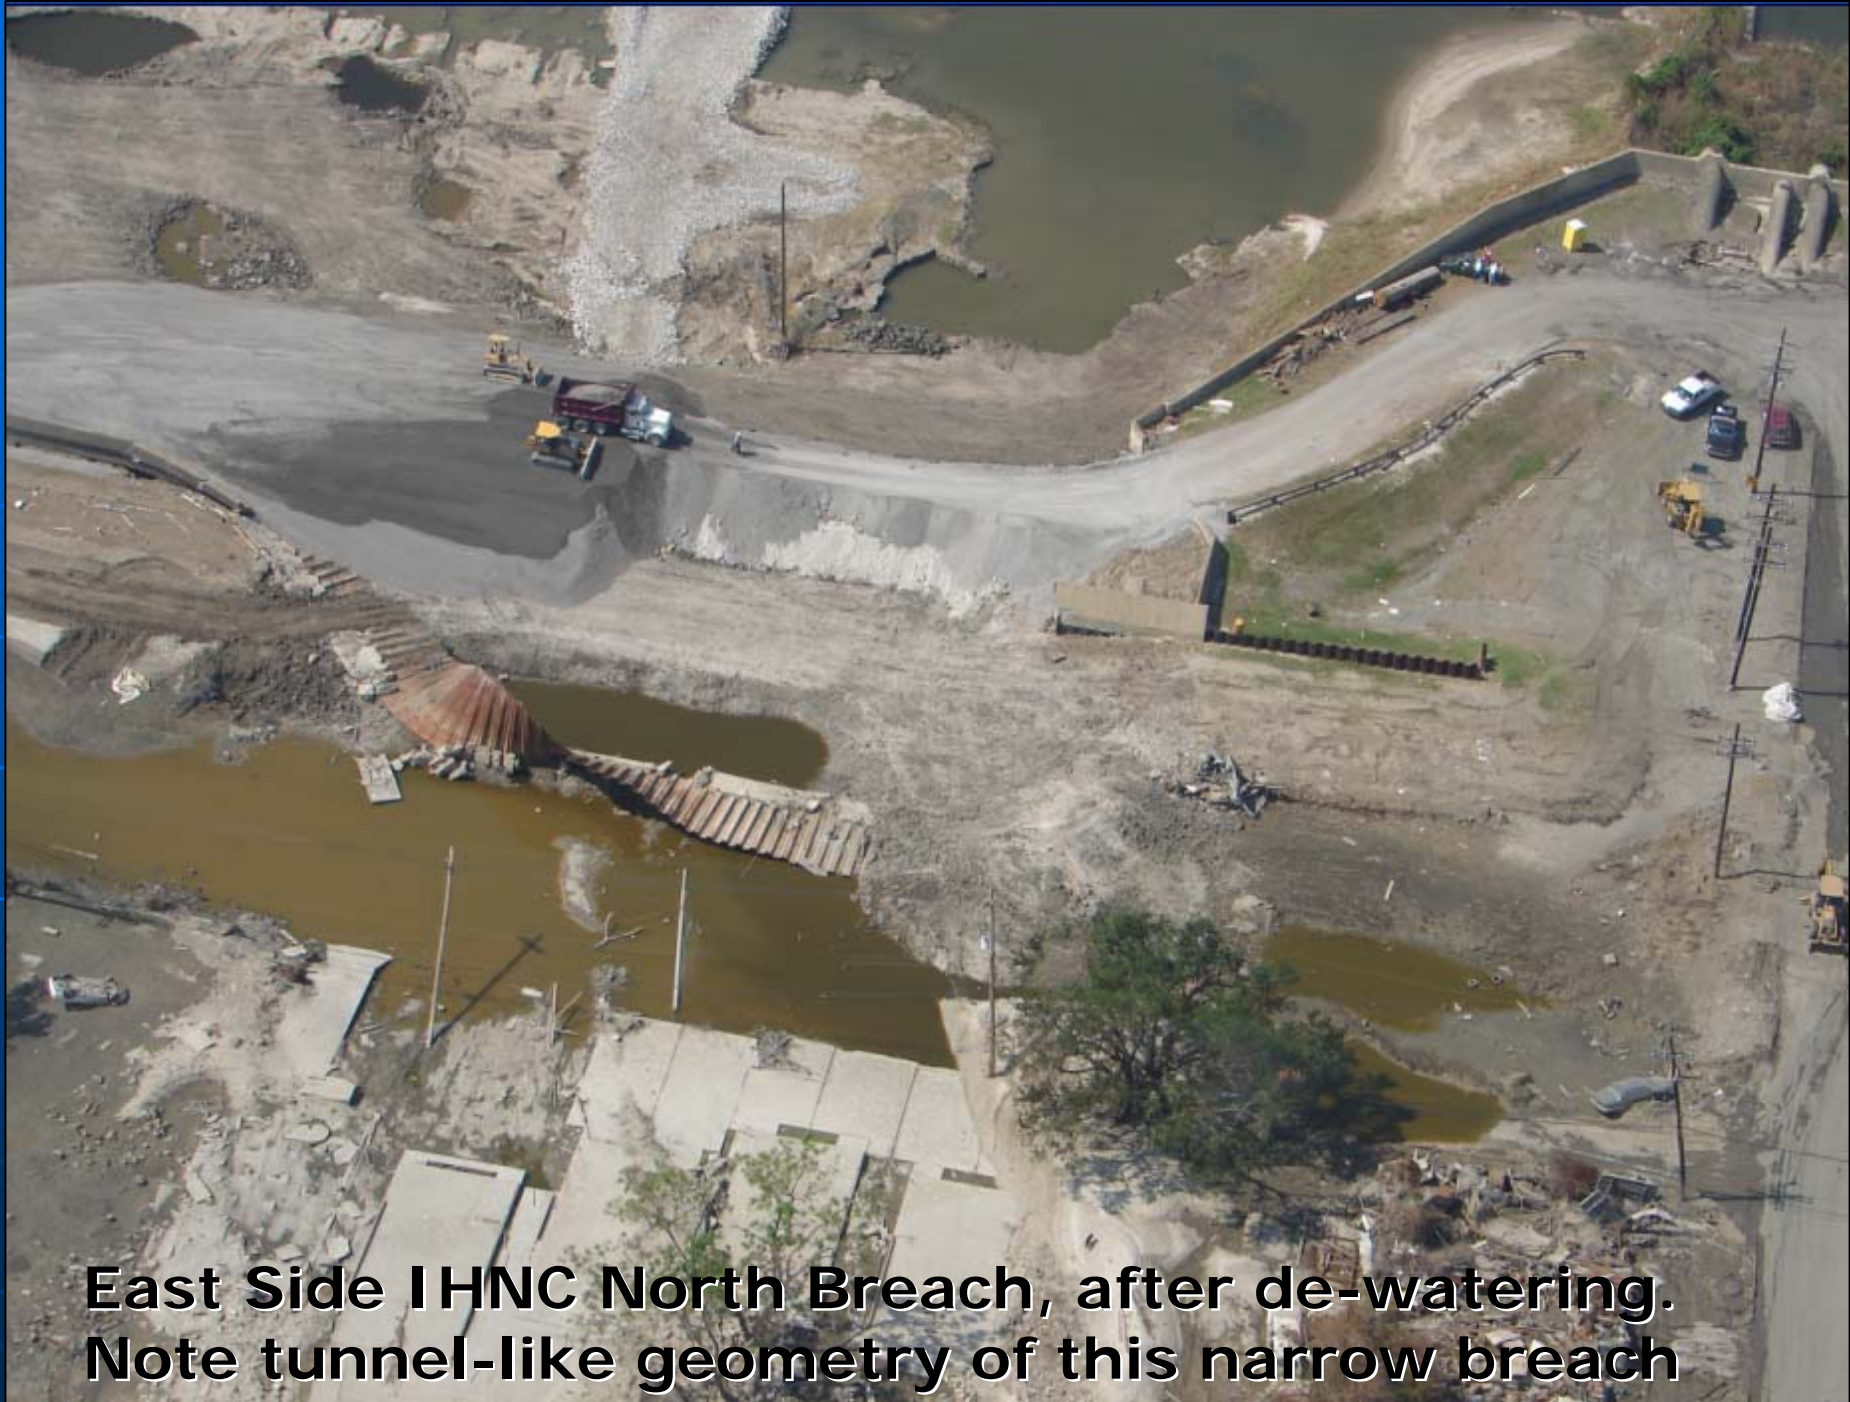
**East Side IHNC North Breach, after de-watering.  
Note tunnel-like geometry of this narrow breach**

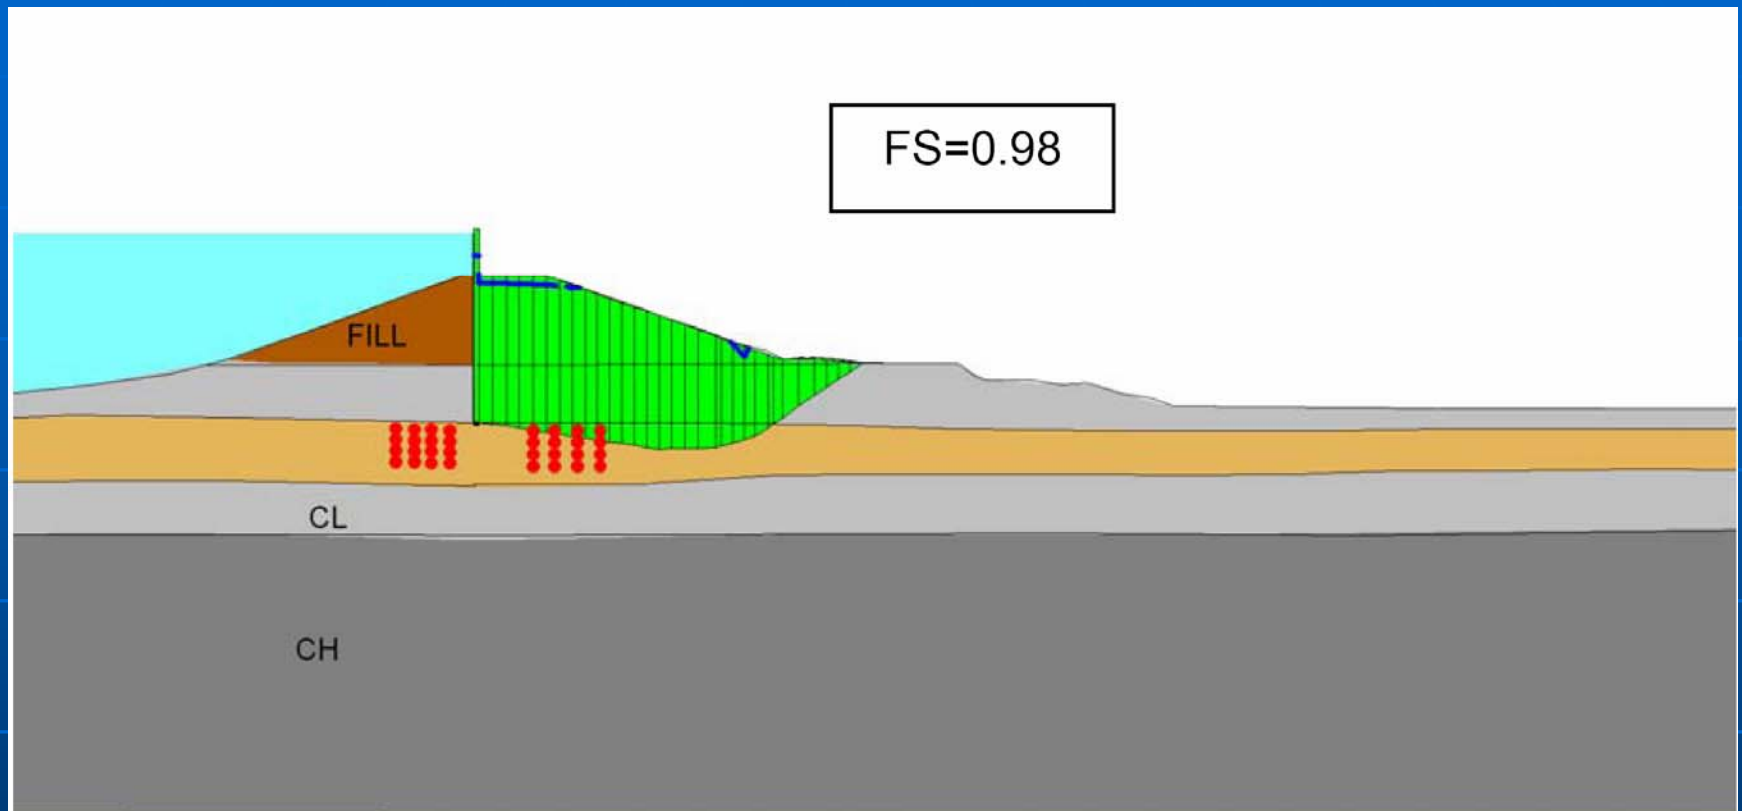
Critical stability conditions for East IHNC North Breach occur when the storm surge reaches +14 feet (MSL), which was not achieved until 9 AM. Note that the presumed failure surface passes through the marsh layer.

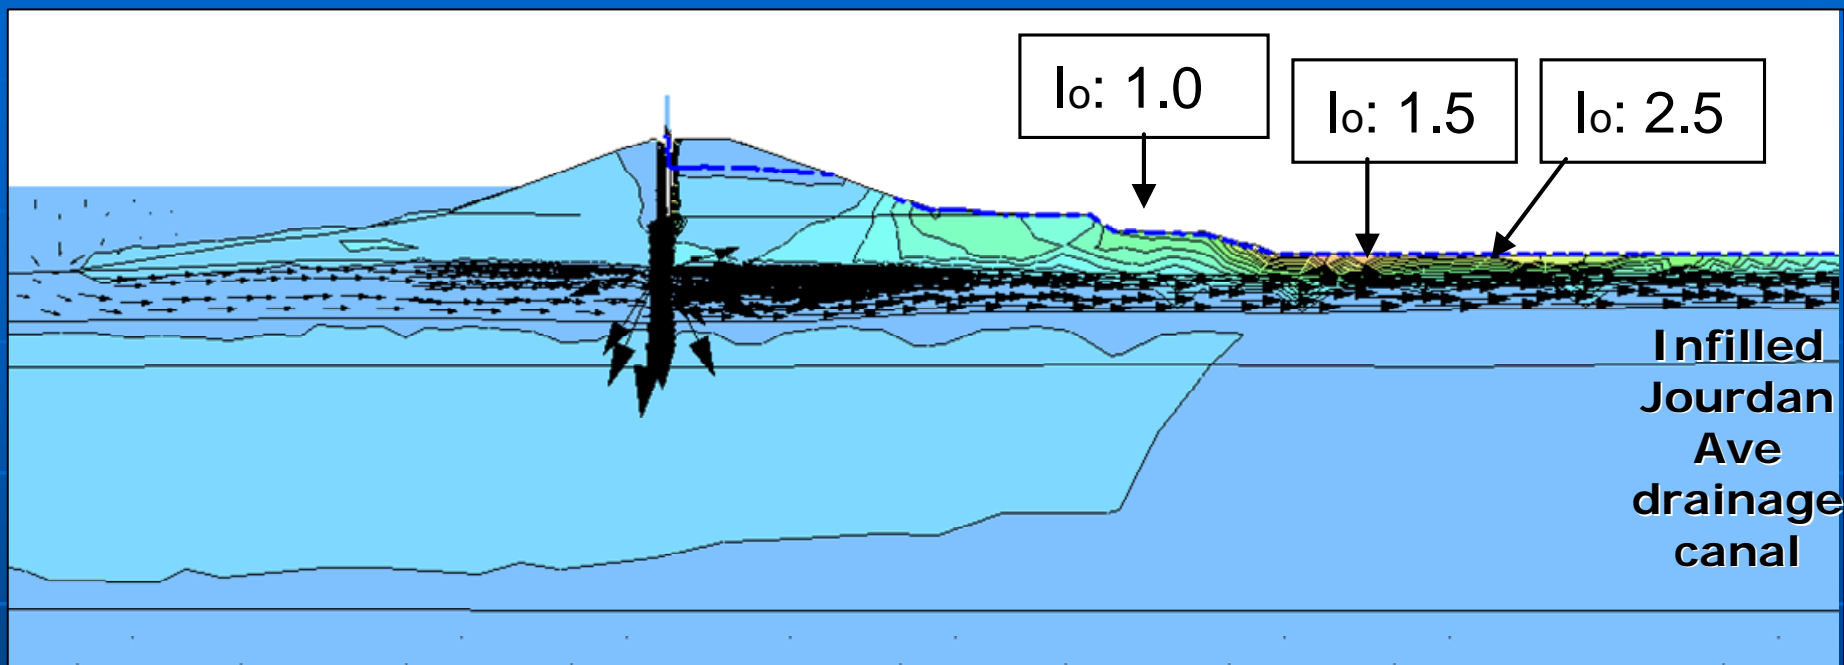
Hydraulic gradients for the north breach on IHNC. Storm surge at +14.4ft (MSL). Maximum exit gradient on the upper levee toe is  $i_o \approx 1.0$ , and  $i_o \approx 1.5$  to 2.5 in the lower toe area. The distal toe value could have been worse, depending on  $k$  value of backfill used on Jourdan Ave. drainage canal.

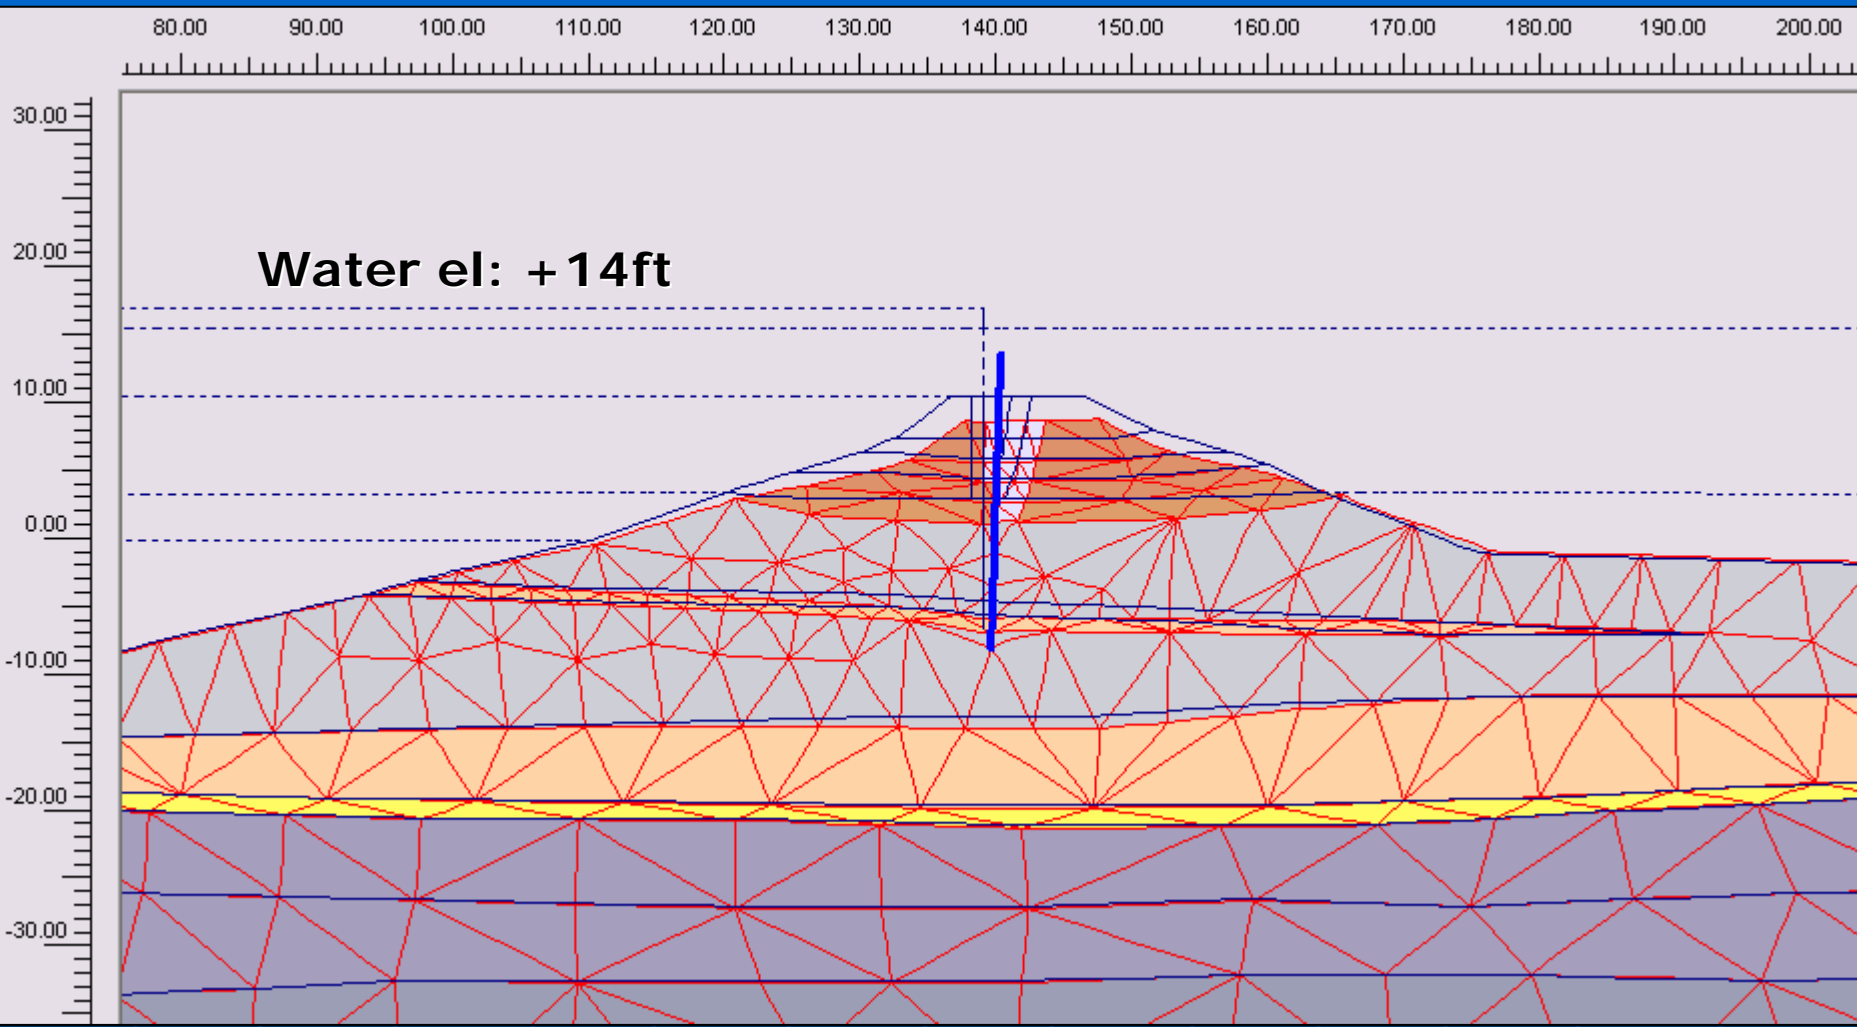
**Plaxis soft soil constitutive modeling of 7.5 ft deep scour trench and 4.5 ft gap – deformed mesh – true scale (max displacement of embankment crest = 1.2 ft)**

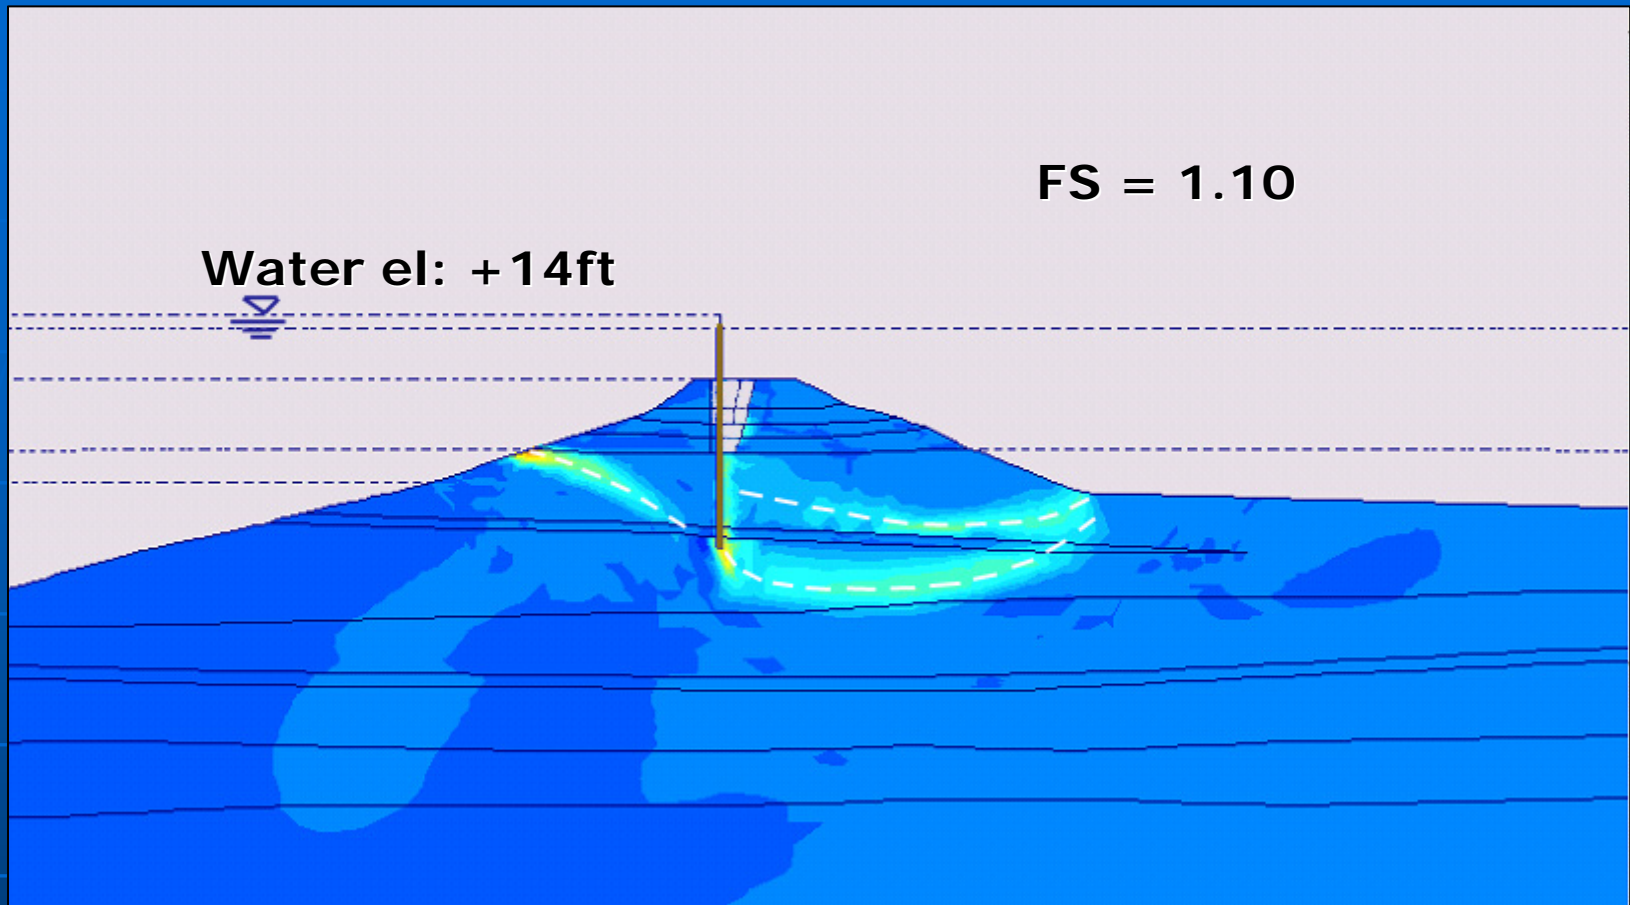
Shear strains predicted by the Plaxis model, assuming a 7.5 ft deep scour trench and 4.5 ft wall gap – using “best estimates” of  $c$  and  $\phi$  – Factor of Safety = 1.10. Underseepage-induced pore pressure trapped along base of less pervious clay stratum, overlying the more pervious marsh deposits.

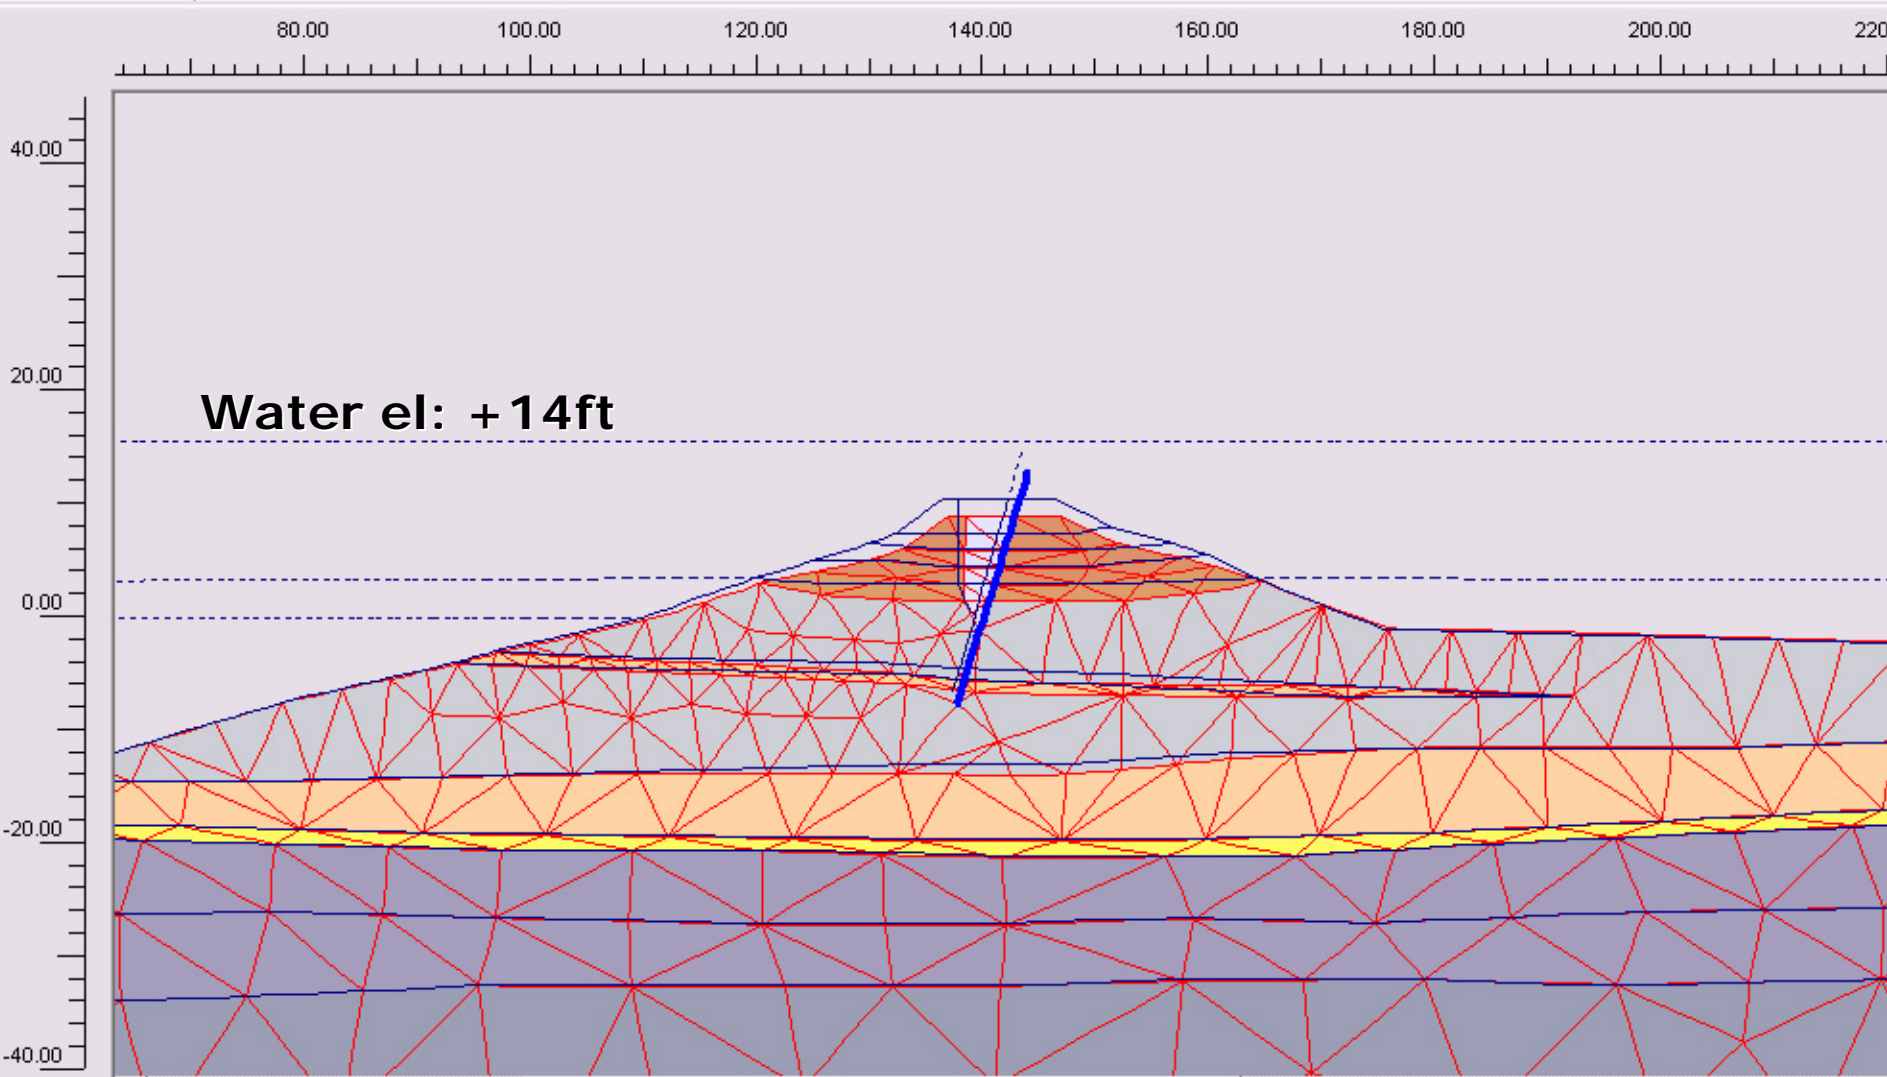
**Leaning wall with 8.5 ft of gap – deformed mesh  
– true scale (max displacement = 1.71 ft)**
