# INVESTIGATION OF LEVEE PERFORMANCE IN HURRICANE KATRINA: Levee Failures Along the Inner Harbor Navigation Channel

J. David Rogers, Ph.D., P.E., R.G., C.E.G., C.HG.

**OVERVIEW:  
East Side IHNC  
Failures  
During Hurricane  
Katrina**

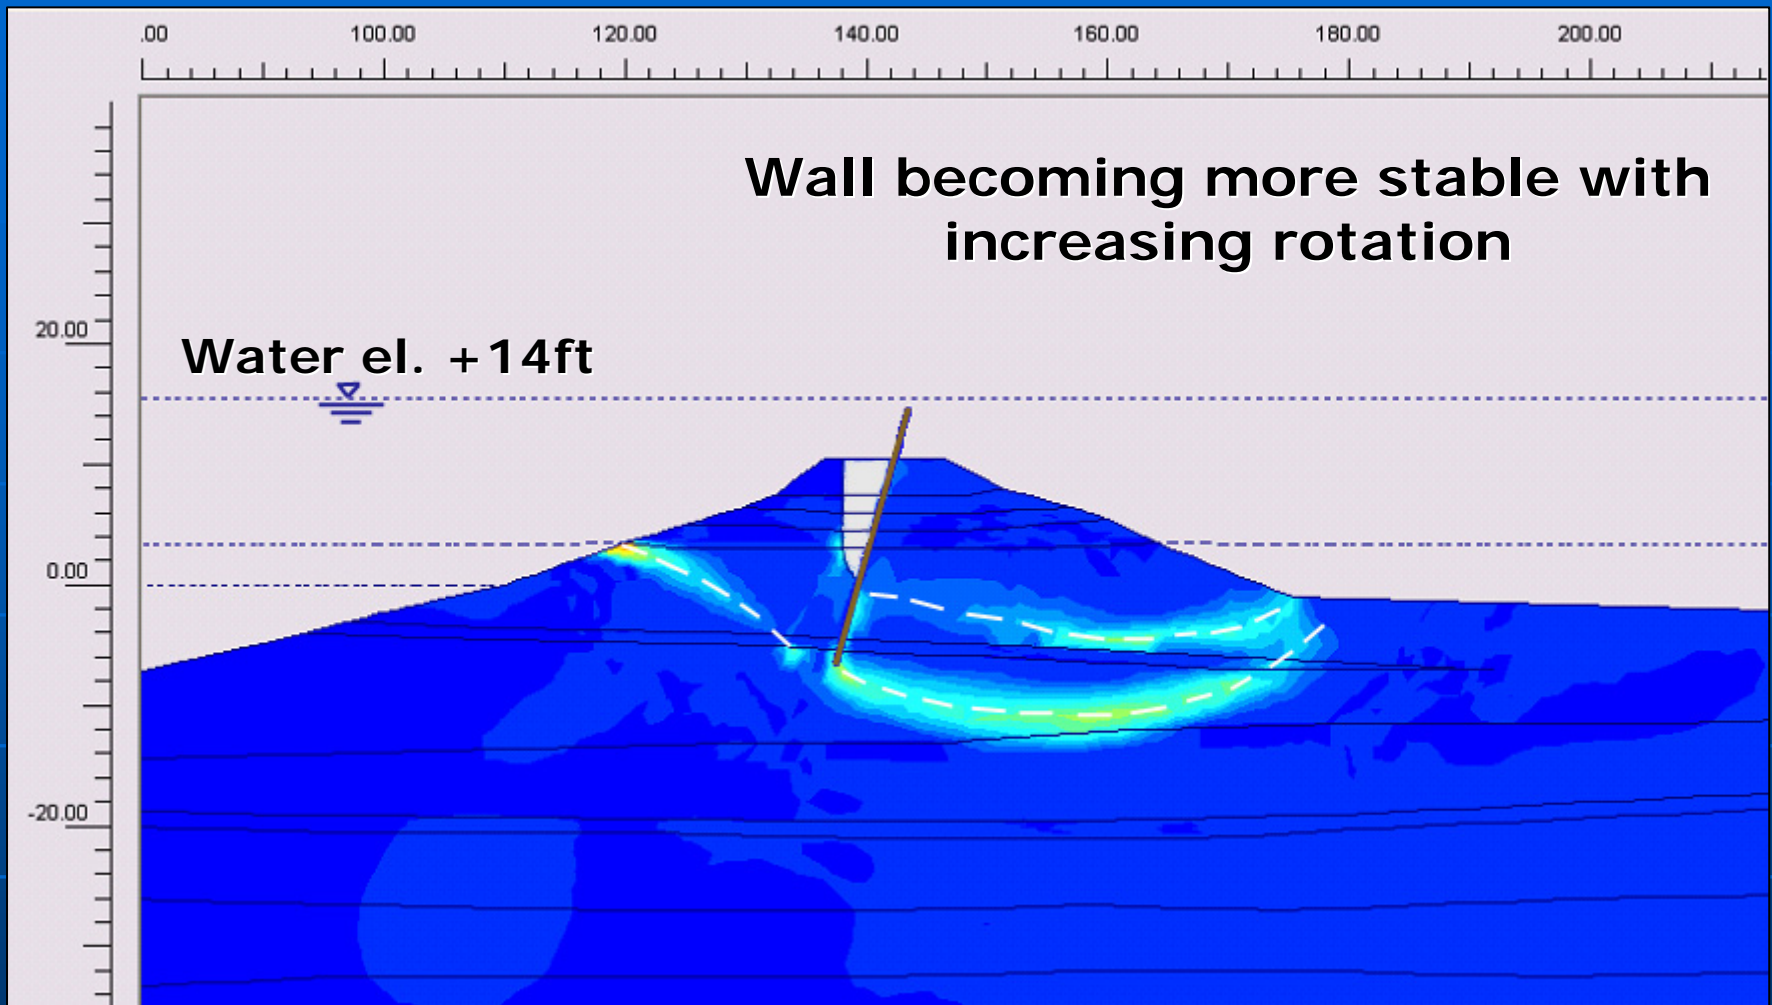
Leaning wall with 8.5 ft of gap. Predicted shear strains using "best estimates" of  $c$  and  $\phi$ .  
Factor of Safety now = 1.15

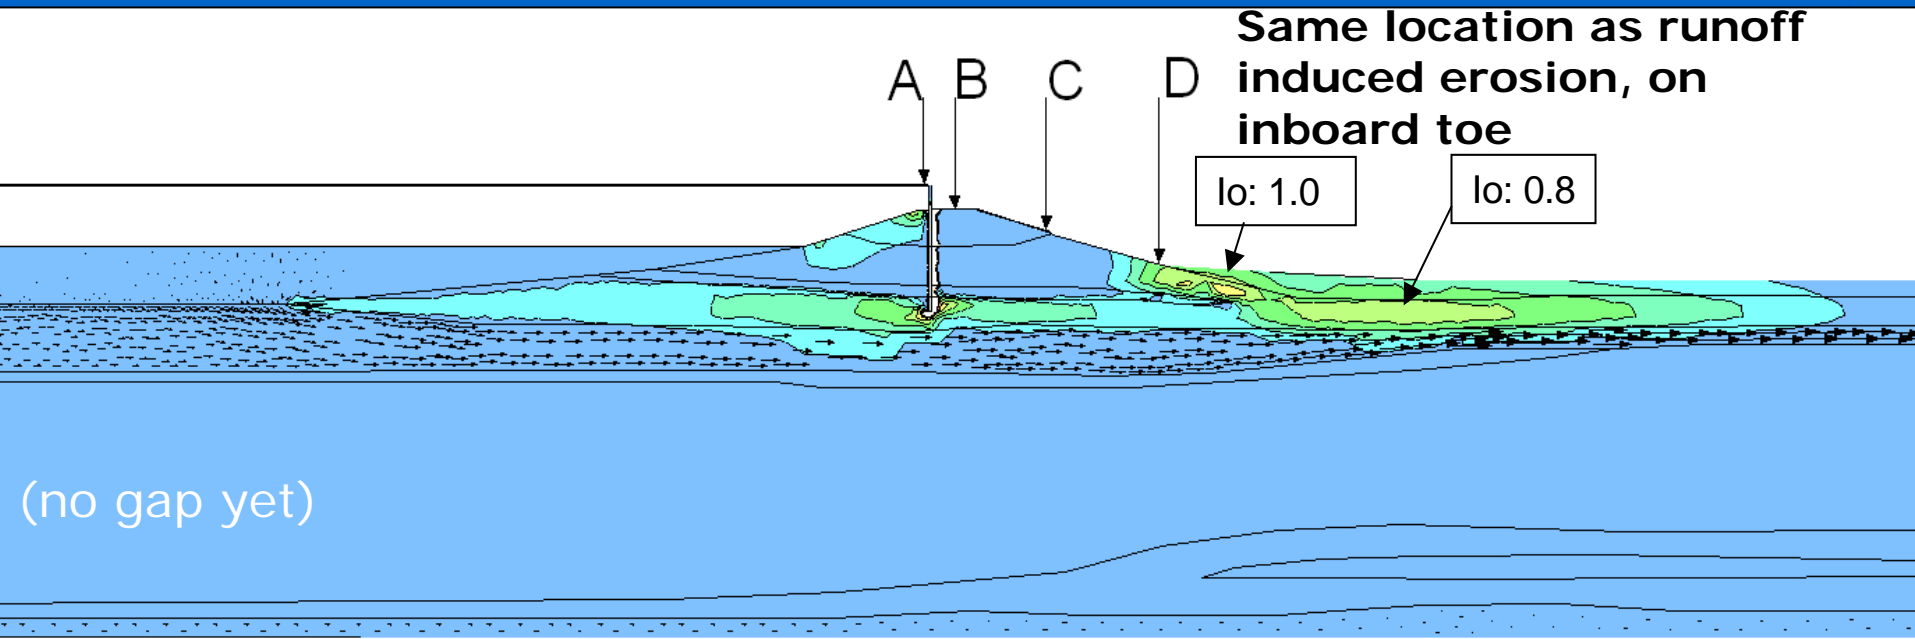
- Hydraulic gradients for the south breach on IHNC east bank; storm surge at 14.4ft (MSL). Maximum exit gradient at the levee toe is  $i_o \approx 0.8$  to 1.0, at threshold for hydraulic piping.
- This may help to explain the persistent wet spot noted on the backfill of the Jourdan Avenue conduit backfill for weeks afterward.

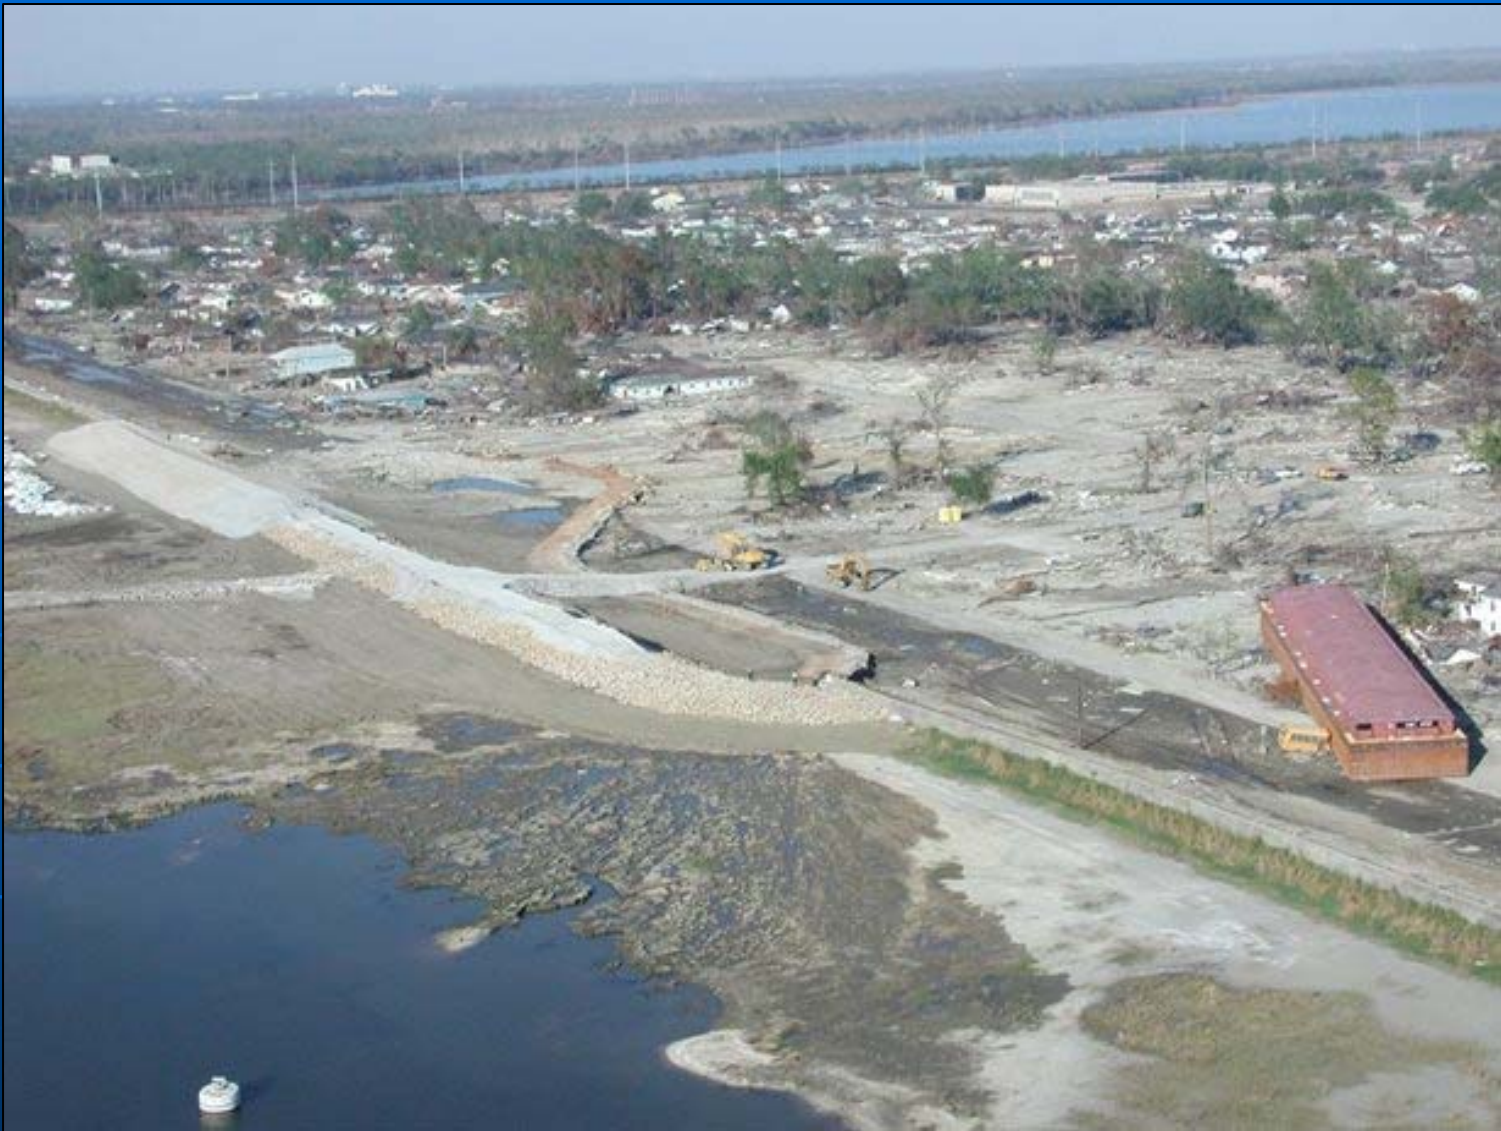
**Aerial view of the south breach at the east bank of the IHNC (at the west end of the Ninth Ward), showing the 'wet spot' along the inboard side and the crevasse splay generated by reverse drainage flow. [Photograph by U.S. Army Corps of Engineers]**

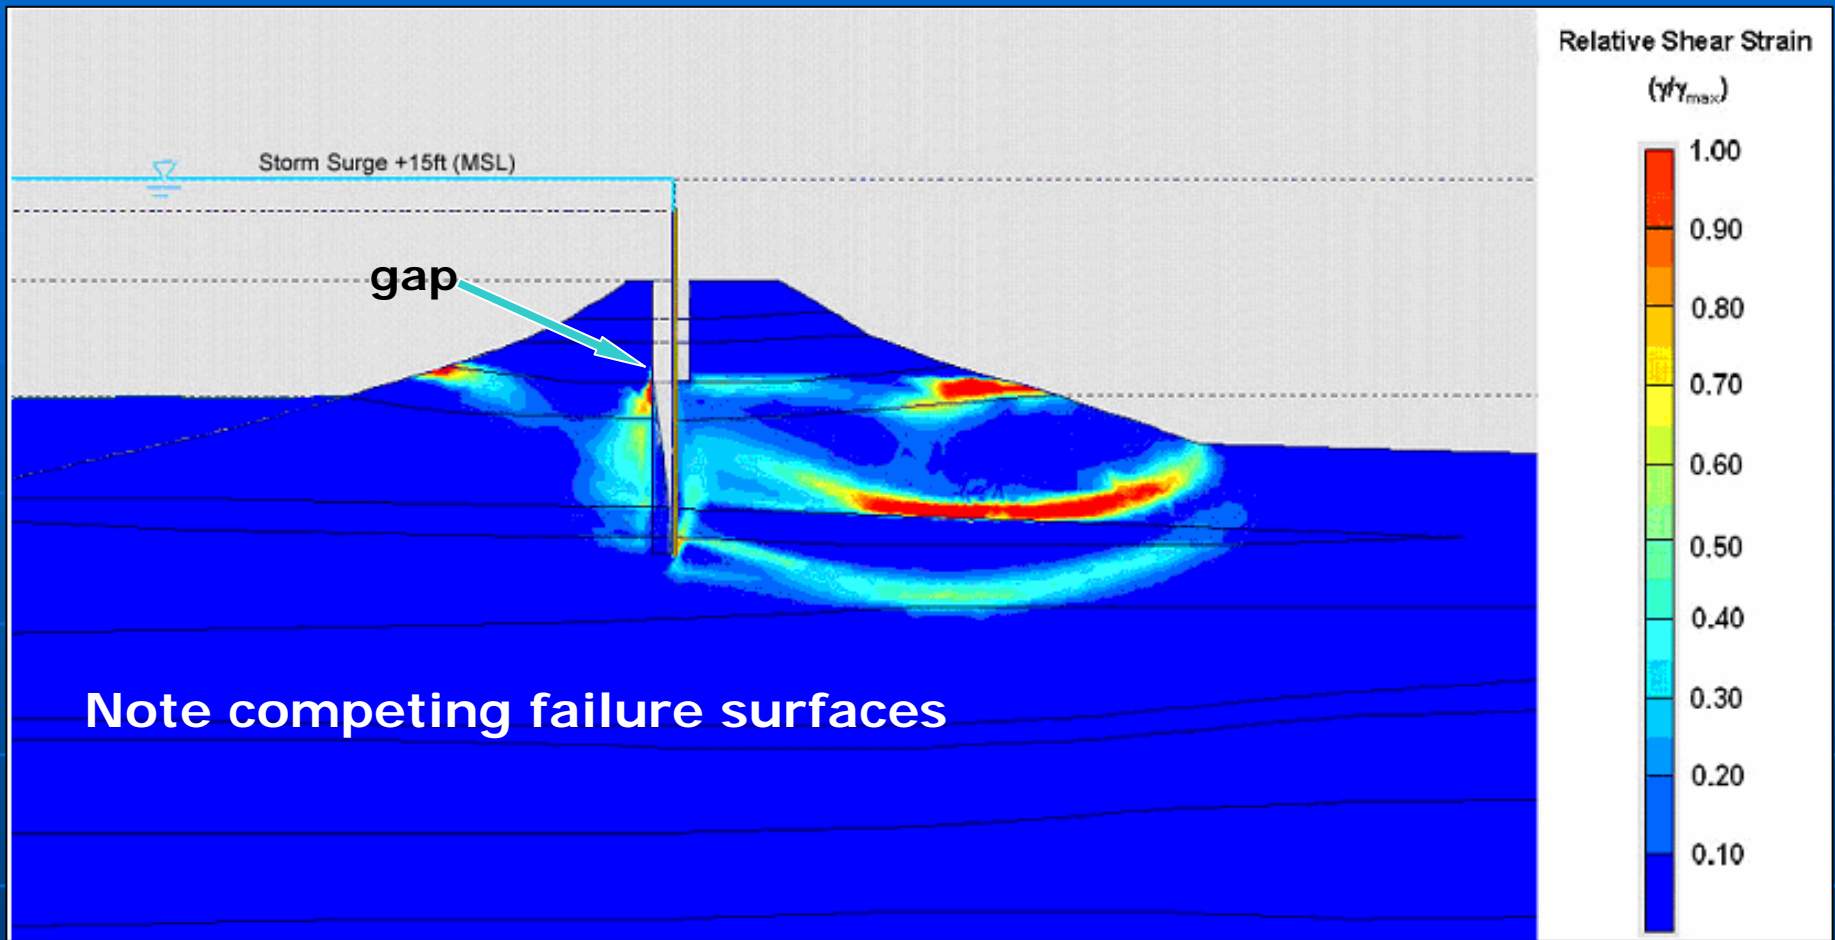
Normalized shear strain contours (shear strain divided by strain to failure) for a storm surge at Elev. + 14 feet (MSL) on the east IHNC south breach; gapping at outboard toe of floodwall is fully developed.

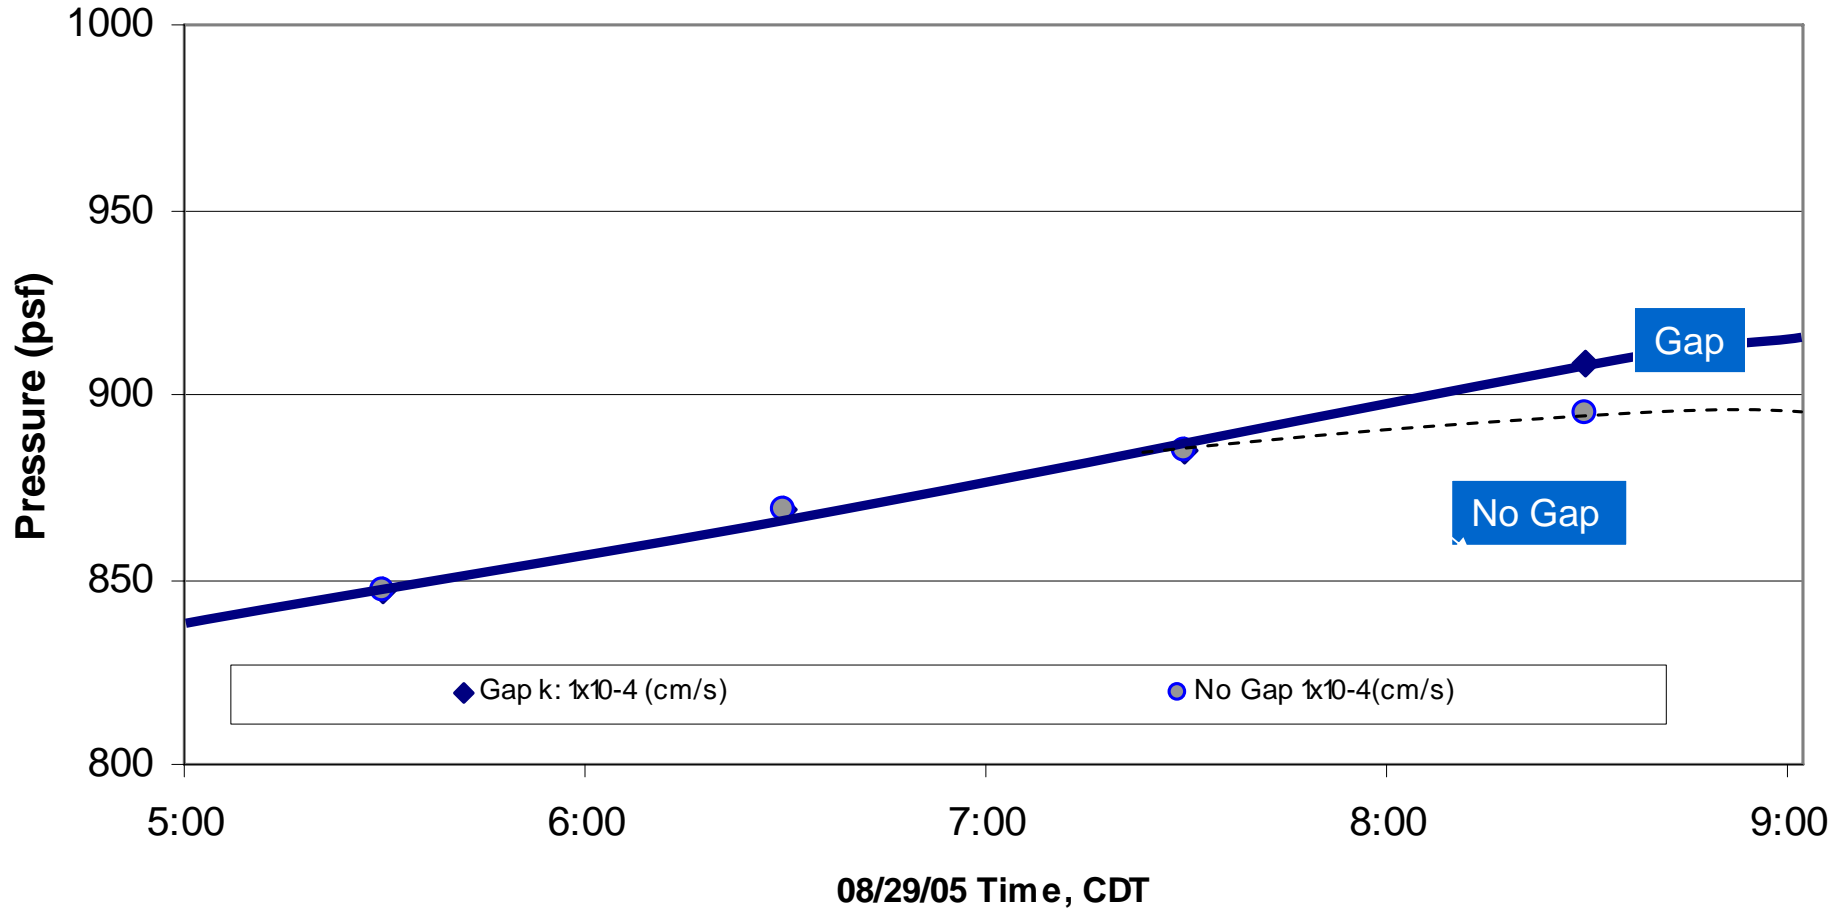
**Increase of pore pressure at top of lower marsh unit if the gap on water side of flood wall opened around 7:30 AM. This would have hastened the build-up of pore pressure at this location.**

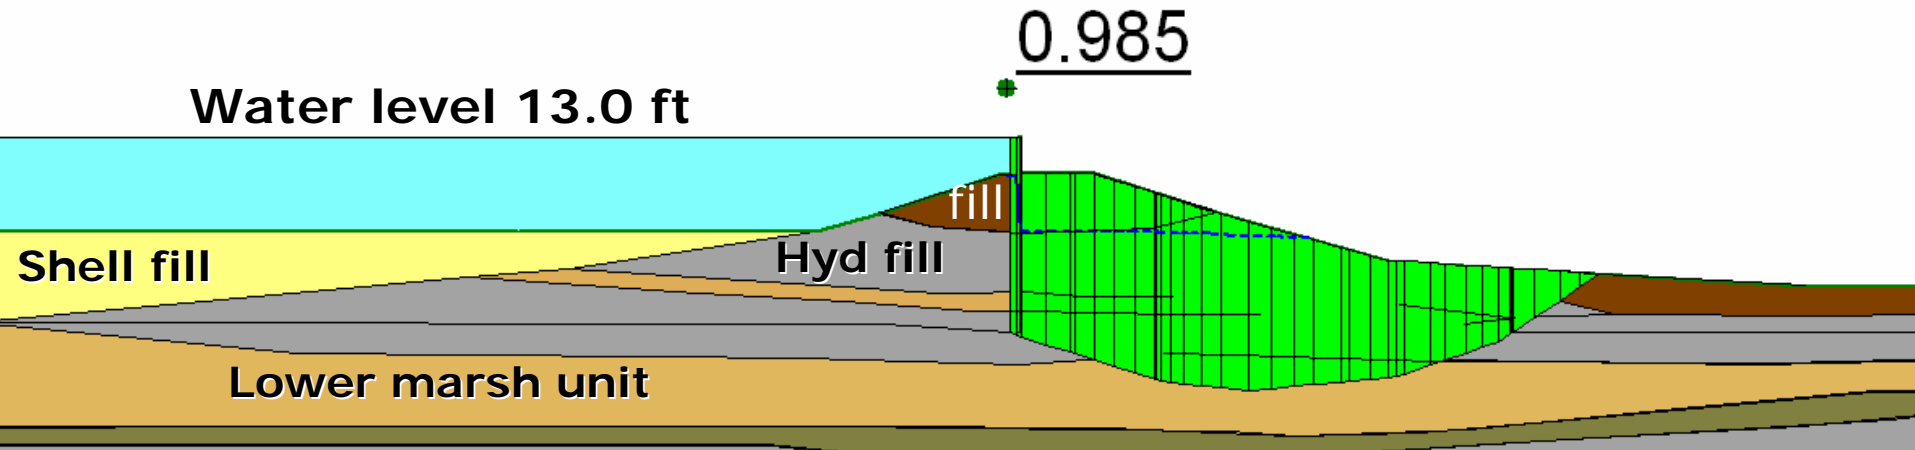
# Deep failure mode (in lower marsh) with wall gap– FS=0.985

Deeper slope failure most likely, with  $k$  values as low as  $3 \times 10^{-5}$  cm/sec; with wall gap forming around 7:30 AM, at a water level of 13 ft (MSL).

This would appear to be the best explanation for a massive translational failure, 800 feet long.

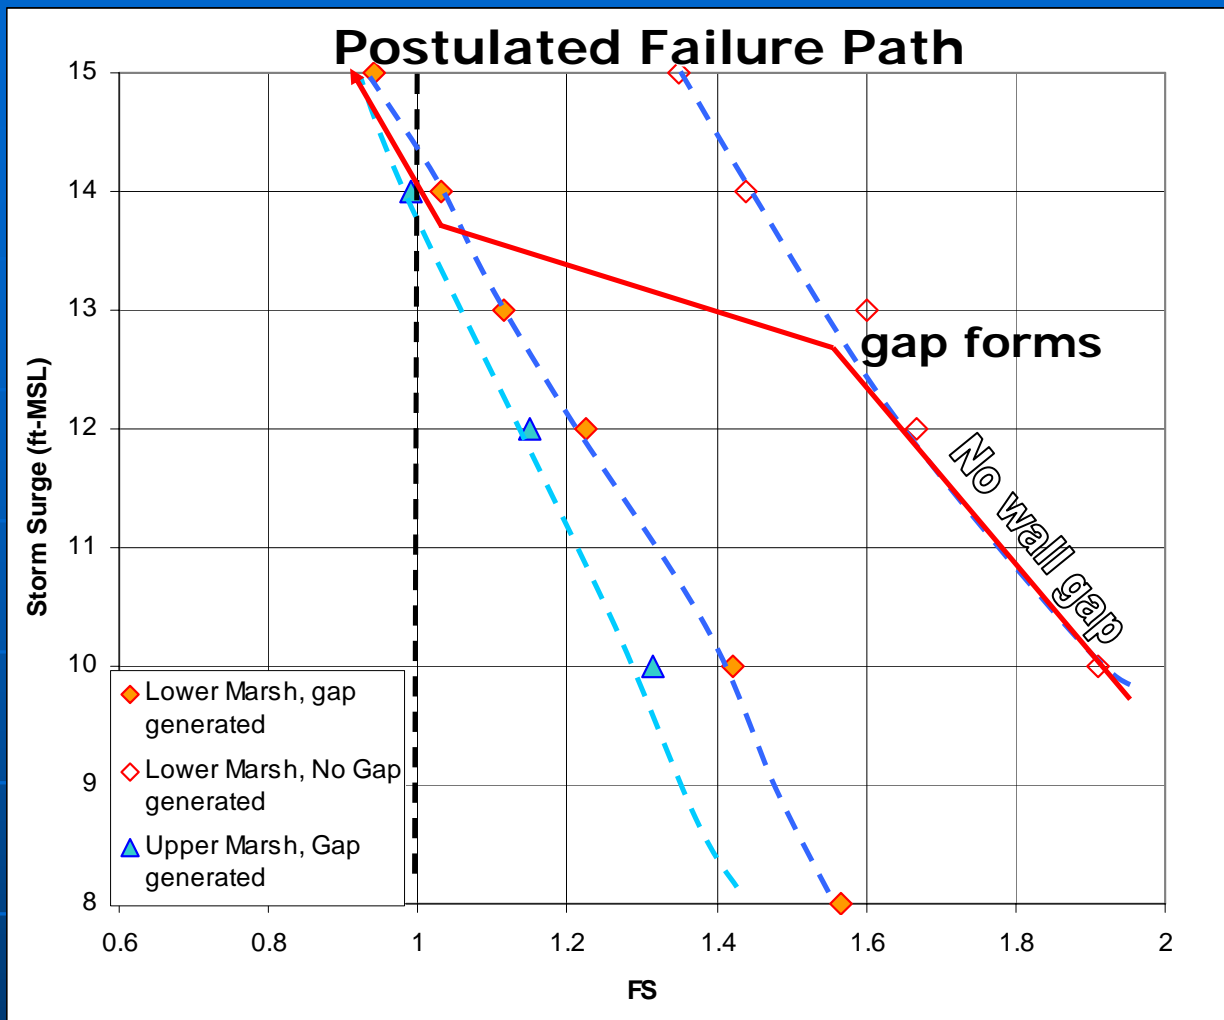
**Calculated Factors of Safety for three modes based on SLOPE/W analyses of the East Bank IHNC South Breach site for various surge levels; showing the best-estimated path to failure.**
