**IMPORTANCE OF GEOLOGIC
CHARACTERIZATION FOR LEVEE
FOUNDATION AND BORROW MATERIALS AS
STUDIED AT THE INDIAN GRAVES LEVEE
DISTRICT, ADAMS COUNTY, IL**

AEG Annual Meeting - September 24, 2009

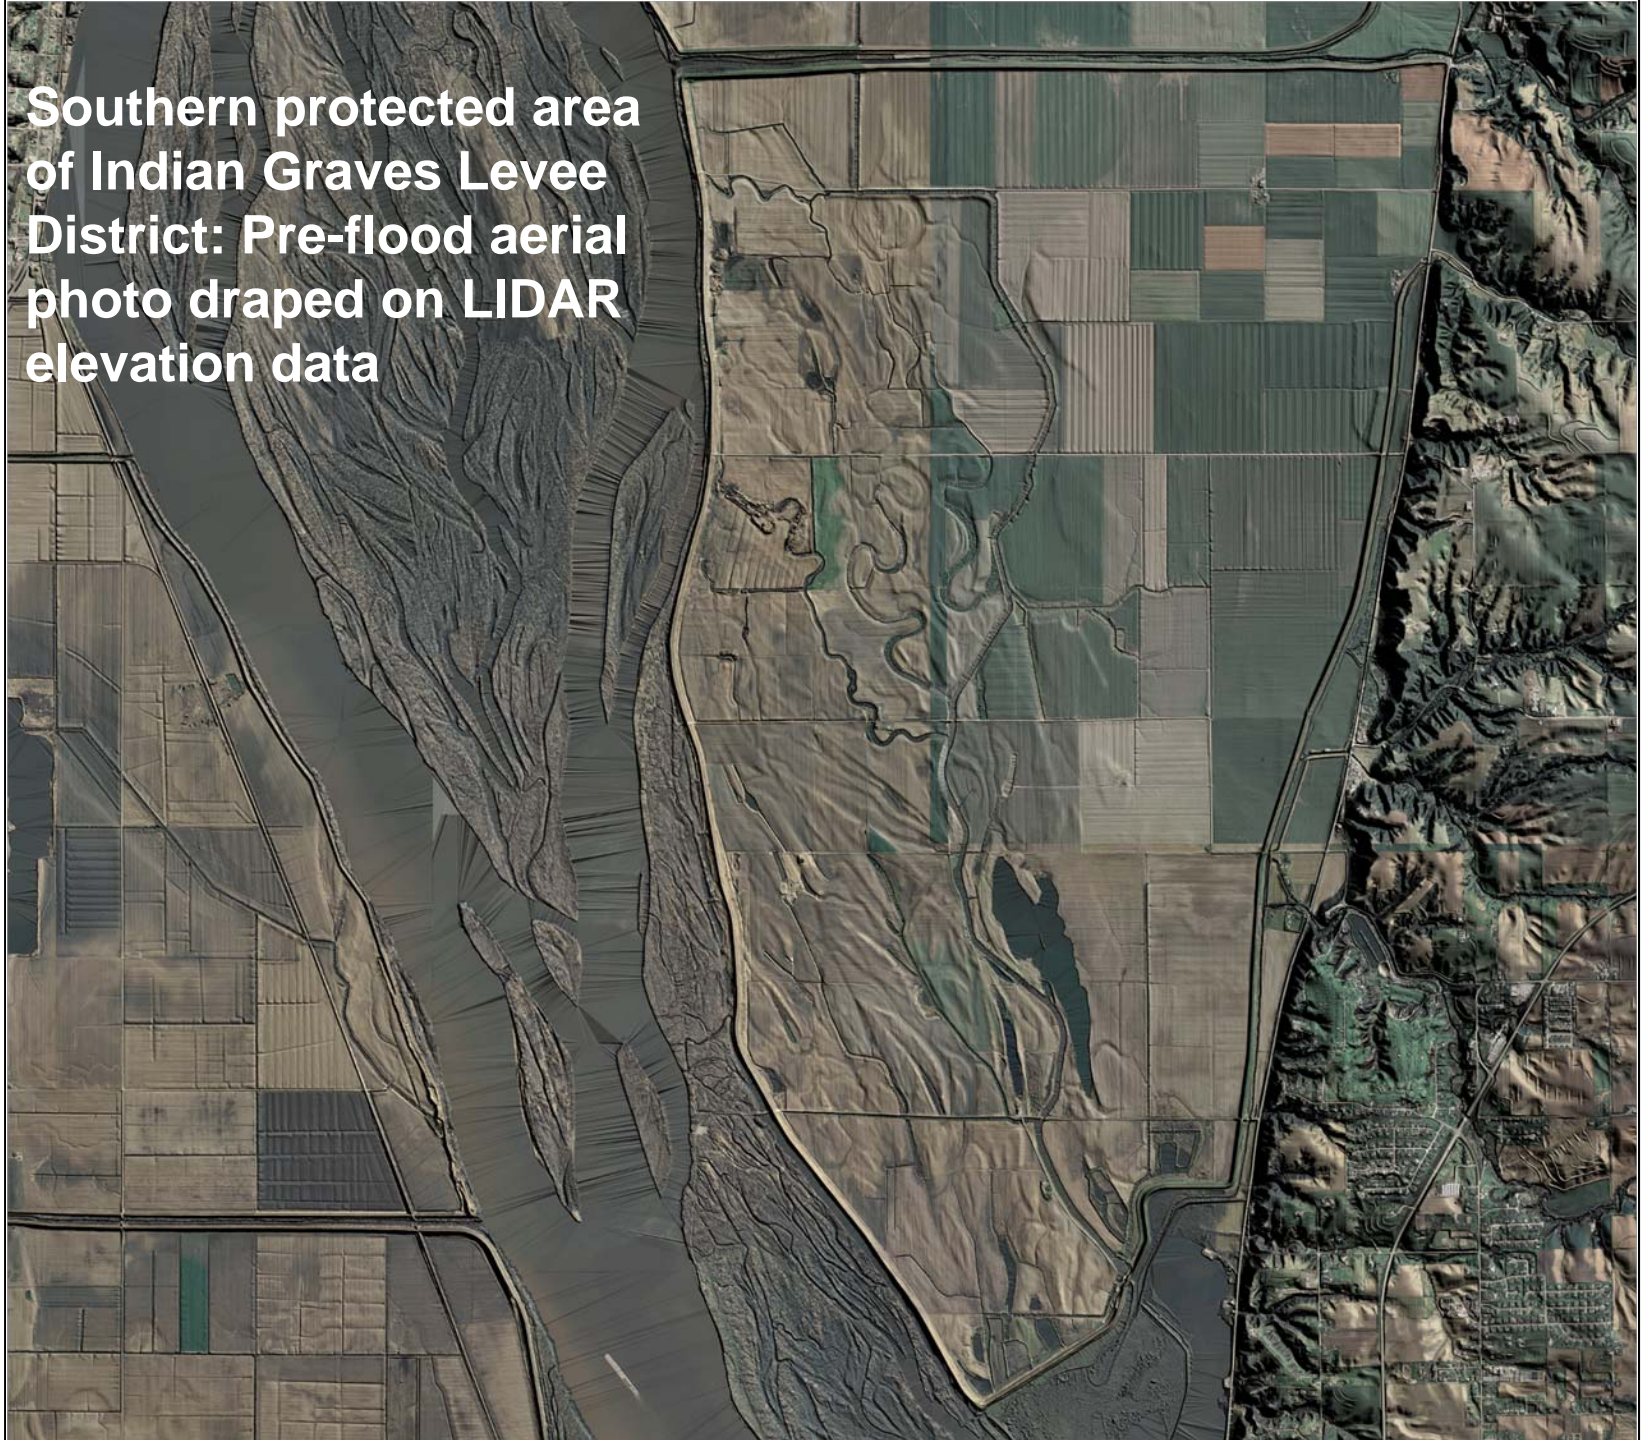
**Southern protected area
of Indian Graves Levee
District: Pre-flood aerial
photo draped on LIDAR
elevation data**

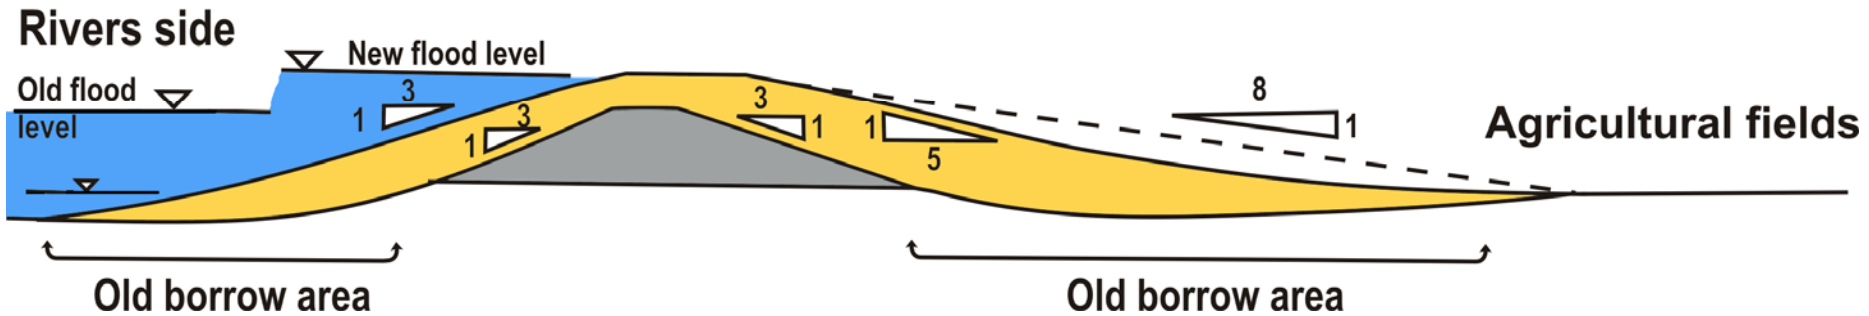
Typical Clay Core Sand Shell Levee

- **Clay core sand shell levees experience a notable increase in through seepage once flood level exceeds level of old buried clay/silt core**

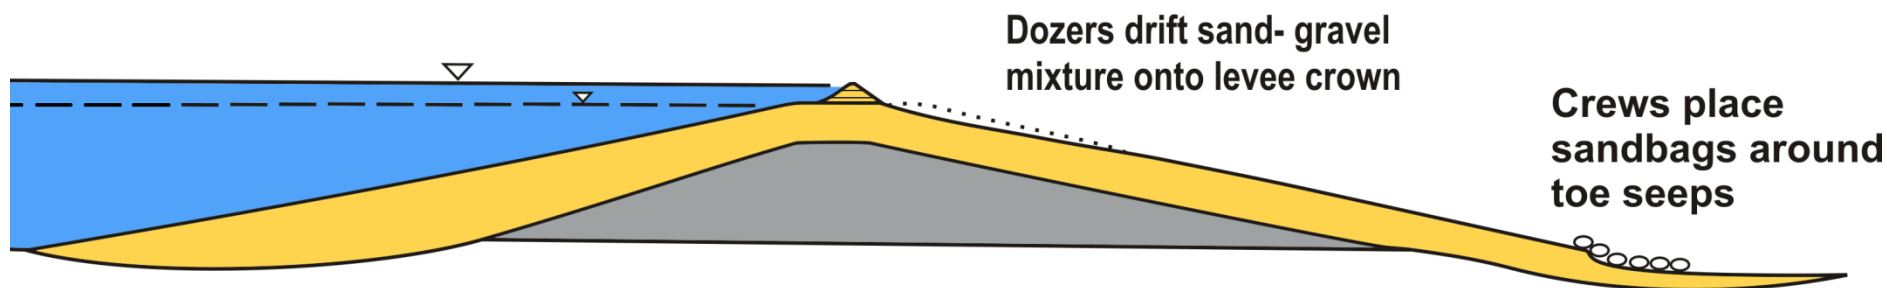
Increased Flood Storage Using “Push-Ups”

- Technique known as a “push-up” is used to increase the flood capacity of sand shell levees
- This involves using a dozer, tractor, or other equipment to push sand/gravel material onto the levee crown, allowing for ~3-5 extra feet of storage when flood forecasts call for a flood exceeding the height of the levee
- The “push-up” is subsequently covered in plastic sheeting to prevent erosion and through seepage
- Seepage rates are quite high at this point, forming numerous toe-seeps, which must be managed with plastic mesh, sandbags, etc. at the base of the levee

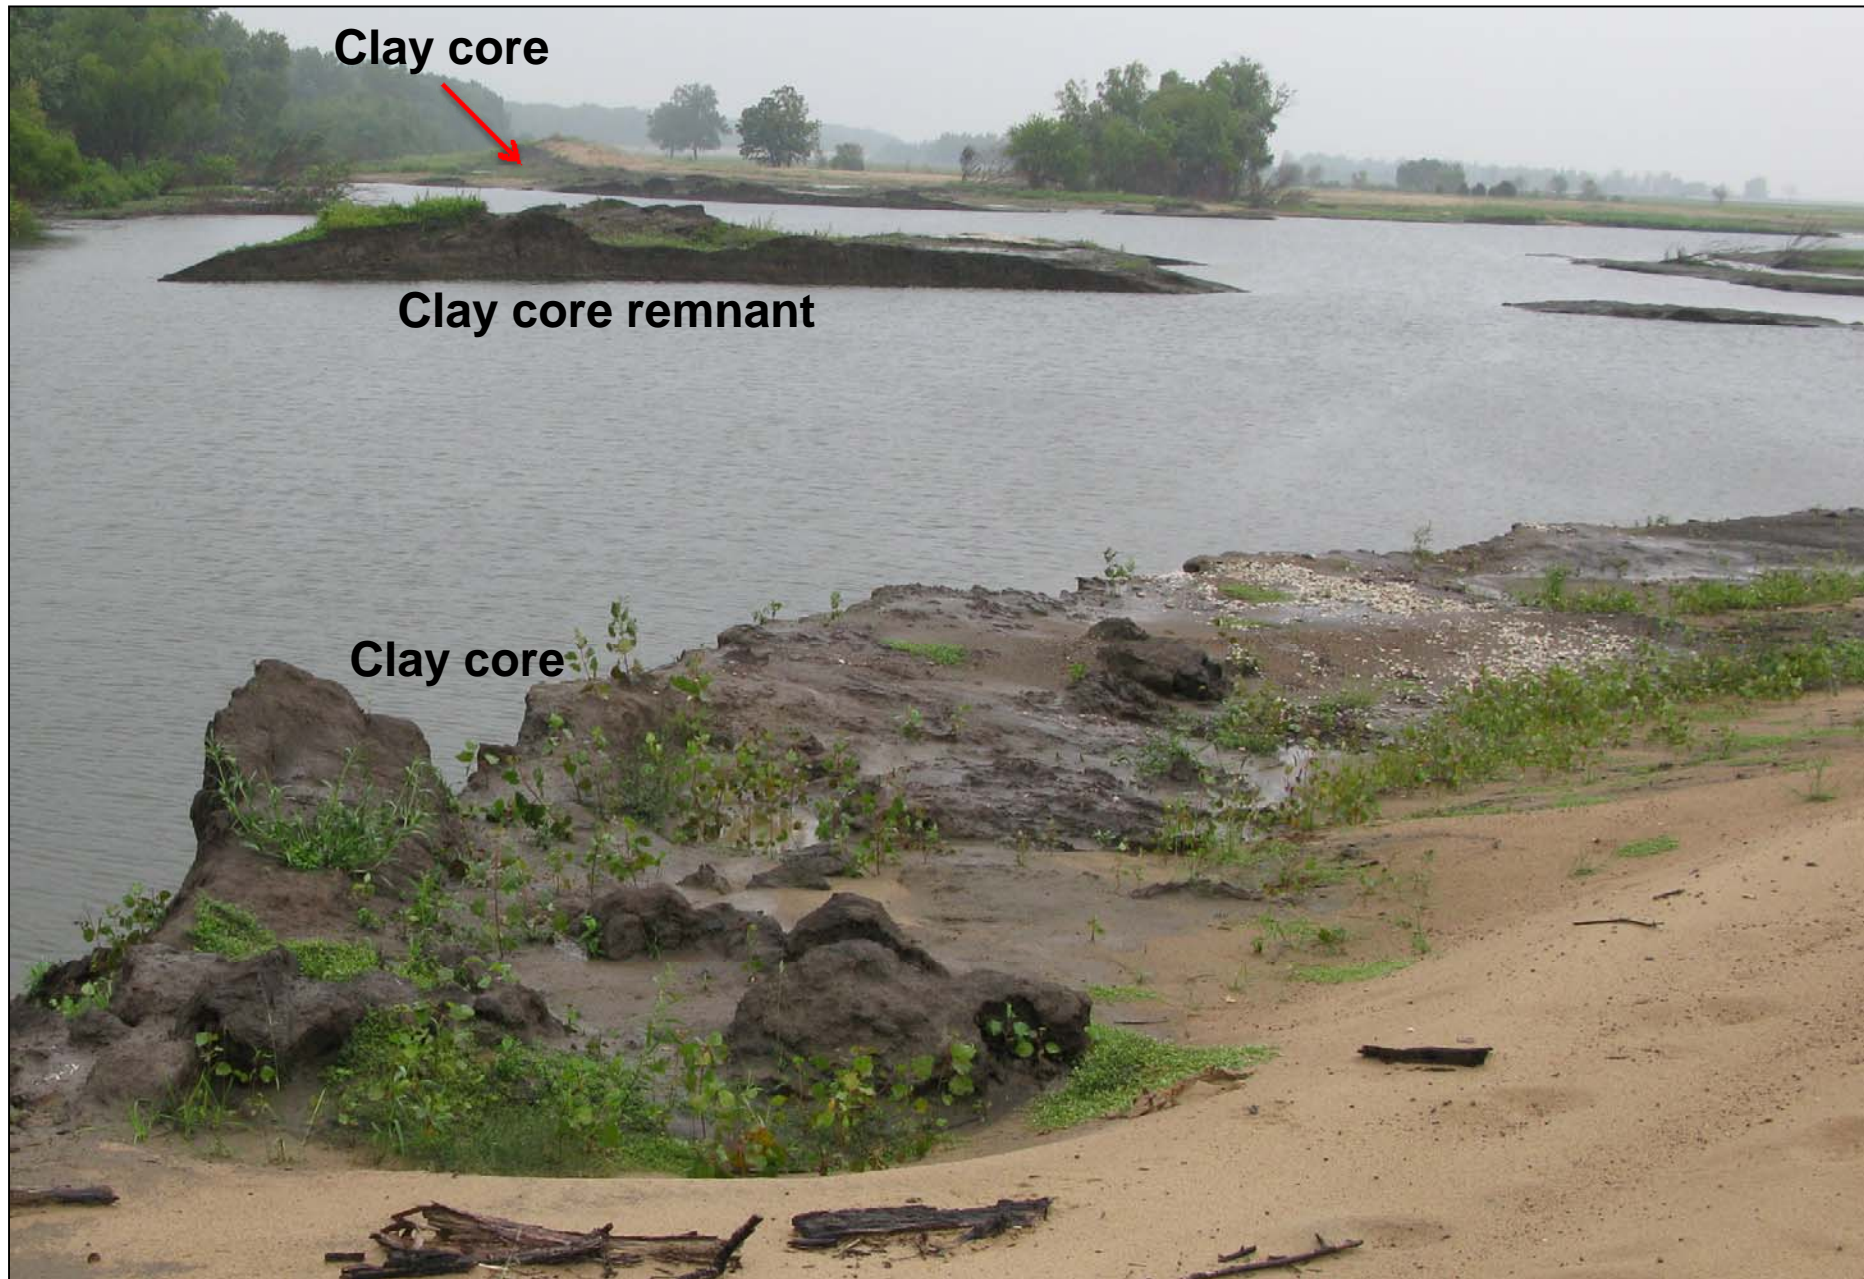
Clay core

Clay core remnant

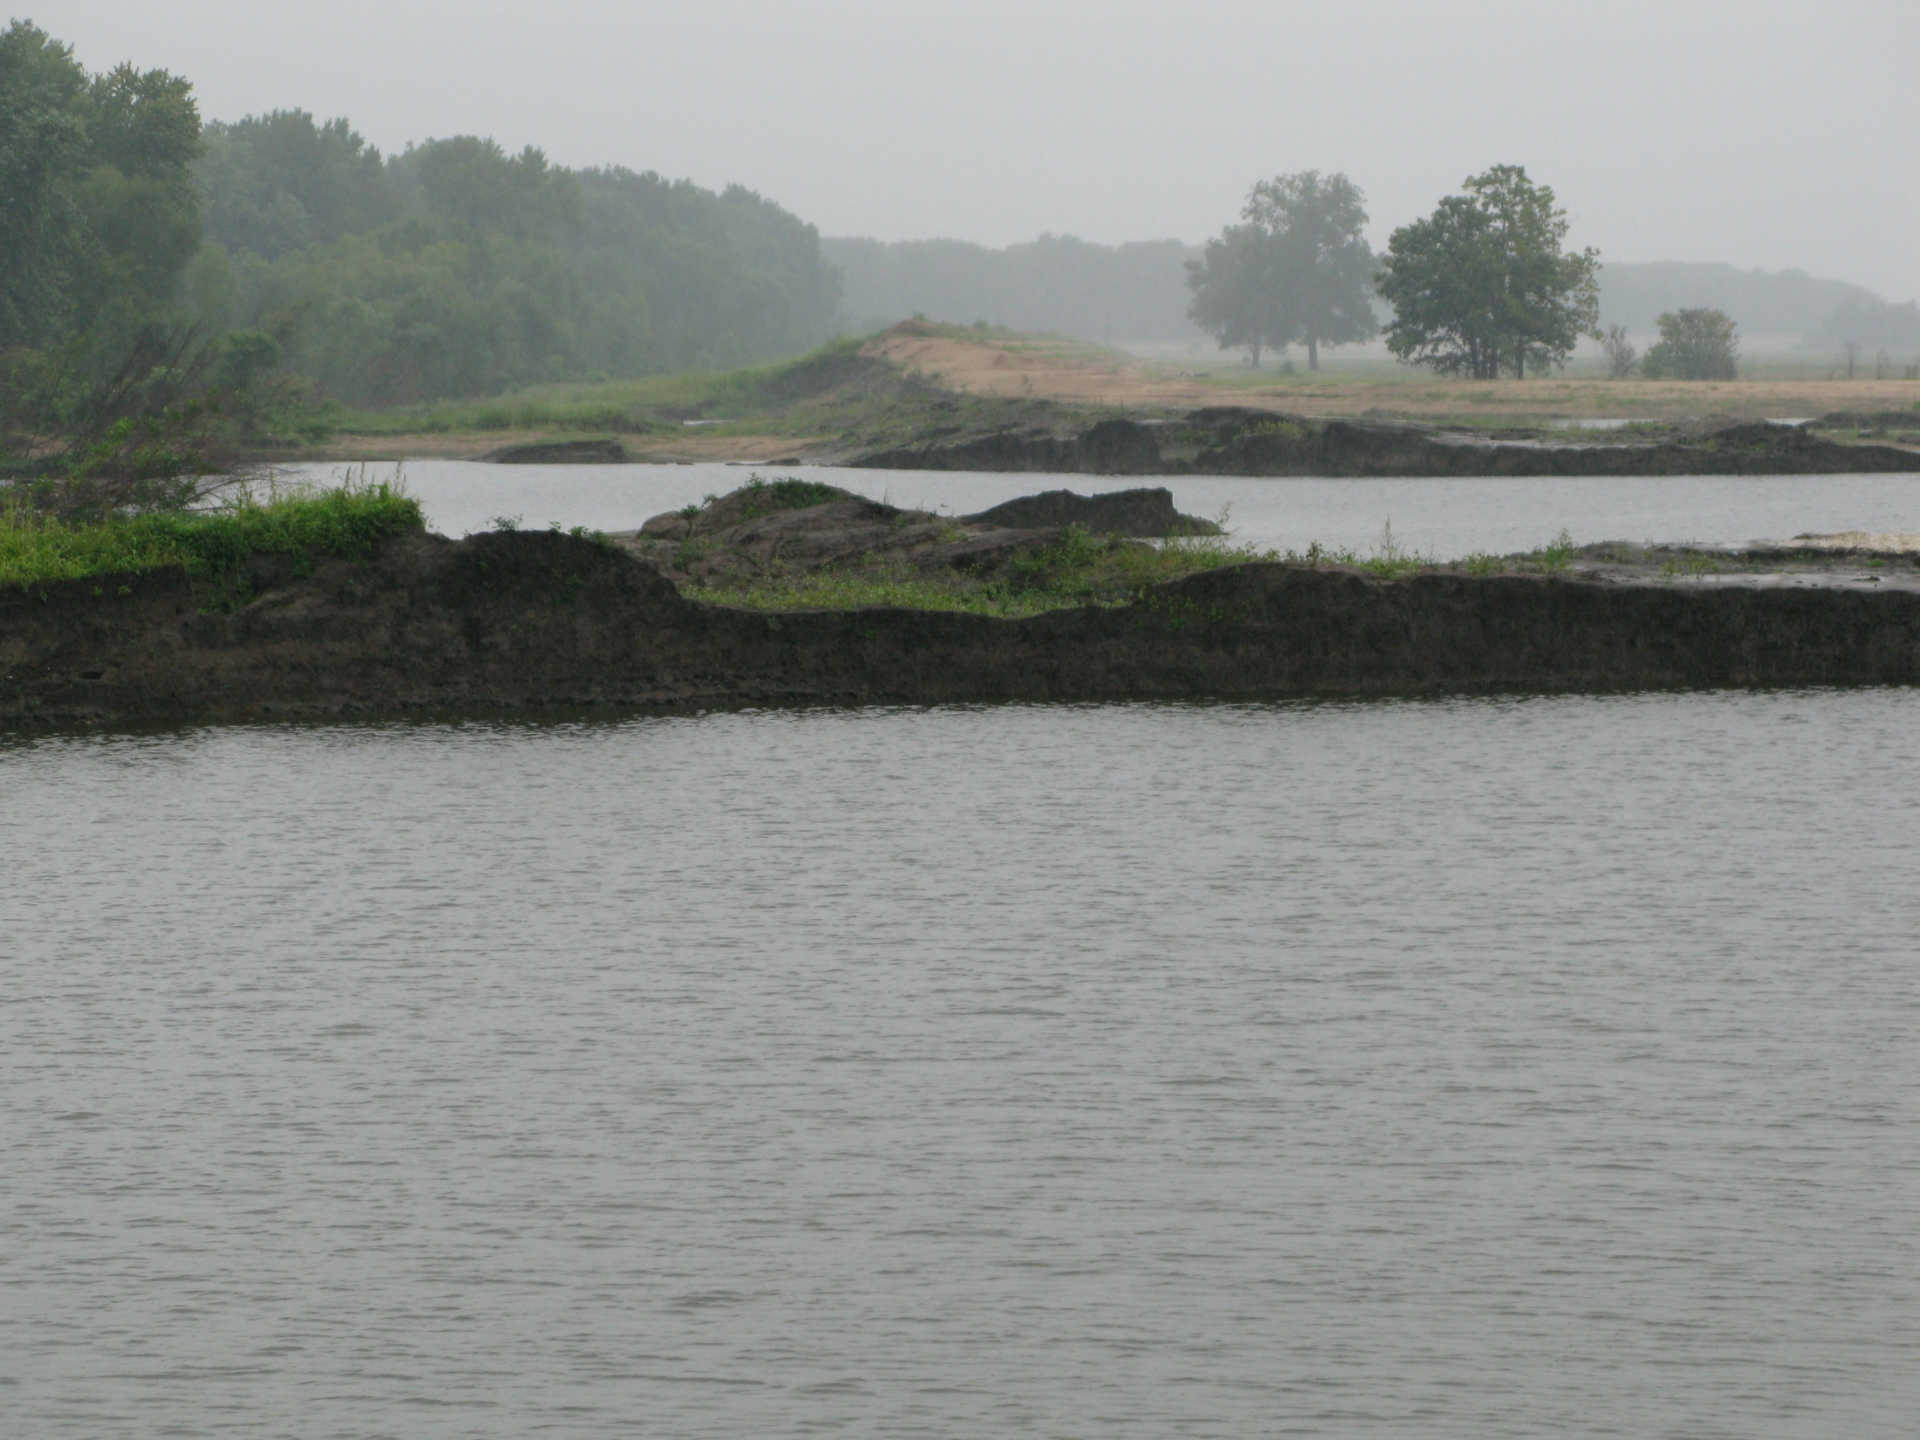
Main 2008 break was over 1000 ft. wide and the resulting scour hole ~35 ft. deep

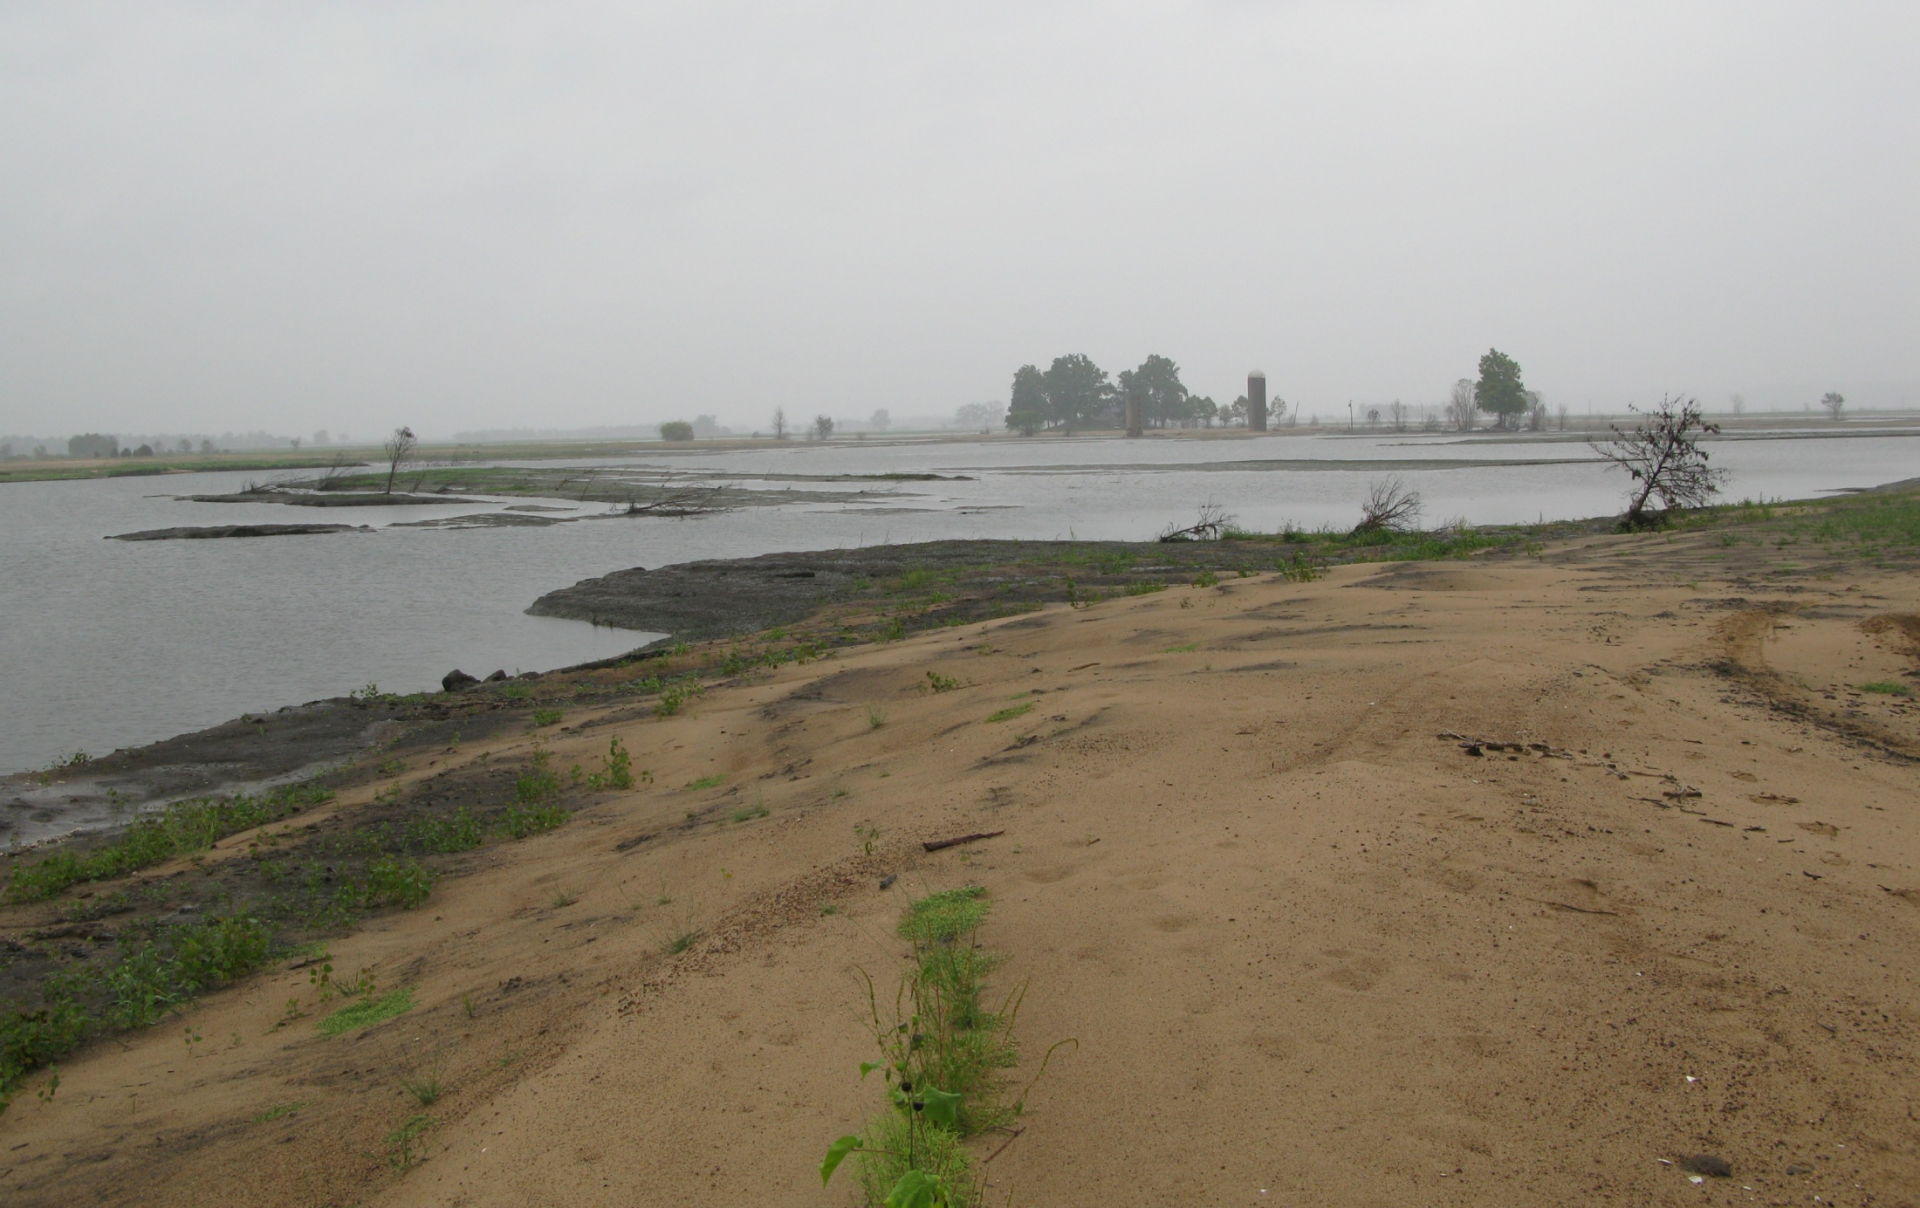
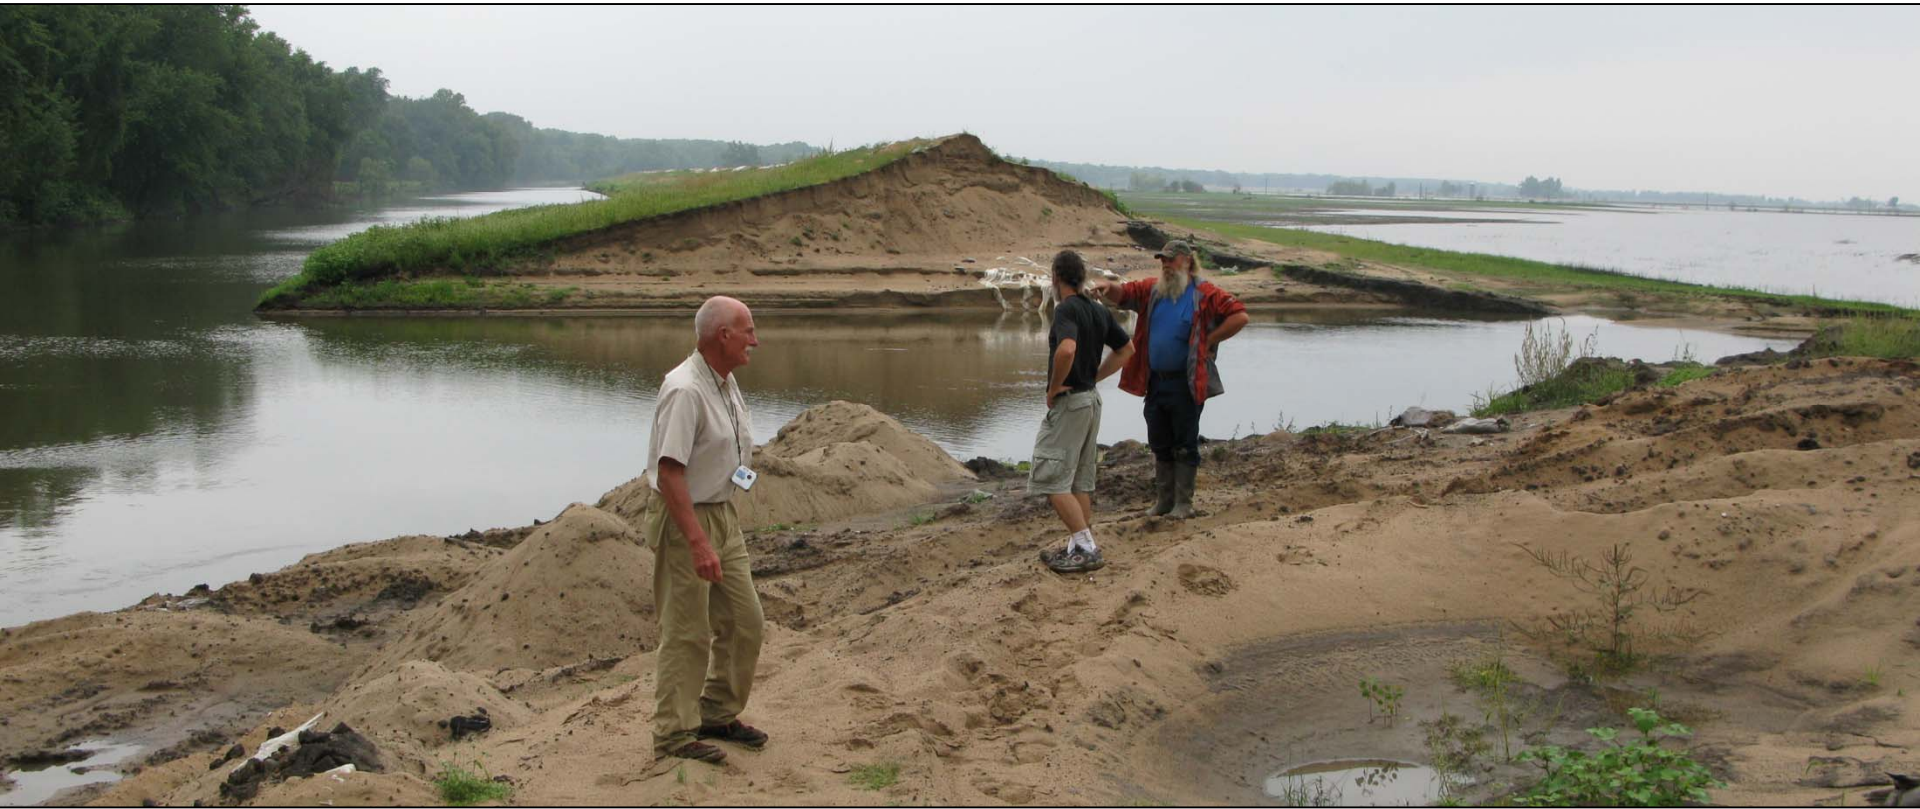
One of the levee Commissioner's farm was just behind the 2008 break, resulting in loss of farm structures, much of the land being scoured, and sand being deposited on much of the remaining land.

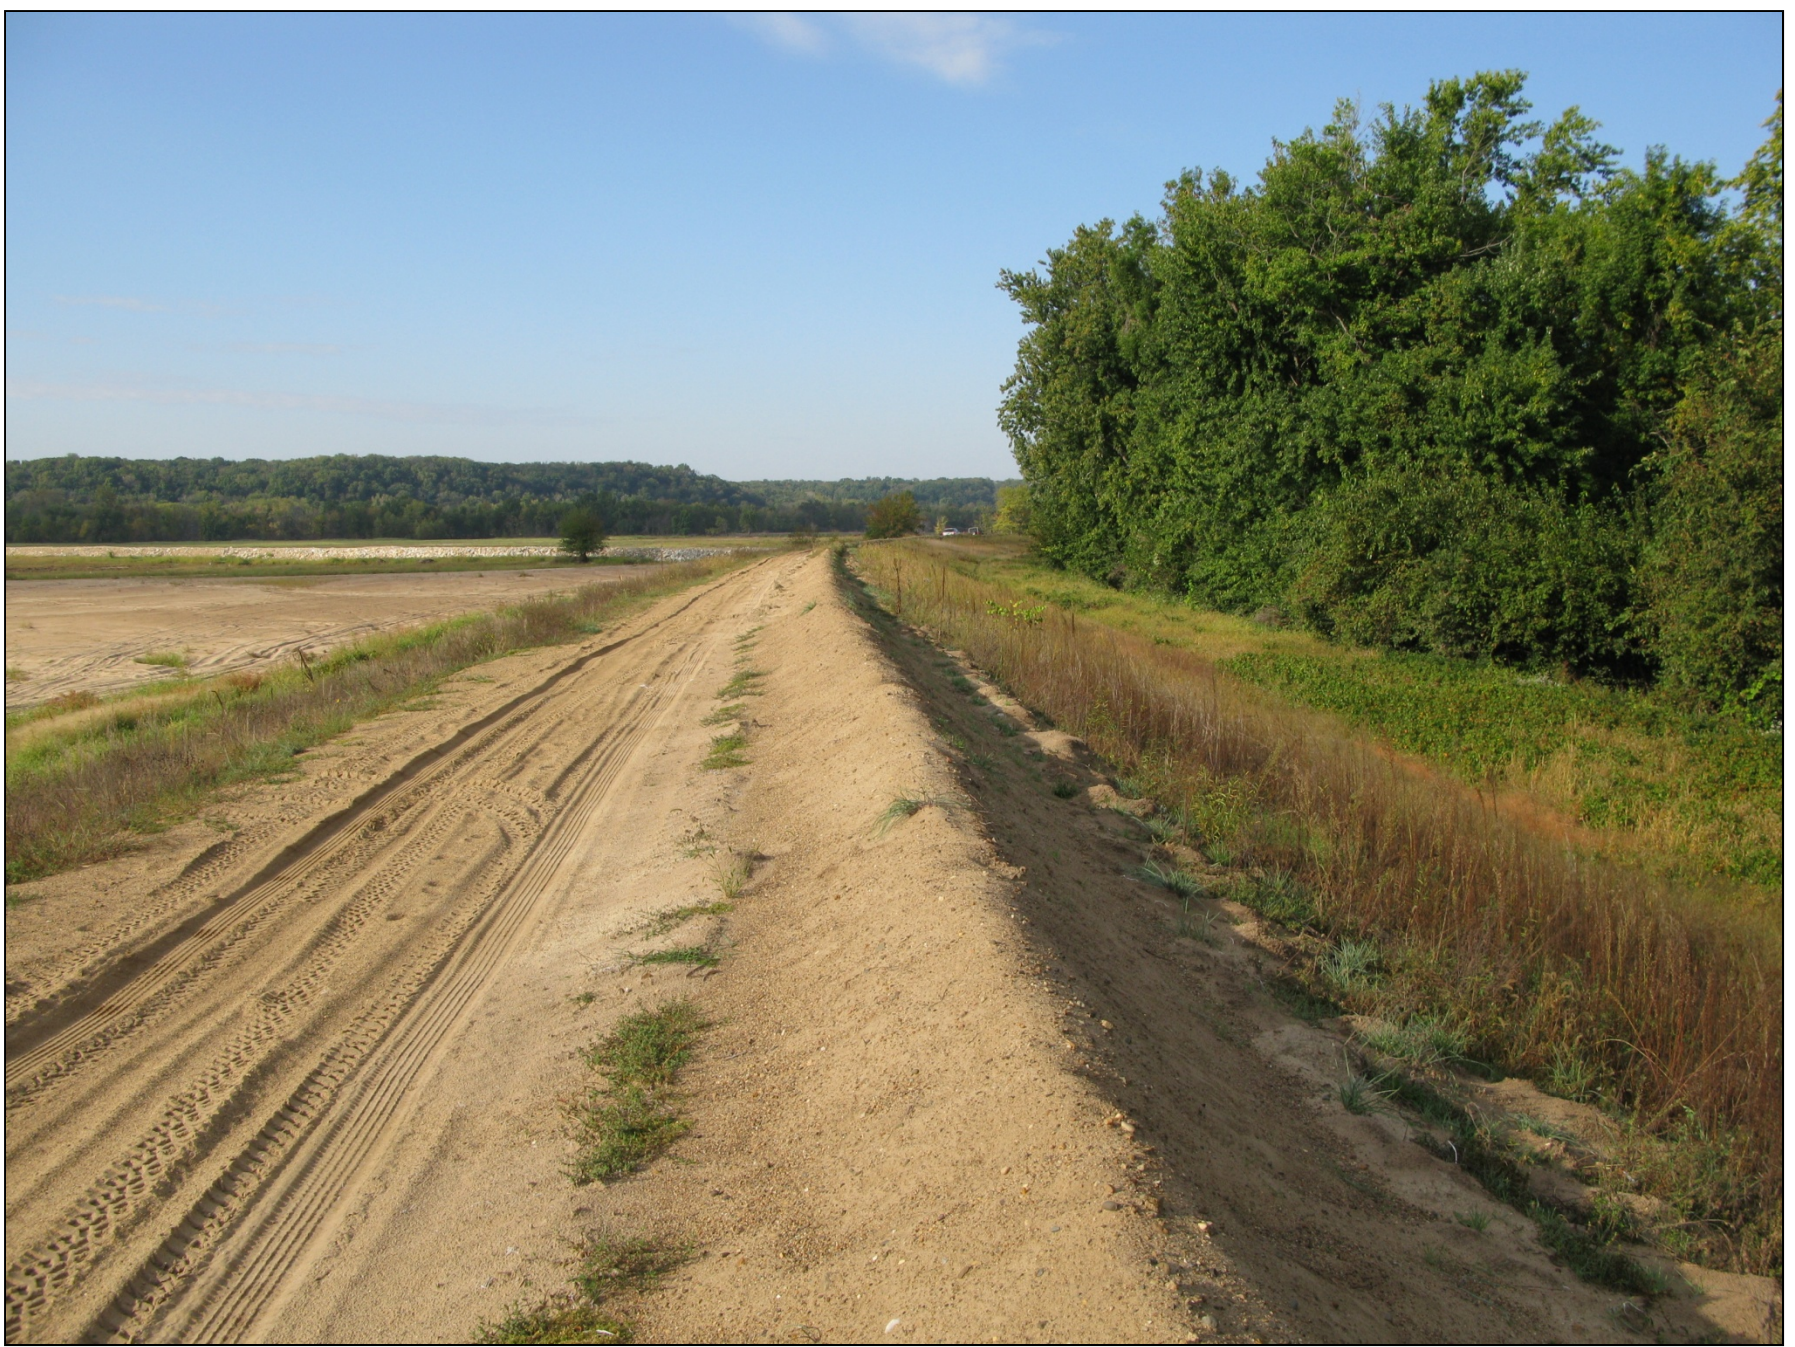
A secondary break resulted when water exited through the southern (downstream) end of the levee district. This location had breached in the past and was repaired with only sand as seen in the exposed levee cross section.

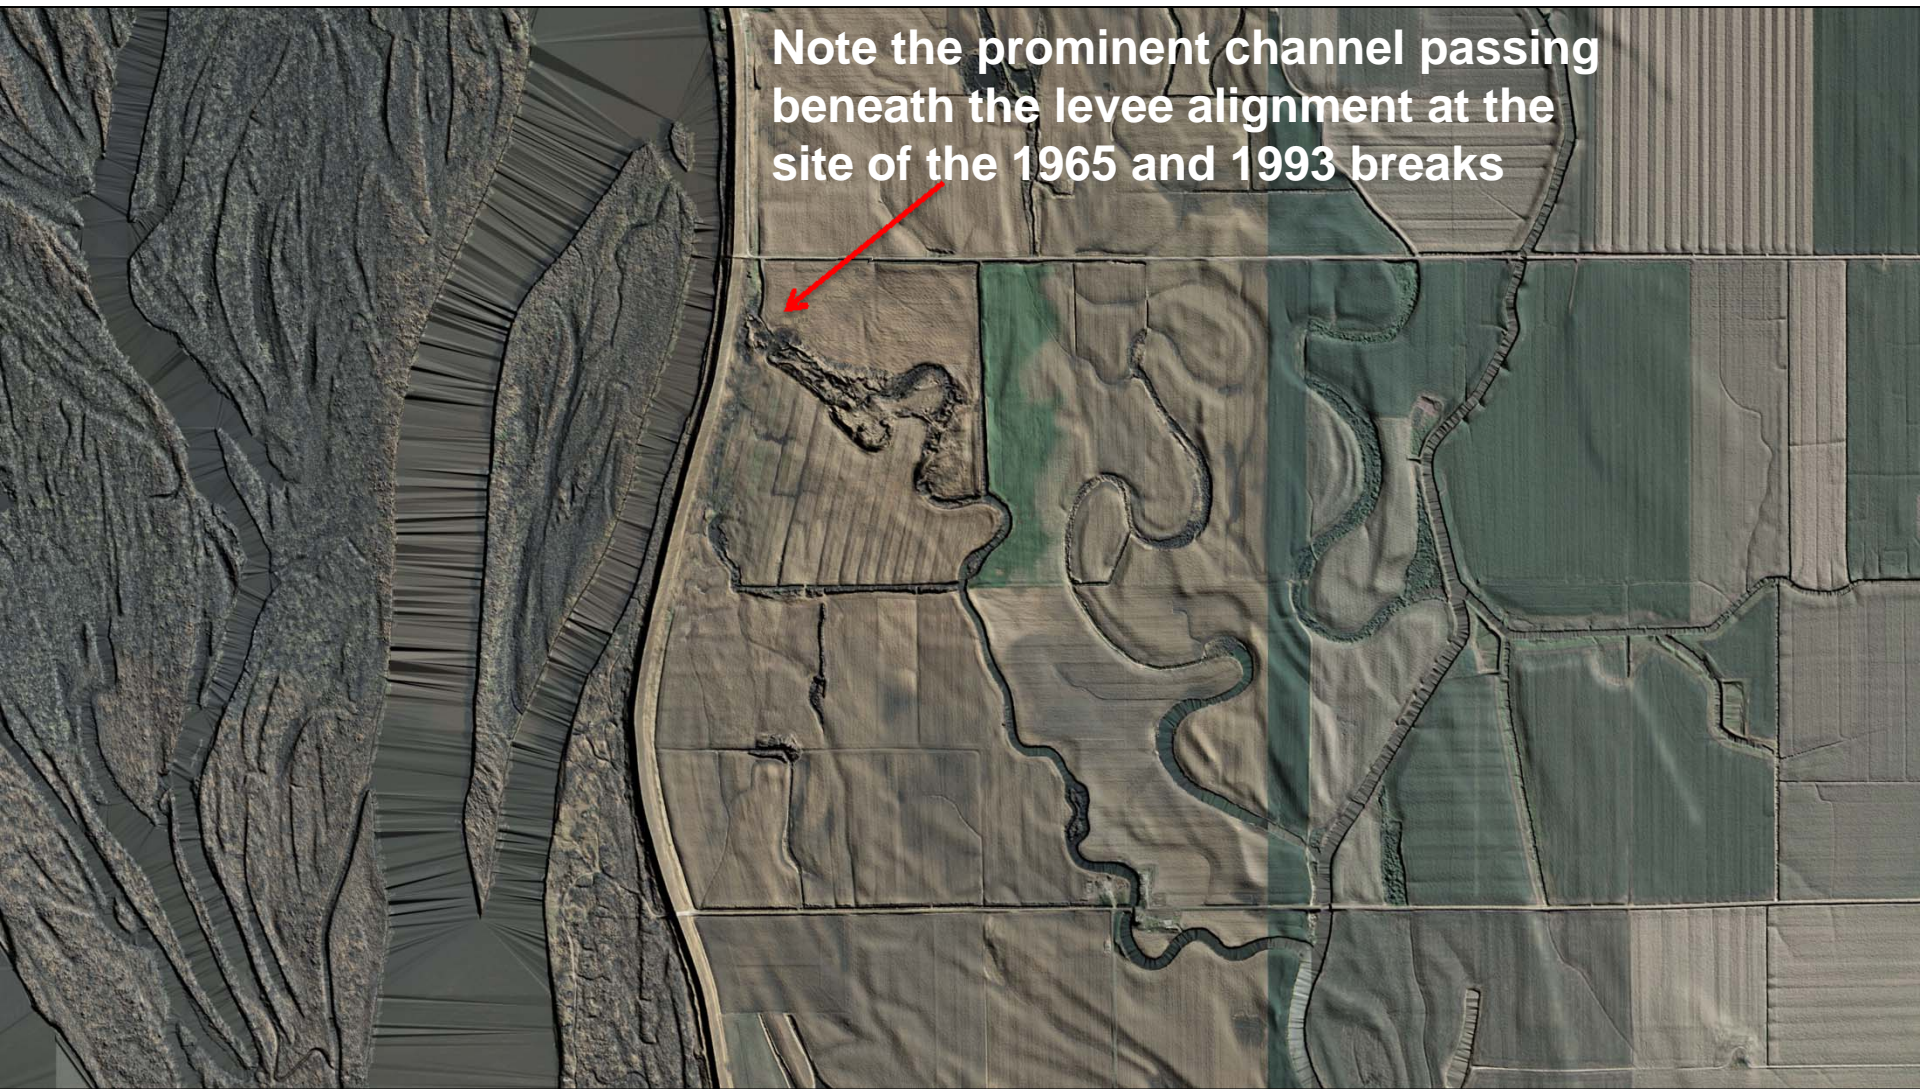
- **Reviews of USDA soil surveys and aerial photography/elevation data reveal that levee breaks at Indian Grave and other levee districts commonly occur where old channels cross beneath the levee alignment**
- **A prominent channel appears to cross beneath the site of the 1965 and 1993 breaks while at least one, likely two, smaller channels pass beneath the site of the 2008 break**

Note the prominent channel passing beneath the levee alignment at the site of the 1965 and 1993 breaks

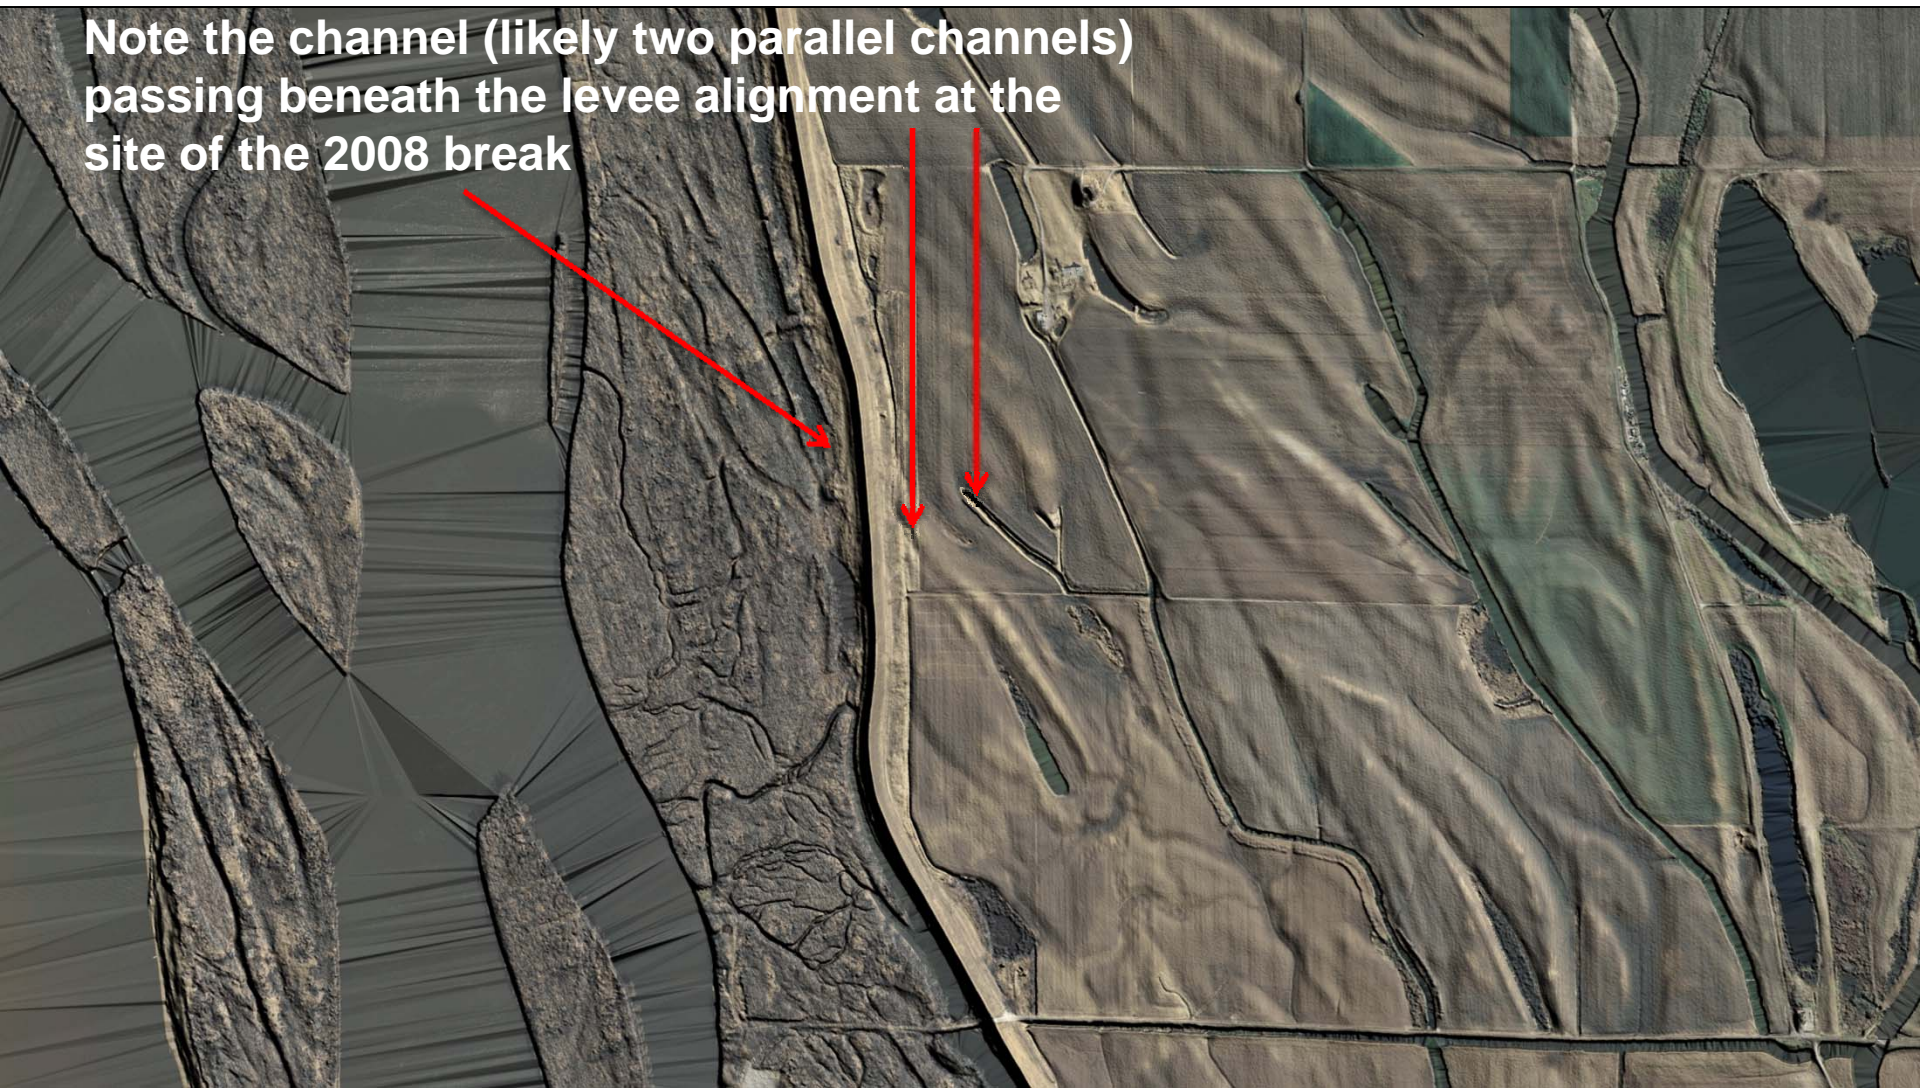
Note the channel (likely two parallel channels) passing beneath the levee alignment at the site of the 2008 break

- **These filled channels likely contain sand and other materials more pervious than the surrounding overbank silts and clays**
- **This leads to more pronounced underseepage in sites where filled channels pass beneath levees due to these preferential seepage paths**
- **Unfortunately the materials were blown out of the scour holes during the failures, precluding material recovery for sampling and testing**

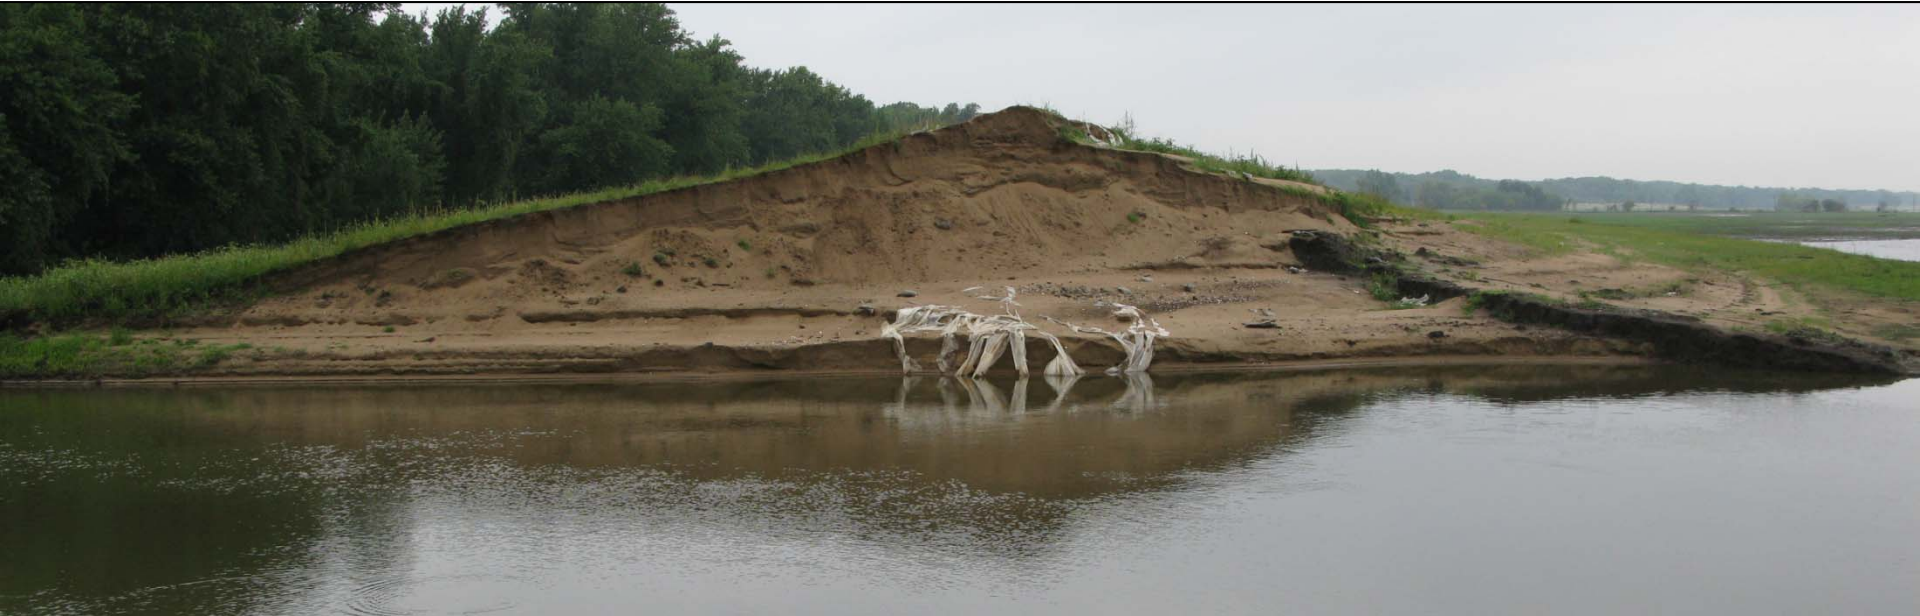
- **Water-filled scour holes at the Indian Grave Levee District, among others, have been filled with dredge sands from the Mississippi River channel**
- **The repaired levee cross section is constructed entirely of sand and the pre-existing clay core is not replaced**
- **This type of repair leaves the levee just as likely to fail as prior to failure, as shown by the repeated failures**
- **Some levee repairs have been performed by constructing “ring levees”, which curve around the old scour hole, forming a semi-circle in the levee alignment while avoiding scour hole repair to avoid the necessity of filling in these holes in the wet**

Previously repaired section of Indian Grave Levee that experienced a repeat failure in 2008; note that clay core had not been replaced at this location

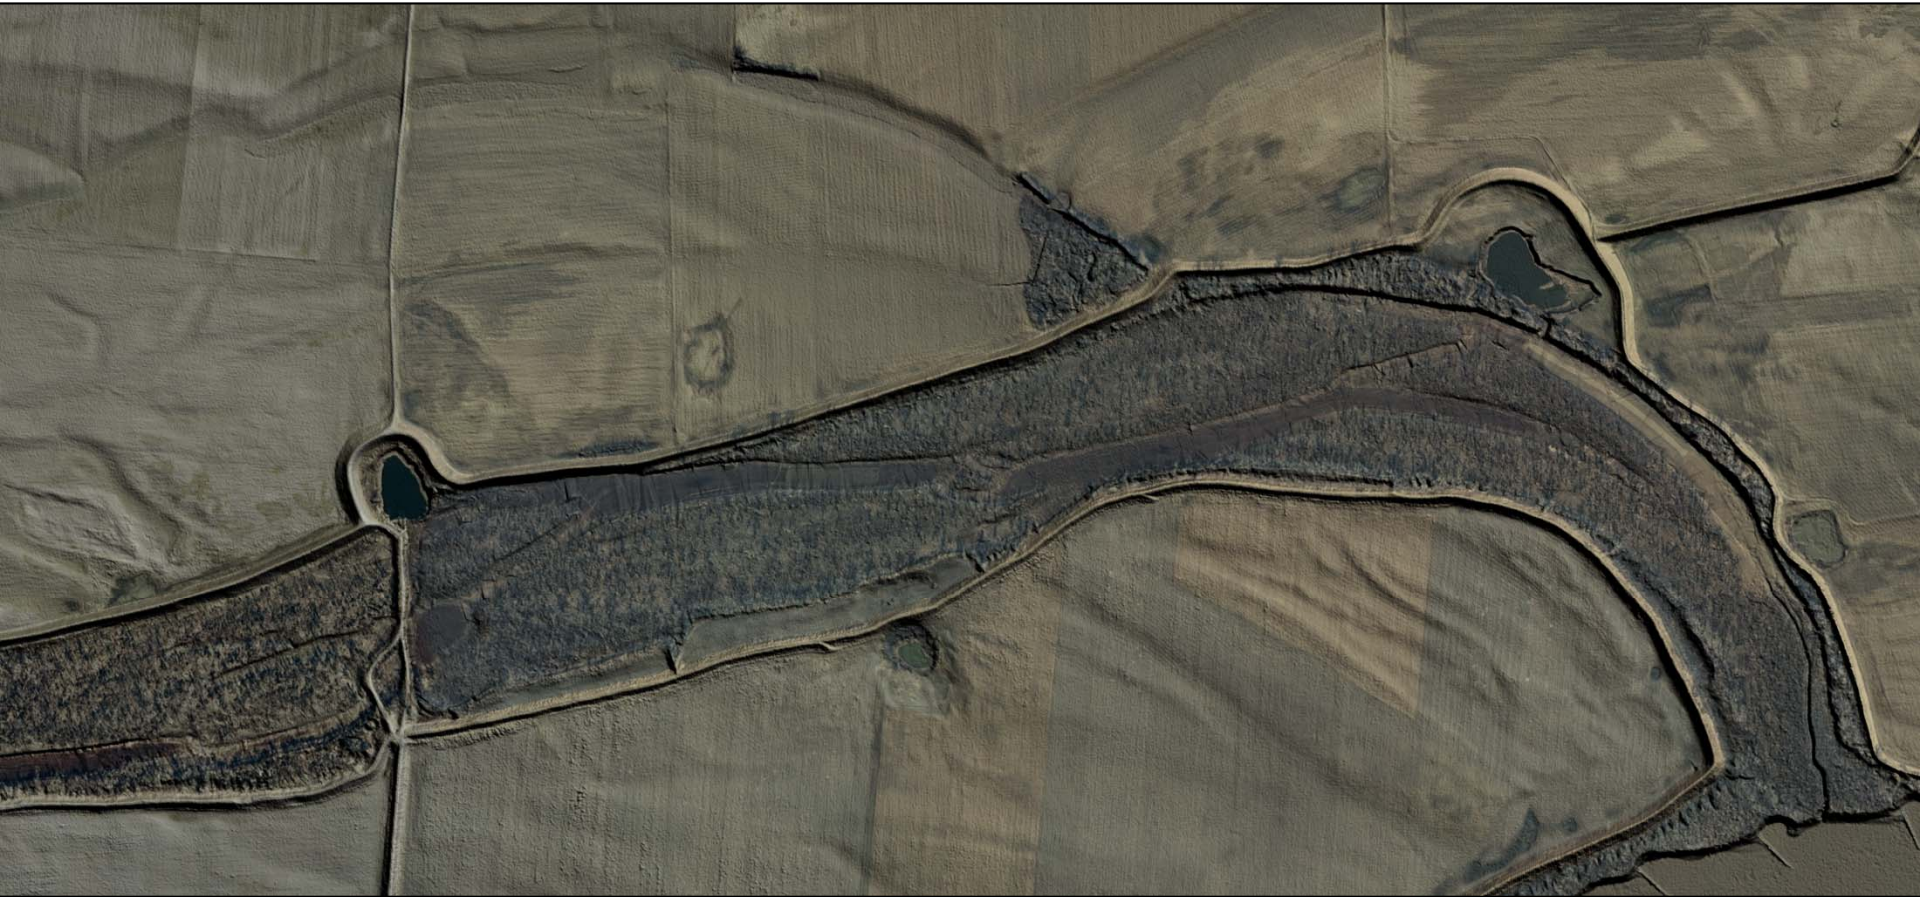
Example of repairs conducted using “ring levees” at the Consolidated North County and Kuhs Point Levee Districts along the Missouri River in St. Charles County, MO
