**IMPORTANCE OF GEOLOGIC
CHARACTERIZATION FOR LEVEE
FOUNDATION AND BORROW MATERIALS AS
STUDIED AT THE INDIAN GRAVES LEVEE
DISTRICT, ADAMS COUNTY, IL**

AEG Annual Meeting - September 24, 2009

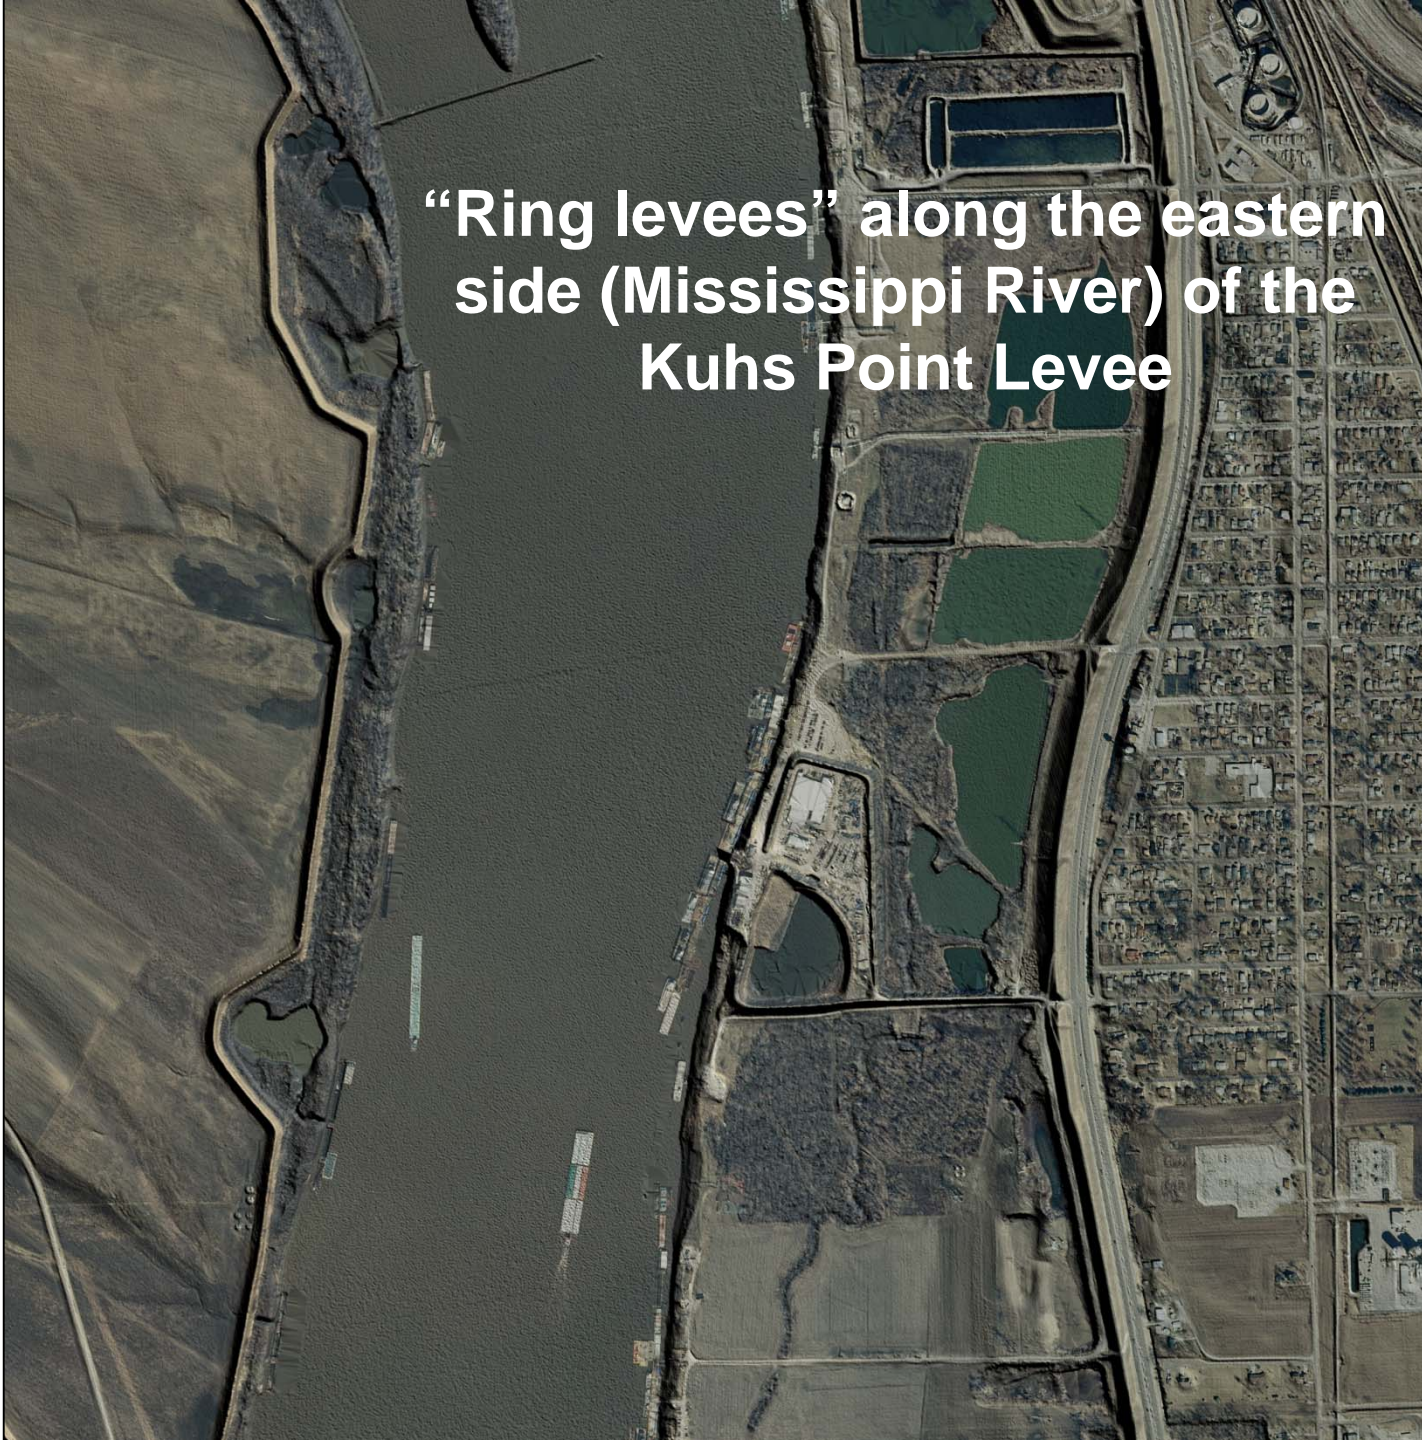
“Ring levees” along the eastern side (Mississippi River) of the Kuhs Point Levee

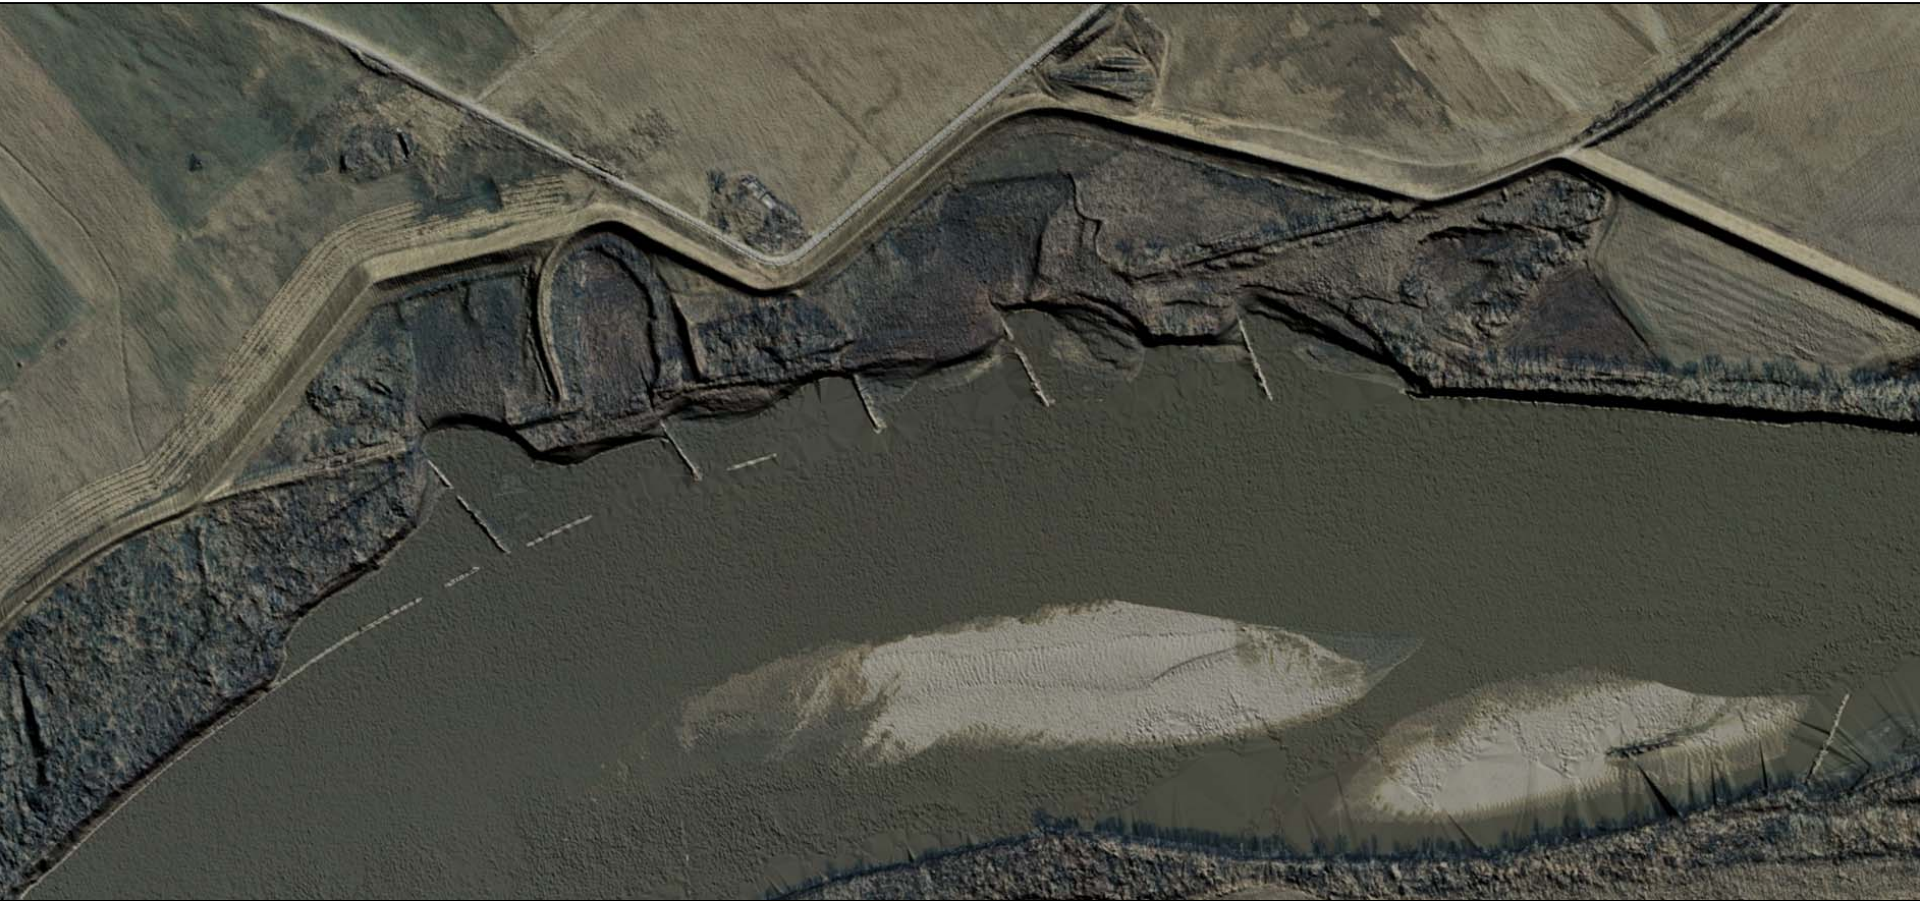
Levee showing at least two generations of repairs using “ring levees” at the Consolidated North County Levee District in St. Charles County, MO on the Missouri River – Note that the third levee constructed has a much wider cross section than the previous two attempts
