# **ENGINEERING GEOLOGIC CHARACTERIZATION OF LEVEE FAILURES IN NEW ORLEANS DURING HURRICANE KATRINA**

**J. David Rogers, Ph.D., P.E., R.G.**

**Member, National Science Foundation Independent Levee Investigation Team and  
Karl F. Hasselmann Chair in Geological Engineering  
University of Missouri-Rolla**

**2006 Annual Meeting  
Association of Environmental and Engineering Geologists  
Boston, Massachusetts  
November 1, 2006**

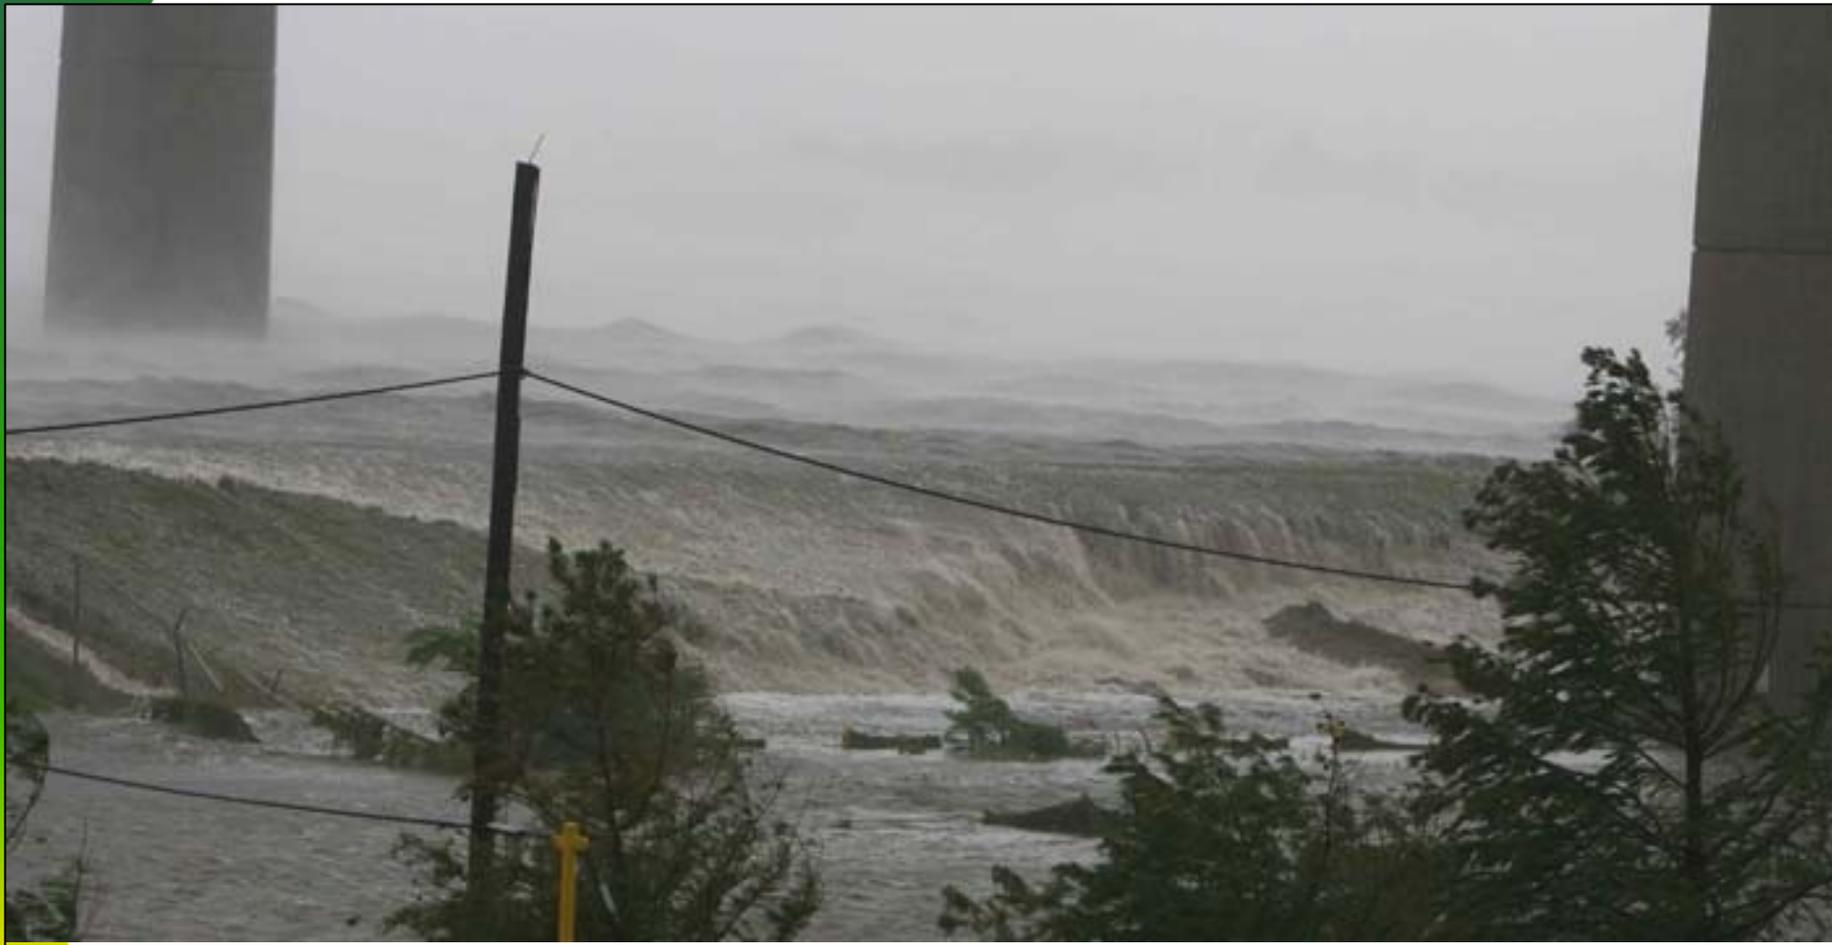
- **Around 6 AM on August 29<sup>th</sup> the 9 ft storm surge swept into the Inner Harbor Navigation Canal area, engulfing the Entergy Power Plant area with waves up to 17 ft high.**

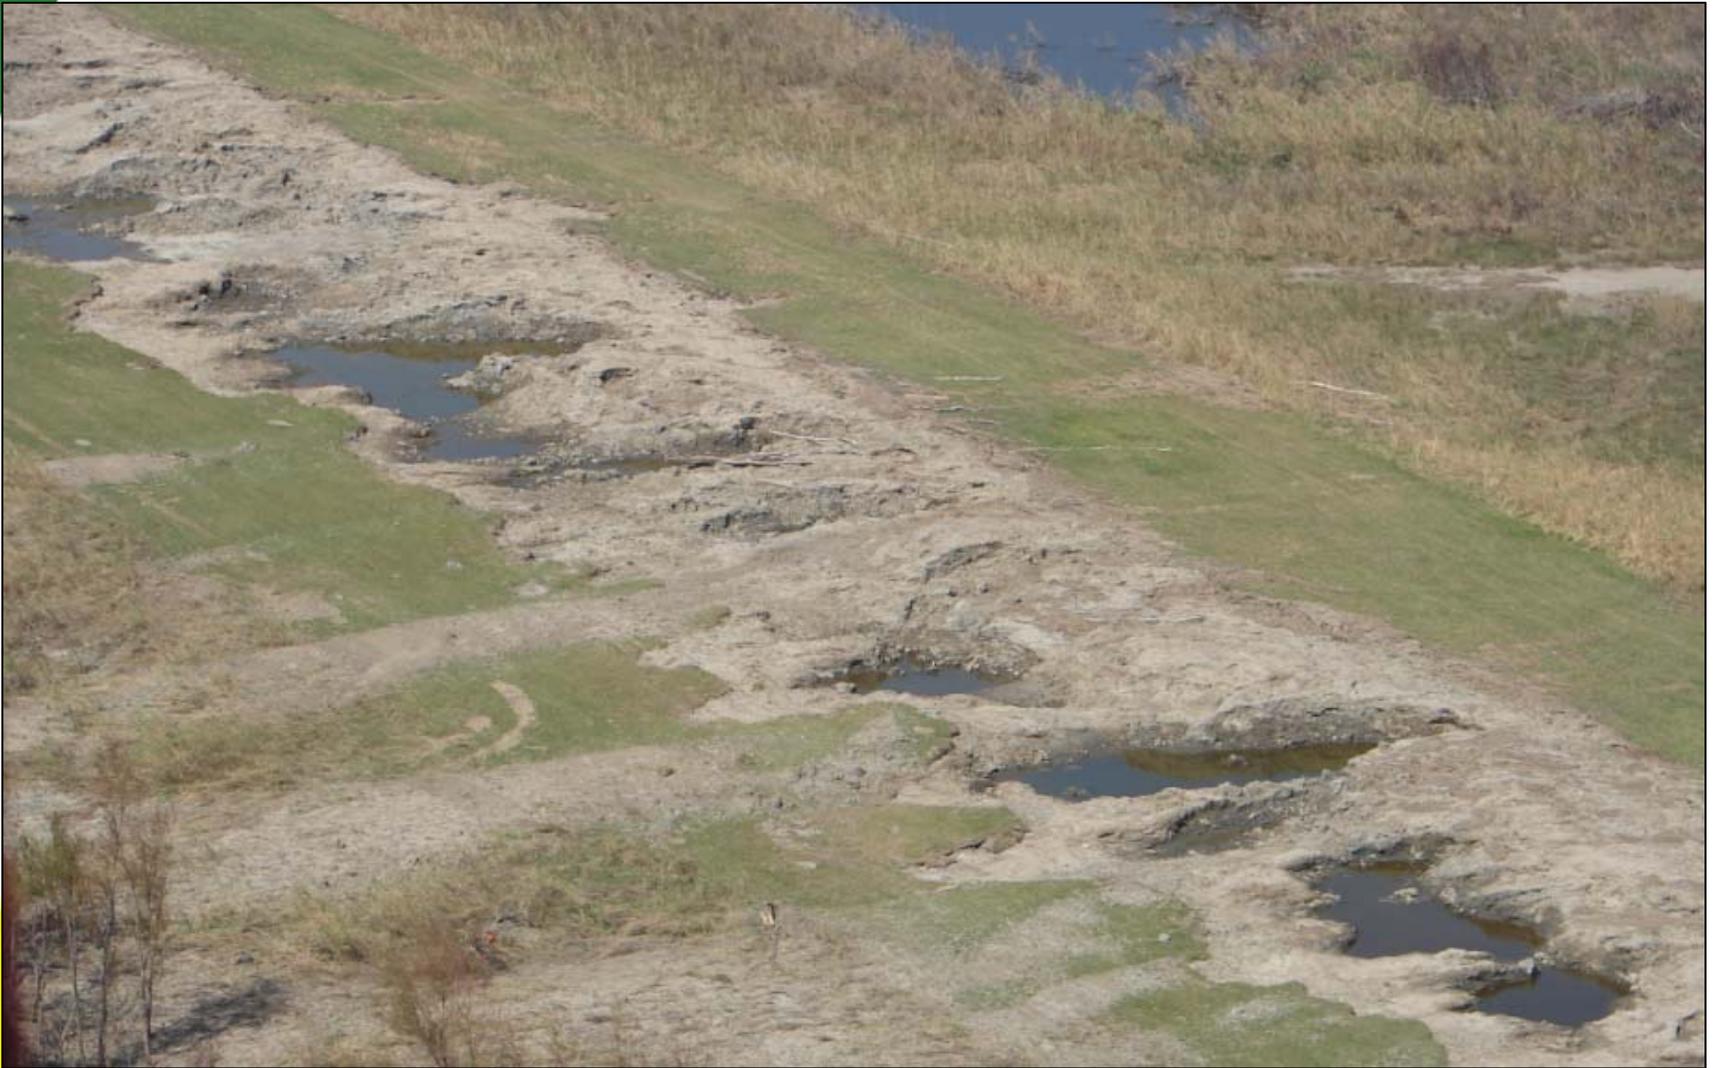
- **Miles of levees just disappeared: MRGO levee completely washed away about two miles southeast of Bayou Dupree.**

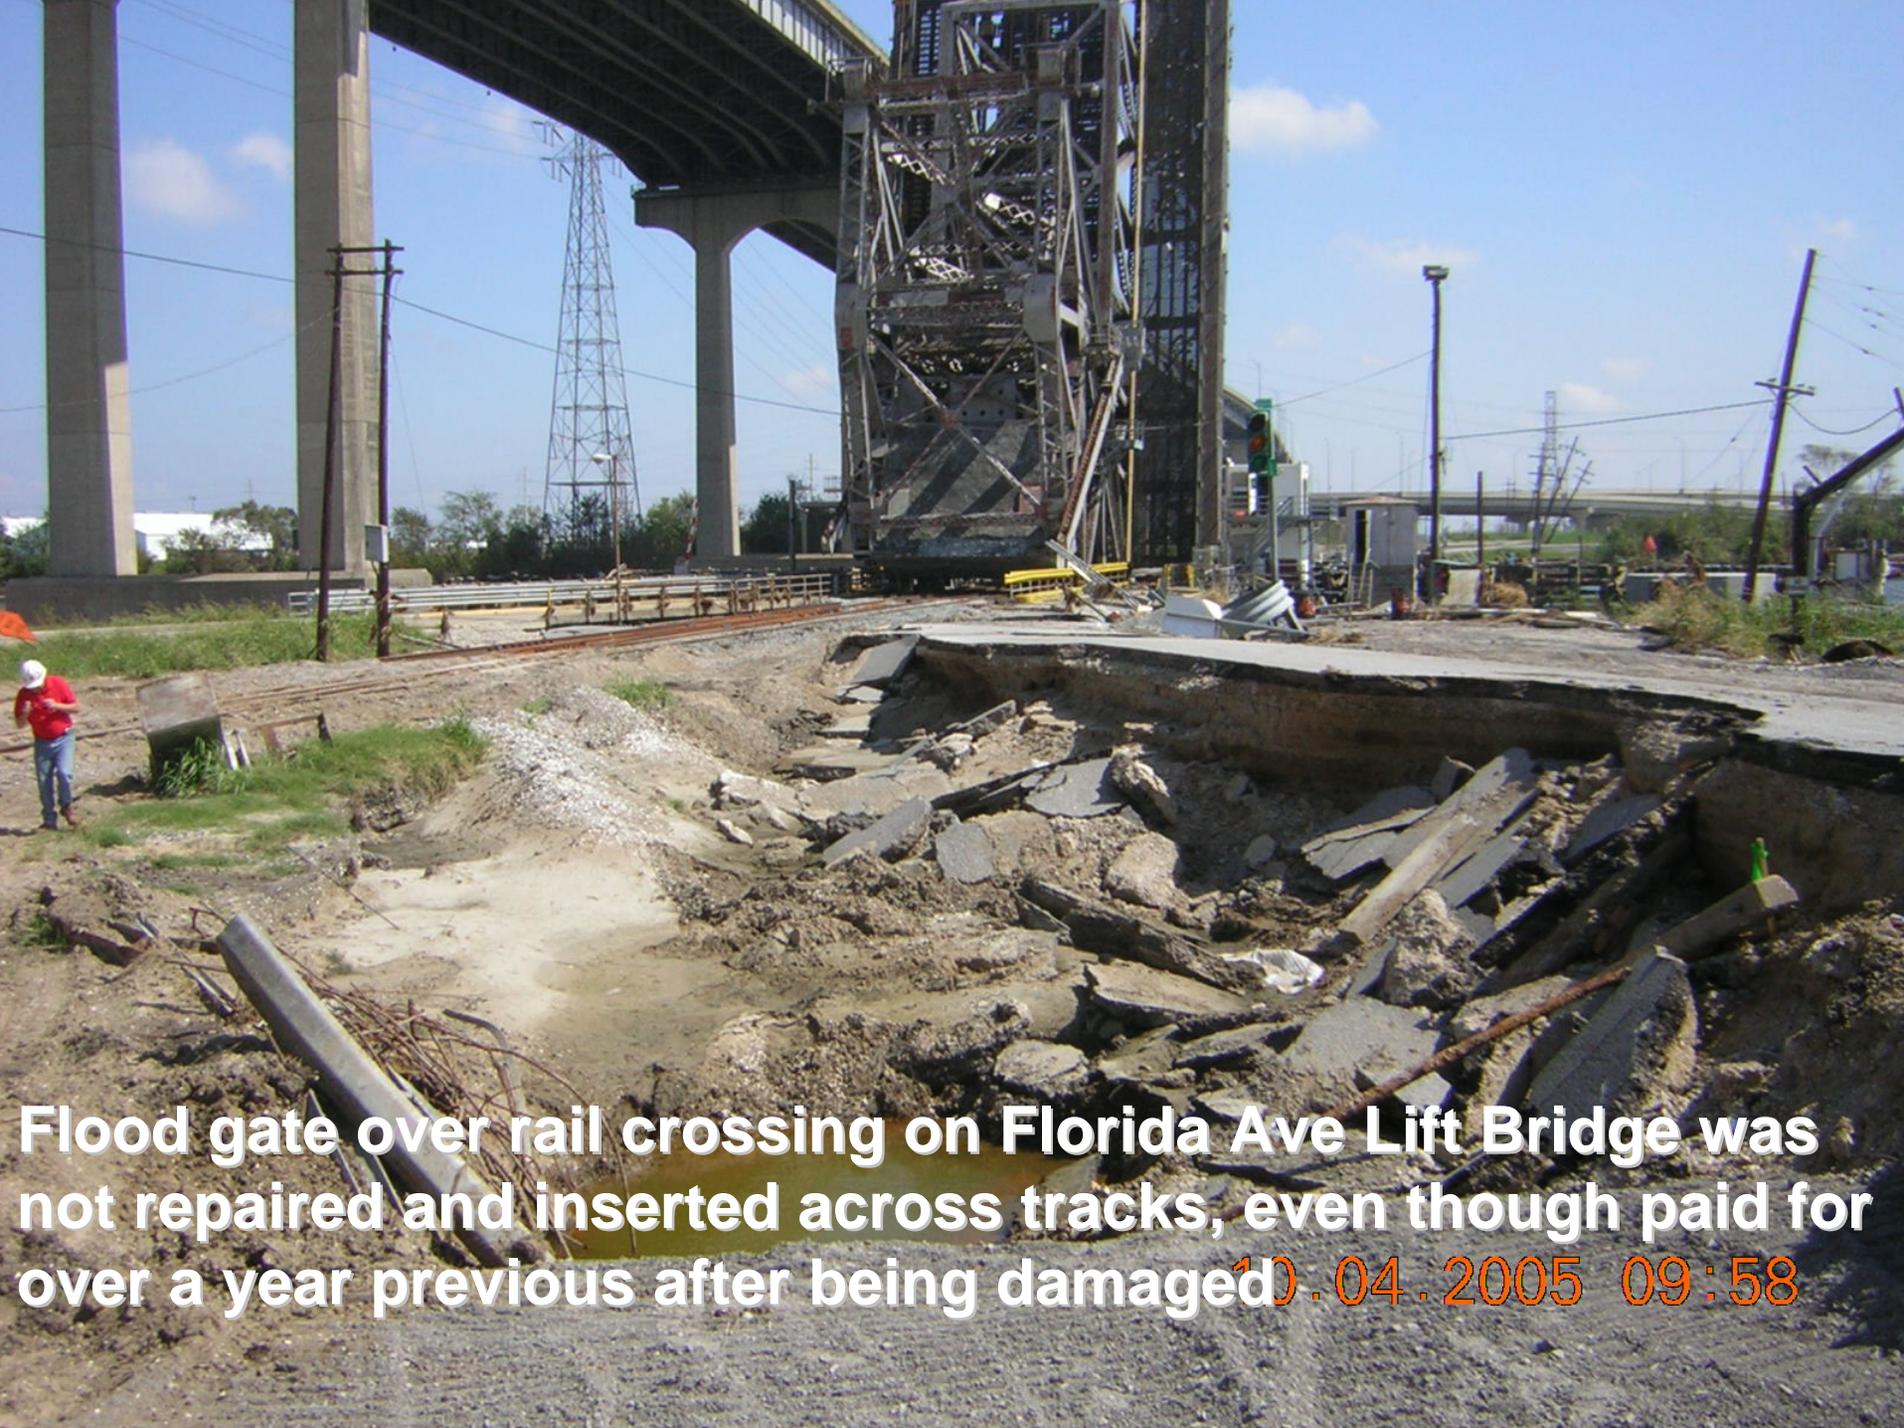
**Flood gate over rail crossing on Florida Ave Lift Bridge was not repaired and inserted across tracks, even though paid for over a year previous after being damaged** 10.04.2005 09:58

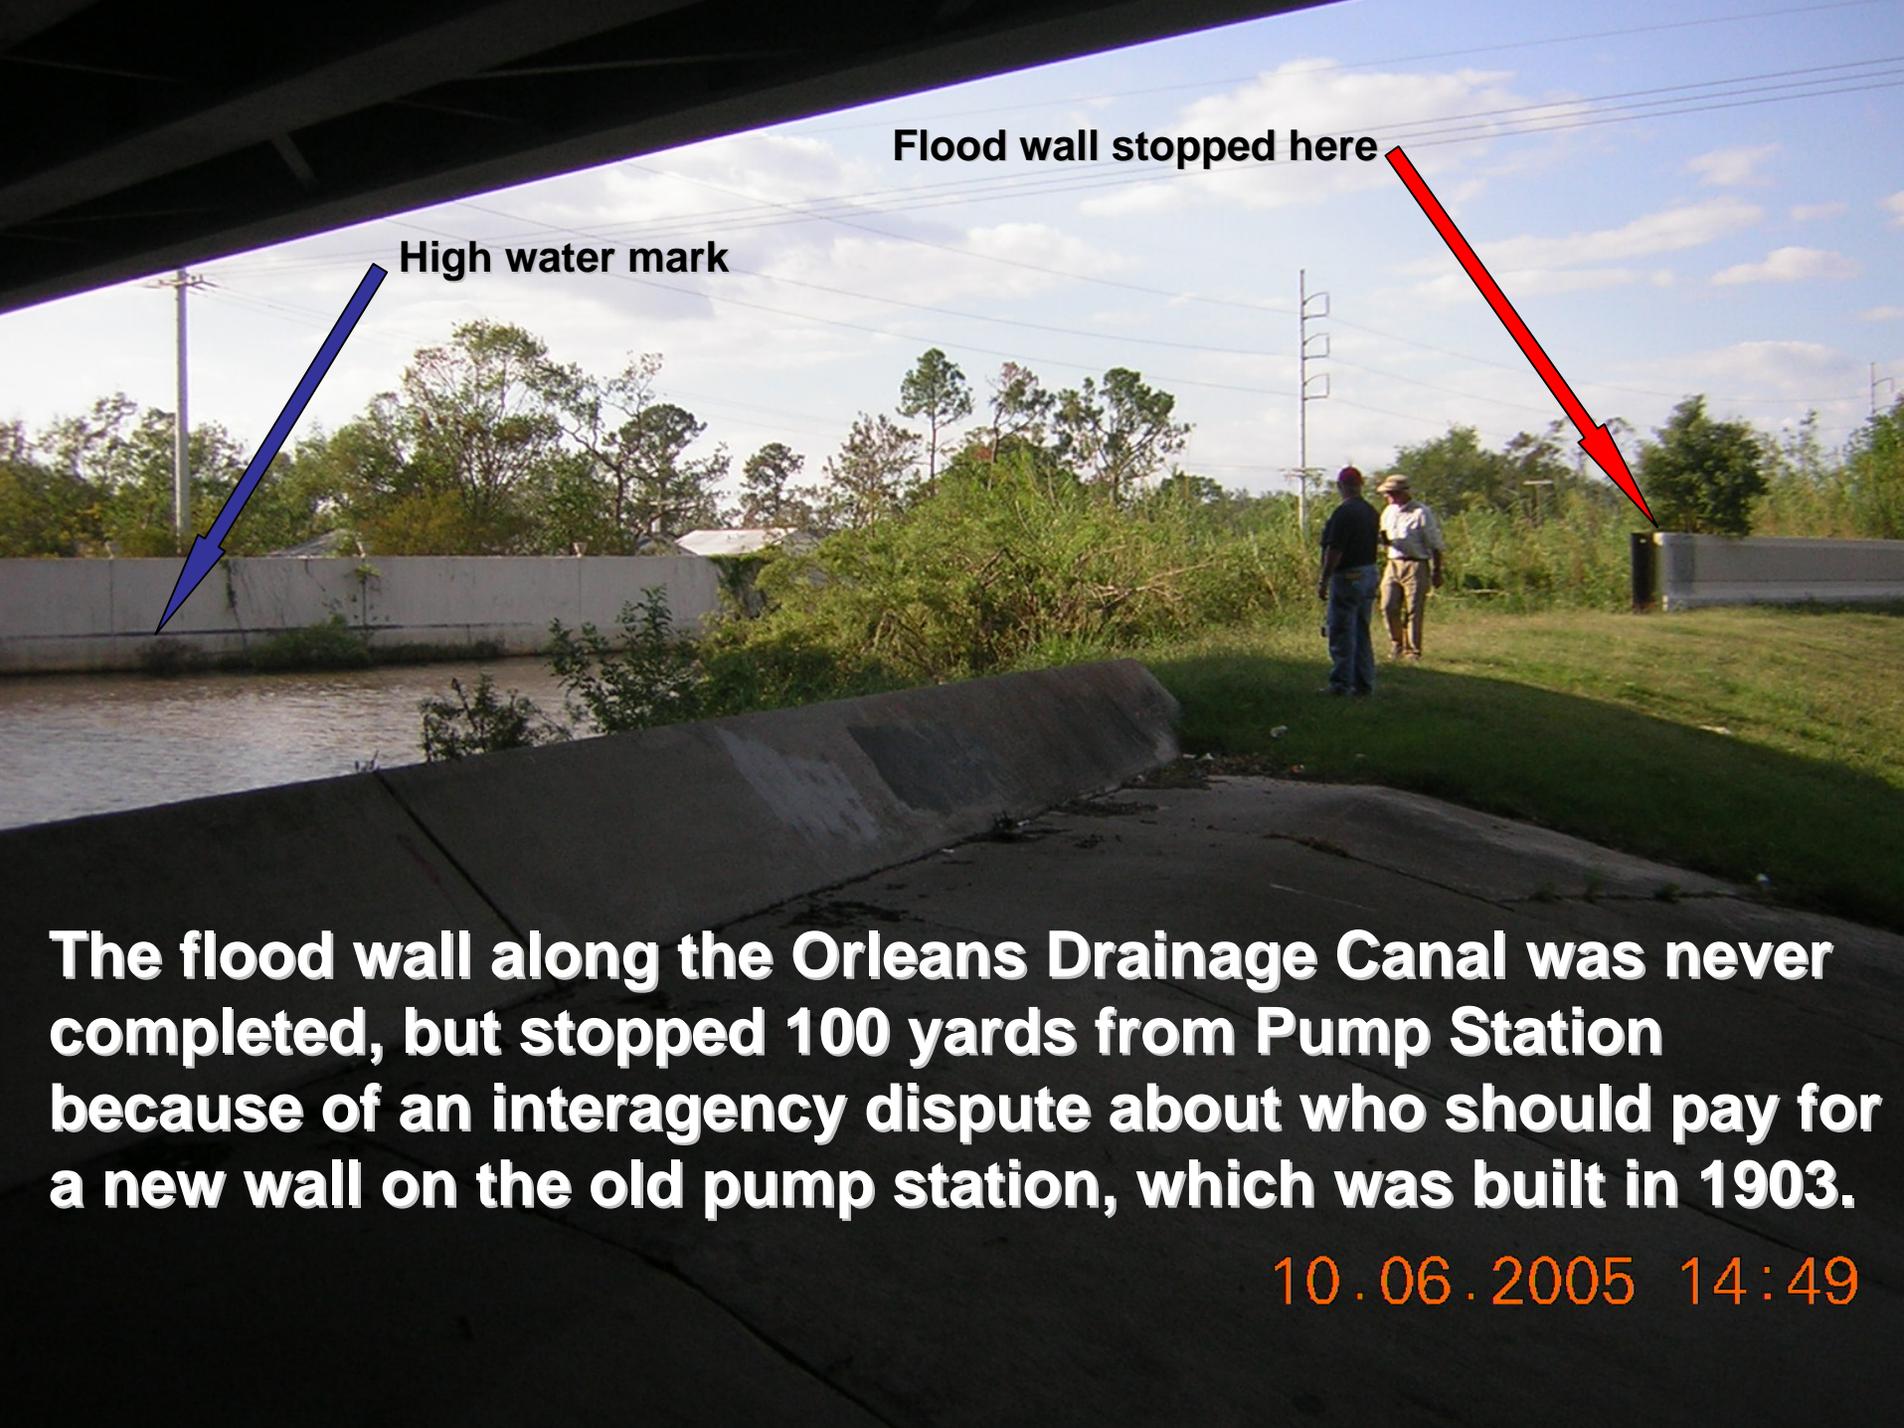
**Flood wall stopped here**

**High water mark**

**The flood wall along the Orleans Drainage Canal was never completed, but stopped 100 yards from Pump Station because of an interagency dispute about who should pay for a new wall on the old pump station, which was built in 1903.**

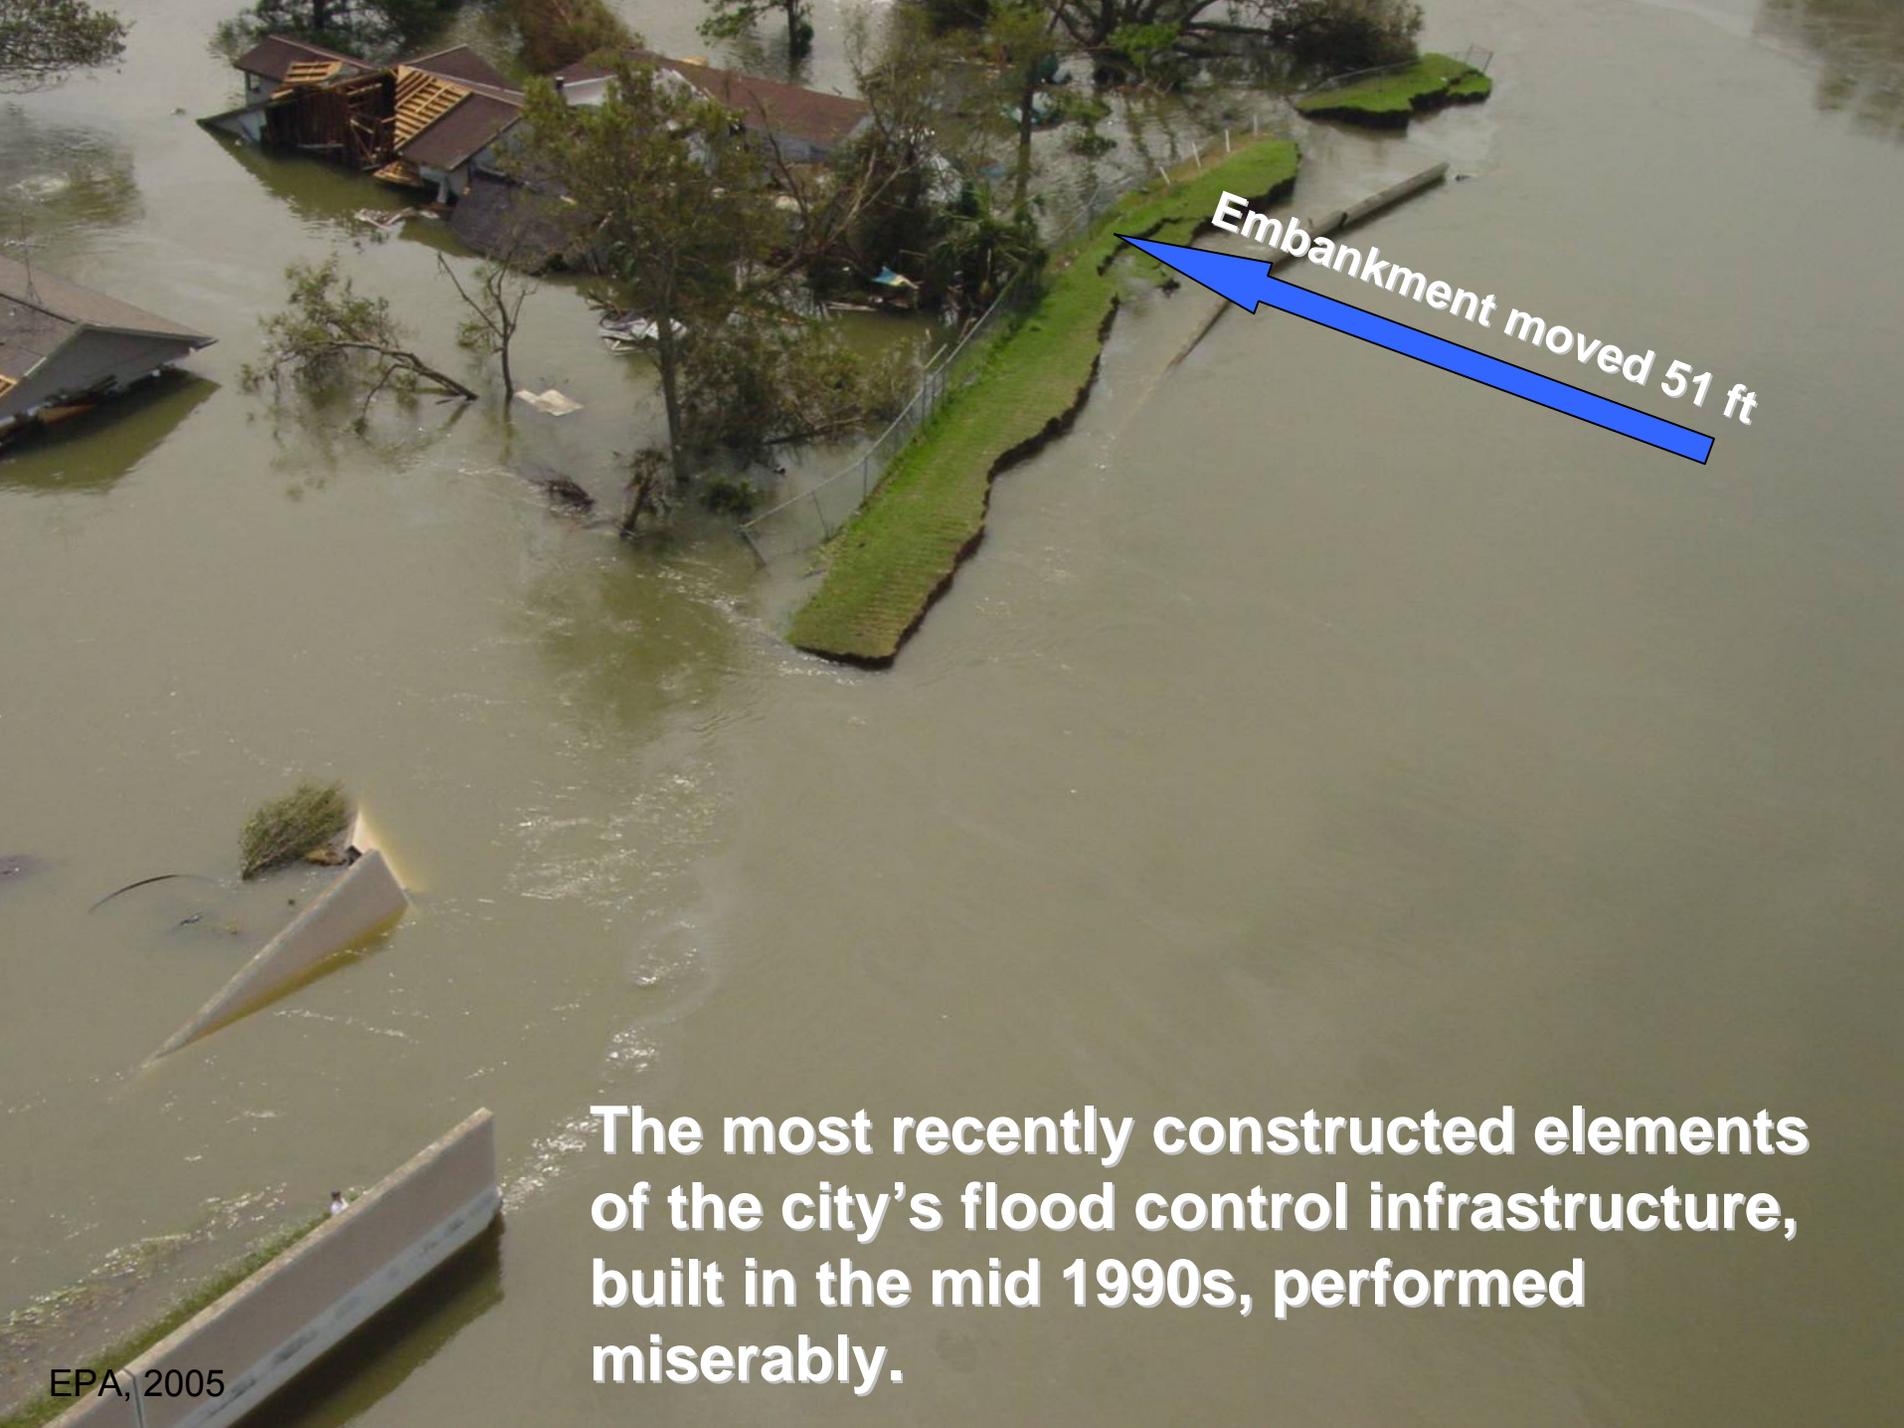
Embankment moved 51 ft

**The most recently constructed elements of the city's flood control infrastructure, built in the mid 1990s, performed miserably.**

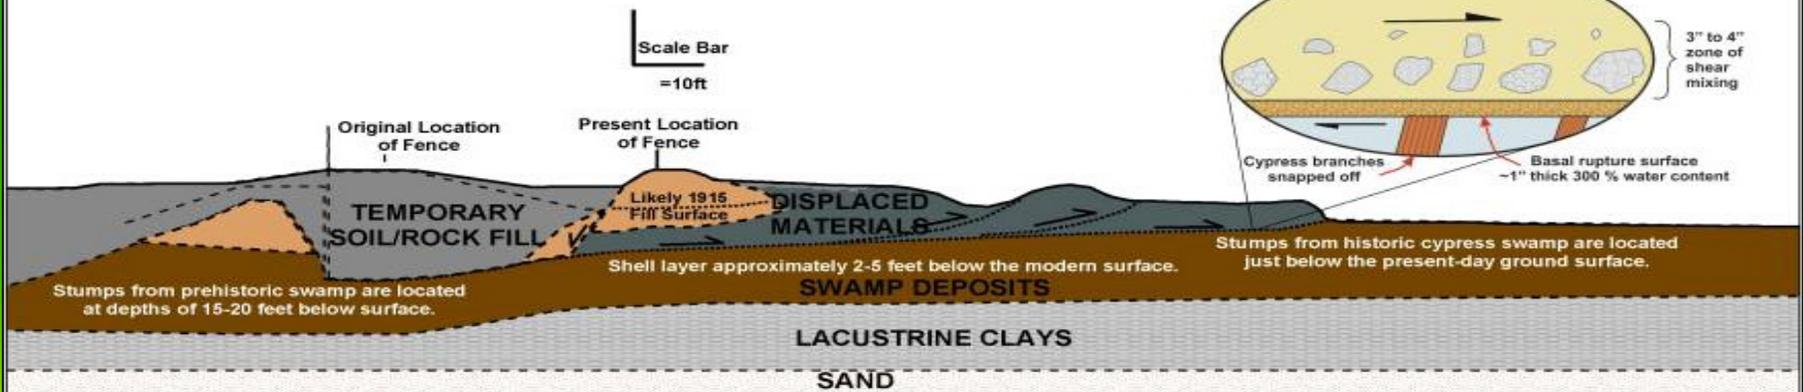
**17th St. Canal Levee Break Cross Section, South  
After Construction of USACOE Temporary Embankment Fille and Sheet Pile Wall  
-From Intact Levee Block To Yard With School Bus**

- **West-to-east geologic cross section through the 17<sup>th</sup> Street Canal failure approximately 60 feet north of Spencer Avenue. A detailed sketch of the basal rupture surface is shown above right.**
- **The slip surface was about one inch thick with a high moisture content (watery ooze). A zone of mixing 3 to 4 inches thick lay above this. Numerous pieces of cypress wood, up to 2 inches diameter, were sheared off along the basal rupture surface.**

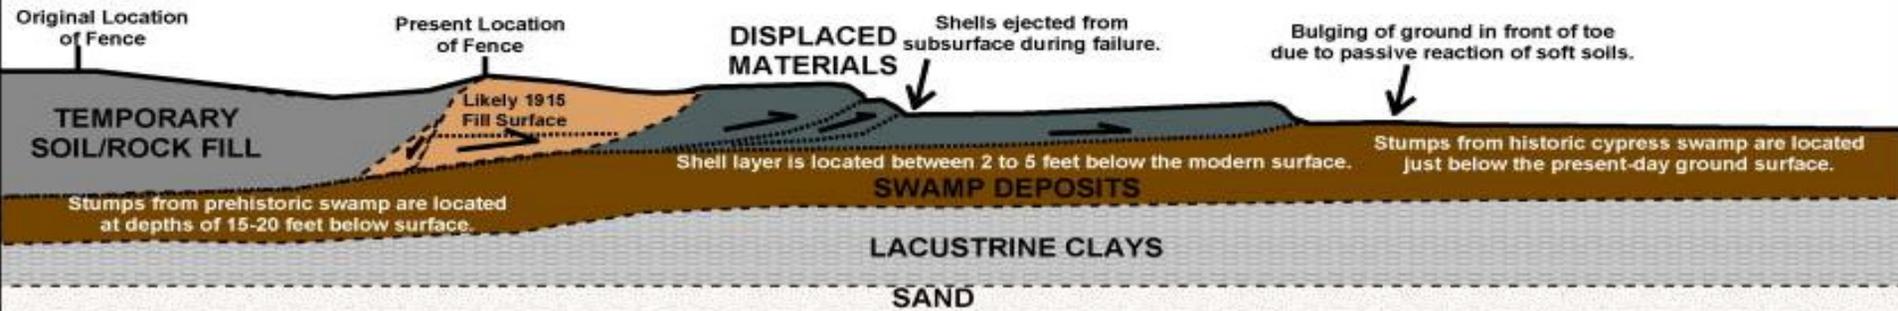
**17th St. Canal Levee Break Cross Section, North**  
**-From Intact Levee Block Between Two Houses Affected By Failure**

- **West-to-east geologic cross section through the 17<sup>th</sup> Street Canal failure approximately 140 feet north of the northern curb of Spencer Avenue.**
- **Large quantities of bivalve shells were extruded by high water pressure along the advancing toe thrusts. Note the slight back rotation of the distal thrust sheet.**

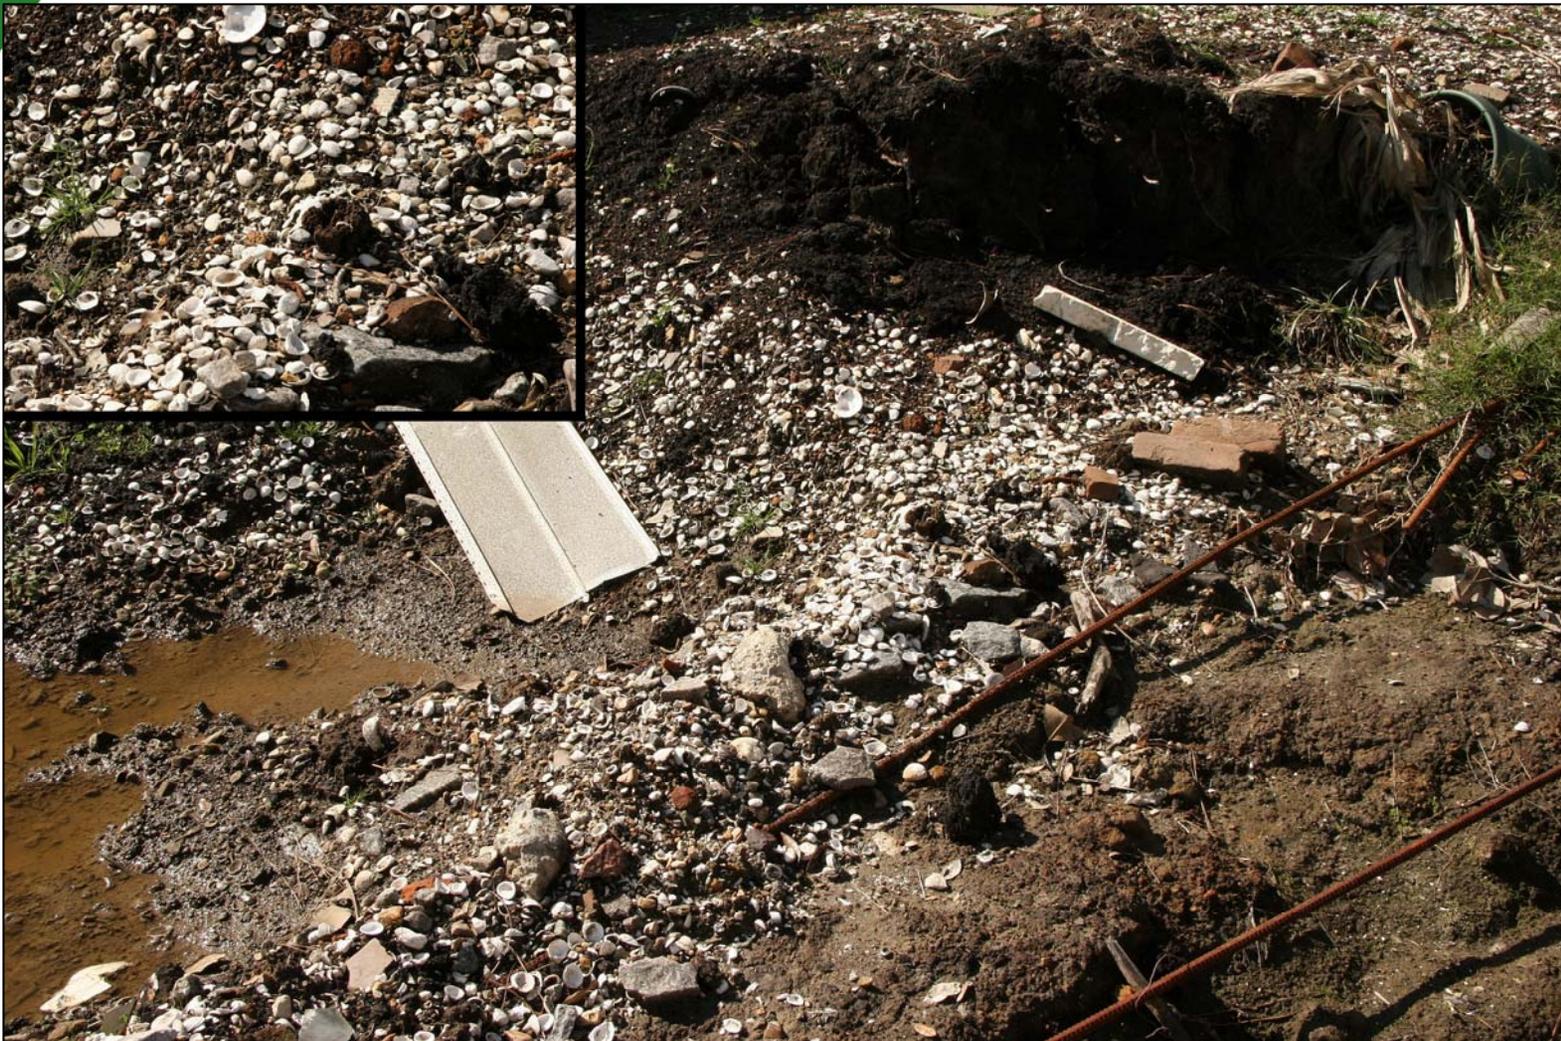
- **Bivalve shells ejected by high pore pressures emanating from toe thrusts on landside of failed levee at the 17 Street Canal (detail view at upper left). These came from a distinctive horizon at a depth of 2 to 5 feet below the pre-failure grade.**

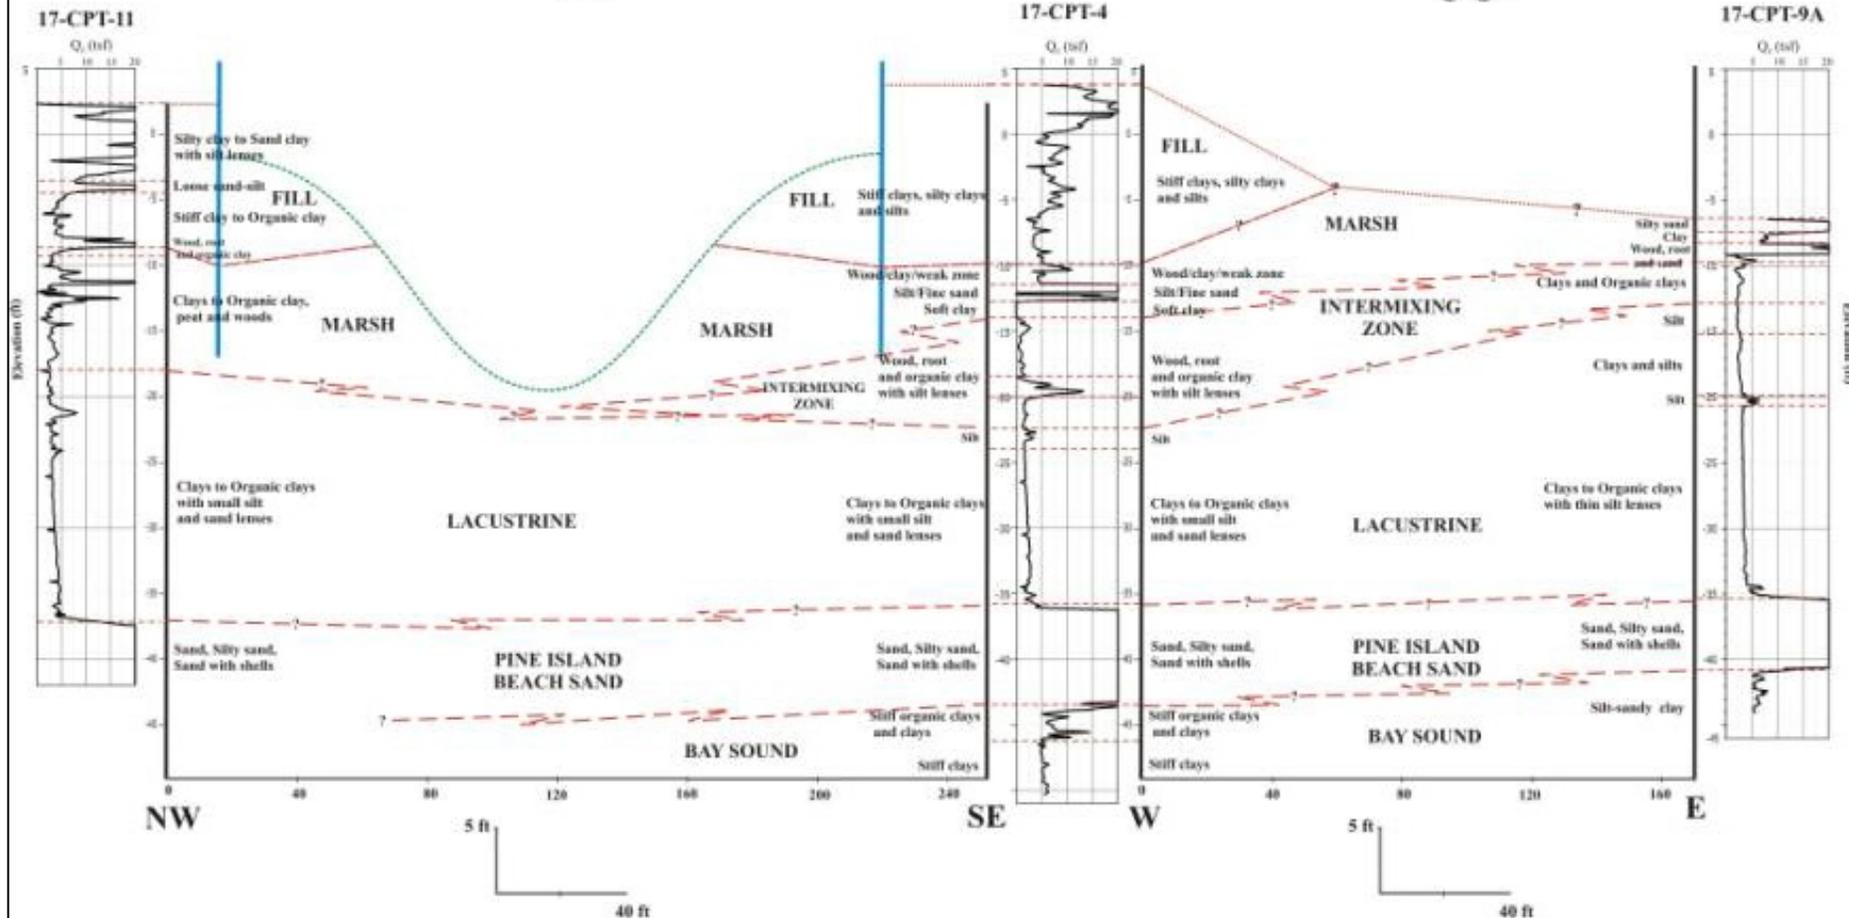
- **Stratigraphic interpretations across the 17<sup>th</sup> Street Canal breach.** The swamp much appeared to be thinning northerly, as does the underlying **Pine Island Beach Trend**. The lacustrine clays appear to thicken southward, as shown.
- The approximate positions of the flood walls (light blue) and canal bottom (dashed green) are based on information provided by the Corps of Engineers.

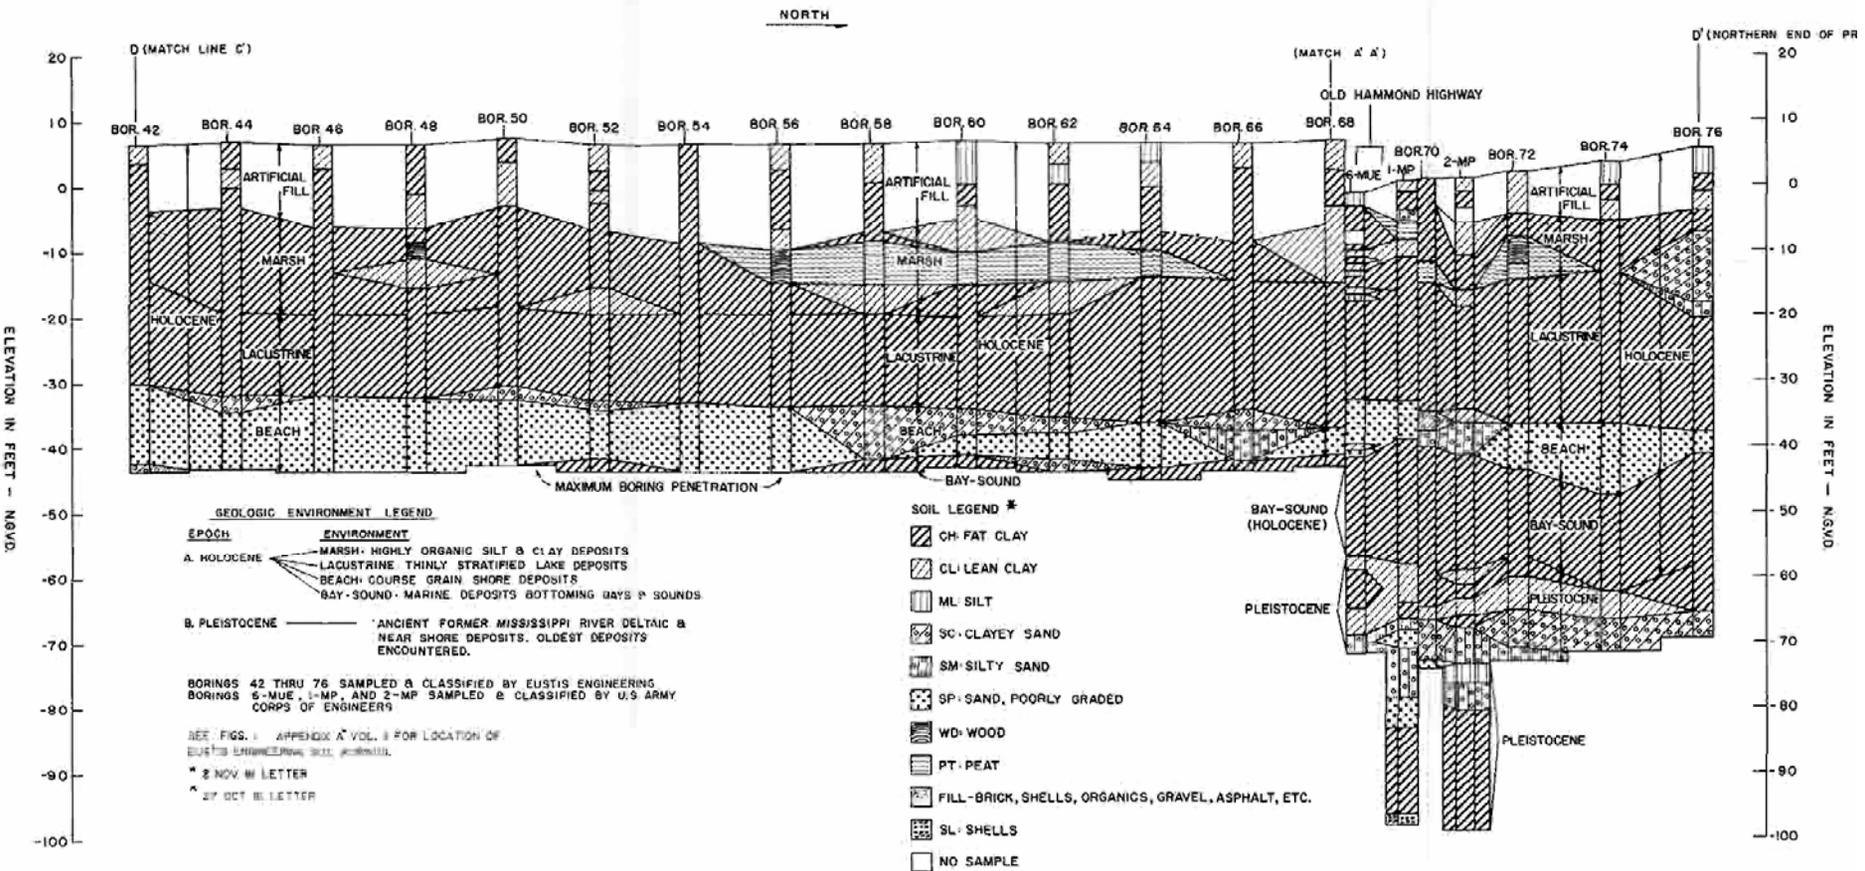
17<sup>TH</sup> STREET OUTFALL CANAL - EAST LEVEE (NORTHERN HALF)

Geologic profile for the 17<sup>th</sup> St Canal flood wall prepared by Corps' New Orleans District office in 1990. Three of four holes in vicinity of the 2005 failure (spaced 500 ft apart) had zero sample recovery. These contacts were projected and sheet pile tips designed, accordingly.

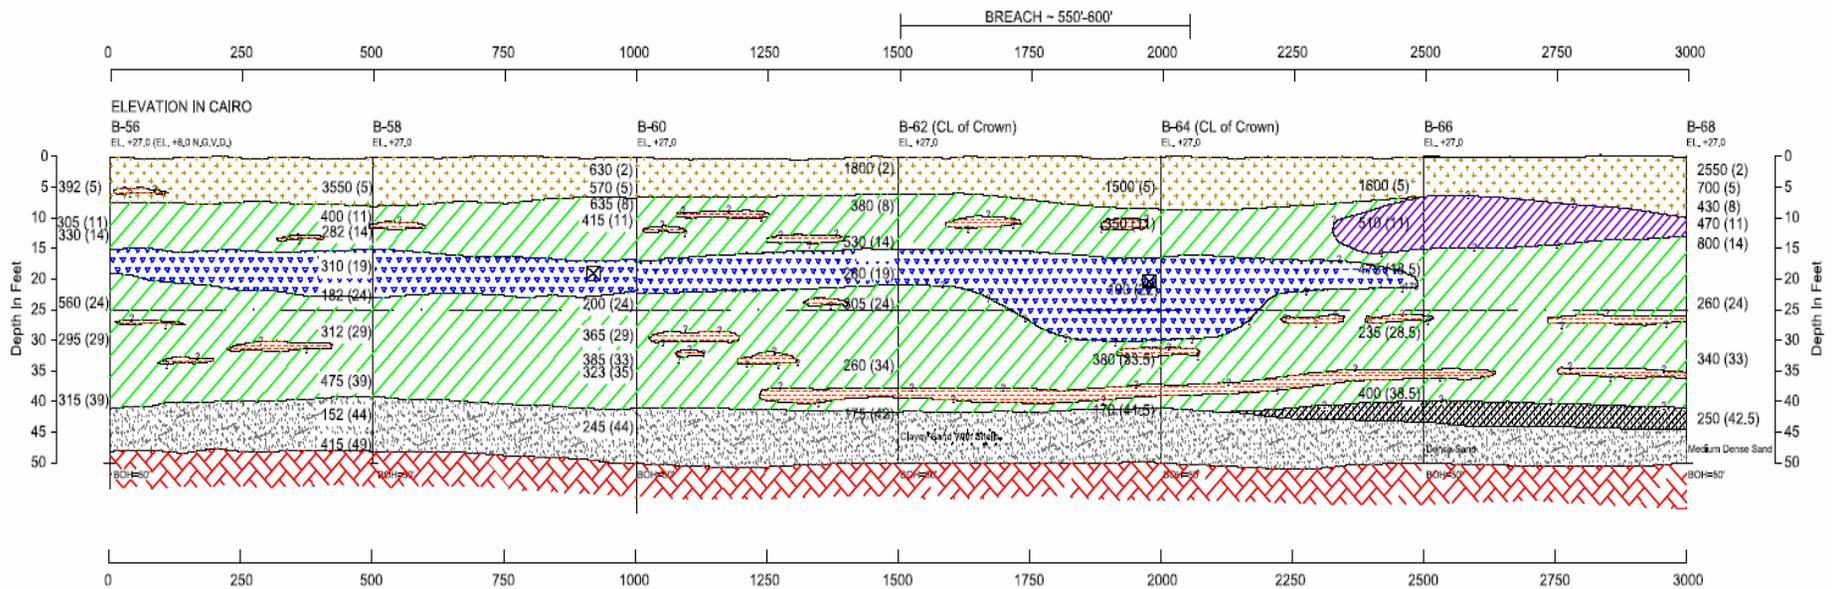
17th Street Canal East Levee- Draft Soil Profile  
New Orleans, Louisiana

- Alternative interpretation of the Eustis 1982 borings for the 17<sup>th</sup> Street Canal East Levee, near the 2005 break. In this case the swamp deposits would extend beneath the sheetpile tips over a zone 300 feet long, where the break occurred.

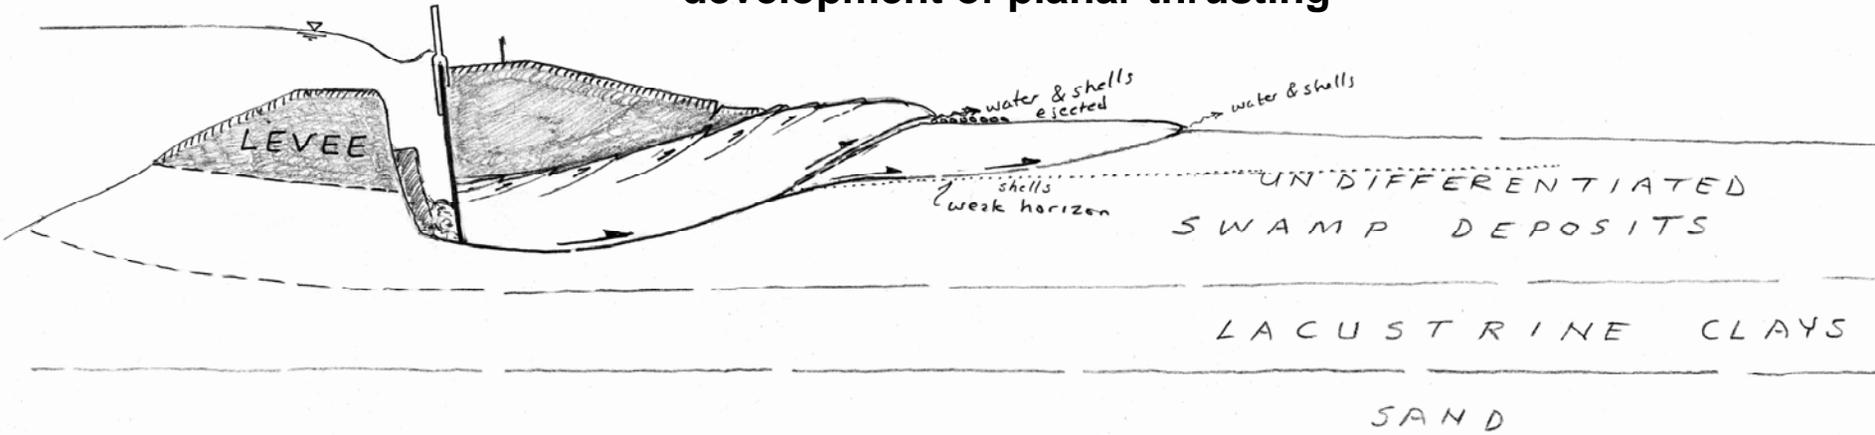
Passive reaction wedge coincided with stratigraphic horizon depressed by weight of the levee embankment on the compressible cypress marsh deposits

Traction shears noted along base of embankment. Note initial back rotation component of motion and development of planar thrusting

Initial loading conditions. Storm surge rises to within 4 feet of flood wall crest. Hydrostatic pressures on sheetpile supported I-wall highlighted in blue. Translational failure begins.

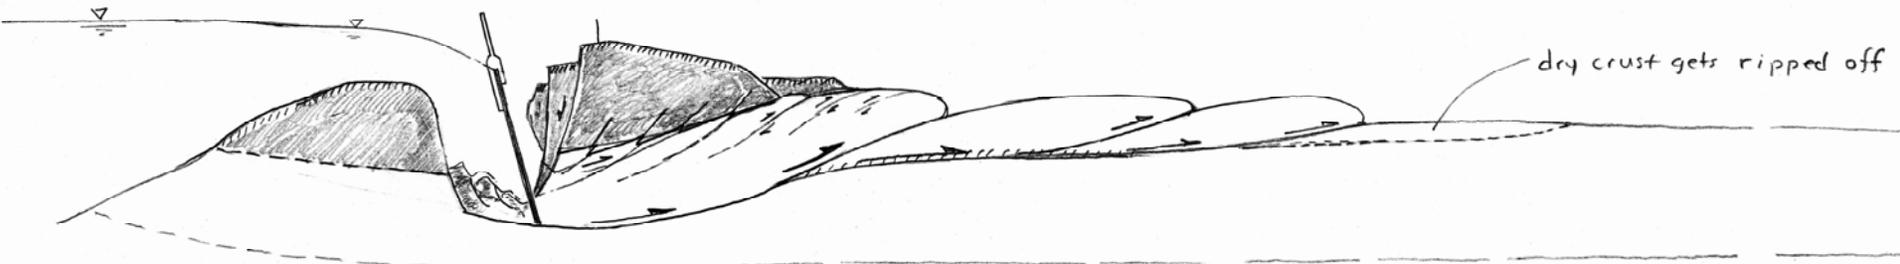
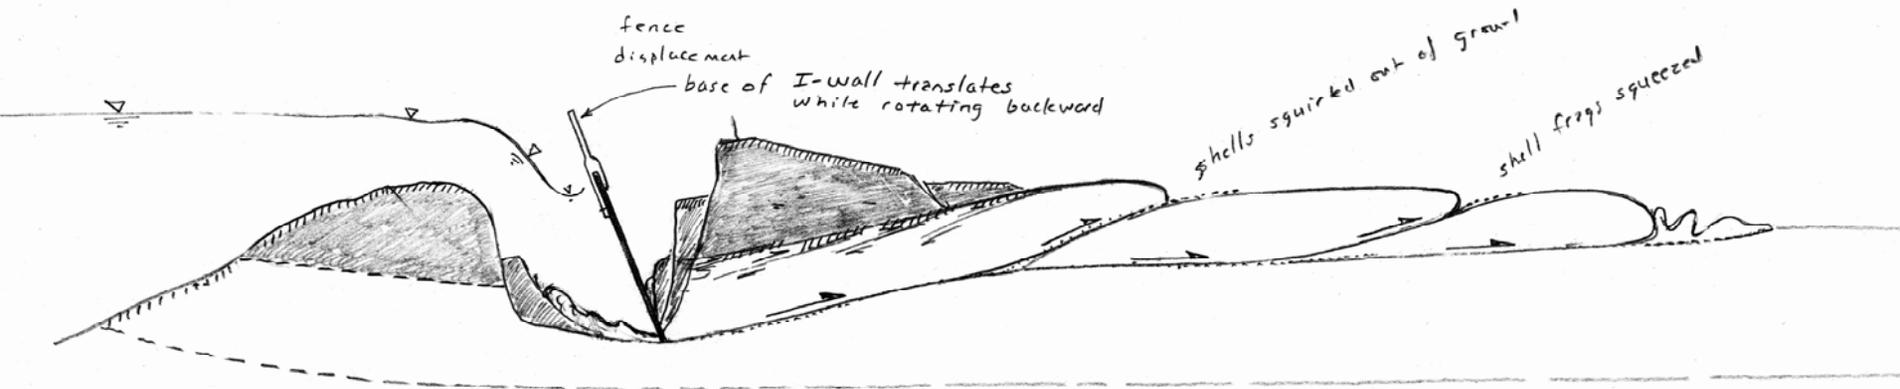
**Progression of translational failure sequence. Multiple thrust sheets develop in partially saturated crust, comprised of sandy fill over organic cypress swamp deposits. Buckles like a rug being rolled up.**

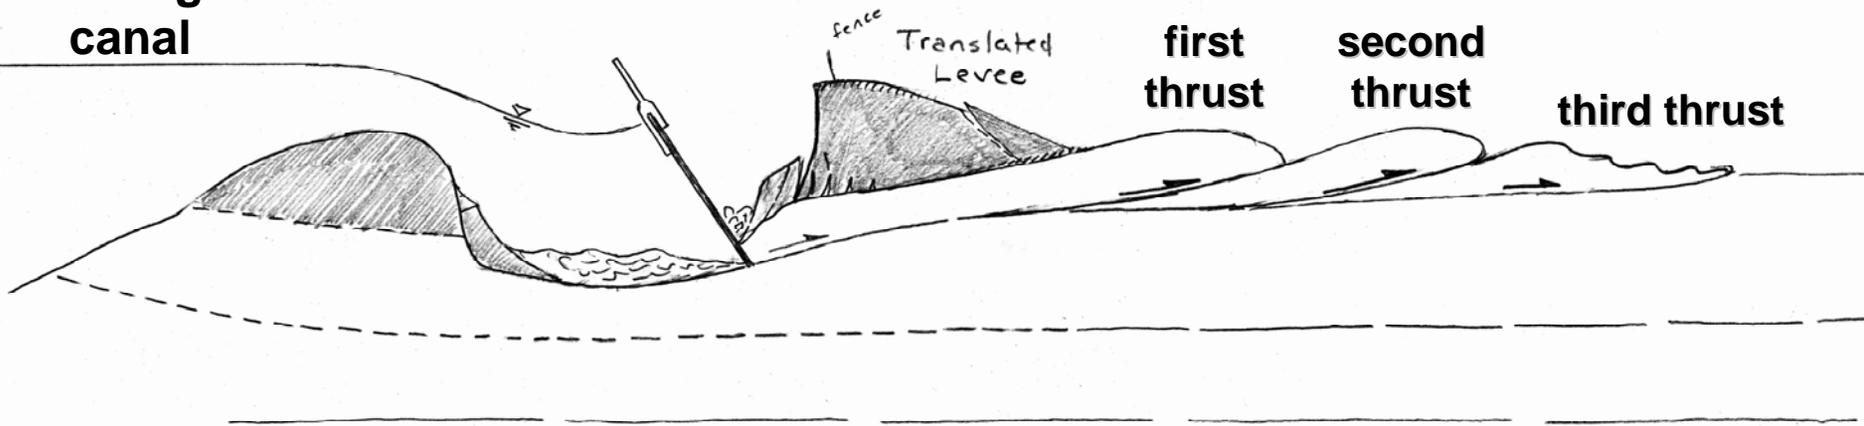
**Some sheetpile supported I-walls fell backward; others fell forward**
